AN H.V.D.C. INSTABILITY AT  
A.C. SYSTEM FREQUENCY

A REPORT PRESENTED TO  
THE DEPARTMENT OF ELECTRICAL ENGINEERING  
UNIVERSITY OF MANITOBA

by  
D. T. Y. TANG

The h.v.d.c. link of Manitoba Nelson River project had experienced this form of instability. The following report describes and examines this phenomenon, based on the experience of Manitoba Nelson River Project; and attempts to relate this phenomenon with those reported in the papers (1, 2, 3).

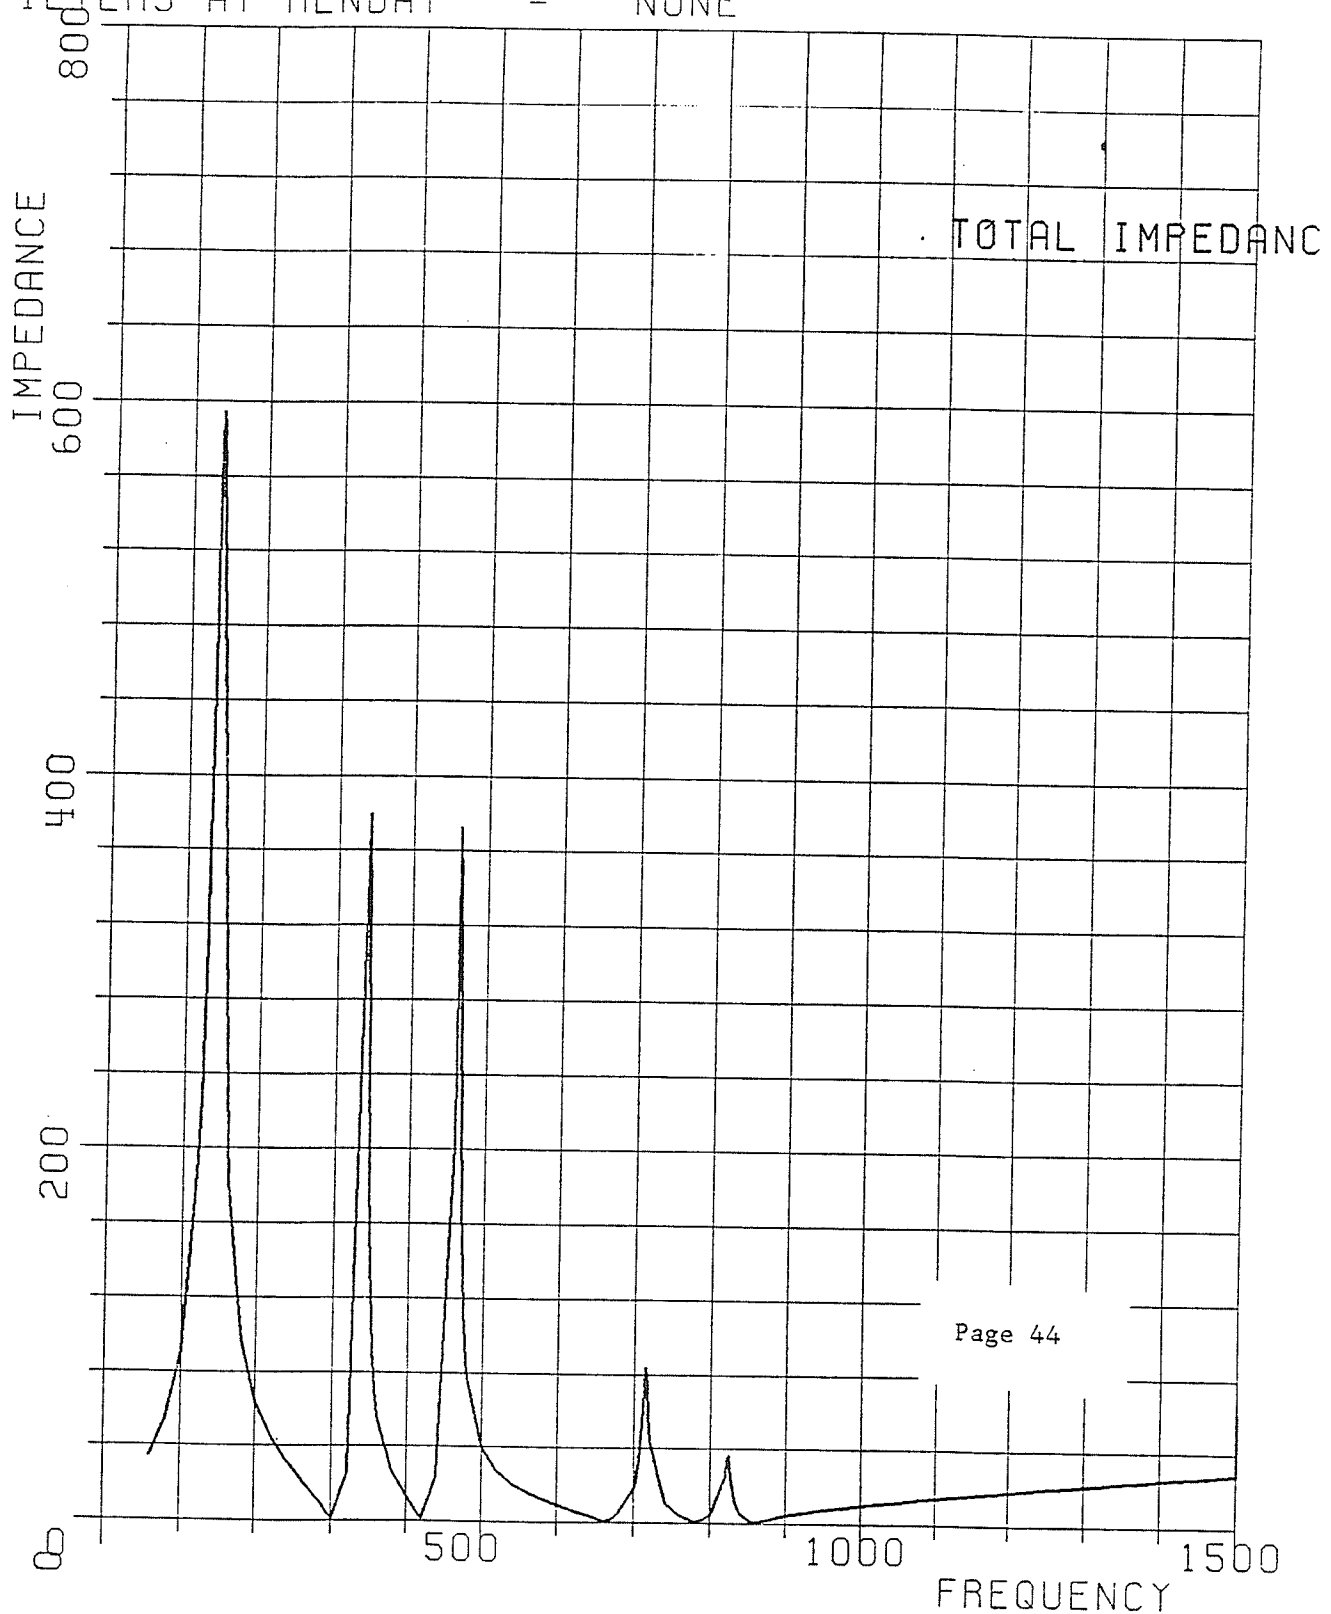
Fig.11 System impedance profile for July 30,80 disturbance after LS unit tripped

IMPEDANCE AT RADISSON STATION:  
2 -KETTLE UNITS, 0 -LONG SPRUCE UNITS  
2 -RADISSON - LONG SPRUCE LINES,  
3 -LONG SPRUCE - HENDAY LINES  
FILTERS AT RADISSON - 5 7 11 13  
FILTERS AT HENDAY - NONE

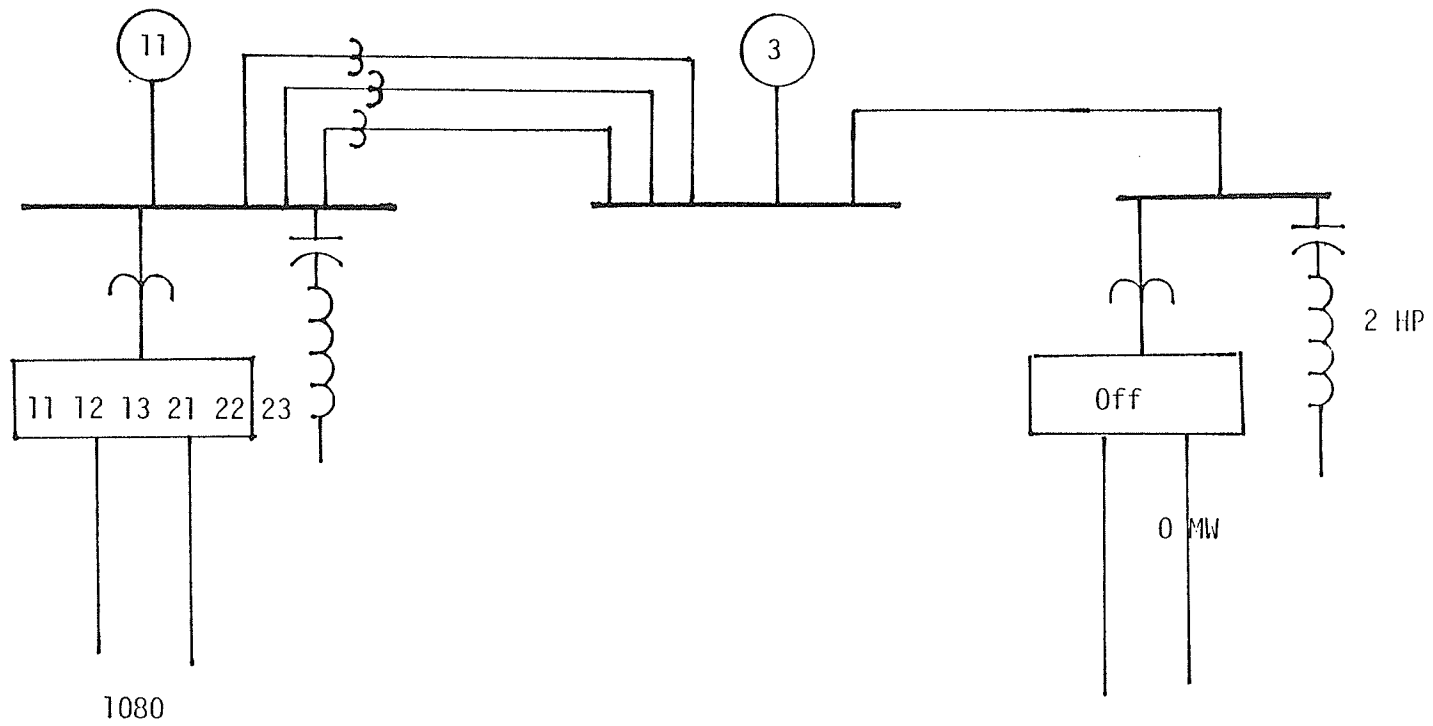
Fig.12 System Configuration for October 27, 1978 at 23:34

Prior to the energization, both the d.c. and the a.c. voltages were normal, and there was no sign of instability. The system configuration is shown in Fig. 12. When the transformer was energized at Henday, considerable 60 Hz oscillation appeared on BPI d.c. voltage, and started to decay (transient fault recording is attached in Appendix G). All these were normal occurrences for transformer energizations. After the oscillations decayed for approximately 60 cycles they started to increase, which indicated that 60 Hz instability had begun to set in. Core saturation instability started at this point instead of at the beginning of the oscillation.

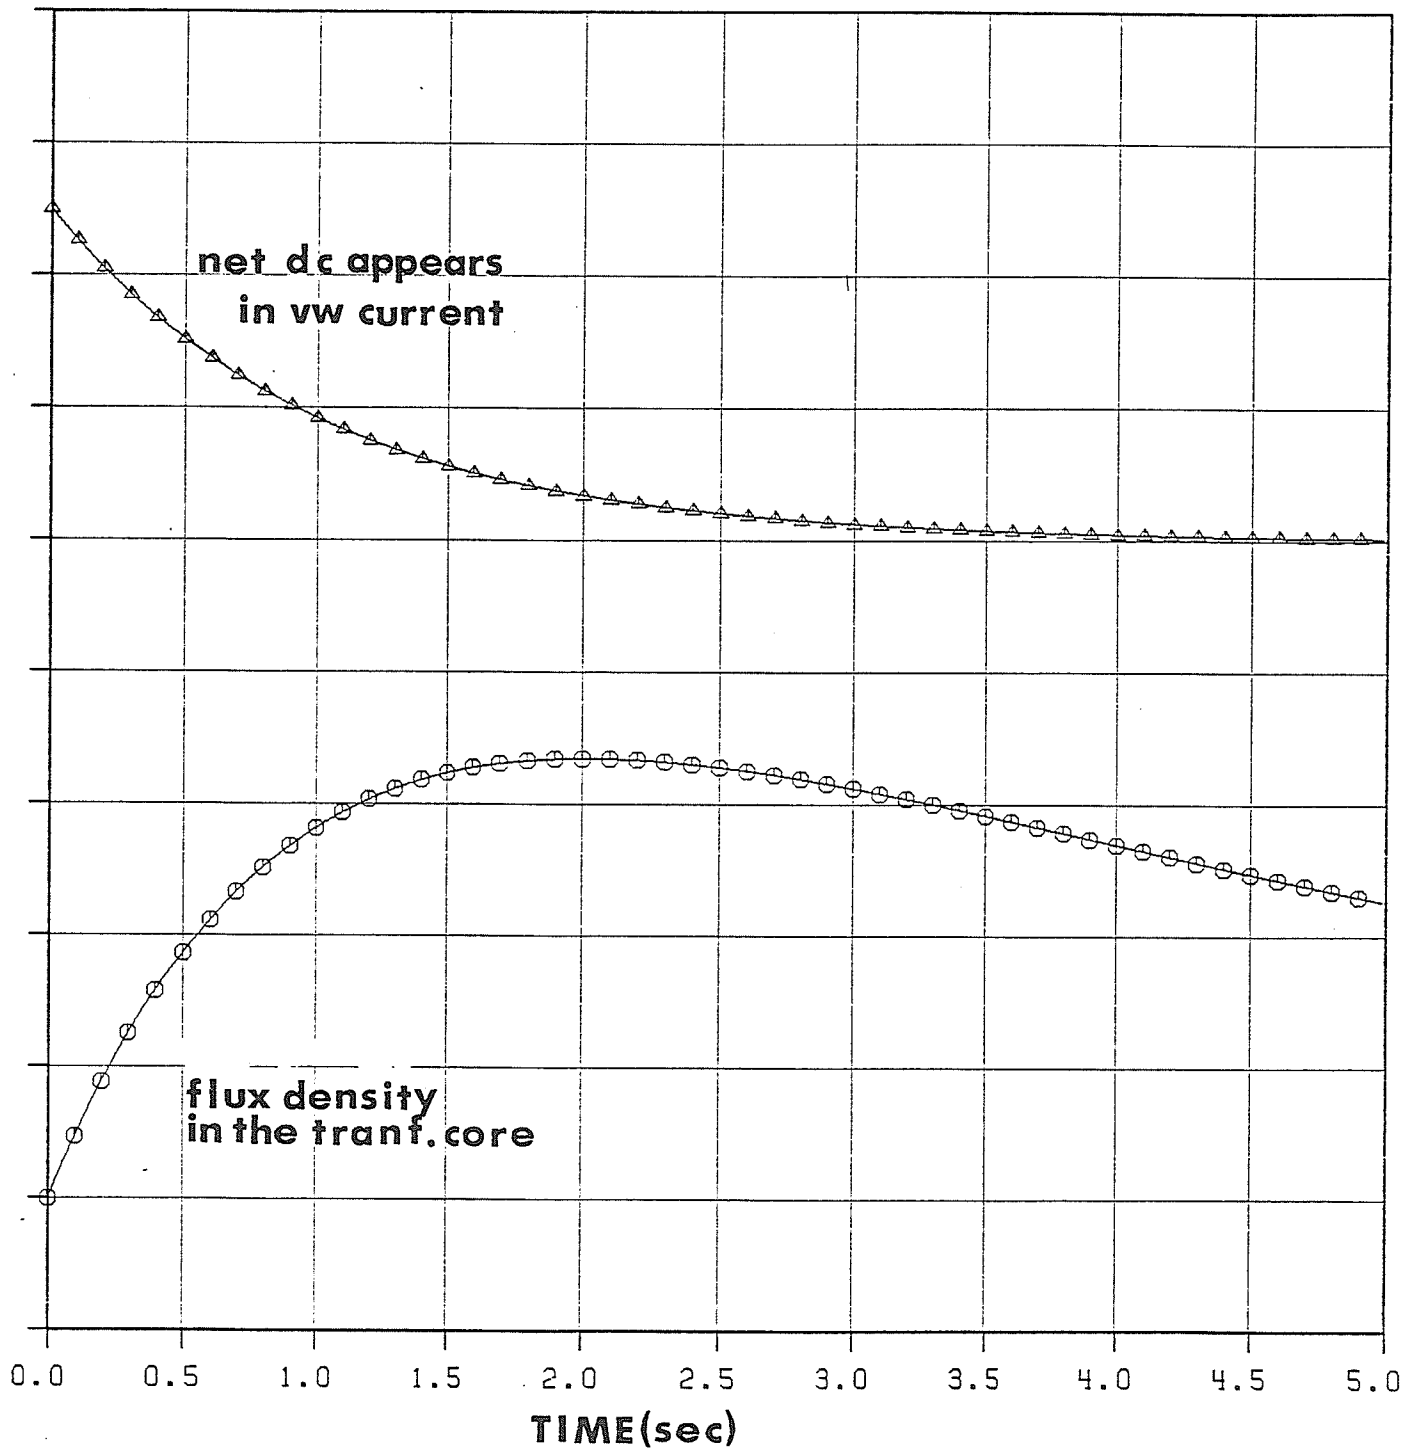
Fig. 13 The net d.c. component in the valve winding current and the flux in the converter transformer during a transformer energization

The moment the 60 Hz oscillation appeared on the d.c. side, a d.c. component, which was proportional to the amplitude of the 60 Hz oscillation, appeared in the valve winding current. The manner in which the amplitude of the 60 Hz oscillation decays for a normal transformer energization, shows a profile similar to an expression  $A \exp(-t/T_1)$

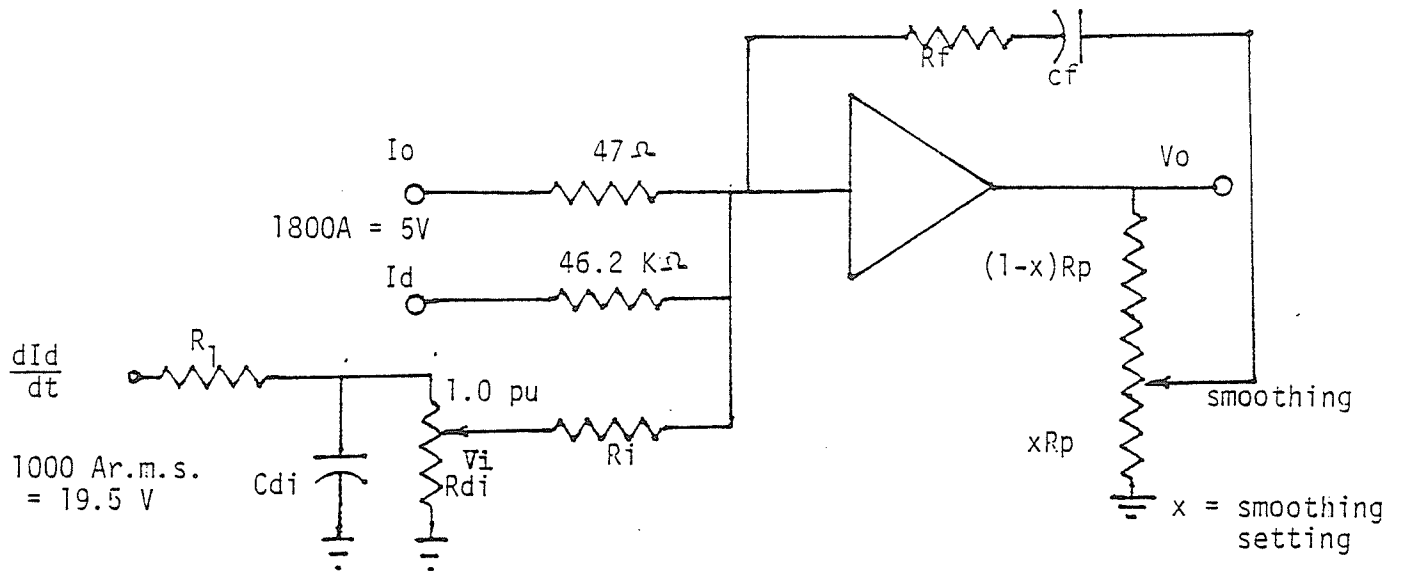
Fig. 15 BPI Current Regulator Before Modification

The effect of  $di/dt$  setting on control instability was more straightforward. Higher  $di/dt$  feedback meant higher loop gain, which could put the control system into an unstable region under certain operating conditions. Using the concept in Section 3.3, the situation can be readily seen. As  $di/dt$  increases,  $|G(s)|$ , the gain of the linear controller increases also. The circle of  $G(s)$  on the complex plane is enlarged. Therefore, more of the  $-1/N(E)$  locus is encircled by  $G(s)$  (it was said to be unstable if  $-1/N(E)$  was inside the circle of  $G(s)$ ) and thus the d.c. is unstable in more situations.

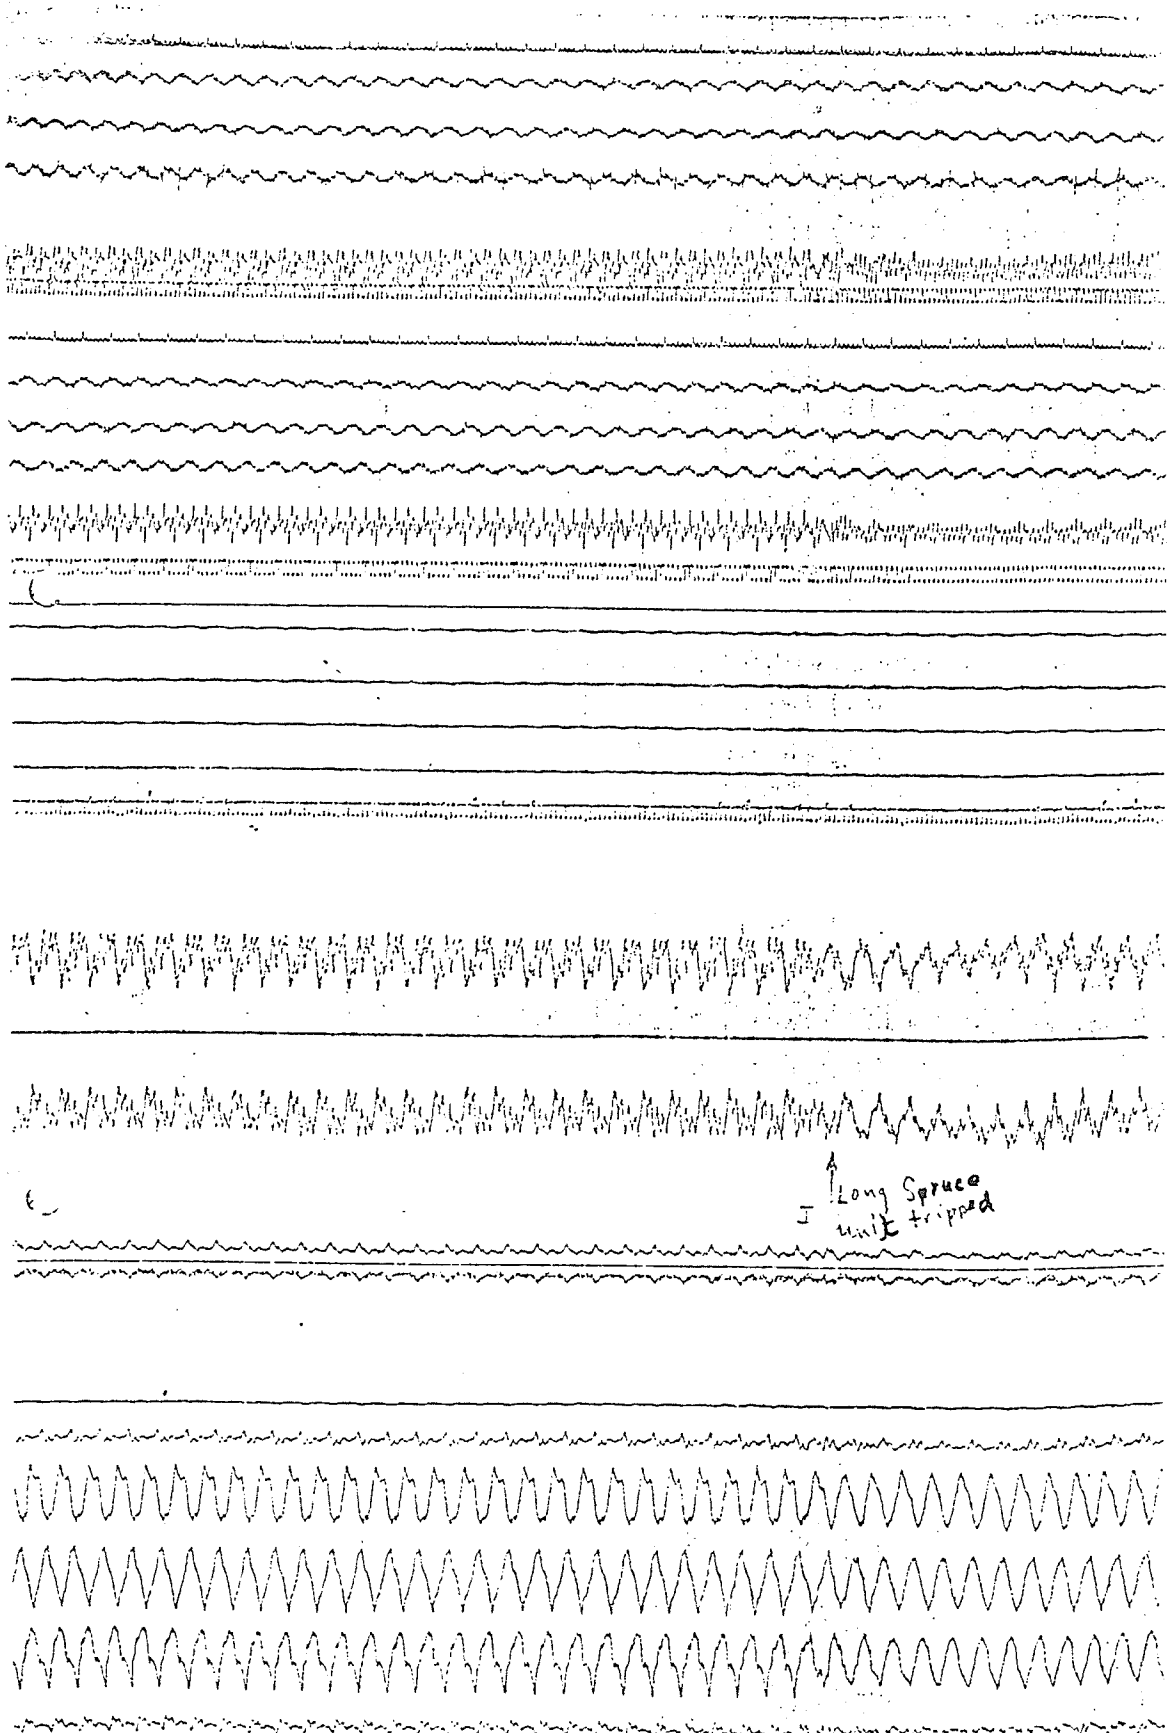
↑ Long Spruce  
unit tripped

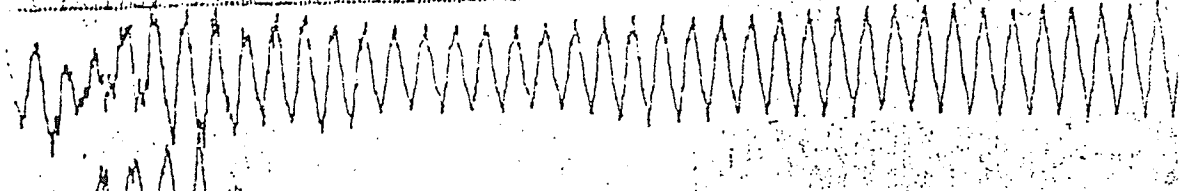
↑ pole 1 blocked by  
asymmetry protection

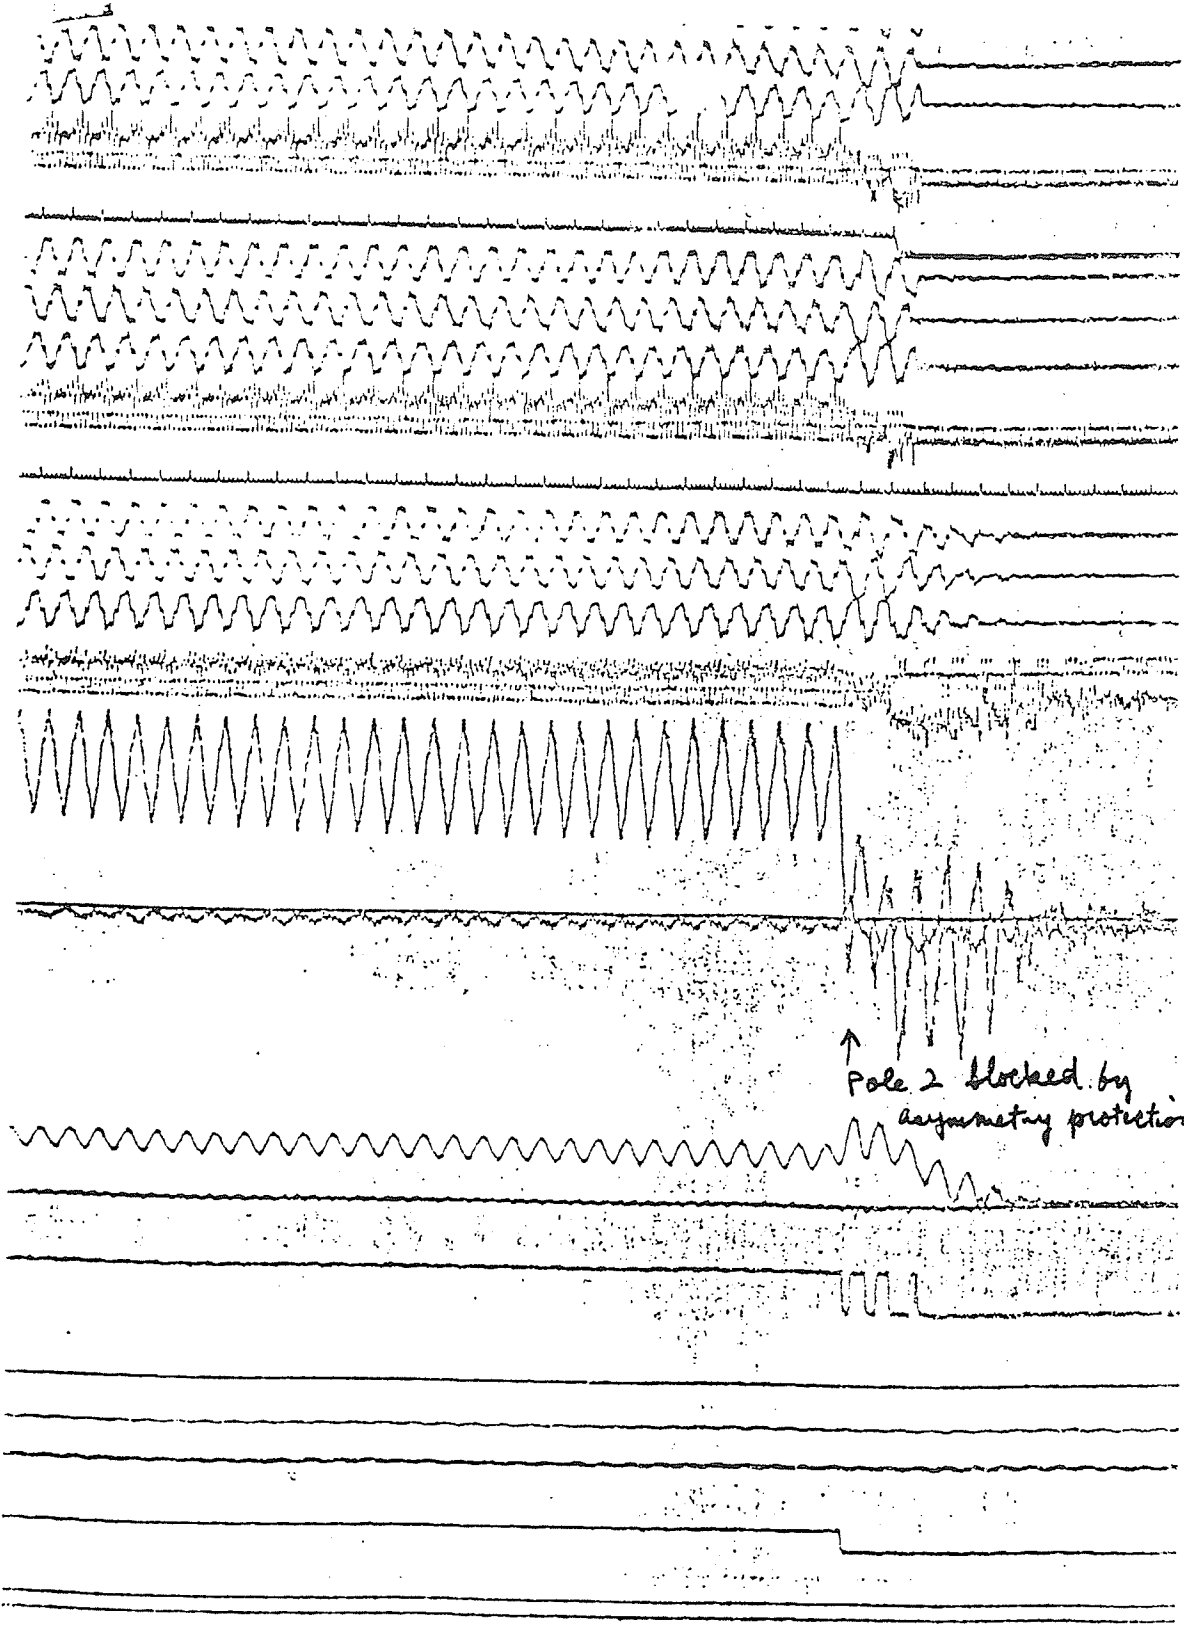
↑ Pole 2 blocked by asymmetry protection
