THE UNIVERSITY OF MANITOBA  
STABILIZATION OF A TYPICAL CLAY RIVERBANK  
IN THE WINNIPEG AREA

by  
Kenneth A. Buhr

A THESIS  
SUBMITTED TO THE FACULTY OF GRADUATE STUDIES  
IN PARTIAL FULFILLMENT OF THE REQUIREMENTS FOR THE  
DEGREE OF MASTER OF SCIENCE

OCTOBER 1973

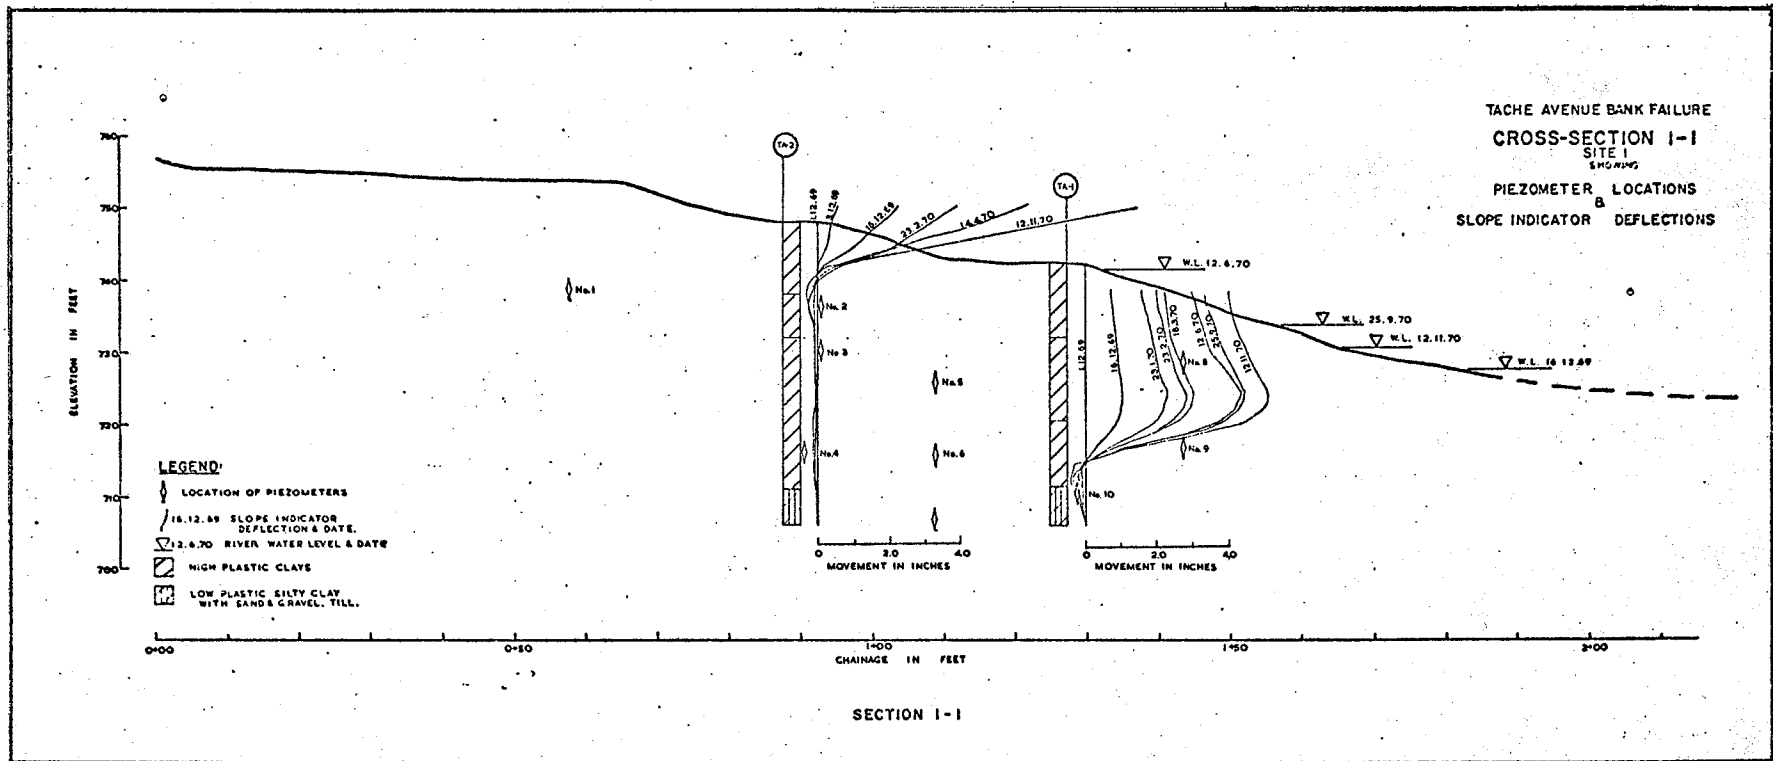
FIGURE 4.1

Periodic deflections versus depth were plotted on Figure 4.1 and 4.2 to indicate the possible failure plane. It is of interest to note that in slope indicator pipe TA-2 the depth of fill on the bank at this point corresponds to the depth at which movement took place. In TA-1 the move-

ment appears to take place over a 10 foot depth of soil which corresponds to the thickness of the high plastic clay layer at this point. The movement in both TA-1 and TA-2 was of such a degree that they failed approximately one year after installation. Slope indicator pipes, TA-4 and TA-5 showed only some minor movements as shown on Figure 4.2.

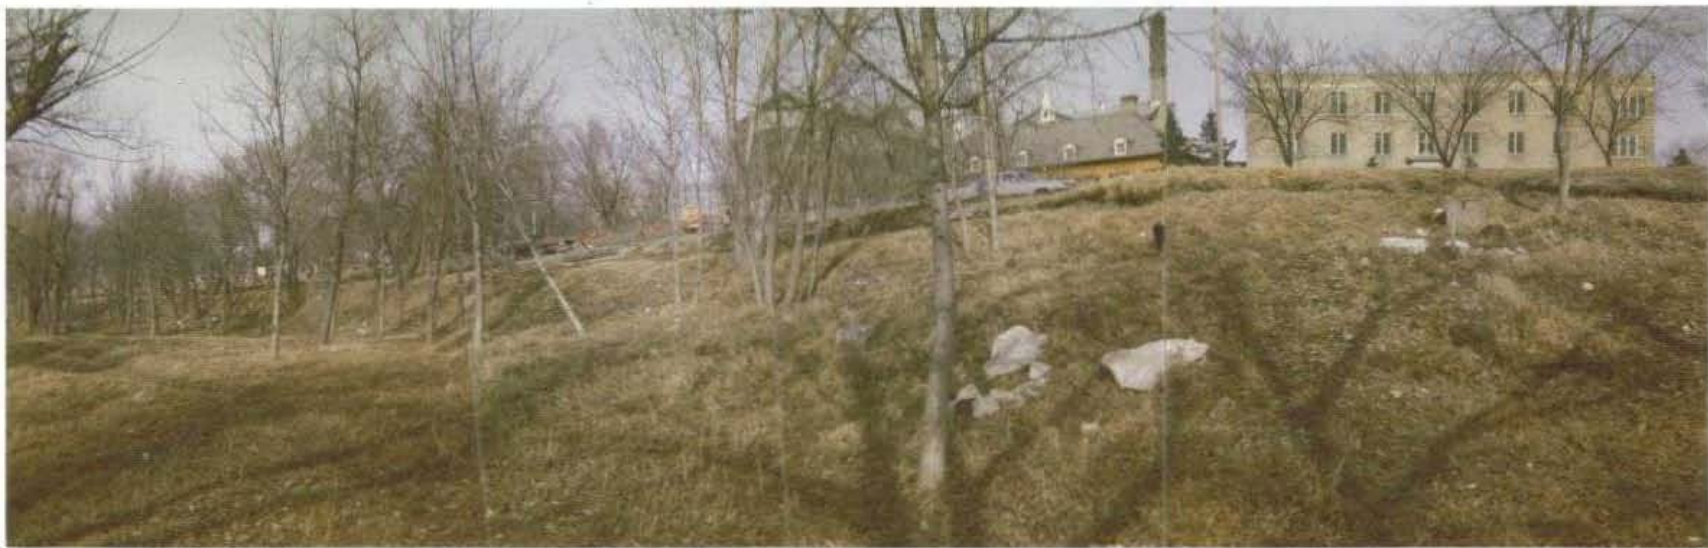
Most of the riverbanks in the Winnipeg area have a history of failure and of attempts, some successful, some not, to prevent further movement. The Tache Avenue site, illustrated by Photograph P1, may be considered typical of many such sites.

There is considerable evidence of past instability of the bank as is indicated in Photograph, Pl. The photograph shows that in 1971 the failure extended from the pumping station at Rue Despins to almost the Provencher Avenue bridge, a distance of about 1500 feet along the top of the bank. A much older, well-grassed-in failure scarp may be noted in the photograph. Evidence of movement was also obvious from cracks in the pavement.

Pl. Tache Avenue riverbank, August 1971.

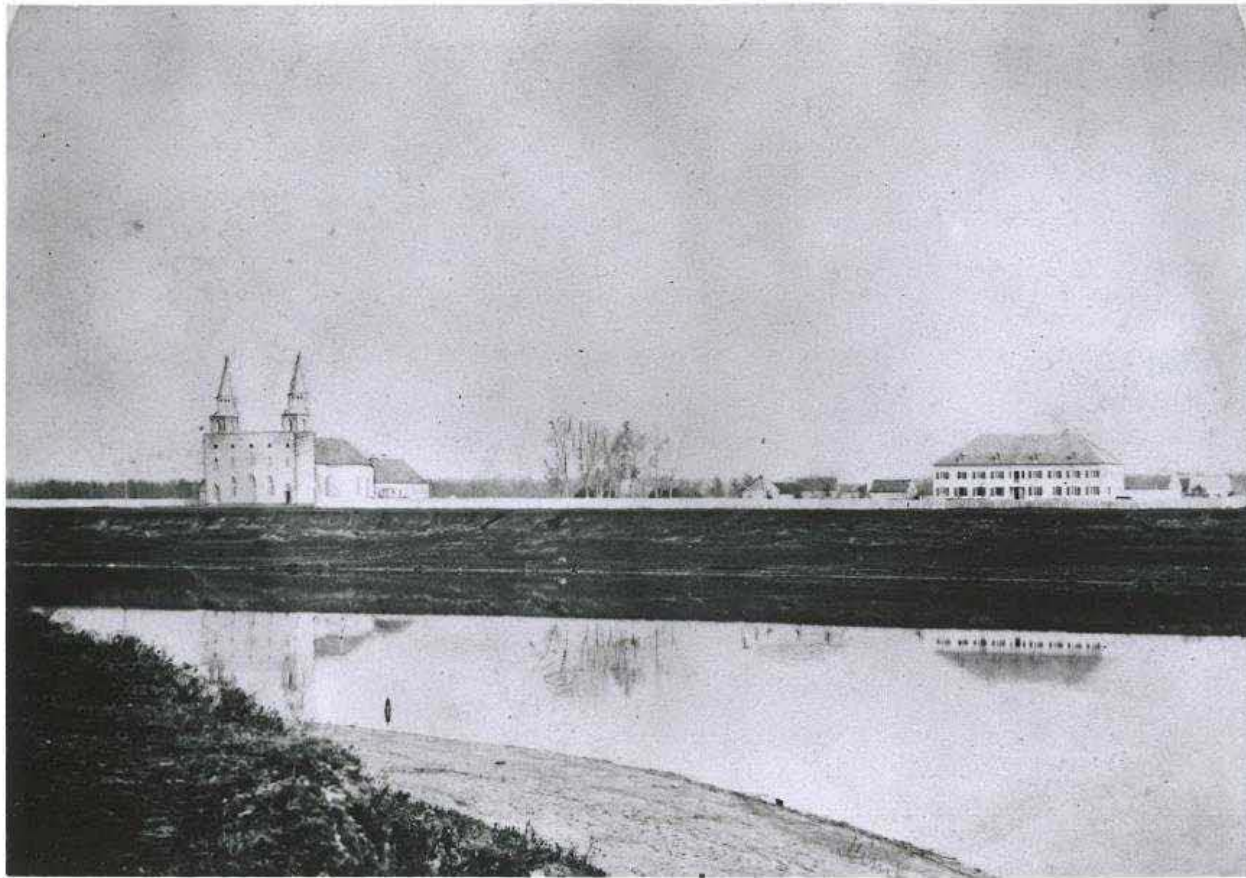
Little recorded information was found regarding the site prior to 1950. A photograph (P2) of the riverbank taken in 1858 shows a steep, ungrassed bank without any trees. The ungrassed bank appears typical of banks having undergone recent movement.

P2. Tache Avenue riverbank site, 1858. Note what appears to be a fresh failure scarp. Courtesy Manitoba Provincial Archives.

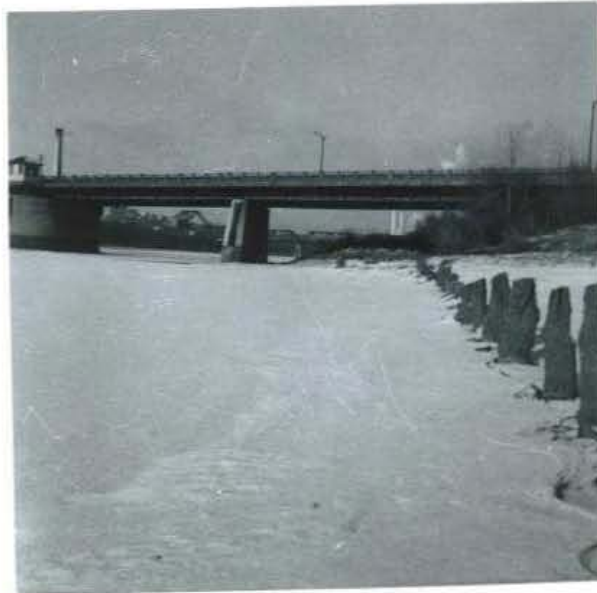
There is evidence of more recent movements and the remedial measures employed in an attempt to stop it. A photograph (P3.1) of the bank taken in December of 1959 shows a row of vertical timber piles at the water's edge. The deterioration of the piles would indicate that they had been placed some time prior to the time of the photograph. A photograph (P3.2) taken of the site in 1971 indicates the apparent ineffectiveness of the piles to prevent further movement.

P3.1 Timber pile retard at toe of slope.  
Tache Avenue riverbank, 1959.

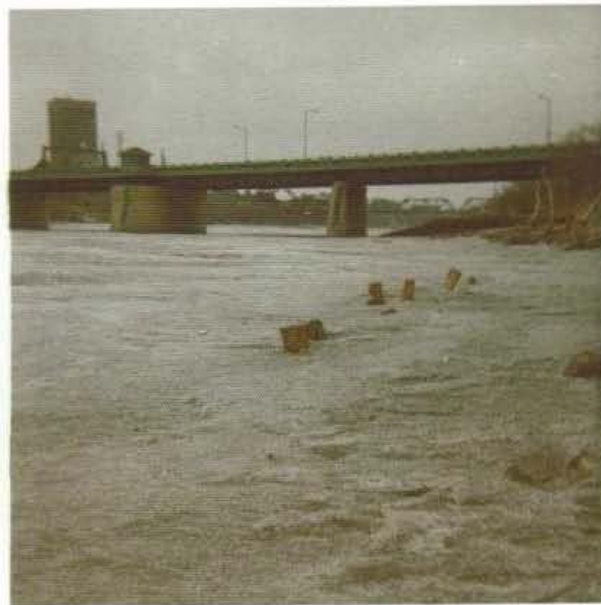
P3.2 Timber pile retard in P3.1 displaced  
by bank movement, Tache Avenue, 1971.

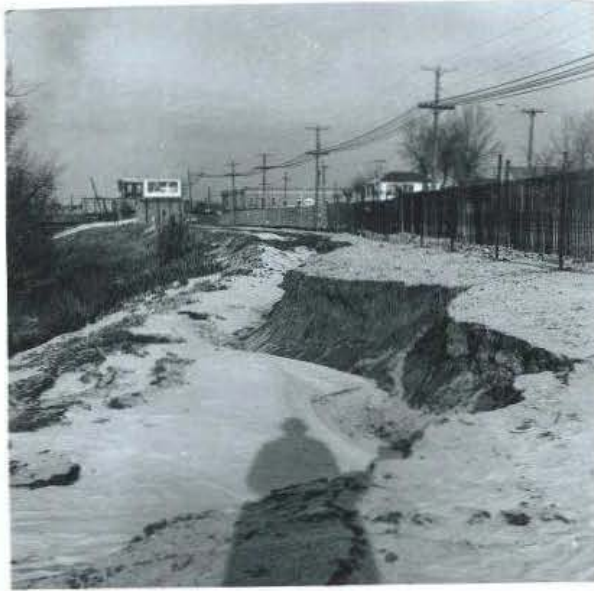
P4.1 New failure scarp, Tache Avenue site, 1959.

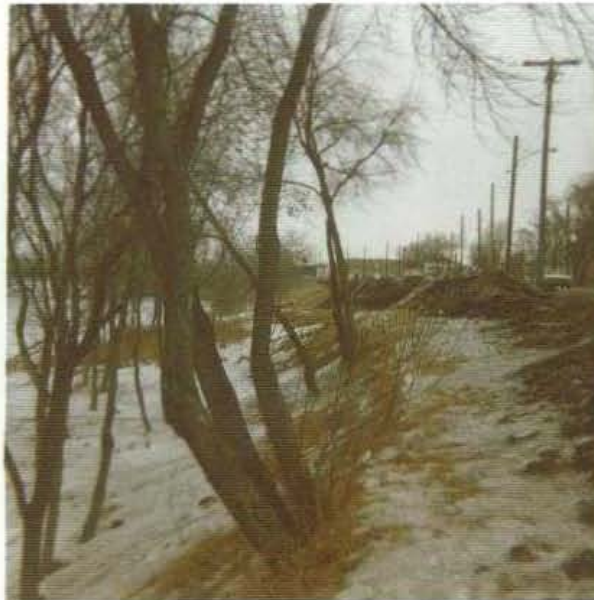
P4.2 Failure scarp of P4.1 with grass cover and small trees, Tache Avenue, 1971.

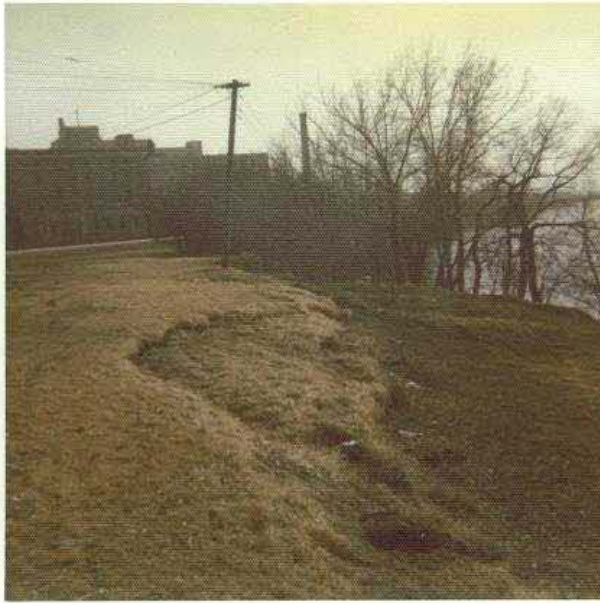
Pins 5 averaged a rise in elevation of 0.3 feet with an average lateral movement of 1.8 feet and a maximum of 2.8 feet. This would confirm that the failure is moving out at the toe of the slope as shown in Photograph P5.

such as cracks at the top of the slope (Photograph P5) and overthrusts at the toe (Photograph P6). A counterbalance of the desired shape (within right-of-way and causing the least interference with existing structures, roads and waterways) is superimposed on the failure and the new safety factor determined.

P5. Example of an older failure with fresh cracks and slumps appearing, Tache Avenue, 1971.

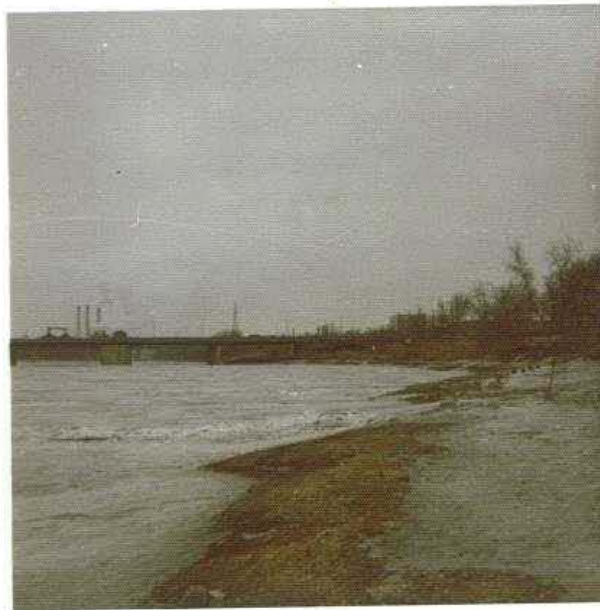
P6. Example of an overthrust of soil at the toe of the failure, Tache Avenue, 1971.

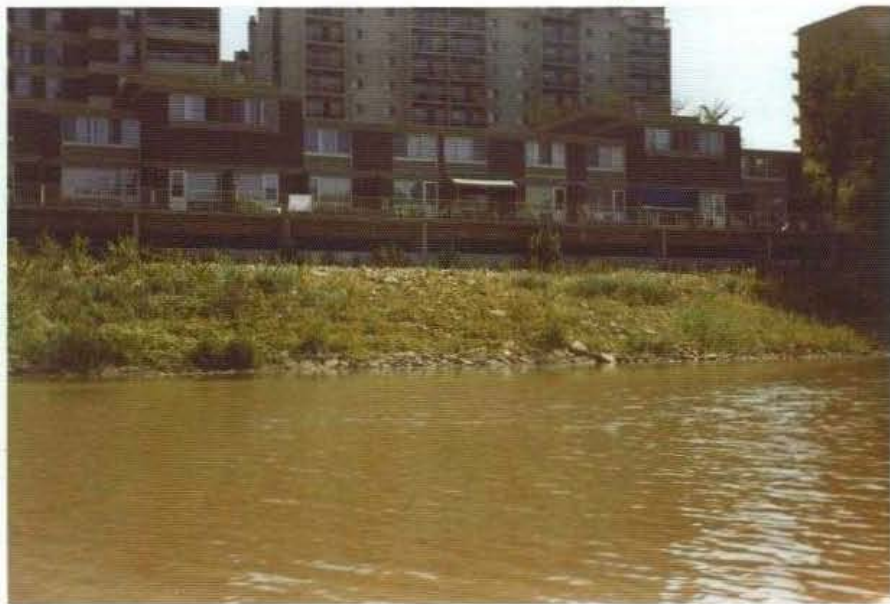
P9. Riprap protection of slope to above flood stage. Note failure of bank through riprap at right, Assiniboine River, 1972.

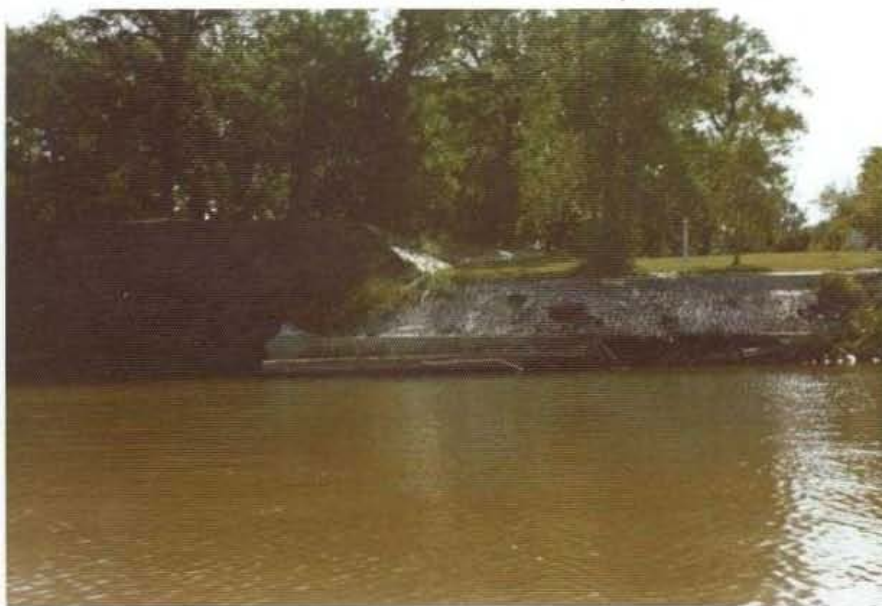
P12 Rigid revetment for slope protection. Note failure of revetment on the right. Red River, 1972.

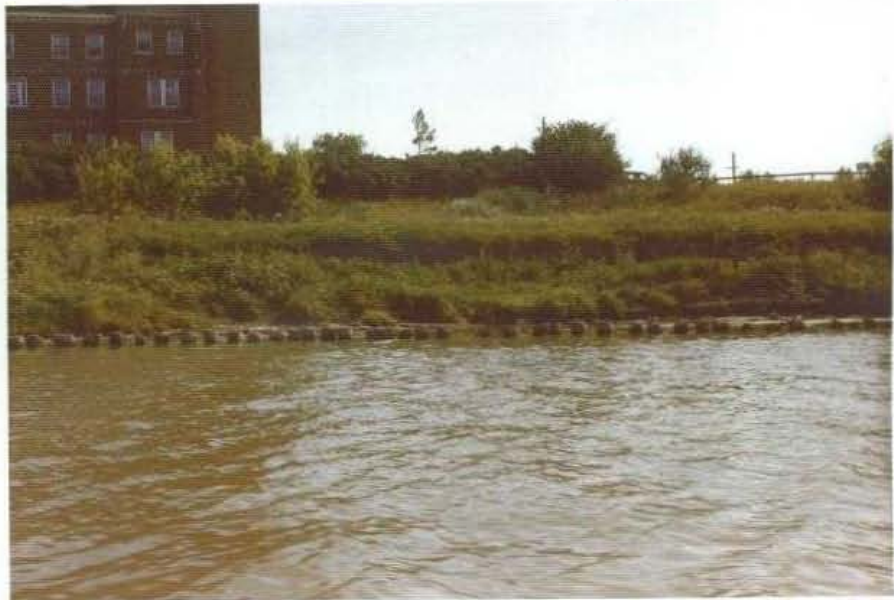
P15. Timber pile retard, single pile spacing.  
Note condition of bank behind retard.  
Red River, 1972.

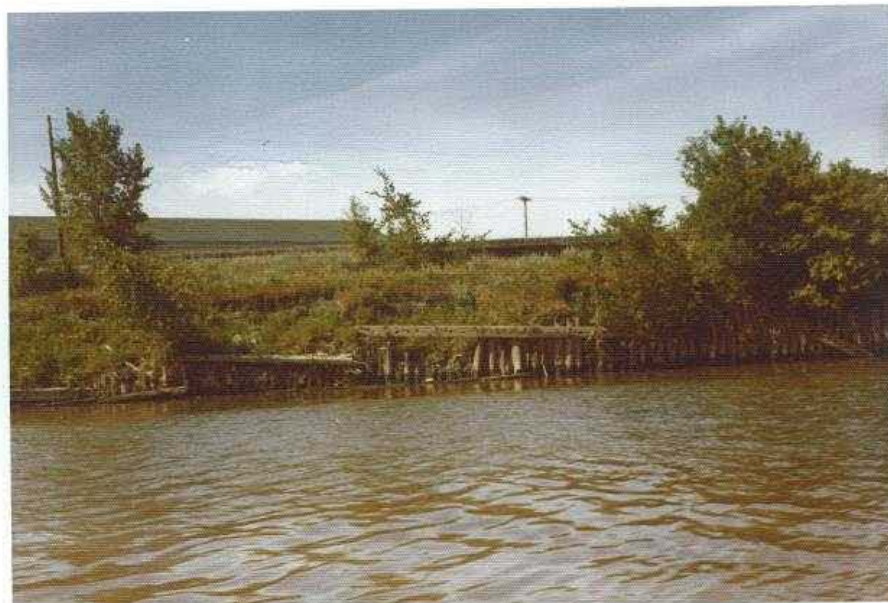
P17. Timber pile retard, piles closely spaced. Note condition of piles above summer water level and failure of bank behind damaged portion of retard. Red River, 1972.

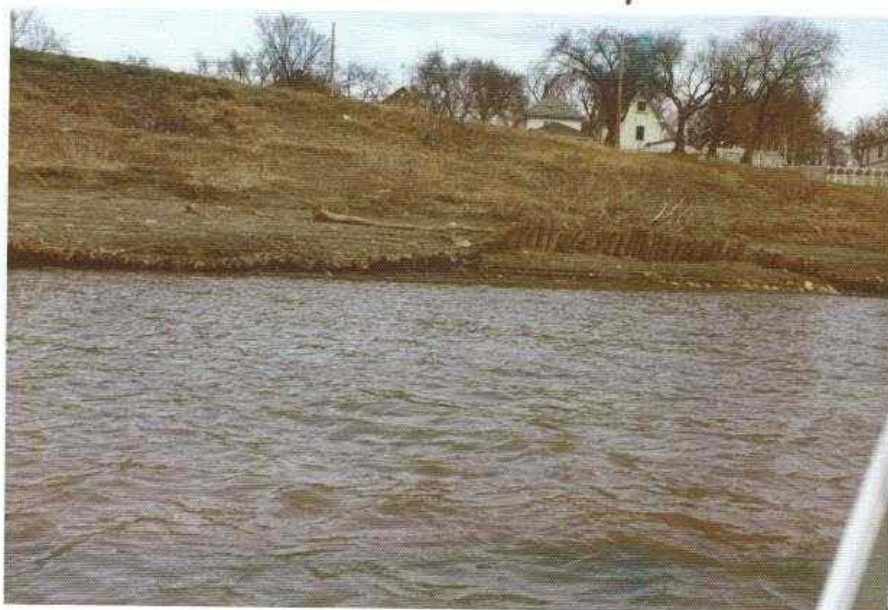
P18. Timber pile retard, closely spaced piles. Note overturning of piles due to bank failure. Red River, 1972.

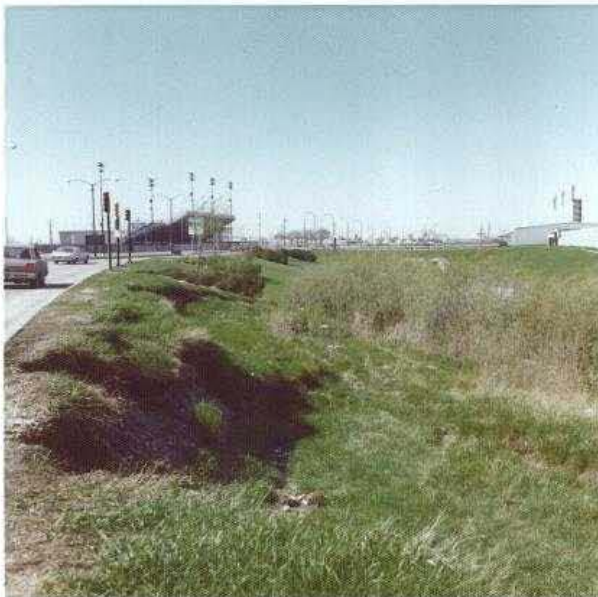
P22.1 Bank failure in backfilled portion of an old channel. Cmands Creek, 1970.
