AN INVESTIGATION INTO RIVER BANK IMPROVEMENT
IN THE WINNIPEG AREA

A Thesis
Presented to
The Faculty of Engineering
University of Manitoba

by
Edwin H. Klassen
March 1963

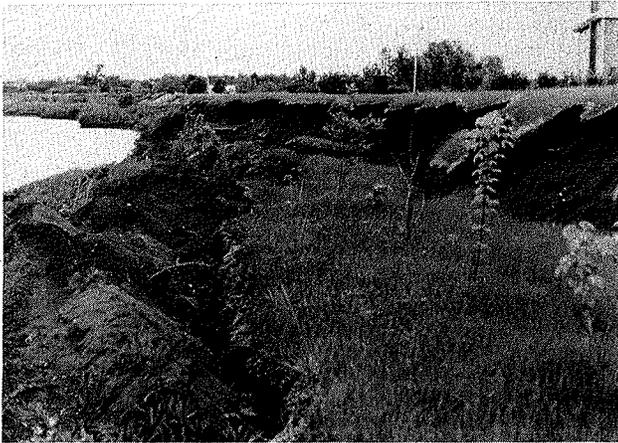
PHOTOGRAPH 1 - Recent Slide
Concave Edge, East Bank
Height 33 ft. Average Slope 6.8 : 1

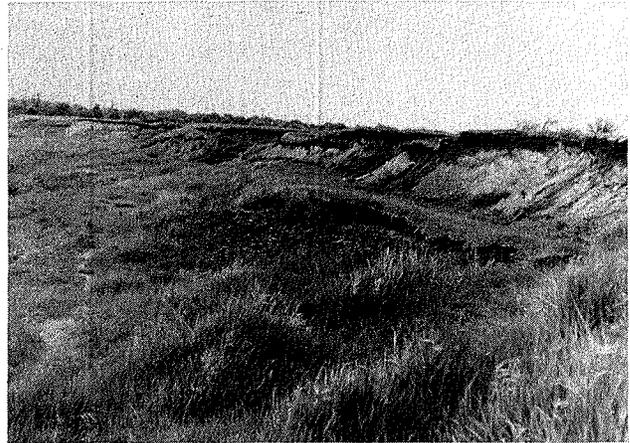
PHOTOGRAPH 2 - Older Slide
Concave Edge, East Bank
Height 33 ft. Average Slope 6.7 : 1

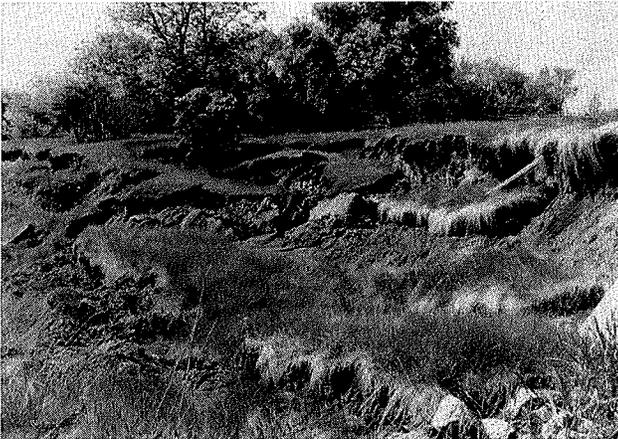
PHOTOGRAPH 3 - Recent Slide
Concave Edge, West Bank Looking South
Height 40 ft. Average Slope 5.1 : 1

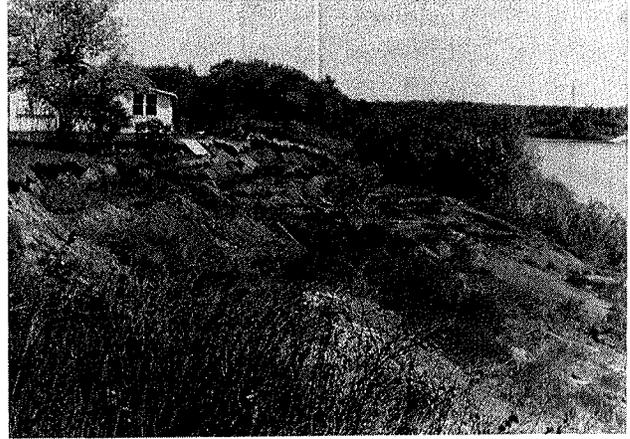
PHOTOGRAPH 4
Same as Photograph 3
West Bank Looking North

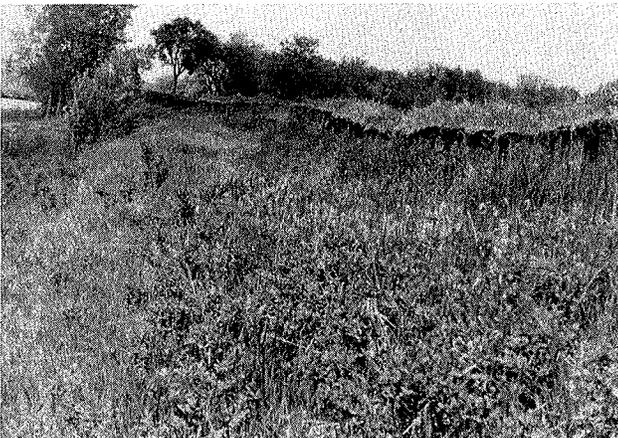
PHOTOGRAPH 5 - Old Slide
Convex Edge, East Bank
Height 30 ft. Average Slope 5.4 : 1

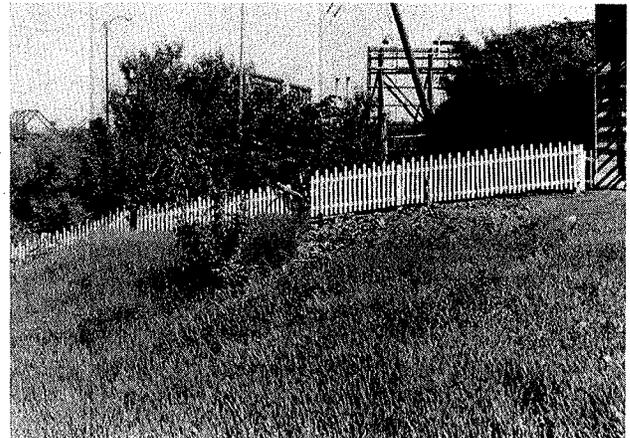
PHOTOGRAPH 6 - Old Slide with Fill
Concave Edge, East Bank
Height 34 ft. Average Slope 4.9 : 1
Note Fence Separation indicating
continued movement
