THE ANALYSIS OF FRACTURED Ti-6Al-4V MODULAR REVISION HIP STEMS WITH THE USE OF RADIOGRAPHIC ASSESSMENT, FINITE ELEMENT ANALYSIS, AND MECHANICAL TESTING

Department of Mechanical and Manufacturing Engineering

University of Manitoba

Five failed retrieved modular Ti-6Al-4V hip stems were examined to determine causes of failure. Investigation included microscopic and macroscopic analysis, finite element analysis, and mechanical testing of the modular hip implant. Method of failure was found to be fatigue, with crack initiation occurring on the lateral side of the modular junction. Bony ingrowth across the modular junction and on the proximal body was not present on both medial and lateral sides. Finite element analysis confirmed that the highest point of stress was where the crack was initiating, its magnitude, and that by utilizing a medial bone support, overall stresses on the modular implant decreased significantly. Tensile and hardness tests of the stem material produced results that were consistent with standard values. Fatigue results followed typical S-N curves and indicated that failure in vivo should have occurred after 10 million cycles. Implant assembly involves pulling th

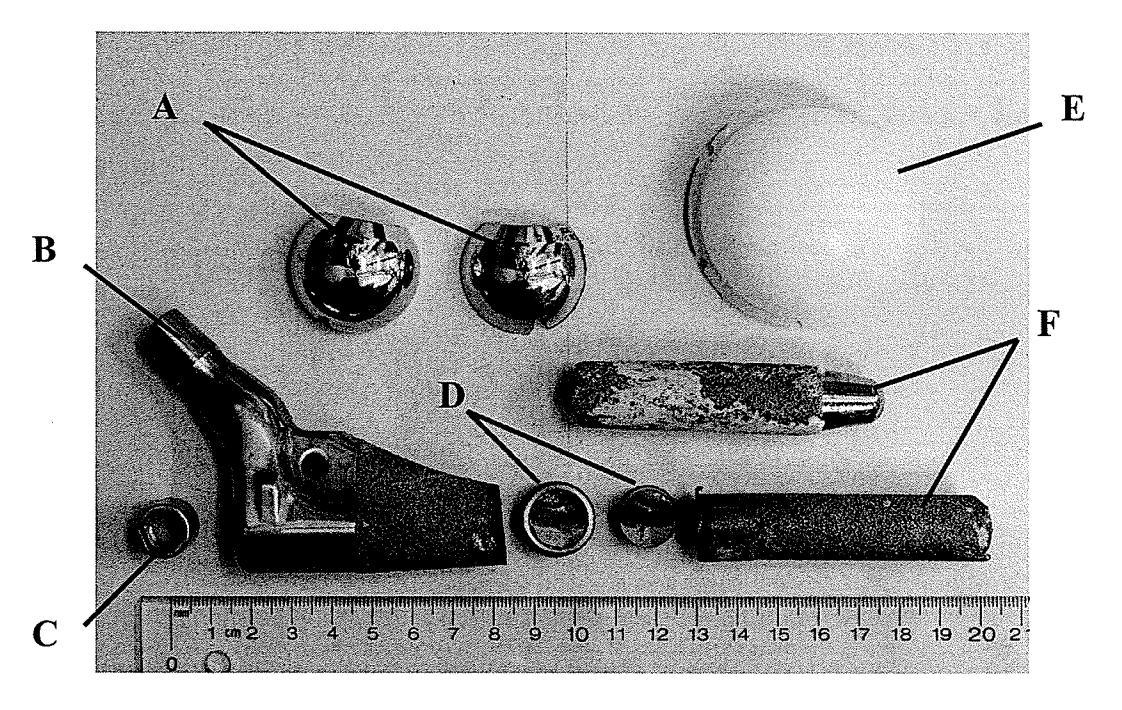
FIGURE 9: MACROSCOPIC IMAGE OF IMPLANT #1, WHERE A IS THE FEMORAL HEAD CUT IN HALF, B IS THE BODY, C IS THE COMPRESSION NUT, D ARE THE TWO MATING FRACTURE SURFACES, E IS THE POLYETHYLENE ACETABULAR LINER, F IS THE FEMORAL STEM

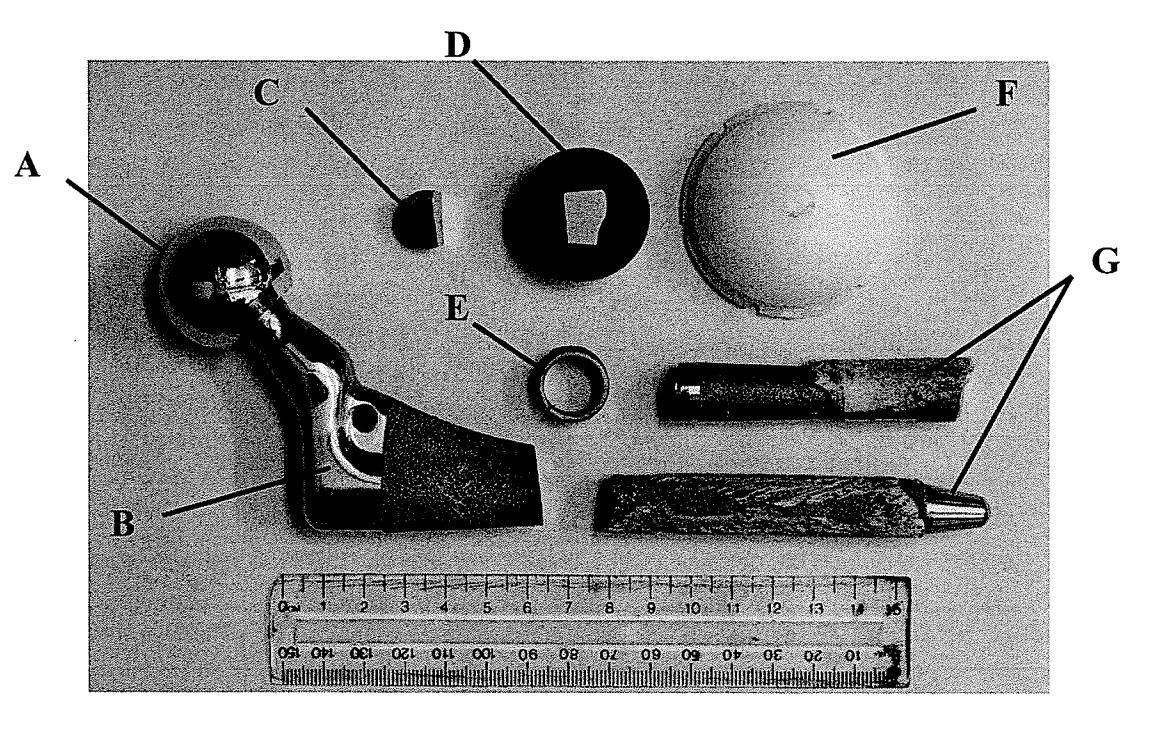
FIGURE 10: MACROSCOPIC IMAGE OF IMPLANT #2, WHERE A IS THE FEMORAL HEAD, B IS THE BODY, C IS THE FRACTURE SURFACE WITH A SMALL PORTION CUT OFF, D IS A MOUNTED AND POLISHED PORTION OF THE FRACTURE SURFACE, E IS PART OF THE BODY THAT WAS CUT OFF FROM AROUND THE FRACTURE SURFACE, F IS THE POLYETHYLENE ACETABULAR LINER, G IS THE FEMORAL STEM

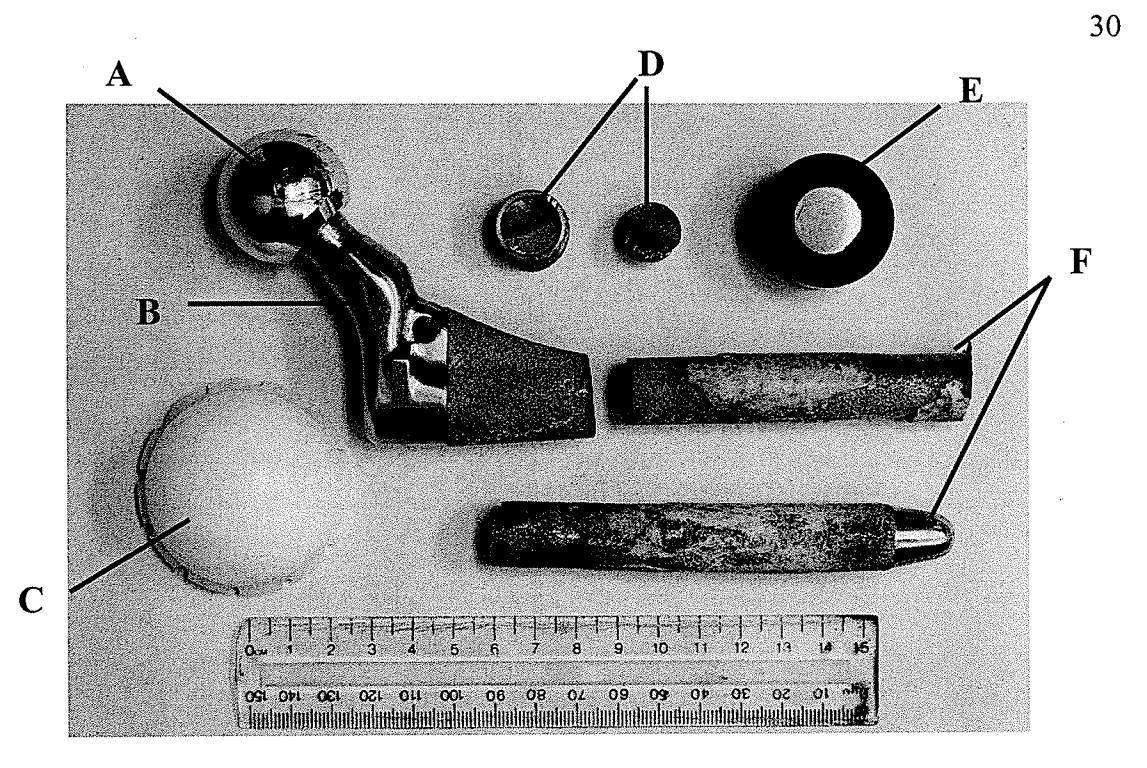
FIGURE 11: MACROSCOPIC IMAGE OF IMPLANT #3, WHERE A IS THE FEMORAL HEAD, B IS THE BODY, C IS THE POLYETHYLENE ACETABULAR LINER, D ARE THE TWO MATING FRACTURE SURFACES, E IS A MOUNTED AND POLISHED SAMPLE OF THE STEM, F IS THE FEMORAL STEM

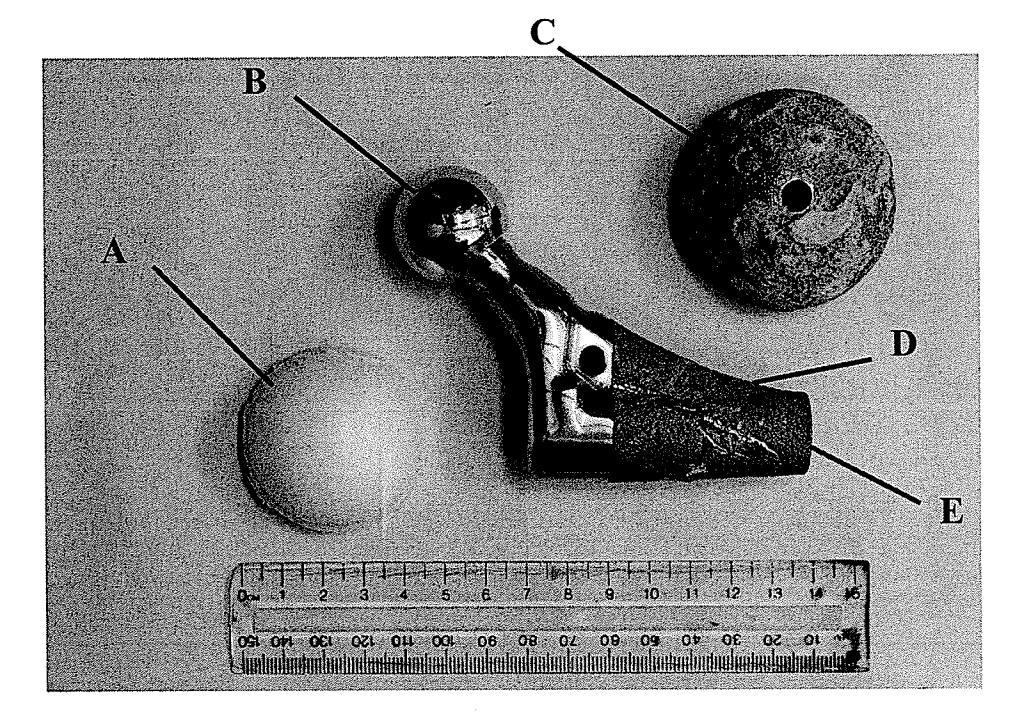
FIGURE 12: MACROSCOPIC IMAGE OF IMPLANT #4, WHERE A IS THE POLYETHYLENE ACETABULAR LINER, B IS THE FEMORAL HEAD, C IS THE ACETABULAR CUP, D IS THE BODY, E IS THE LOCATION OF FRACTURE

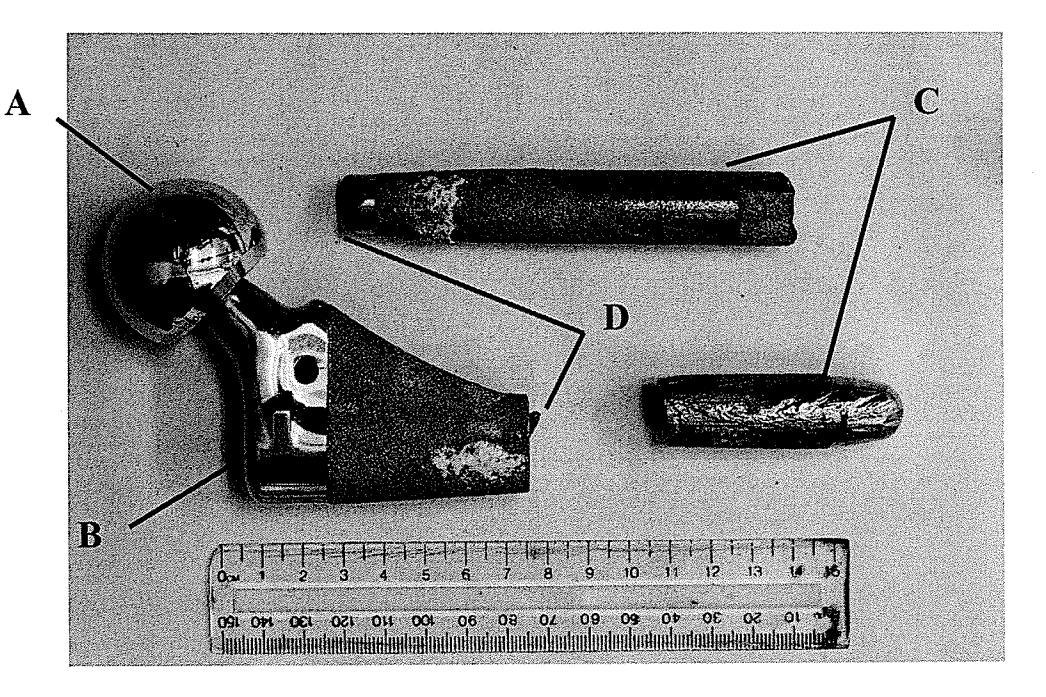
FIGURE 13: MACROSCOPIC IMAGE OF IMPLANT #5, WHERE A IS THE FEMORAL HEAD, B IS THE BODY, C IS THE FEMORAL STEM, D ARE THE TWO MATING FRACTURE SURFACES

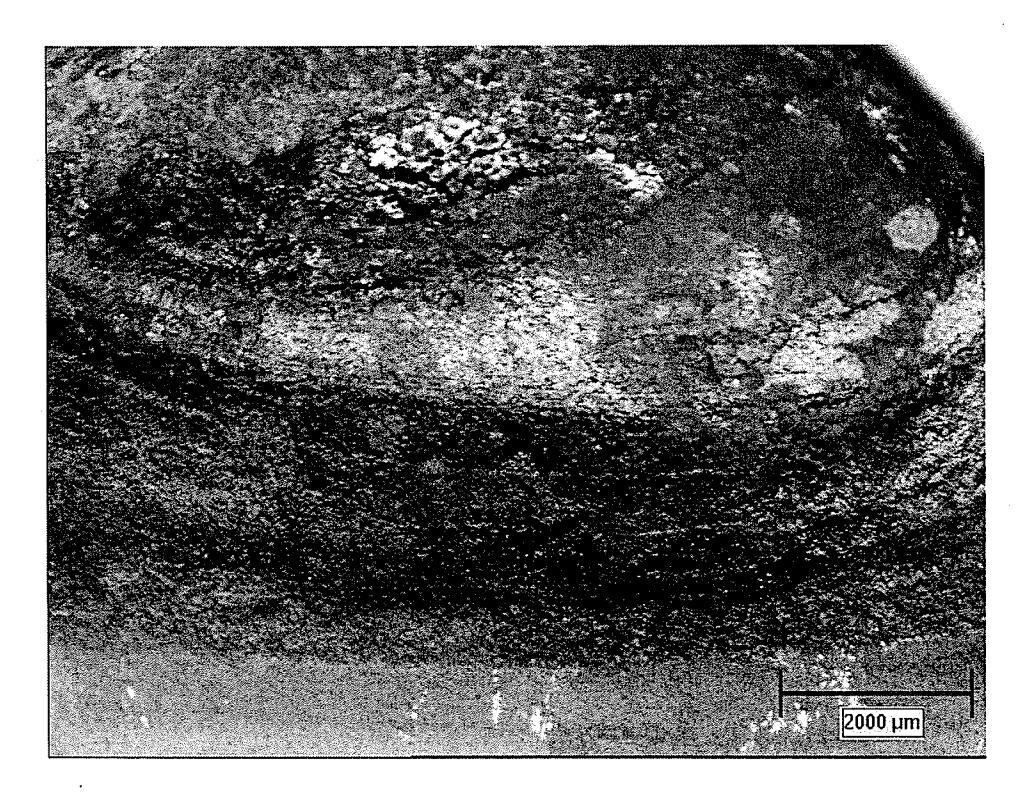
FIGURE 18: FRACTURE SURFACE OF IMPLANT #1 TAKEN AT 10X, SLOW FATIGUE AND TRANSITION ZONES, CRACK INITIATION IS TOWARDS THE TOP OF THE SECTION

From Figure 18, the slow fatigue and transition zone of the fracture surface of implant #1 can be seen. Crack initiation occurs towards the top of the section. The slow fatigue area occurs over a longer duration of time than the rapid fracture area since the crack tip propagates very slowly. Surface damage is likely to occur in this region since the mating surface remains in contact with it despite having separated by crack propagation. Surface damage can be seen in Figure 18 where there are lighter, brighter spots. The transition zone is where the crack tip will start to propagate faster and lead to the rapid fracture zone. When the rapid fracture area appears, beachmarks are present. This is because the rate of crack propagation is increasing. The slow fatigue area is darker in appearance than the rapid fracture area due to surface corrosion from exposure to extracellular fluid that enters the crevice during fatigue. When extracellular fluid enters the crevice decreases. This creates a more acidic environment for the fracture surface.

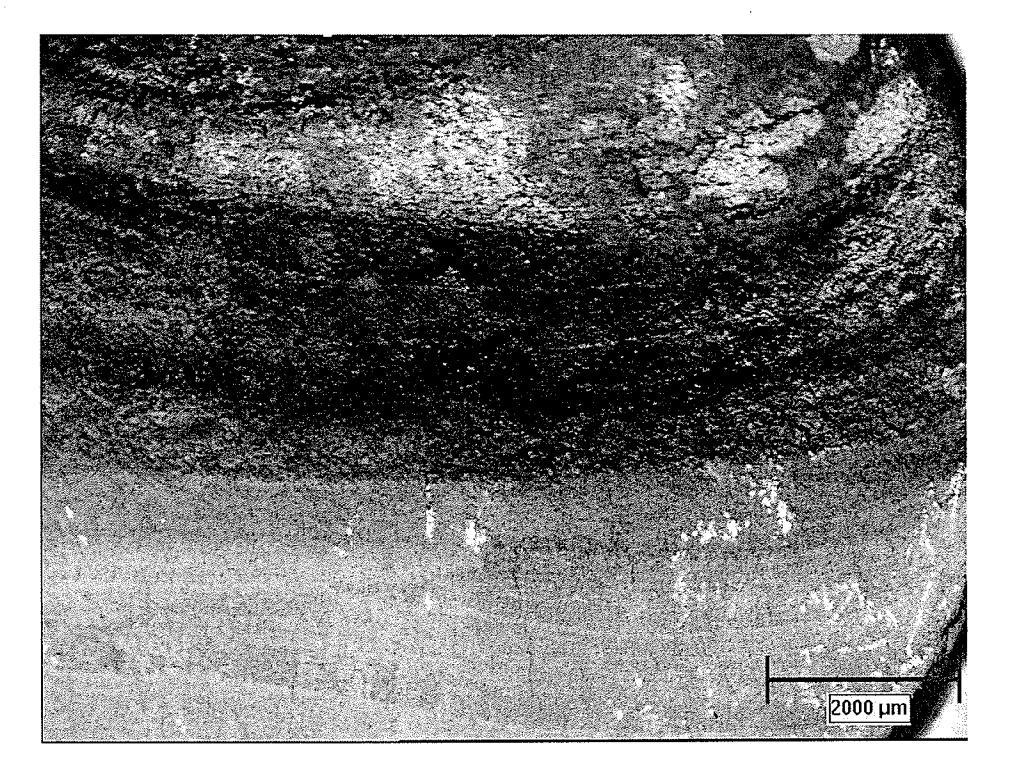
FIGURE 19: FRACTURE SURFACE OF IMPLANT #1 TAKEN AT 10X, TRANSITION ZONE BETWEEN SLOW FATIGUE AND RAPID FRACTURE ZONES, CRACK INITIATION IS TOWARDS THE TOP OF THE SECTION

Figure 19 shows the transition zone between the slow fatigue area and the rapid fracture area of implant #1. Crack initiation occurs towards the top of the section. It can be seen that the rapid fracture zone is lighter in comparison to the slow fracture zone. This is likely because when rapid fracture occurs, the surface is not attacked by extracellular fluid in a crevice and surgery to remove the implant occurs soon after fracture. Beachmarks are also evident in this area. The curvature of the beachmarks indicates the location of crack initiation of the implant, since they expand away from that point. It is clear from Figures 18 and 19 that crack initiation occurred in the upper portions of these images, which is the lateral side of the stem at the modular junction. However, due to the fracture surface damage of this implant, the exact point cannot be indicated.

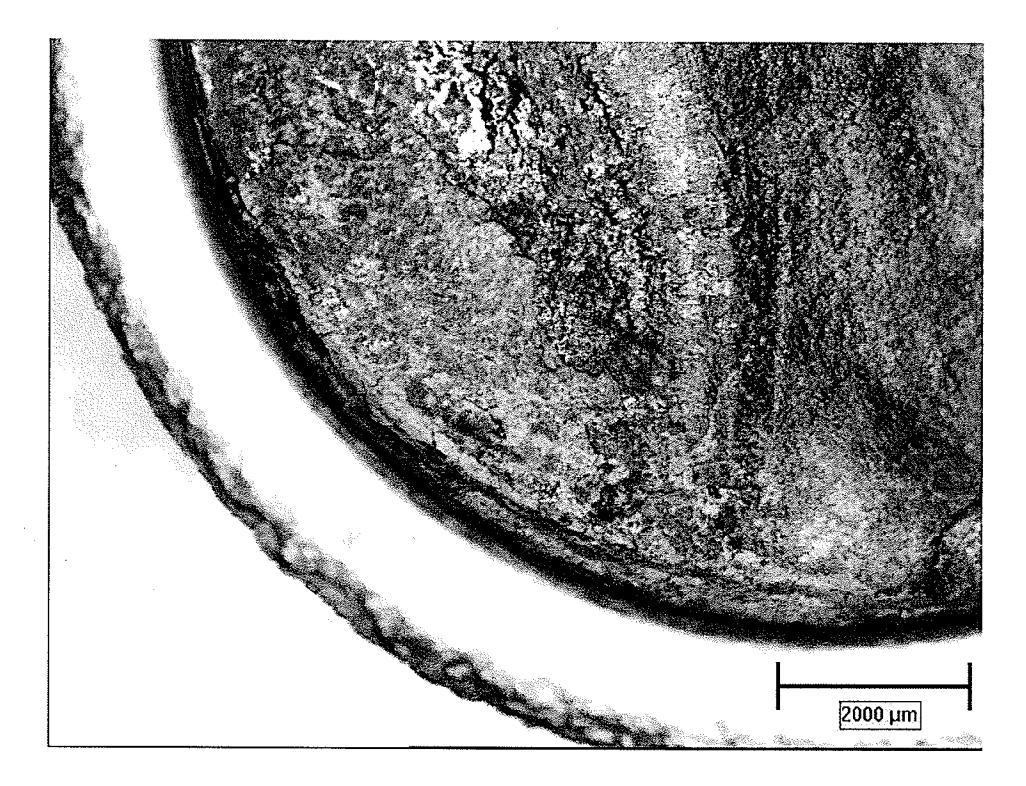
FIGURE 20: FRACTURE SURFACE OF IMPLANT #1 TAKEN AT 10X, DAMAGED SLOW FATIGUE ZONE, CRACK INITIATION IS TOWARDS THE LEFT OF THE SECTION

Figure 20 shows the damaged area of the slow fatigue zone of implant #1. Crack initiation occurs towards the left of the section. It is clear that the exact point of crack initiation cannot be determined since no beachmarks are visible, although an approximate point can be determined on the lateral side of the modular stem. This area of the fracture surface appears to be covered in a layer of unknown material. This was investigated further using the SEM.

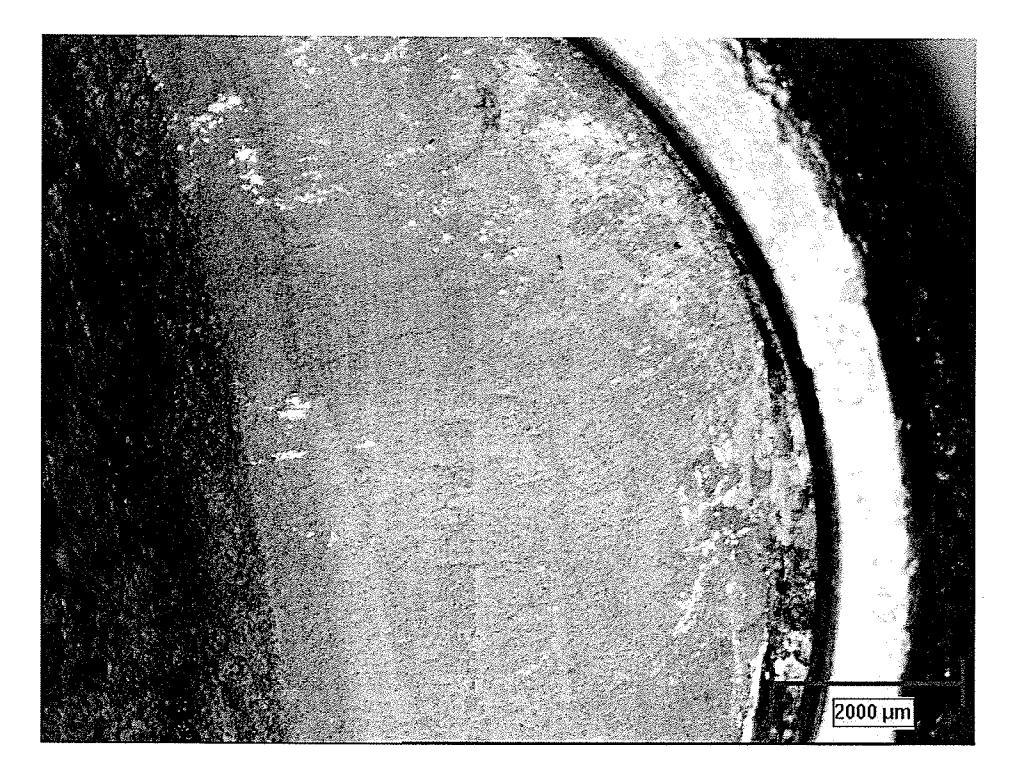
FIGURE 21: FRACTURE SURFACE OF IMPLANT #1 TAKEN AT 10X, RAPID FRACTURE ZONE, CRACK INITIATION IS TOWARDS THE LEFT OF THE SECTION

Figure 21 shows the rapid fracture zone of implant #1. Crack initiation occurs towards the left of the section. Beachmarks are clearly visible in this area. Brighter spots on the surface indicate damage.

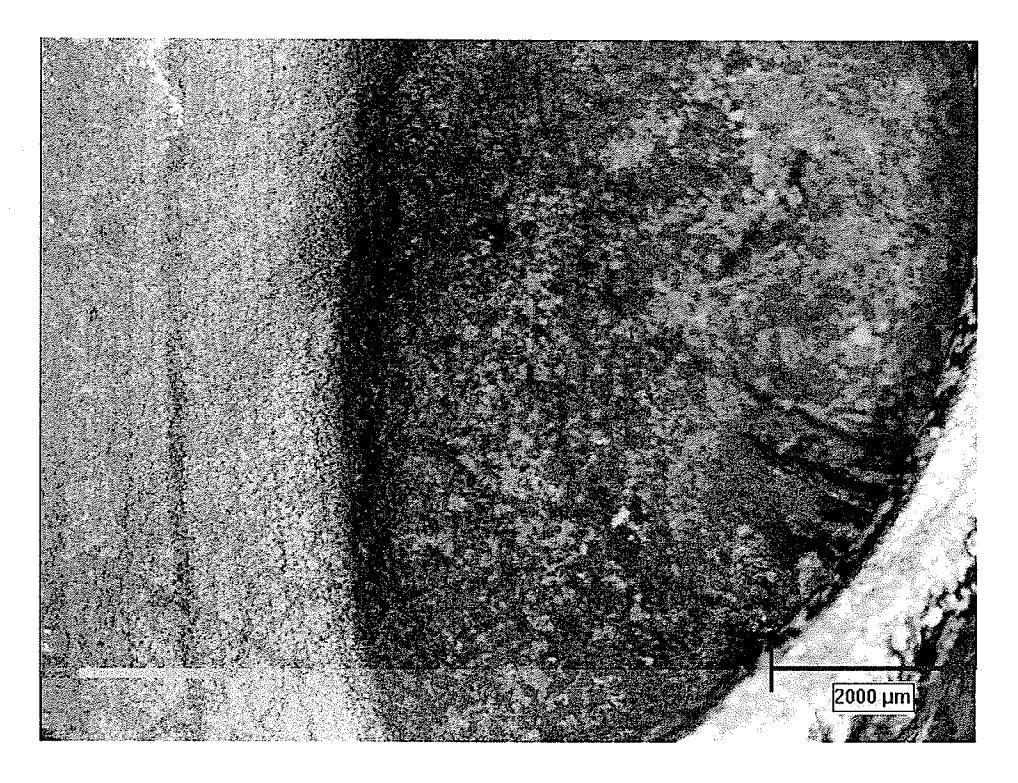
FIGURE 22: FRACTURE SURFACE OF IMPLANT #2 TAKEN AT 10X, CRACK INITIATION IS TOWARDS THE RIGHT OF THE SECTION

Figure 22 shows the fracture surface of implant #2. The slow fatigue zone, the transition zone, and the rapid fracture zone can be seen in this picture. Crack initiation occurs towards the right of the section. The slow fatigue area for implant #2 is darker in appearance due to crevice corrosion from extracellular fluid. It also appears to be covered in a layer of unknown material, which will undergo investigation using the SEM. The beachmarks on the rapid fracture area are very clear and their curvature confirms that the point of crack initiation occurred on the lateral side of the stem in the slow fatigue zone.

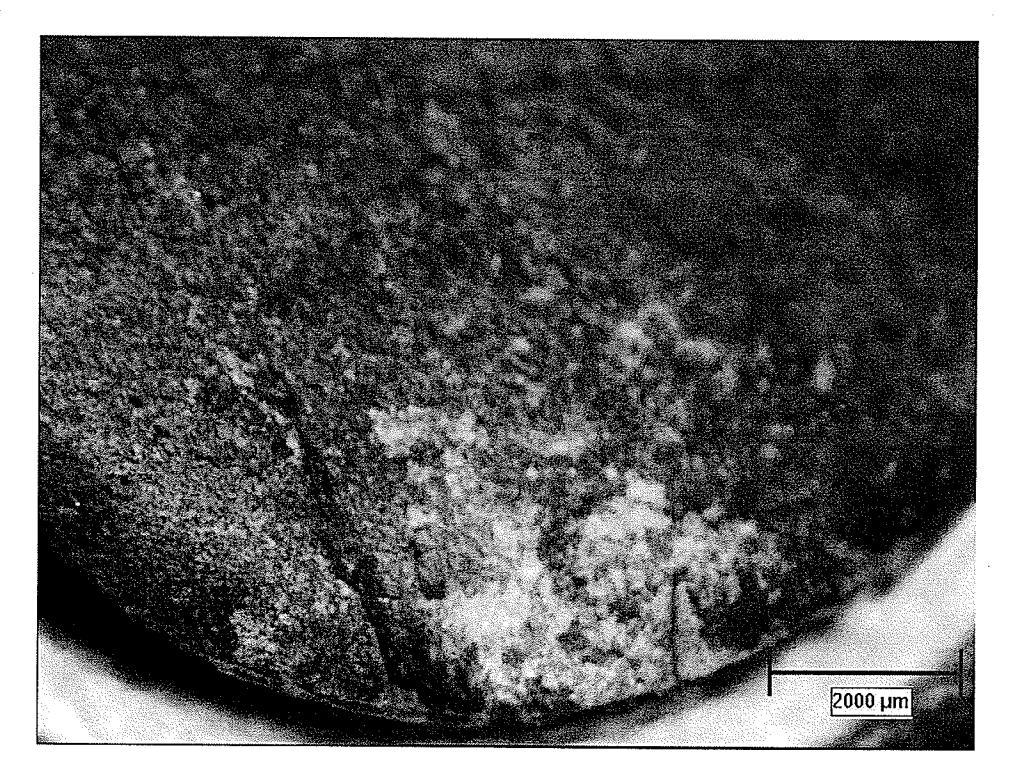
FIGURE 23: FRACTURE SURFACE OF IMPLANT #3 TAKEN AT 10X, DAMAGED SLOW FATIGUE ZONE, CRACK INITIATION IS TOWARDS THE BOTTOM OF THE SECTION

Figure 23 shows the slow fatigue zone of implant #3. Crack initiation occurs towards the bottom of the section. Similar to implant #1 and #2, the surface is darker due to crevice corrosion by extracellular fluid and appears to be covered in a layer of unknown material. The image also displays surface damage that occurred in vivo. Although there seems to be a crack on the surface, which would indicate signs of stress corrosion cracking, closer inspection revealed that this was merely topography created by the fracture. There are no visible beachmarks in this area. Therefore, an exact point of crack initiation cannot be determined solely from this section.

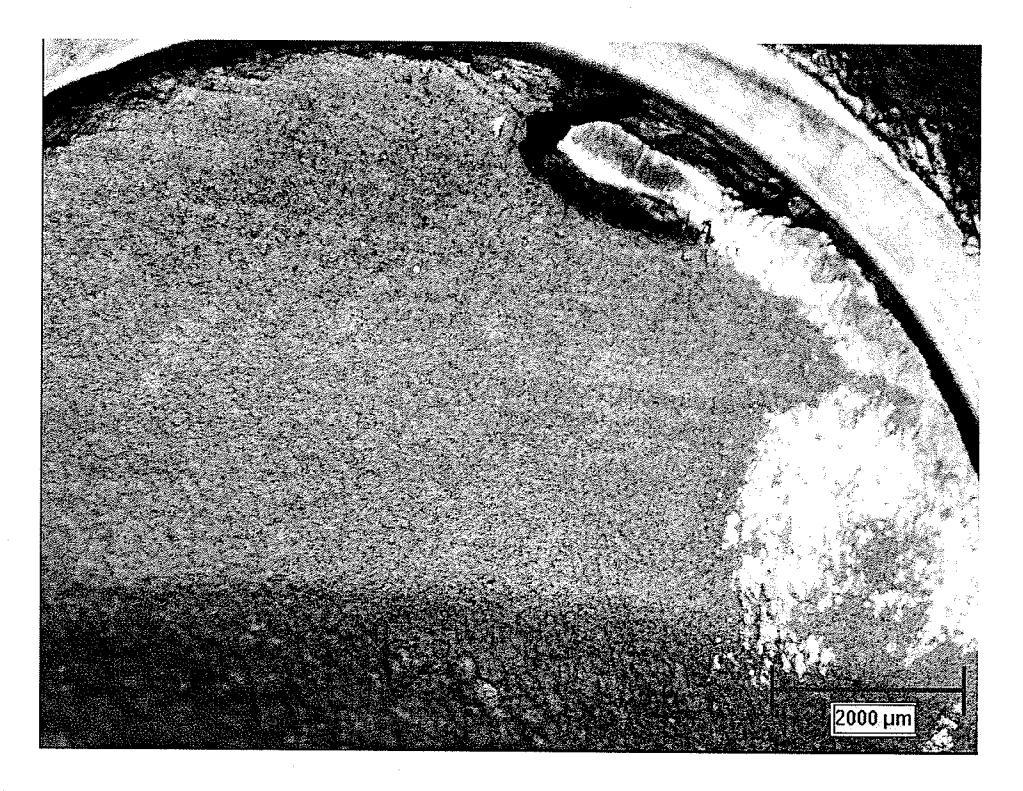
FIGURE 24: FRACTURE SURFACE OF IMPLANT #3 TAKEN AT 10X, TRANSITION AND RAPID FRACTURE ZONES, CRACK INITIATION IS TOWARDS THE BOTTOM OF THE SECTION

Figure 24 shows the transition zone and the rapid fracture zone of implant #3. Crack initiation occurs towards the bottom of the section. The beachmarks that are present are visible, but not as pronounced as implant #1 or implant #2. Again, the curvature of the beachmarks indicates that crack initiation occurred on the lateral side of the stem. Surface damage due to the mating fracture surface can be seen on the right side of the image. It is also clear to see that the final point of fracture removed a portion of the surface.

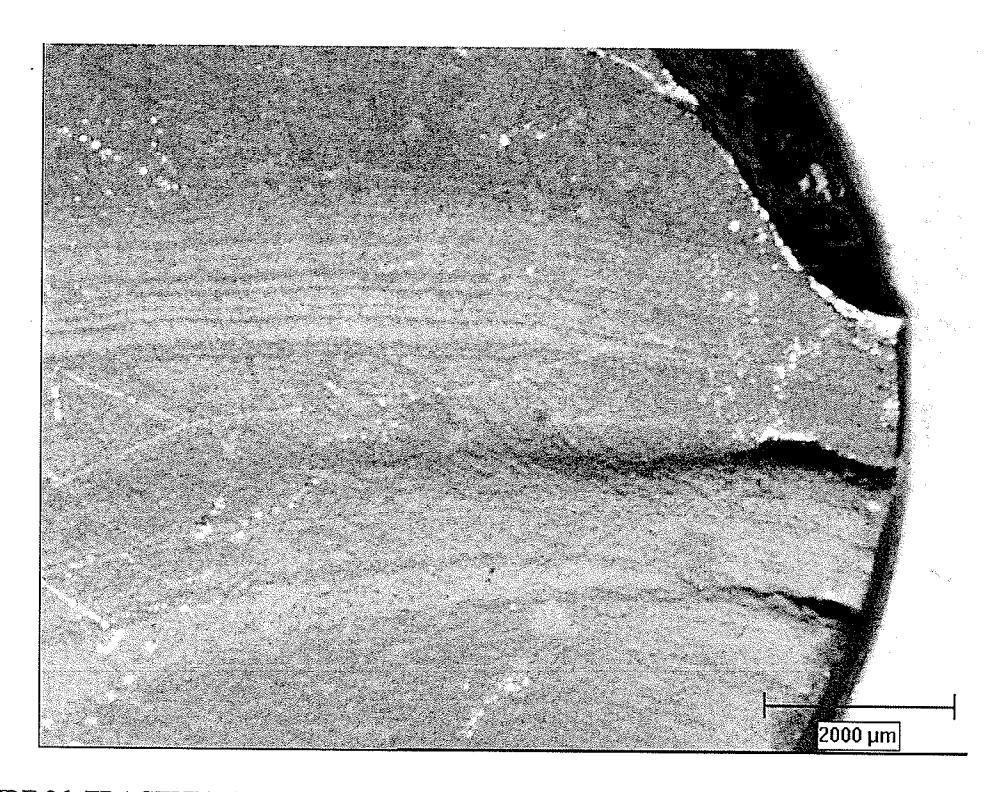
FIGURE 26: FRACTURE SURFACE OF IMPLANT #4 TAKEN AT 10X, RAPID FRACTURE ZONE, CRACK INITIATION IS TOWARDS THE BOTTOM OF THE SECTION

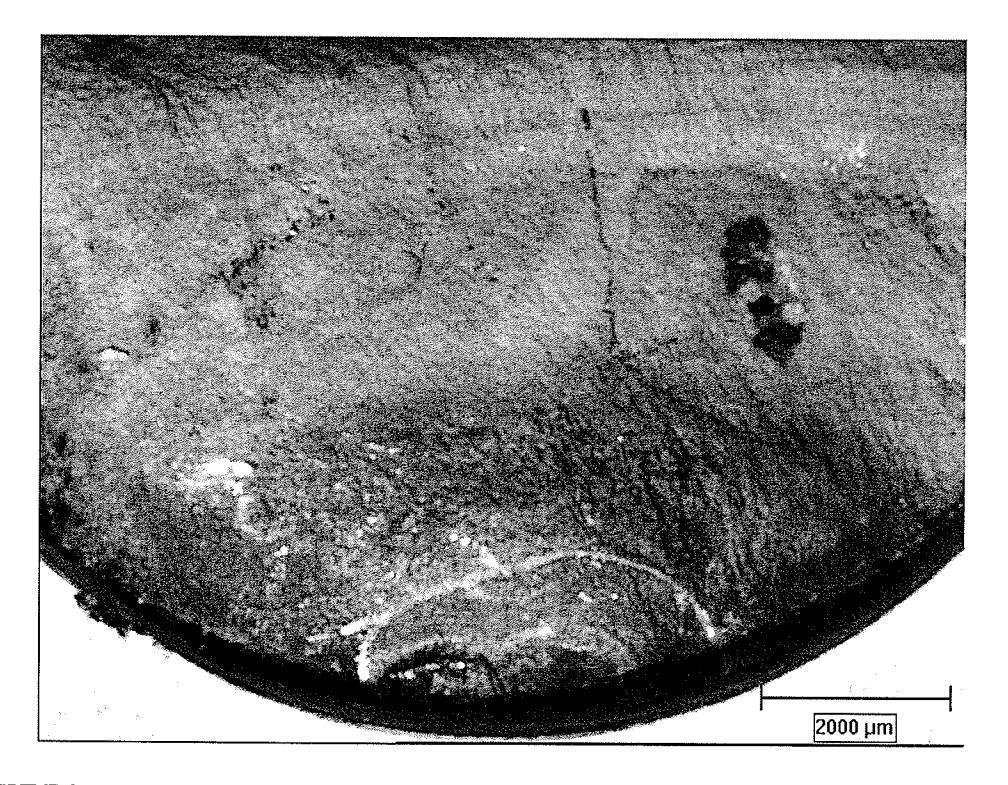
FIGURE 27: FRACTURE SURFACE OF IMPLANT #5 TAKEN AT 10X, SLOW FATIGUE AND TRANSITION ZONES, CRACK INITIATION IS TOWARDS THE BOTTOM OF THE SECTION

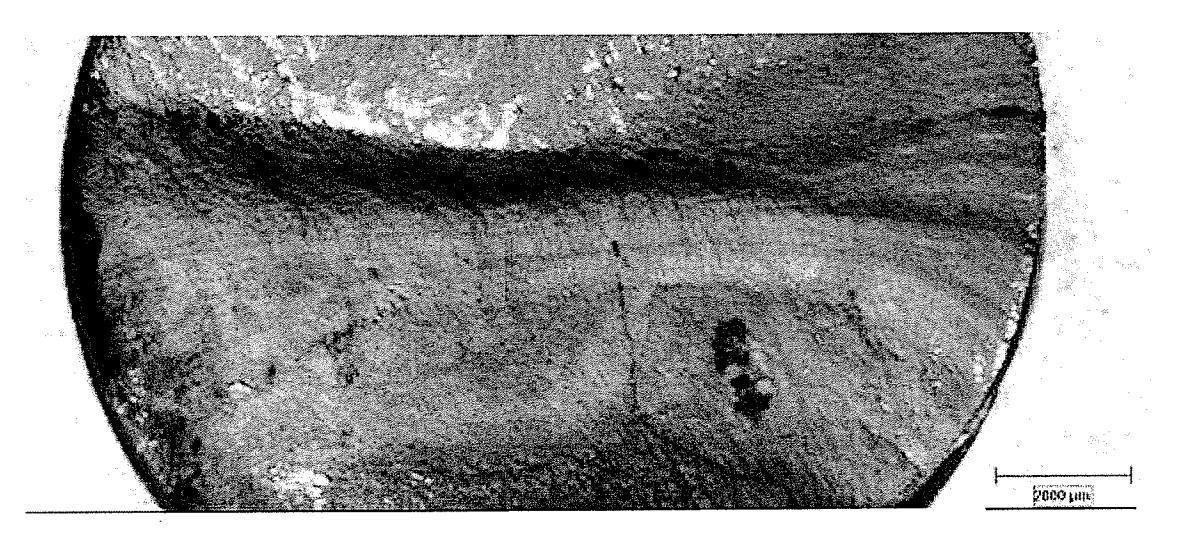
FIGURE 28: FRACTURE SURFACE OF IMPLANT #5 TAKEN AT 10X, RAPID FRACTURE ZONE, CRACK INITATION IS TOWARDS THE BOTTOM OF THE SECTION

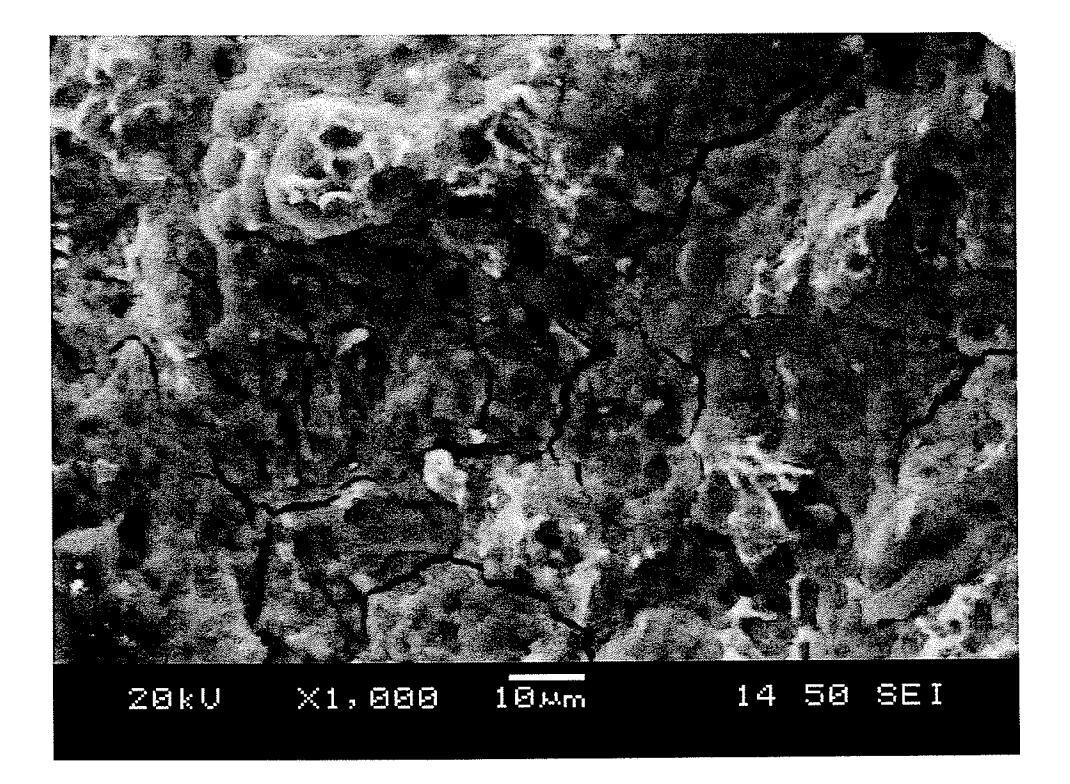
FIGURE 34: UNKNOWN LAYER COVERING SLOW FATIGUE ZONE OF IMPLANT #3 TAKEN AT 1000X

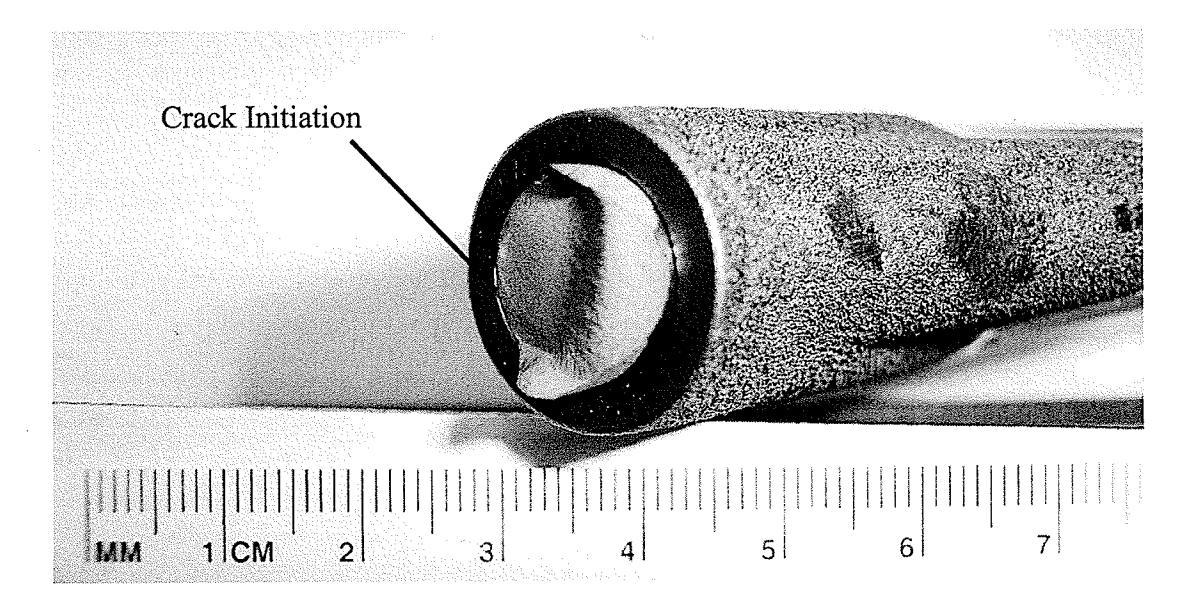
FIGURE 58: TYPICAL FRACTURE SURFACE FROM TI-6AL-4V FATIGUE TESTS 21-26, CRACK INITIATION IS INDICATED IN THE IMAGE

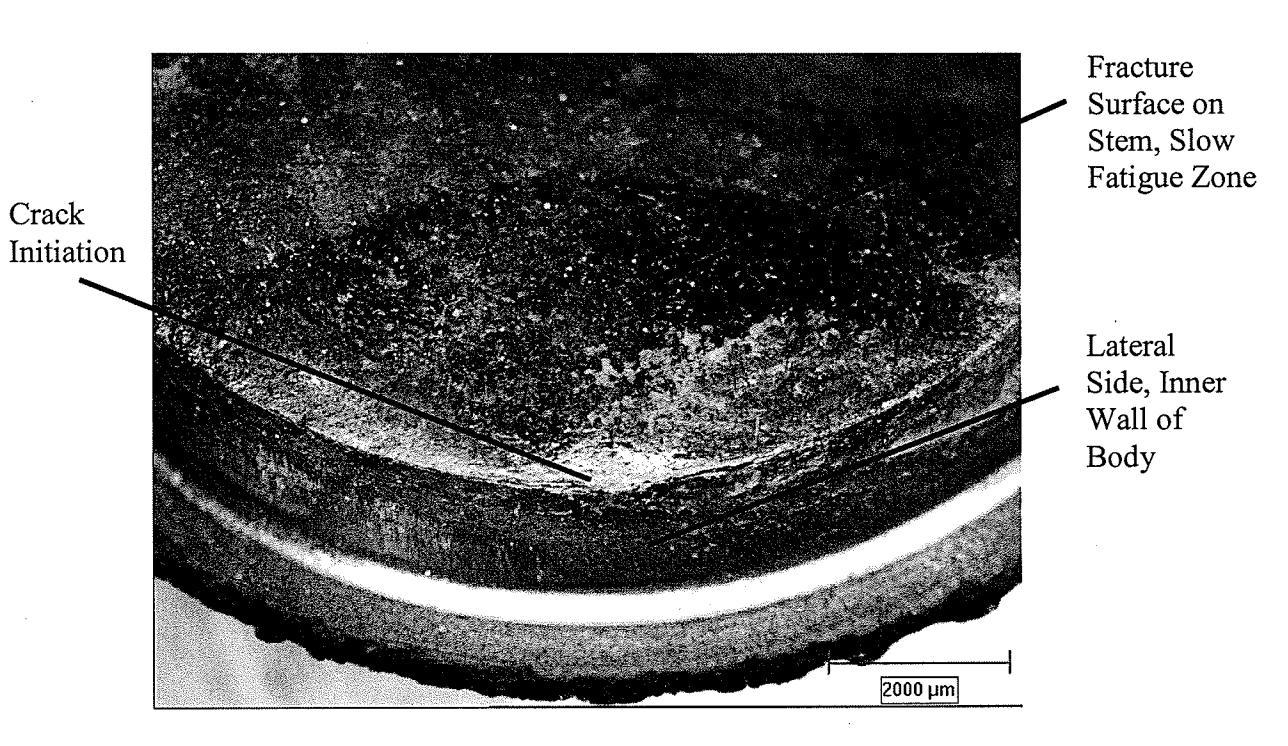
FIGURE 60: IMPLANT #1 - TYPICAL RETREIVED FRACTURE SURFACE FOR IMPLANTS STUDIED TAKEN AT 10X, CRACK INITIATION IS TOWARDS THE BOTTOM OF THE SECTION
