PUNCHING BEHAVIOUR OF A
HYBRID REINFORCED
CONCRETE BRIDGE DECK

A Thesis

MASTER OF SCIENCE

Department of Civil & Geological Engineering
University of Manitoba
Winnipeg, Manitoba

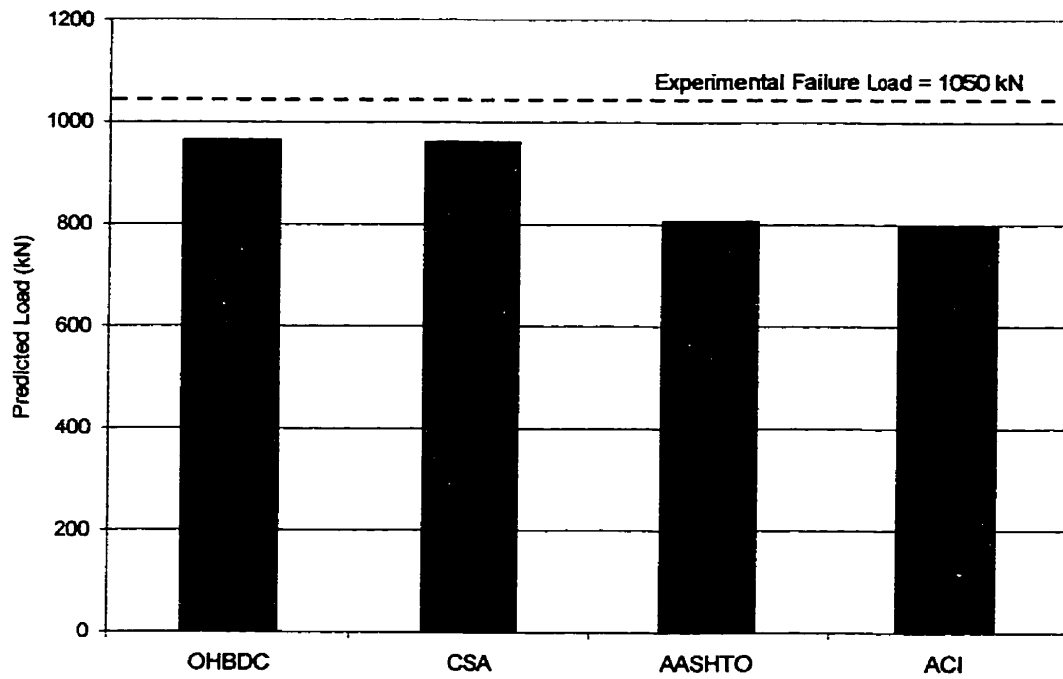
Figure 2-3: Predicted Punching Strength According to Design Codes

The predicted values for the punching capacity of the experimental model presented in this thesis according to the methods shown above are given in Figure 2-3.

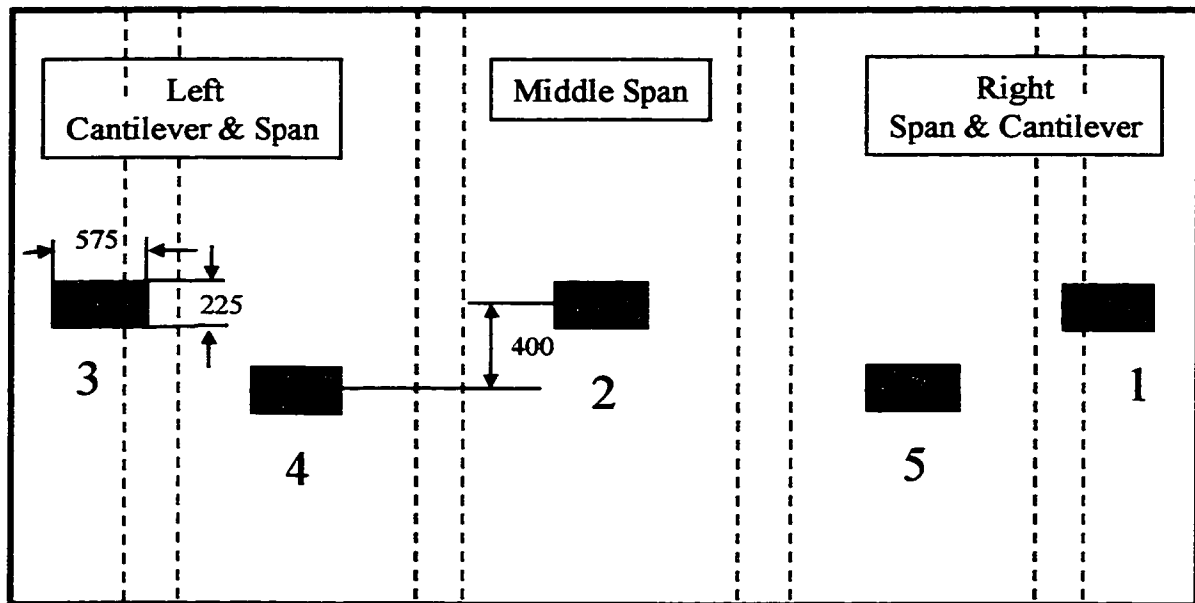
Figure 3-5: Applied Load Locations for Tests

Bridge was scheduled to begin in the summer of 1997; therefore the right cantilever was selected to be tested first. During testing of the right cantilever, cracks formed on the top surface of the adjacent right span due to the induced negative bending moment in this region. Following testing of the right cantilever, the middle span was tested. This was done so that there would be no effect from other tests on the adjacent spans. Following test 2 on the middle span, test 3 was conducted on the left cantilever. This was done to expose the left and right interior spans to the same cracking conditions due to the induced negative bending moment from the adjacent cantilever tests. However, it should be mentioned that the failure load of the left cantilever was 875 kN, in comparison to an ultimate load of 500 kN for the right cantilever. Consequently, there was more cracking at the top surface of the left cantilever and its behaviour was affected to a greater extent than that of the right interior span. The left and right interior spans were tested last, both having incurred cracks from the adjacent cantilevers. The applied load in tests 4 and 5 was offset by 400 mm from the girder midspan, as shown in Figure 3-5. This was done to minimise the effect of the circumferential cracks that formed during test 2 on the middle span.

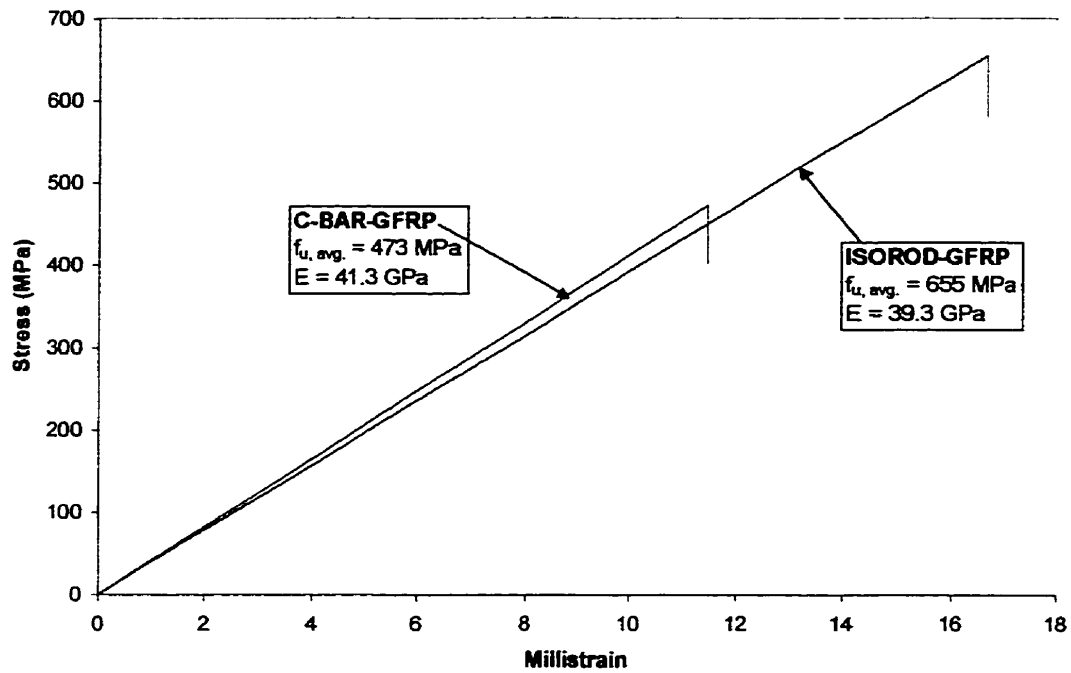
Figure 4-1: Typical Stress–Strain Curves for C-BAR and ISOROD GFRP Specimens

Three C-BAR tension specimens were prepared and tested by A. Abdelrahman. Due to flaws in the pultrusion manufacturing process of the C-BAR, “joints” were formed in the bars at 200-mm intervals. These joints resulted in a visible offset in the centreline of the bars and initiated a premature failure. The average tensile strength that was measured was 473 MPa, with an average elastic modulus of 41.3 GPa, as shown in Figure 4-1. Bars without such visible flaws were tested at the University of Manitoba by ISIS Canada (1997) and achieved a minimum tensile strength of 640 MPa and a mean elastic modulus of 41 GPa. Information from the manufacturer gives a nominal ultimate tensile strength of 680 MPa with an elastic modulus of 42 GPa.

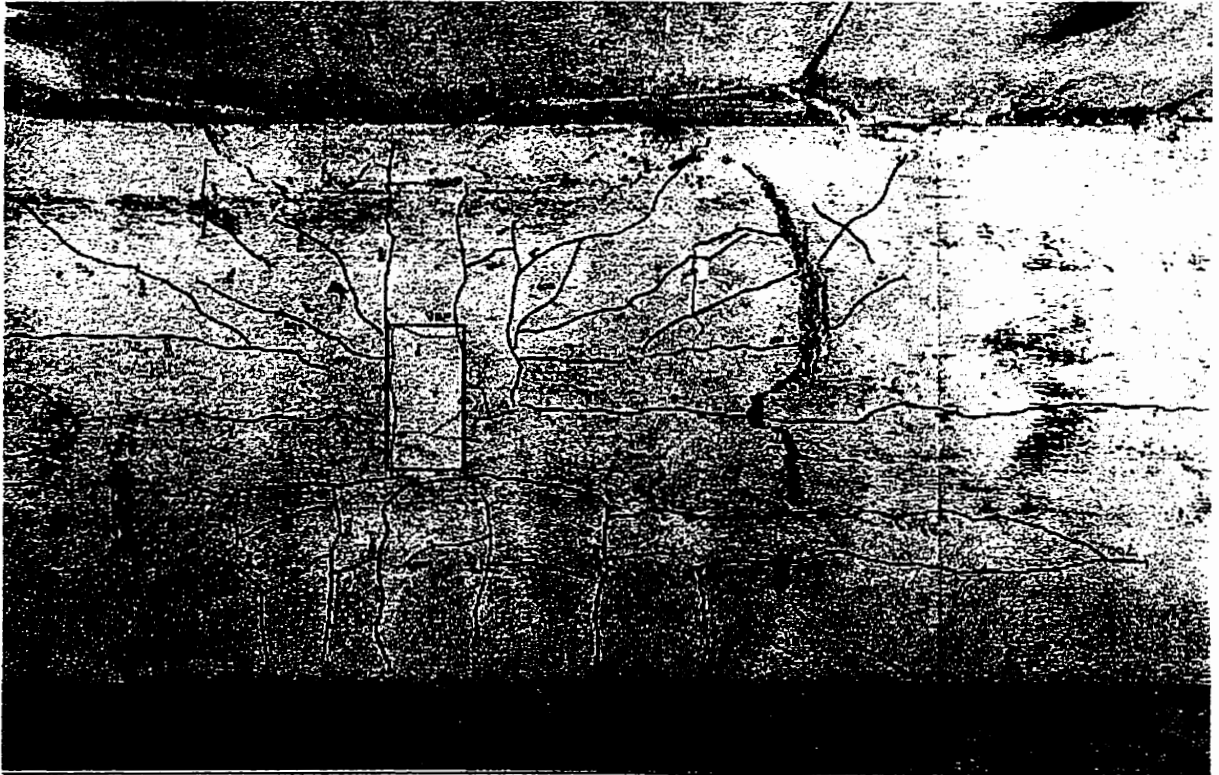
Figure 4-46: Test 4 Crack Pattern at Failure (Bottom Surface)

The crack pattern of the bottom surface of left span (Test 4) at failure is shown in Figure 4-46. The cracking load was 80 kN, with a flexural crack forming at midspan, parallel to the supporting beams. At a load level of 300 kN, radial cracks extended from the load location to the outer edges of the slab. A major crack was formed at failure (1090 kN) by punching shear to the right of the load location as shown in Figure 4-46.

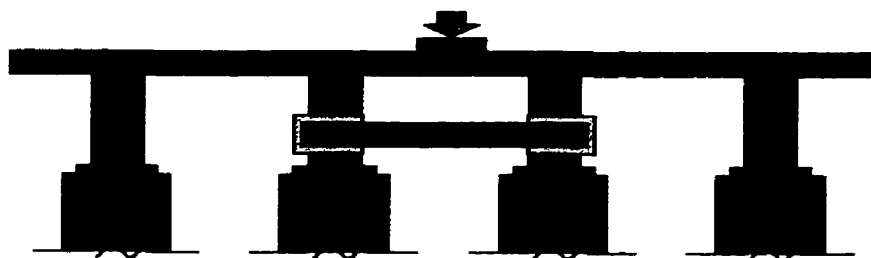
Figure 6-2: End Restraint for First Part of Slab C-1 Test

Slab C-1 was tested by applying a concentrated load at the middle span of the model, as shown in Figure 6-1. Steel straps were used as end restraints to model the intermediate diaphragms of the bridge, as shown in Figure 6-2. Before the test was completed, at a load of 600 kN, the steel straps were found to have yielded. The span was unloaded, the straps were taken off, and testing resumed without end restraints up to failure.

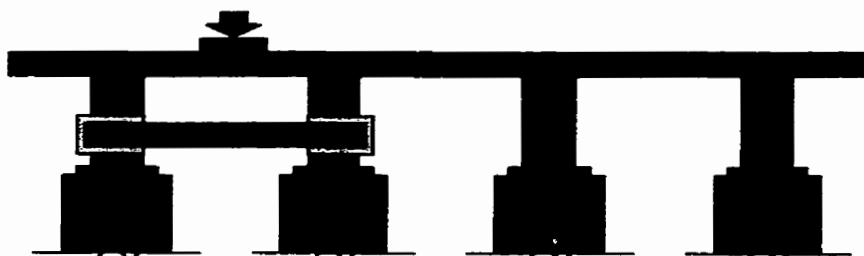
Figure 6-3: End Restraint for Slab C-2 Test

The left slab (C-2) was tested with a load applied eccentrically with respect to slab C-1, as shown in Figure 6-3. The end restraints used for this test had a larger cross-

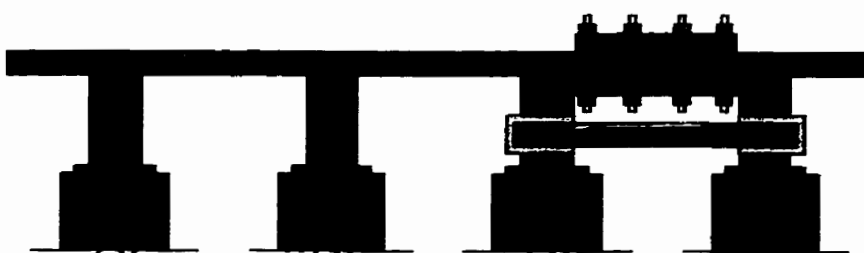
Figure 6-4: End Restraint and Edge Stiffeners for Slab C-3

Slab C-3 on the right span of the model was tested in a similar manner to C-2, as shown in Figure 6-4. In order to further investigate the effect of continuity of the slab, edge stiffeners were used in addition to the steel straps, as shown in Figure 6-1 and Figure 6-4.
