THE PALISADES CENTRE

JASPER NATIONAL PARK

An Adaptive Rehabilitation of a Cultural Landscape

A Practicum Submitted in Partial Fulfillment
of the Requirements for the Degree of Master
of Landscape Architecture

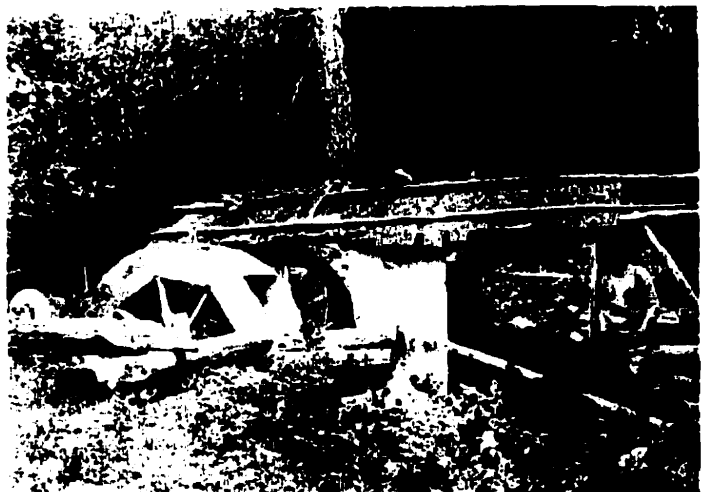
Fig. 21 Swift's waterwheel (Courtesy of Jasper-Yellowhead Museum and Archives)

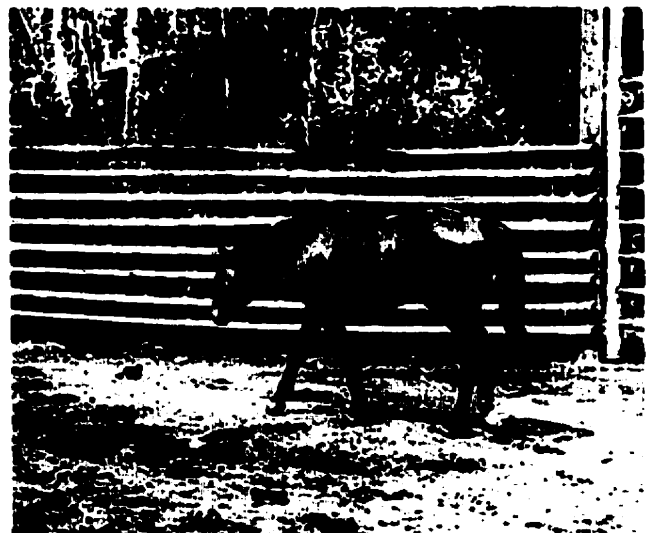
Fig. 35 Horse corral behind saddle-shed (Courtesy of Elaine Mellor)

This working area was kept more rustic; long grass, wildflowers and young Aspen trees filled the space between the bunkhouse and the barn. Along the southern side of the barn was a chicken coop and run. Behind the saddle and implement sheds were two octagonal-shaped corrals used to separate and break the new horses.

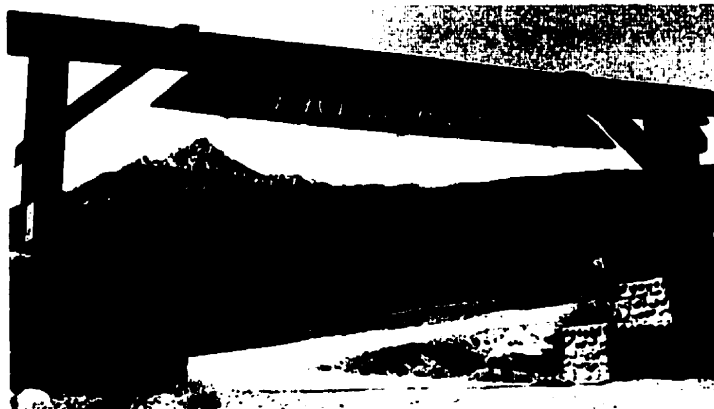
Fig. 40 View towards the new entry gate (Courtesy of Gordon Bried)

Throughout the Brieds' time there, Gordon did the alterations, repairs and new construction, along with the help of numerous local tradesmen while Connie and Gwen managed the guest operations. By 1954, Bried had created a new entry into the property, constructing a large stone and wooden, western style gate, lit by small, electric lanterns on either side of the sign displaying the name "Palisades". (Refer to Figure 41, page 34)

There does exist, however, historical precedence for signage appropriate for entering the site. During Gordon Bried's tenure, he constructed a western style entry gate, displaying the name "Palisades". On either side of the sign was a small lantern, similar to the cast iron lamp still located on the property. This gate was the first time there was any real sense of public entry into the property, letting people know they had finally arrived. (Refer to Figure 40, page 33)

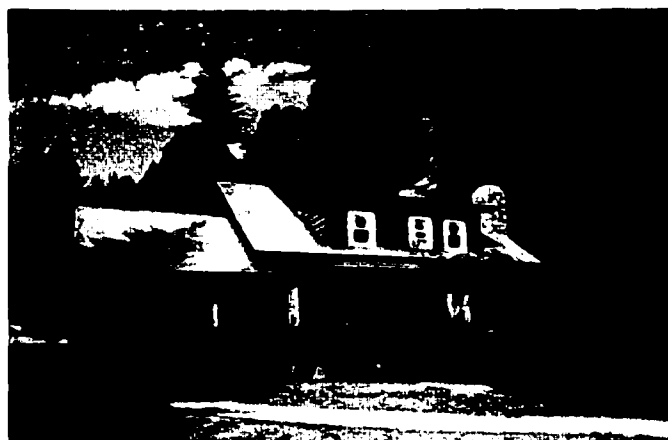
Fig. 60 East Face of Lodge (Photo by J. Wagner)

Constructed in 1936, the Lodge had been extensively remodeled in 1953. The building was originally a gable-roofed, 1 1/2 story structure set upon a stone and concrete foundation. The lower portion of the "Big House", as it was once referred to, is log, while the upper story is covered with wood shakes. Major changes to the building include a gable-roofed extension to the east and the addition of a screened porch to the south of the first addition. The house was designed to offer a commanding view of the lawn and the mountains beyond. (The screened porch had built in benches that could be covered with the seat cushions from Wilby's boat and placed on the small table was a pair of binoculars which visitors could use to look at the mountains. (Elaine Mellor notes, 1997)

Today, the Lodge essentially serves its original function; there are sleeping accommodations upstairs and the lower story is an informal lounge.

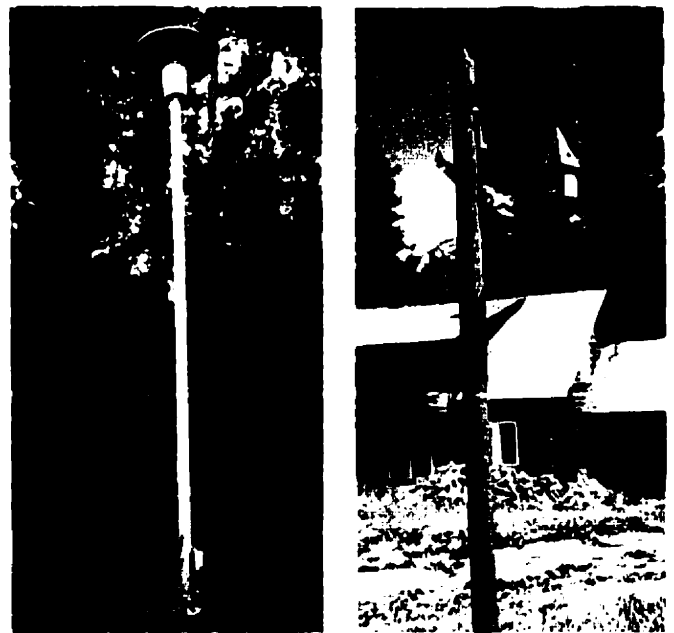
Figs. 90 and 91 Park light (Left) and light installed in the 1950's (right) (Photos by J. Wagner)

While every door into each of the buildings is individually lit, these lamps consist of nothing more than a light bulb inside a protective, plastic shell.

One light standard, installed in the 1950's by the Bechtel Corporation is still present and offers a model which other lights could follow. Approximately, 7' in height, the lamp relates to the pedestrian movement on the site. The cast iron pole supports an old-fashioned iron and glass lantern, reminiscent of the ones once used on the property.

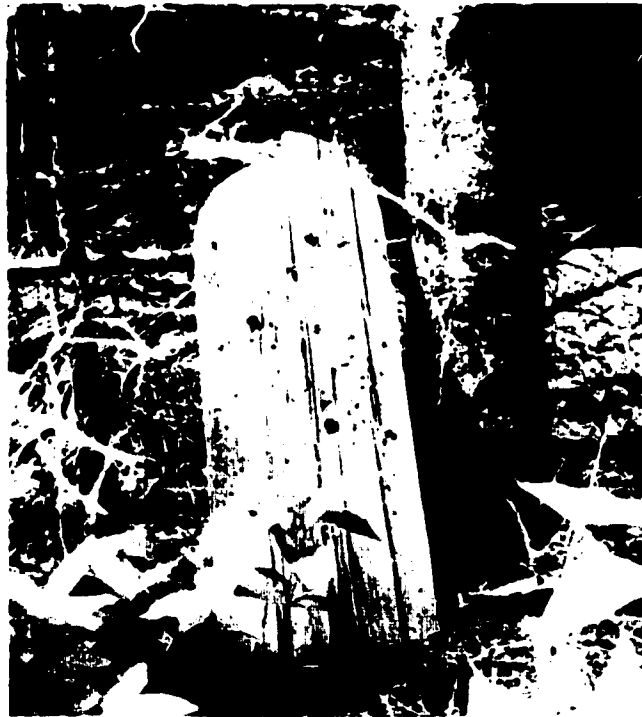
Fig. 95 Grave headstone (Photo by J. Wagner)

There are three graves related to the history of the Palisades Centre, two of them being the Swift childrens' graves and the third belonging to the late A.C. Wilby. While Wilby's grave is quite overgrown, because of its relative proximity to the buildings, the grave is frequented by many visitors, and its durable materials have left it in remarkably good condition. However, the more remote location of the childrens' graves, as well as their deteriorated state have left the area less visited.

At some time during the Parks' possession of the property, an iron fence had been erected around the graves as an effort to preserve the graves. While this has protected the graves from passersby, the fence hinders the peaceful feelings one might expect to experience at a mountain burial site.

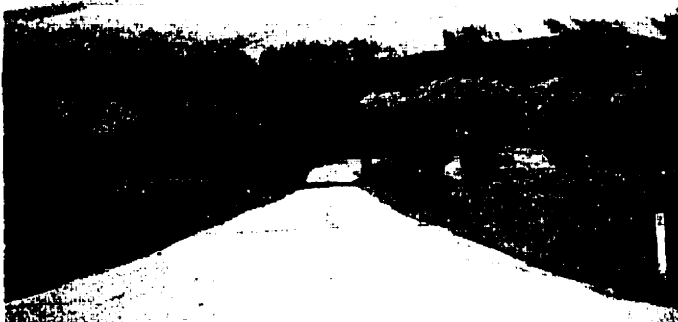
Fig. 101 Access Road to the Centre (Photo by J. Wagner)

According to the "Ecological Design and Operations Policy", as described in the Centre's Third Party Management Proposal, the physical footprint, meaning the area of land occupied by buildings, roadways, pathways, lawns and other artificial elements will remain the same or decrease. Thus, decreasing the road surface area through the removal of some of the later additions to the road system not only is in accordance with the Centre's policies but may help to restore some of the character and order the property once had.

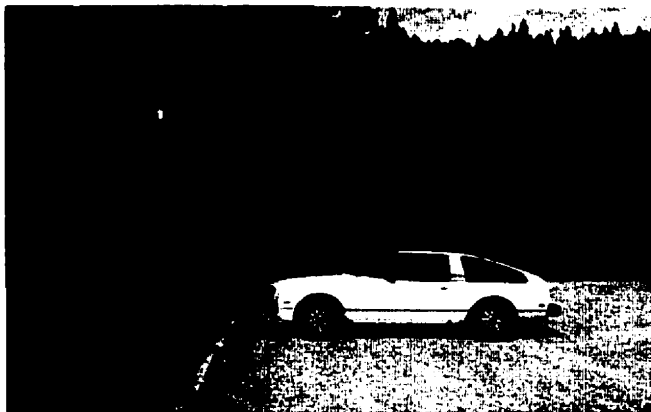
Fig. 102 Entry Parking Lot (Photo by J. Wagner)

With the exception of the entry parking lot, parking on the property is very ill-defined. However, visitor parking is separated from the Centre's employees. For the most part, vehicles are parked directly in front of the buildings, detracting from views to and from them and resulting in very little human activity around the buildings. The parking spaces are haphazardly created as seen fit for any given situation, often resulting in a disorderly appearance, inappropriate uses of spaces throughout the property, as well as lack of direction for first time visitors.

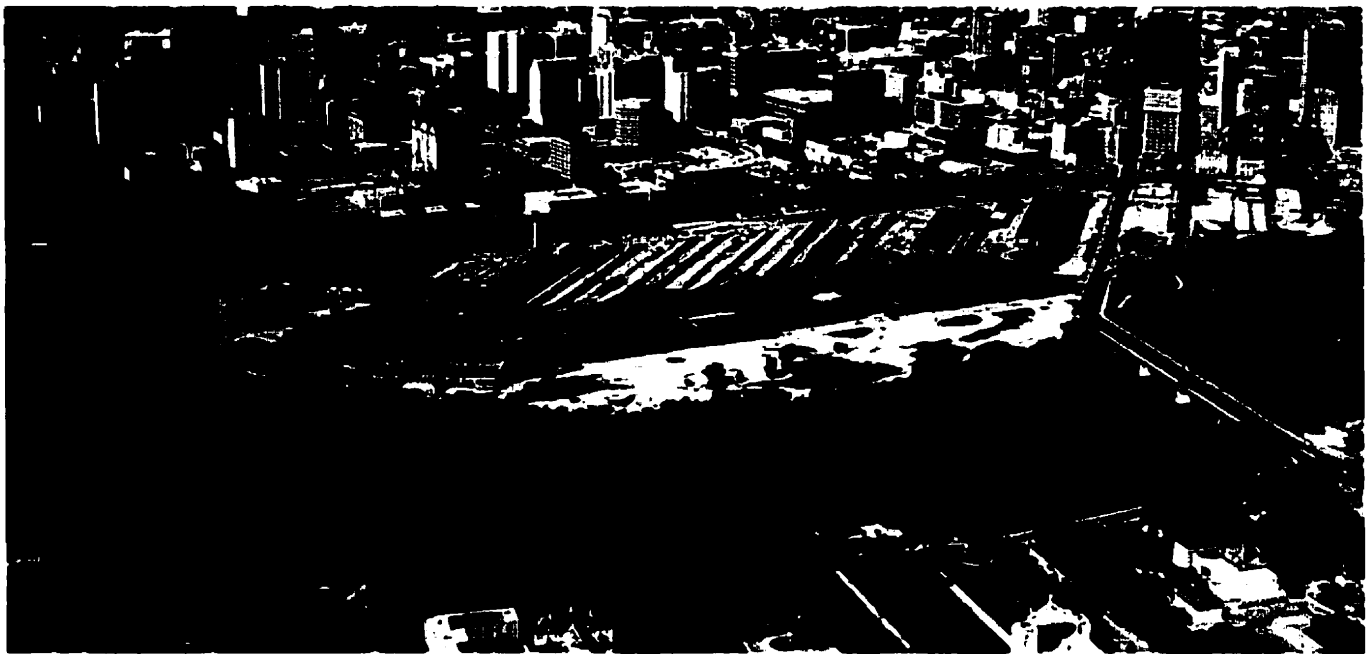
Fig. 117 Aerial View of the Forks prior to re-development (Courtesy of the Forks Renewal Corporation)
