# **REPAIR OF WOODEN UTILITY POLES USING FIBRE-REINFORCED POLYMERS**

**A Thesis**

**Department of Civil and Geological Engineering  
University of Manitoba  
Winnipeg, Manitoba  
Canada**

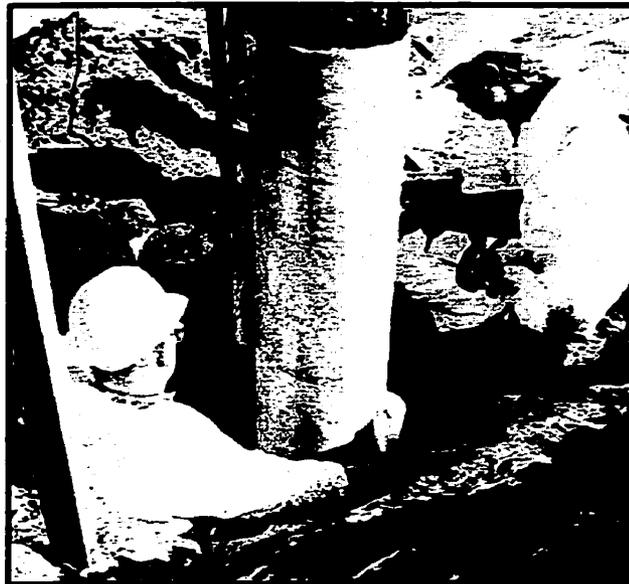
*Figure 2.10 – PoleCares Fibertect system (SPI Composites Institute, 1995).*

More recently, several companies have designed composite systems for pole repair. PoleCare Industries have developed FiberTect, as shown in Figure 2.10, a system designed to restore standing utility poles that have been weakened by decay, insect attack or structural damage and allow them to remain in service. After a pole is cleaned and treated to prevent further decay, a fibreglass fabric is wrapped around the pole, in a spiral fashion, starting 900-mm to 1220-mm below the ground up to approximately 900-mm to 1524-mm above the ground. Alternating layers of fabric and phenolic resin are applied to achieve a 10 to 13 mm composite layup. A final pigment layer is applied, and the composite cures on its own in a few hours. PoleCares claims that their system restores poles to their original strength while providing a class A fire rating on the pole wrap and preventing splitting due to seasonal changes in the dimensional structure of the pole (SPI Composites Institute, 1995).
