**Repair of Heavily Decayed Timber Piles  
Using Glass Fiber Reinforced Polymers (GFRP)  
and Cementitious Grout**

A Thesis Submitted to  
the Faculty of Graduate Studies  
in Partial Fulfillment of the  
Requirement for the Degree of

**Master of Science**

Department of Civil and Geological Engineering  
University of Manitoba  
Winnipeg, Manitoba  
Canada

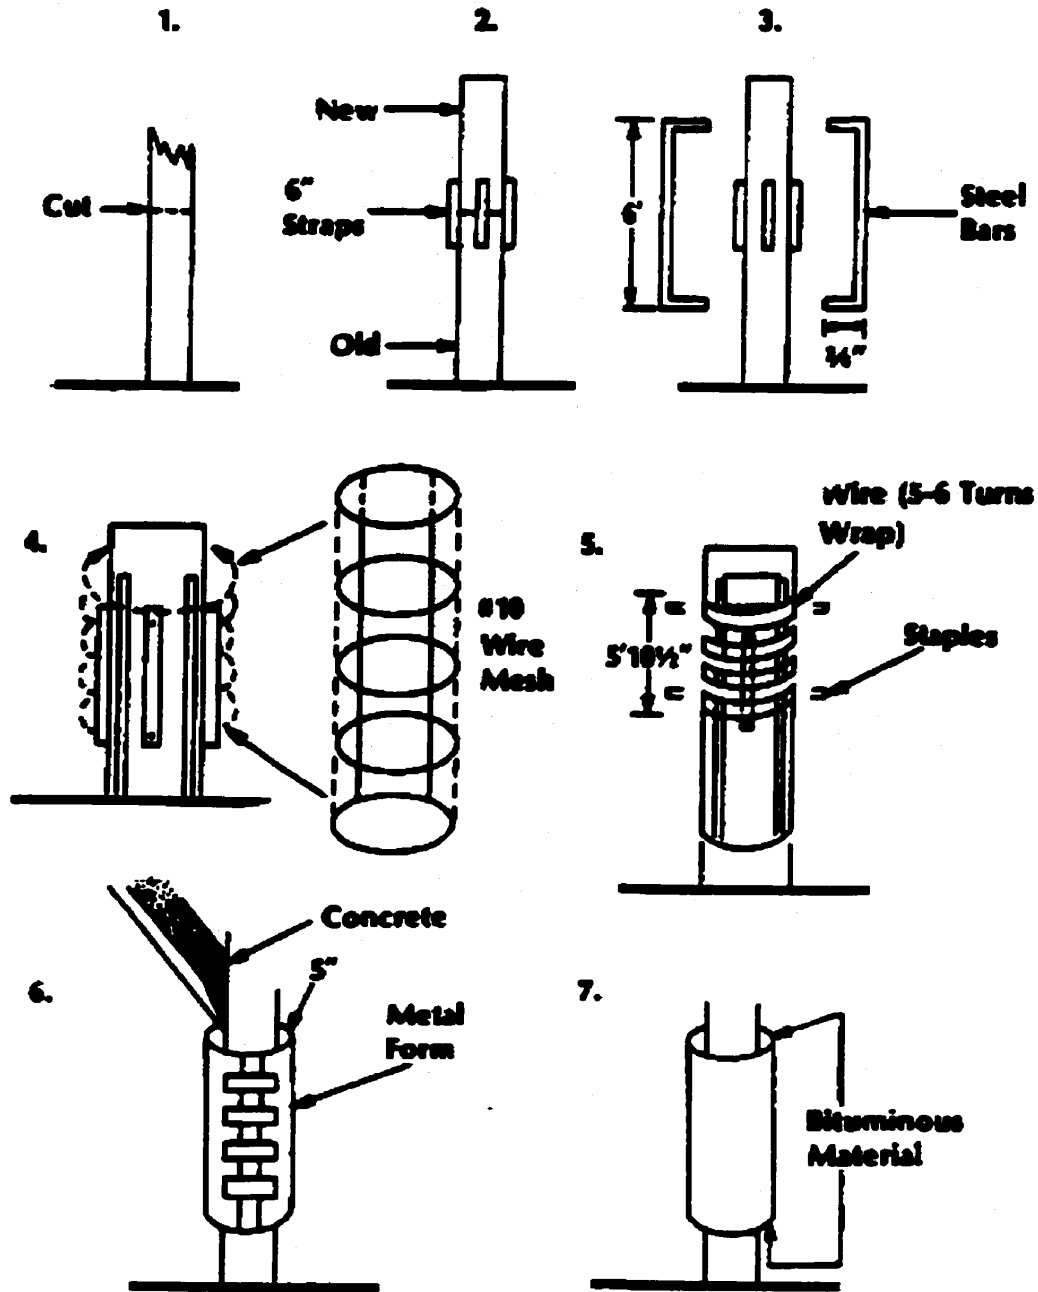
Figure 2.1: Timber Pile Repair Scheme by Splicing Using Reinforced Concrete.  
 After US ARMY FM 5-134 (1985)

Repair by pile splicing involves the addition of new materials and connectors, such as attaching a new section of timber pile to the existing pile, bolting or splicing sections of steel, or adding steel or timber bracing. A typical splicing repair scheme is shown in steps one through seven in Figure 2.1. As shown in Figure 2.1, the deteriorated upper portion of the pile is removed and a new section of pile is installed and spliced to the existing timber below. If long, unsupported piles are spliced using new timber, the flexural strength at the splice is typically much less than that of the original pile. A stronger splice can be obtained with a reinforced concrete encasement as shown in Figure 2.1 US ARMY Field Manual (1985). However, the complexity of the technique,

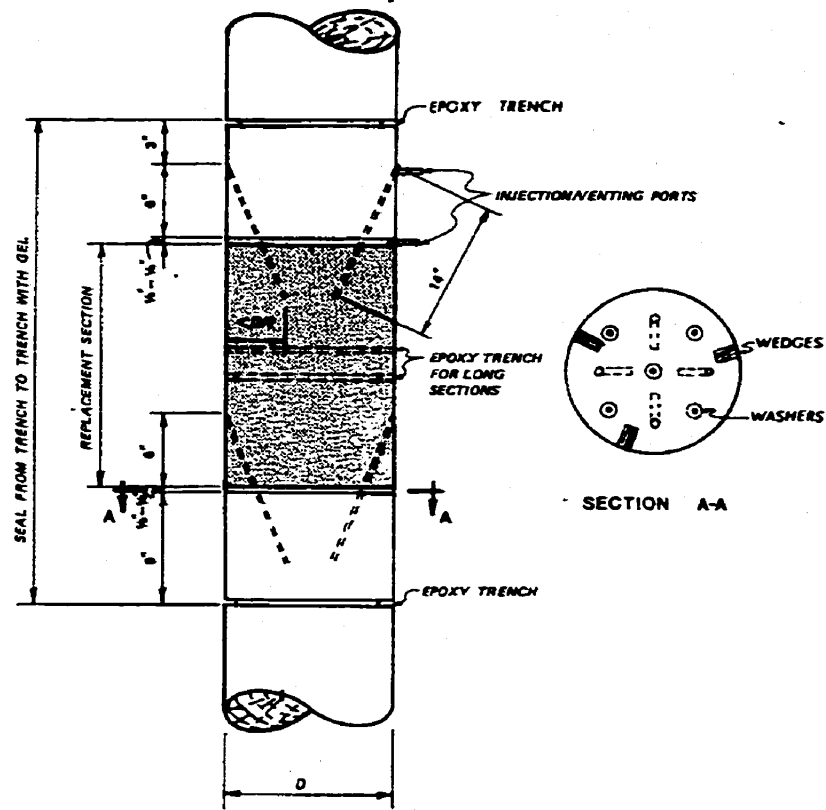
Figure 2.2: Schematic of Cutting and Posting Timber Pile Repair (Avent, 1986)

Cutting and posting is a repair technique that is similar to pile splicing, and involves cutting out the damaged section of pile and replacing it with a new section of timer pile. The extent of damage in the existing pile is first determined by drilling. The deteriorated pile section is then cut perpendicular to the longitudinal axis of the pile and removed. A jack is used to provide temporary support to the structure above. A new length of timber pile of similar diameter is then cut and placed into position, as shown in Figure 2.2. The new piece of timber is spiked or bolted to the existing pile and a relatively weak connection is formed. In order to increase the capacity of the repaired pile, a low viscosity epoxy may be pressure injected through a predrilled port connecting the new piece to the existing timber pile, as shown in Figure 2.2.

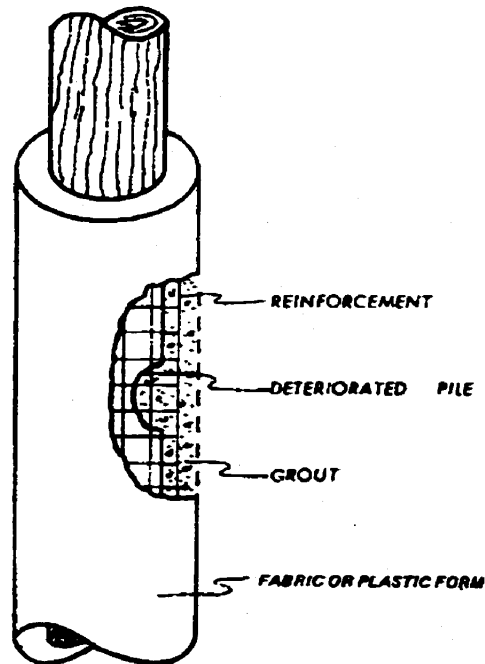
Figure 2.3: Reinforced Concrete Jacketed Timber Pile (Avent, 1986)

Reinforced concrete jackets have also been used to repair damaged timber piles. As shown in Figure 2.3, reinforcement is first placed in the annular space between the deteriorated timber pile and the formwork, followed by concrete injection. Concrete jackets have also been formed using a 25 mm – 50 mm thick coating of shotcrete reinforced with a wire mesh. In addition, precast concrete jackets have also been used for timber pile repair applications.

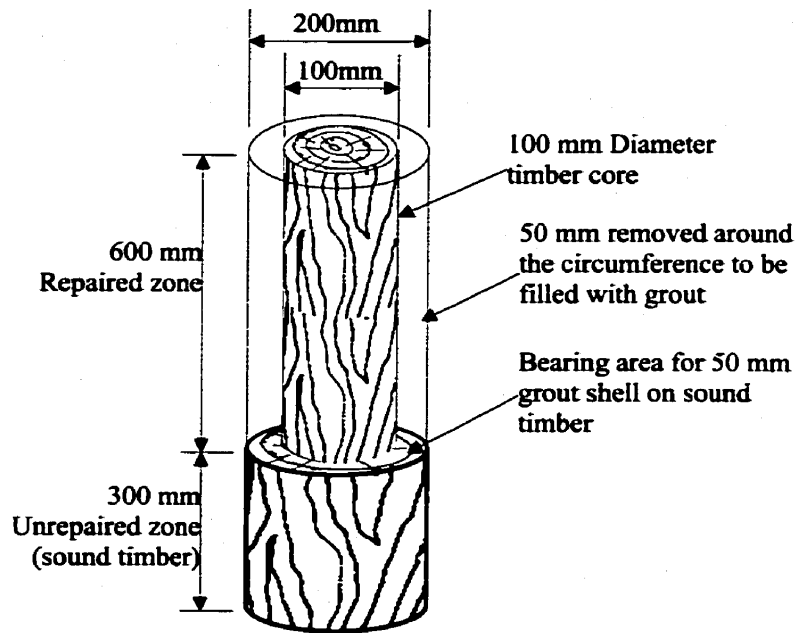
*Figure 3.1(a): Schematic of Bearing Specimens before Grout Injection and GFRP Wet-Wrap Application*

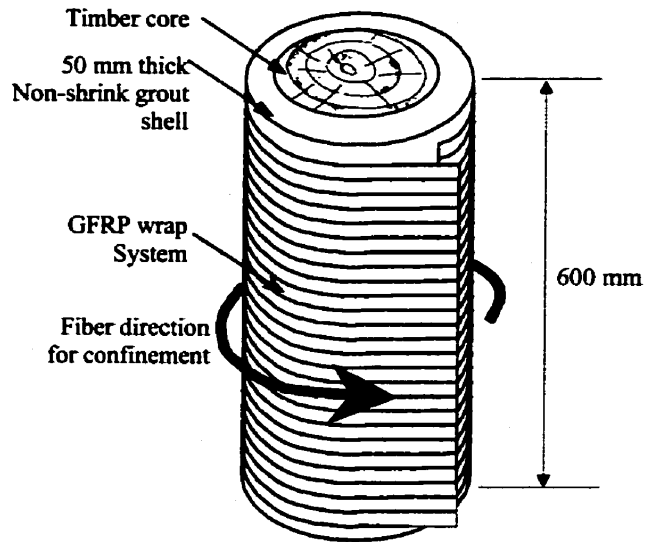
*Figure 3.1(b): Schematic of Repair Technique Using GFRP Wet-Wrap Sheets*

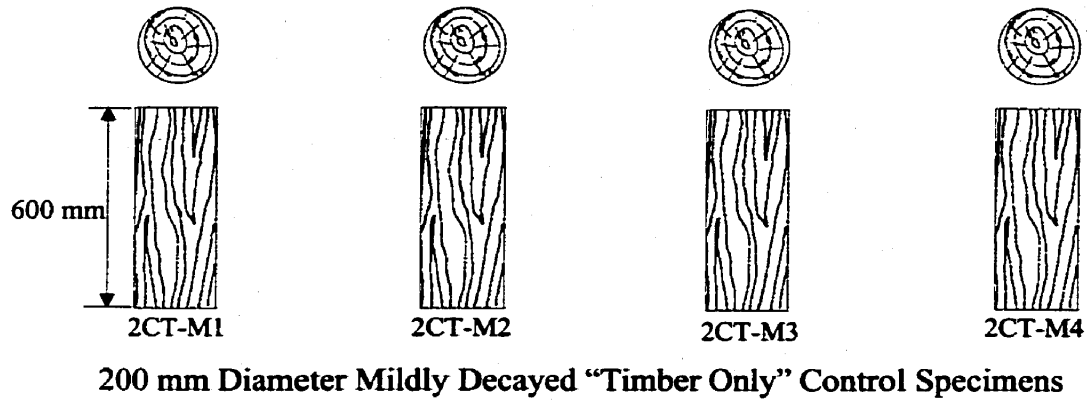
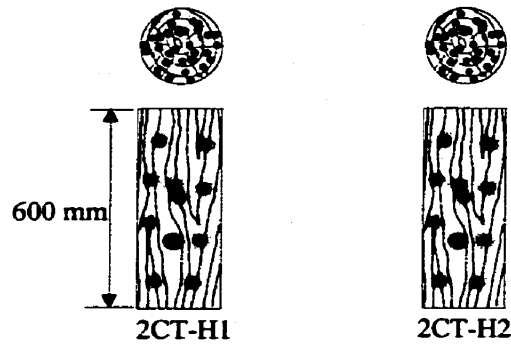
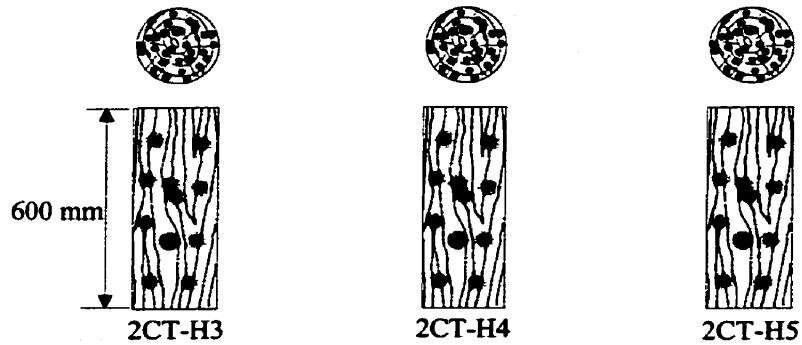
200 mm Diameter Heavily Decayed "Timber Only" Control Specimens

Figure 3.3: 200 mm Diameter "Timber Only" Control Specimens

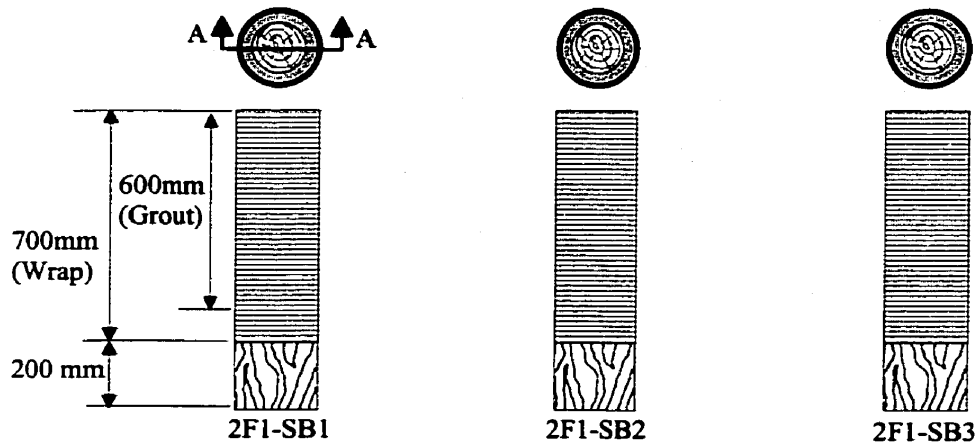
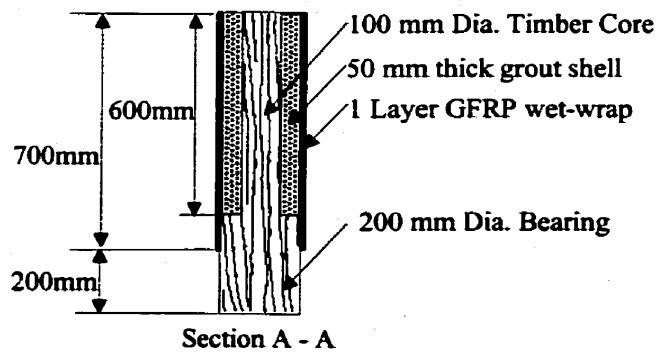
200 mm Diameter Specimens with Bearing Surface Strengthened

Figure 3.5: 200 mm Diameter Bearing Specimens

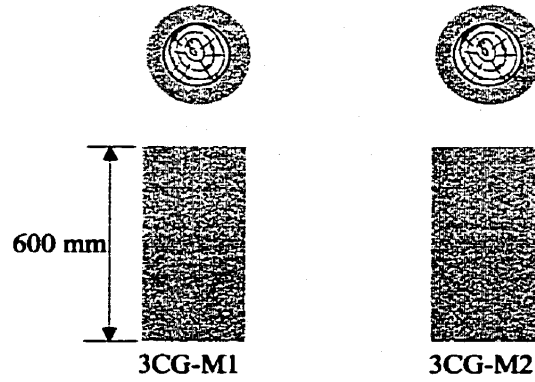
Figure 3.6: 300 mm Diameter "Grout Only" Control Specimens

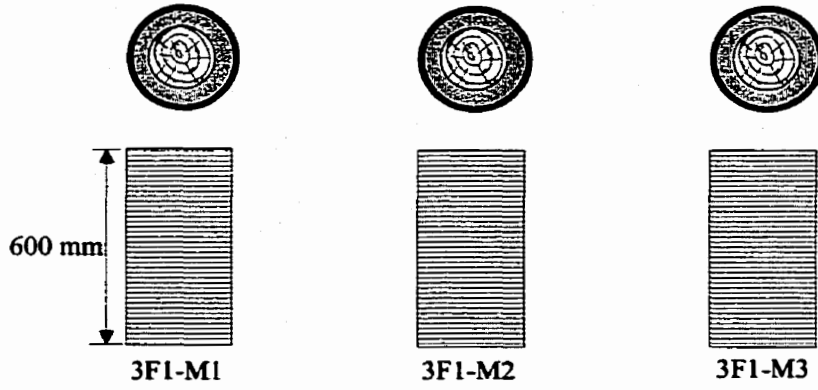
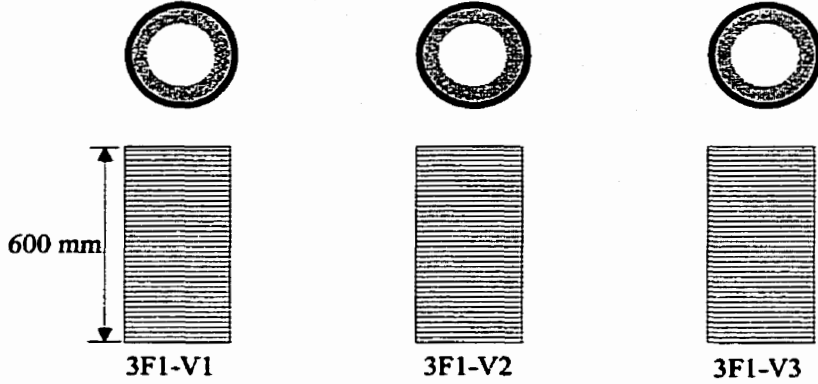
300 mm Diameter Piles with 200 mm Diameter Mildly Decayed Timber Core

300 mm Diameter Piles with 200 mm Diameter Void Core

Figure 3.7: 300 mm Diameter Single Layer GFRP Wet-Wrap Specimens

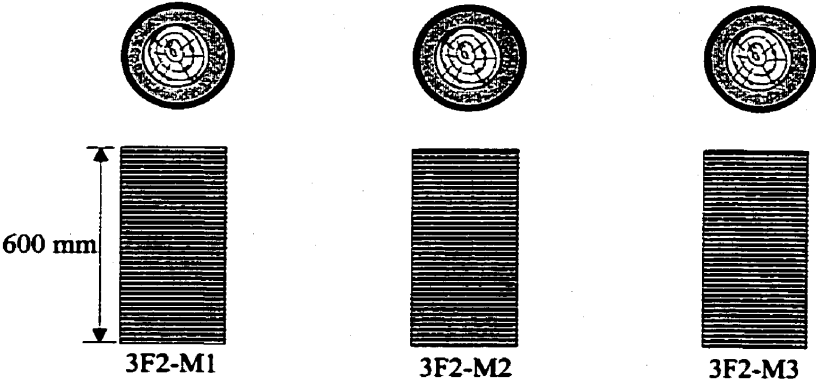
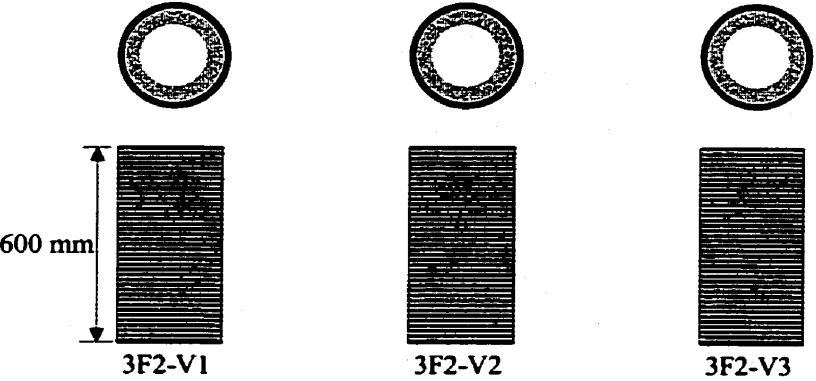
300 mm Diameter Piles with 200 mm Diameter Mildly Decayed Timber Core

300 mm Diameter Piles with 200 mm Diameter Void Core

Figure 3.8: 300 mm Diameter Double Layer GFRP Wet-Wrap Specimens

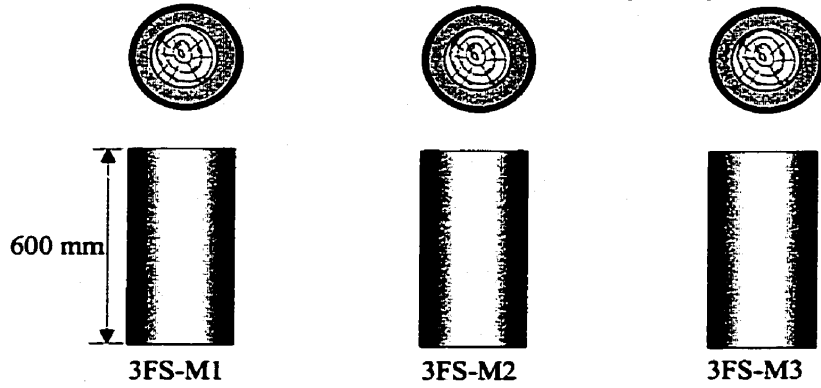
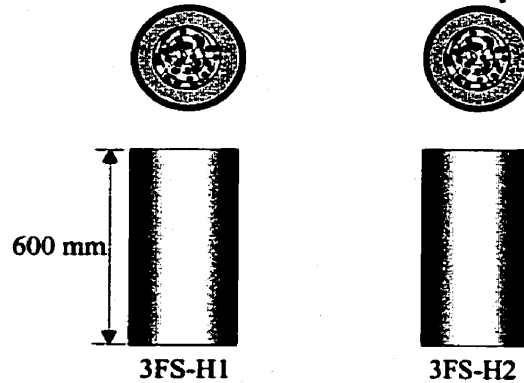
300 mm Diameter Piles with 200 mm Diameter Mildly Decayed Timber Core

300 mm Diameter Piles with 200 mm Diameter Heavily Decayed Timber Core

Figure 3.9: 300 mm Diameter Specimens Repaired Using Prefabricated GFRP Shell

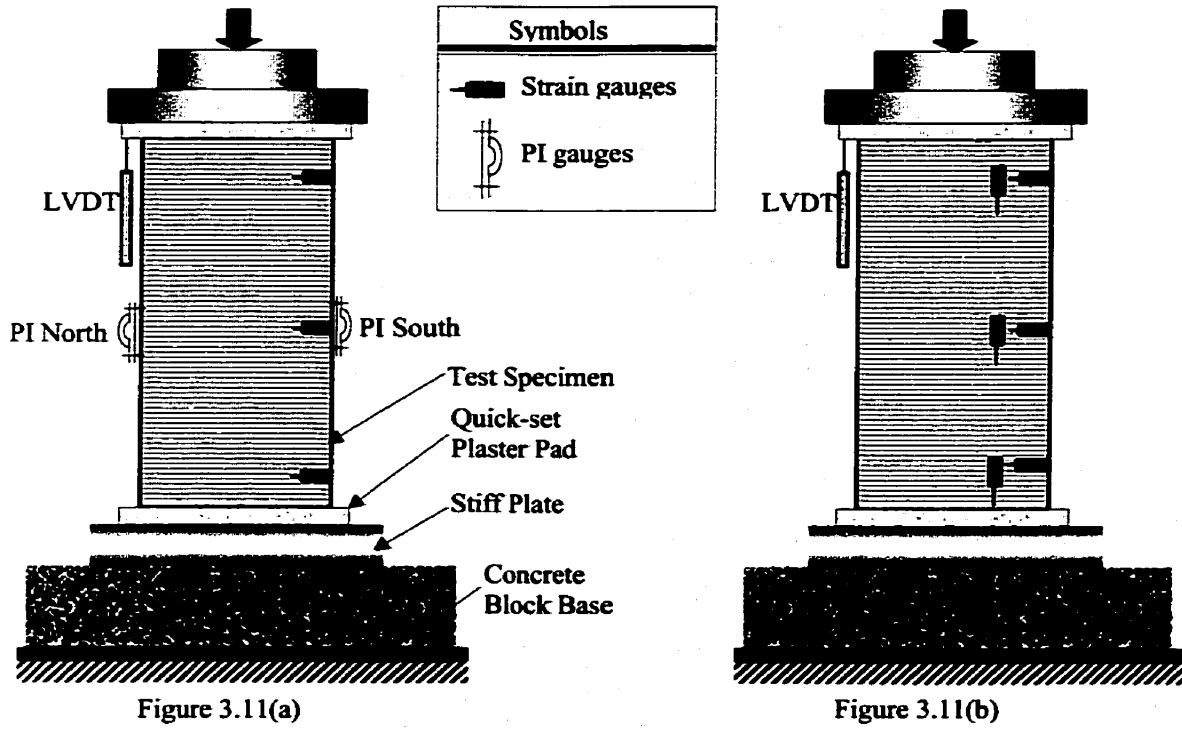
Figures 3.11(a) and (b): Schematic of Test Set-Up and Instrumentation Layout for Piles Tested in Axial Compression

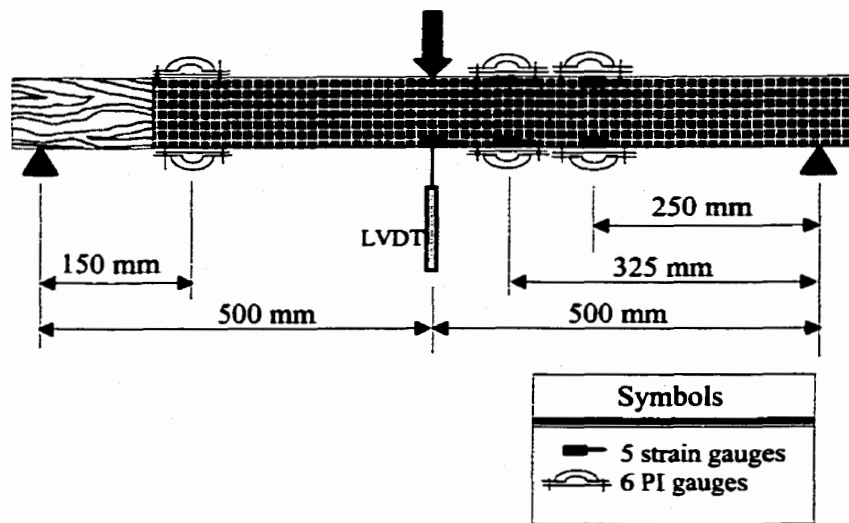
Figure 3.15(b): Instrumentation Layout for 200 mm Diameter Repaired Specimens Tested in Bending

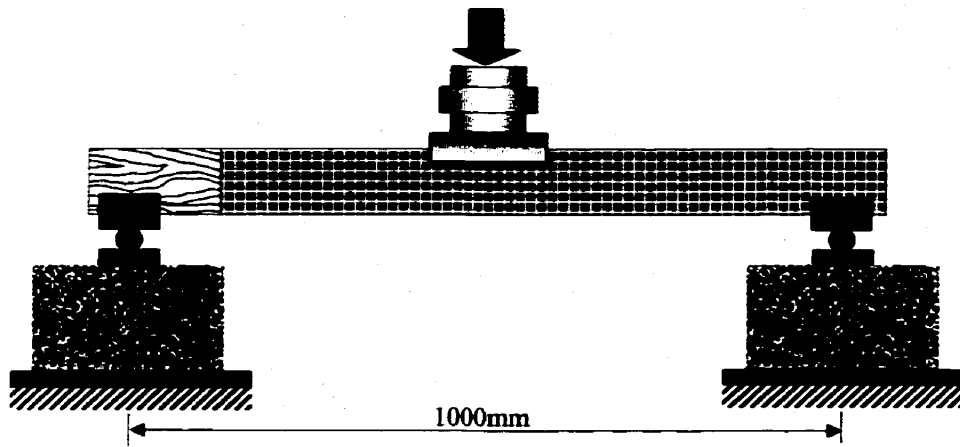
*Figure 3.16: Schematic of Test Set-Up for Piles Tested in Bending*

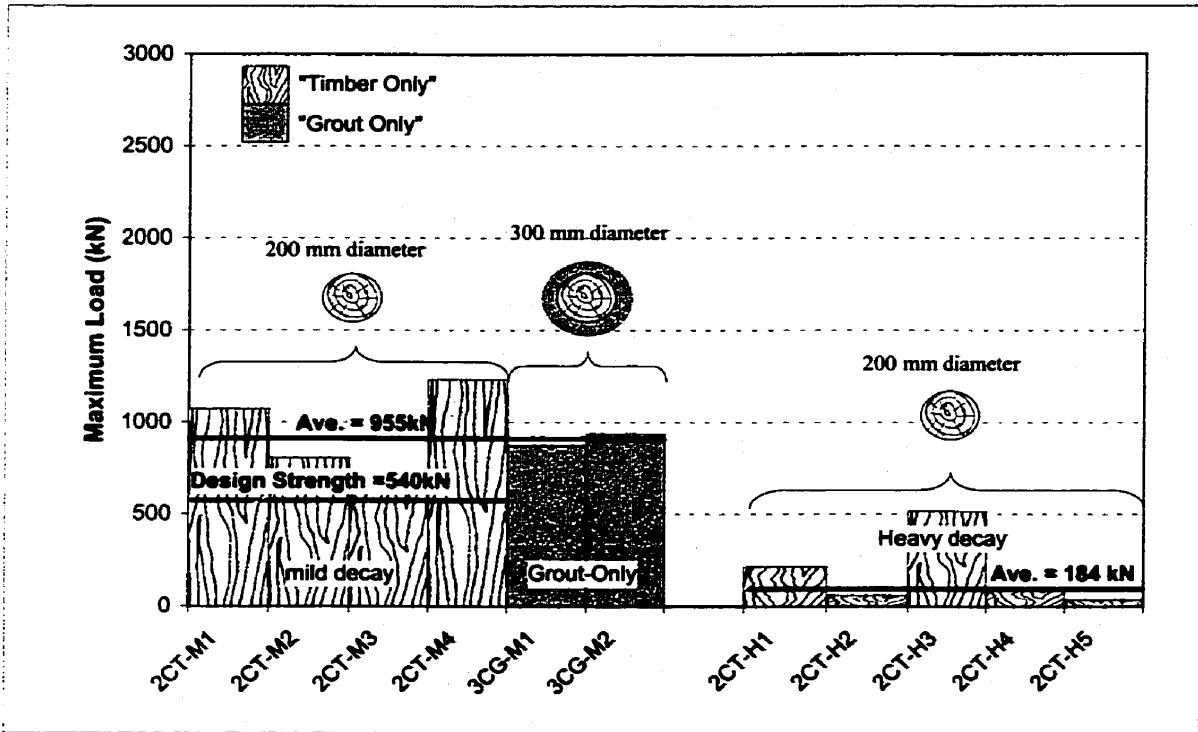
Figure 4.1(a): Maximum Load for all Control Pile Specimens

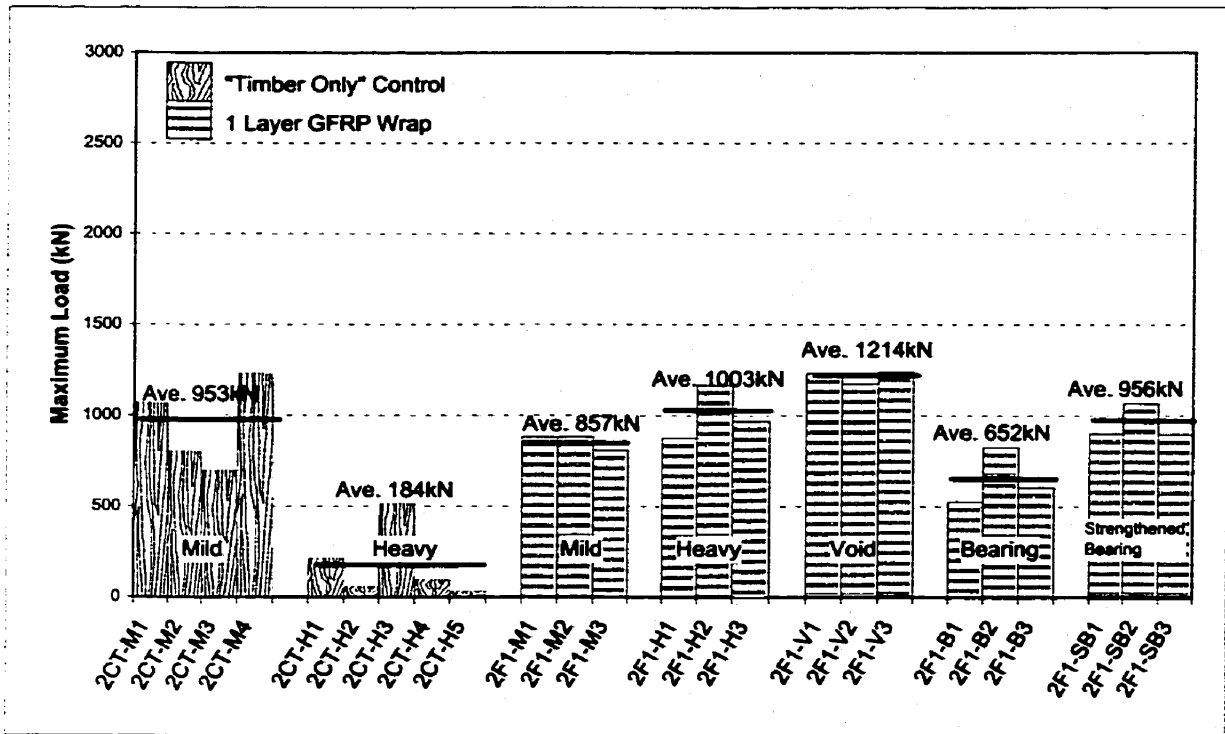
Figure 4.1(b): Summary of Test Results for 200 mm Overall Diameter Piles

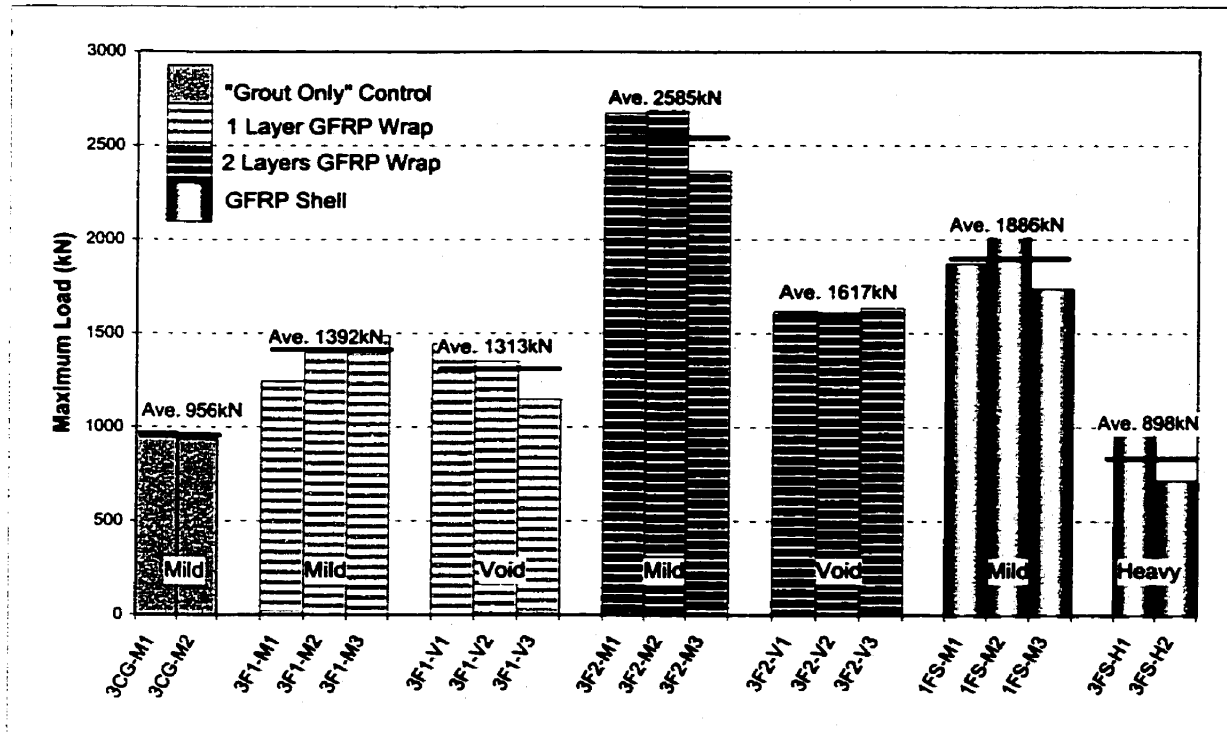
Figure 4.1(c): Summary of Test Results for 300 mm Overall Diameter Piles

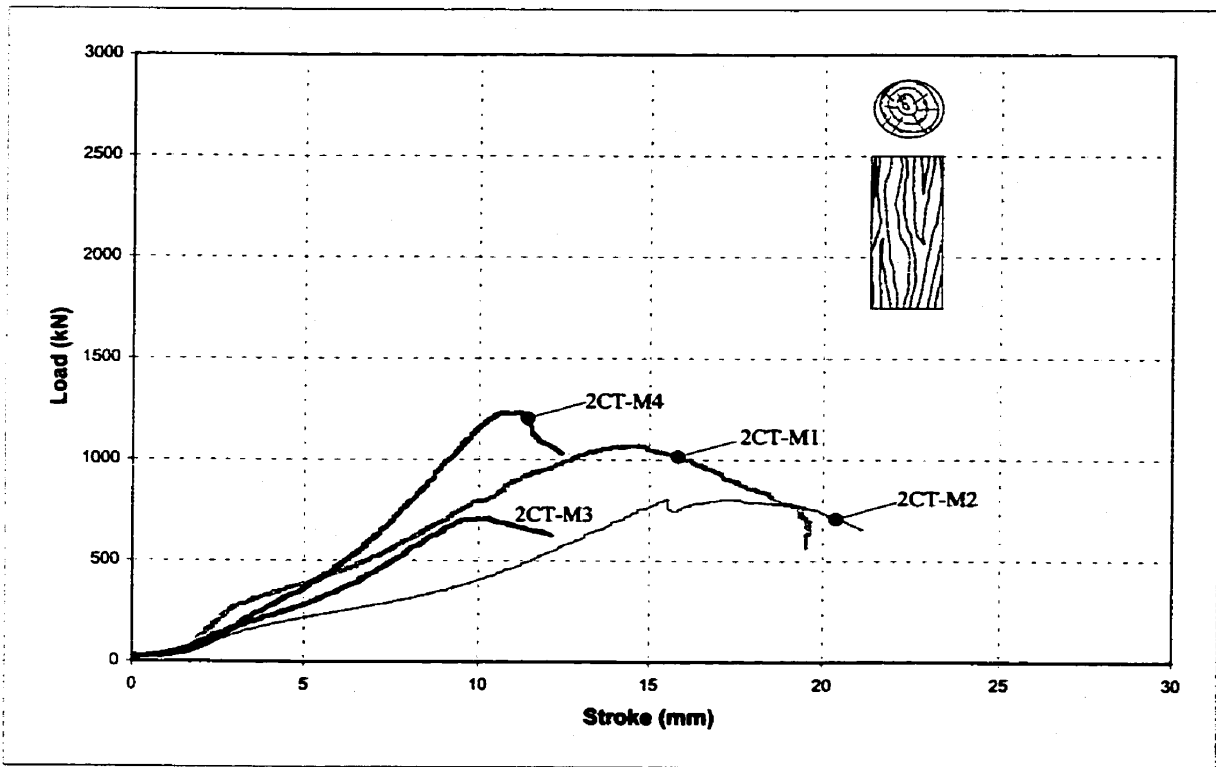
Figure 4.2(a): Load vs Stroke for Mildly Decayed "Timber Only" Control Specimens

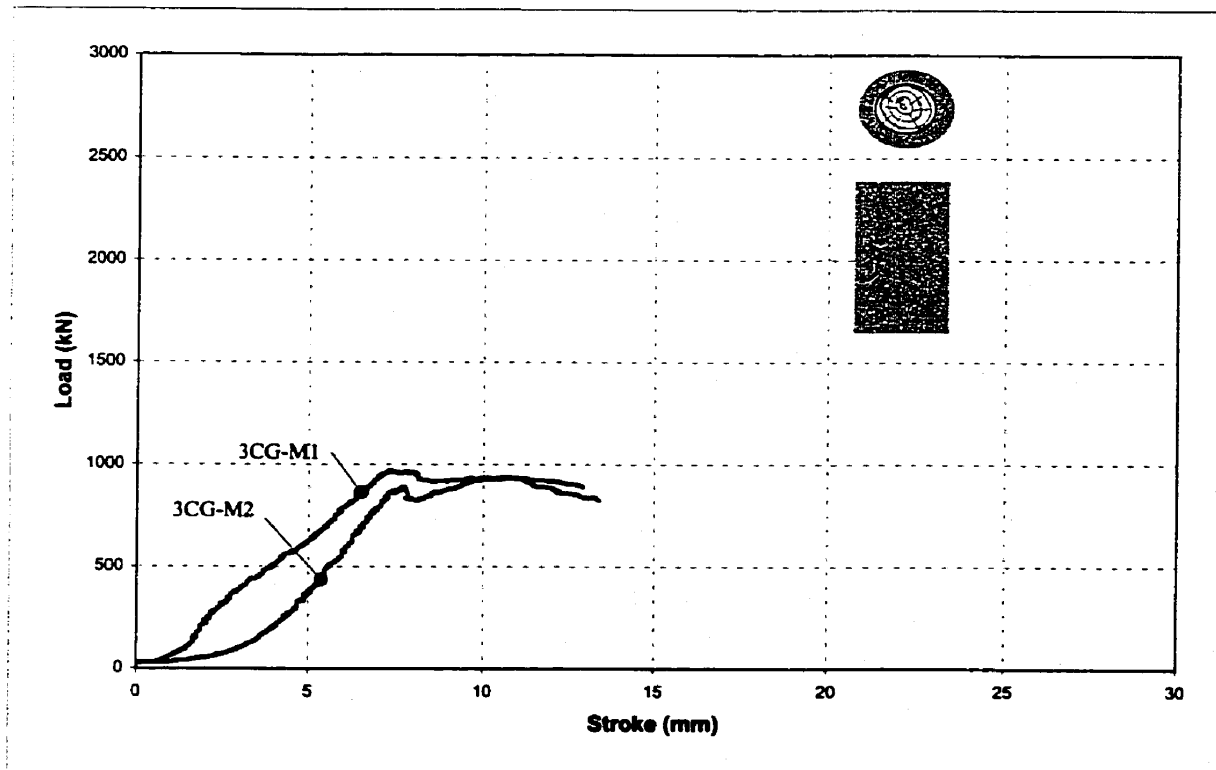
Figure 4.2(b): Load vs Stroke for "Grout Only" Control Specimens

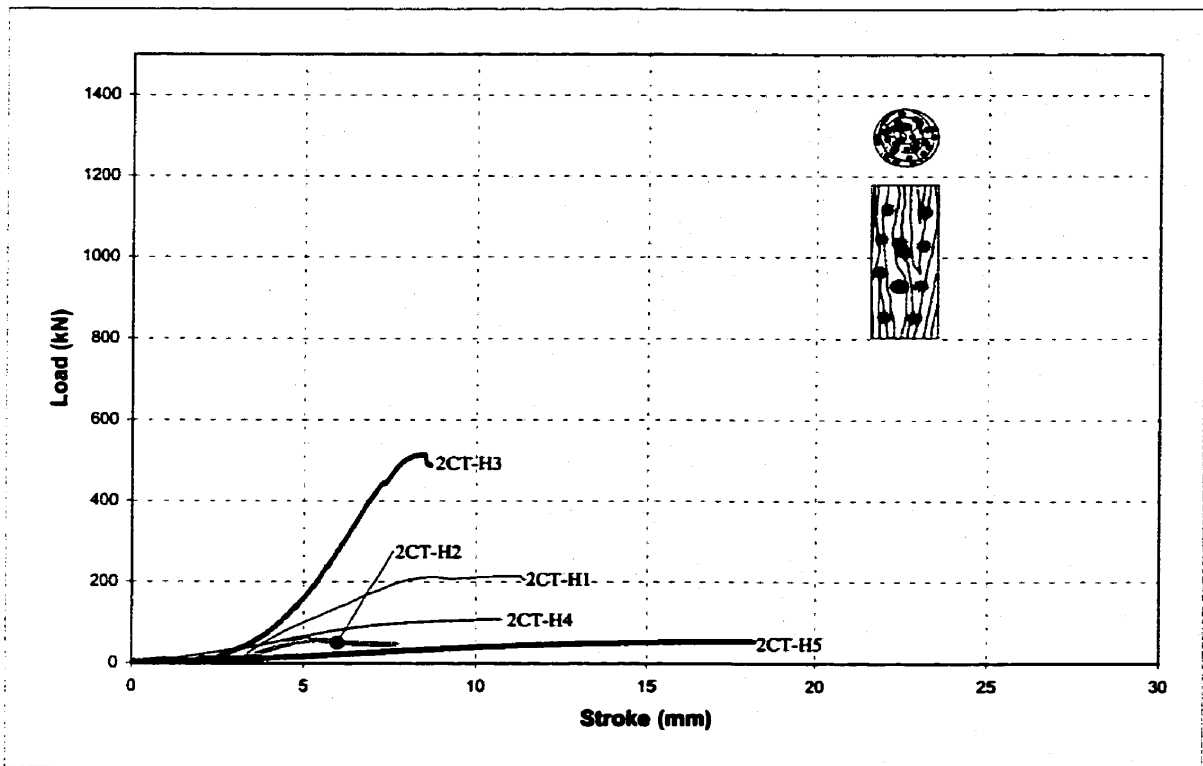
Figure 4.2(c): Load vs Stroke for Heavily Decayed "Timber Only" Control Specimens

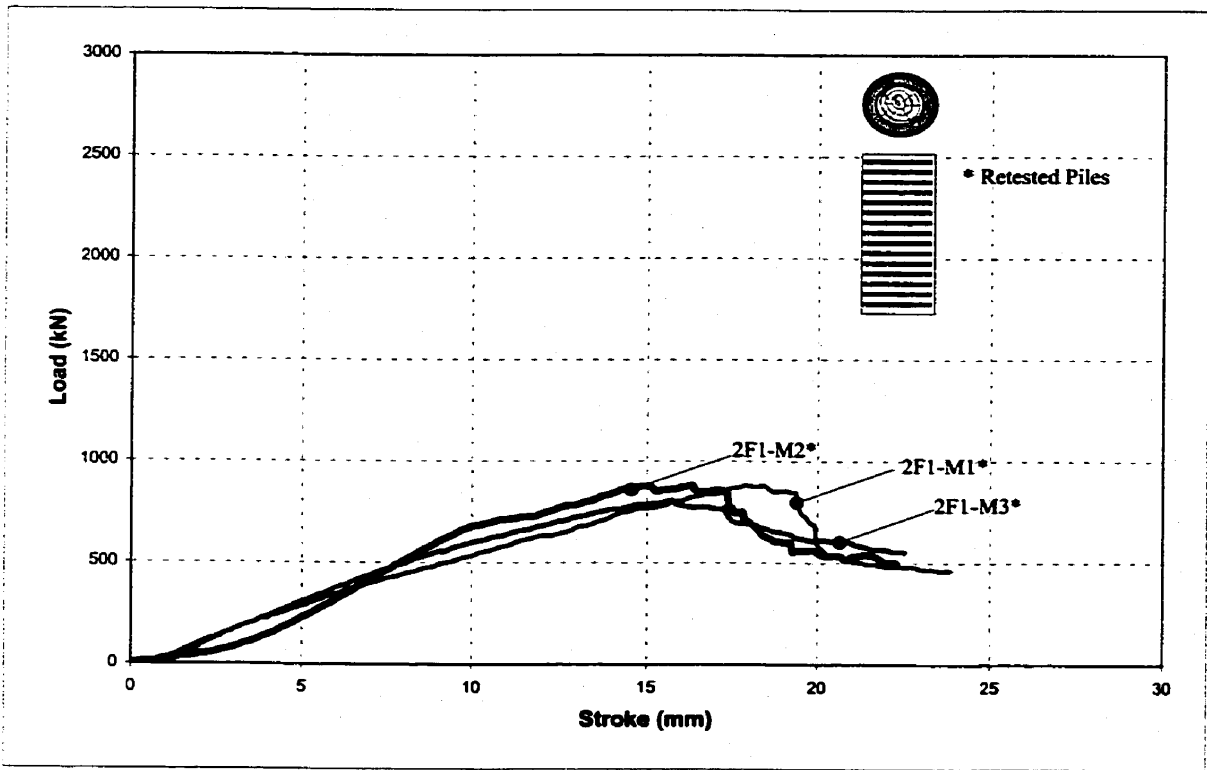
Figure 4.5(a): Load vs Stroke for Piles with a Single Layer of GFRP Wrap and Mildly Decayed Timber Core

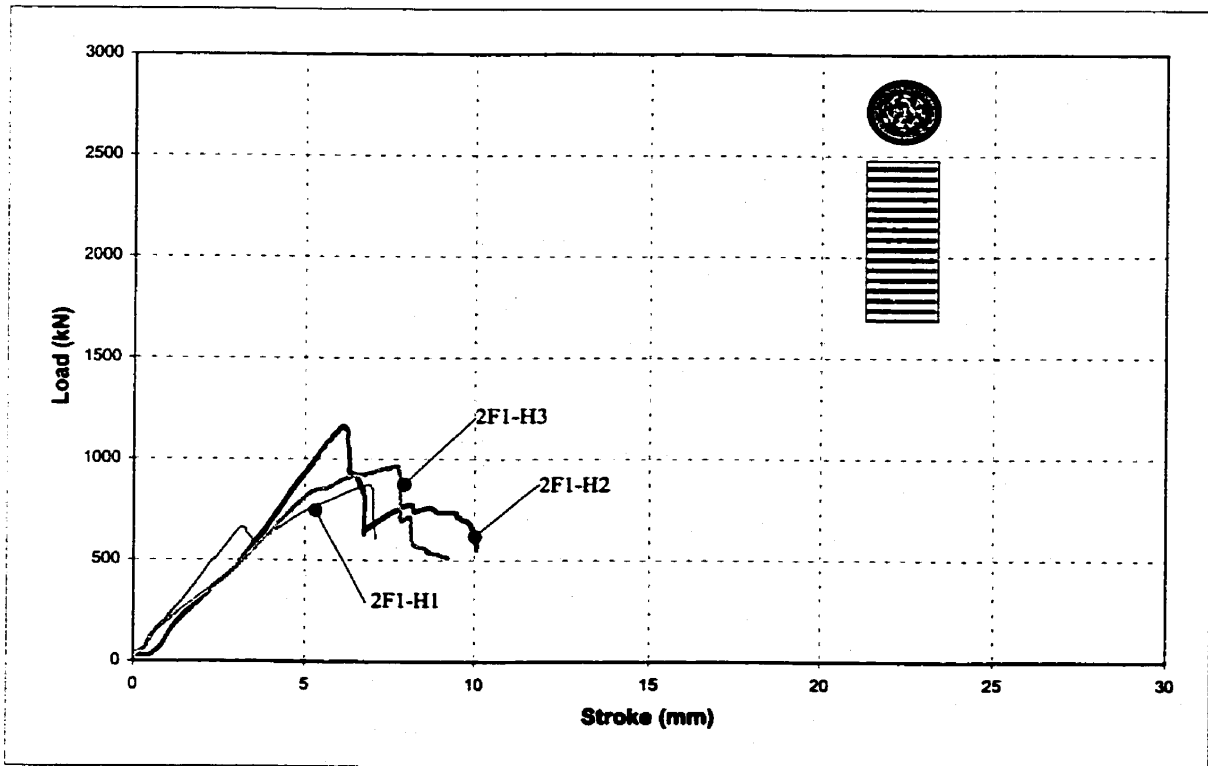
Figure 4.5(b): Load vs Stroke for Piles with a Single Layer of GFRP Wrap and Heavily Decayed Timber Core

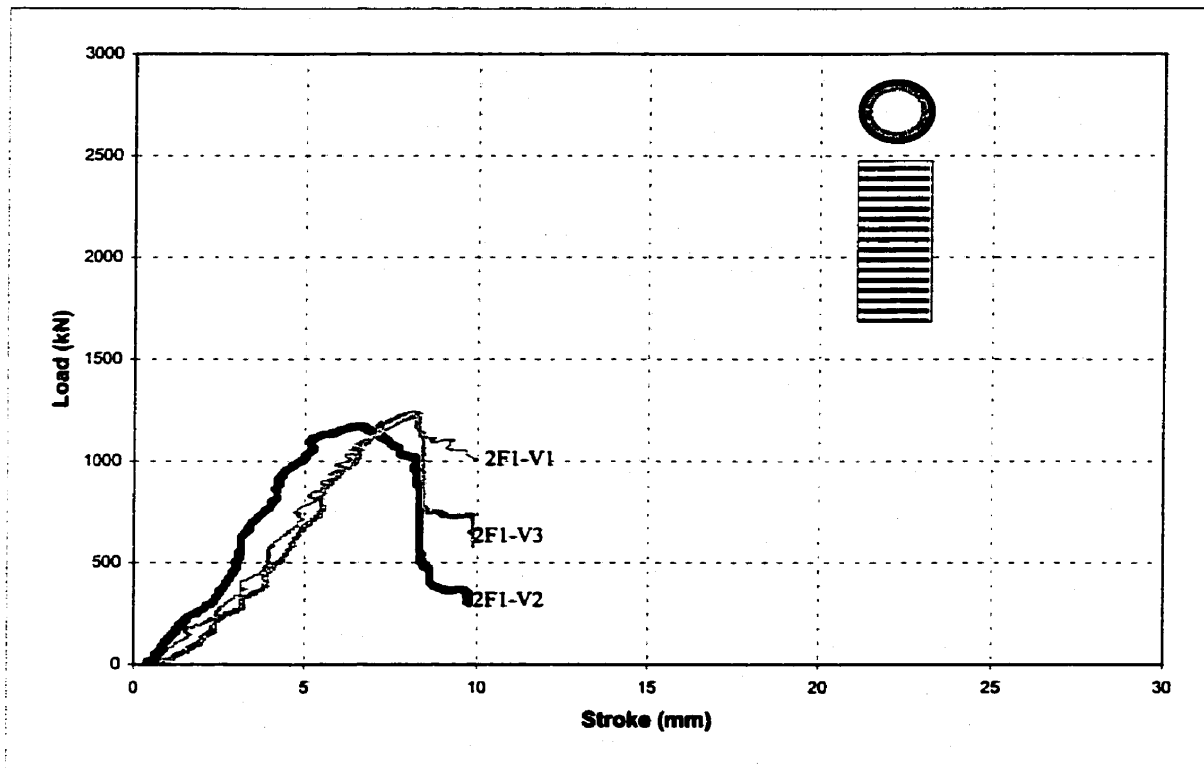
Figure 4.5(c): Load vs Stroke for Piles with a Single Layer of GFRP Wrap and Void Core

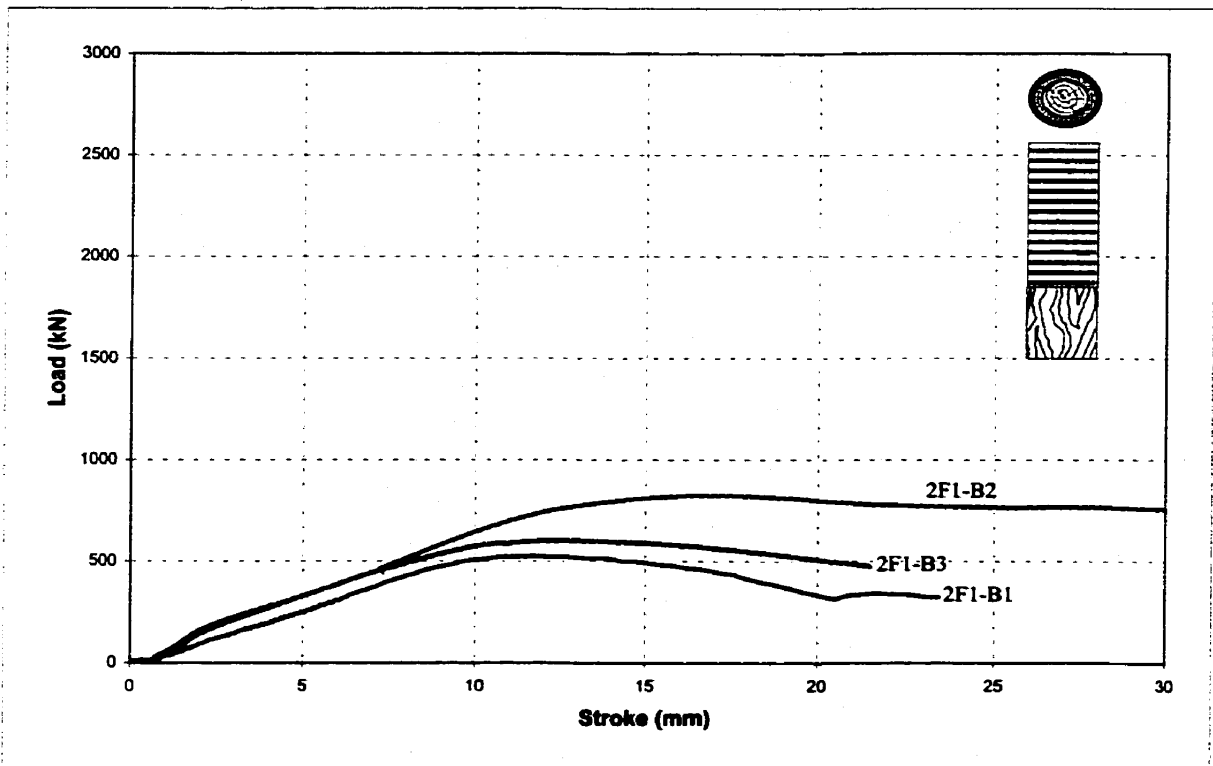
Figure 4.6(a): Load vs Stroke Curves for Bearing Specimens

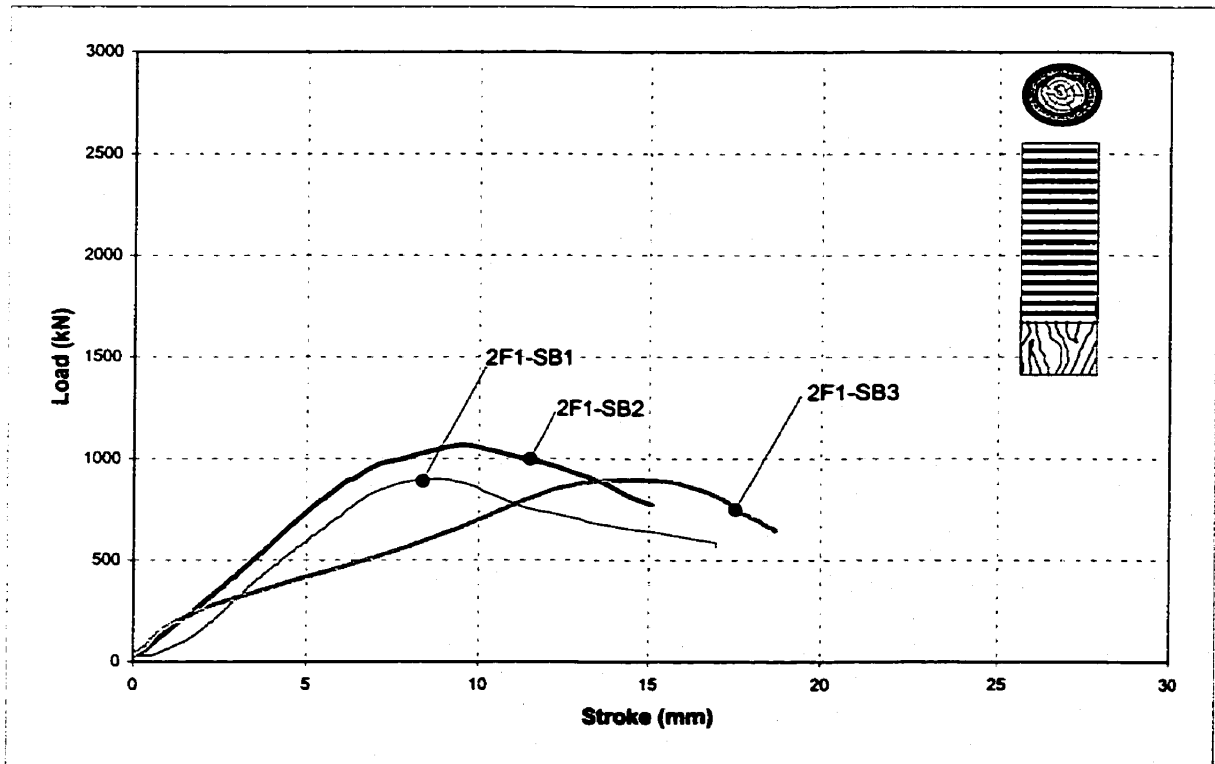
Figure 4.6(b): Load vs Stroke Curves for Piles with Strengthened Bearing Surface

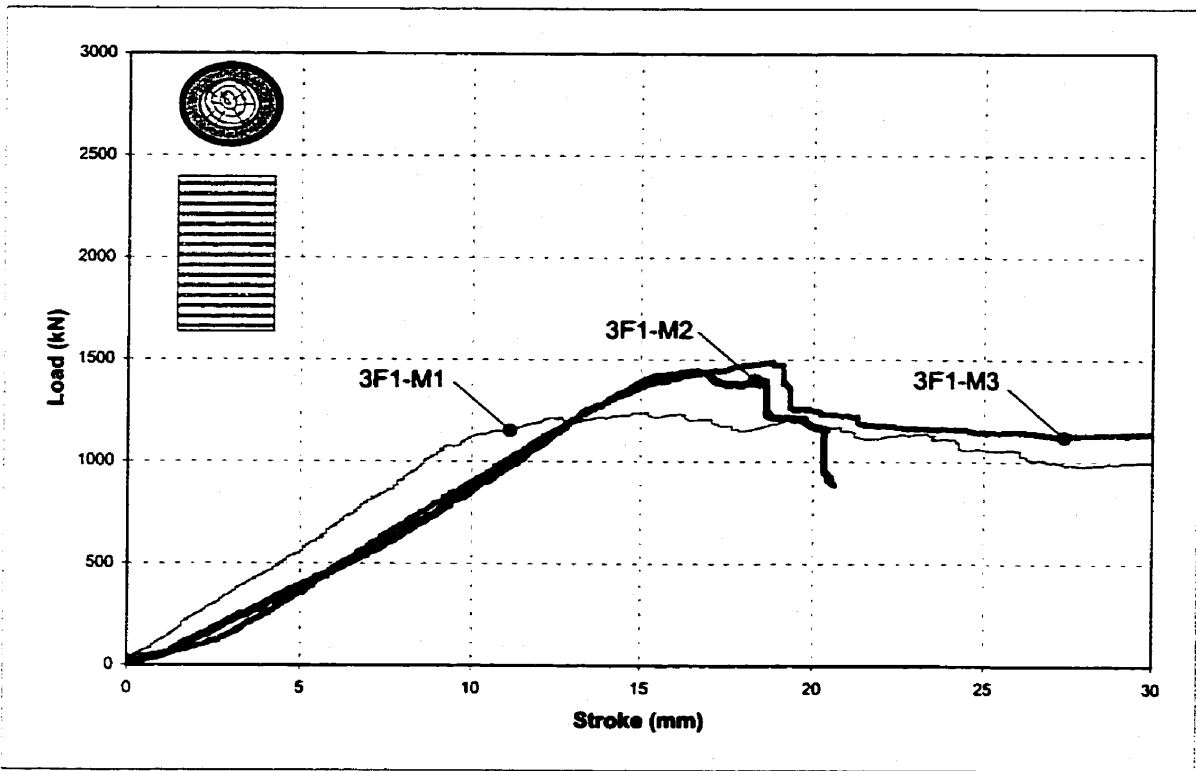
Figure 4.9(a): Load vs Stroke for 300 mm Diameter Piles with a Single Layer of GFRP Wrap and Mildly Decayed Timber Core

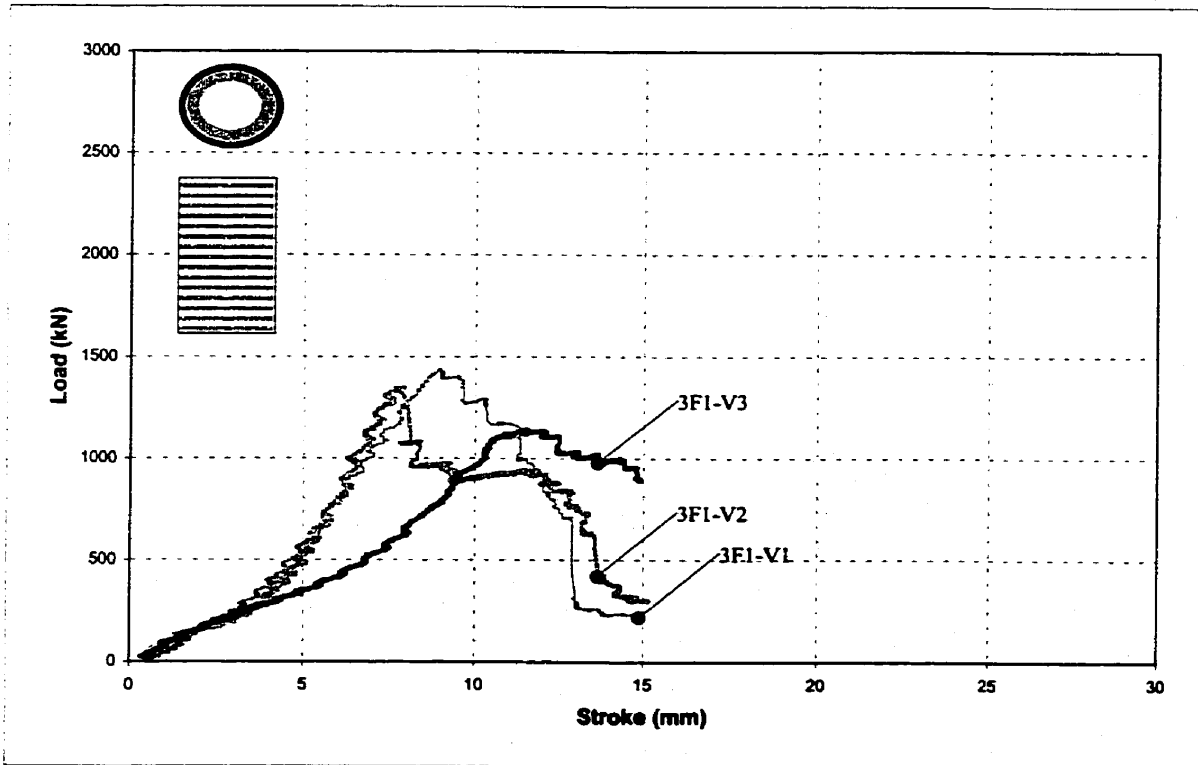
Figure 4.9(b): Load vs Stroke for 300 mm Diameter Piles with a Single Layer of GFRP Wrap and Void Core

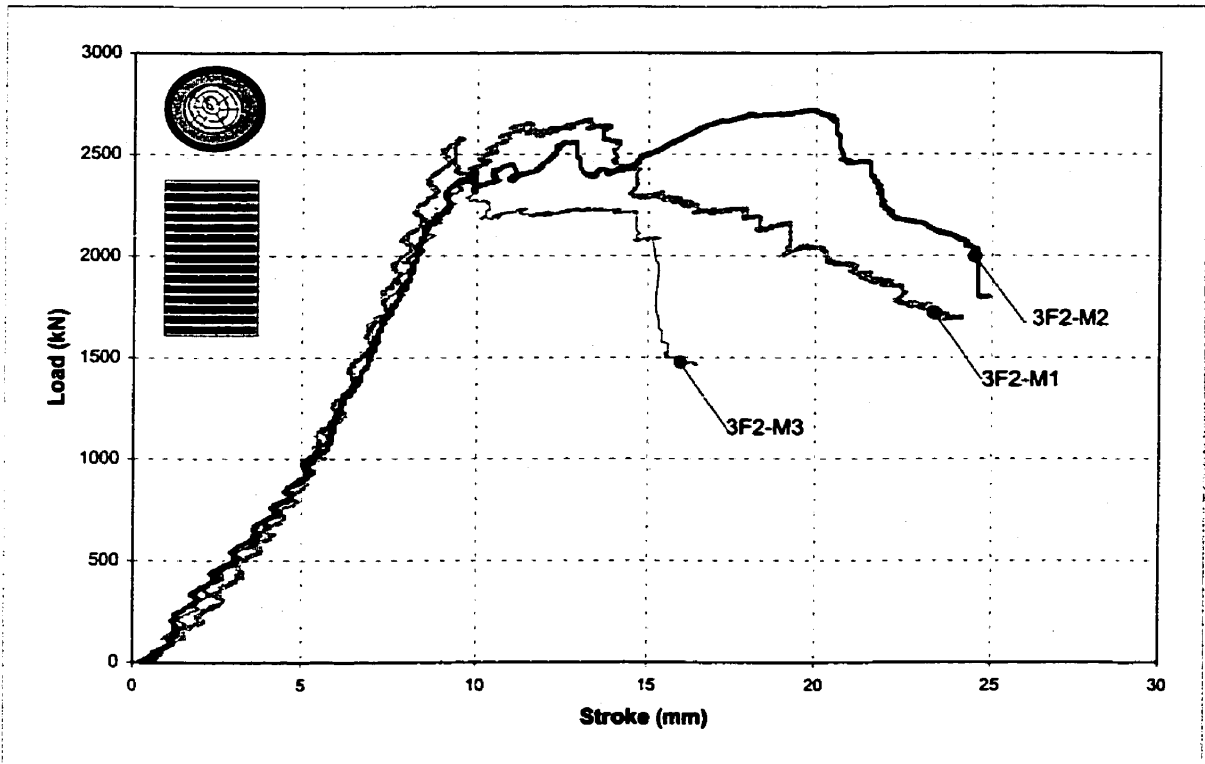
Figure 4.10(a): Load vs Stroke for 300 mm Diameter Piles with a Double Layer of GFRP Wrap and Mildly Decayed Timber Core
