**Repair of Heavily Decayed Timber Piles  
Using Glass Fiber Reinforced Polymers (GFRP)  
and Cementitious Grout**

A Thesis Submitted to  
the Faculty of Graduate Studies  
in Partial Fulfillment of the  
Requirement for the Degree of

**Master of Science**

Department of Civil and Geological Engineering  
University of Manitoba  
Winnipeg, Manitoba  
Canada

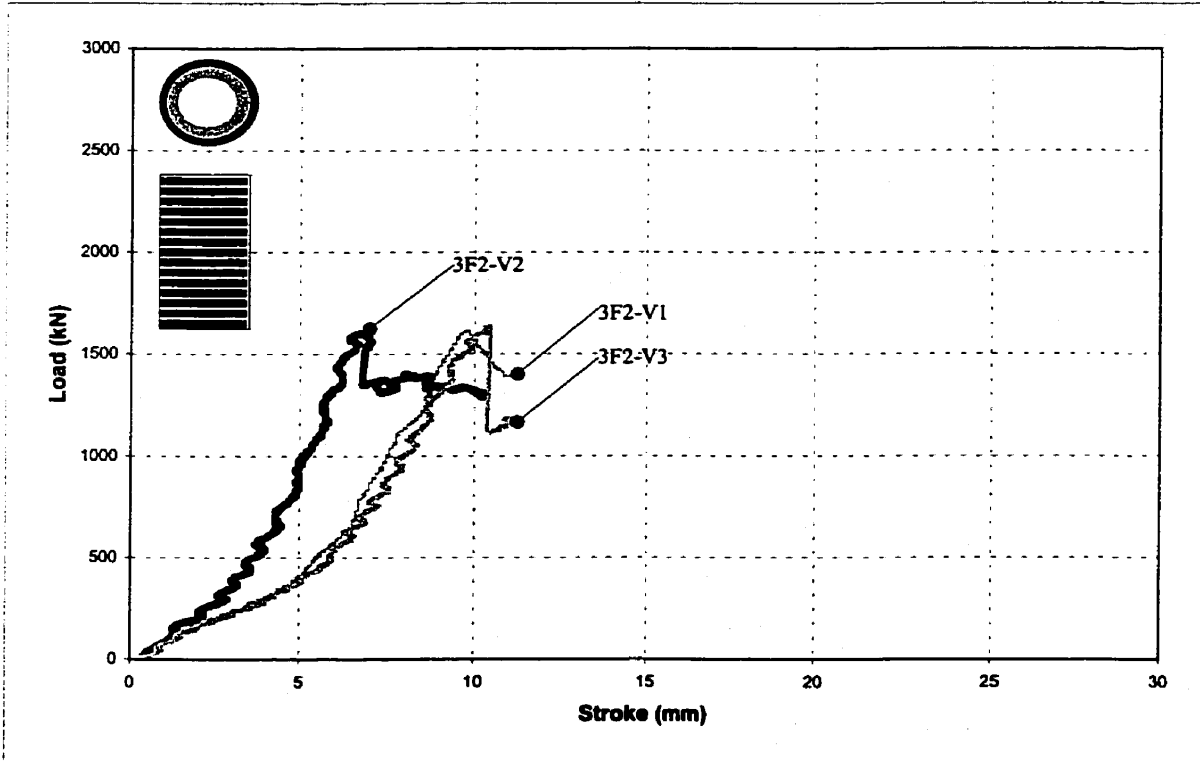
Figure 4.10(b): Load vs Stroke for 300 mm Diameter Piles with a Double Layer of GFRP Wrap and Void Core

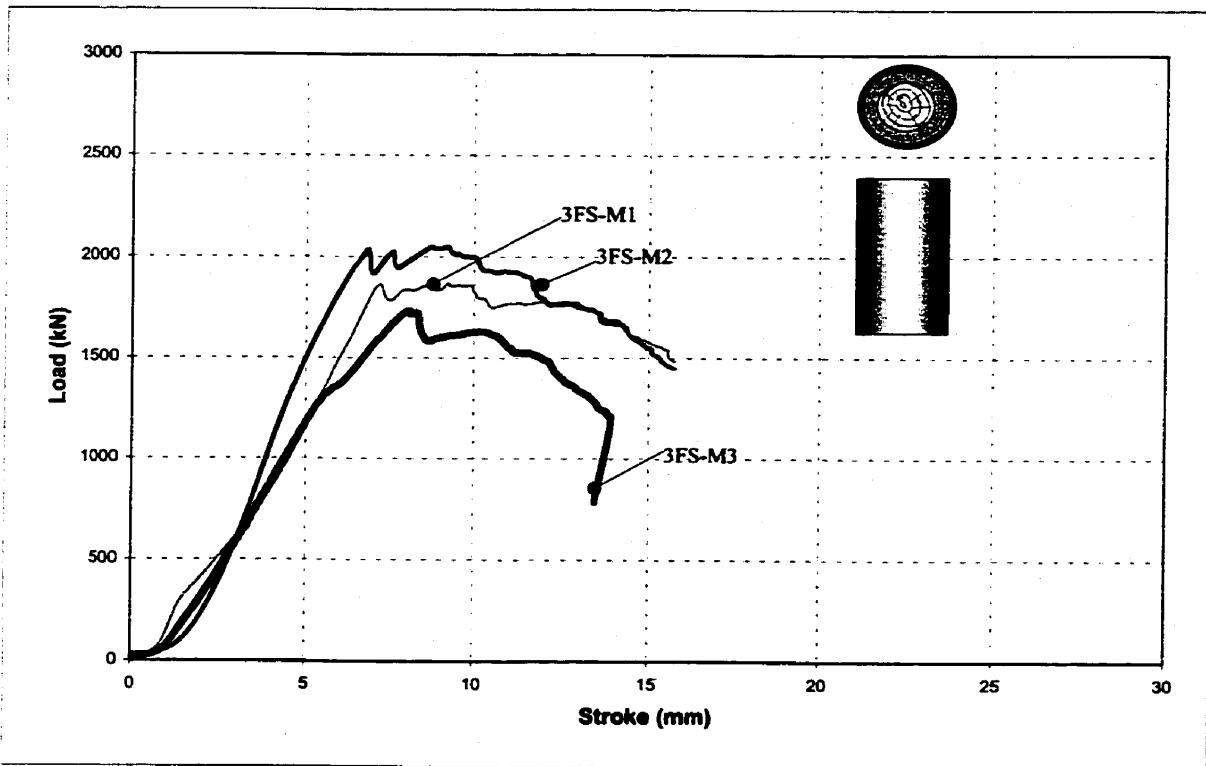
Figure 4.11(a): Load vs Stroke for 300 mm Diameter Piles With a Prefabricated GFRP Shell and Mild Decay Timber Core

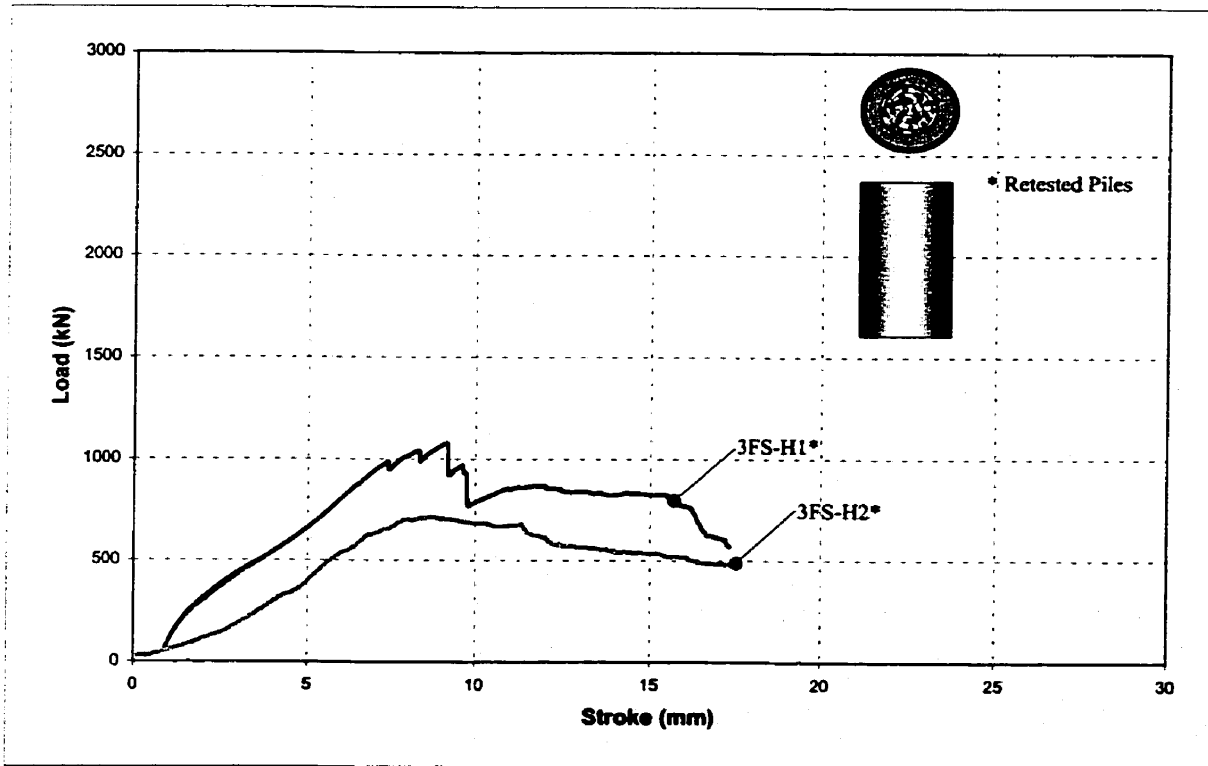
Figure 4.11(b): Load vs Stroke for 300 mm Diameter Piles With a Prefabricated GFRP Shell and Heavy Decay Timber Core

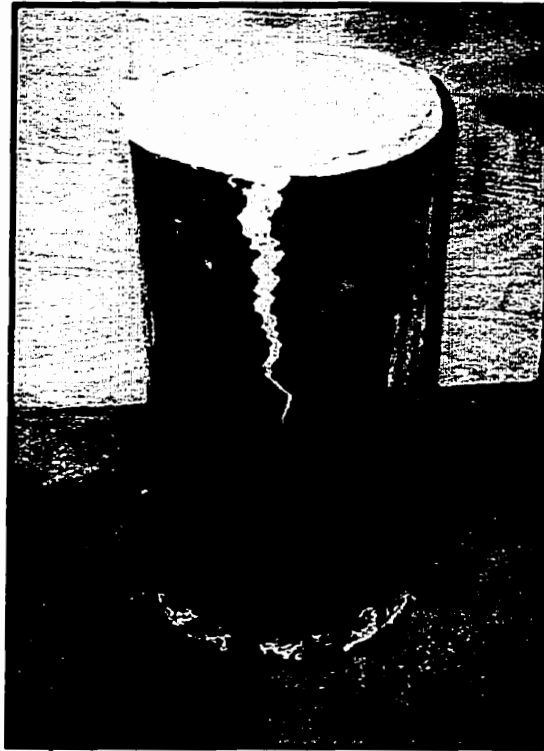
*Figure 4.15: Pile with a Prefabricated GFRP Shell After Failure.*

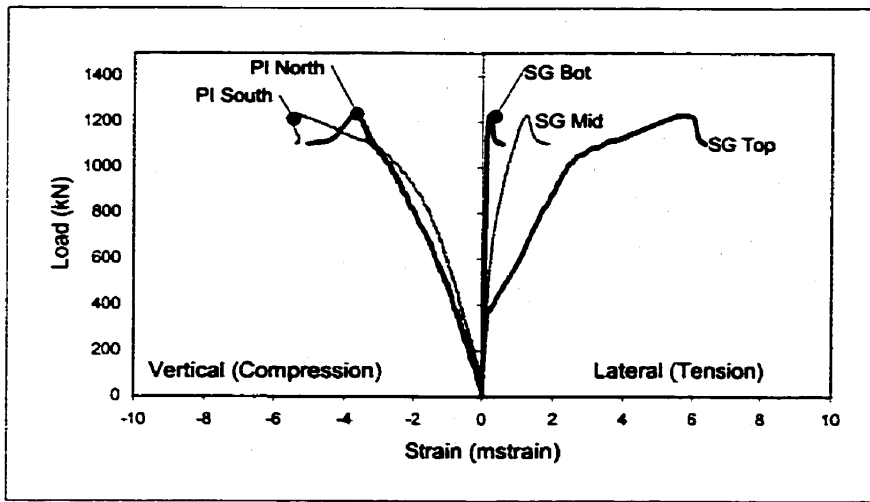
Figure 4.16(a): Load vs Strain Curves for 2F1-V1

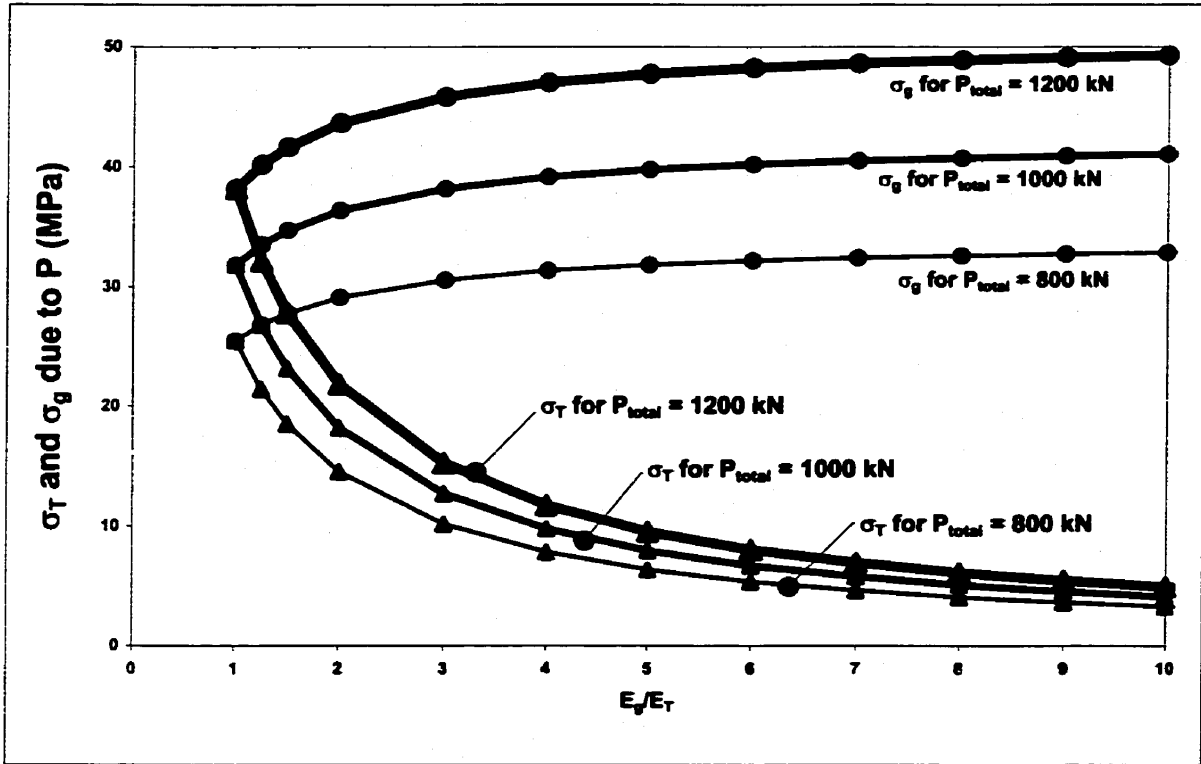
Figure 4.18: Stress in Timber Core,  $\sigma_T$ , and Grout Shell,  $\sigma_g$ , vs Material Stiffness Ratio  $E_g/E_T$

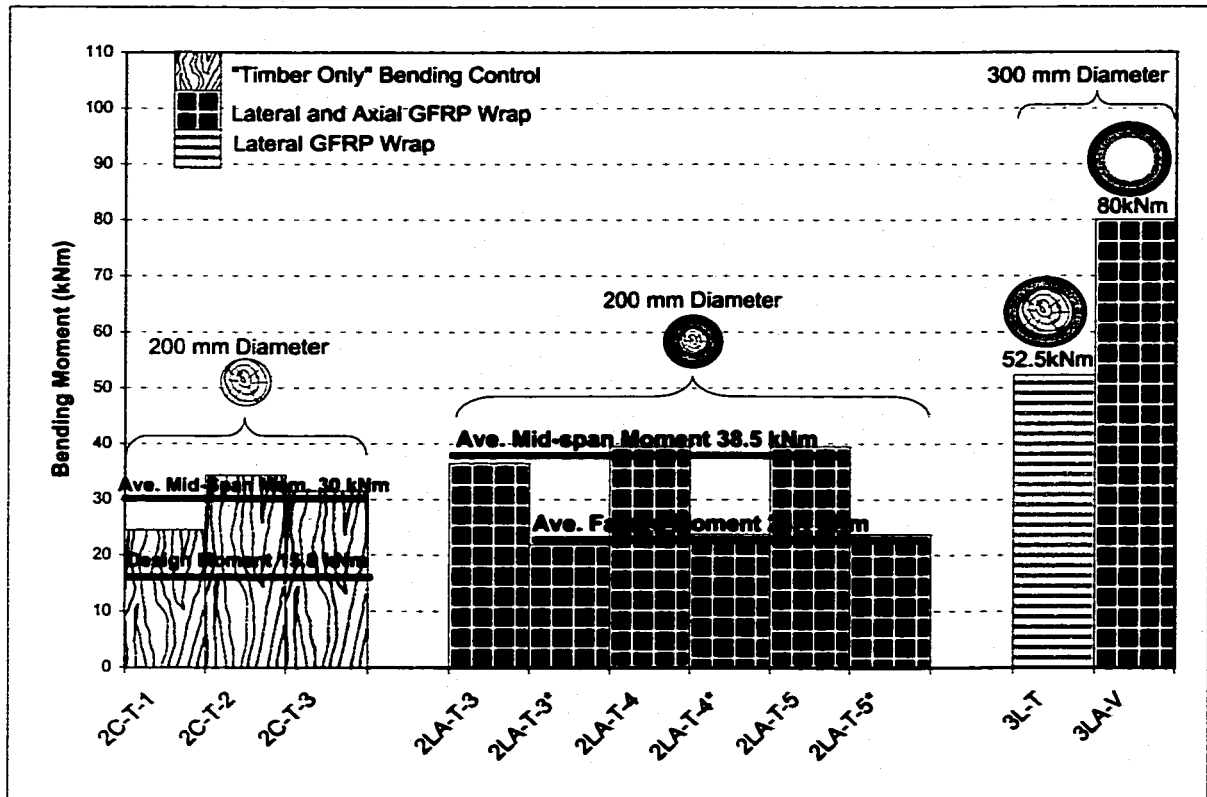
Figure 5.1: Summary of Bending Moment at Mid-Span and at Location of Failure

Note: Asterisk (\*) Denotes Bending Moment of the Specimen at Location of Failure

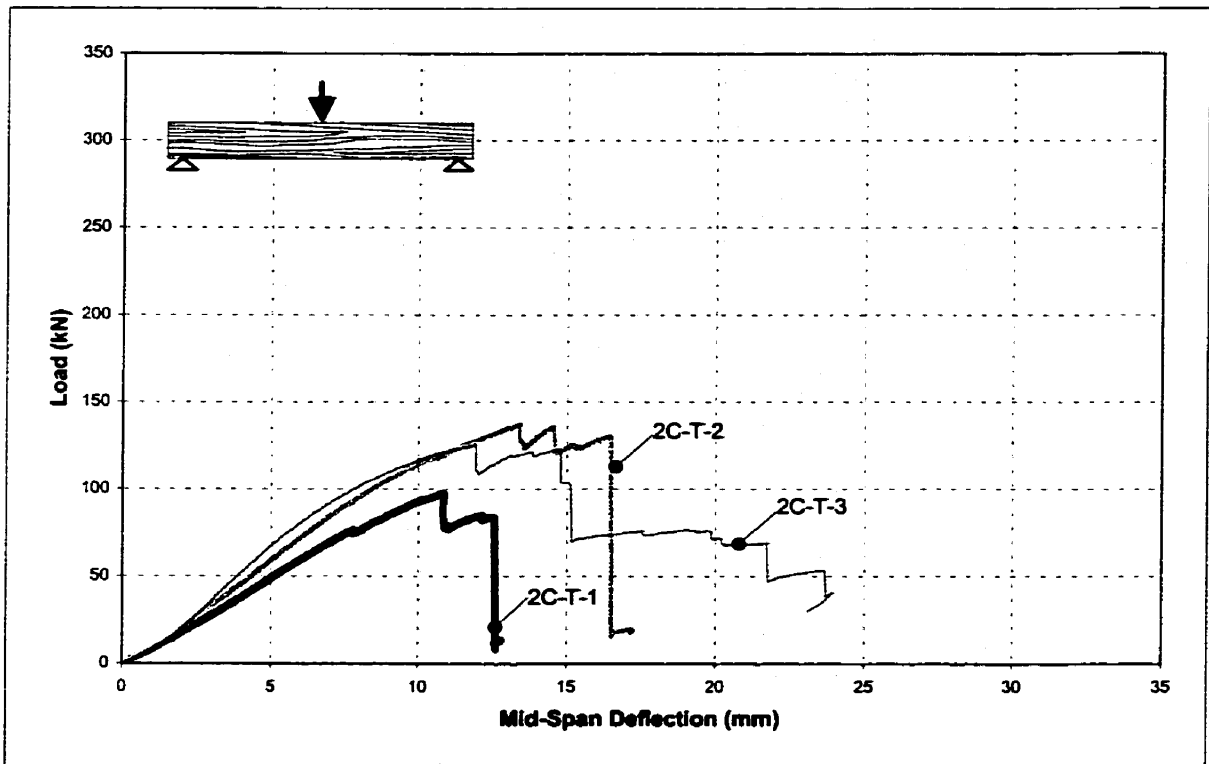
Figure 5.2: Load vs Mid-Span Deflection Curves for 200 mm Diameter "Timber Only" Bending Control Specimens

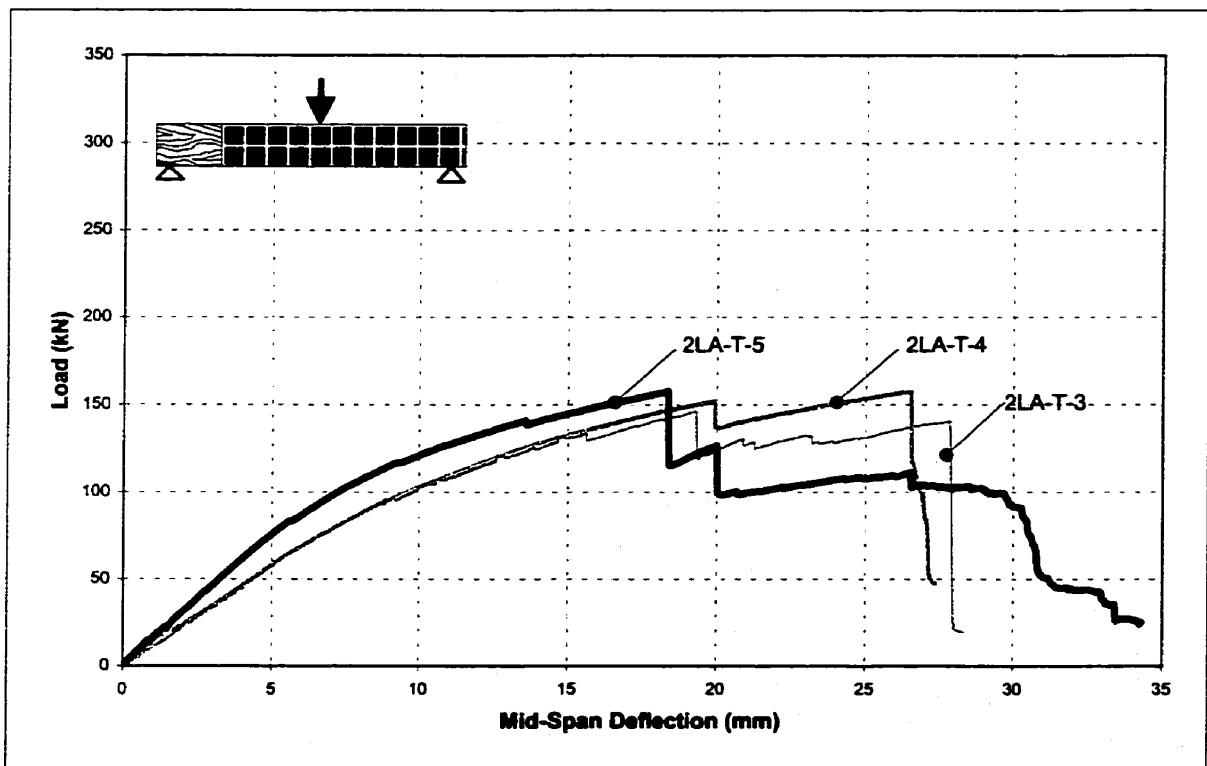
Figure 5.3: Load vs Mid-Span Deflection Curves for 200 mm Diameter Repaired Specimens Examining the Transition Zone

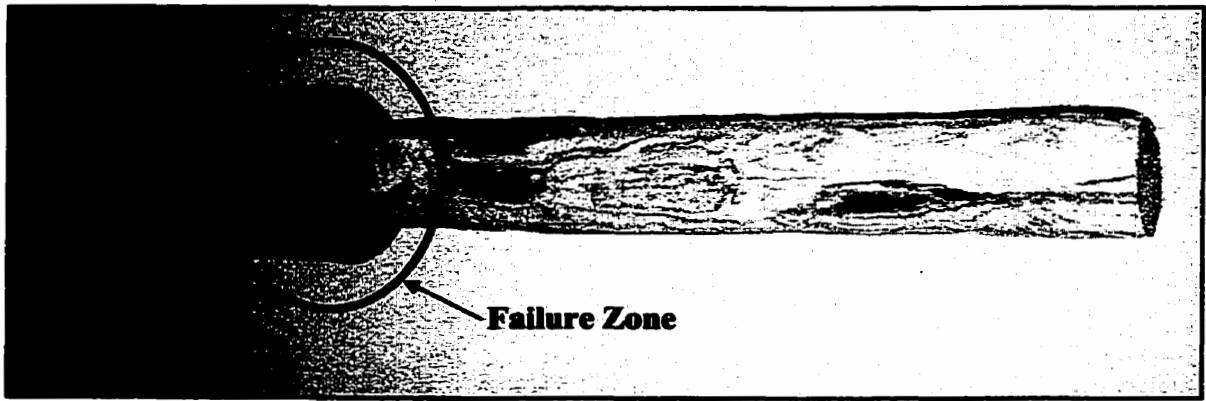
Figure 5.9(a): Photo of Trimmed Timber Pile Before Grout Injection

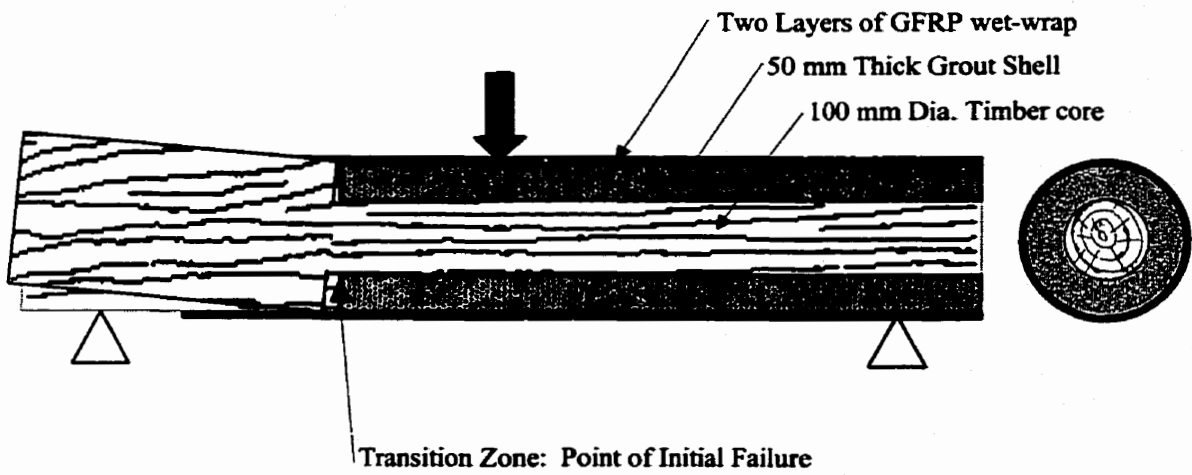
Figure 5.9(b): Schematic of Longitudinal Cross-Section of Repair Specimen at Failure

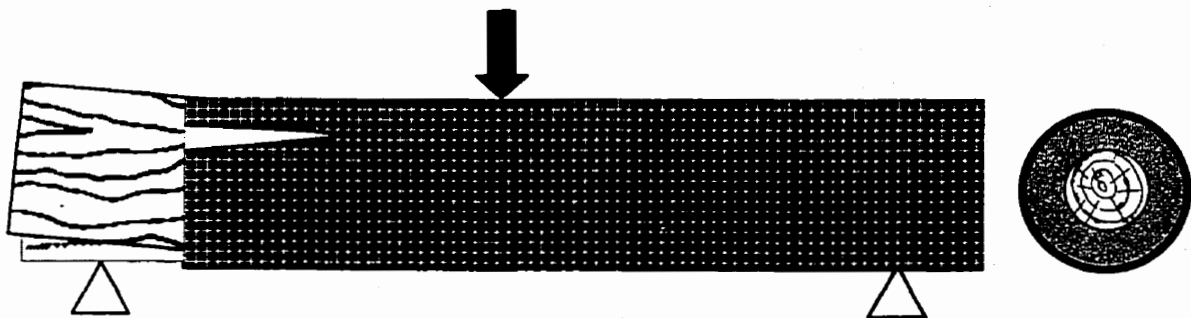
Figure 5.9(c): GFRP Sheet Ruptured Over 200 mm Length

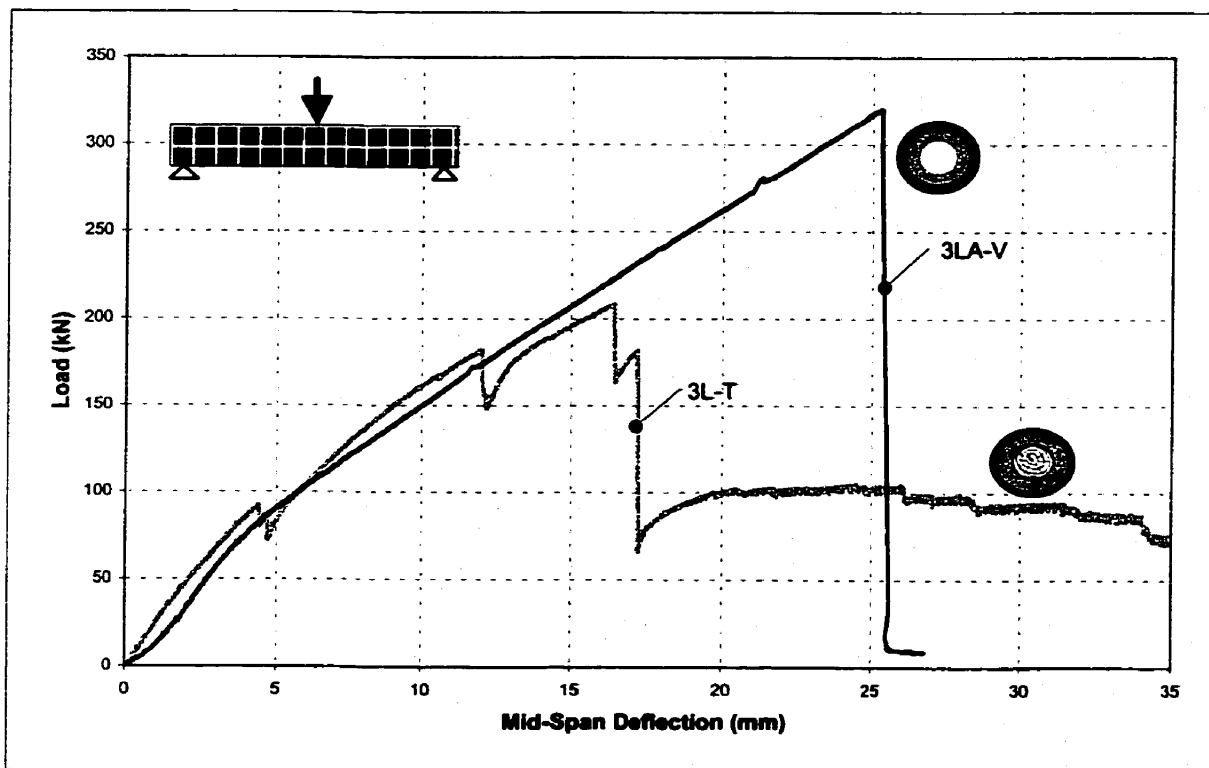
Figure 5.12: Load vs Mid-Span Deflection Curves for 300 mm Diameter Piles Tested in Bending
