SHORELINE PROCESSES ON LAKE WINNIPEG

A THESIS
PRESENTED TO
THE FACULTY OF CIVIL ENGINEERING
UNIVERSITY OF MANITOBA

In Partial Fulfillment
of the Requirements for the Degree
MASTER OF SCIENCE

by
Willem Martinus Veldman
January 1969

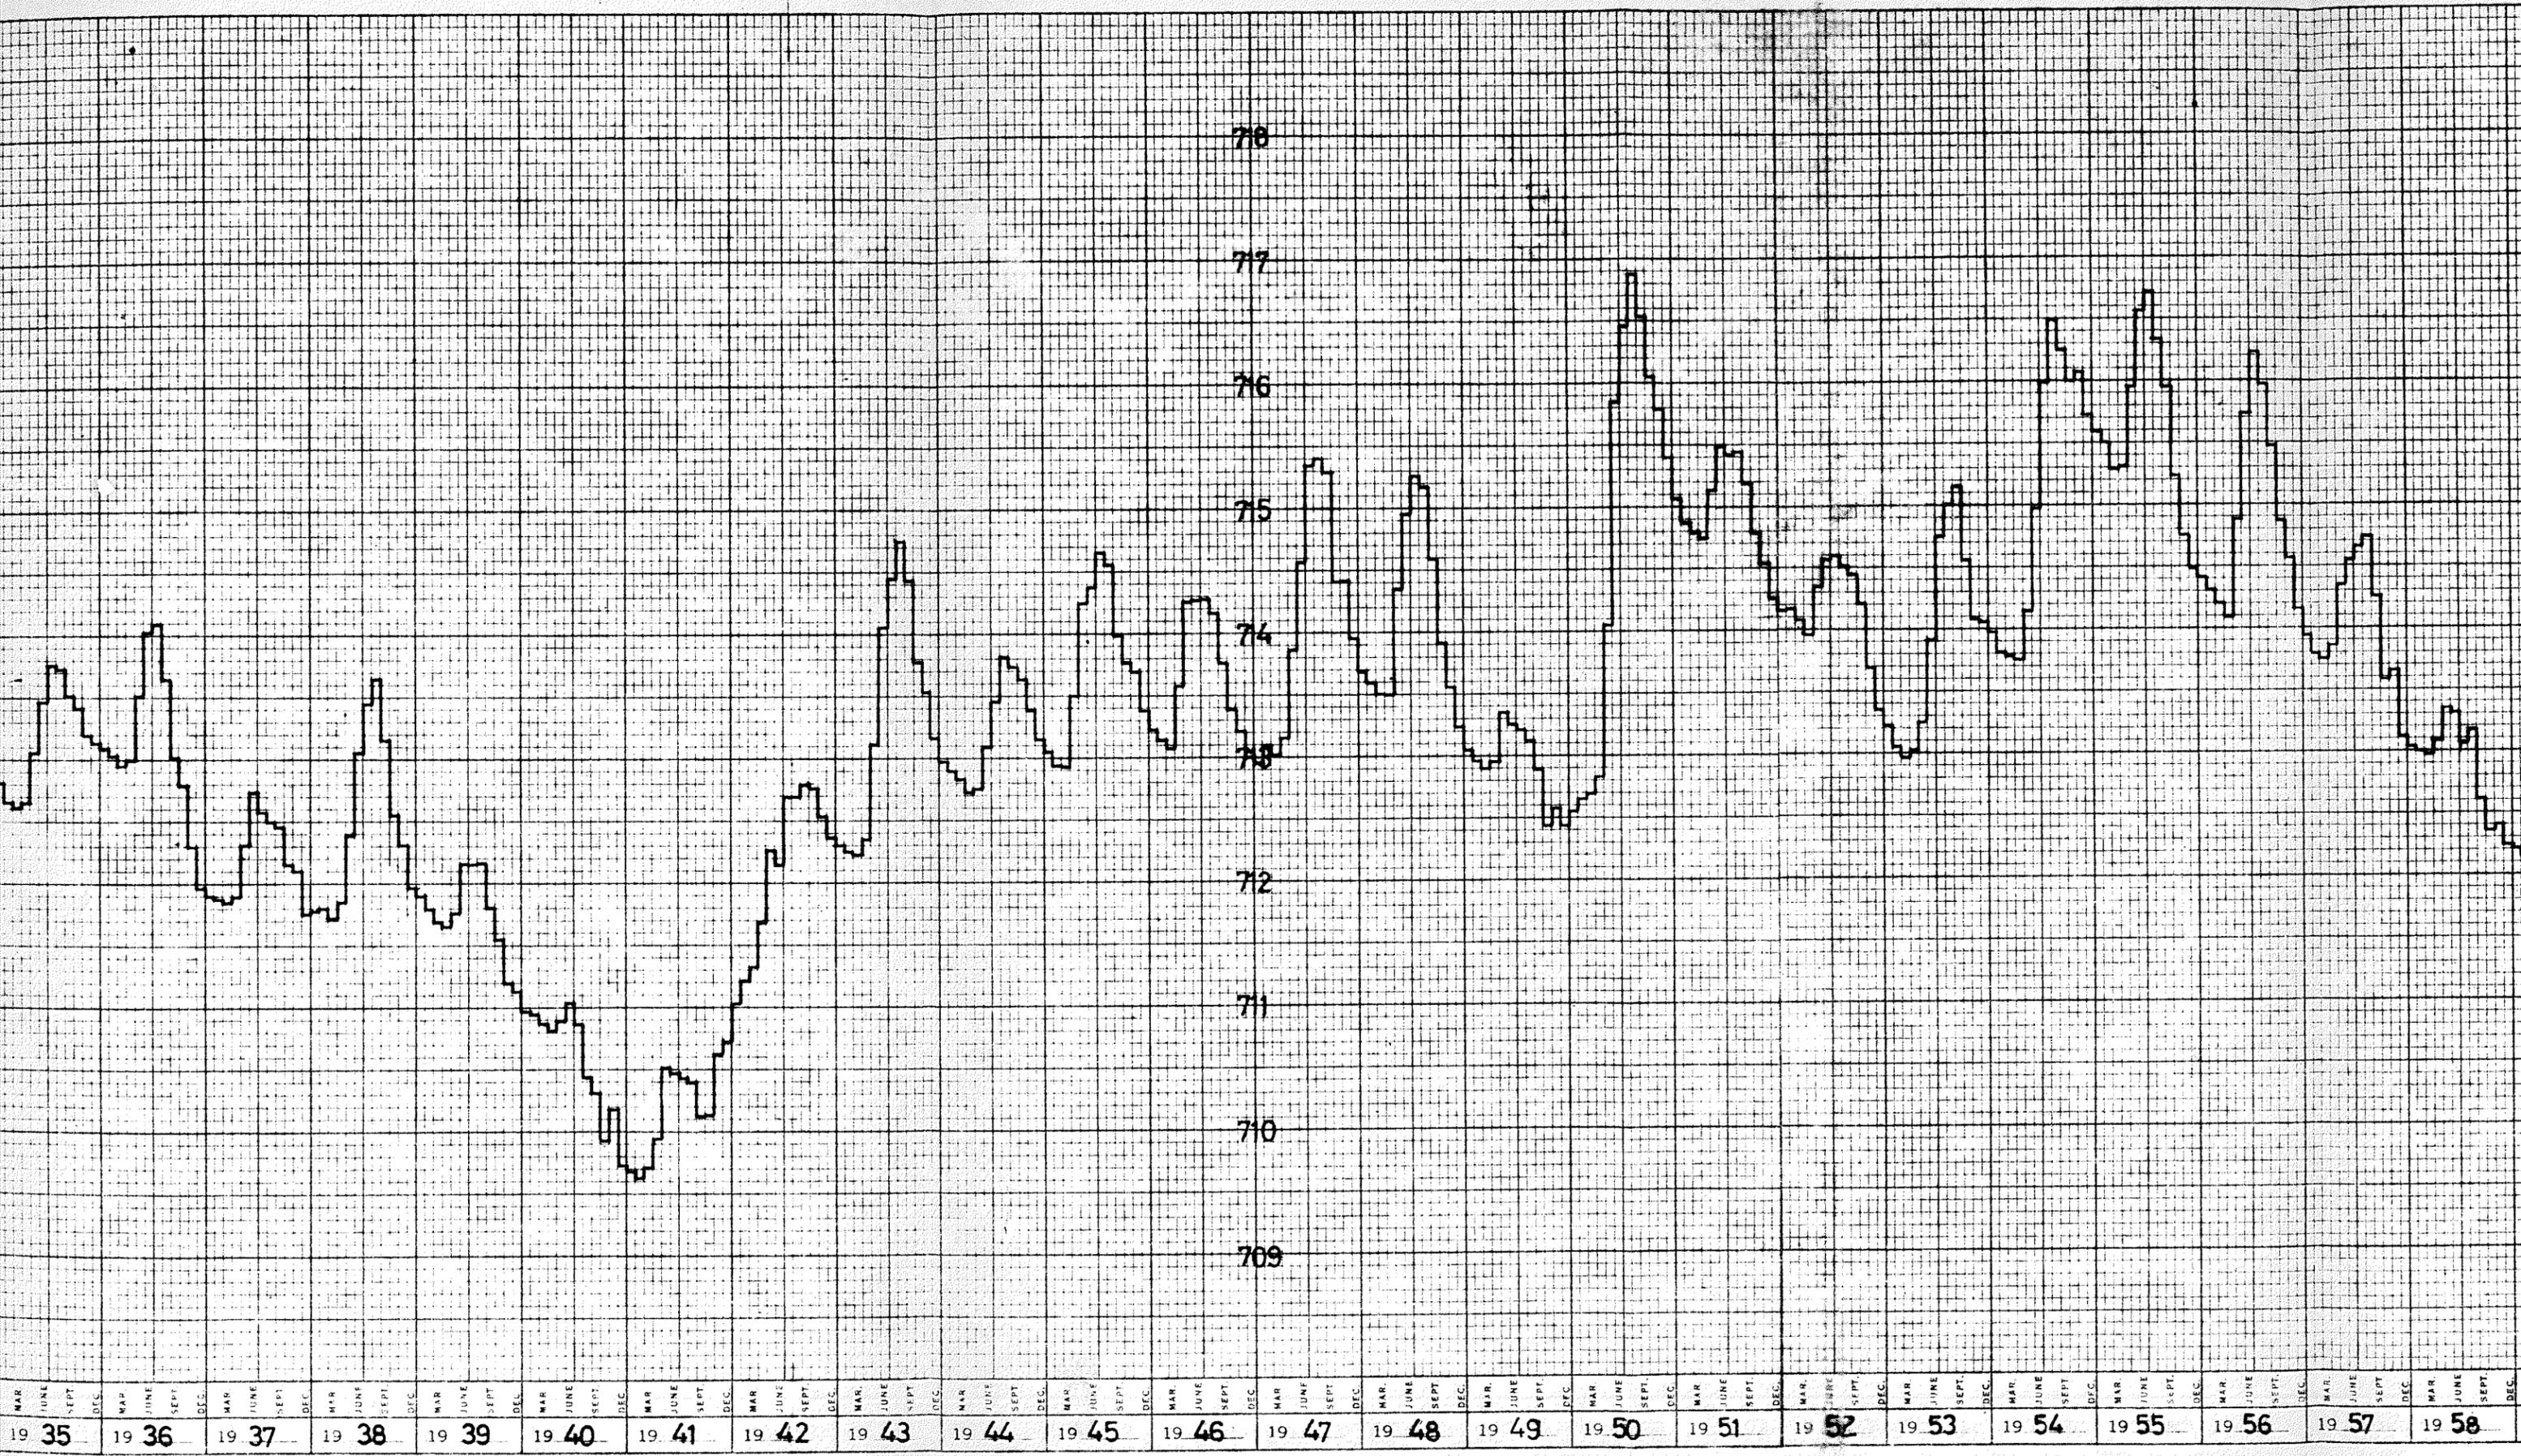
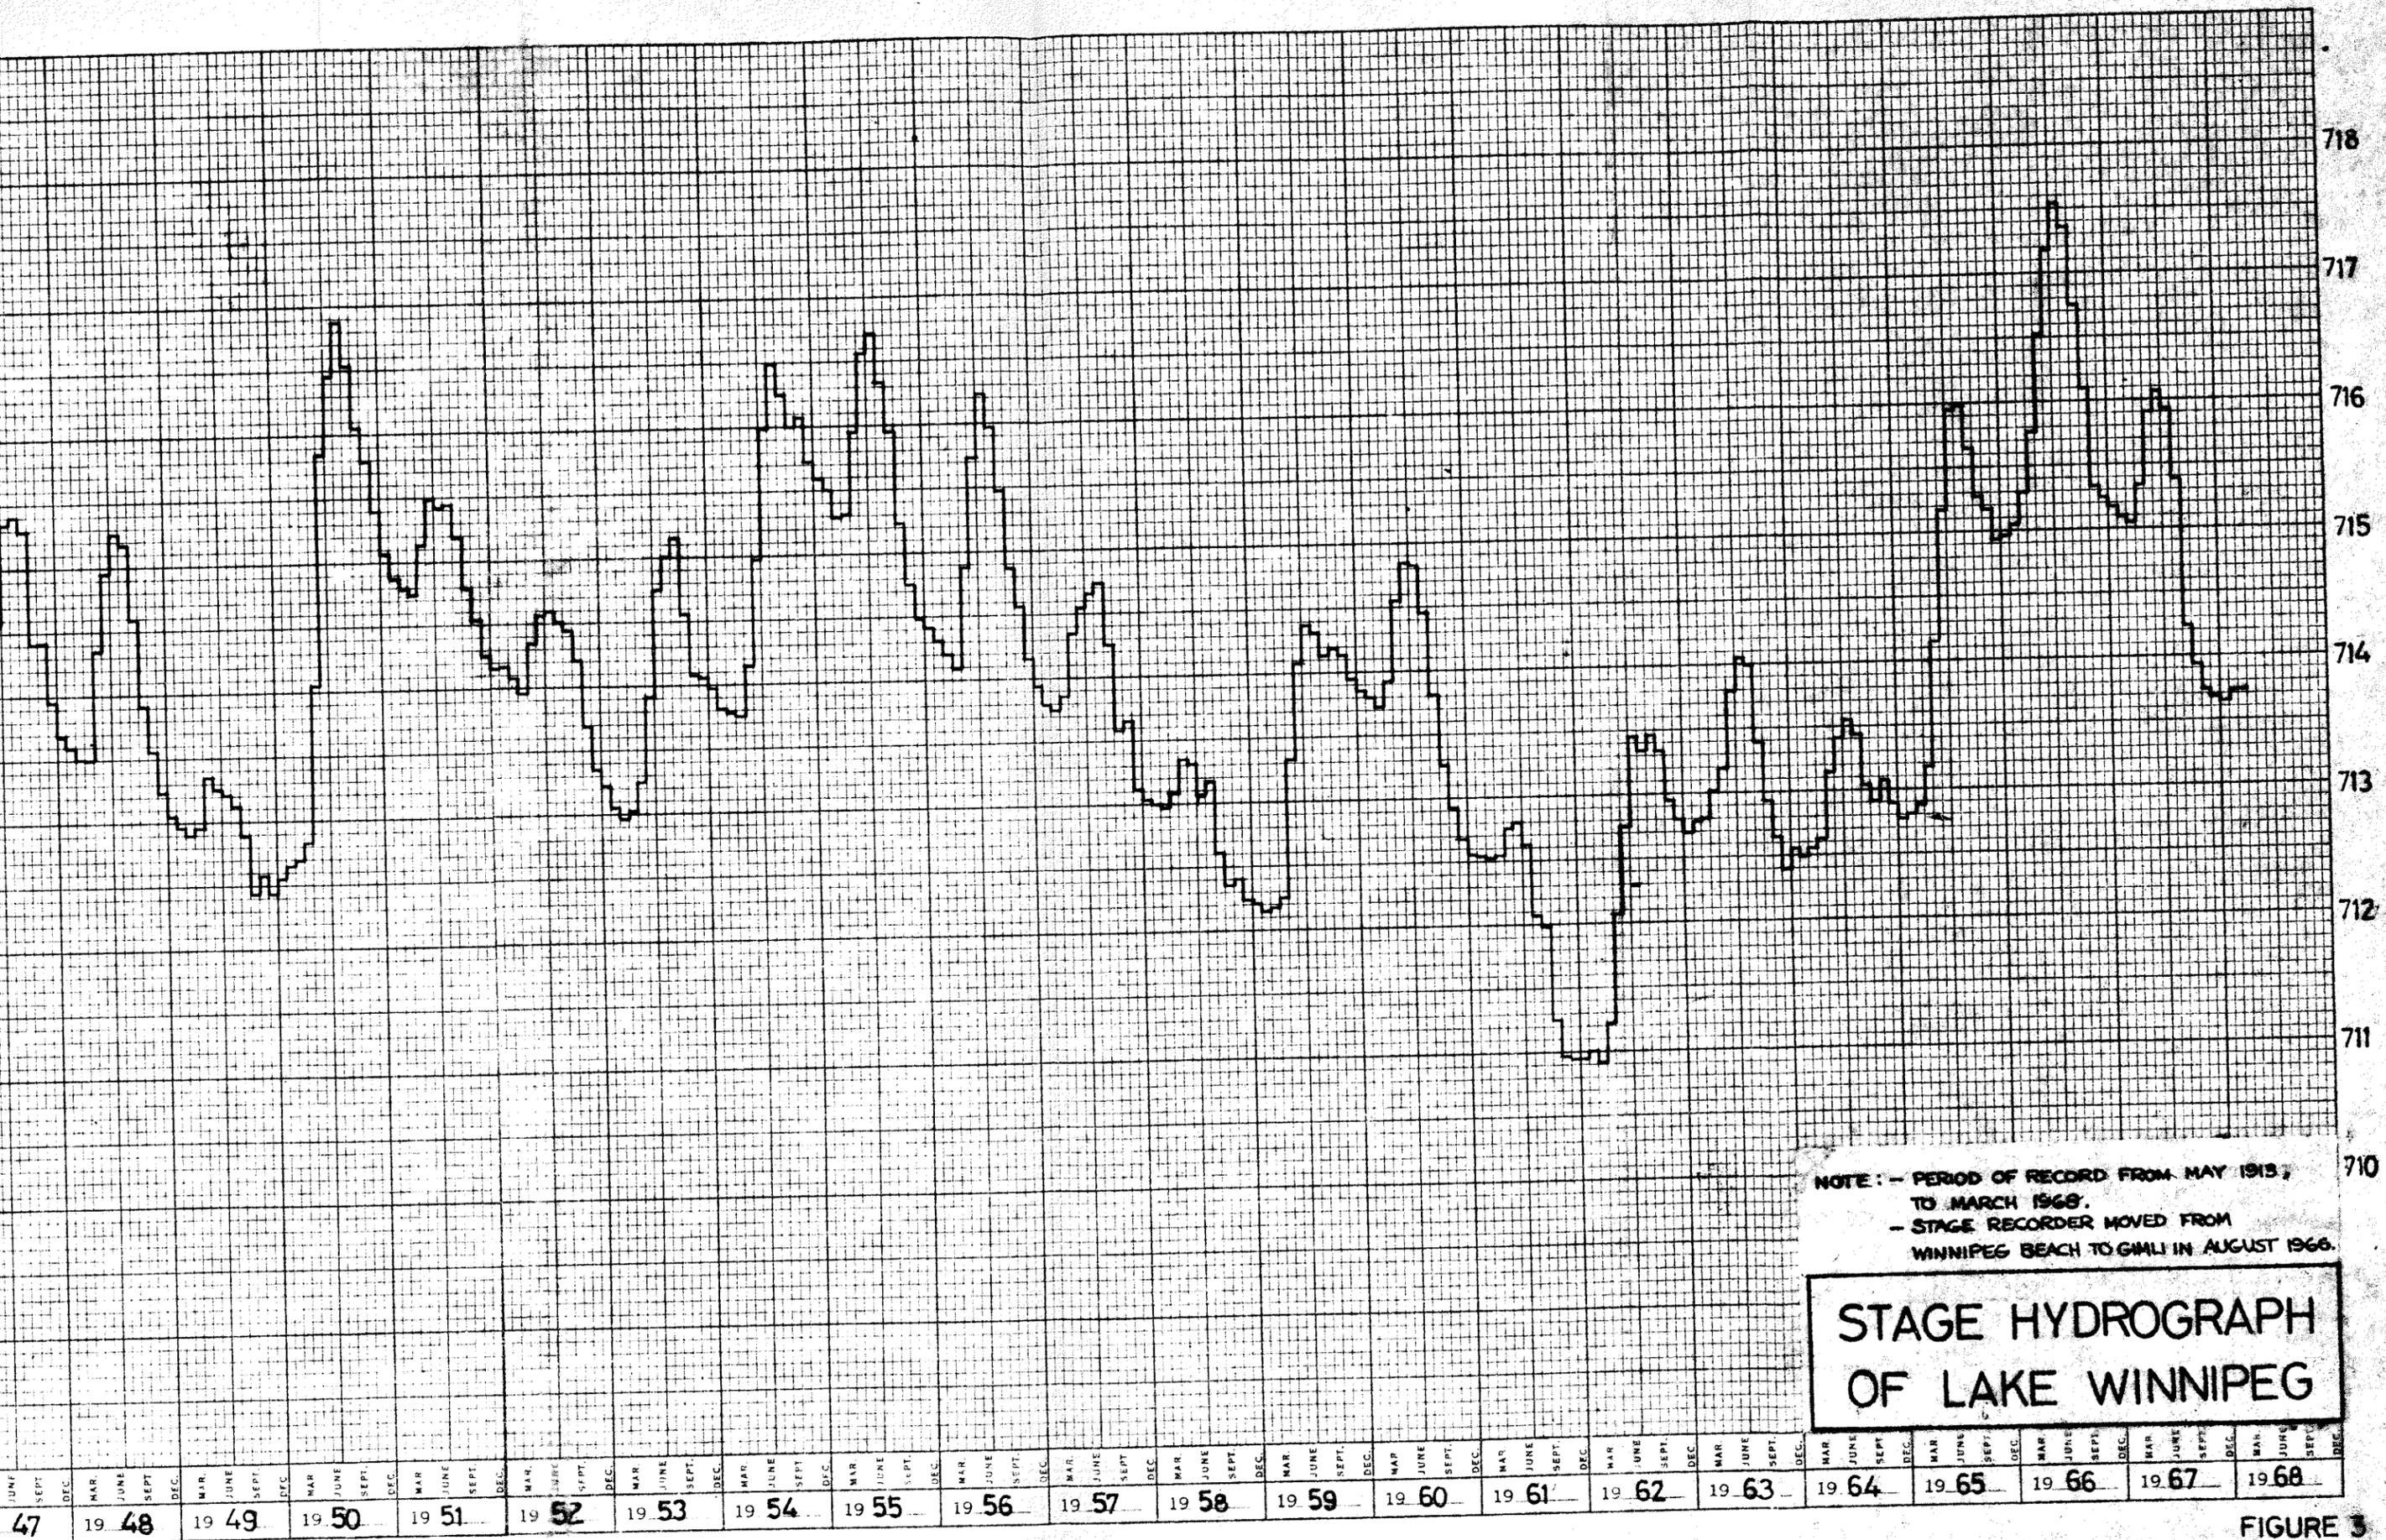
FIGURE 3

NOTE: - PERIOD OF RECORD FROM MAY 1913,
 TO MARCH 1968.
 - STAGE RECORDER MOVED FROM
 WINNIPEG BEACH TO GIMLI IN AUGUST 1966.

**STAGE HYDROGRAPH
 OF LAKE WINNIPEG**

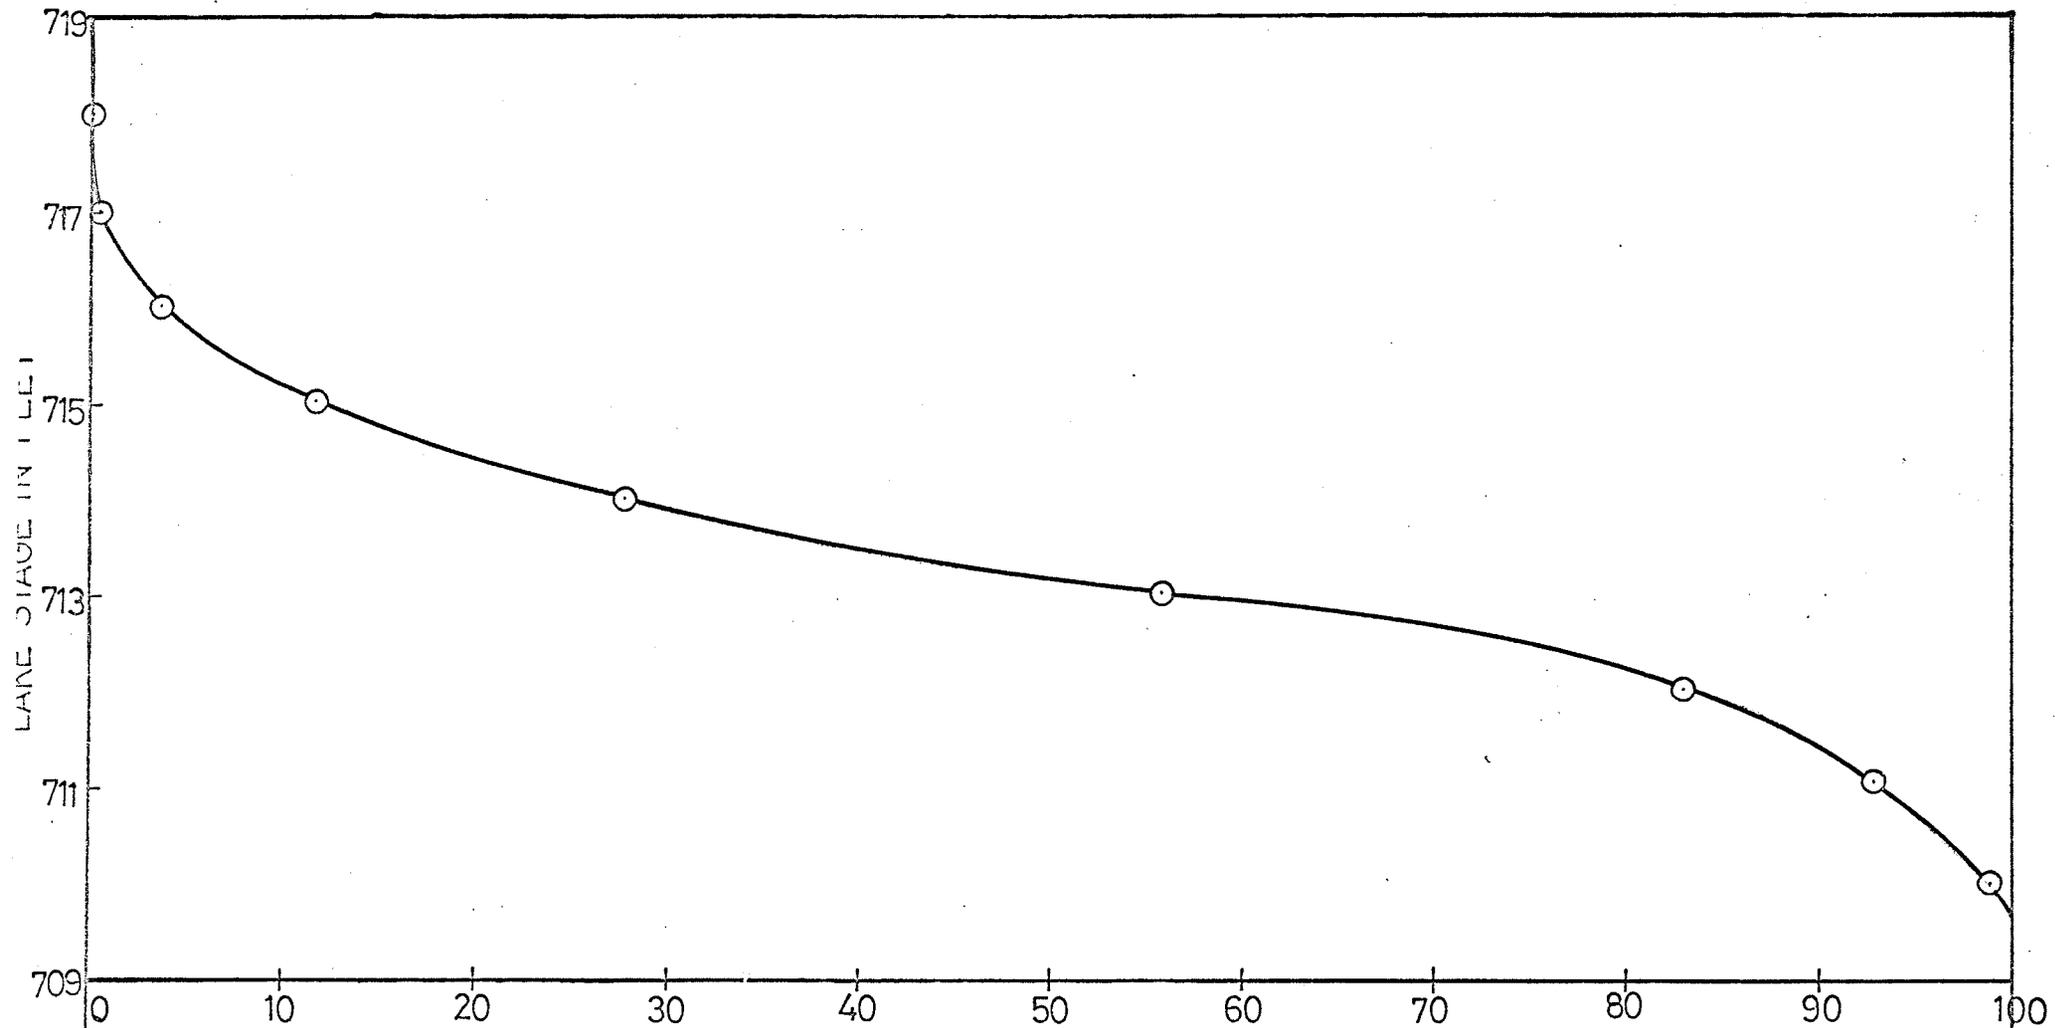
NOTE: - PERIOD OF RECORD FROM MAY 1913, TO MARCH 1968.

**MONTHLY STAGE DURATION
OF LAKE WINNIPEG**

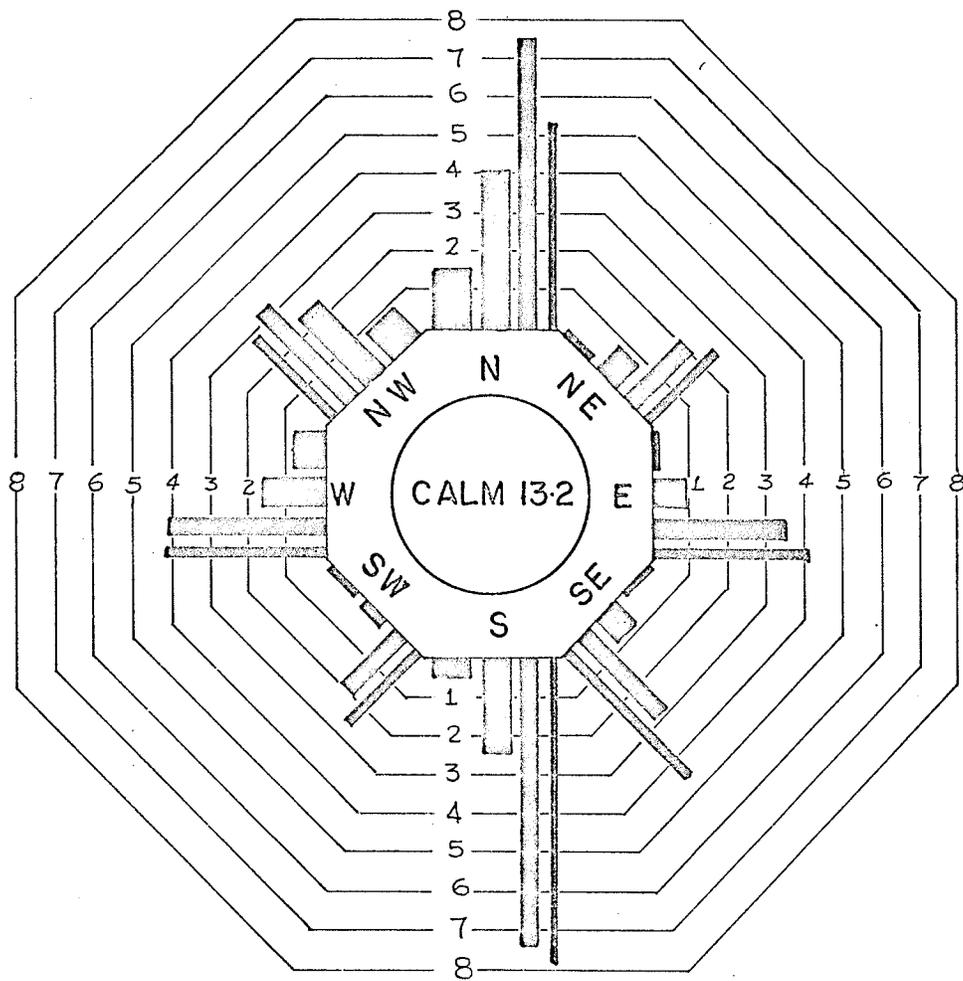
FIGURE 6

Data from DPW Dredge No. 201

WIND ROSE DIAGRAM

The hourly wind records from the dredge for 1961 to 1966 were analyzed and the average direction, duration and velocity for the period of record are shown on Figure 6. The wind velocities were not available for the whole period but the period of record considered was generally continuous from June to September. A total of 15,531 readings were used in the present analysis. The frequency of occurrence from the various directions compared favourably with McKay's data except that calm winds on the dredge occurred during 13.20 percent of the time while McKay found calm winds to occur during less than 1/2 per cent of the time. This is partly due to the difference in the definition of calm. In the present study, calm winds were considered to have a speed

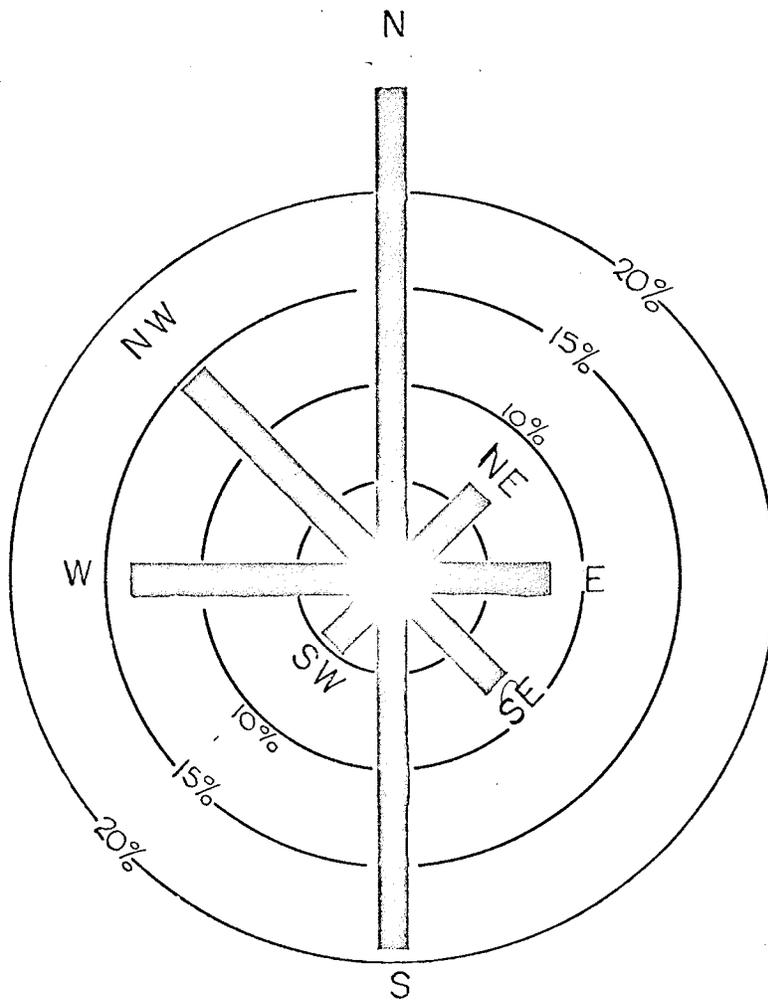
FIGURE 9

WAVE ENERGY DISTRIBUTION, LAKE WINNIPEG

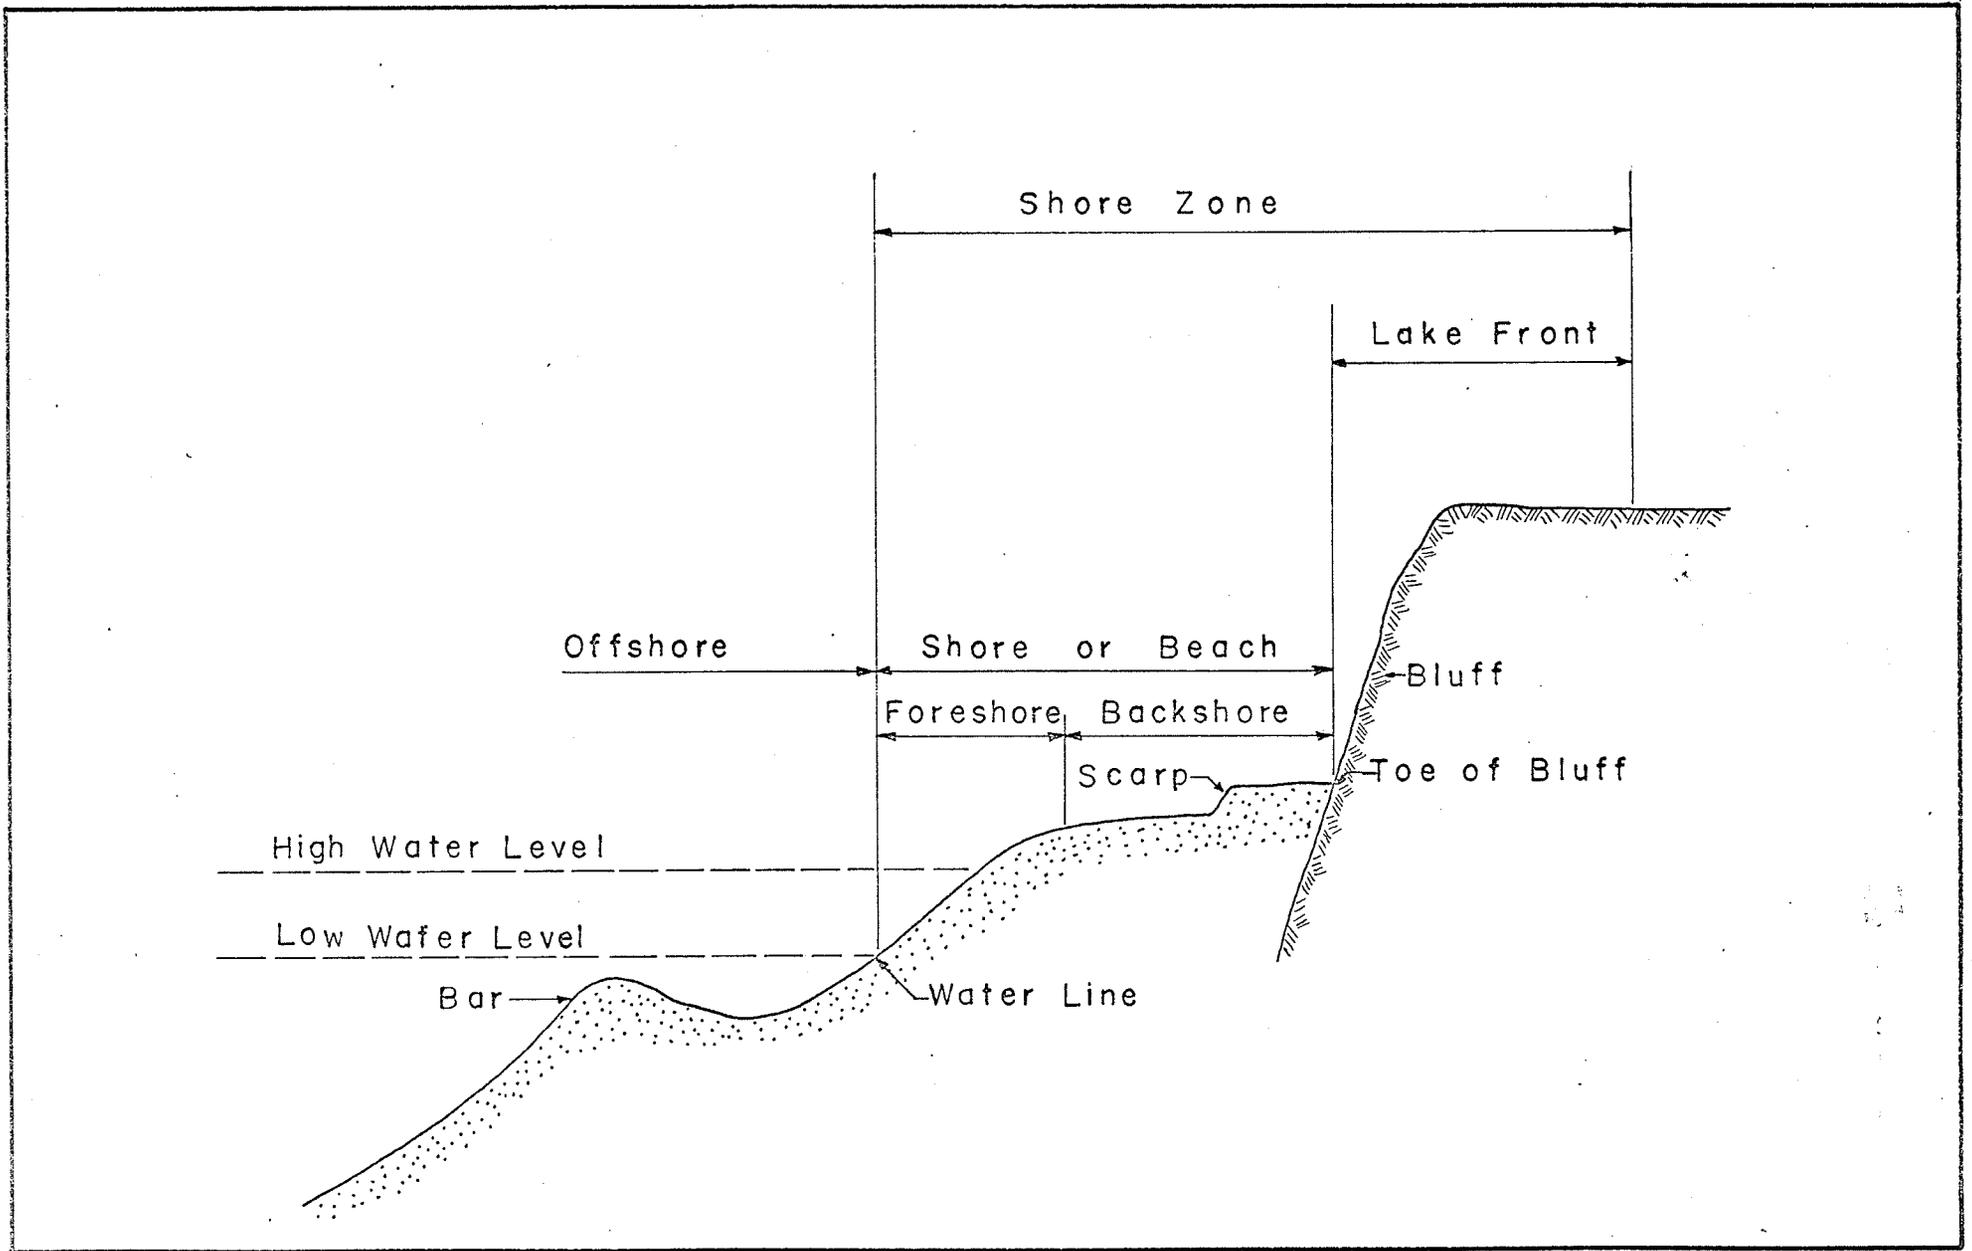
BEACH AND BLUFF TERMINOLOGY (2-11)

the high-water mark or to the base of the cliff or bluff where present. The beach and bluff terminology as used by Chieruzzi (15) and the Coastal Engineering Research Center (16) was used throughout this chapter. A definition diagram of the pertinent terms is shown in Figure 10. The terms shore zone and lake front were used rather than the more common terms of coastal area and coast respectively as the study pertains to a lakeshore rather than an ocean coast. Bluff erosion is similar to natural slope failures except that the additional forces induced by waves and ice are present. Chieruzzi notes that bluff erosion is still present at times in areas where the beach is stable and where the wave action is expended upon the beach.

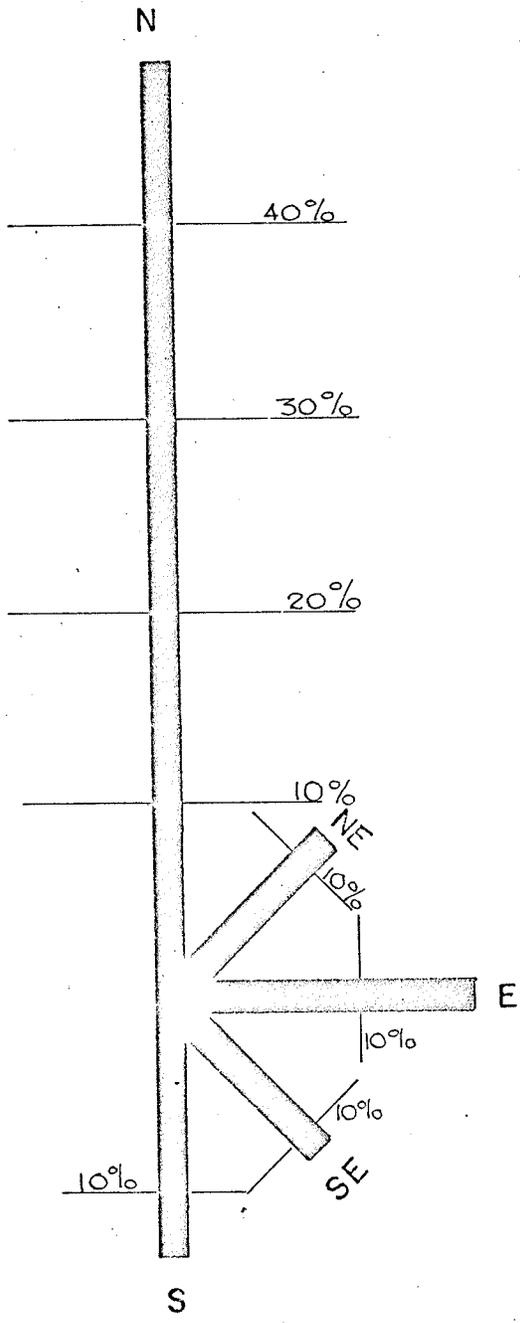
WAVE ENERGY DISTRIBUTION, WINNIPEG BEACH

Wind Direction Tested: It may be noted from the wave energy distribution diagram, Figure 16, that the predominant wave energy at Winnipeg Beach is from the north. However, due to the offshore limits of the model, a north wind direction could not be tested as one end of the wave

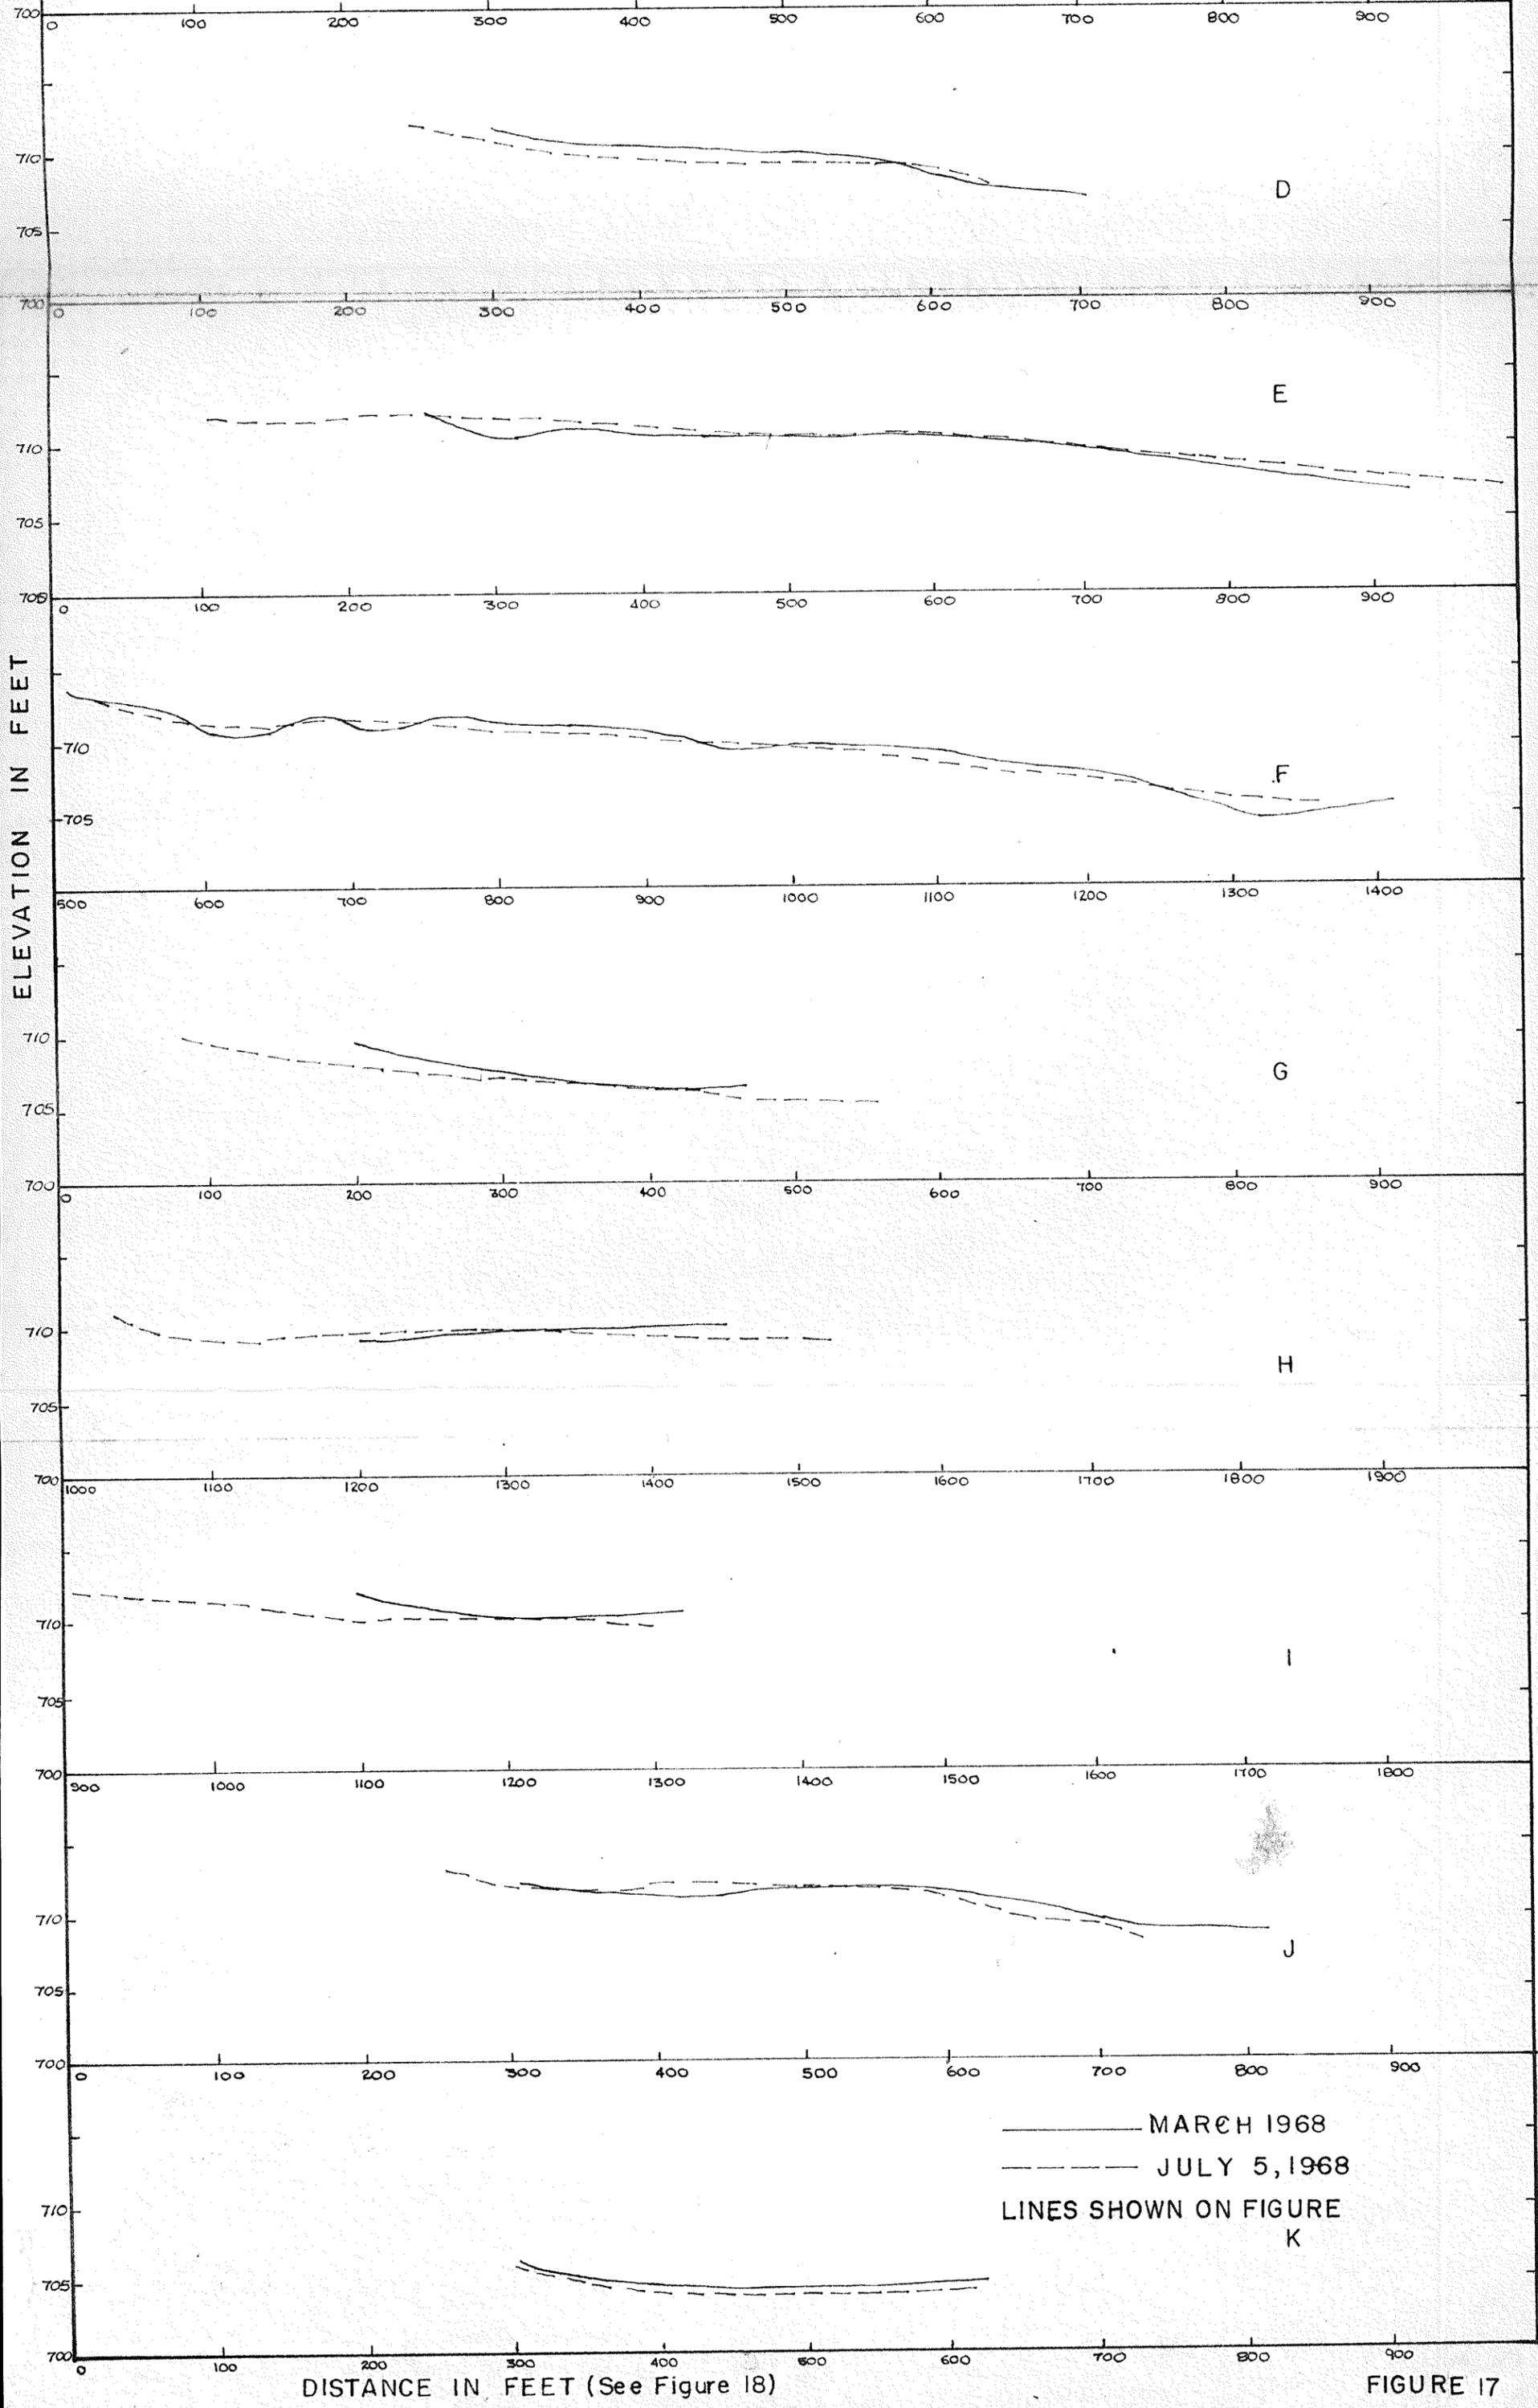
FIGURE 17

— MARCH 1968
 - - - JULY 5, 1968
 LINES SHOWN ON FIGURE
 K

COMPARISON OF PROFILES, WINNIPEG BEACH

Prior to the June 30th storm, approximately 500 cubic yards of sand were dumped in front of the seawall. After the storm it was observed that most of the sand had disappeared. From Figure 17 it is difficult to postulate where the sand moved to since the quantity transported is negligible as compared to the extent of the beach area.

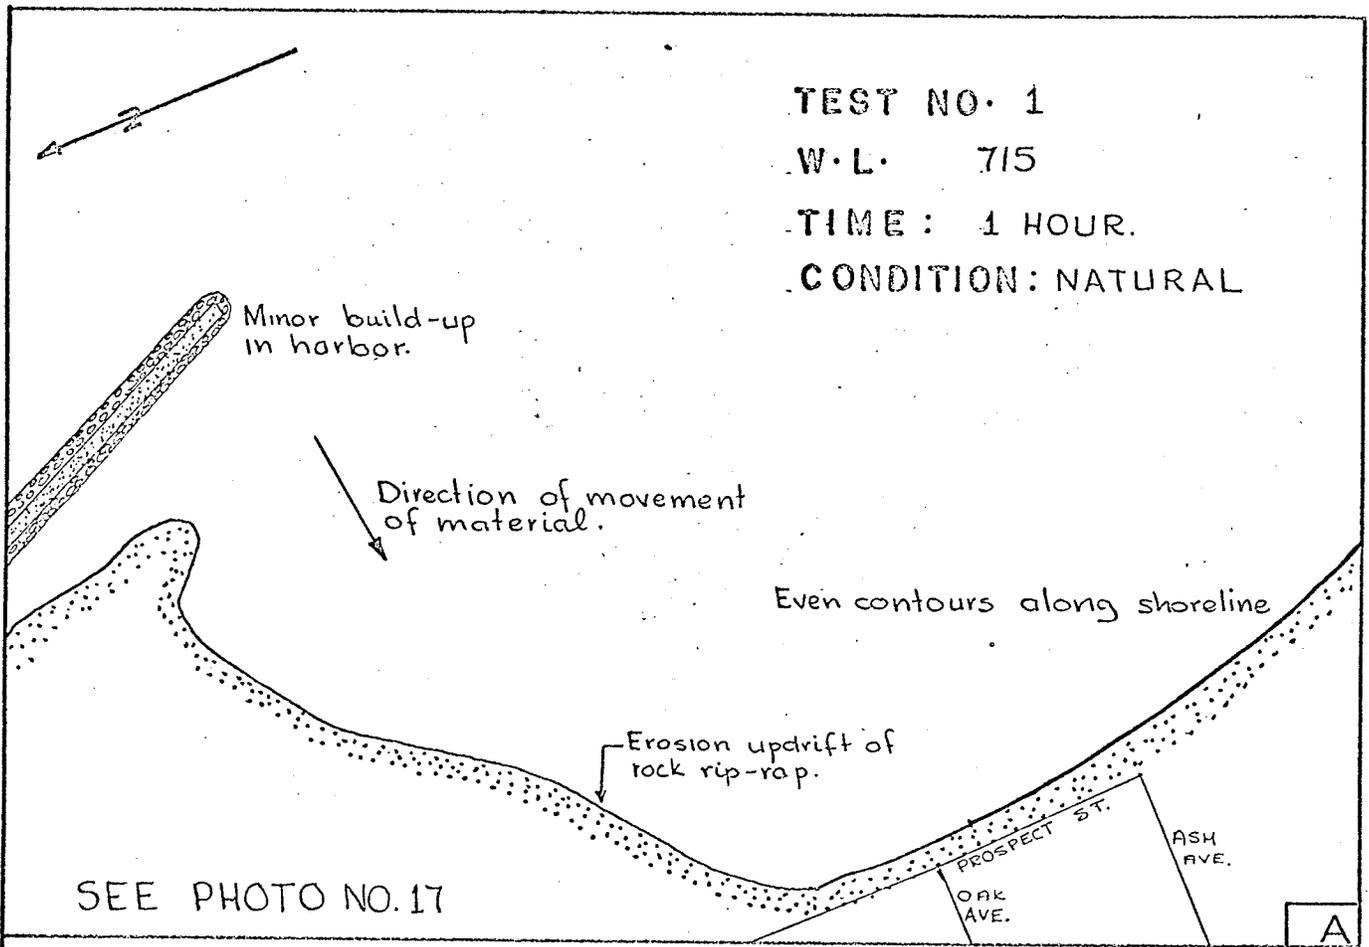
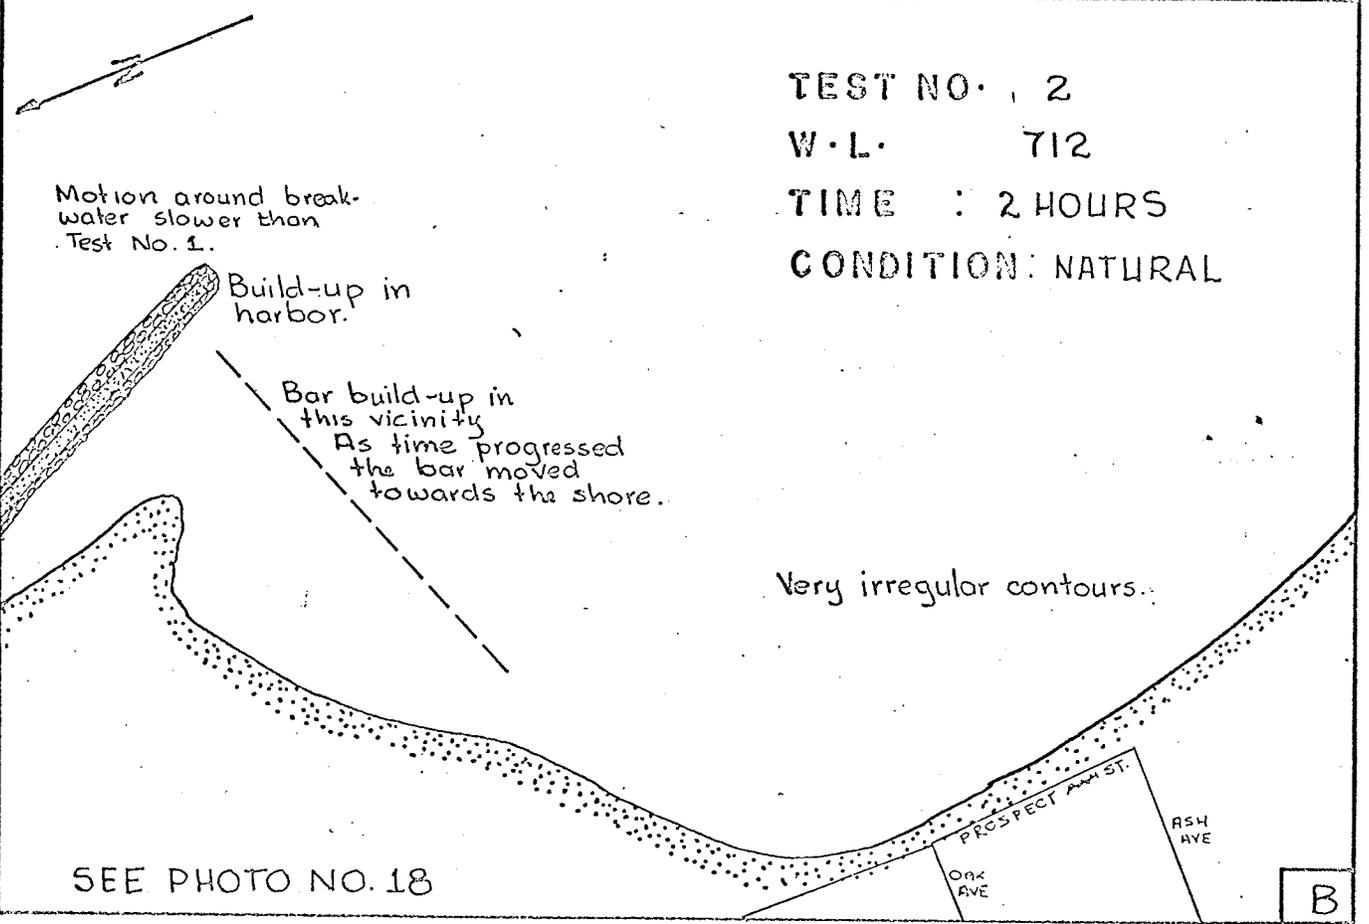
FIGURE 19

MODEL STUDY RESULTS

Tests 1, 2 and 3(a) were run at water levels of 715, 712 and 717 respectively to determine the relationship, if any, between material movement and lake level. It was found that for the lower lake levels, material moved around the breakwater and to the shoreline in the vicinity of Oak Street; the motion being via bars (Photographs Nos. 17 and 18). However, for a lake level of 717, it was found that material moving around the breakwater was deposited in the harbor, and furthermore as the motion of material to the beach area was thus reduced, serious erosion occurred in front of the rock rip-rapped section (Photograph No. 19). With a drawdown in lake levels to 714 in Test 3(b), it was found that the material deposited in the harbor during Test 3(a) moved by means of a bar, to the beach. Motion of material was along the shore zone only and the offshore erosion experienced during Test 3(a) was not alleviated. In these tests, it was found that material moved much more rapidly around the breakwater during a high lake level than during a low lake level.
