SHORELINE PROCESSES ON LAKE WINNIPEG

A THESIS
PRESENTED TO
THE FACULTY OF CIVIL ENGINEERING
UNIVERSITY OF MANITOBA

In Partial Fulfillment
of the Requirements for the Degree
MASTER OF SCIENCE

by
Willem Martinus Veldman
January 1969

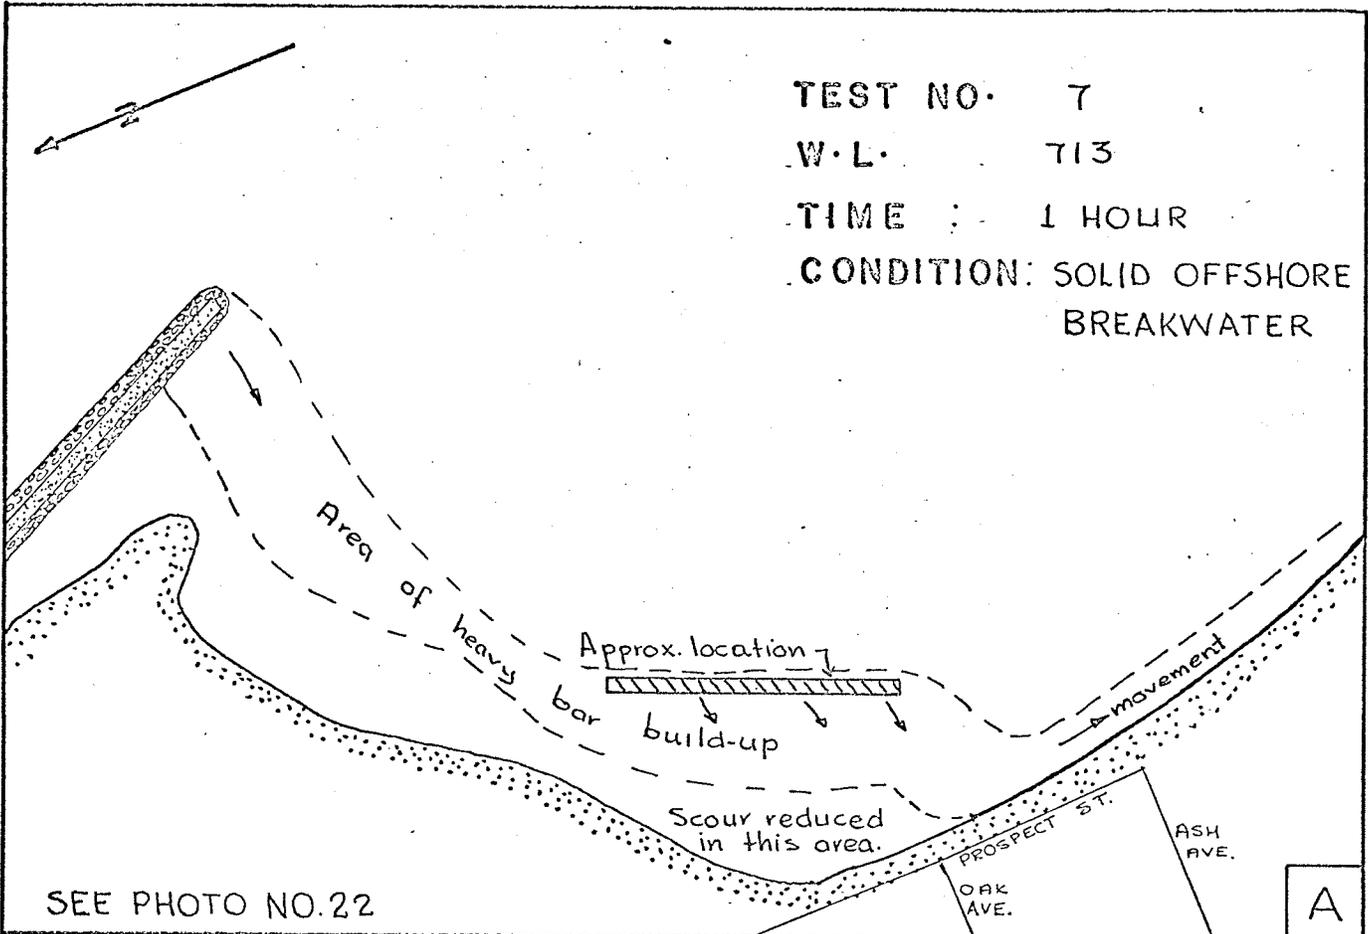
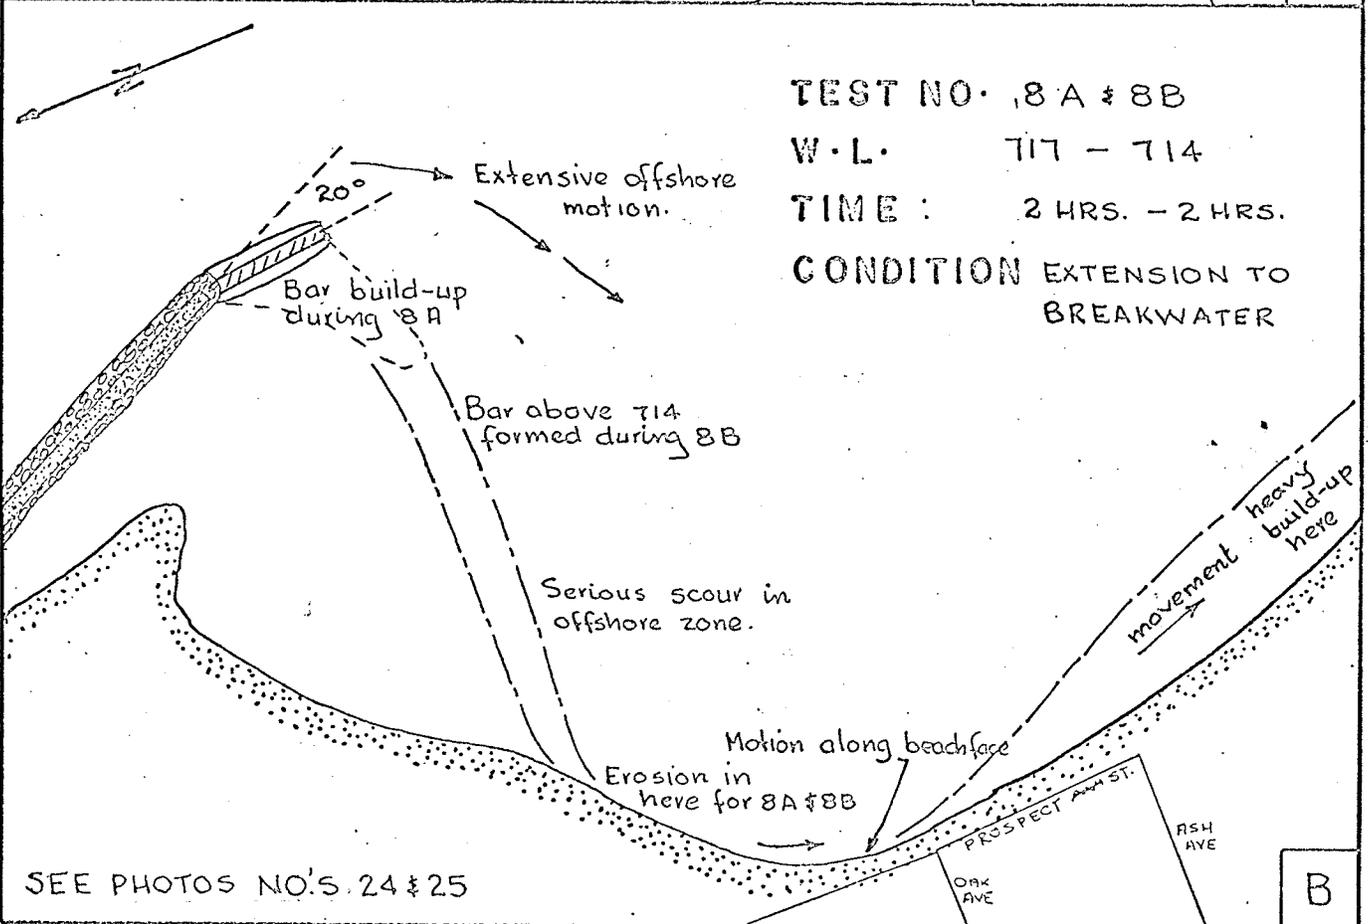
FIGURE 22

MODEL STUDY RESULTS

Tests 8, 9 and 10 involved alterations to the existing breakwater (Figures 22B, 23A and 23B). With a 160 foot extension of the breakwater (prototype) orientated 20° into the entrance of the harbor, it was found that during Test 8(a) (water level 717) only a small bar was developed in the harbor with the majority of the material being swept around the tip of the breakwater and in the direction of the seawall (Photograph No. 24). With a drawdown in lake level to 714 (Test 8(b)) and after adding material updrift of the breakwater, it was found that a minor bar developed in the harbor and that this bar progressed to the shoreline in the area updrift of the rock rip-rap. Motion of the material was along the shore zone and erosion offshore in the area of the rip-rap was apparent (Photograph No. 25). With a 160 foot extension of the breakwater (prototype) orientated 20° away from the entrance of the harbor, (Figure 23A) it was found that during Test 9(a) (water level 717) an extremely heavy buildup of material occurred in the harbor entrance and with the subsequent lowering of the water level to 714, some of this material moved towards the shore in the area of the rock rip-rap. Serious erosion occurred offshore as indicated on Figure 23A. A modification of Tests 8(a) and 8(b) constituted Tests 10(a) and 10(b). In these tests

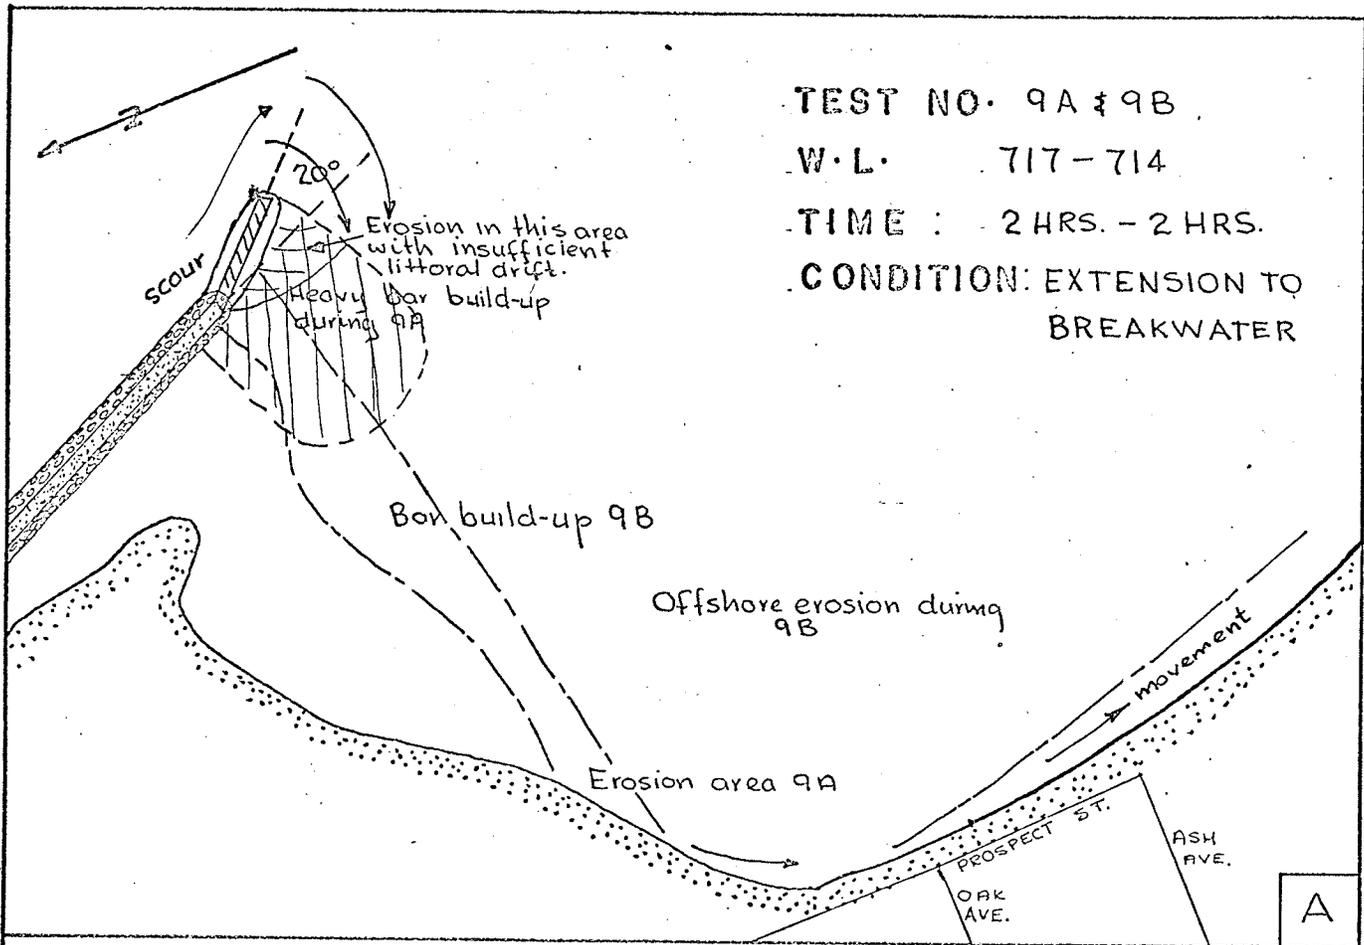
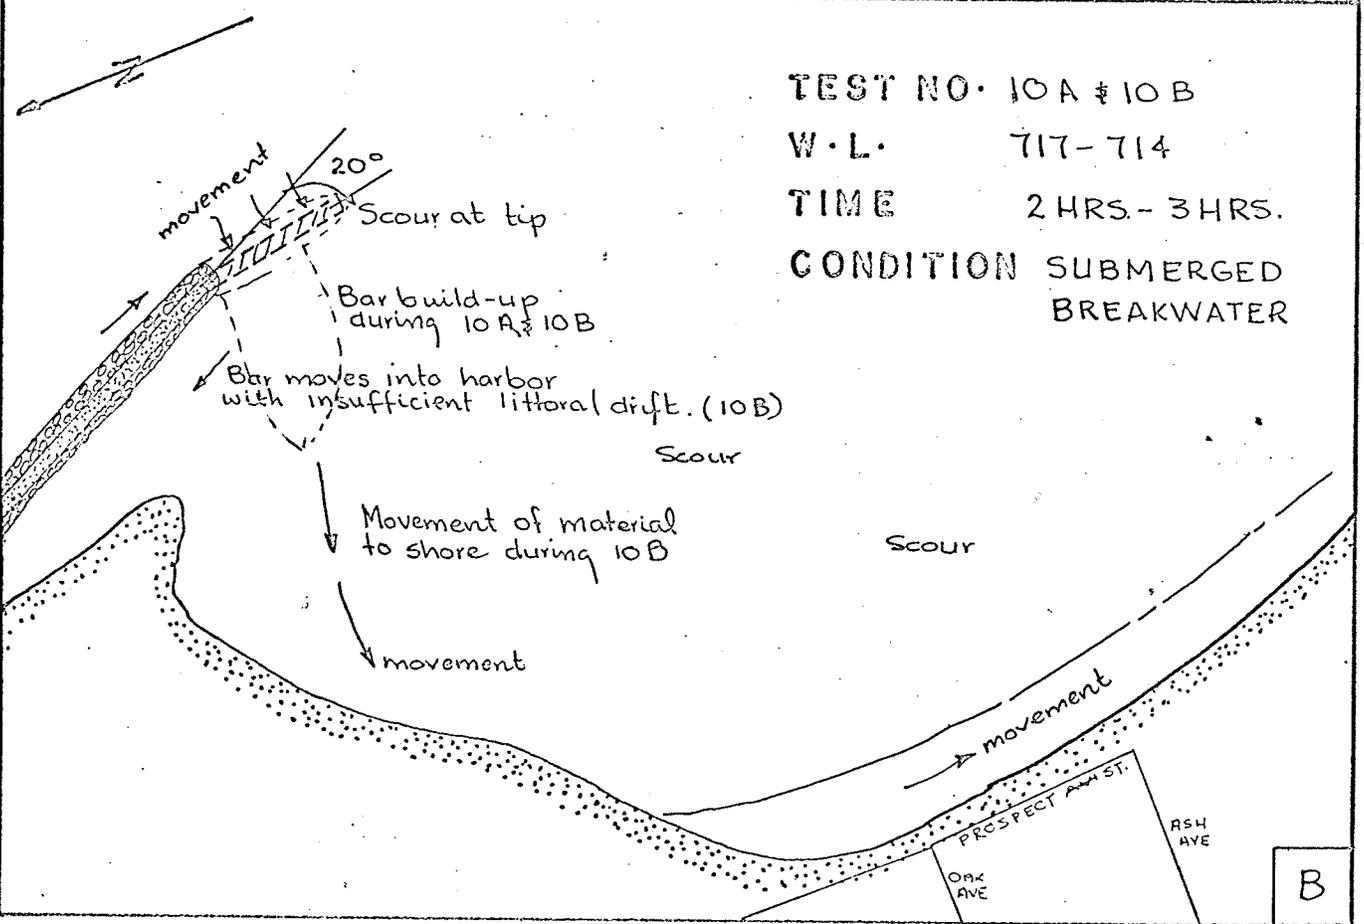
FIGURE 23

MODEL STUDY RESULTS

the extension to the breakwater was set at a crest elevation of approximately 714 rather than the 723 crest elevation of the existing breakwater. A small bar was formed inside the harbor during Test 10(a) and with the subsequent lowering of the water level to 714 during Test 10(b), this bar progressed towards the shoreline as shown on Figure 23B. It was also noted that as the movement of littoral material around the breakwater was reduced, the bar in the harbor had a tendency to move further into the harbor entrance. Further discussion of this point is not warranted as the transition between the existing breakwater and the extension, as constructed in the model, was rather abrupt and would need refinements before further conclusions can be made.

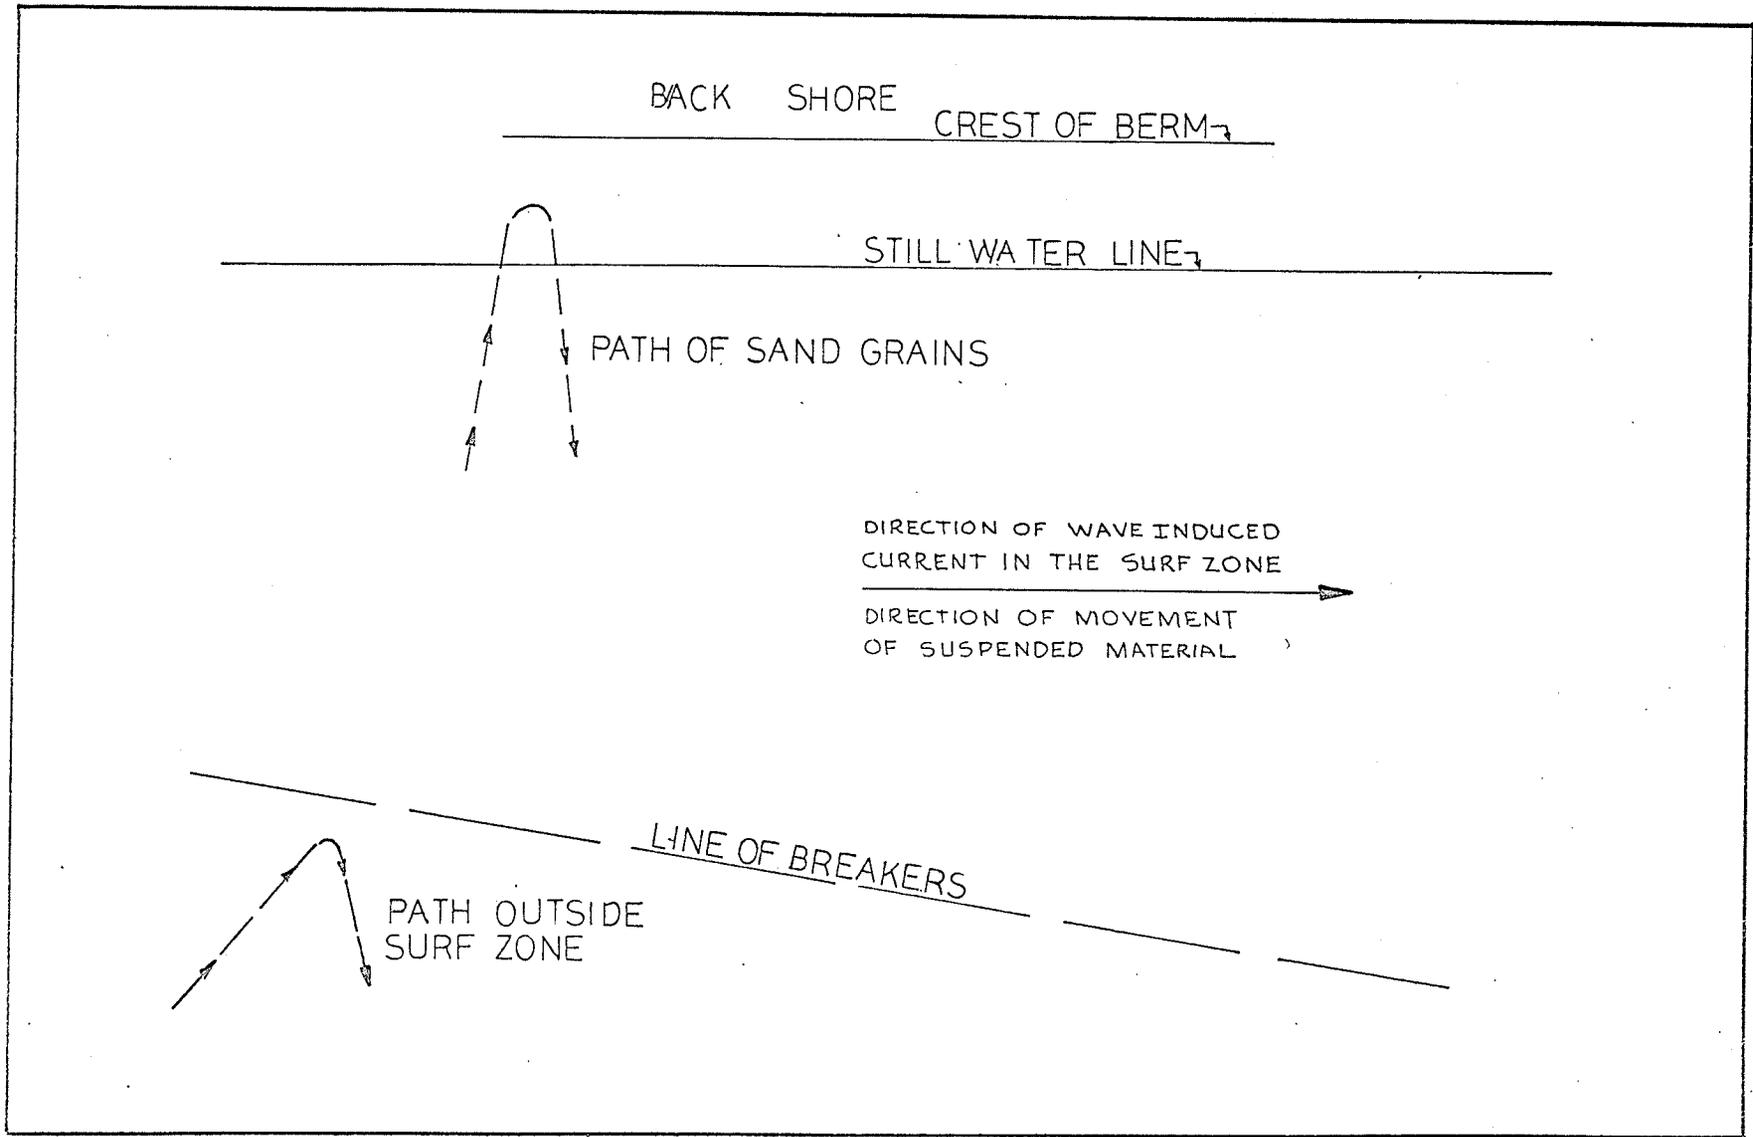
LONGSHORE MOVEMENT OF LITTORAL DRIFT (REF 16)

Figure D1 shows the basic modes of transport. Johnson in 1956 (27) stated that the movement of sand takes place in two manners, namely, in suspension and by rolling in a zig-zag motion along the beach face. Johnson also stated that Saville (1950) found that movement during storm periods was mainly by suspension, while movement during calm periods was a result of rolling in a zigzag motion along the beach face. It is believed that as much as 80 per cent of the material moved by wave action is moved in the area shoreward of the breaking point (Mason, 1953), but sufficient tests have not yet been made to prove this conclusively (45).

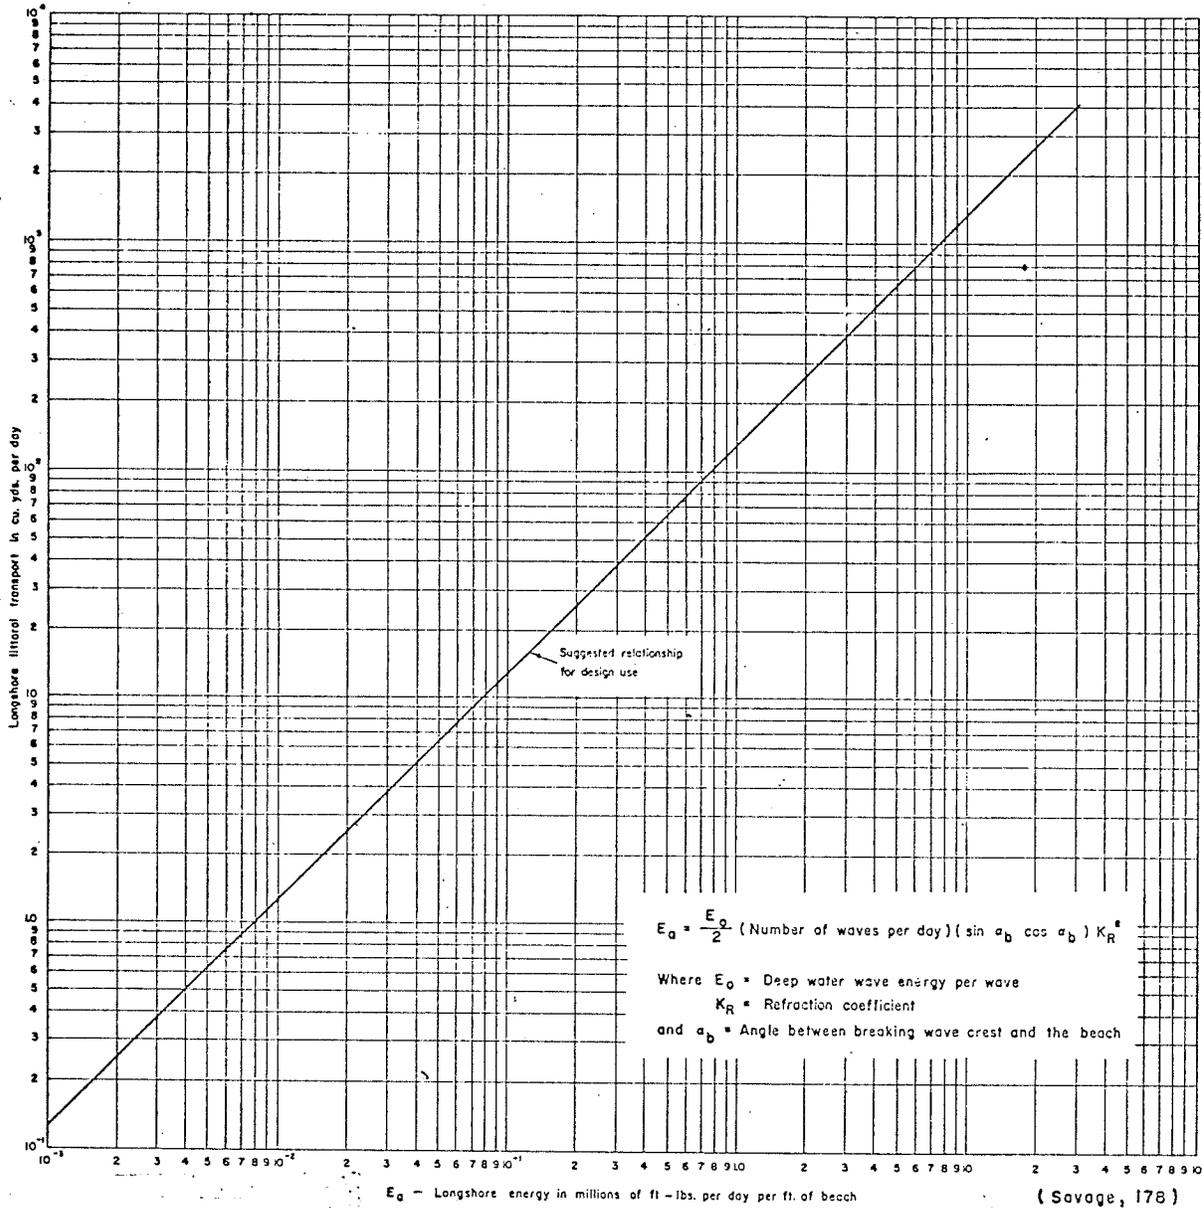
RELATION BETWEEN LONGSHORE COMPONENT OF WAVE ENERGY AND LITTORAL TRANSPORT RATE

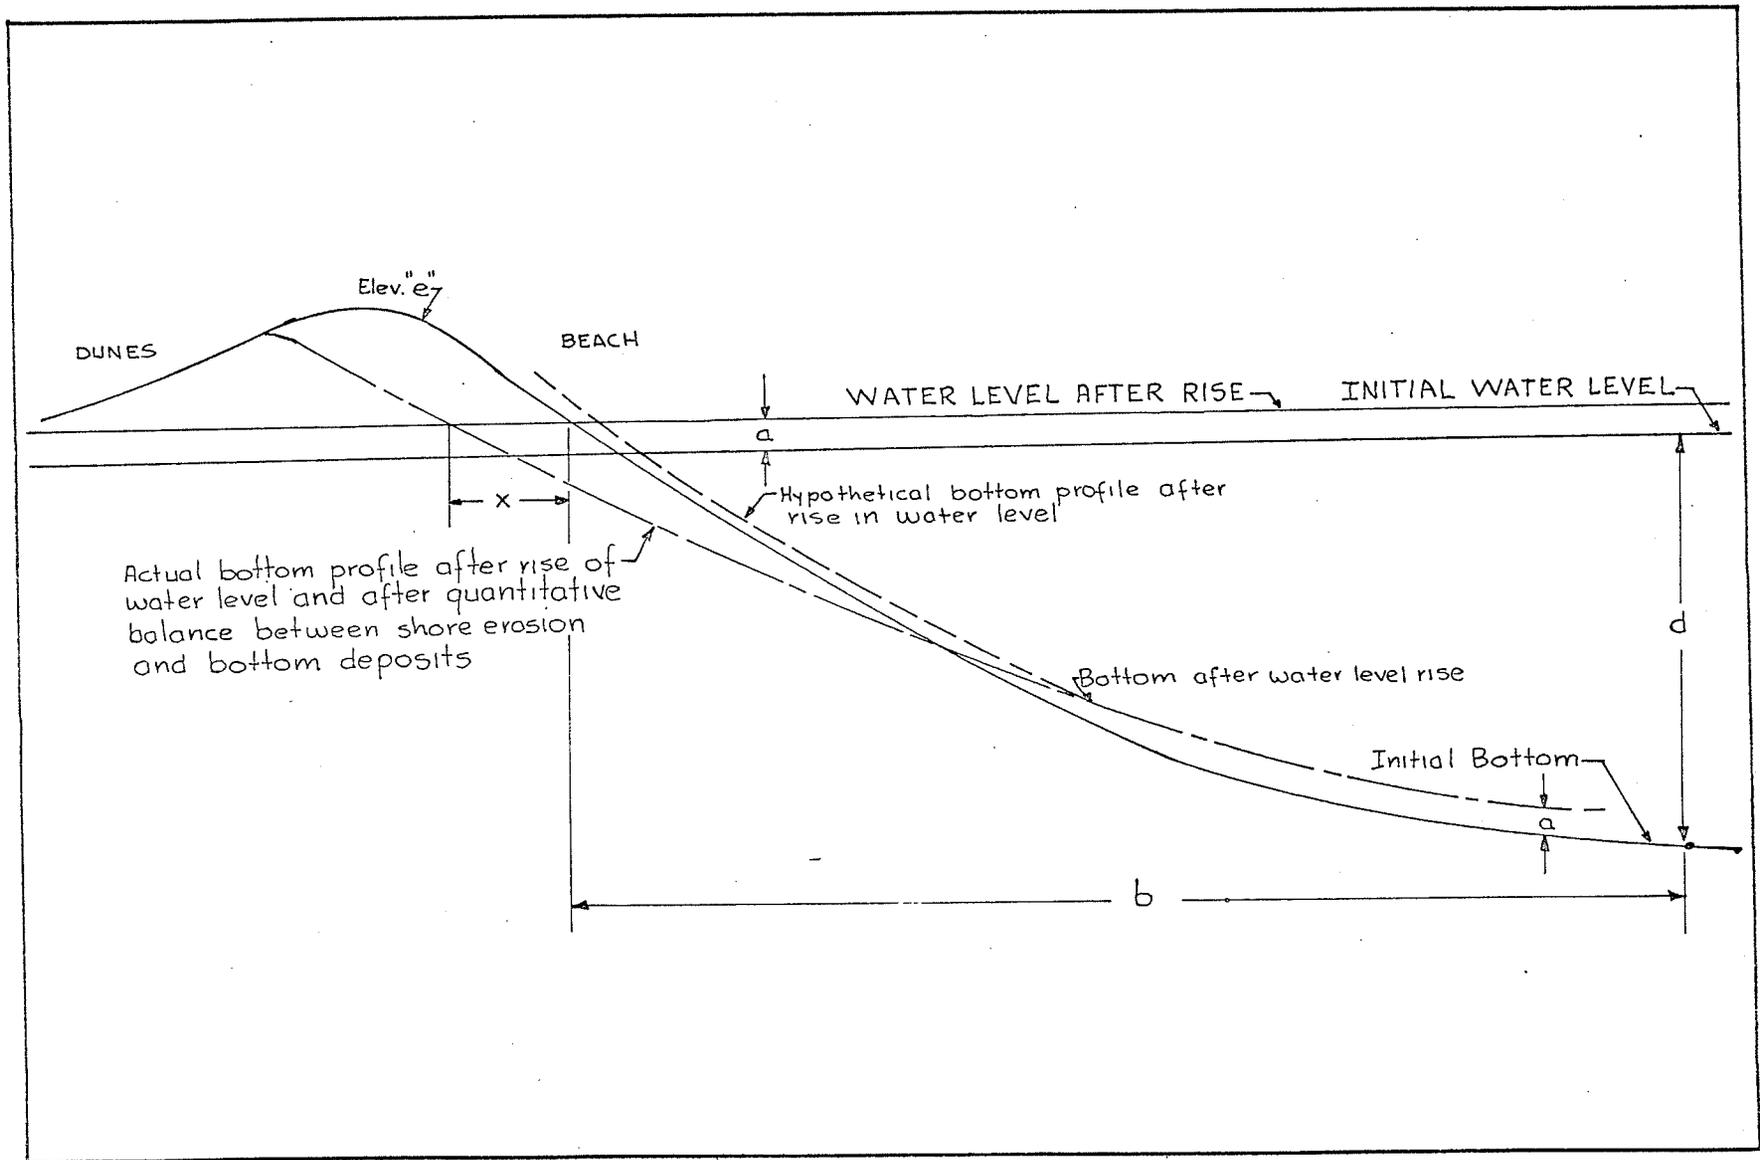
EFFECT OF A RISE IN WATER LEVEL ON BEACH PROFILES

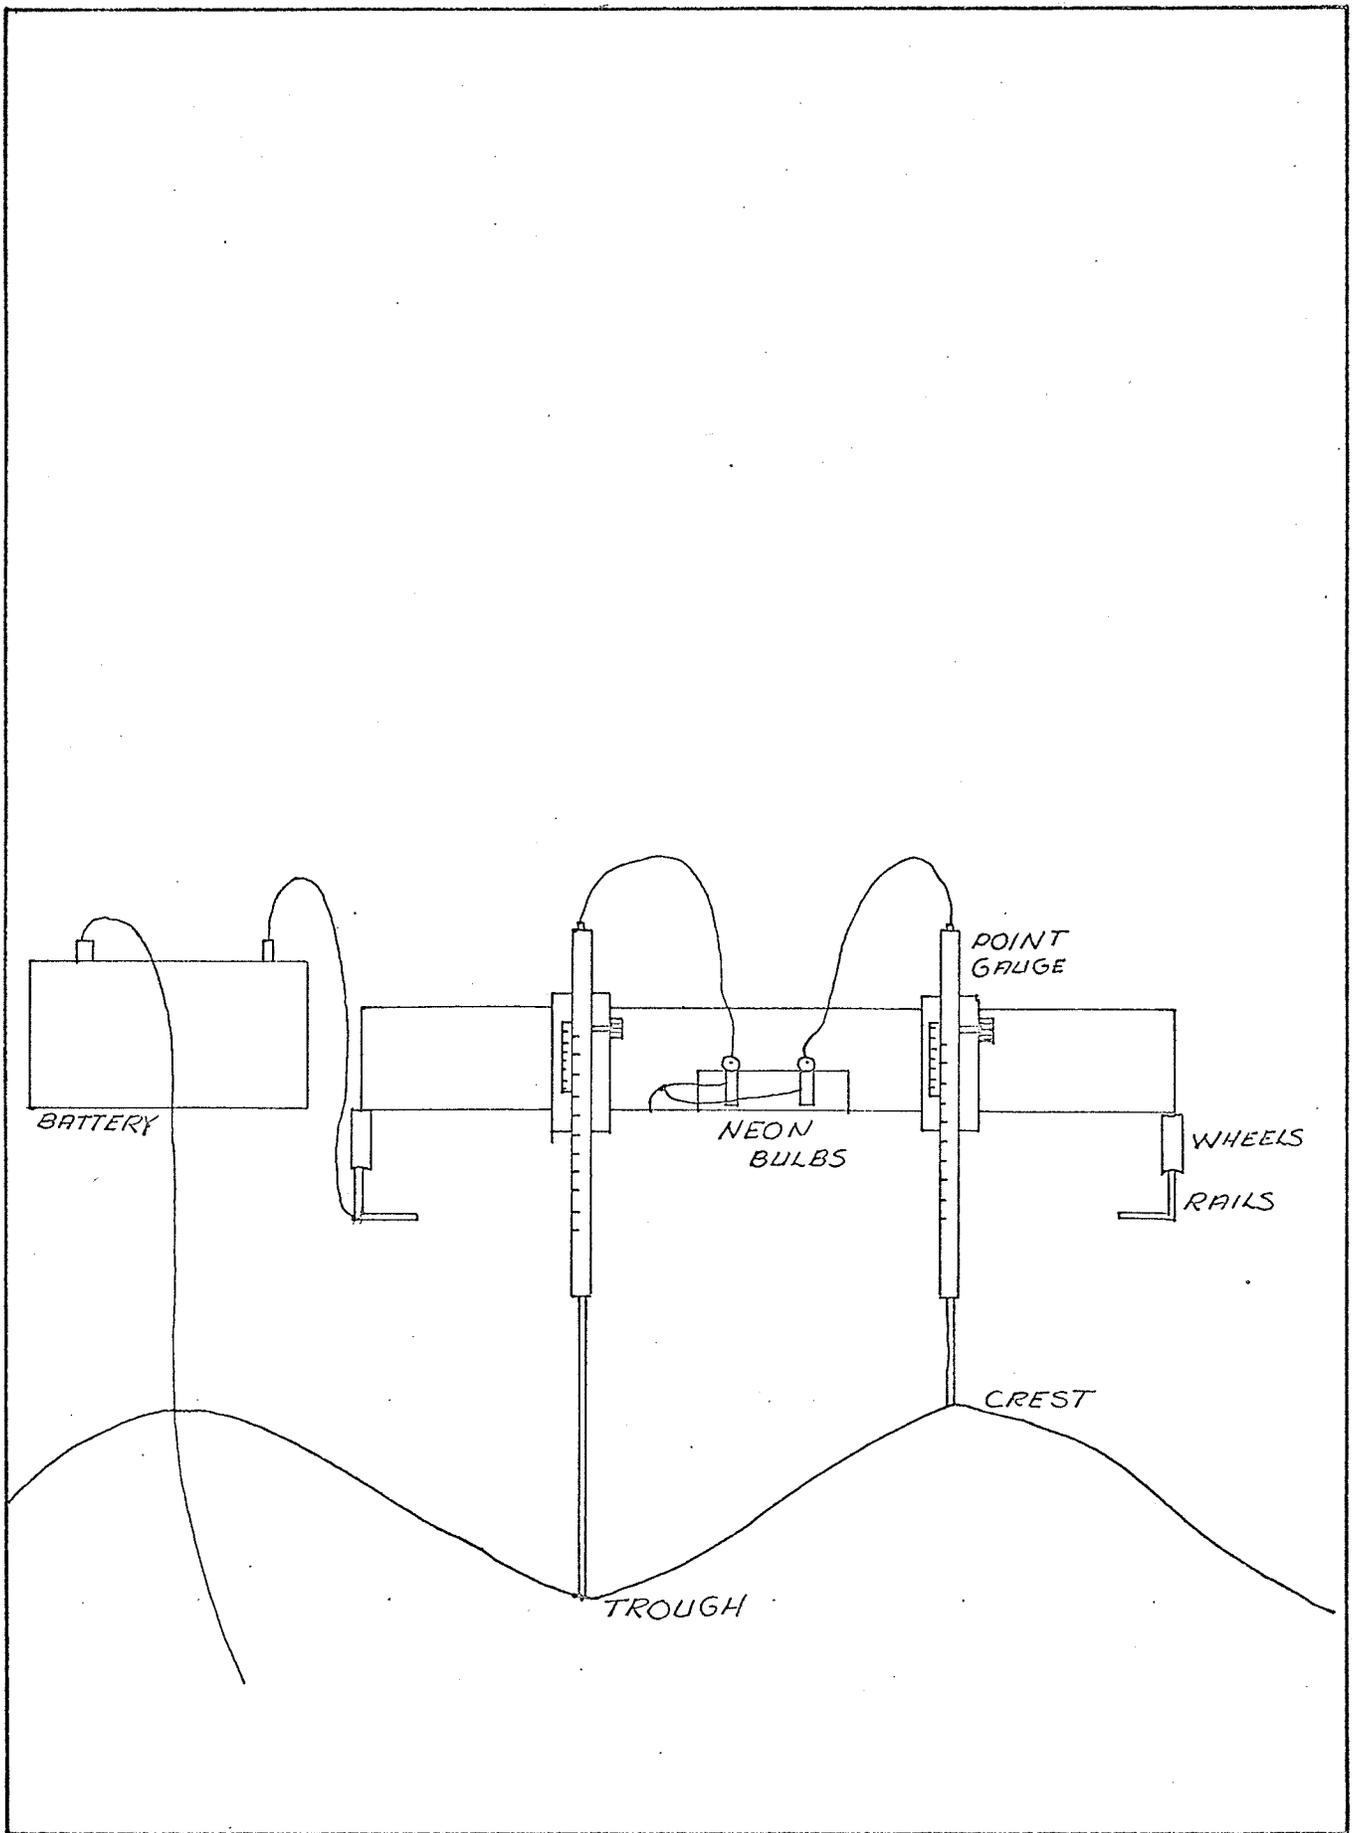
FIGURE C-1

WAVE HEIGHT INDICATOR

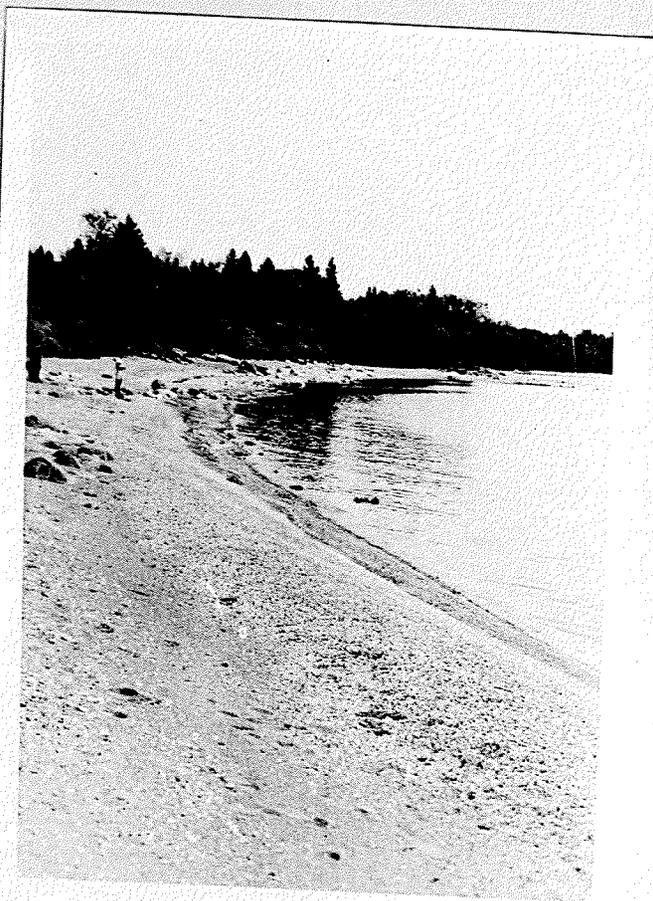
PHOTOGRAPH NO. 1
Camp Morton, looking northward.
Note serious bluff erosion and
pebbly beach. Rock groins are
visible in the background.

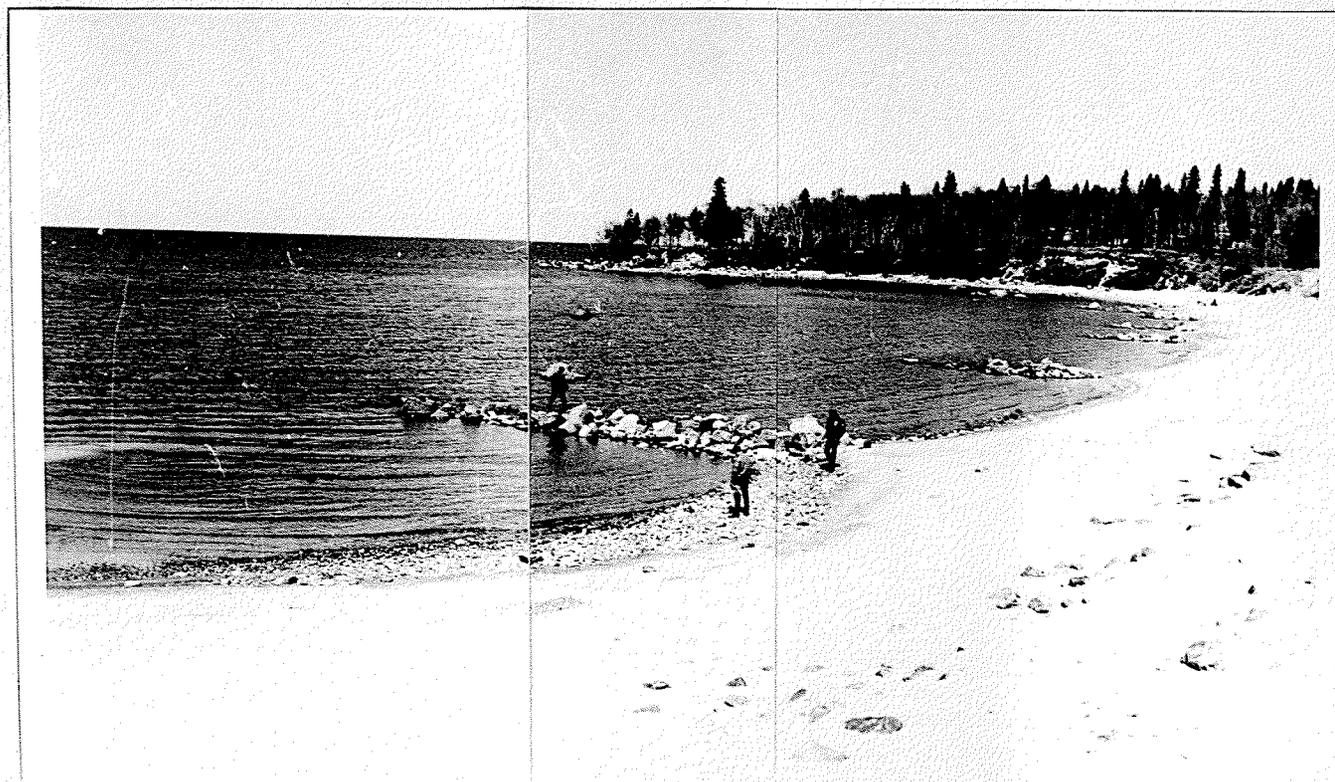
PHOTOGRAPH NO. 7

Victoria Beach, looking northward along the public beach. Note rock groins, fine sand and serious erosion in the background.

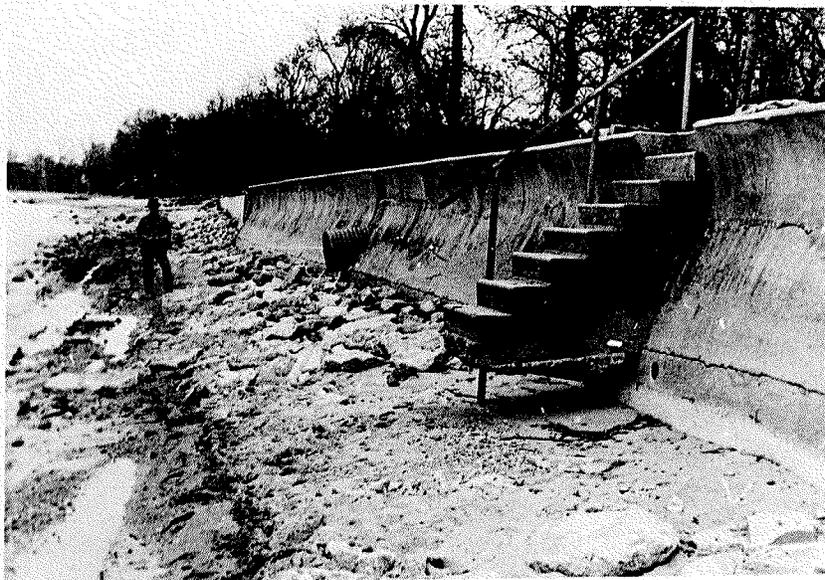
PHOTOGRAPH NO. 14

Winnipeg Beach. View of old portion of seawall. Sand was previously to the level of the second step. Portions of the seawall failed in 1966.

During the fifties a seawall was constructed from the Old Pavillion in the Amusement Area to approximately Oak Avenue as shown on Figure 18. Portions of the wall failed during the storms of 1966. Failure was caused by the erosion at the toe of the seawall as a result of wave reflection and may have also been partly due to the lack of proper drains to alleviate the excessive groundwater in the area. The serious erosion experienced along the old seawall is depicted in Photograph No. 14. The seawall was repaired and a new 400 foot extension, as shown in Photograph No. 15, built southward from the old section.

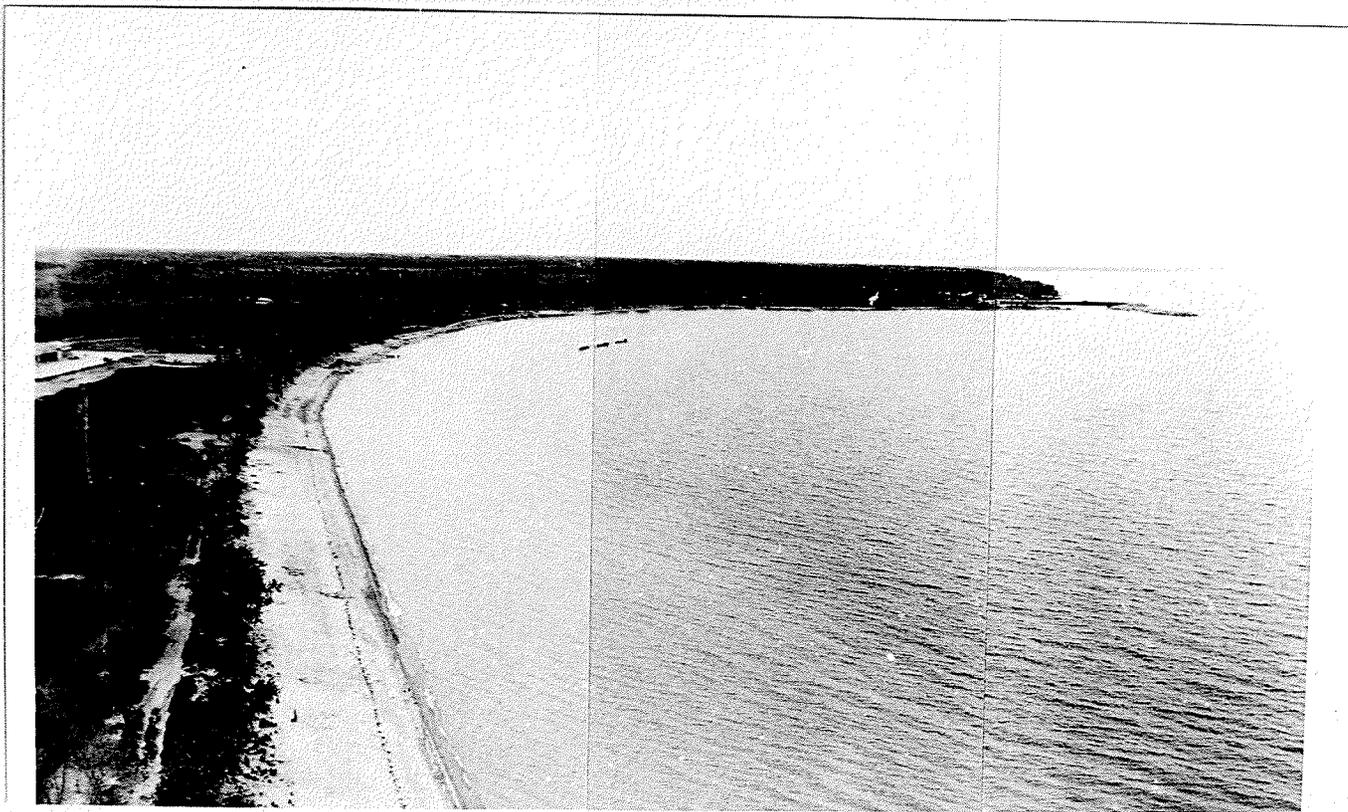
PHOTOGRAPH NO. 15

View of Winnipeg Beach looking northward from
the water tower. Rock breakwater can be seen
in upper right hand corner. Dashed line
indicates location of offshore breakwater.

During the winter of 1967-1968 a number of 4 foot square concrete blocks were placed some 500 feet offshore in a line parallel to the shore as shown in Photograph No. 15. The aim of this measure is to reduce wave action along the beach and cause deposition of littoral material shoreward of the blocks.

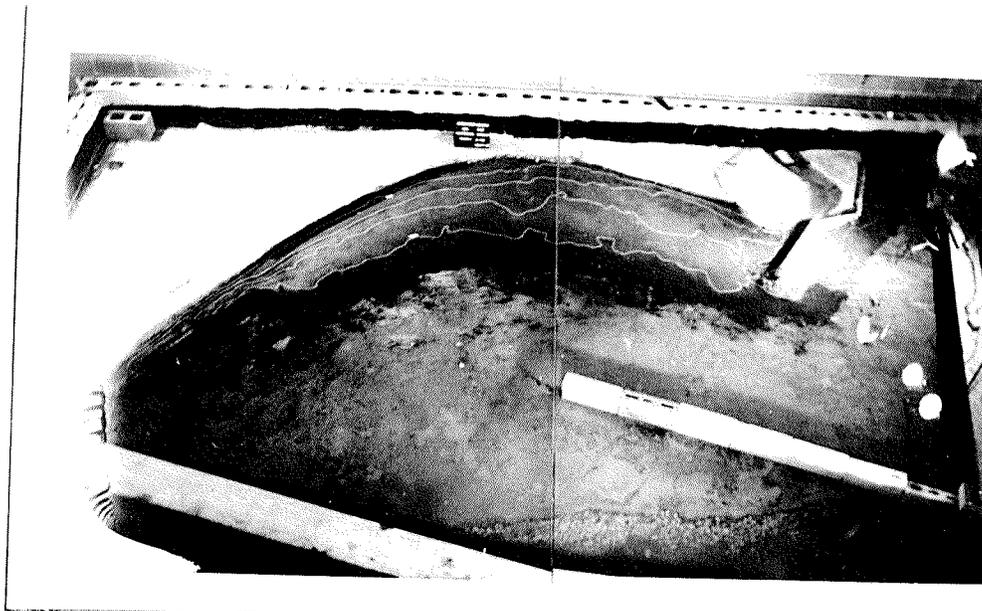
PHOTOGRAPH NO. 16

Contour lines before initiation of
test. (Based on March 1968 survey).

- 1) the ground walnut shells were placed to the proper elevation with the use of plywood templates, the elevations being based on the March 1968 surveys,
- 2) the basin was filled to the desired lake level,
- 3) the water was then drawn down in two foot (prototype) intervals and at each contour a white string was laid out to follow the water line,
- 4) photographs were taken of the initial conditions,
- 5) the basin was then re-filled to the desired water level,

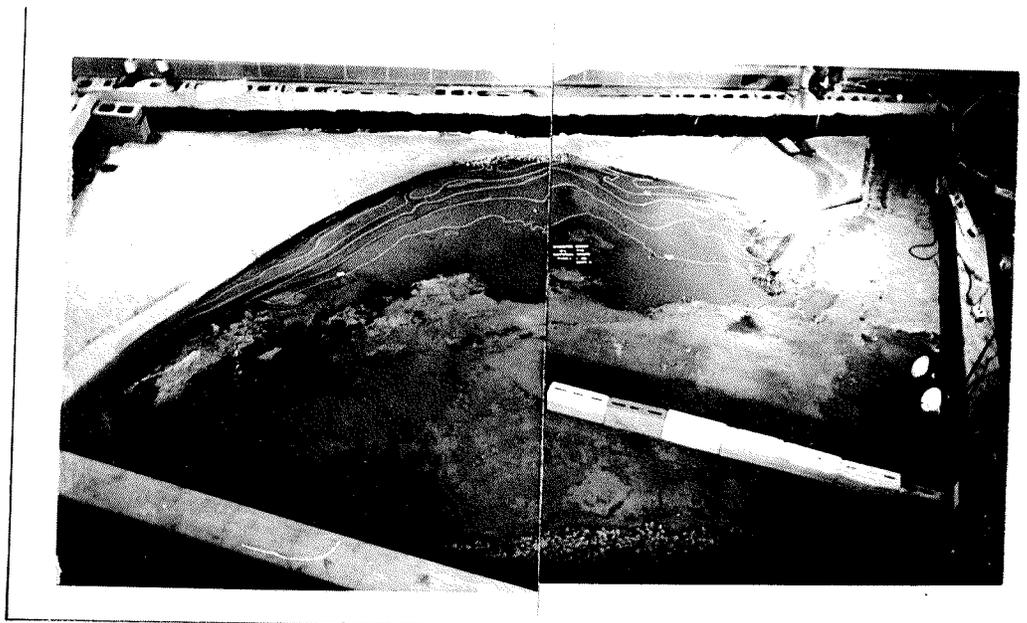
PHOTOGRAPH 17

Contour lines at termin-
ation of Test No. 1

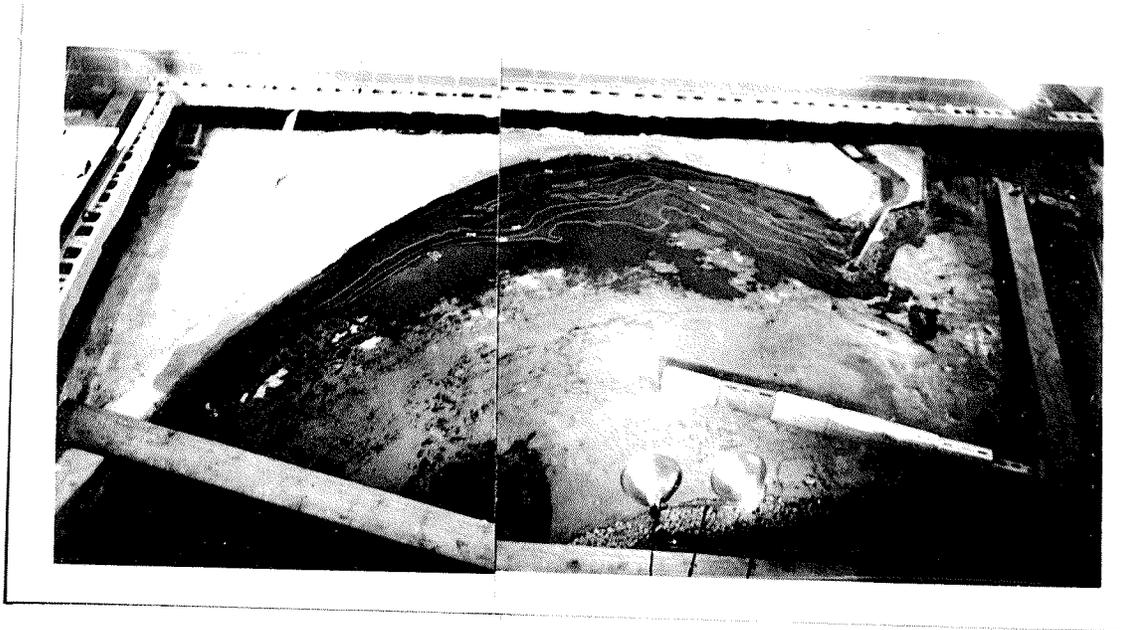
PHOTOGRAPH NO. 18
Contour lines at termina-
tion of Test No. 2

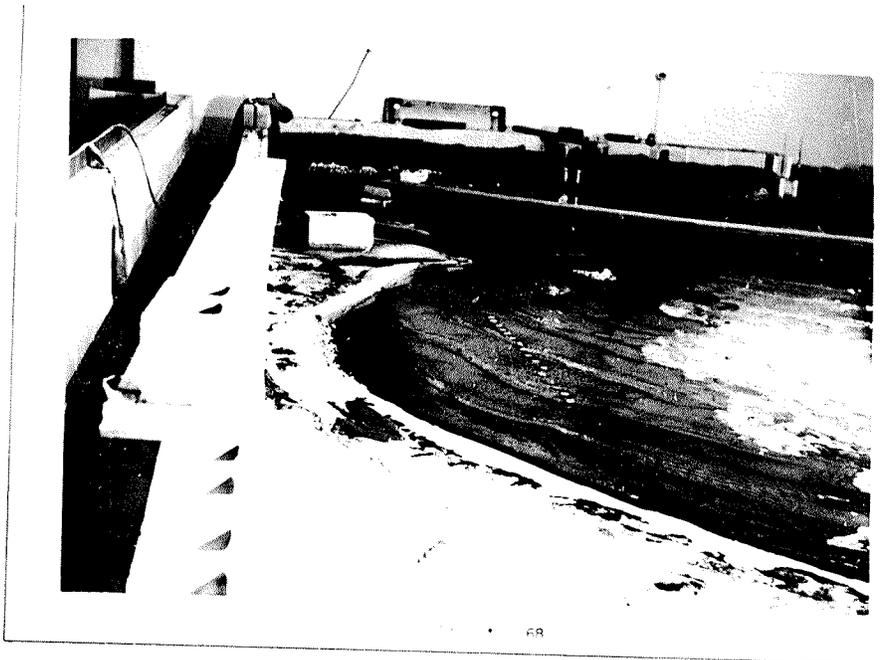
PHOTOGRAPH NO. 20

Test No. 5 in progress. Note
little effect of blocks on waves.

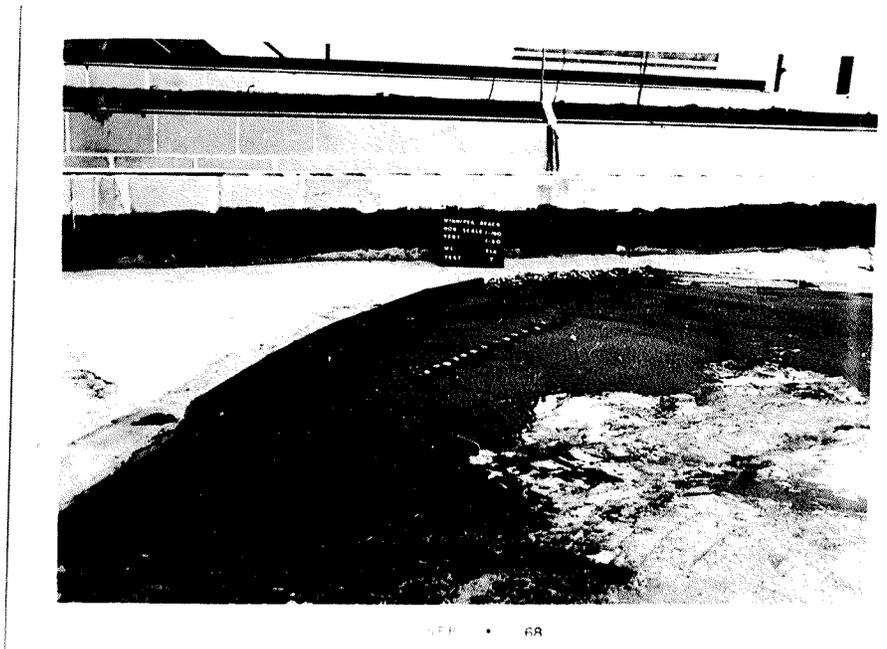
PHOTOGRAPH NO. 21

Beach condition at termination
of Test No. 6. Note negligible
deposition onshore of the blocks.

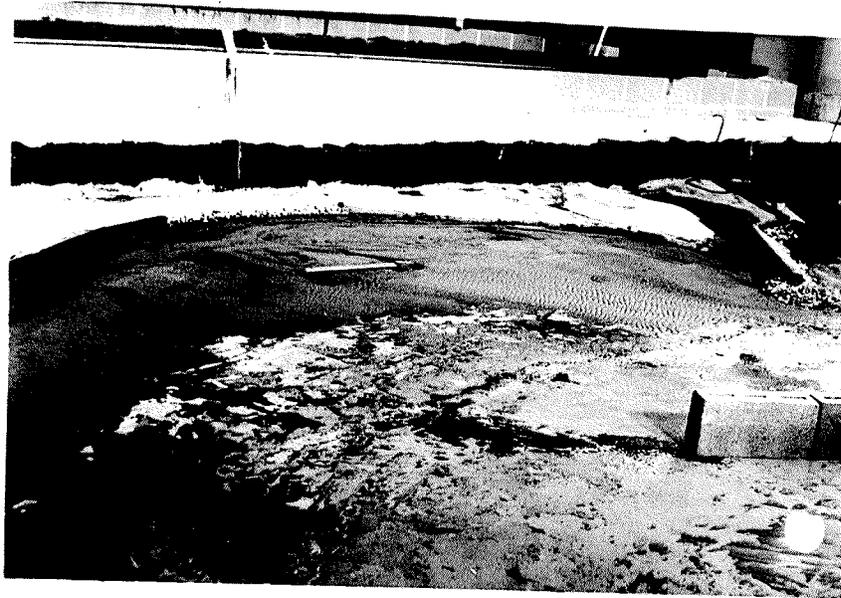
PHOTOGRAPH NO. 22

Beach condition at termination
of Test No. 7. Note heavy
deposit around breakwater.

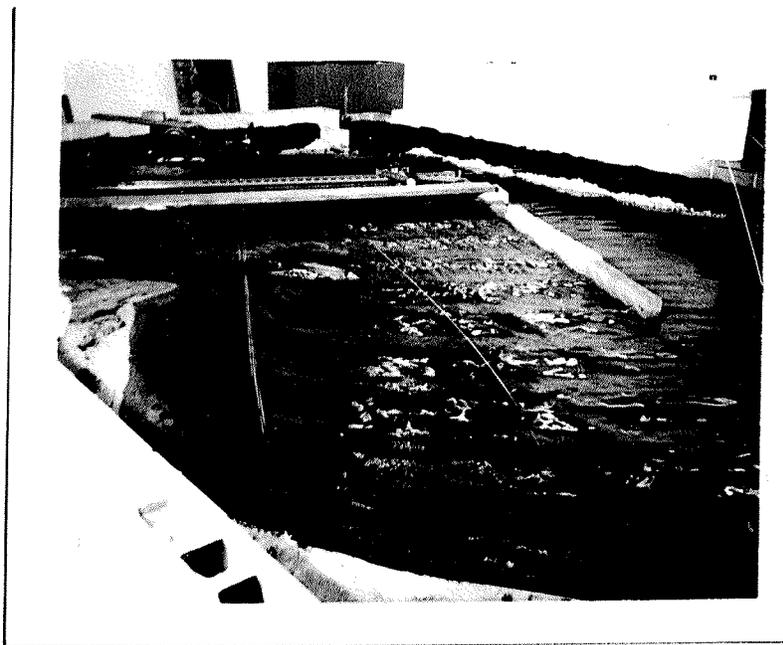
PHOTOGRAPH NO. 23

Wave action with extension of
breakwater 20° into entrance.

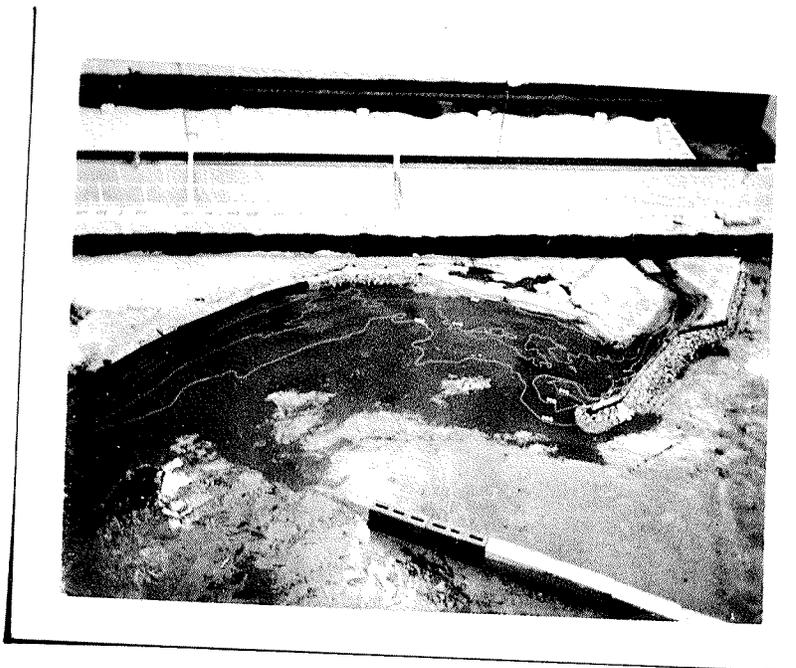
PHOTOGRAPH NO. 24

Contour lines at termination
of Test No. 8(a). Note bar
buildup in harbor.

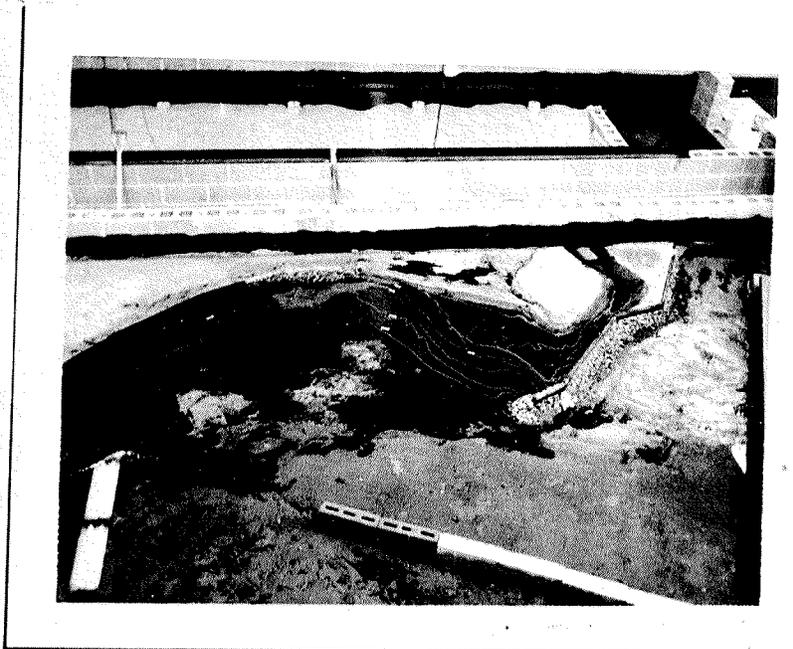
PHOTOGRAPH NO. 25

Contour lines at termination of
Test No. 8(b). Note that bar
of 8(a) has extended to the beach.
