Behaviour of GFRP Prestressed

Concrete Straps

A Thesis

The University of Manitoba

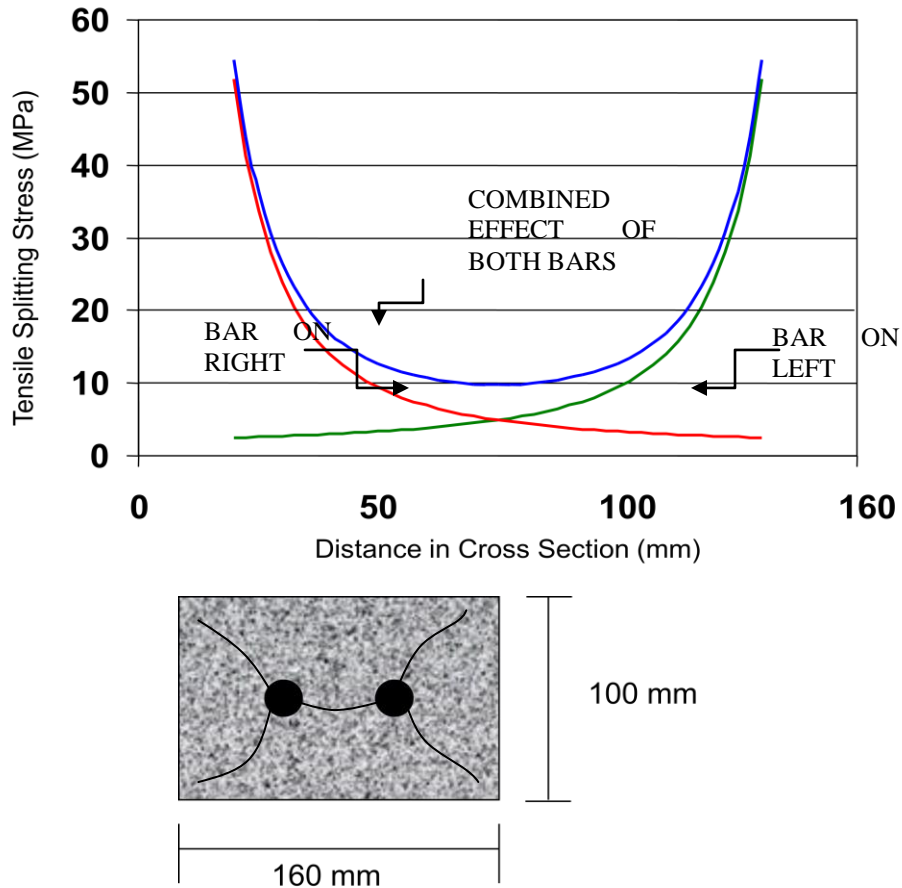
Figure 3.3 Model representing FRP bar embedded in concrete.

concrete which exceeds its tensile strength, and since the bars are close to each other, there is a cumulative effect of the radial stress occurring between bars.

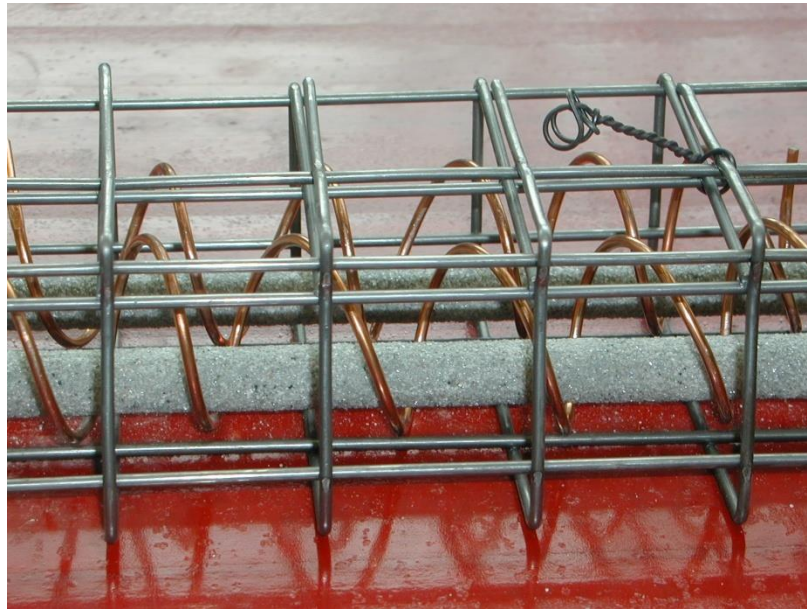
Figure 3.4 Reinforcing Cage Placed at the Transfer Region.

the bars. After a careful study it was decided to use a spiral shaped wire with a diameter of 2.5 mm which was placed to provide the proper confinement. The wire was bent in the lab into a coil having a pitch of 20 mm. In addition to the coils a steel cage using 51 x 51 mm wire mesh was used and was bent to cover the transfer length of 375 mm at each side of the strap (Fig. 3.4).

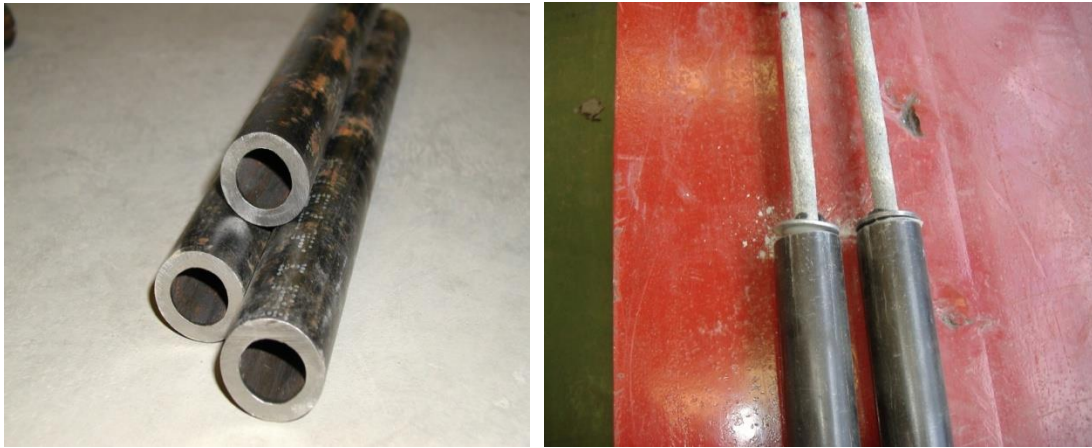
Figure 3.5 Anchors Casting.

sleeves were designed, following Annex B S806-02 (2002). The inner diameter of the anchor is 27 mm with 3 mm thick walls and the length of 450 mm.

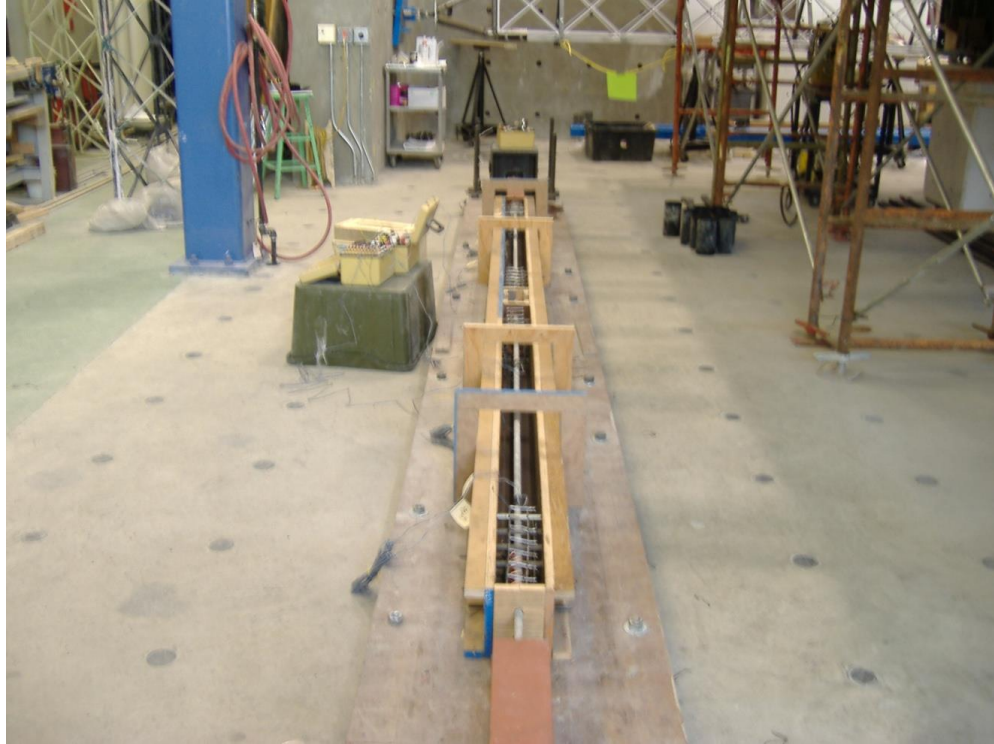
Figure 3.9 Prestressing Layout of the Straps.

The dywidag bars were then connected to the bulkhead that transfers the force from the prestressing to the 1m thick structural floor of the laboratory. The mechanism was conceptually similar to that used in the previous research of Banthia (2003). Figure 3.9 presents the prestressing set up for two straps.

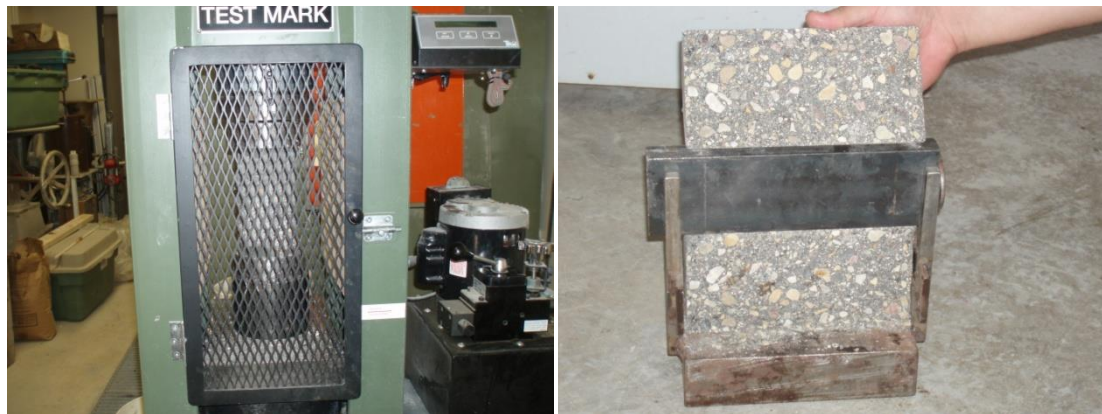
Figure 3.10 Testing for Mechanical Properties of Concrete

No. of Days after casting	Compressive Strength MPa	Tensile Splitting Strength MPa
14	40.4	3.8
28	47.5	4
125	50	4.1

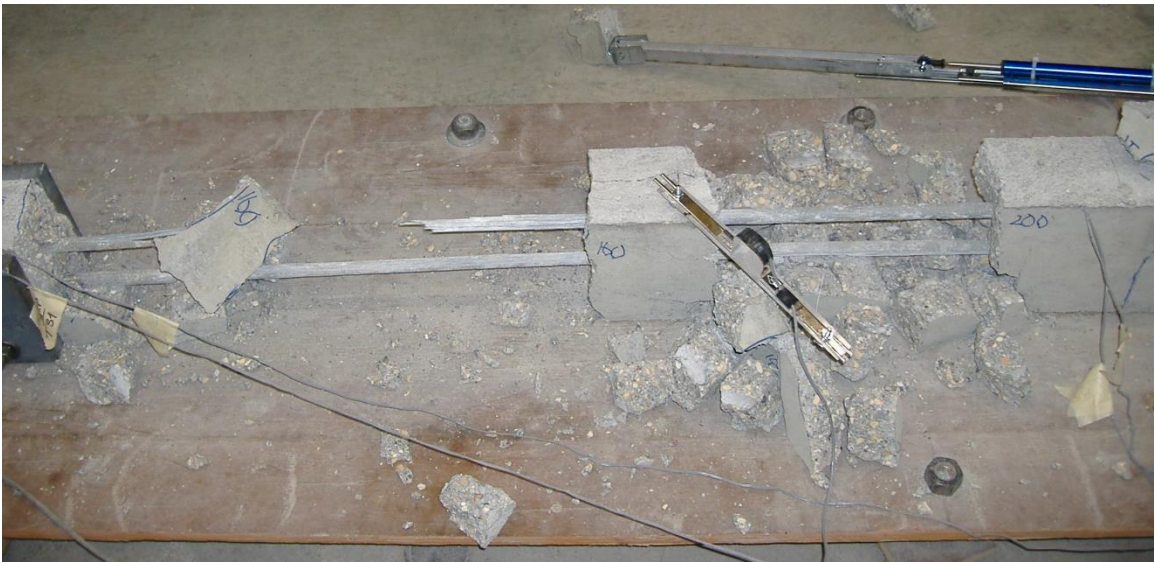
Figure 3.16 Failure of GFRP Prestressed Concrete Strap

Each strap was subjected to a fatigue test of 50 cycles of 50 kN load. The straps were then tested to failure. Initially, the samples were placed on the pre-stressing bed which was elevated from the structural floor to keep the straps leveled and assure that the load was applied at the center, thus preventing the development of any moment which would not occur in an actual strap in a steel-free bridge deck slab. During the cyclic loading the straps did not experience any cracking. When loading to failure the cracking pattern was observed at each load step and recorded until reaching the ultimate load. A typical cracking pattern is shown in Figure 3.15. The explosive and sudden rupture of the GFRP bars occurred at the center of the straps and is shown for Strap I trial 35% in Fig. 3.16.

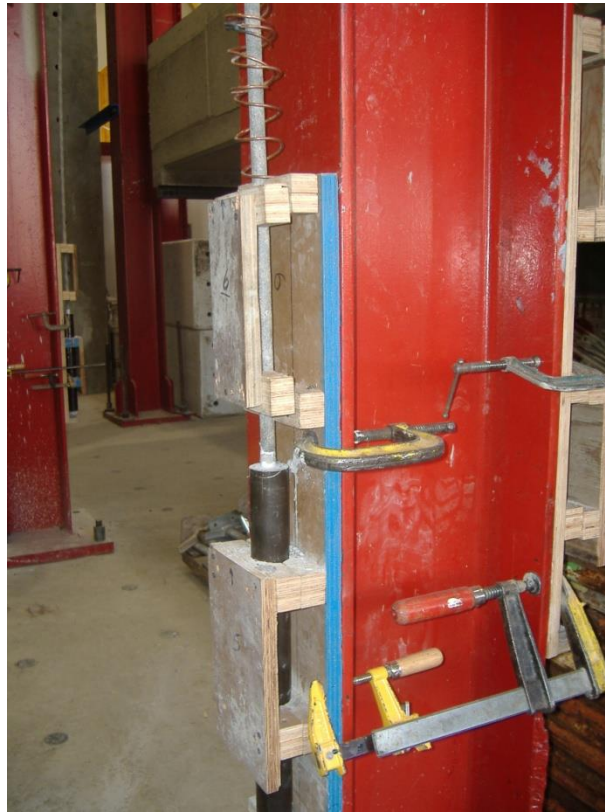
Figure 4.1 Wooden Jig Alligning the GFRP Bar in Steel Anchor Sleeves.

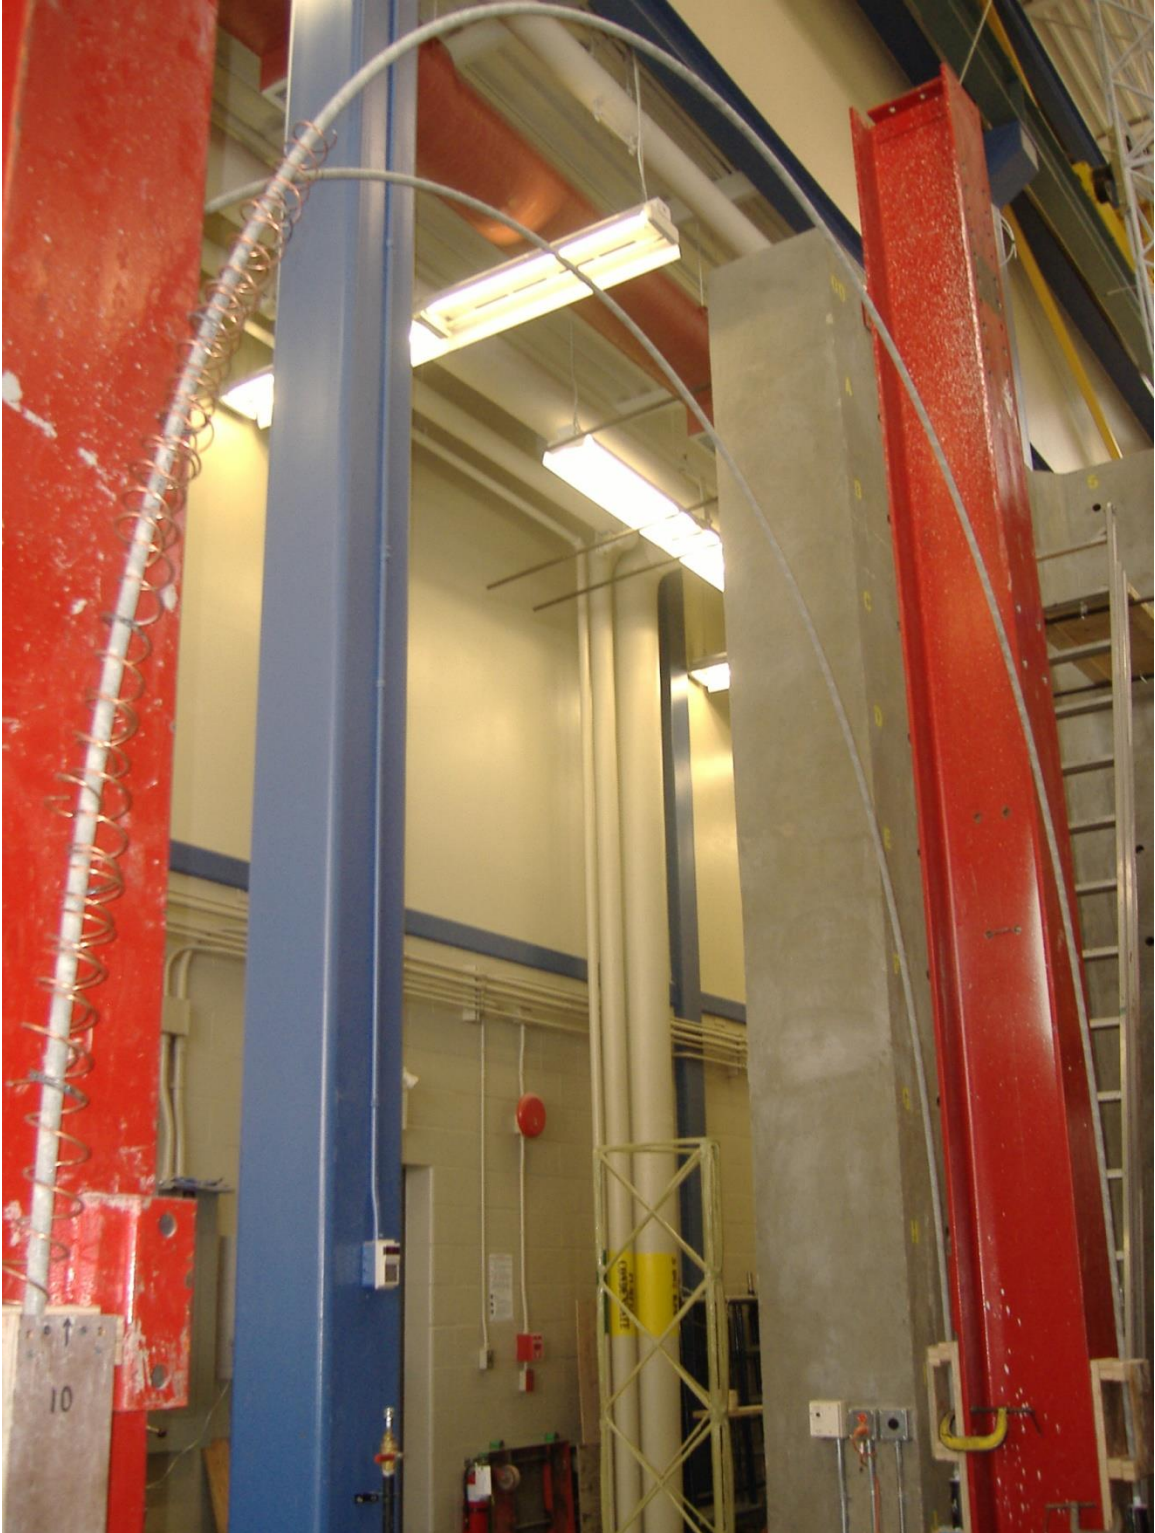
Figure 4.2 GFRP Bars Bent for Casting of Anchorage.

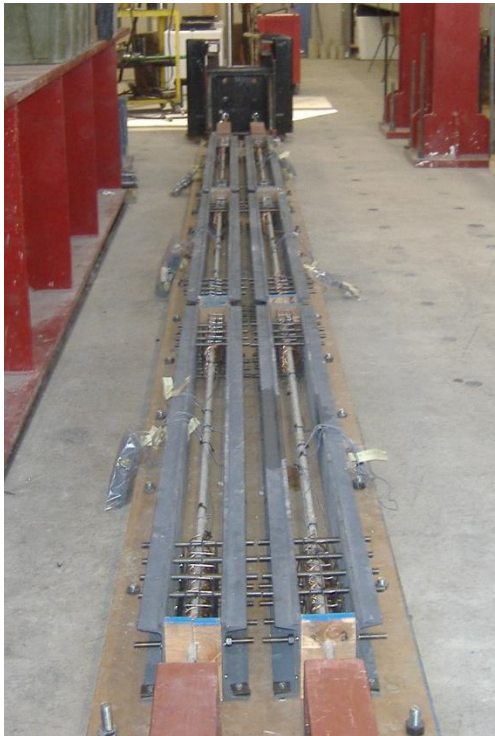
Figure 4.3 PreStressing Setup

A new prestressing bed was set up to accommodate the manufacturing of six straps at a time. The bed was 10 m in length and 1 m in width. One lineup prestressed the straps for 35% and the second line prestressed the straps at 45% for the first cast. The second cast was to prestress the straps at 55%. The third cast was for the straps designated for future research. Steel formworks were designed and manufactured using channel sections, C 150x12 mm, they were 2 m in length and had holes drilled at the required height and width for the stainless steel rods to go through as these are needed for the pulling mechanism. The anchorage zone is reinforced using the bent wire mesh cage as well as the stainless steel coils along the development length. To align the GFRP bars, wooden ends were used instead of plastic chairs to prevent the instigation of cracks in the concrete. The setup is presented in Figure 4.3.

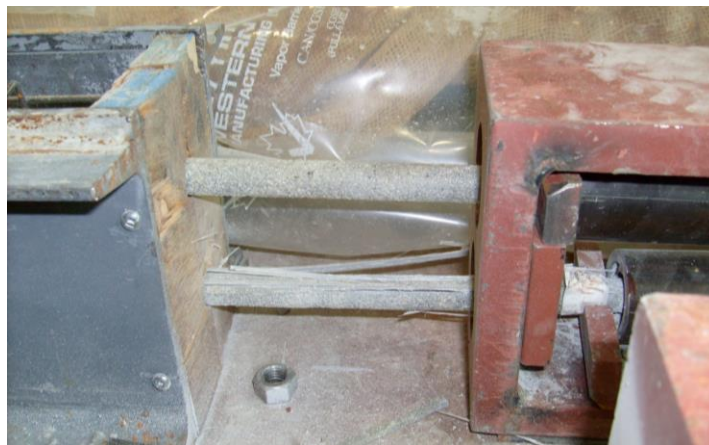
Figure 4.4 Rupture of GFRP After Prestressing

The prestressing for the 35% and 45% of the ultimate strength went smoothly. The stressing of the 55% straps experienced problems were the GFRP bars ruptured after stressing in one line-up (Fig. 4.4). The second lineup maintained the prestressing during casting, but ruptured after 12 days of casting and before release at the anchors and between the formworks. (Fig. 4.5). Creep rupture of GFRP was suspected to be the cause of these failures.

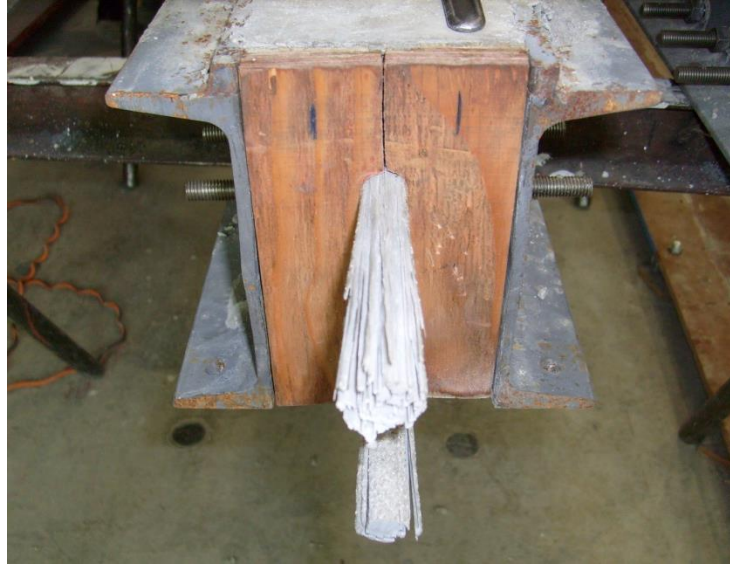
Figure 4.5 Rupture of GFRP After Casting

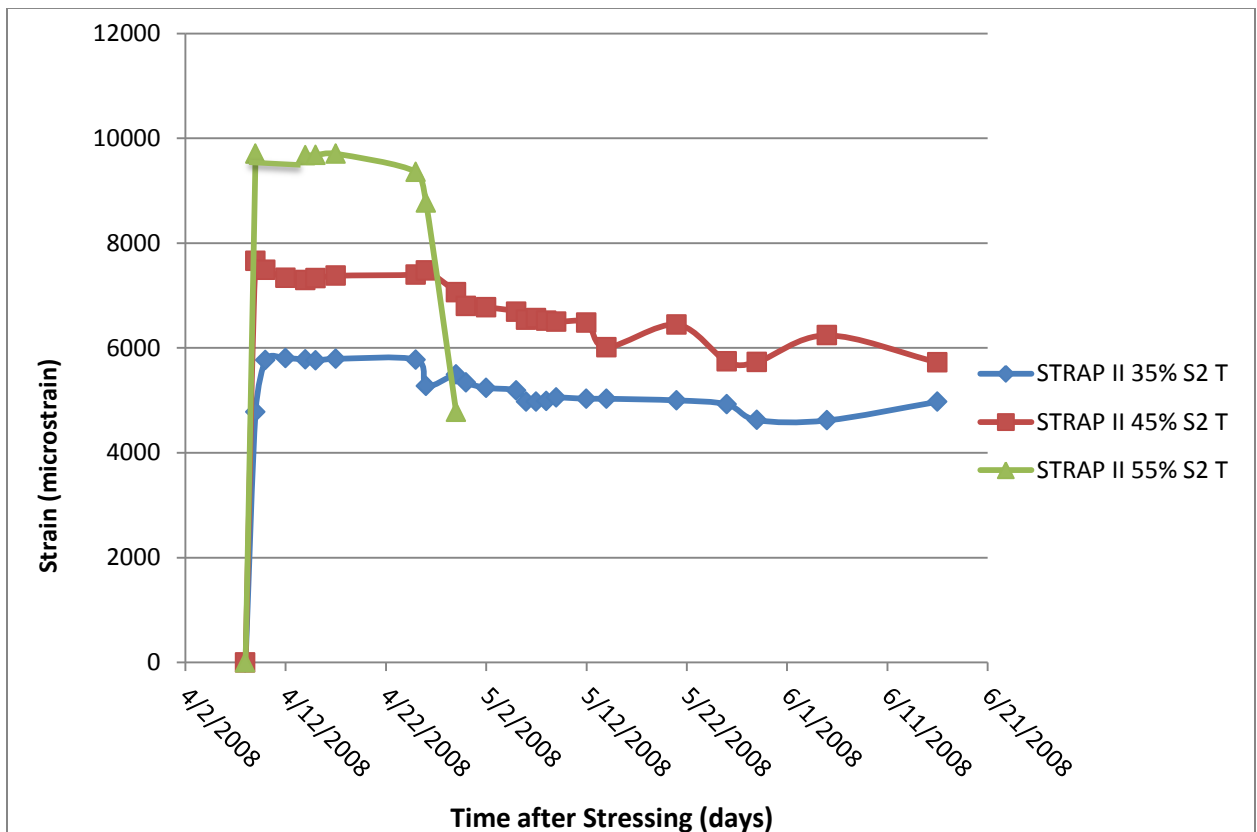
Figure 4.6 Prestressing Losses Observed

Strains in the bars were monitored at various locations daily using a portable strain gauge monitor. The prestressing losses included long-term losses for the straps prestressed at 35% which ranged between 10% and 20% while the straps prestressed at 45% faced losses ranging between 15% and 25%. As for the straps prestressed at 55%, many of the strain gauges were damaged after the rupture and the readings indicated losses ranging between 15% and 45%.

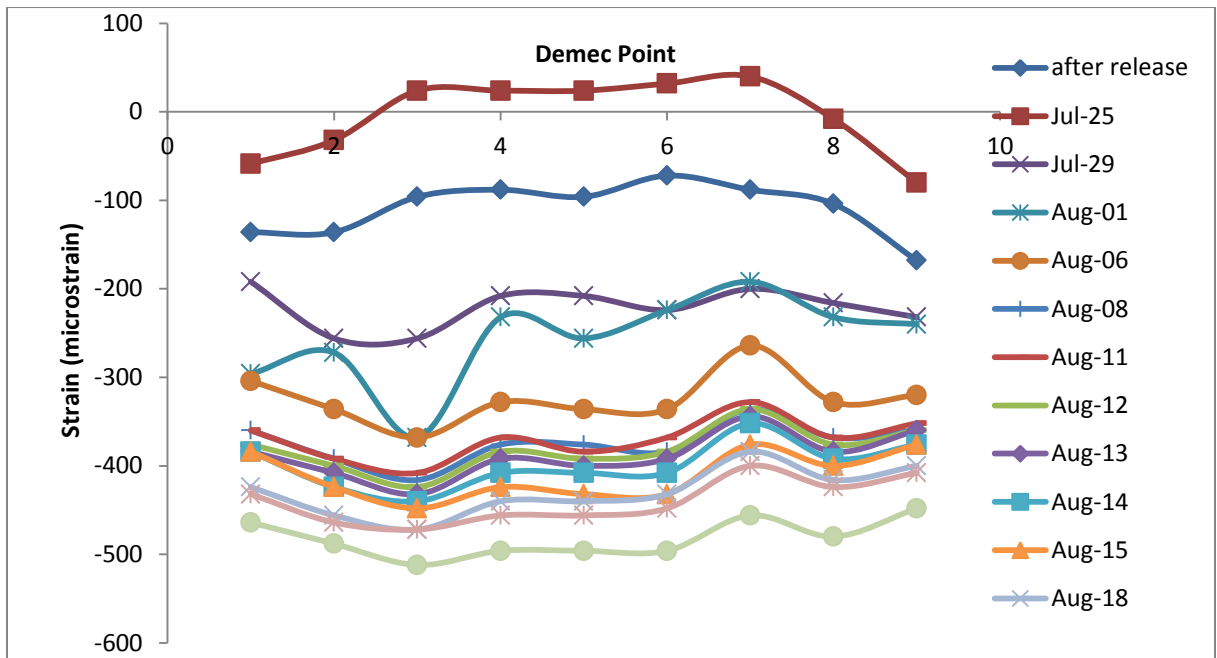
Figure 4.7 Prestressing Losses of Strap 35% I using Demec Points Readings

placed on the surface of the beams at the centre of the top surface of the straps of set B. Ten Demec points were placed at 20 cm intervals, which were then cemented to the straps using 5-minute epoxy after removal of the formworks. Figure 4.7 illustrates the prestress losses of the strap prestressed at 35% of the ultimate strength, which is consistent with readings from the strain gauges, as both strain reading methods show a loss of 400 – 500 μ strain within 25 days, while Figure 4.8 presents that of the strap prestressed at 45% of the ultimate strength.

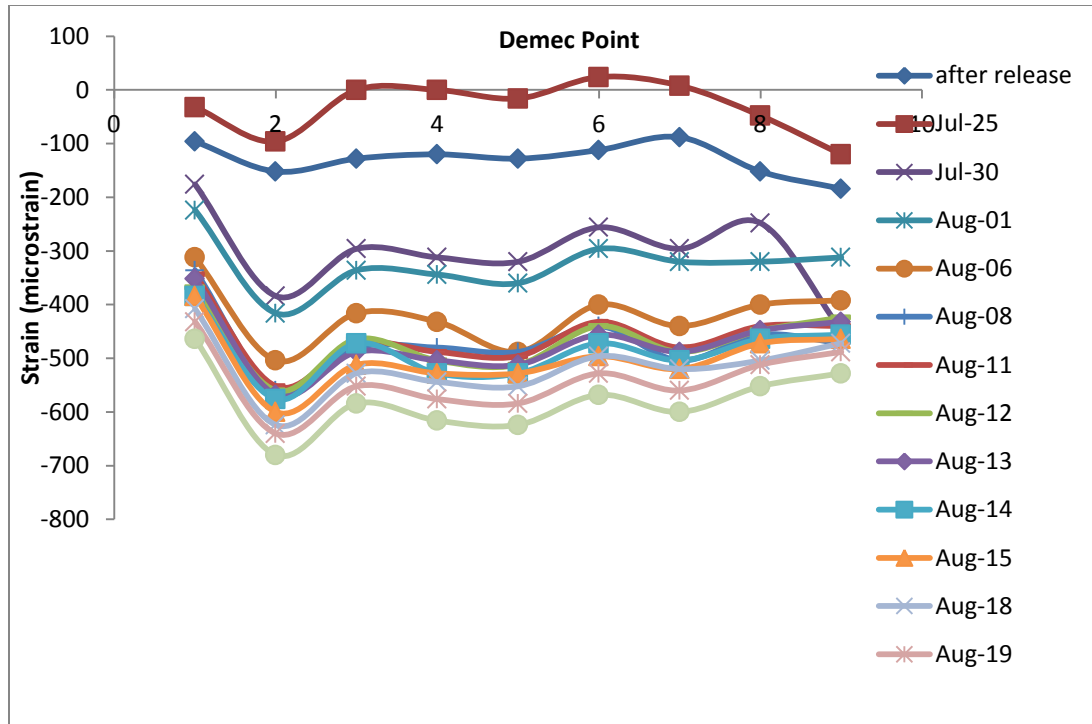
Figure 4.8 Prestressing Losses of Strap 45% I using Demec Points Readings

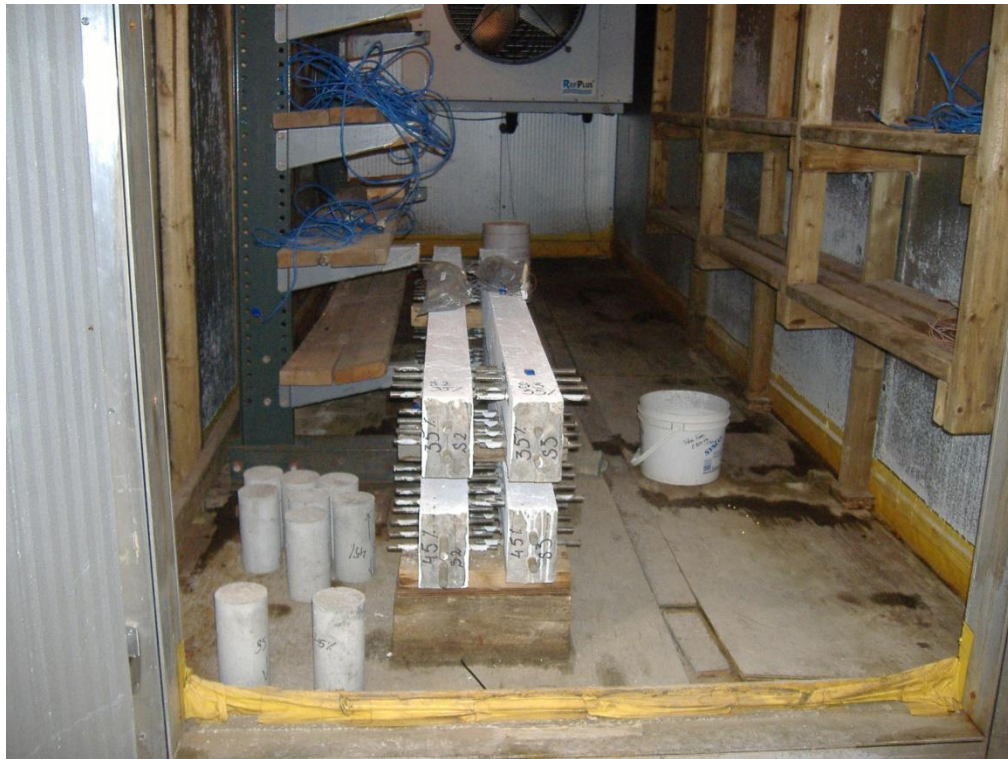
Figure 4.9 Arrangement of the Straps in the Environmental Chamber

performed using an environmental chamber capable of reaching the specified temperatures with humidity control. The straps were then placed in the chamber at room temperature and placed on wooden blocks to prevent damaging the floor under excessive bearing stresses. Figure 4.9 presents the layout of the beams in the environmental chamber. This arrangement allowed for efficient air circulation around the samples to reach the desired temperature at the center of all the straps. Figure 4.10 shows the fluctuation of temperature in the environmental chamber with time, and Figure 4.11 indicates the variation of temperature at the center of the straps when conditioned to a Manitoba climate.

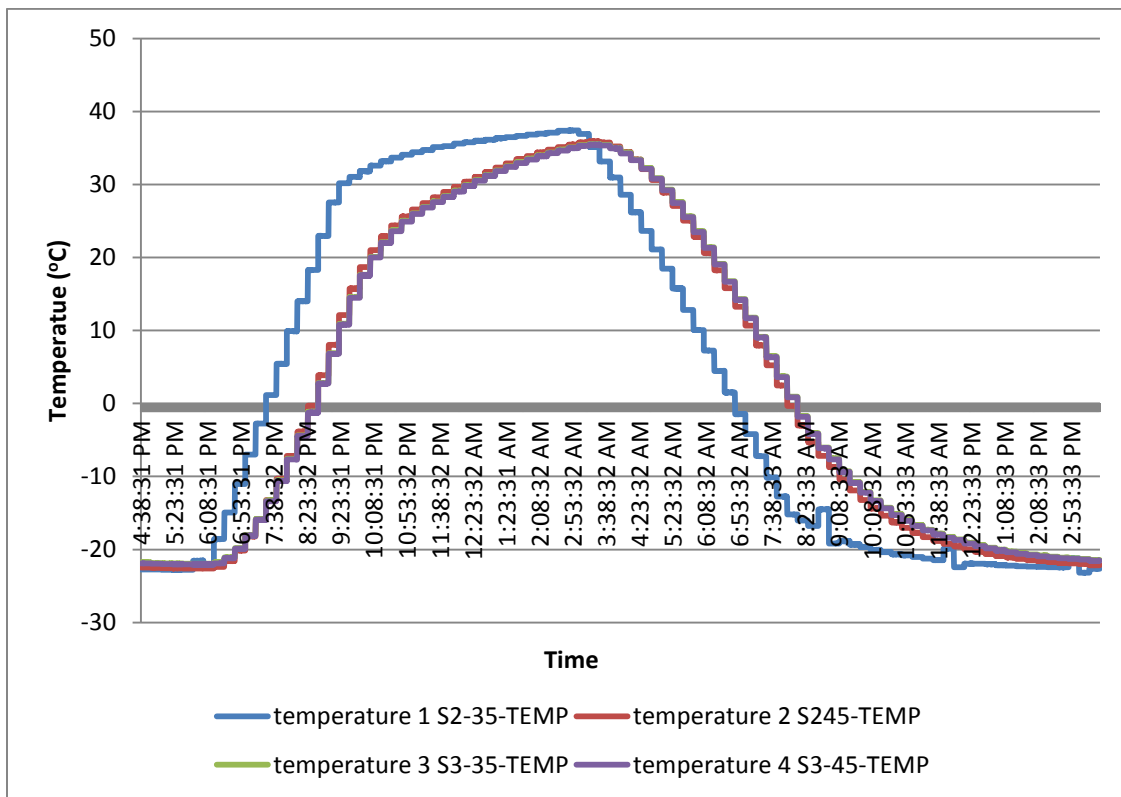
Figure 4.11 Fluctuation of Temperature at the Centre of the Strap in The Environmental Chamber

Figures 4.10 and 4.11 illustrate that the extreme temperatures within the environmental chamber were maintained during a total of three hours to achieve equivalent temperatures at the reinforcing level. Strains were also monitored during the thermal cycling, using electric resistance strain gauges, and as indicated in the figure 4.12, the prestressing levels remained stable with the change of temperature. During the thermal cycling, the beams were randomly checked for damage along their lengths, as well as being superficially inspected at the level of the reinforcement using a 0.1 mm accuracy hand-held microscope. No damage was detected in the straps as a result of exposure to the freeze-thaw cycles.

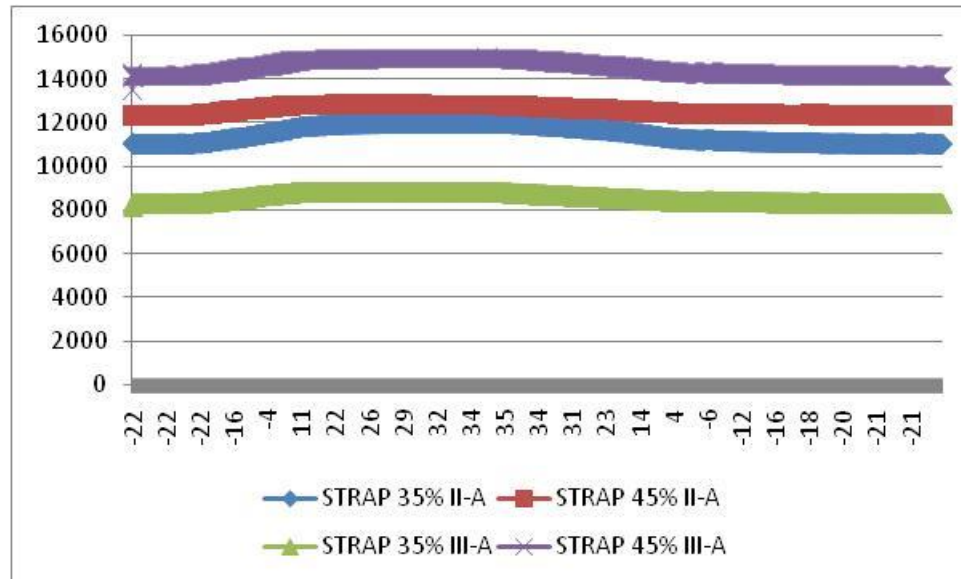
Figure 4.12 Fluctuation of Strains in Straps at varying Temperatures in the Environmental Chamber

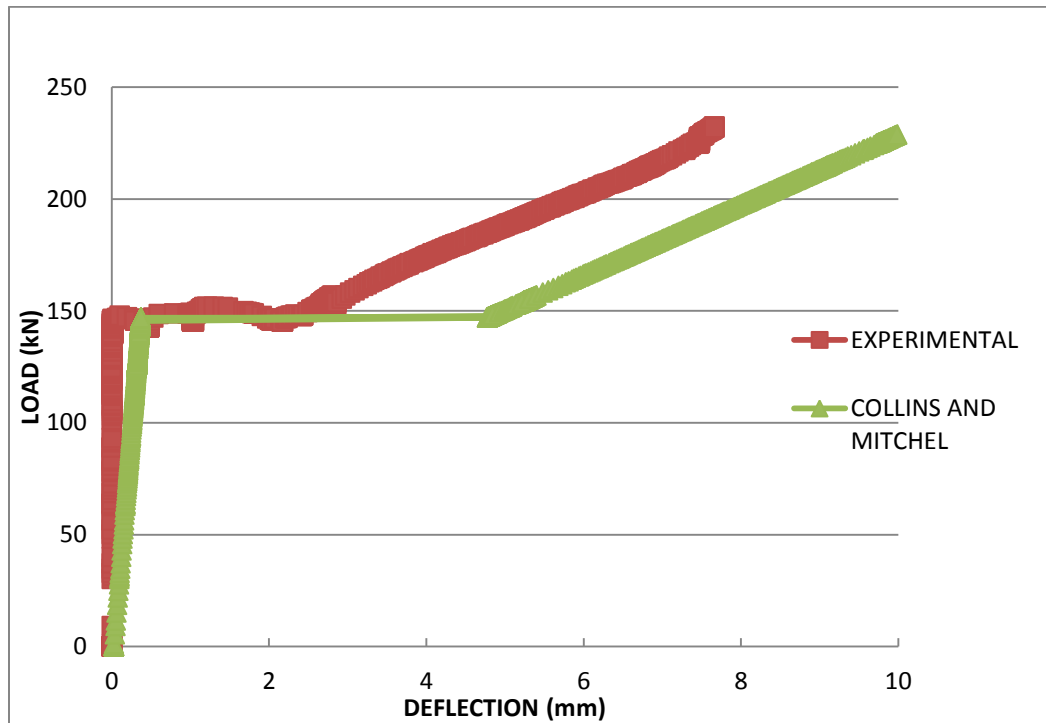
Figure 4. 31 Comparison of the Experimental and Theoretical Behaviour of 35% I-A

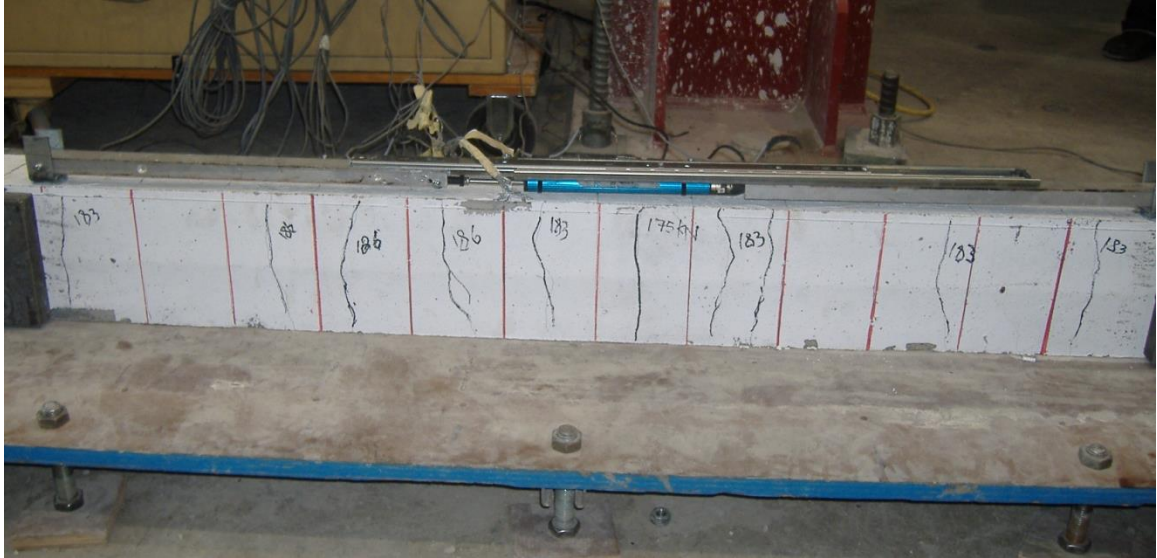
Figure 4.32 Crack Propagation of Strap 35% I-A

Strap 35% I-A failed at the anchorage zone, at 380 mm from the loading end. Both bars slipped at the same location and no rupture occurred at 240kN. Cracking of the strap during the application of the load was at 152 kN, which was closer to the loading end. At failure de-bonding cracks were observed at the anchorage zones with cracking width varying between 0.25 and 0.4 mm. Figure 4.29 and Figure 4.30, are readings of Strap 35% I-A and indicate a typical strain reading and crack width reading for the 35% prestressed straps. On comparing the experimental to the analytical results, the experimental response of the strap was a stiffer than theoretical, as seen in Figure 4.31, which may be contributed to the higher strength of the concrete of the sample to that of the cylinders. Figure 4.32 shows the crack formation in the strap at a load of 200 kN.

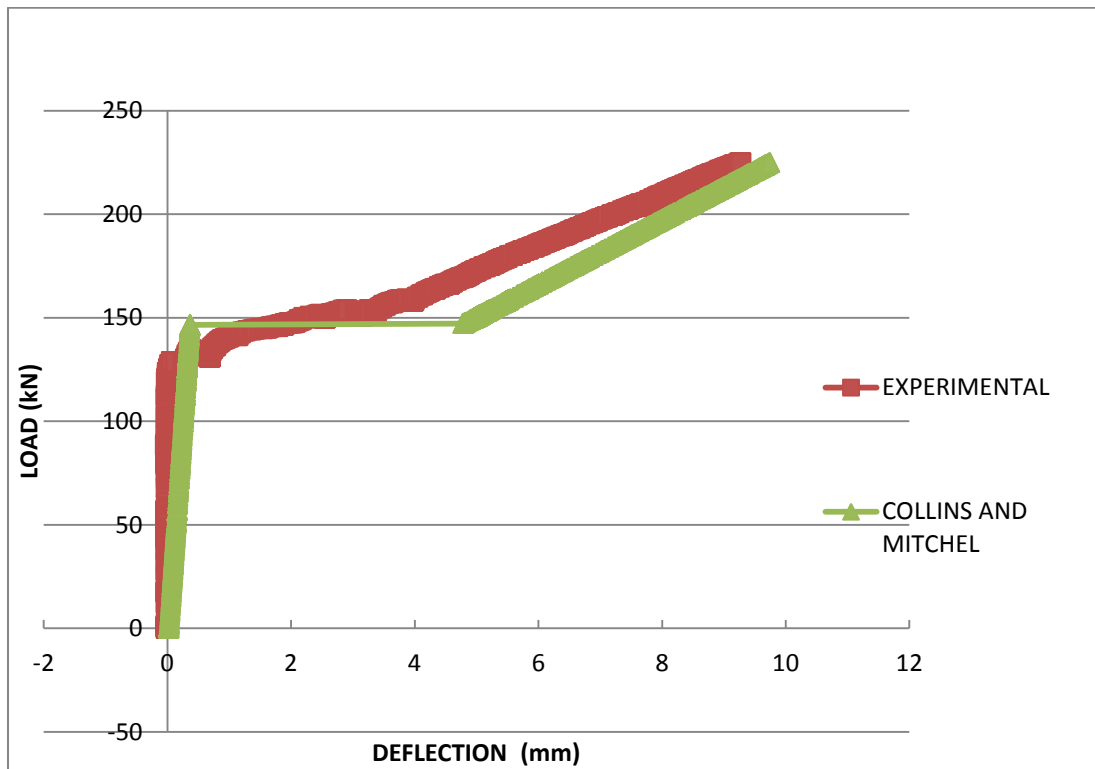
Figure 4.34 Elongation of Strap 35% II-A

Strap 35% II-A had an anchorage failure which occurred at 380 mm from the dead end, where the top bar slipped while the bottom bar ruptured at 230 kN, as seen in Figure 4.33. While placing the plates of the pulling mechanism, a crack of 30 cm by 0.2 mm appeared at the dead end between the two GFRP bars. This crack might have appeared while trying to manipulate the plate to pass through the threaded bars. During the application of load the first crack appeared at 130 kN at the loading end, whereas the failure of the strap occurred at the dead end. De-bonding cracks were observed and ranged between 0.15 and 0.5 mm. The strap had cracked at a lower load than would have been expected in comparison with the experimental results (Fig. 4.34).

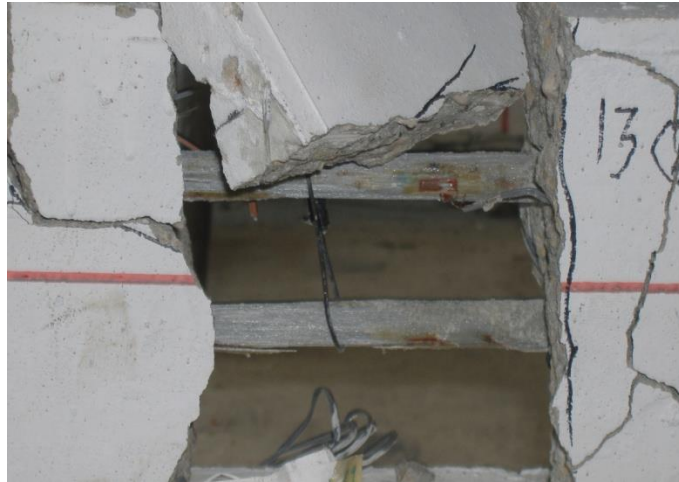
Figure 4.35 Failure Mode of Strap 35% III-A

Strap 35% III-A first cracked at 150 kN in the center of the strap, and failed through rupture of both bars at the center of the strap at 250 kN, as seen in Figure 5.35. Debonding cracks could be observed running along the length of the strap with a width varying between 0.1 and 0.5 mm. No cracks were present at the anchorage zone. Figure 4.36 shows comparable stiffness and deflection between the experimental and the analytical results.

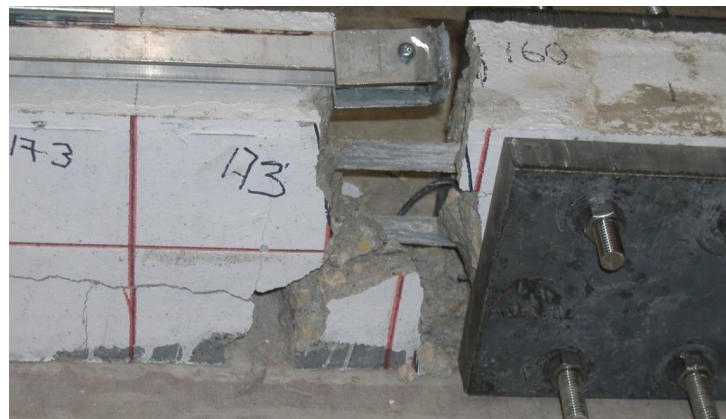
Figure 4.39 Failure Mode of Strap 45% II-A

Strap 45% II-A had its first crack at 173 kN and suffered from slip of both bars, similarly to the first strap; the top bar experienced more slip than the bottom bar causing its rupture at 230 kN, as seen in Figure 4.39. The total deflection was less than the strap should have sustained at higher loads as observed in Figure 4.40. The fluctuations observed in the LVDT reading was because the wire was accidentally stepped on by the wheel of the cart. Failure of the strap occurred at 450 mm from the loading end. De-bonding cracks were present ranging between 0.1 and 0.8 mm.

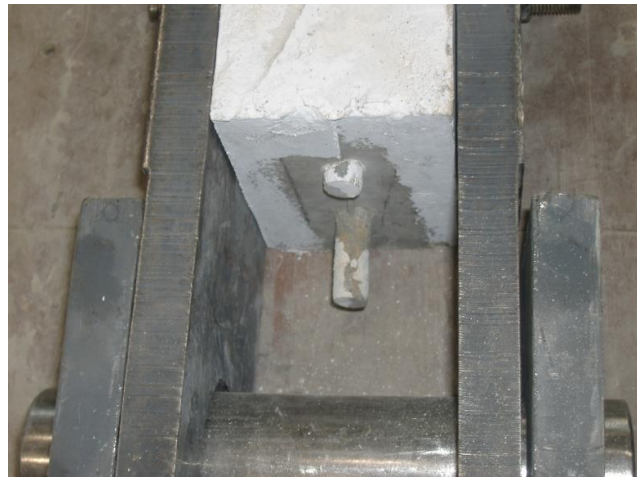
Figure 4.41 Failure Mode of Strap 45% III-A

Strap 45% III-A cracked at 165 kN and failed at 480 mm from the loading end, where the top bar slipped leading to the rupture of the bottom bar at a load of 225 kN (Fig.4.41). De-bonding cracks were observed along the whole length of the strap ranging between 0.1 and 0.8 mm. Figure 4.42 presents the comparison between the experimental and analytical results.

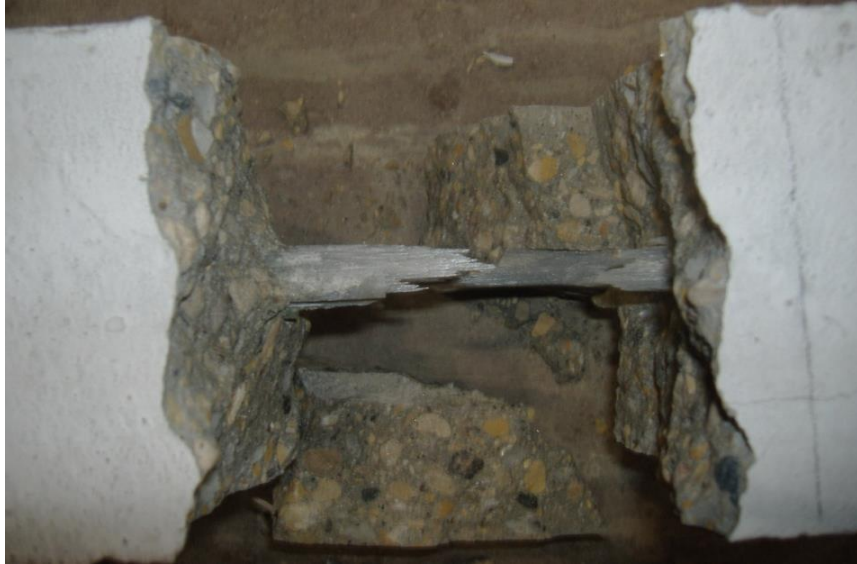
Figure 4.43 Failure Mode of Strap 55% I-A

All three straps experienced a single crack, then rupture of both bars without slip as seen in Figs. 4.43– 45). Strap 55% I-A failed at the center of the strap by rupture of both bars at 210 kN (Fig. 4.43). The de-bonding cracks appeared along the length of the strap with crack width ranging between 0.1 and 0.9 mm. Strap 55% II-A failed by rupture of both bars at 200 kN at 500 mm from the loading end; these de-bonding cracks ranged between 0.1 and 0.75 mm. Strap 55% III-A had a crack appearing along the length of the strap during the manipulation of the plate for the pulling mechanism. The crack prompted the strap to fail at a lower load of 70 kN. The experimental results (Fig.4.46) illustrate that the straps elongated for less than 1 mm, that the failure was sudden and with very little warning, and that the straps had very low elongation.

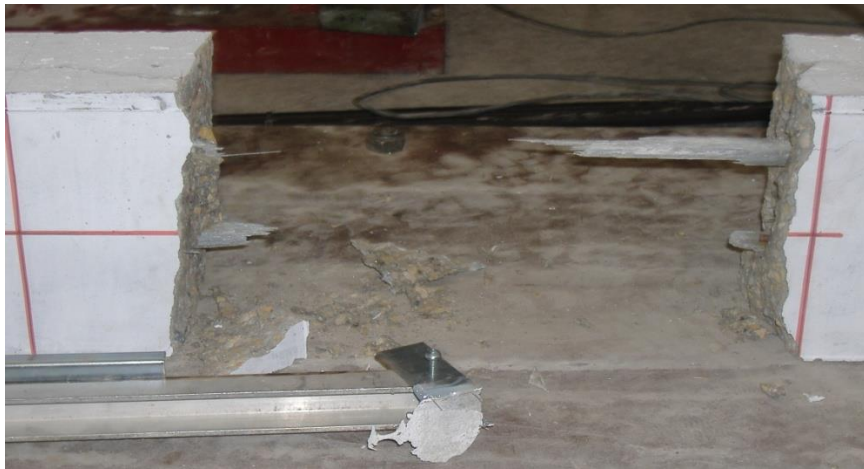
Figure 4.44 Failure Mode of Strap 55% II-A

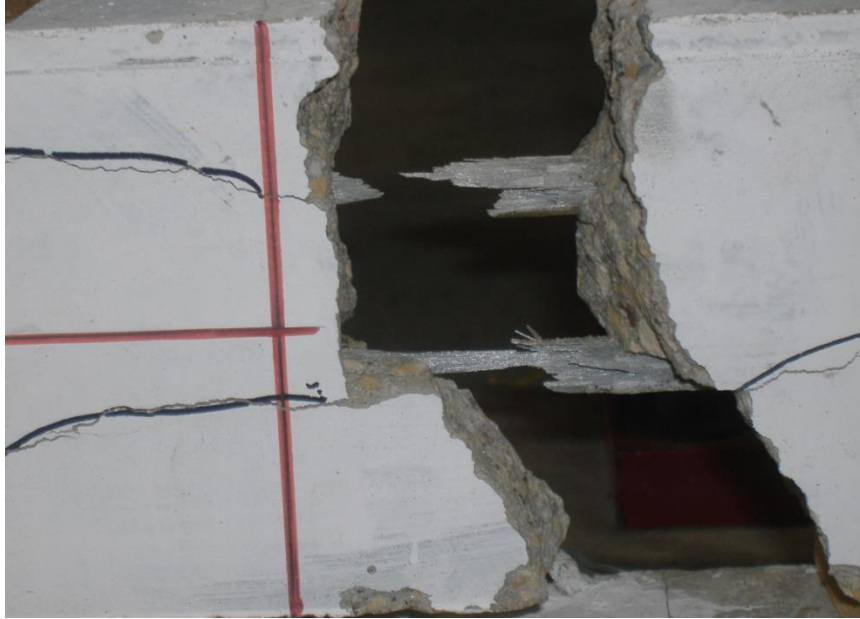
Figure 4.45 Failure Mode of Strap 55%III-A

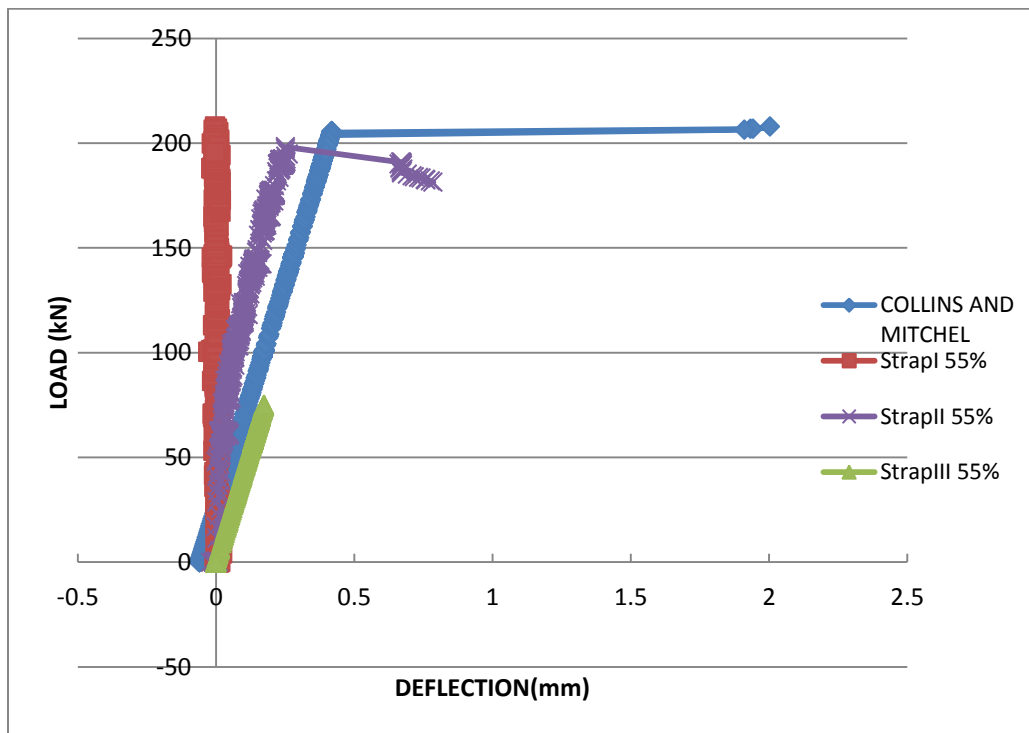
Figure 4.46 Elongation of Straps Prestressed at 55%

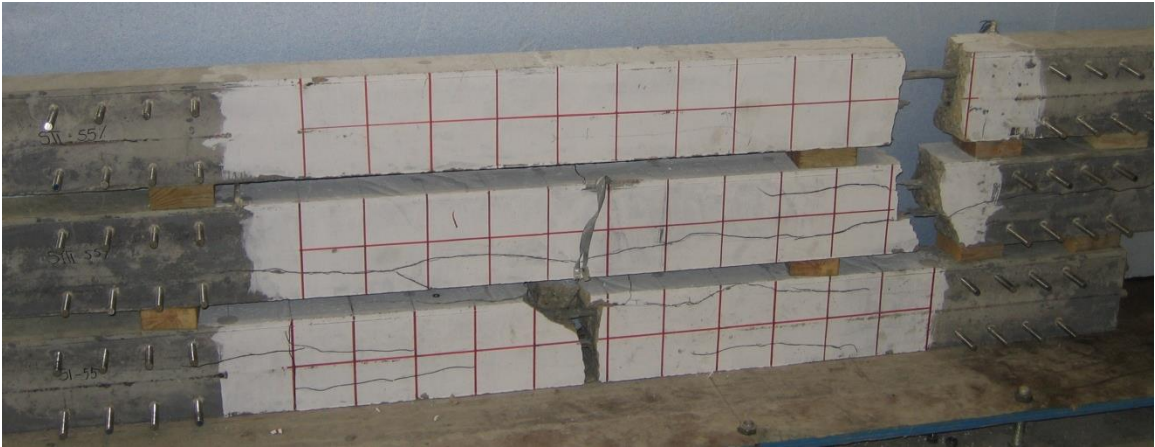
Figure 4.49 Crack Pattern and Mode of failure of Straps Prestressed at 55%-A

The straps did not crack during the cyclic testing under 50 kN force, but during the ultimate loading the straps exhibited a characteristic sequence and crack pattern. The occurrence and development of cracks was closely monitored during the application of the axial load. The straps prestressed at 35% and 45% of the ultimate strength exhibited different cracking loads for all the straps: the straps prestressed at 35% cracked at 150, 130 and 150 kN, while straps prestressed at 45% cracked at 180, 173 and 165 kN. The cracking patterns as well as the widths were similar ranging between 0.1 and 0.5 mm for straps prestressed at 35% and 0.1 and 0.8 for straps prestressed at 45%. As the straps were close to failure, a transverse crack appeared indicating bond failure. When comparing the results of the control sample to the weathered straps, the strain readings measured along the bars among all straps were consistent. This was deemed sufficient evidence to conclude that the bond strength was not affected by the environmental conditioning. Once the straps cracked there was a sudden drop in the stiffness of the member at the location of cracking, as the concrete becomes ineffective in sharing the stress and the GFRP takes over; however, the effect of tension stiffening is very visible at the uncracked sections. The straps prestressed at 55% of the ultimate load had a distinctive mode of failure where a single crack appeared and then rupture of the bars occurred, demonstrating that the cracking load is the same as the ultimate load. The material's behaviour changed when the GFRP bars were stressed at a high sustained load of 55% of the ultimate strength and failed due to creep. In this case the failure process of the members was directly affected by the sustained load alone. Figures 5.47 - 47 present the crack pattern and failure mode of all the straps tested in this research.

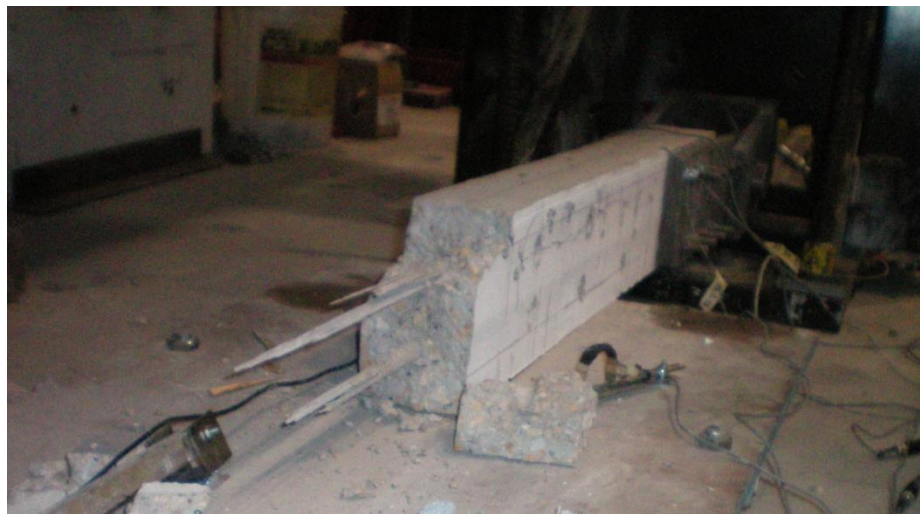
Figure 4.53 Failure Mode of Strap 35% I-B

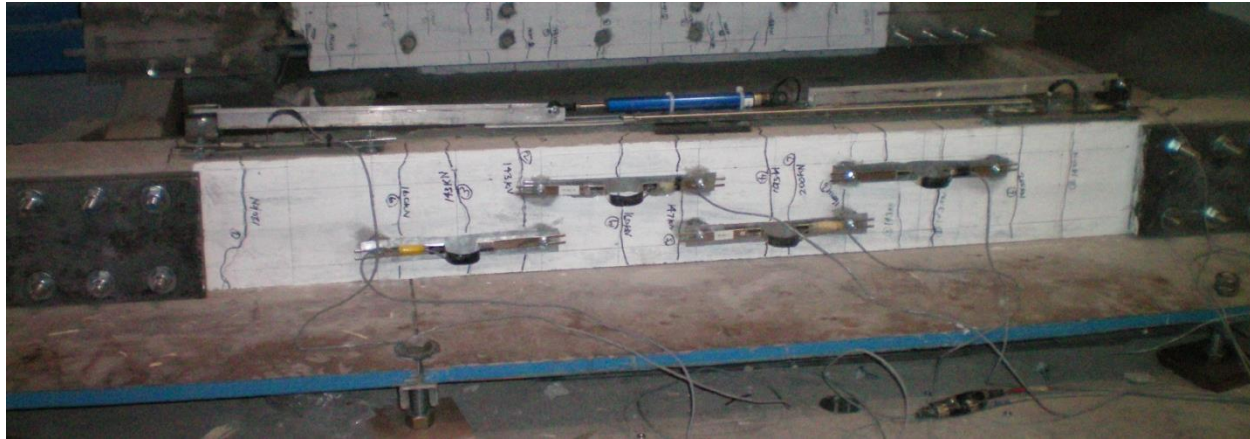
Figure 4.54 Crack propagation of Strap 35% II-B

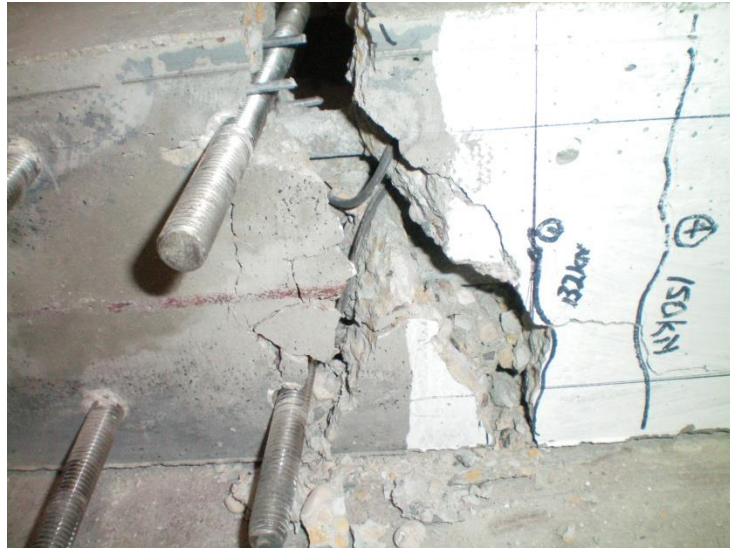
Figure 4.56 Failure Mode of Strap 35% III-B
