Behaviour of GFRP Prestressed

Concrete Straps

A Thesis

The University of Manitoba

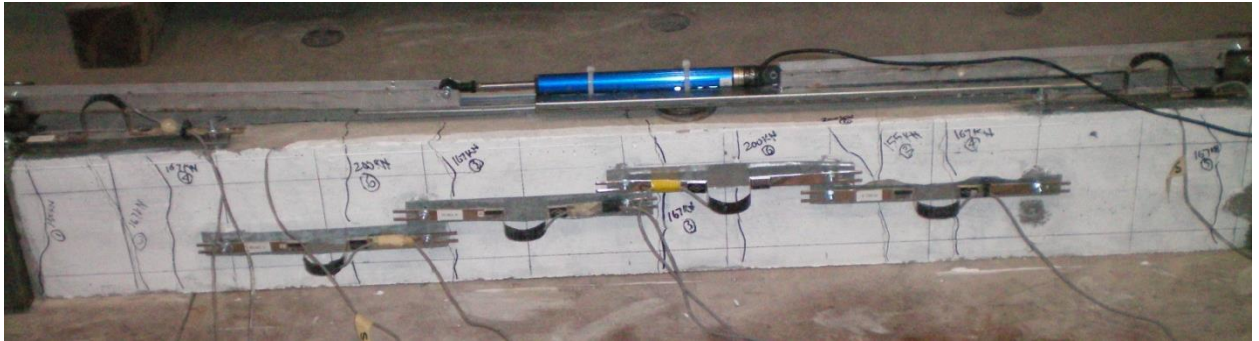
Figure 4.58 Crack Pattern of Strap 45% I-B

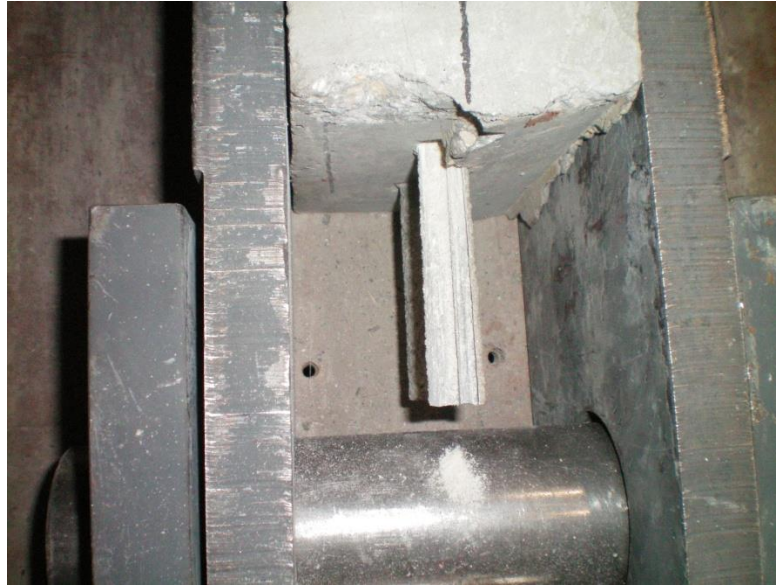
Figure 5.60 Failure Mode of Strap 45% I-B

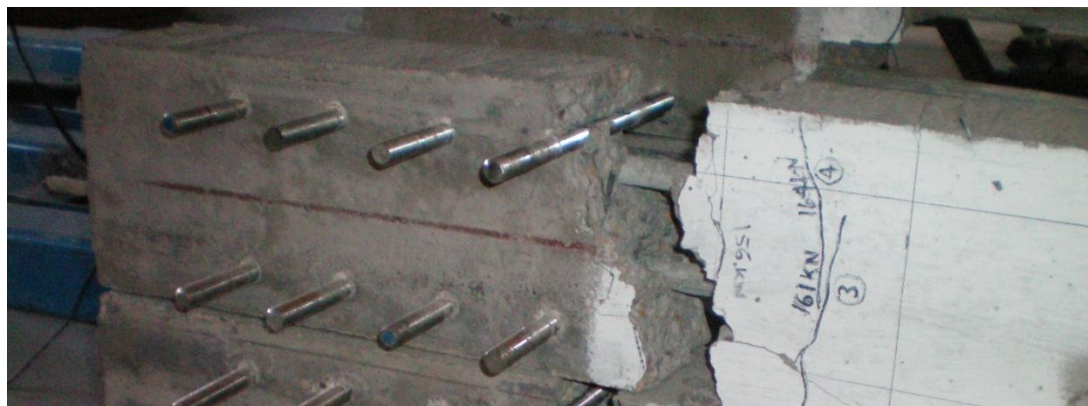
Figure 4.61 Failure Mode of Strap 45% II-B

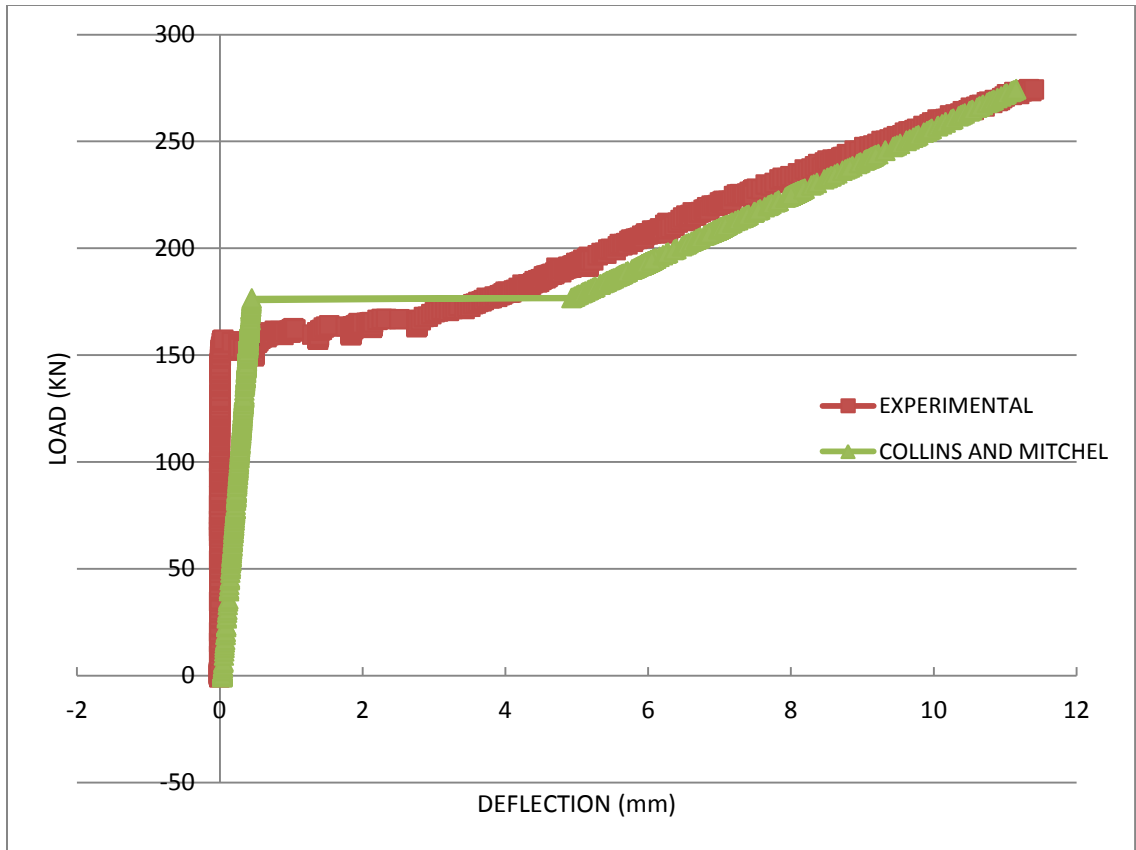
Figure 4.62 Elongation of Strap 45% II-B

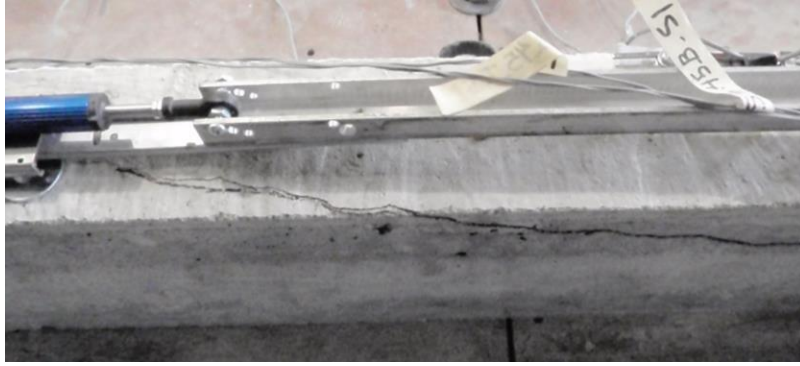
Figure 4.63 Horizontal Cracks on Strap 45% III-B

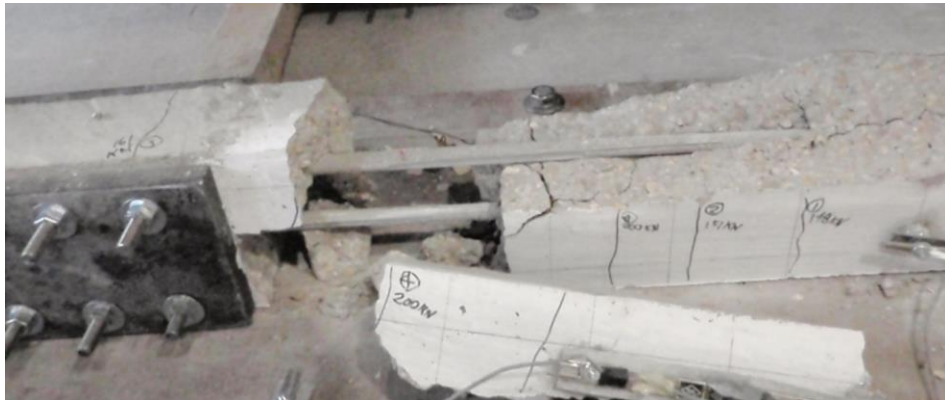
Figure 4.64 Failure Mode of Strap 45% III-B
