Royal Canadian Mint

Plating Line Transporter Retrofit

Draft Design Report

December 5, 2011

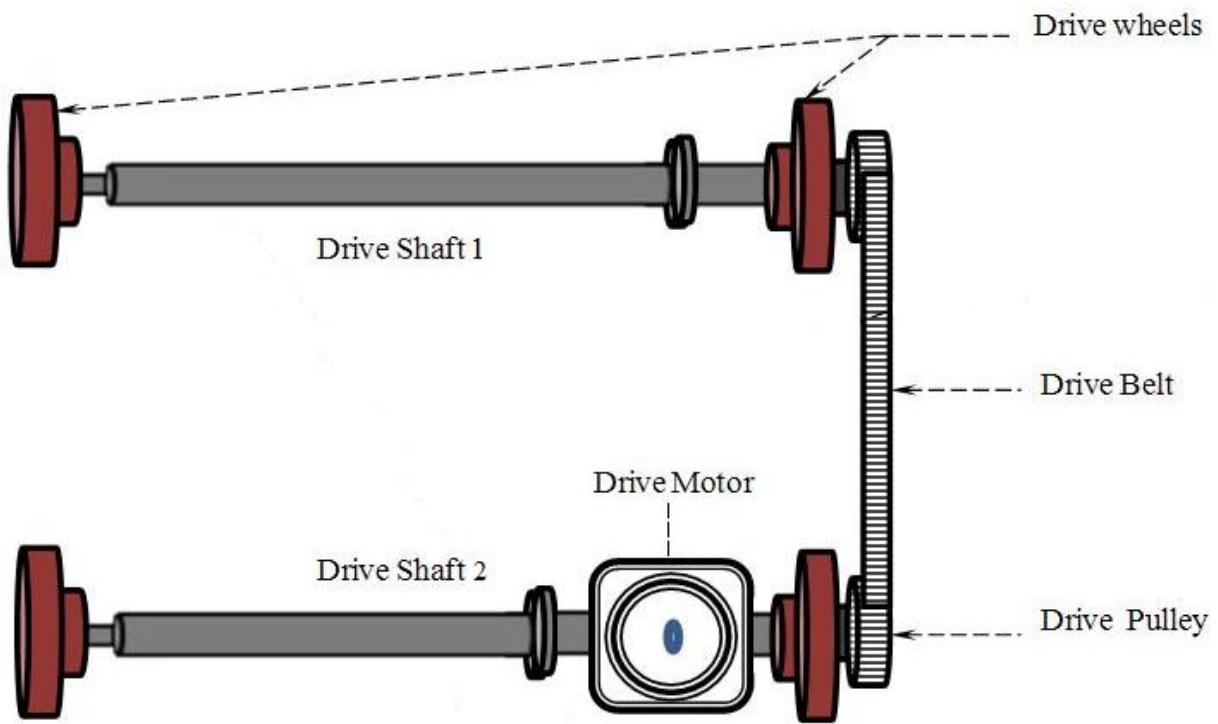
In the current drives system, the gearbox is attached directly to the front shaft of the transporter, and a belt passing through sheaves on one side of the transporter transmits power to the rear shaft. This results in different front and rear shafts, as well as providing unequal power distribution as seen in Figure 1.

Figure 1: Current system

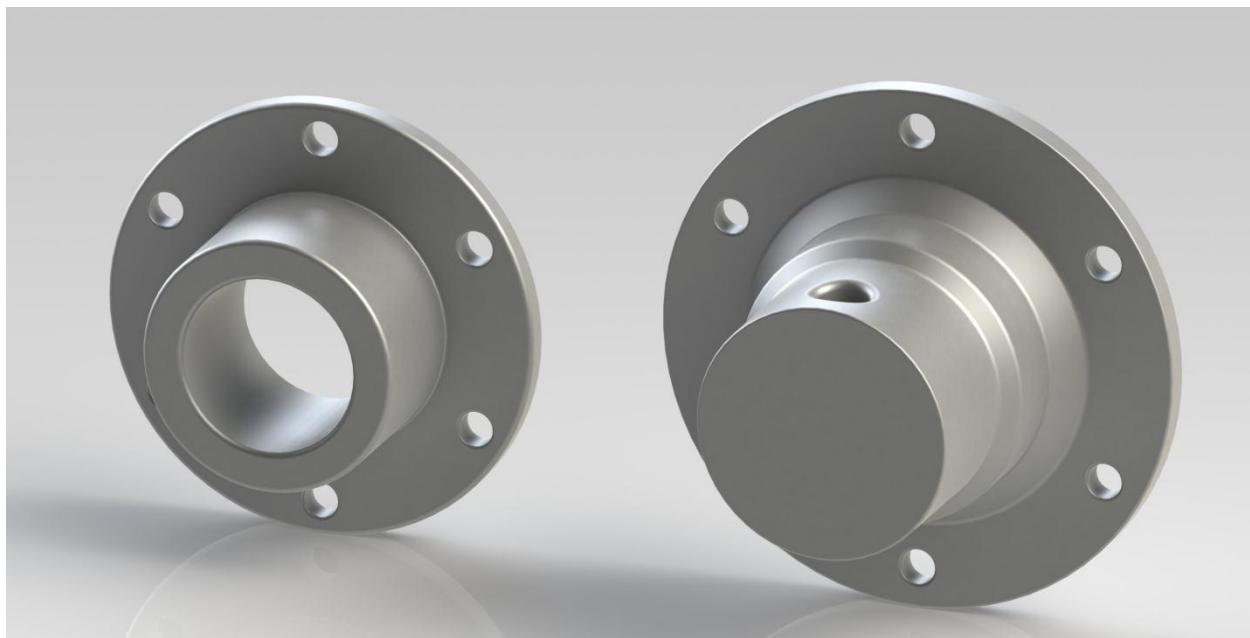
Figure 2: Visual comparison of flange designs, Old (Left) and New (right)

The RCM possesses highly specialized CNC equipment, capable of producing variety of complex components, which allows for freedom in design. As shown in Figure 2, the flange size has been increased considerably and the hollow section has been removed. This significantly increases the strength and lowers the machining time as the flange is formed from solid stock. The transitions in diameter are also chamfered to prevent the stress concentrations in the flange. A pin will be used as a primary connection instead of a weld to prevent the initiation of cracks in the parts. As an added benefit, the bolted connection will allow the RCM to reuse parts that haven't failed if breakdown does reoccur.

The new design prevents the faults that were associated with the initial driveshaft by manipulating the flange geometry and connection method. A visualization of the old and new flanges is provided in Figure 2 and detailed drawings attached in Appendix C.

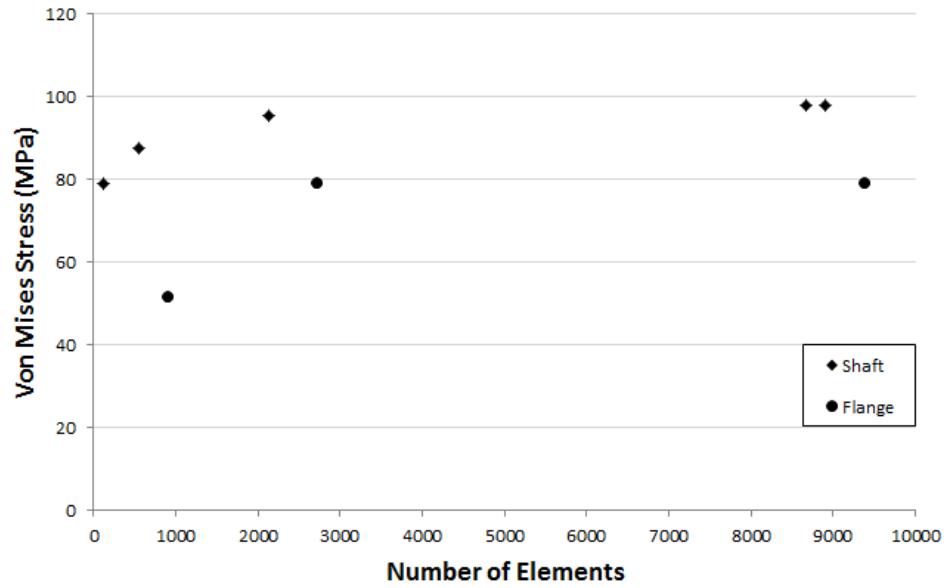
Figure 3: Convergence data from previous tables illustrating the convergent behaviour.

Figure 3 illustrates the convergence in the simulations with respect to the number of elements in the stress bearing surfaces.

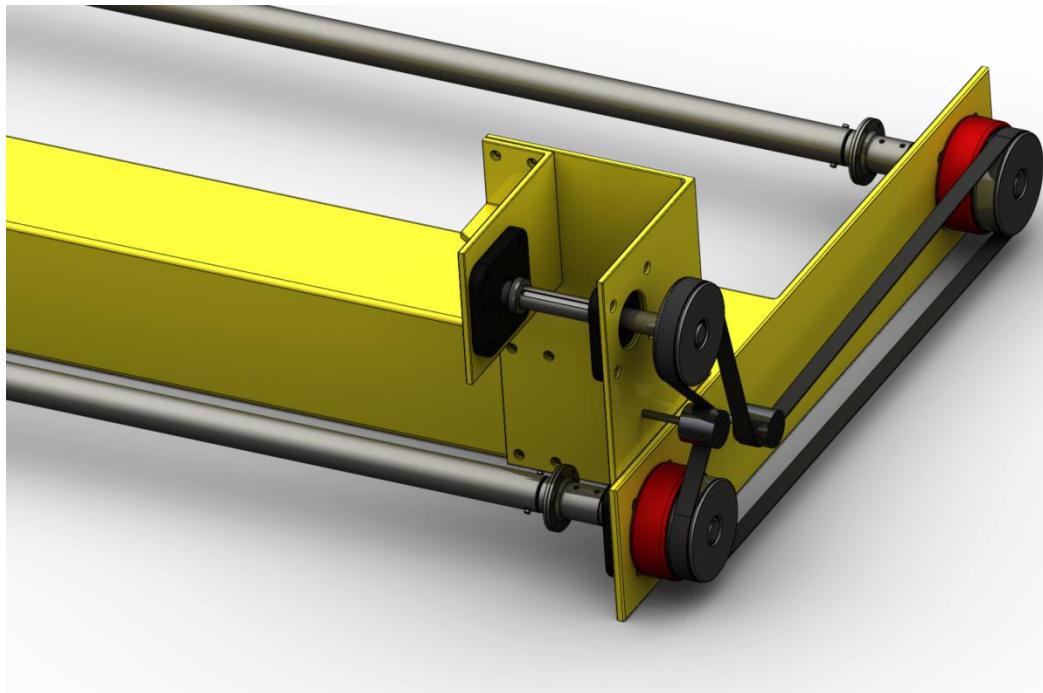
Figure 4: Overall view of the left side of the transporter. The brackets, idlers and belt path are clearly visible.

In the figure above, the motor and transfer case are not shown. They are located between the main support bracket and the secondary support bracket, and attached using current hardware to locations near the outer bearing. The body of the transporter is carbon steel, painted yellow.

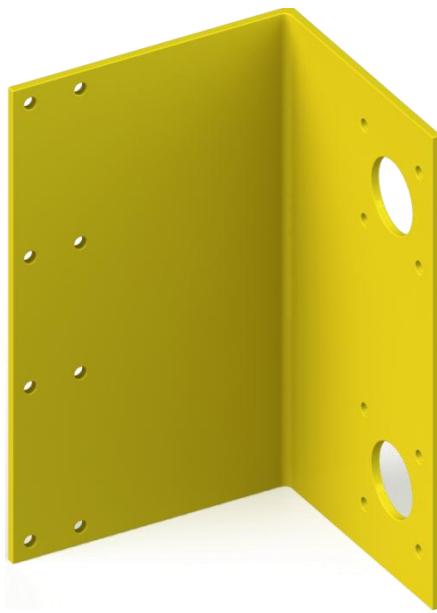
The brackets are to be made from 3/8in carbon steel plate, with the main bracket forming an L-shape. The secondary bracket is to be a duplicate of the current design, however it will be adjusted for length.

Figure 5: View of the Main Support Bracket

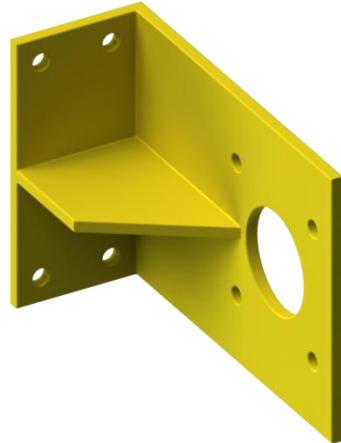
Figure 6: View of the Secondary Support Bracket

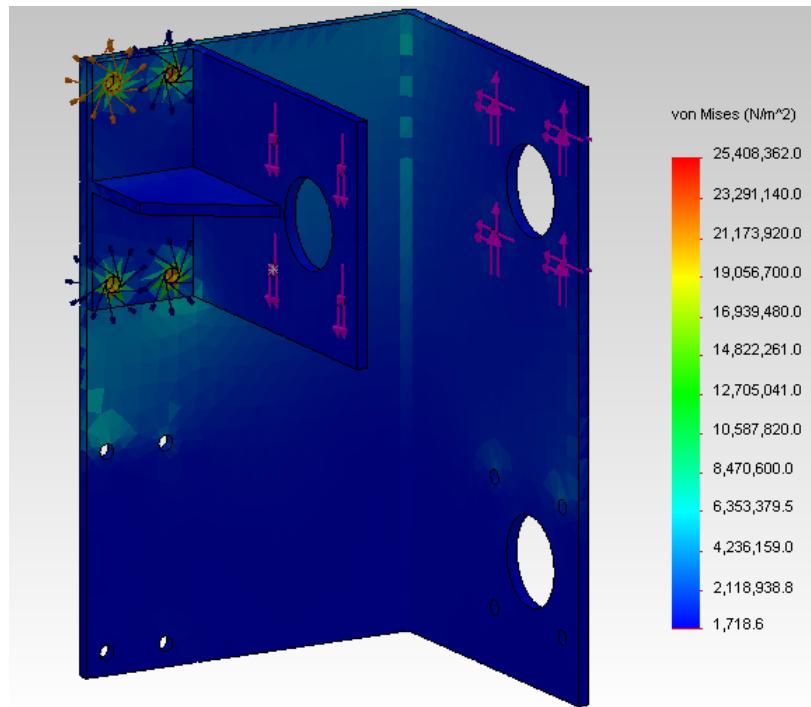
A model of the support bracket assembly was created in SolidWorks, and loaded using a belt tension of 100N as well as the sideways force generated by the transfer case. Although convergence could not be achieved, the figure below shows that the geometry of the location in question is identical to that currently being used without failure.

Figure 8: FEA Simulation of the Bracket Assembly. The solution did not converge, but the local geometry is identical to that currently being used.

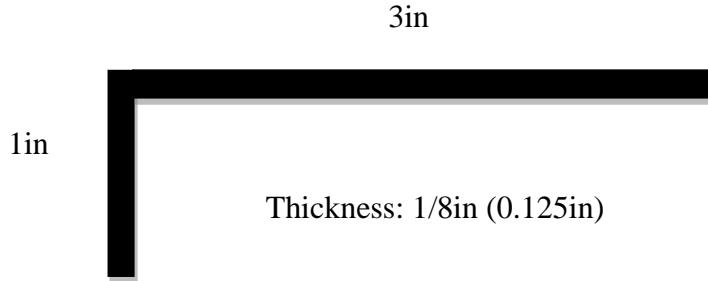
Since a 1.5in section will need to be cut out of the lateral stiffener, a doubler will be required to retain the same stiffness. The stiffener cross-section was approximated as shown in the following figure:

Figure 9: Approximation of the current lateral stiffener

This gives a cross-sectional moment of inertia of 2.25in^4 .

Removing the outer 1.5in of the horizontal plate yields a moment of inertia of 1.27in^4 .

This requires a doubler at least 0.11in thick, such as a 1/8in plate, on the vertical section.

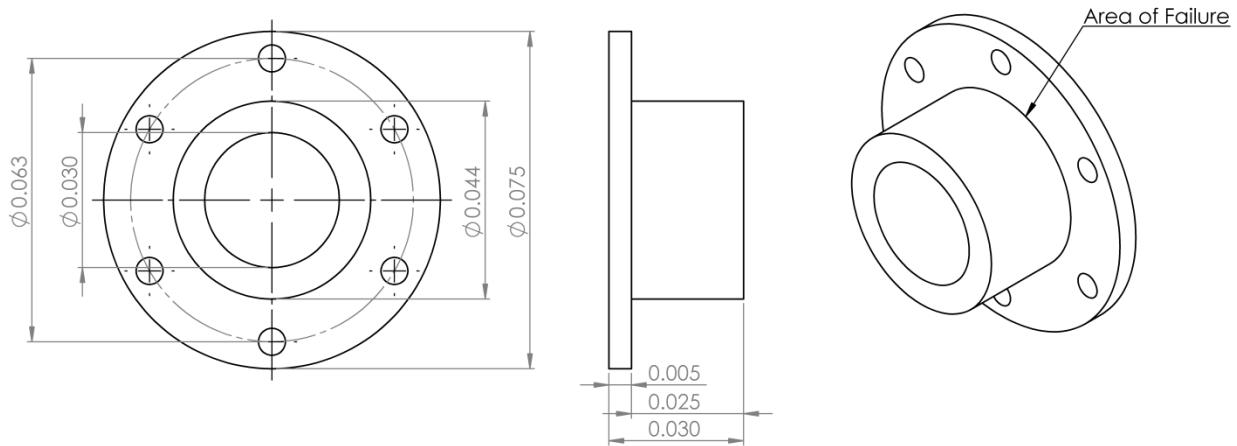
Figure 10: Drawing of existing flange

The issue in the flange stems from the sharp geometrical change which can cause large stress concentrations in torsional loading as well as bending in the case of misalignment. Plastic deformations can readily occur when transition fillets between geometrical changes are not used, which leads to crack propagation. Beach marks on the failed flanges indicate that the parts failed because of fatigue, however a picture was not made available to us.

From studying the failure in the flange, it was determined that there are two primary modes of material failure; the flange breaking off in the sharp transition zone between the 44mm shank and 63mm circle that is coincident with the center points of the bolts, and the welded connection between the shank and tube.

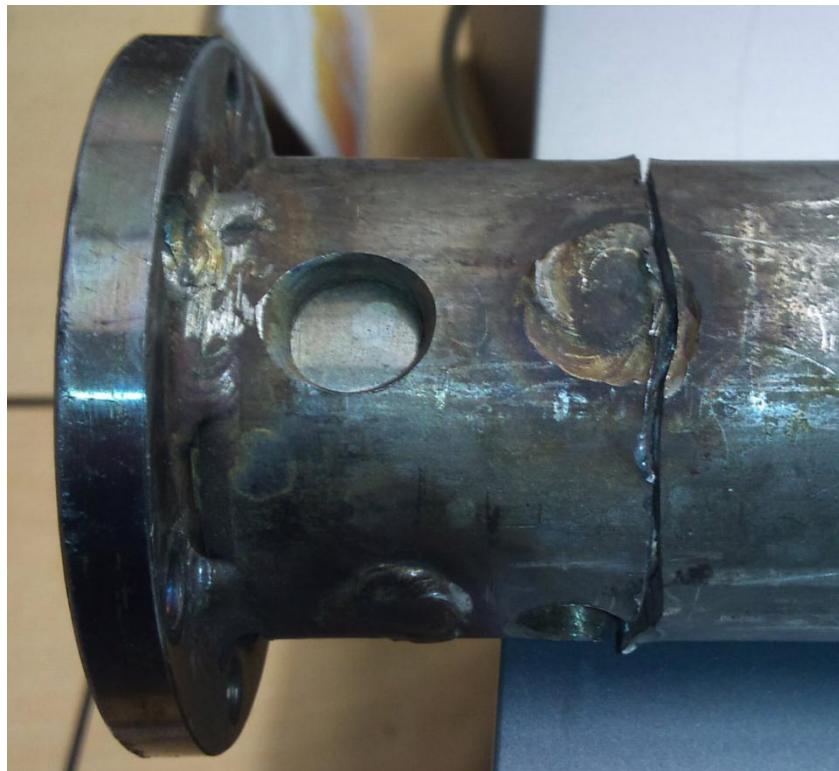
Figure 11: Broken shaft component showing crack propagating through welded area into the tube.

It is also noted that the cracks passes through the area of highest stress concentration at the interface where the weld fuses with the circular hole.

Speaking with the lead hands that maintain and rebuild the plating line transporter when it fails has led to additional considerations for the design. Figure 11 shows weld beads along the perimeter of the interface between the flange and the tube. The figure also shows that there is no weld in the areas below the bolt holes, in contrast with the initial design. This deviation from the initial design is due to clearance issues between the weld bead and the bolt holes. This failure is not due to manufacturing, but from poor design choices.

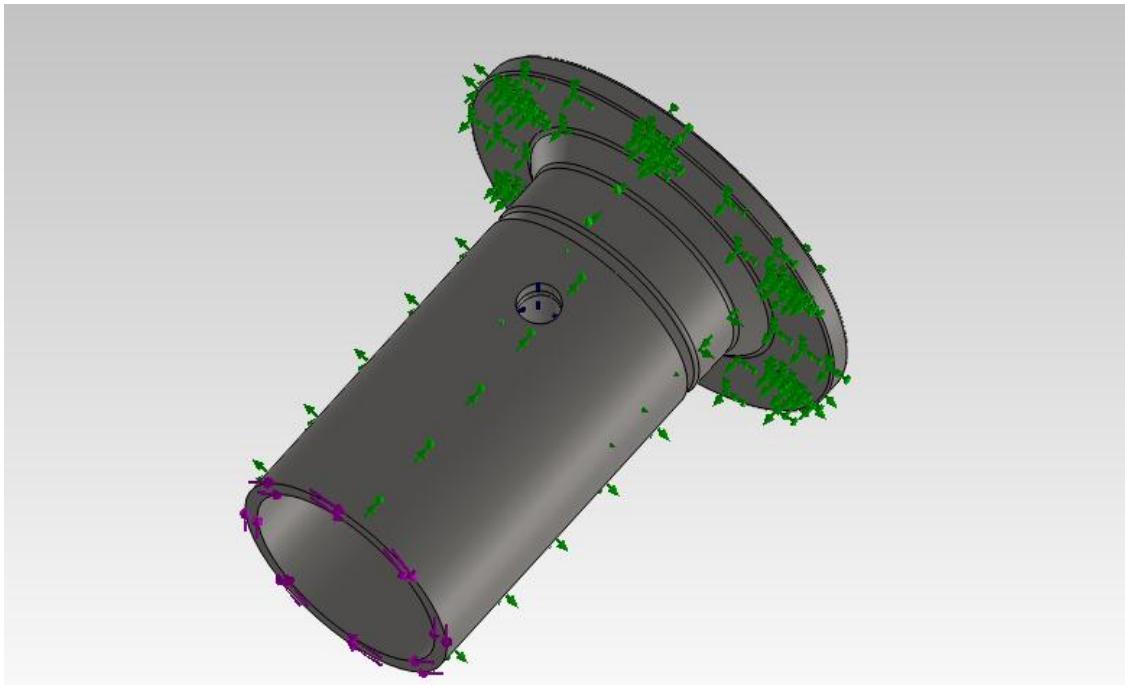
A preliminary analysis was performed using the bolted connections to a fixed plate. The resultant forces in the flange plate were sufficiently far away that they did not influence the results near the pin hole. This justifies the simplification of the loading conditions to speed up the simulations. The simplified loading conditions are highlighted in Figure 12. It was also found that the stresses between the flange plate and shank were minor compared to those in the components around the pin.

Figure 12: Screen cap from SolidWorks Simulator illustrating simulation conditions. Cylindrical surfaces are free to move in the Θ direction. Flange was constrained in the X direction and bolt holes were fixed. Join it pinned and load applied 100Nm.

SolidWorks Simulation uses 10 node tetrahedral elements. Mesh controls were then applied around the pin holes until convergence was reached. The convergence data for the flange is given in Table 5, and for the outer tube Table 6. The data is then visualized in the Figure 13.

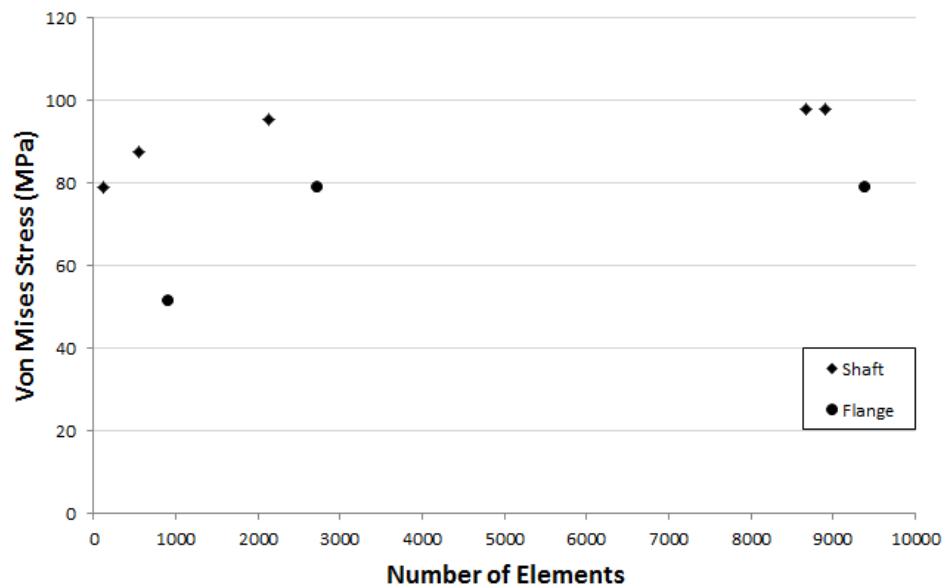
Figure 13: Convergence data from previous tables illustrating the convergent behaviour.

With the factor of safety of 2, the stress in the connection does not exceed those of the design limitations therefore the connection is not likely to fail under normal conditions. The detailed drawings of the drive shaft design are provided in Appendix C.
