D-CRACKING IN MANITOBA

A thesis
presented to the University of Manitoba
in partial fulfillment of the
requirements for the degree of
MASTER OF SCIENCE
in
CIVIL ENGINEERING

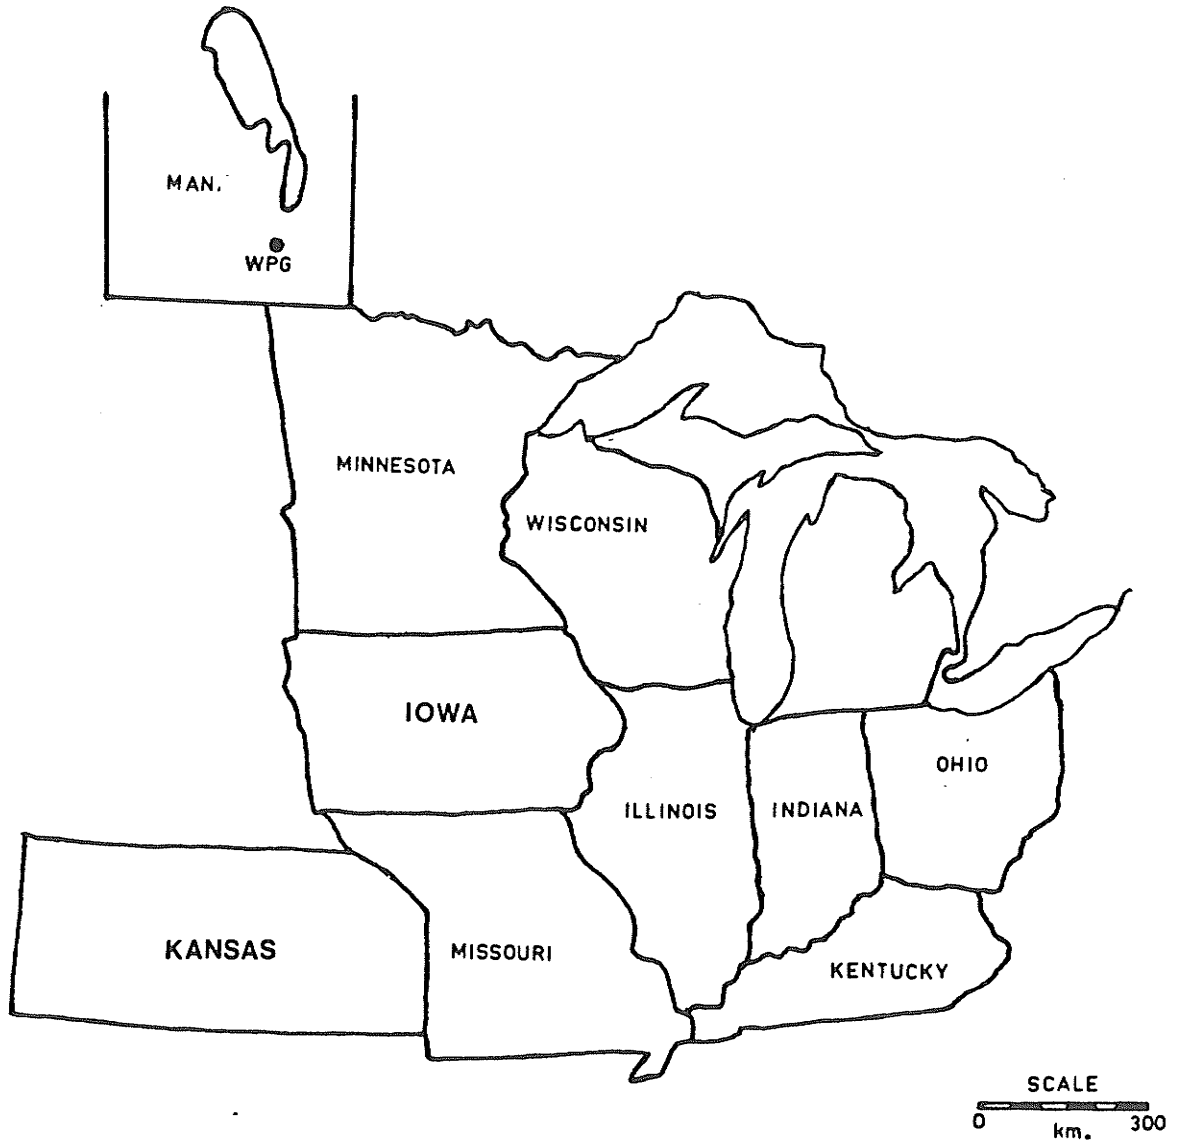
Figure 1: Location of D-cracking studies

The majority of literature on D-cracking originated from studies of concrete pavements initiated by several mid western States. Figure 1 shows the areas in which D-cracking has been reported in the literature. A detailed overview of the literature may be found in Thompson et al (1980).

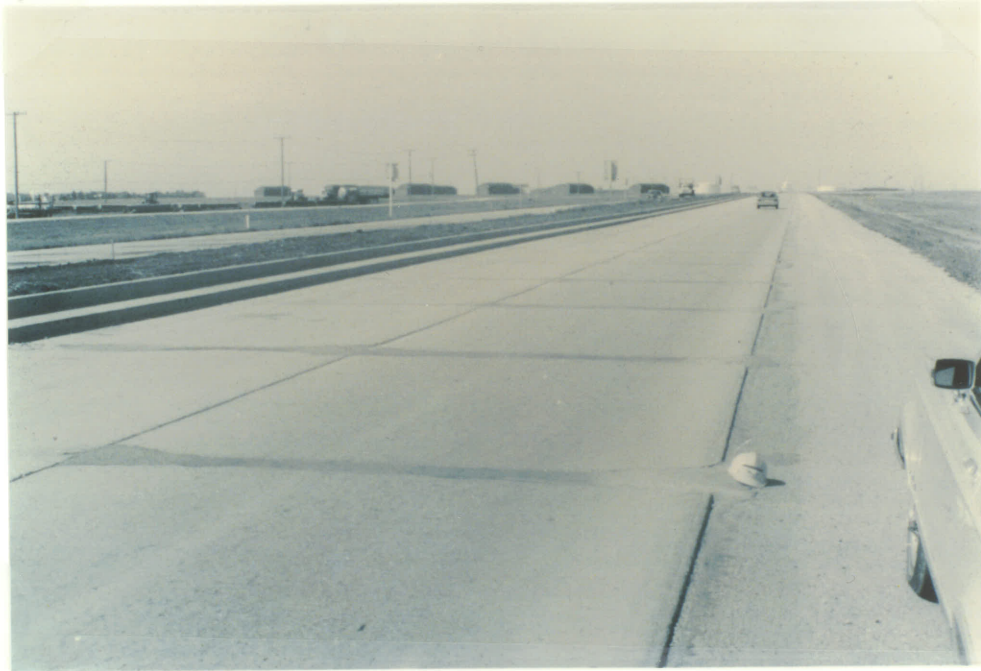
Figure 10: Severe D-cracking on highway 100W 3RB

In summary pavements incorporating Birdshill Type 1 coarse aggregate exhibited extensive D-cracking. Drainage conditions rather than traffic loading appeared to be the most influential factor in the rate of deterioration. Pavements with crown drainage displayed improved durability while the downslope side of divided highways showed the highest D-cracking ratings. Figures 10 to 14 show typical sections of the pavements in this group.

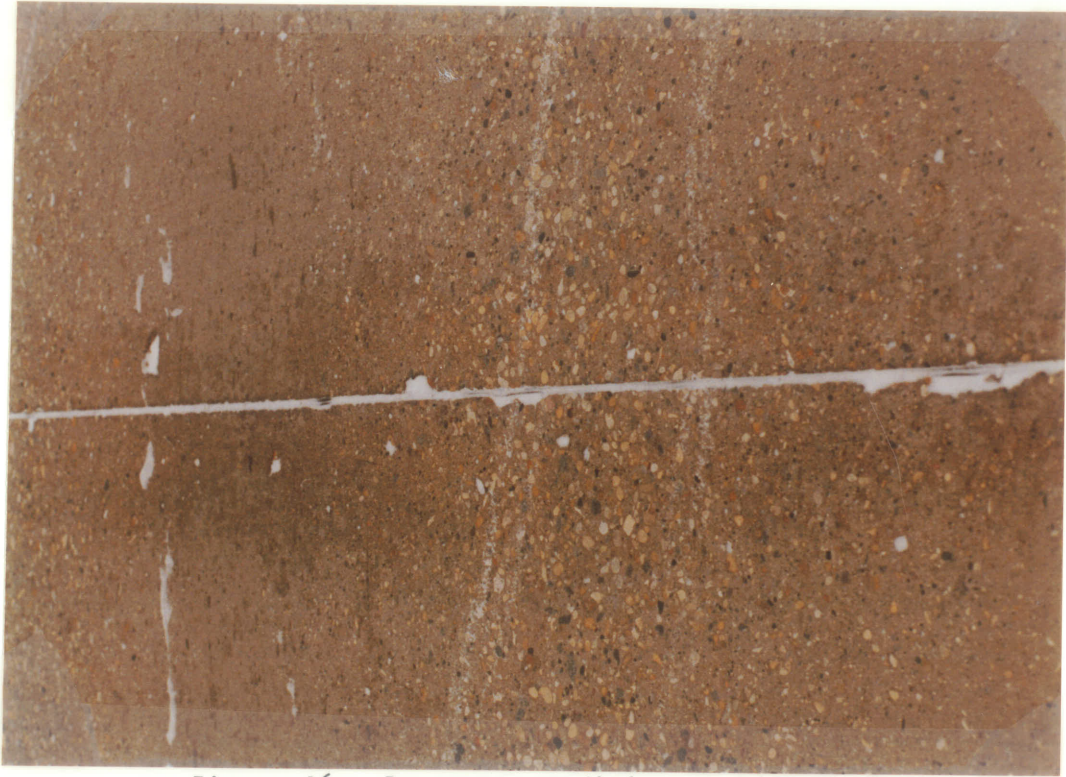
Figure 16: Pavement condition on highway 3

The only construction data available for two sections of highway 3, at Ft. Whyte and south of Oak Bluff, was the year of construction. The D-cracking ratings are listed in Table 3 .
