**An Autopsical Examination of 40 Year Old
Pre-Tensioned Concrete Channel Girders**

Brandon James Mills

The University of Manitoba

This thesis report examines six decommissioned pre-tensioned concrete channel girders which were part of the Canadian National Railway overpass on the Trans-Canada Highway No. 1 (CN Overpass on TCH Site No. 0709-00) east of Portage La Prairie constructed in 1965. The six girders are representative of the various levels of deterioration observed on the in-service bridge.

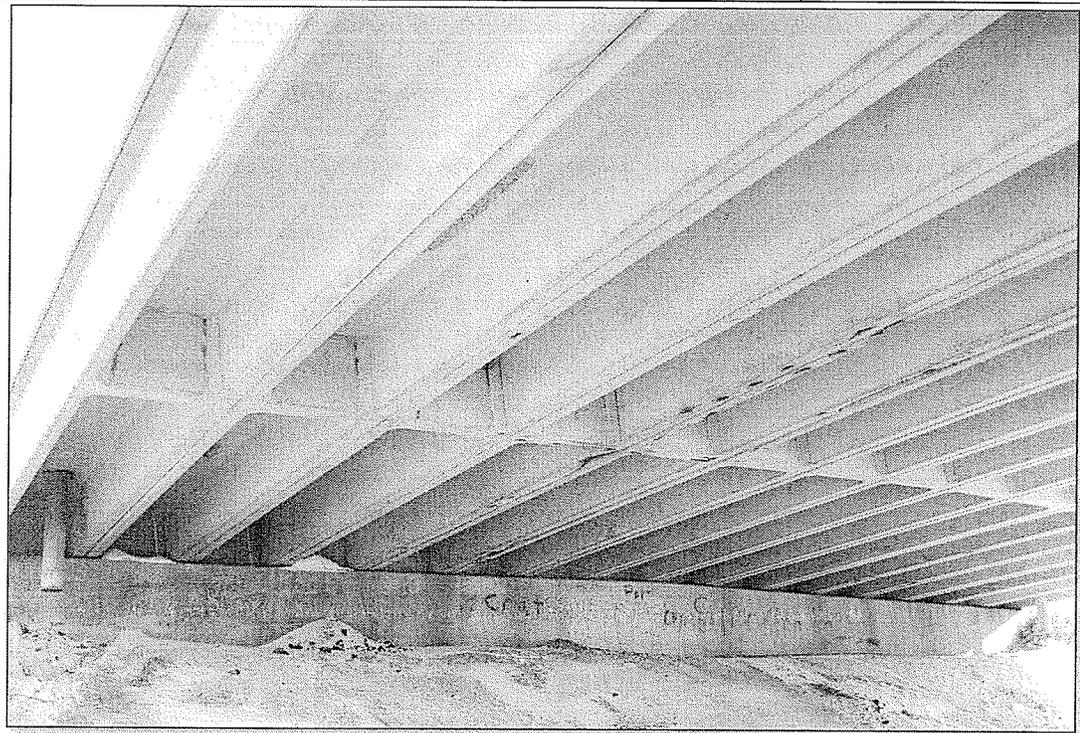
Figure 1-1: Underside of the north span of the Portage La Prairie CN overpass.

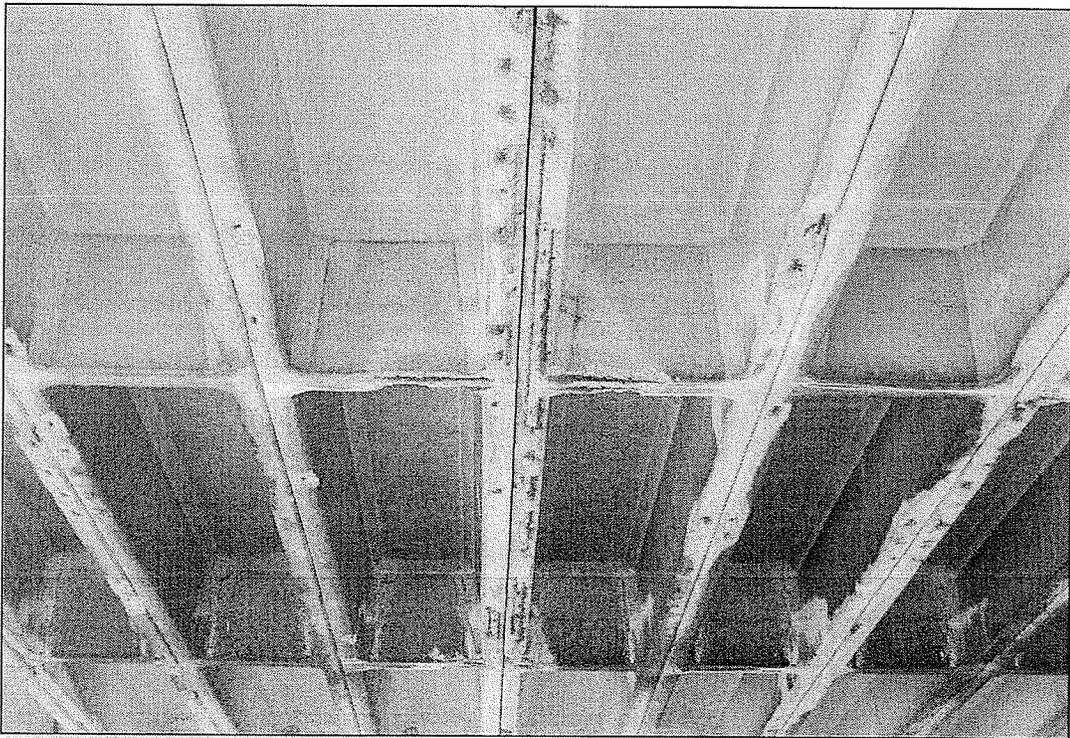
Figure 1-2: Underside of the center span of the Portage La Prairie CN overpass.

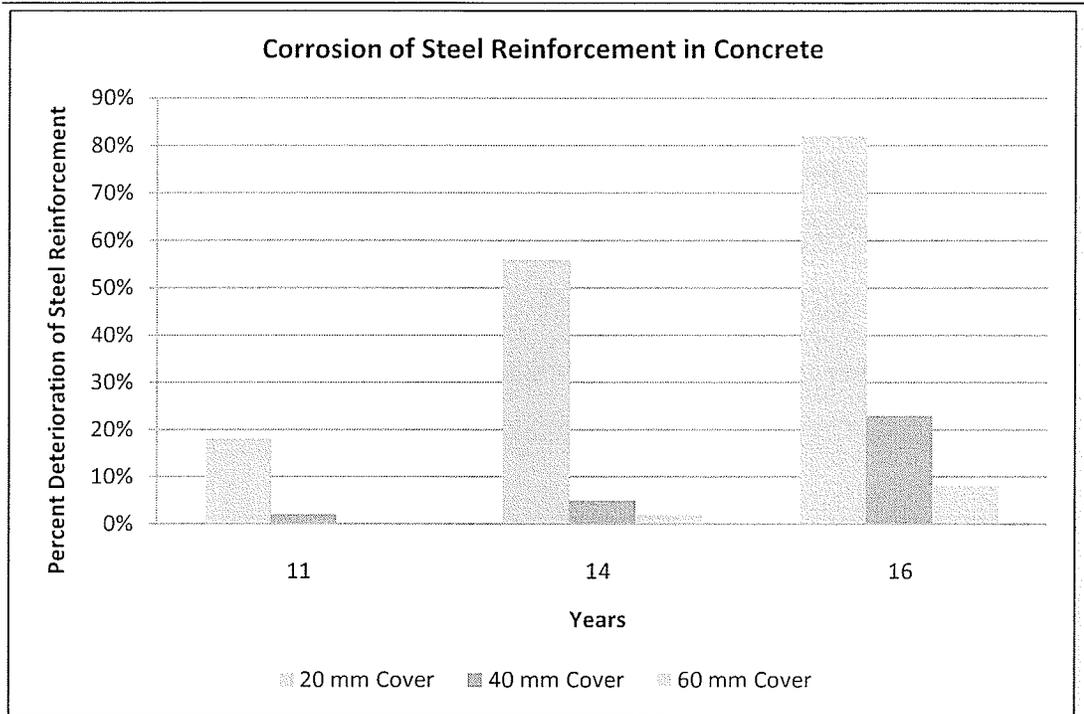
Figure 2-1: Corrosion of steel reinforcement in concrete at various cover depths over time [12].

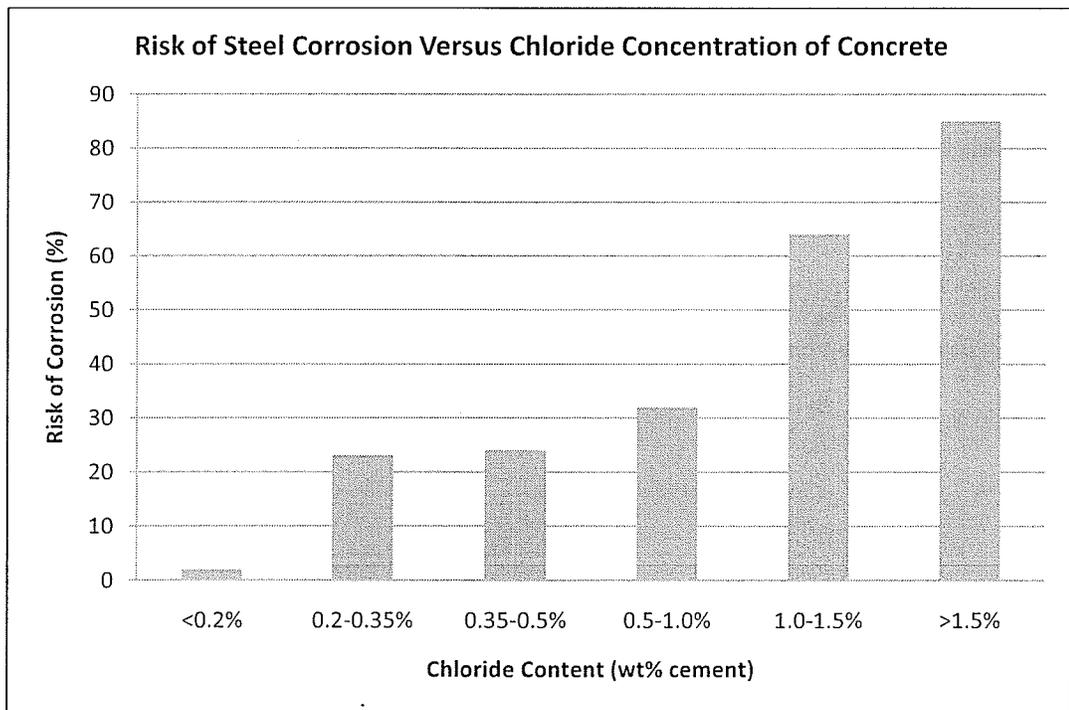
Figure 2-2: Probability of steel failure versus chloride ion concentration of concrete [13].

In Figure 2-2, the probability of steel corrosion initiation is displayed as a function of percent chloride concentration per weight cement. A chloride ion concentration of one percent or less does not have a significant impact on steel corrosion. However, a chloride ion concentration of 1.5 percent or greater is likely to cause corrosion.

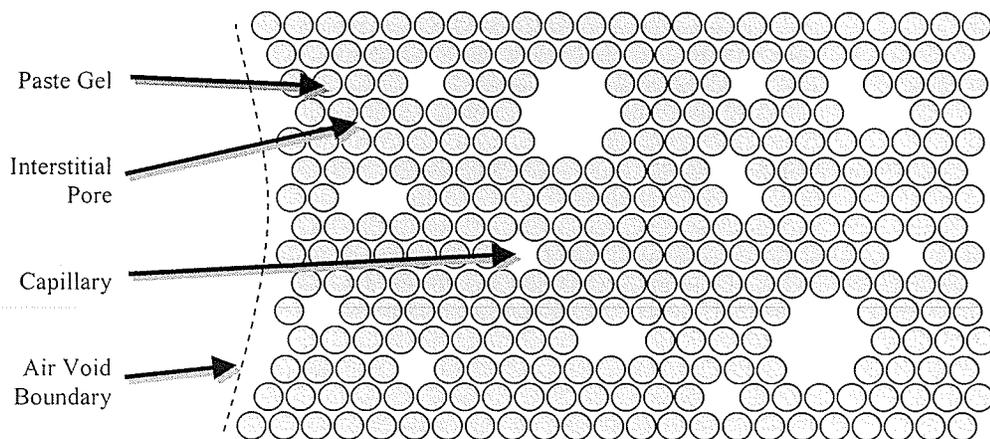
Figure 2-3: The microstructure of concrete paste [14].

To understand the role air voids play it is necessary to be familiar of the microstructure of concrete paste. The concrete paste encompasses roughly 25 to 30 percent of the total concrete mix [14]. The paste is made up of paste gels, interstitial pores between the paste gels where moisture is incapable of freezing and capillaries where moisture is capable of partial freezing. The interstitial pore diameters range in size from 5×10^{-7} to 25×10^{-7} mm while capillaries are an order of magnitude larger, typically ranging from 10×10^{-6} to 50×10^{-6} mm [14]. Figure 2-3 depicts the physical location and the size of the various micro-structural components within the concrete matrix.

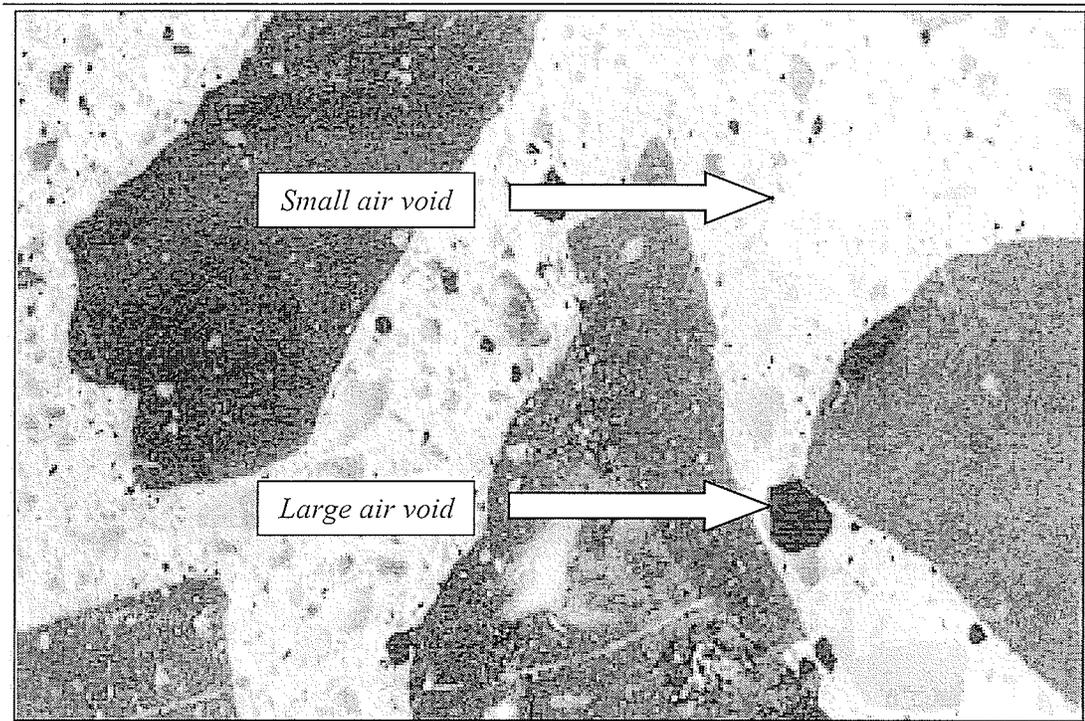
Figure 2-4: Surface of a finely lapped slice of concrete containing 5.6 percent total air voids [14].

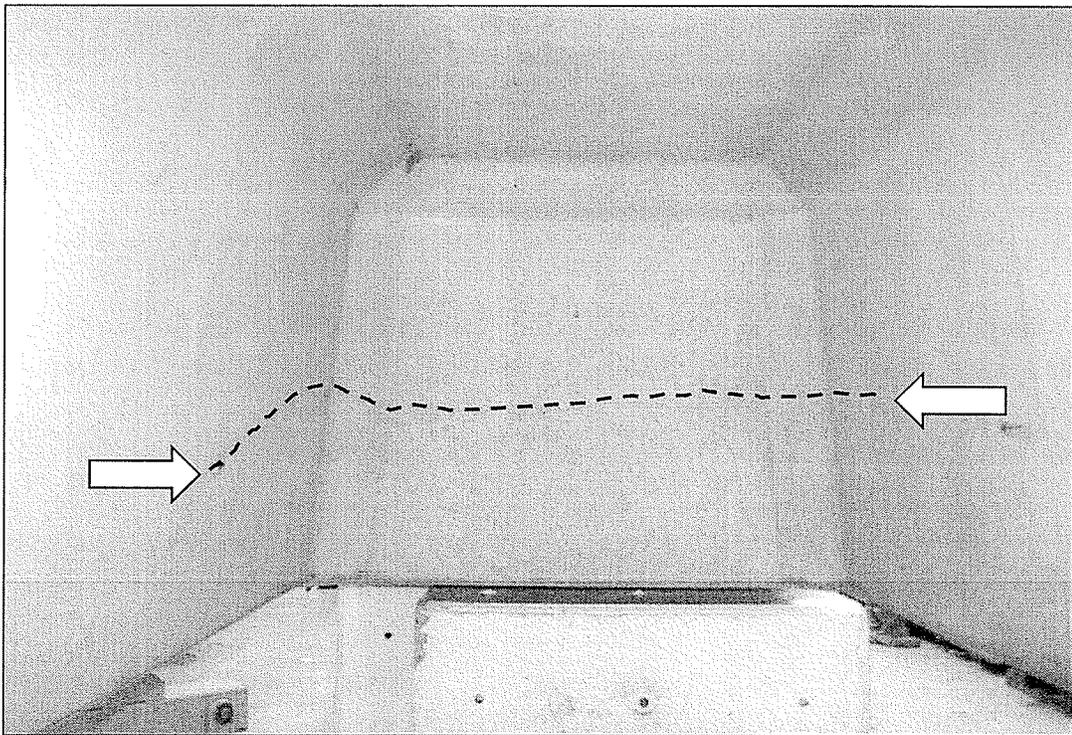
Girder one was characterized as good in relation to the other girders. The only deterioration that was observed during the condition cataloguing were longitudinal cracks 500 to 1000 mm in length located on both webs propagating away from the post-tensioning ducts. These cracks also extended transversely through the diaphragms. These cracks are illustrated in Figures 3-3 and 3-4. Aside from these cracks the girder appeared to be as it was 40 years ago. There was no cover loss or corrosion staining of the concrete which correlate with the relatively low occurrence of water leaching stains seen on the webs. Perhaps most importantly, no vertical flexure cracks or signs of shear distresses were observed throughout the length of the girder.

Figure 3-3: Transverse cracking through the diaphragm of girder one.

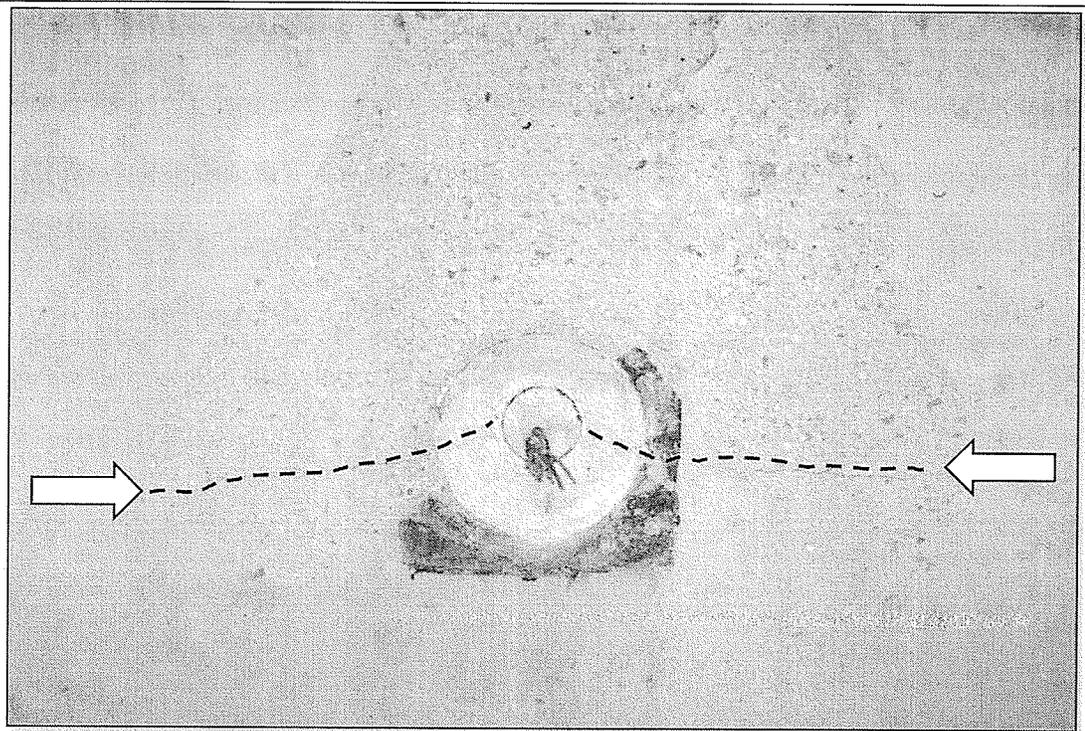
Figure 3-4: Longitudinal cracking on web at the post-tensioning ducts of girder one.

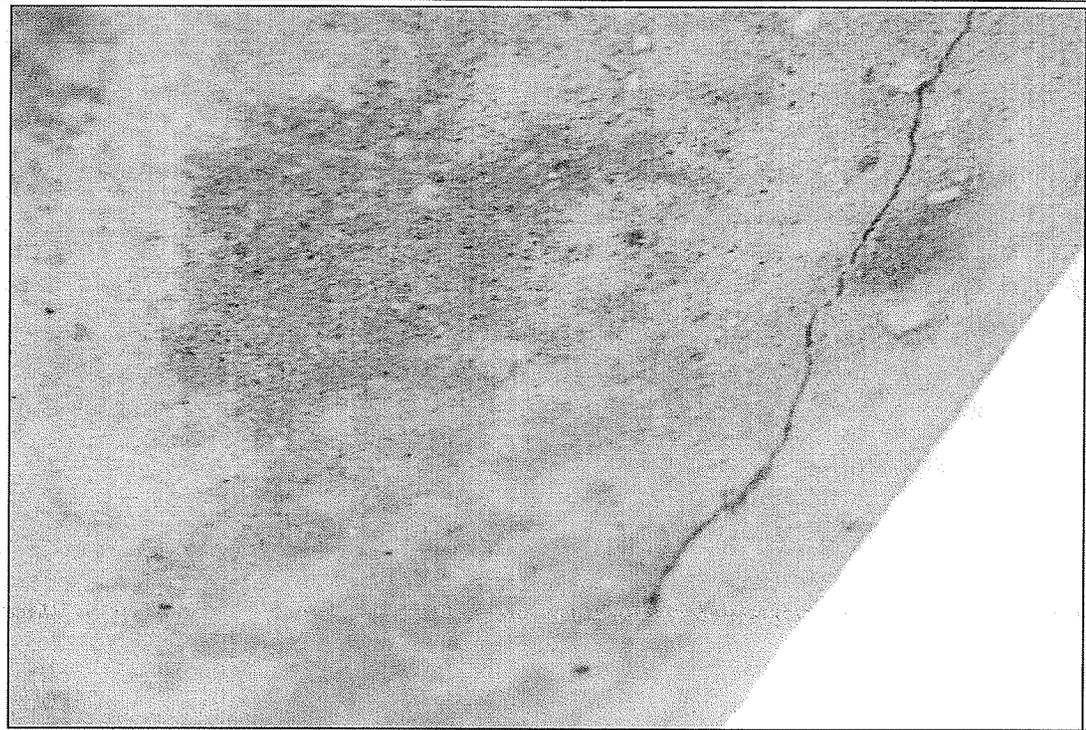
Examination of the second girder revealed much of the same deterioration characteristics with a few additions and was categorized as being in fair condition. No longitudinal cracks around the post-tensioning ducts were observed as there were with girder one. The only signs of deterioration were horizontal cracks and corrosion stains which were noticed on the west side on and near the bottom of the web at the mid-span. These are illustrated in Figures 3-5 and 3-6. Water leaching stains, shown in Figure 3-7, were also observed on the webs indicating that there was water leakage between the girders. There was however, no web loss at all or signs of vertical flexure cracks or shear distress.

Figure 3-5: Longitudinal cracking on the bottom of east web of girder two.

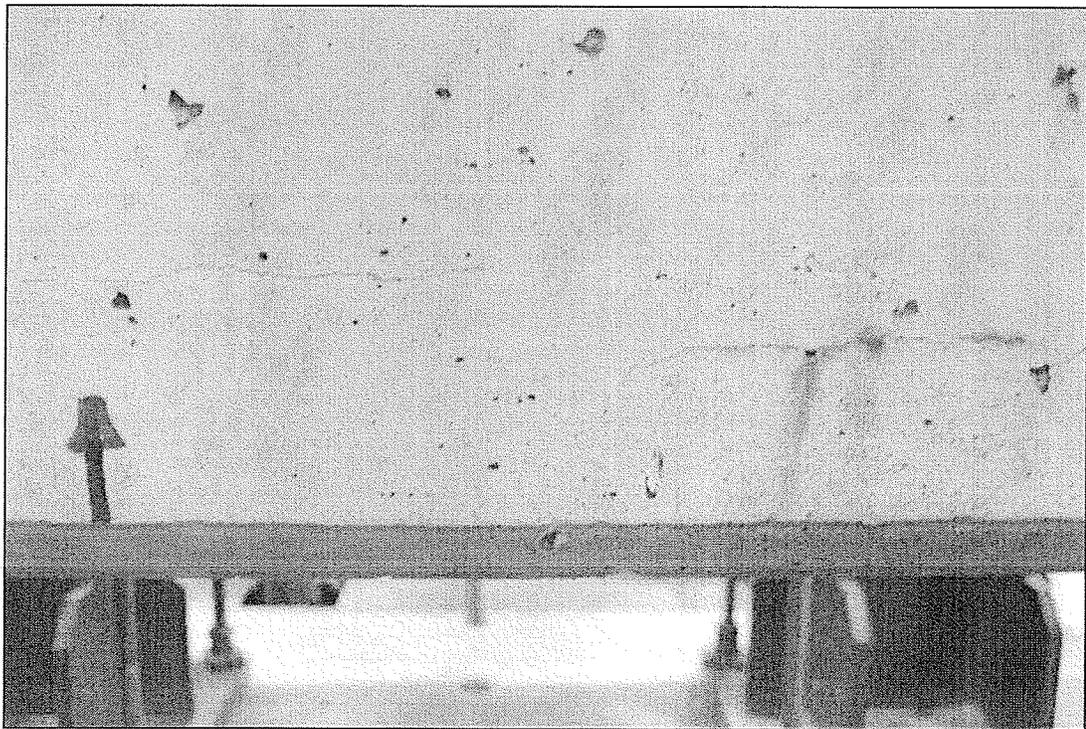
Figure 3-6: Longitudinal cracking on the side of east web at the bottom of girder two.

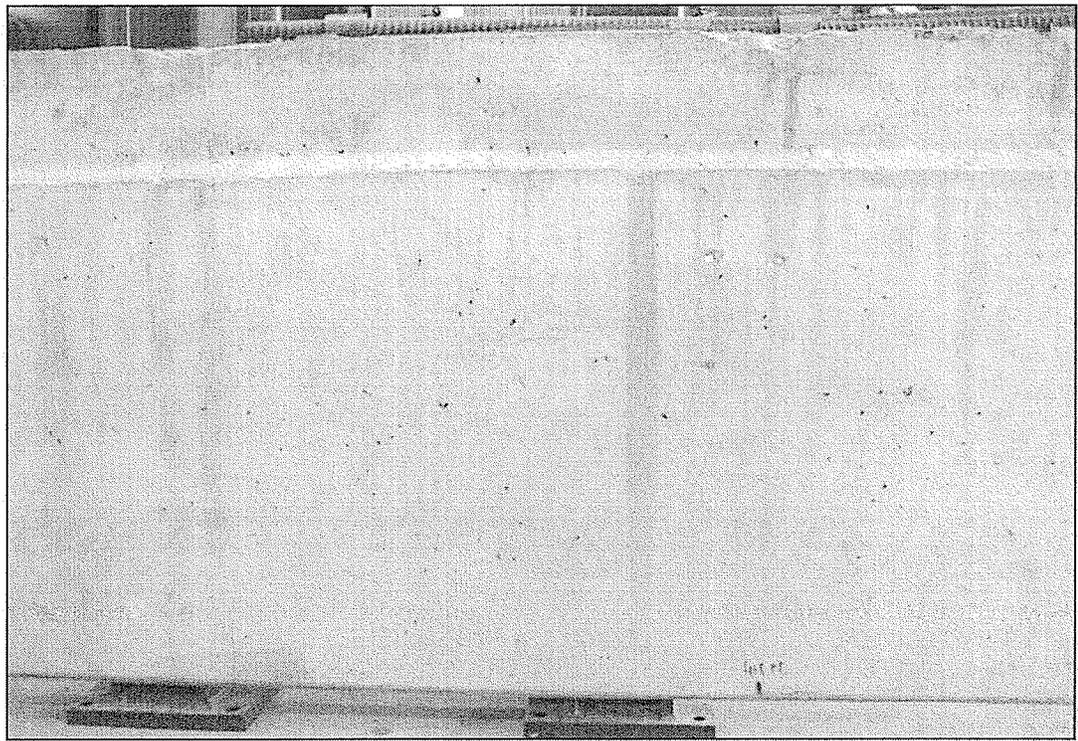
Figure 3-7: Water leaching stains on the web of girder two.

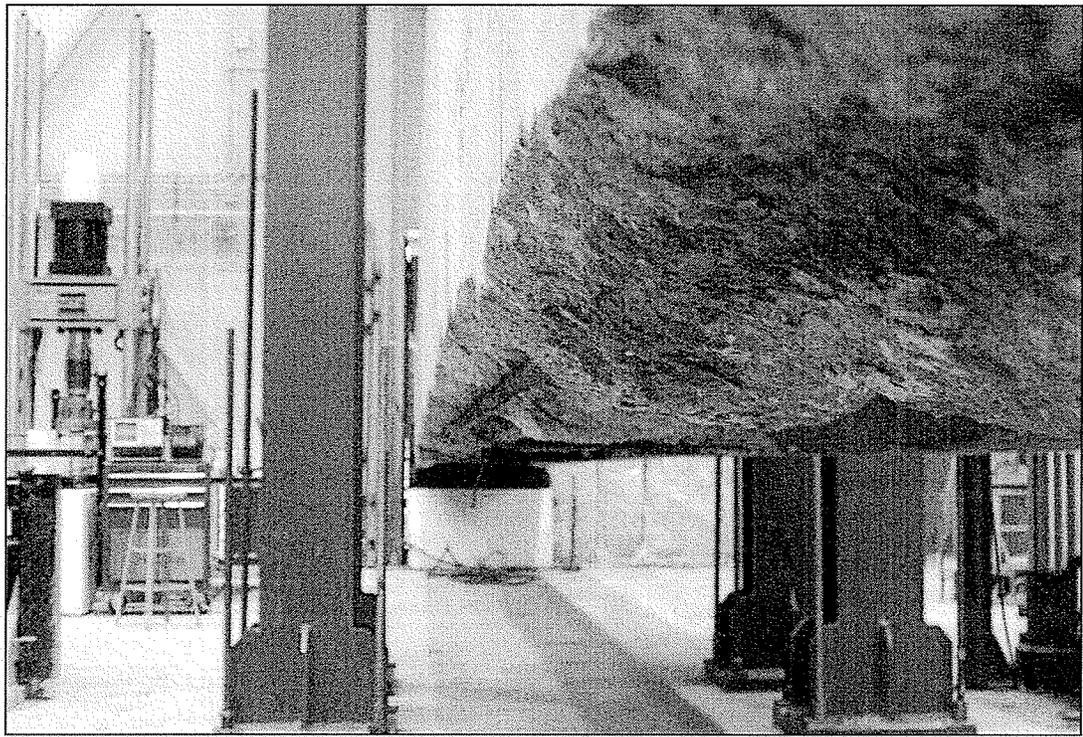
Girder three was in a greater deteriorated state than girders one and two. Horizontal cracks were observed on all ducts which extended transversely through the diaphragms seen in Figures 3-11 and 3-12. Water leaching stains were visible on both webs. The web loss was quite significant and had exposed the bottom layers of pre-stressing on both sides which is depicted in Figure 3-8. Both bottom layer pre-stressing strands had corroded considerably on the east web. This corrosion can be seen in Figures 3-9 and 3-10. Girder three also displayed signs of surface scaling on the east web. As a result of the level of deterioration, girder three was classified as being in poor condition. With that said, no visible vertical flexure cracks or signs of shear distress were observed.

Figure 3-8: A long view of the east web including lost concrete and strand corrosion of girder three.

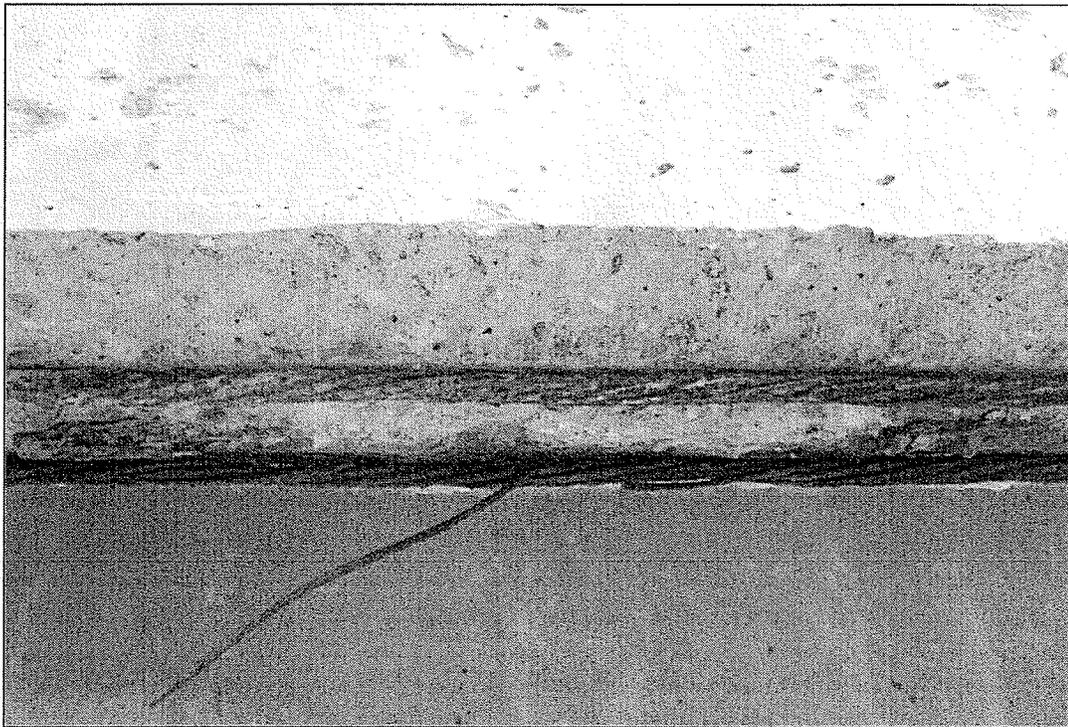
Figure 3-9: Strand corrosion near the mid-span on the east side of girder three.

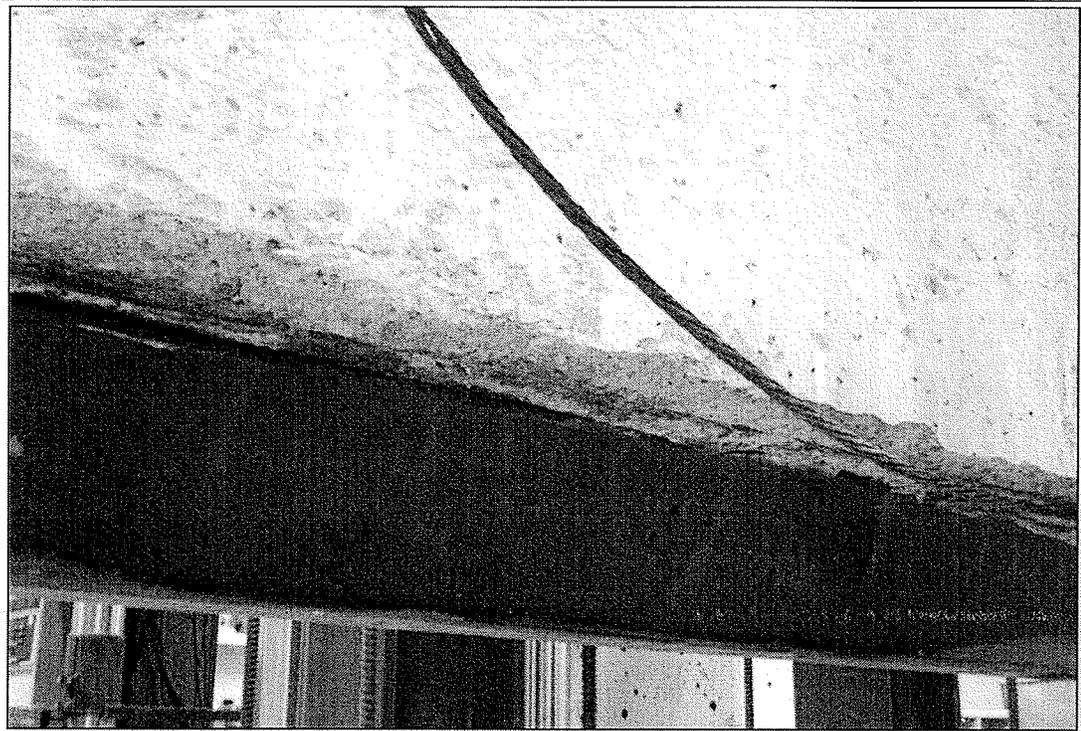
Figure 3-10: Surface scaling and a ruptured strand on the east side of girder three.

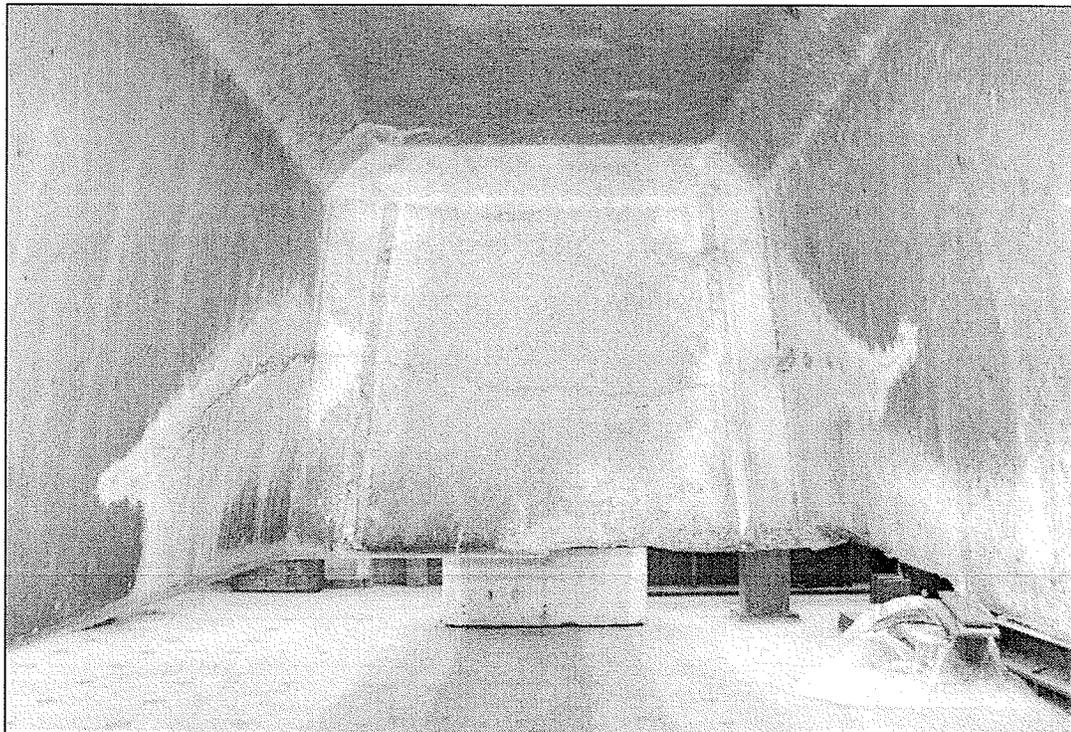
Figure 3-11: Transverse cracking through the diaphragm of girder three.

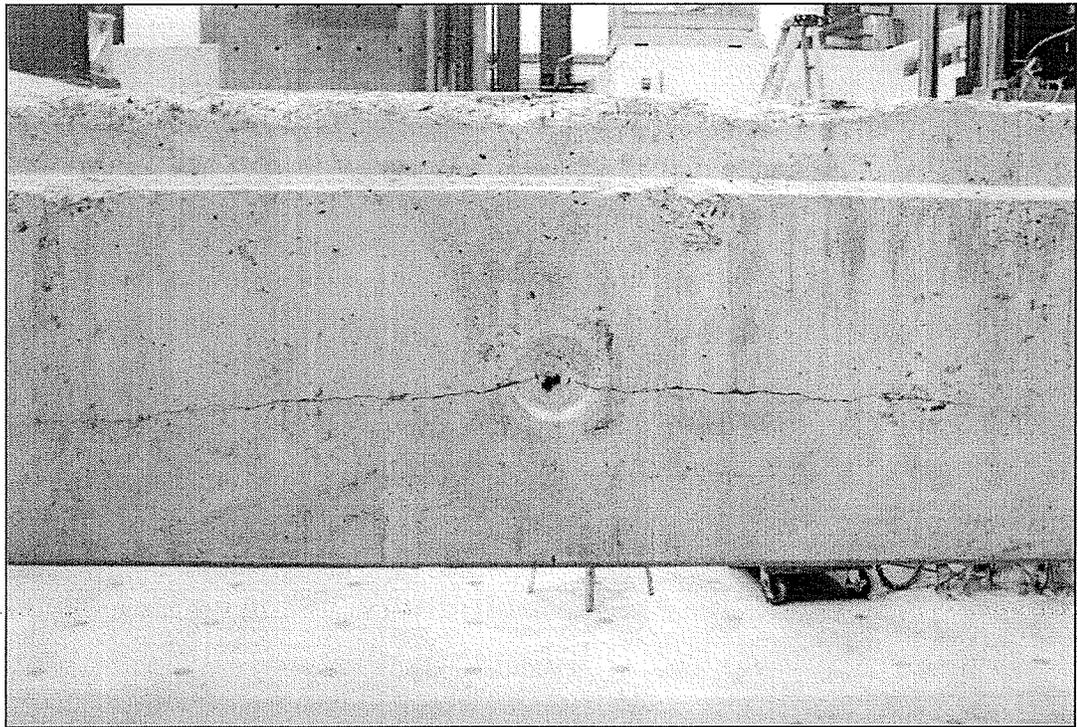
Figure 3-12: Longitudinal cracking on web at post-tensioning ducts of girder three.

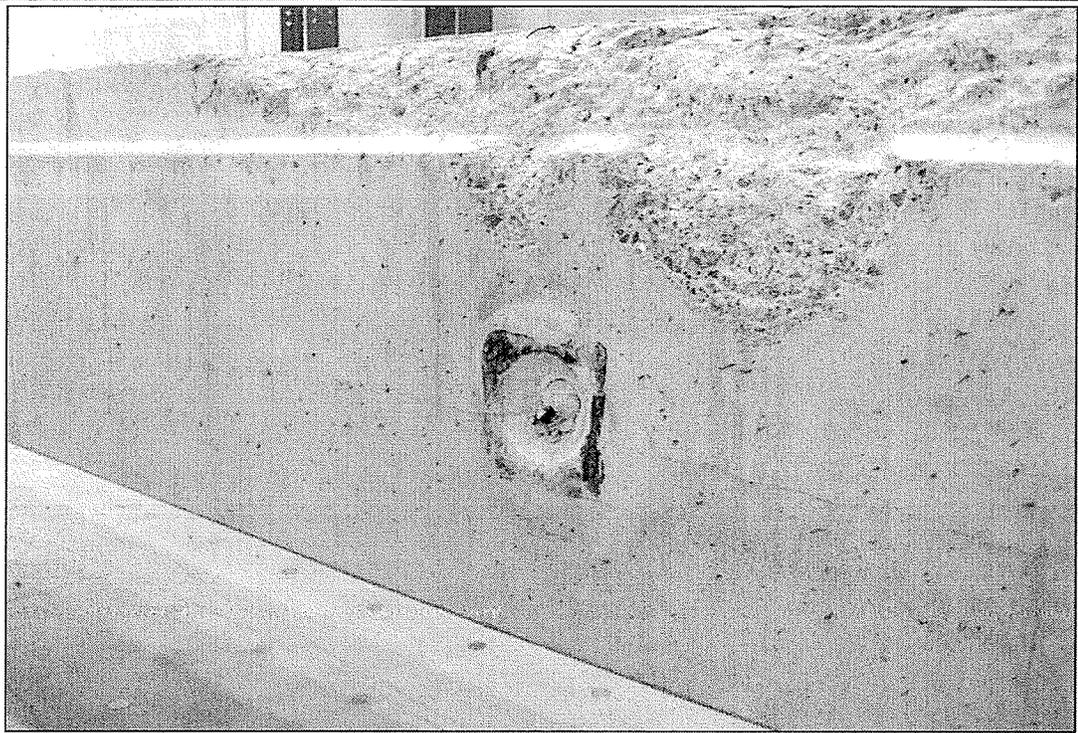
The specimen of the first shear test, girder four, was categorized as being in good condition. No concrete cover had spalled from the webs nor were there any delaminations or horizontal cracking observed on the webs at the pre-stressing regions. Water leaching stains were observed on both webs as were longitudinal cracks at the ducts and through the diaphragms. The longitudinal cracking and water leaching stains can be seen in Figure 3-13. As with the previous three girders, no vertical flexure cracks or signs of shear distress were observed.

Figure 3-13: Cracking and water leakage stains on the web at the post-tensioning ducts of girder four.

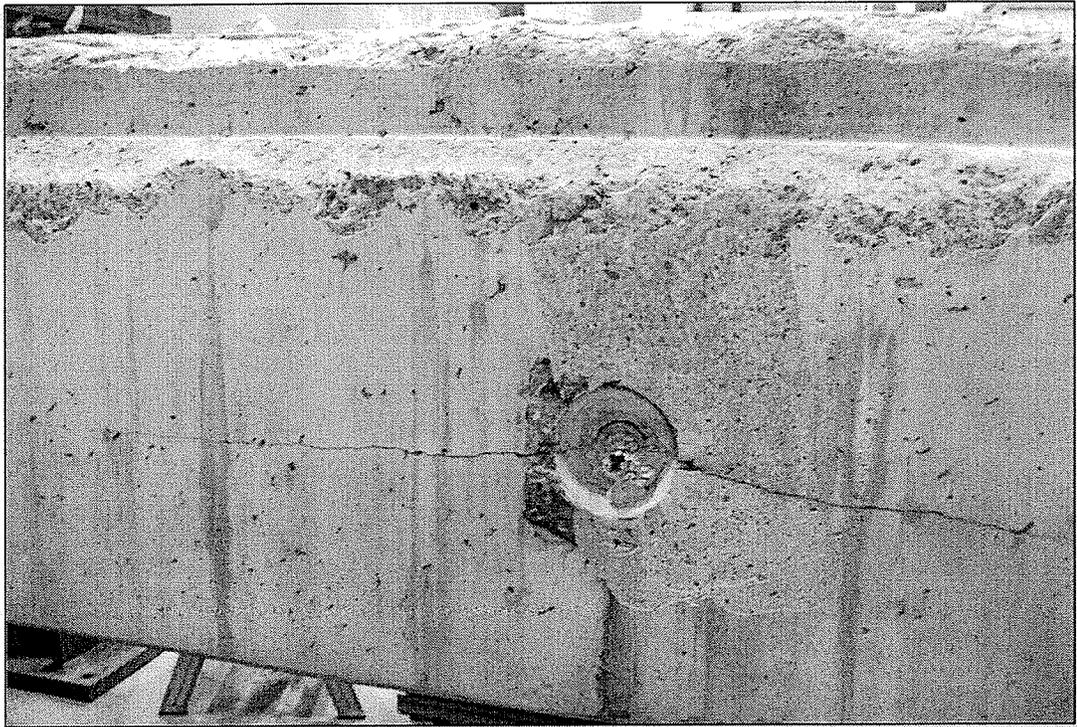
The fifth girder was in the poorest condition of all the girders tested. Water leaching stains were observed as was surface scaling on the east web. Longitudinal and transverse cracking was seen at the post-tensioning ducts and diaphragms, respectively. This is illustrated in Figure 3-14. Shown in Figures 3-15 and 3-16, the bottom of the webs displayed significant concrete loss and in some locations had lost up to 100 mm on the east web. Figure 3-17 demonstrated concrete cover cracking and steel corrosion staining. There was also considerable strand deterioration at the bottom layer of reinforcement where at least one strand was rendered ineffective. Due to these factors this girder was categorized as being in poor condition. However, no flexural cracks or signs of shear distress were seen.

Figure 3-14: Cracking and water leaching stains at the post-tensioning duct on the west web of girder five.

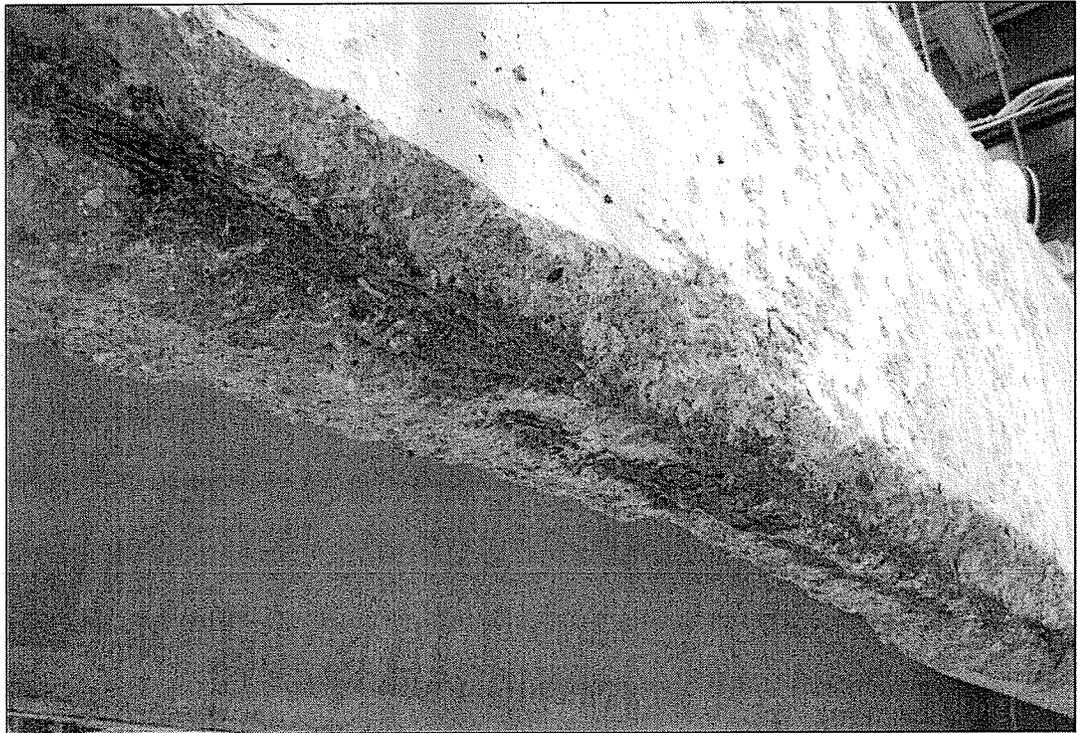
Figure 3-15: Strand corrosion, lost concrete and surface scaling on the east web of girder five.

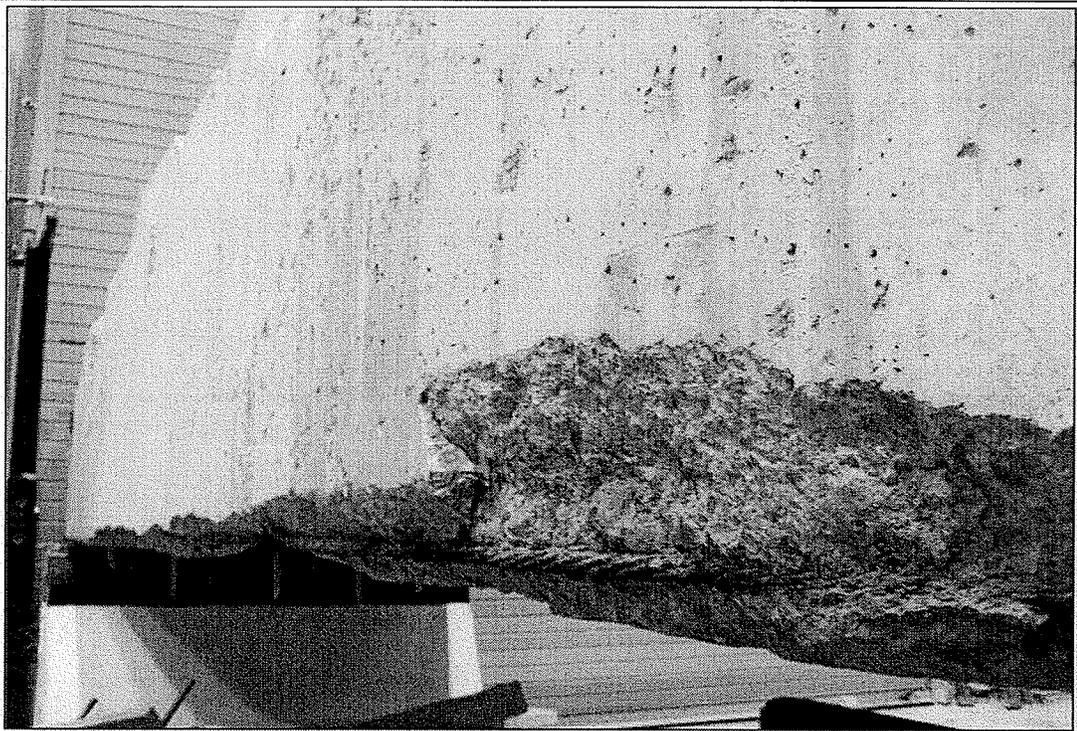
Figure 3-16: Significant concrete loss on the east web near support of girder five.

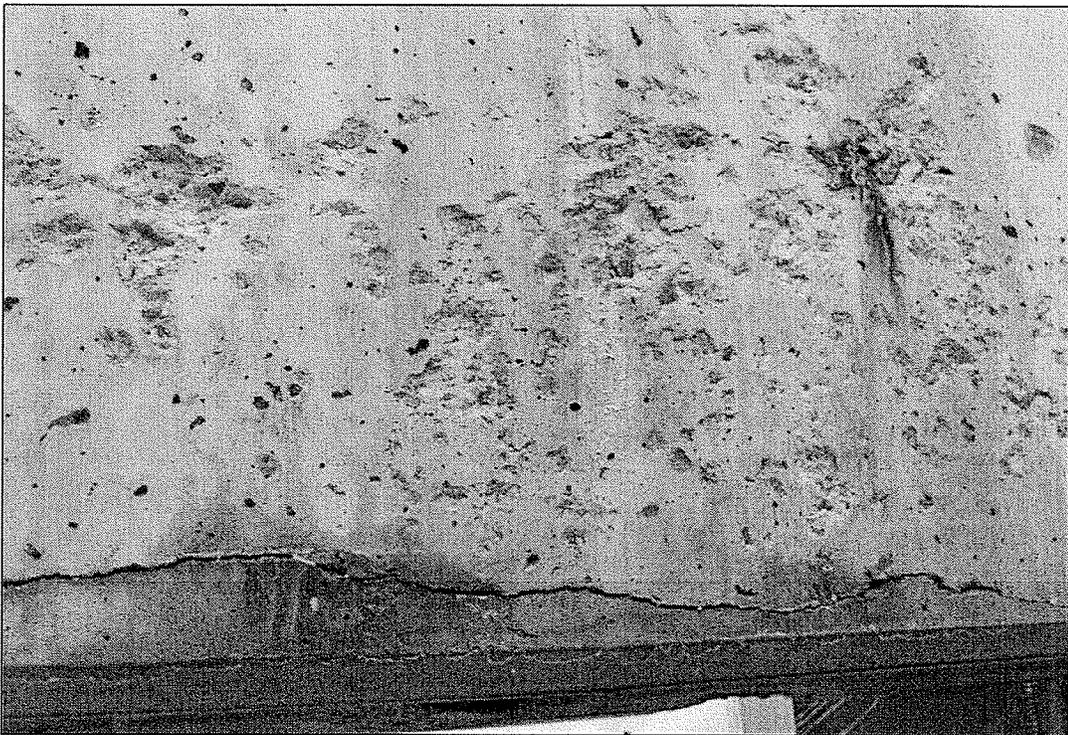
Figure 3-17: Web cracking and delamination, corrosion staining and surface scaling of girder five.

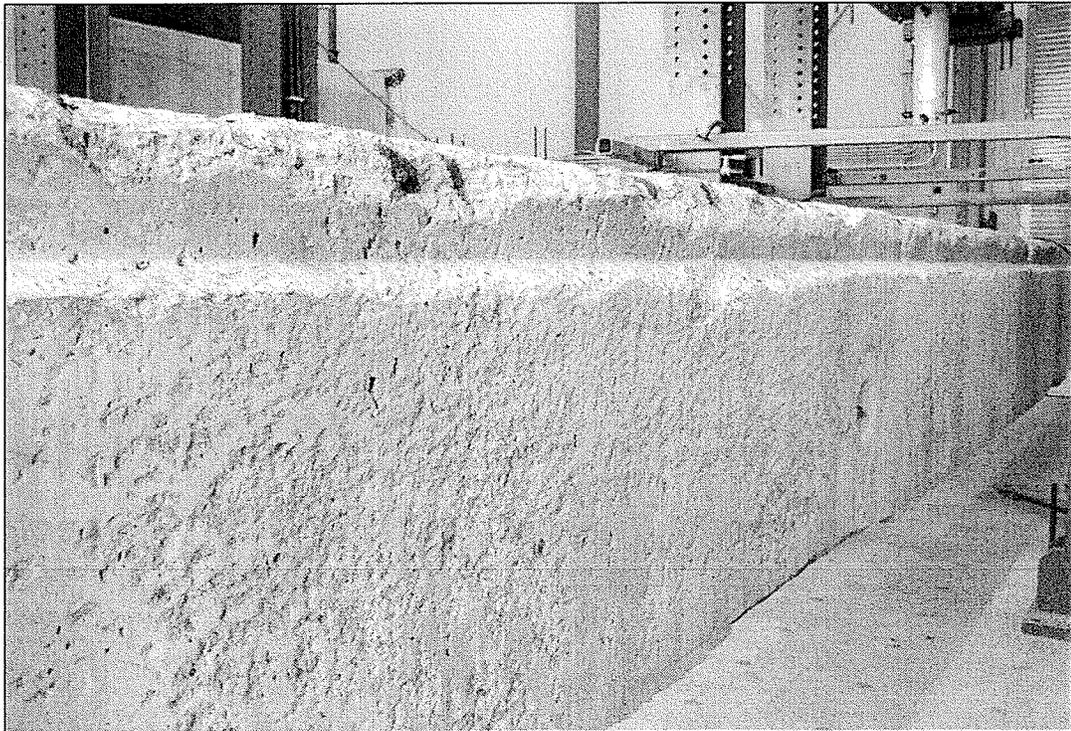
Girder six was classified as being in poor condition relative to the other girders. Significant surface scaling was observed on the west web of this girder. This environmental damage can be seen in Figure 3-18. On that same side, the bottom layer of tensioning strands were exposed and corroded. This can be seen in Figure 3-19. Similar to the previous five girders, horizontal cracks that extended away from some of the post-tensioning ducts were observed. At this location, the cracking propagated transversely through the diaphragms as well. On the web opposite to that of the surface scaling, significant water leaching stains were visible. As with the previous five girders no flexural cracks or signs of shear distress were observed.

Figure 3-18: Surface scaling on the west web of girder six.

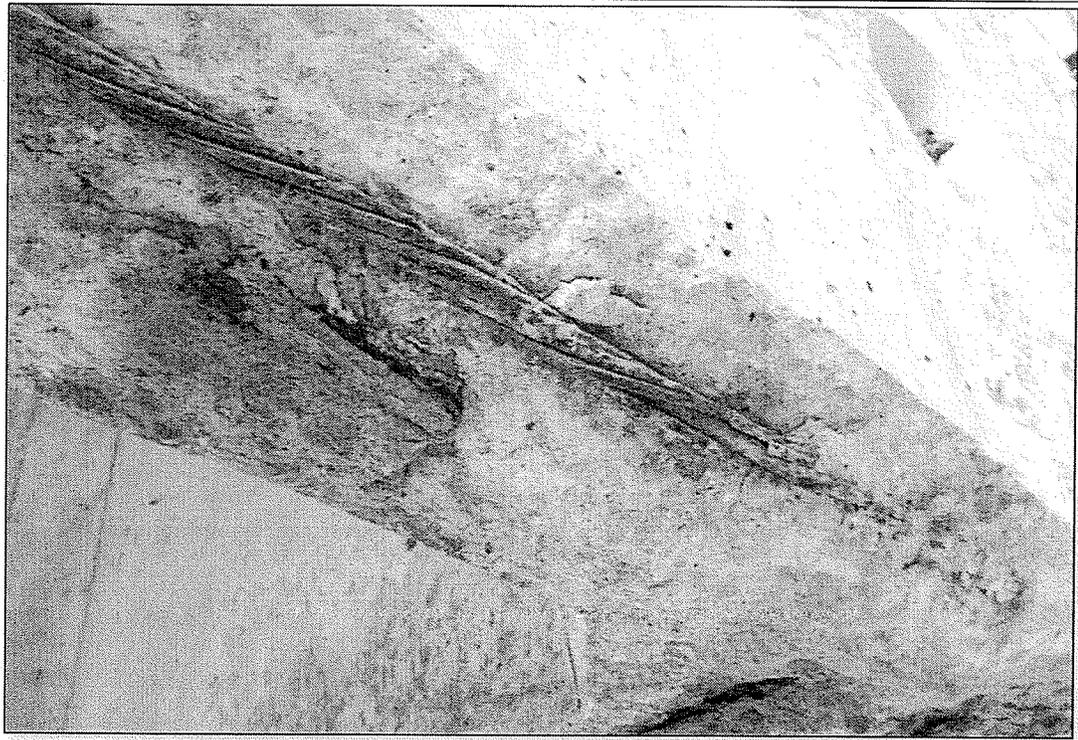
Figure 3-19: Exposed and corroded strands on the web of girder six.

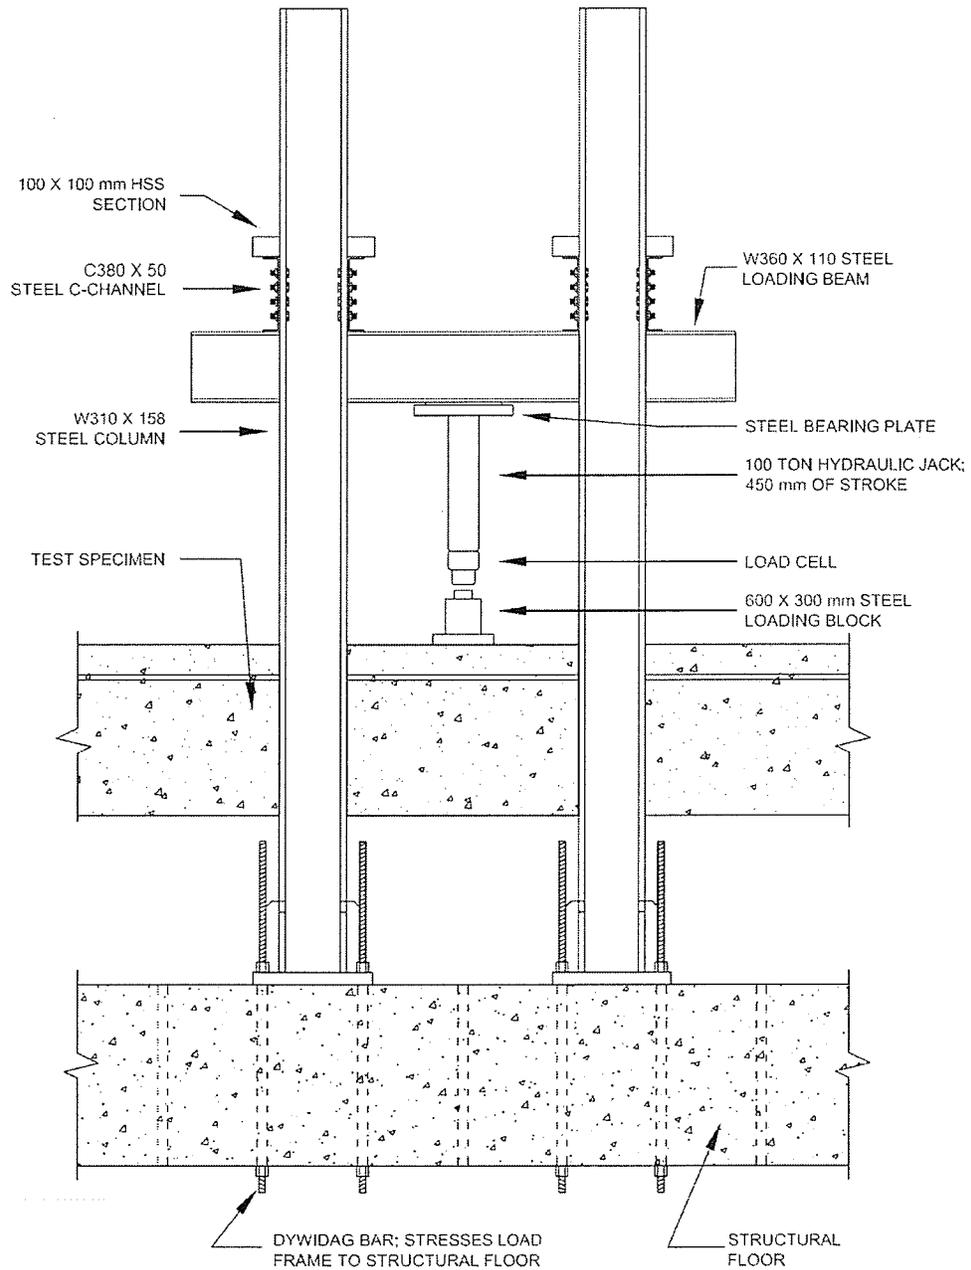
A
S03

LOAD FRAME DETAIL

Figure 4-1: Loading frame detail.

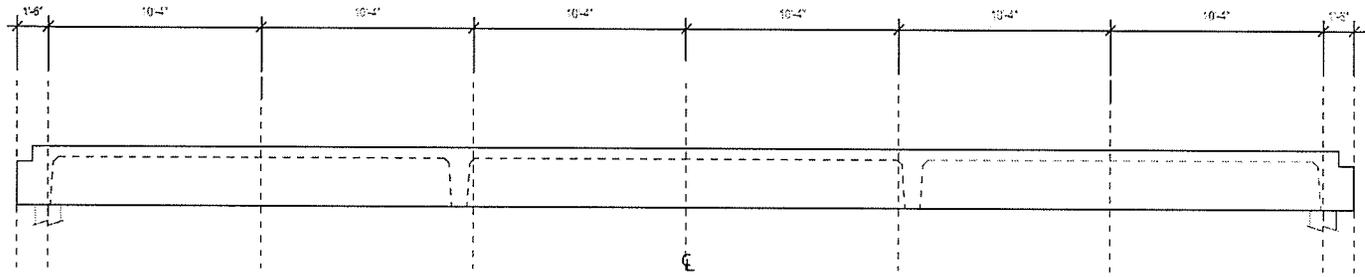
1
S04 TOP PLAN VIEW

A
S04 STRAIN GAUGE AND LVDT PLACEMENT FOR FLEXURAL TESTING

Figure 4-2: Flexural testing instrumentation setup.

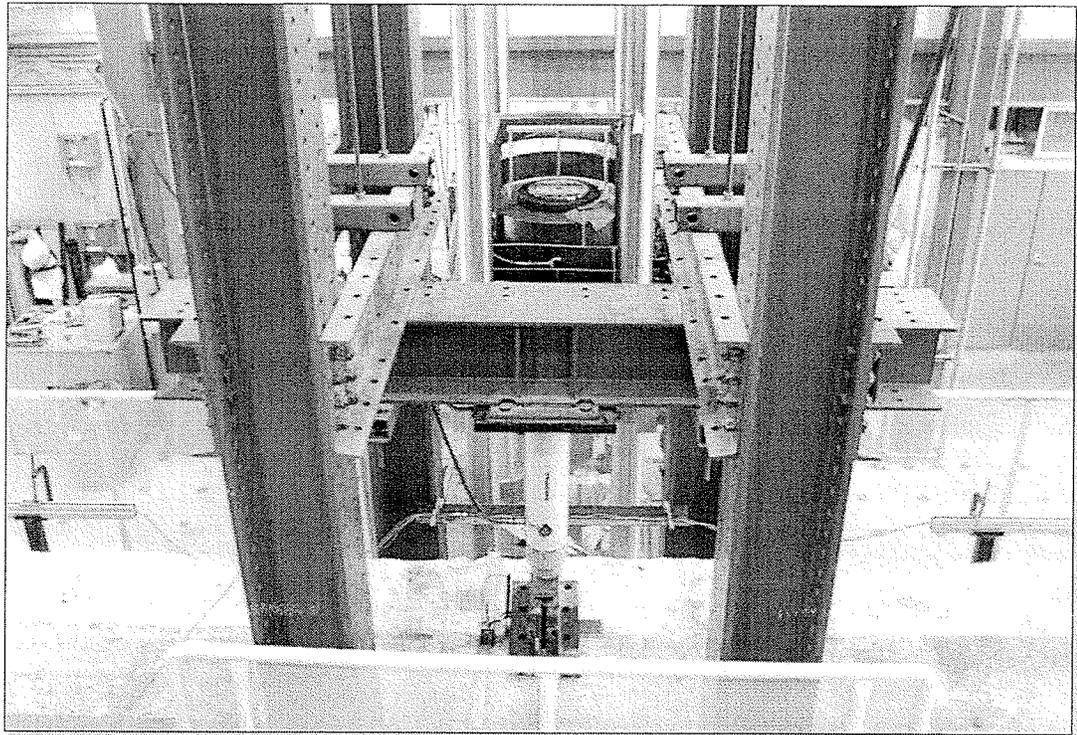
Figure 4-3: The loading frame of the flexural test setup.
