**An Autopsical Examination of 40 Year Old
Pre-Tensioned Concrete Channel Girders**

Brandon James Mills

The University of Manitoba

This thesis report examines six decommissioned pre-tensioned concrete channel girders which were part of the Canadian National Railway overpass on the Trans-Canada Highway No. 1 (CN Overpass on TCH Site No. 0709-00) east of Portage La Prairie constructed in 1965. The six girders are representative of the various levels of deterioration observed on the in-service bridge.

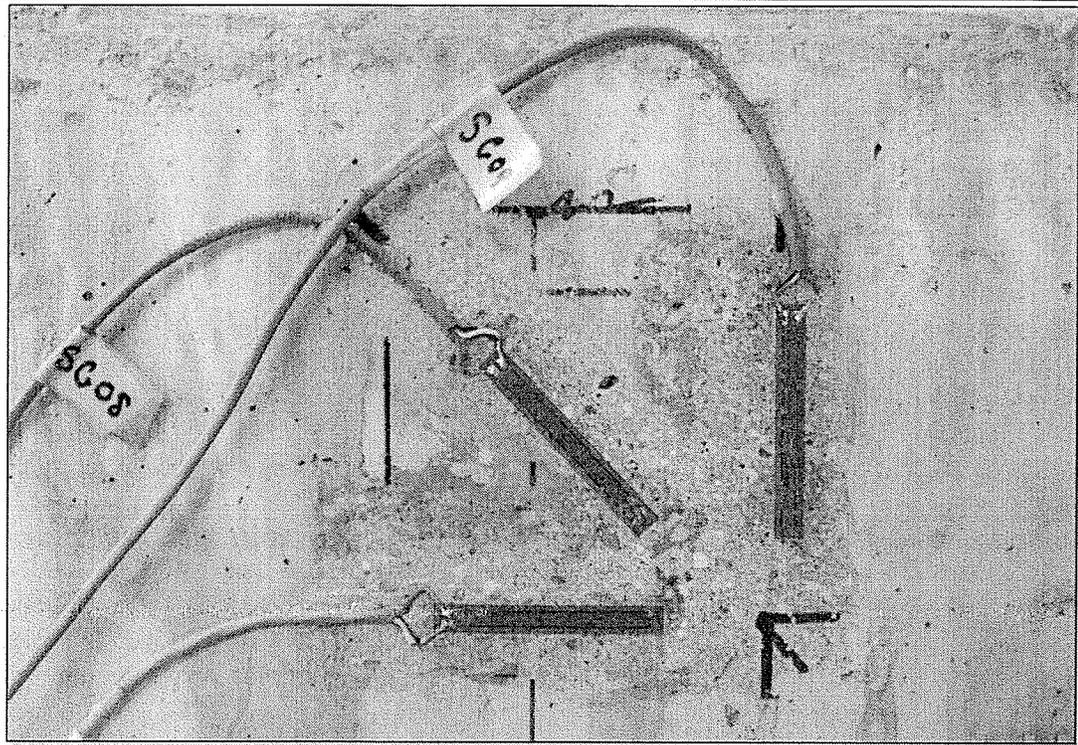
Figure 4-4: Strain gauge rosette on the web of girder at the point of loading.

A rosette of pi gauges was installed at the mid-height locations as shown in Figure 4-5 to confirm the readings given by the electronic strain gauges. In addition, the pi gauges should yield readings to failure where as once a crack occurs through a strain gauge, it no longer functions.

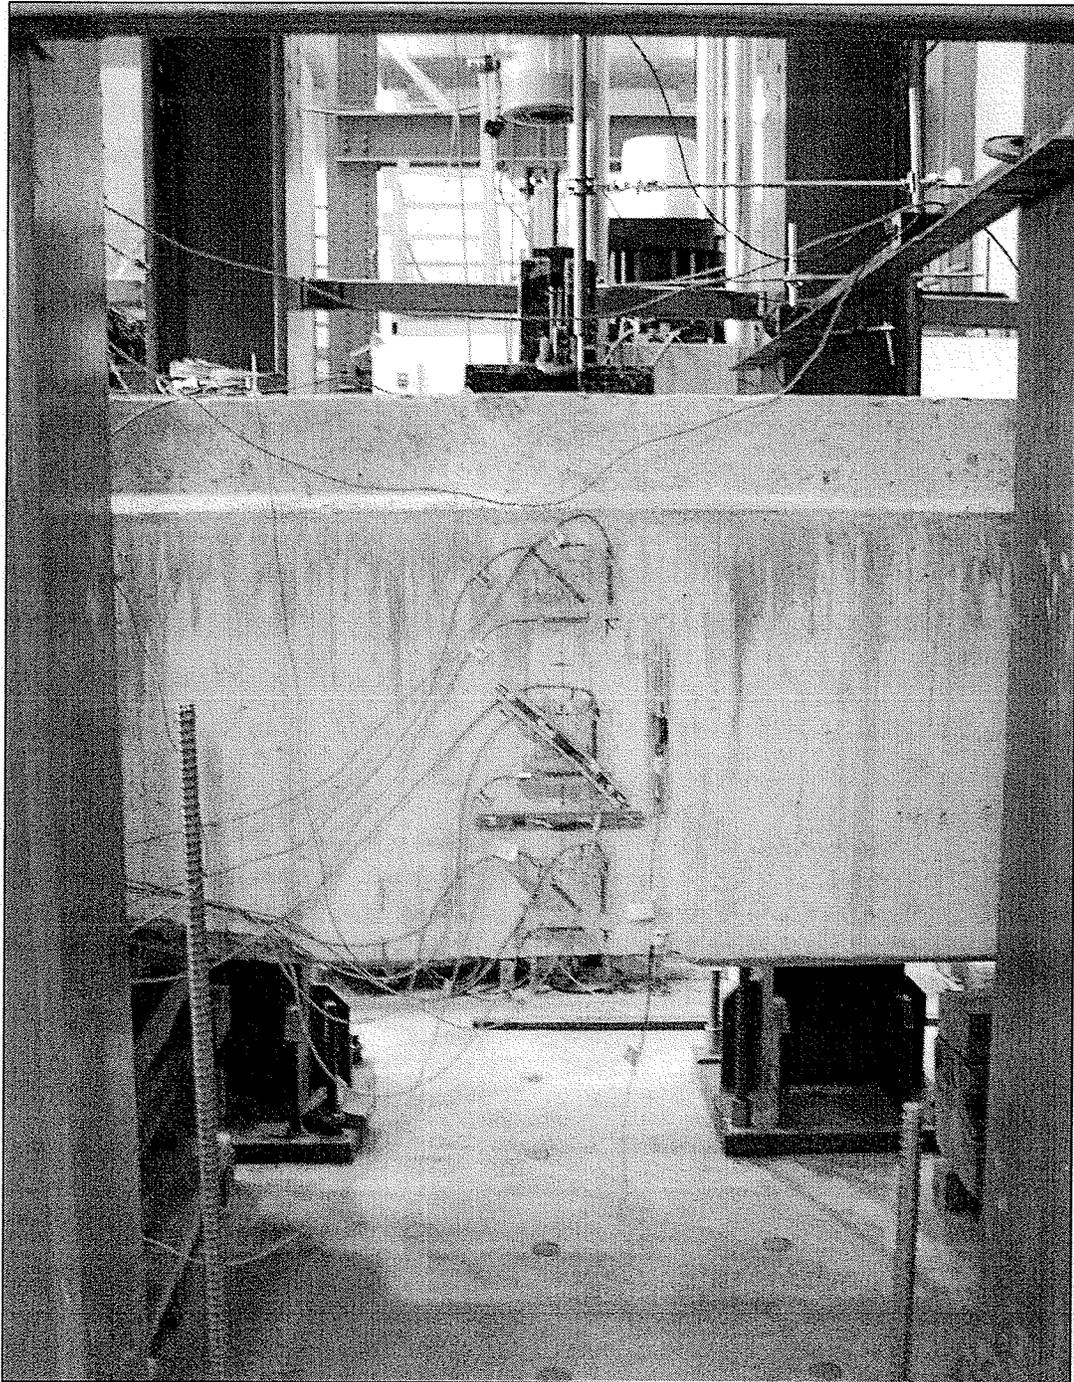
Figure 4-5: Shear electronic instrumentation setup including strain and pi gauge rosettes.

Five LVDTs were used to measure the displacement along the length of the girder. These were situated at the supports, the mid-span, and one on either side of the point of load. This would allow measurement of bearing pad compaction, span displacement, and any possible torsion. The five LVDTs were wired to the data acquisition system and measurements were recorded at one reading per second.

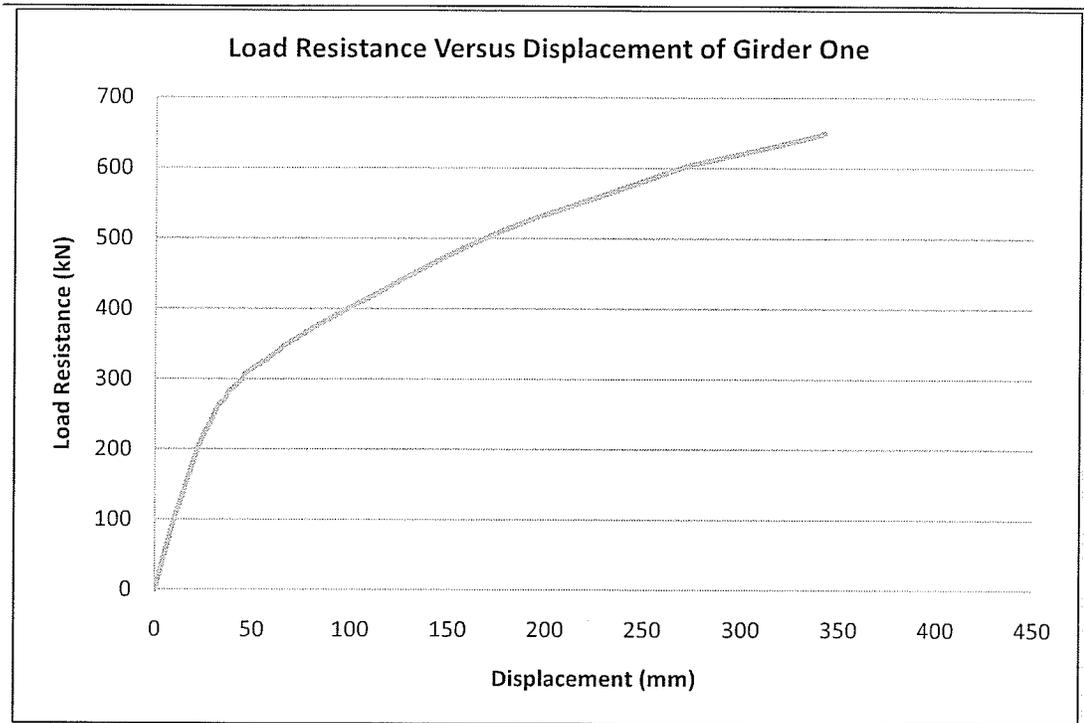
Due to safety concerns the first girder was not taken to failure. However, it was supposed that the girder was loaded very close to its ultimate strength based on comparisons between it and the other girder within this program. This specimen resisted a load of 650 kN at a displacement of 343 mm. This load converted to a total nominal resistance of 3577 kNm which was 29 percent greater than anticipated by theoretical calculations. The cracking load of the girder was 238 kN which was within the expected range of one-third to one-half the ultimate failure load. Once the load had been removed the girder rebounded from a displacement of 343 mm to roughly 40 mm of total displacement. After the test, typical flexural cracks were observed within the central third of the girder. Figures 5-1 and 5-2 display the loading versus displacement plots of the test. Figures 5-3 and 5-4 are photographs taken near ultimate loading of the girder.

Figure 5-1: Load versus displacement for flexural test one.

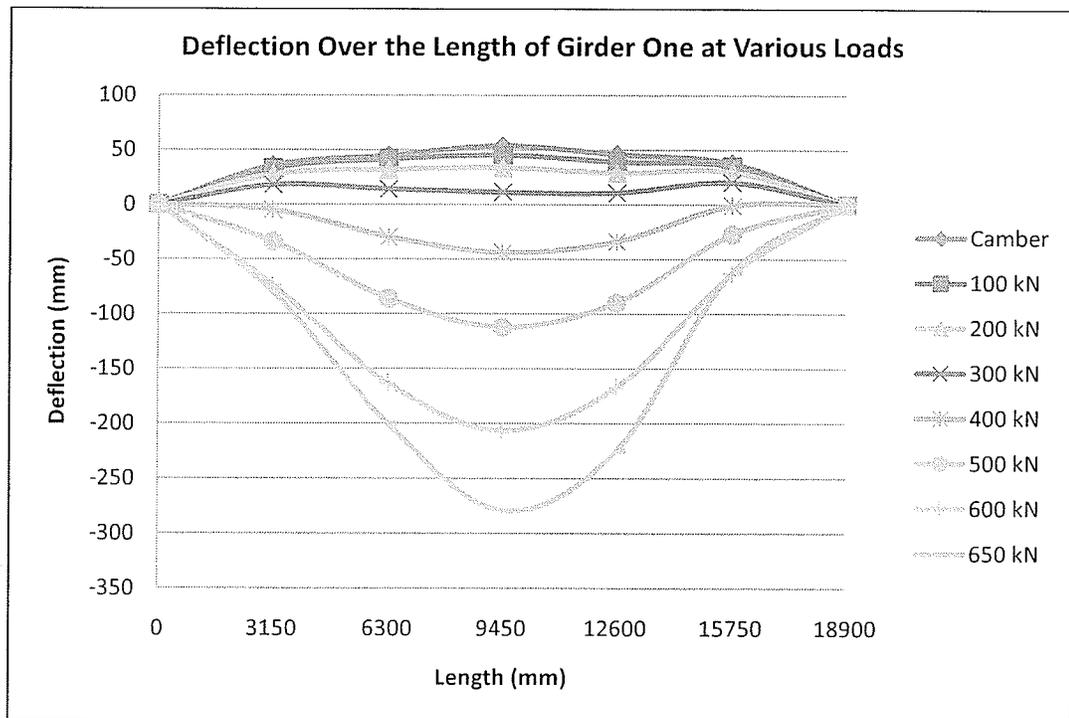
Figure 5-2: Deflection over the length of the girder for various loads during flexural test one.

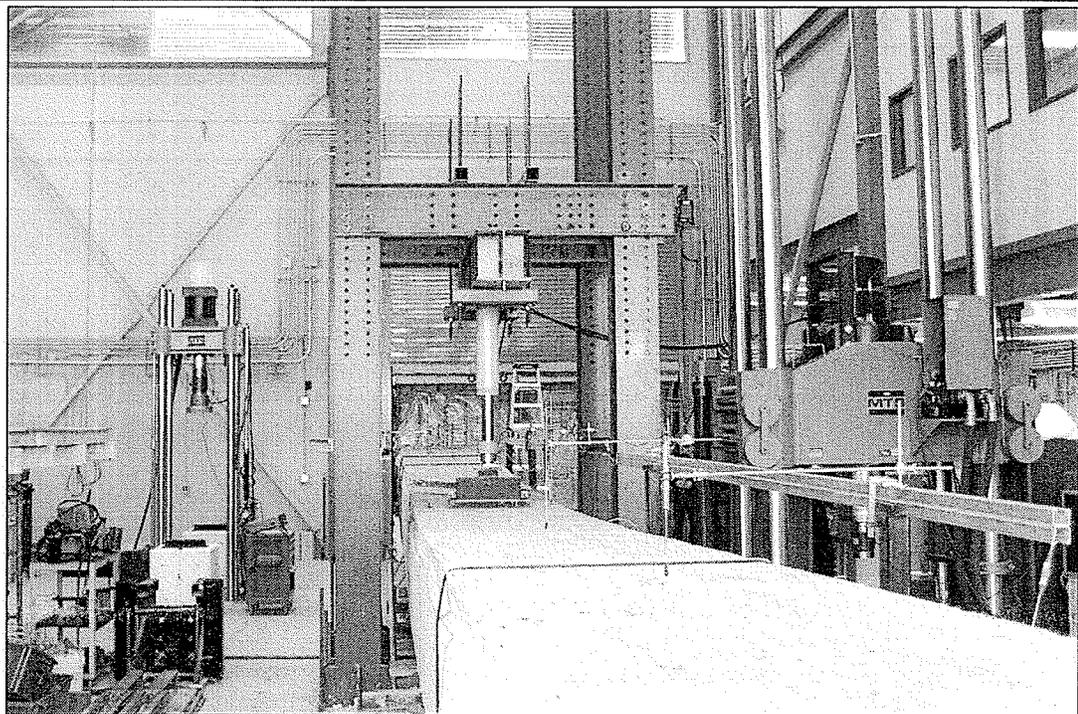
Figure 5-3: Flexural testing at the maximum deflection of girder one.

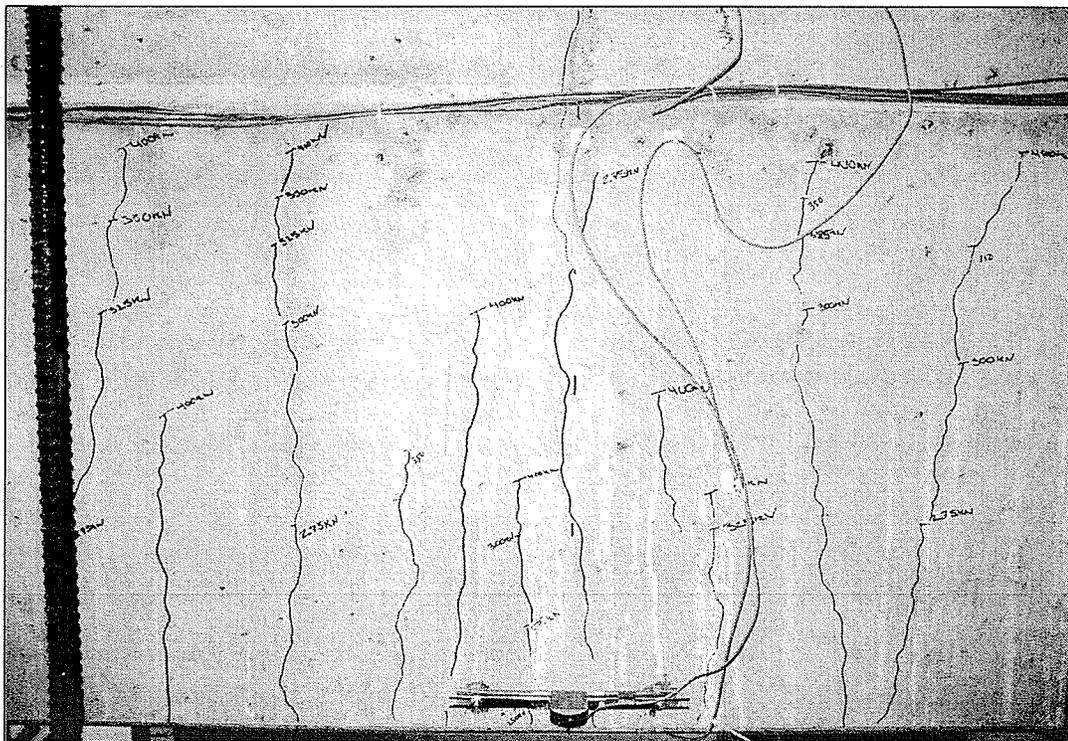
Figure 5-4: Flexural cracks at the mid-span region on the west side of girder one.

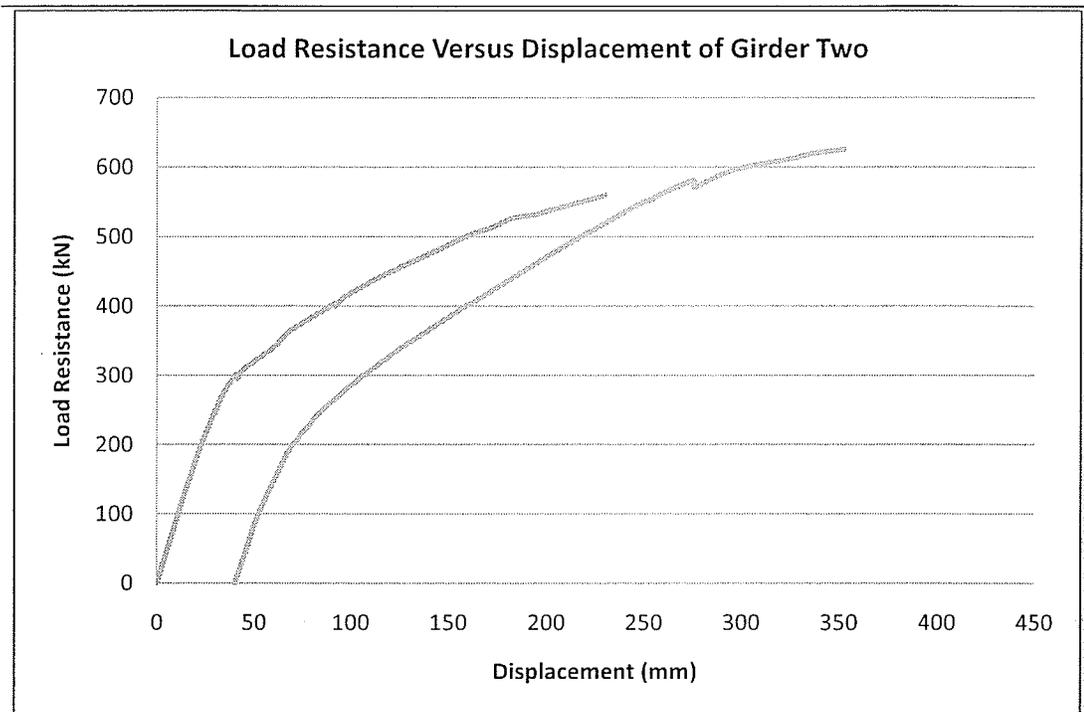
This second test saw the girder monotonically loaded in increments of 50 kN to failure. The formation of cracks were marked every 50 kN to 400 kN. Cracks were not marked beyond 400 kN for safety purposes. Cover loss was observed at loads of 300 kN and greater which was expected due to the cracking at the bottom layer of strand reinforcement seen during the condition cataloguing. The mode of failure was a non-ductile explosion of the compressive zone. The girder reached an ultimate failure load of 626 kN at displacement of 317 mm. At this load, the girders' nominal moment capacity was calculated to be 3462 kNm, 25 percent greater than that calculated theoretically. Figures 5-5 and 5-6 display the loading versus displacement plots of the test. Figures 5-7 and 5-8 are photographs of the girder after failure had occurred.

Figure 5-5: Load versus displacement for flexural test two.

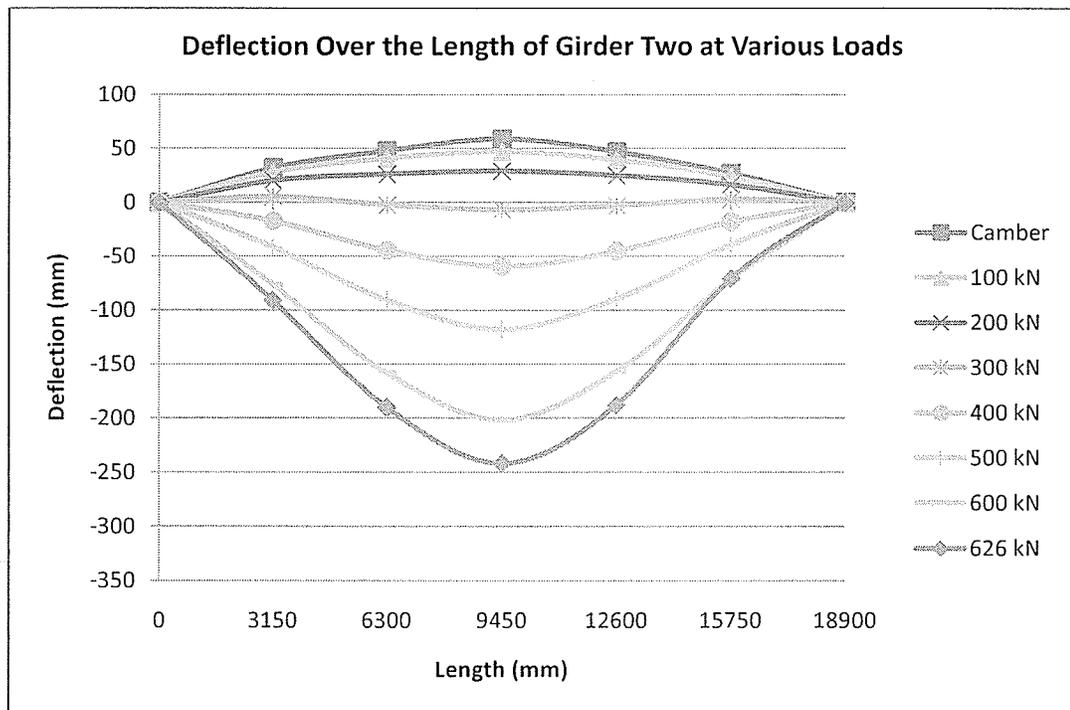
Figure 5-6: Deflection over the length of the girder for various loads during flexural test two.

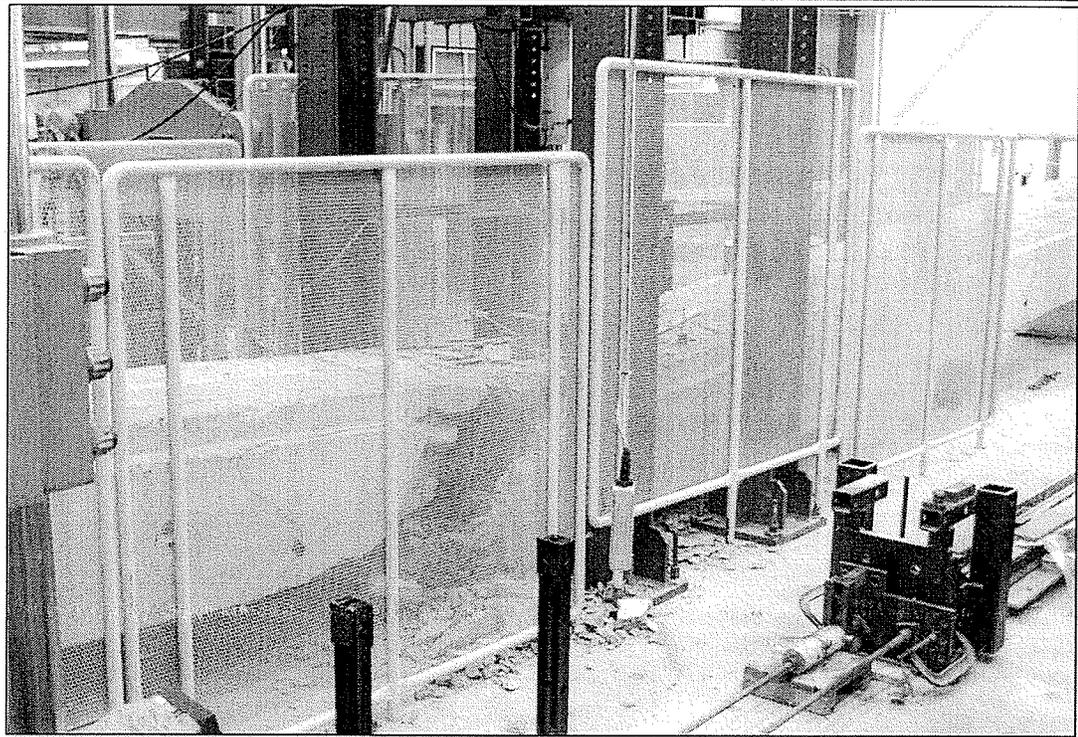
Figure 5-7: Long view of failure at the mid-span on the east side of girder two.

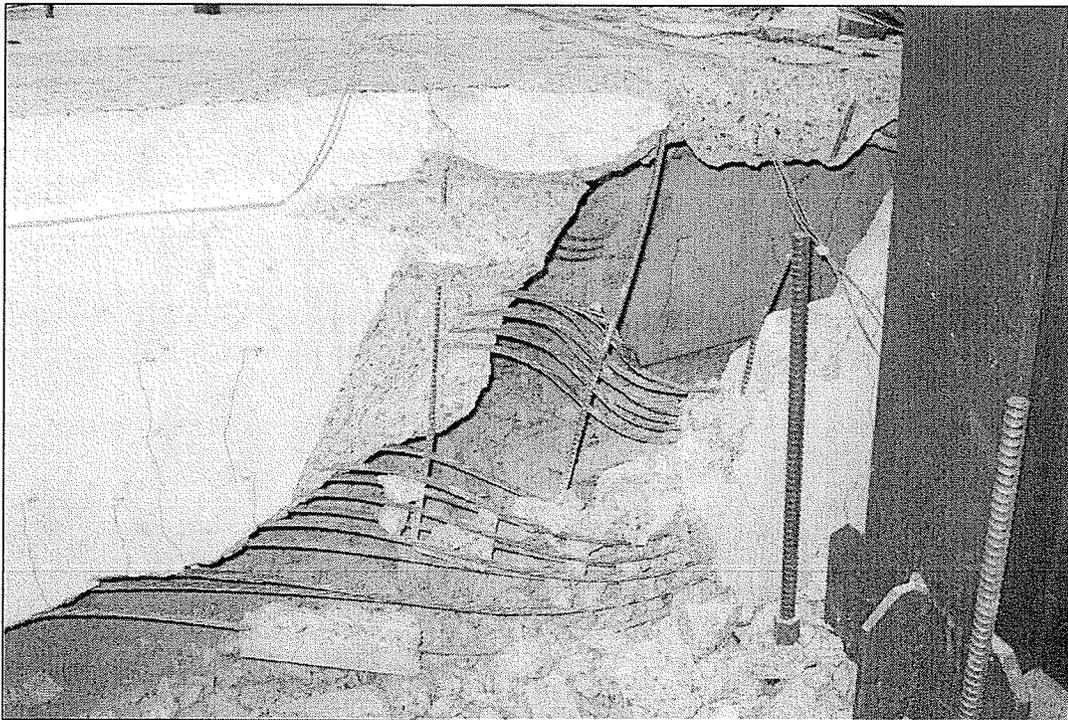
Figure 5-8: Close up of the failure zone at the mid-span on the east side of girder two.

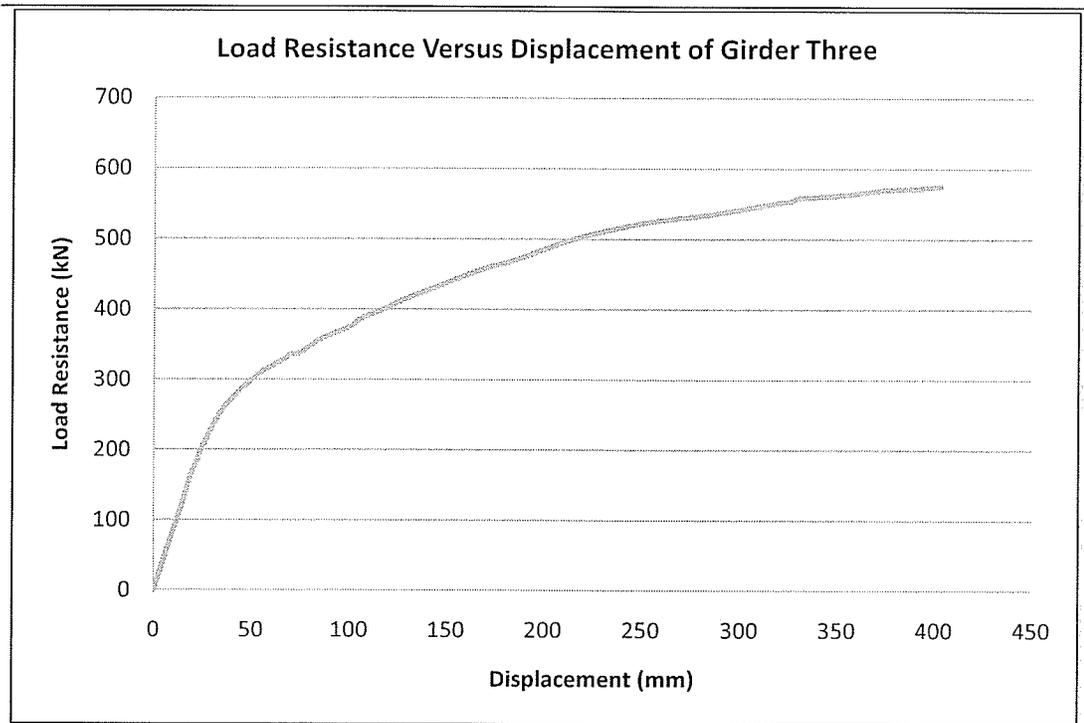
Like the second test, the girder was loaded monotonically to failure. The formation of cracks were marked every 50 kN to a load of 400 kN. Cracks were not marked beyond 400 kN for safety purposes. During the test a considerable amount of web loss due to concrete spalling was also observed. The mode of failure was a non-ductile explosion of the compressive zone. The girder reached an ultimate failure load of 575 kN at a displacement of 403 mm. At this load the girder had a nominal moment resistance of 3224 kNm, which was 26 percent greater than calculated theoretically for a scenario of two ineffective strands and 50 mm of concrete cover loss. Figures 5-9 and 5-10 display the loading versus displacement plots of the test. Figures 5-12 and 5-13 are photographs of the girder after failure was reached.

Figure 5-9: Load resistance versus displacement for flexural test three.

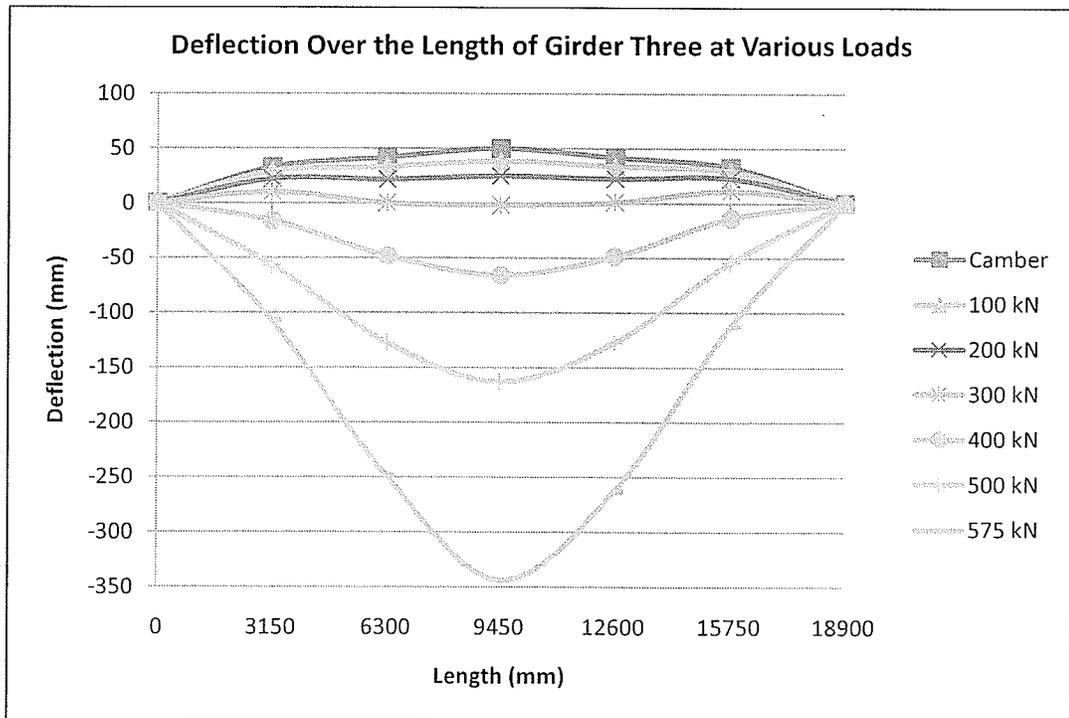
Figure 5-10: Deflection over the length of the girder for various loads during flexural test three.

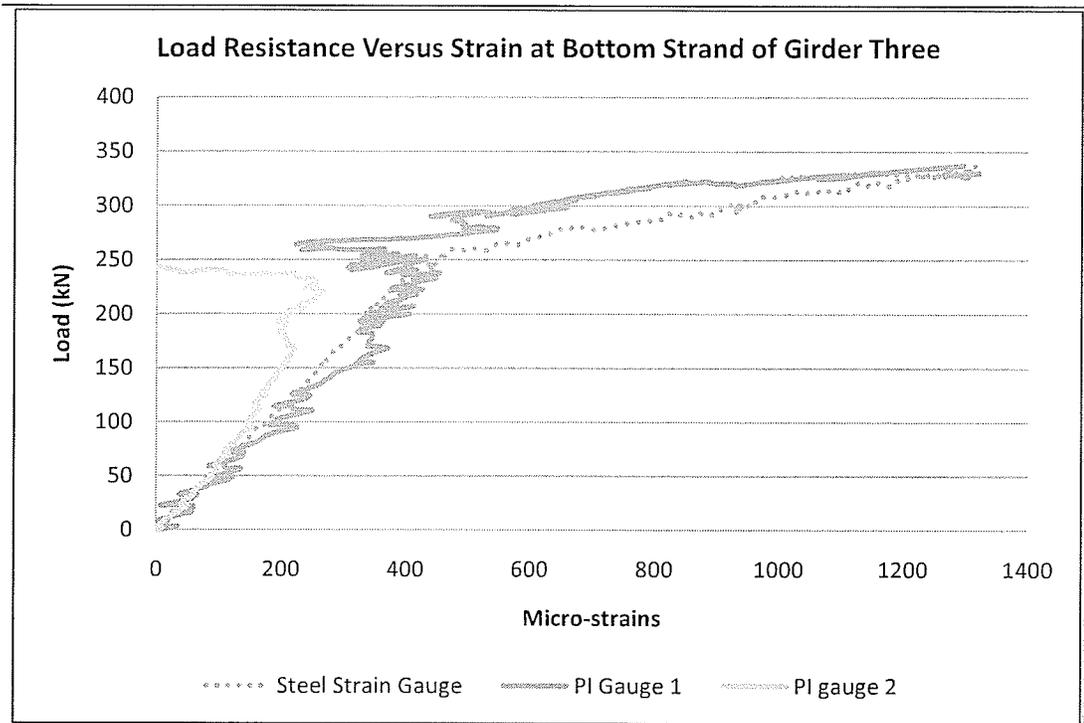
Figure 5-11: Comparison of pi gauge and strain gauge results for flexural test three.

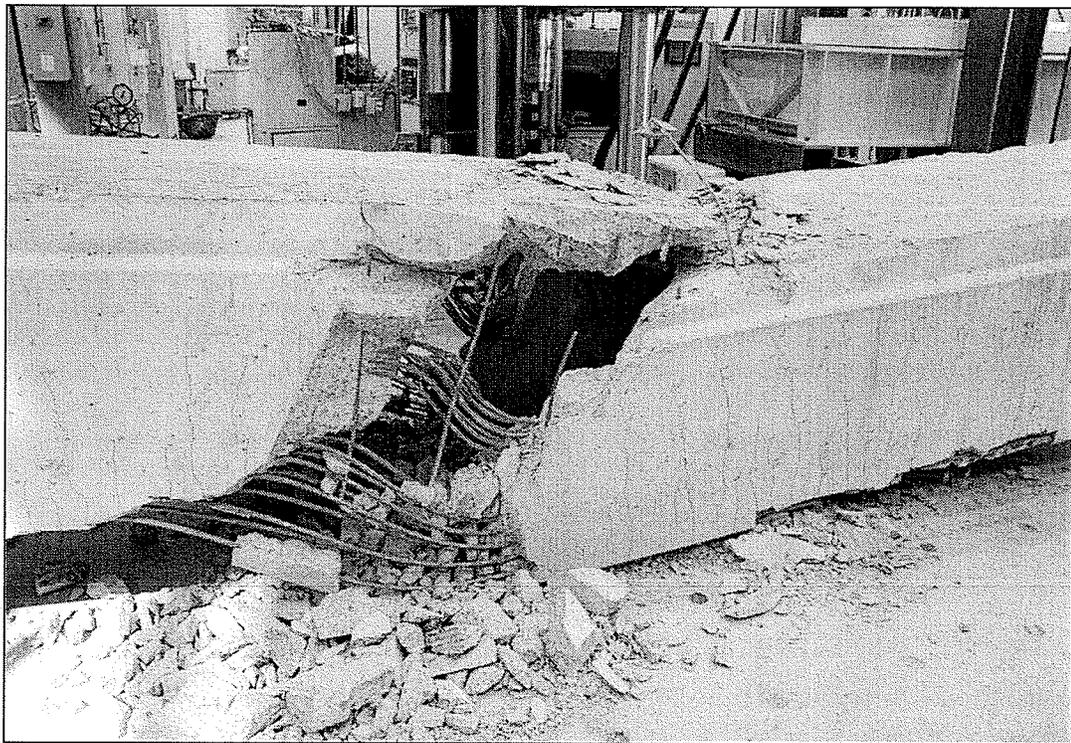
Figure 5-12: Failure near the mid-span on the east side of girder three.

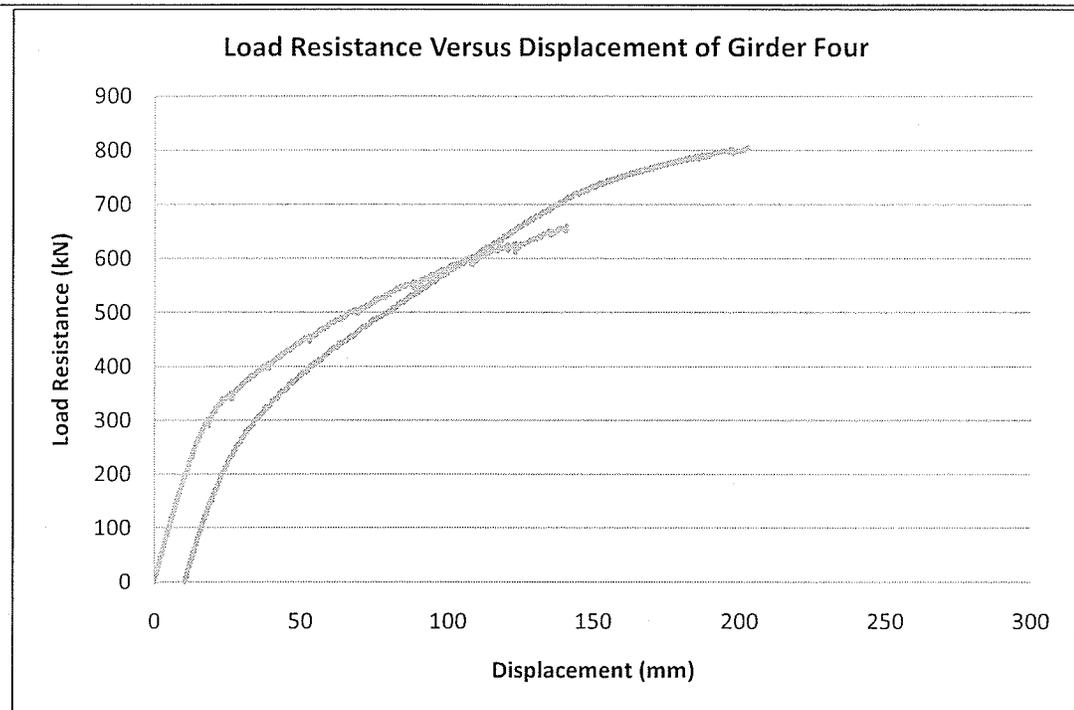
During this test, the pump used for extending the jacking device had stopped functioning and it was necessary to release the load and change the pump. In doing so the load cell was displaced giving an erroneous reading. This reading was corrected in the final plot. Once the pump was changed the girder was retested and monotonically loaded to failure. The first visible flexural cracks occurred under the point of loading at a resistance of about 400 kN. Diagonal shear cracks began to appear around 600 kN. As more force was applied, loss of concrete on the bottom of the webs occurred yet no strands ruptured. The cracks increased in number and size up to the ultimate load of 805 kN. This value of 805 kN converts to a nominal section shear resistance of 692 kN, 45 percent greater than the theoretically calculated nominal section shear capacity. Figures 5-13 and 5-14 display the loading versus displacement plot of the test. Figures 5-15 and 5-16 are photographs of the girder after failure was reached.

Figure 5-13: Load resistance versus displacement for shear testing of girder four.

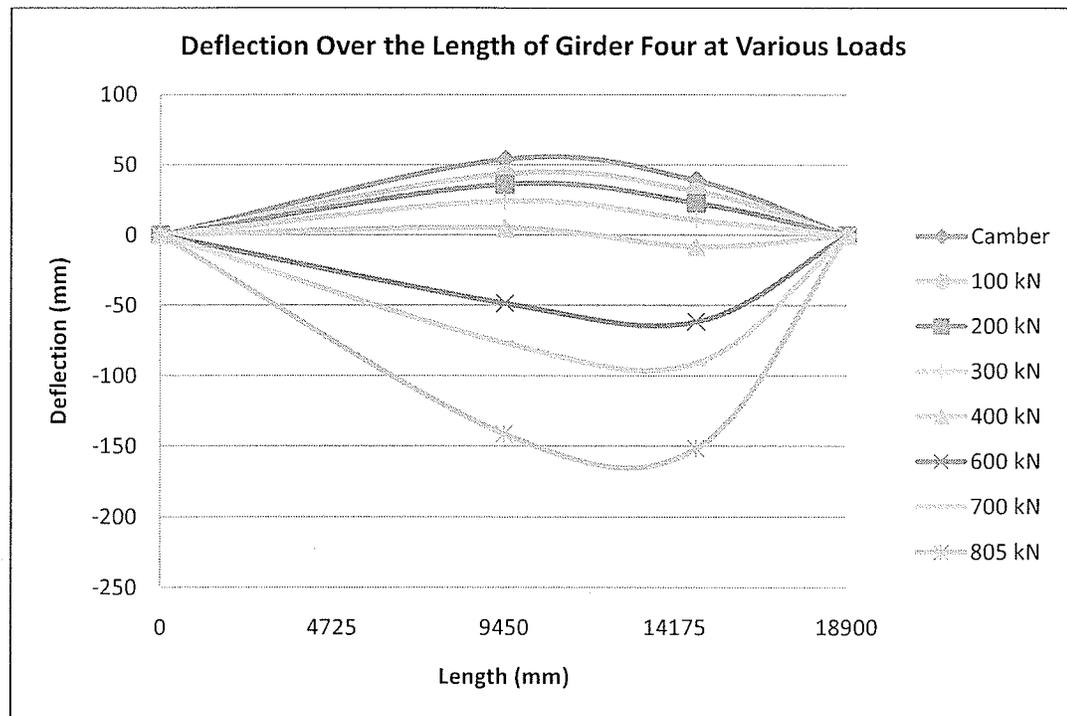
Figure 5-14: Deflection over the length of the girder for various loads during shear test one.

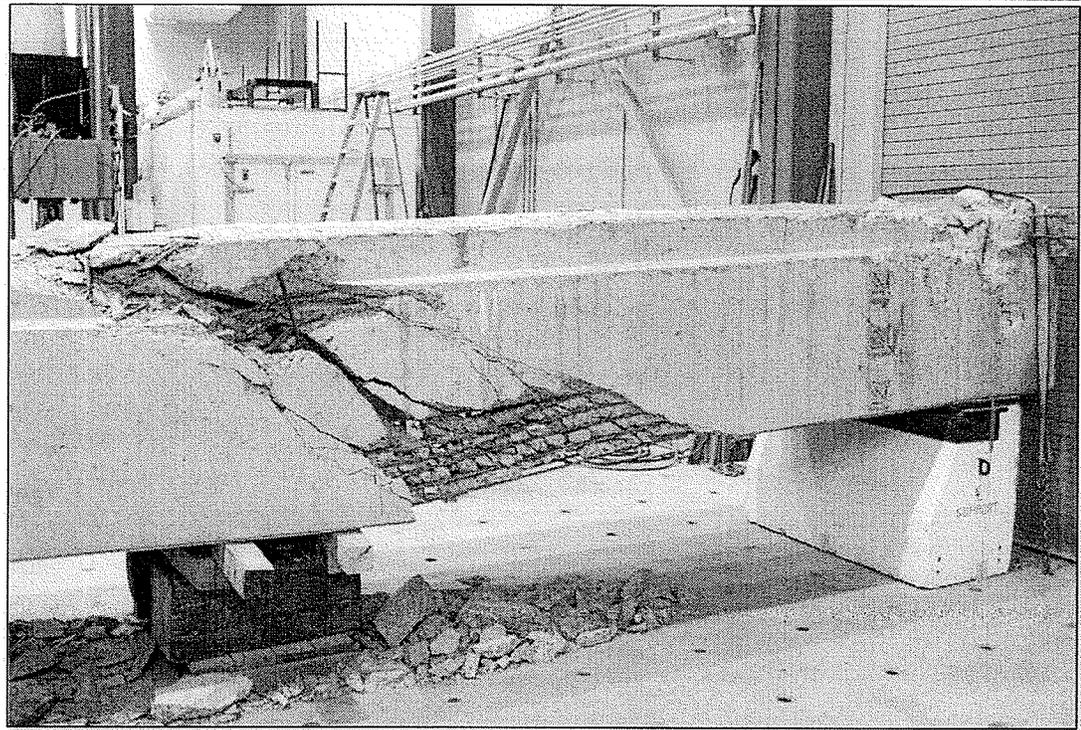
Figure 5-15: Failure near the quarter span on the west side of girder four.

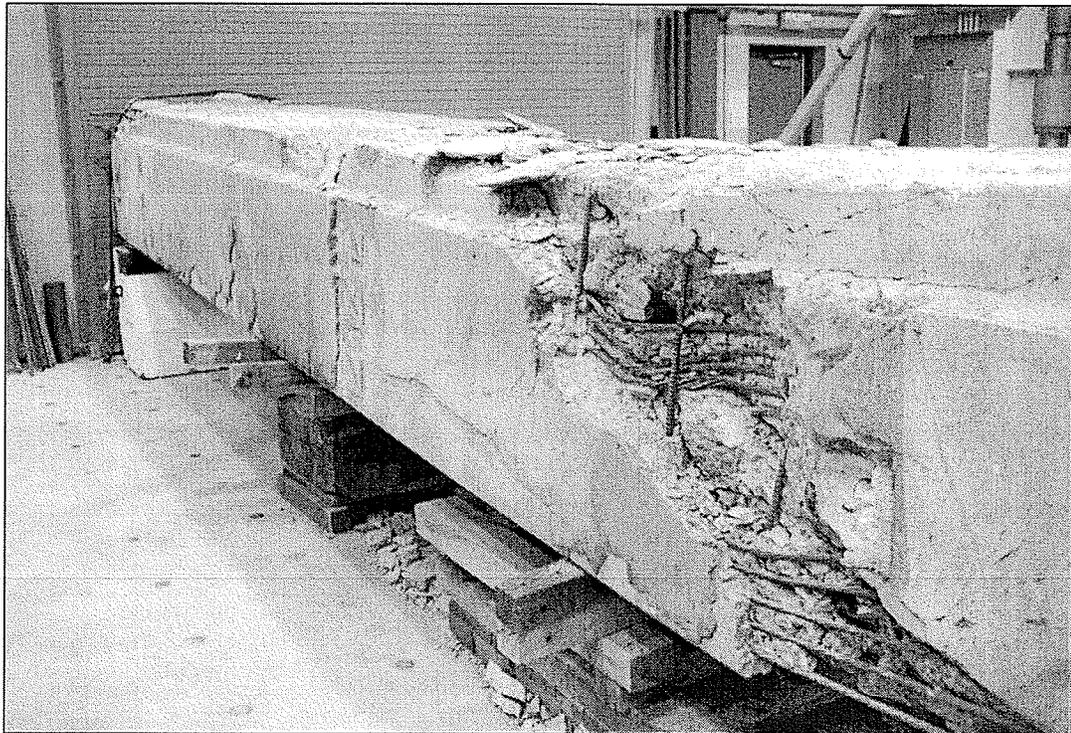
Figure 5-16: Failure near the quarter span on the east side of girder four.

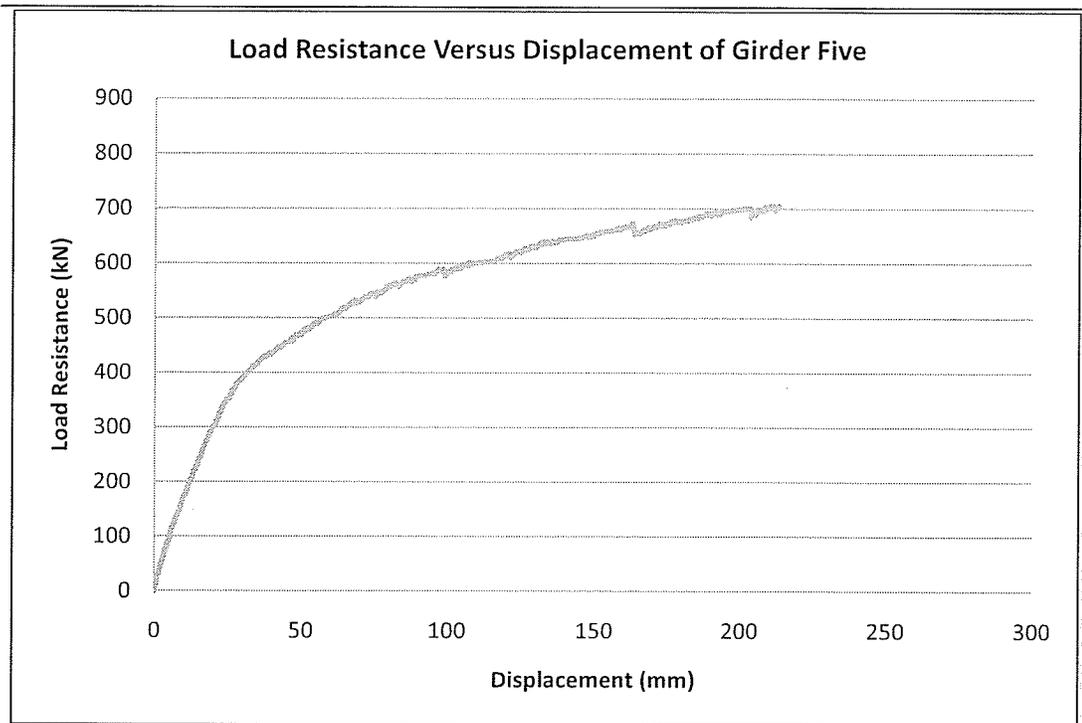
The first visible flexural cracks occurred under the point of loading at a capacity of about 350 kN. Diagonal shear cracks began to appear around 500 kN. Beyond 500 kN there was a substantial amount of concrete delaminations and cover loss on the bottom of the webs as well as a ruptured strand on the east facing web. The cracks increased in number and size up to the ultimate load of 706 kN. This value converts to a nominal section shear resistance of 615 kN which was 40 percent greater than the theoretically calculated nominal section shear resistance of a girder with a cover loss of 75 mm and two ineffective strands. It is important to keep in mind that this girder was not able to resist to its potential due to the demolition damage. This damage can be clearly seen in Figure 5-20. Figures 5-17 and 5-18 display the loading versus displacement plot of the test. Figures 5-19 through 5-22 are photographs of the girder after failure was reached.

Figure 5-17: Load resistance versus displacement for the shear testing of girder five.

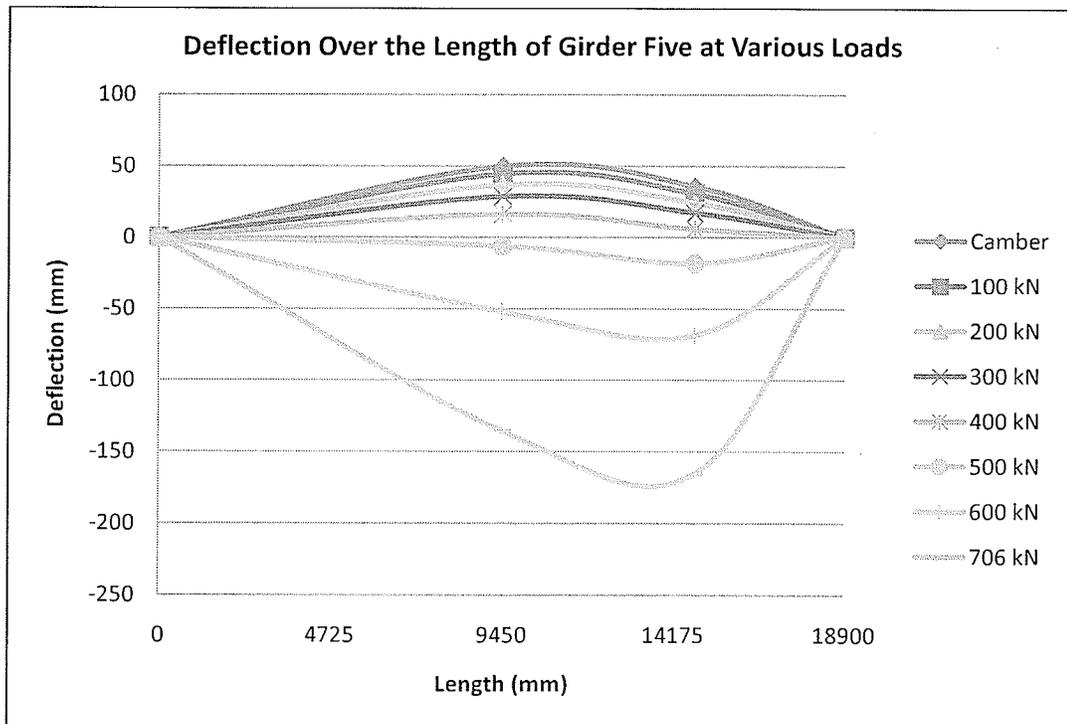
Figure 5-18: Deflection over the length of the girder for various loads during shear test two.

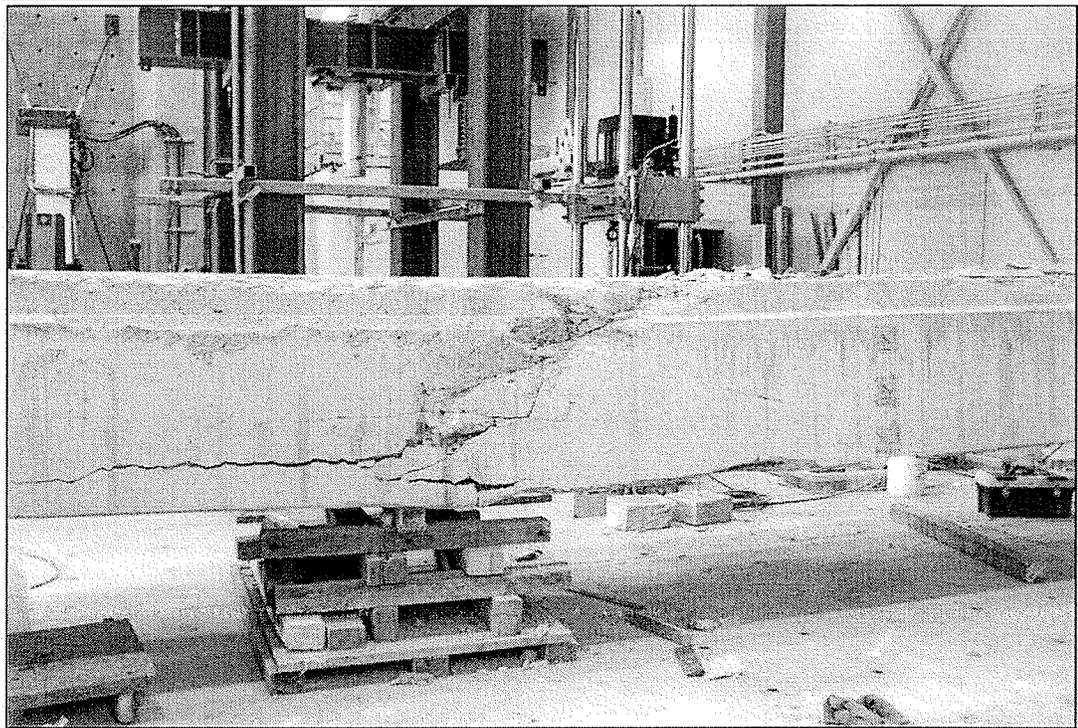
Figure 5-19: Failure near the quarter span on the west side of girder five.

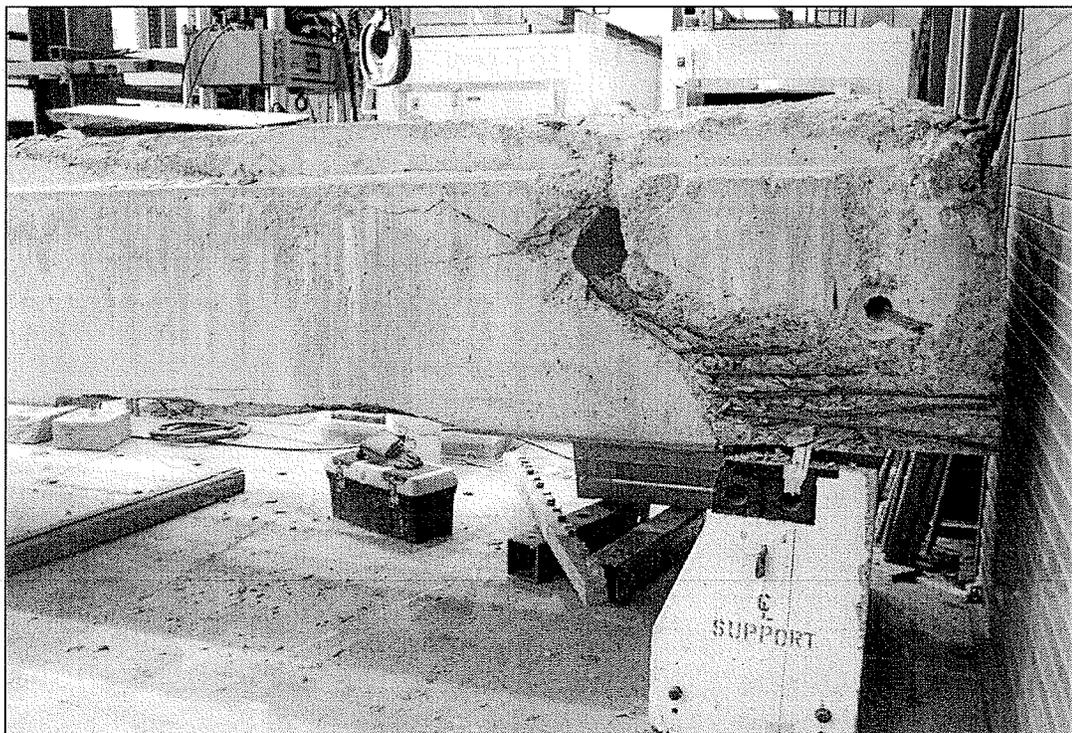
Figure 5-20: Failure at the support on the west side of girder five.

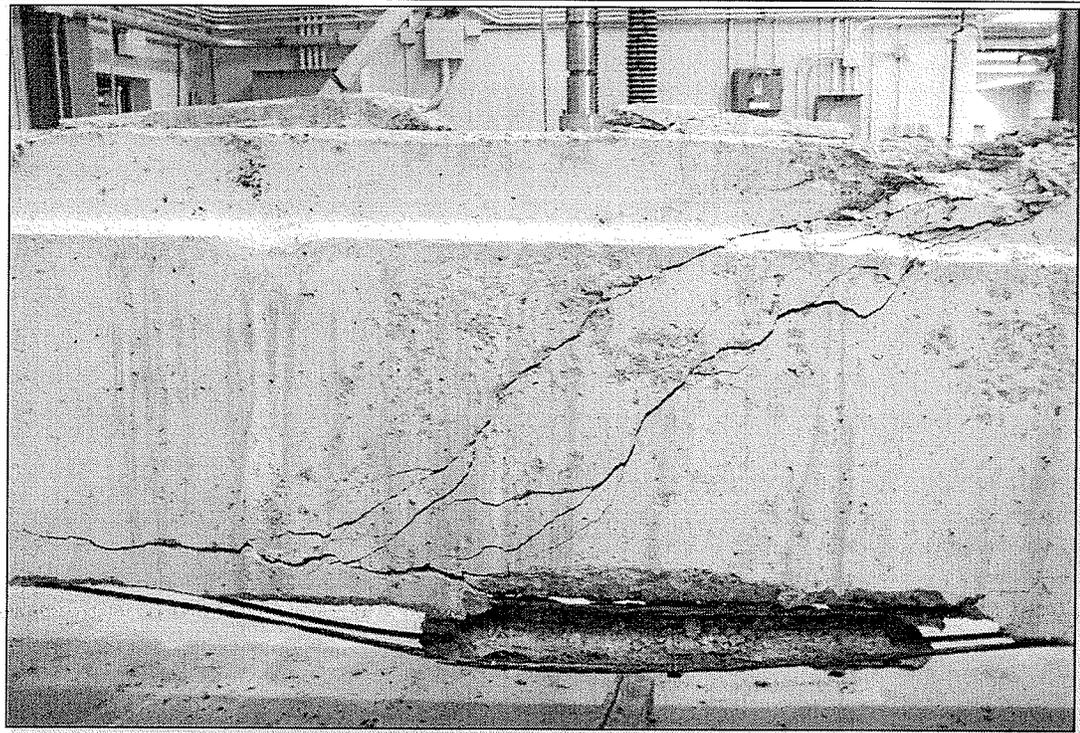
Figure 5-21: Failure between the support and quarter span on the east side of girder five.

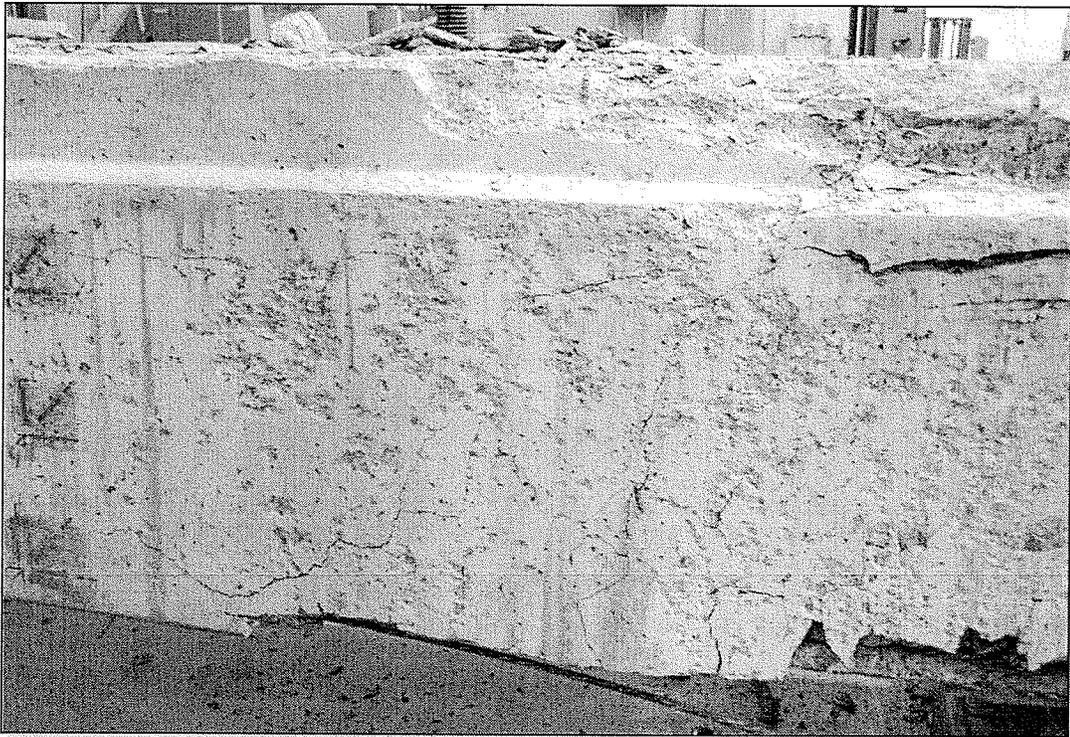
Figure 5-22: Diagonal cracking at the quarter span on the east side of girder five.

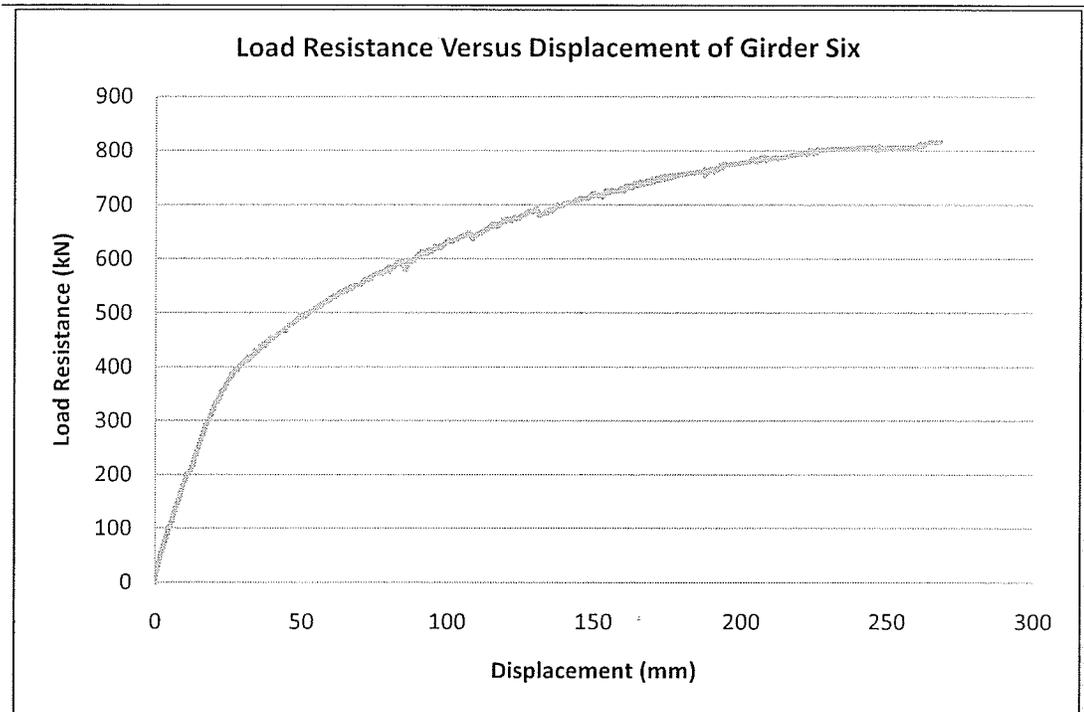
At a load of 350 kN, concrete from the already delaminated cover zones began to spall off the webs to the floor. The first visible flexural cracks occurred under the point of loading at a resistance of about 415 kN. Diagonal shear cracks began to appear around 625 kN. As more force was applied there was a substantial amount of concrete delaminations and spalling on the bottom of the webs as well as a ruptured strand on the east facing web. The cracks increased in number and size up to the ultimate load of 817 kN. This value converts to a nominal shear capacity of 701 kN which was 55 percent greater than the theoretically calculated nominal shear capacity of a girder with 50 mm of cover loss and one ineffective strand. Figures 5-23 and 5-24 display the loading versus displacement plots of the test. Figures 5-25 and 5-26 are photographs of the girder after failure was reached.

Figure 5-23: Load resistance versus displacement for shear test three.
