**An Autopsical Examination of 40 Year Old
Pre-Tensioned Concrete Channel Girders**

Brandon James Mills

The University of Manitoba

This thesis report examines six decommissioned pre-tensioned concrete channel girders which were part of the Canadian National Railway overpass on the Trans-Canada Highway No. 1 (CN Overpass on TCH Site No. 0709-00) east of Portage La Prairie constructed in 1965. The six girders are representative of the various levels of deterioration observed on the in-service bridge.

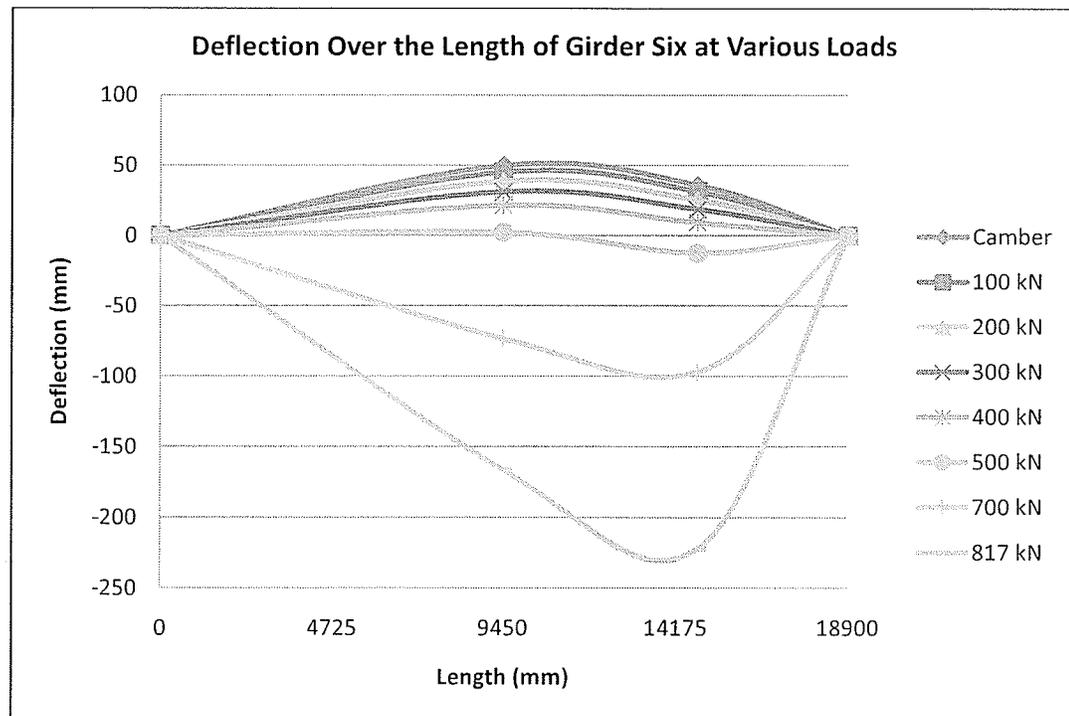
Figure 5-24: Deflection over the length of the girder for various loads during shear test three.

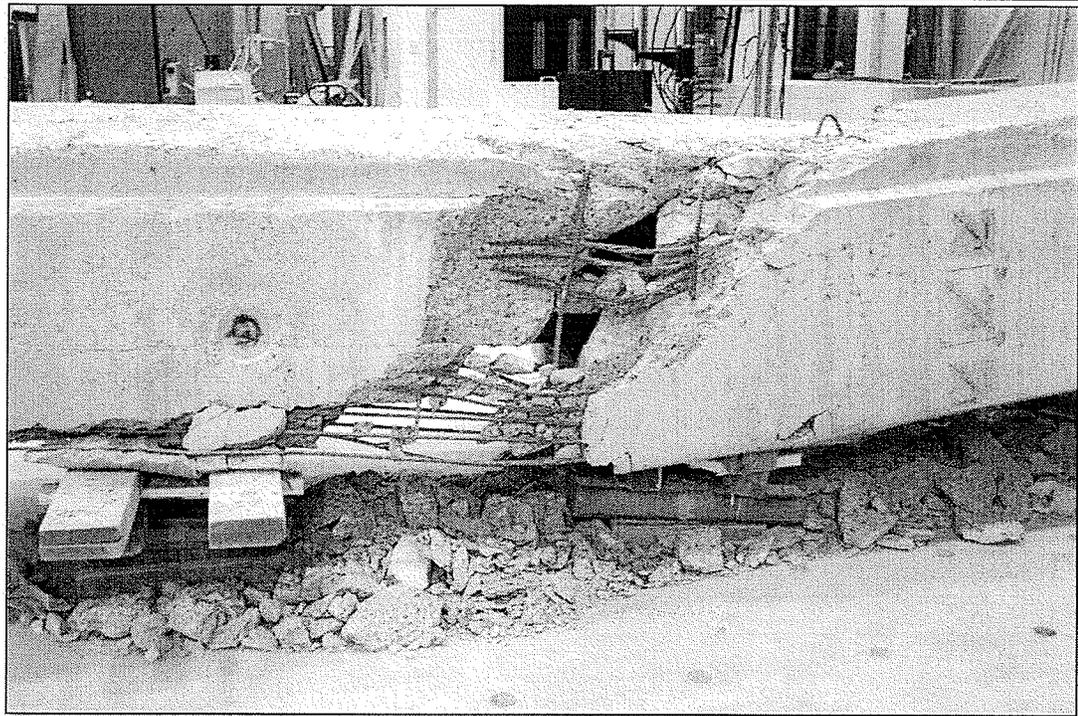
Figure 5-25: Failure near the quarter span on the west side of girder six.

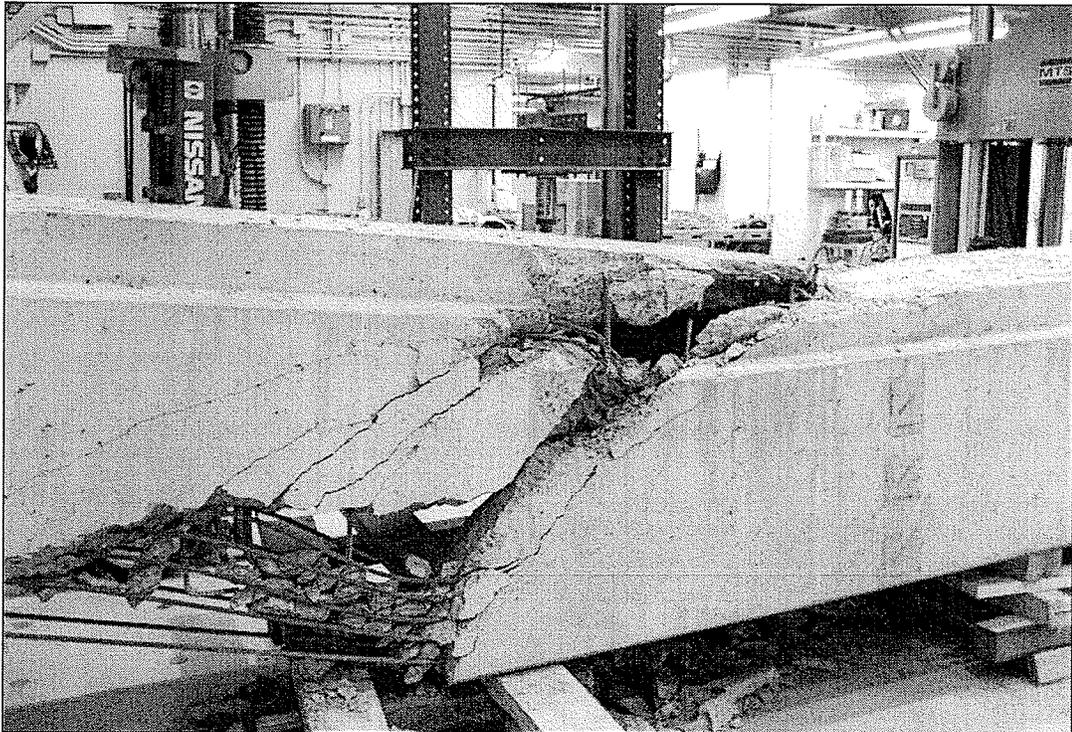
Figure 5-26: Failure zone on the east side of girder six.

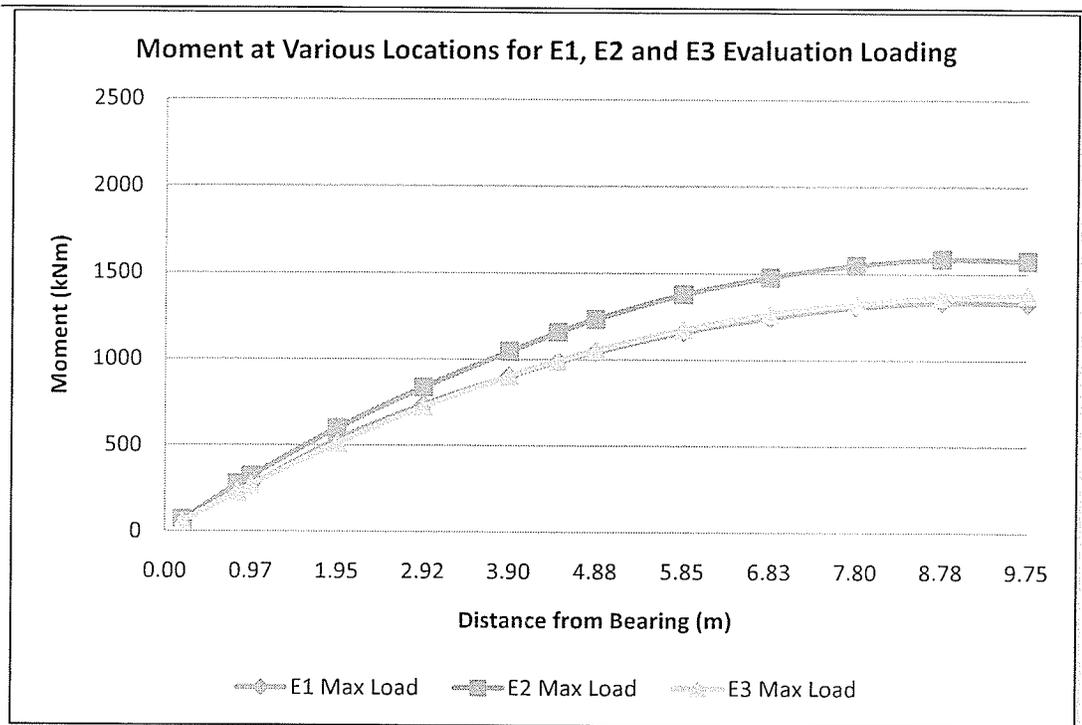
An influence moment and shear analysis was carried out to determine the maximum loading for each evaluation vehicle. In most cases the combination of a lane and 80 percent truck load was the dominant loading scenario. Although, the CHBDC does not require a dynamic loading factor to be applied to the combined truck and lane loading, the difference in maximums between truck load alone and truck and lane load combined was on the order of less than ten percent and therefore the dynamic load factor was applied. In Figures 6-1 and 6-2, the maximum shear and flexural moments are given for each evaluation level along the length of the girder. It can be seen from the figures that the E2 level evaluation loading is largely the governing load.

Figure 6-1: Moment at various location for E1, E2, and E3 evaluation loading.

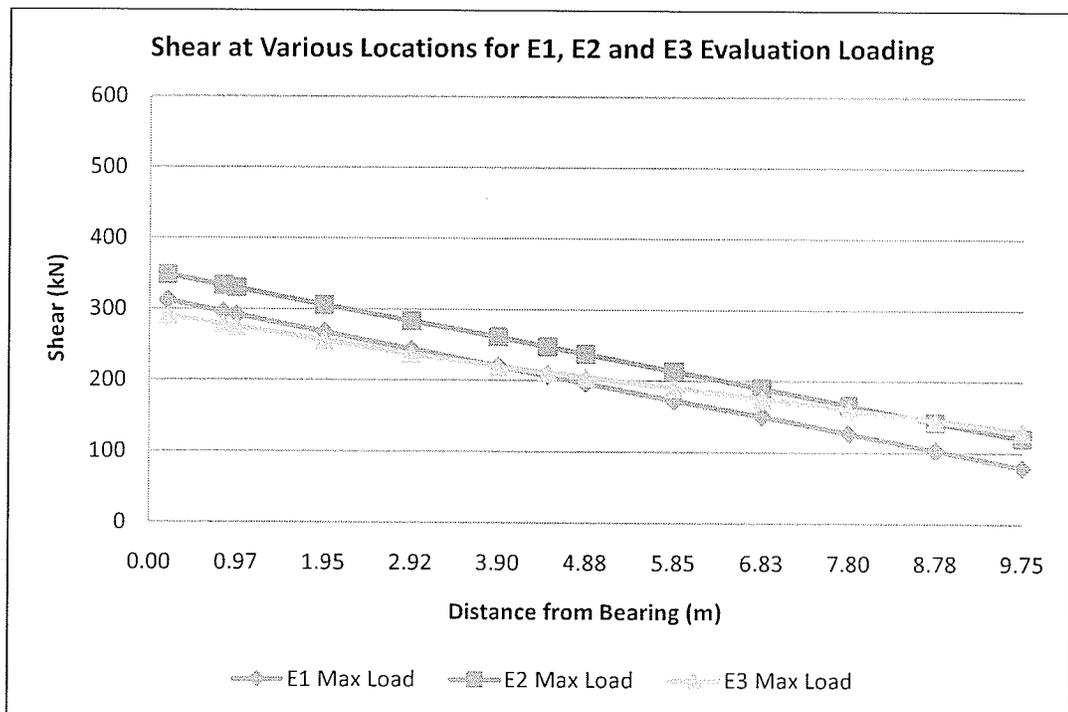
Figure 6-2: Shear at various locations for E1, E2, and E3 evaluation loading.

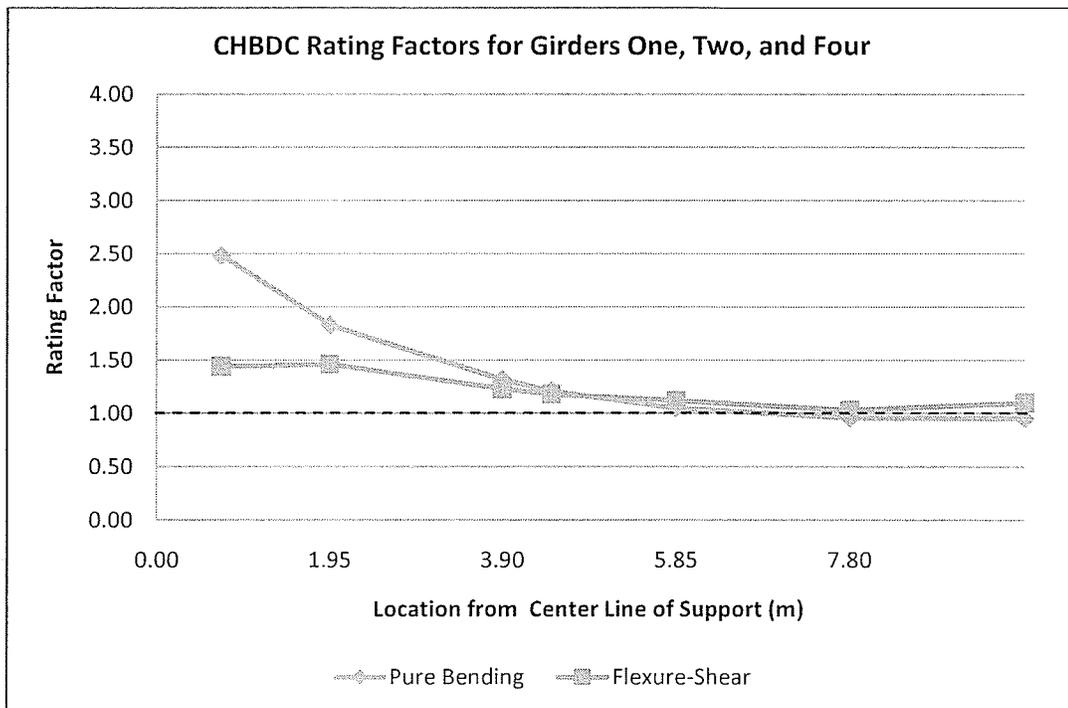
The results of the theoretical CHBDC evaluation analysis demonstrated that no girders met the required rating factor of one. The governing failure case did not receive a rating factor greater than one at all points examined along the length of the girder and therefore it can be said that the girders within this program did not pass the evaluation. The full results of the theoretical evaluation analysis are shown in Figures 6-3 to 6-6.

Figure 6-3: CHBDC rating factors at various locations along the length of girders one, two, and four.

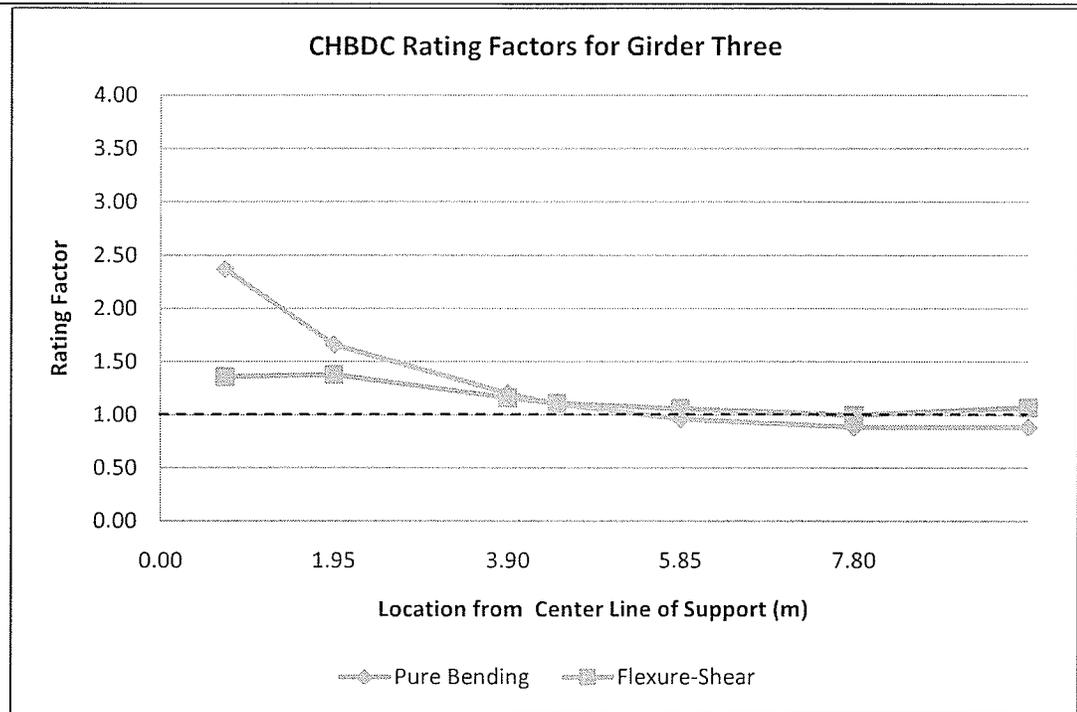
Figure 6-4: CHBDC rating factors at various locations along the length of girder three.

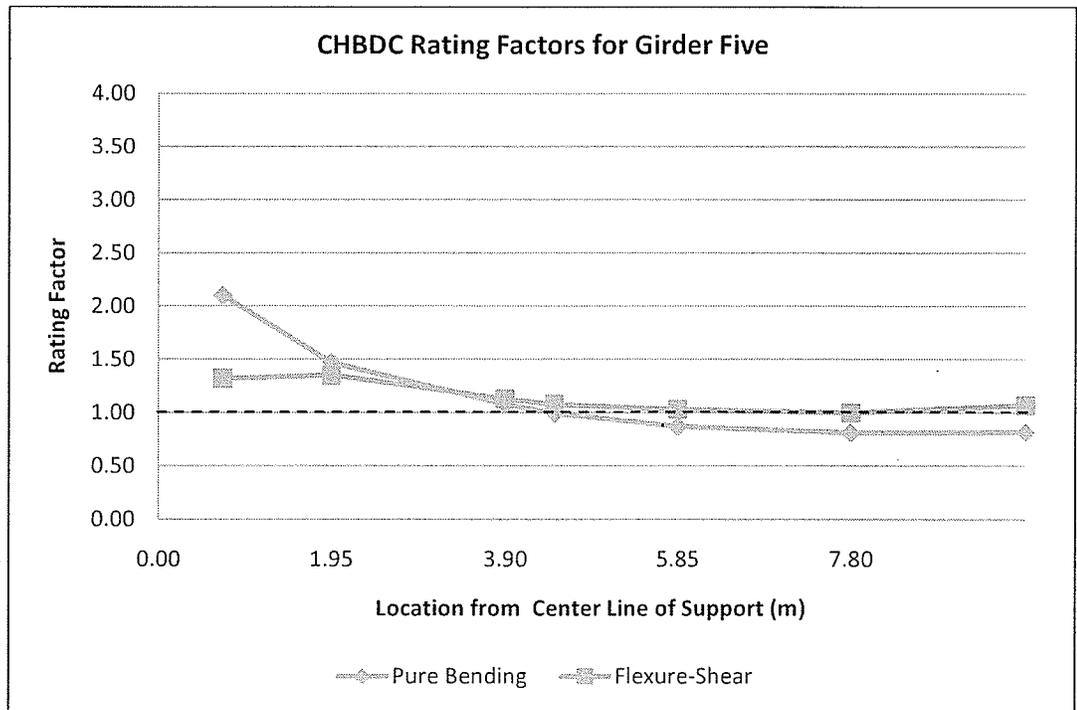
Figure 6-5: CHBDC rating factors at various locations along the length of girder five.

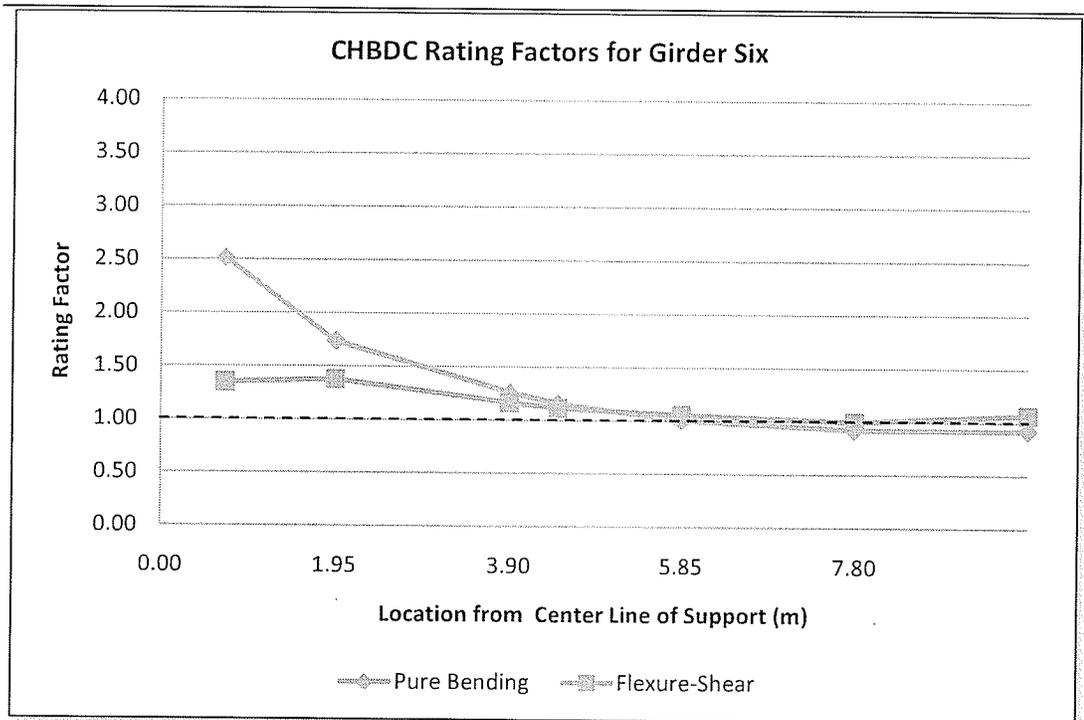
Figure 6-6: CHBDC rating factors at various locations along the length of girder six.

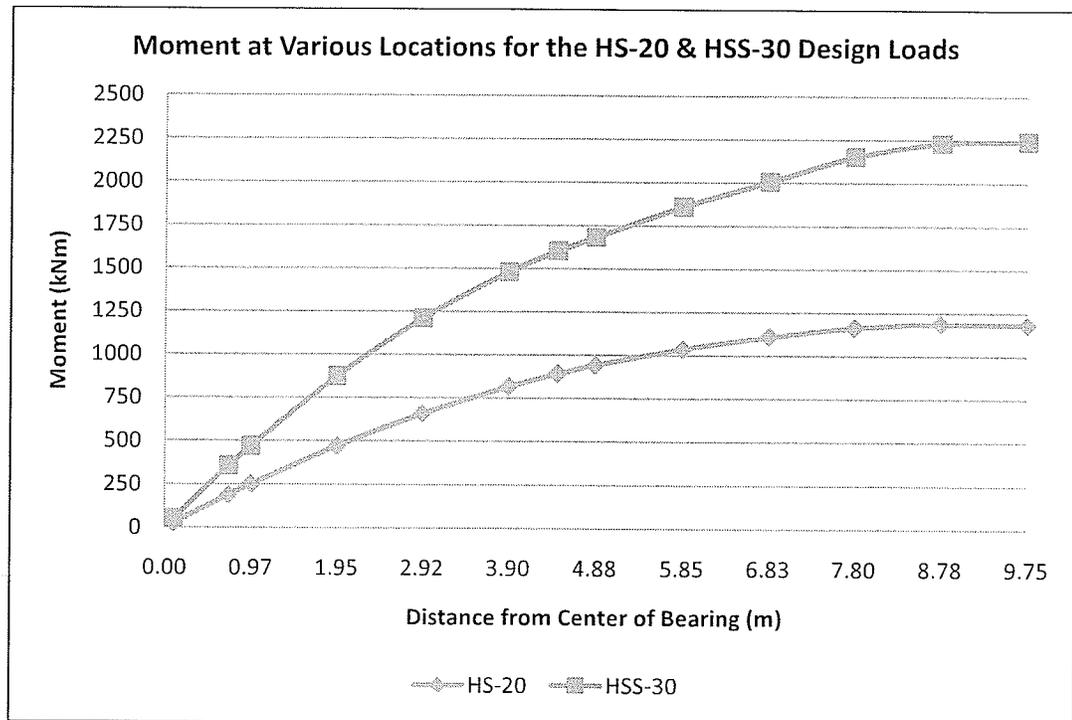
The LRFR analysis was carried out with the HS-20 and the HSS-30 design loads. Comparing the evaluation levels of the CHBDC bridge evaluation to the HS-20 and HSS-30 design loads of the AASHTO LRFR method it was found that the maximum CHBDC evaluation loading falls somewhere between the HS-20 and the HSS-30 design loads. Comparing the HSS-30 design truck to the HS-20 design truck demonstrates approximately a two to one difference especially at locations closer to the mid-span for bending and closer to the bearing support for shear. Figures 6-3 and 6-4 show the moment and shear effects of the HS-20 and HSS-30 design truck loading.

Figure 6-7: Moment at various locations for the HS-20 and HSS-30 truck loading.

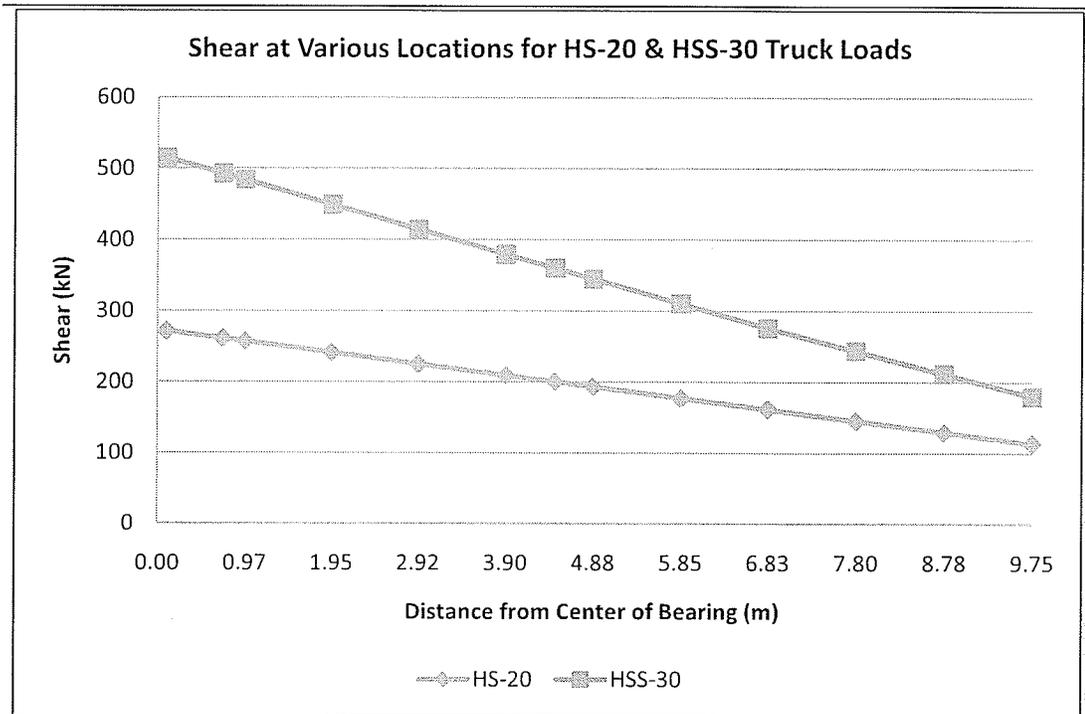
Figure 6-8: Shear at various location for the HS-20 and HSS-30 truck loading.

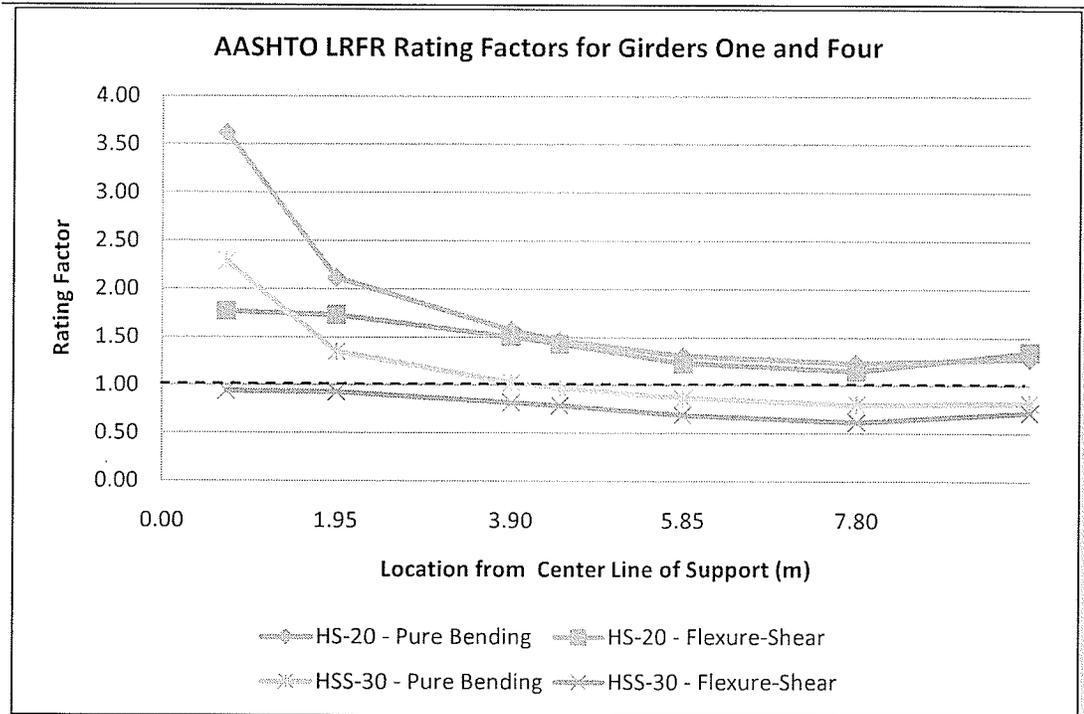
Figure 6-9: AASHTO rating factors at various locations along the length of girders one and four.

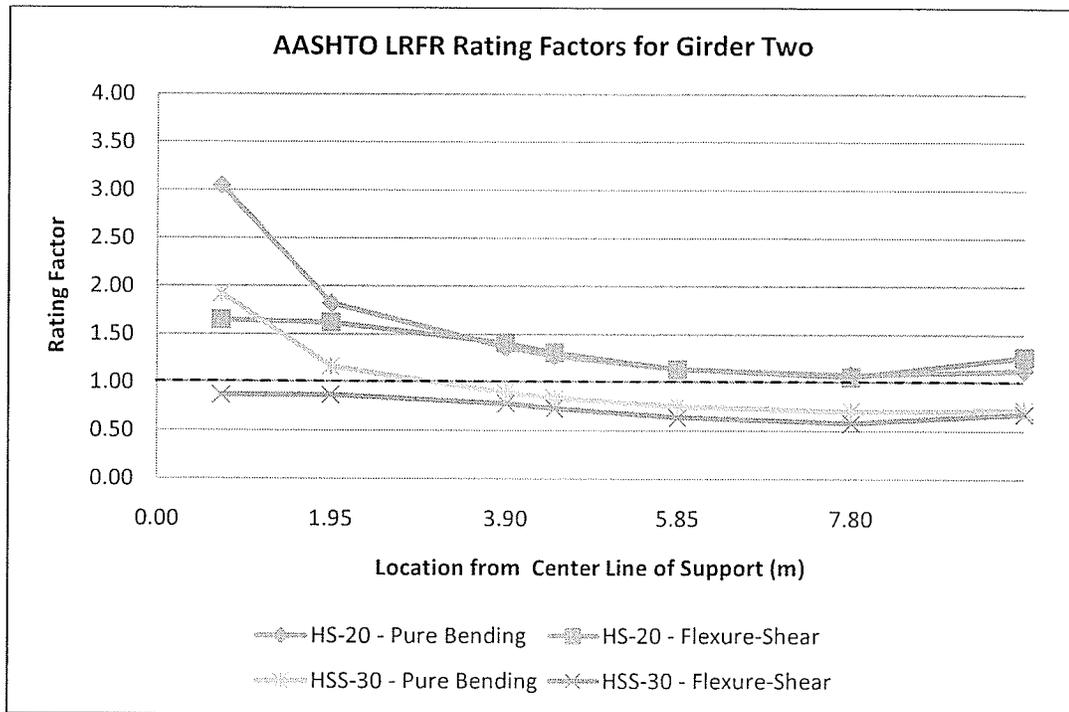
Figure 6-10: AASHTO rating factors at various locations along the length of girder two.

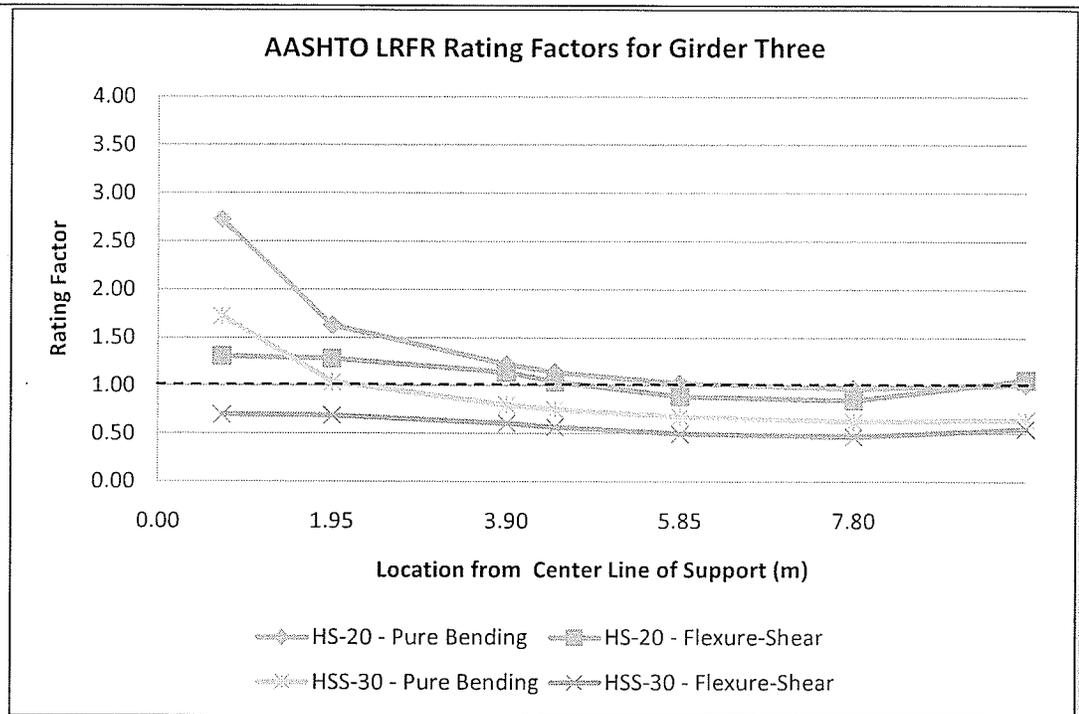
Figure 6-11: AASHTO rating factors at various locations along the length of girder three.

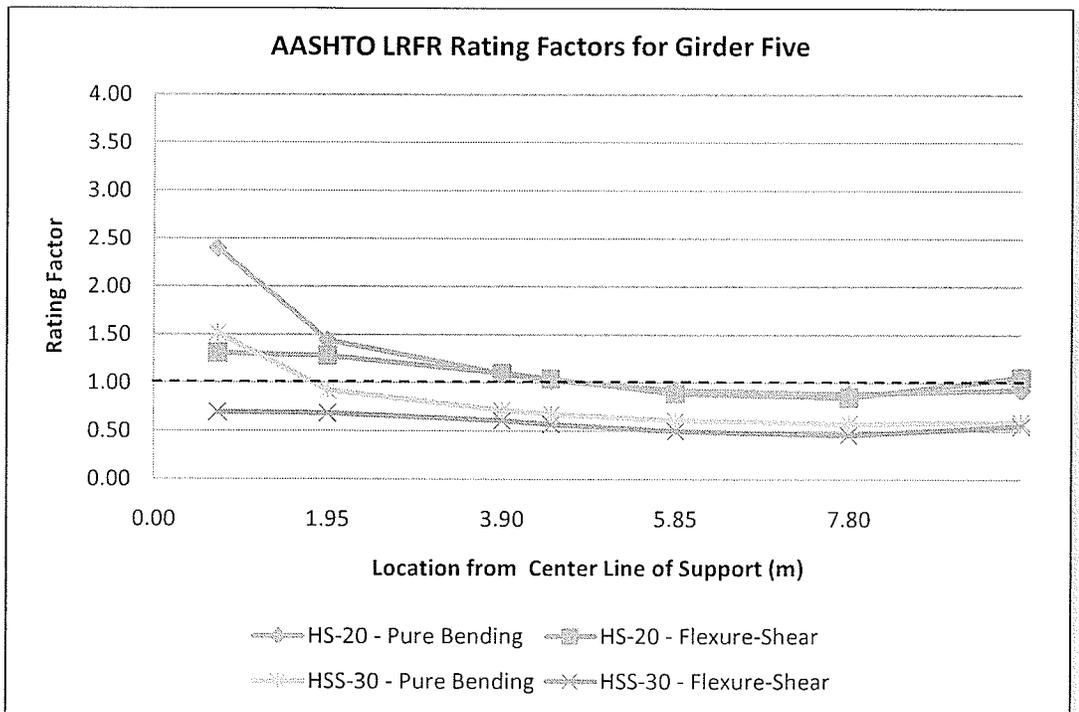
Figure 6-12: AASHTO rating factors at various locations along the length of girder five.

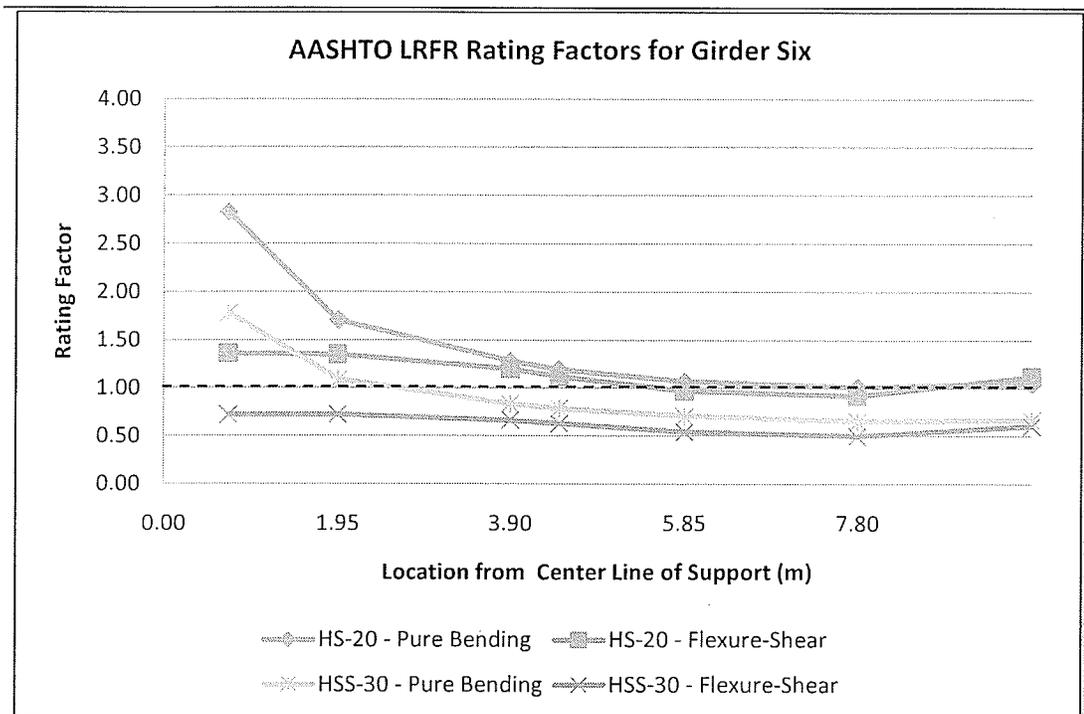
Figure 6-13: AASHTO rating factors at various locations along the length of girder six.
