**ACCELERATED LABORATORY EVALUATION OF
JOINT SEALANTS UNDER CYCLIC LOADS**

A Thesis

Department of Civil Engineering
University of Manitoba
Winnipeg, Manitoba

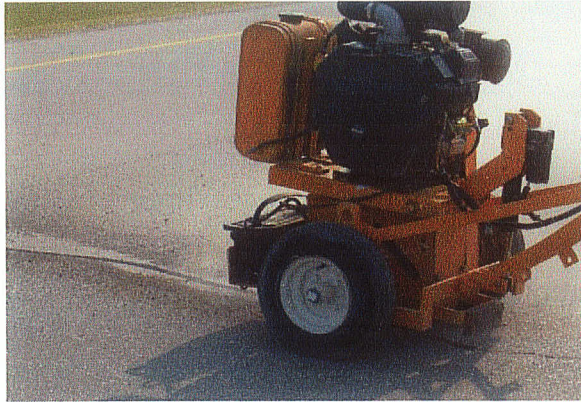
FIGURE 3.2: Routing of Crack to a 3:1 configuration

Figures 3.2 to 3.7 display the placement of the sealants in the field and the steps followed. Figure 3.2 shows routing of the crack which for this research is 3:1 width to depth configuration. Figure 3.3 displays cleaning of the crack using an air blower and Figure 3.4 displays heating of the crack using a hot-air lance. These three activities take place prior to the sealing of the crack. Figure 3.5 displays the placement of the sealant using a wand and squeegee. Figures 3.6 and 3.7 show the final product, sealed with a slight overband.

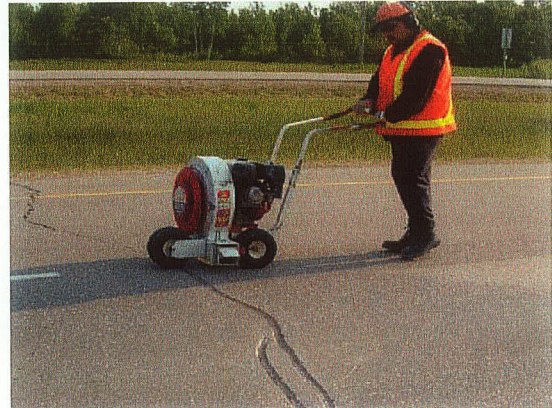
FIGURE 3.3: Cleaning of the crack using an air blower

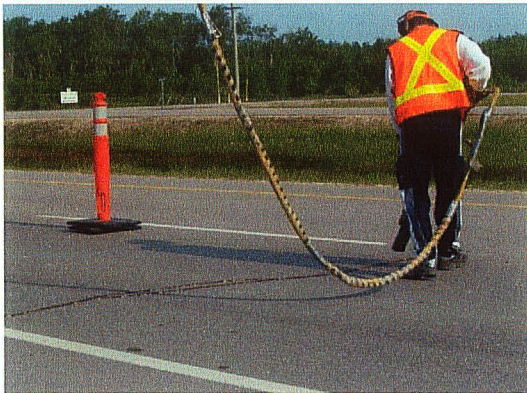
FIGURE 3.4: Heating of the crack using a hot-air lance

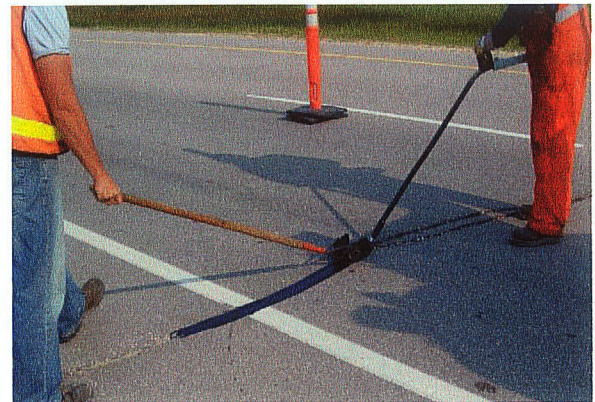
FIGURE 3.5: Sealant application using a wand and squeegee

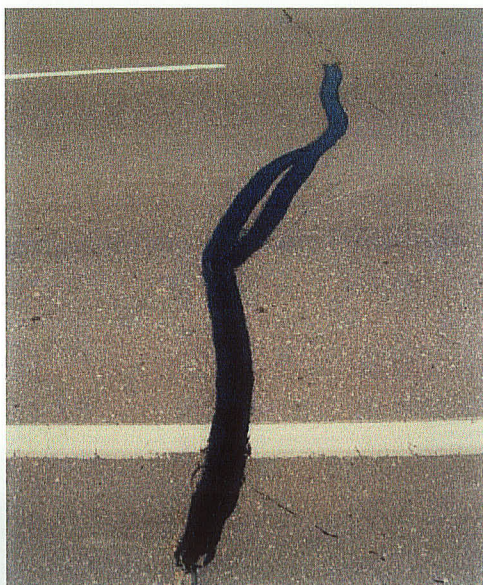
FIGURE 3.6: Final sealed crack

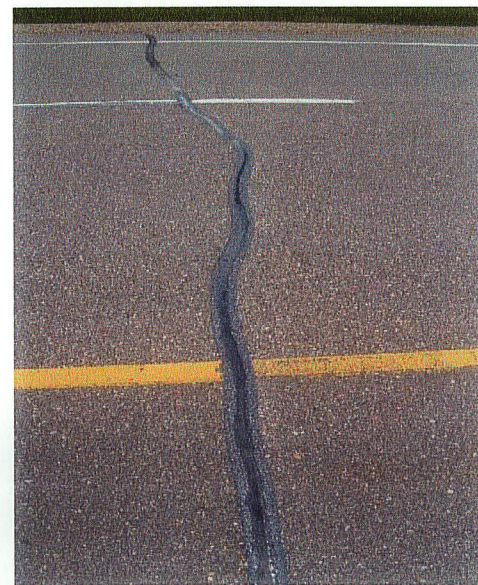
FIGURE 3.7: Final Sealed crack across the entire road surface

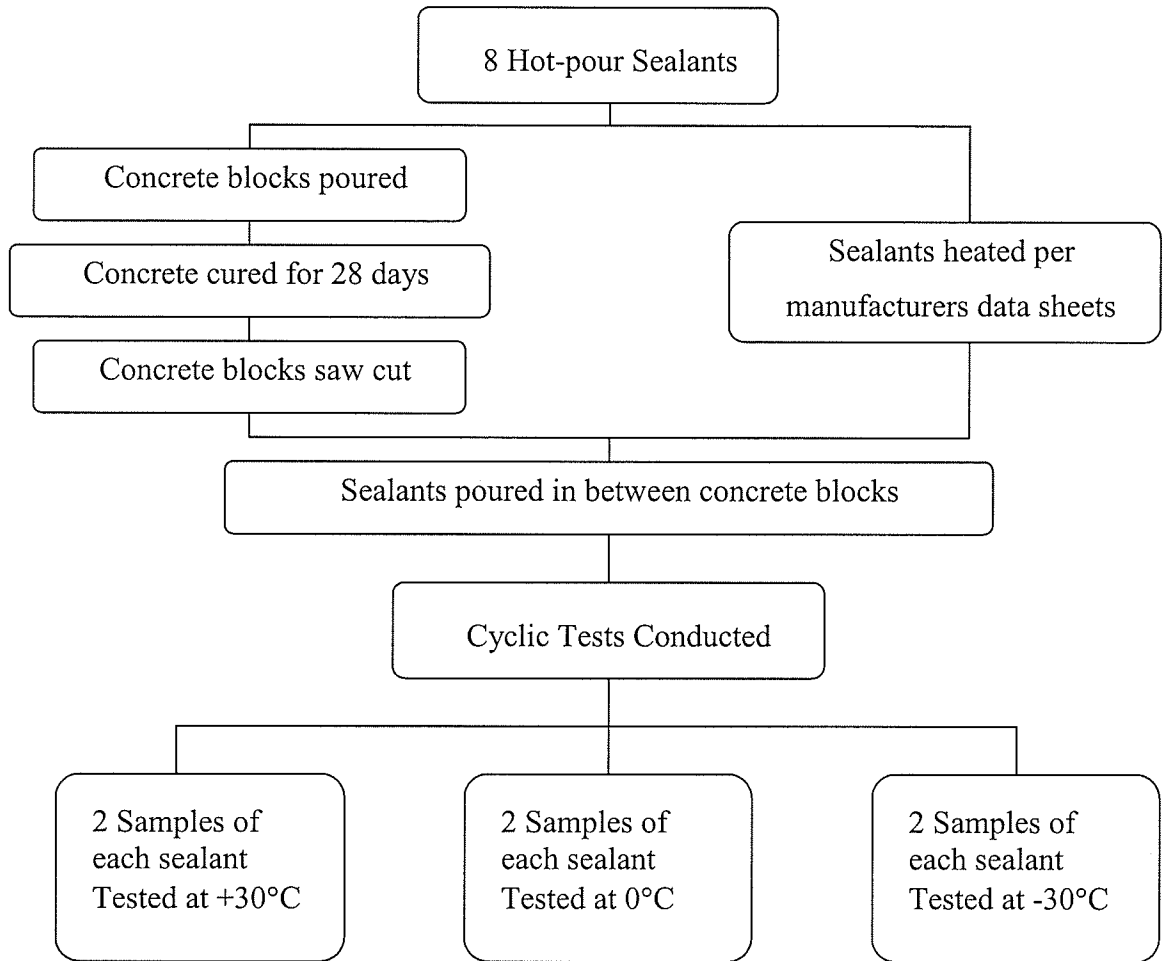
FIGURE 3.8: Testing Procedure

The test procedure was designed to provide an accelerated laboratory testing method for hot-pour sealants. This procedure could be used by local transportation agencies wishing to test new materials on the market. This set up does not directly replicate a specified number of years in the field but provides a fatigue test to compare sealants against one another. Eight hot-pour sealants were provided for the laboratory testing procedure and followed the testing plan outlined in Figure 3.8.

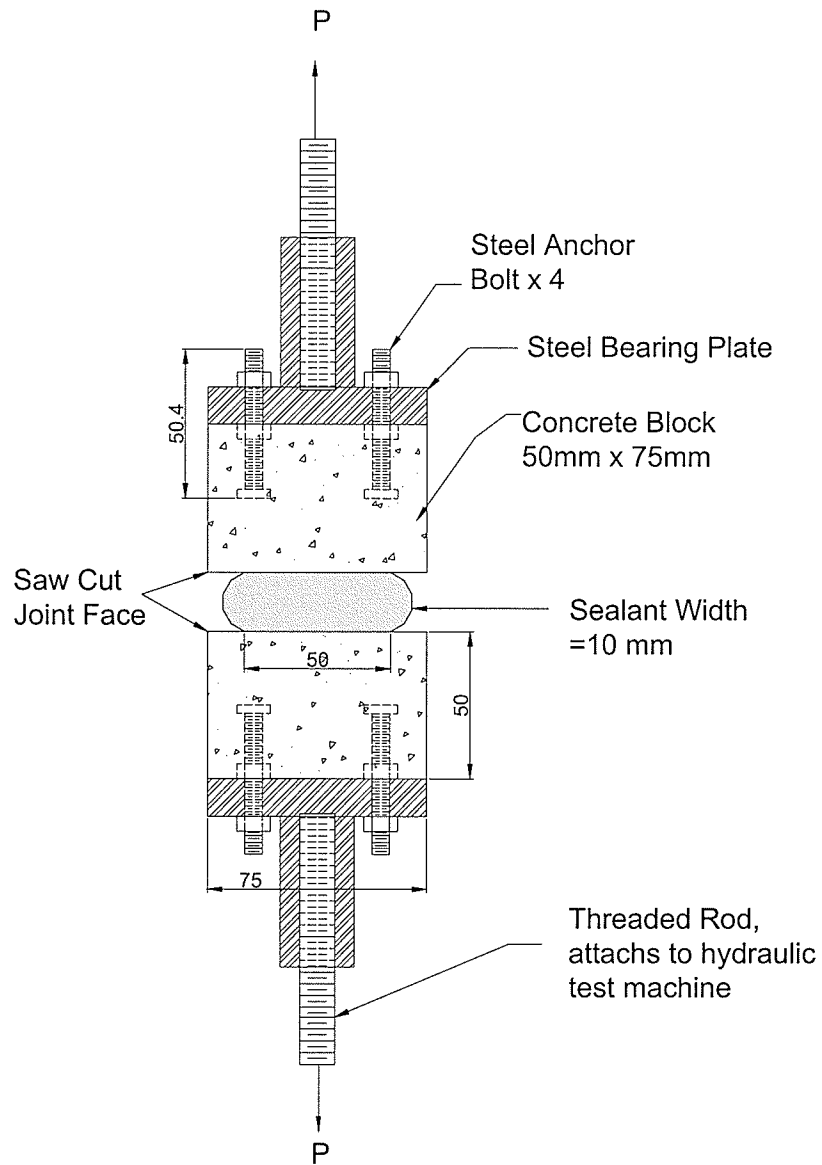
FIGURE 3.9 Concrete block, sealant specimen and bearing plates.

The sample preparation consists of the placement of a 10 mm strip of sealant between two concrete blocks and applying a predetermined cyclic displacement at three temperatures; +30°C, 0°C and -30°C. A schematic of the concrete block, sealant specimen and bearing plates set up is shown in Figure 3.9. The blocks were cast with four anchor bolts per end to connect to the loading frame, as shown in Figures 3.10, 3.11 and 3.12. The aggregate used in the concrete was a mix of granite and river gravel, with a nominal aggregate size of 10 mm to allow the mix to flow around the bolts. The blocks, were allowed to cure after casting, until a minimum 28-day strength of 30 MPa was achieved. The blocks were saw-cut to simulate the surface of a typical concrete pavement joint. The sawn concrete blocks dimensions are 50 mm x 75 mm x 50 mm as shown in Figure 3.13. The concrete blocks were washed and allowed to dry to minimize the debris

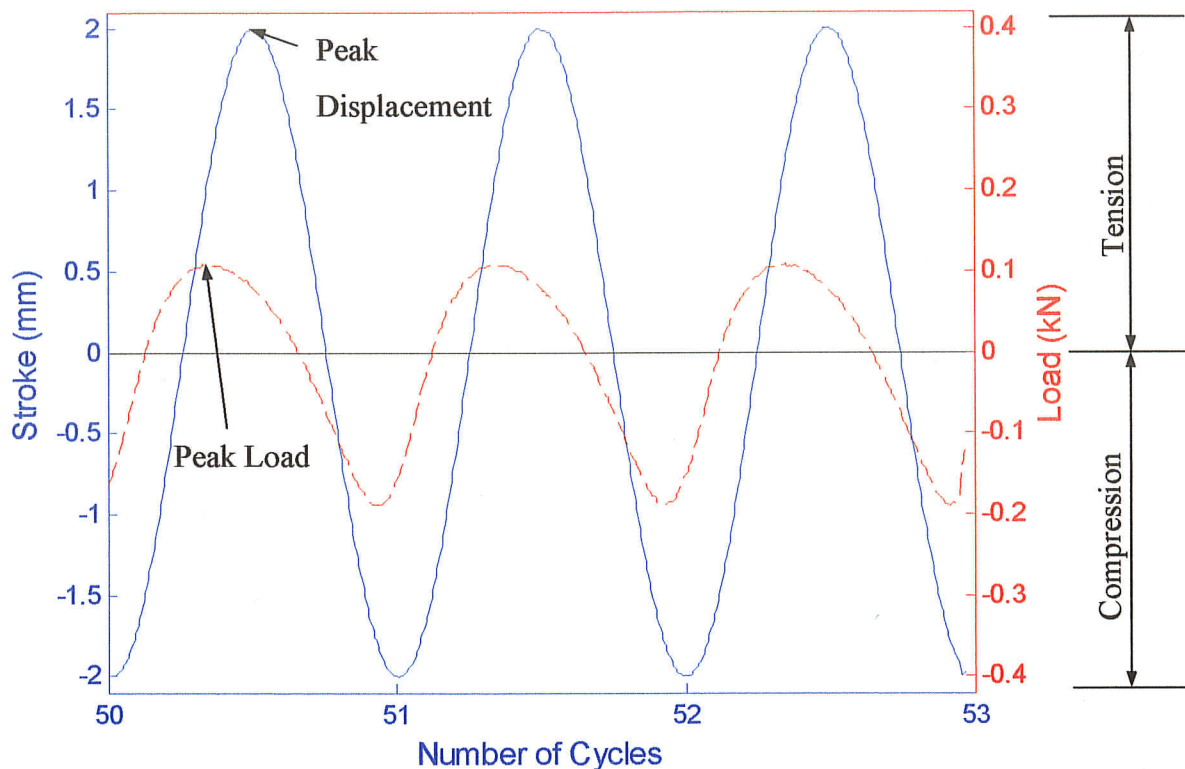
FIGURE 3.18: Typical load and stroke versus number of cycles conducted at +30°C and 1Hz frequency.

Based on the above factors for Southern Manitoba it was decided to subject the blocks to extension and compression. Each test was run using displacement control in a sinusoidal wave form, with the blocks subjected to plus and minus 2 mm displacement, shown in Figure 3.18. The sealant was loaded uniformly to minimize the torsion of the sample and the load and displacement values were recorded by the data acquisition system.

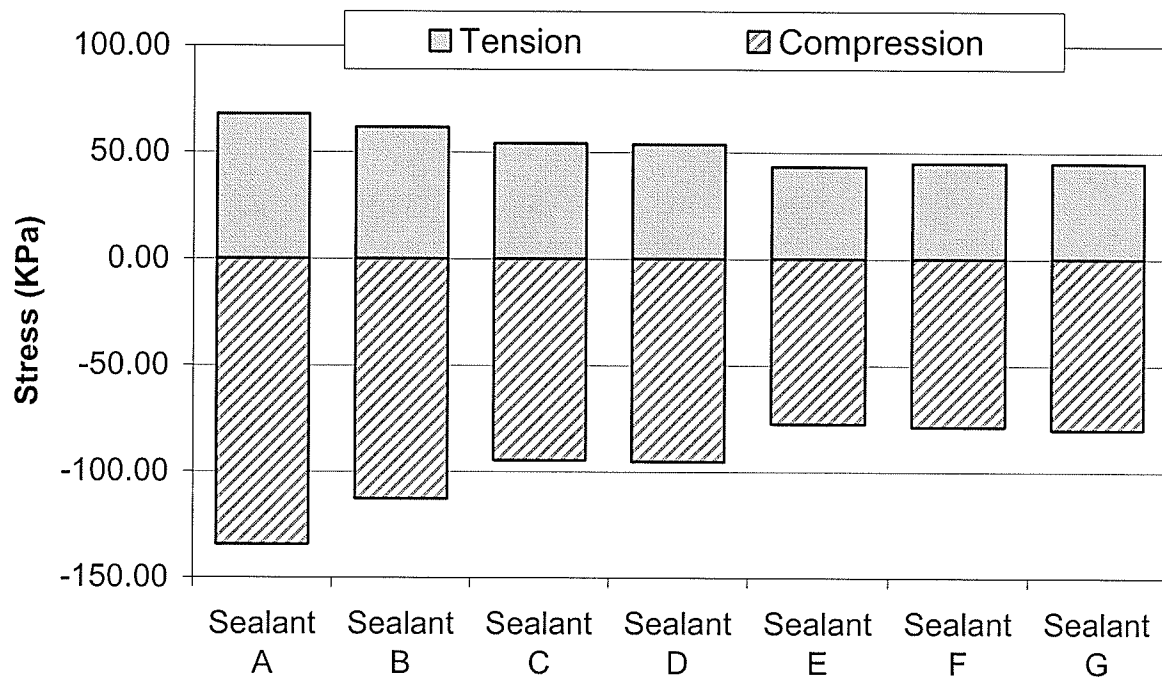
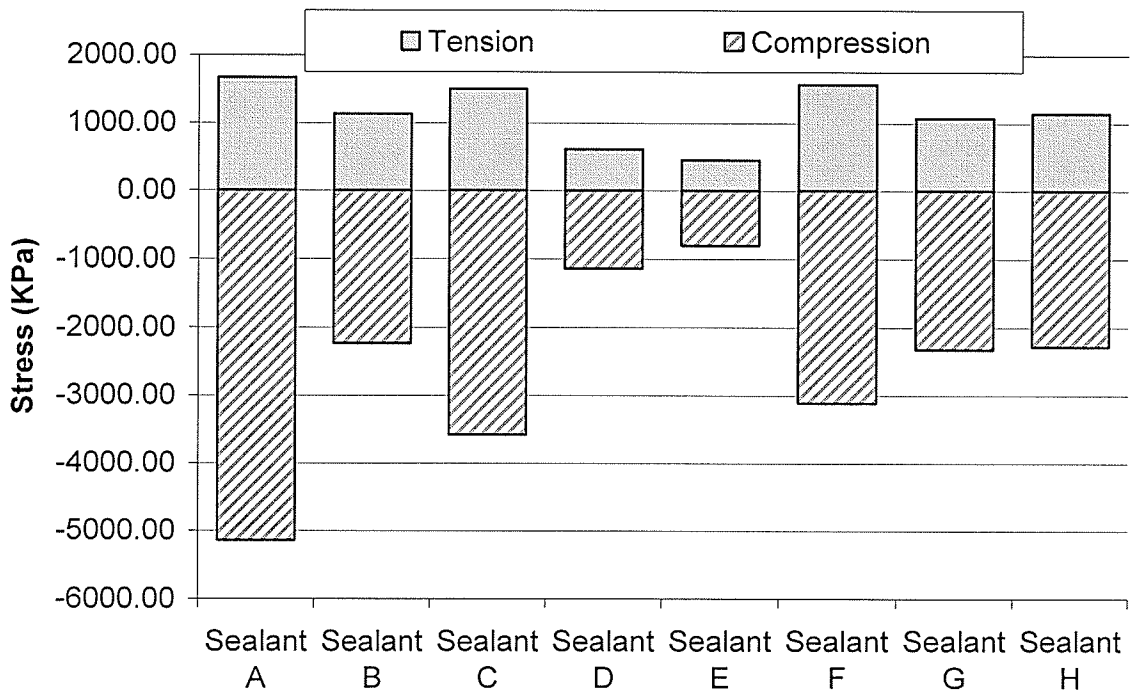
FIGURE 4.1: Average Initial Stress Values at +30°C

FIGURE 4.2: Average Initial Stress Values at 0°C

FIGURE 4.3: Average Initial Stress Values at -30°C

Figures 4.1 to 4.3 display the average initial stress values for each sealant at the three in-service temperatures. It is clear from the figures that the Type I sealants, sealants A and B consistently have larger initial stress values than the Type IV sealants. At +30°C the Type I sealants display higher initial results than the Type IV sealants. At 0°C sealants A, B and C display higher initial stress results and at -30°C only sealants D and E maintain low initial stress values.

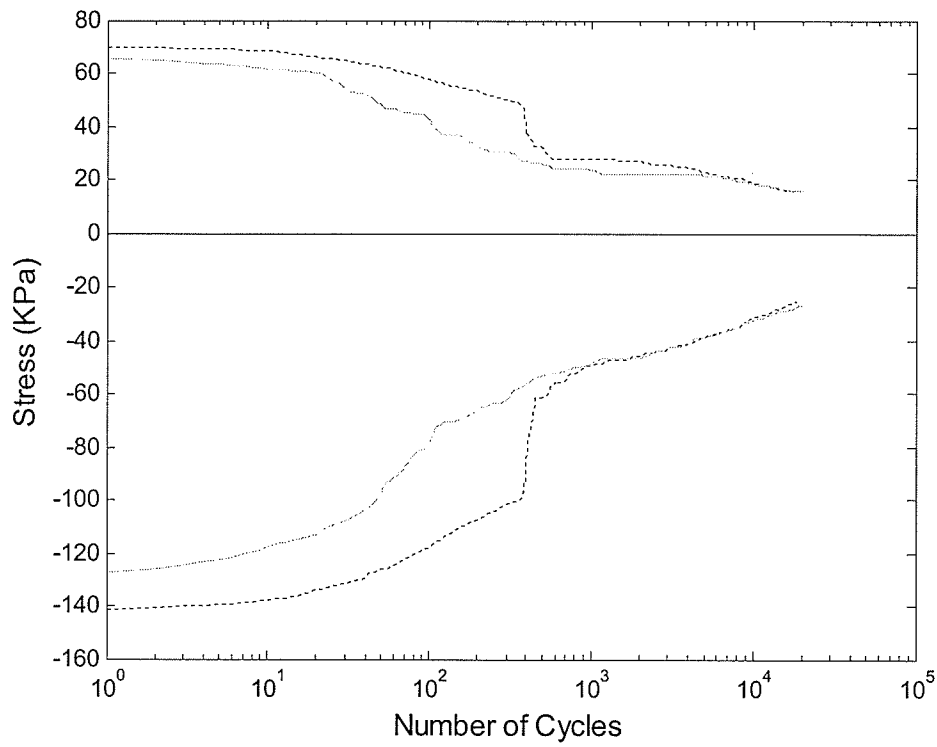
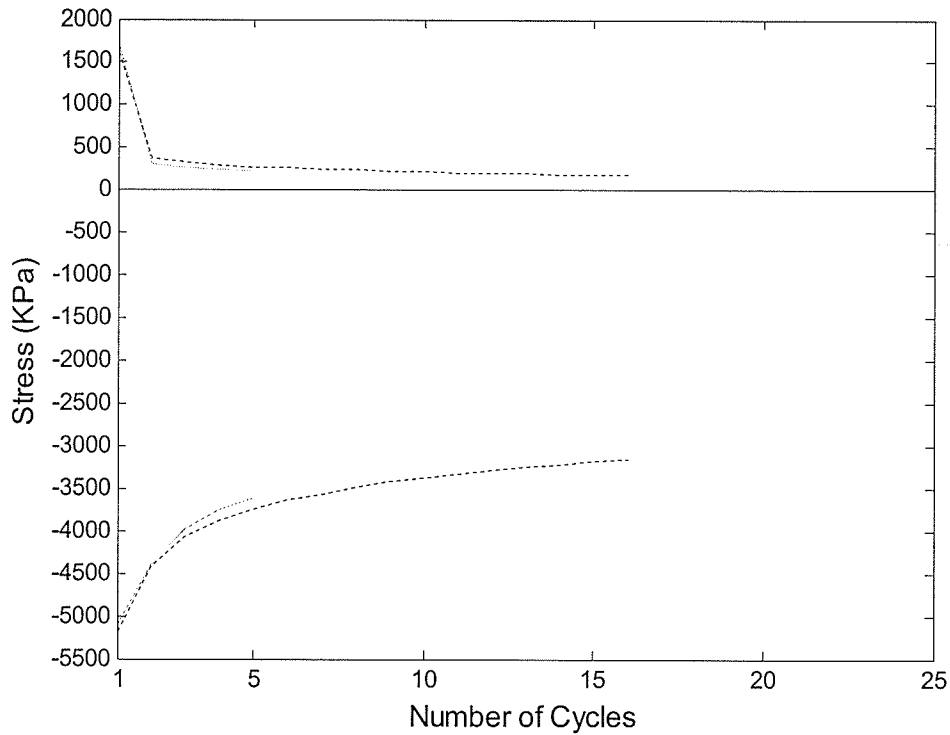
FIGURE 4.4 Sealant A Stress vs. Number of Cycles (+30°C)

FIGURE 4.5 Sealant A Stress vs. Number of Cycles (0°C)

FIGURE 4.6: Sealant A Stress vs. Number of Cycles (-30°C)

Figure 4.6 displays the results from the -30°C testing for Sealant A. The initial stress values were greater than 1500 KPa in tension and greater than 5100 KPa in compression. The sealants experienced adhesion failure during the first cycle as they were extended towards the plus 2 mm mark. Test 1 was stopped after 6 cycles experiencing an 86 percent drop in load in tension and Test 2 was allowed to continue for 16 cycles, finally ending with an 88 percent load drop. This sealant did not perform well at any of the test temperatures. The sealant experienced adhesion failure at two of the test temperatures as well a sudden drop in load was experience at the +30°C temperature. The adhesion failure for Sealant A is shown in Figure 4.7. The sealant completely debonded from the concrete joint face and the sealant retained its initial shape.

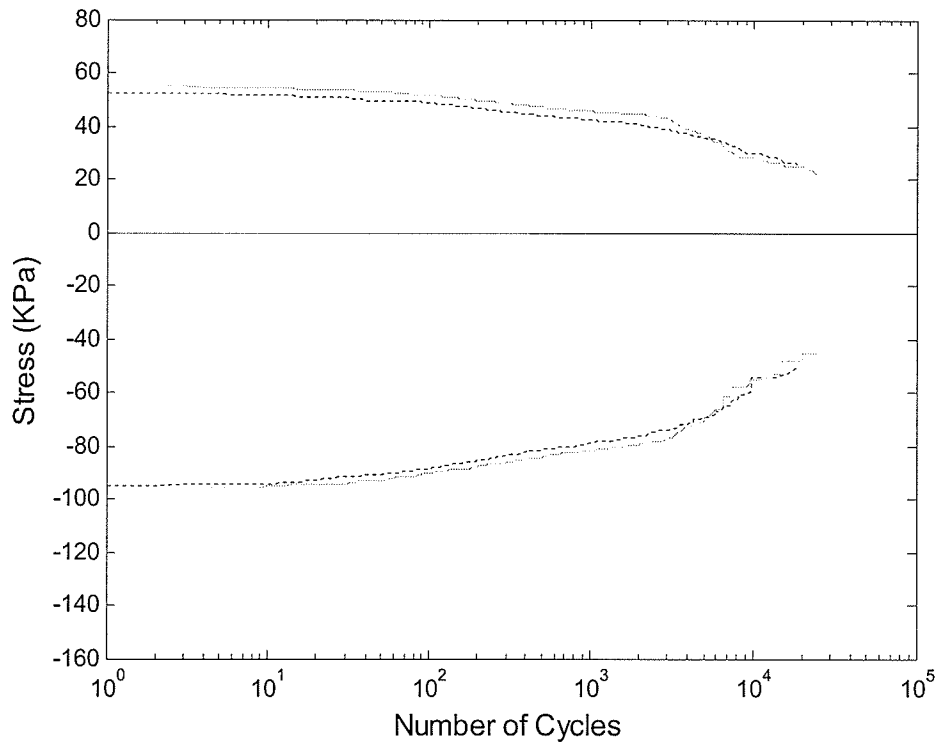
FIGURE 4.14 Sealant D Stress vs. Number of Cycles ($+30^{\circ}\text{C}$)

FIGURE 4.15: Sealant D Stress vs. Number of Cycles (0°C)

Figures 4.14 to 4.16 highlight the results from Sealant D testing. This sealant displayed consistent results through all three test temperatures. No adhesion failure was noted at any temperature and at the -30°C test recorded the second lowest stress values in both tension and compression. The sealant remained soft and flexible throughout the entire testing procedure. At the $+30^{\circ}\text{C}$ test the percent drop in stress was close to 50 percent. At 0°C the percent drop remained relatively constant between 50 and 60 percent. This sealant really performed well at -30°C recording a low 50 percent reduction in stress. Low initial stress values were also realized and the sealant remained pliable when it was removed from the testing machine. This sealant would be recommended for Manitoba climates as it was not too soft in at $+30^{\circ}\text{C}$ or 0°C and at -30°C performed very well.

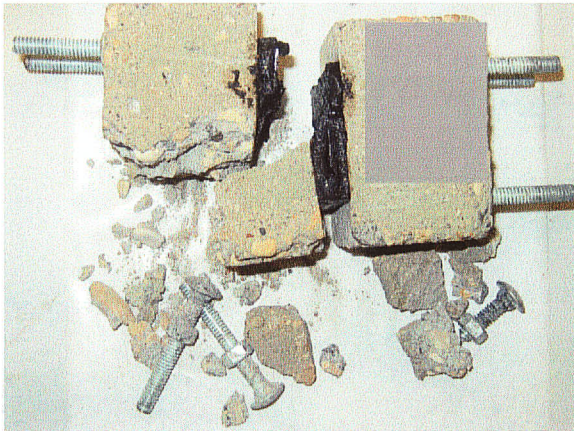
FIGURE 4.30A: Concrete Shattering

At the -30°C test temperature the 1Hz frequency was not possible to maintain. During the initial testing the concrete blocks and in some cases the sealant completely shattered as they were too stiff to withstand the rapid movement. The frequency was lowered to 0.1Hz with the same result and finally at 0.003 Hz we were able to test from the beginning to the end without shattering the blocks. An example of concrete shattering is shown in Figure 4.30A and an example of the sealant shearing is shown in Figure 4.30B. The lowering of the frequency allowed for the completion of the tests at -30°C this did not adversely affect the results since each sealant was compared against one another at each test temperature. The sealants were not compared across the different temperatures due to the different loading rate and the number of cycles performed at each test temperature.

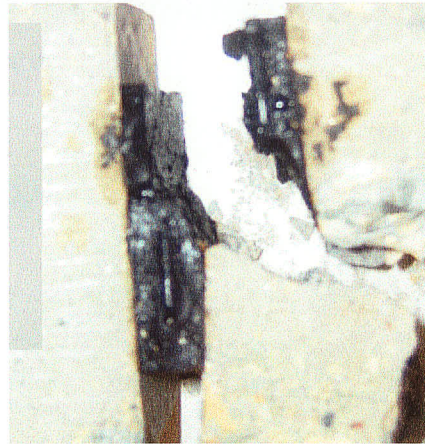
FIGURE 4.310B: Close up of failure within the sealant

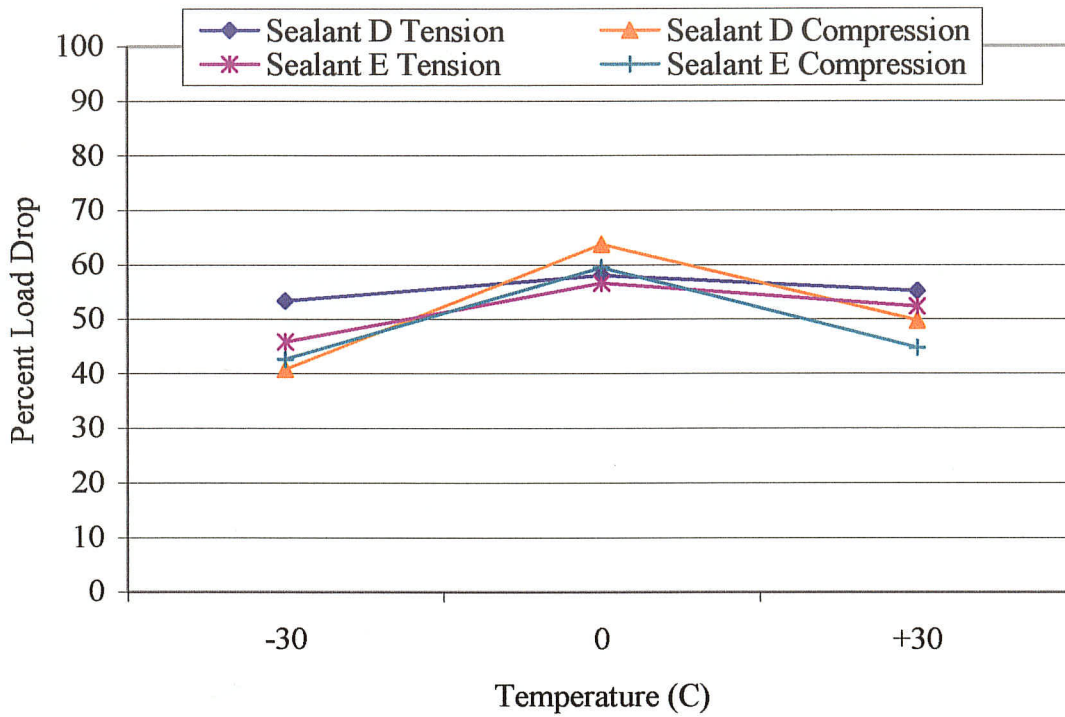
FIGURE 5.1: Sealants that performed well – Average Percent Load Drop vs. Temperature

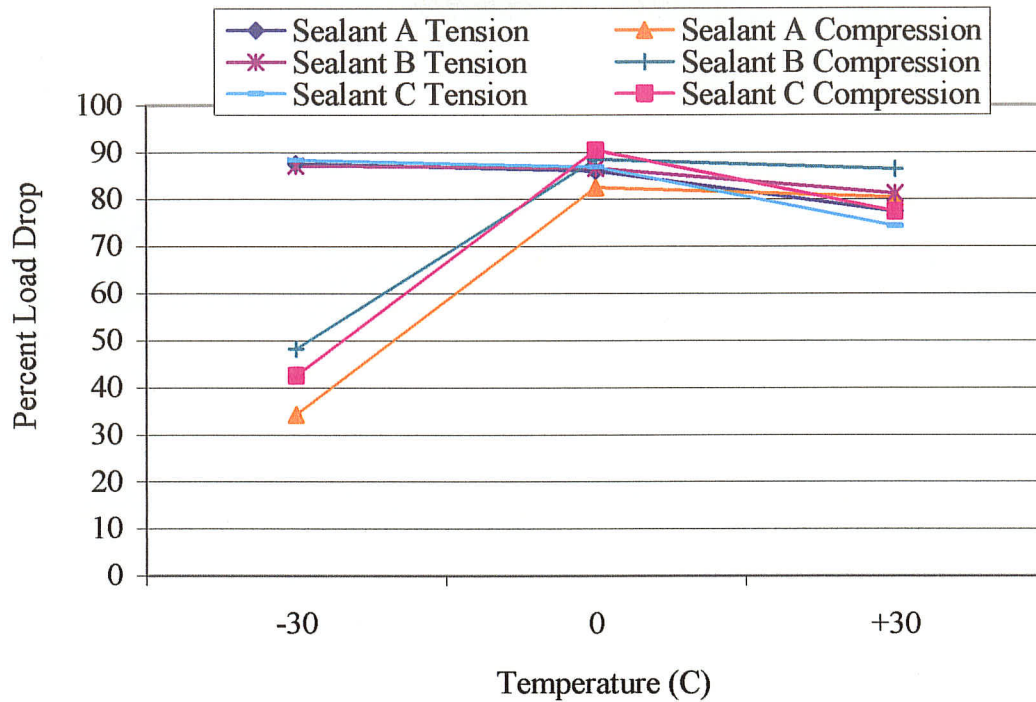
FIGURE 5.3: Sealants that performed poorly - Average Percent Load Drop vs. Temperature

The third category covered the sealants that would not be recommended for use in cold climates due to their poor performance. The percent load drop results versus temperature for Sealants A, B and C are displayed in Figure 5.3. These sealants extend the results from Sealants F, G and H which performed satisfactory, displaying higher percent load drops in tension at -30°C and lower percent load drops in compression due to the increased stiffness of the materials. At -30°C the percent load drop in tension ranged from 85 to 90 percent and all three sealants experienced adhesion failure. At 0°C the percent load drop in tension reduced by one to two percent with Sealants A and B experiencing adhesion failure. At $+30^{\circ}\text{C}$ in tension the percent load drop ranged from 75 to 81 percent and none of the sealants experienced adhesion failure. In compression at -30°C the results show 30 to 50 percent load drop, increasing dramatically to 80 to 90 percent at 0°C and decreasing slightly to 75 to 86 percent at $+30^{\circ}\text{C}$. These sealants experienced significant load drop at all three test temperatures and showed very stiff behaviour at -30°C in compression. Based on this criteria these three materials would not be recommended for use in cold climates.

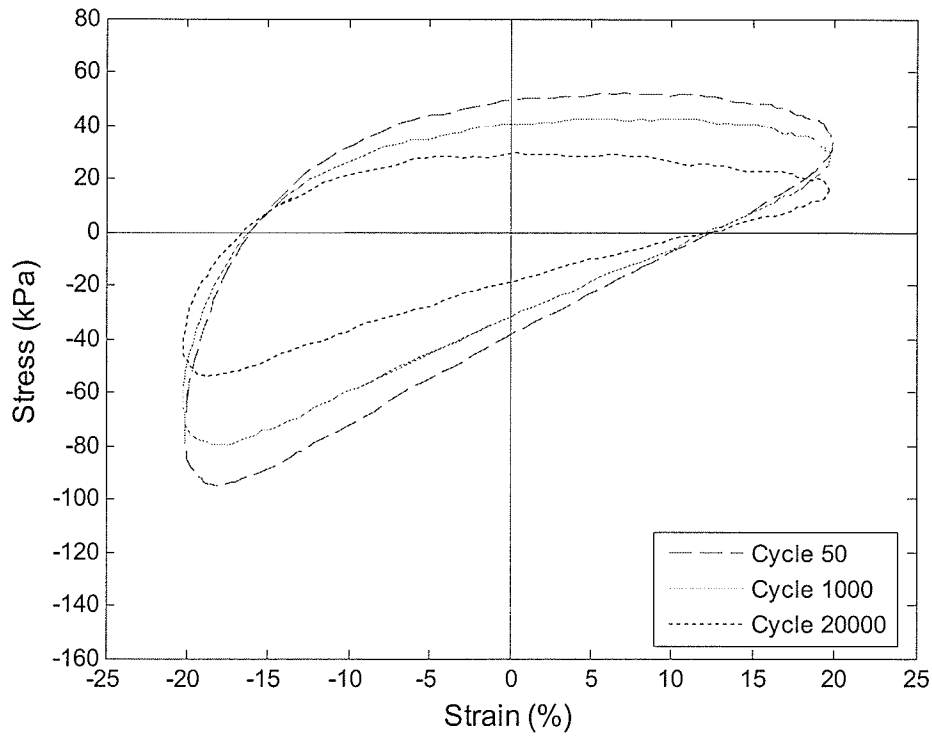
FIGURE 5.5: Sealant A Hysteresis Loops (+30°C)

FIGURE 5.6: Sealant B Hysteresis Loops (+30°C)

FIGURE 5.7: Sealant C Hysteresis Loops (+30°C)

FIGURE 5.8: Sealant D Hysteresis Loops (+30°C)

FIGURE 5.9: Sealant E Hysteresis Loops (+30°C)

FIGURE 5.10: Sealant F Hysteresis Loops for (+30°C)

FIGURE 5.11: Sealant G Hysteresis Loops for (+30°C)

FIGURE 5.12: Sealant H Hysteresis Loops for (+30°C)

The results are further broken down with Sealants A and B showing high initial stress values at 50 cycles but as shown in Figure 5.5 Sealant A after 1000 cycles has experienced a significant dissipation in stress to less than half its initial value. Sealant B experiences this result between the 1000 and 20000 cycles, Figure 5.6. Sealant C in Figure 5.7 displays an equal dissipation from cycle 50 to 20000, no abrupt failure occurring. Sealant D in Figure 5.8 displays similar results to Sealant C. Sealants E to G displayed in Figures 5.9 to 5.11 showed very consistent results amongst each other. Each sealant's minimum and maximum stress values at 50 cycles started out in compression close to the 80 KPa range and in tension close to the 40 KPa range. The final values at cycle 20000 had lowered minimally to 50 KPa in compression and 20 KPa in tension. Sealant H shown in Figure 5.12 displayed a slightly flatter slope when travelling from tension to compression and the maximum and minimum stress values were 60 KPa in compression and 40 KPa in tension. At cycle 20000 the results show 30 KPa in compression and 15 KPa in tension, this sealant was extremely soft to work with and the stress values calculated confirm this result.

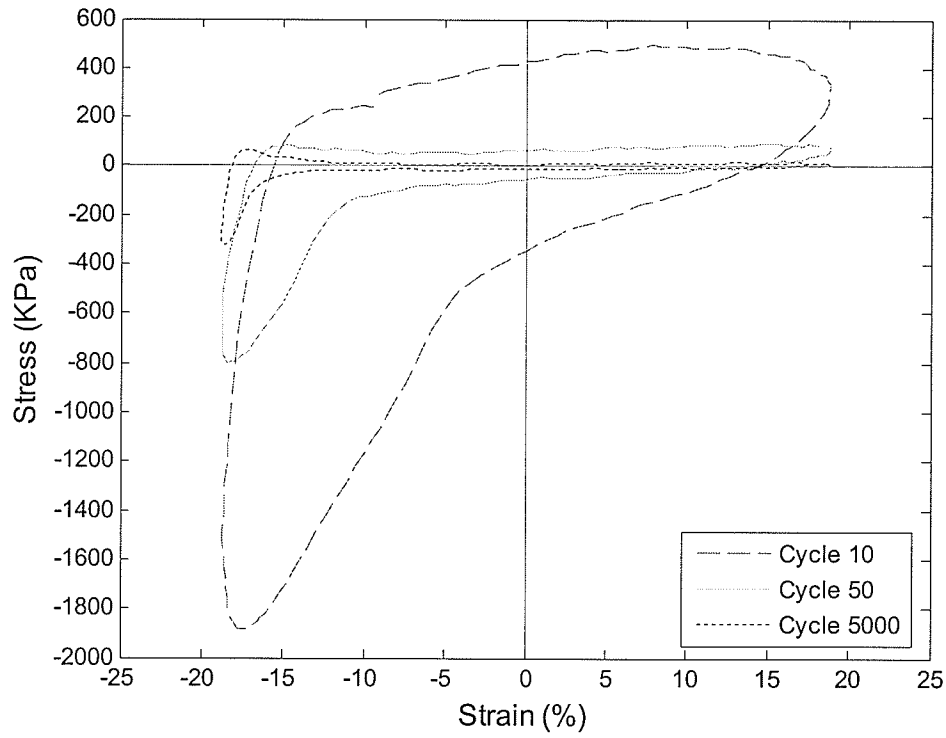
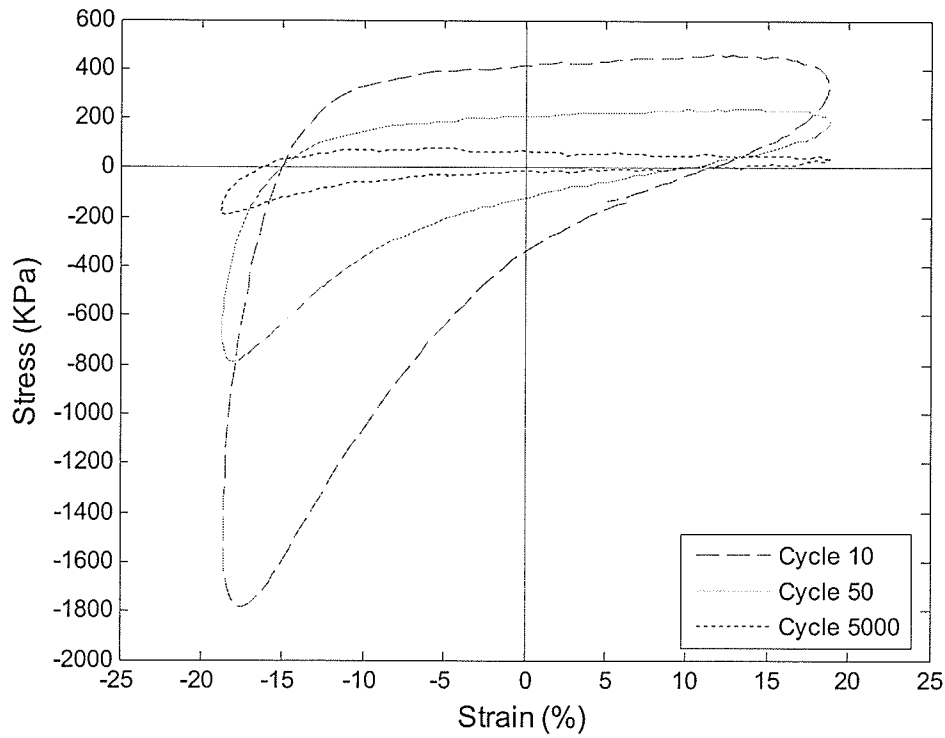
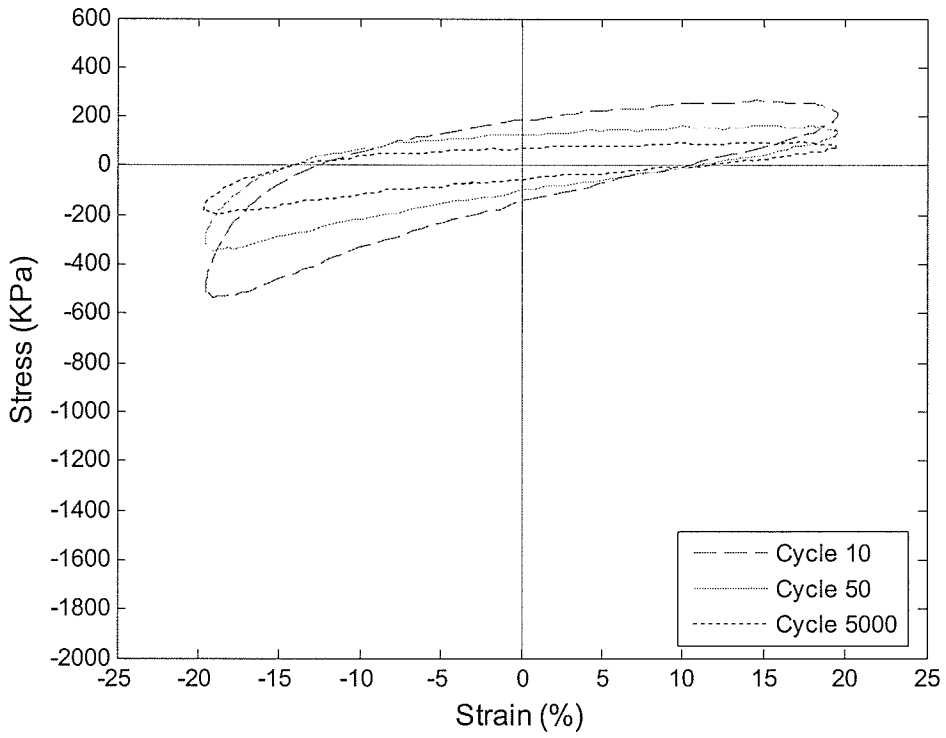
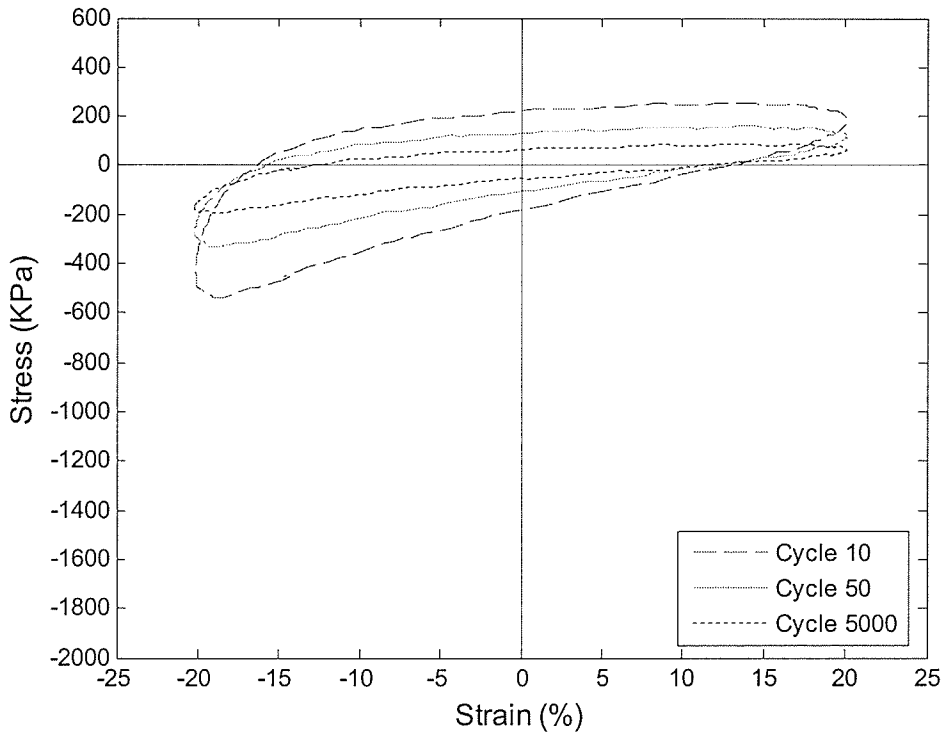
FIGURE 5.13: Sealant A Hysteresis Loops (0°C)

FIGURE 5.14: Sealant B Hysteresis Loops (0°C)

FIGURE 5.15: Sealant C Hysteresis Loops (0°C)

FIGURE 5.16: Sealant D Hysteresis Loops (0°C)

FIGURE 5.17: Sealant E Hysteresis Loops (0°C)

FIGURE 5.18 Sealant F Hysteresis Loops for (0°C)

FIGURE 5.19: Sealant G Hysteresis Loops for (0°C)

FIGURE 5.20: Sealant H Hysteresis Loops for (0°C)

The results from Sealant C shown in Figure 5.15, display a fairly high initial stress value of 1100 KPa in compression and 450 KPa in tension. This sealant experienced greater than 80 percent load drop in both tension and compression although no adhesion failure was noticed. Sealants D through H displayed similar results amongst each other. These sealants experienced no adhesion failure and the hysteresis loops display straight line movement from tension to compression. The lower initial stress values realized are consistent with materials that at the cooler temperatures are able to handle the plus and minus 2 mm movement for a minimum of 5000 cycles. These five sealants are good candidates for cool climate use.

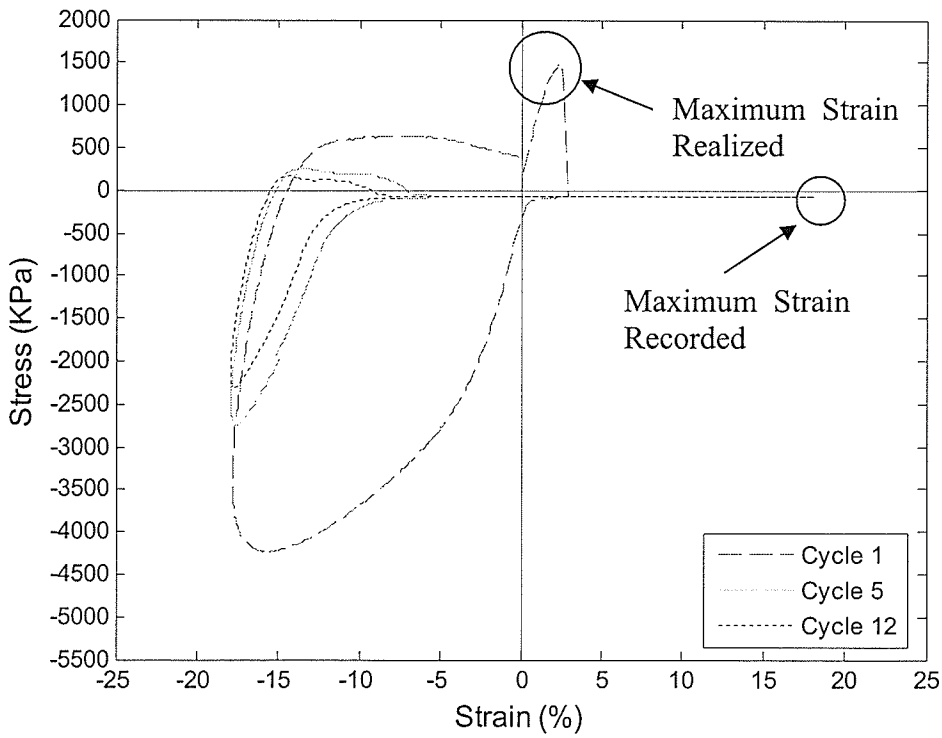
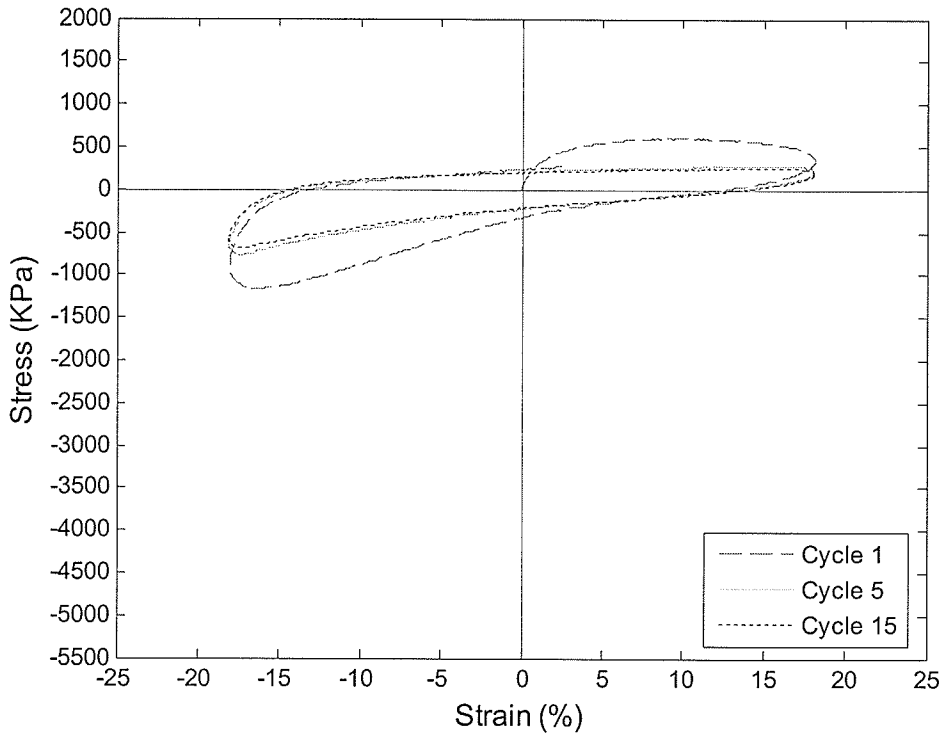
FIGURE 5.21: Sealant A Hysteresis Loops (-30°C)

FIGURE 5.22: Sealant B Hysteresis Loops for (-30°C)

FIGURE 5.23: Sealant C Hysteresis Loops for (-30°C)

FIGURE 5.24: Sealant D Hysteresis Loops for (-30°C)

FIGURE 5.25: Sealant E Hysteresis Loops for (-30°C)

FIGURE 5.26: Sealant F Hysteresis Loops (-30°C)

FIGURE 5.27: Sealant G Hysteresis Loops (-30°C)

FIGURE 5.28: Sealant H Hysteresis Loops (-30°C)

load drop in compression and 60 percent load drop in tension. This sealant did not perform as well as Sealants D and E and its results put it closer to Sealants F and H.

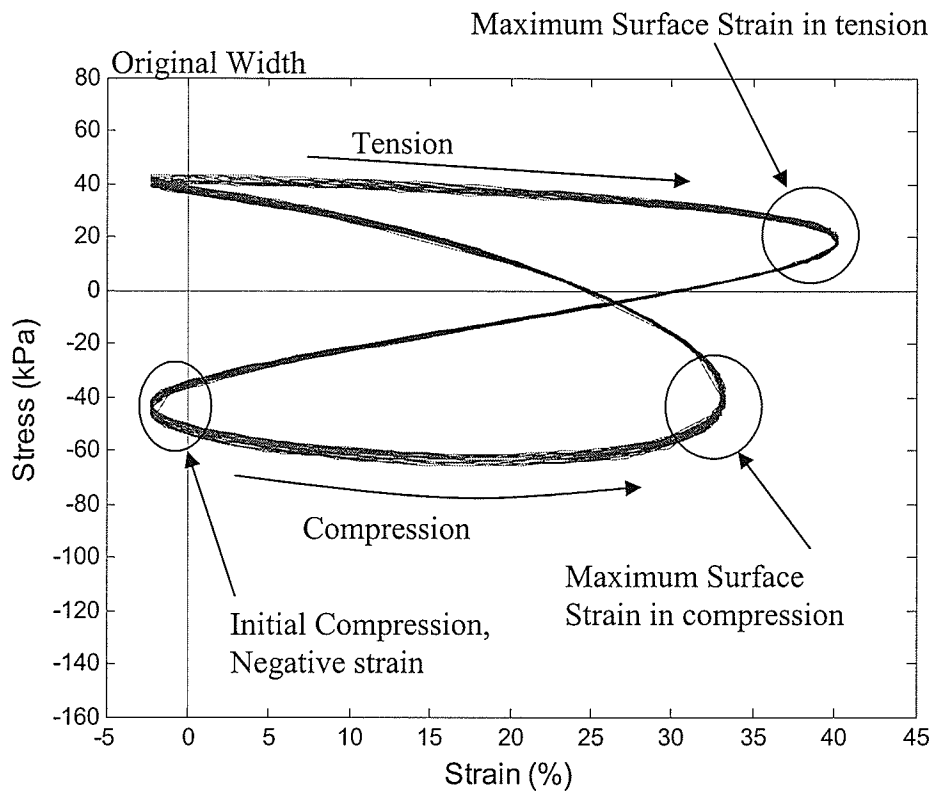
FIGURE 5.30: Typical +30°C Analysis of Surface Strain

Shown in Figure 5.30 the sealant travels from the neutral position, its original width, towards the maximum tensile strain which corresponds with the maximum tensile displacement. The sealant then starts to relax the strain as it travels back to its original width. As the sealant starts to compress the strain becomes negative but due to the fact that this is looking at the surface strain the surface of the sealant begins to go into tension again. The surface fibres are being strained in tension shown in Figure 5.31. This strain is not as critical as the maximum tensile displacement which corresponds to the test results of the sealants that failed, which failed in tension. Figure 5.32, displays the results from Sealant A, which although the test continued to run did not realize the maximum strain. The sealant realized 2.9 percent strain before adhesion failure occurred.

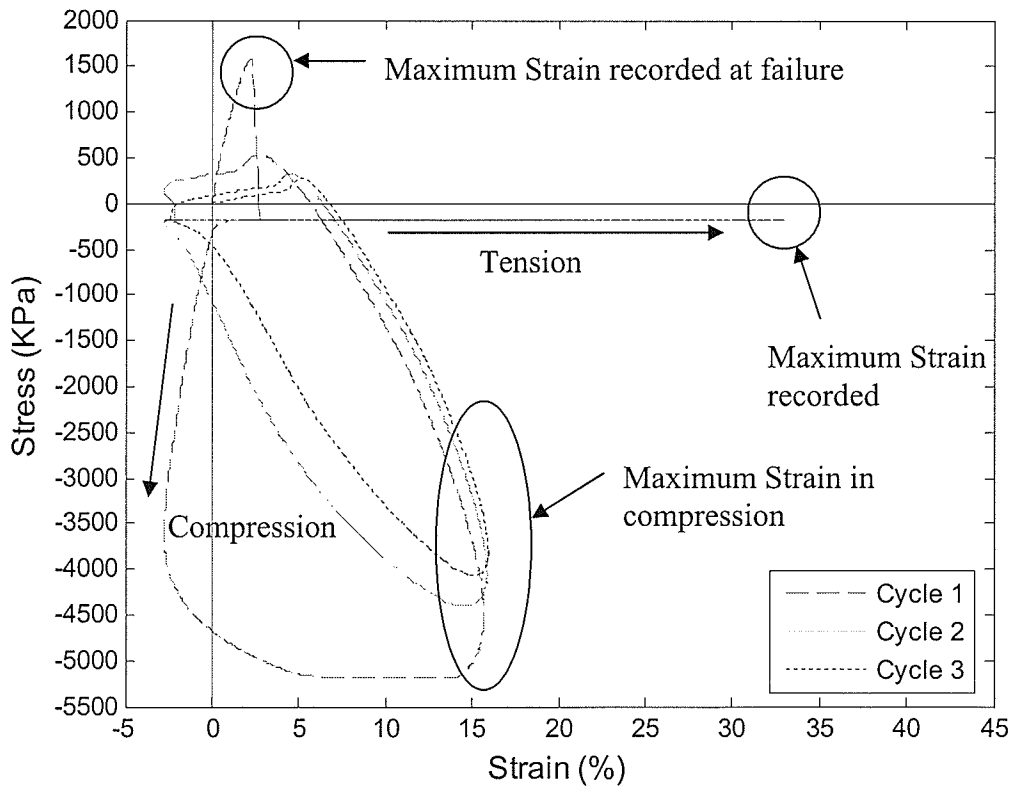
FIGURE 5.32: Sealant A Analysis of Surface Strain at -30°C
