Stability Assessment of Aging Water-Retaining Earth Fill Dams

Irene Olivia Ubay

A Thesis submitted to the Faculty of Graduate Studies of

The University of Manitoba

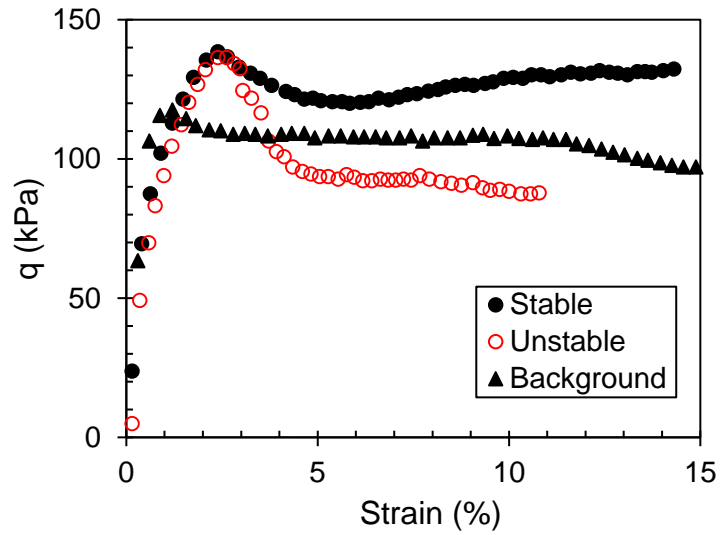
Figure 2.1 Deviatoric stress – strain behaviour of stable, unstable, and background clay samples from triaxial test results (Republished with permission of Canadian Science Publishing, from Instability of dykes at Seven Sisters Generating Station, Garinger, et al., 41, 5, 2004; permission conveyed through Copyright Clearance Center, Inc.)

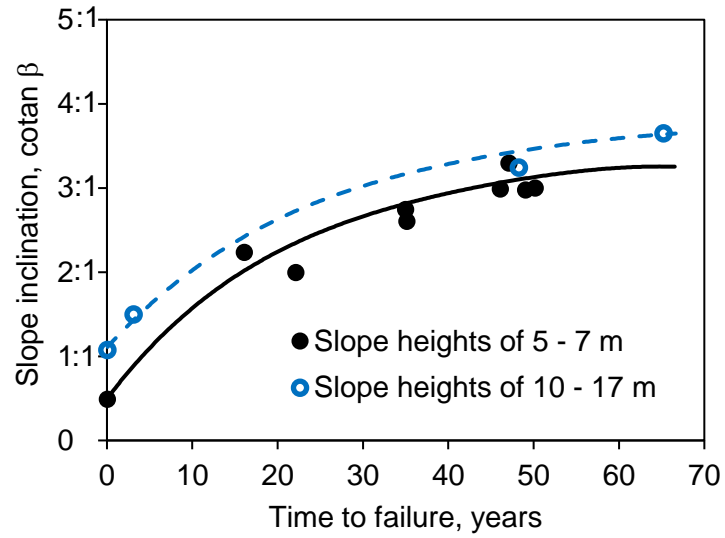
Figure 2.4 Relationship between slope inclination, slope height, and time to failure for London clay in cut slopes (Republished with permission of Canadian Science Publishing, from Creep and failure of slopes in clays, Tavenas and Leroueil, 18, 1, 1981; permission conveyed through Copyright Clearance Center, Inc.)

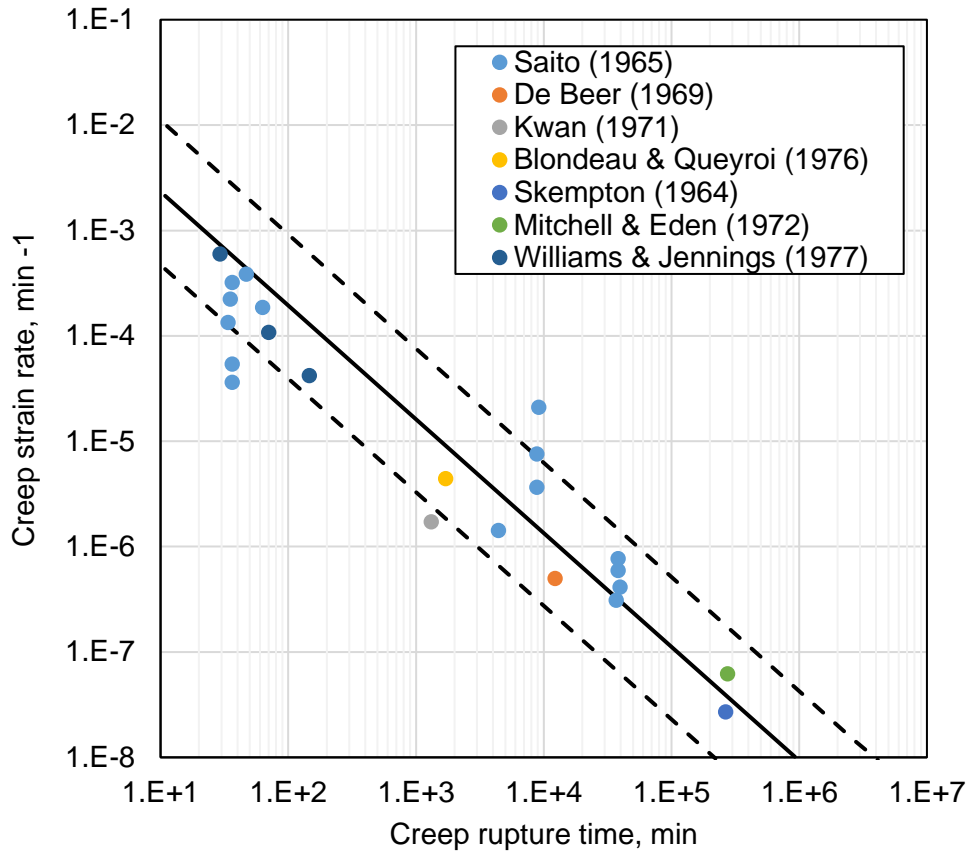
Figure 2.5 Relationship between creep strain rates and time to failure based on case histories
 (Republished with permission of Canadian Science Publishing, from Creep and failure of slopes in clays, Tavenas and Leroueil, 18, 1, 1981; permission conveyed through Copyright Clearance Center, Inc.)

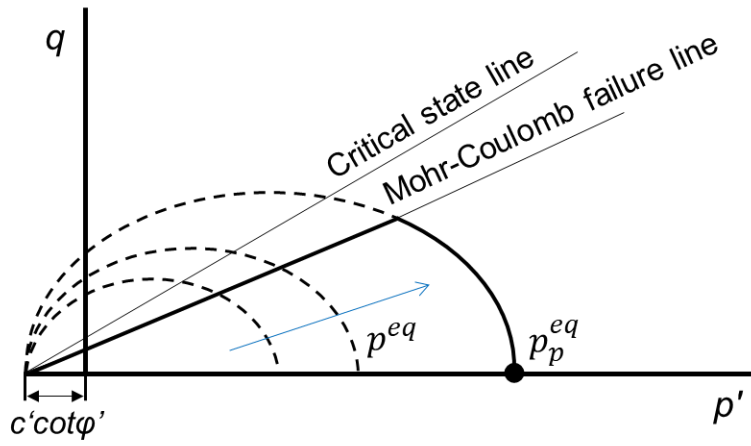
Figure 2.6 Yield surfaces of the SSC model in the p' - q plane

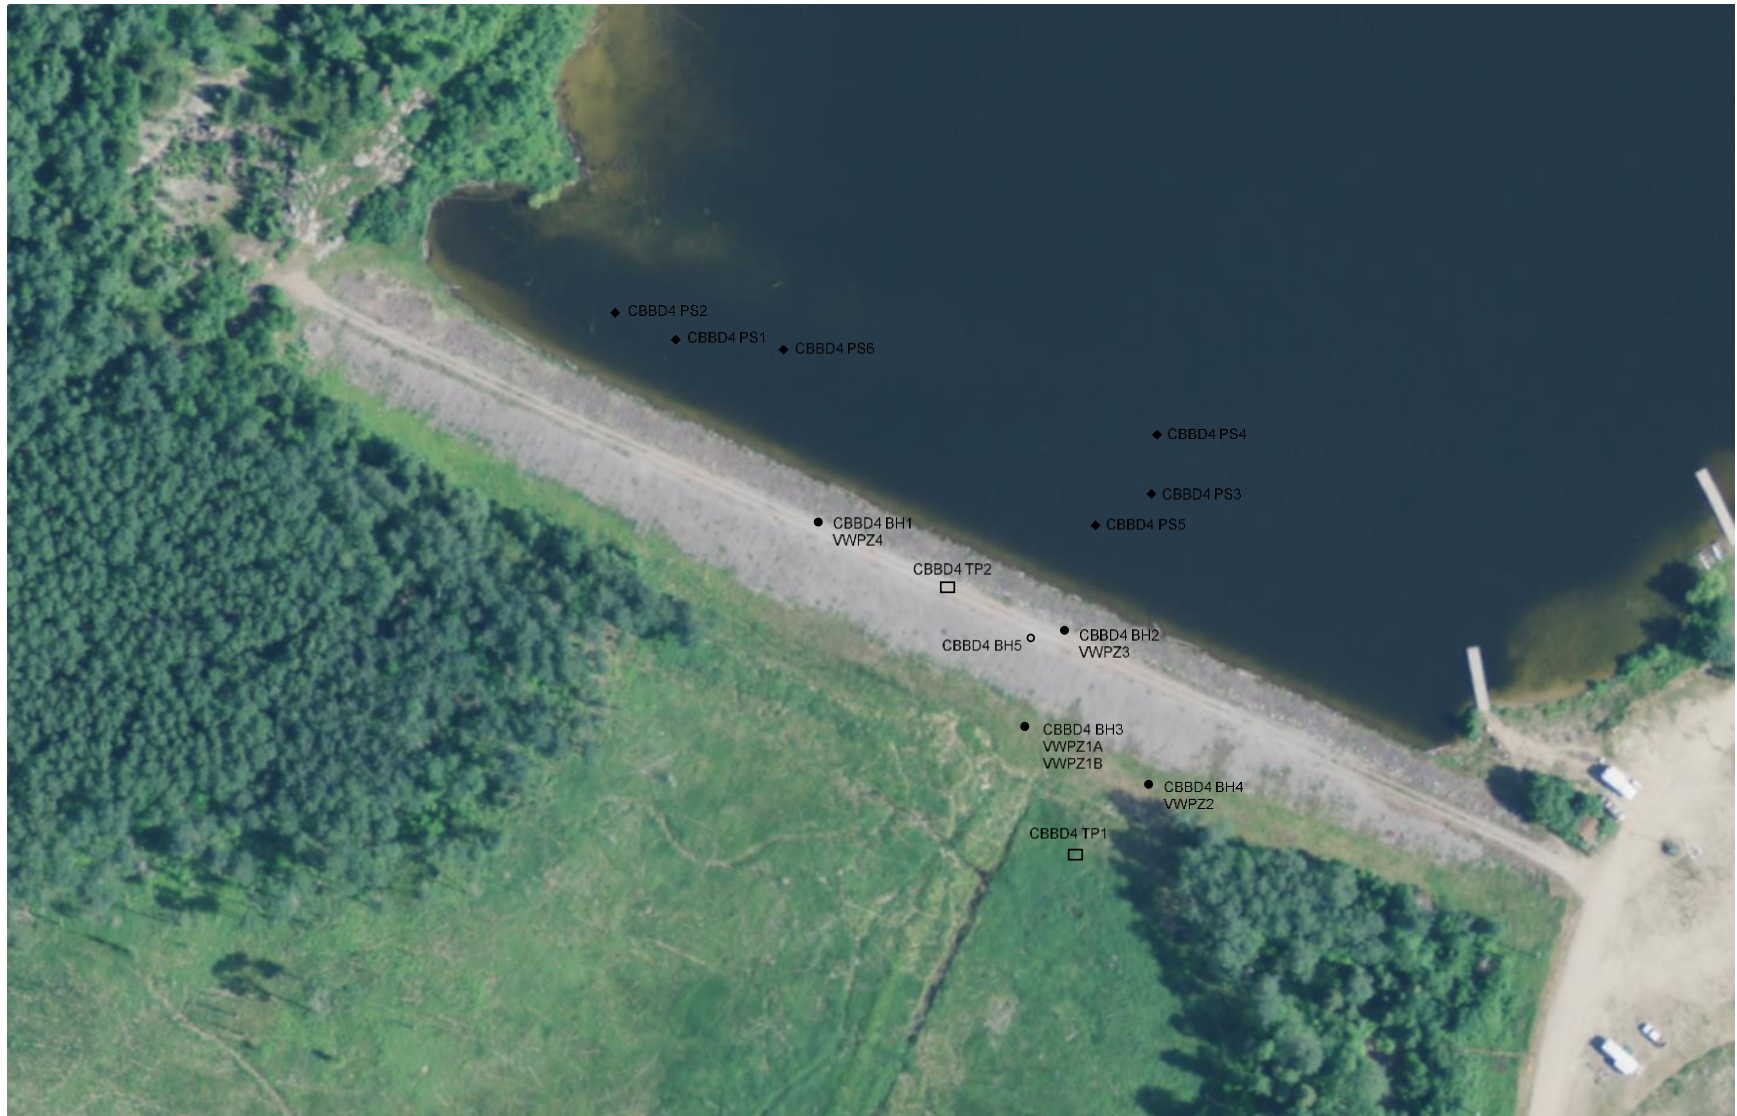
Figure 3.2 Approximated location of boreholes, test pits and installed vibrating wire piezometers in CBB4

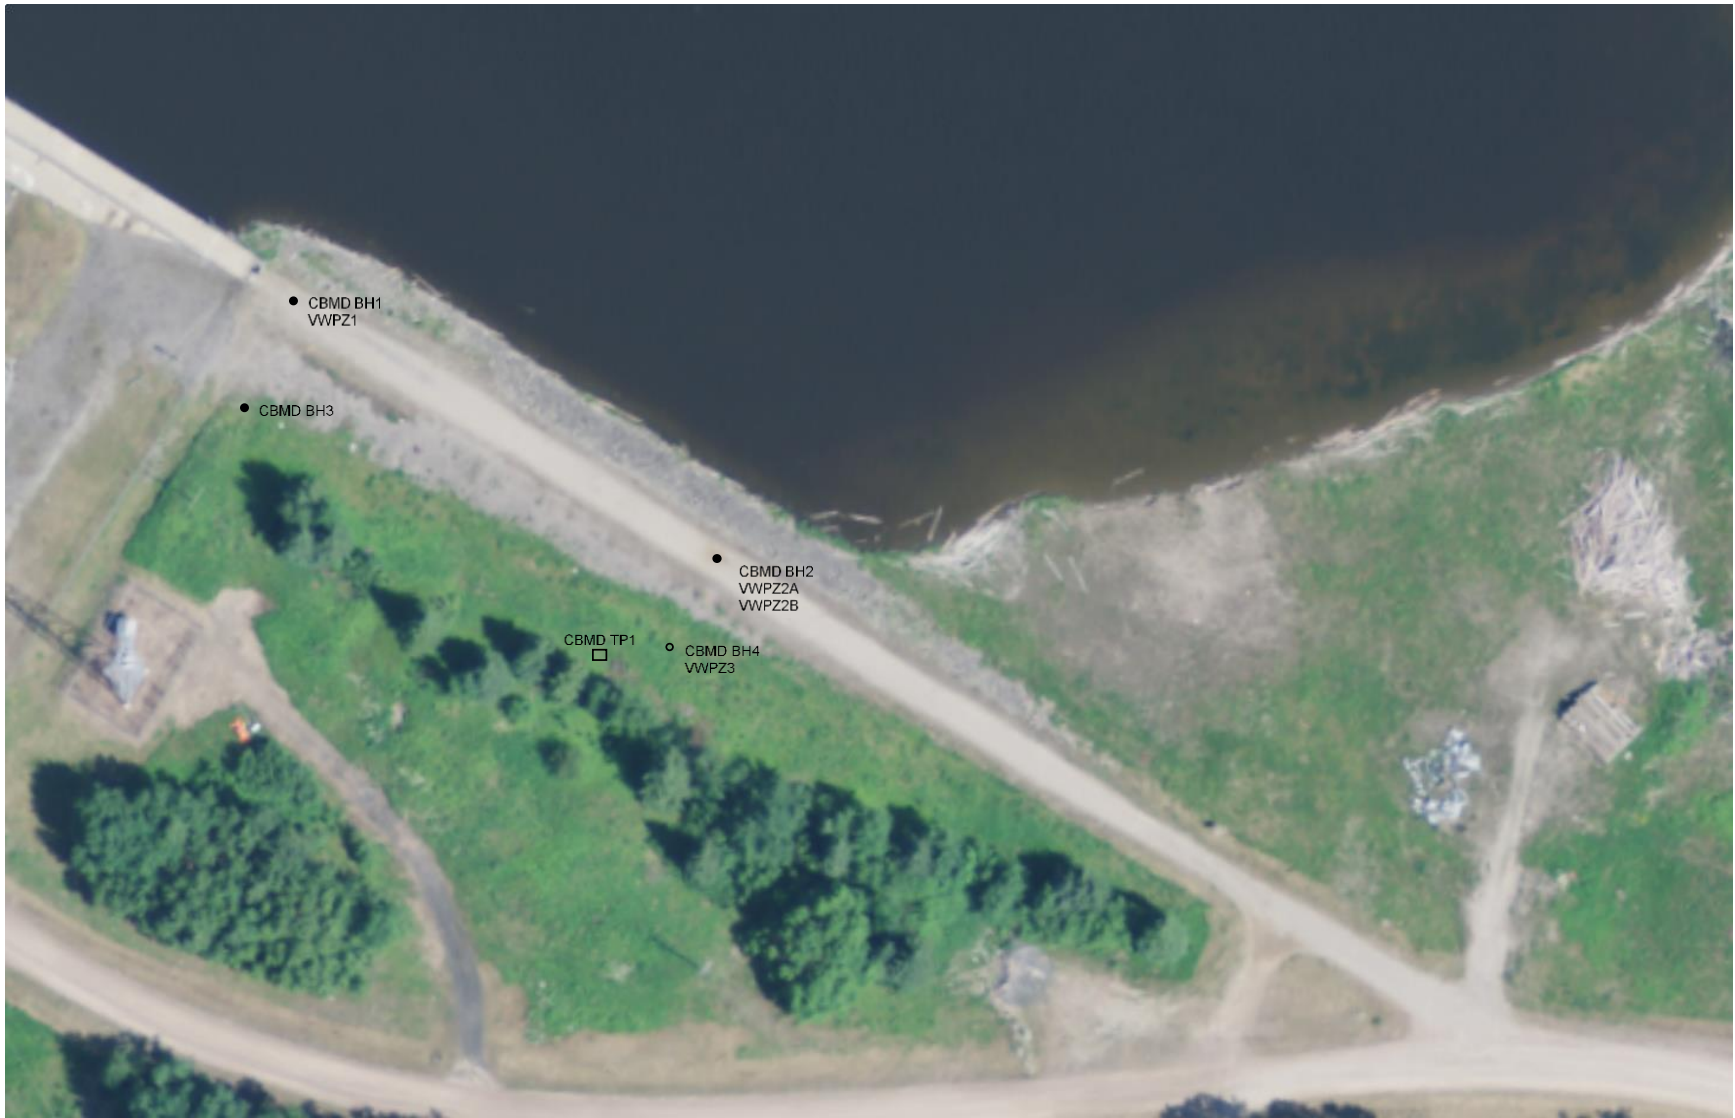
Figure 3.3 Approximated location of boreholes, test pits and installed vibrating wire piezometers in CBMD

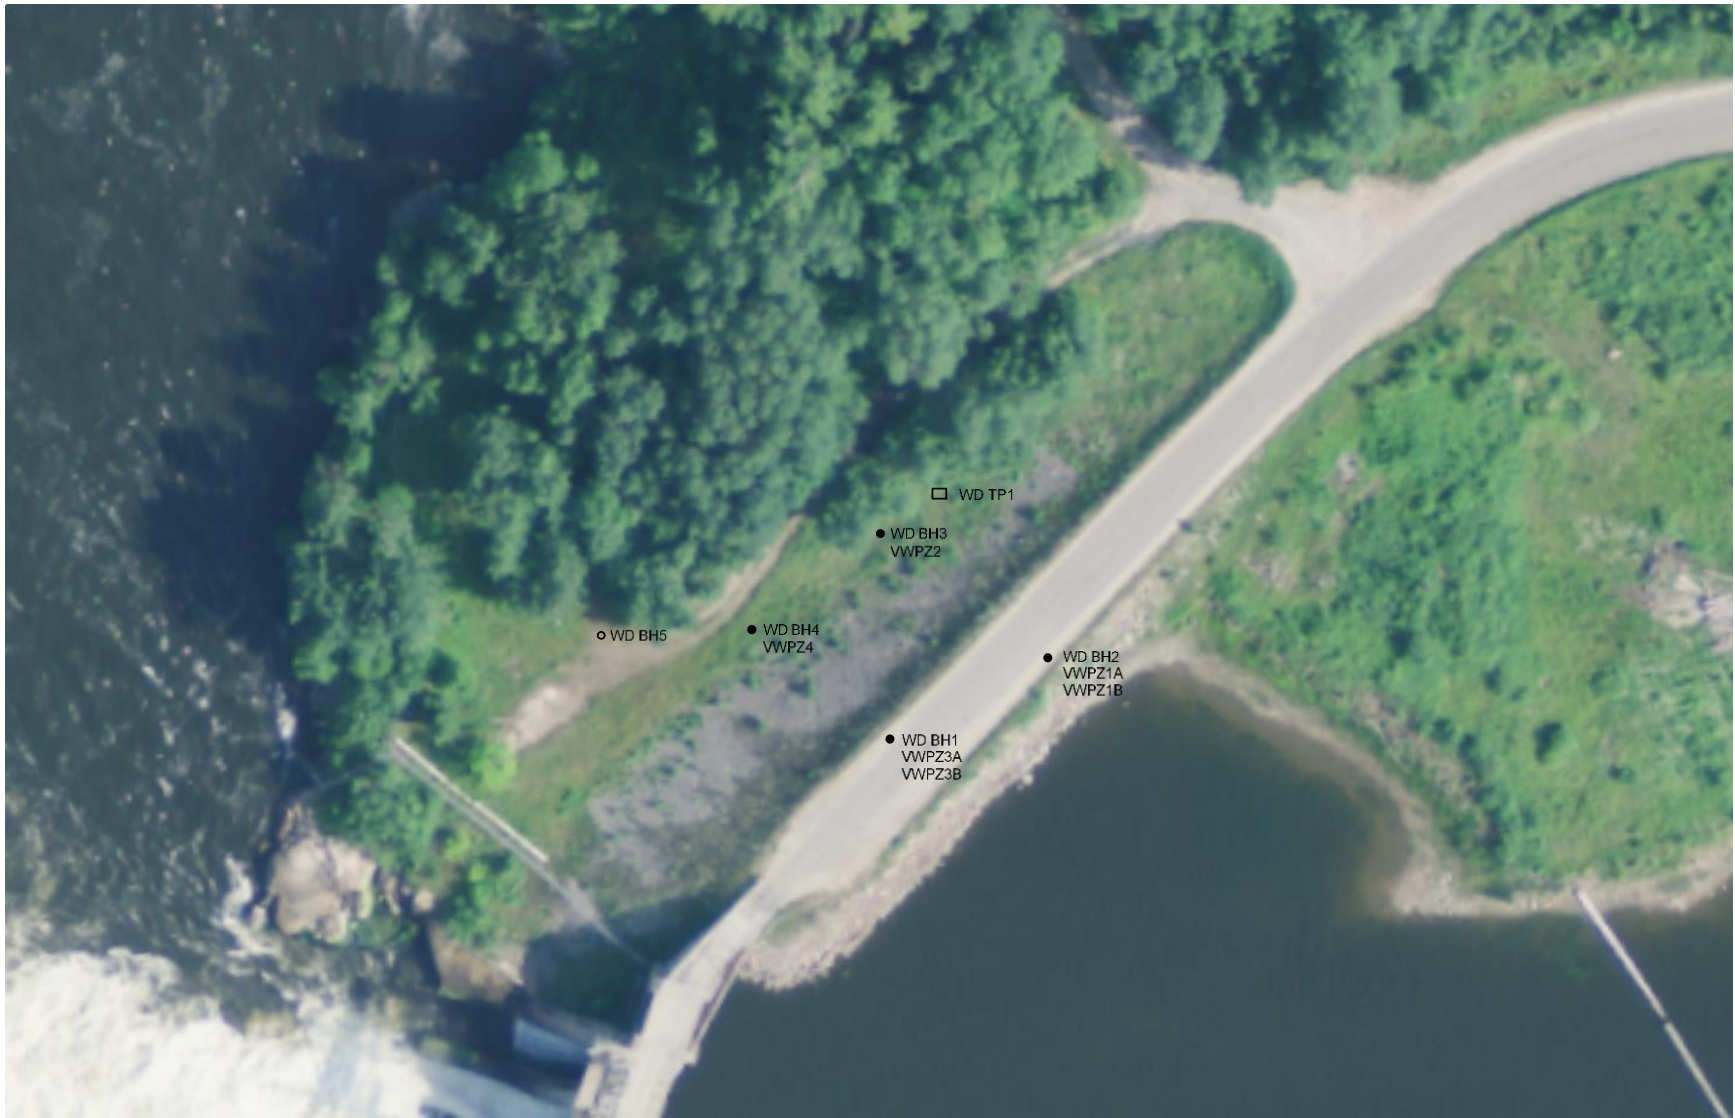
Figure 3.4 Approximated location of boreholes, test pits and installed vibrating wire piezometers in WD

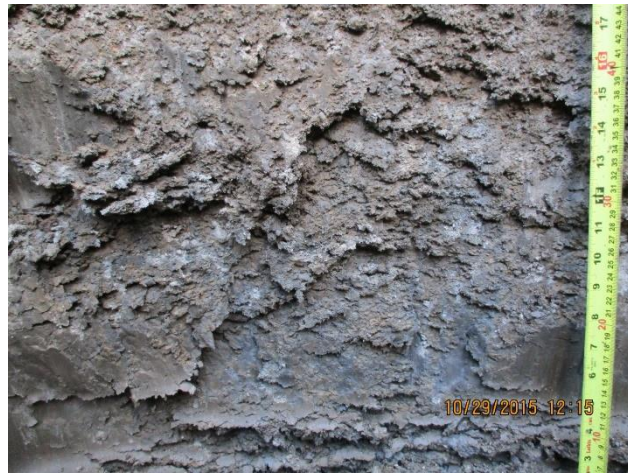
Figure 3.13 Fissured clay in a CBB2 test pit

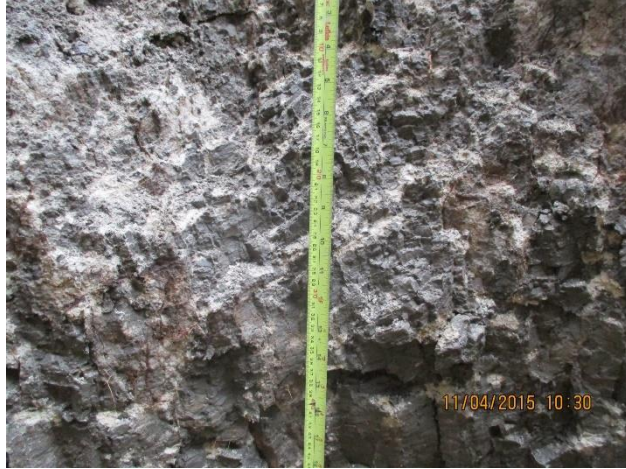
Figure 3.14 Silt pockets observed within fissured clay in a CBBD2 test pit

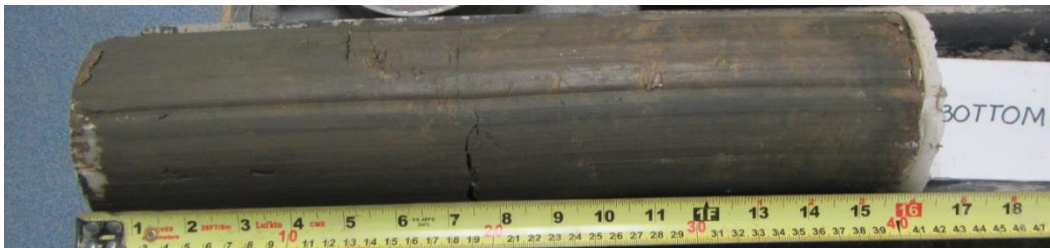
Figure 4.3 CBB2 clay foundation extruded Shelby tube sample

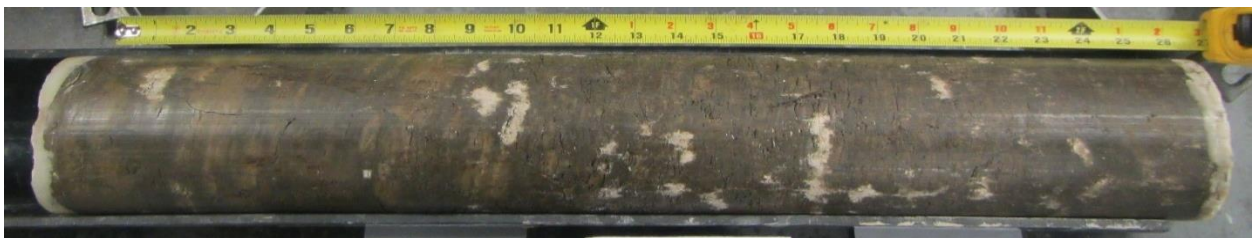
Figure 4.4 CBB2 clay foundation sample at location further away from CBB2

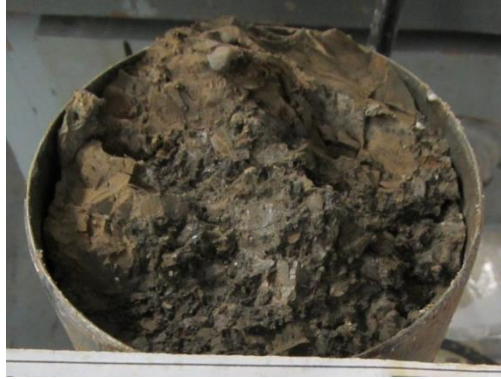
Figure 4.5 CBB2 clay core sample

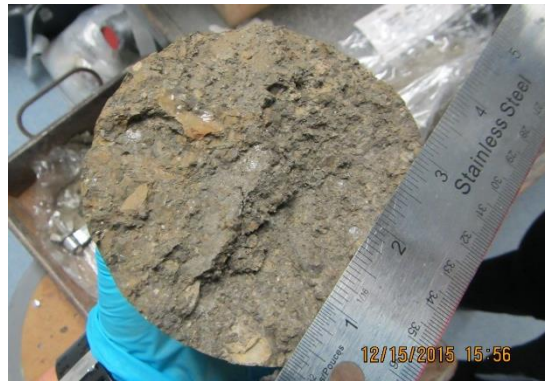
Figure 4.6 Polished surfaces observed in CBB2 clay core sample

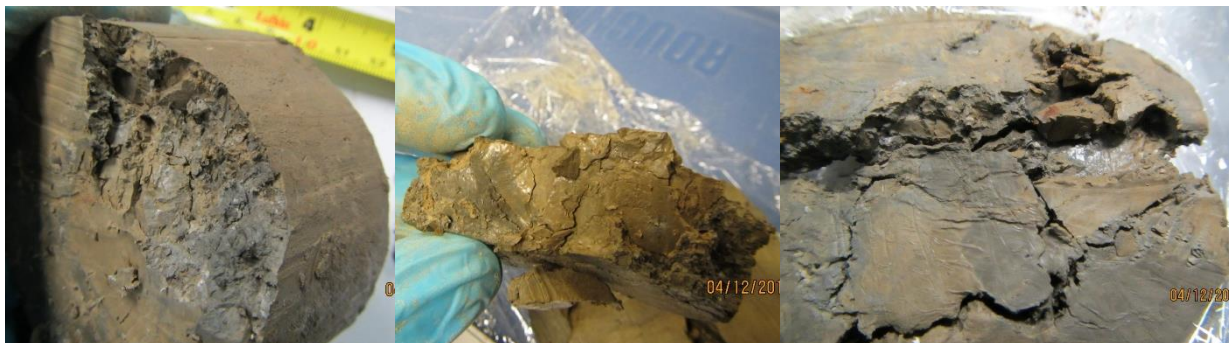
Figure 4.7 Fissures and polished surfaces observed in clay blanket samples

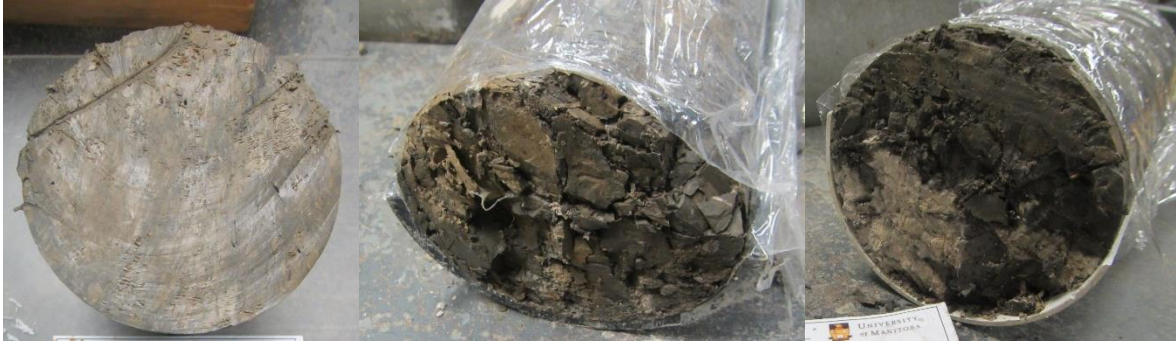
Figure 4.8 CBBD2 clay foundation samples

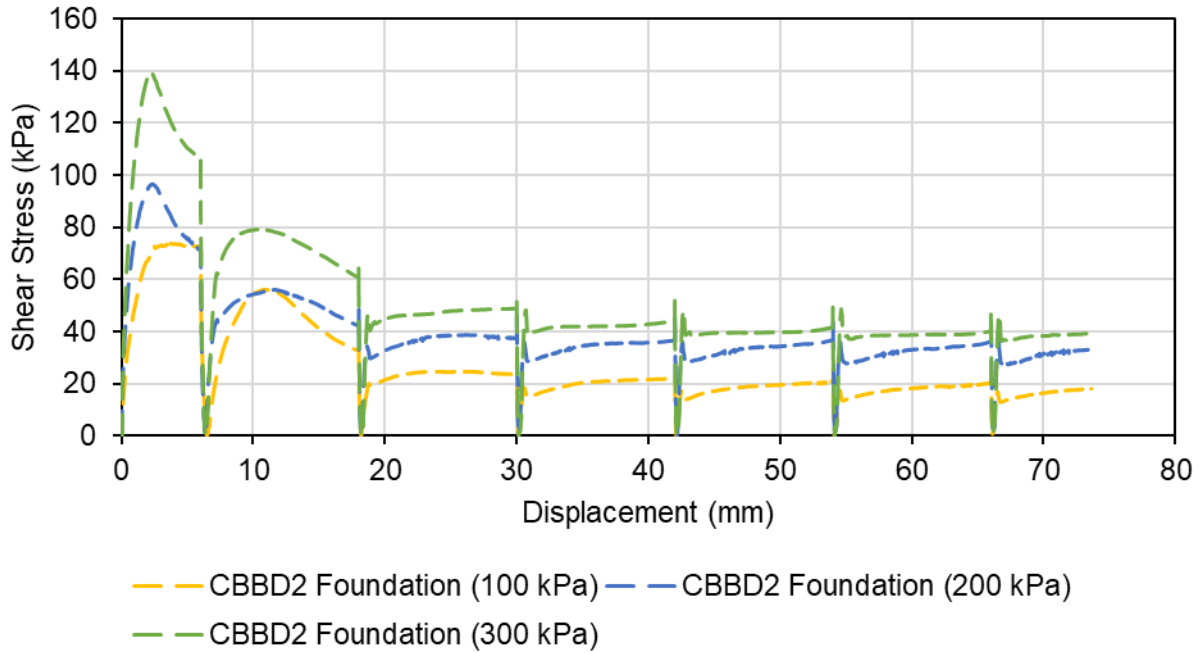
Figure 4.16 Stress-displacement behaviour of CBBD2 foundation samples from Direct Shear tests

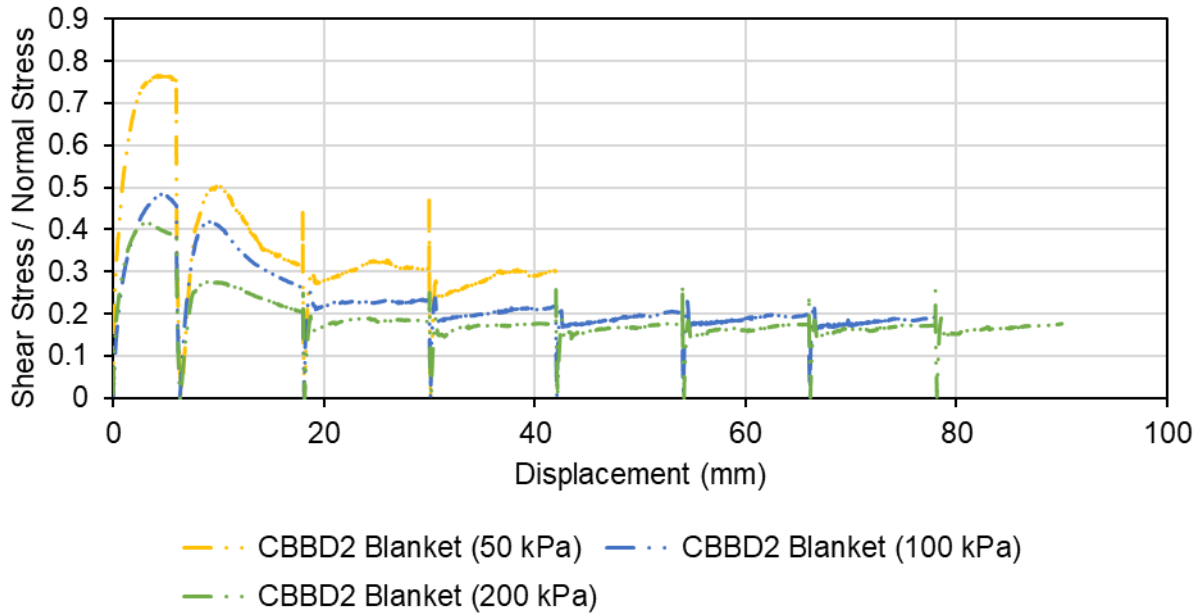
Figure 4.20 Normalized stress-displacement behaviour of CBBD2 blanket samples from Direct Shear tests

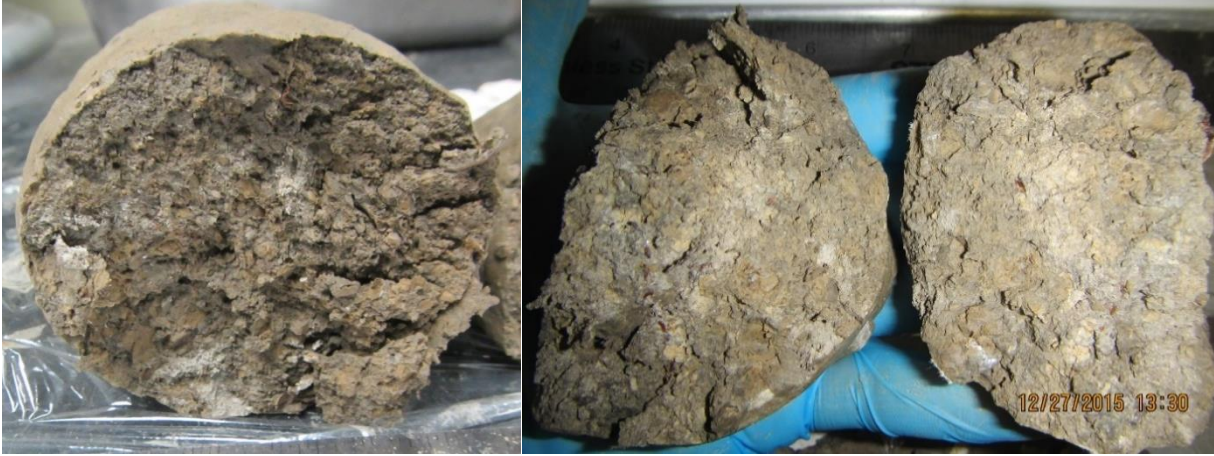
Figure 4.34 CBB2 clay foundation post-CIU Triaxial test samples

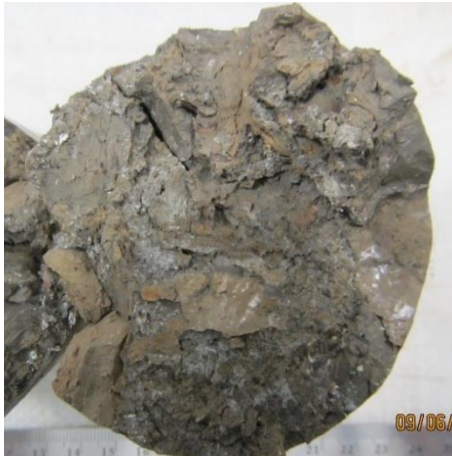
Figure 4.35 CBB4 clay core post-CIU Triaxial test samples

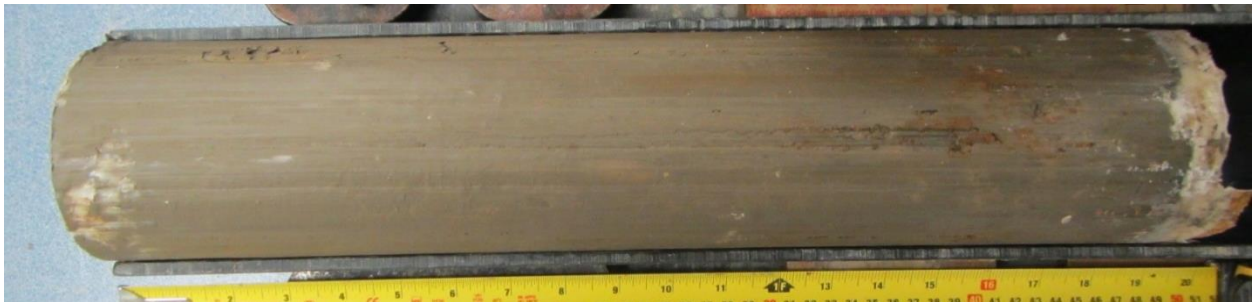
Figure A-B.3 CBMD clay core extruded Shelby tube sample

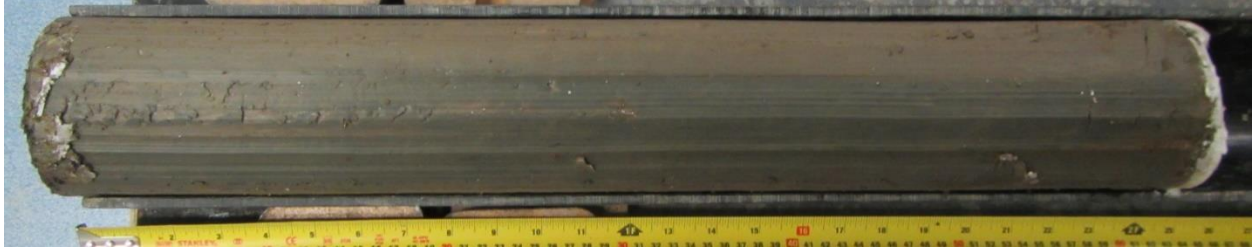
Figure A-B.5 WD clay foundation extruded Shelby tube sample

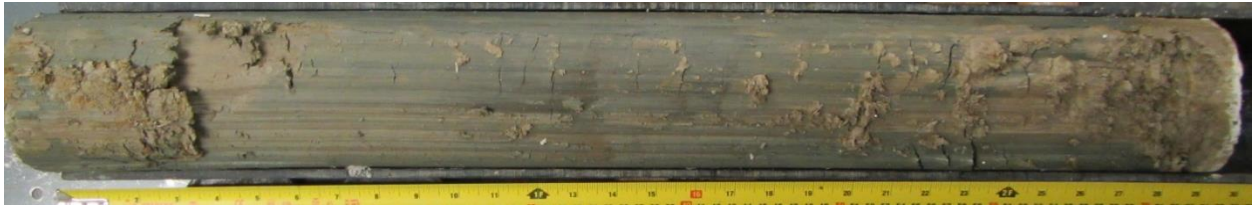
Figure A-B.7 EF clay foundation extruded Shelby tube sample

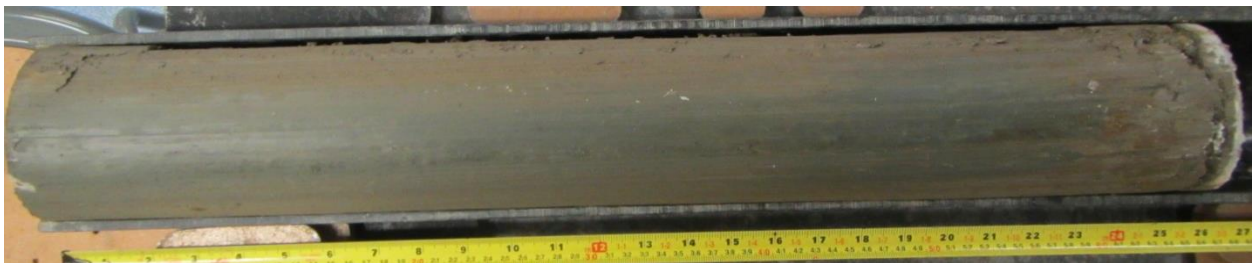
Figure A-B.8 MFRED clay core extruded Shelby tube sample

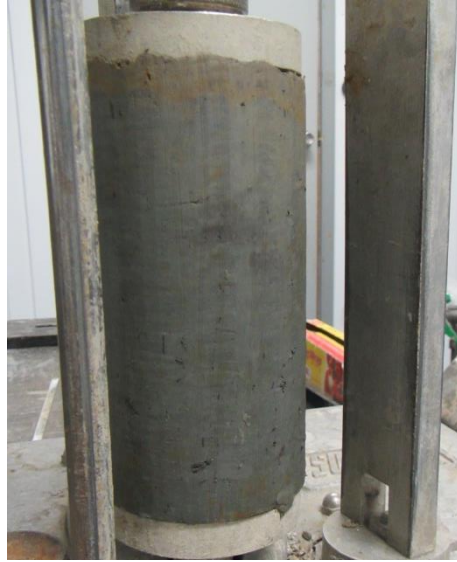
Figure A-B.10 CBBD4 clay foundation trimmed sample

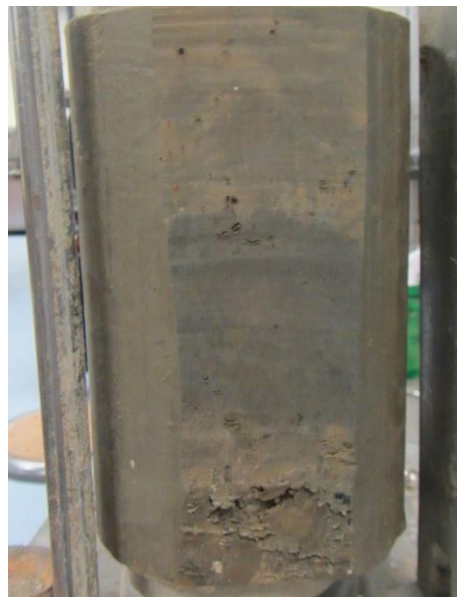
Figure A-B.11 WD clay core trimmed sample

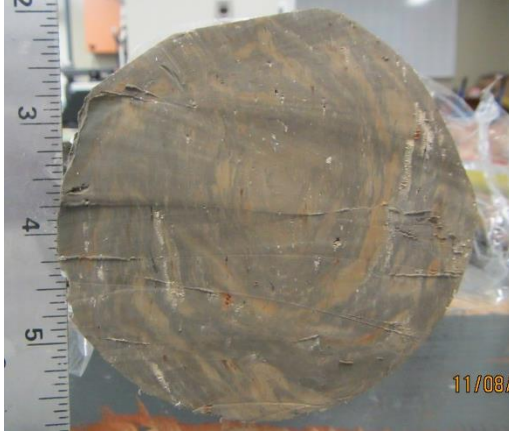
Figure A-B.12 WD clay foundation trimmed sample

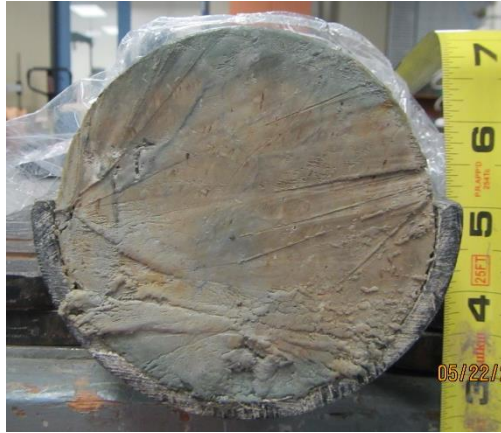
Figure A-B.13 EF clay core trimmed sample

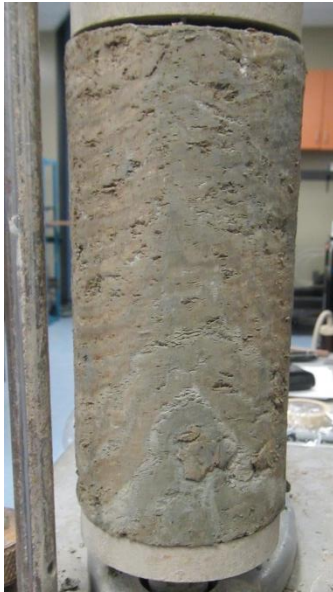
Figure A-B.14 EF clay foundation trimmed sample

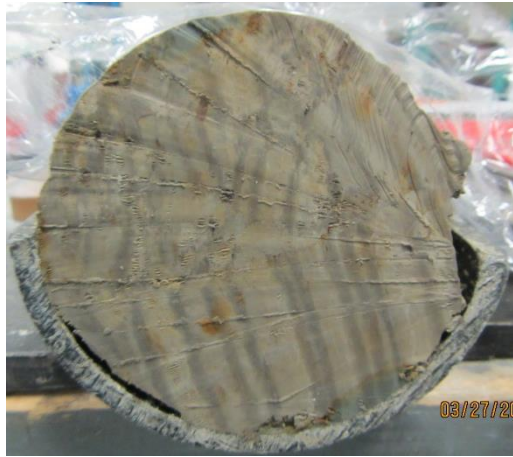
Figure A-B.15 MFRED clay core trimmed sample
