**THE BEHAVIOUR OF ULTRA-HIGH-PERFORMANCE CONCRETE IN  
PRECAST CONCRETE BRIDGE DECK CONNECTIONS**

A Thesis submitted to the Faculty of Graduate Studies of  
The University of Manitoba  
in partial fulfillment of the requirements of the degree of

Department of Civil Engineering  
University of Manitoba  
Winnipeg, Manitoba

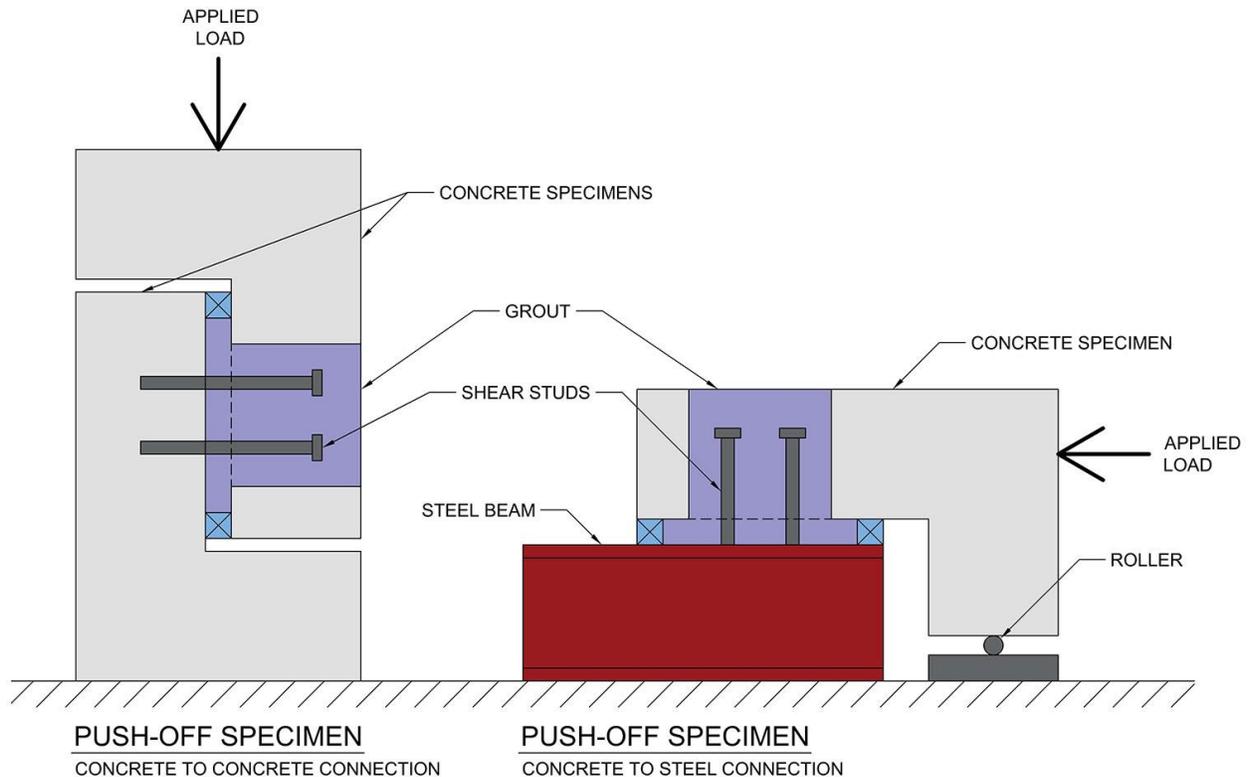
Figure 2.1 Typical push-off test specimens.

The “L” shaped concrete specimens are cast with blockouts for the shear pocket connection. For concrete-to-concrete connections, another “L” shape is cast with the shear studs embedded, whereas with the concrete-to-steel connection, the shear studs are welded onto the flange of the steel beam. The assembly may be tested in the vertical position, as shown, or horizontally in a similar manner to the concrete-to-steel connection. The applied loads cause shearing forces on the grouted shear stud connection. The objective is to observe if the connection fails through stud shearing from its support structure, or if the failure will be due to concrete crushing.

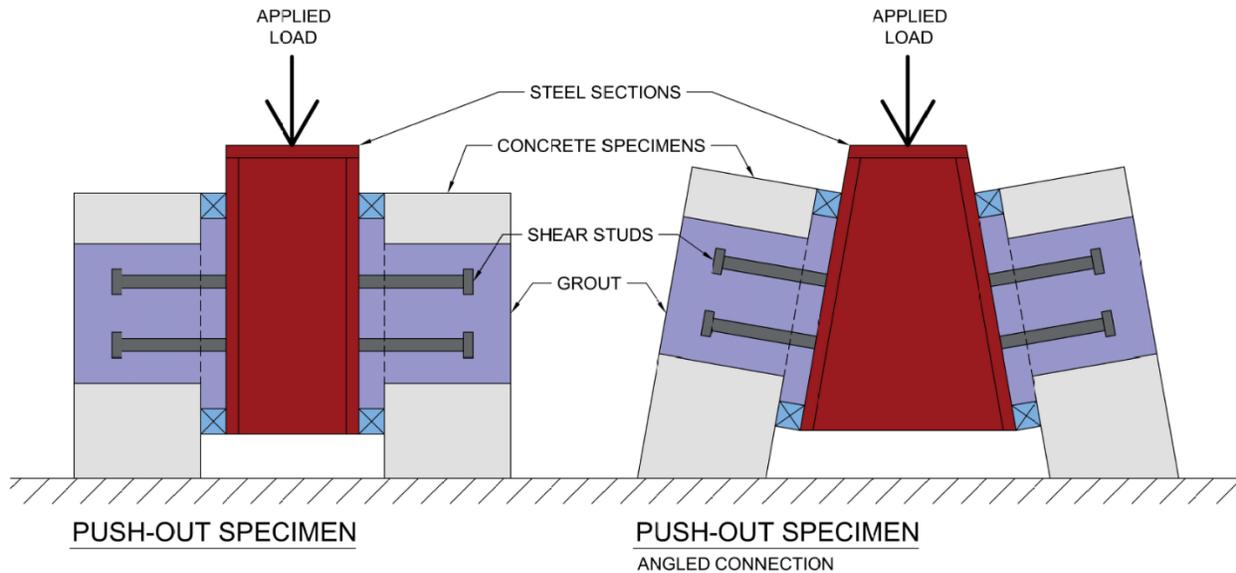
Two typical push-out test setups are shown in Figure 2.2. Small concrete slabs with shear pocket blockouts are cast, and then mounted vertically and cast against the steel section around the shear stud groupings. The shear studs are welded to the flange of the steel section. This type of test utilizes two connections within the same setup, which has the benefits and setbacks in comparison to the push-off tests. This setup allows double the amount of connections to be tested, however care must be taken to minimize the construction discrepancies between sides to ensure the loading is as equal as possible on each connection. As seen in Figure 2.2, the column may either be 90° vertical or slightly angled. The vertical specimens are only subjected to shear forces, similar to the push-off tests. The angled specimens subject the shear pocket connection to shear and tension forces. The angled push-out method is less common since it is more difficult to construct. The steel section must be custom made and the flange angles must be equal. The requirements for all the angled pieces create greater risk of discrepancies between concrete specimens and the accuracy of the stud angles; the studs would still be welded at 90° to the flange, which would be challenging if they are welded after the support section is fabricated.

Figure 2.2 Typical push-out test specimens.

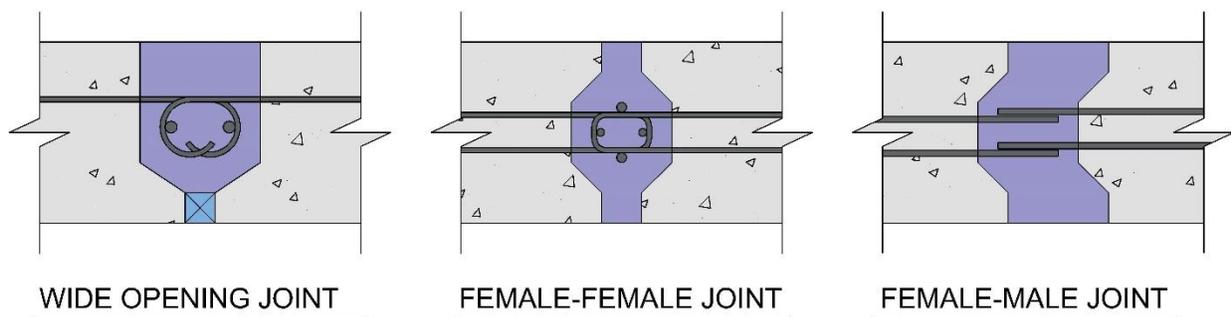
protruding out of the panels to be cast within the joint, and the rebar may be straight, hooked or a complete “U” back into the panel. Joints typically contain transverse reinforcement that is tied to the longitudinal rebar once the panels are placed. It is also common to use post-tensioning across the bridge deck joint to reduce cracking. Figure 2.3 includes some examples of the joint reinforcement: the wide opening joint includes hooked rebar and transverse bars; the female-female joint includes “U” shaped rebar with transverse bars; and the female-male joint shows only straight spliced bars and no transverse bars. The wide opening style of joint is commonly plugged with ethylene-vinyl acetate (EVA) foam to close the joint to avoid additional formwork requirements on site.

Figure 2.3 Typical Joint Shapes

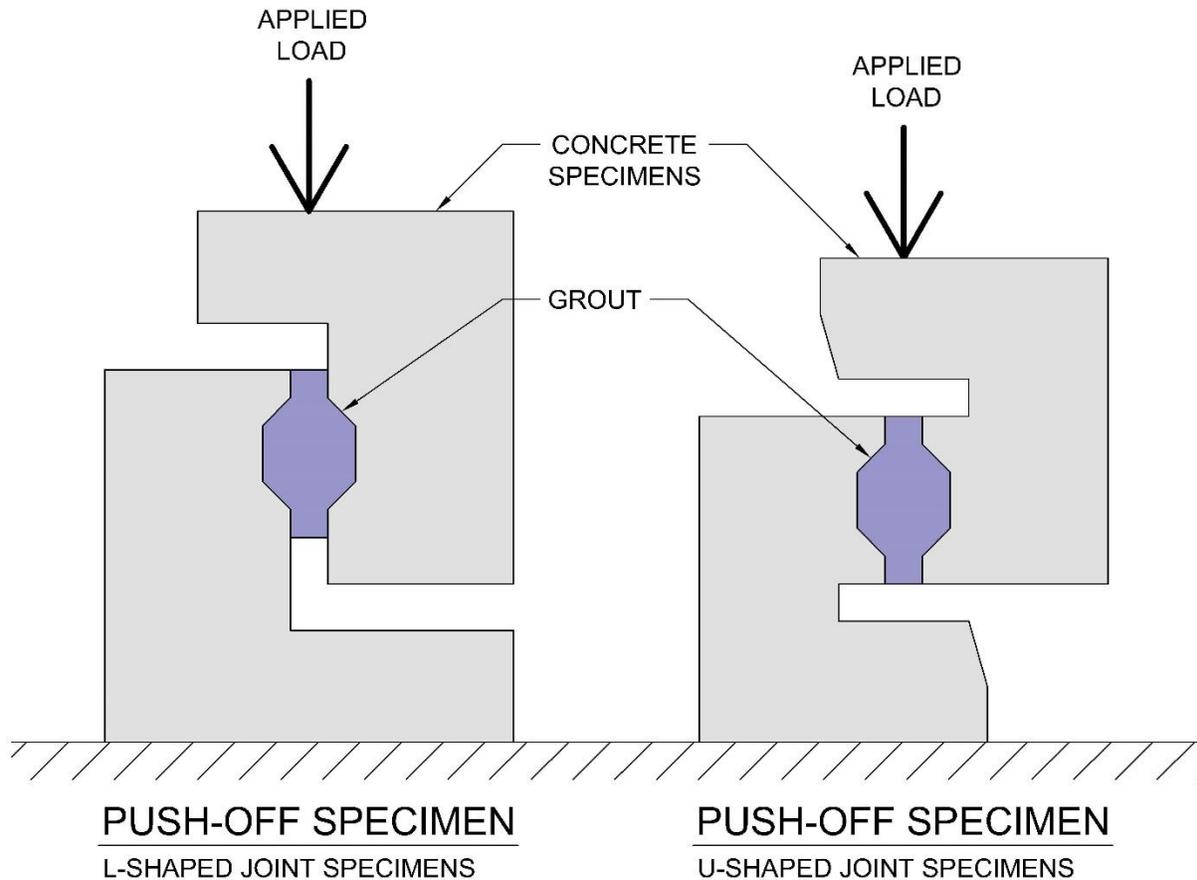
Similar to the shear pocket connections, the joints may be tested in small-scale experiments or as part of a full bridge deck system. The concrete-to-concrete push-off test specimens may be designed to test joint shapes in shear; rather than the full blockout, the inside of the “L” shaped specimens is formed to cast the desired joint shape for testing [see Figure 2.4].

Figure 2.4 Typical Push-Off Joint Specimens

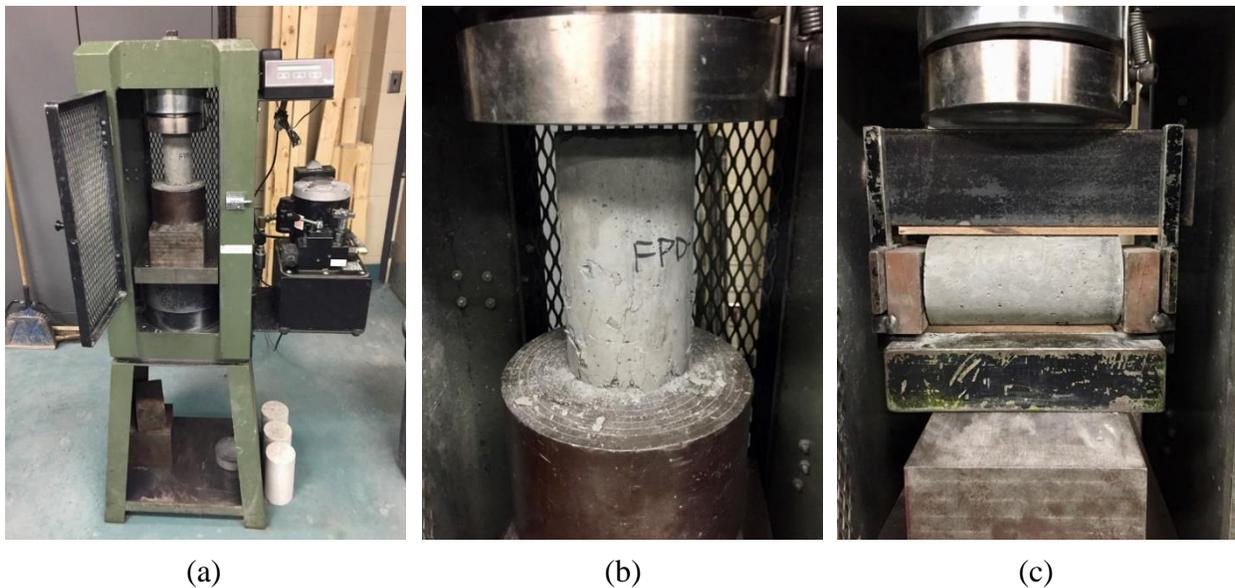
The compression testing machine at the University of Manitoba is a Test Mark Industries CM-3000-DIR with a capacity of 1334 kN (300,000 lbs) and was used to test the compression and tension cylinders.

Figure 3.1 (a) Test Mark Industries CM-3000-DIR test machine; (b) Compression cylinder test setup; (c) Splitting tension cylinder test setup.

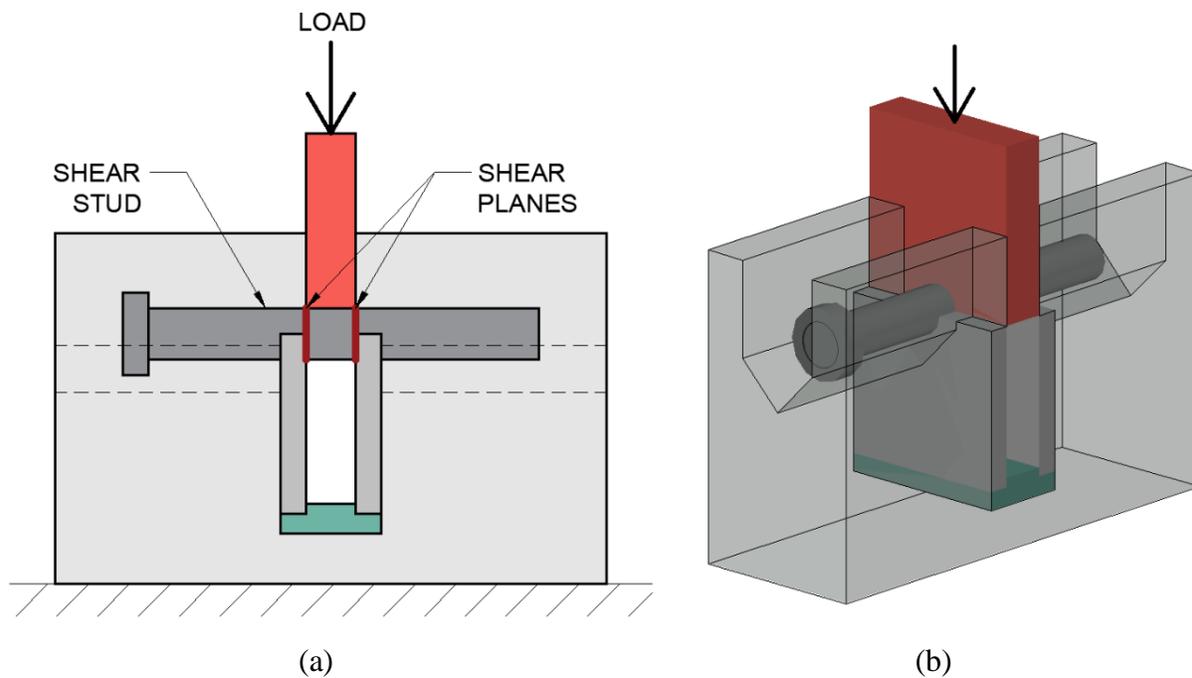
Figure 3.2 Shear stud shear test setup: (a) side view, and (b) isometric view.

The shear test involved shearing off a section in the center of the shear stud. A slotted steel support block is used to secure the head and end of the shear stud, and the load is applied downwards on a plate that is aligned with the slot in the steel block. The load is applied until failure of the stud. The shear stud was not instrumented for this test since the shear capacity of the studs could be determined with the load data and the stud's cross-sectional area. The test setup creates two

shearing planes along the stud. Figure 3.2 and Figure 3.3 show the direct shear test setup. The shear studs are fixed at each end with bolts that are tied across the steel block; however, to simplify the figure, these restraints are not shown but can be seen in the photographs.

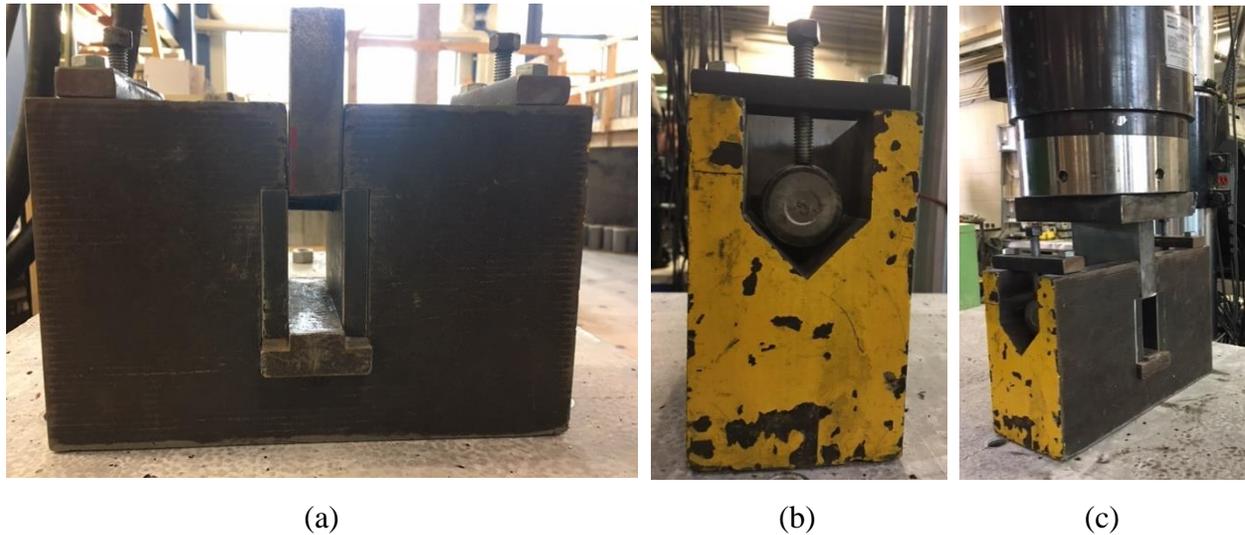
Figure 3.3 Shear stud test equipment: (a) side view, (b) end view, and (c) during testing.

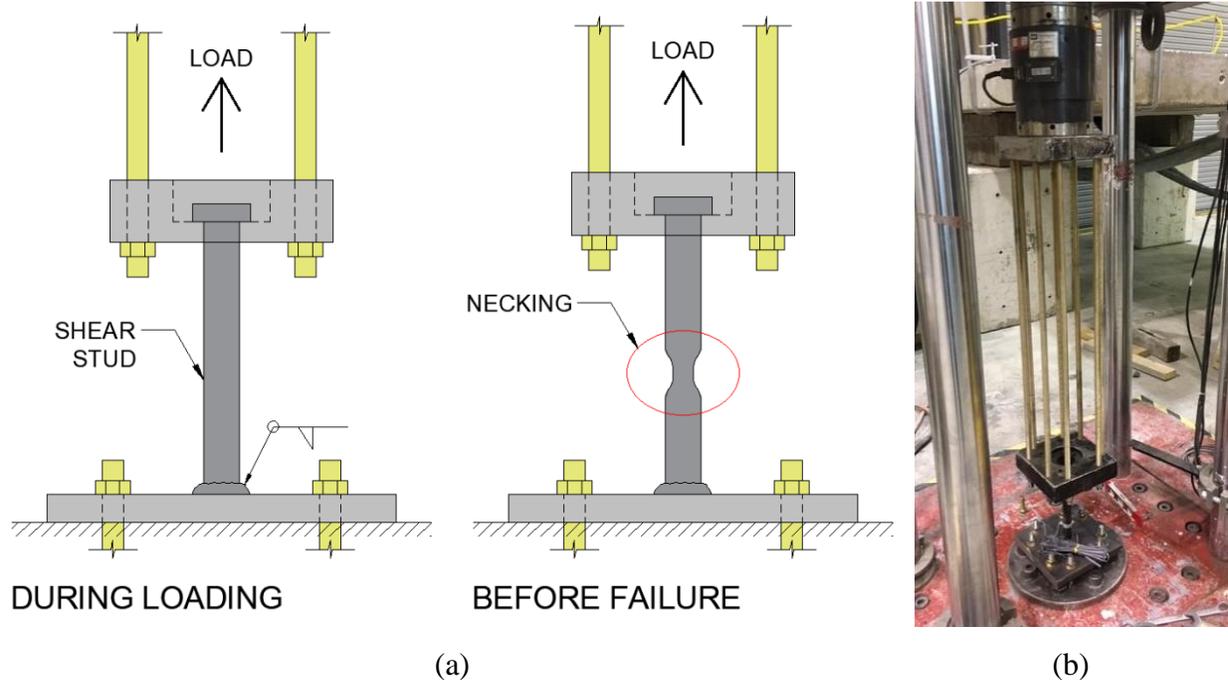
The tension test was a slightly more complicated setup. The shear stud was welded onto a small steel base plate with a weld strong enough to resist failure during the tension testing. The steel plate was then fixed to the strong floor, and the head of the stud was clamped to the MTS testing machine. The MTS testing machine pulled upwards on the stud, creating tensile forces along the stud, until its failure. The MTS machine is typically for larger specimen tests; however, its capacity was required to fail the shear studs. Long threaded rods were used to secure the load cell to the top plate that supported the clamp, pictured in Figure 3.4. Long threaded rods were also used to secure the base plate to the strong floor.

Figure 3.4 Shear stud direct tension test setup: (a) side view, and (b) instrumented stud.

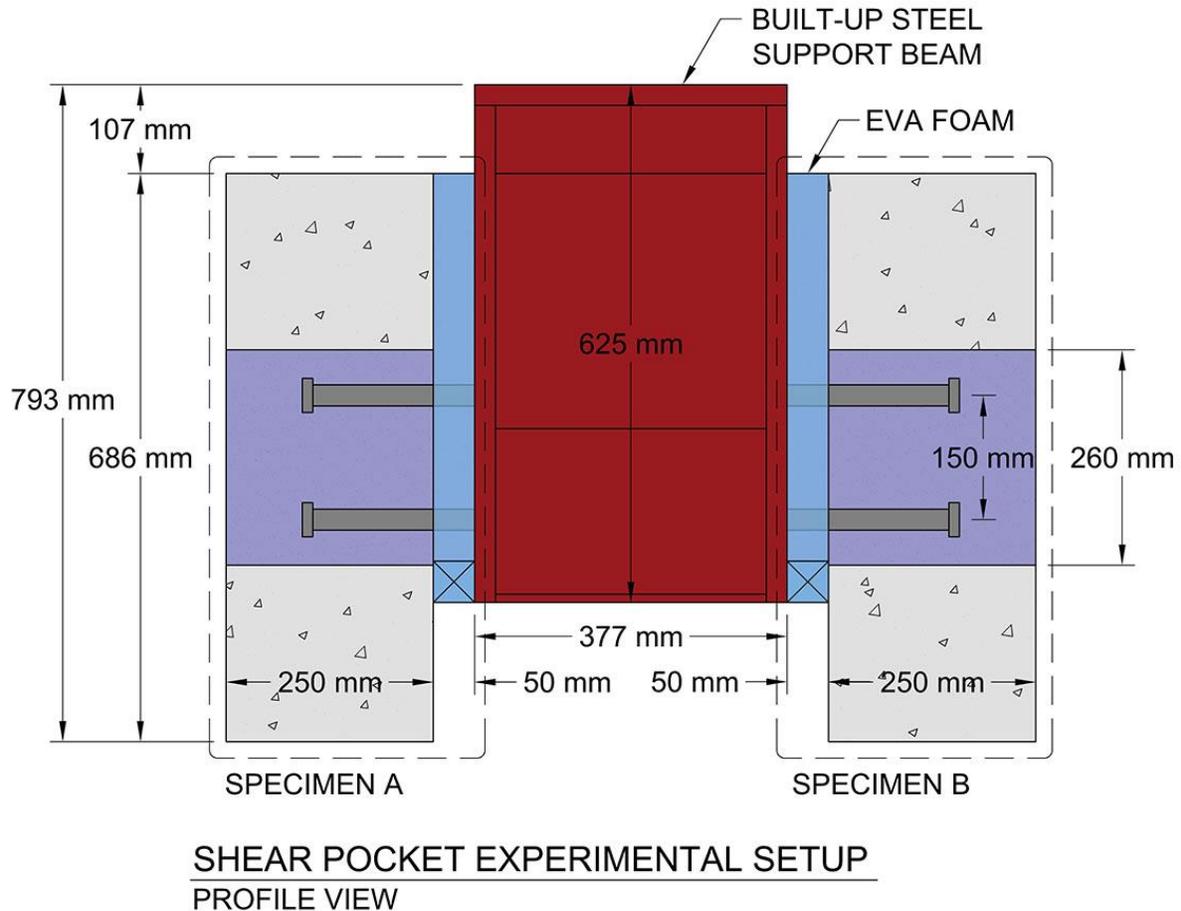
Figure 3.5 shows the push-out test setup with 6-stud layout specimens. The 3-stud specimens had one row of 3 studs, which can be seen later in Figure 3.9.

Figure 3.5 Push-out shear pocket test setup.

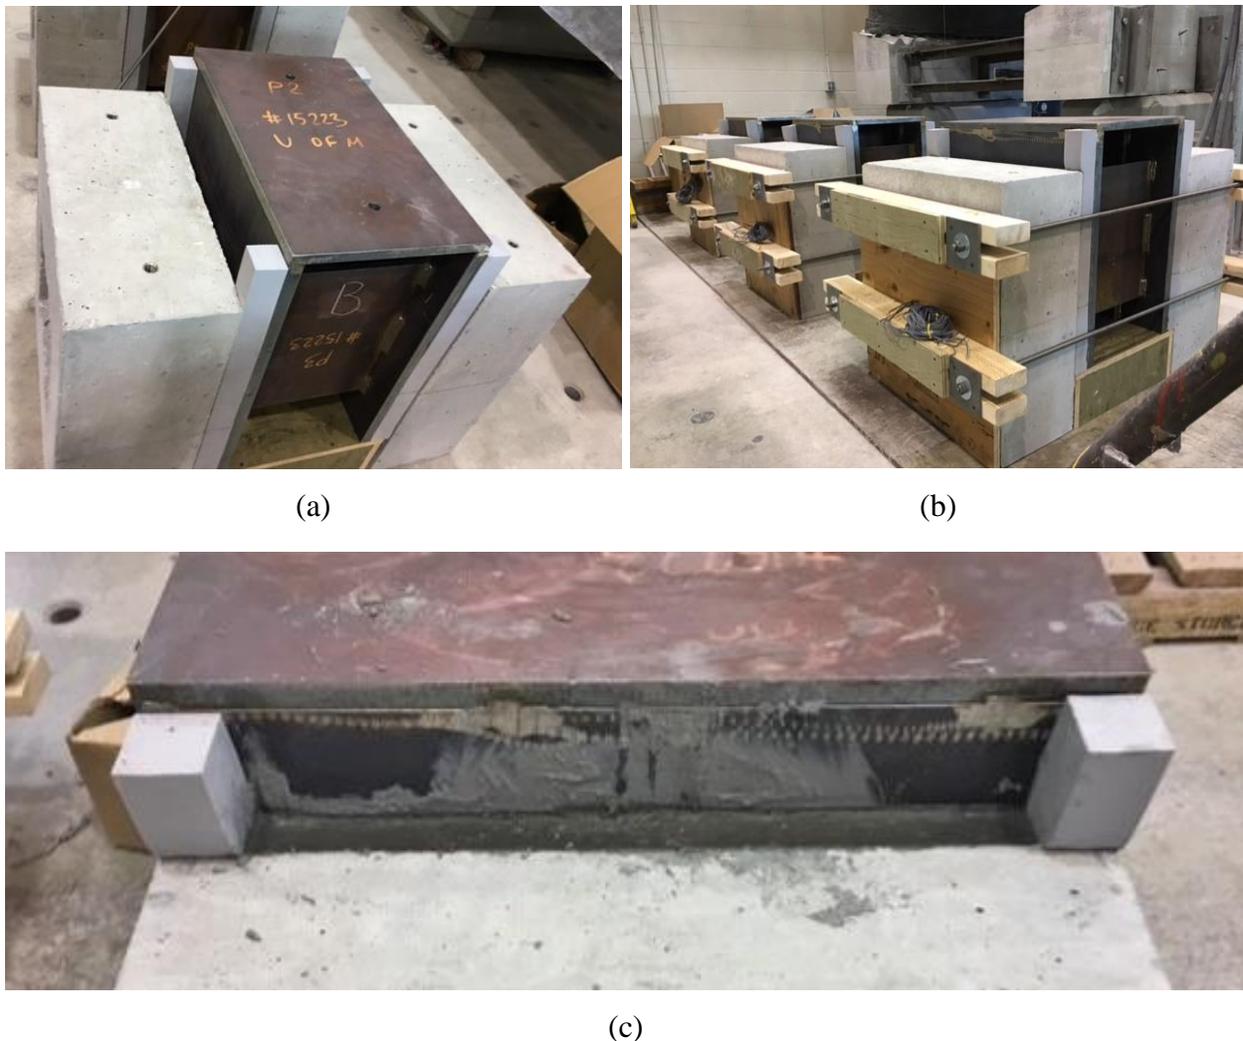
Once the test date was set for the push-out tests, the push-out test specimens could be assembled through the casting of the UHPC shear pockets. The gap for the haunch, between the built-up steel beam and the shear pocket slabs, was created by gluing EVA foam to the flange of the beam. The slabs were then placed on either side and tension rods were tightened to secure the slabs during casting and curing, as seen in Figure 3.12(b).

Figure 3.12 Push-out test specimen UHPC shear pocket casting: (a) slab placement; (b) UHPC cast formwork; and (c) UHPC haunch post-casting.

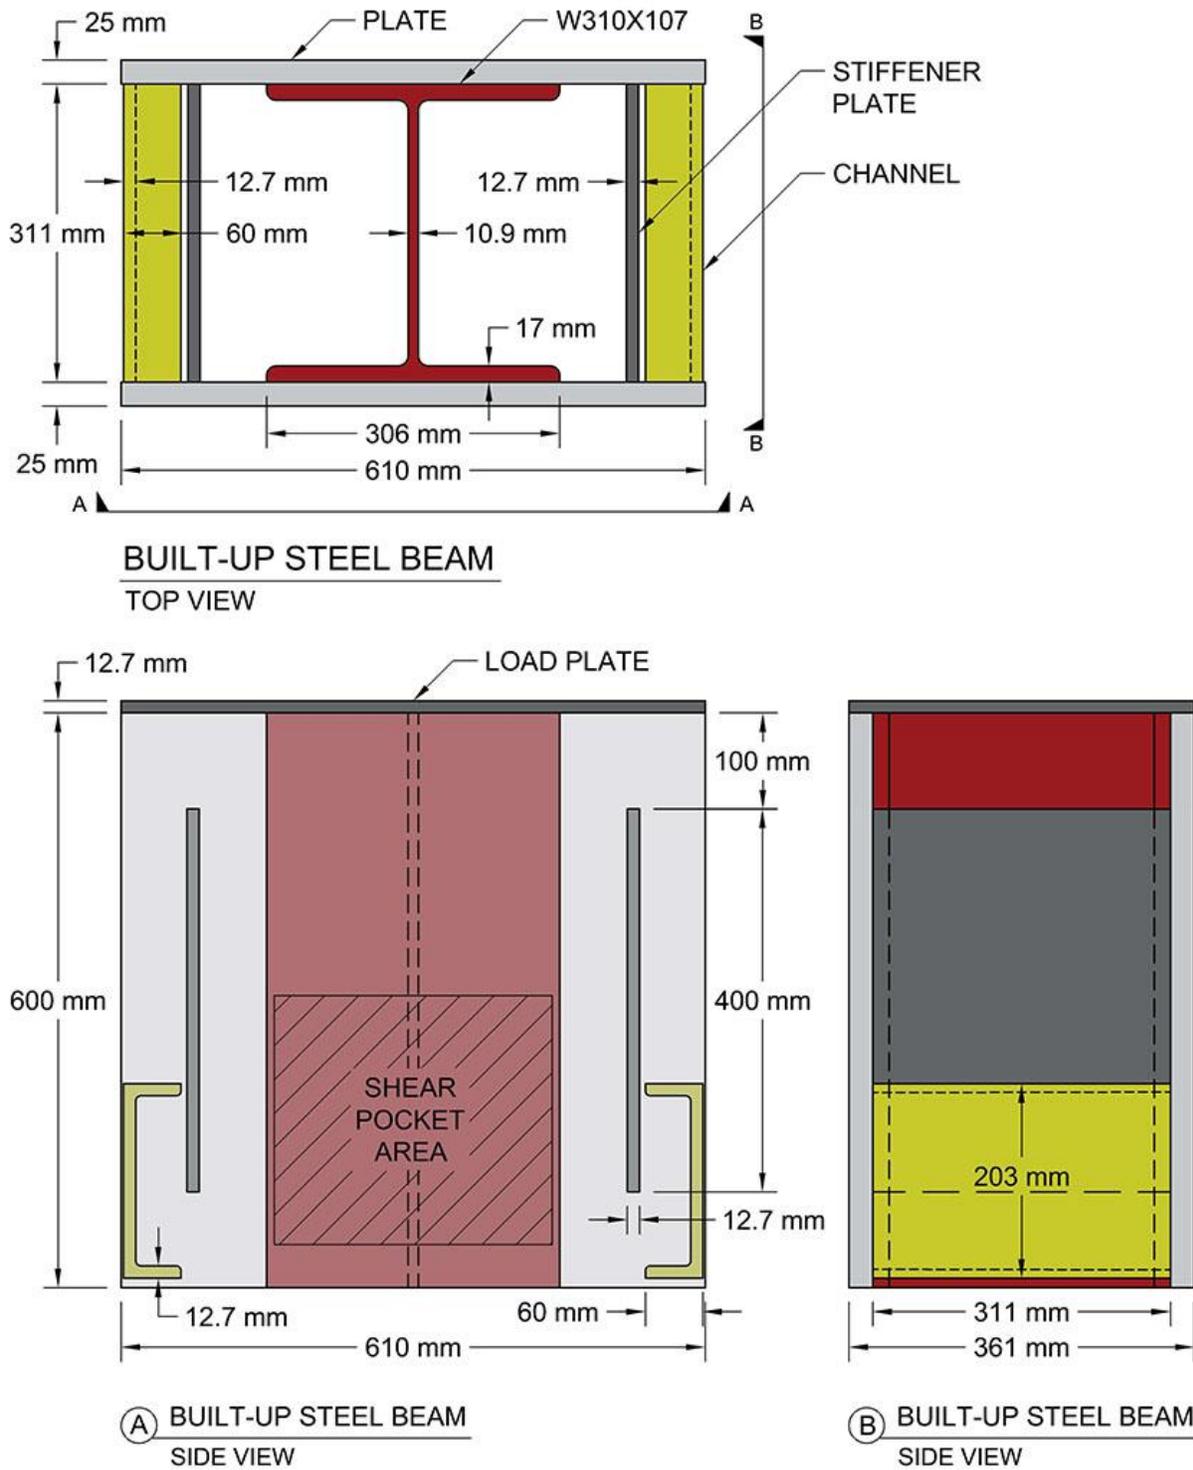
Figure 3.13 Built-up steel support beam for push-out test specimens.

A built-up steel beam was designed and constructed for the shear pocket slabs to be cast against, as seen in Figure 3.13. The push-out shear pocket test is setup for an axial load on the top of the steel section and it must resist buckling to allow the concrete and/or shear studs to fail first. The built-up steel beam for these push-out tests were comprised of a 600 mm tall W310x158 section and various plates welded together. The W310x158 section had 600 x 610 x 25 mm thick plate welded to each flange. The flange plates were previously shipped to Falcon Machinery to have the shear studs welded on with a stud gun. The use of a stud gun creates a better weld to the steel surface, rather than stick welding. Welding the plates with pre-installed shear studs cut down on the overall construction time for the built-up beams, since the W-sections had to be special ordered. Once the plates were welded onto the flanges of the W-section, a 25 mm thick loading plate was welded to the top of the built-up section. Stiffener plates (350 x 327 x 25.4 mm thick) were also welded between the flanges adjacent to the stud groupings location. During the first push-out test completed the steel buckled under loading. Therefore, a stiffener plate and channel were also welded between the flanges for added stiffness for the remaining six test setups.

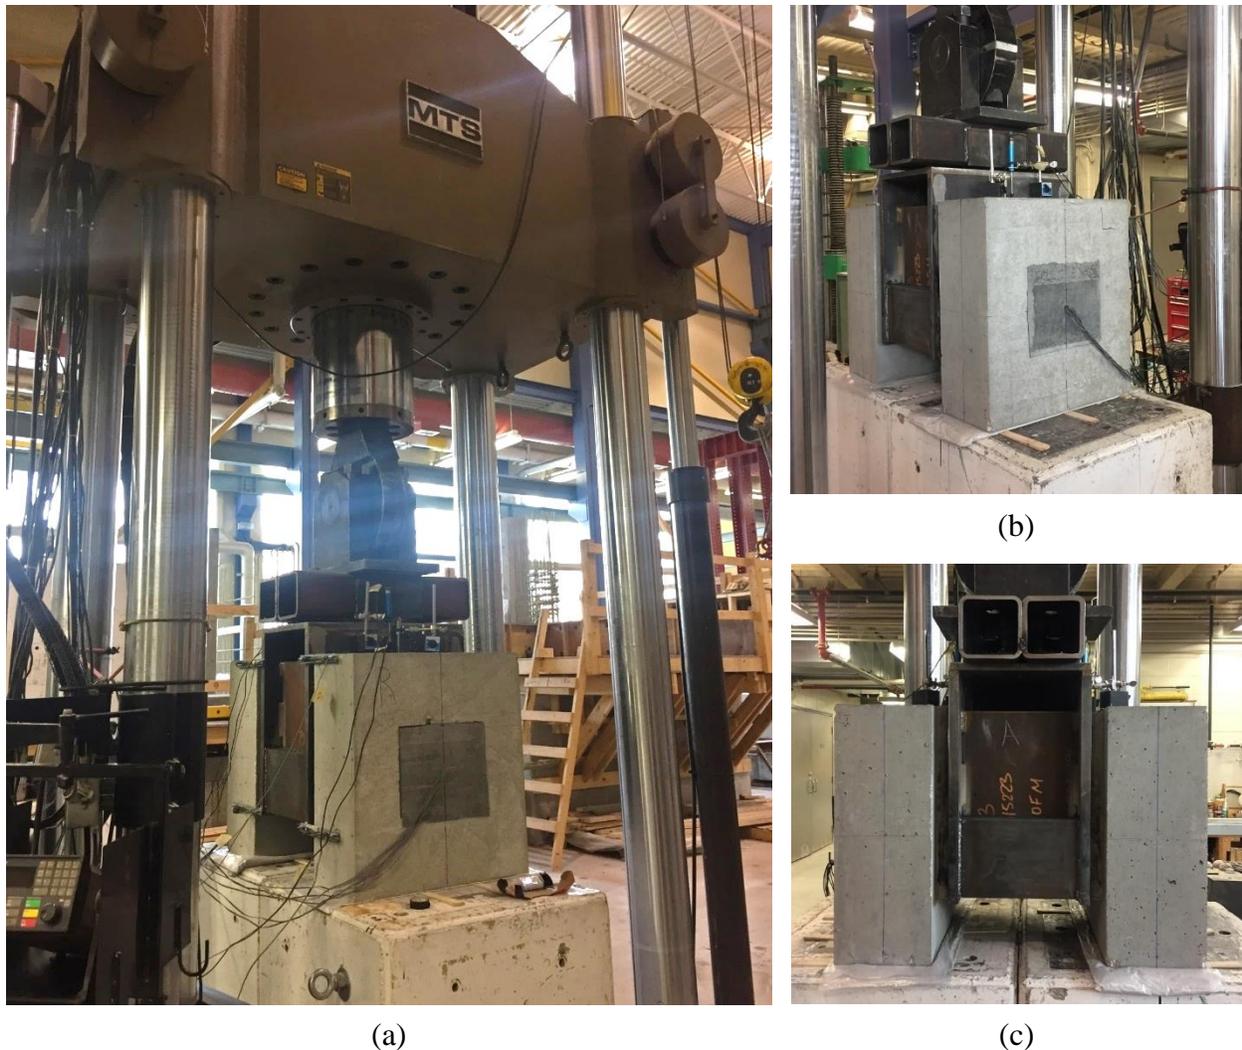
The push-out tests were performed in a hydraulic testing machine equipped with a 5000 kN capacity closed loop servo-hydraulic machine. Two large 550 x 550 x 1000 mm tall concrete blocks were placed below the testing machine to elevate the test specimens off the floor, and reduce their distance from the actuator. The push-out test specimens were levelled with plaster filled bags and shims. Figure 3.14 shows the test setup and machine.

Figure 3.14 (a) Push-out test setup and MTS machine; (b) push-out test; (c) side view of test setup.

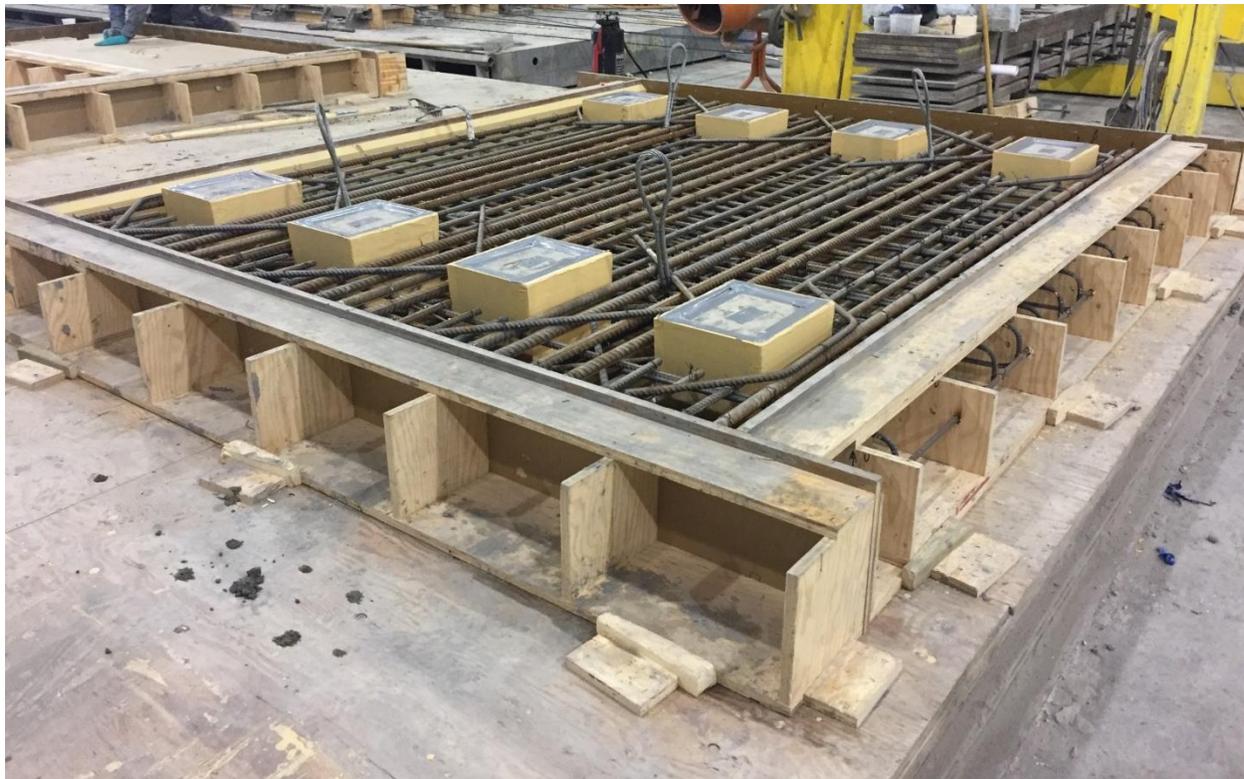
Figure 3.19 JPD half panel formwork, shear pocket blockouts and reinforcement.

The decks had bottom and top layers of reinforcement comprised of mainly 15M rebar and 20M and 25M bars in the transverse direction. The shear pocket blockouts had bent bars surrounding the openings for support. The shop drawings of the three slabs can be found in Appendix A.

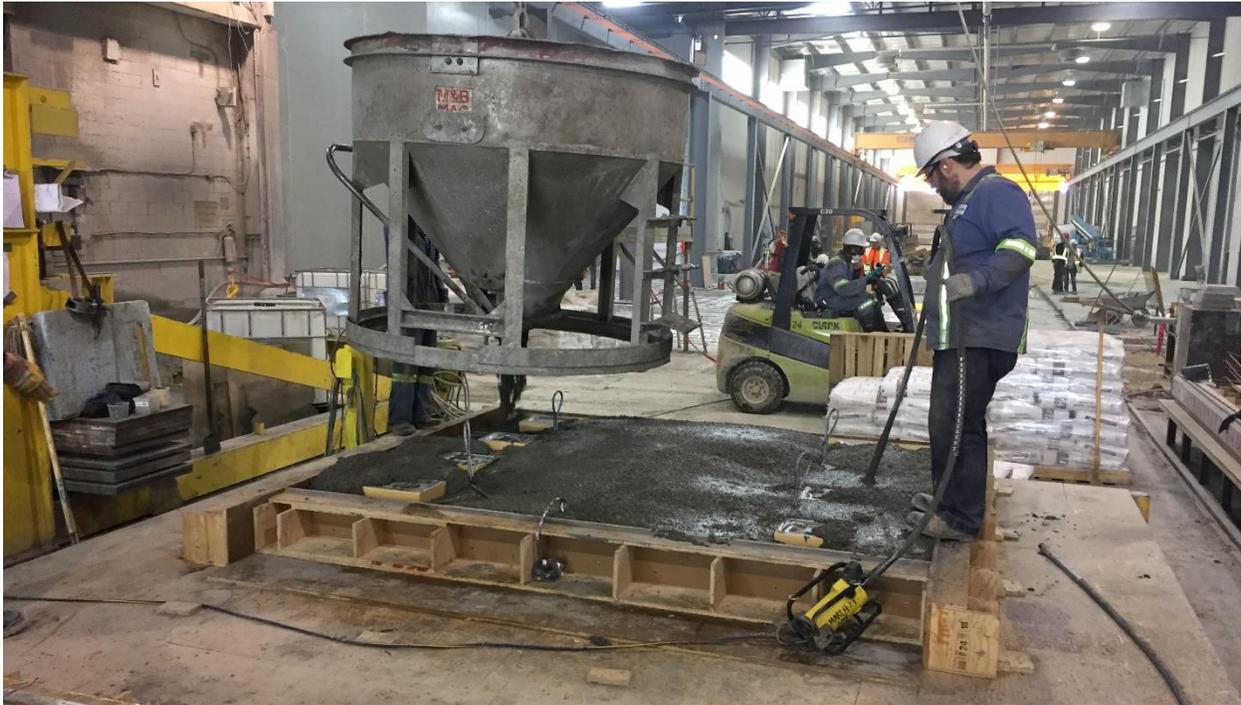
Figure 3.20 JPD half panel concrete casting and vibrating.

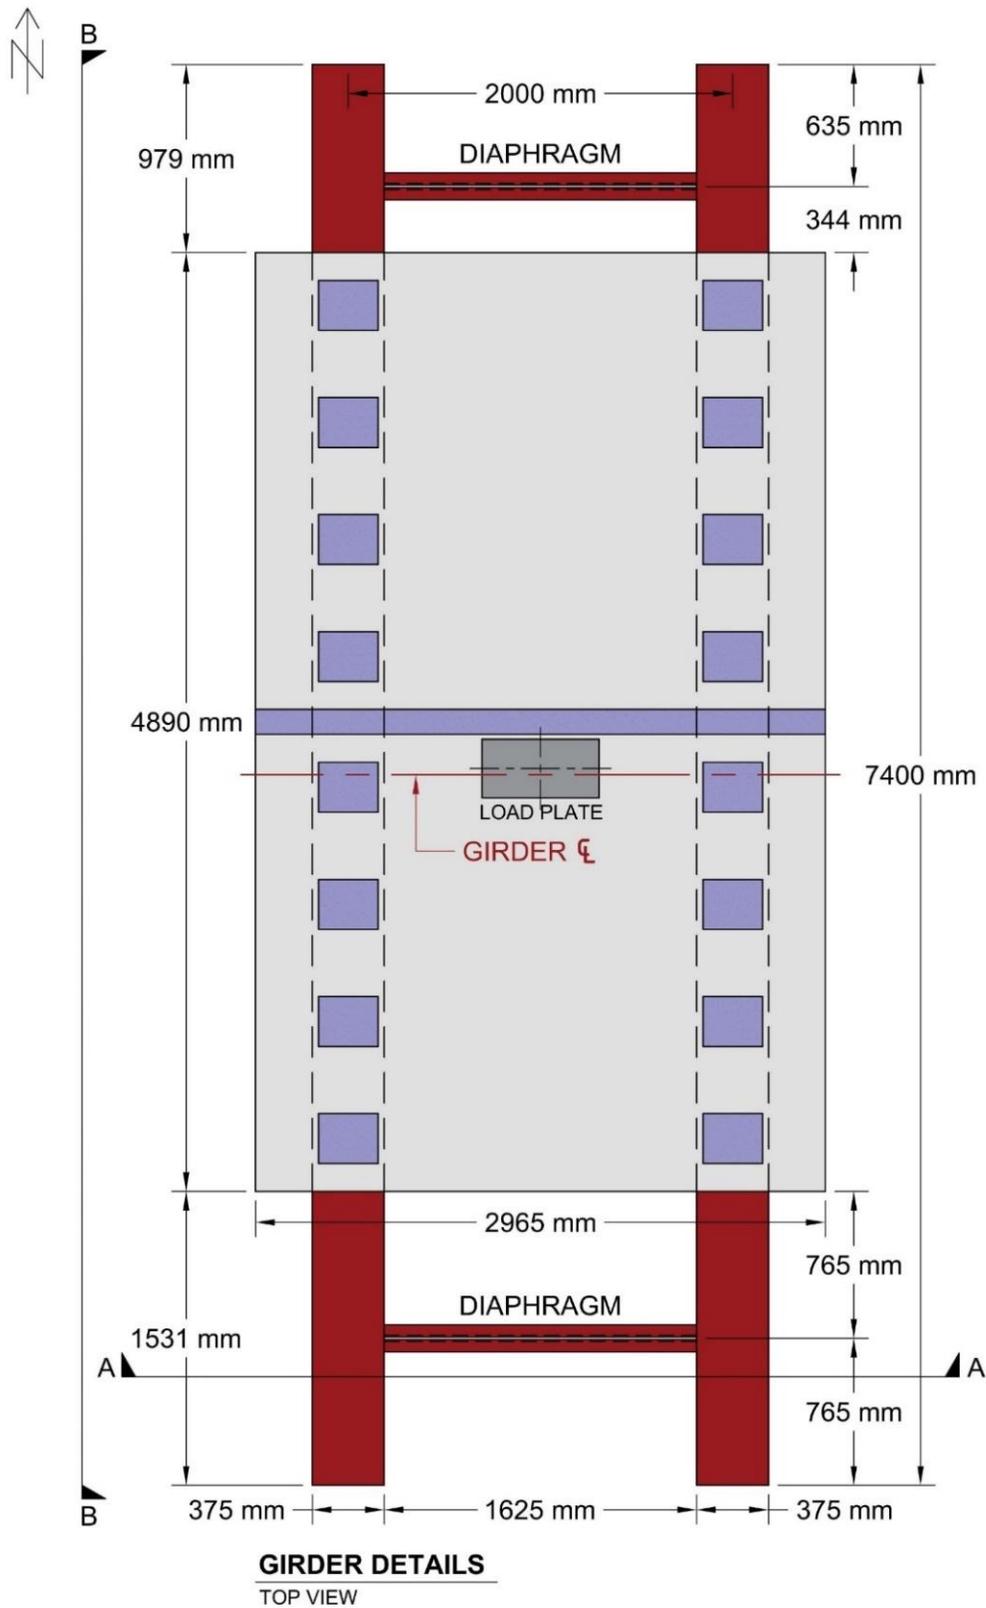
Figure 3.22 Bridge deck and support girder setup.

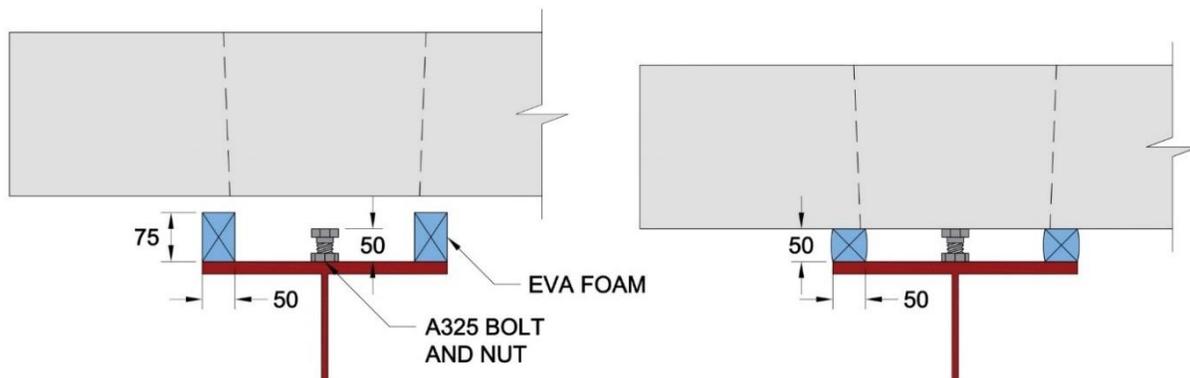
The Eden Lake bridge was designed with a 50 mm haunch between the top of the girder flanges and the bottom of the precast concrete decks. To achieve the haunch, EVA foam was glued to the edges of the girder flanges to contain the UHPC during the shear pocket casting. The EVA foam was 75 mm tall x 50 mm wide, allowing 25 mm of vertical compression to create a tight seal upon deck placement, preventing leakage of the wet UHPC during casting. As the EVA foam would not be able to support the deck slabs unaided, four nuts were welded along the centerline of both girder flanges and A325 bolts were screwed into the nuts until a height of 50 mm.

Figure 3.27 Precast deck placement for 50 mm haunch.

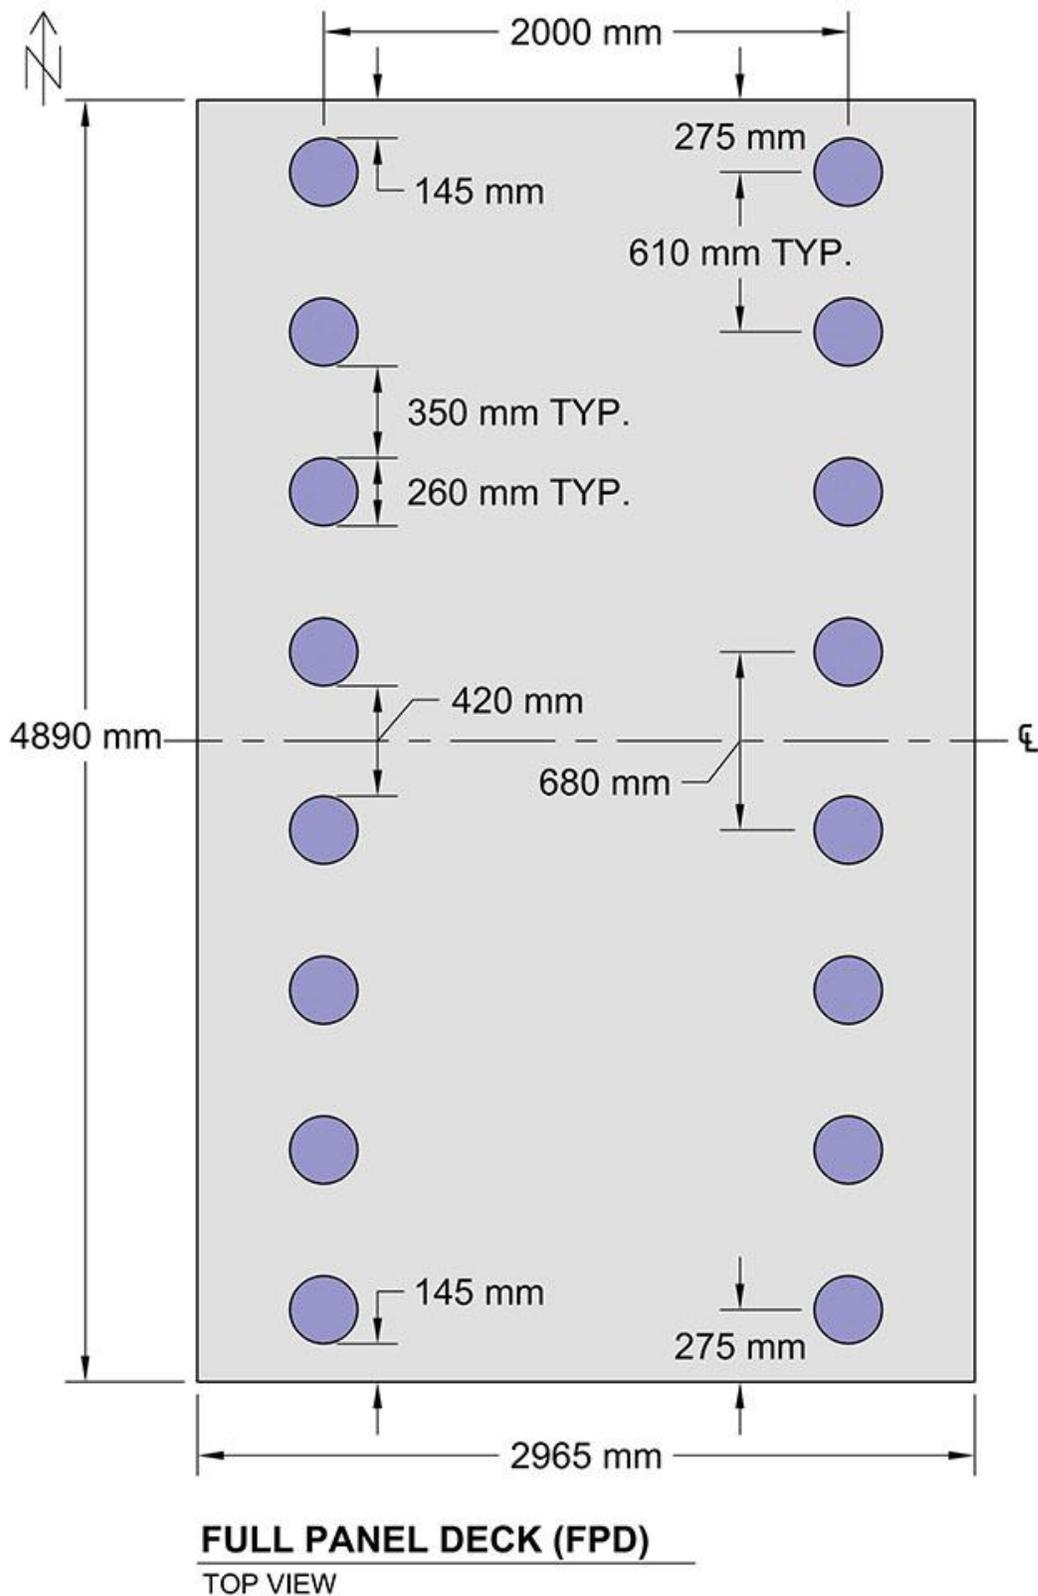
The full shear pocket layout details for the FPD and JPD can be seen in Figure 3.31 and Figure 3.32, respectively.

Figure 3.31 FPD shear pocket layout.

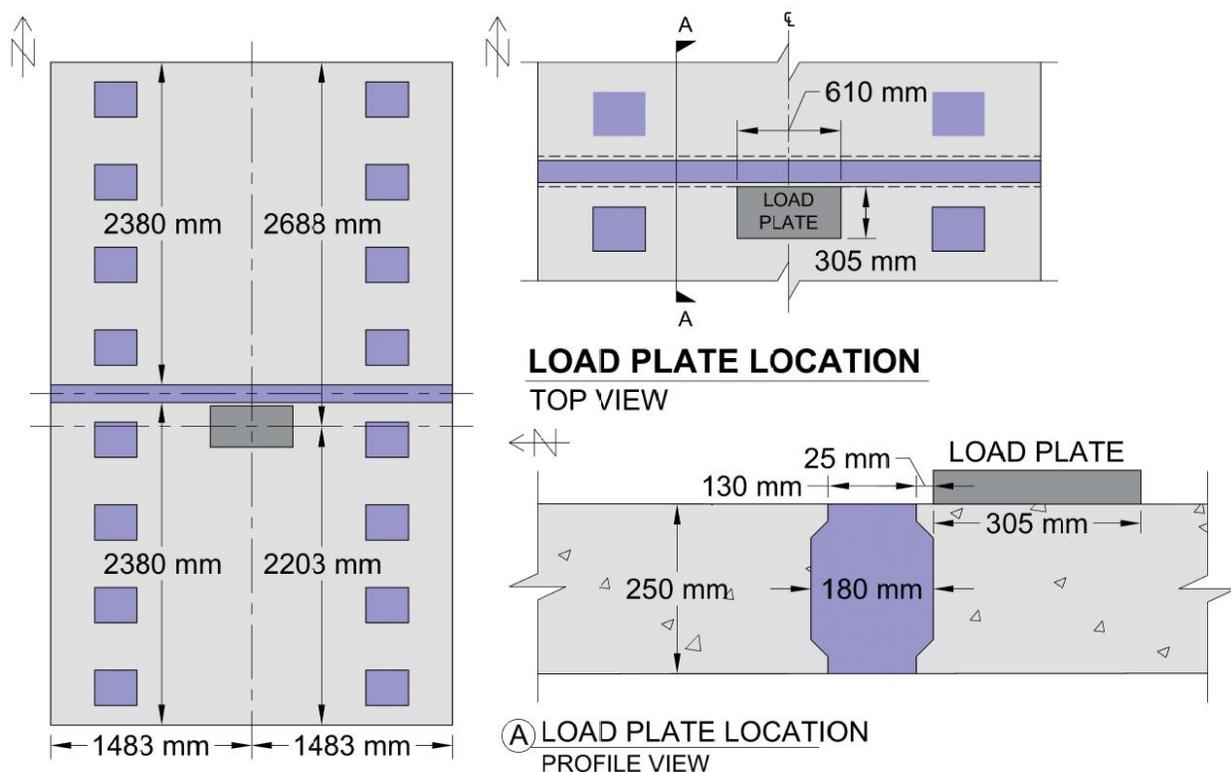
The main goal in the bridge deck testing was to understand how the load transfers across the UHPC deck-to-deck joint. Therefore, rather than place the load plate directly over the joint center, it was decided to place it adjacent to the joint interface. The load plate was aligned with the inner face of the joint, rather than the opening [Figure 3.36].

Figure 3.36 Load plate location.

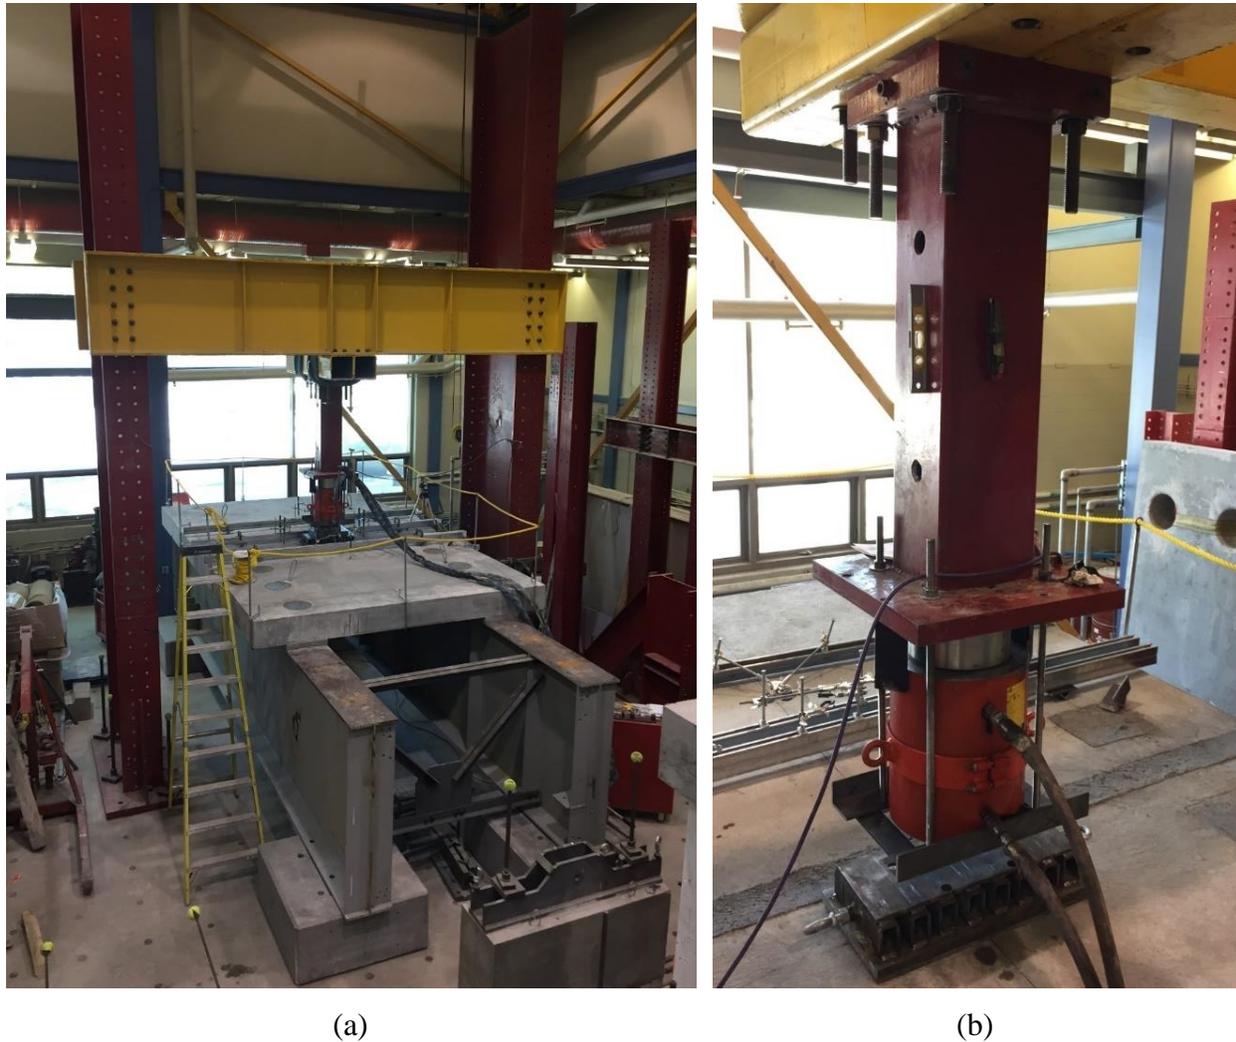
The bridge decks were tested statically until punching failure occurred. The decks were loaded with a hand operated hydraulic jack, connected to a cylindrical spring piston with a capacity of 5000 kN. Once the first crack appeared the loading was paused every 200 kN to mark crack progressions until a load of 1400 kN for both decks. After this point the loading continued without interruption until complete failure. The load frame used consisted of two heavy duty W-section

steel columns with a beam across from which to mount the load cell. To secure the load frame for testing, each column had two 25 mm diameter bars prestressed at 3175 kgs to the strong floor.

Figure 3.37 Load setup for deck testing: (a) overall test setup, (b) close-up of load cell and load plate.
