**THE BEHAVIOUR OF ULTRA-HIGH-PERFORMANCE CONCRETE IN  
PRECAST CONCRETE BRIDGE DECK CONNECTIONS**

A Thesis submitted to the Faculty of Graduate Studies of  
The University of Manitoba  
in partial fulfillment of the requirements of the degree of

Department of Civil Engineering  
University of Manitoba  
Winnipeg, Manitoba

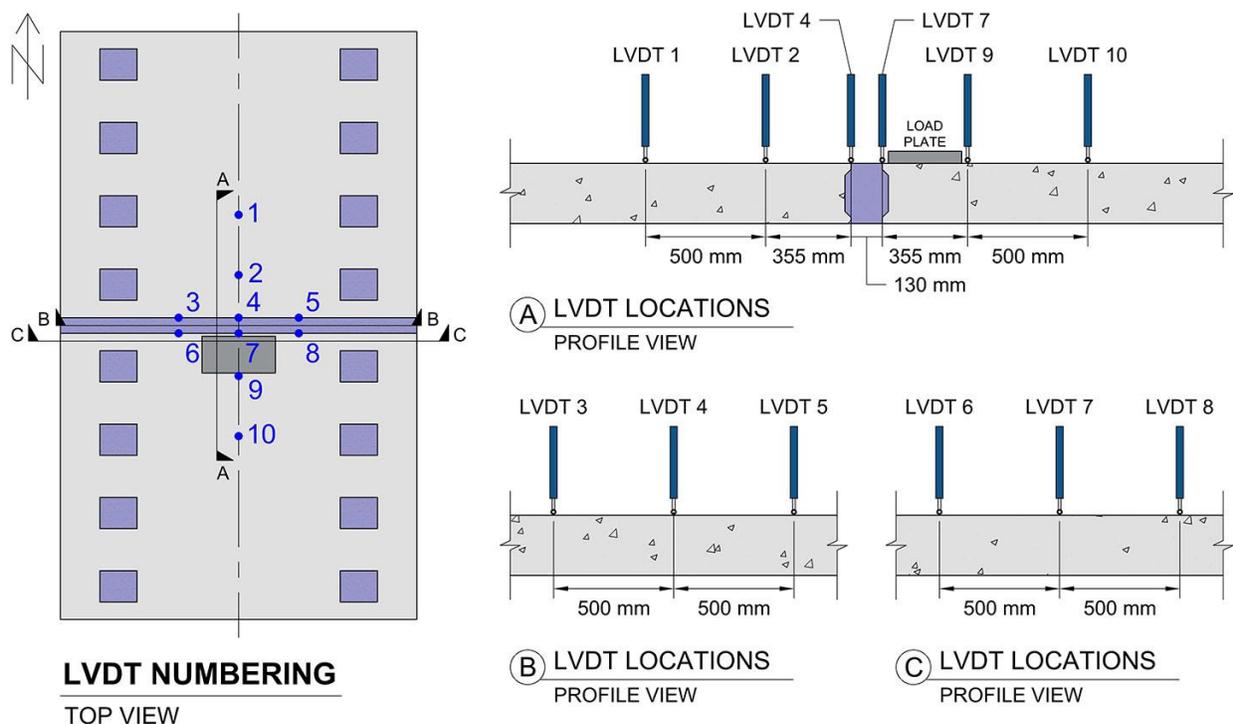
LVDTs were placed along the bridge deck centerlines and two rows transversely along both joint-deck interfaces [see Figure 3.38]. Though the figure shows the JPD, the LVDT locations on the FPD are the same. The LVDTs were mounted to clamps attached to three channels placed transversely between LVDTs 1 and 2, along the joint centerline, and between LVDTs 9 and 10. For simplicity, this is not shown in Figure 3.38.

Figure 3.38 LVDT setup for JPD and FPD.

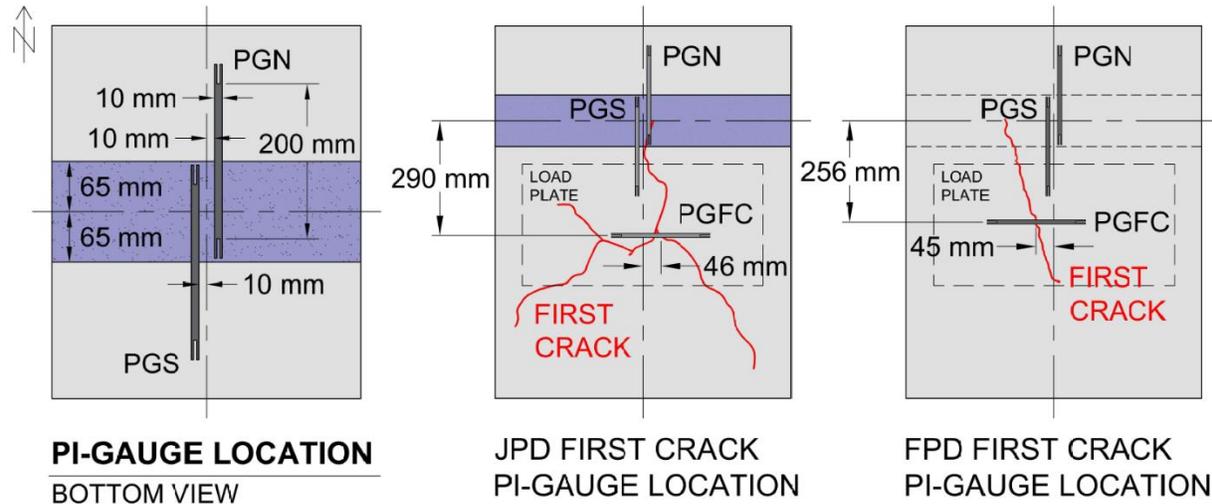
readings to the JPD. On both decks a third pi-gauge was placed perpendicular to the first crack. The first crack on both decks occurred underneath the load plate, therefore the pi-gauges are in similar locations as shown in Figure 3.39. The pi-gauge nomenclature for the results section will herein refer to the gauge across the northern joint-deck interface as “PGN” and similarly the gauge across the southern joint-deck interface is “PGS”. The pi-gauges added at the first visible crack are referred to as “PGFC”.

Though the pi-gauge readings are labelled as crack widths, the JPD-PGN and PGS are measuring the separation across the deck-joint interface indicating if debonding occurred.

Figure 3.39 Pi-gauge locations for JPD and FPD.

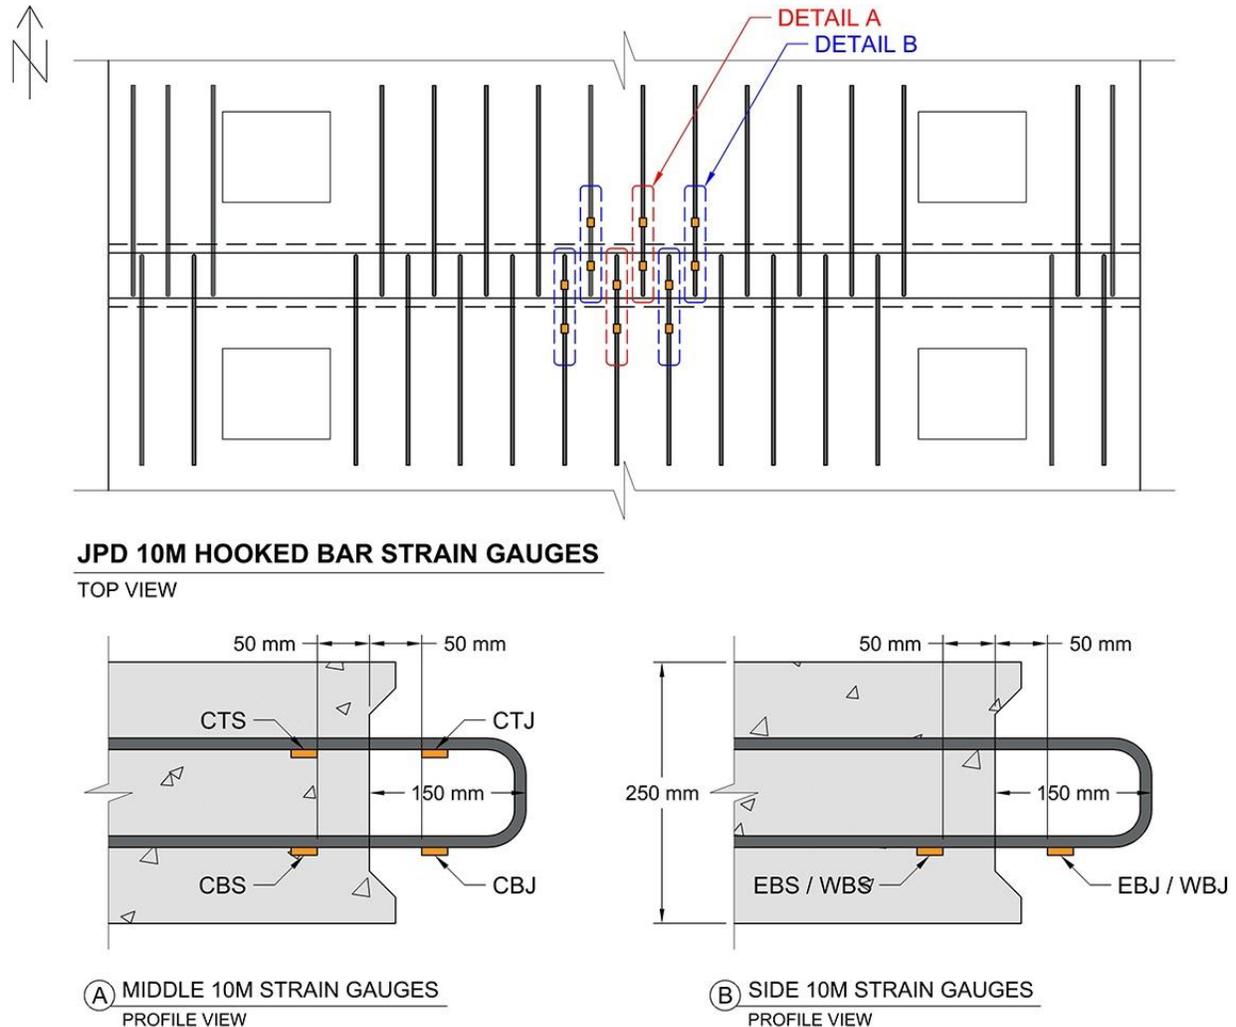
transfer of load from the RC panel through the UHPC joint to the connected RC panel. Therefore, the three centermost 10M hooks from each JPD panel were instrumented. The gauges were installed 50 mm from the joint interface within the RC for both JPD panels, and 50 mm into the joint. The strain gauges in the RC panels were instrumented prior to the panel casting at LafargeHolcim, whereas the strain gauges within the joints were instrumented at the University of Manitoba prior to casting the UHPC joint. The middle 10M hook had gauges on the bottom face of the top and bottom of the hooked bar, and the bars on either side only had gauges on the bottom face of the bottom of the hooks [see Details A and B of Figure 3.42].

Figure 3.42 JPD internal rebar strain gauge instrumentation.

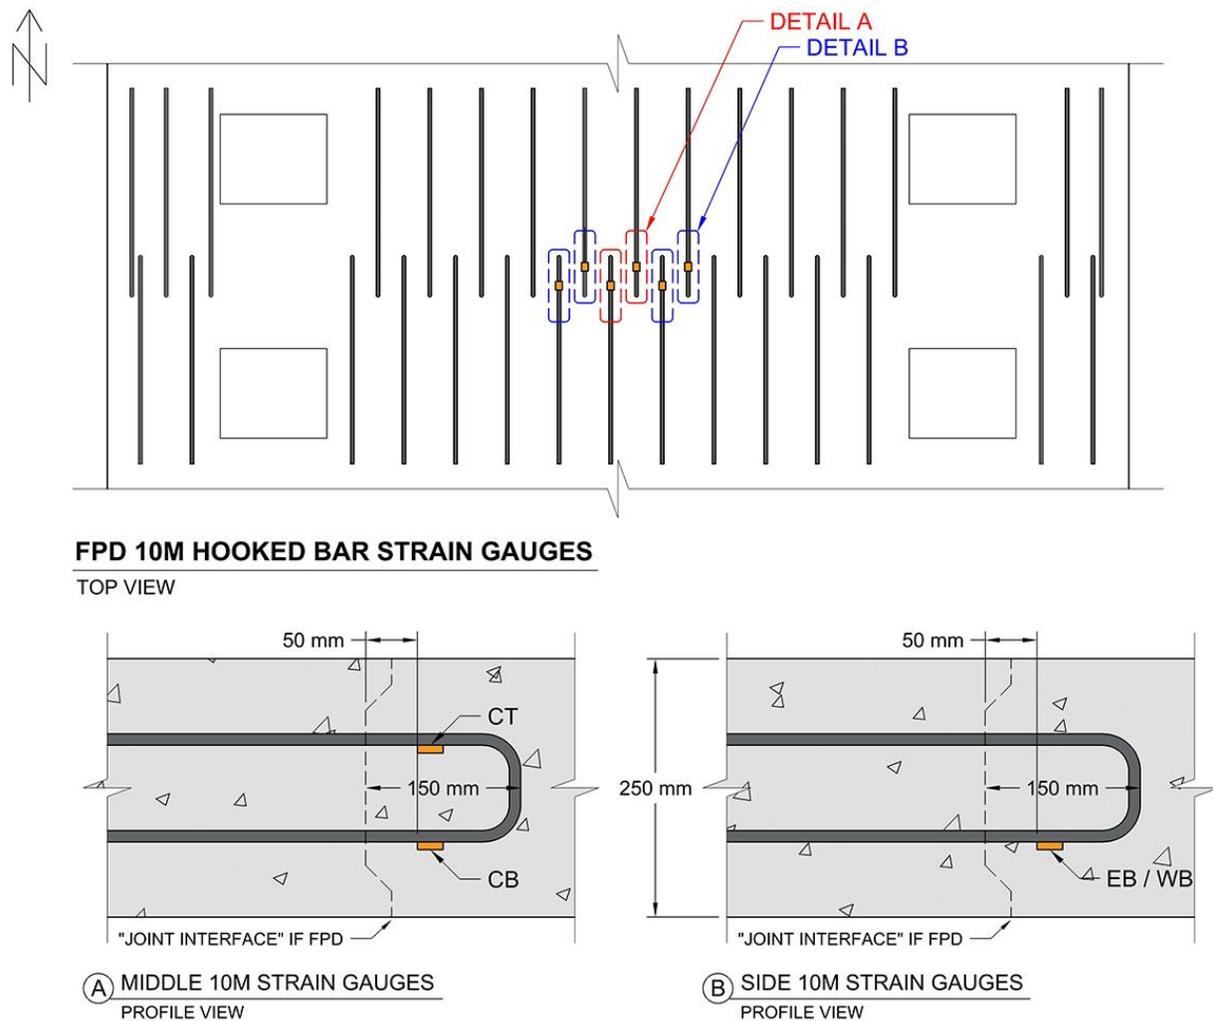
The 10M hooks located in the center of the FPD were instrumented with strain gauges similar to the JPD; however, since there was no UHPC joint, there was only one set of strain gauges glued to the bars [see Figure 3.43]. The two transverse 15M bars along the “joint” location were instrumented with strain gauges on the bottom face at the center of the bars in the FPD only.

Figure 3.43 FPD internal rebar strain gauge instrumentation.

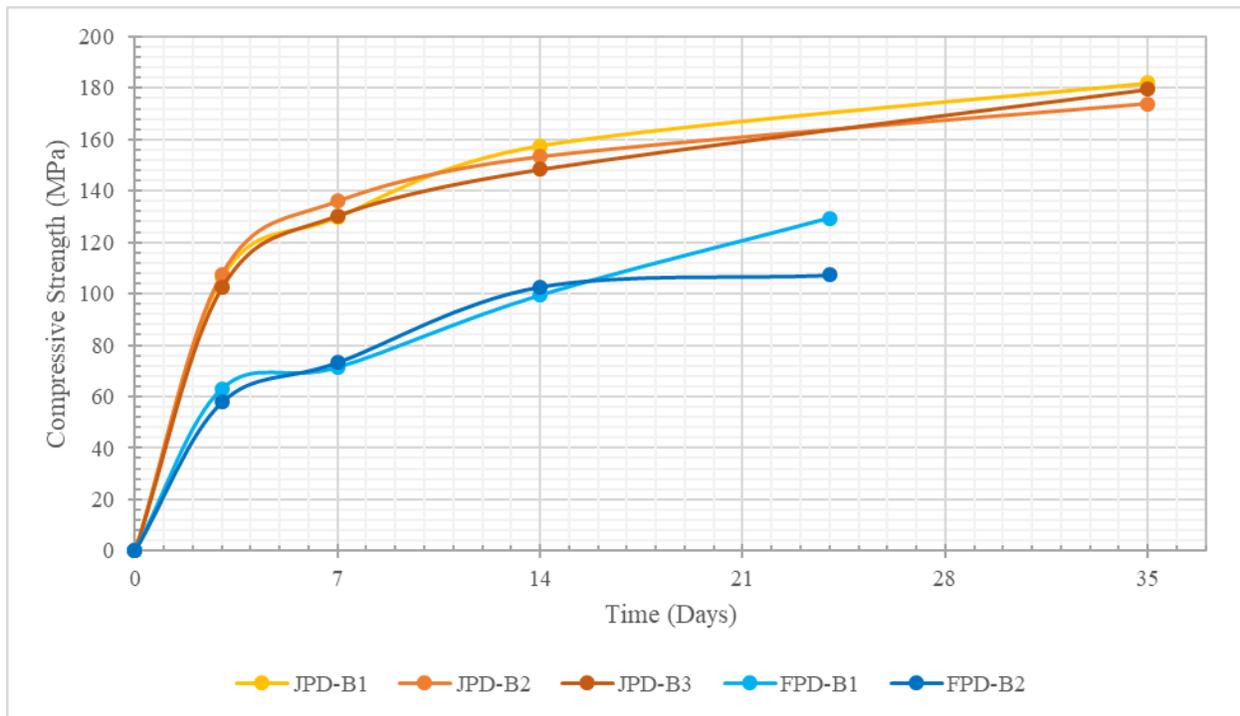
assumed to have resulted from the age of the UHPC cement and potential exposure to moisture. The second batch of the FPD demonstrates a slow strength increase, whereas the first batch appears to be increasing at a greater rate, approaching the expected compressive strengths with time [Figure 4.2].

Figure 4.2 Bridge deck connection UHPC compressive strength development.

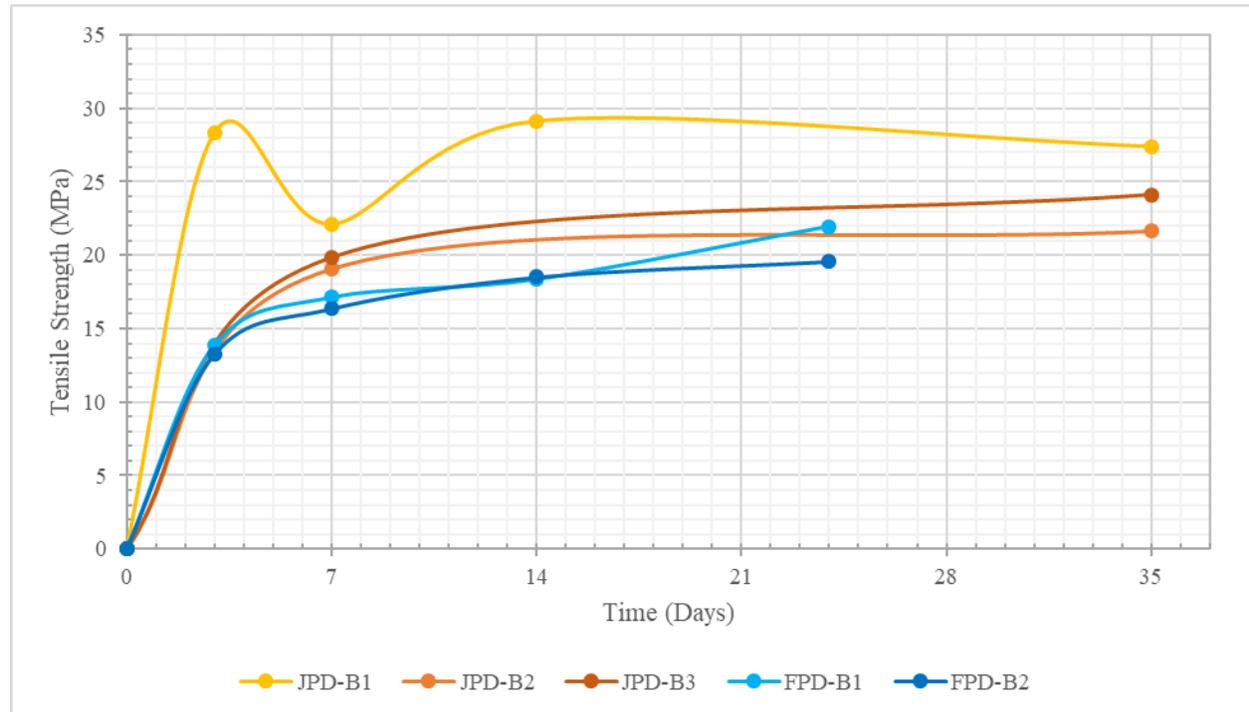
Figure 4.3 Bridge deck connection UHPC tensile strength development.

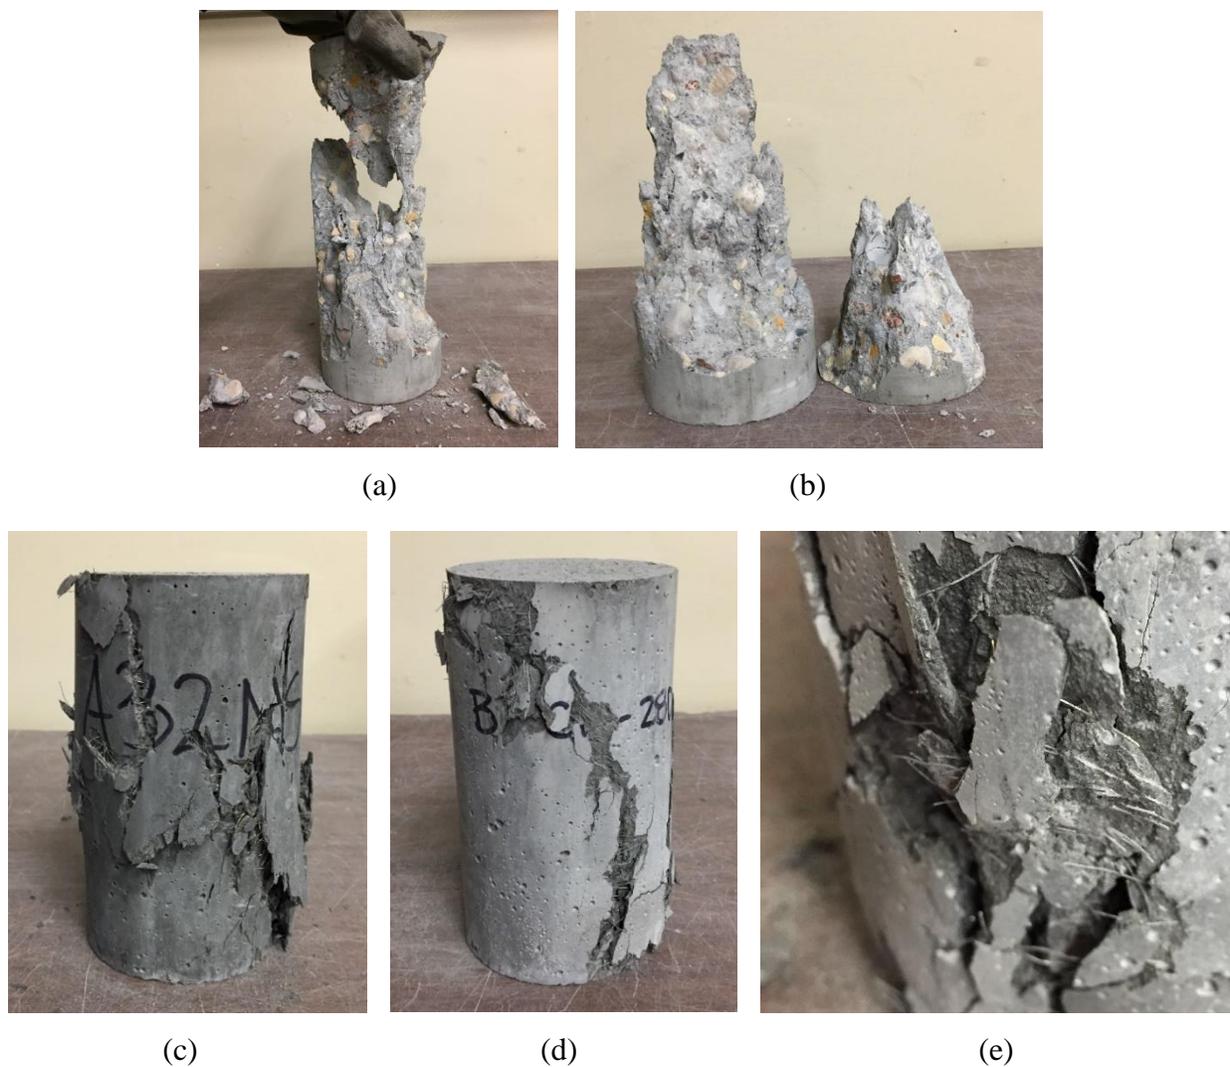
Figure 4.4 includes photographs of the RC and UHPC compression cylinders after testing. The first two photographs are of the same cylinder from the RC, and display a typical compression cylinder failure that would be defined as a Type 2 in the ASTM C39 compression cylinder test standard since there is one defined cone from one end and not from the other [8]. The UHPC cylinder failure is not as disruptive since the steel fibers hold the concrete together and prevent the cylinder from breaking apart. Photographs (c) and (d) are of different UHPC cylinder failures, and (e) is a close up on the cracking seen from another angle of the cylinder from (d).

Figure 4.4 Compression cylinders after testing: (a) and (b) are RC, and (c) to (e) are UHPC.

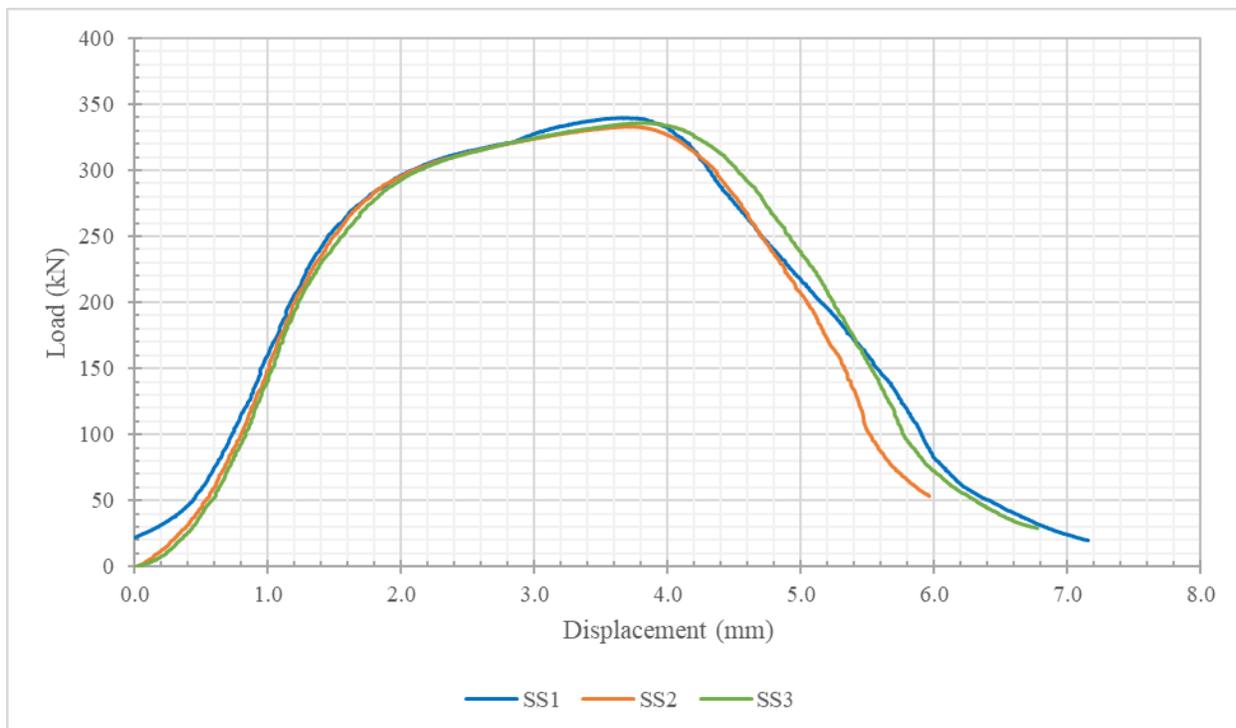
The shear test results on the shear studs are presented below. The three studs failed at very similar loads for an average ultimate load of 336 kN and an average shear strength of 332 MPa [Table 4.6]. Due to the high strength and ductility of steel, the shearing surface is not a perfectly clean break, which can be seen in the photographs of Figure 4.6.

Figure 4.5 Shear stud shear tests displacement development.

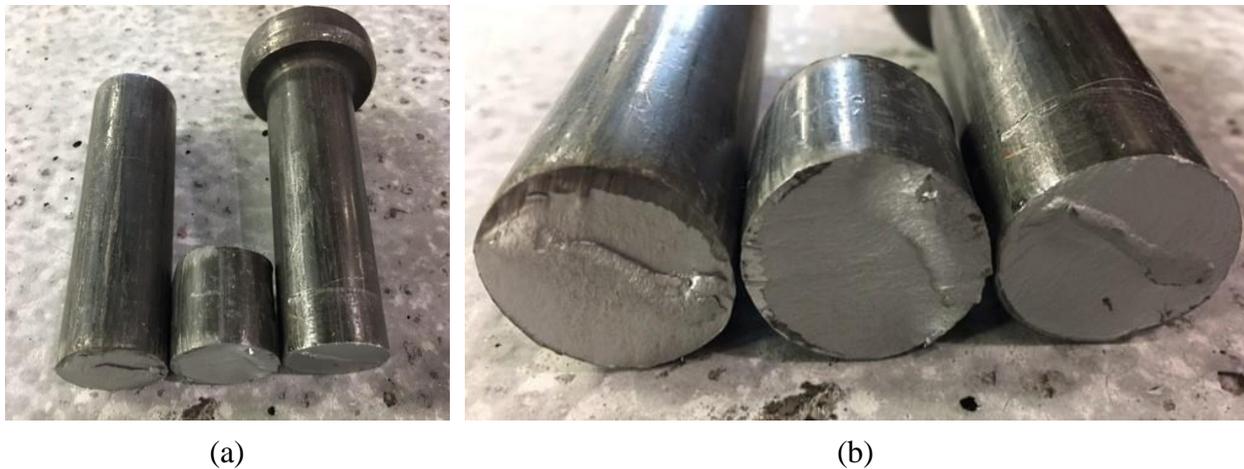
Figure 4.6 Shear stud shear failure.

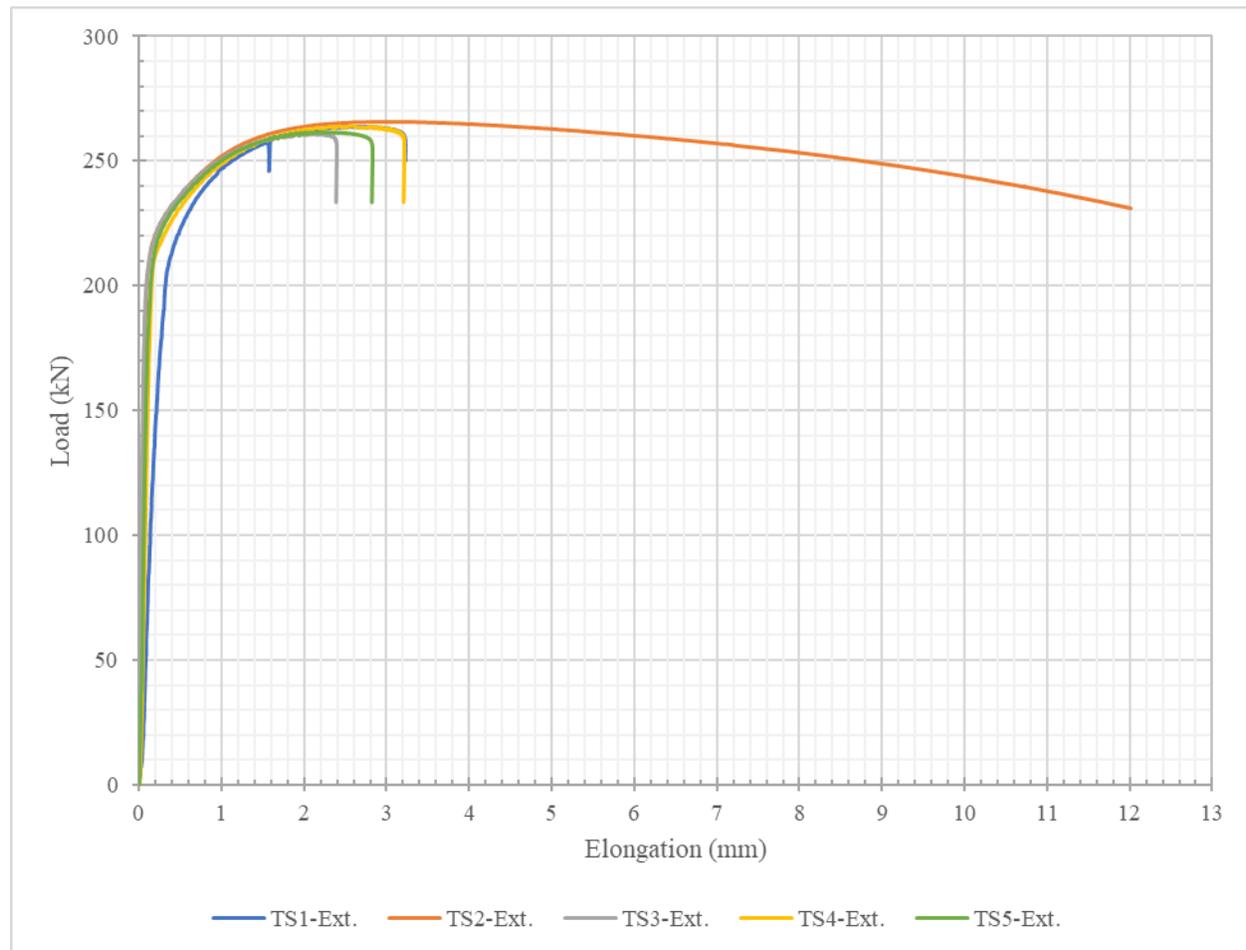
Figure 4.7 Elongation of the shear studs during direct tension testing.

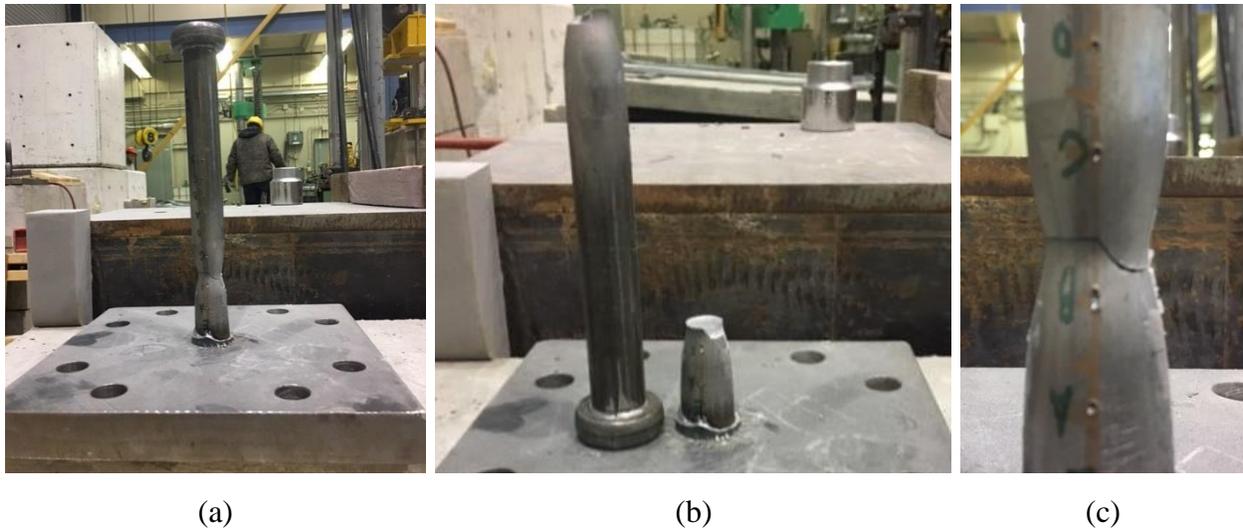
Figure 4.8 Shear stud tension failure.

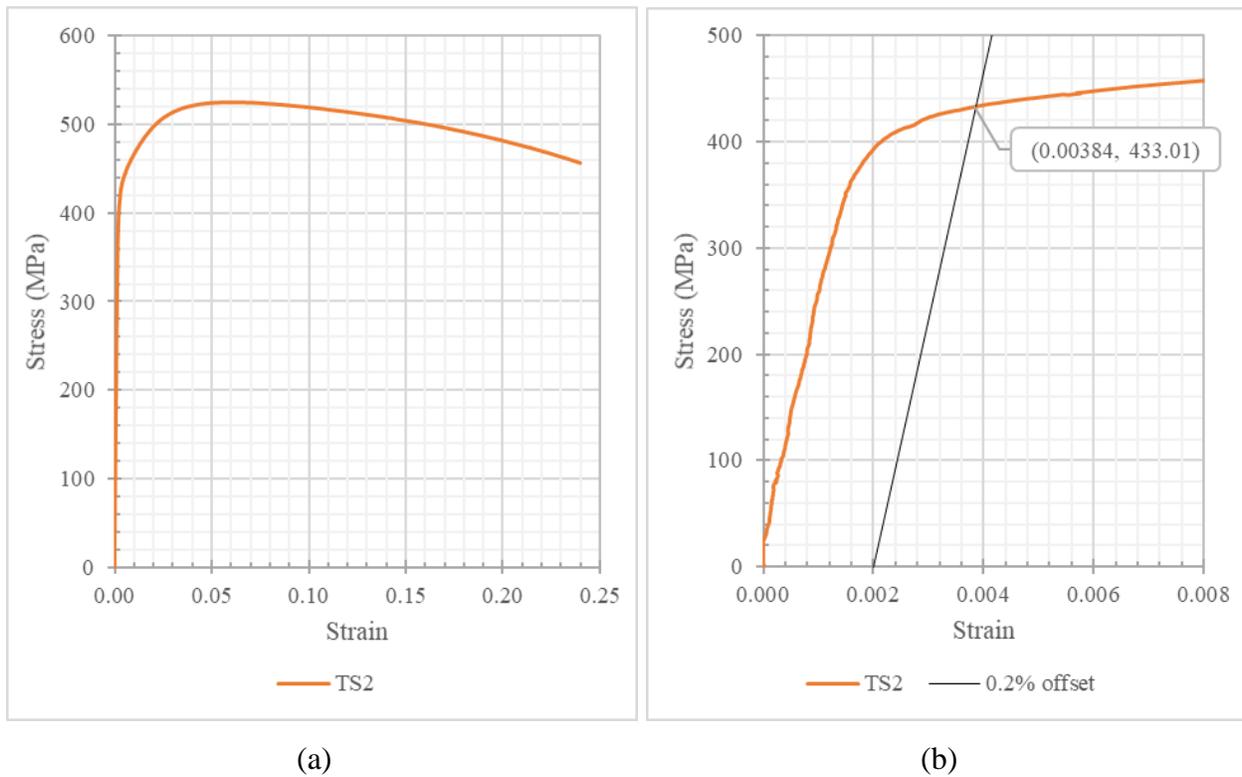
Figure 4.9 Stress-strain curves for shear stud TS2: (a) full data set; (b) 0.2% offset method for shear stud yield strength and modulus of elasticity.

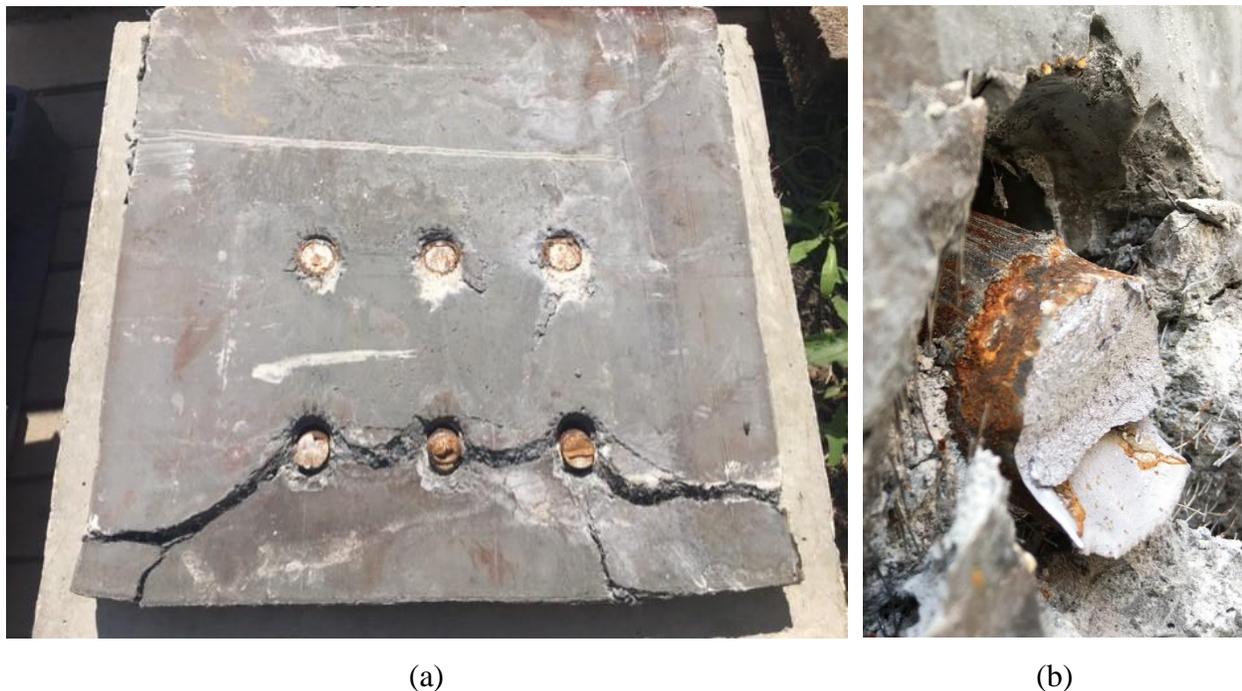
Figure 4.10 SP6-2A stud shearing failure: (a) UHPC haunch with studs still inside, and (b) close-up on bottom left shear stud base.

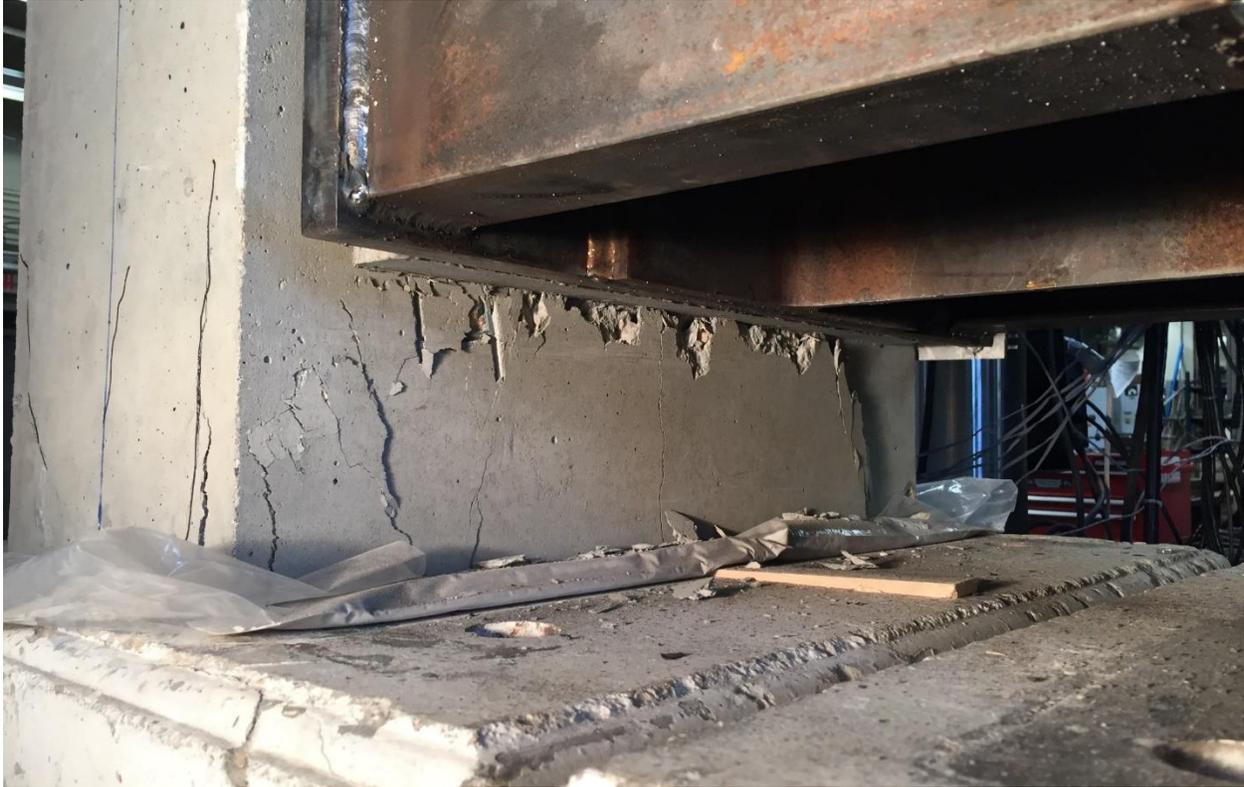
Figure 4.11 SP6-3A concrete crushing failure.

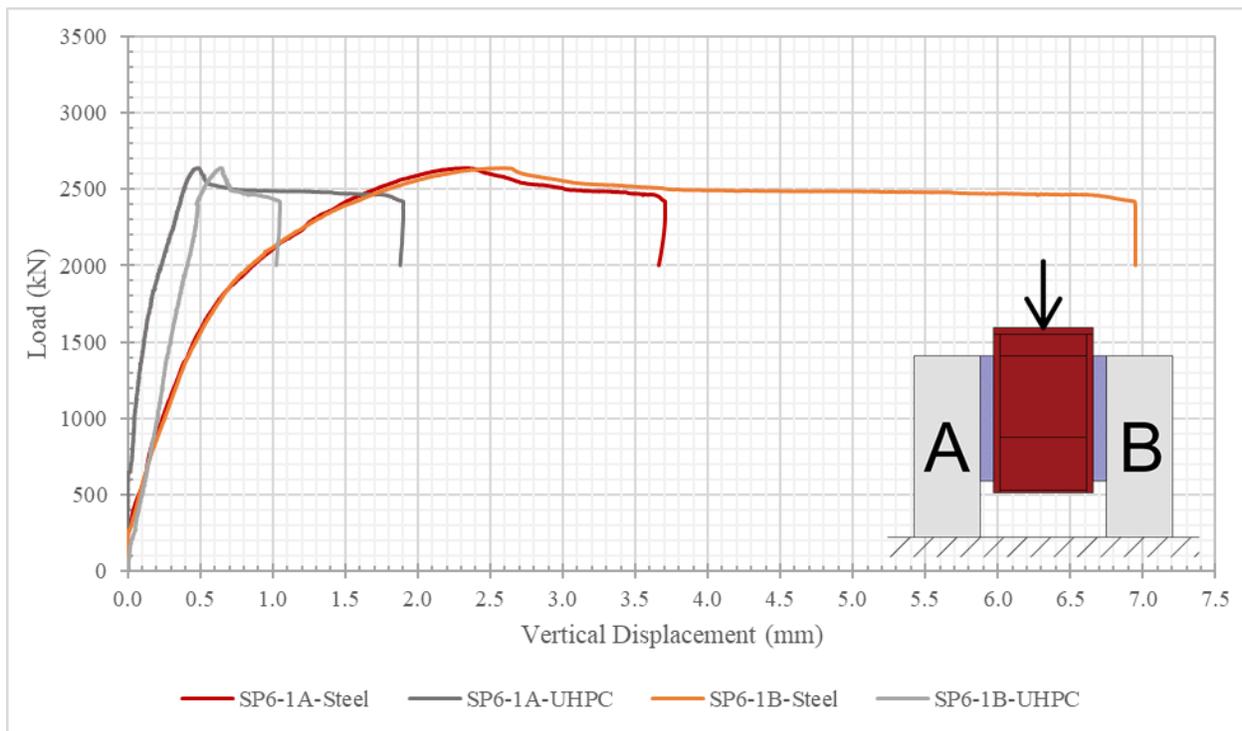
Figure 4.12 SP6-1 vertical displacement development.

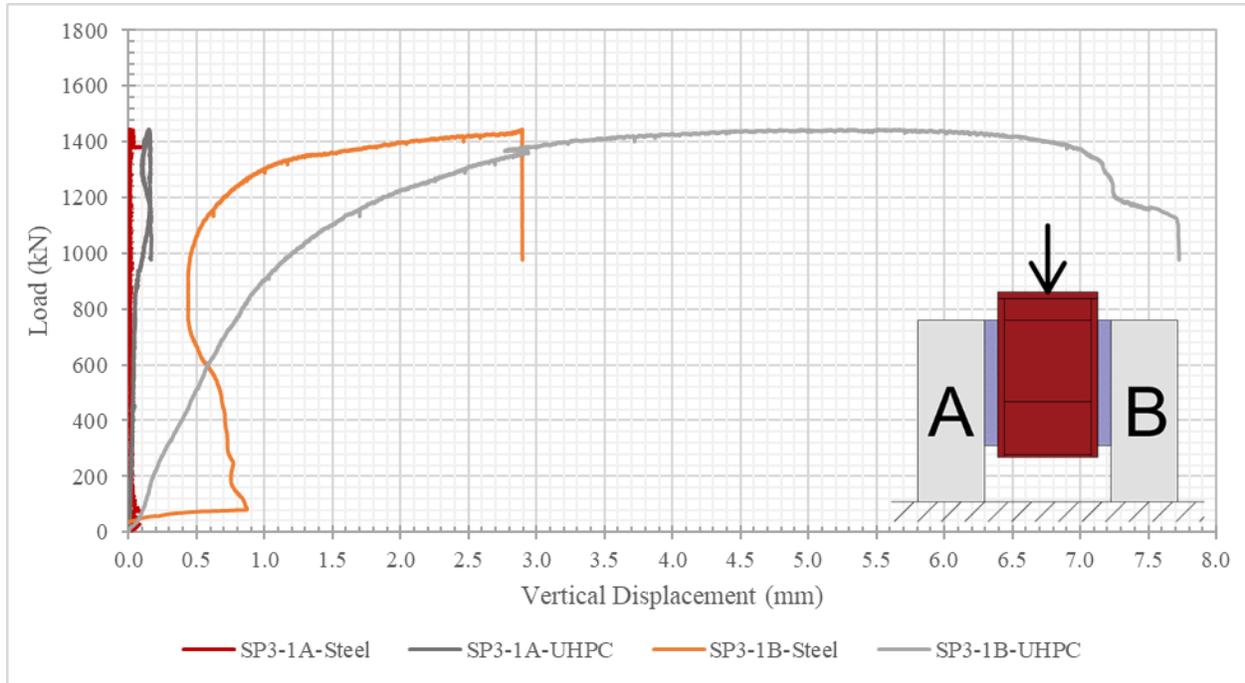
debonded from their shear pockets. Despite displacement behaviour, both SP3-2A and B failed through the eventual shearing off of the studs.

Figure 4.15 SP3-1 vertical displacement development.

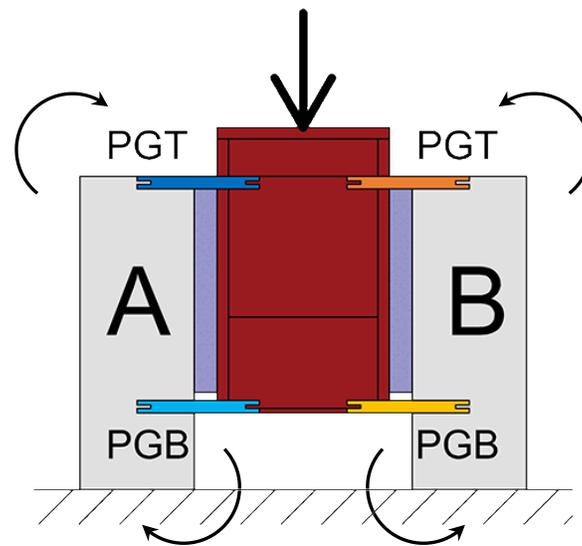
Figure 4.17 Shear pocket specimen rotation.

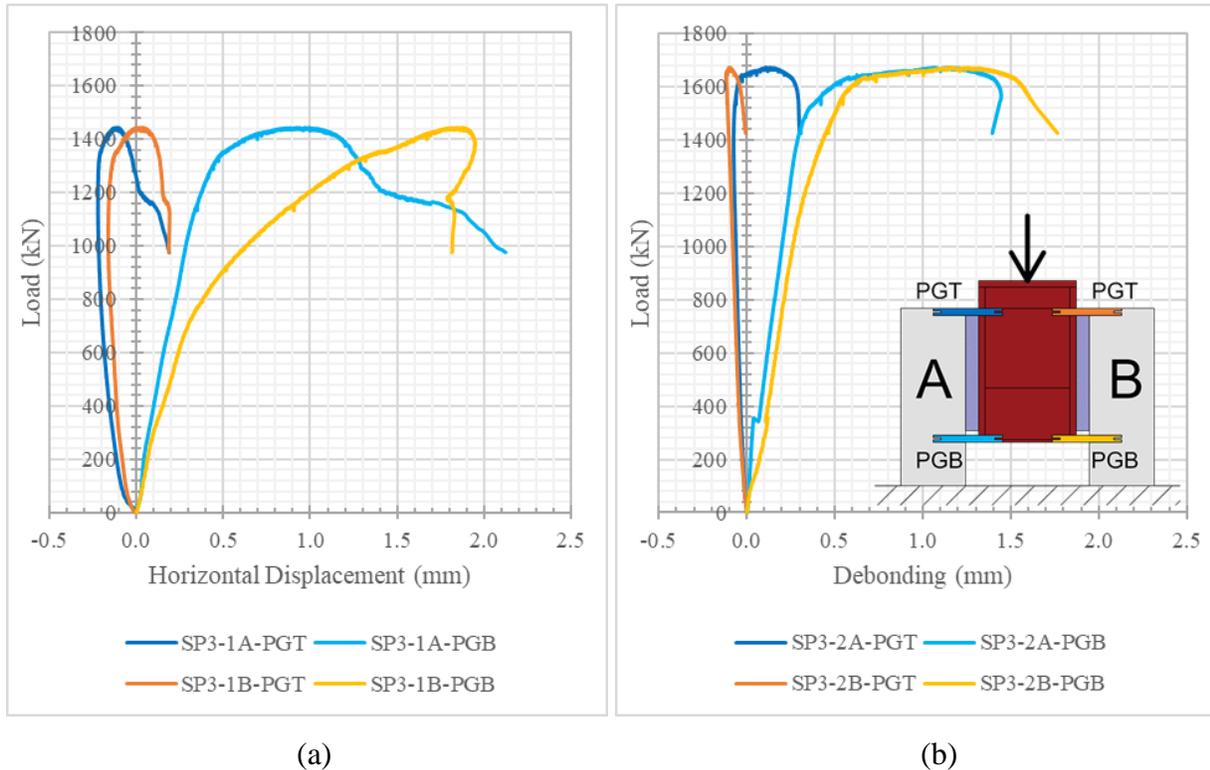
Figure 4.19 UHPC and steel debonding for specimens (a) SP3-1, and (b) SP3-2.

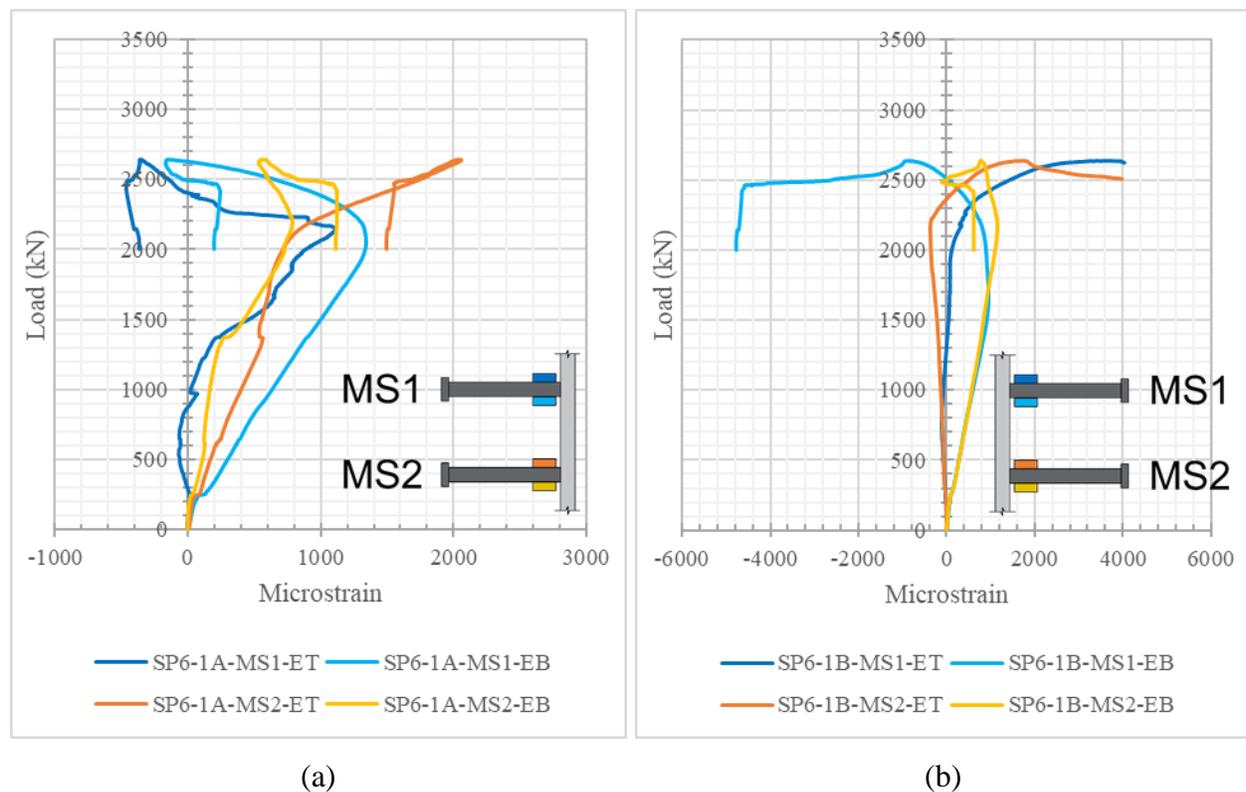
Figure 4.22 SP6-1 shear stud strain development for (a) specimen A, and (b) specimen B.

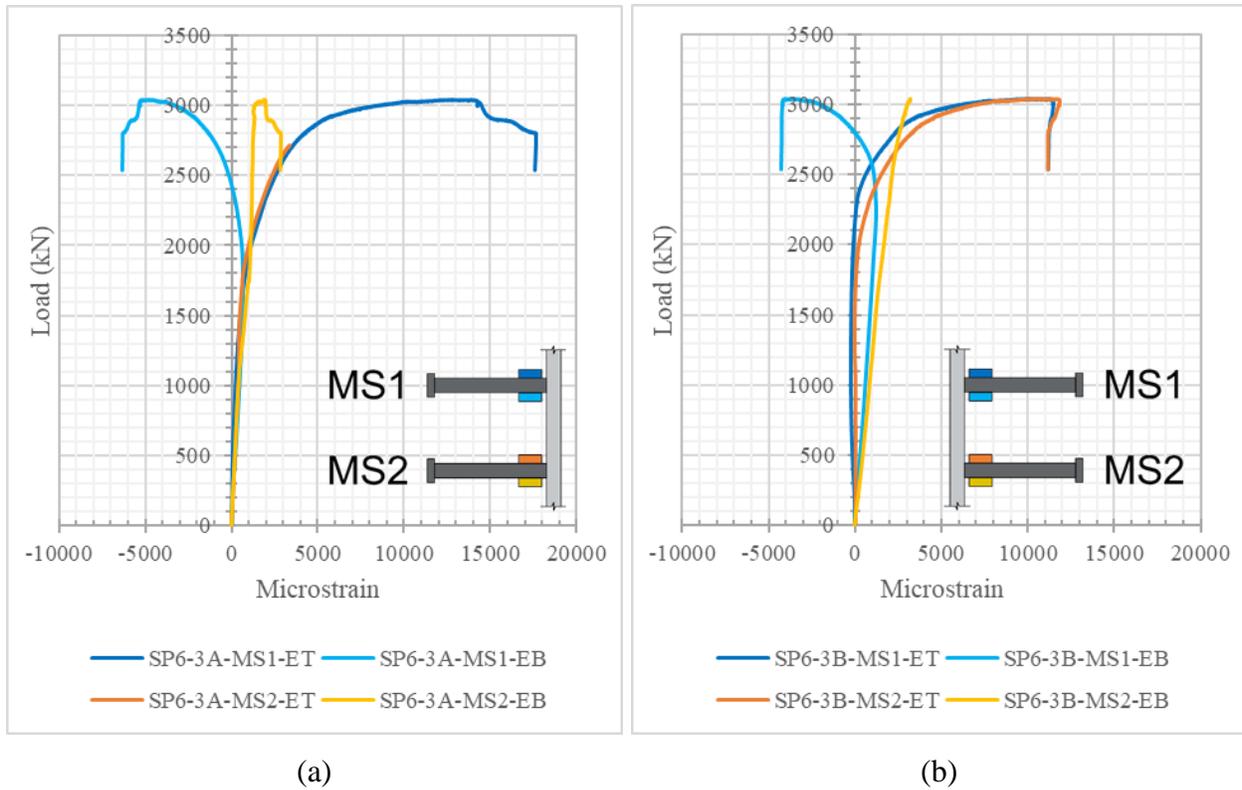
Figure 4.24 SP6-3 shear stud strain development for (a) specimen A, and (b) specimen B.

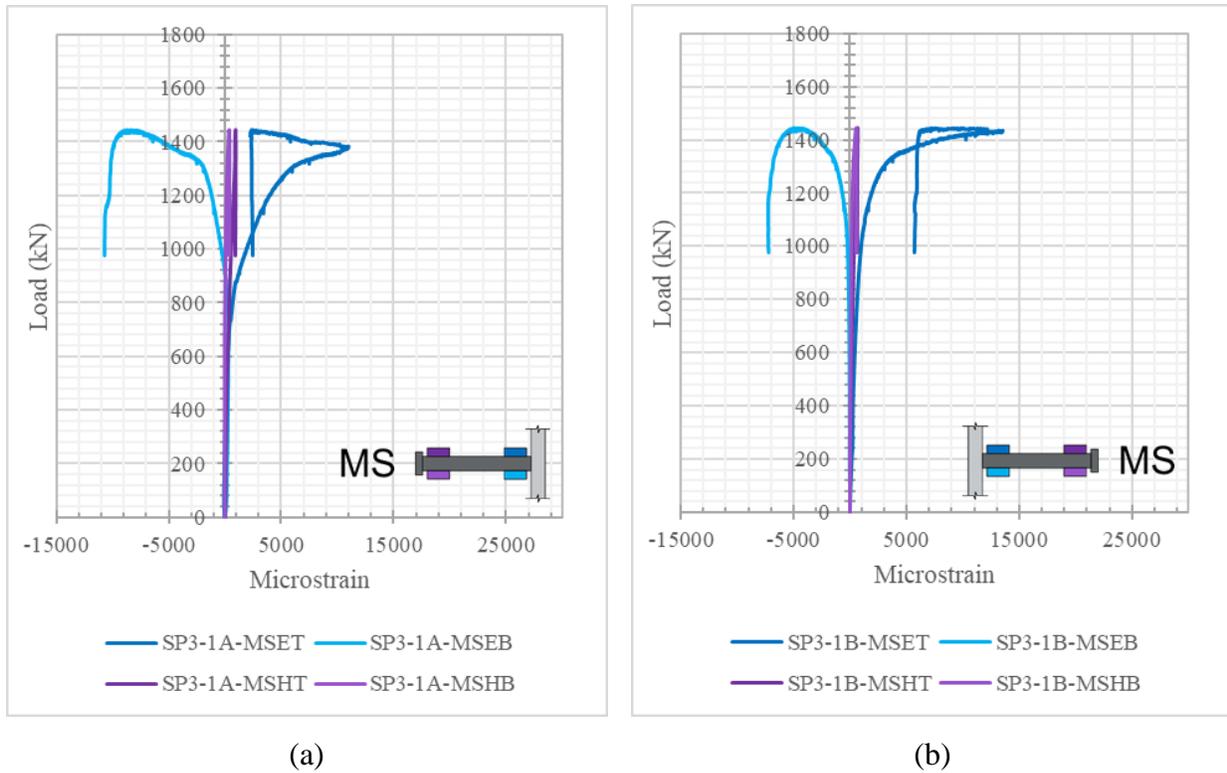
Figure 4.25 SP3-1 shear stud strain development for (a) specimen A, and (b) specimen B.

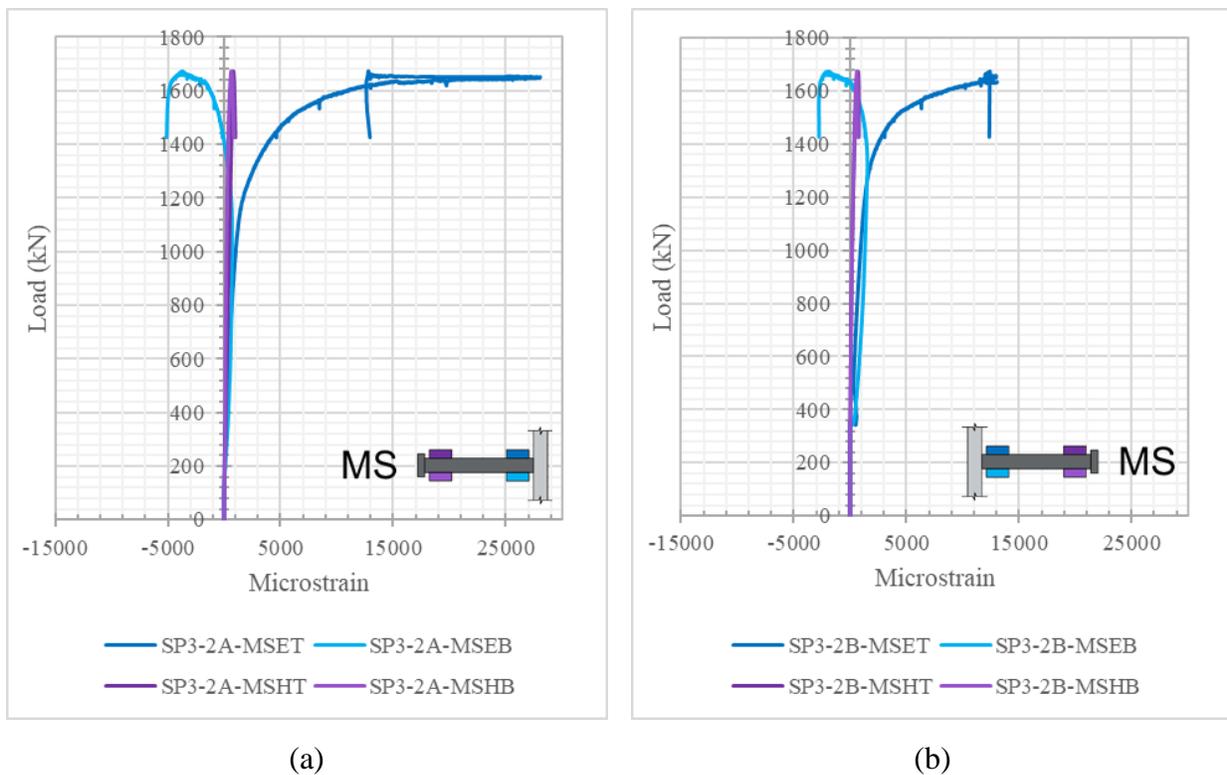
Figure 4.26 SP3-2 shear stud strain development for (a) specimen A, and (b) specimen B.

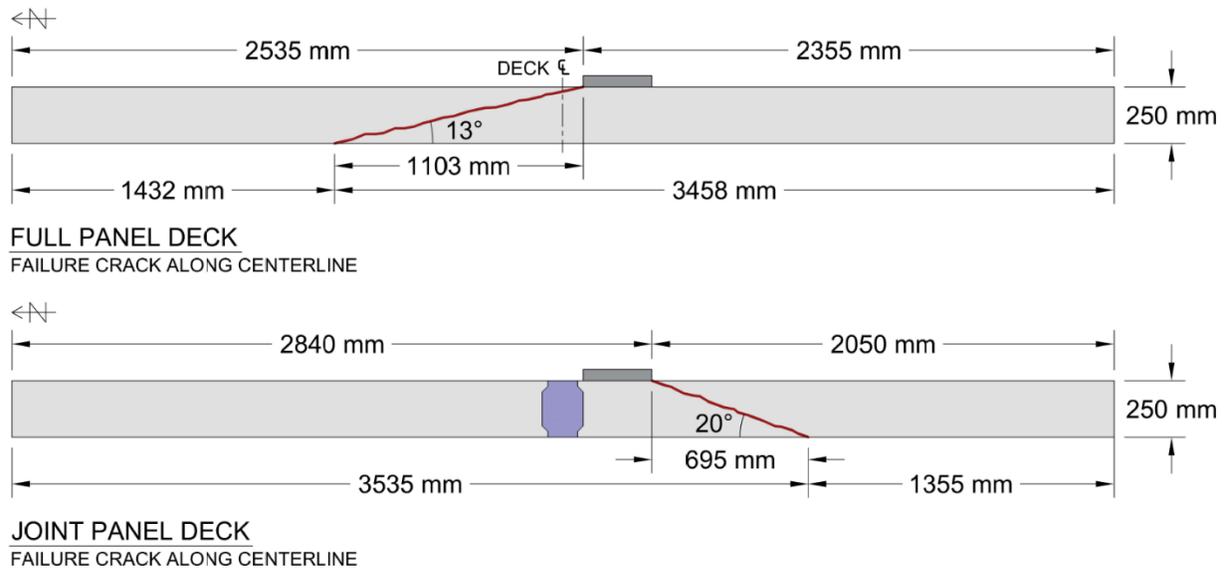
Figure 4.27 Failure crack along longitudinal centerline for FPD and JPD.
