**THE BEHAVIOUR OF ULTRA-HIGH-PERFORMANCE CONCRETE IN  
PRECAST CONCRETE BRIDGE DECK CONNECTIONS**

A Thesis submitted to the Faculty of Graduate Studies of  
The University of Manitoba  
in partial fulfillment of the requirements of the degree of

Department of Civil Engineering  
University of Manitoba  
Winnipeg, Manitoba

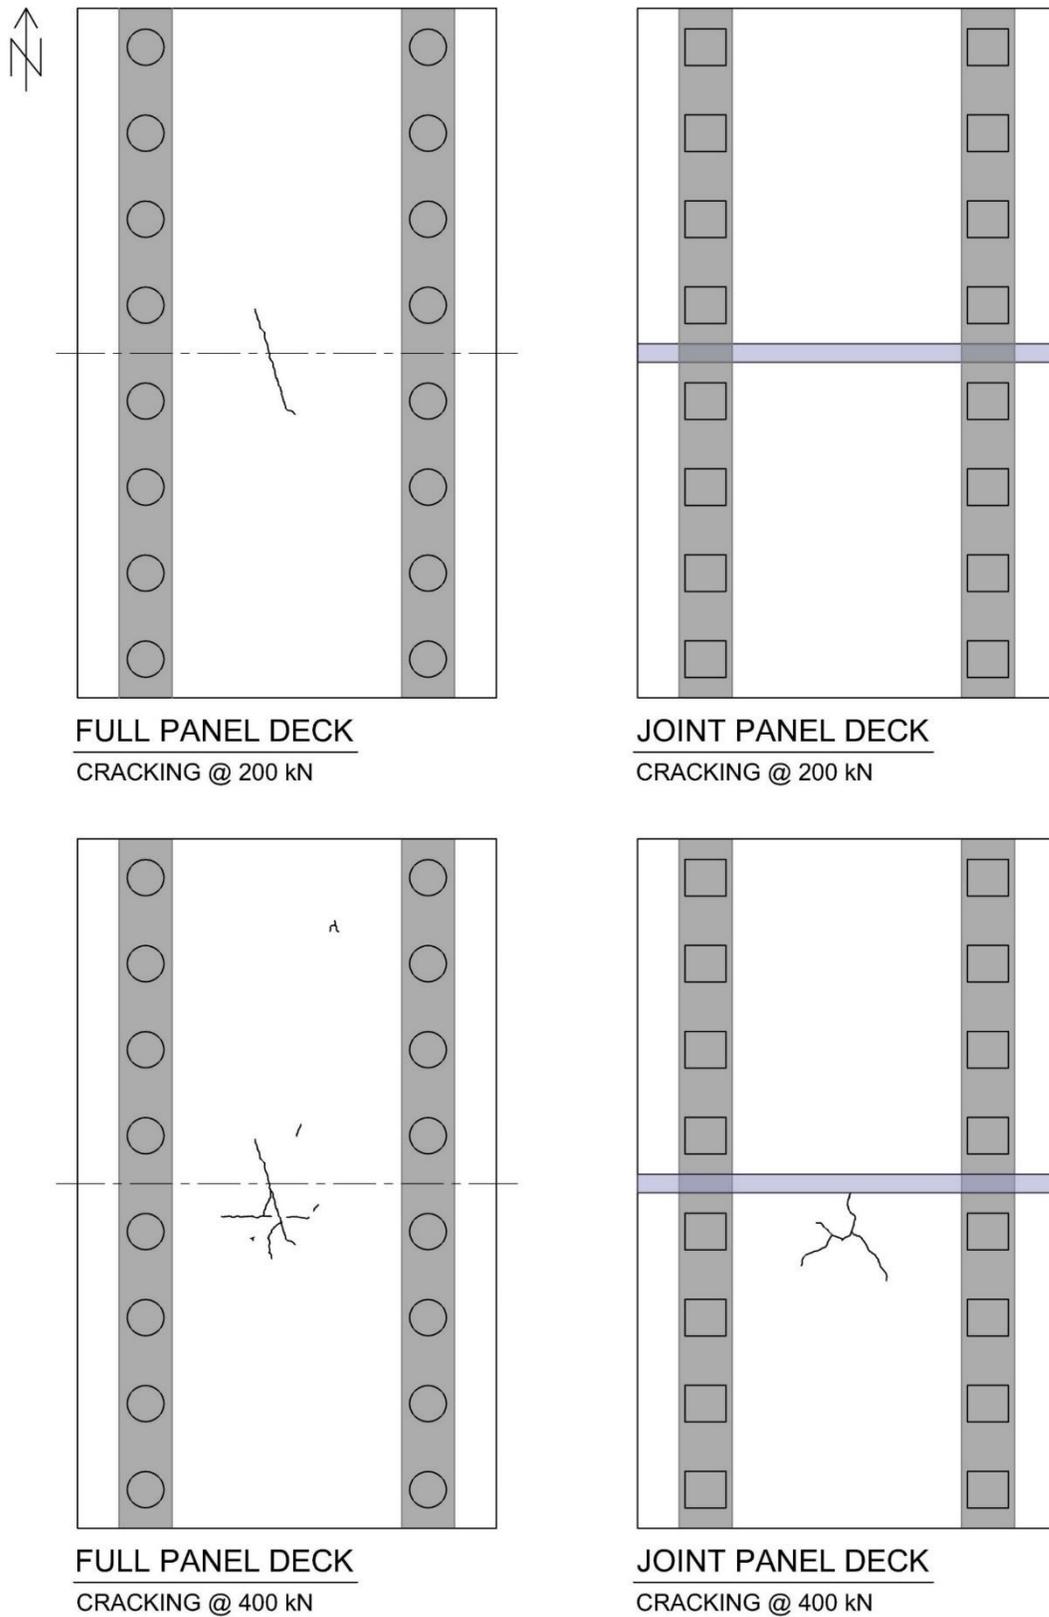
Figure 4.28 Crack development at 200 kN and 400 kN during bridge deck testing.

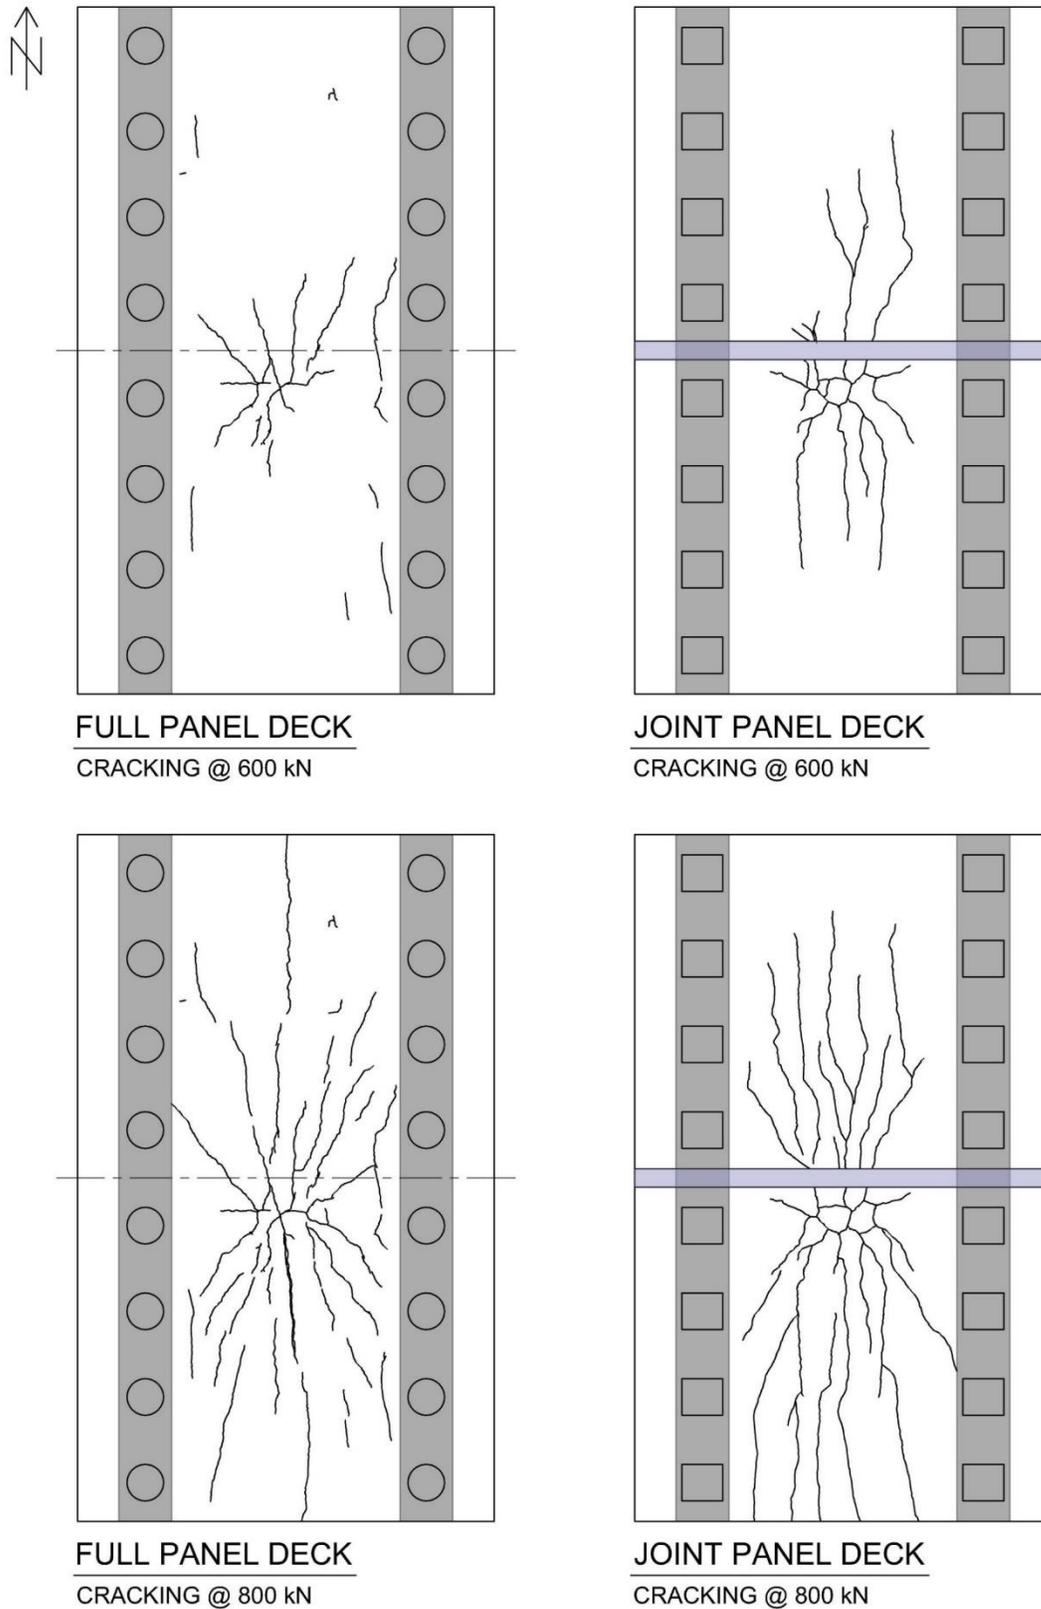
Figure 4.29 Crack development at 600 kN and 800 kN during bridge deck testing.

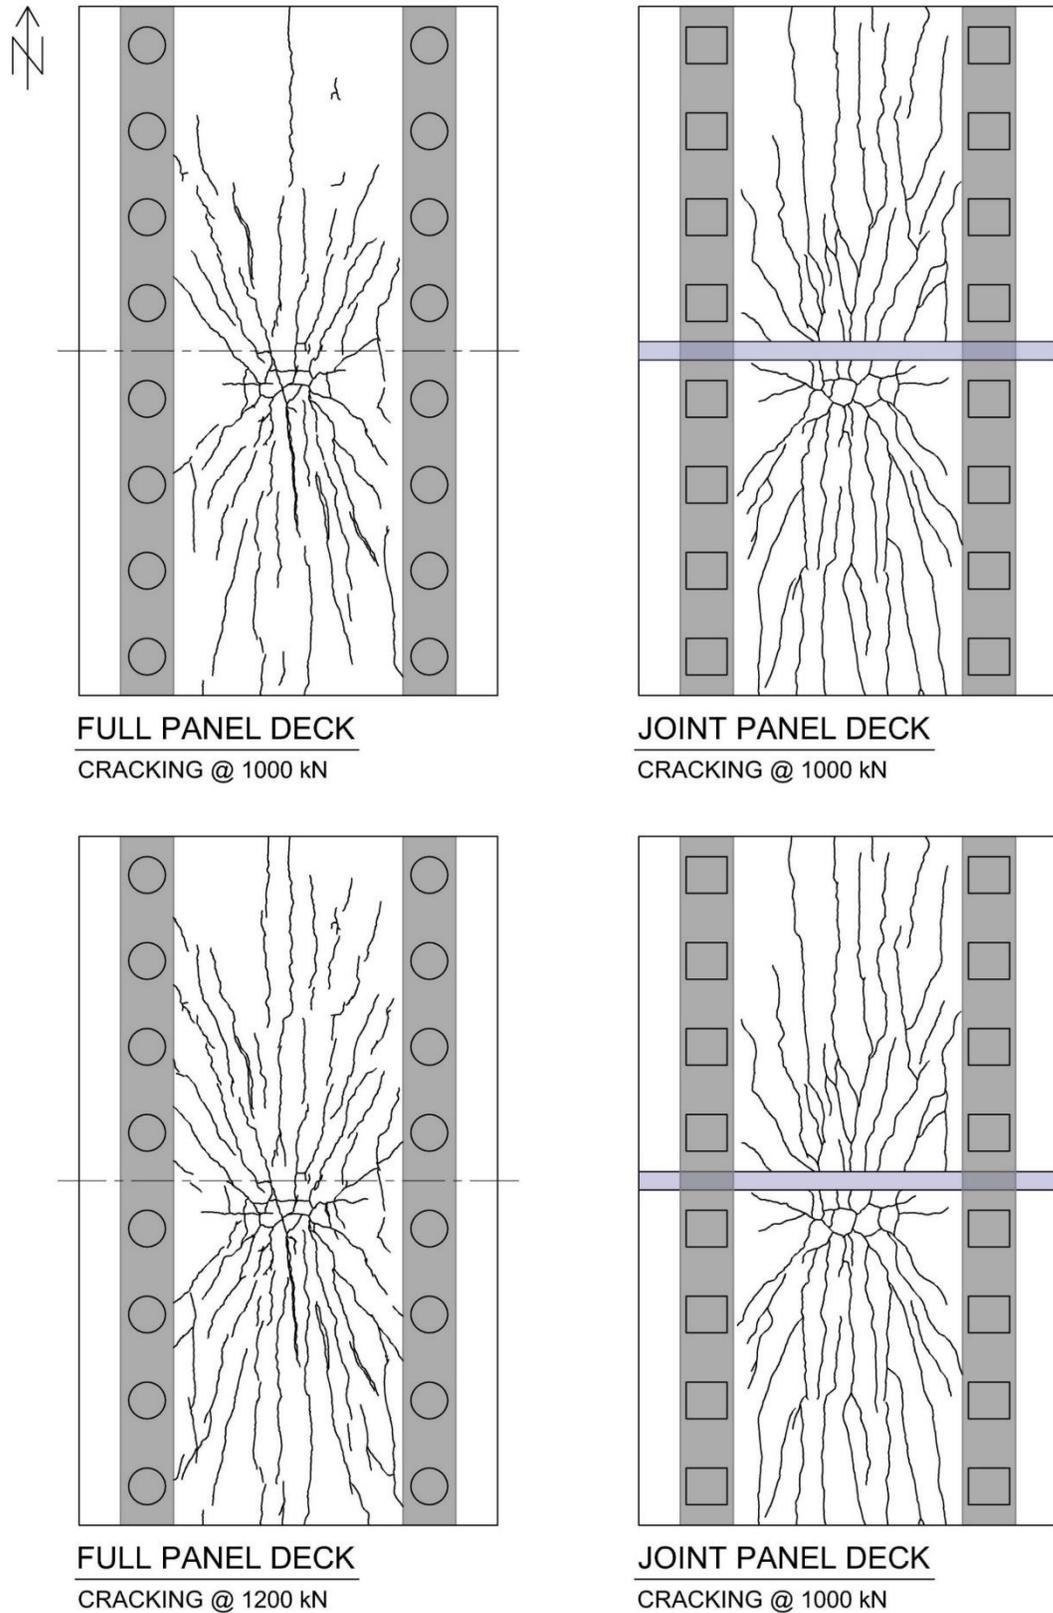
Figure 4.30 Crack development at 1000 kN and 1200 kN during bridge deck testing.

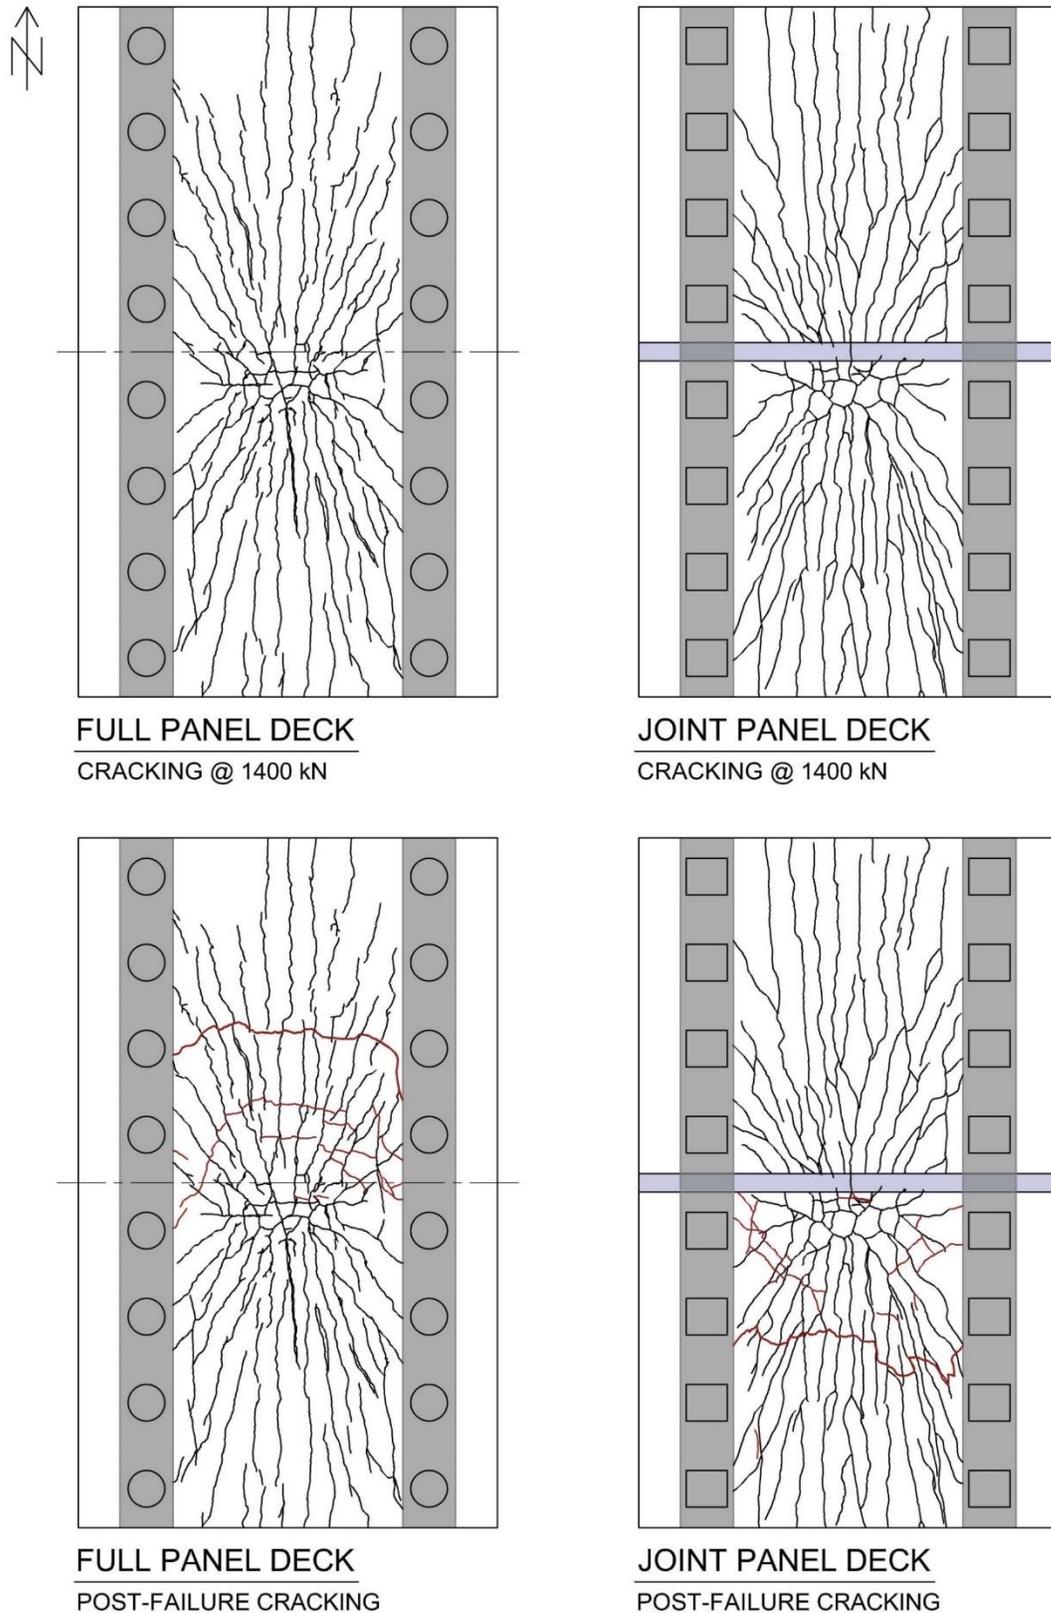
Figure 4.31 Crack development at 1400 kN during bridge deck testing and post-failure cracking.

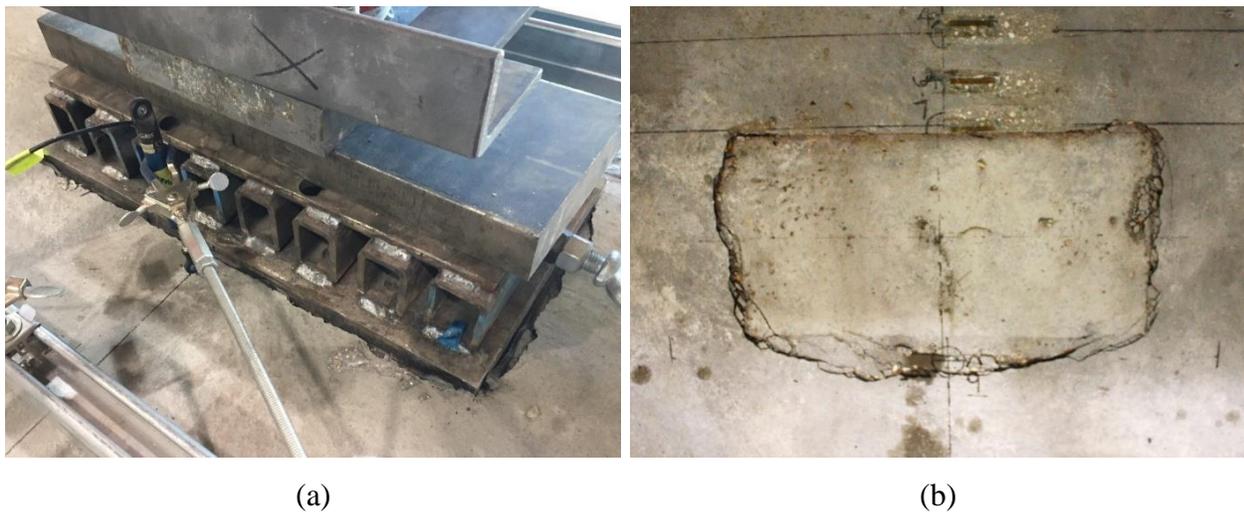
Figure 4.32 Post-failure load plate punch shape in bridge deck surface: (a) JPD with load plate; (b) FPD after load plate removed.

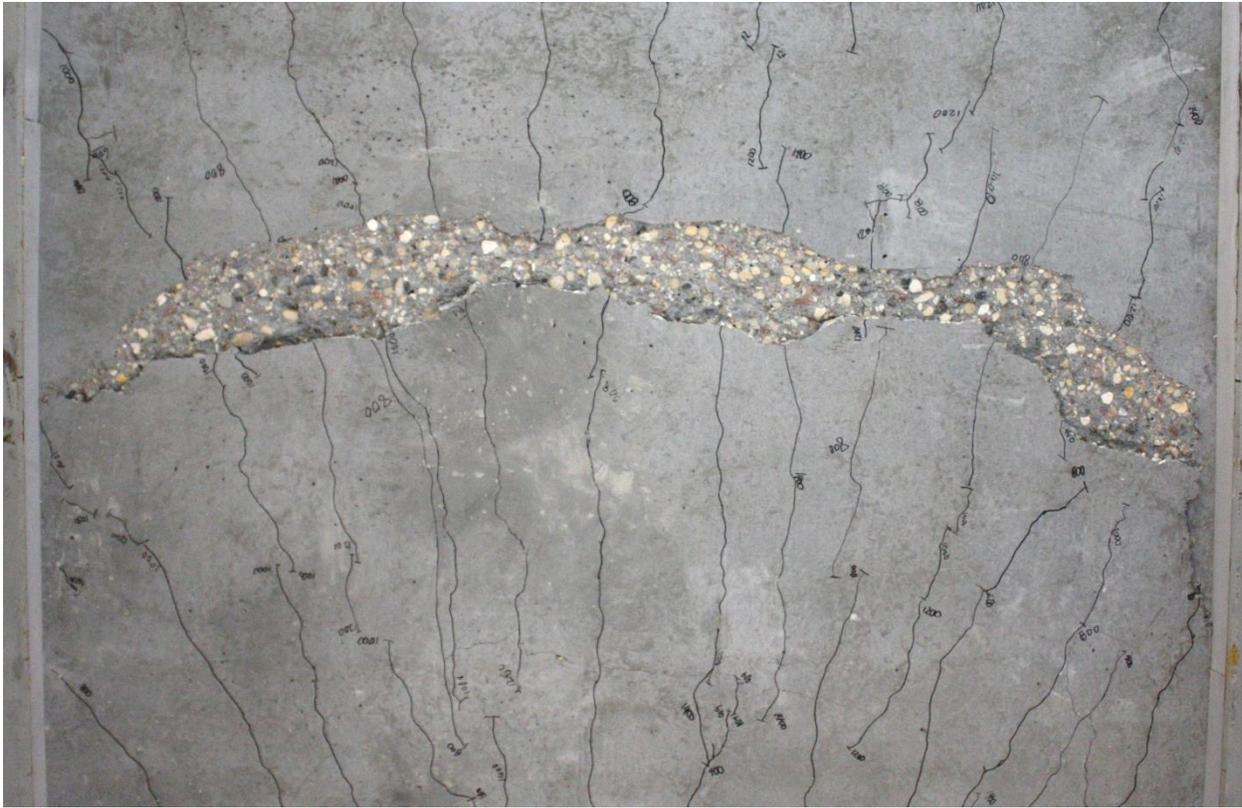
Figure 4.33 FPD failure crack after chiselling away loose pieces of concrete (north half of deck).

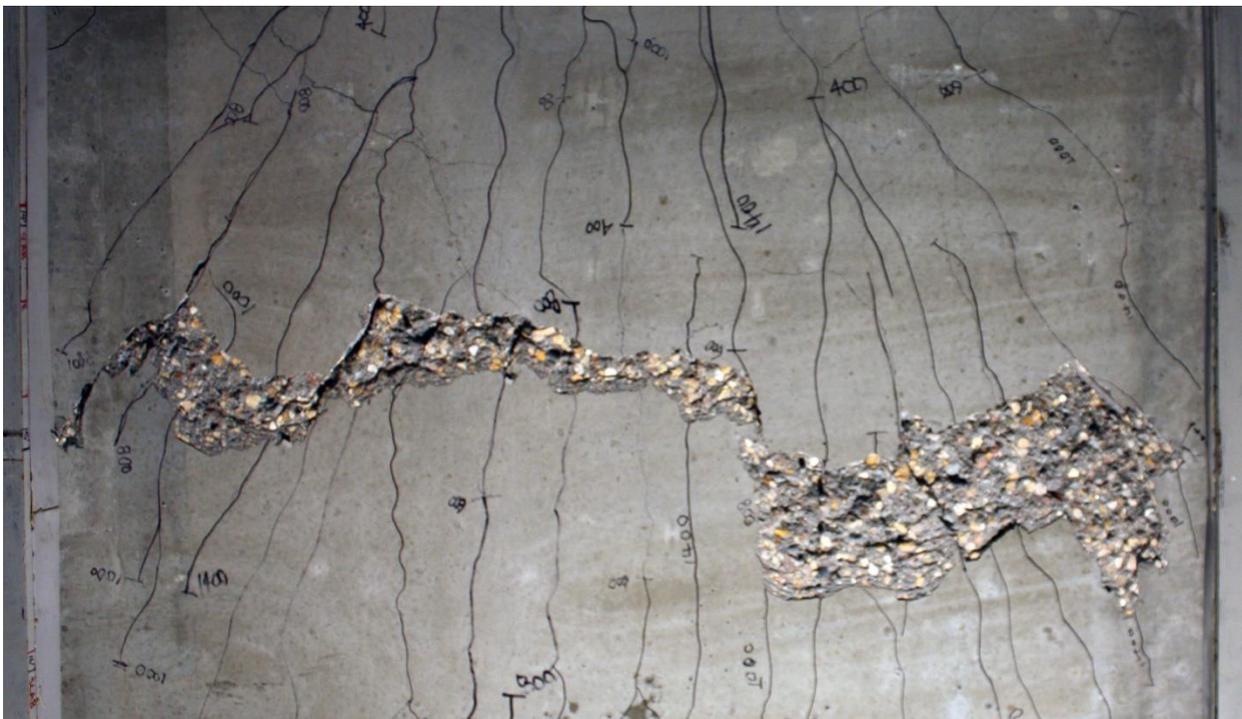
Figure 4.34 JPD failure crack after chiselling away loose pieces of concrete (south panel).

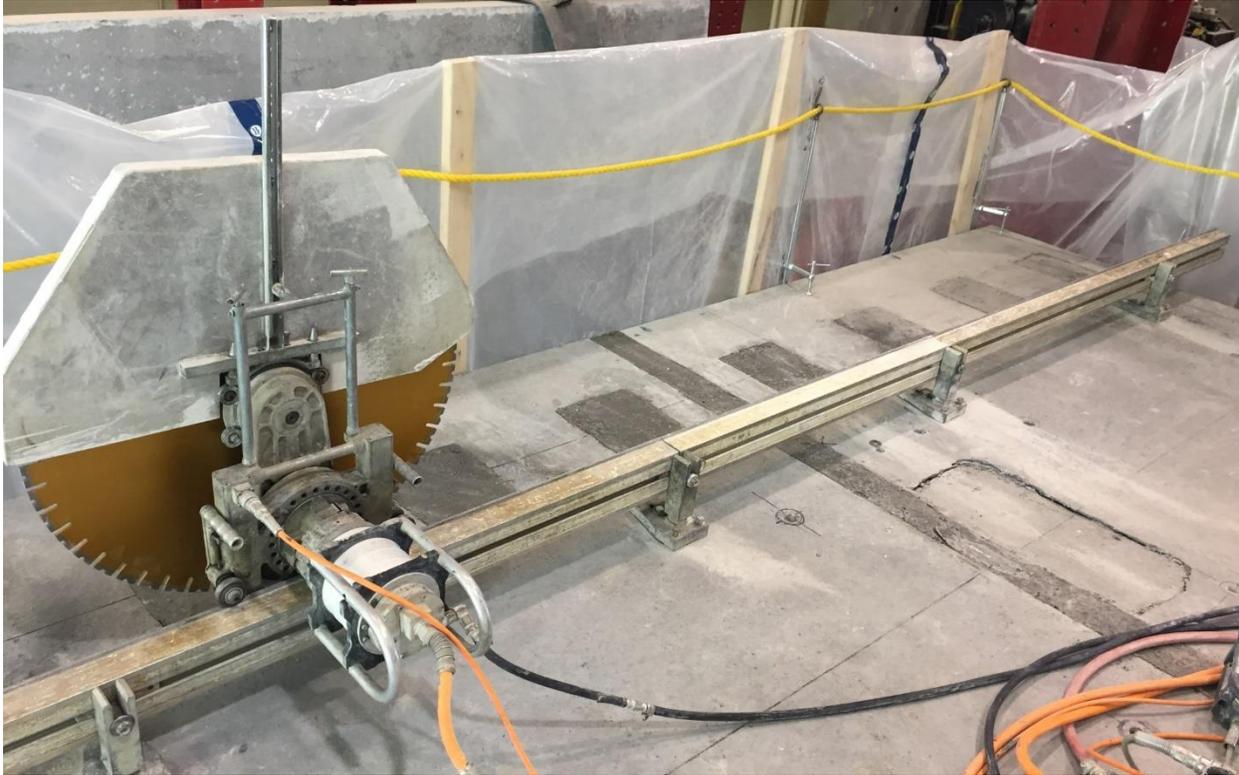
Figure 4.35 JPD demolition setup with concrete water saw.

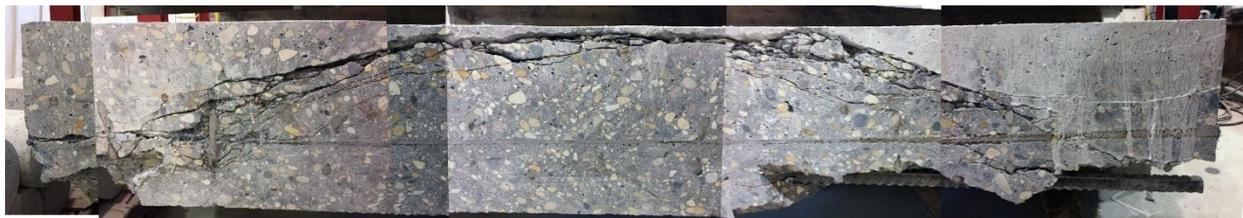
Figure 4.37 FPD deck section of south half (looking south).

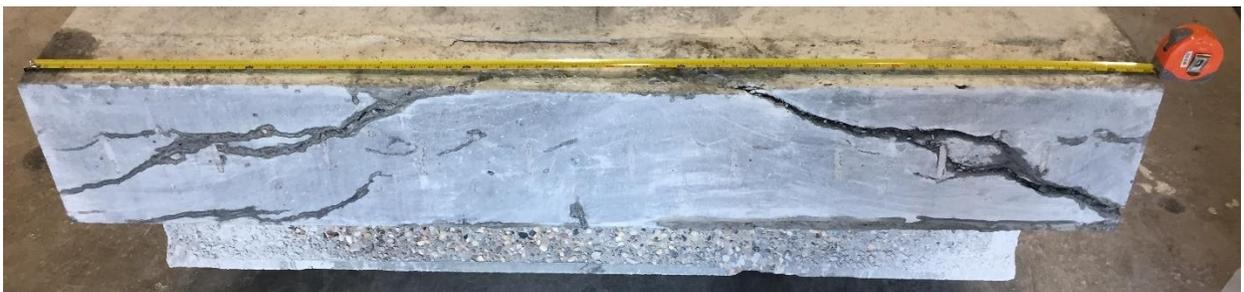
Figure 4.39 JPD deck section of north panel, cut through UHP joint (opposite cut of Figure 4.38(a), looking north).

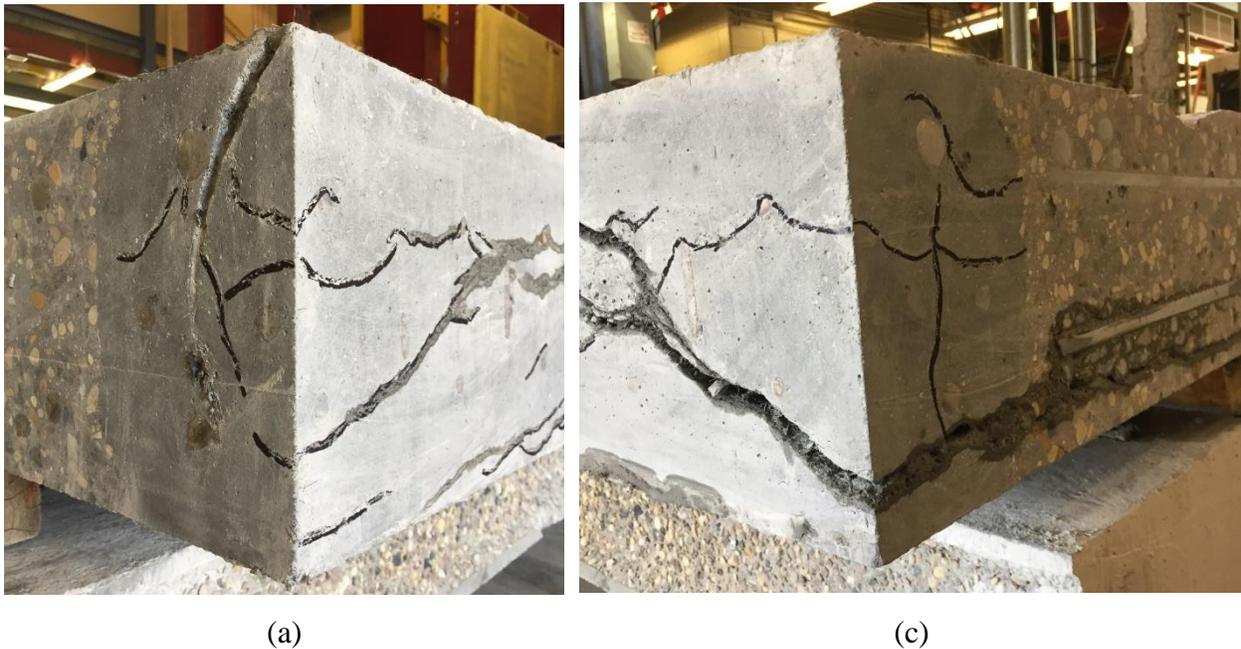
Figure 4.40 South corners of the north JPD section from Figure 4.39: (a) south-west corner, and (b) south-east corner.

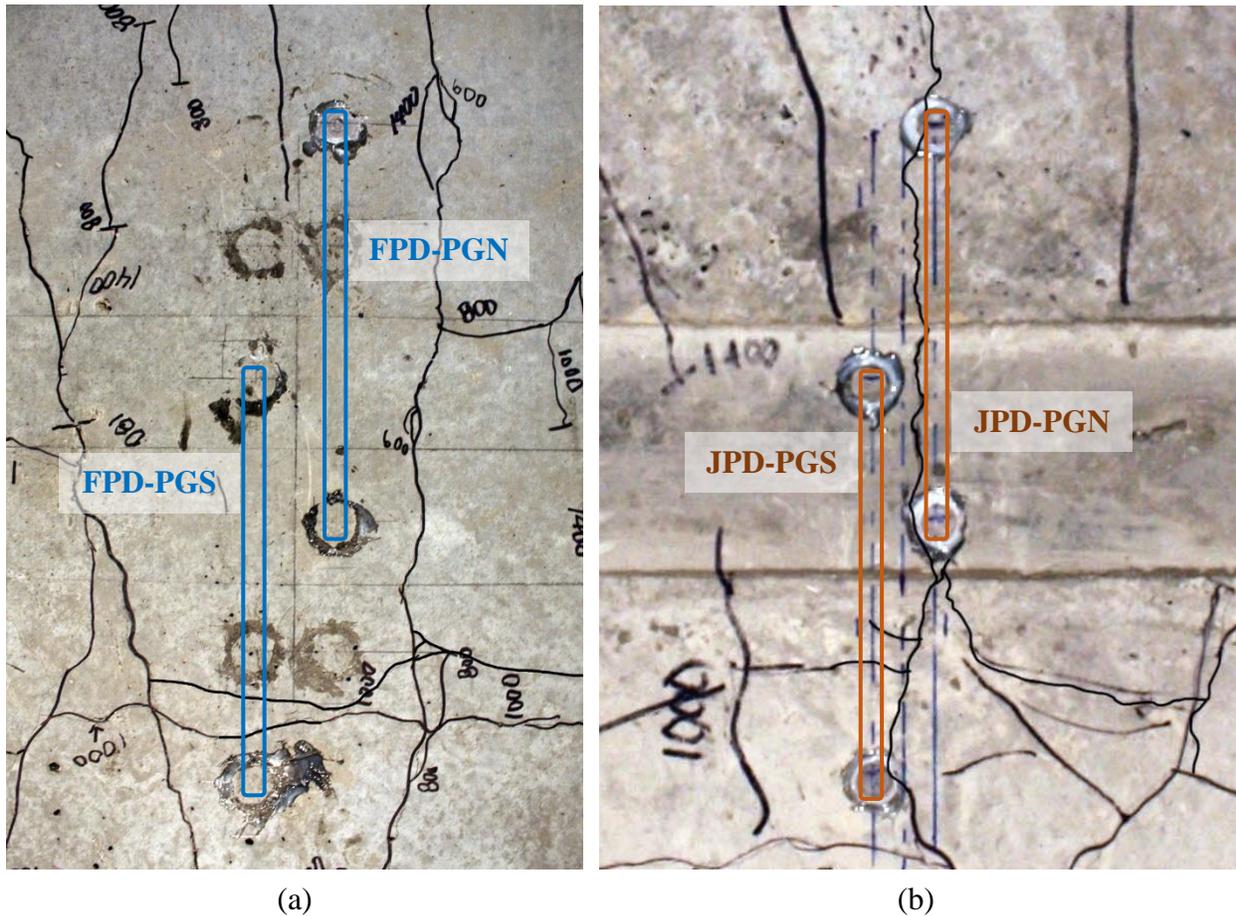
Figure 4.41 Close-up photographs at the deck center post-testing of (a) FPD, and (b) JPD.

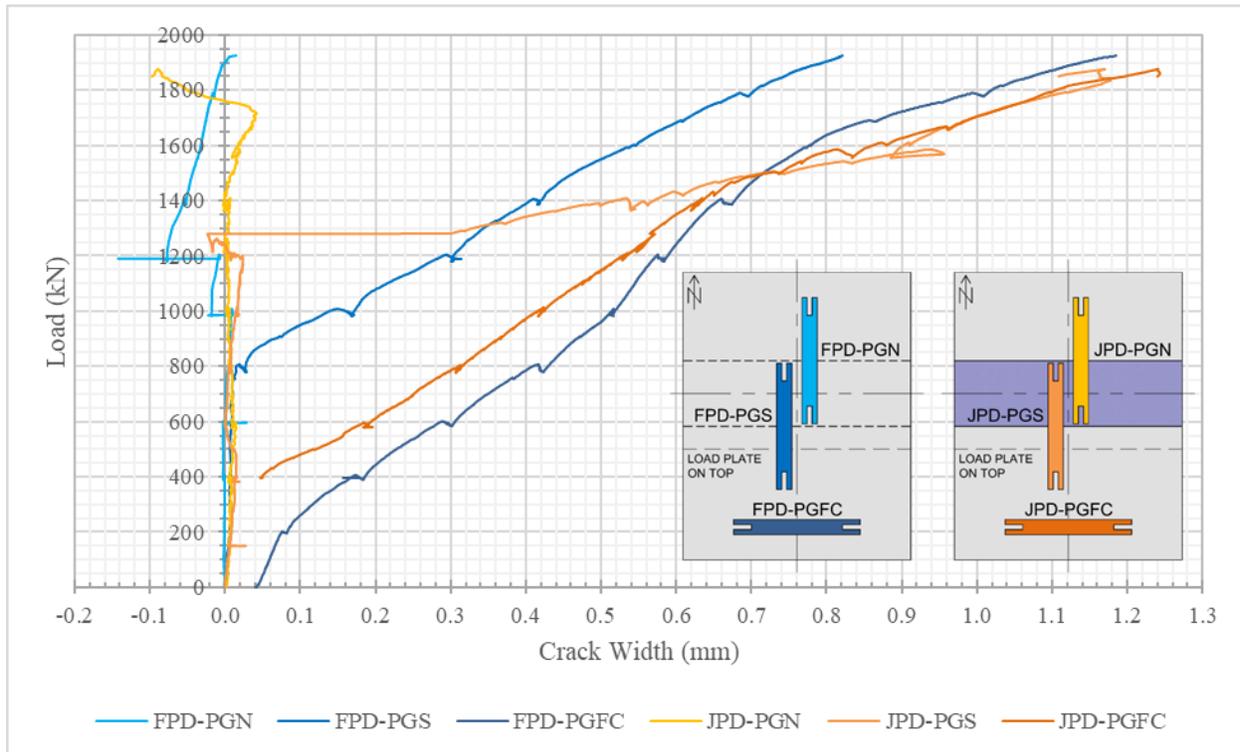
Figure 4.42 Crack width development during bridge deck testing.

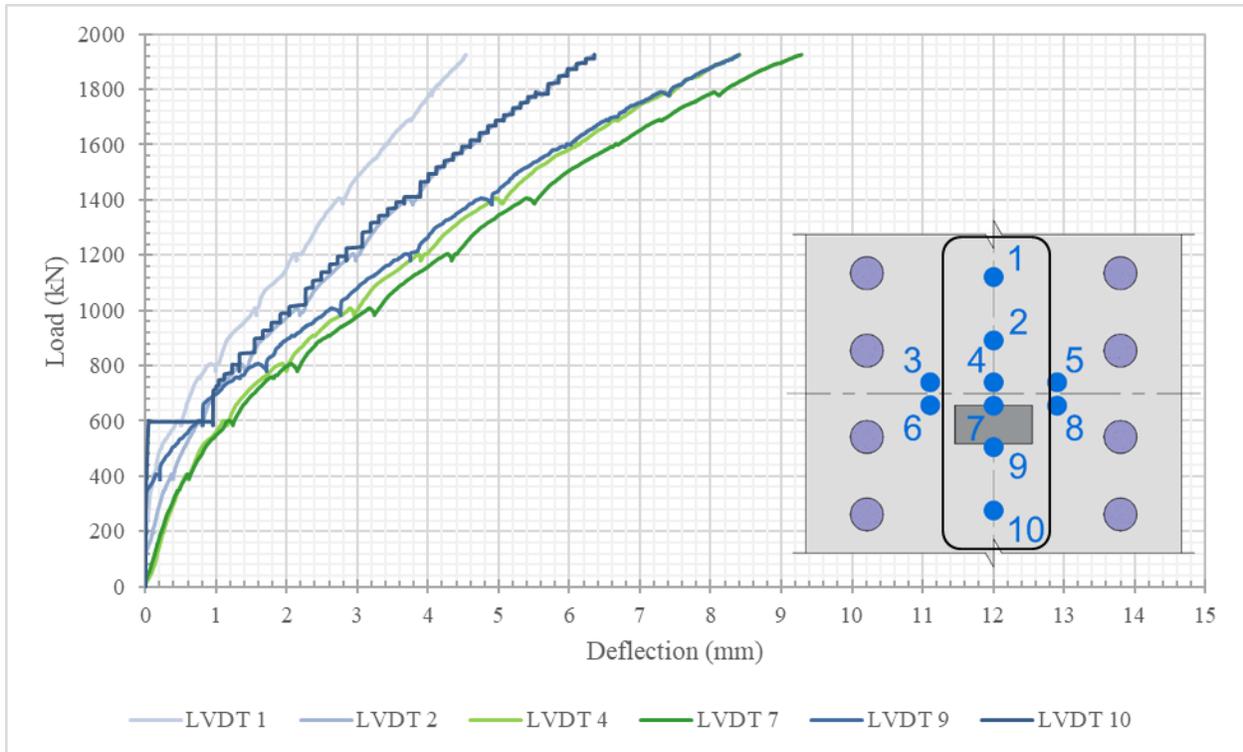
Figure 4.43 FPD longitudinal centerline deflection development during testing.

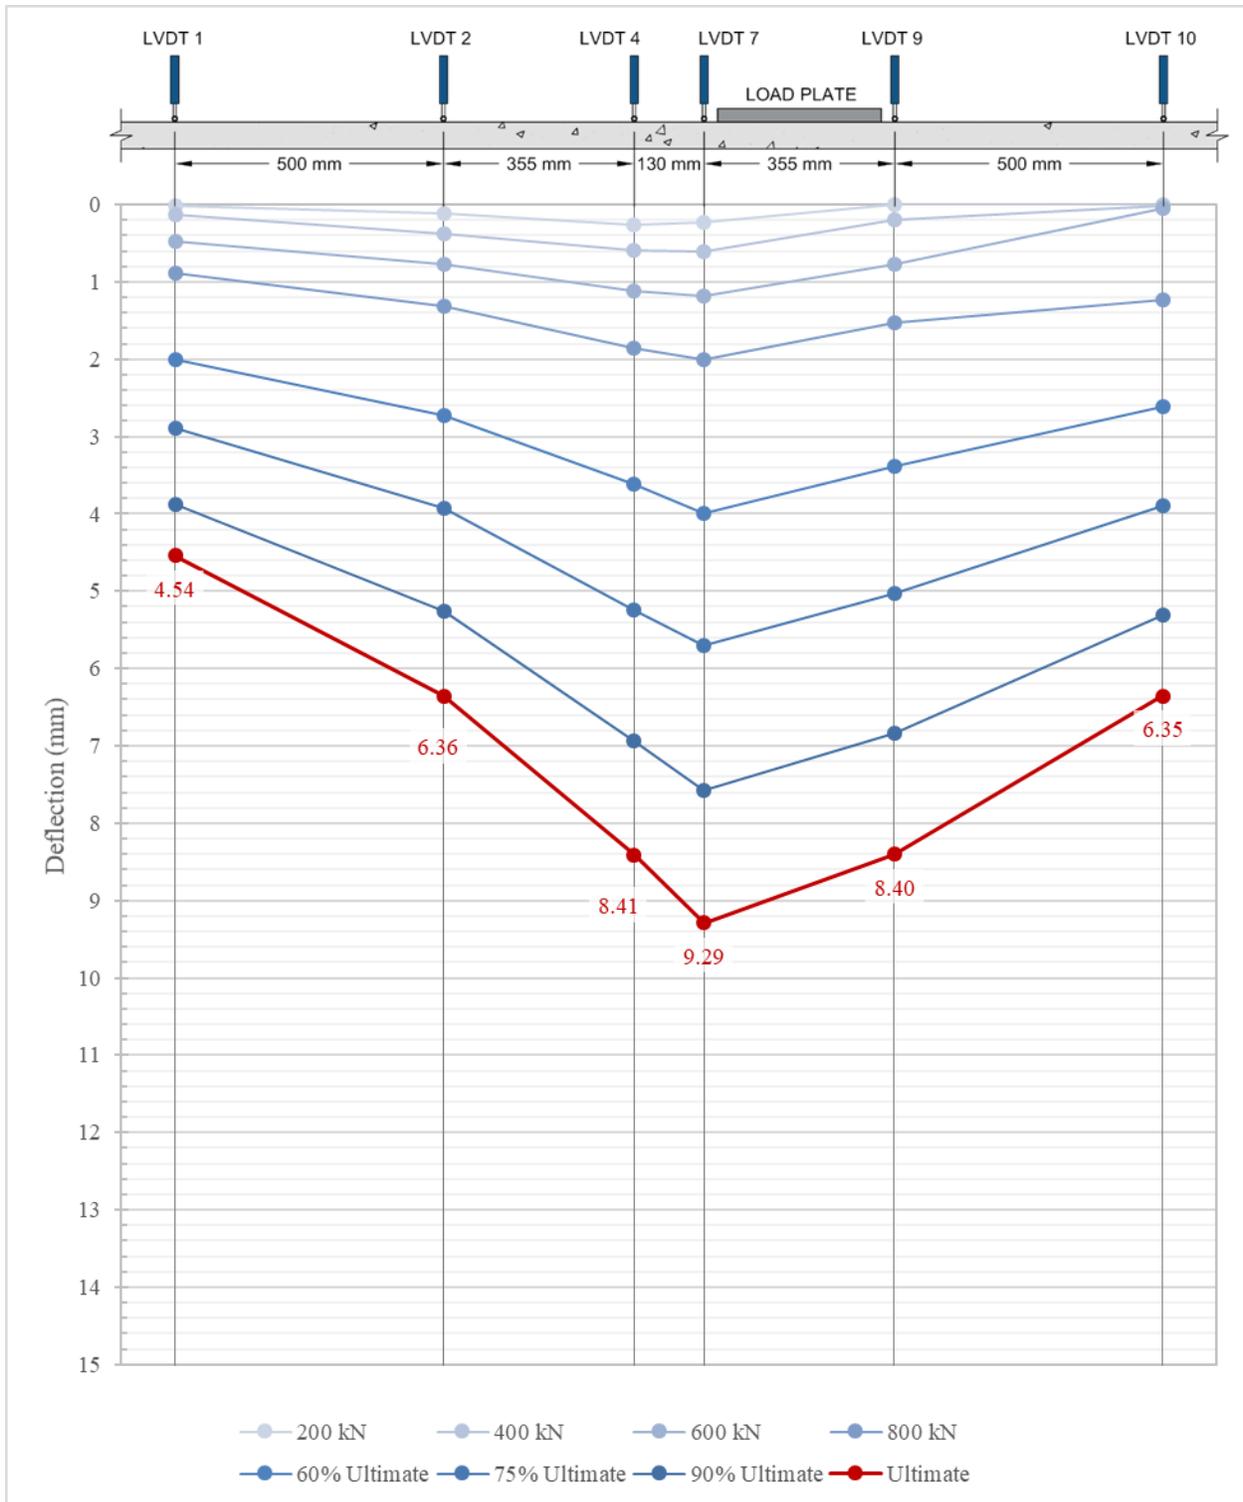
Figure 4.47 FPD centerline longitudinal deflection profiles during testing.

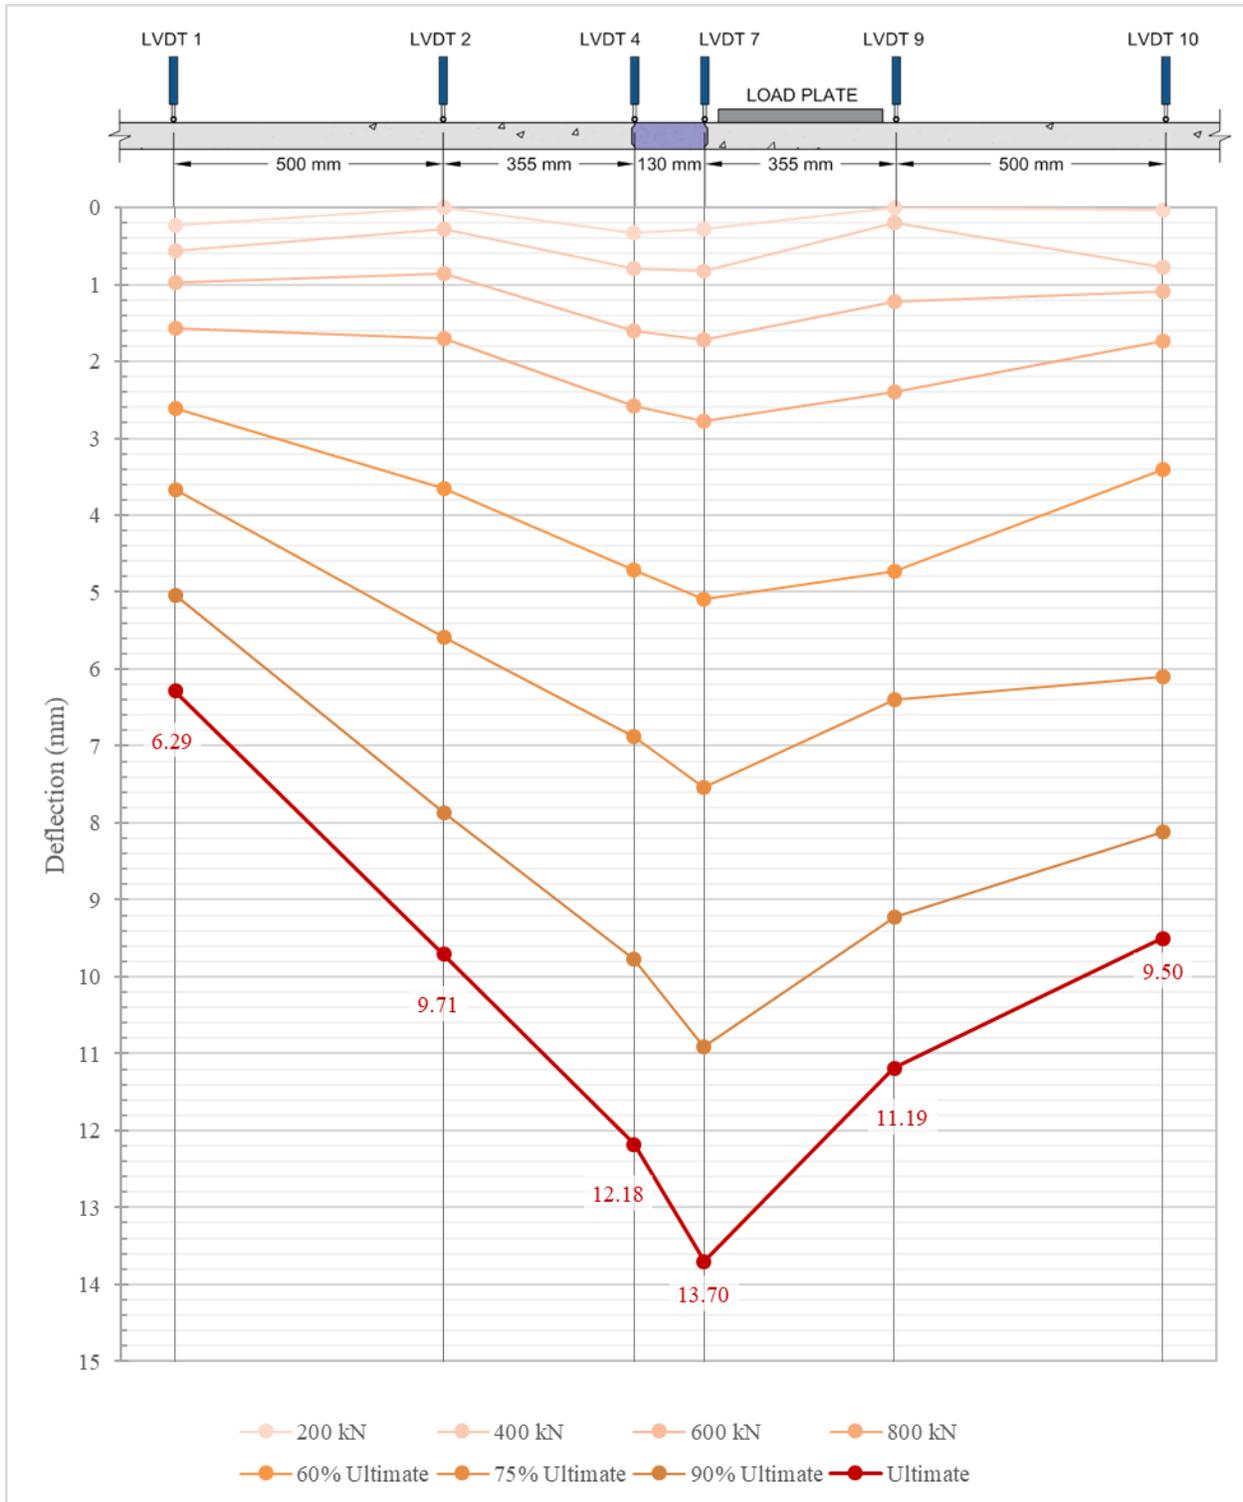
Figure 4.48 JPD centerline longitudinal deflection profiles during testing.

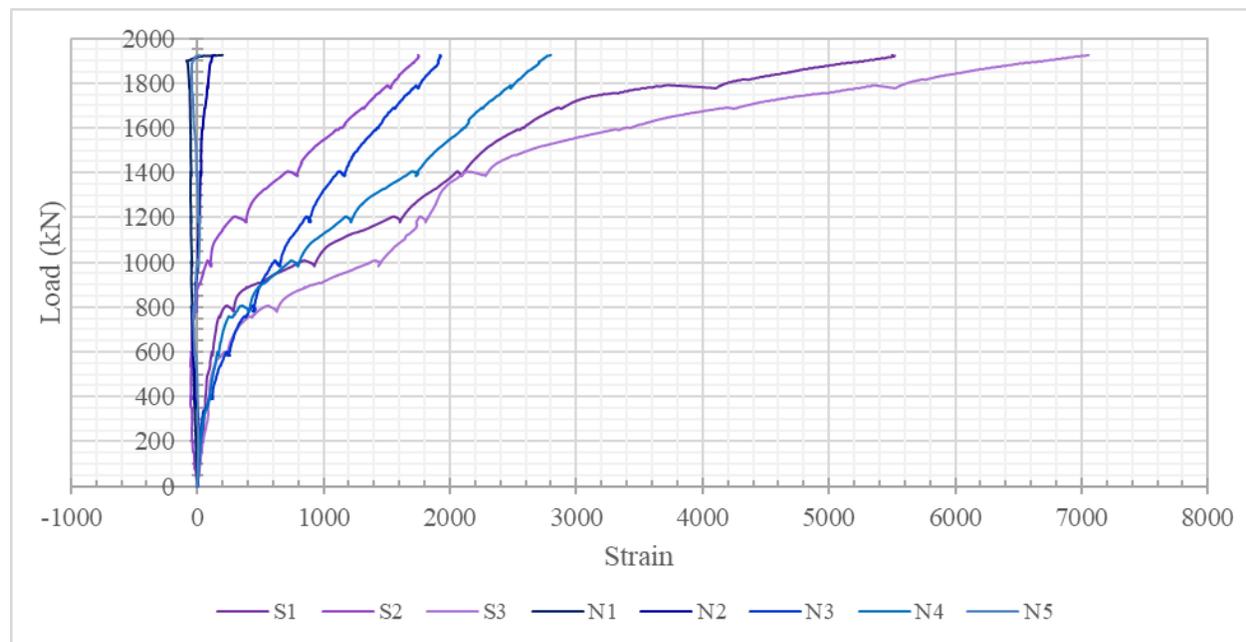
Figure 4.50 FPD internal reinforcing bar strains at deck center.

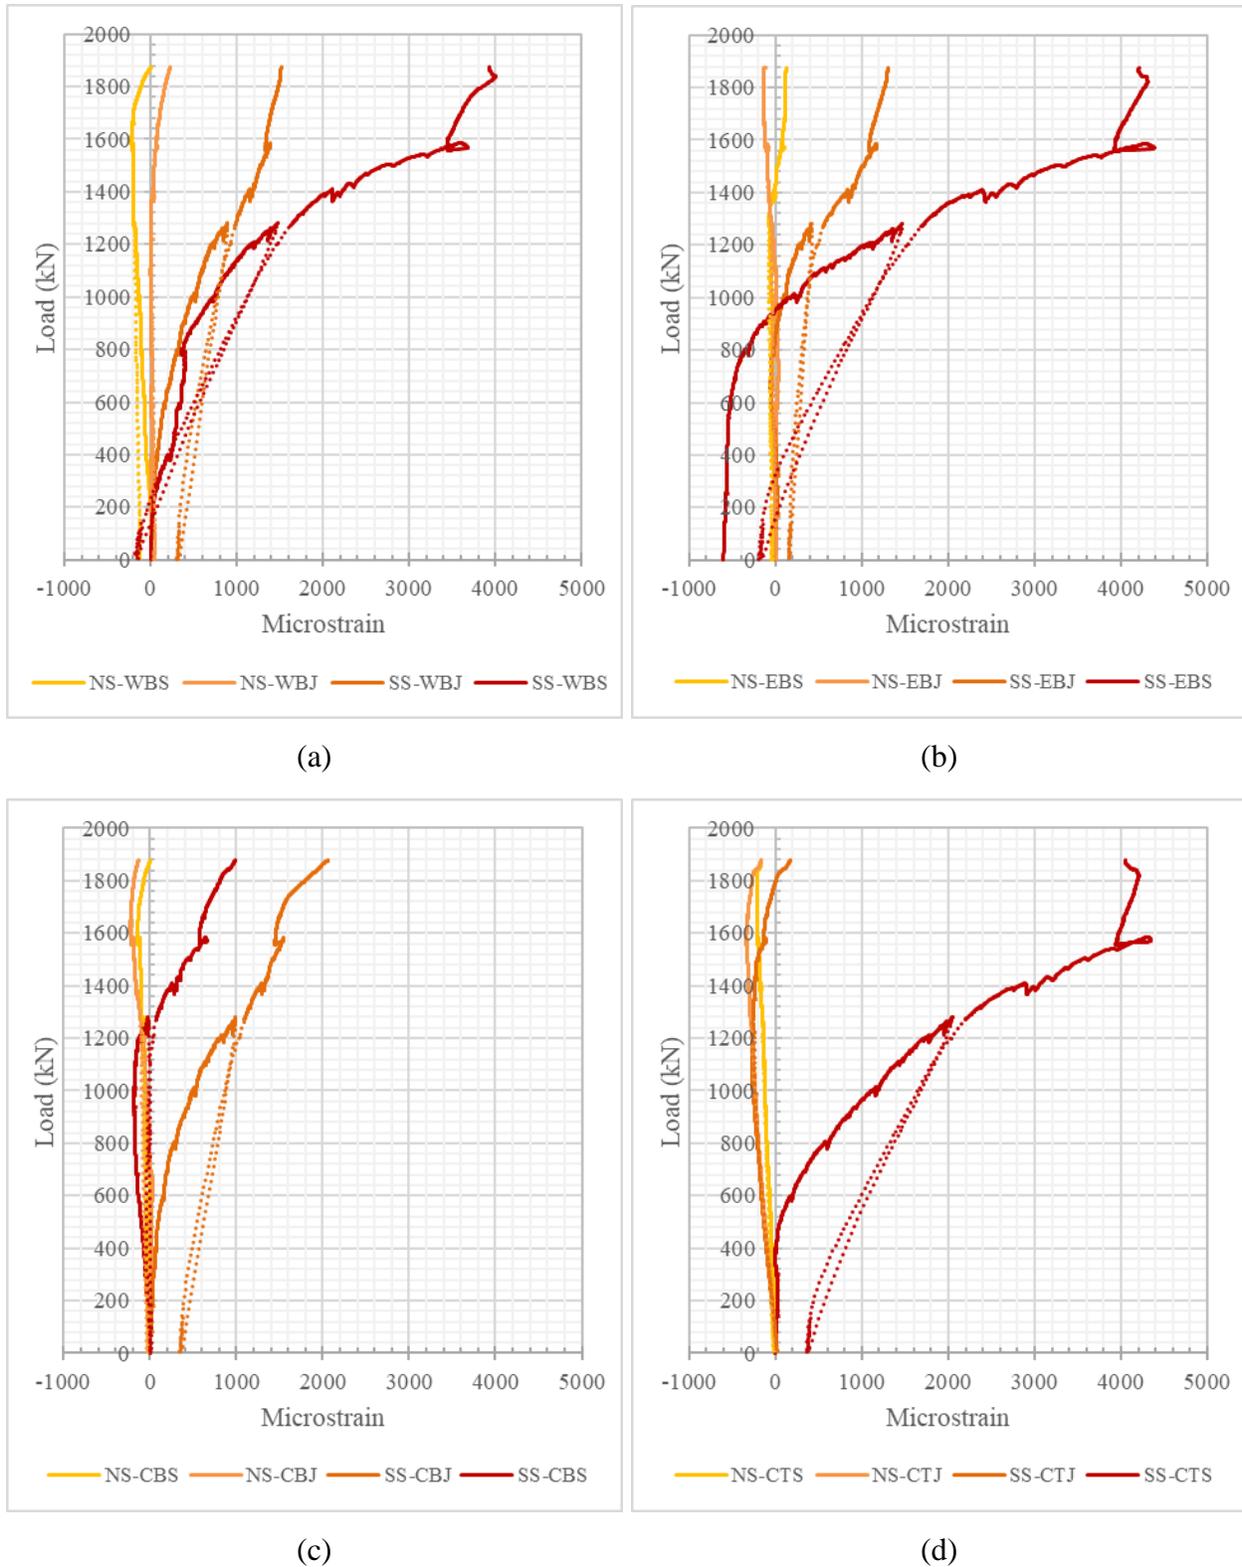
Figure 4.51 JPD strain development of 10M hooked bars on (a) bottom of west bars, (b) bottom of east bars, (c) bottom of center bars, and (d) top of center bars.

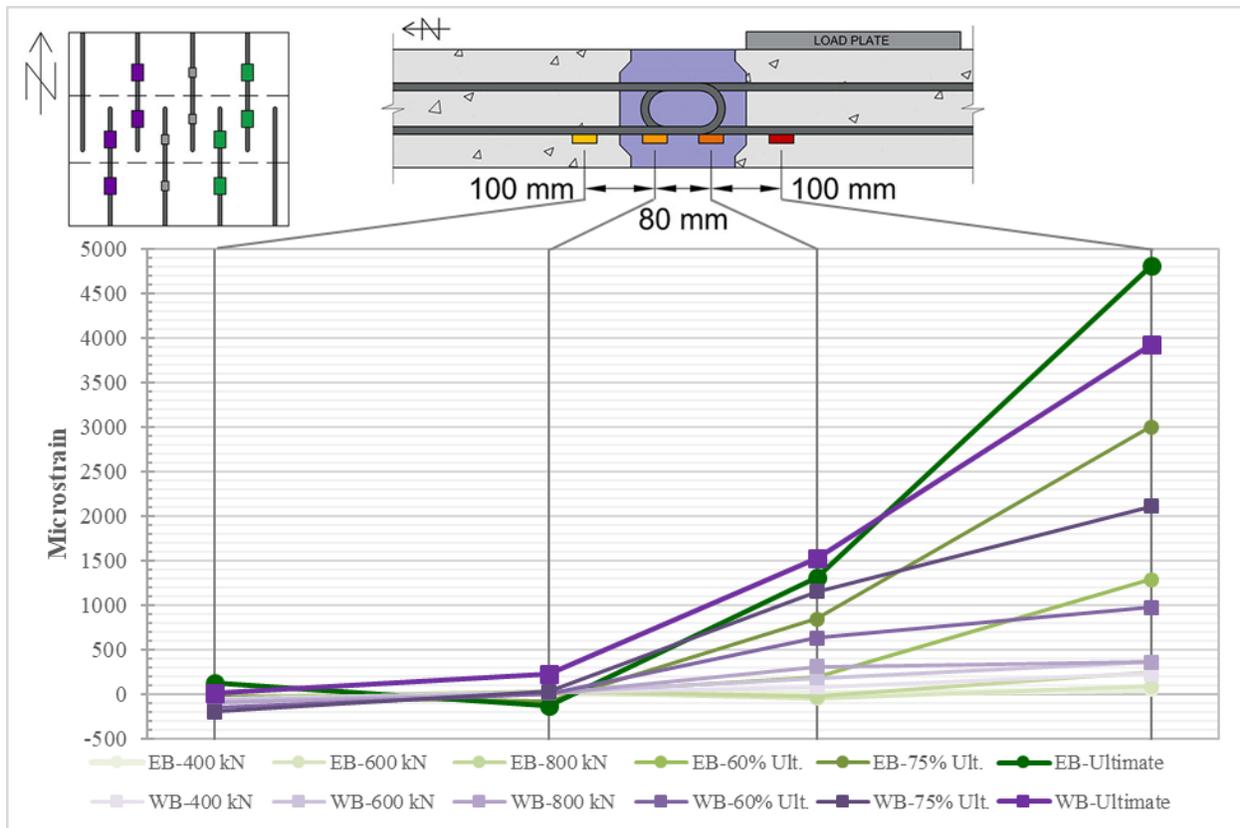
Figure 4.54 JPD strain profiles for easternmost and westernmost internal strain gauges.
