**THE BEHAVIOUR OF ULTRA-HIGH-PERFORMANCE CONCRETE IN  
PRECAST CONCRETE BRIDGE DECK CONNECTIONS**

A Thesis submitted to the Faculty of Graduate Studies of  
The University of Manitoba  
in partial fulfillment of the requirements of the degree of

Department of Civil Engineering  
University of Manitoba  
Winnipeg, Manitoba

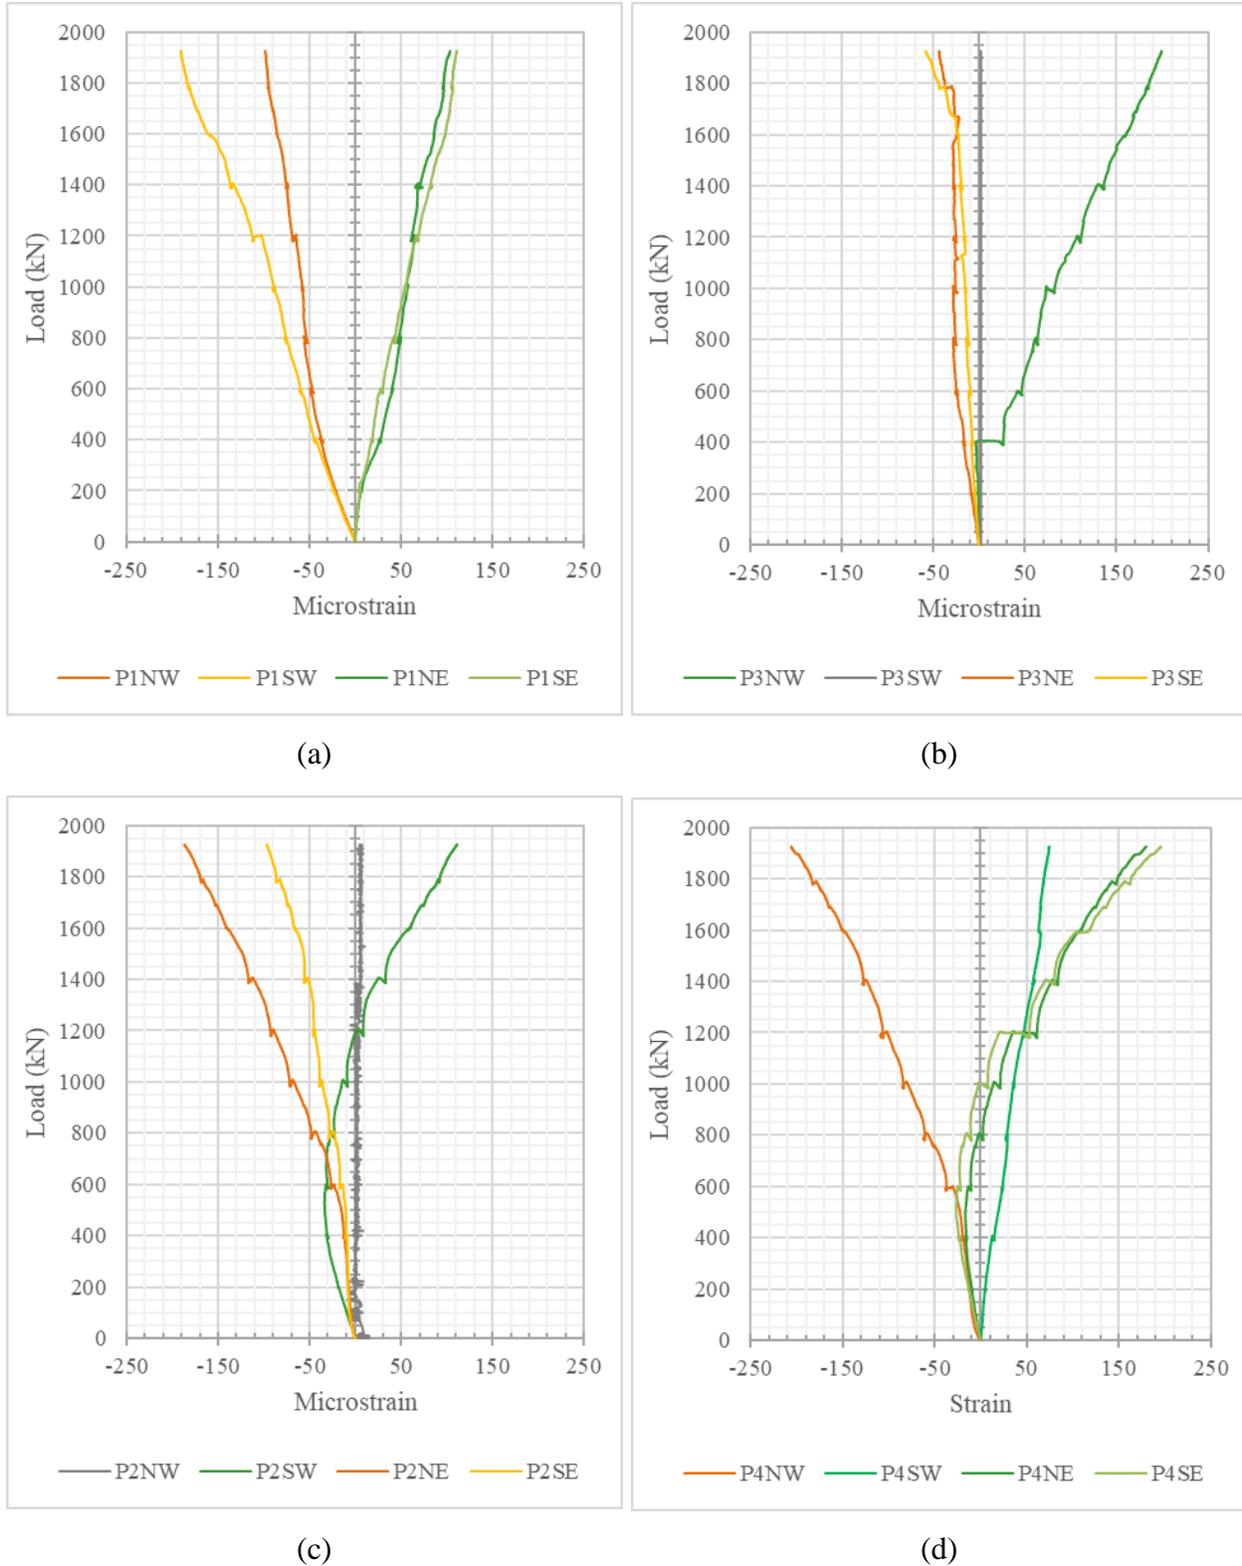
Figure 4.56 FPD shear stud strain development during testing for shear pockets (a) P1, (b) P3, (c) P2, and (d) P4.

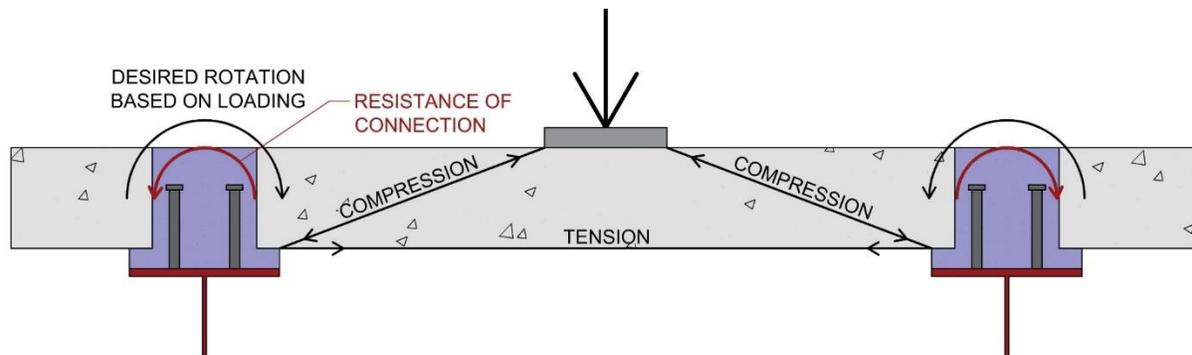
Figure 4.57 Arching action and load resistance.

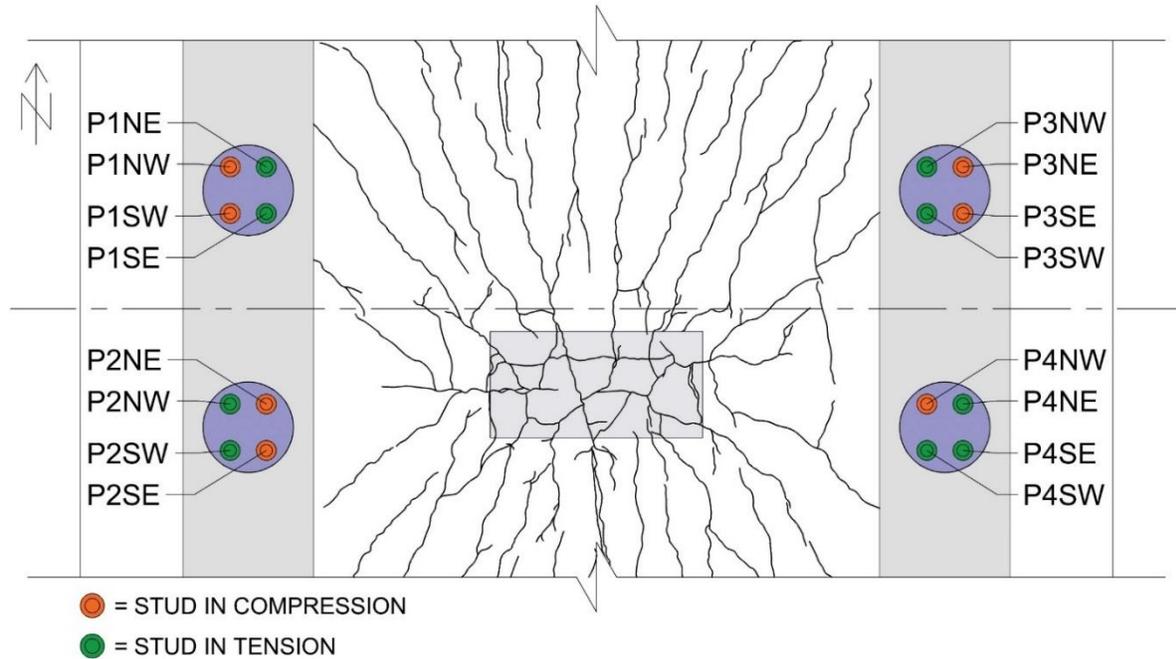
Figure 4.58 FPD 1400 kN cracking and shear stud behaviour.
