**HOUSE DAMAGE COSTS IN WINNIPEG  
DUE TO SHIFTING FOUNDATIONS**

A Thesis  
Presented to the University of Manitoba  
In Partial Fulfillment of the  
Requirements for the Degree of  
Master of Science in Civil Engineering  
In the Department of Civil Engineering

FEBRUARY, 1986

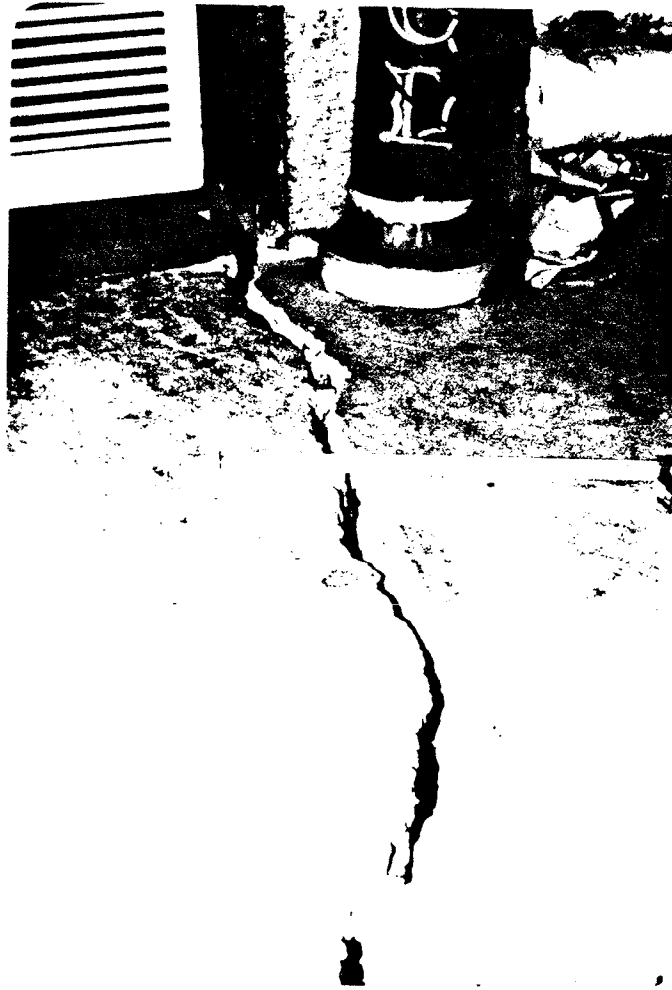
Figure 25 Cracks in Basement Floors

Examples of cracking illustrated in Figures 25, 26, 27 were categorized as major, requiring costly professional repair work. Unfortunately repairing the cracks can be of a very temporary nature, as further cracking will occur as the foundations continue to shift. Thus homeowners are faced with the prospect of undertaking costly maintenance with no guarantee that the problem will not reoccur within a short period of time.

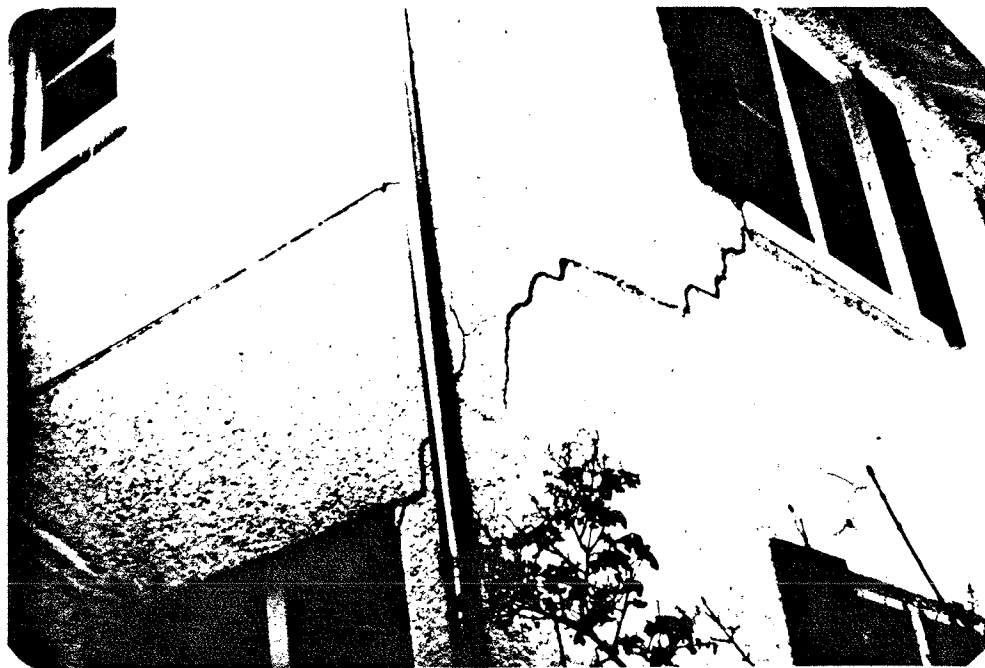
Figure 28 Cracks in Exterior Walls

The severity of some of the exterior wall cracks are shown in Figures 28 and 29. There again repairs are costly and may be of a very temporary nature. Even when repaired, the cracks cannot be totally camouflaged, which can only adversely affect the resale value of the house.

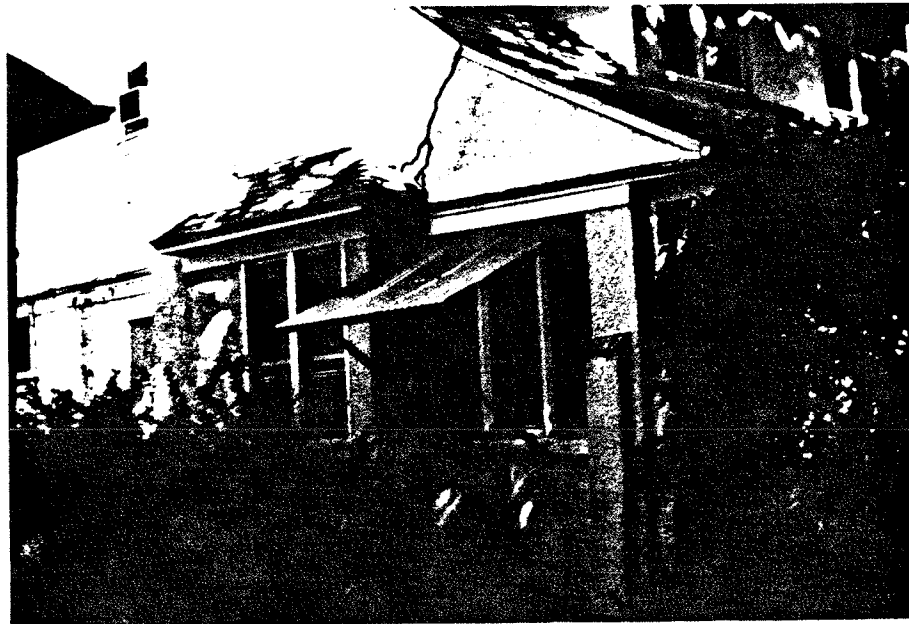
Figure 32 Differential Settlement of Additions

Other undesirable construction practices included adding such things as verandas, sunrooms and porches to the house without taking necessary steps to avoid differential movement between the addition and the house. Fig. 32 shows cracking that occurs where an addition has been attached to the main structure.

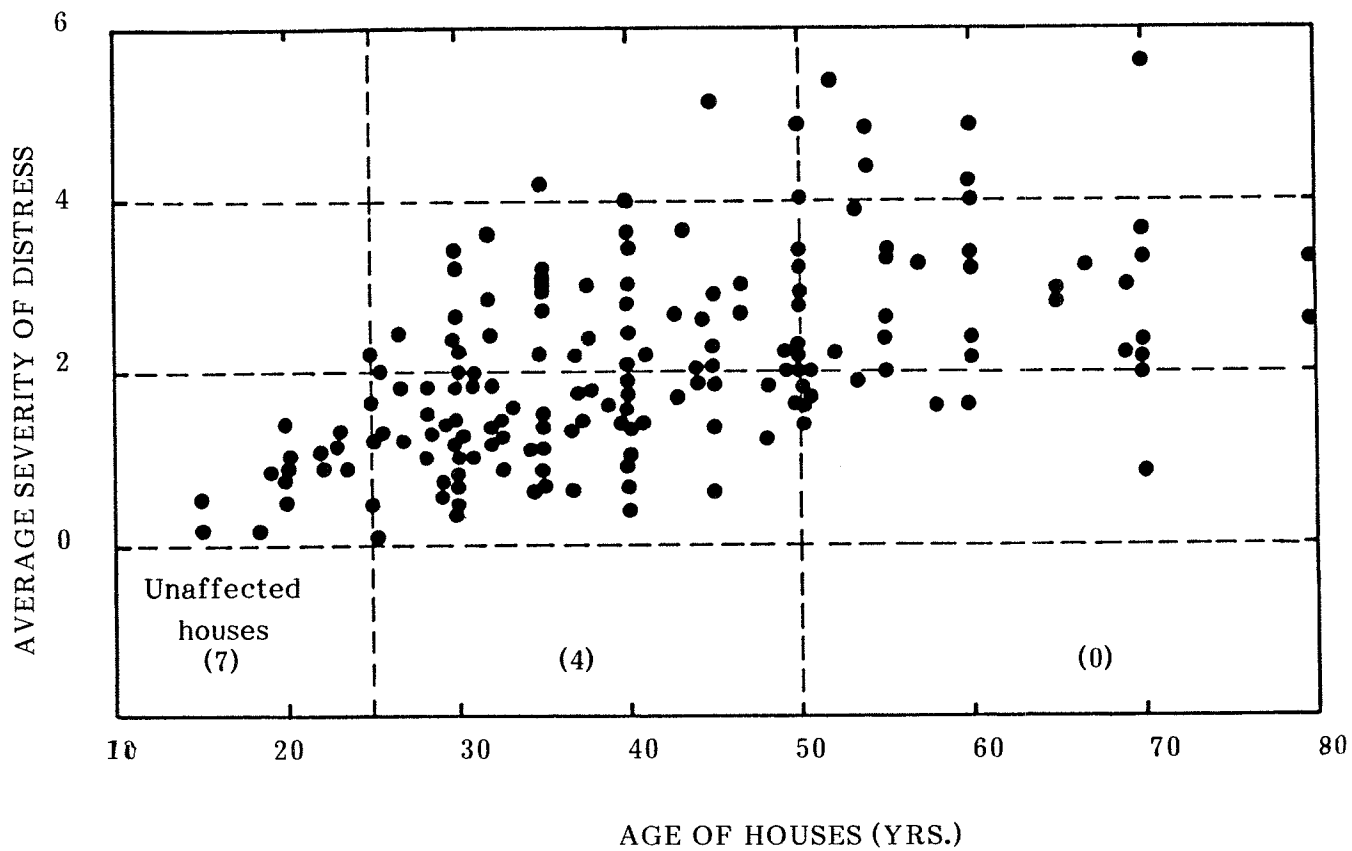
Figure 34 Severity of Damage Versus Age of House

The overall configuration of all points in Fig. 34 suggests that a correlation between age of house and distress can be found but it is recognized that climatic factors play a far more important role in the performance of shallow foundations than age alone. Age simply reflects the frequency of climatic alterations that influence foundation performance. There have been cases where houses of 15 to 24 years of age have undergone severe damage.
