DESIGN OF TEMPORARY GRAIN STORAGES

A Thesis

Department of Agricultural Engineering
University of Manitoba
Winnipeg, Manitoba

May, 1974

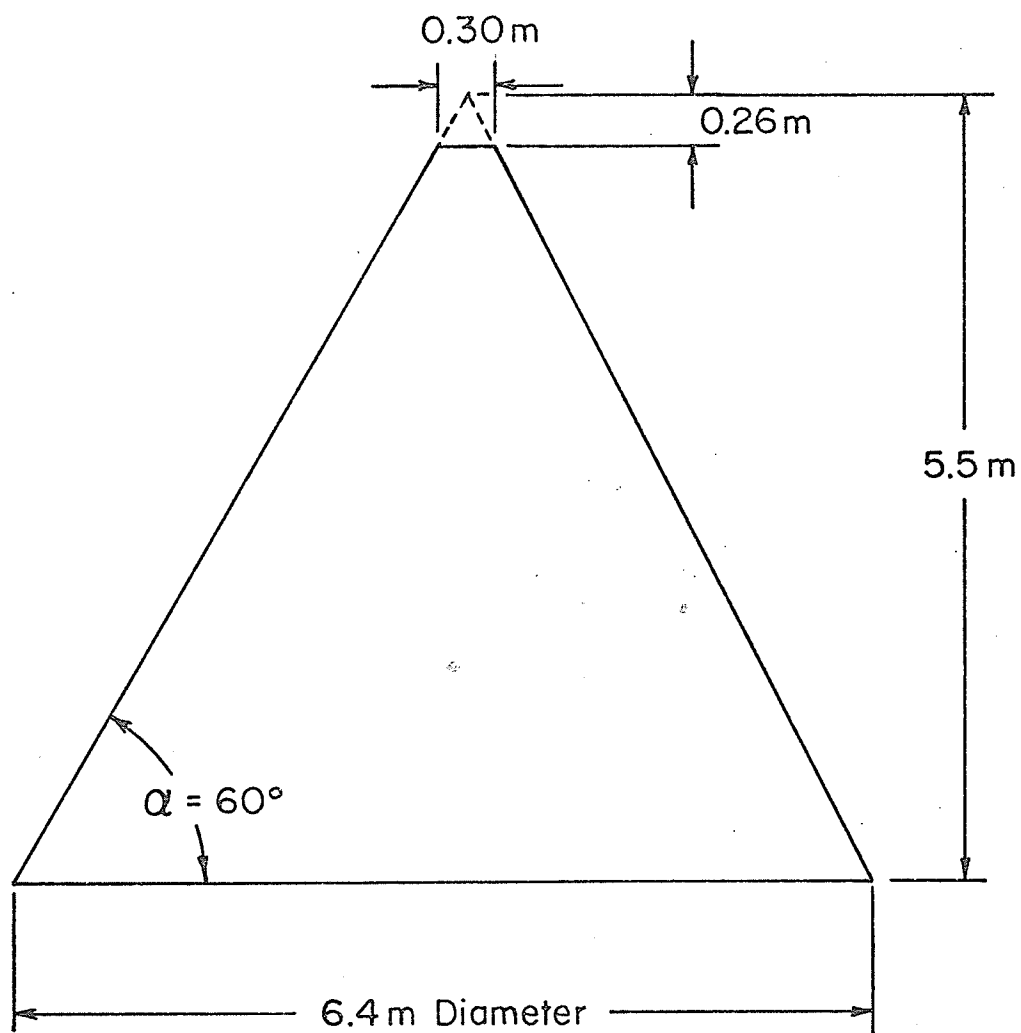
Fig. 5.1 Conical grain bin.

Good material utilization is obtained with this bin since the wall angle of 60° requires a piece of material in the form of a semi-circle to obtain the conical shape (Appendix A).

The structure could be fabricated from non-self-supporting materials available in large sheets. Both the floor and wall structures could then be fabricated from single sheets of material minimizing the number of joints.

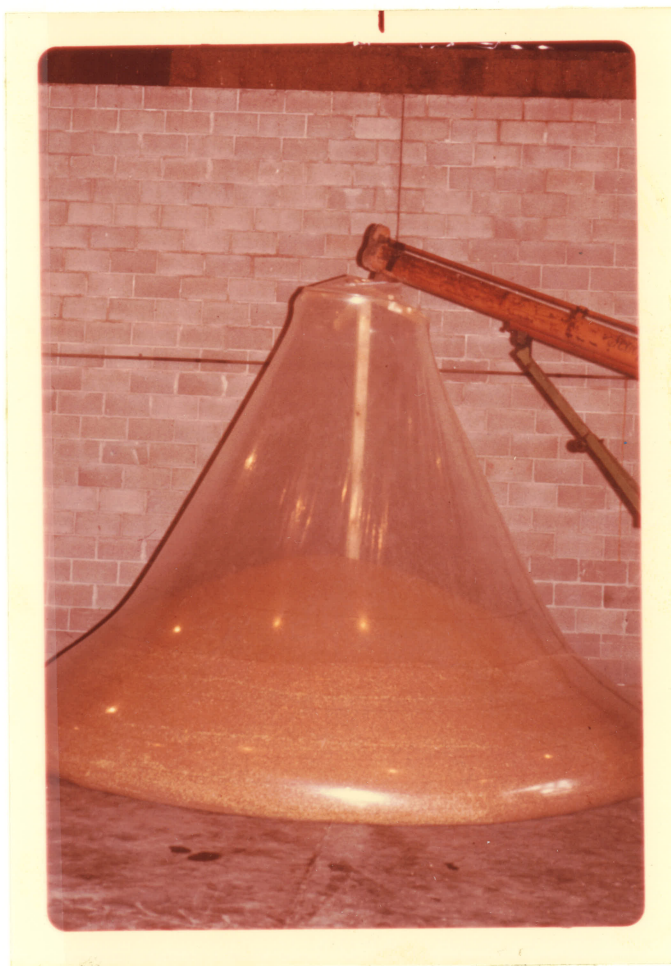
Fig. 5.2 Conical bin under structural test.

Upon filling of the bin, there was excessive elongation of the wall due to the high stresses (Fig. 5.2). Filling was discontinued upon buckling of the interior wooden frame. Failure was induced by the high forces which were transferred from the wall to the frame.

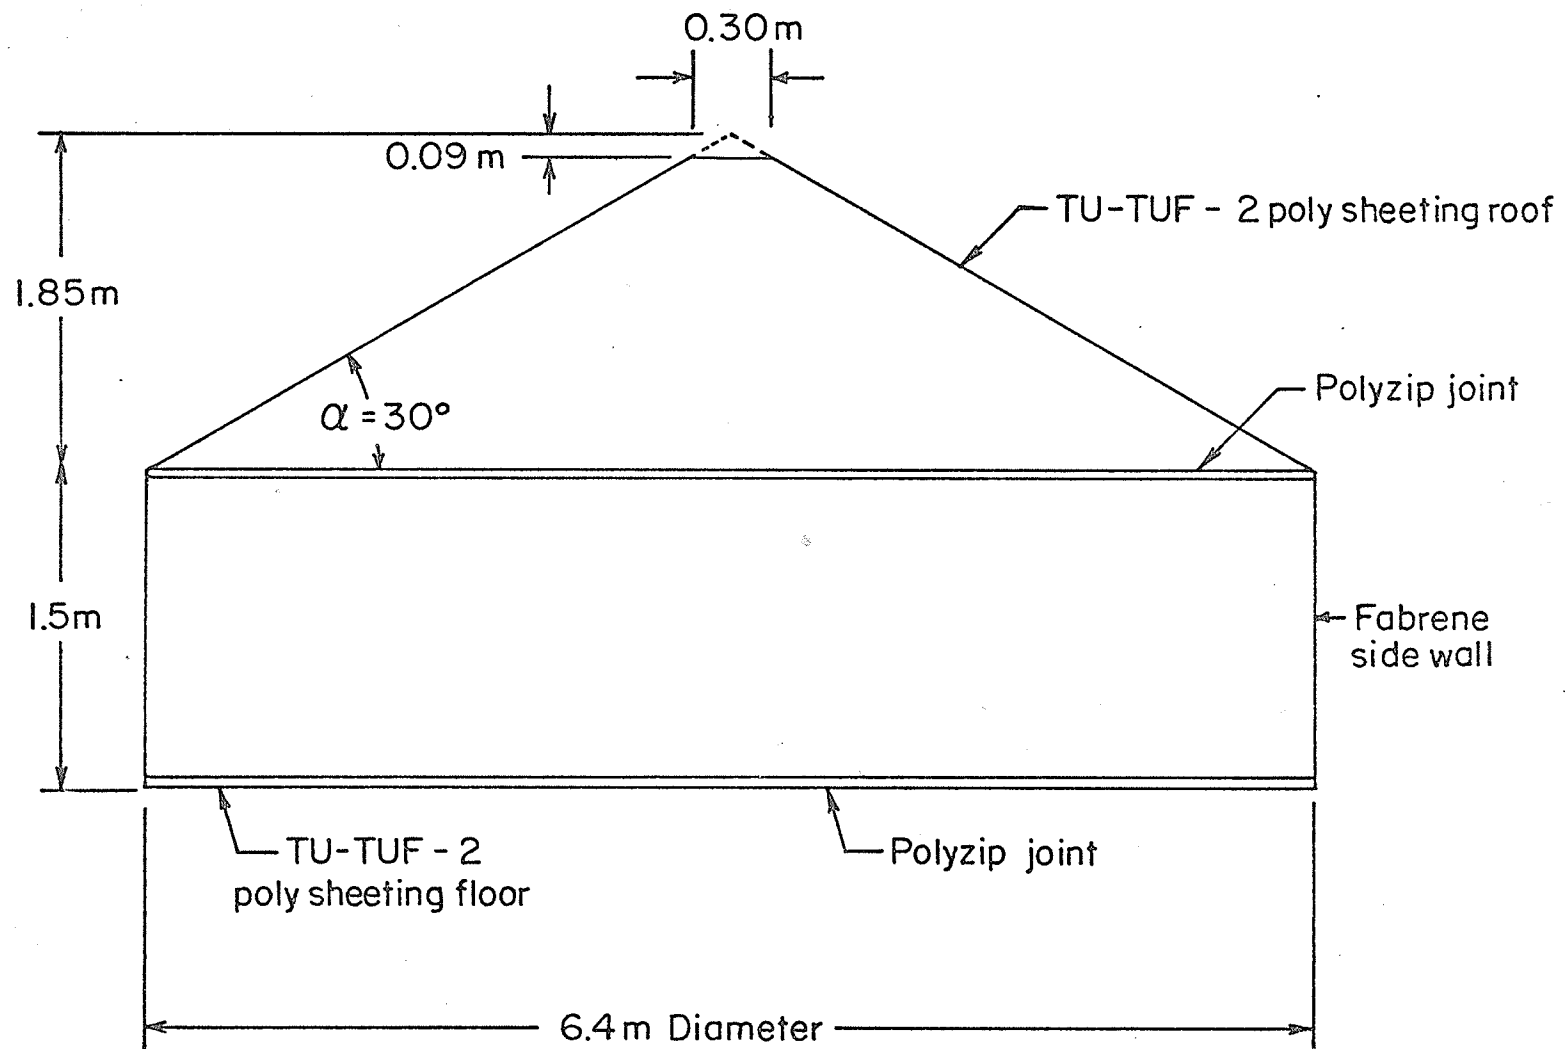
Fig. 5.3 Cylindrical bin with monolithic wall and conical roof.

radius of 3.2 m, sidewall height of 1.5 m, and a conical roof with a roof angle of 30° has a capacity of 69 m^3 (Fig. 5.3). The roof angle of 30° was selected on the premise that the roof would be structurally loaded by cereal grains which normally have an angle of repose less than 30° . This was expected to minimize damage to the roof caused by wind flutter.

The floor of the structure was fabricated from a piece of TU-TUF-2 poly sheeting 6.4 m in diameter. The roof was fabricated from a piece of TU-TUF-2 poly sheeting 7.7 m in diameter (allows 0.3 m overlap). A segment of 48.2° was removed from the roof section to obtain the conical roof with a 30° slope (Appendix A).

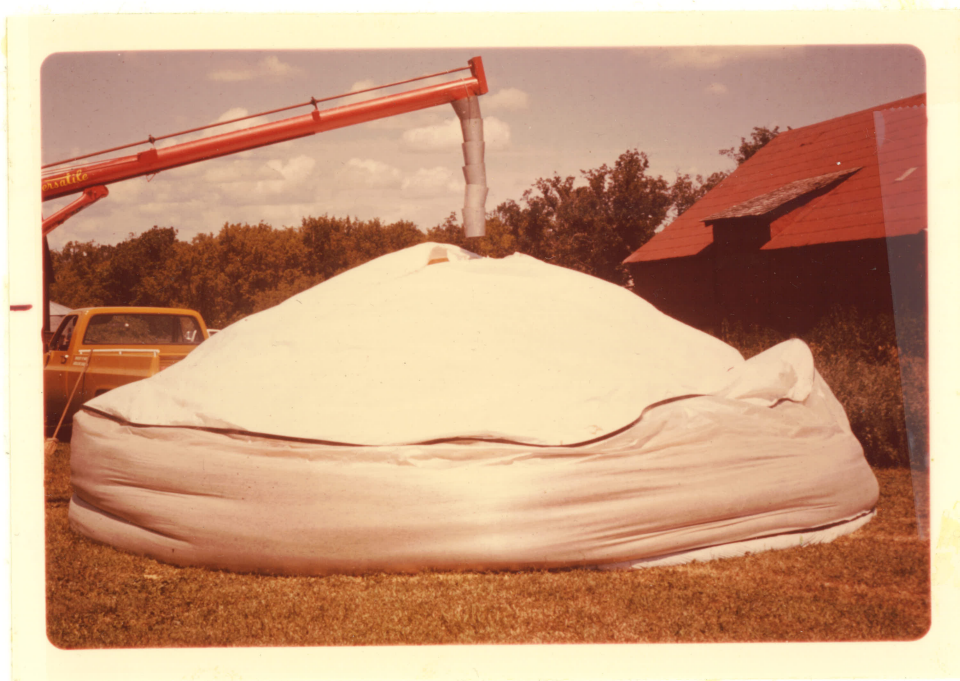
Fig. 5.4 Cylindrical bin with monolithic wall and conical roof under structural tests.

The bin did not perform as expected. Great difficulty was experienced with the air inflation system. Over-inflation of the bin occurred resulting in an unstable structure. Any slight breeze caused the structure to move a large amount both laterally and vertically. Stakes had to be provided along the base of the structure to prevent movement. When the fan was stopped, the bin did not remain inflated.

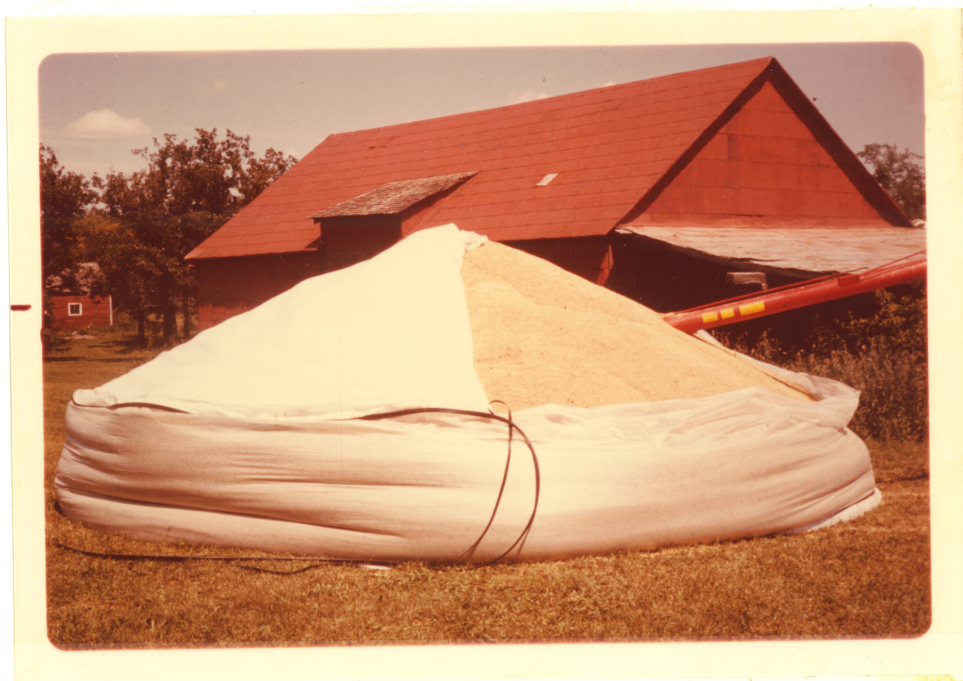
Fig. 5.5 Unloading of cylindrical bin with monolithic wall and conical roof.

Unloading of the structure was relatively easy. The Polyzip joint between the wall and roof was unfastened. The roof was then removed and a grain auger inserted into the grain bulk (Fig. 5.5). The bin had to be unloaded evenly to prevent wall sagging. Easy clean-up was facilitated by the TU-TUF-2 floor which did not puncture under severe abuse.

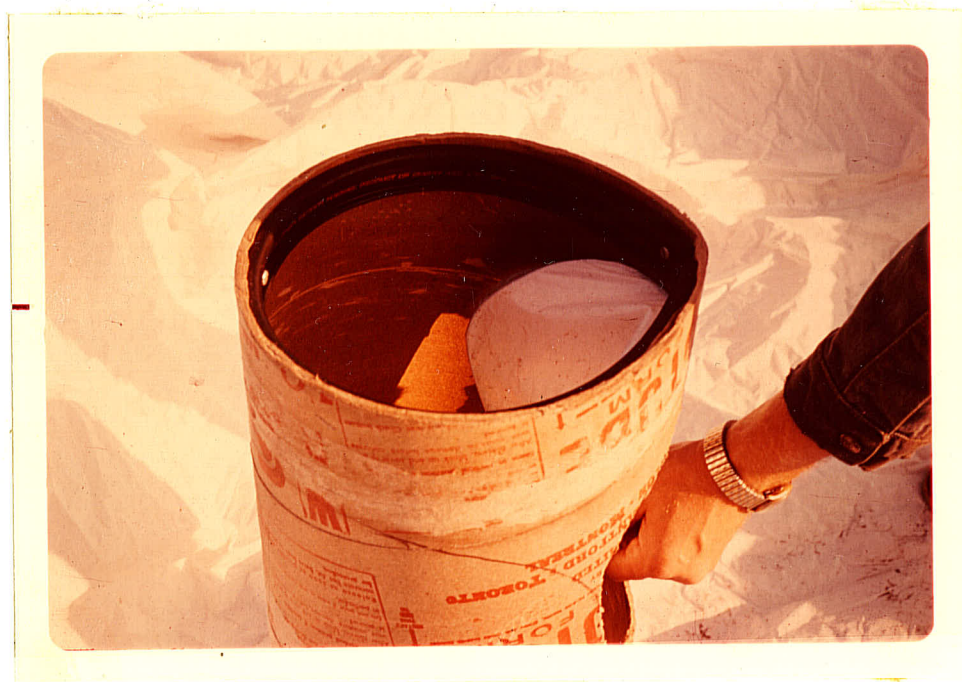
Fig. 5.6 Combination grain filling spout and air valve shown in the loading position.

During inflation, the valve was closed by air pressure. When filling began the grain flow opened the valve which then blocked the air duct to prevent over-inflation of the bin. The resultant increased backpressure on the fan caused a reduction in the air volume.

The valve was constructed from a cardboard tube with an outer diameter of 25.4 cm. TU-TUF-2 poly sheeting attached to Polyzip tape was used for the valve diaphragm. The Polyzip tape provided a flexible valve which conformed to the curved surface of the tube during grain loading. Polyzip channel attached to the tube prevented the valve from opening outwards during inflation.

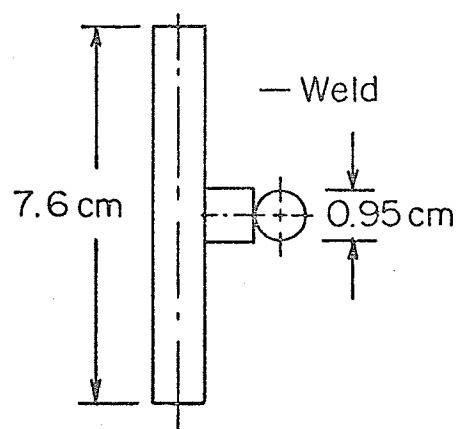
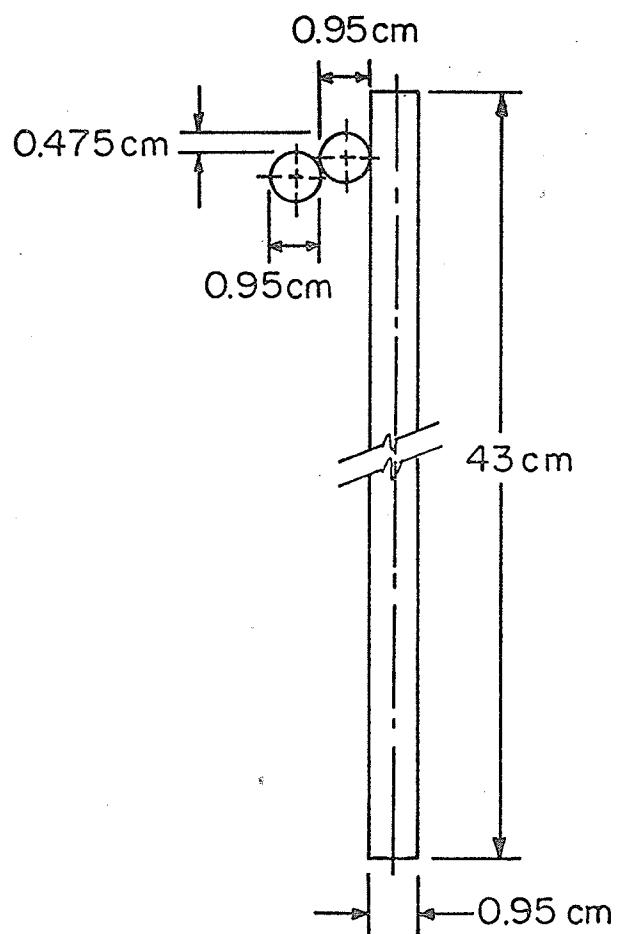
Fig.5.7 Anchor stake.

Steel stakes were driven into the ground every 1.8 m around the bin circumference to anchor the bin firmly to the

ground during inflation (Fig. 5.7). The stakes locked over the tape section of the Polyzip.

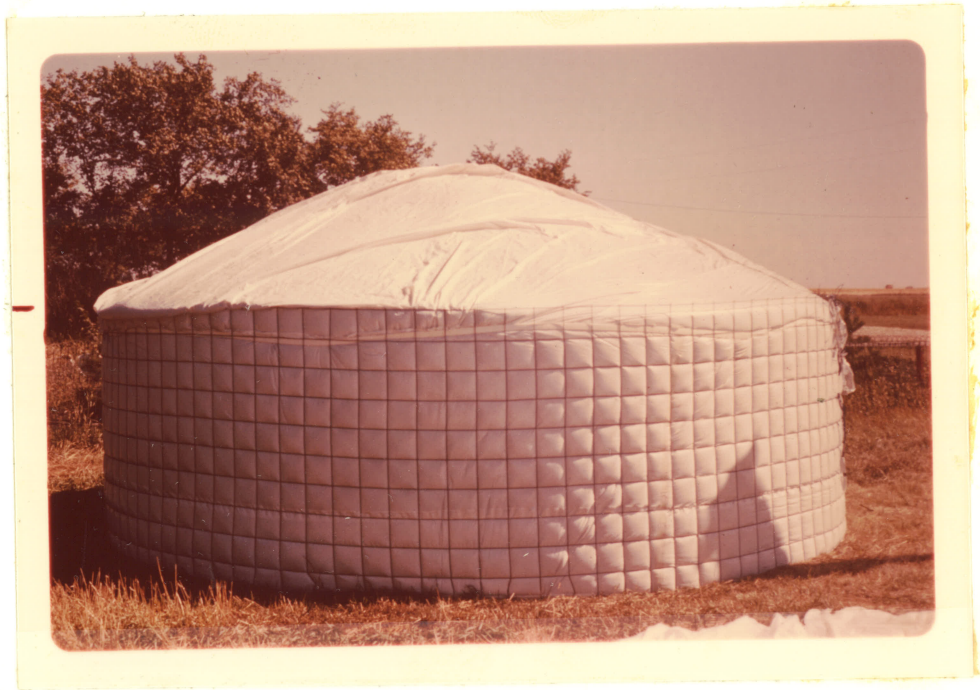
Fig. 5.8 "Climbing" effect of bin roof
on the steel mesh wall.

The roof eave did not occur at the top Polyzip joint (roof-to-wall joint). Rather, a "climbing" effect of the roof on the steel mesh was exhibited (Fig. 5.8). This phenomenon is advantageous because then the top Polyzip joint is not directly exposed to run-off water from the roof. There was no danger of the roof structure sagging over the top of the steel mesh since the steel mesh is 1.5 m high while the actual height of the wall membrane is 1.4 m. Fastening overlap of 10 cm caused this reduction in wall height.

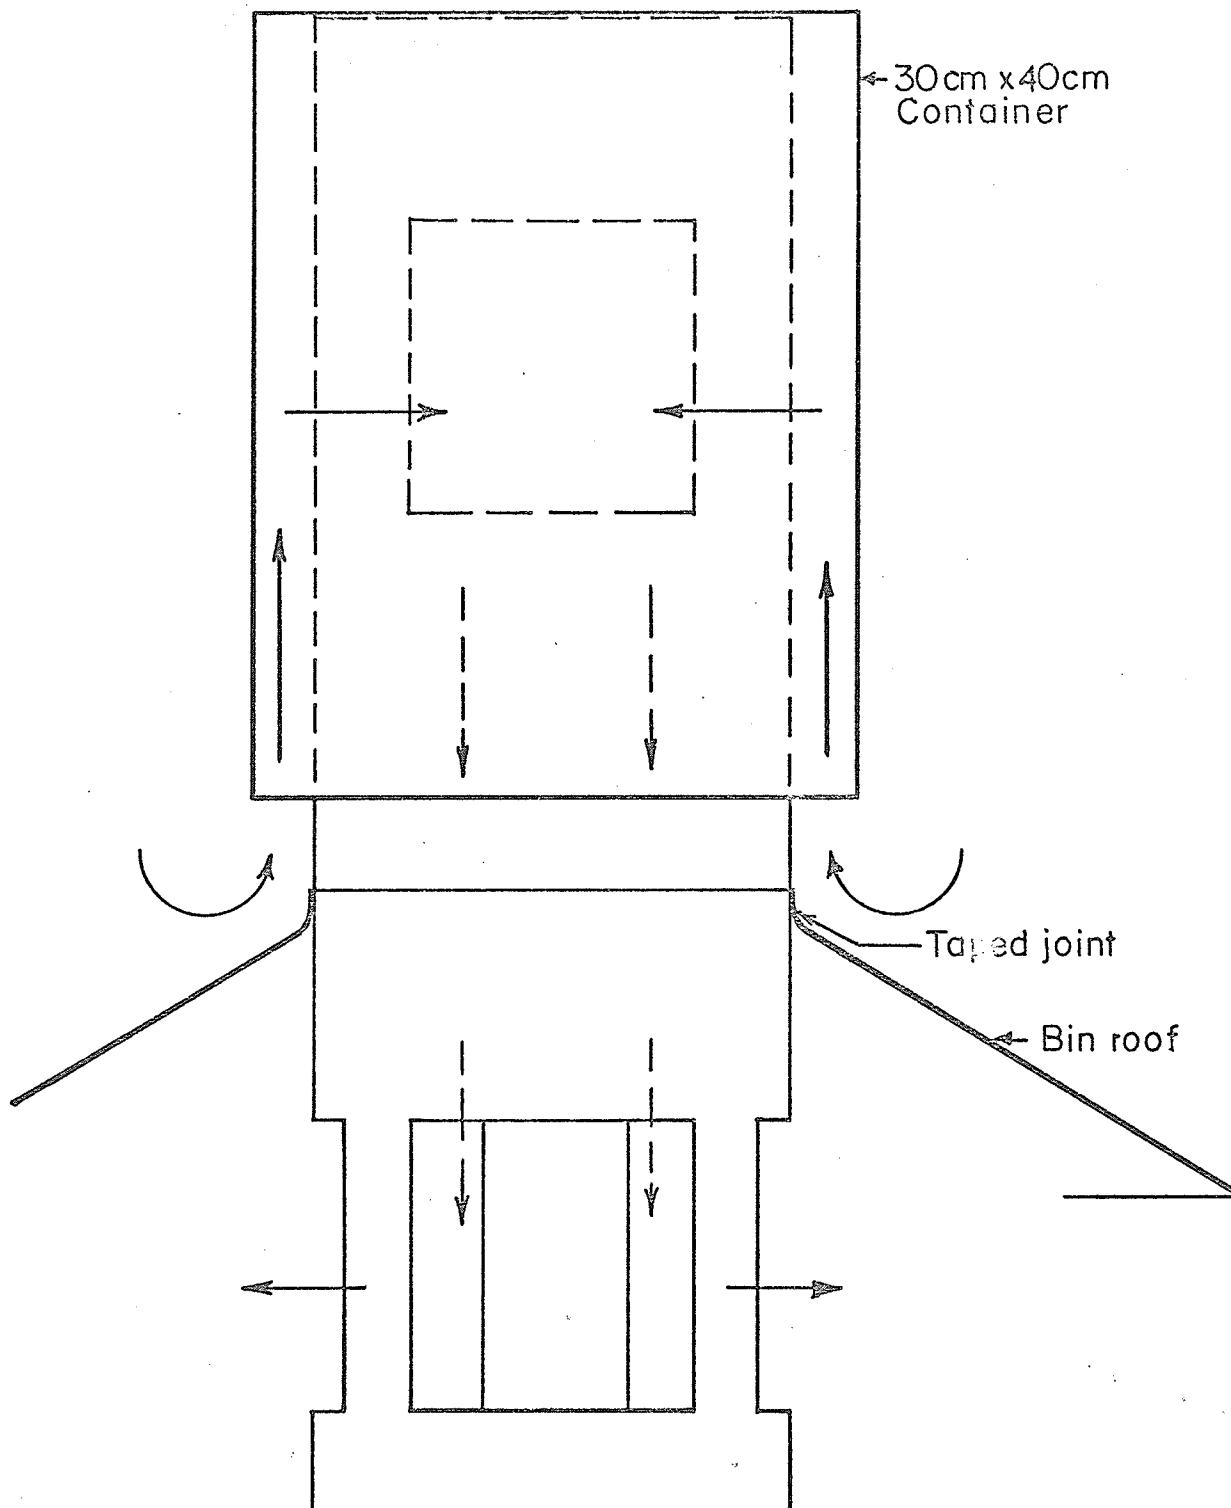
Fig. 6.2 Air flow through Sonotube vent.

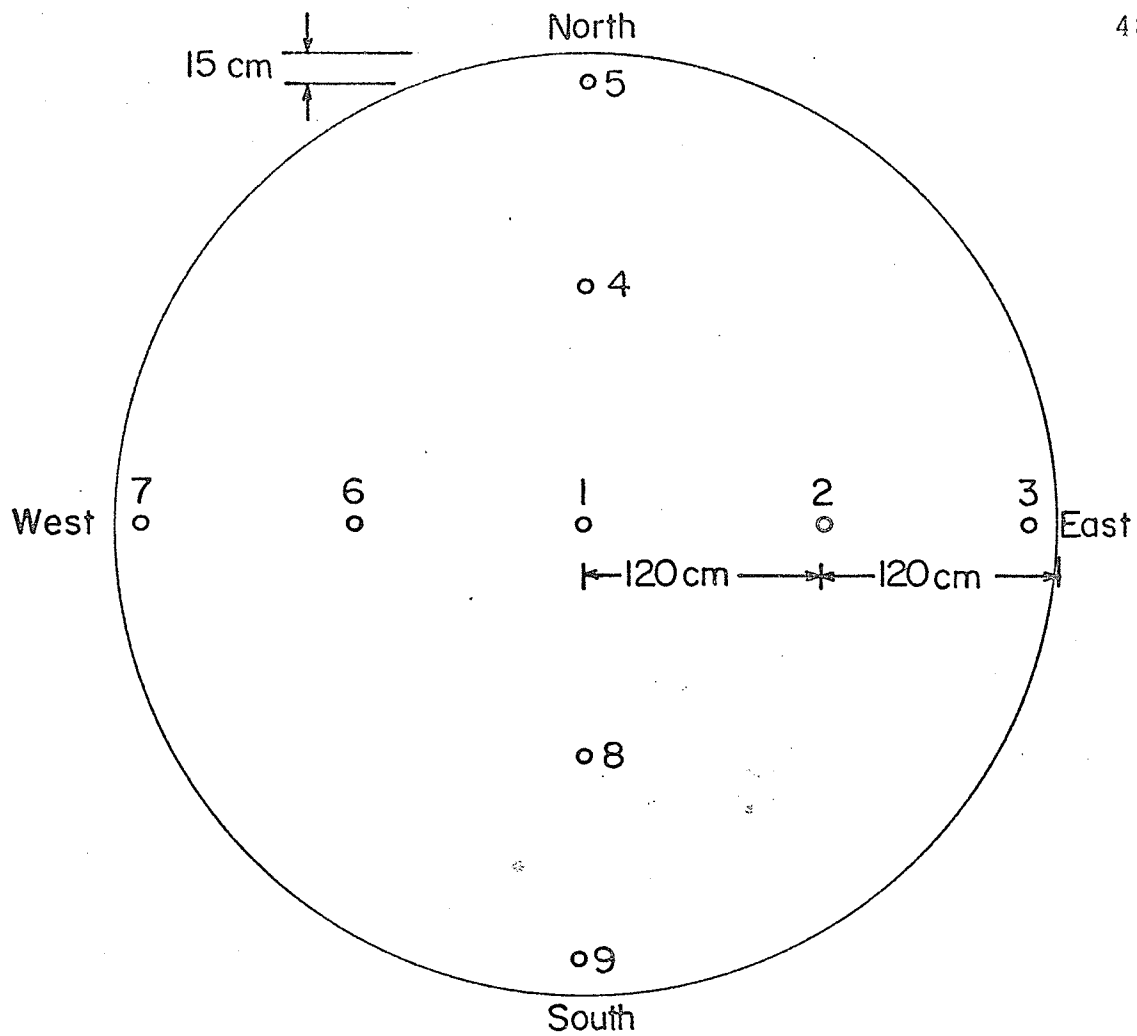
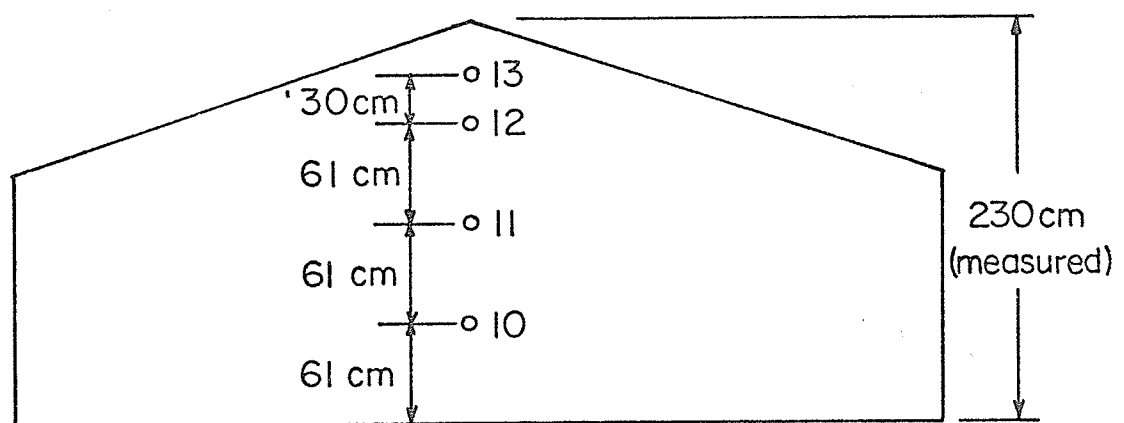
Plan view (all locations are on bin floor)

Elevation view (all locations are at the center of the bin)

Fig. 6.4 Thermocouple locations.

Temperature measurements were taken in each bin at 13 locations (Fig. 6.4). Temperatures on the floor of each bin were measured with 18-gauge (B&S) copper-constantan thermocouples taped to the floors before filling. Temperatures down the centre of each bin were measured with 22-gauge (B&S) copper-constantan thermocouples. The thermocouples were attached together at their respective distances to form a harness. This harness was pushed to the bottom of the bin with a 1.8-cm diameter wooden rod. A nail was placed at an incline 61 cm from the bottom of the rod. The harness

Early in the storage period, however, hot spots developed at thermocouple location 1 in bin A and at thermocouple location 4 in bin B (Fig. 6.4). The temperature at location 1 was approximately 11 C greater than the average temperature of the four thermocouples located on the floor a radial distance of 120 cm from location 1 (Fig. 7.1). The hot spot occurred two weeks after filling the bin and lasted for approximately two weeks. The temperature at location 4 in bin B was also approximately 11 C greater than the average temperature of the other three thermocouples locations on the floor a radial distance of 120 cm from the centre of the bin floor (Fig. 7.2). The hot spot occurred three weeks after filling the bin and lasted for approximately three weeks. The above normal temperatures

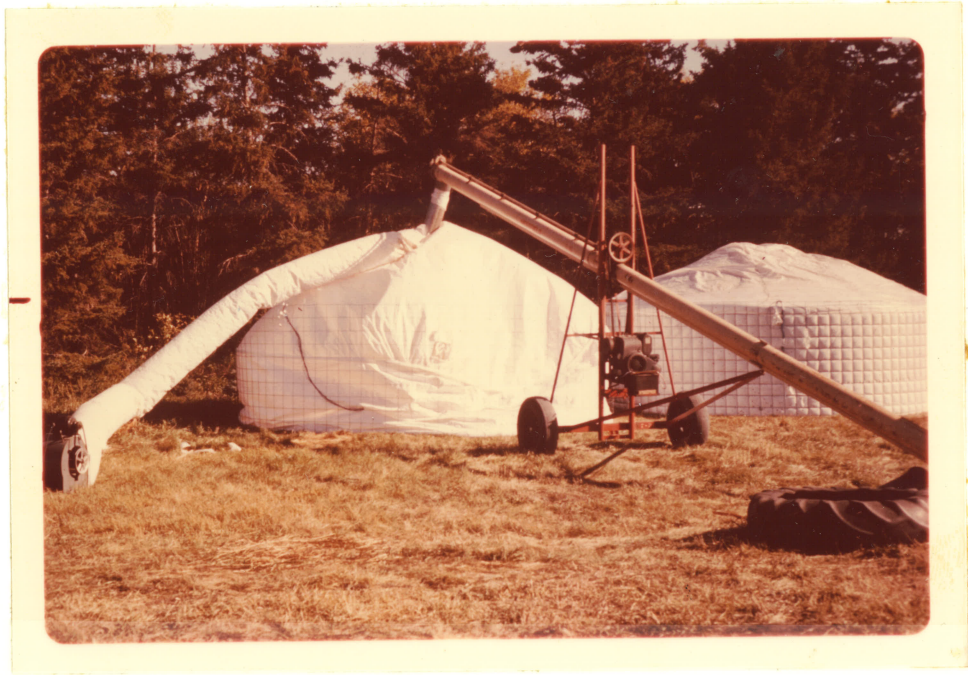
Fig. 6.3 Air inflation system in operation.

Loading of all three bins occurred in September, 1973. An air inflation system similar to that described in Sec. 5.4 was used. Air entered the structure through a hole near the

apex of the roof (Fig. 6.3). Anchor stakes were provided every 1.5 m around the periphery of the bin to constrain the structure prior to filling.

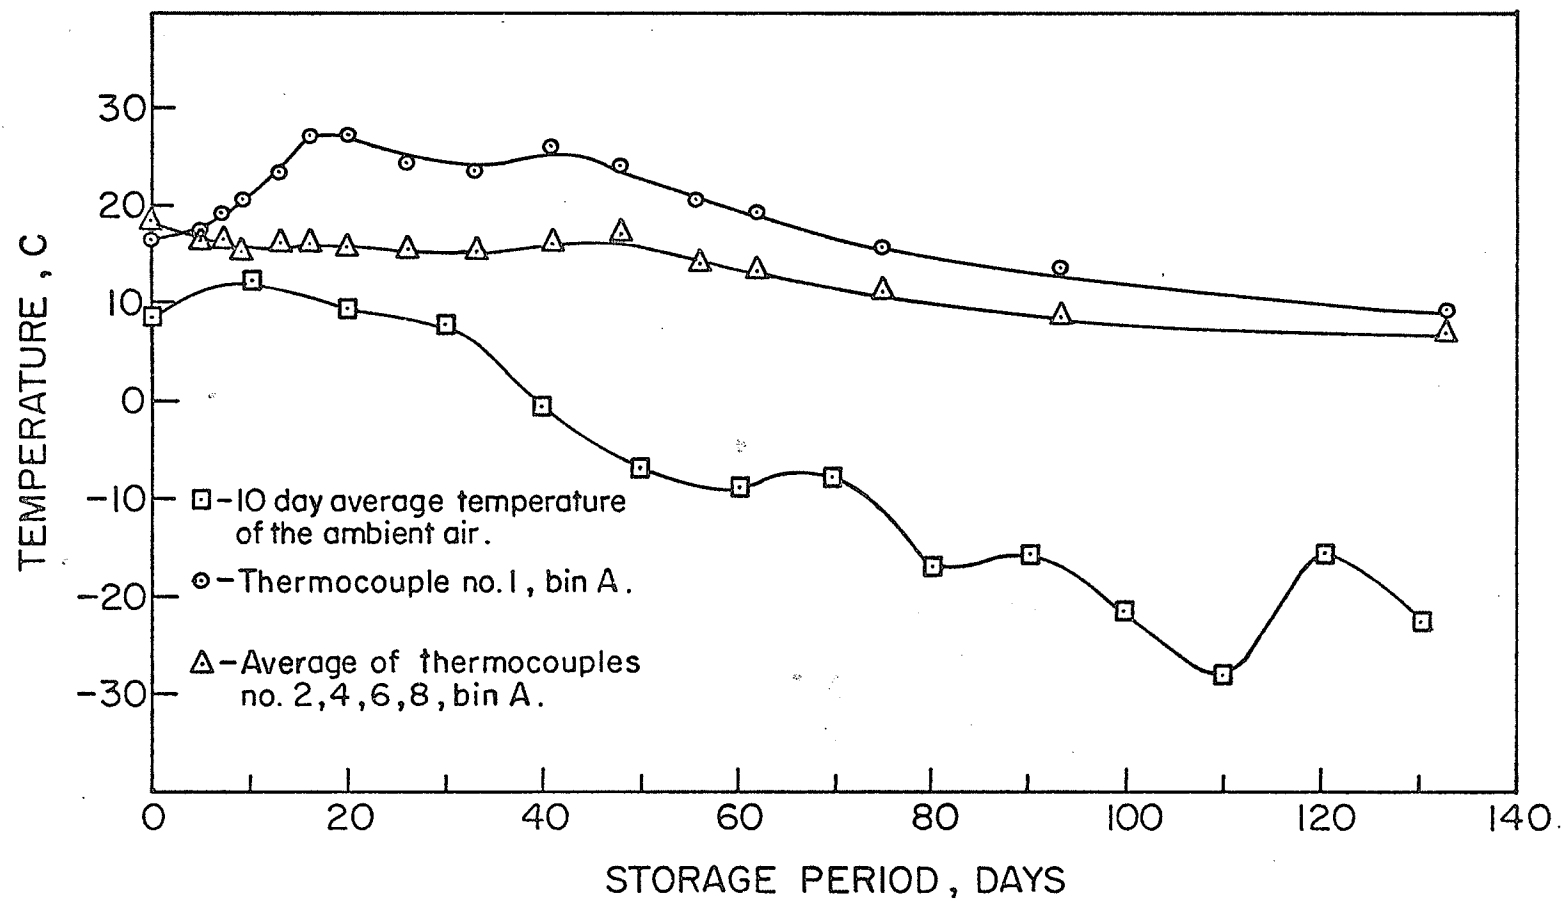
Fig. 7.1 Temperature of hot spot in bin A.

indicated that deterioration was taking place at these localized areas (Sinha and Wallace, 1965). Unloading of the bins confirmed that deterioration had occurred at the localized hot spots.

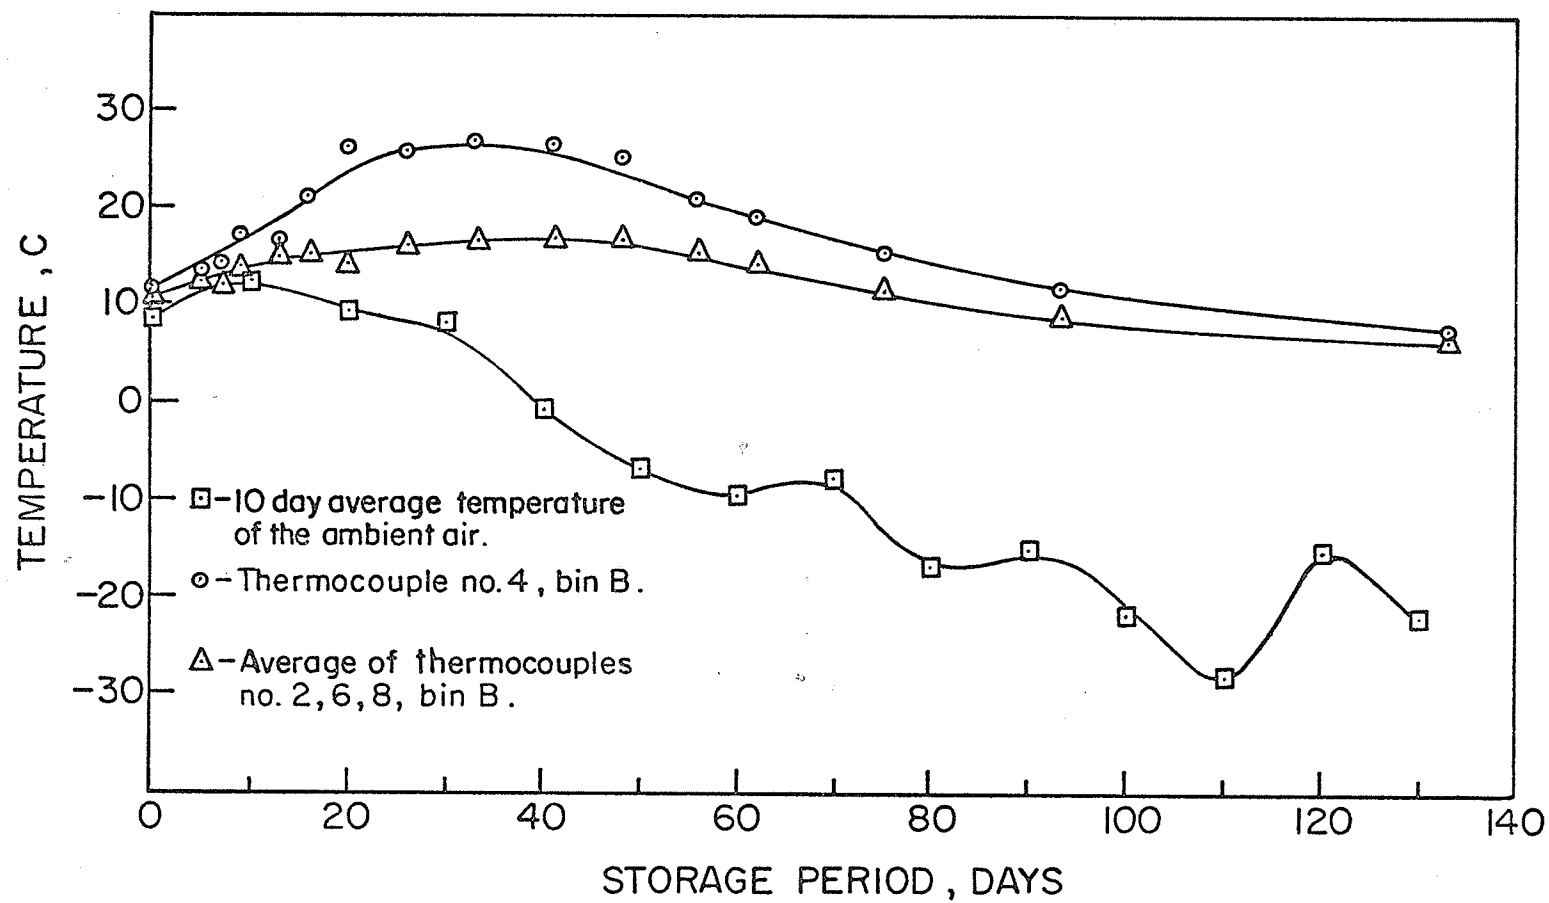
Fig. 7.2 Temperature of hot spot in bin B.

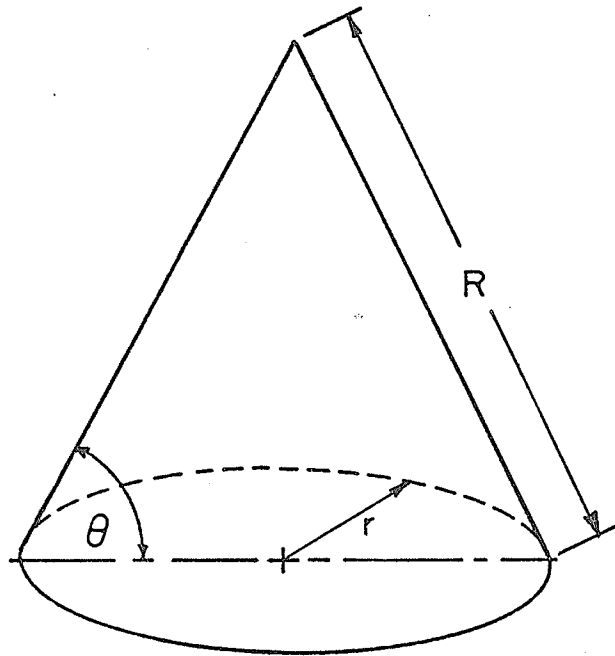
where: θ = wall angle of cone , radians
 r = radius of the base , m
 R = length of the conical sidewall , m

Fig. A.1 Conical wall .

$$\beta = 360(1 - \cos \theta) \quad \dots (A.7)$$

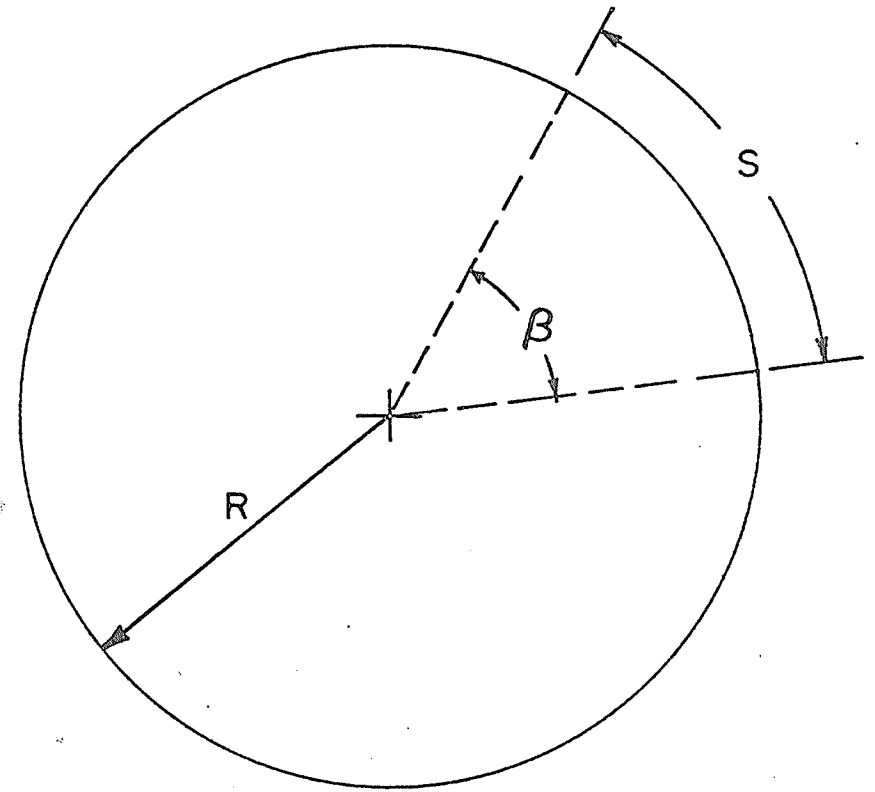
where: R = radius of the material section , m
 S = arc length of the segment , m
 β = segment angle , radians

Fig. A.2 Material section .
