# Testing Setup for the Investigation of Bone Fractures due to the Impact of Hockey Pucks

A Thesis submitted to the Faculty of Graduate Studies of

Department of Mechanical and Manufacturing Engineering

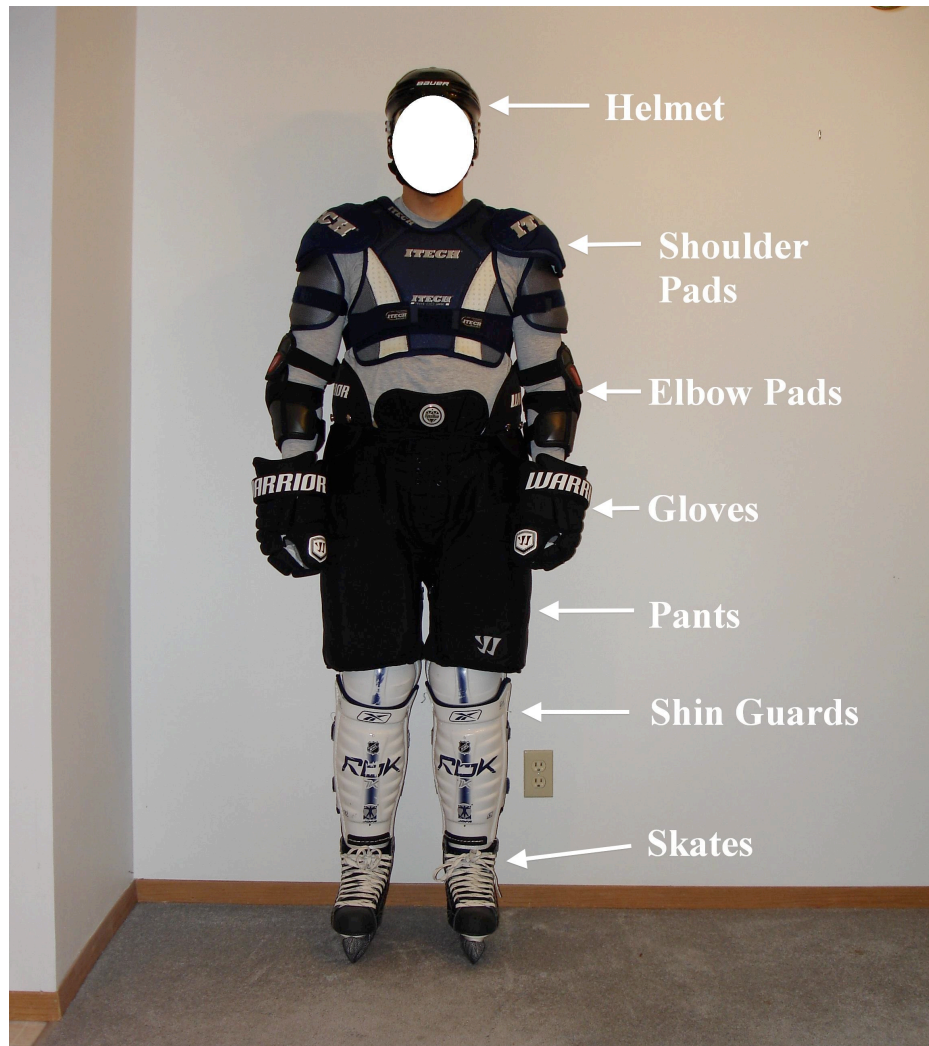
Figure 1: The main pieces of a skater's protective equipment in ice hockey

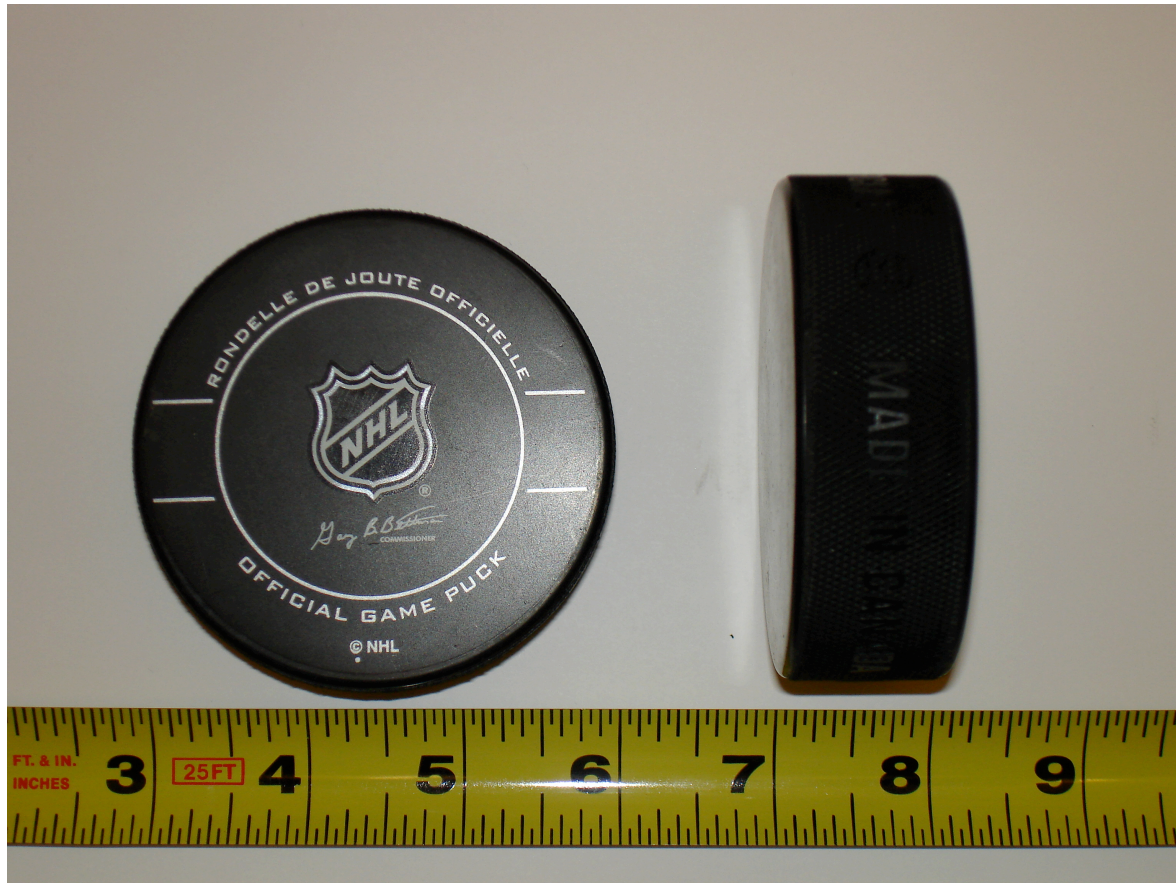
Figure 2: A standard NHL game puck

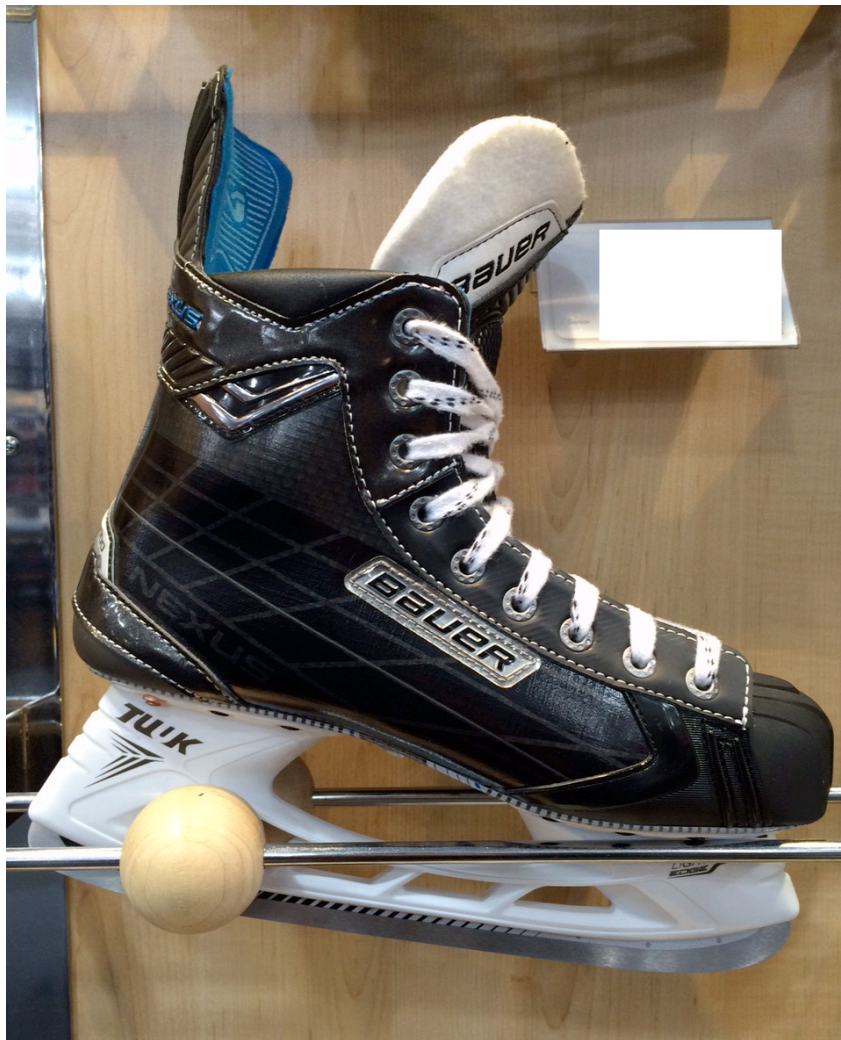
Figure 3: A current ice hockey skate with composite boot material

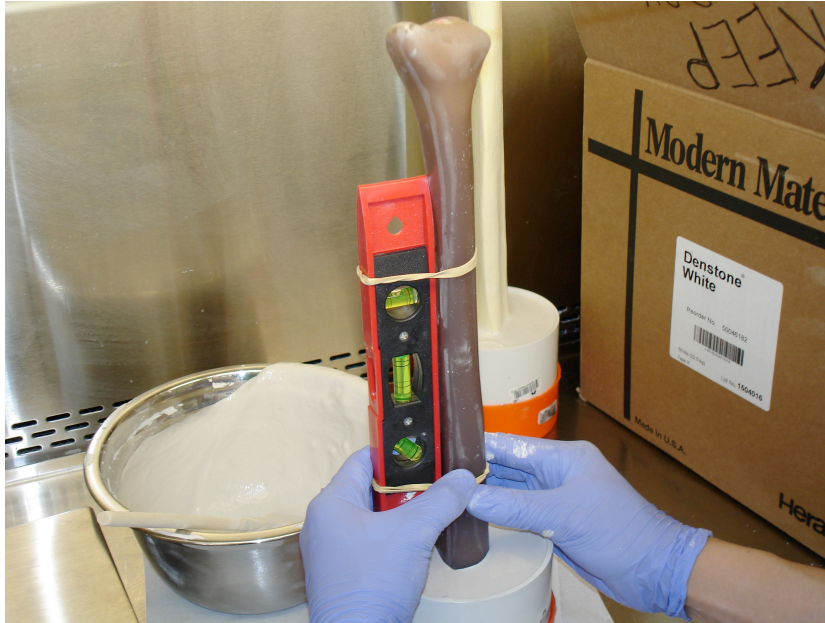
Figure 5: The cementing process of the composite tibia specimen

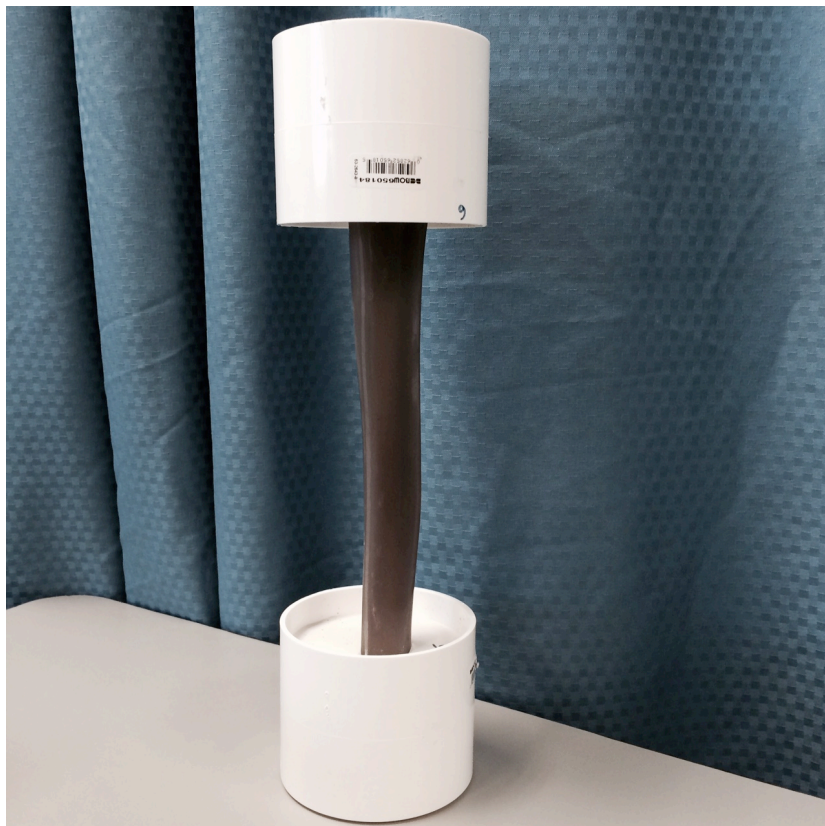
Figure 6: A composite tibia specimen prepared for testing

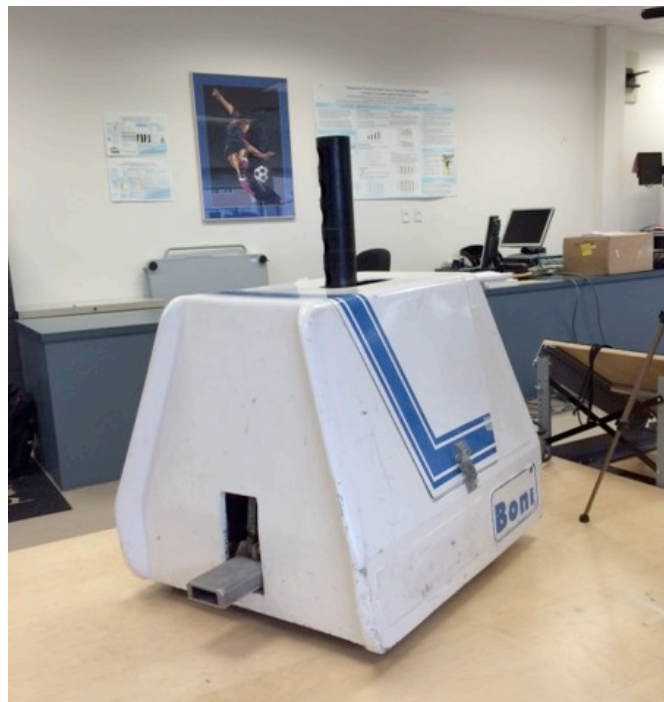
To accelerate the puck towards the target, a Porta-Puck shooting machine (Boni Goalie Trainers, Ontario, Canada) was used (Figure 8 and Figure 9). The Porta-Puck is similar to a baseball-pitching machine in that there are two wheels that are independently driven by electric motors that grip the puck and propel it through an exit port. The shooting speed is advertised to vary between 5 and 80 miles per hour. An actuator raises the exit port to vary the shooting angle. Pulling a lever that pushes the puck in between the two spinning wheels operates the machine. The pucks used for testing were produced by Lindsay Rubber (Ontario, Canada) and had an average mass of  $165.4 \pm 0.9$  g ( $5.8 \pm 0.03$  oz).

Figure 8: The Porta-Puck shooting machine

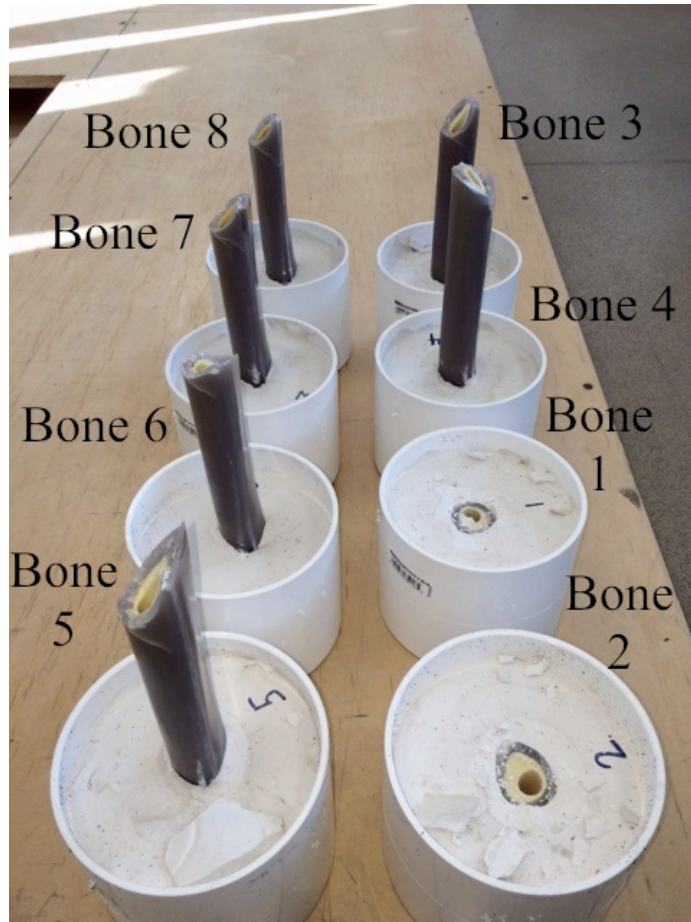
An effort to reduce the motion of the Porta-Puck, which was thought to influence the impact location, was performed. This effort involved placing lumber under the Porta-Puck so that the wheels under the machine were no longer touching the ground. The exit port was raised as a result of this. Bone specimens #1 and 2 were impacted with this adjusted setup. These bone specimens fractured at the inferior end. Video analysis of these impacts showed hardly any deflection in the specimens upon impact. Shear forces would be higher in the superior end where the puck was now impacting. It can be seen that the other bone specimens fractured in bending at mid-shaft (Figure 22). When the puck was impacting closer to mid-shaft the bone specimens did not fracture at the inferior end suggesting that shear forces in the inferior end were not sufficient to cause fracture even when the loading was closer to that location. It may be possible that the indirect impacts of bone specimens #1 and 2 were causing an increased torque due to being impacted in an area of the shaft that was wider. The rest of the bone specimens had similar fracture characteristics (Figure 23).

Figure 23: Inferior portions of the composite bone specimens after fracture

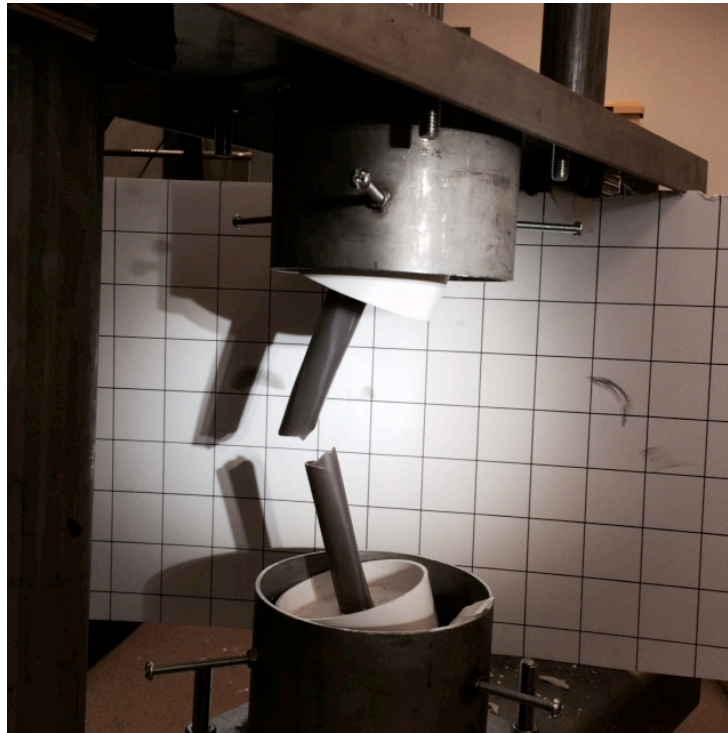
The supports of the bone specimens within the impact frame fixture may have not have behaved consistently. The bone specimen itself is fixed within the Denstone material inside of a PVC pipe coupling. The PVC pipe coupling, however, is held in place inside of the impact frame with 1/4 inch machine screws that feed through the wall of a larger stainless steel pipe. The machine screws were tightened by hand. After a few impacts during testing the machine screws were beginning to bend. This suggests that they were taking up some of the force of the impact. The screws were straightened and some were replaced when no longer useful. The ends of the machine screws were sharpened to a point with an angle grinder to provide a better grip onto the PVC pipe coupling. This sharpened point appeared to scratch and remove some of the PVC

material when the impacts occurred. Due to the bending of the machine screws there may have been impacts where the PVC pipe coupling was translating within the frame fixture. It is difficult to determine if this was the case or not. There were also cases of the PVC pipe couplings rotating after fracture of the bone specimens (Figure 24). It may be beneficial to have stronger machine screws as well as a stainless steel pipe in the impact frame that is just large enough to fit the PVC coupling inside. The impact frame performed flawlessly, except for the  $\frac{1}{4}$  inch machine screws. A major failure of any of the other elements of the impact frame due to puck impact is not expected should future tests be performed.

Figure 24: Orientation of the PVC pipe couplings after bone specimen fracture
