EVALUATION OF EROSION RATES AND THEIR IMPACT ON RIVERBANK STABILITY

A Thesis
Submitted to the Faculty of Graduate Studies
in Partial Fulfillment of the Requirements for the Degree of

Department of Civil Engineering
University of Manitoba
Winnipeg, Manitoba

July, 2014

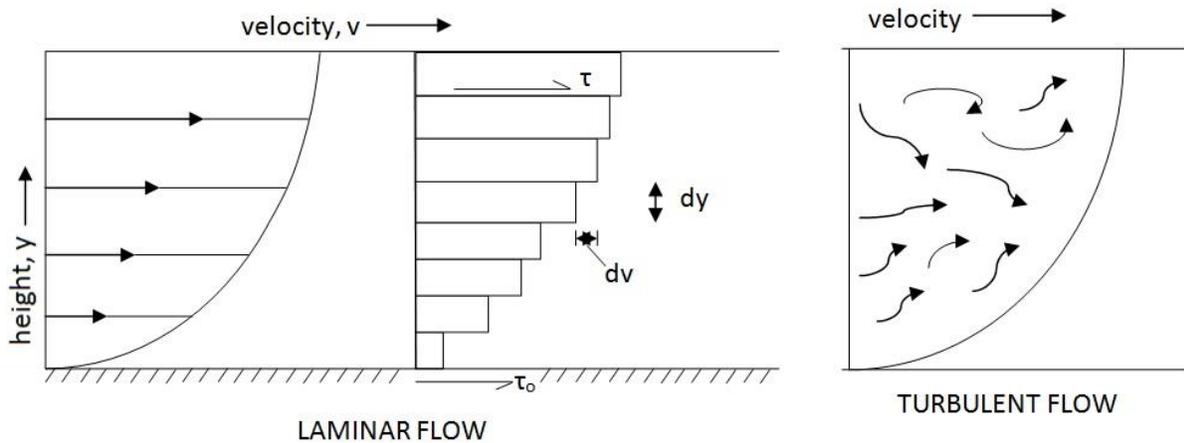
In Figure 2.2 the velocity distribution of laminar flow in a symmetrical river channel cross-section is shown to have a parabolic shape along the channel depth with the velocity decreasing to zero at the channel bed due to frictional resistance between the fluid and channel bed (Knighton 1998). The maximum velocity gradient is found in the bed and lower bank region, which experience the greatest amount of erosion due to the highest shear stress acting on them. Flow is described as laminar or turbulent. Laminar flow is the smooth flow of layers of fluid, moving together without mixing and crossing each other. Turbulent flow is the chaotic movement of fluid, which causes greater erosion (Morisawa, 1968). The configuration of the cross section can further change the velocity distribution.

Figure 2.2: Average velocity distribution at the center of a channel under laminar and turbulent flow conditions

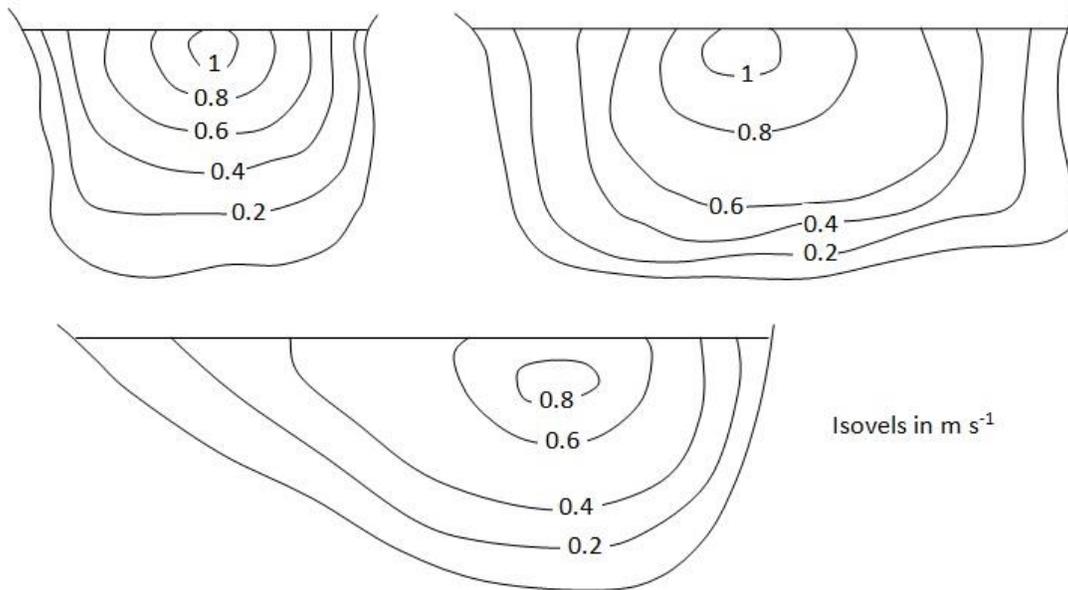
The mean velocity distributions (lines of equal velocity) for different symmetrical and asymmetrical channel cross-sections are shown in Figure 2.3 and Figure 2.4. Generally the isovels are closer together near the boundaries. The maximum velocity observed is at the center of the channel due to the decline in frictional effects from the channel banks (Knighton 1998). Velocity gradient and therefore shear stresses are highest where the isovels are closer together. The shear stress is greatest at the bed in wide shallow sections and greatest on the banks in narrow deep sections, which produce greater bank erosion (Knighton 1998). The velocity distribution becomes skewed when compared to asymmetrical cross-sections. As shown in Figure 2.4, the maximum velocity shifts from the center to the outer edge of the channel (Morisawa, 1985).

Figure 2.3: Velocity isovels in different channel cross-sections

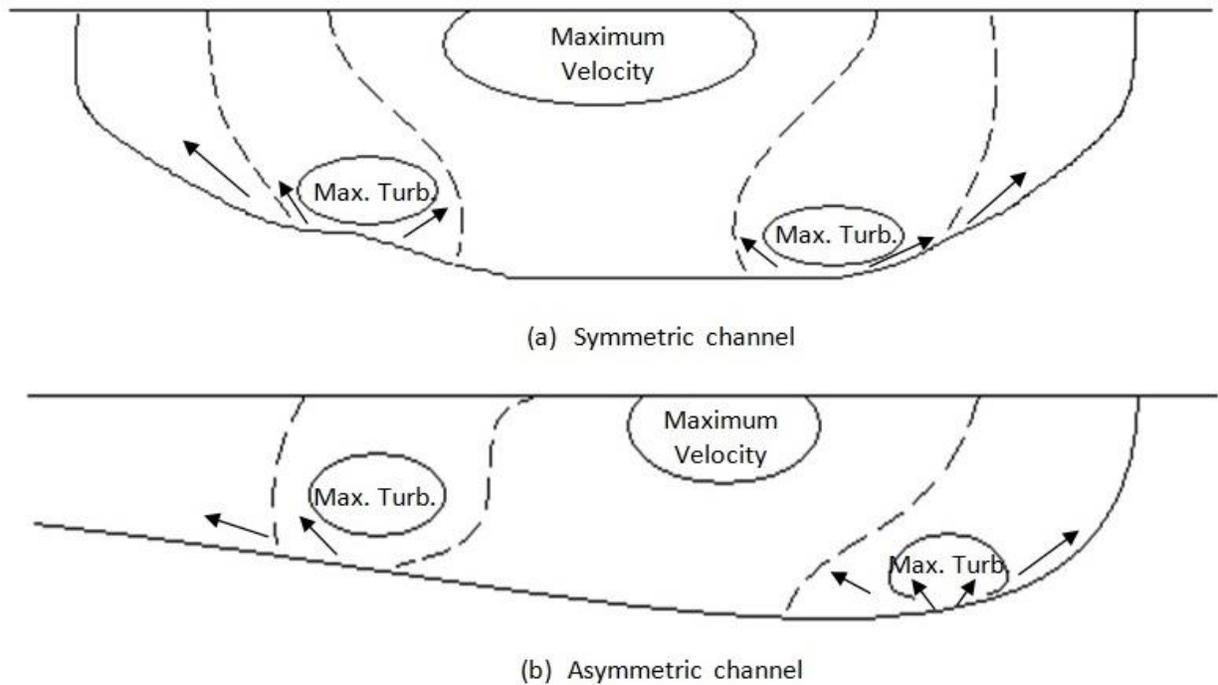
Figure 2.4: Velocity and turbulence distribution in (a) symmetrical channel and (b) asymmetrical channel

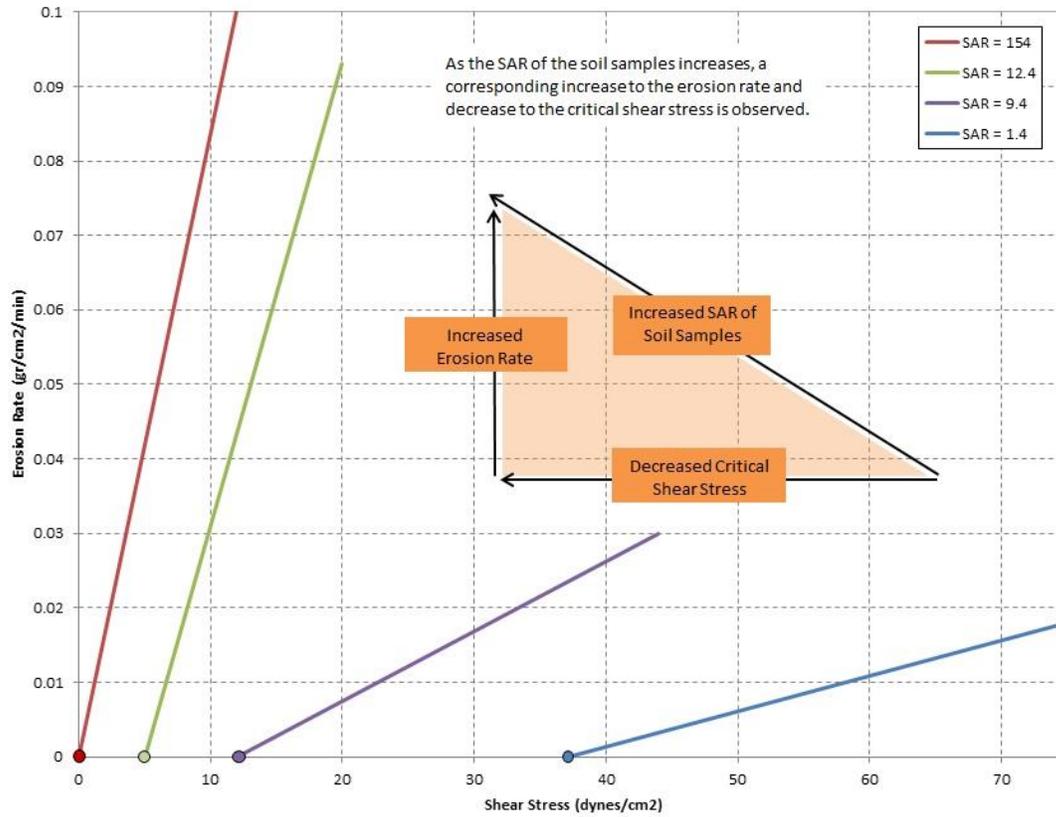
Arulanandan *et al.* (1980) stated that the main property governing the erosion of clays is the concentration of dissolved sodium, calcium and magnesium cations in the pore water, represented by SAR. The correlations between SAR and erosion rate, and SAR and τ_c are shown in Figure 2.15, as proposed by Arulanandan *et al.* (1975). Higher erosion rates and lower critical shear stress are seen for soils with SAR values greater than 10, as shown by their steep lines and x-axis intercepts. For SAR values lower than 10, τ_c is shown to be as high as 38 dynes/cm² or 3.8 Pa with more gradual erosion rates. The concentration of dissolved salts in the eroding fluid is another main factor in erosion rates. As shown in Figure 2.16, if the salt content in the eroding water is low, the soil is more susceptible to erosion (Arulanandan *et al.* 1975). Arulanandan *et al.* (1975) also stated that erosion is a surface phenomenon where mechanical soil properties such as shear strength, moisture content and plasticity index do not accurately describe the state of the soil at the surface.

Figure 2.15: Effect of Sodium Adsorption Ratio (SAR) and Eroding Fluid Concentration (CONC) on Erosion Rate and Critical Shear Stress (used with permission from American Society of Civil Engineering April 4th 2013, based on data from Arulanandan *et al.* 1975)

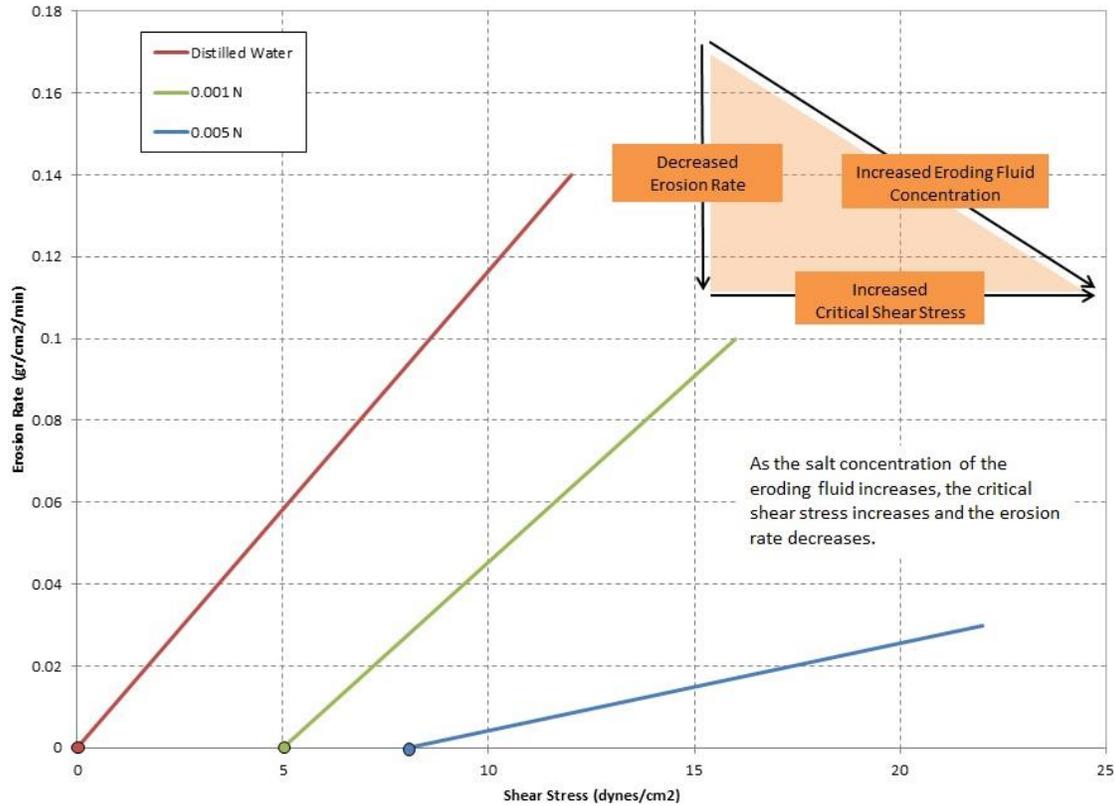
Figure 2.16: Effect of Eroding Fluid Concentration (CONC) on Erosion Rate and Critical Shear Stress (used with permission from American Society of Civil Engineering April 4th 2013, based on data from Arulanandan *et al.* 1975)

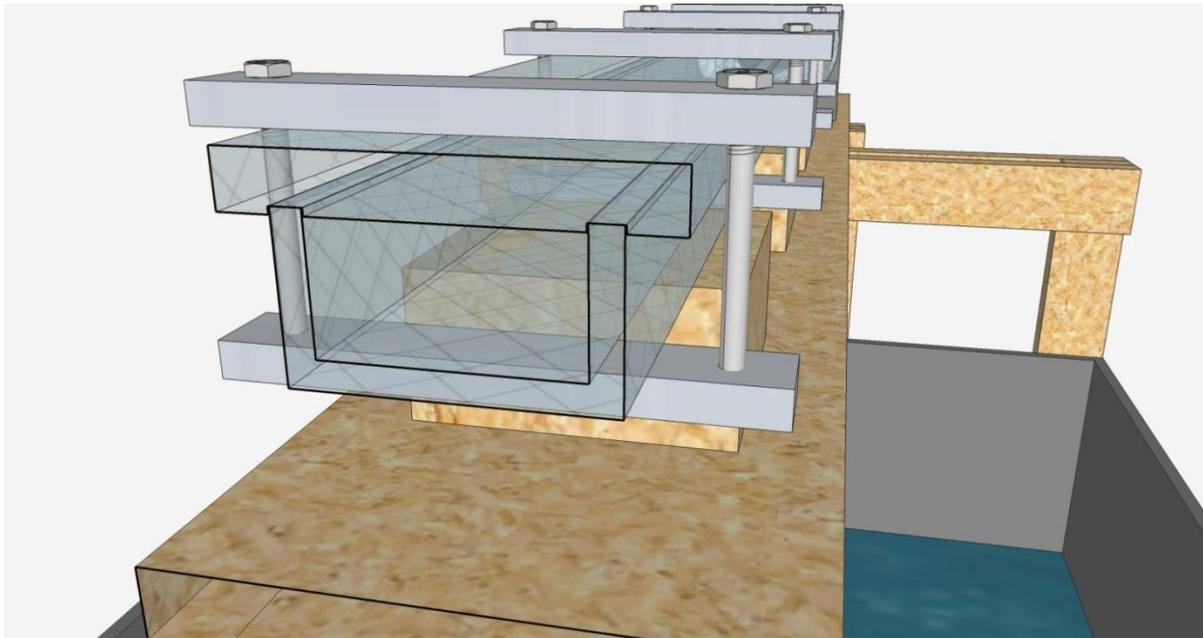
Figure 3.1: Cross section of flume and lid

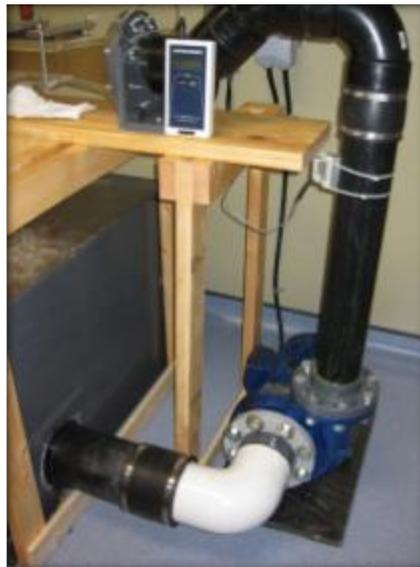
The device includes a number of key components. Figure 3.3 displays the right end of the device, where the pump and the frequency drive regulate the flow into the flume and the ultrasonic flow meter that displays the flow in the pipe is located. The flow velocity in the flume is then calculated using the flow volume and the cross-sectional area of the pipe and the flume.

Figure 3.3: Pump and Ultrasonic Flow meter

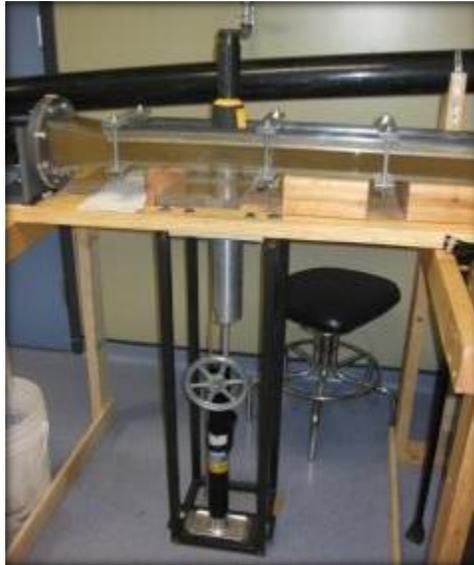
Figure 3.4 shows the end of the flume where the tube with the sample being tested is fastened to the bottom of the flume and extruded with the screw jack. The sample is observed in the dark with a flashlight and lasers mounted on the platforms on both sides of the flume. This allows for visual observation of the erosion at positions on the specimen in the flow field.

Figure 3.4: Extrusion System and Observation Deck

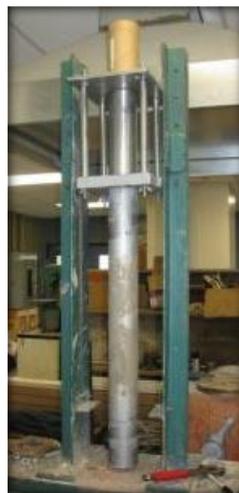
Figure 3.5 illustrates the extraction of a Shelby tube sample into the customized pipe that fits under the flume with O-rings to prevent leakage.

Figure 3.5: Shelby Tube Extraction Device

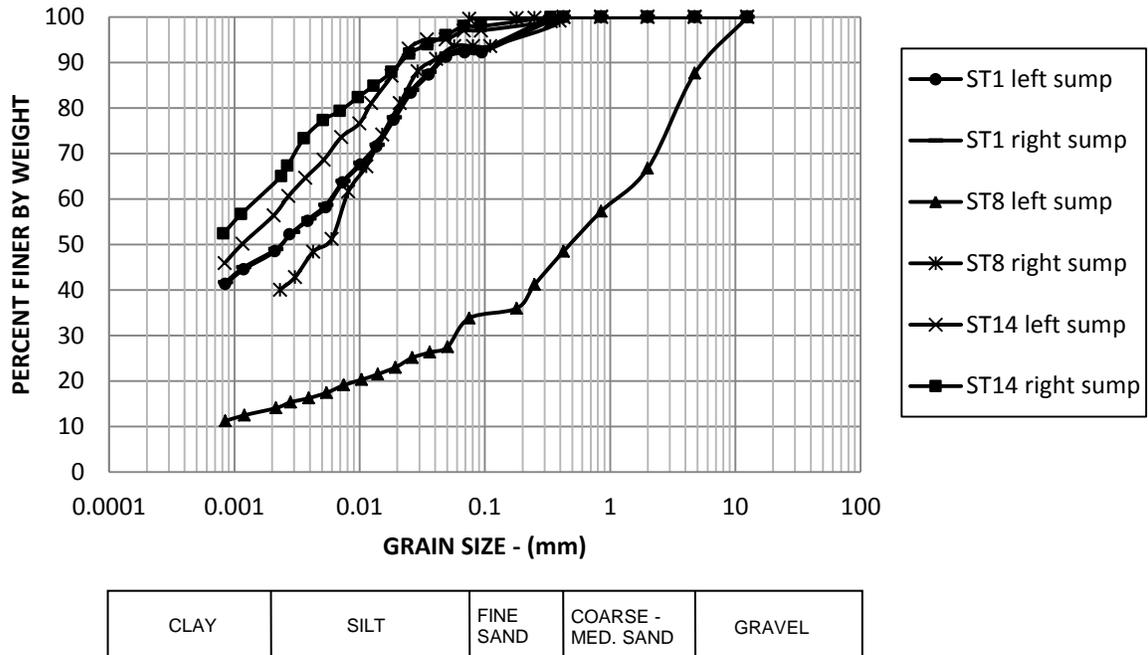
Hydrometer analyses were performed on two samples of water taken directly from the flume. Figure 4.9 and Figure 4.10 illustrate the results. It can be seen that the flume water contains mostly clay and some silt.

Figure 4.8: Grain Size Analysis of Sump Water Samples

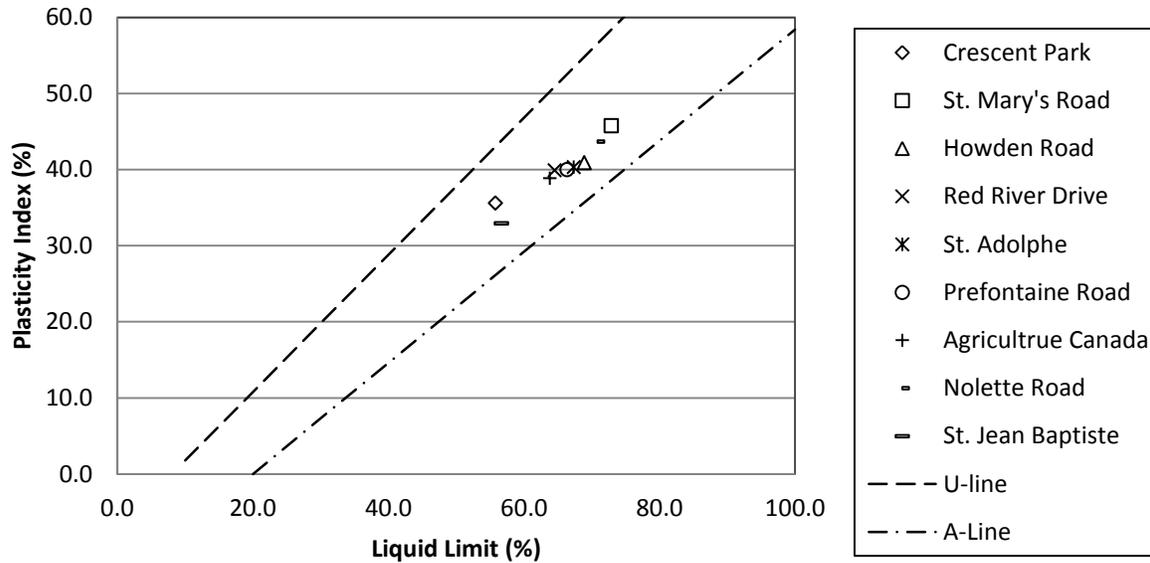
Figure 4.11: Phase I Plasticity Chart of the Nine Study Sites

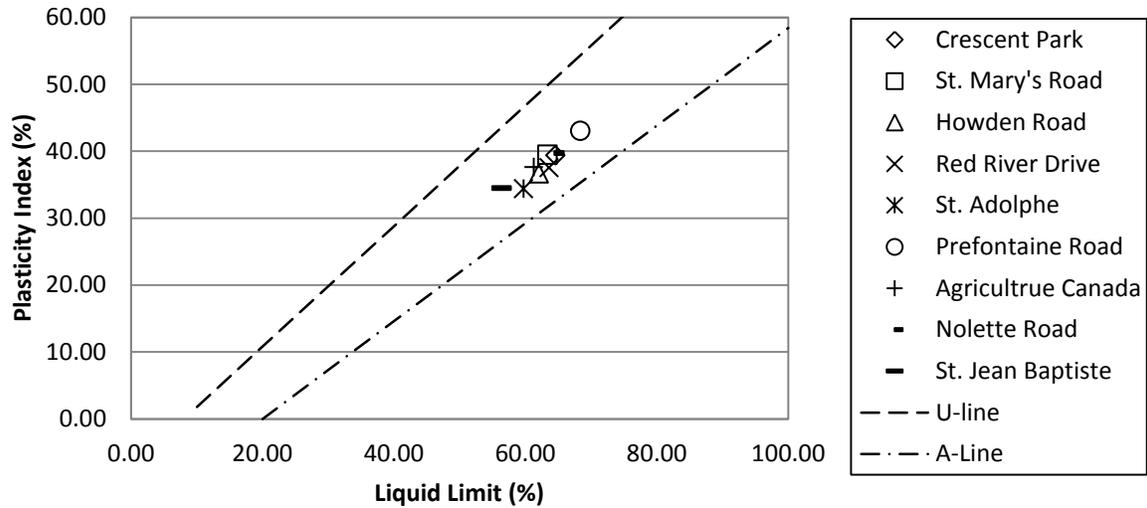
Figure 4.12: Phase II Plasticity Chart of the Nine Study Sites

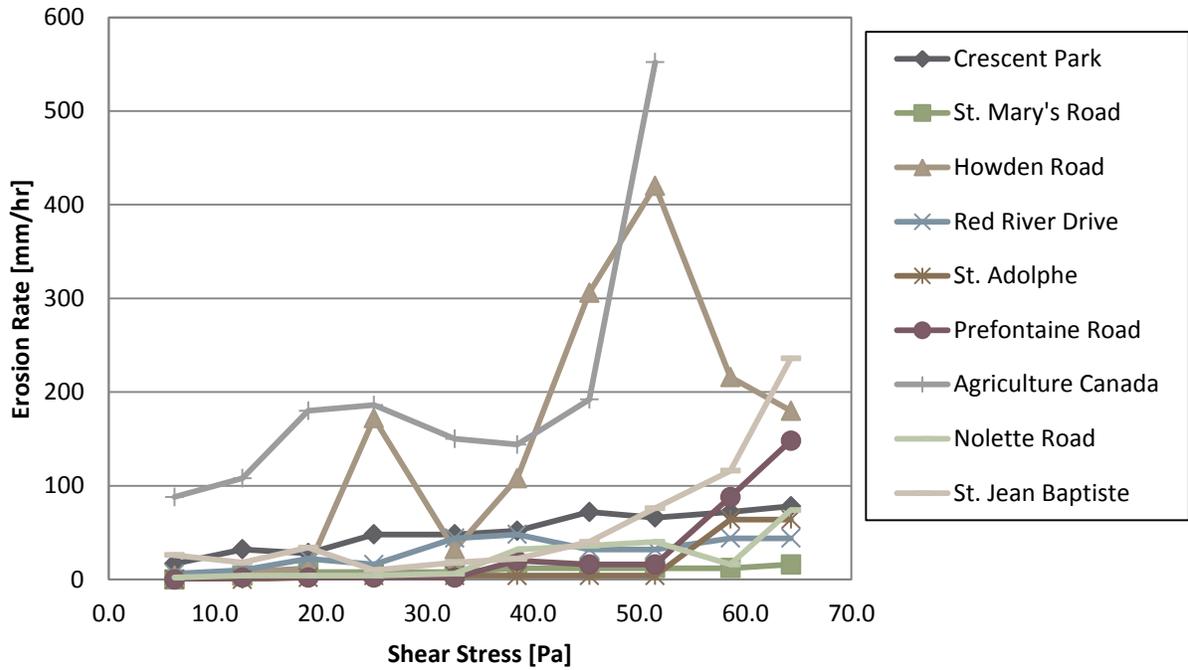
Figure 4.13 compares the nine study sites' erosion rates and in Figure 4.14 the erosion rates are compared to Fernando (2007) results which were taken from Kingston Crescent and tested at Texas A&M University. This comparison has simply been made to indicate, although based on limited data, that the sediment load does not appear to have a notable effect on erosion rates over tap water. This was further examined in the second phase of the study. The erosion rates are grouped together in Figure 4.15 and Figure 4.16 depending on if the samples were taken from inside or outside/transition bends and straight sections along the Red River.

Figure 4.13: Erosion Rate vs. Shear Stress of Nine Study Sites

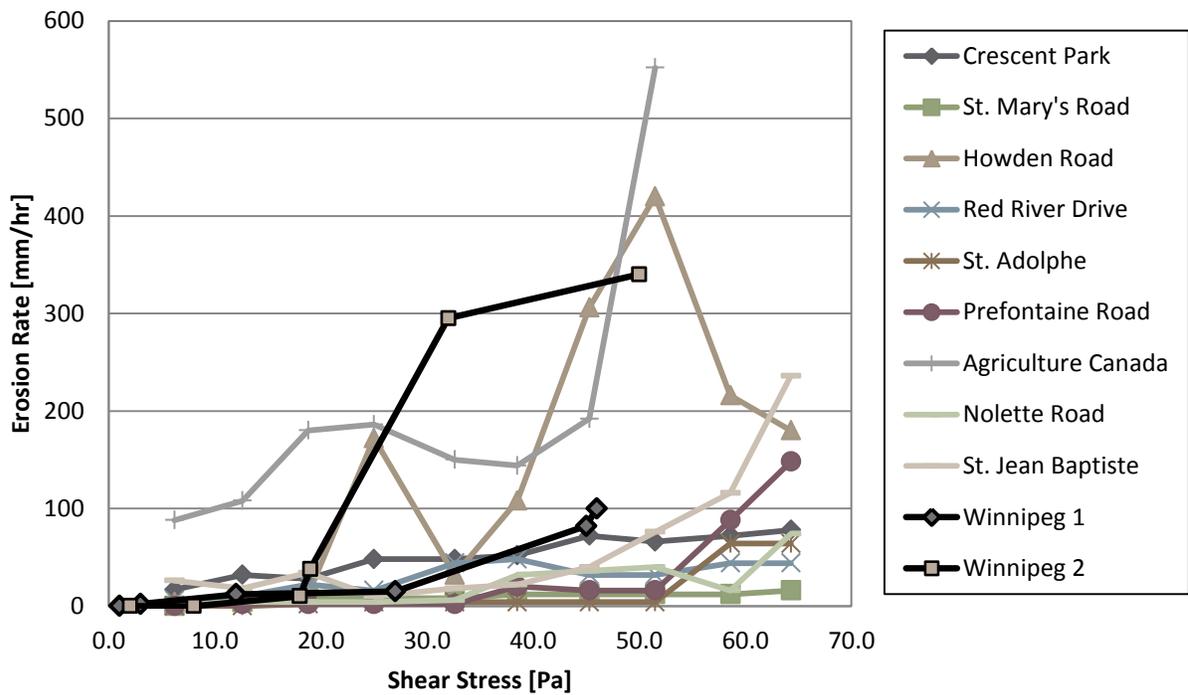
Figure 4.14: Erosion Rate vs. Shear Stress of Nine Study Sites and Fernando 2007 data

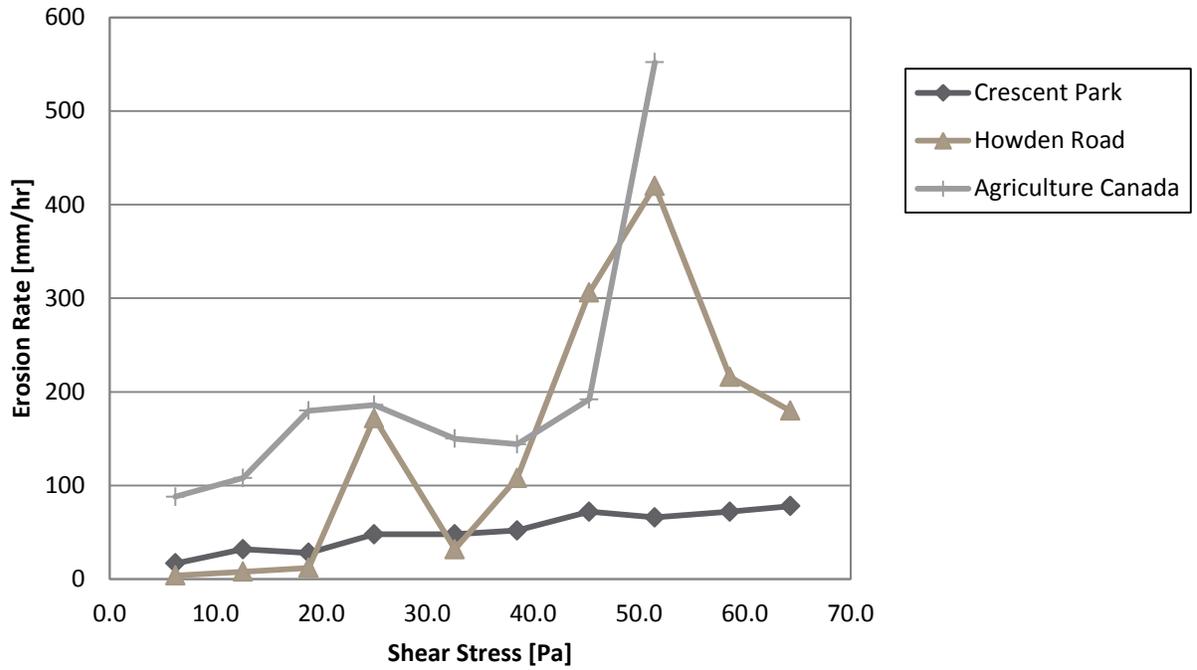
Figure 4.15: Erosion Rate vs. Shear Stress of the Inside Bend

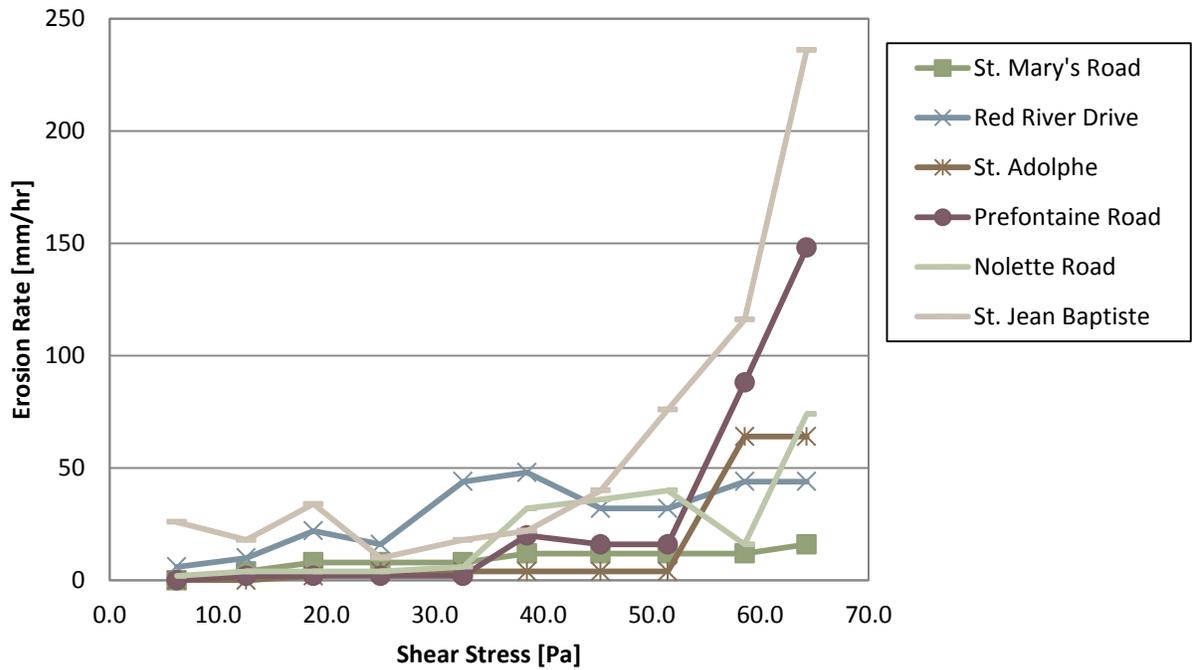
Figure 4.16: Erosion Rate vs. Shear Stress of the Outside Bend and Transition Sites

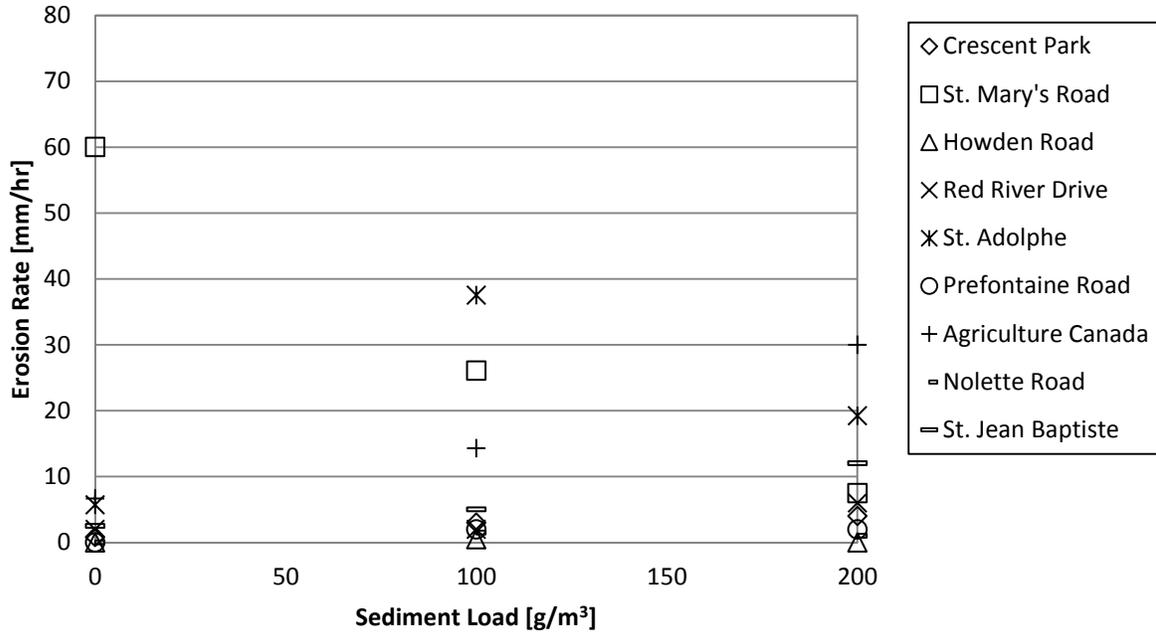
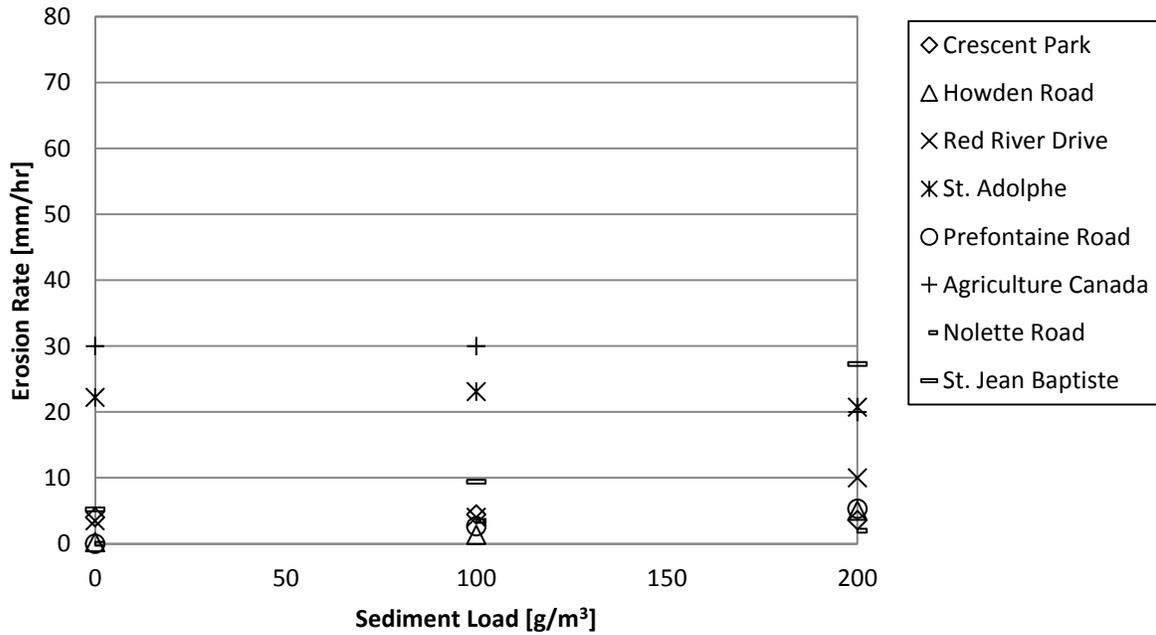
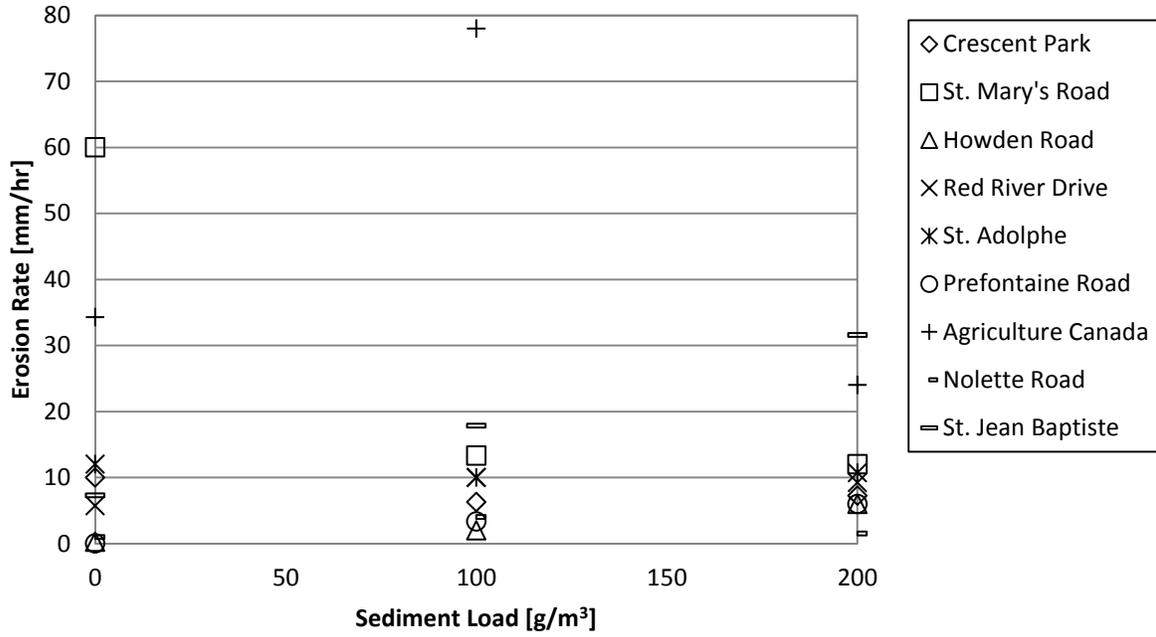
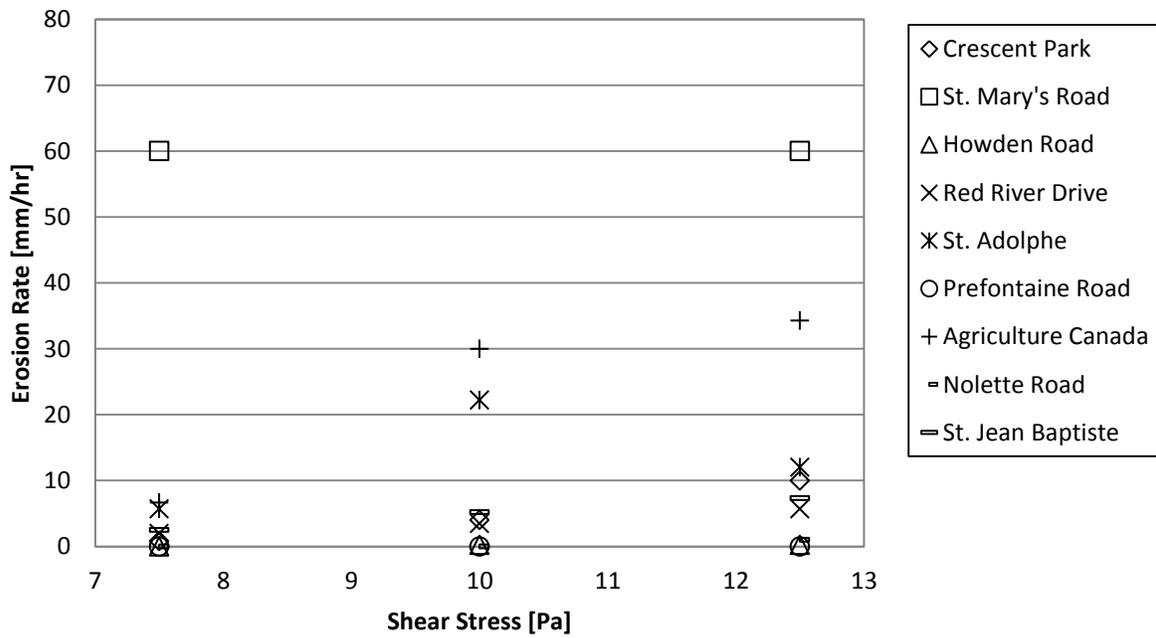
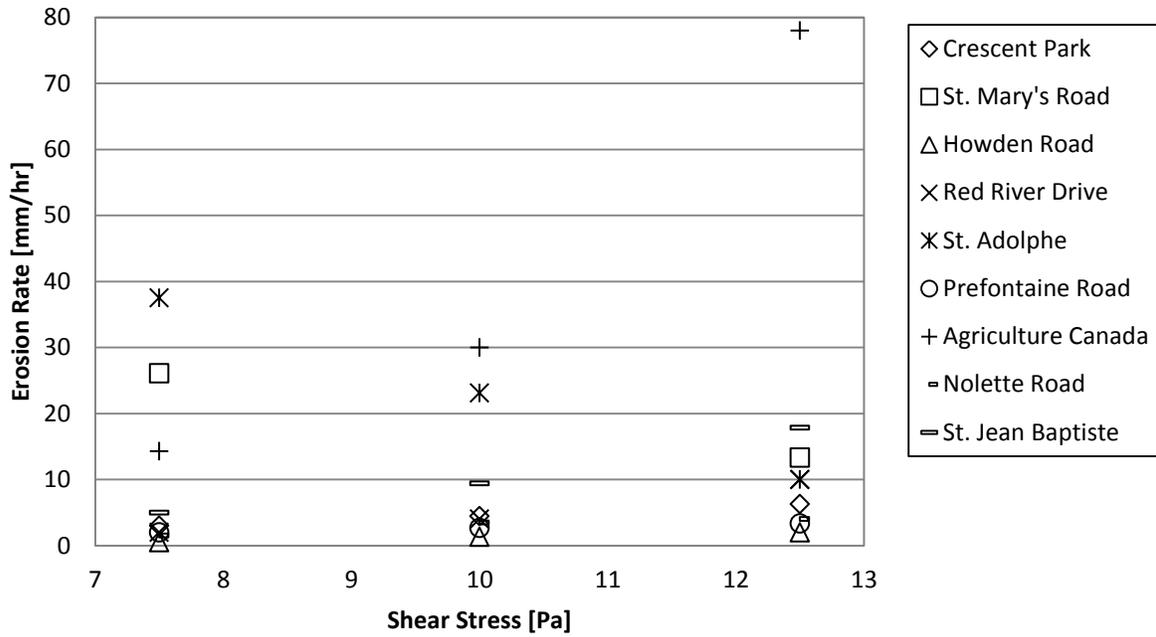
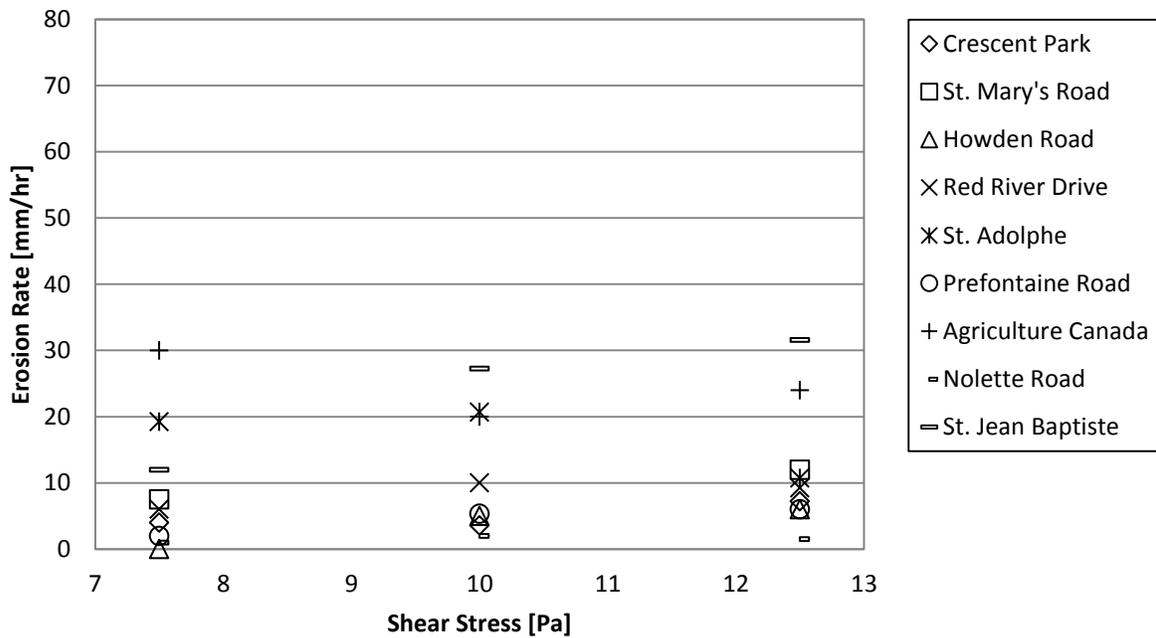
The combined erosion results are grouped into the shear stresses and sediment loads tested and are presented in Figure 4.17 to Figure 4.22.

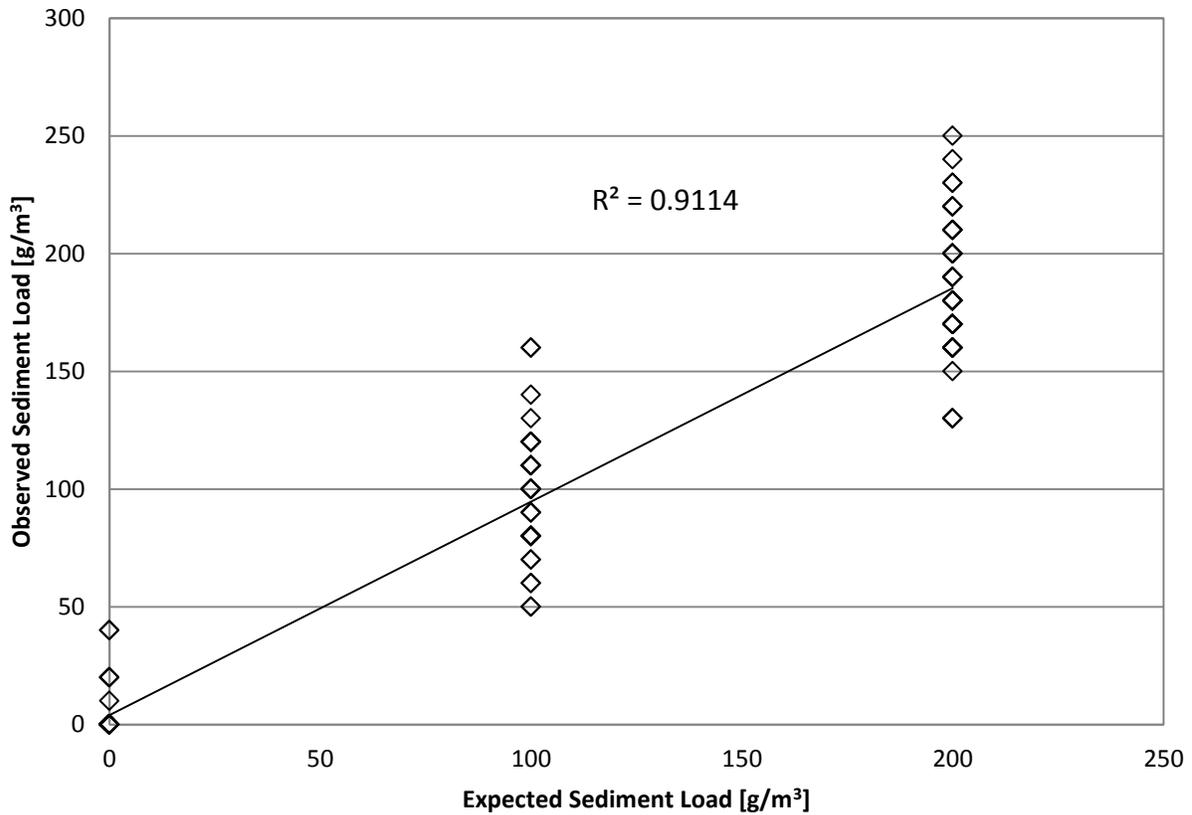
Figure 4.32 illustrates the expected versus measured sediment load using over 120 samples that were taken. The results show a strong correlation given the accuracy of the measurements involved.

Figure 4.32: Observed vs. Expected Sediment Loads

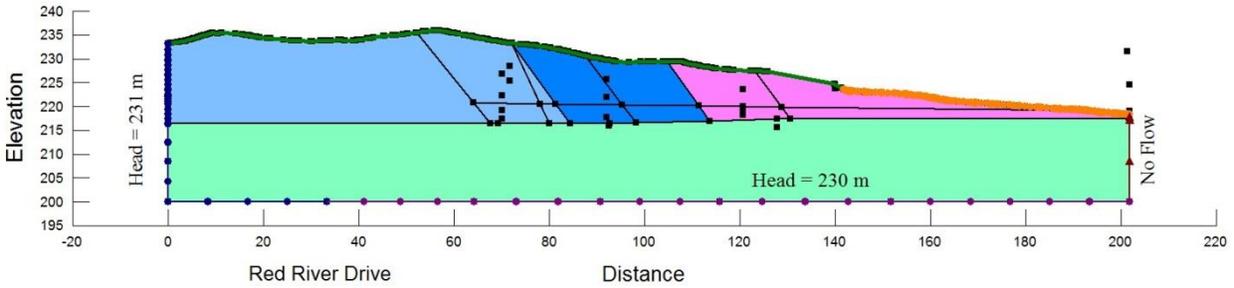
Figure 5.1: Boundary Conditions of Calibrated Model

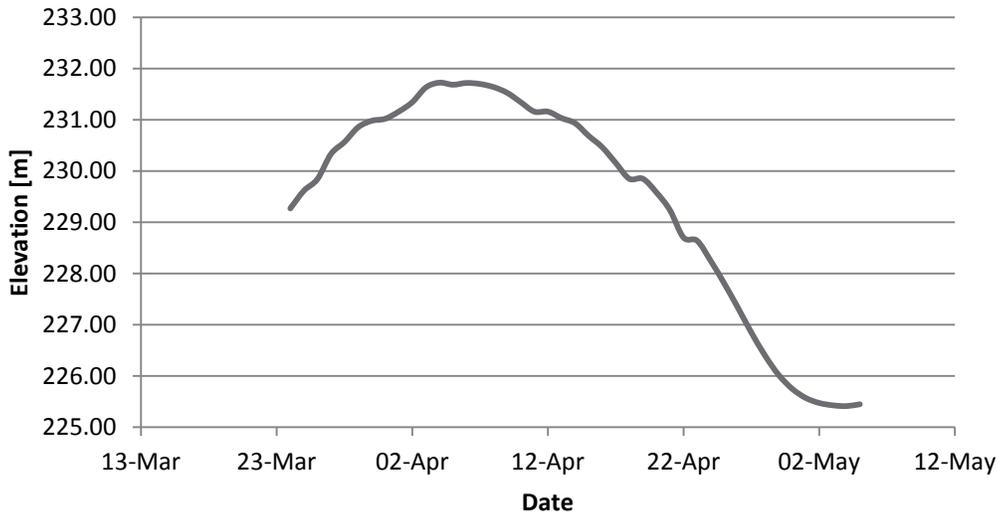
used for the baseline calibration model and the hydrograph in Figure 5.2 was used in the transient portion of calibrations.

Figure 5.2: Hydrograph Used for Model Calibration

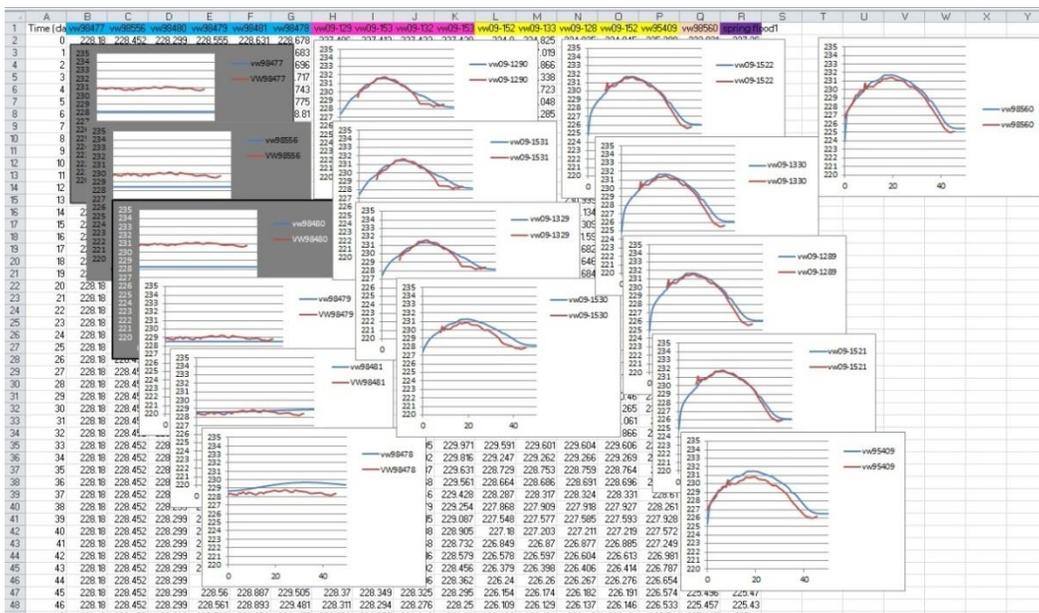
The measured (in red) and modeled total heads (in blue) in Figure 5.3 show that the model was calibrated to an acceptable range.

Figure 5.3: Comparison of Measured Head to Modeled Head

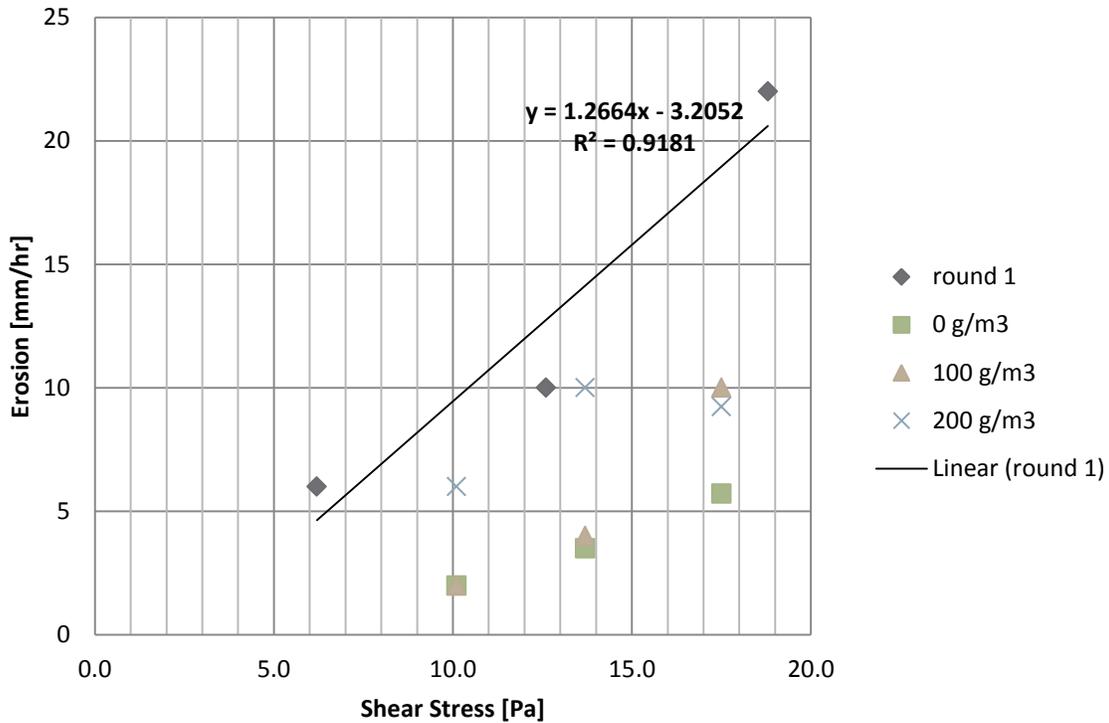
Due to the limited amount of sample material available sparse testing was performed in the range of shear stresses. Even then the samples were not homogenous which resulted in fluctuations in the erosion rates measured. Therefore there is a range of possible erosion rates for each shear stress tested. Equation 5.1 was used as it was the only measured erosion rate available for this location.

Figure 5.4: Red River Drive Erosion Rates

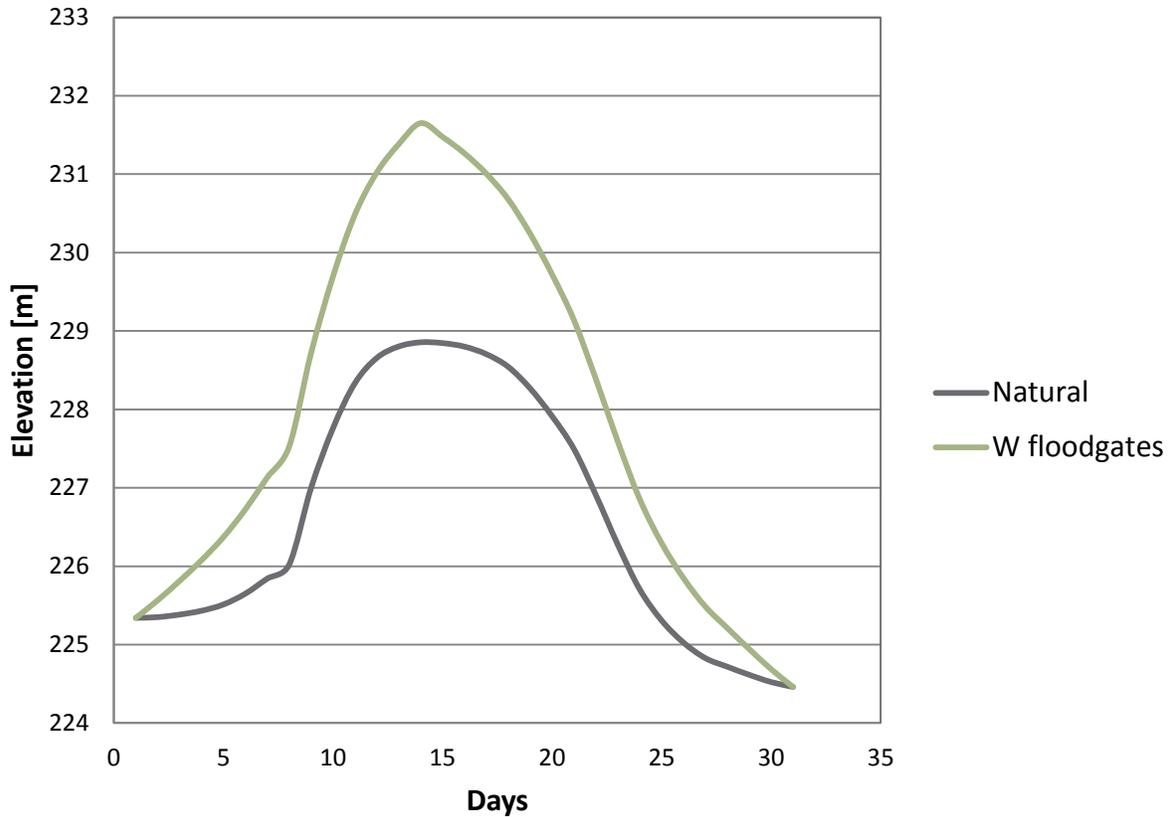
The two scenarios modeled would generate different shear stresses along the bed and the banks of the Red River. The shear stresses considered were for natural condition and one under the operation of the floodway. Figure 5.5 presents the hydrographs used for both cases. The natural condition hydrograph was taken from the data KGS Group had provided and the one used for the Floodgate operation scenario was produced assuming maximum elevation at the same maximum of the natural condition hydrograph and applying a linear increase to each increment from the same elevations as the natural conditions' hydrograph's start and end.

Figure 5.5: Hydrographs Used for Models

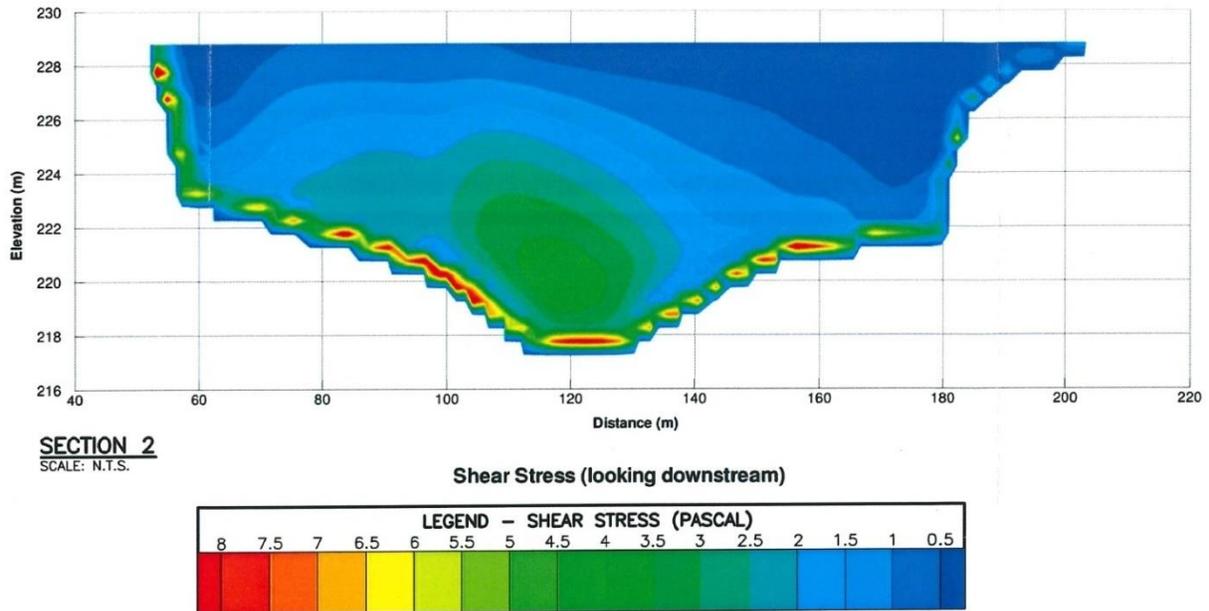
Figure 5.6: Shear Stress Profile under Natural Conditions - Water Level 228.67 m (used with permission from KGS Group April 8th 2013)

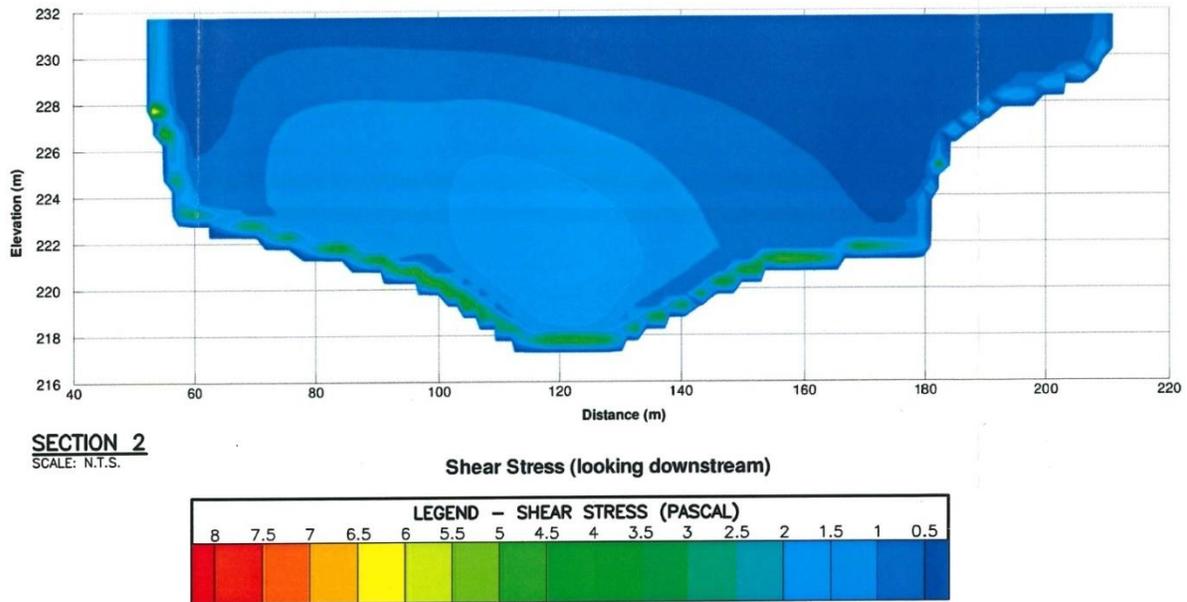
Figure 5.7: Shear Stress Profile with Floodgate in Operation – Water Level 231.65 m (used with permission from KGS Group April 8th 2013)
