EVALUATION OF EROSION RATES AND THEIR IMPACT ON RIVERBANK STABILITY

A Thesis
Submitted to the Faculty of Graduate Studies
in Partial Fulfillment of the Requirements for the Degree of

Department of Civil Engineering
University of Manitoba
Winnipeg, Manitoba

July, 2014

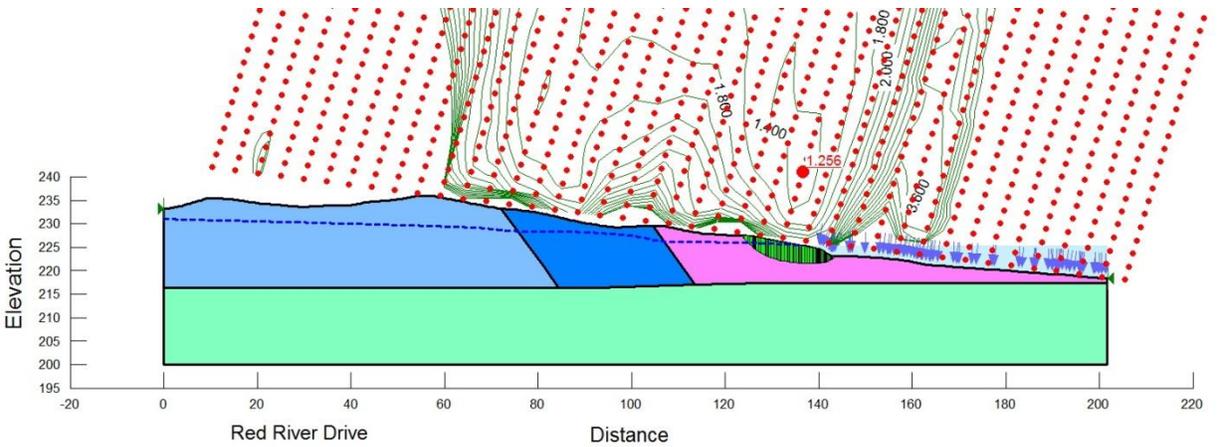
Figure 5.9: Baseline Slope Stability Model Result

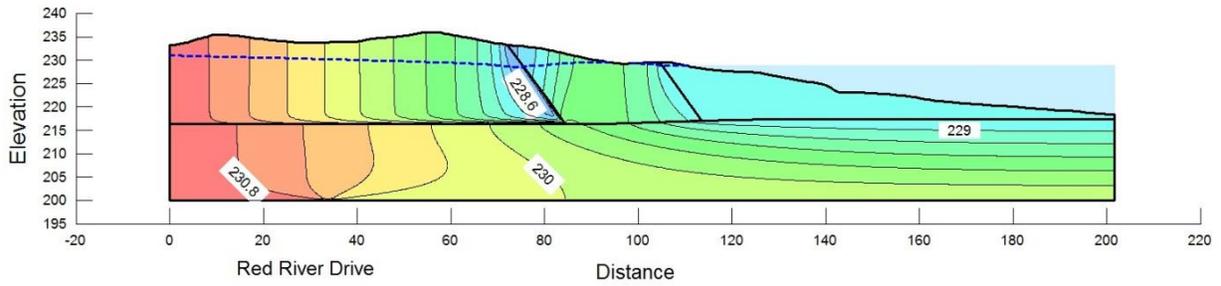
Figure 5.10: Natural Condition 16th Day Seepage Model Result

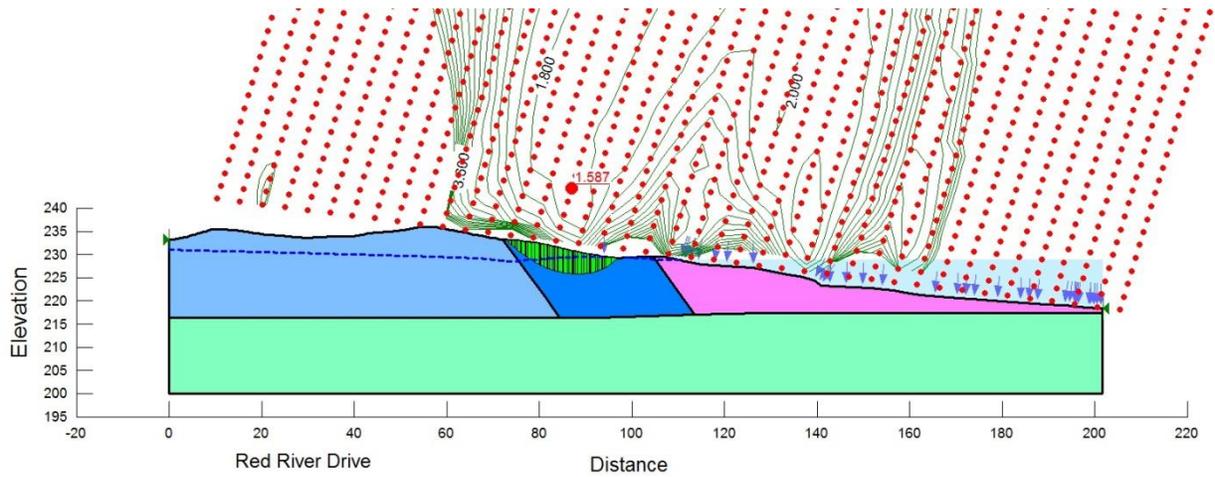
Figure 5.11: Natural Condition 16th Day Slope Stability Model Result

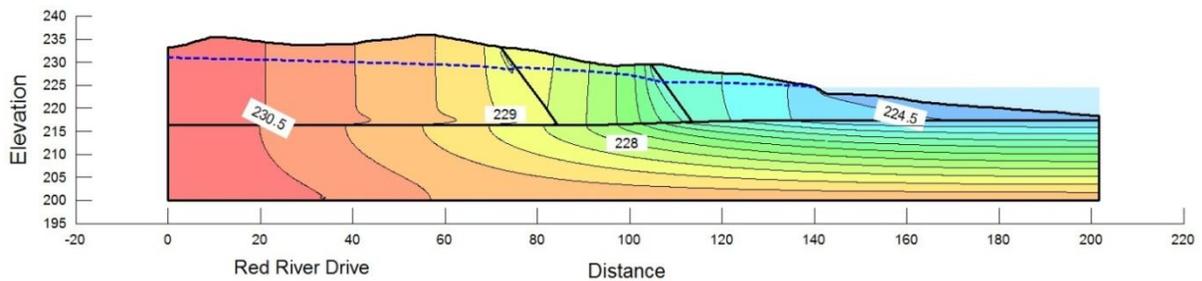
sections of the last (31st) day of model whose results are presented in Figure 5.12 and Figure 5.13. The factor of safety calculated is 1.097 and is at the lower sections of the river bank.

Figure 5.12: Natural Condition 31th Day Seepage Model Result

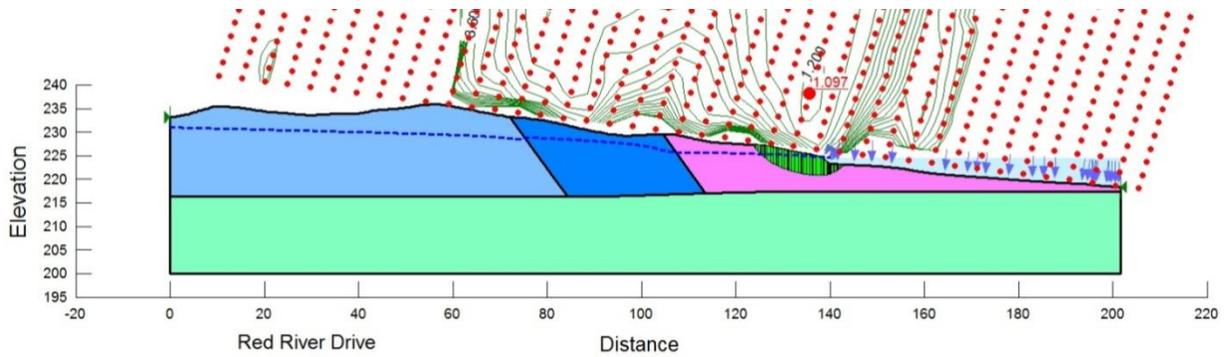
Figure 5.13: Natural Condition 31th Day Slope Stability Model Result

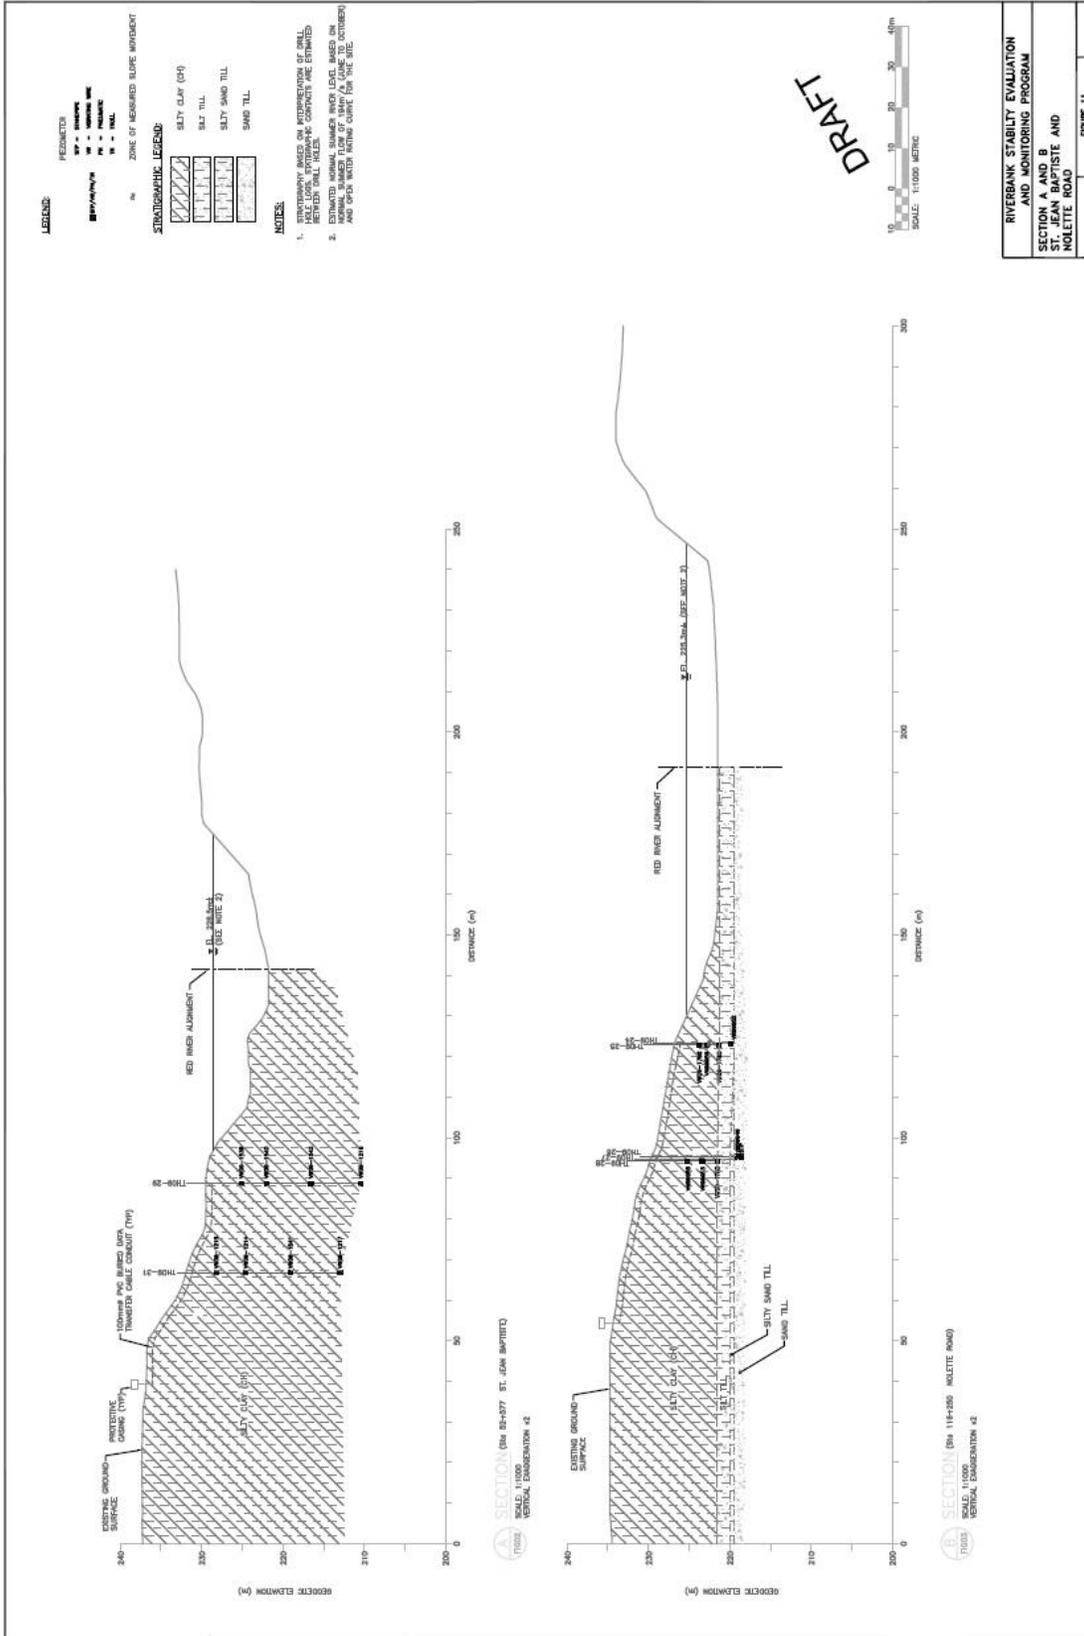
Figure A.1: Cross Section of St Jean Baptiste and Nolette Road (used with permission from KGS Group April 8th 2013)

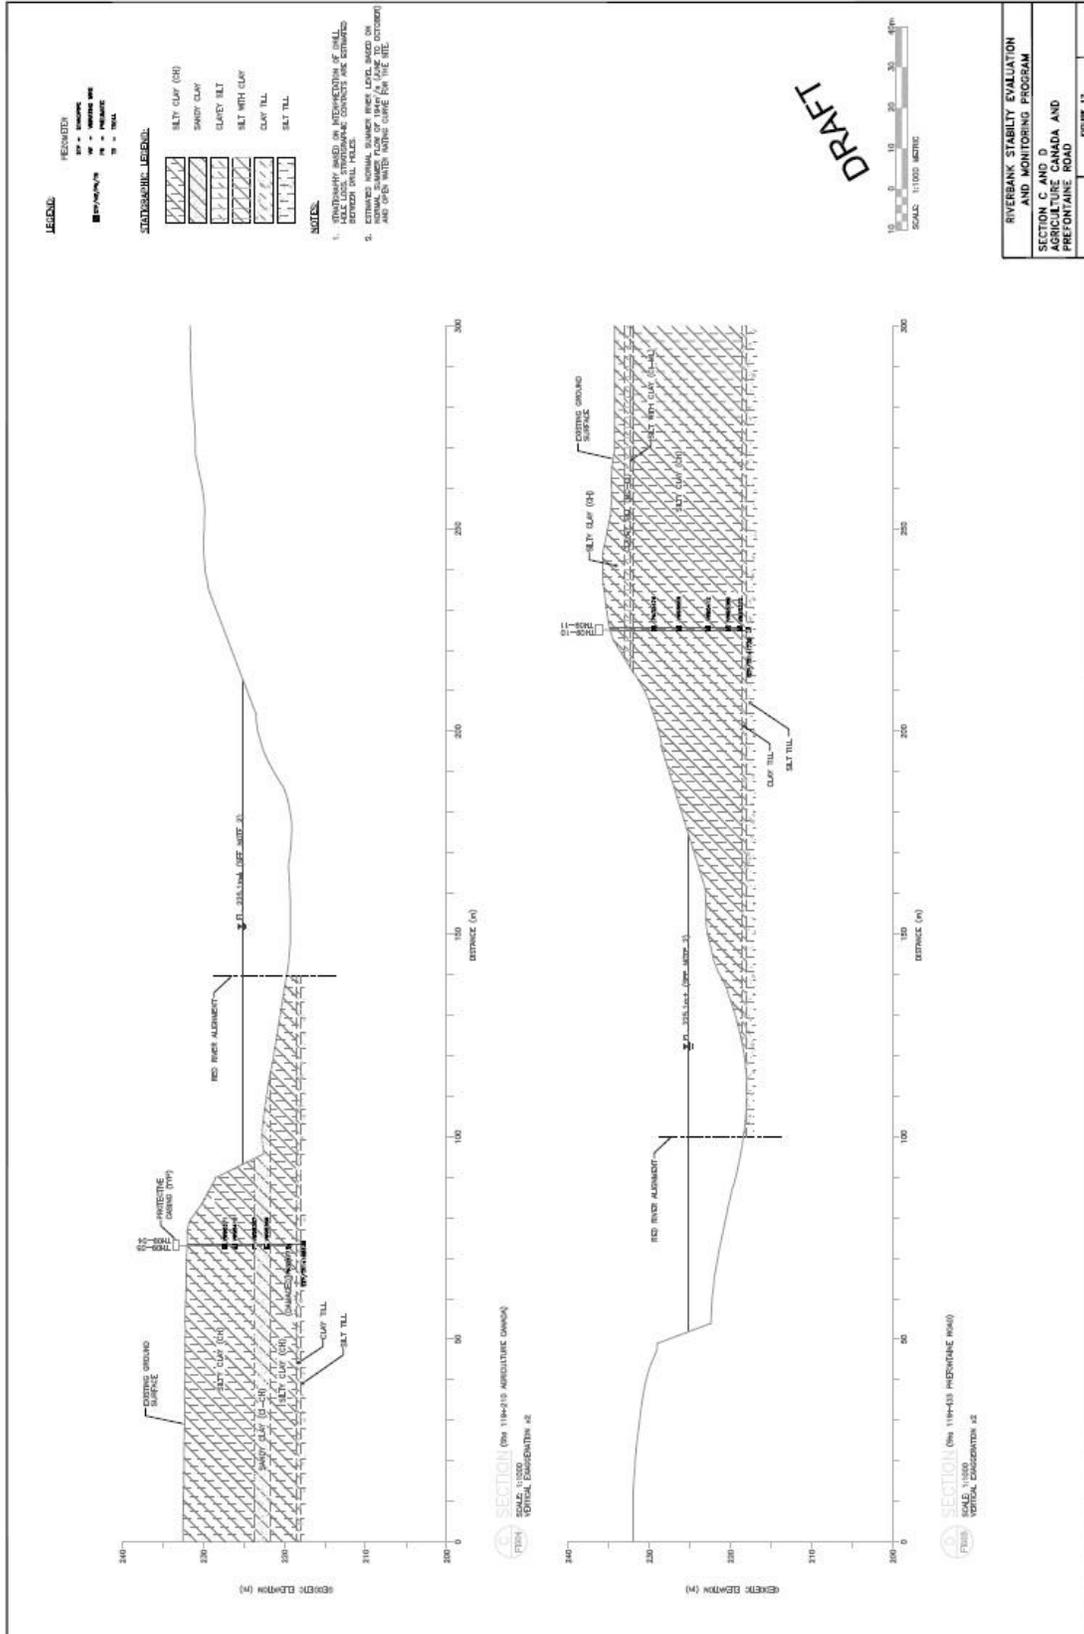
Figure A.2: Cross Section of Agriculture Canada and Prefontaine Road (used with permission from KGS Group April 8th 2013)

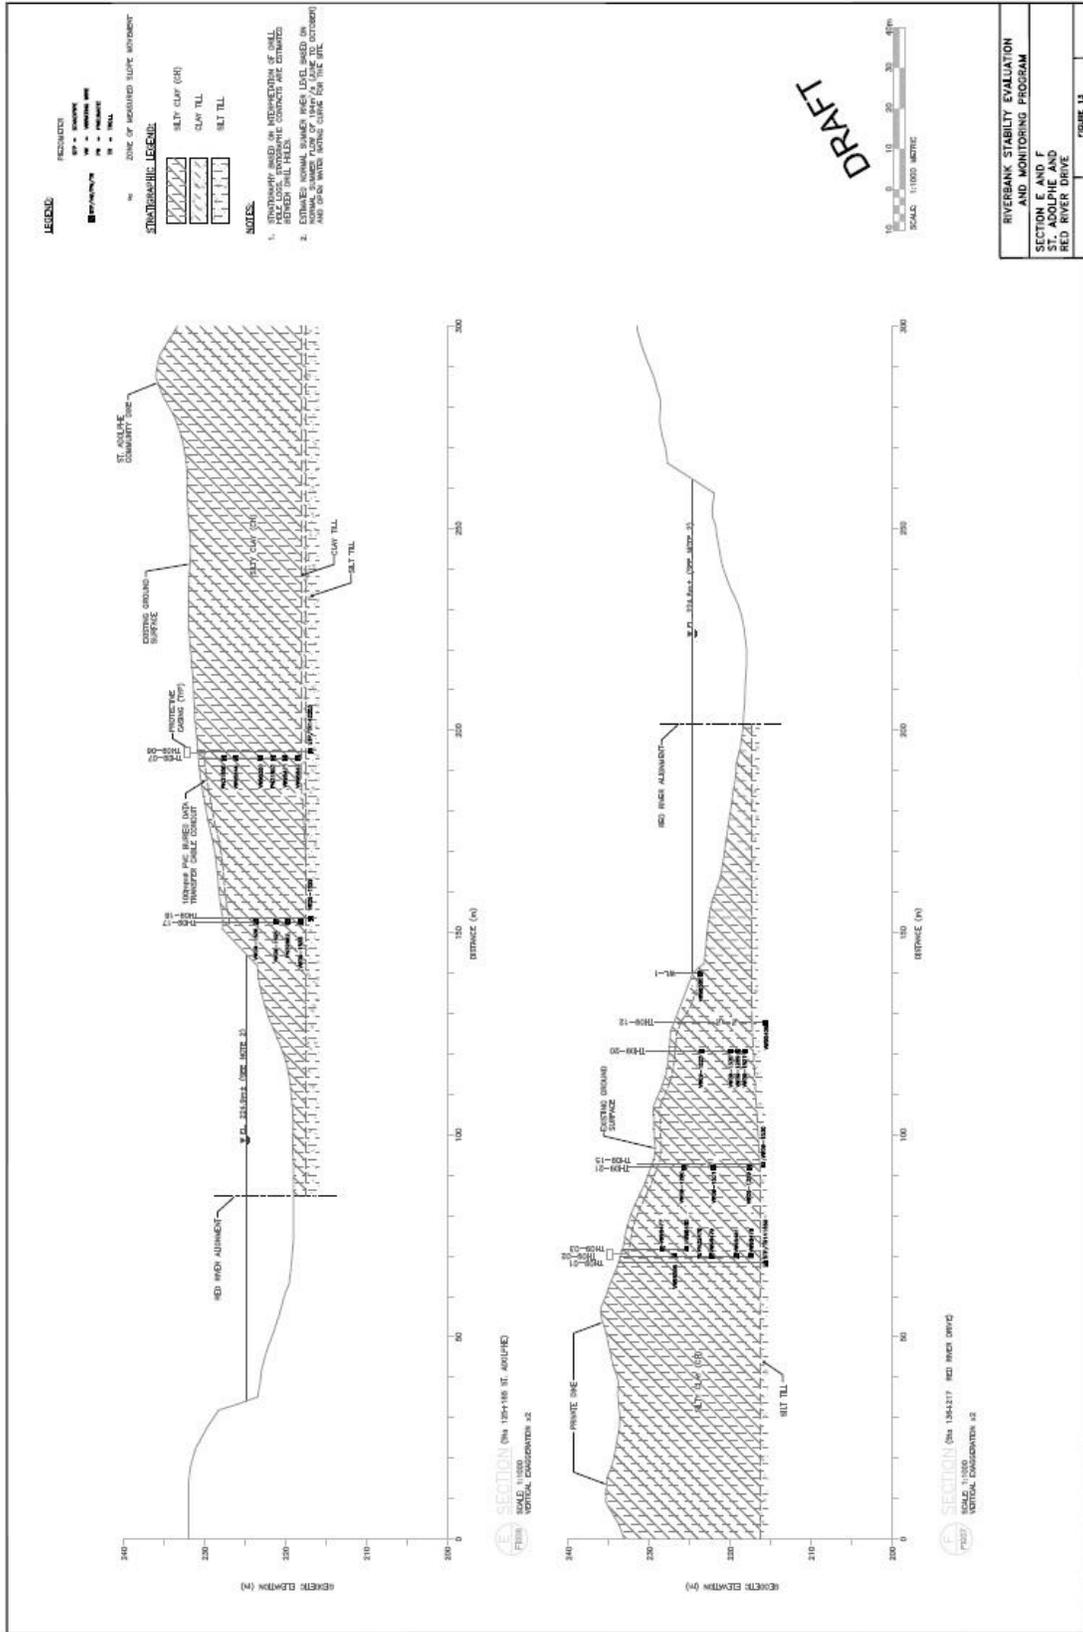
Figure A.3: Cross Section of St. Adolphe and Red River Drive (used with permission from KGS Group April 8th 2013)

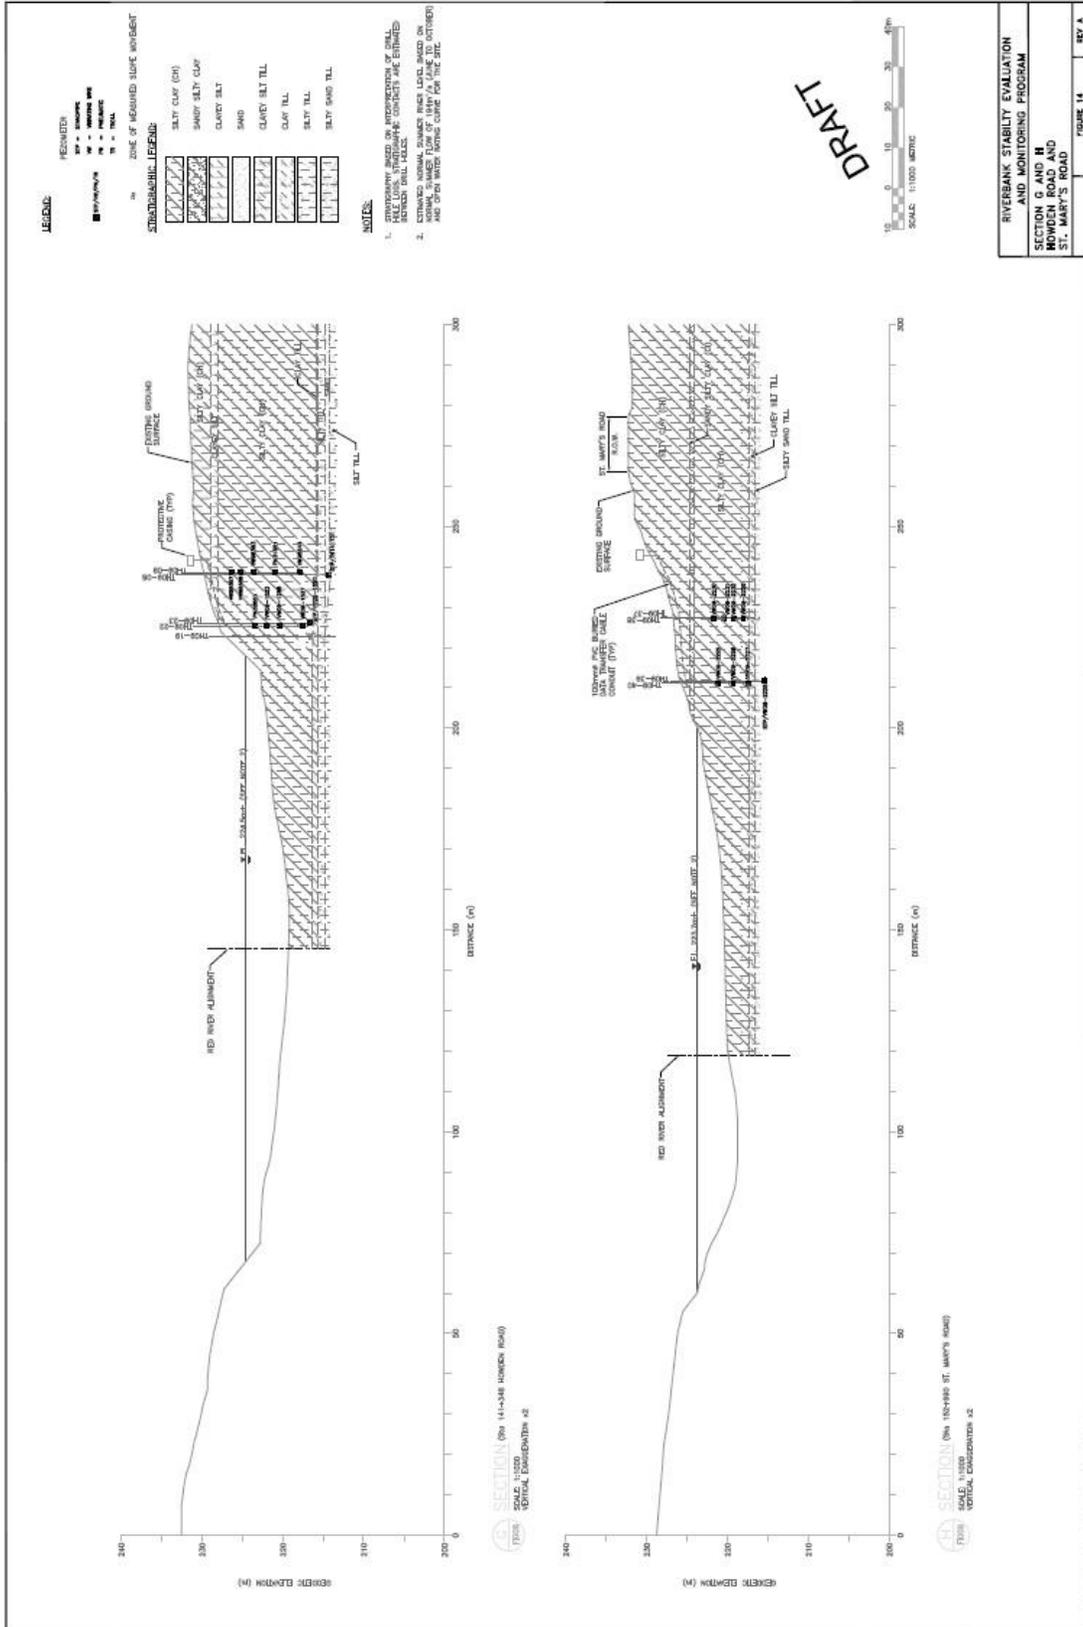
Figure A.4: Cross Section of Howden Road and St. Mary's Road (used with permission from KGS Group April 8th 2013)

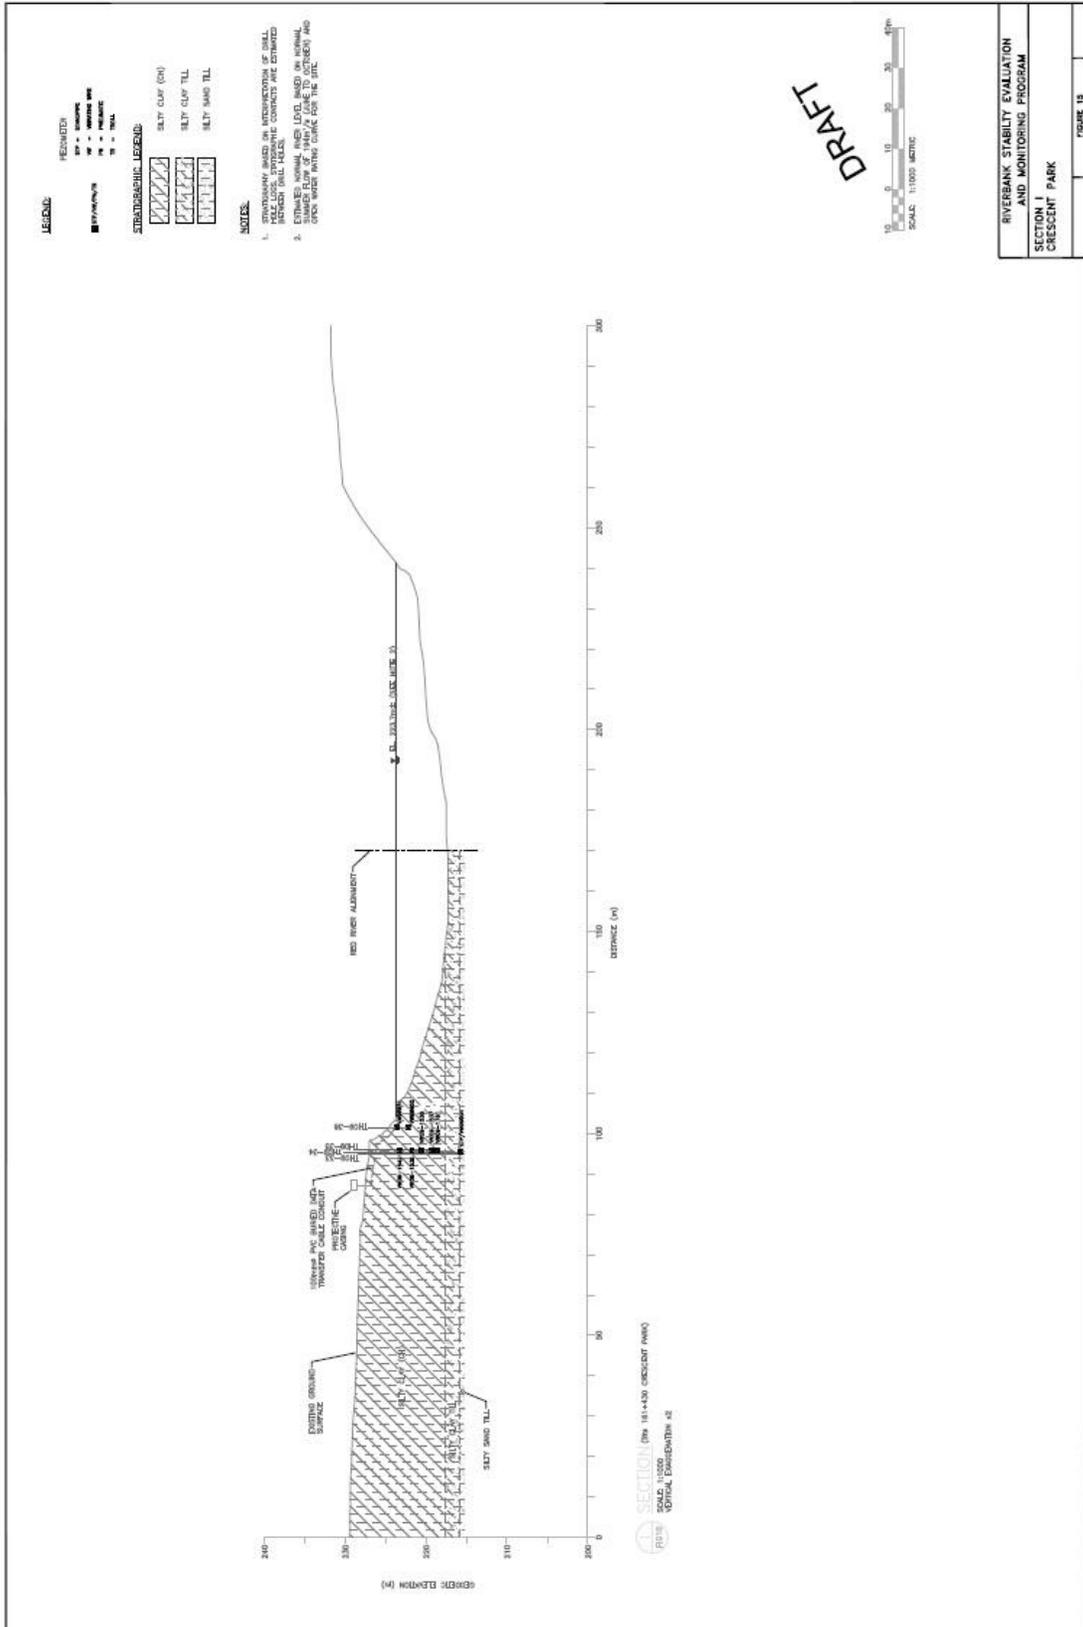
Figure A.5: Cross Section of Crescent Park (used with permission from KGS Group April 8th 2013)

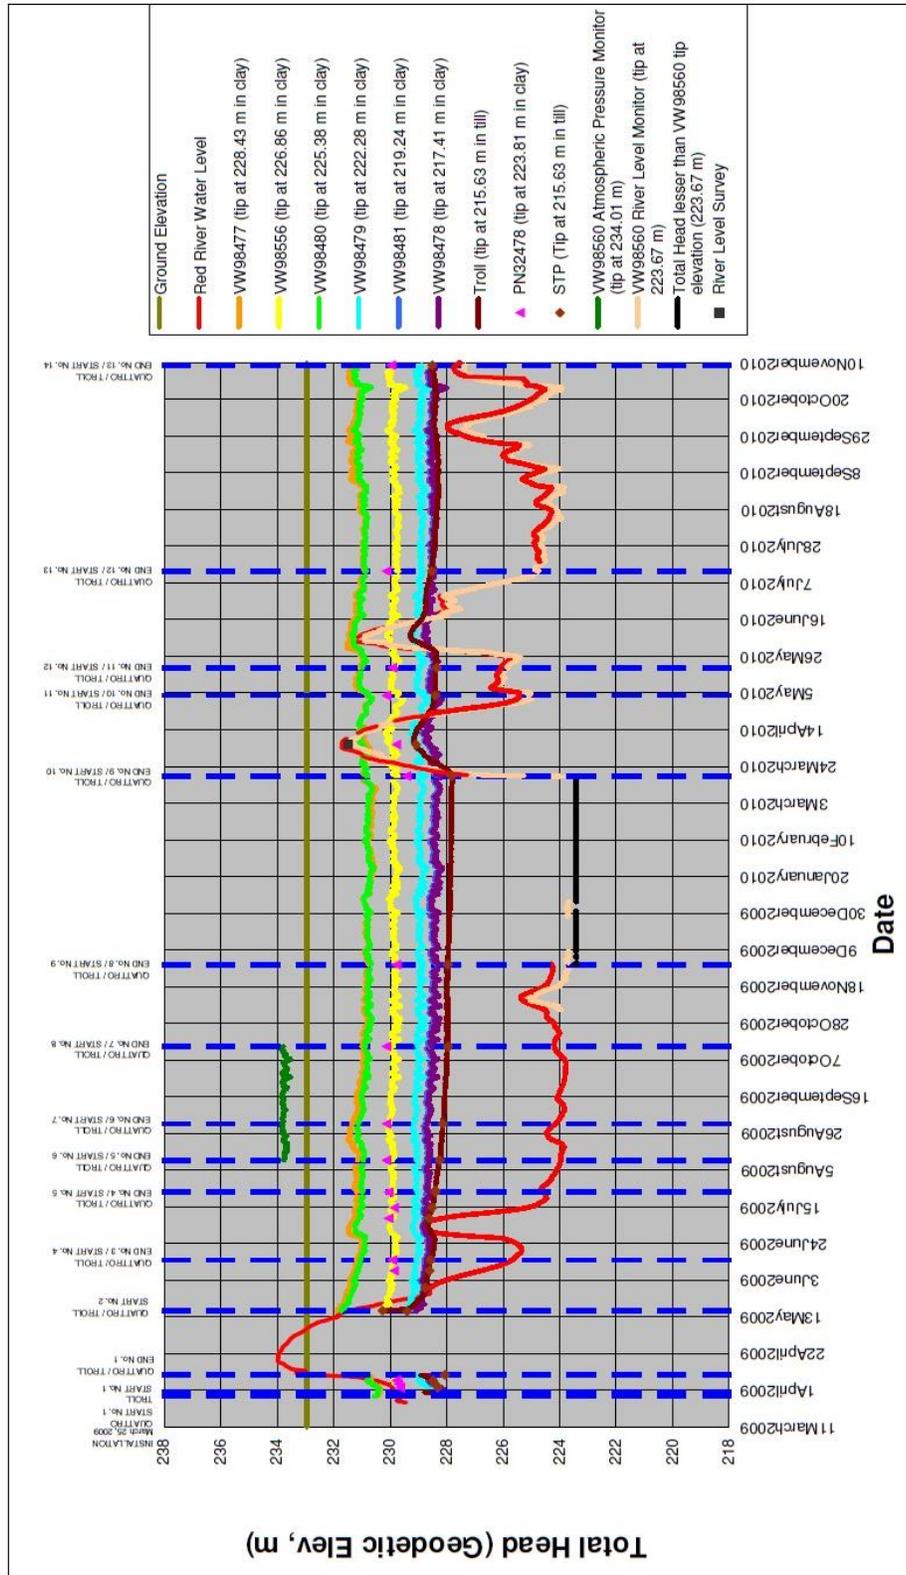
Sta 136+217 Red River Drive: Upper Bank

Figure G.1: Red River Drive Upper Bank Piezometer Data (used with permission from KGS Group April 8th 2013)

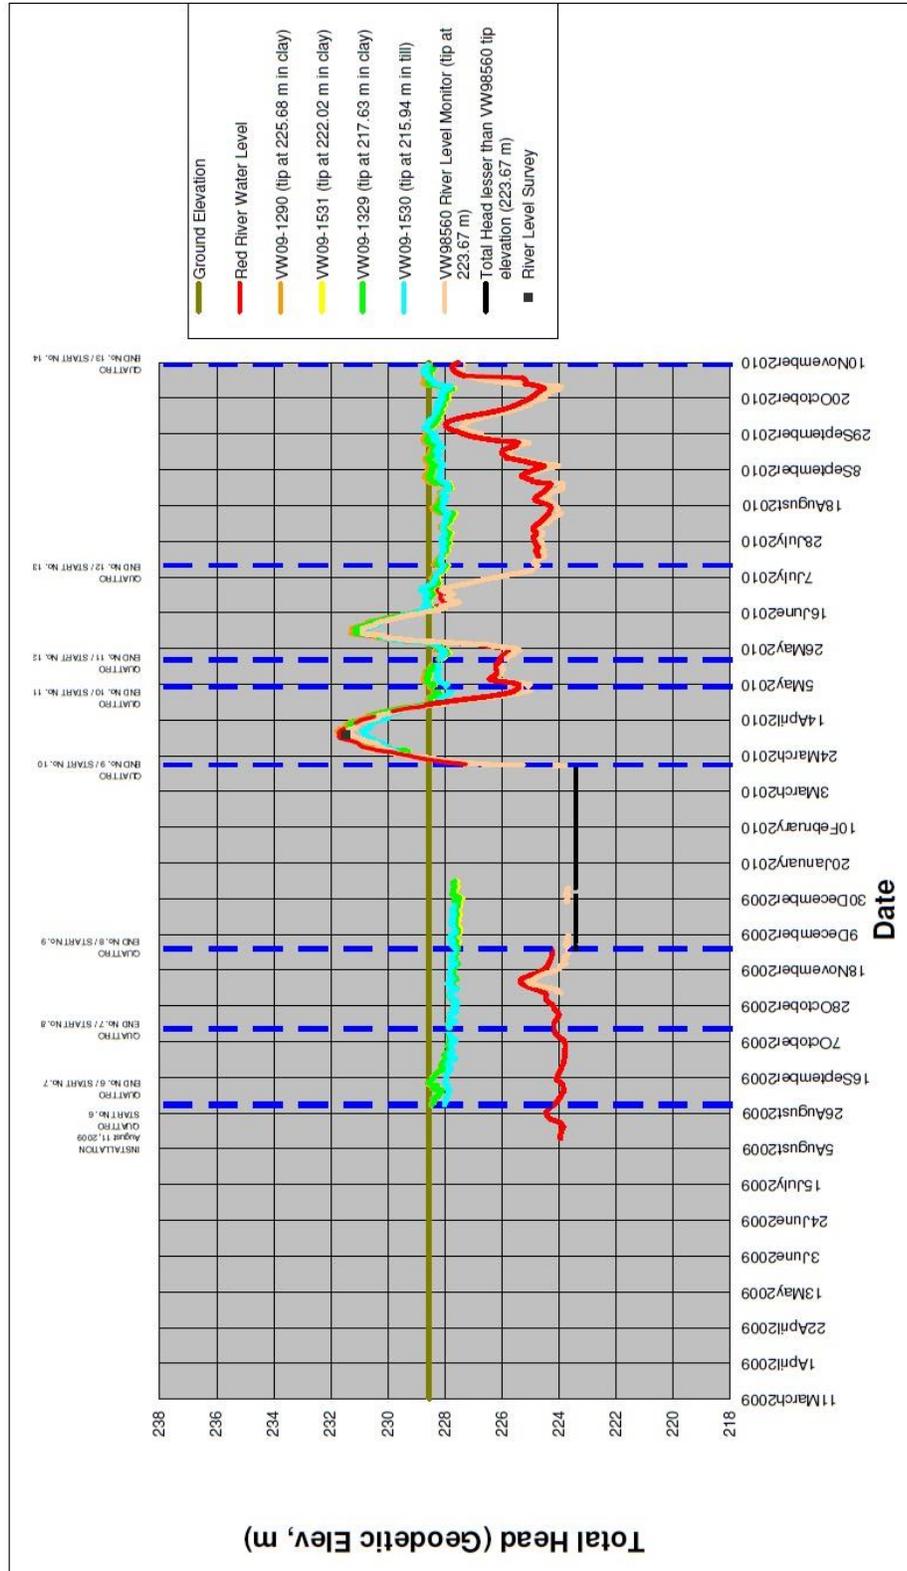
Sta 136+217 Red River Drive: Mid Bank

Figure G.2: Red River Drive MidBank Piezometer Data (used with permission from KGS Group April 8th 2013)

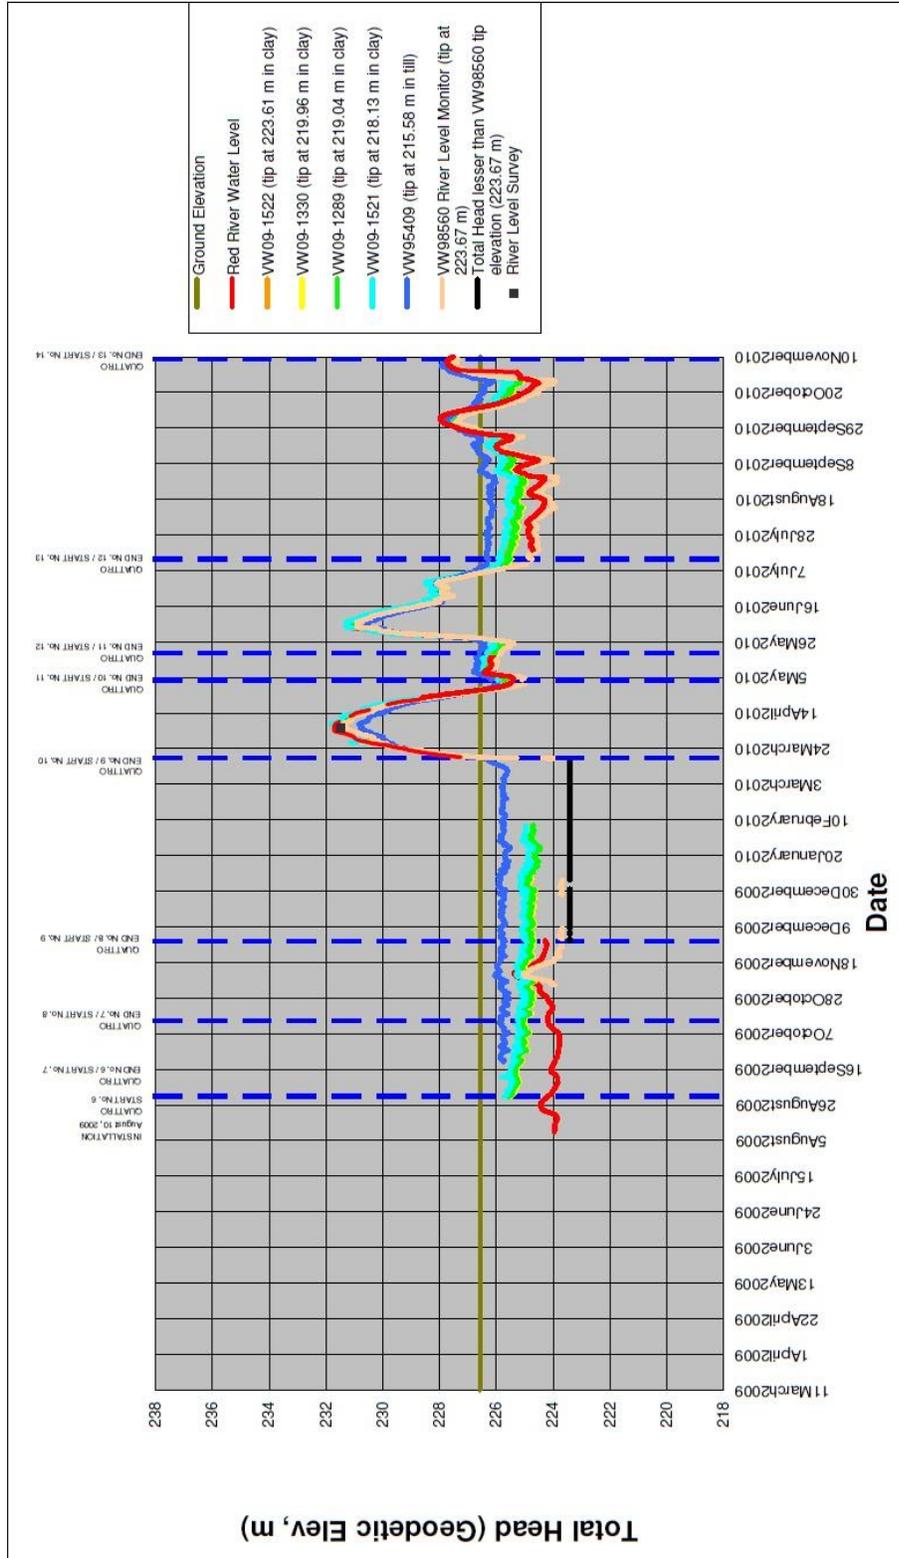
Sta 136+217 Red River Drive: Lower Bank

Figure G.3: Red River Drive Lower Bank Piezometer Data (used with permission from KGS Group April 8th 2013)
