Comparative Study between Steel-Free and Steel Reinforced Concrete Bridge Deck Slabs Subjected to Fatigue Loading

A Thesis Submitted to the Faculty of Graduate Studies of

The University of Manitoba

Master of Science

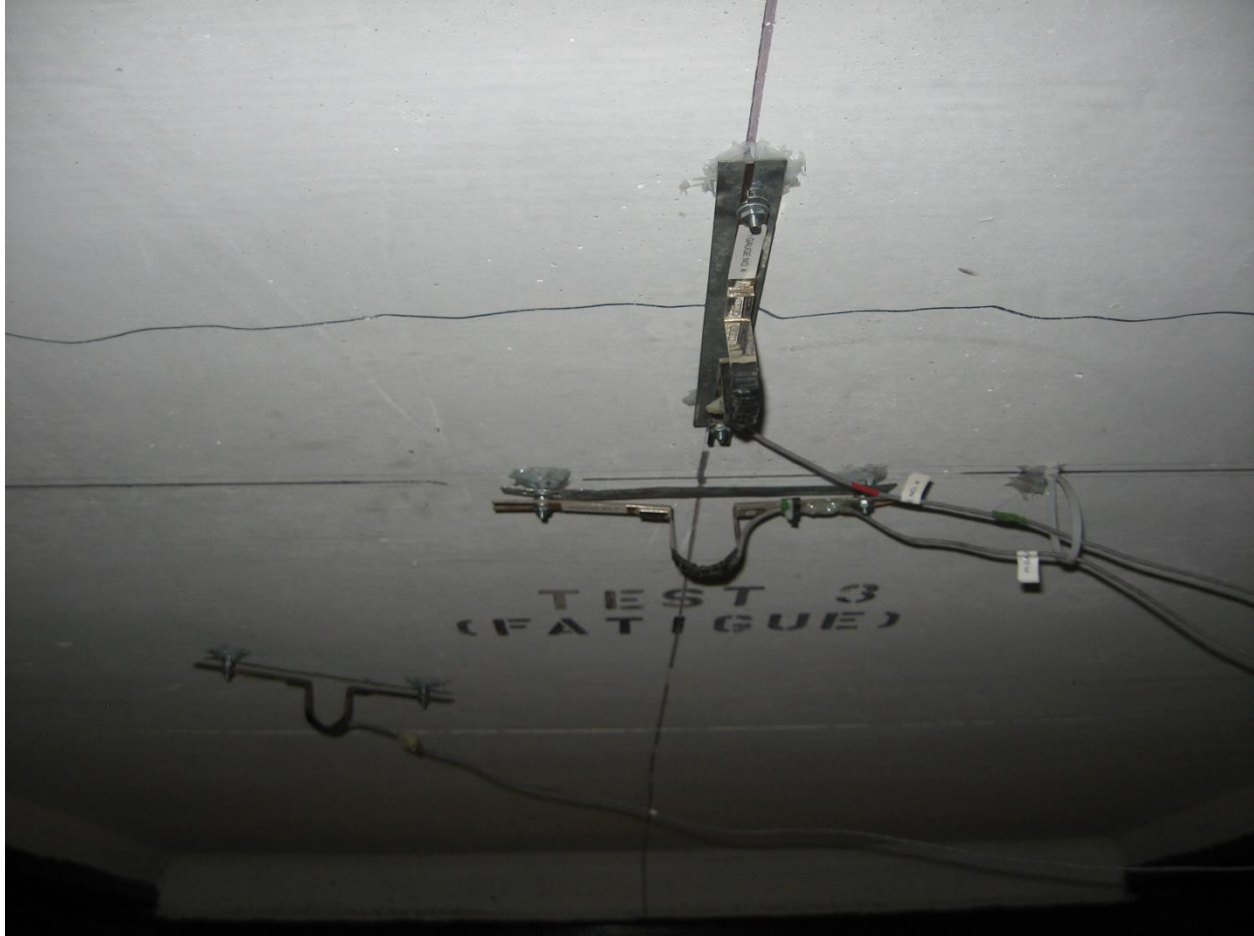
Figure 4.6 Pi gauge arrangement in Segment A

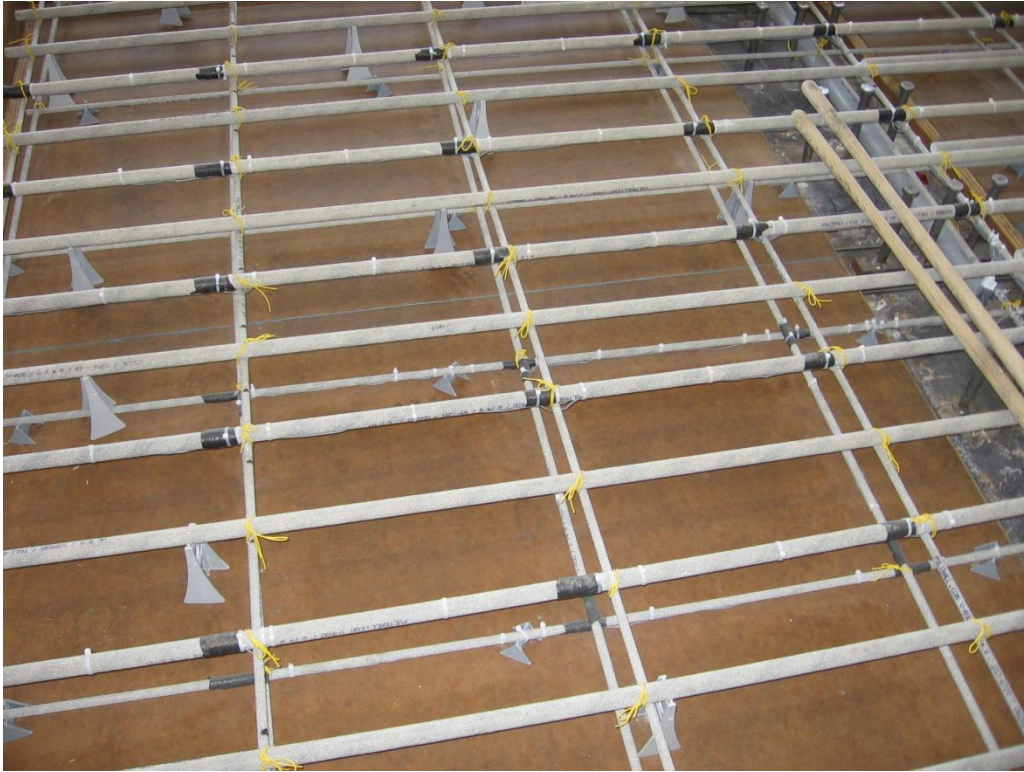
Figure 4.9 Strain gauges attached to GFRP bars in Segment B

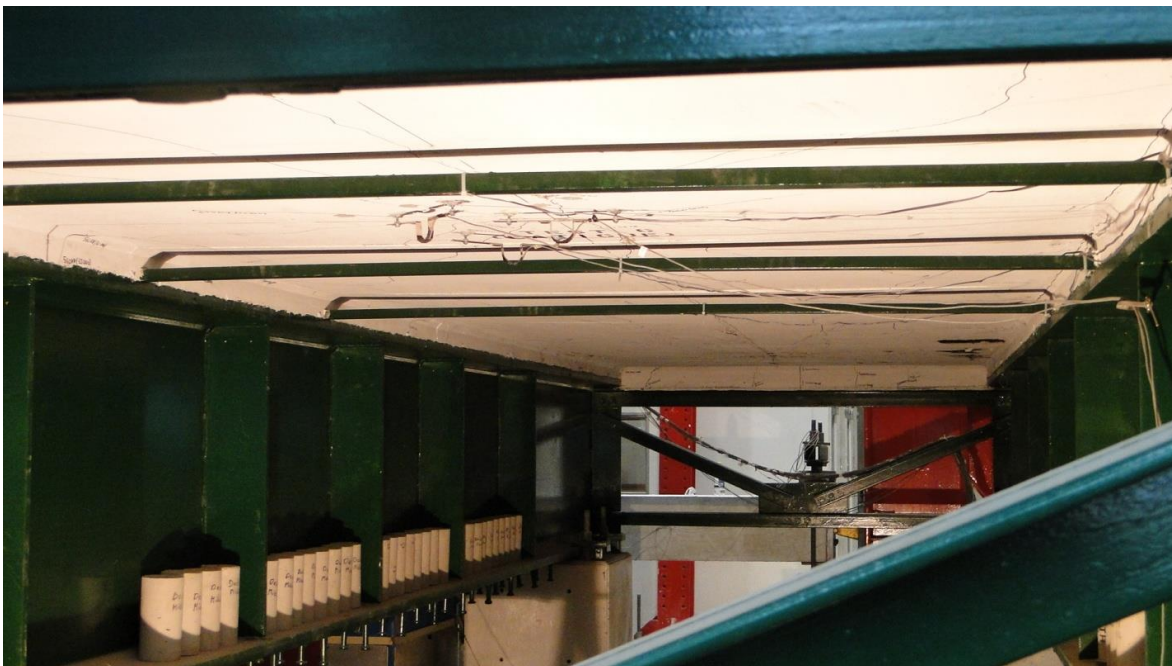
Figure 4.11 Transverse steel straps below the bridge deck

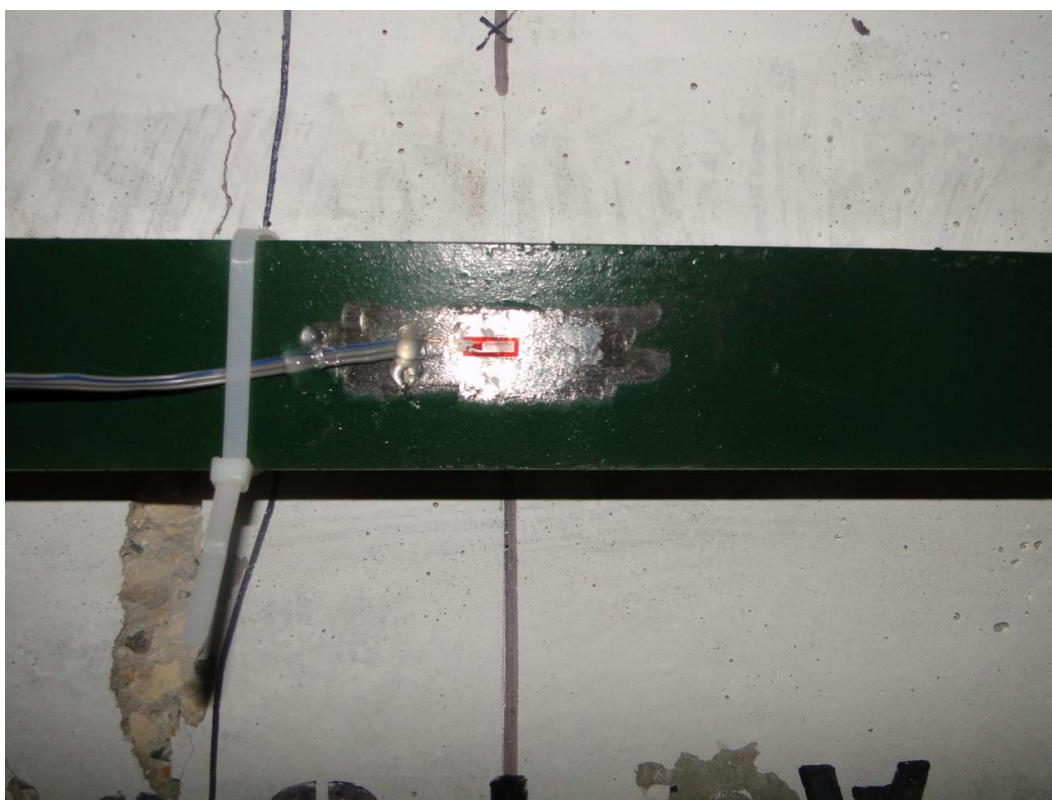
Figure 4.12 Close up photo of a strain gauge attached to a steel strap

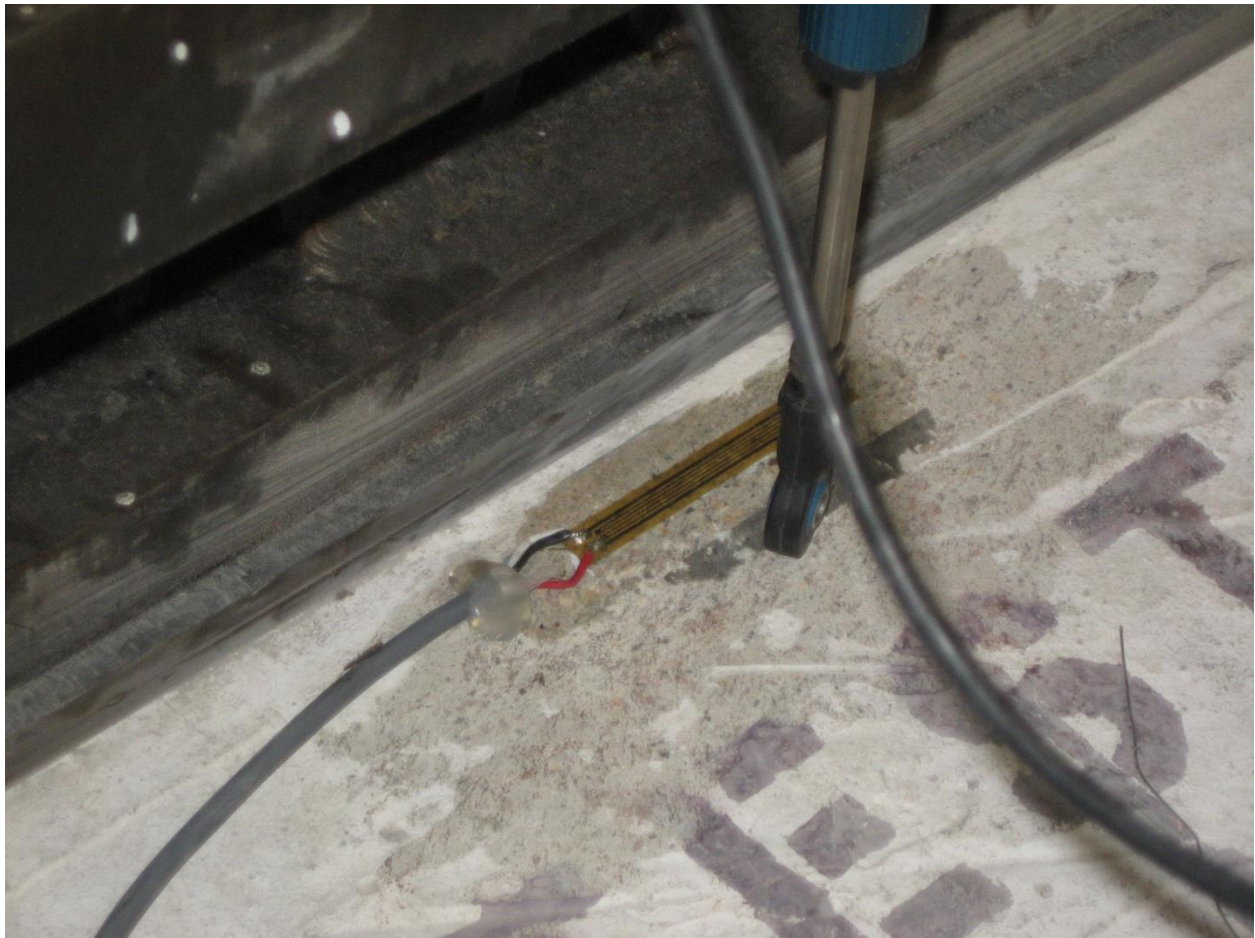
Figure 4.13 Concrete strain gauge

In an effort to measure the concrete strain near the load plate, concrete strain gauges were installed on the top side of the deck within close proximity to the load imprint. One concrete strain gauge was used per fatigue test, as shown in Figure 4.14. Figure 4.13 shows the installed concrete strain gauge. All strain gauges were connected to a data acquisition system which recorded and saved the extracted data for future analysis.

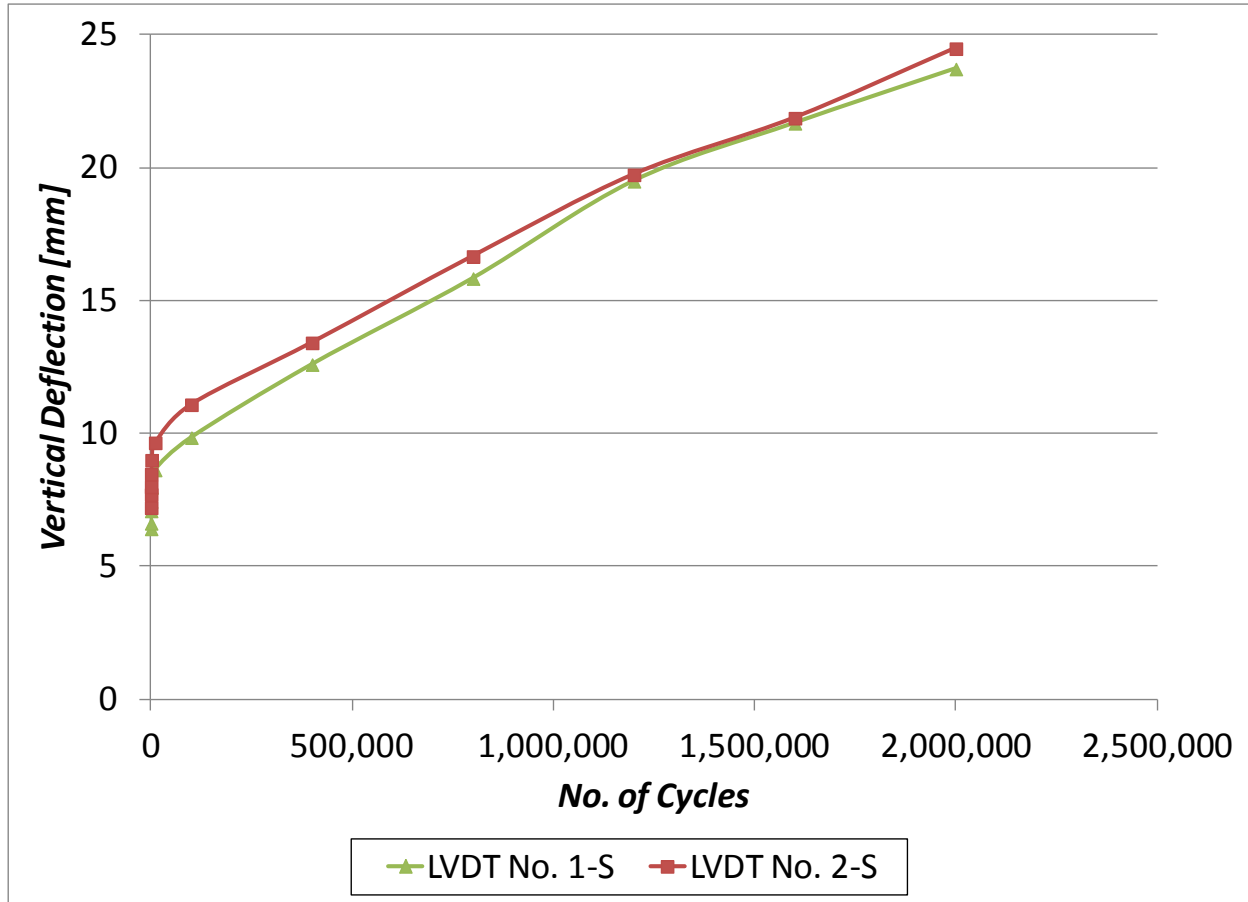
Figure 5.3 Plot of maximum vertical deflection vs. number of cycles in Segment A

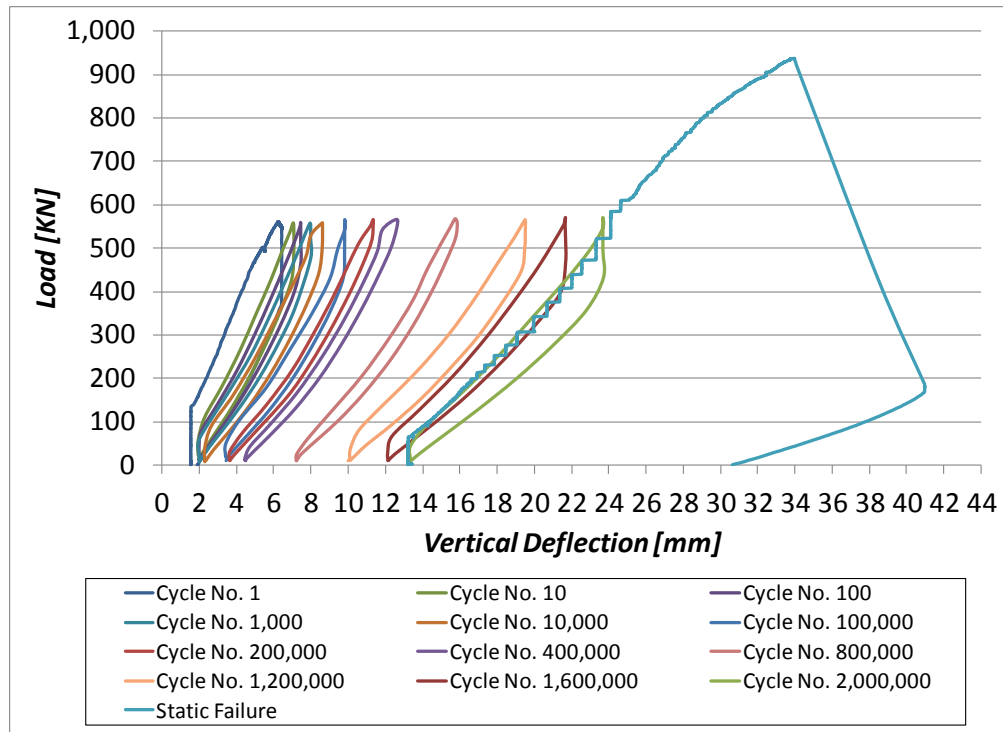
Figure 5.4 Plot of load vs vertical deflection at specified cycles in Segment A, recorded by LVDT No. 1-S

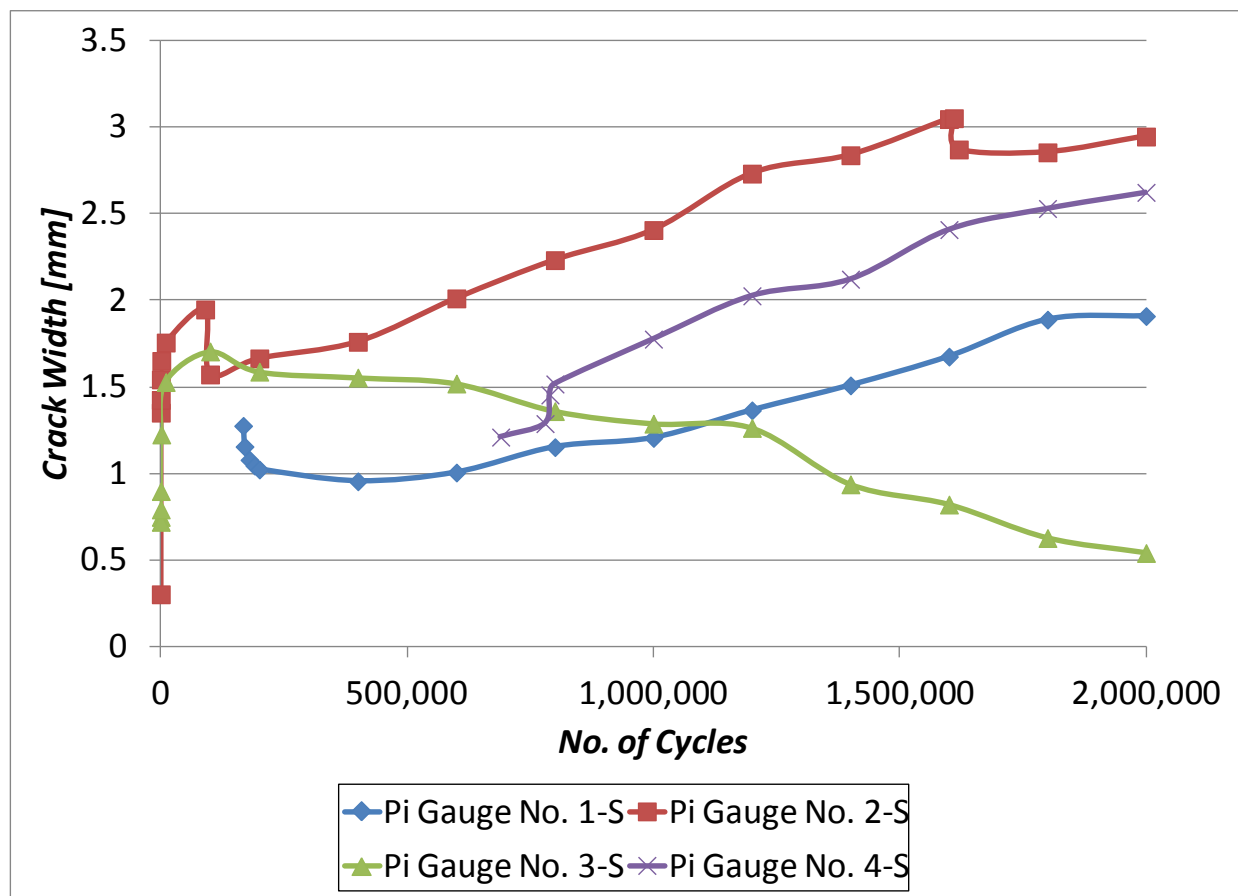
Figure 5.6 Plot of maximum crack width vs. number of cycles in Segment A

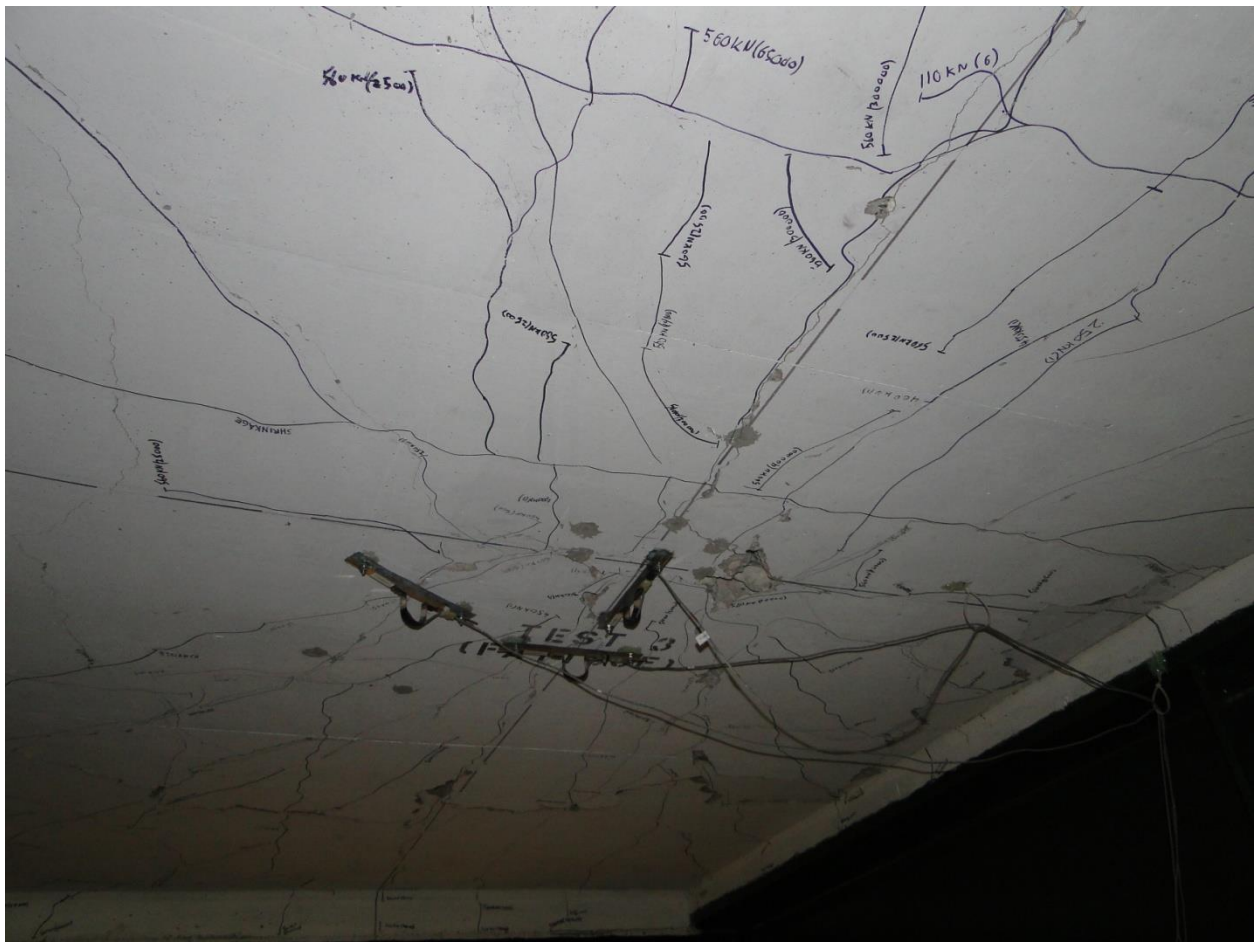
Figure 5.7 Crack patterns observed on the soffit of the deck throughout the lifespan of Segment A

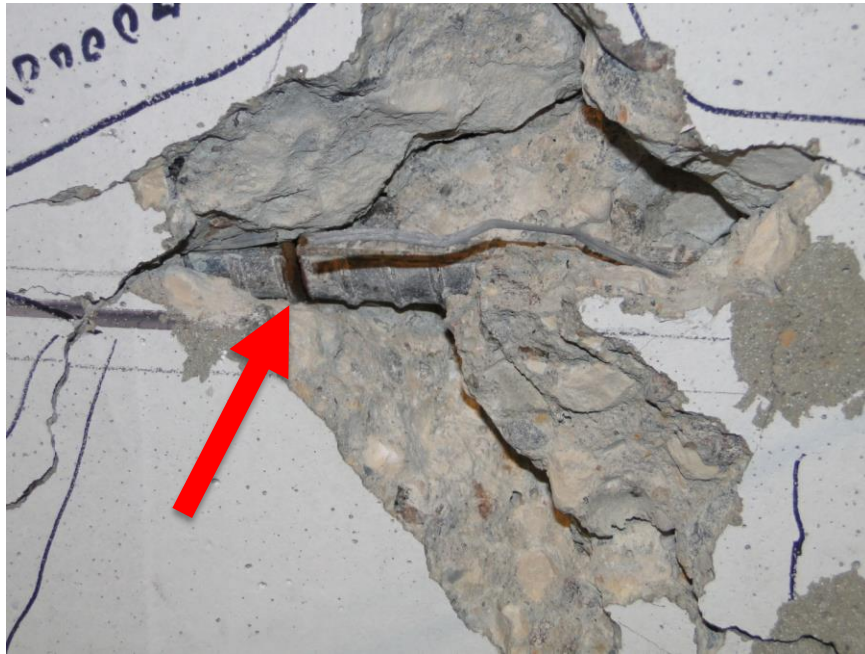
Figure 5.9 Ruptured bottom transverse steel bar in Segment A. Visible due to concrete spalling. ESG No. 2-S-B was attached to the steel bar shown in the picture

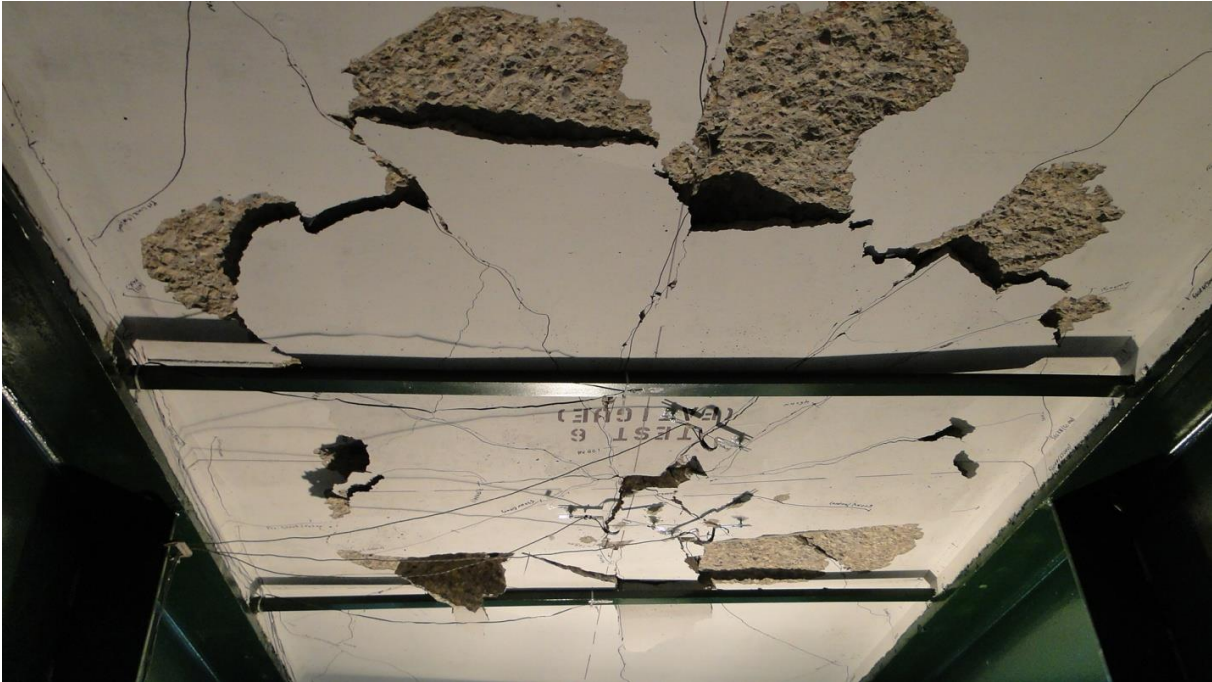
Figure 5.15 Punch cone on bottom side of deck in Segment B

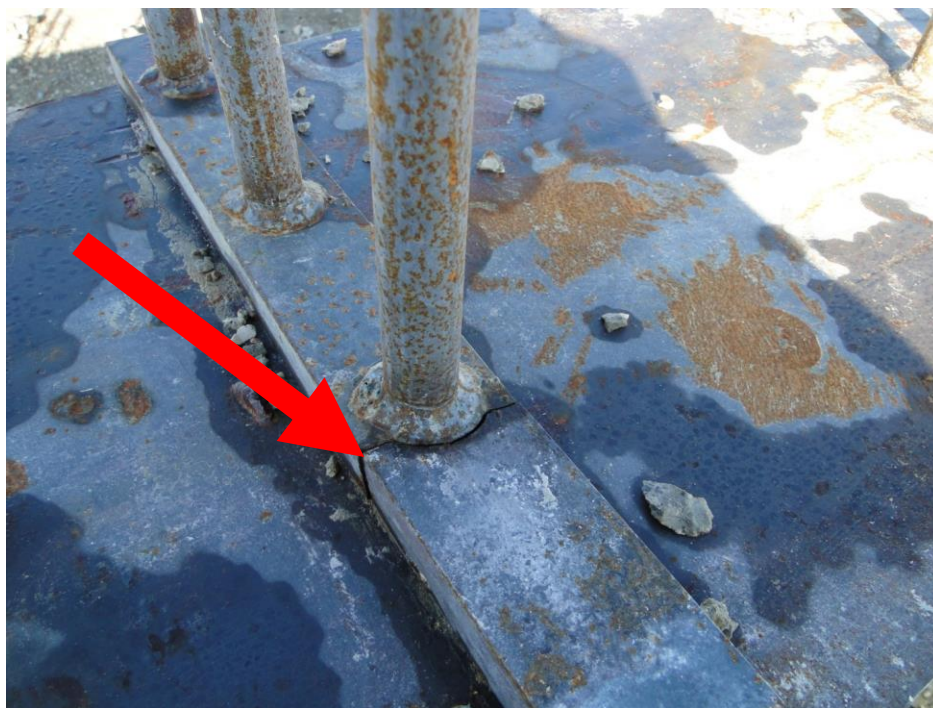
Figure 5.27 Rupture point in Strap No. 3

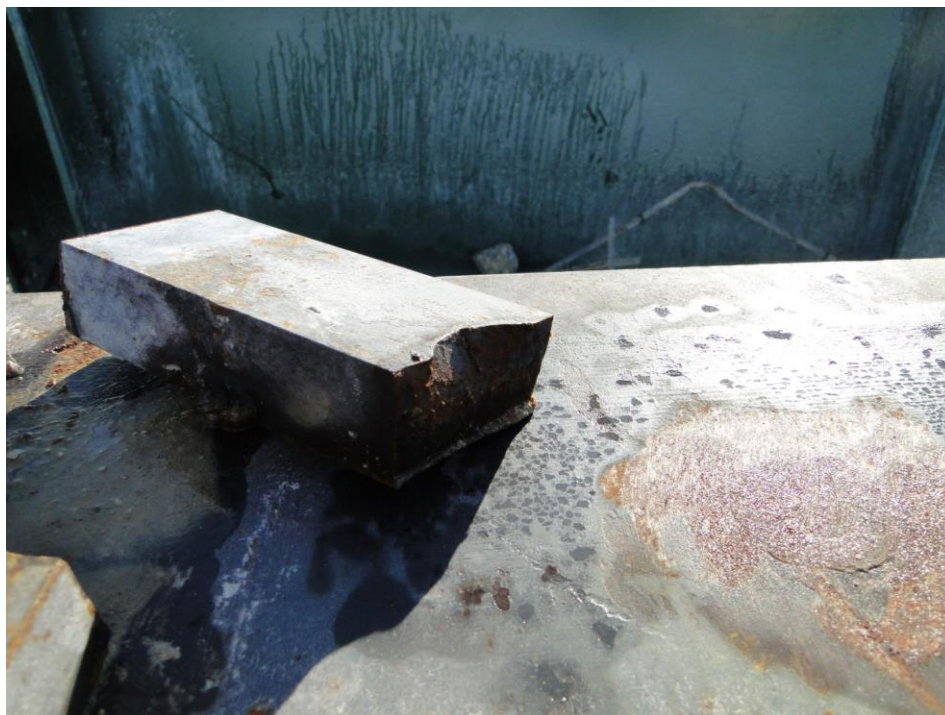
Figure 5.28 Rupture interface in Strap No. 3

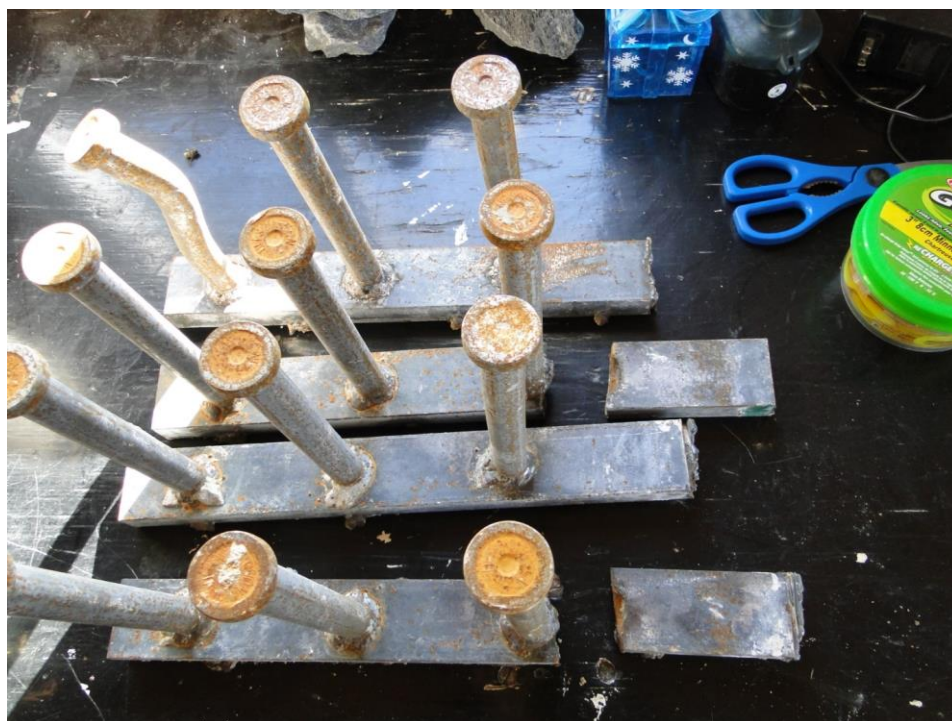
Figure 5.29 Strap No's 1, 2, 3, and 4 after removal from concrete haunches
