ULTIMATE STRENGTH ANALYSIS OF REINFORCED CONCRETE GRILLAGES

A Thesis Submitted in Partial Fulfilment
of the Requirements for the Degree of Master of Science

February, 1970

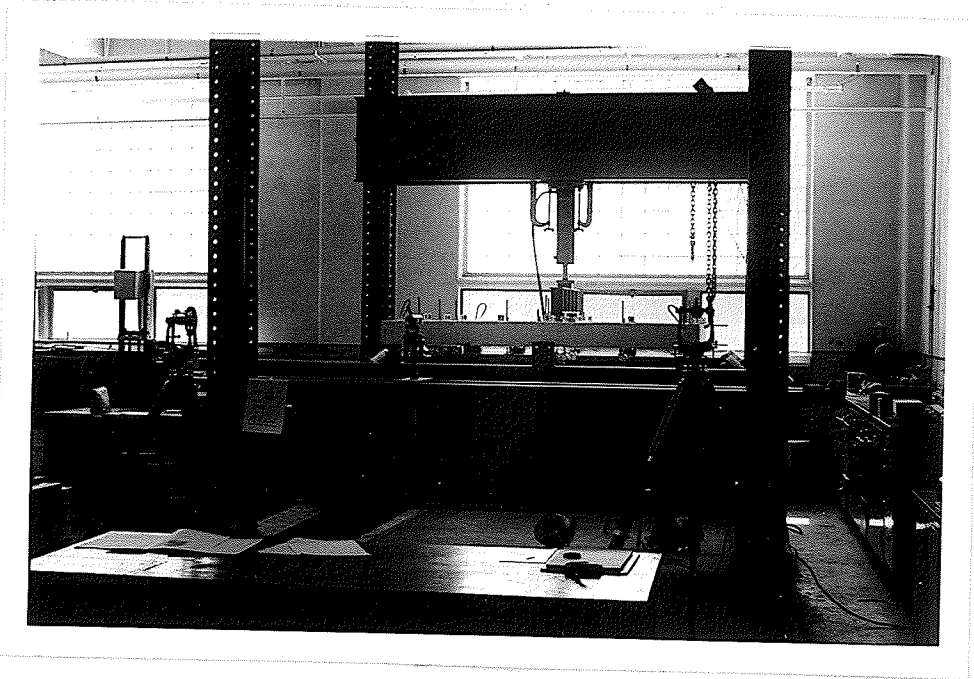
For the second test two equal point loads were applied to the interior longitudinal. As before, the base of the jack was attached to the channels of the portal frame, but this time the head of the jack rested on the center of a stiffened I spreader-beam. The point loads were transferred from the spreader-beam to the concrete beam by means of two roller bearings identical to the one used in the first test. Figure 19, page 35, shows the overall test set-up for the second grillage, while Figure 20, page 35, shows in detail the loading arrangement with the spreader-beam.

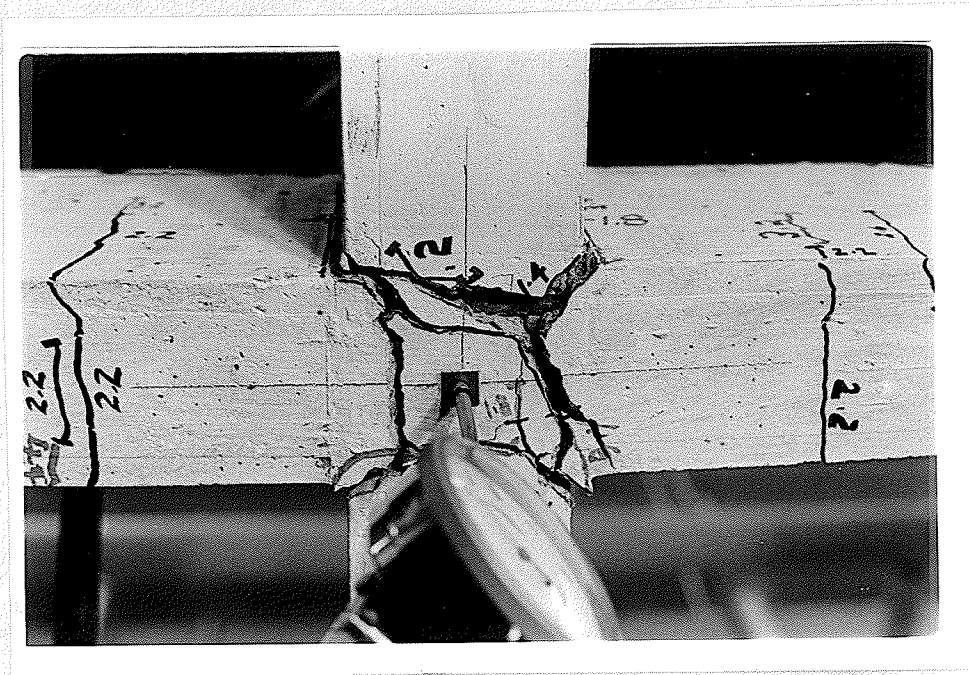
The above constituted the first part of test no. 1 and the entire sequence of events can be traced in Figures 28 to 33 inclusive, pages 49 to 51. Load-deflection curves for several gauge positions appear in Figure 27, page 48. Test data is listed in Appendix B, page 112. Rotation of the exterior beams was negligible to this point in the test. It was decided that observation of further deflection might be useful and the jack was reset as described earlier. The second section of test no. 1 proceeded from this point.

The first run progressed very smoothly. The grillage model sat on its supports very well as load was applied and cracks did not appear for some time. It was not until a load of 1060 lbs. that the first cracks appeared at the center of the grillage and at the beam junction in the vicinity of gauge 5. At a load of 1260 lbs. no new cracks occurred, but the cracks immediately under the load propagated. All cracks increased in length as the load reached 2050 lbs. At this point new cracks appeared near the center of the grillage on the interior beams at predicted hinge locations. From a load of 2250 lbs. to 2430 lbs., new cracks appeared on the interior beams near their junctions with the exterior members. These cracks were also in predicted hinge areas.

At this point gauge readings were discontinued. Jacking was continued and deflection increased considerably. The test continued until the two bottom bars of the interior transversal broke at a point directly under the load. A reading was taken on the hydraulic point gauge and the total deflection was 0.854 ft. Increased deflection could not be achieved, as the jack had reached its full length of travel.

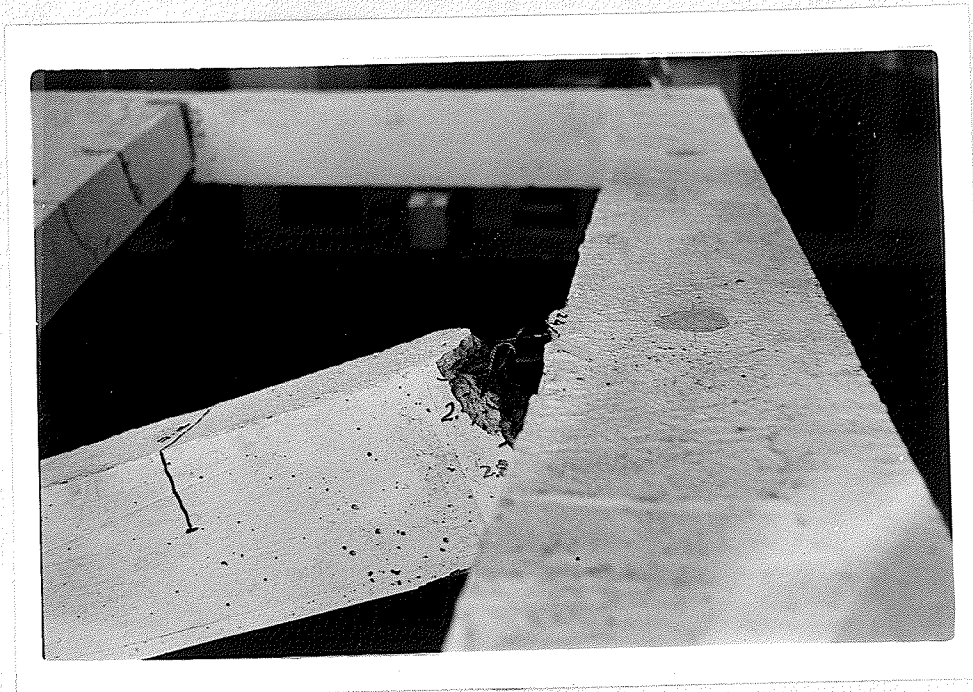
The structure was still able to take renewed loading and at a load of 4800 lbs., the other top bar of the interior longitudinal broke at a deflection of 1.569 ft. The load then dropped off to 0 lbs. when the top bars of the interior longitudinal were completely broken.

At this point the load plate tilted and no further loading was possible. The grillage was shifting on its supports as the load was being applied at an angle. If the load plate had not tilted, more deflection could perhaps have been obtained until the interior transversal bars had broken completely. Nevertheless, the final point gauge reading showed a total deflection of 1.613 ft. Figures 35 to 42, pages 56 to 59, show the progress of the grillage collapse quite well.
