A PRELIMINARY INVESTIGATION INTO THE BEHAVIOUR OF  
VARIOUS FLATTENED-END TRUSS CONNECTION CONFIGURATIONS

A THESIS  
PRESENTED TO THE  
FACULTY OF GRADUATE STUDIES  
THE UNIVERSITY OF MANITOBA

LESLIE E. FROVICH

SEPTEMBER, 1973

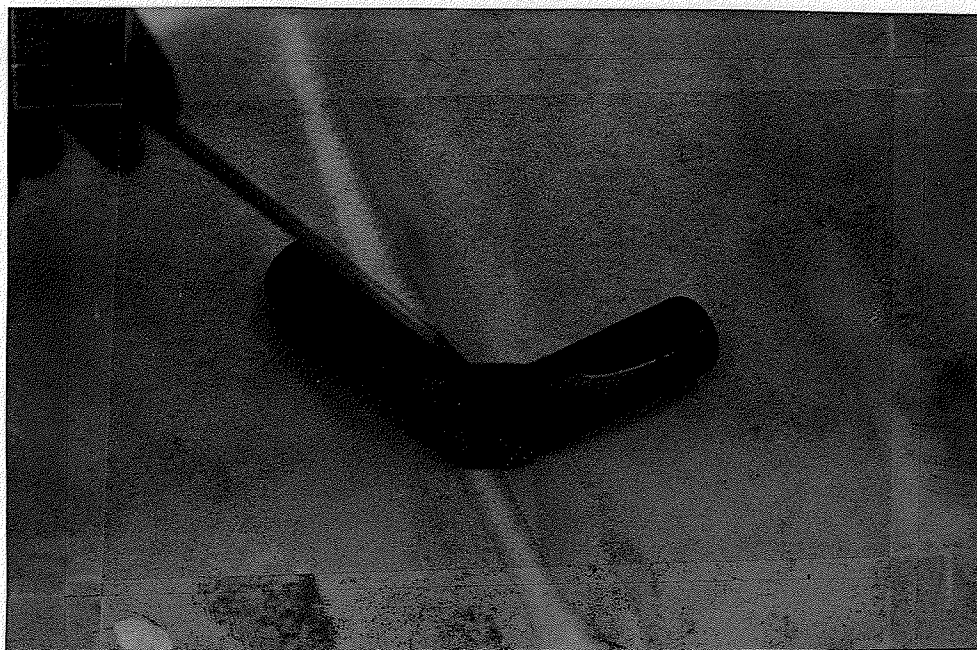
Photo 3.14 Crack In Seam Of Flattened H.S.S.

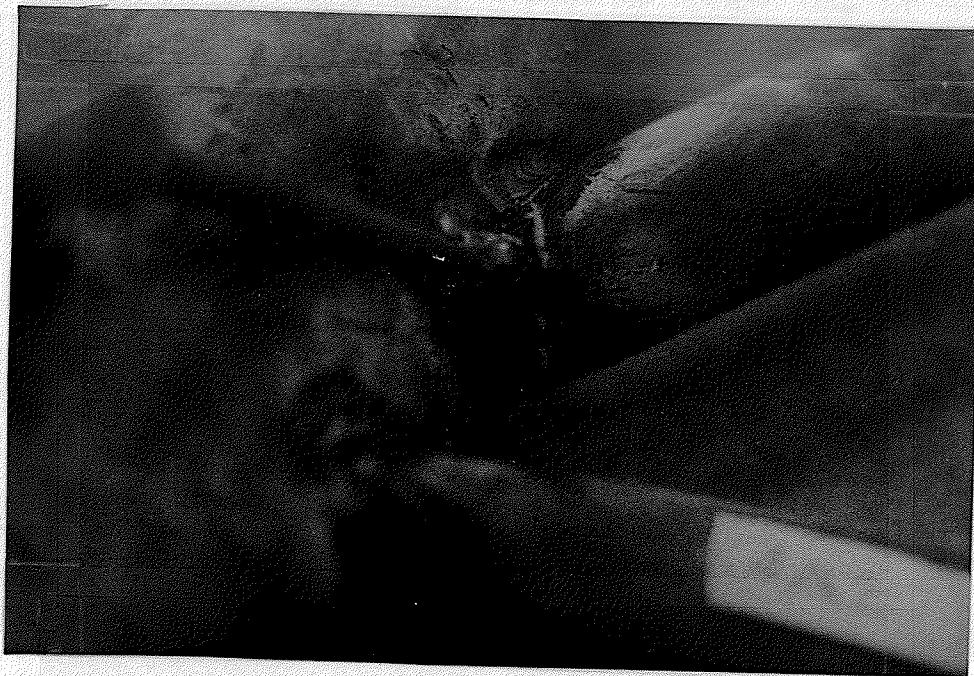
Photo 5.13 View of Specimen 4A2 After Failure
