**REINFORCING BAR CONNECTION OF HOLLOW-CORE
SLABS TO STEEL BEAMS AND MASONRY WALL
SUPPORTS**

A Thesis submitted to the Faculty of Graduate Studies of

The University of Manitoba

MASTER OF SCIENCE

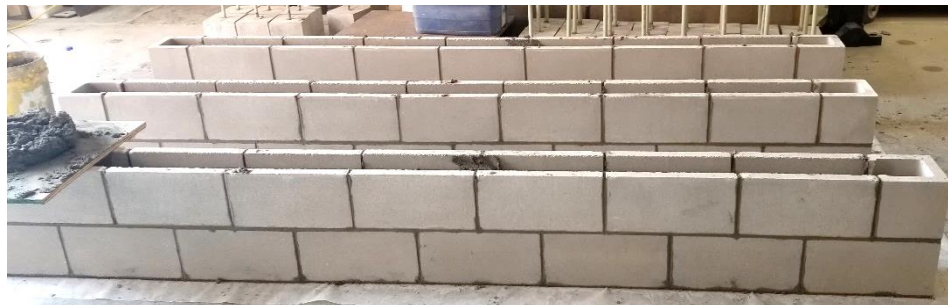
d) Masonry beams before grouting

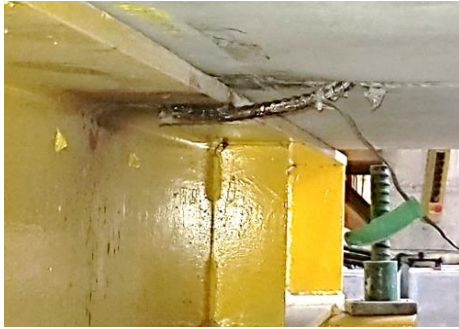
(a) EB-TN-90 (pulling/normal)

Under compression forces (pushing/CN), the mode of failure of end-bearing specimens was governed by bar bending or buckling at the bottom bend (Fig. 4.4 (c), (d), (e) and (f)). In general, the connection bar did not yield before the maximum load, except for specimen EB-CN-45R, in which the connection bar developed yielding strains at the bottom bend before bar buckling. In all specimens, the peak load was attained at the onset of bar buckling. Then, the slabs gradually pulled the unrestrained (free) portion of the connection bar, provoking “dragging” in the bar. Strength degradation was observed thereafter through a gradual load reduction while the bar experienced further bending or buckling. No cracking was observed in the slabs or the grouted shear-key at any point during the test.

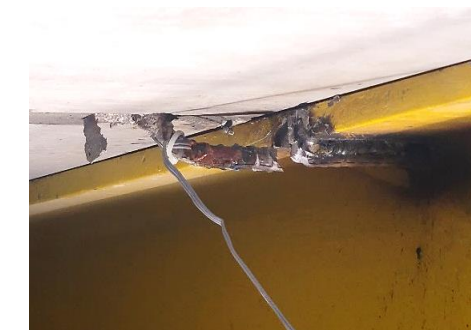
(g) EB-CP-90 (pushing/parallel)

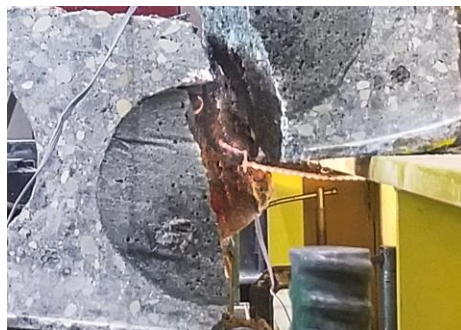
(a) SB-TN-90 (pulling/normal)

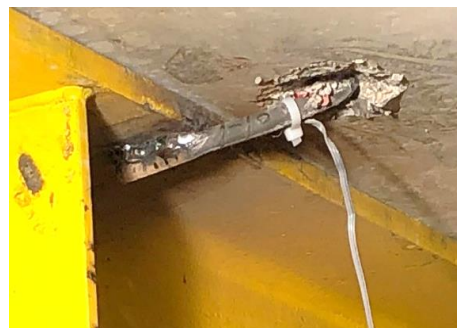
(d) SB-TP-90 (pulling/parallel)

Loading parallel to the axis of the supporting beam: The side bearing connection (SB-CP-90), tested under pushing force, showed similar behaviour to its counterpart with end bearing. The connection bar failed owing to bar kinking and yielding with excessive deformation. However, in this specimen, no bar twisting, or bar rupture was observed (Fig. 4.5 (c)). Conversely, when tested under pulling, the connection bar in specimen SB-TP-90 failed because of bar yielding followed by bar twisting and necking near the welding point (Fig. 4.5 (d)). In both cases, the testing was also halted after significant bar deformation and no further strength gain.

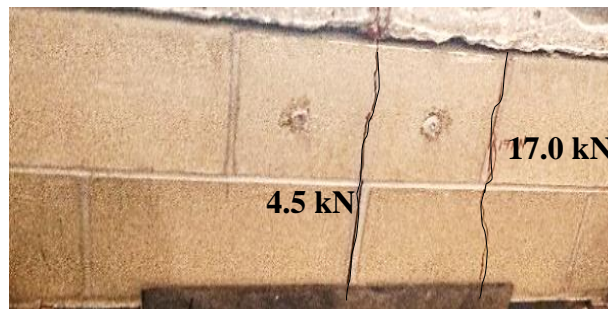
Masonry beam cracking

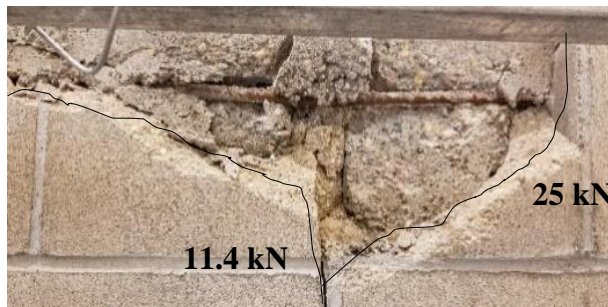
Masonry beam cracking and spalling

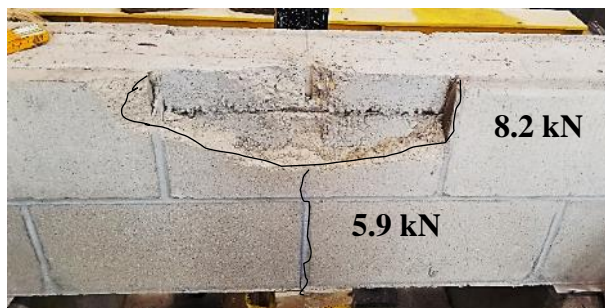
Masonry beam cracking and cover spalling

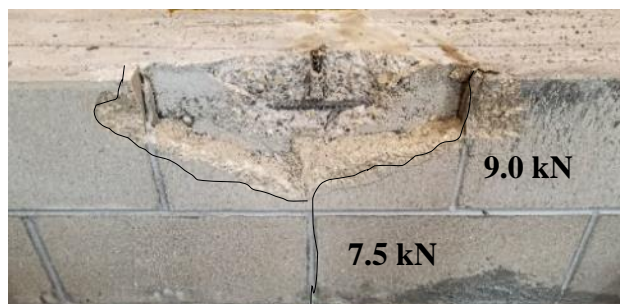
Masonry beam cracking and spalling
