# RIVER & **COMMUNITIES**

a l t e r n a t i v e   s c e n a r i o s

A Practicum submitted to the Faculty of Graduate  
Studies The University of Manitoba in partial  
fulfilment of the requirements of the degree of:

MASTER OF LANDSCAPE ARCHITECTURE

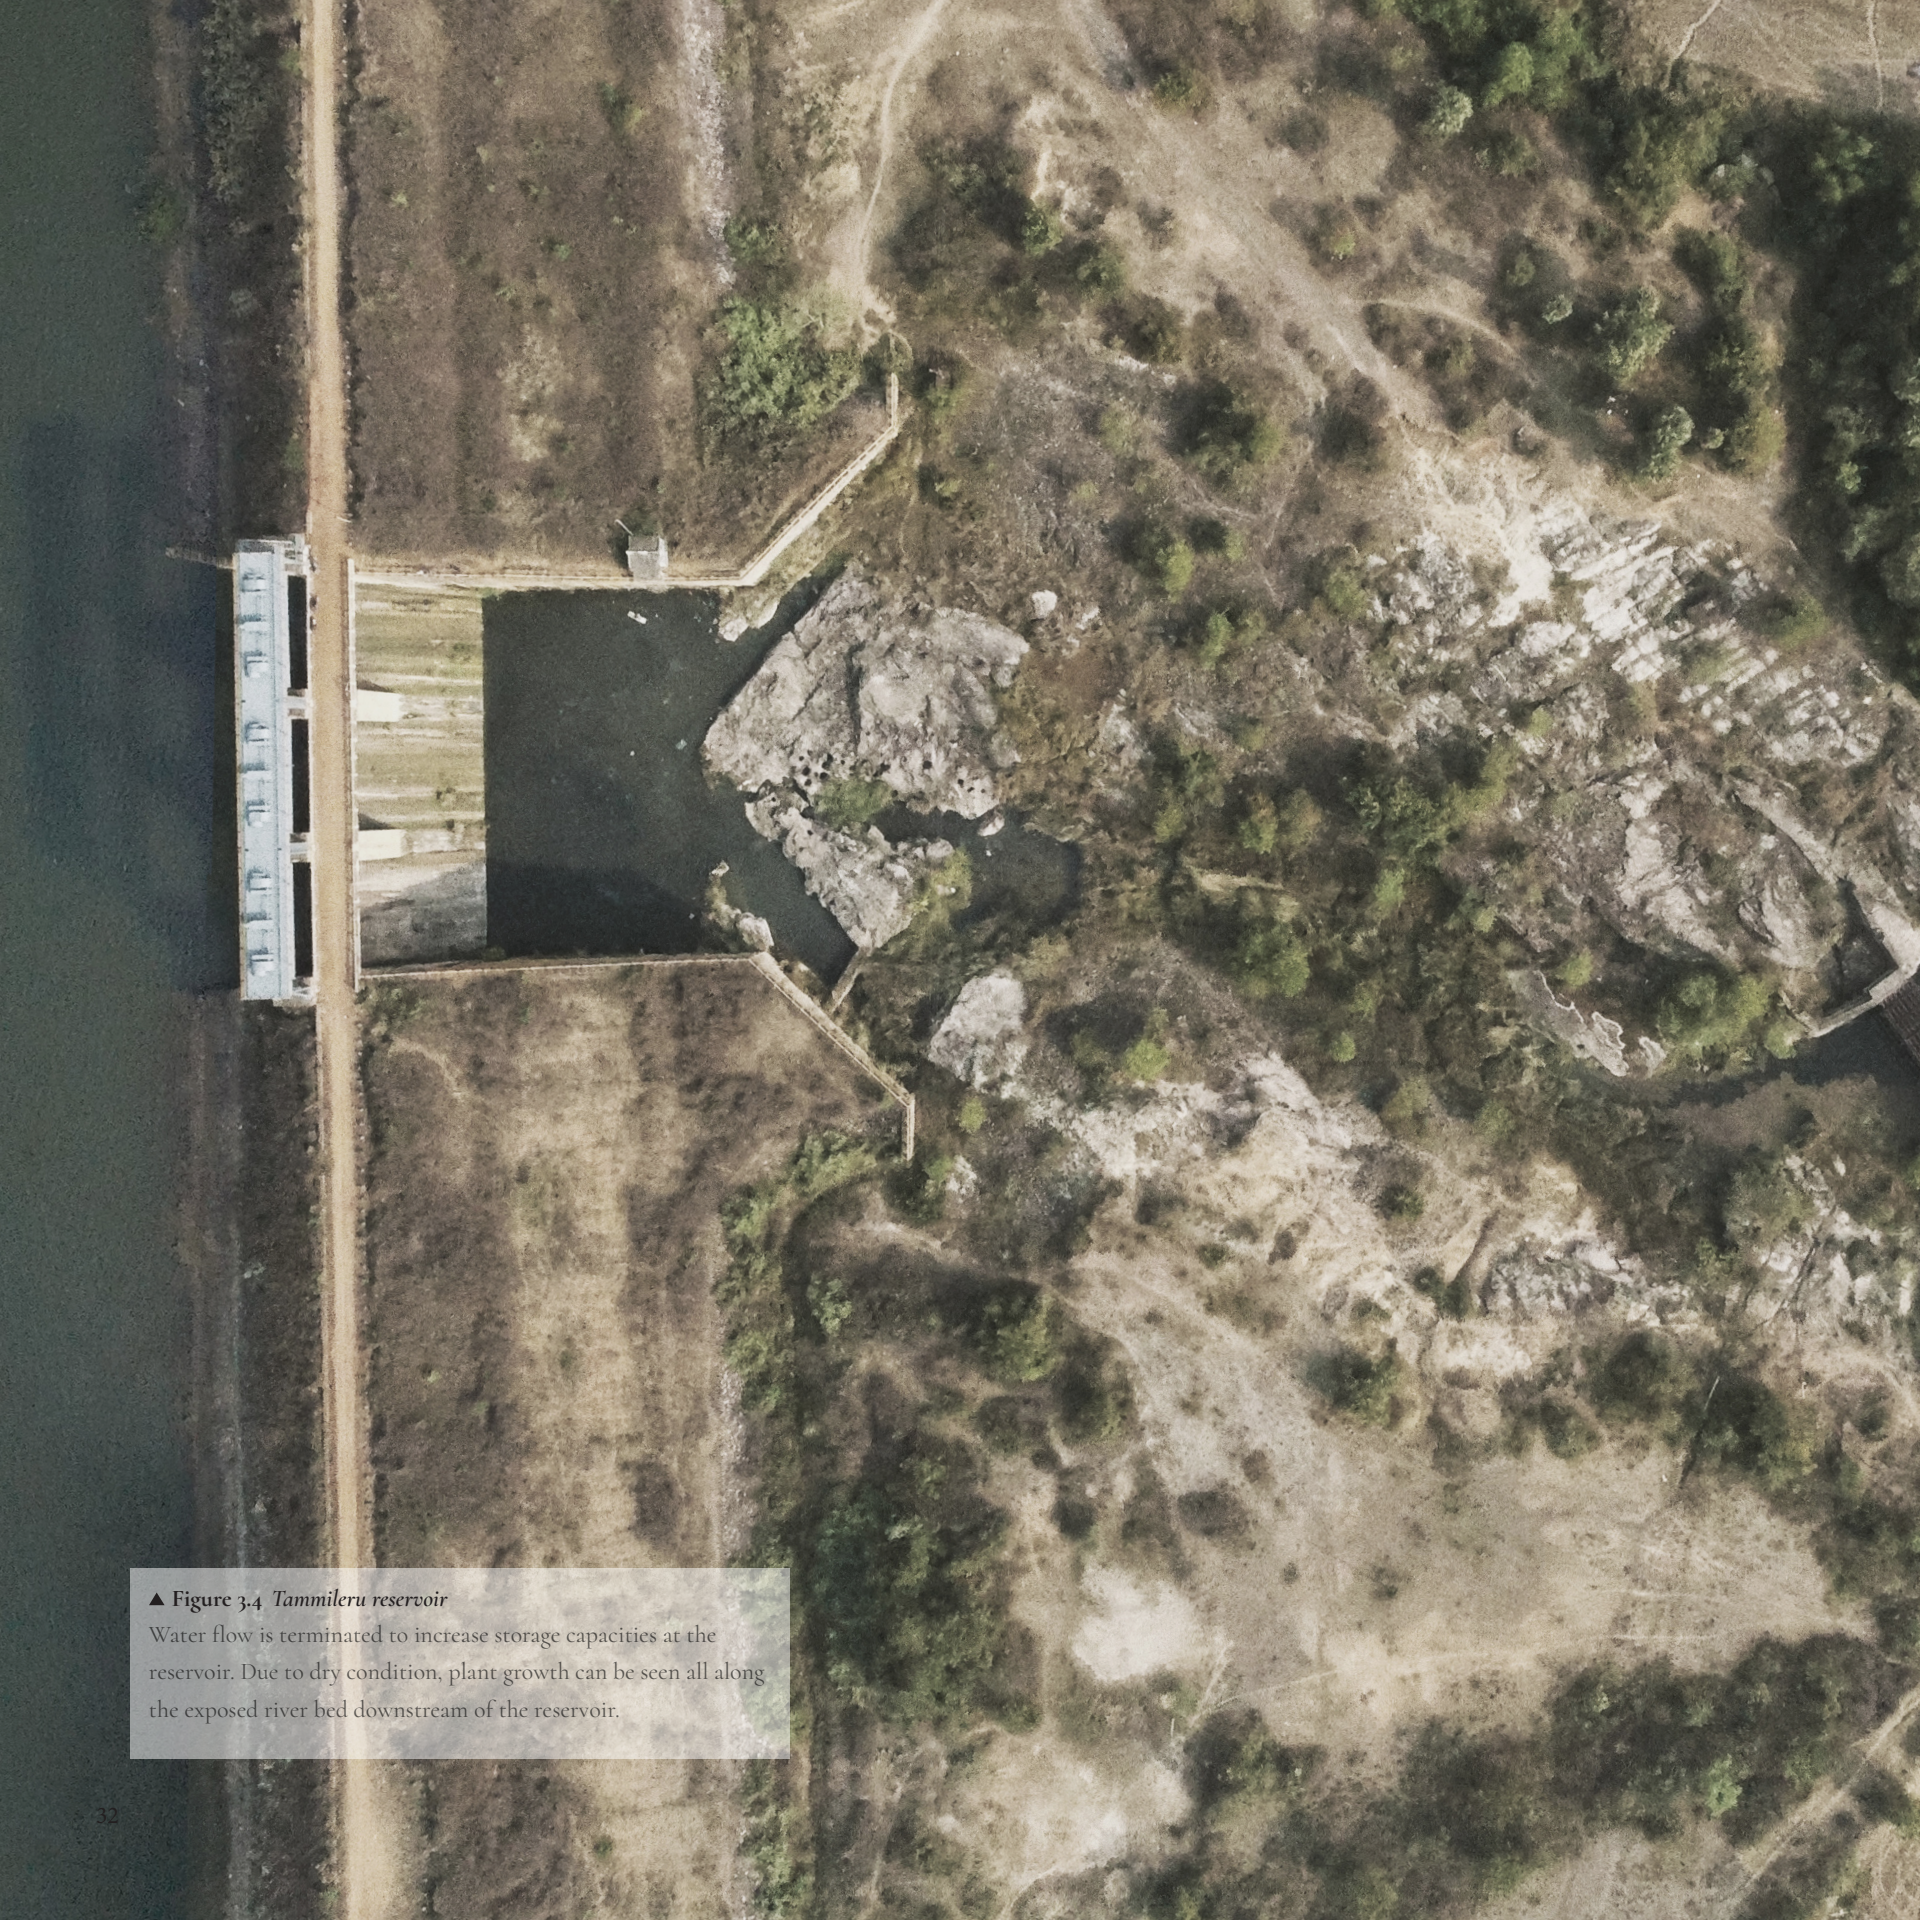
▲ Figure 3.4 *Tammileru reservoir*

Water flow is terminated to increase storage capacities at the reservoir. Due to dry condition, plant growth can be seen all along the exposed river bed downstream of the reservoir.

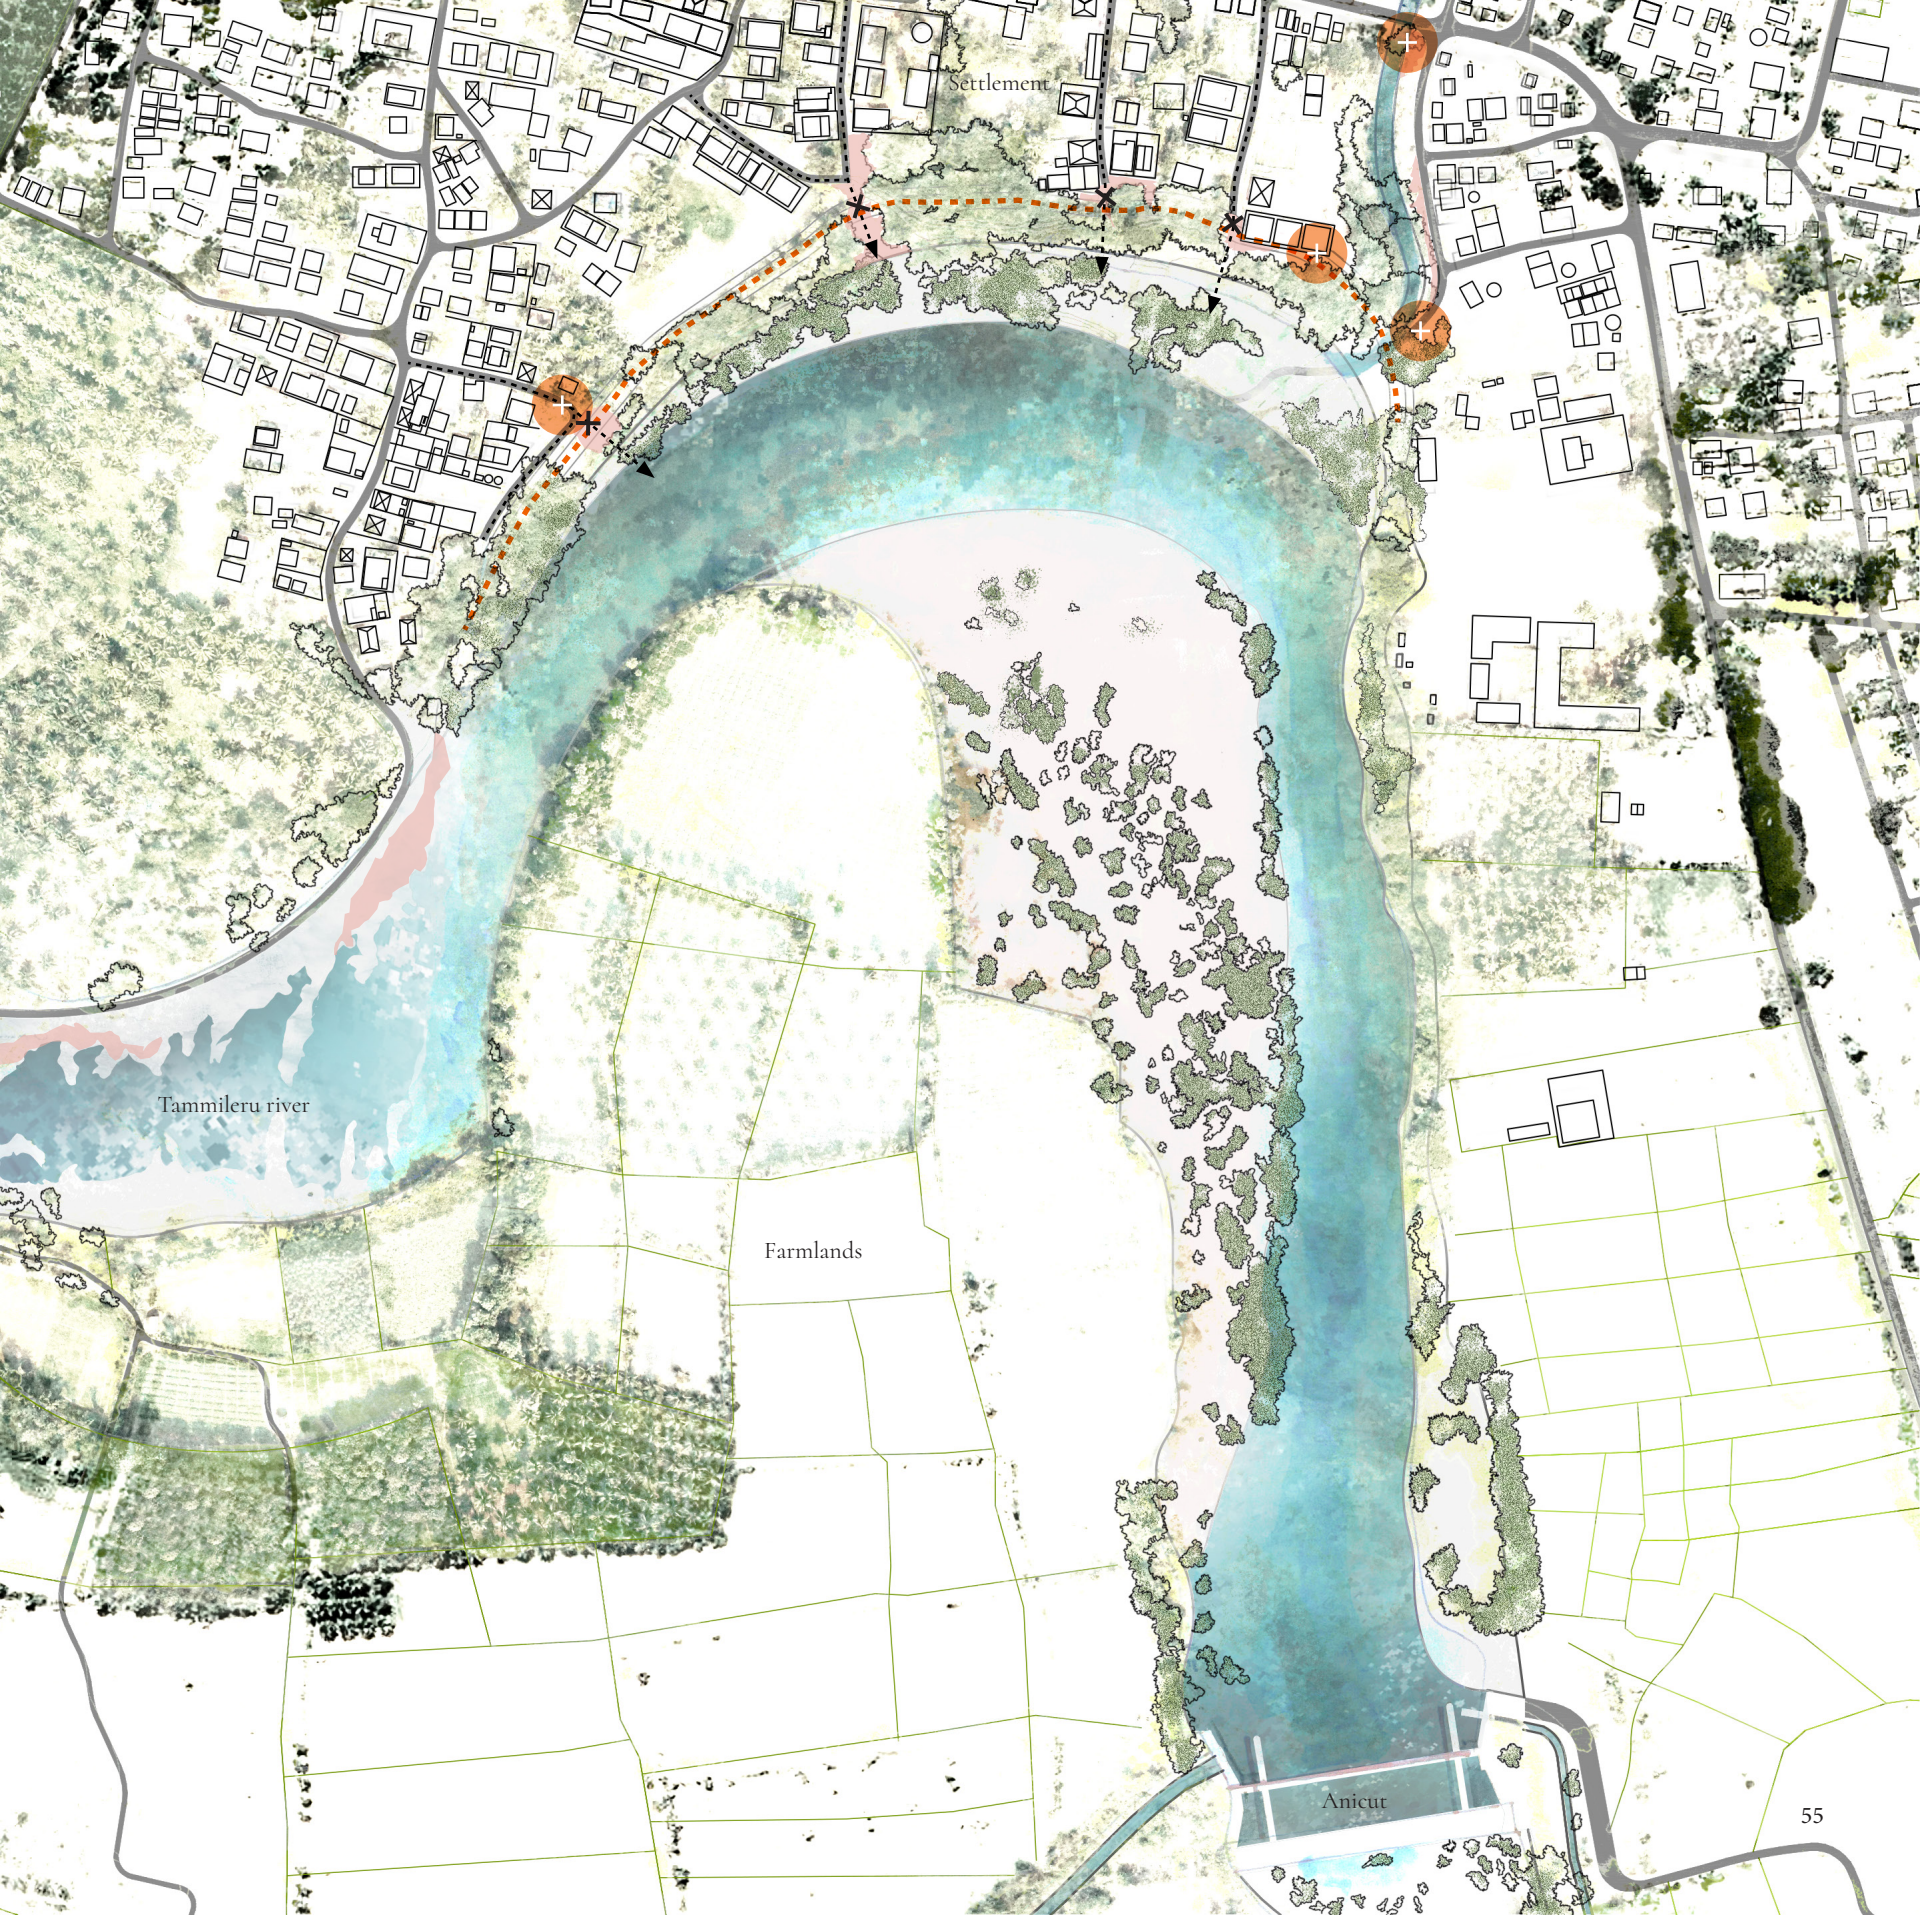
The embankment along the river provided a single access point northeast of the village and blocked all existing entry points from the streets. The five meter high embankment visually disconnected the village, river and the farms. Physical barriers forced people to take a longer route to the river, making it harder for users to carry water pots for longer durations. The barriers, steadily affected traditional river edge activities and discouraged people from accessing the river.

The high embankment creating a physical and visual barrier has been identified a primary cause of behavioural changes in the community and its perceptions of the river. Despite the initial attempts to increase the water storage capacity of the anicut, the embankment has never served its intended purpose due to controlled and reduced water flow from upstream reservoirs. The anicut is not well maintained by the government has failed in its original purpose and is now used by the residents as a swimming pool.

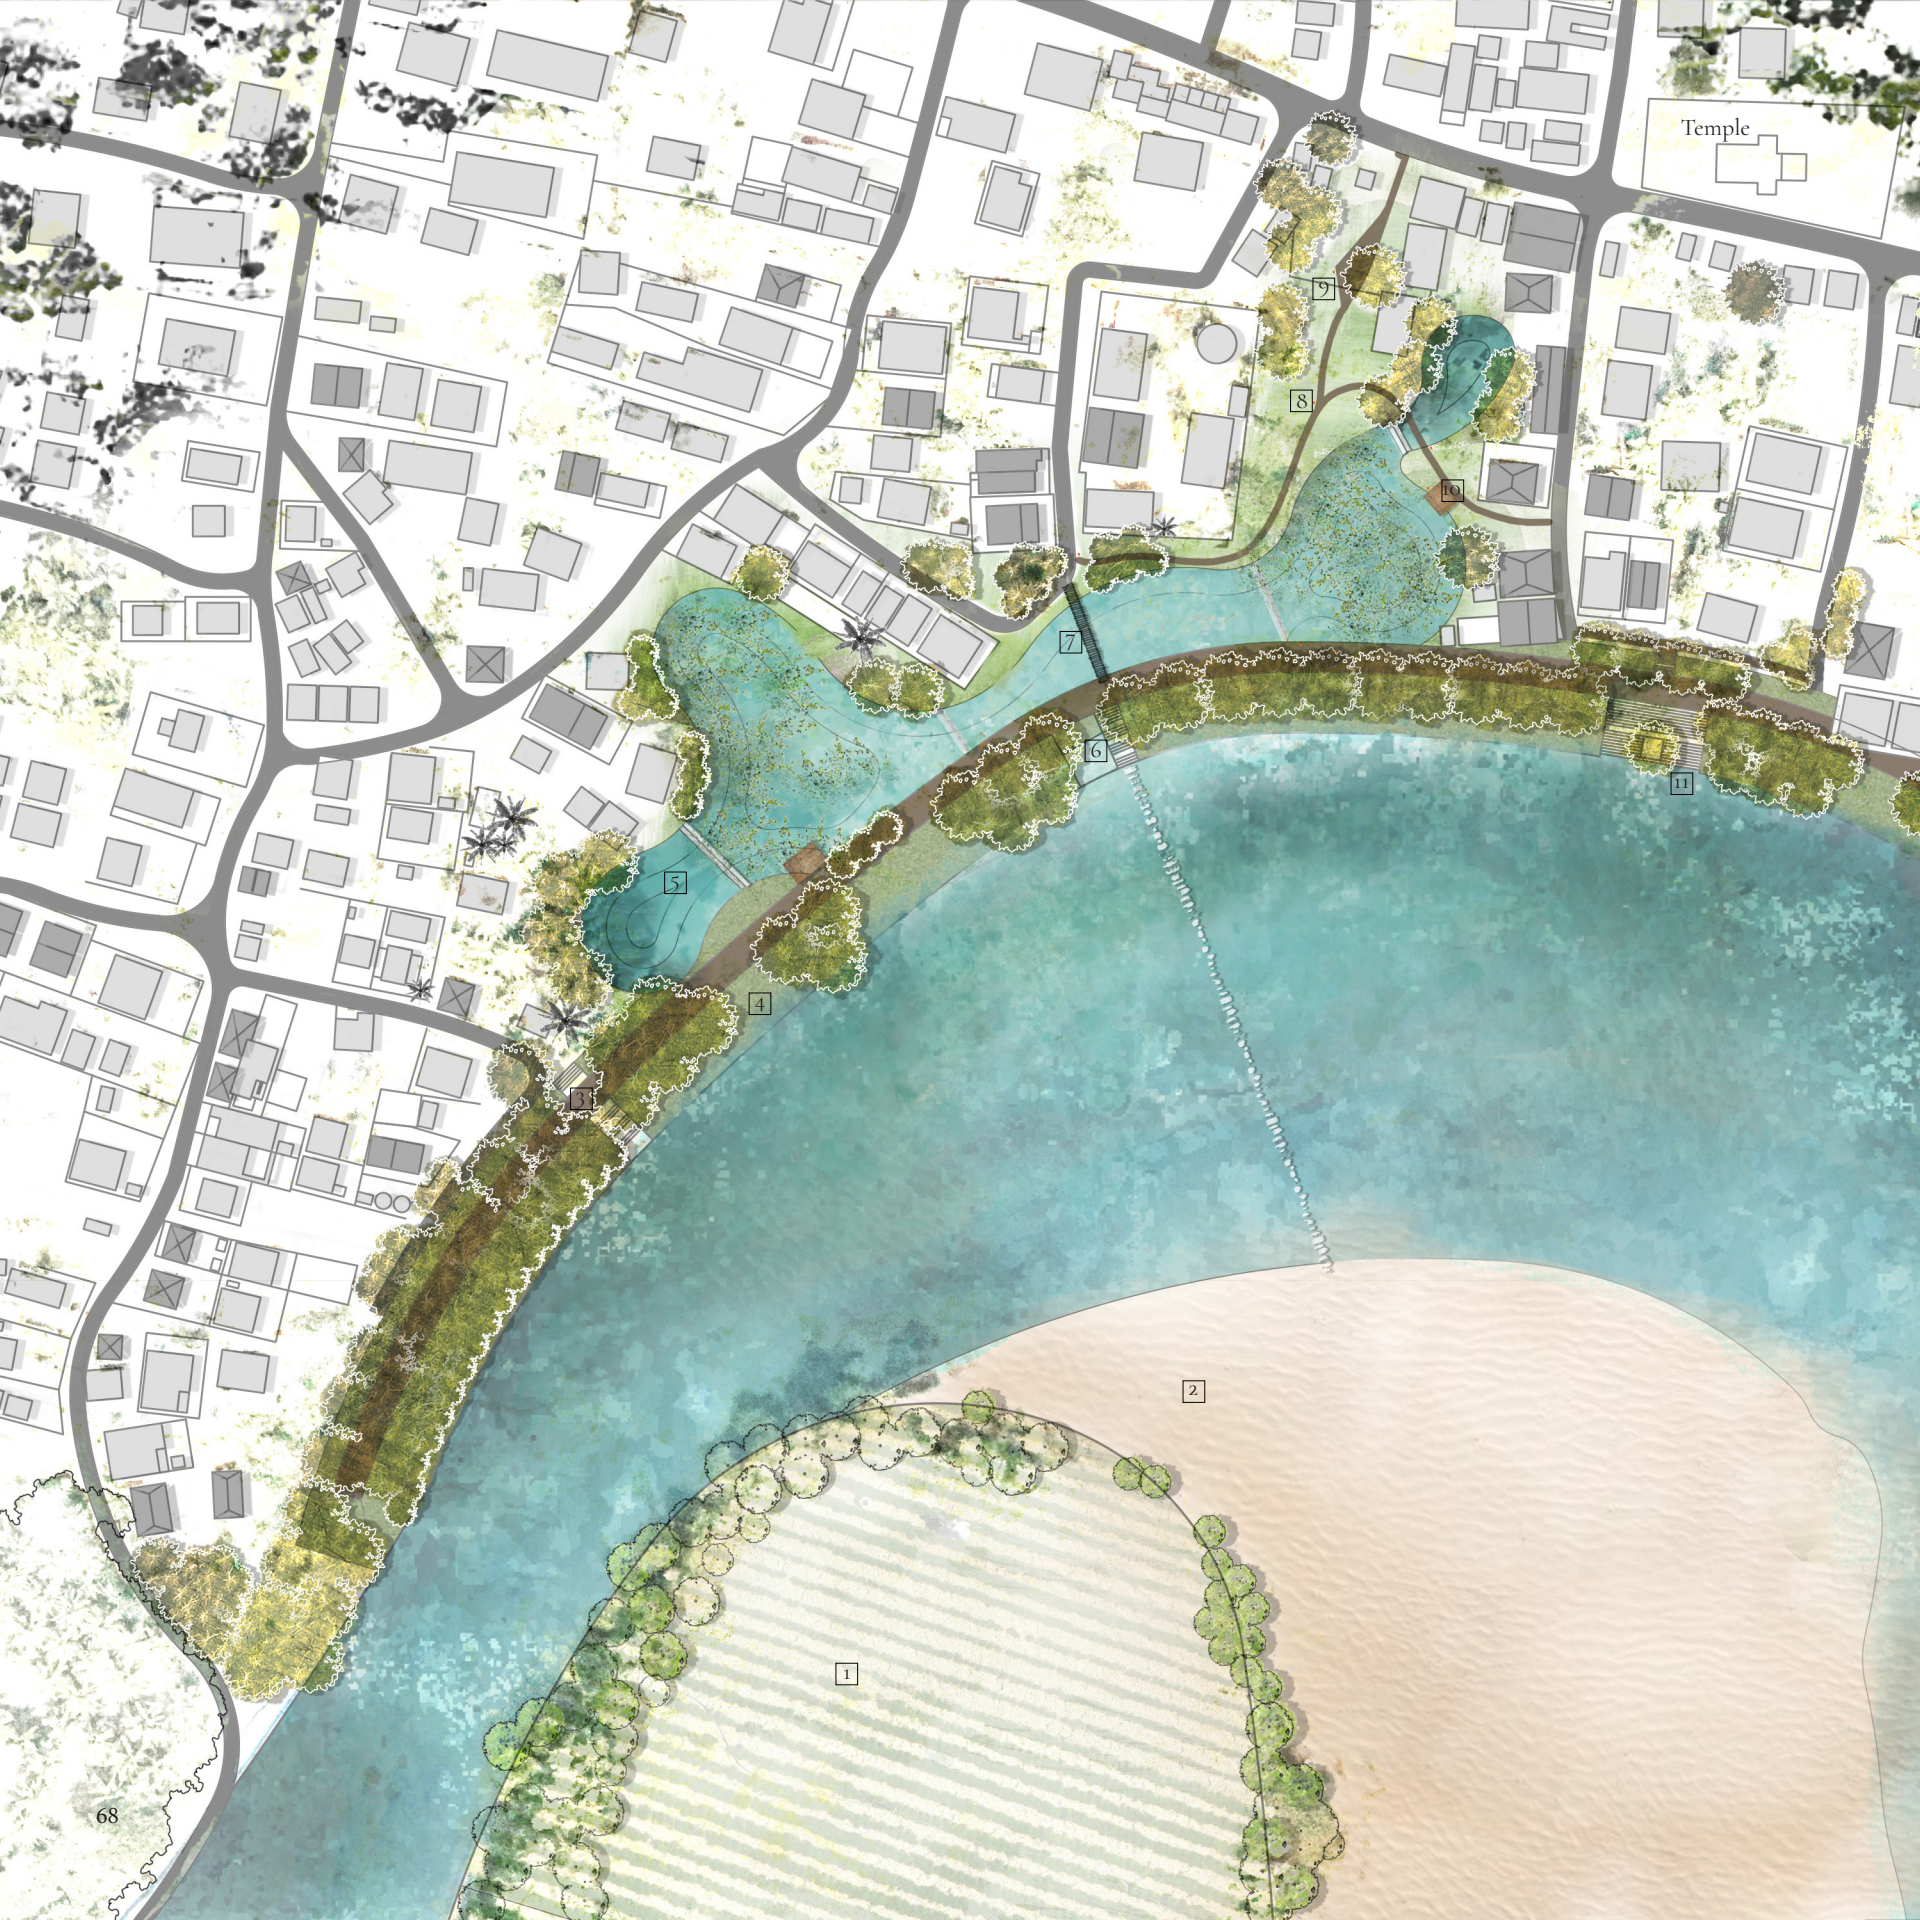
▲ Figure 7.4 *Proposed pedestrian network*

Phase 4 focuses on re-establishing connections between the river and community by creating access points along the embankment. River access points are spaced across the levee to maintain five minute walking commutes between entry points. This connects with the pedestrian network linking the main street, and so people are drawn to the river edge.

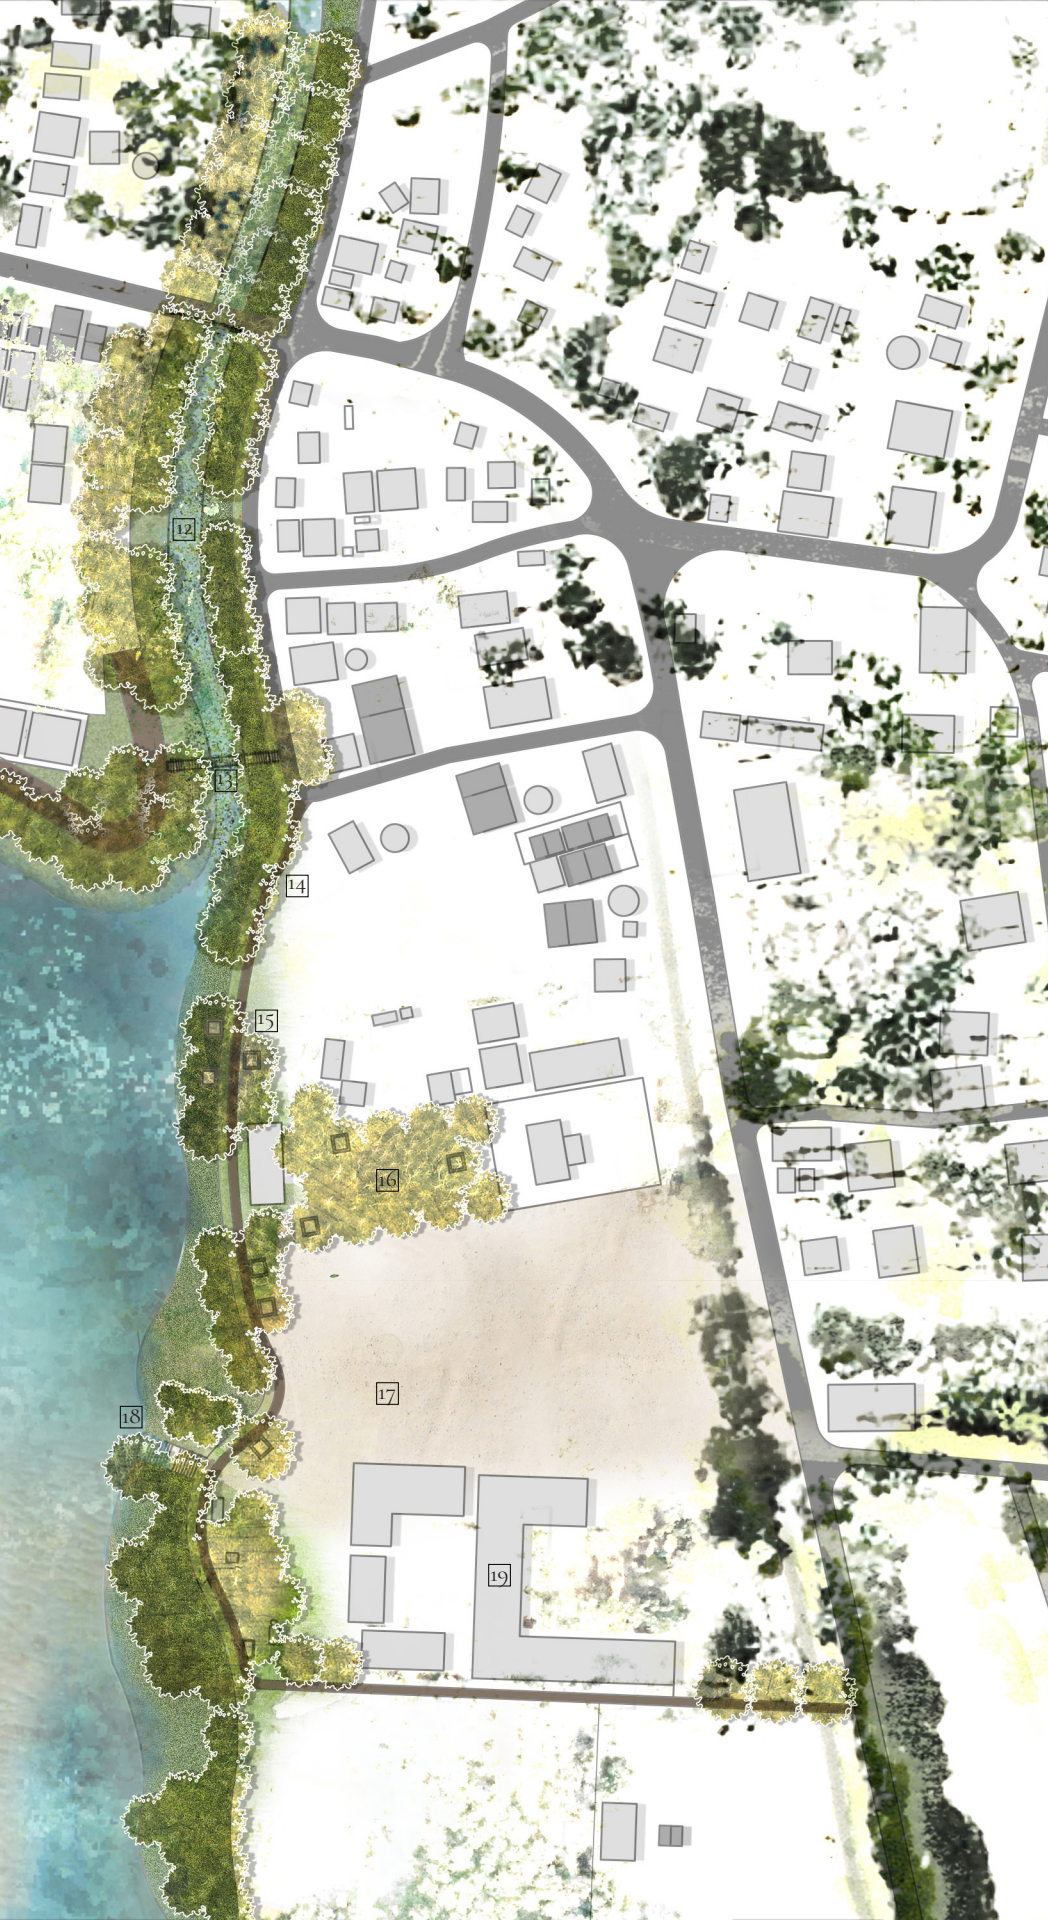
◀ **Figure 7.5** *Vijayarai ecological edge*

The proposal envisions an ecological edge that offers recreational opportunities for the neighbourhood and bringing life to an otherwise disturbed landscape. Through design, the project aims to initiate a dialogue between the people and the natural surroundings by engaging them in solving environmental issues. The pedestrian networks and riparian buffer draw people towards the river edges from the busy main street. The pathways and decks through the wetland allow people to immerse themselves in the surroundings while revealing the wetland's functions through storyboards. The long walks along the embankment open into niches for community engagement, recreation, leisure and learning thus emphasizing human water interface.
