Remediation of brine-contaminated soil using calcium nitrate, gypsum, and  
straw

A Thesis submitted to the Faculty of Graduate Studies of

MASTER OF SCIENCE

Department of Soil Science

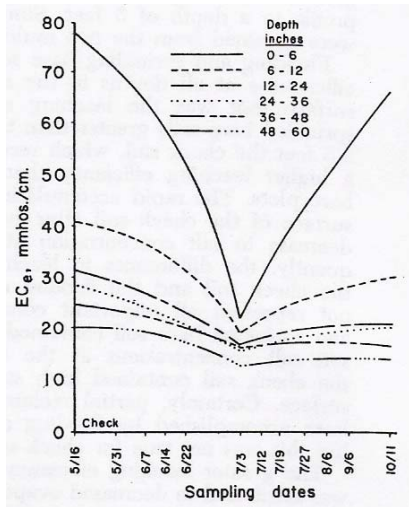
Upward movement of salts occurs during dry periods. When the water evaporates, the salts are left in the soil and subsequently increase the salinity of the soil. In a field study in Texas, the E<sub>Ce</sub> decreased due to rainfall from May to July (Figure 2.10). After July 3, there is a sharp increase in the surface E<sub>Ce</sub> when very little rain fell (Carter and Fanning 1964).

**Figure 2.10 The soluble salt concentration expressed as ECe in mmhos/cm. for various depths of check soil in relation to sampling dates (Carter and Fanning 1964).**

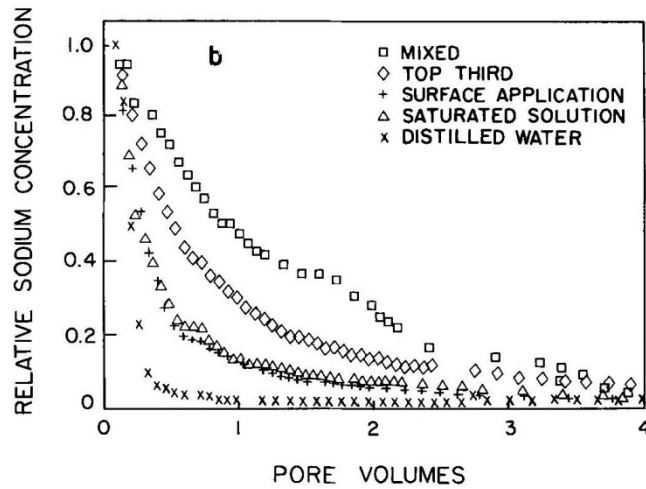
Therefore, when the gypsum is close to the exchange sites it exchanges quickly (Frenkel et al. 1989). More  $Ca^{2+}$  exchanged for  $Na^+$  when the gypsum was mixed in the whole soil column since the amount of  $Na^+$  leached out of the soil was the greatest with this treatment (figure 2.12). Gypsum mixed in the top 1/3 of the column leached the next most  $Na^+$ . Gypsum placed on the surface or applied in a saturated solution leached less  $Na^+$ . Distilled water leached the least amount of  $Na^+$  which would be expected since no  $Ca^{2+}$  was added to exchange the  $Na^+$ .

**Figure 2.12 Scaled ion concentration as a function of leachate pore volume: (b) sodium (sodium per increment/sodium in initial increment) (Frenkel et al. 1989)**

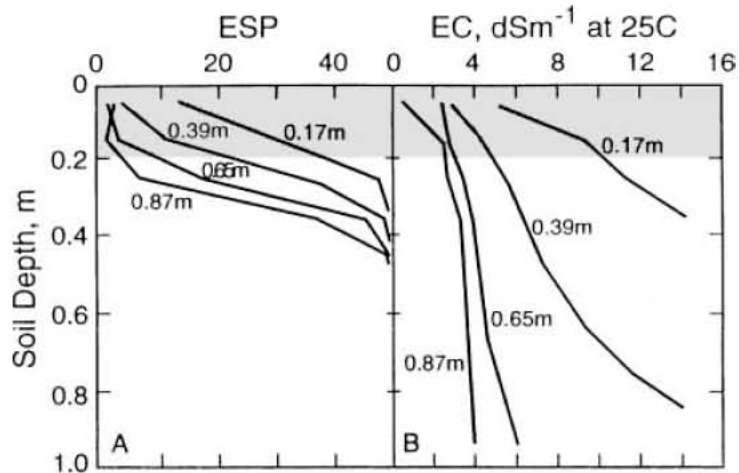
Qadir et al. (2001) also found that gypsum was not mobile in the soil profile. When gypsum was applied to soil to a depth of 0.2 m it lowered the ESP and EC at that depth (Figure 2.13). When 0.87 m of water was applied the ESP and EC were lower in the 0-0.2 m depth compared to only 0.17 m of applied water. Below 0.2 m there was an increase in ESP and EC and this was more pronounced when more water had been applied.

**Figure 2.13** Computer model results (ESP and EC) for amelioration of a soil (initial ESP=50, CEC=200 mmolc kg<sup>-1</sup>) with gypsum and water (EC=0). Numbers next to lines are depths of applied water. (Qadir et al. 2001)

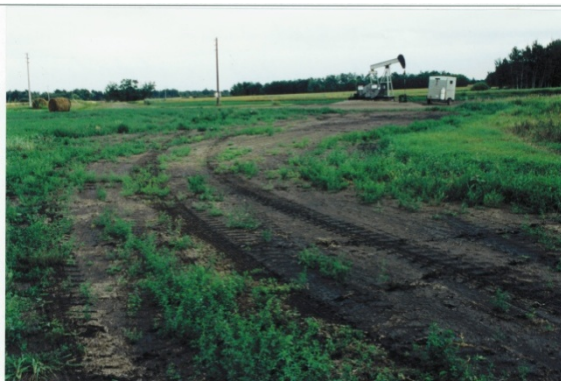
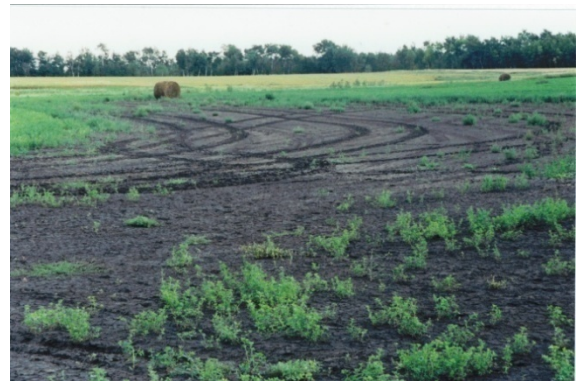
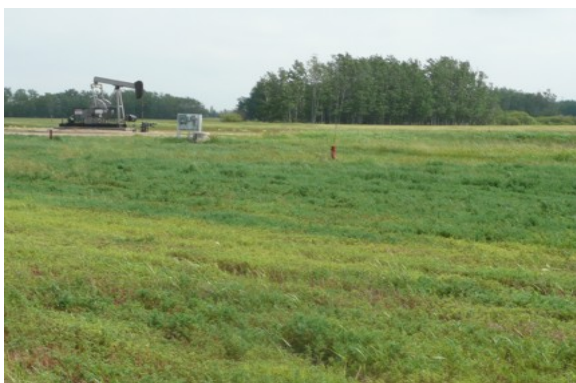
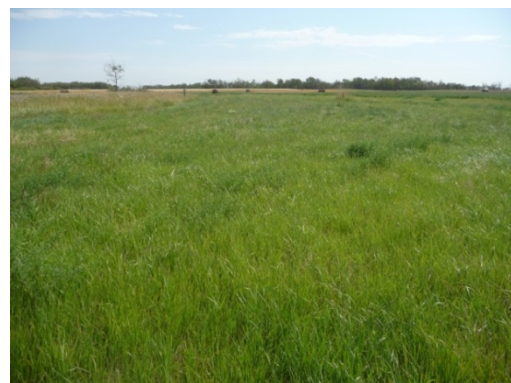
The current salinity status at Hastings was determined by examining EM surveys, soil sample results, topography, soil profiles, and groundwater. Photos from 2002 (Figures 4.1 and 4.2) show the areas of poor growth. Photos from 2008 and 2009 (Figures 4.3 and 4.4) show the same areas now vegetated.

**Figure 4.1 Looking northeast at poor growth (2002)**

**Figure 4.2 Looking south at poor growth (2002)**

**Figure 4.3 Looking northeast at growth (2008)**

**Figure 4.4 Looking south at growth (2009)**

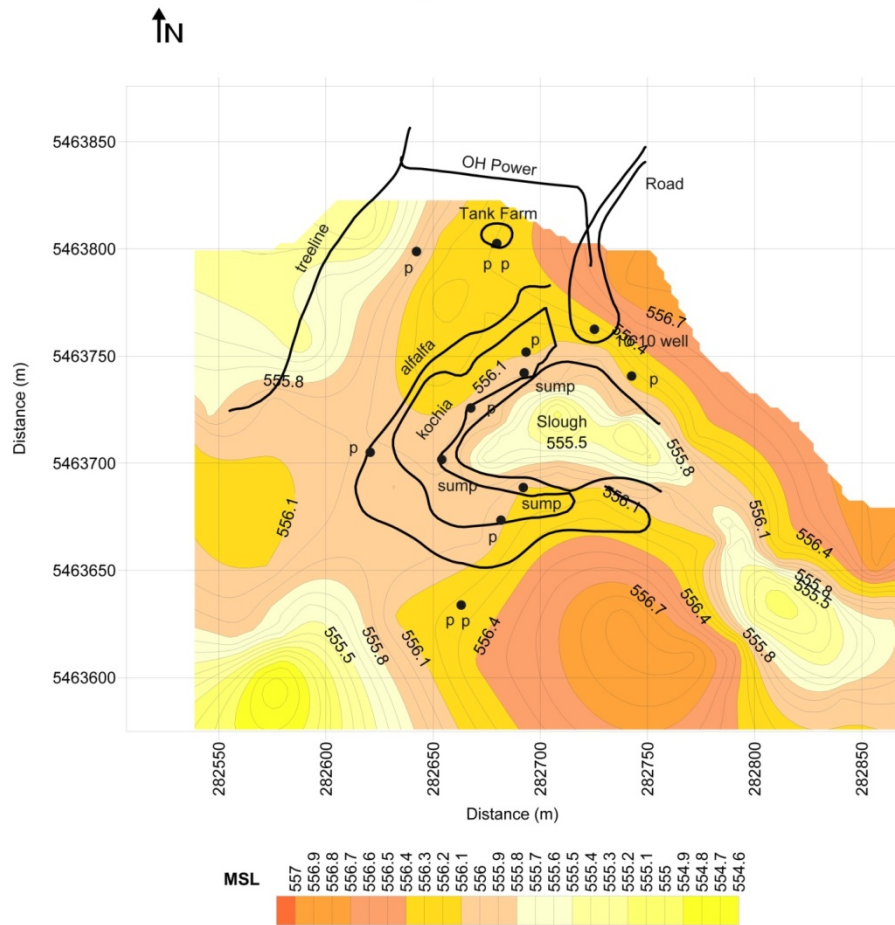
The elevation contour plot showed that the three sloughs in the area are nearly equal in depth (Figure 4.10). The bottom surface of each slough was also nearly level. Excess surface water from snowmelt or very heavy rains that did not infiltrate directly in the soil likely moved into the sloughs.

**Figure 4.10 Topographical contours, May, 2010 (© Canadian Natural Resources Ltd. used with permission)**

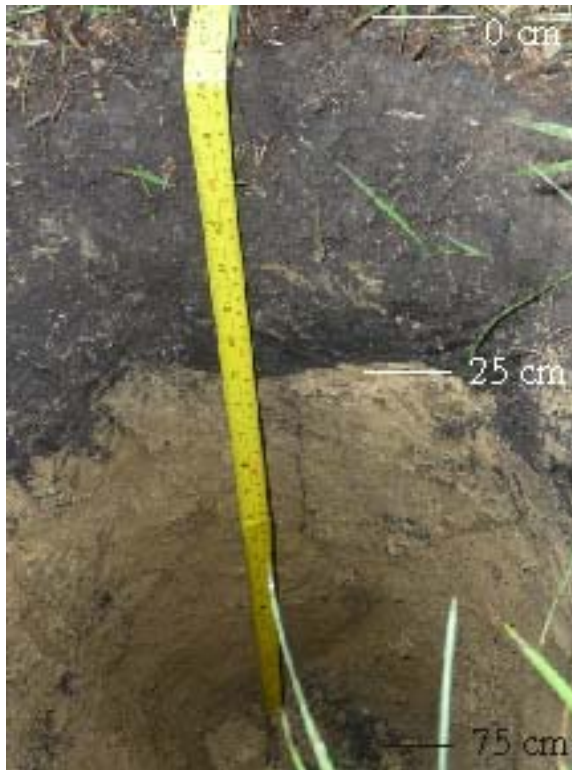
Apk - loam, black, moist, loose friable

Ck - silt loam, olive, moist, loose friable, gypsum and carbonate concretions (pseudo-mycelia) structure is not dispersed

The EM38h and EM38v values at BH1 (figures 4.11) were 393 mS m<sup>-1</sup> and 487 mS m<sup>-1</sup>, respectively and indicated a moderately strong to strongly saline area. BH1 was located in grass; however, in the fall of 2009 this area was in kochia (Figure 4.5). Sufficient moisture during 2010 had allowed grass to compete very well however no roots were visible below 20 cm. The site was probably too saline for alfalfa. Pseudo-mycelia (gypsum and carbonate concretions), visible in the C horizon, were an indication of salinity. No evidence of dispersed structure was found. This is likely due to naturally high calcium carbonate in the soil.

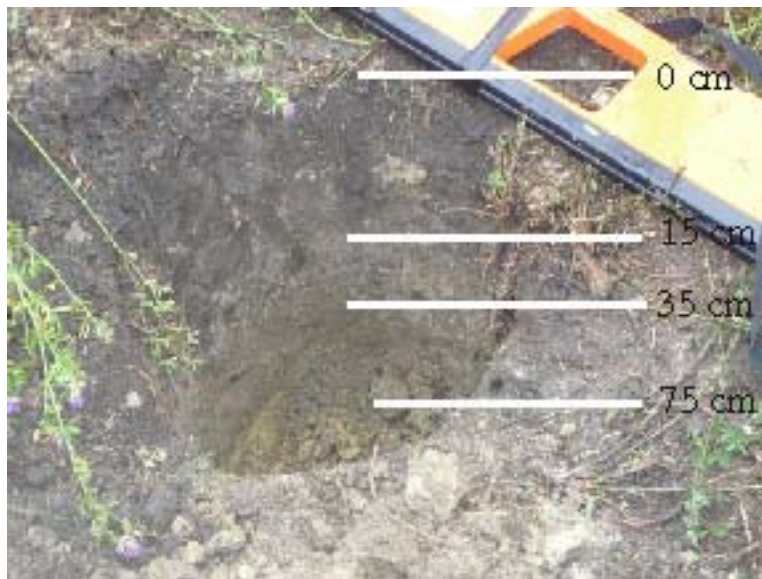
Apk - loam, black, moist, loose friable

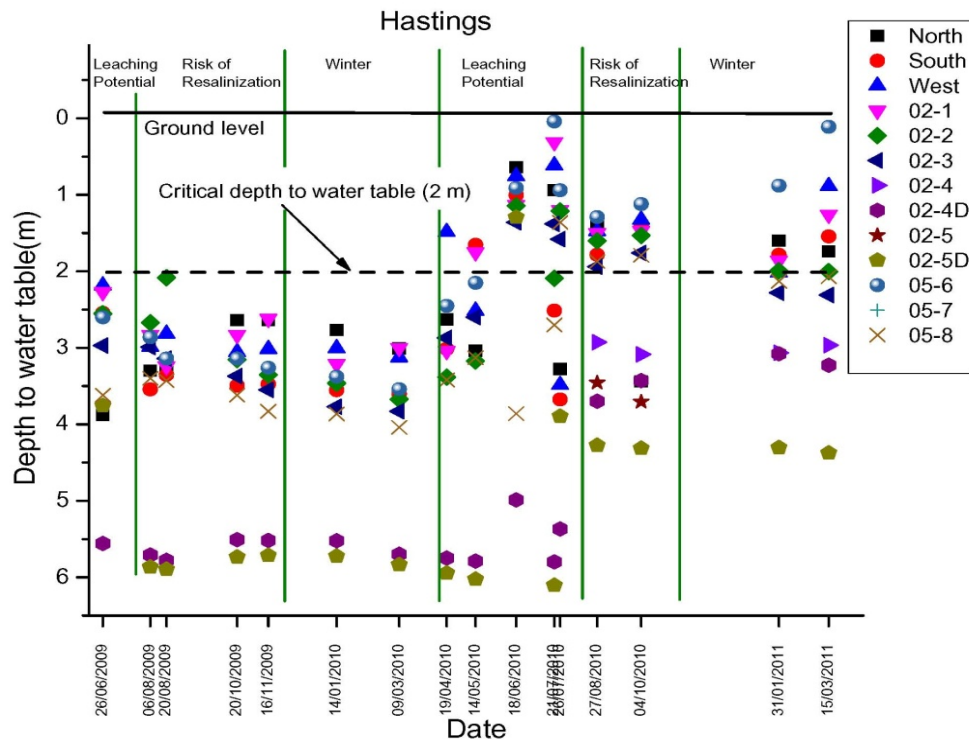
**Figure 4.16 Depth to water at Hastings**

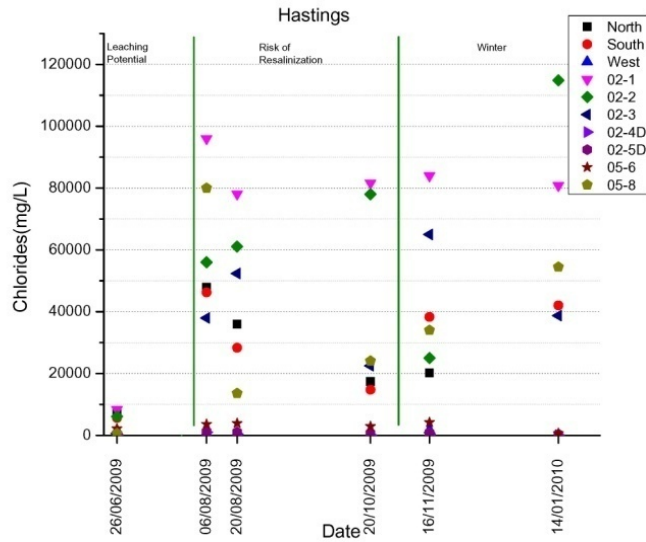
**Figure 4.19 Chloride concentrations (Jun., 2009 to Jan., 2010)**

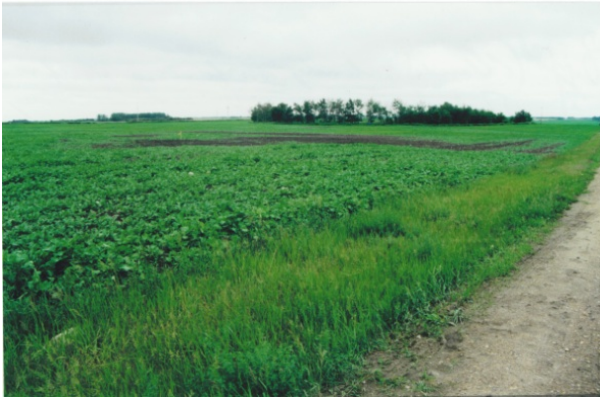
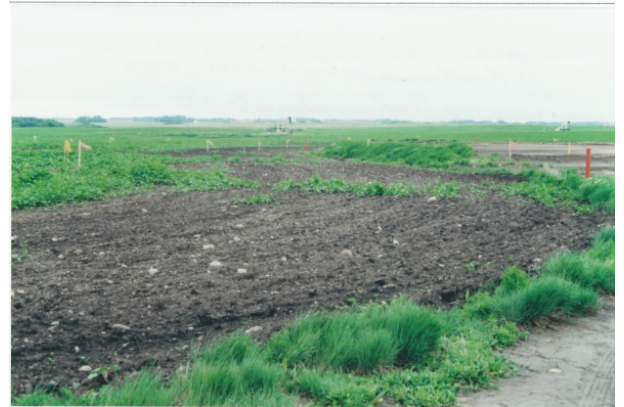
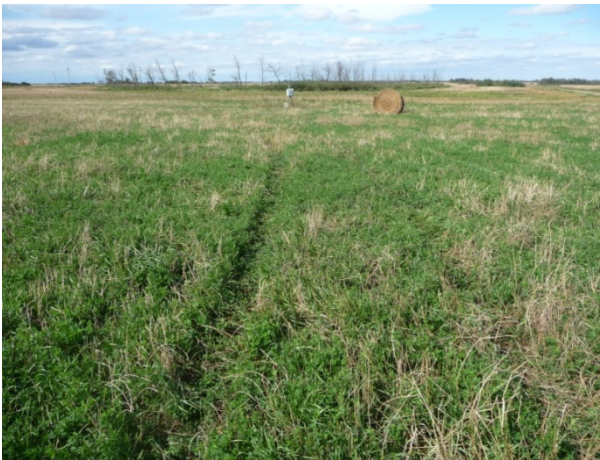
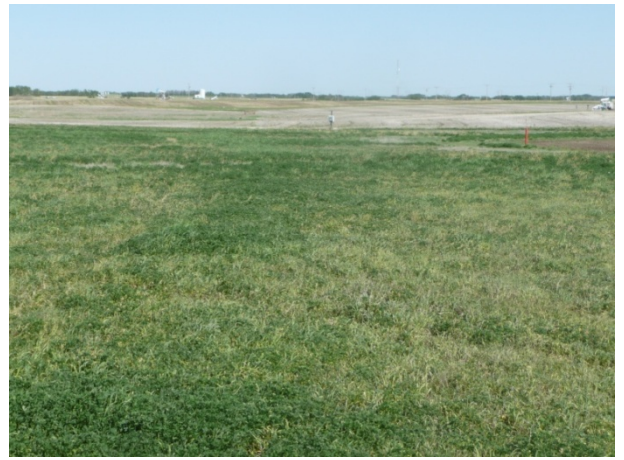
**Figure 4.21 Looking northwest at bare area on west side (2002)**

**Figure 4.22 Looking east at bare area on east side (2002)**

**Figure 4.23 Looking north at good alfalfa growth on west side (2008)**

**Figure 4.24 Looking east at good alfalfa growth on east side (2009)**

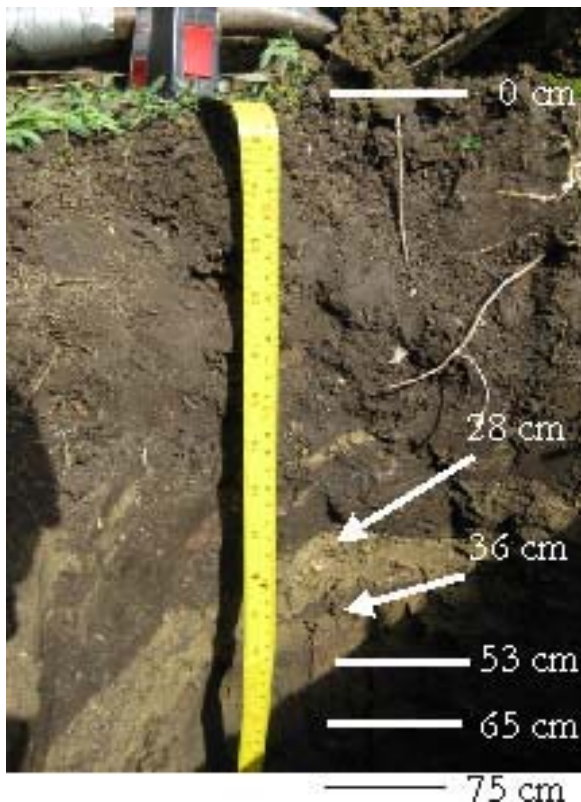
BH1 (figures 4.25 and 4.31) was a disturbed profile with 8 cm of buried parent material (Ckb) between the A and B horizons. This was a well-drained mid slope profile with 3-5% slope to the east / northeast. Alfalfa growth was good even though the EM38h and EM38v readings were  $143 \text{ mS m}^{-1}$  and  $180 \text{ mS m}^{-1}$ , respectively.

Ap - clay loam, black, moist, friable, weakly carbonated (in-situ ECfs =  $1.9 \text{ dS m}^{-1}$ )

Ckb - clay loam, carbonated, disturbed layer (from backfilling C horizon after construction)

The presence of salt precipitates in the B horizons was indicative that secondary salinization had occurred at BH1 and BH2. The chemistry of the salts indicated that it could be from a spill on the surface that had not completely leached out or from upward migration from a high saline water table. The chemistry of the groundwater at culvert 2 indicated that the chloride concentration was 11,000 mg L<sup>-1</sup> and the sulphates were 3,700 mg L<sup>-1</sup>. If the secondary salinization was from a brine spill or from the water table it does not explain the higher proportion of sulphates in the soil. Anecdotally some landowners have said that brine spills were treated in the past with inches of gypsum broadcast on the surface.

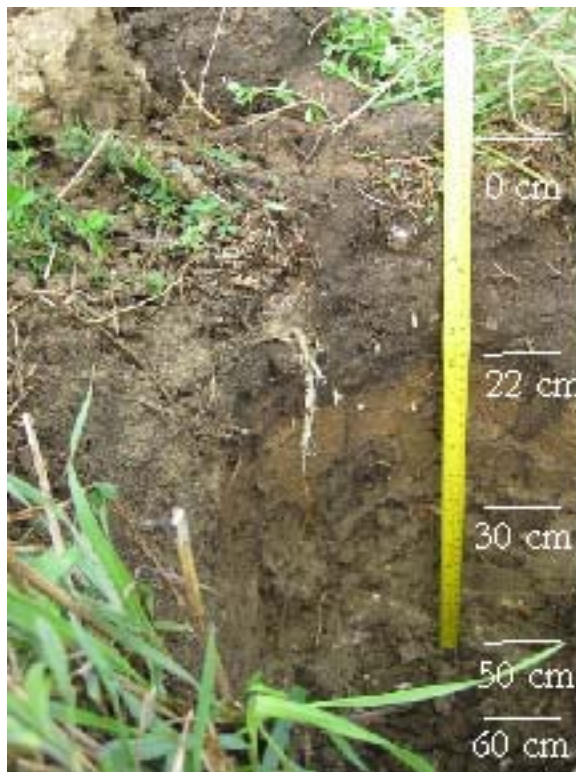
BH2 (figures 4.25 and 4.32) was not a disturbed profile. Gypsum visible as white specks of salts had accumulated in the A and B horizons, indicating that this site had been re-salinized. The EM38h and EM38v readings were 138 mS m<sup>-1</sup> and 193 mS m<sup>-1</sup>, respectively. Salinity analysis from May 2010 showed sulphate concentrations of 2,900 mg L<sup>-1</sup> (0-15 cm), 5,900 mg L<sup>-1</sup> (15-30 cm), 11,000 mg L<sup>-1</sup> (30-90 cm), and 6,400 mg L<sup>-1</sup> (90-120 cm). The chloride concentrations were somewhat less at 100 mg L<sup>-1</sup> (0-15 cm), 220 mg L<sup>-1</sup> (15-30 cm), 1,100 mg L<sup>-1</sup> (30-60 cm), 2,400 mg L<sup>-1</sup> (60-90 cm) and 4,000 mg L<sup>-1</sup> (90-120 cm). The high sulphate levels were interpreted as likely from natural sources, although the presence of chlorides at depth indicate some contamination may have occurred in the past.

Ap - loam, black, moist, friable, cloddy (in-situ EC fs = 0.75 dS m<sup>-1</sup>), grey-white salt precipitates (gypsum)

Ah - loam, moist, friable, weak angular blocky, (in-situ EC fs = 4.4 dS m<sup>-1</sup>)

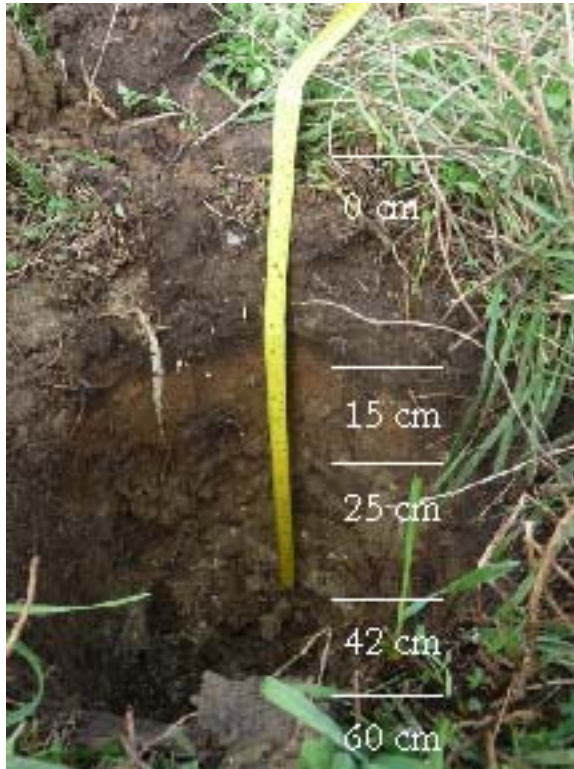
**Figure 4.33 BH3**

BH3 (Figure 4.33) was an upper mid slope profile that was well drained and vegetated with second growth alfalfa. Compared to BH2, BH3 was higher in the landscape (Figure 4.30) and therefore the A horizon was thinner. It had also developed a stronger structure in the B horizon compared to BH2. Like BH1 and BH2, BH3 had an accumulation of gypsum in the B horizon. This salinity was not reflected in the EM38h and EM38v readings of 31 mS m<sup>-1</sup> and 46 mS m<sup>-1</sup>, respectively, which indicated, incorrectly, that there was no salinity in the profile. Soil sample analysis from May, 2010 had sulphate concentrations of 5,200 mg L<sup>-1</sup> (30-60 cm), 6,500 mg L<sup>-1</sup> (60-90 cm), and 5,300 mg L<sup>-1</sup> (90-120 cm). Unlike BH1 and BH2 there were very low levels of chlorides (<160 mg L<sup>-1</sup>) in the profile. If the secondary salinization at BH3 was from a brine spill one would expect to find higher concentrations of chlorides. If the explanation for the secondary salinization at BH 1 and BH2 was correct (a brine spill treated with excess gypsum) perhaps some gypsum was put not only on the brine spill but also on adjacent soil that was not brine contaminated.

Ap - loam, black, moist, friable

Bm1 - clay loam, dark brown, moderate medium blocky structure, large alfalfa roots

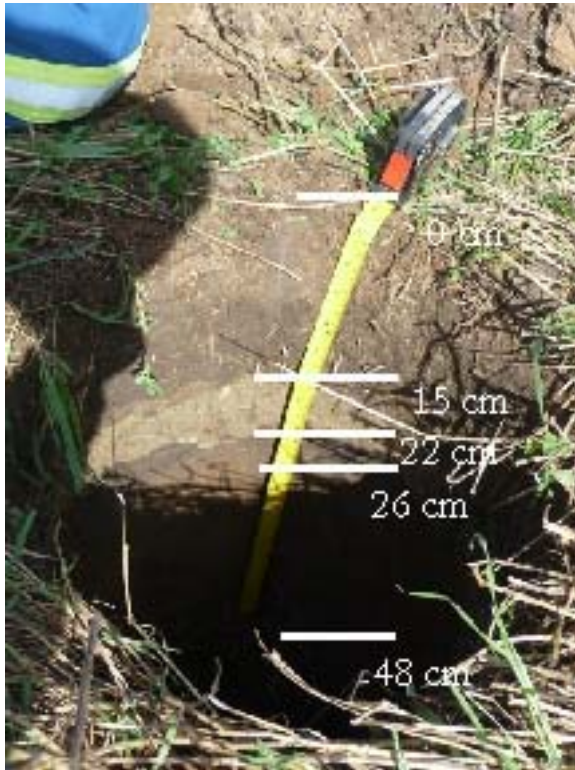
**Figure 4.34 BH4**

BH4 (Figure 4.34) was a disturbed profile with a buried Ck horizon from 15-22 cm. The vegetation was second growth alfalfa and growth was good. This was an upper mid slope profile with drainage to the north and good moisture throughout the profile. The EM38h and EM38v readings were 123 mS m<sup>-1</sup> and 173 mS m<sup>-1</sup>, respectively and indicated some salinity. Laboratory results indicated that there were still oilfield impacts in the subsoil. Chlorides were 4,300 mg L<sup>-1</sup> (30-60 cm), 7,300 mg L<sup>-1</sup> (60-90 cm), and 6,400 mg L<sup>-1</sup> (90-120 cm). Sulphates ranged from 1,400-2,600 mg L<sup>-1</sup> (0-120 cm). This profile was in the process of being reclaimed. Salts were leaching into the subsoil and no visible surface salts remained. Water drained north off the west forage area and east off the east forage area (Figure 4.30). There was a small depression on the west side which may hold some water but this was not affecting the general drainage of the west forage area. On the east side the movement of salts underground from the battery appeared to be following the above ground topography (Figure 4.30).

Ap - loam, black, friable

bCk - clay loam, buried C horizon (evidence of prior soil disturbance)

Bm - silt loam, dark brown (10YR4/3), moist, friable, weak fine sub angular blocky structure
