SOME ASPECTS OF THE MECHANISMS OF DIAGONAL

FAILURE OF REINFORCED CONCRETE BEAMS

A THESIS

DEPARTMENT OF CIVIL ENGINEERING

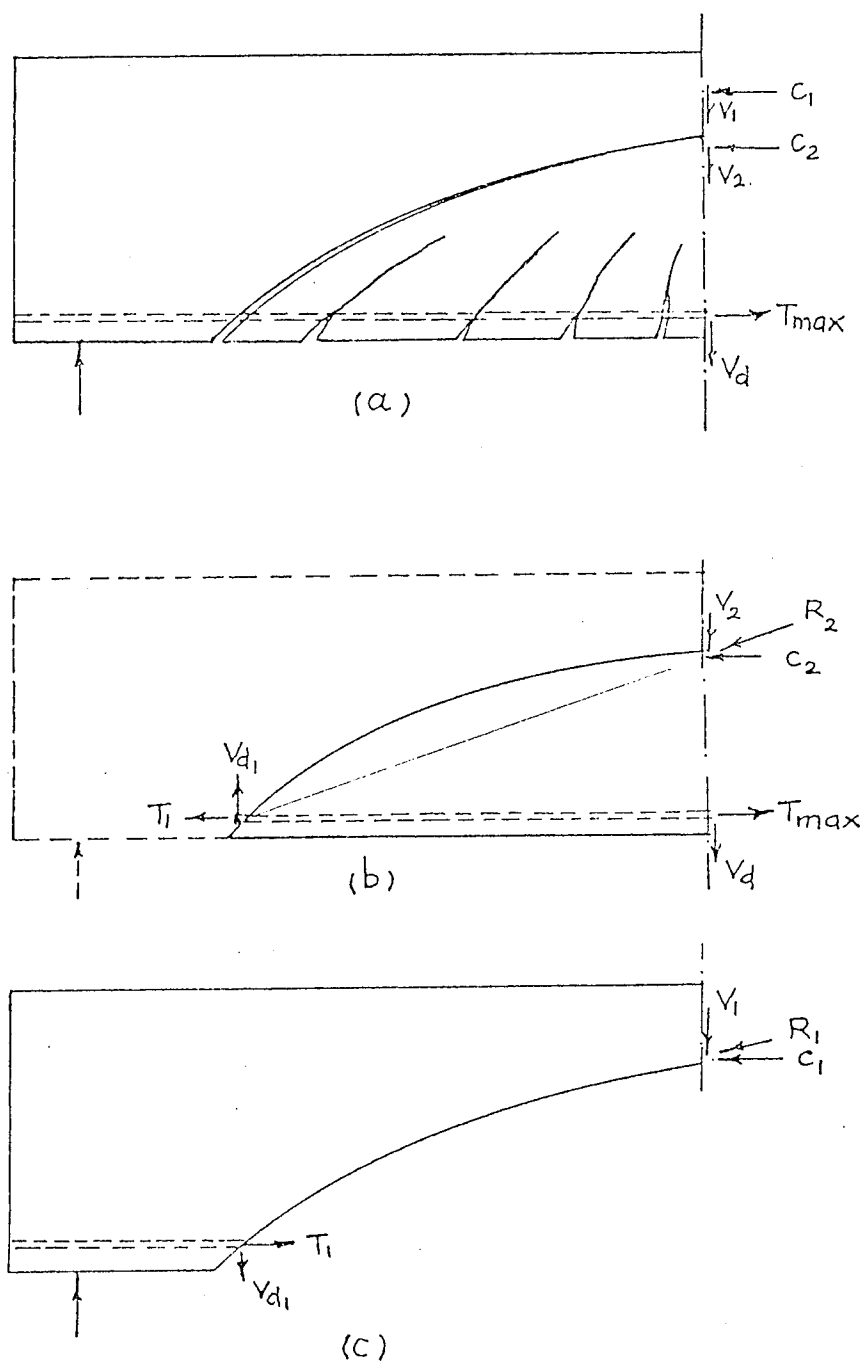
FIG. 3.5 INTERNAL FORCES AT CRITICAL DIAGONAL CRACKING

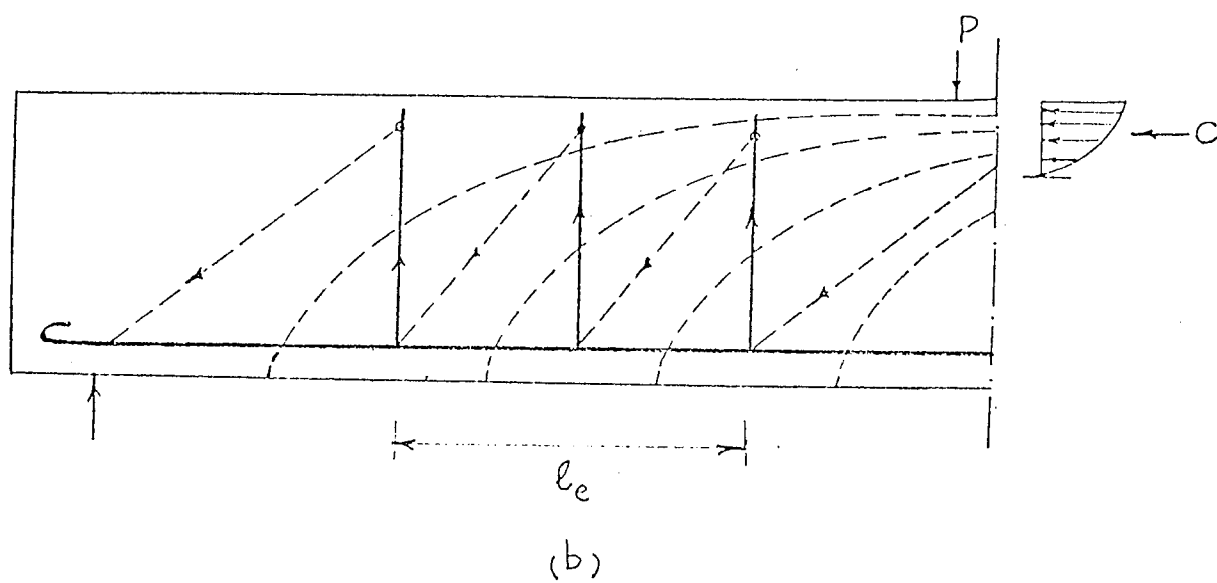
FIG. 3.14 FUNCTION OF WEB REINFORCEMENT

The addition of web reinforcement in a beam enhances the capacity of the concrete cantilevers. The failure of these cantilevers leading to critical diagonal cracking is delayed. After development of such cracking, complete arching may develop in a manner similar to that described for beams without web reinforcement.

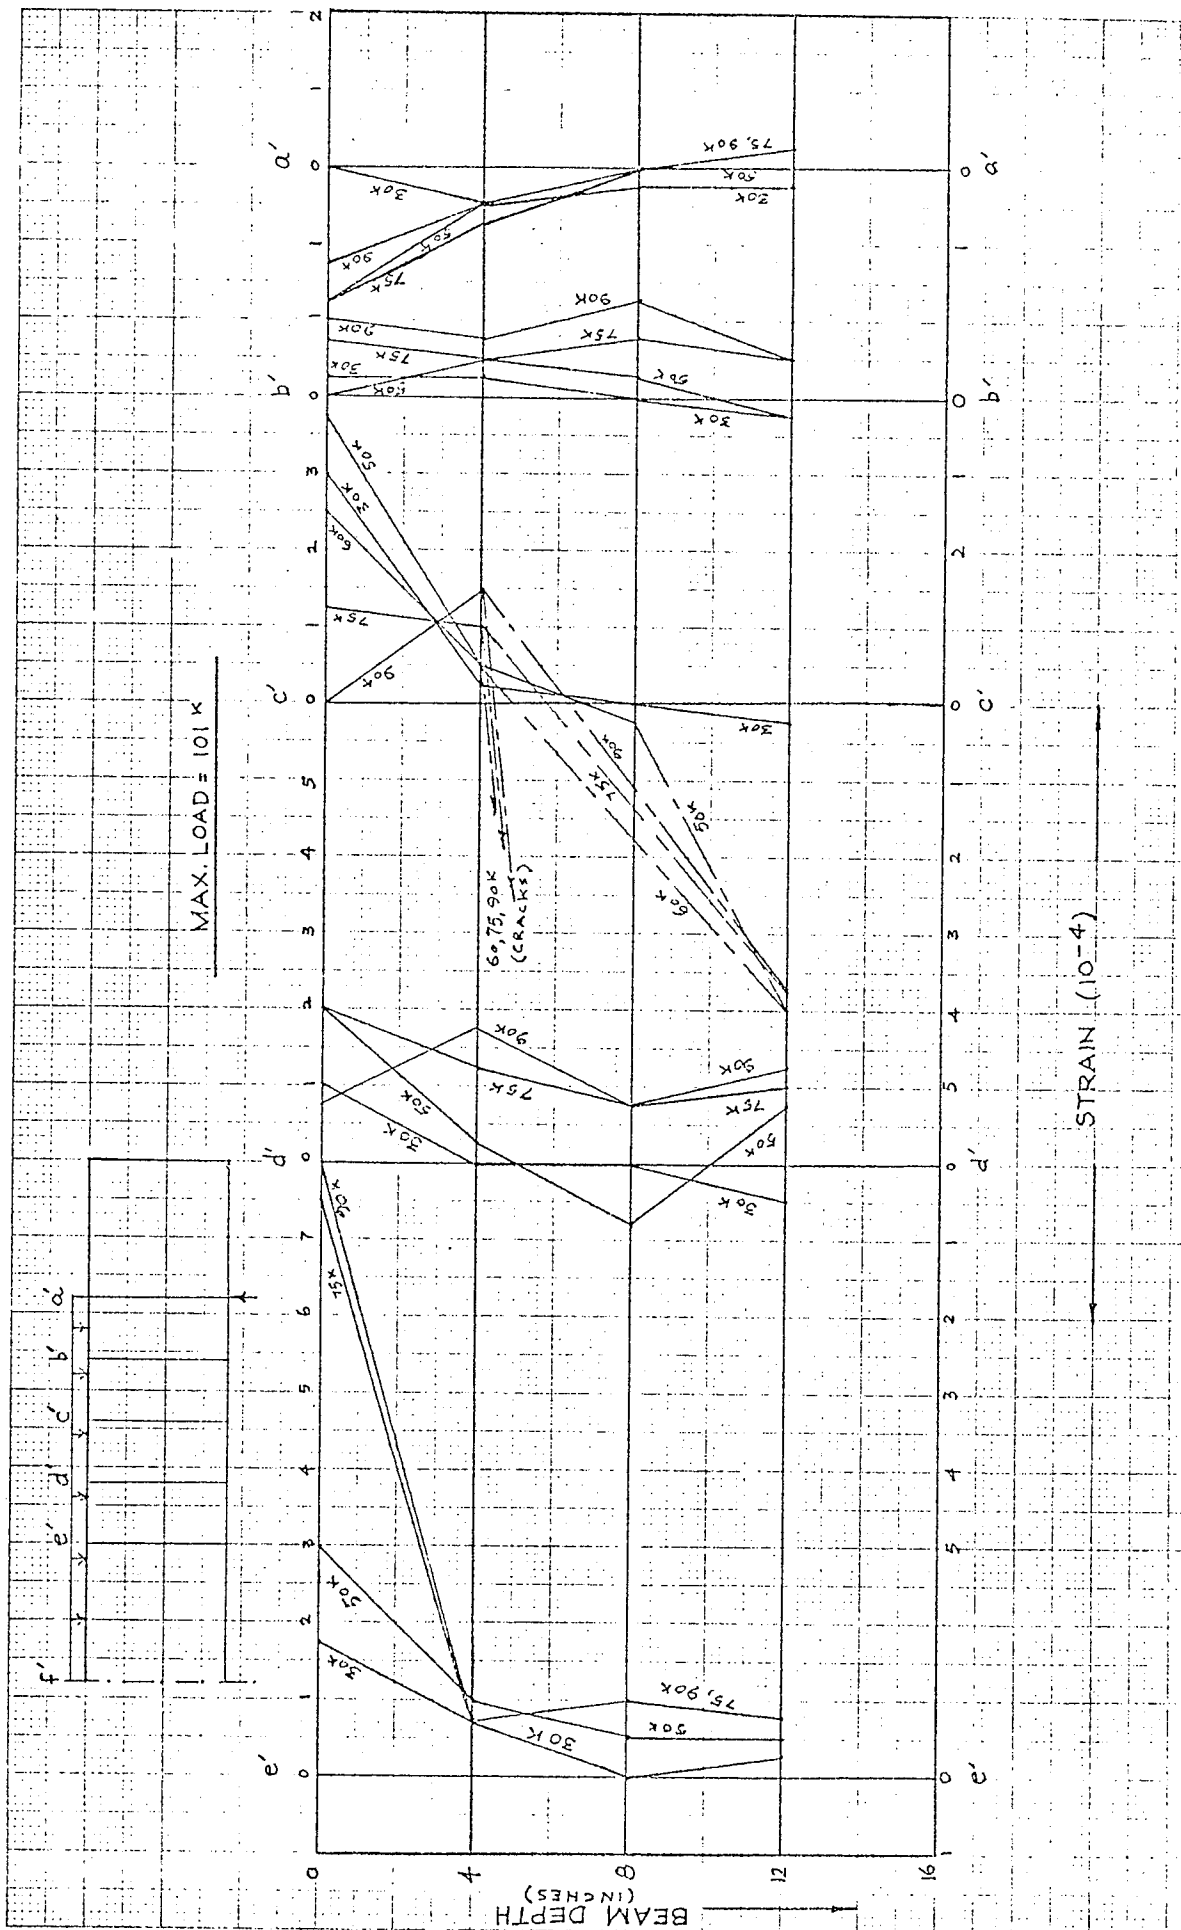
FIG. 5.1(a) LONGITUDINAL STRAIN — DEMEC DATA

As already indicated, detailed results of individual beam tests are presented in Appendix III. It was observed that in beams

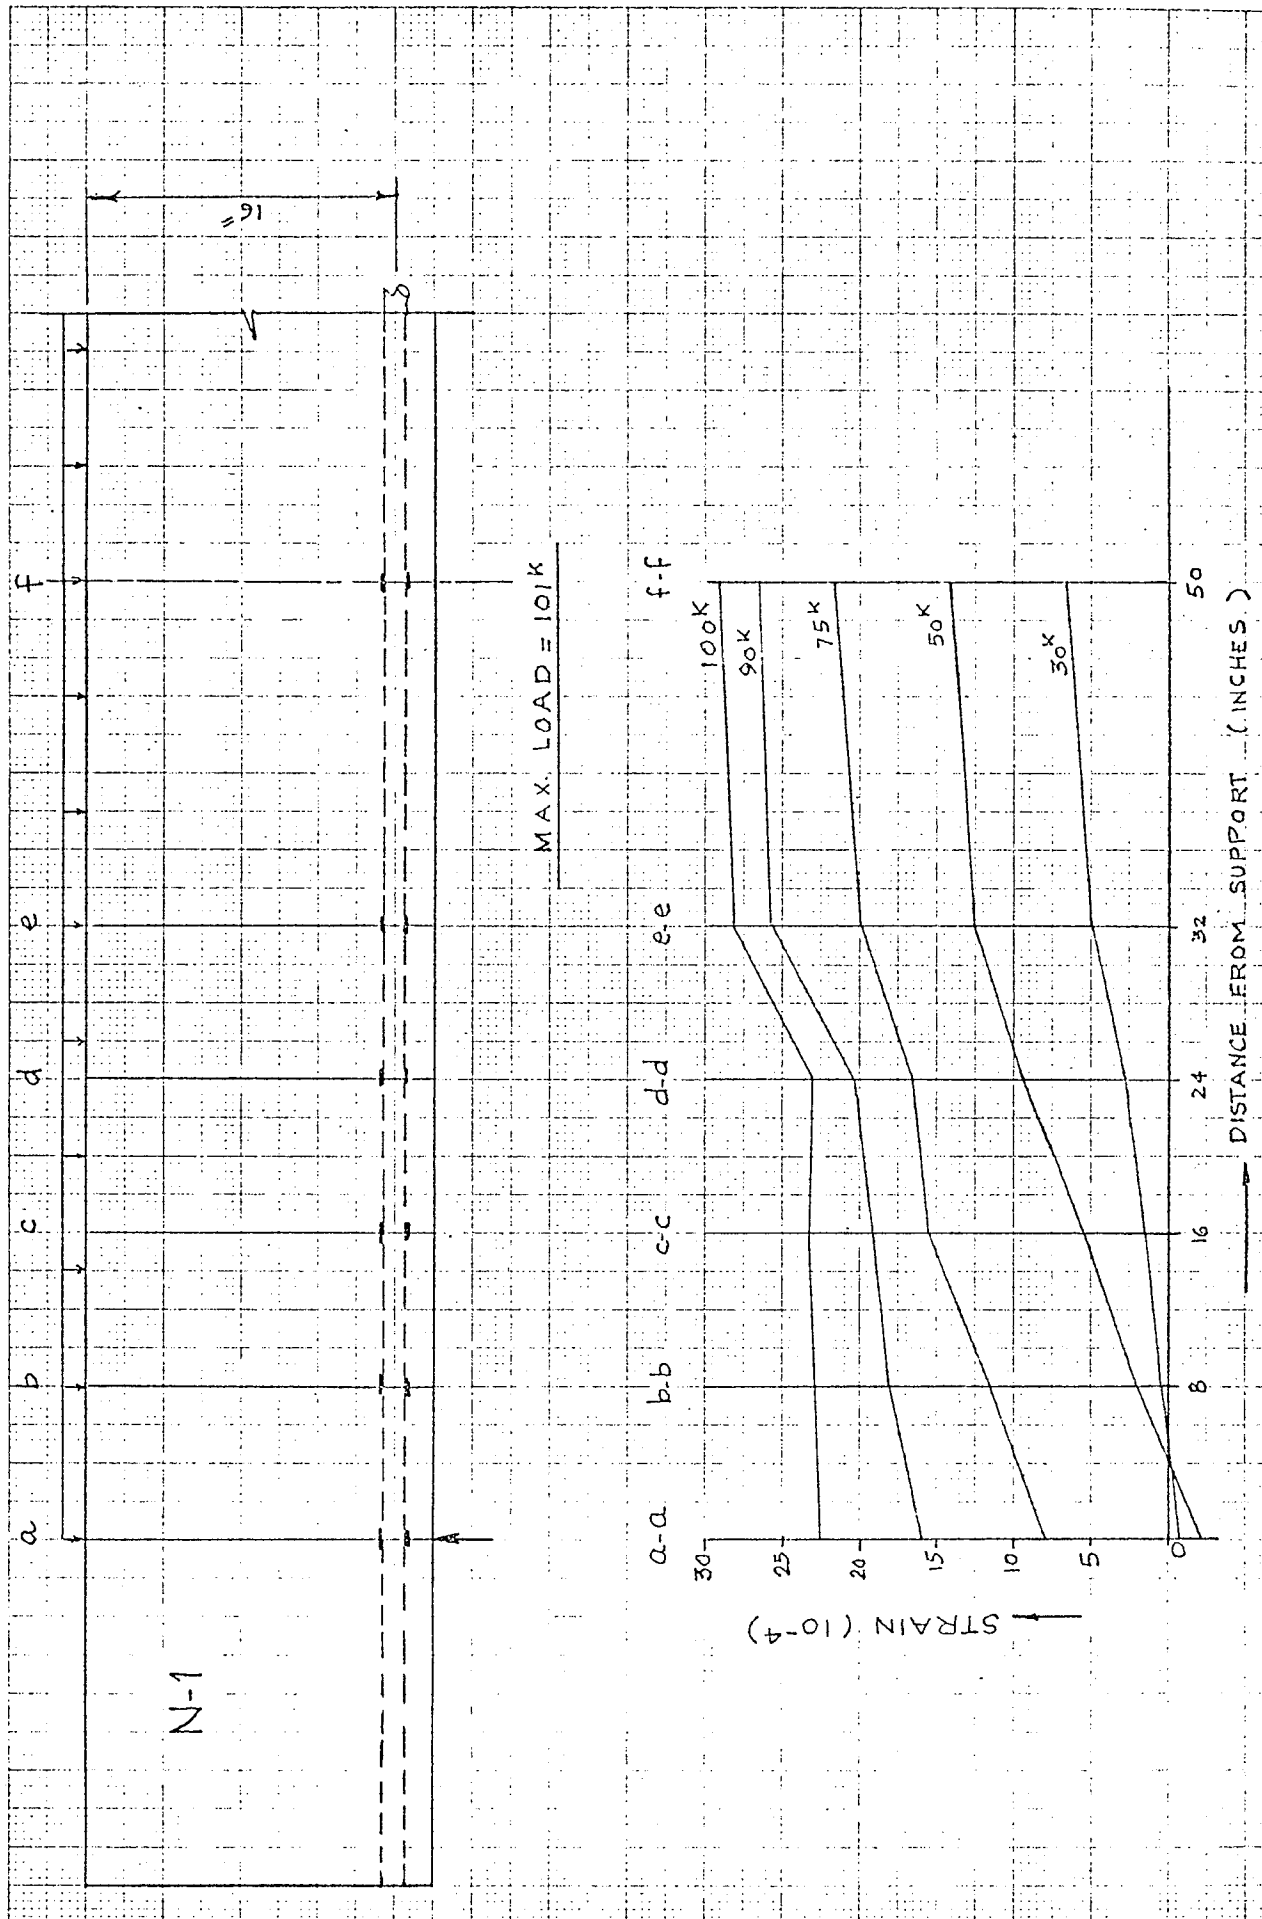
FIG.5.2 — BEAM III A-3: LONGITUDINAL STRAIN IN THE REINFORCEMENT

It can be observed that with the appearance of flexural cracking, the bond forces in the midspan region of the beam were generally smaller than in the outer regions of the beam. The possibility of a sudden diagonal failure was, therefore, greater at the outermost flexural crack where the bond forces were more than those in the inner portions of the beam. When the critical diagonal crack became stabilized, the bond forces were reduced considerably. However, they were not entirely eliminated and disappeared only near ultimate failure. In the previous section, it was observed that compressive concrete strains developed in the regions of flexural cracking in the lower half of the beam. Longitudinal strain diagrams in the reinforcement showed that bond forces were still in existence within this zone. However, as these bond forces were smaller in the inner regions of the beam, internal arching was accompanied by the action of the concrete cantilevers. In slender beams, when the capacity of these cantilevers was exceeded, failure took place at the appearance of a critical diagonal

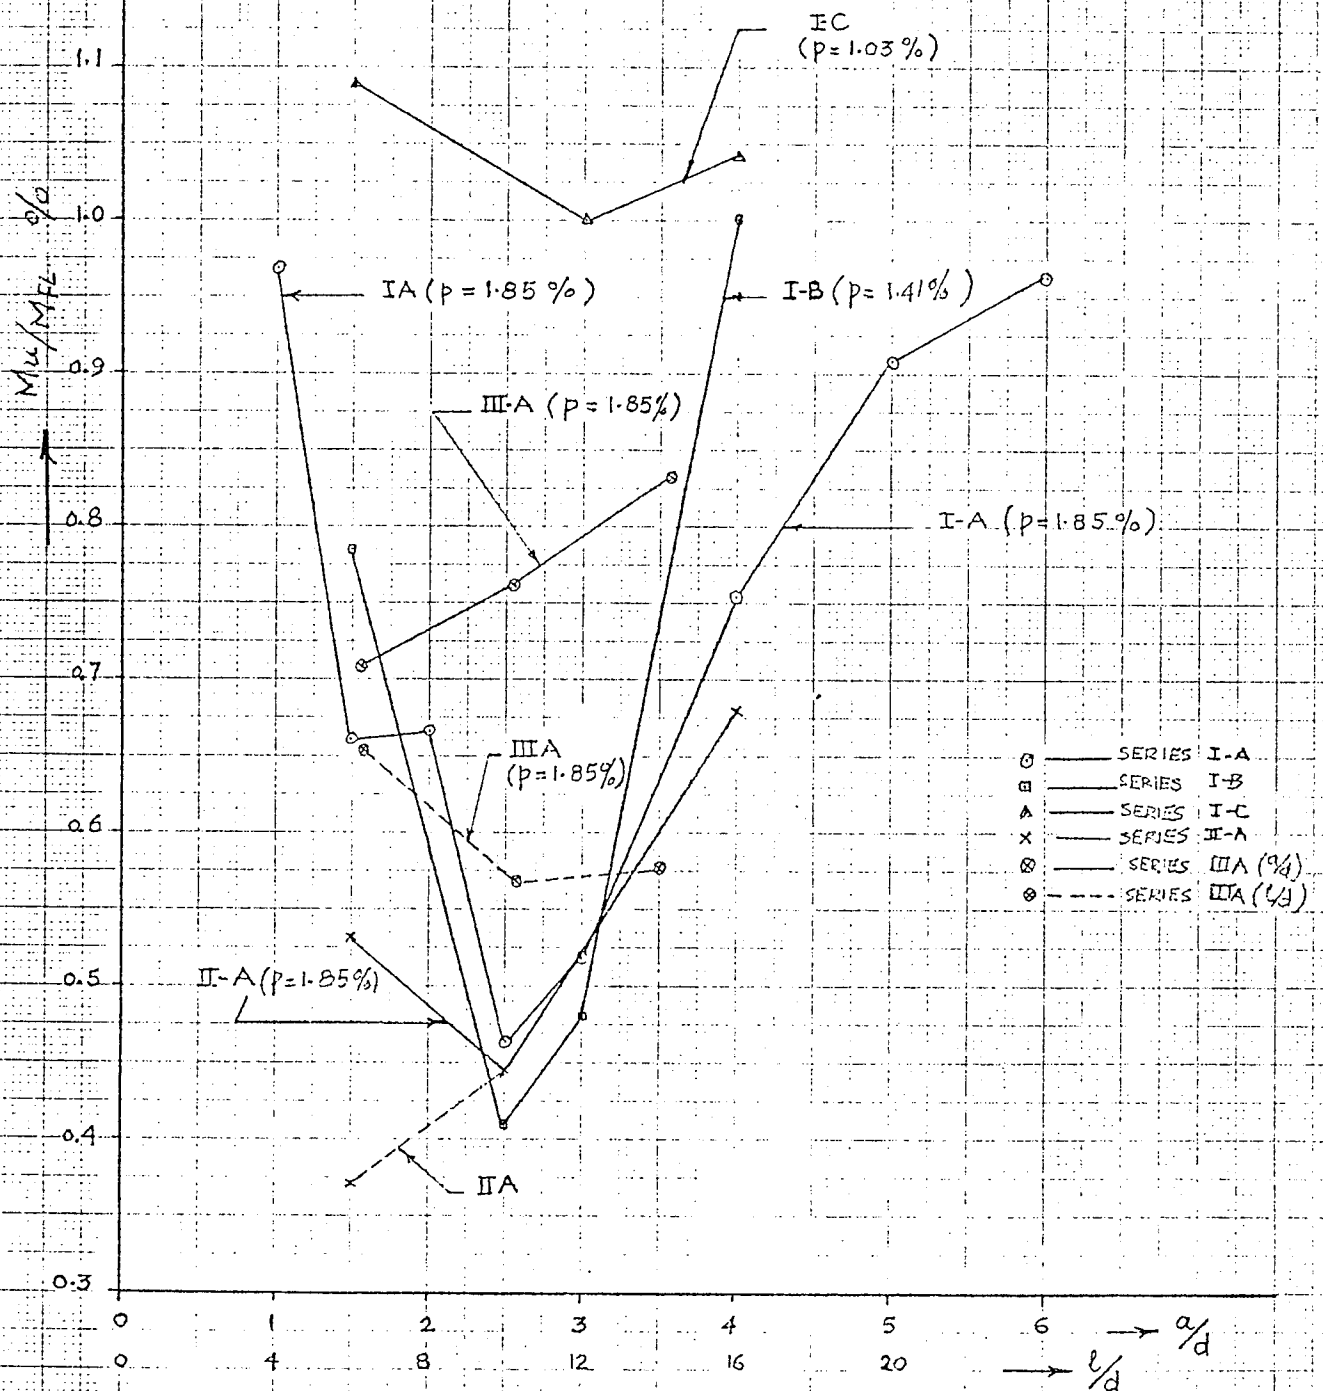
FIG. 5.7 COMPARATIVE MOMENT M_u/M_{FL} Vs a/d

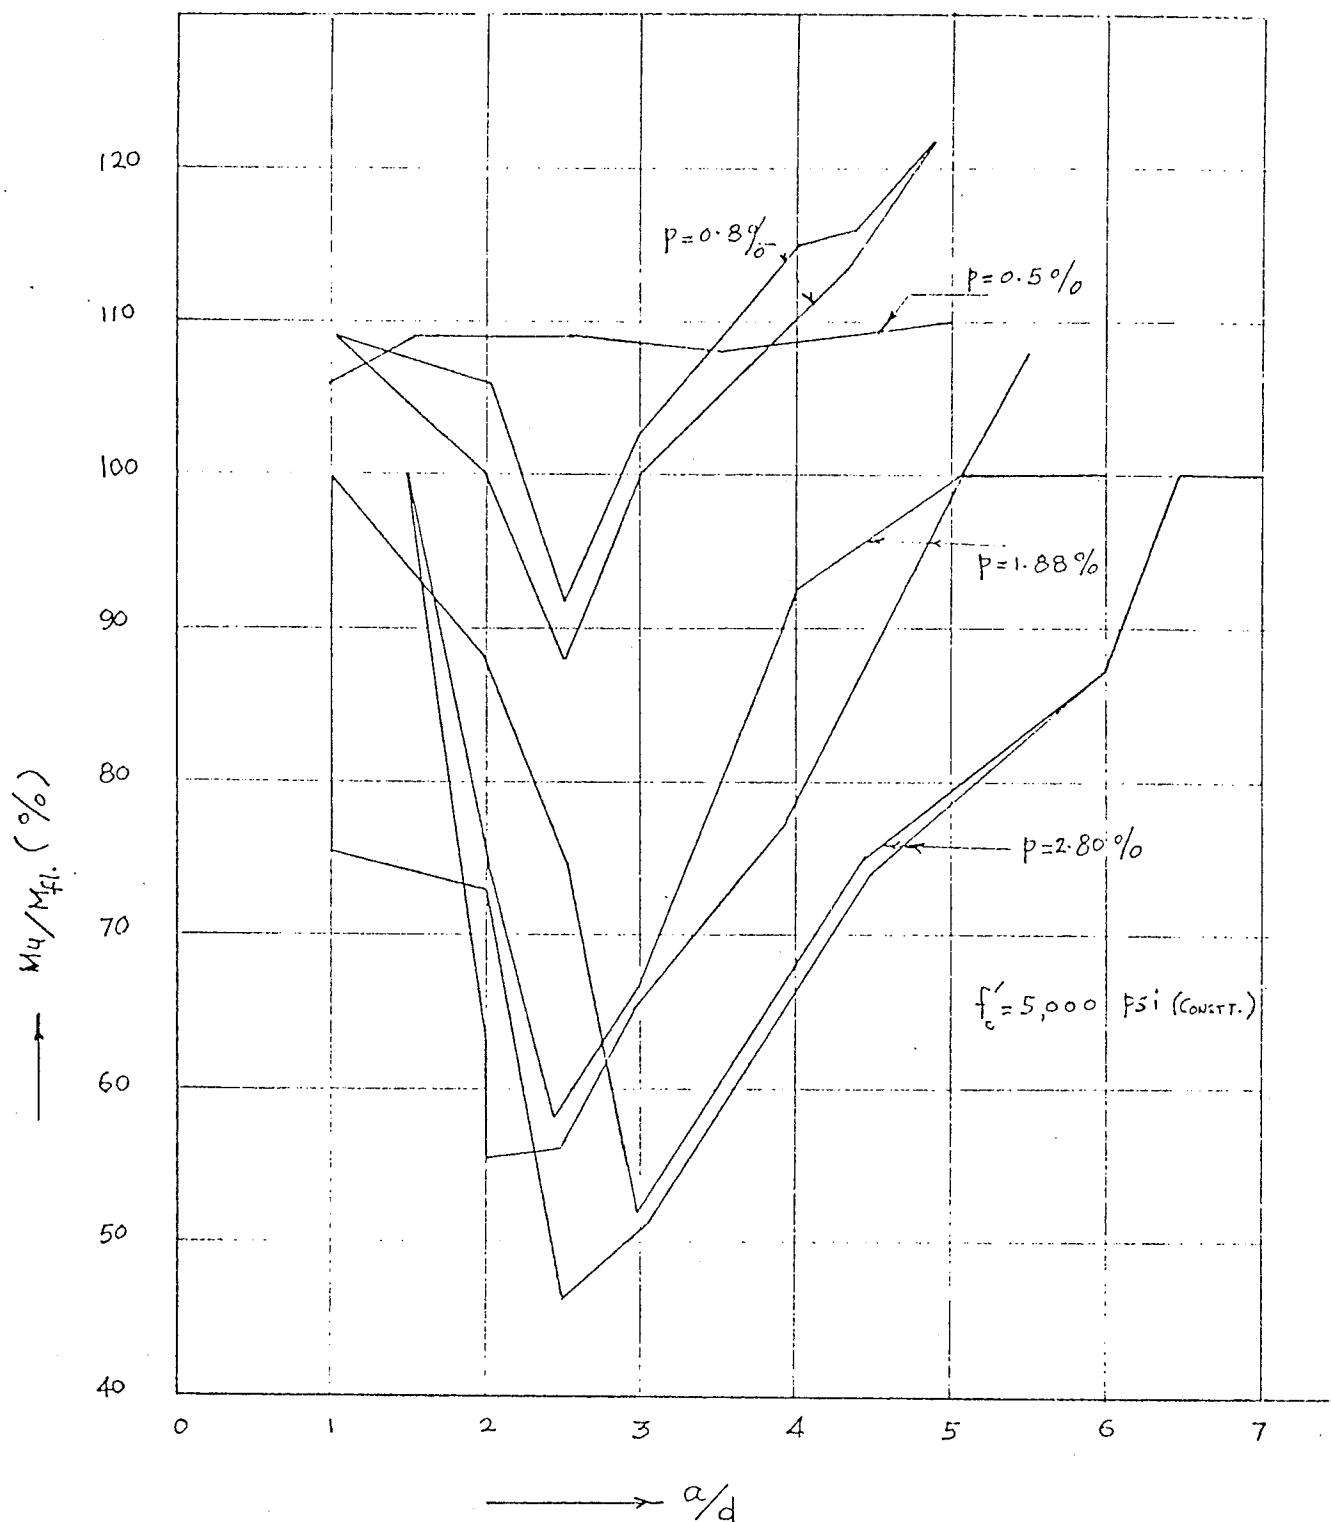
The effect of the percentage of longitudinal reinforcement on beam strength is shown in Figure 6.8 for tests of KANI (1966). These results show that the range of diagonal failures increased with an increase of the longitudinal reinforcement while the point of minimum beam strength was usually obtained at an a/d ratio of

FIG. 6.8 EFFECT OF PERCENTAGE OF LONGITUDINAL REINFORCEMENT ON BEAM STRENGTH
(KANI — 1966)

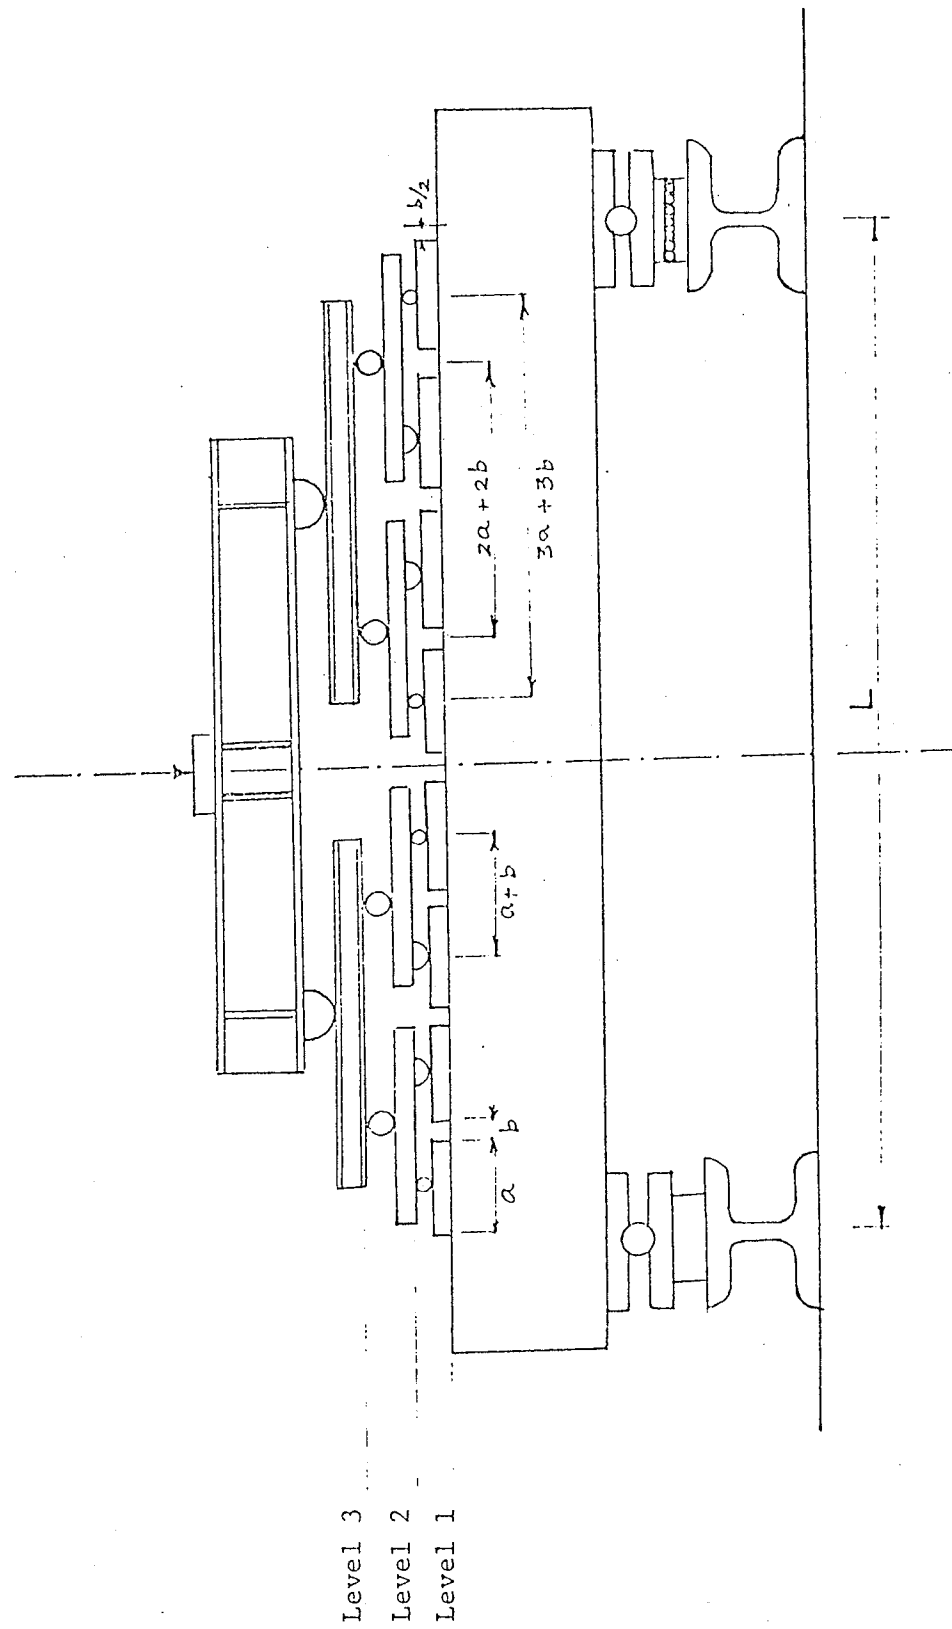
FIG. I.11 LOADING PATTERN FOR UNIFORM LOAD

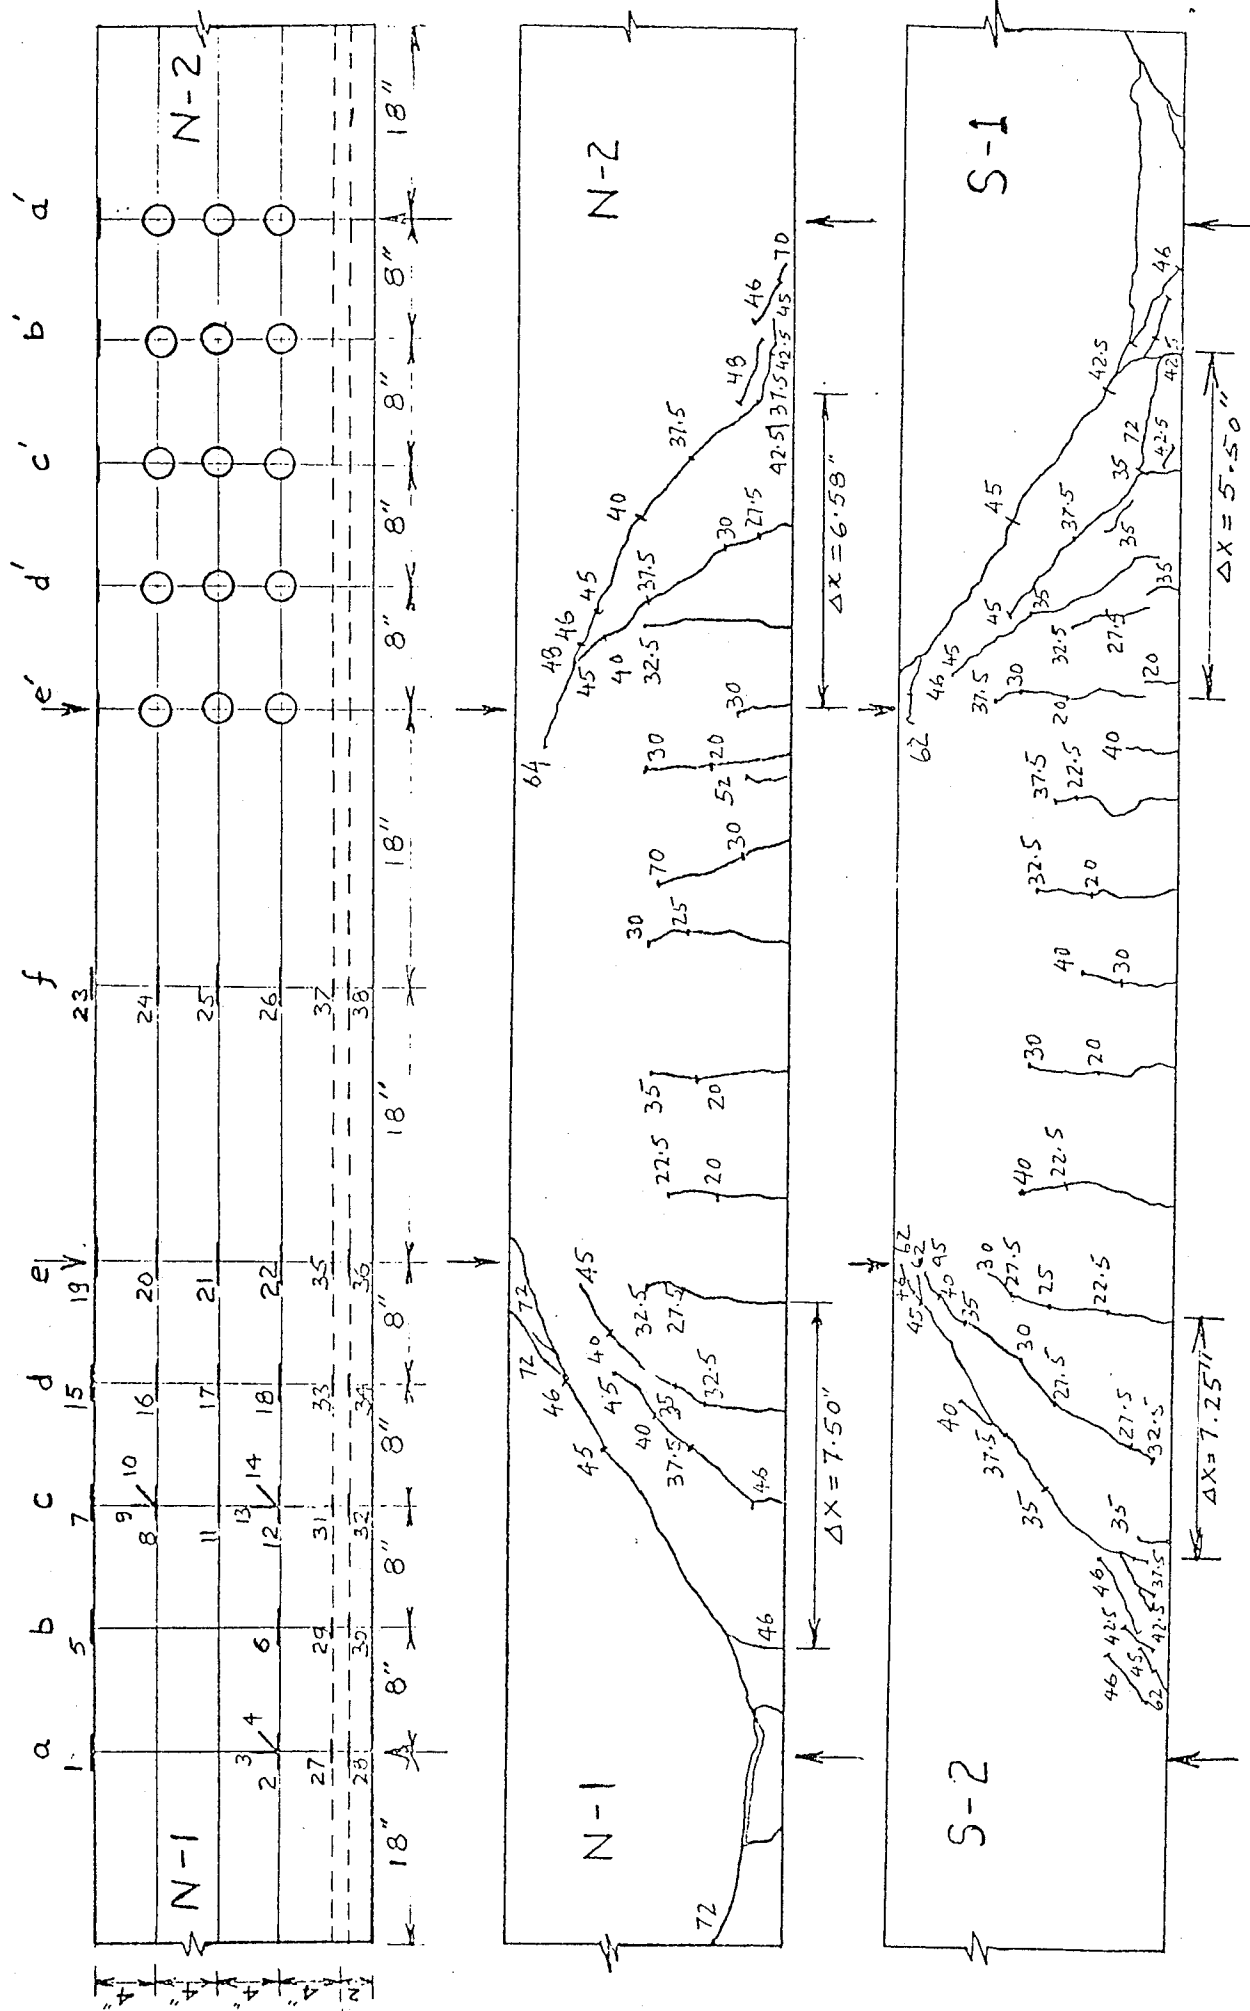
FIG. II.3 - BEAM IA-3 - LOCATION OF STRAIN GAUGES AND CRACK PATTERNS ON BOTH SIDES OF THE BEAM

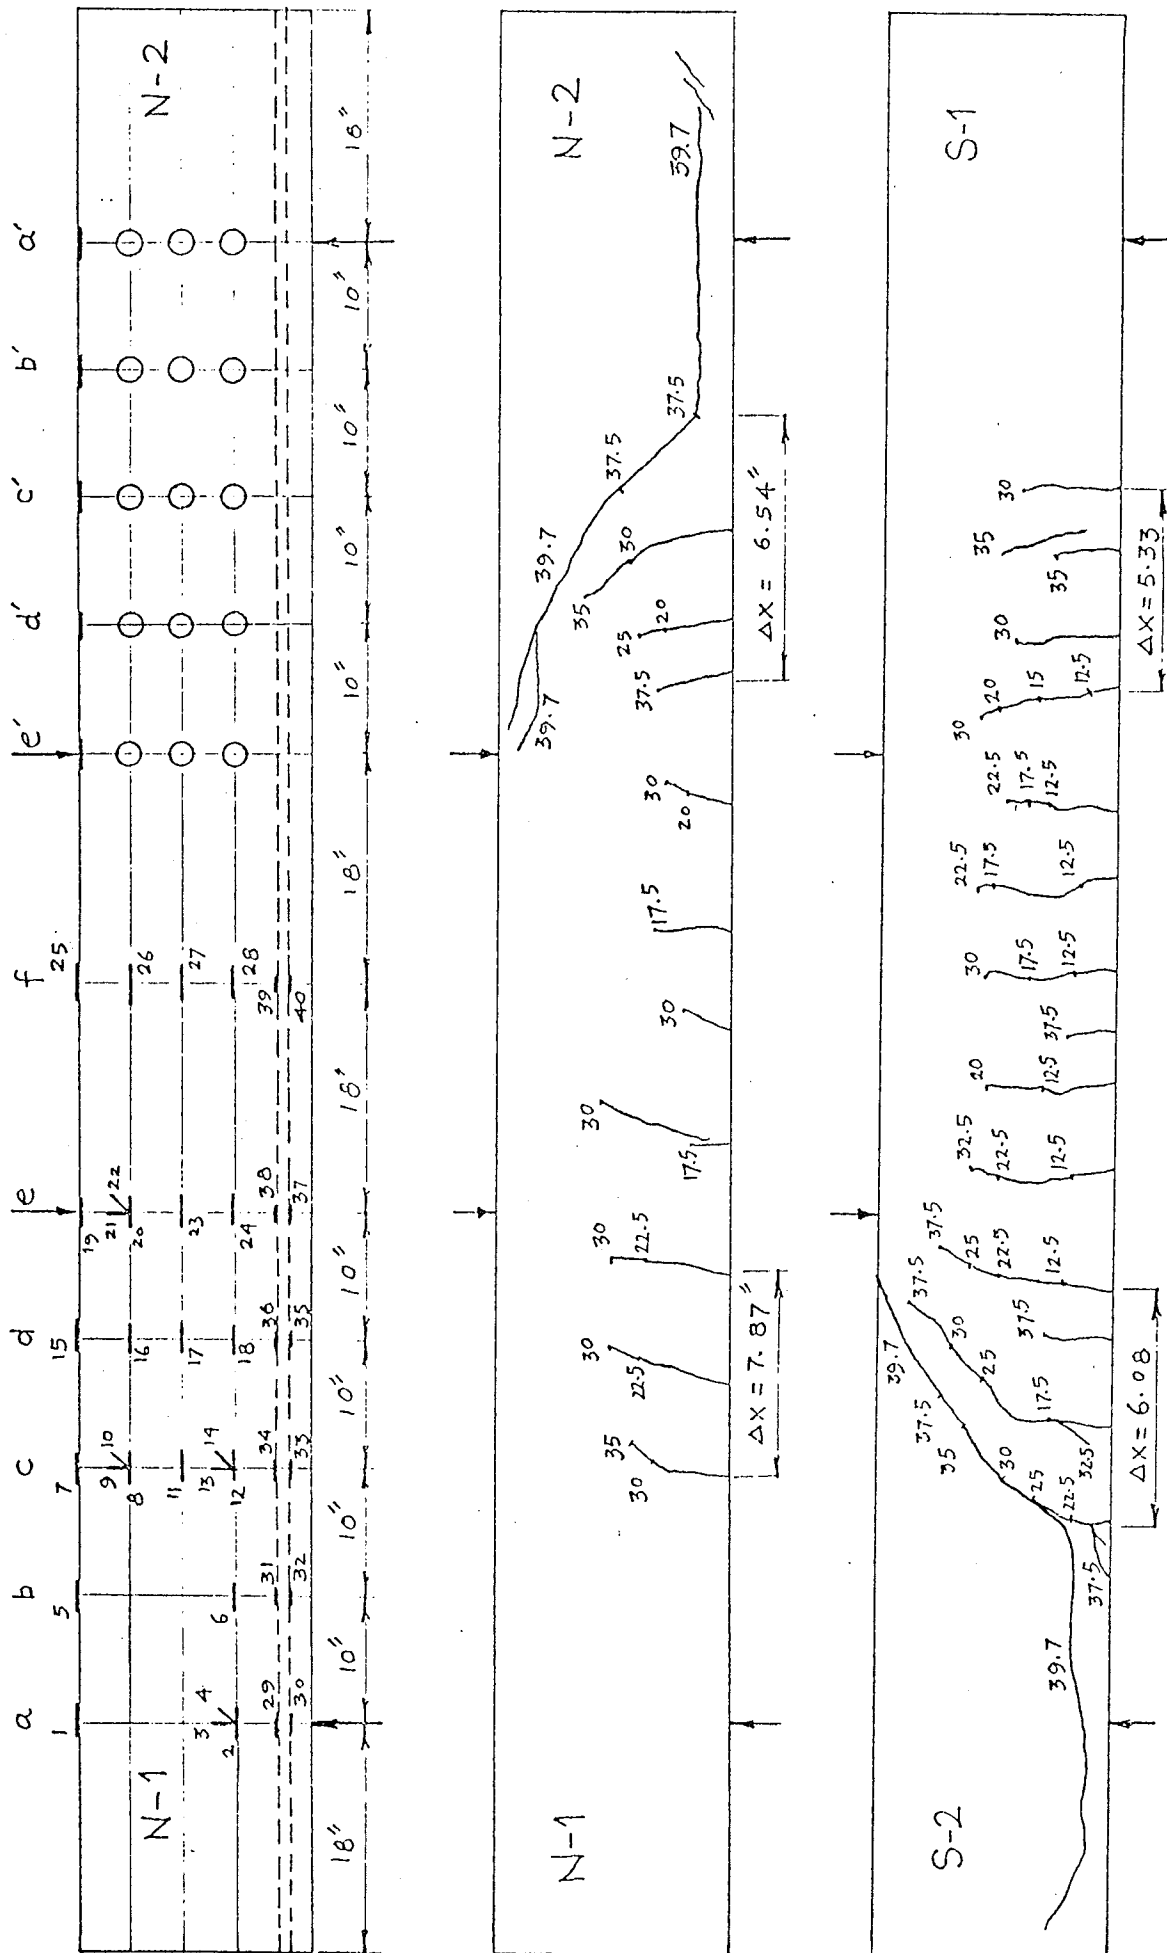
FIG. II.4 -- BEAM IA-4 - LOCATION OF STRAIN GAUGES AND CRACK PATTERNS ON BOTH SIDES OF THE BEAM

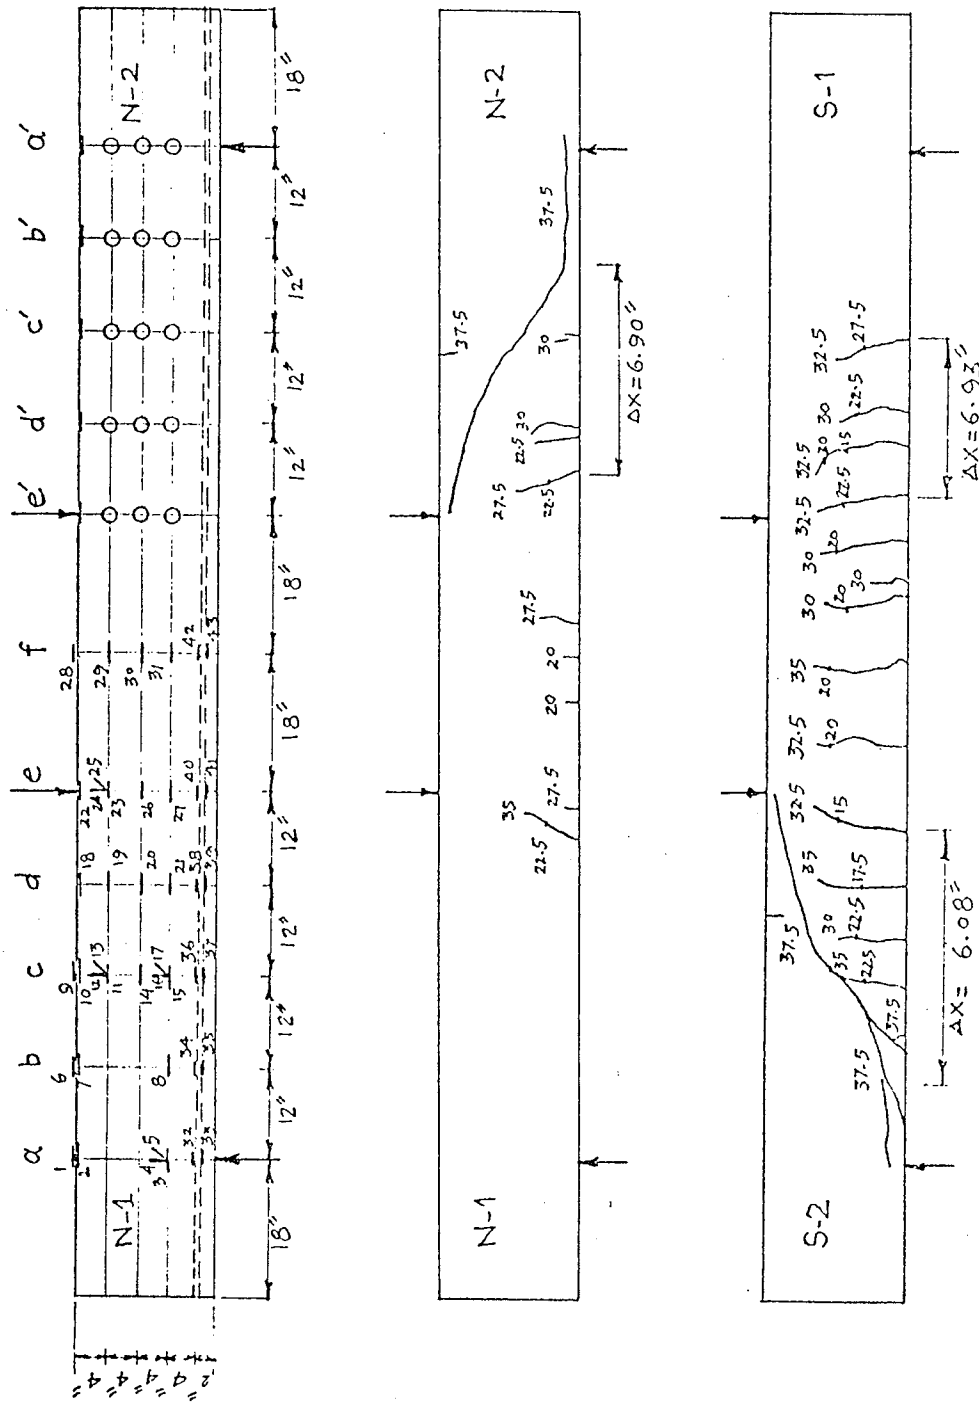
FIG. 11.5 - BEAM IA-5 - LOCATION OF STRAIN GAUGES AND CRACK PATTERNS ON BOTH SIDES OF THE BEAM

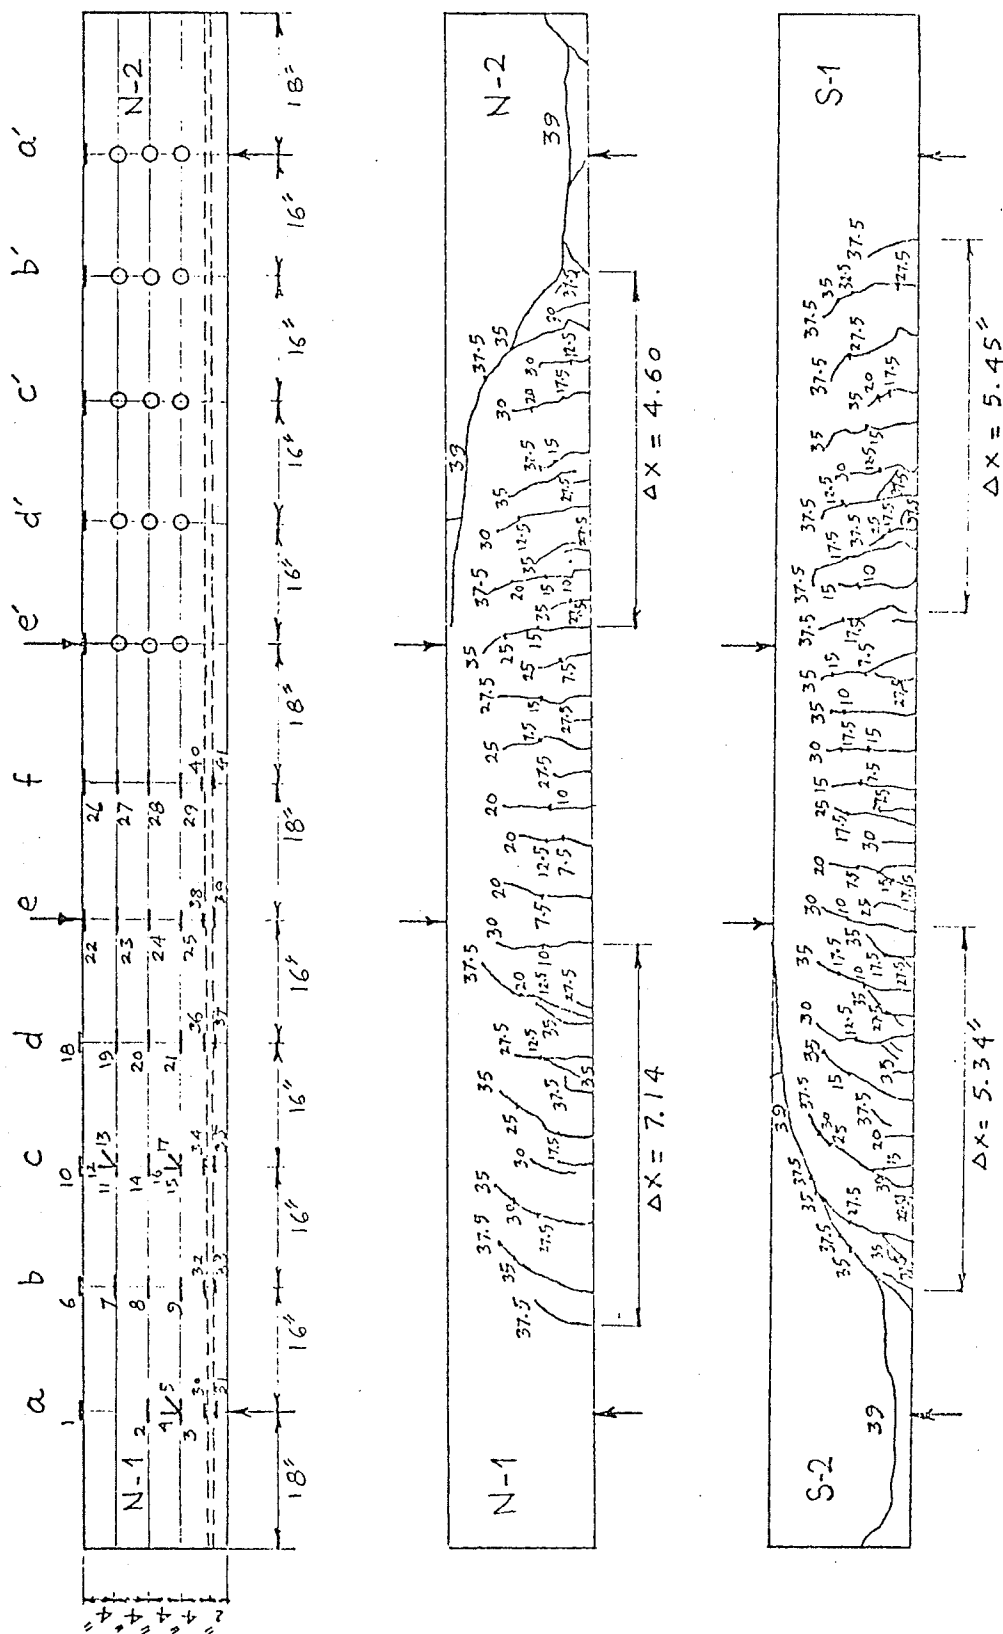
FIG. II.12 - BEAM IB-6 - LOCATION OF STRAIN GAUGES AND CRACK PATTERNS ON BOTH SIDES OF THE BEAM

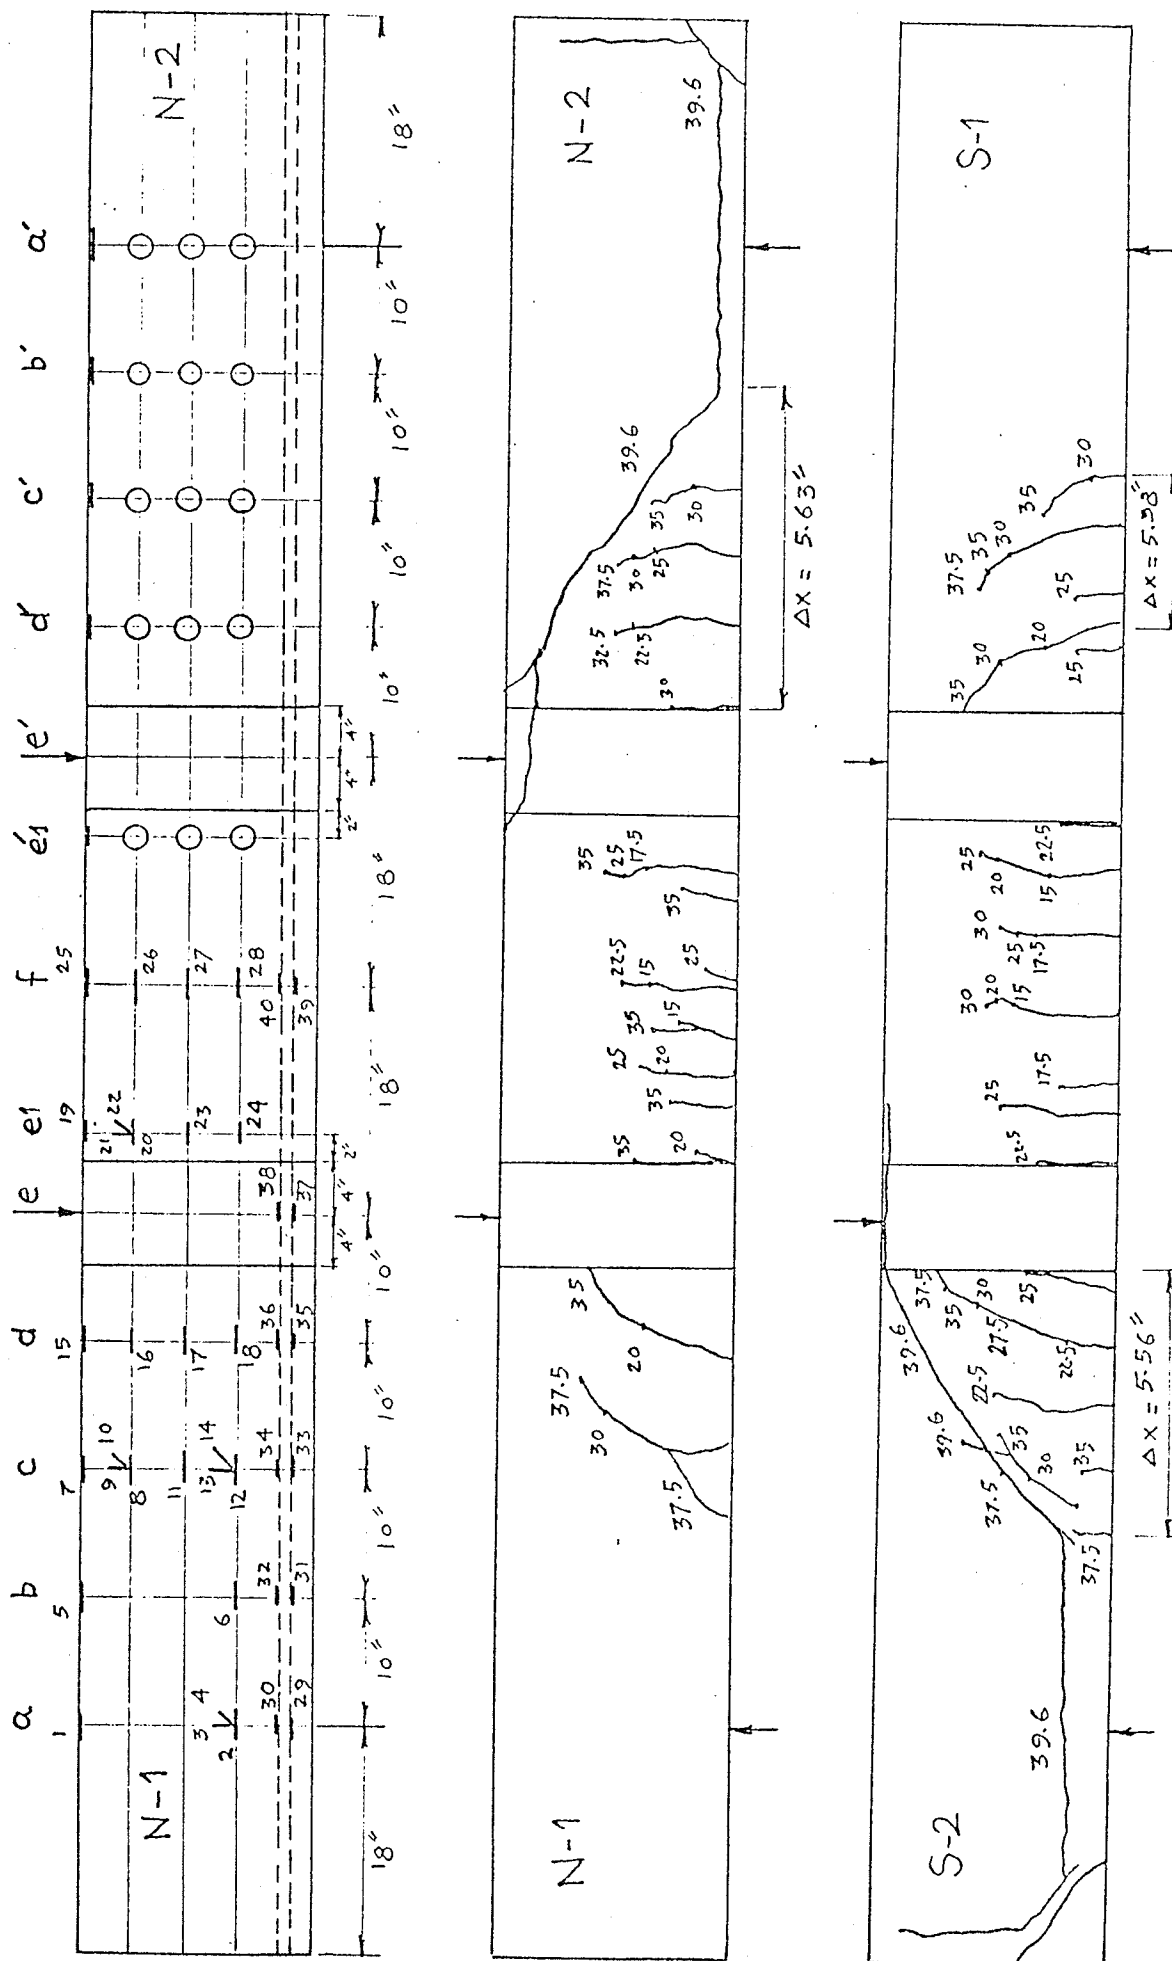
FIG. II.18 - BEAM IIA-4 - LOCATION OF STRAIN GAUGES AND CRACK PATTERNS ON BOTH SIDES OF THE BEAM
