SOME ASPECTS OF THE MECHANISMS OF DIAGONAL

FAILURE OF REINFORCED CONCRETE BEAMS

A THESIS

DEPARTMENT OF CIVIL ENGINEERING

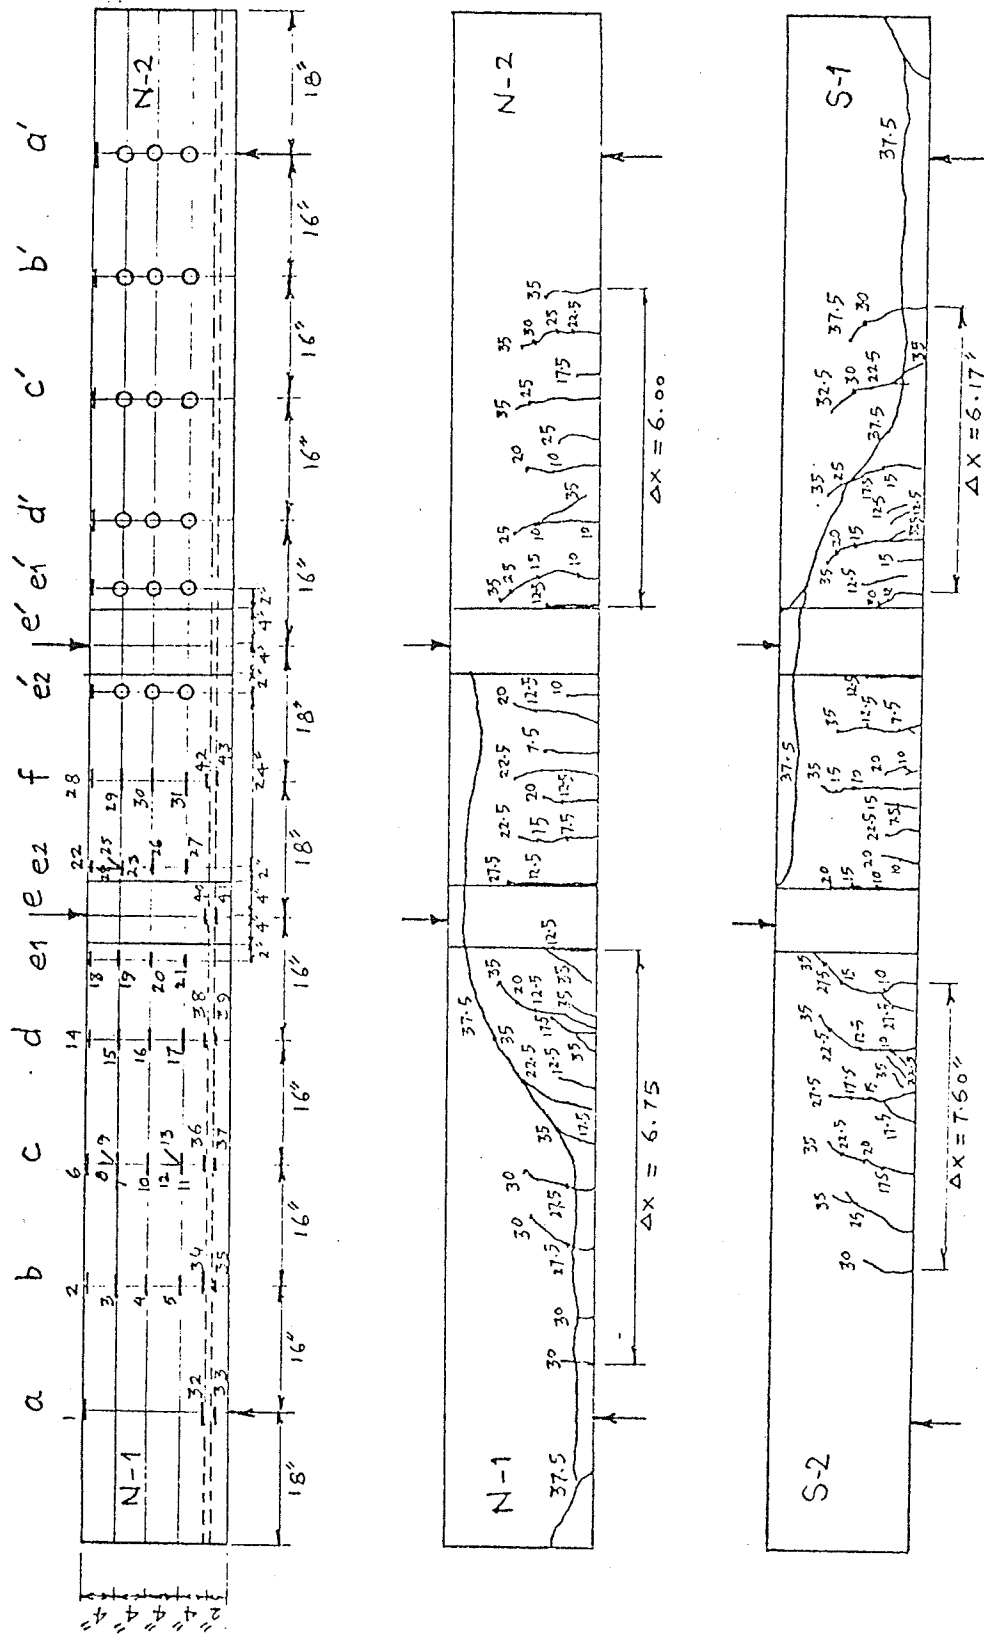
FIG. II.19 - BEAM IIA-6 - LOCATION OF STRAIN GAUGES AND CRACK PATTERNS ON BOTH SIDES OF THE BEAM

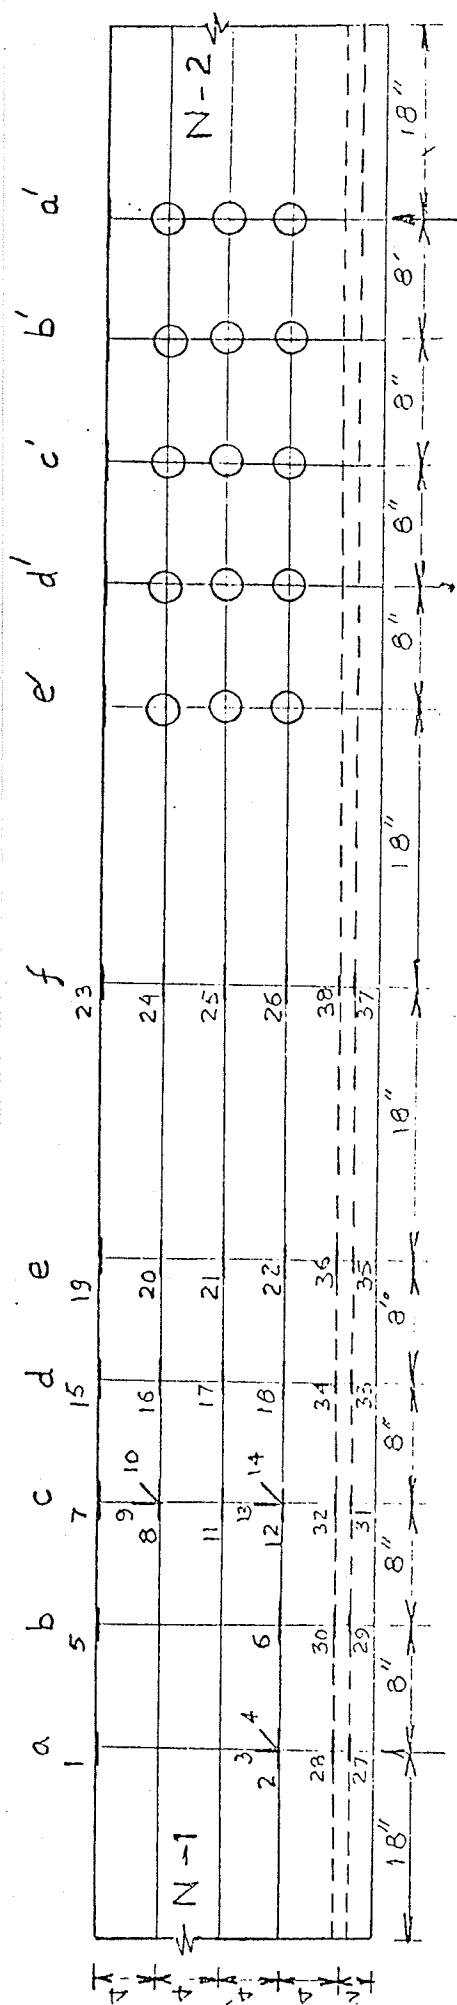
FIG. II.20 - BEAM IIIA-3 - LOCATION OF STRAIN GAUGES AND CRACK PATTERNS ON BOTH SIDES OF THE BEAM

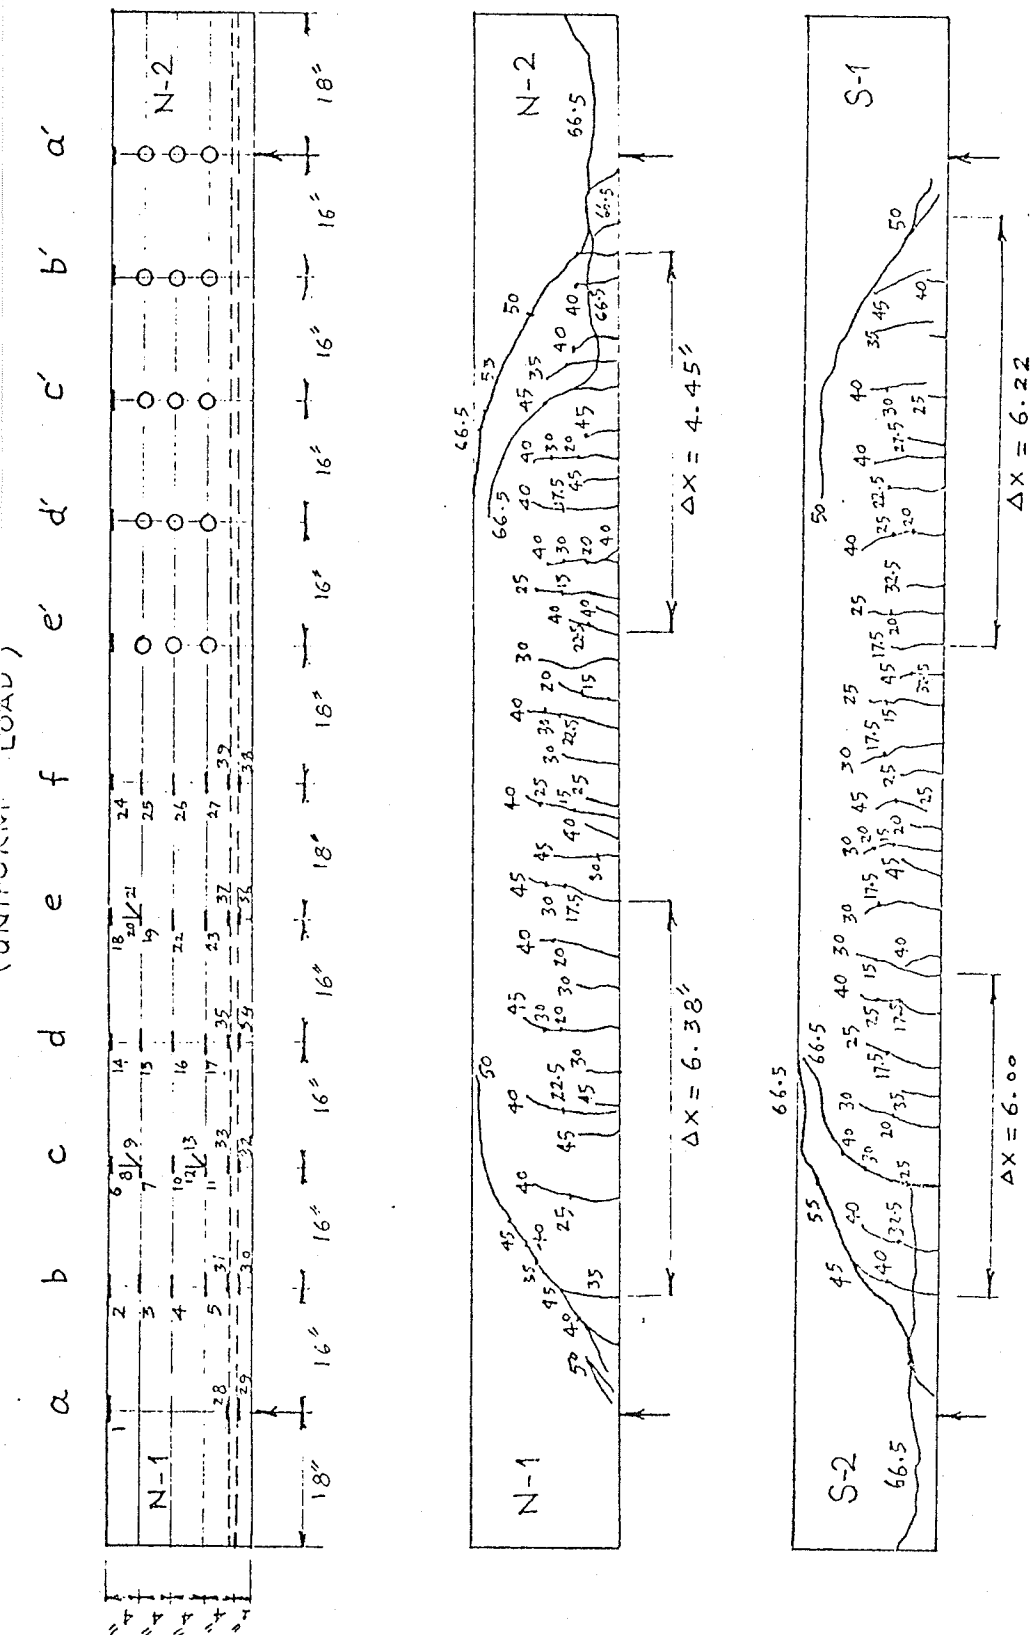
FIG. II.21 - BEAM IIIA-6 - LOCATION OF STRAIN GAUGES AND CRACK PATTERNS ON BOTH SIDES OF THE BEAM

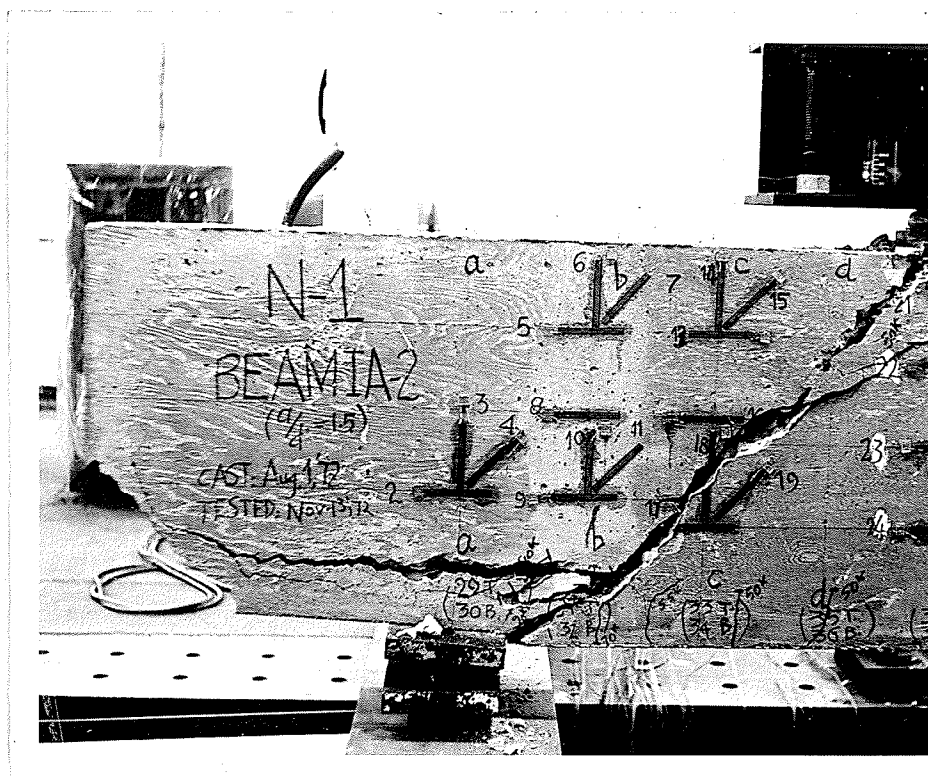
FIG. 27 FAILURE OF BEAM IA-2

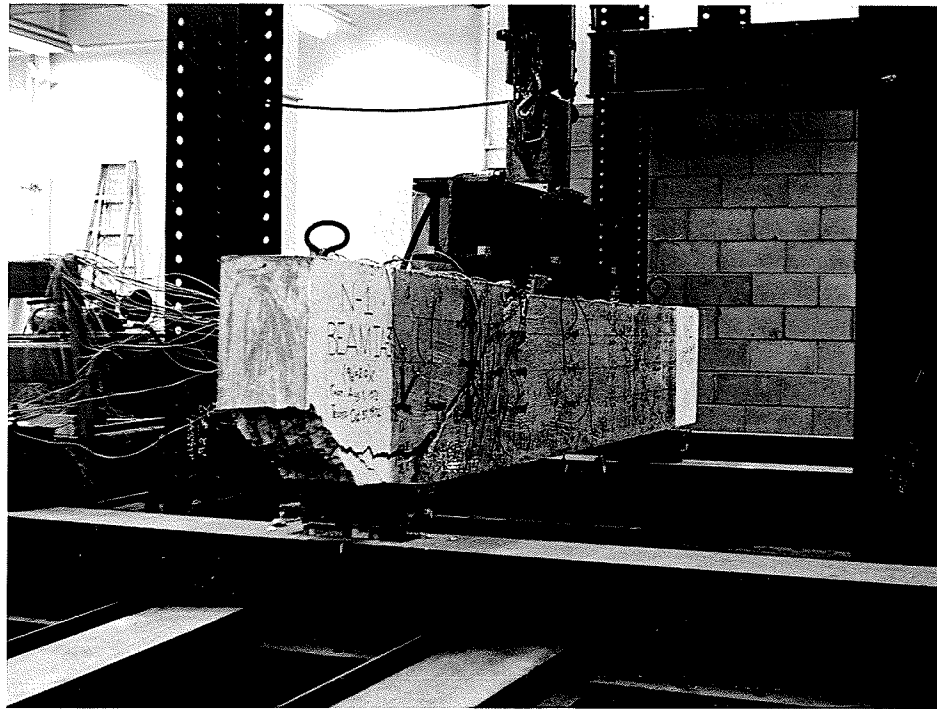
The first flexural cracks appeared in the midspan region at 20 kips and in the shear span at 27.5 kips. Further cracking developed with increase of load. Significant diagonal cracking could be seen at a load of 35 kips and 40 kips. At a load of 45 kips, a major diagonal crack suddenly propagated through the shear span on end S1 and a similar crack on end S2 propagated to within 1 1/2 inches of the compression face. Failure seemed to be imminent. There was a significant drop in the load while the deflection increased slightly. Load was then increased in one thousand pound increments while numerous strain and deflection readings were taken. Despite a fully cracked section, the beam continued taking more load without any further diagonal cracking while these cracks widened. Cracking also occurred over the supports. After a load of 56 kips, the load increment interval was increased to 2000 pounds. At a load of 62 kips, the diagonal cracks proceeded into the constant moment zone with flatter slopes. The ultimate failure occurred at a load of 72 kips, the failure being very similar to that reported for beam IA-2. In both of these beams,

FIG. 29 BEAM IA-3 SHOWING FINAL FAILURE

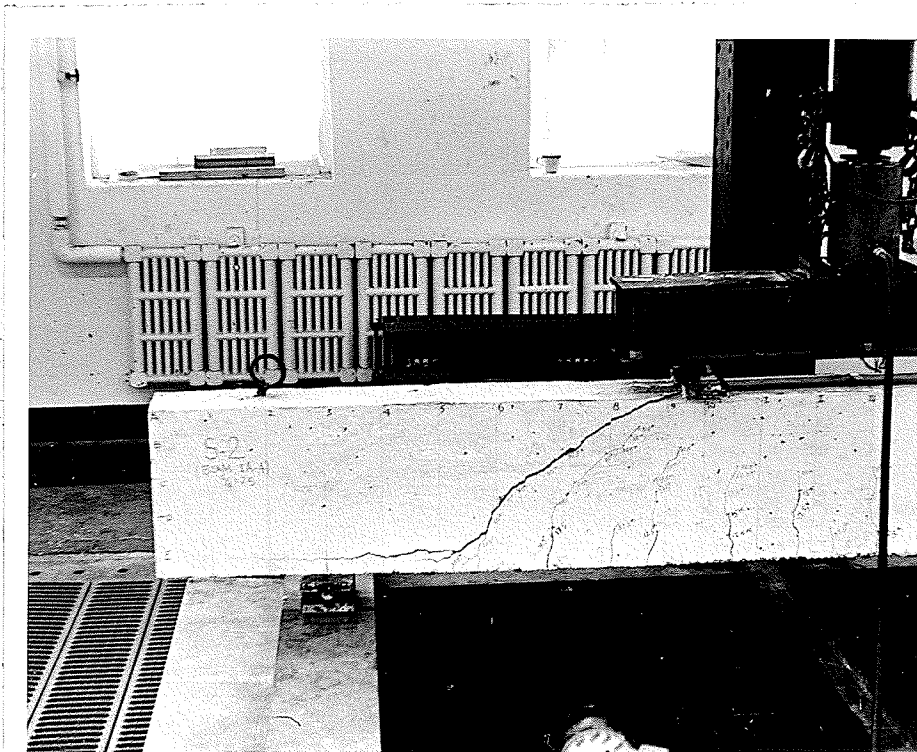
At a load of 37.5 kips, a vertical crack in the shear span on end N2 extended significantly in an inclined direction, while cracks re-

FIG. 31 DIAGONAL FAILURE OF BEAM IA-4

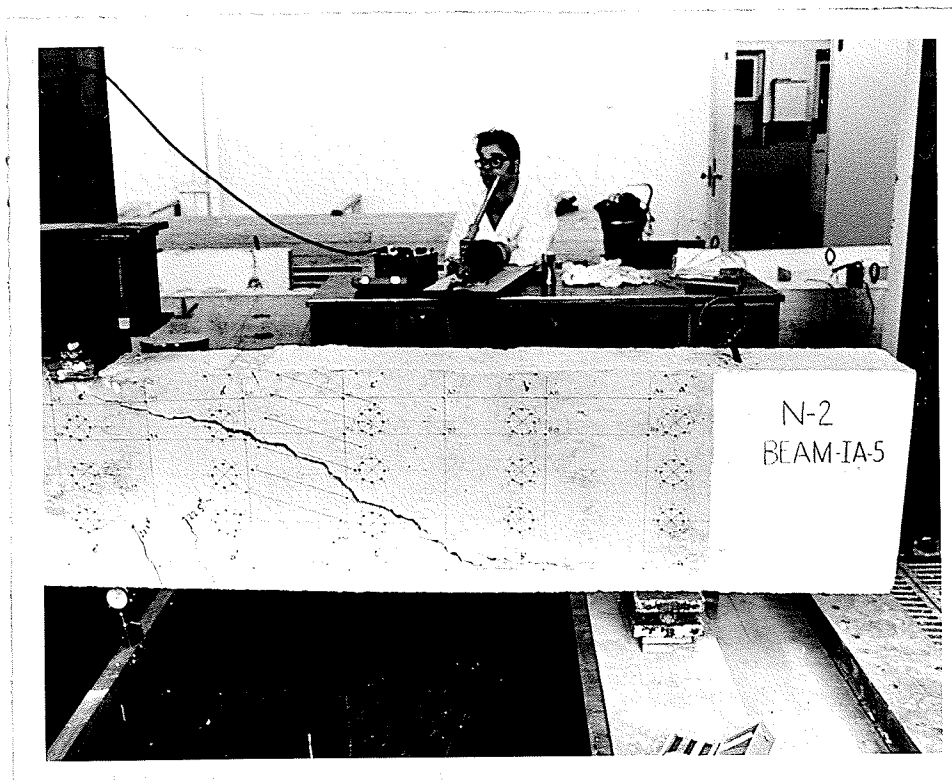
FIG. 32 DIAGONAL FAILURE OF BEAM IA-5

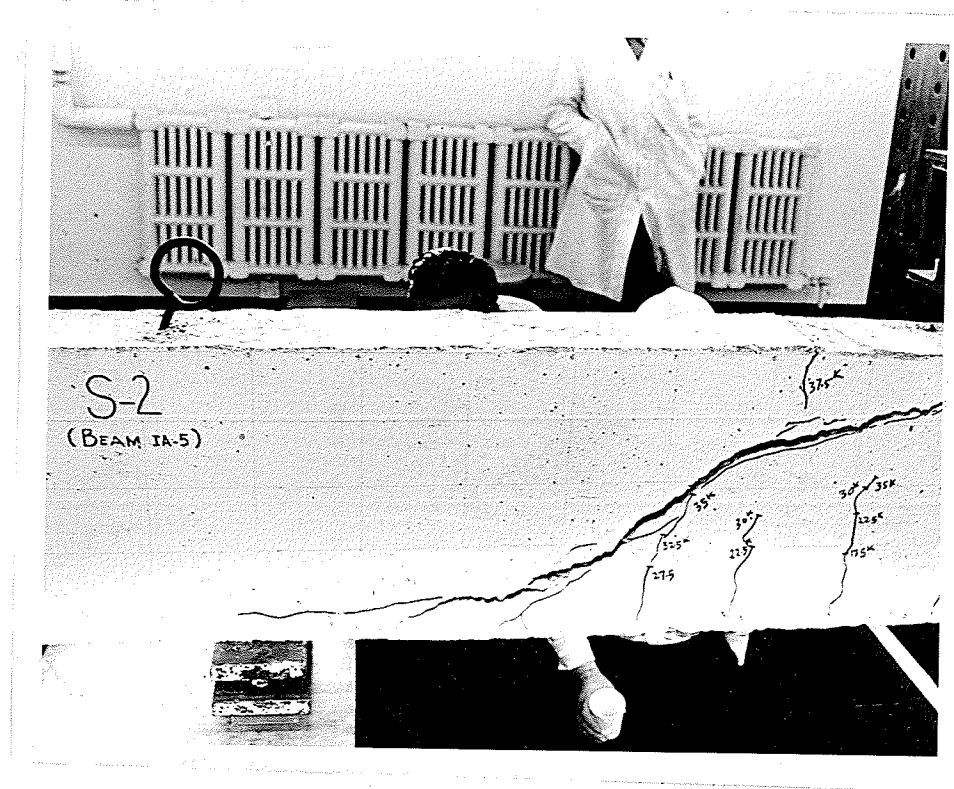
FIG. 33 FAILURE OF BEAM IA-5 ON END S-2

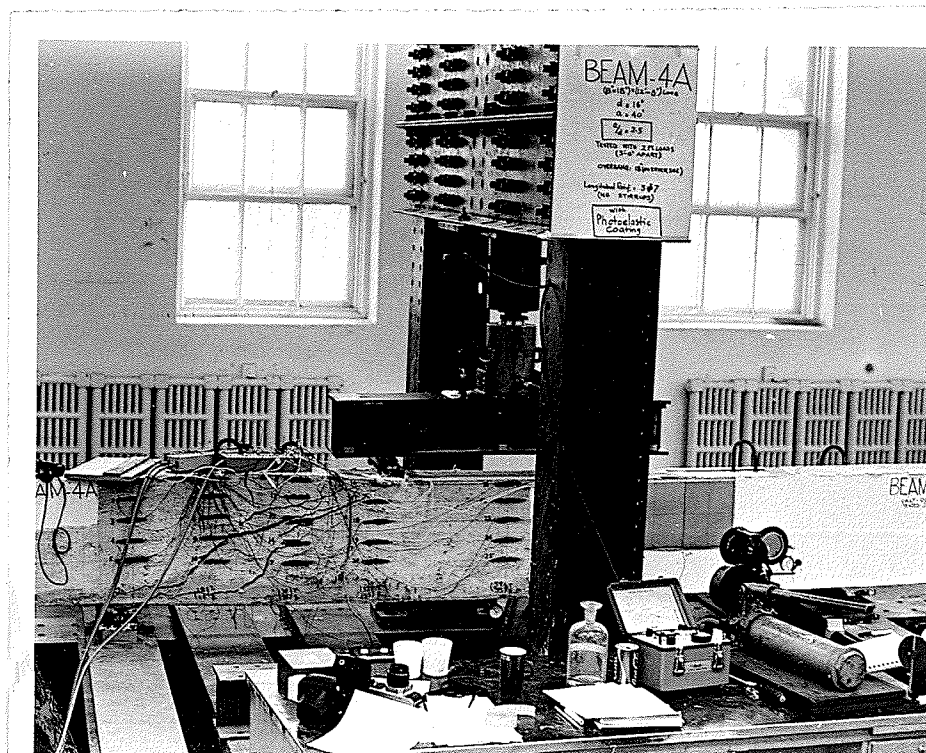
The first flexural cracks appeared at a load of 20 kips. Critical diagonal cracking occurred at a load of 42.5 kips, the diagonal crack progressing considerably through the shear span of the

FIG. 37 FAILURE OF BEAM IB-4

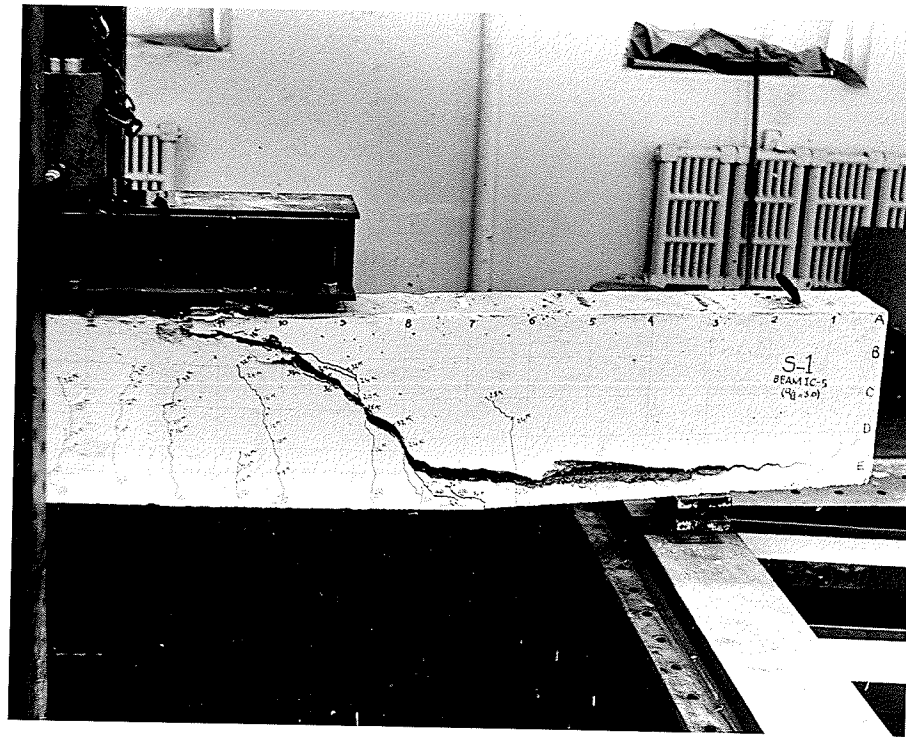
The first flexural cracks appeared at a load of 7.5 kips and numerous cracks developed on further loading. At a load of 30 kips, while

FIG. 45 DIAGONAL FAILURE OF BEAM IC-5

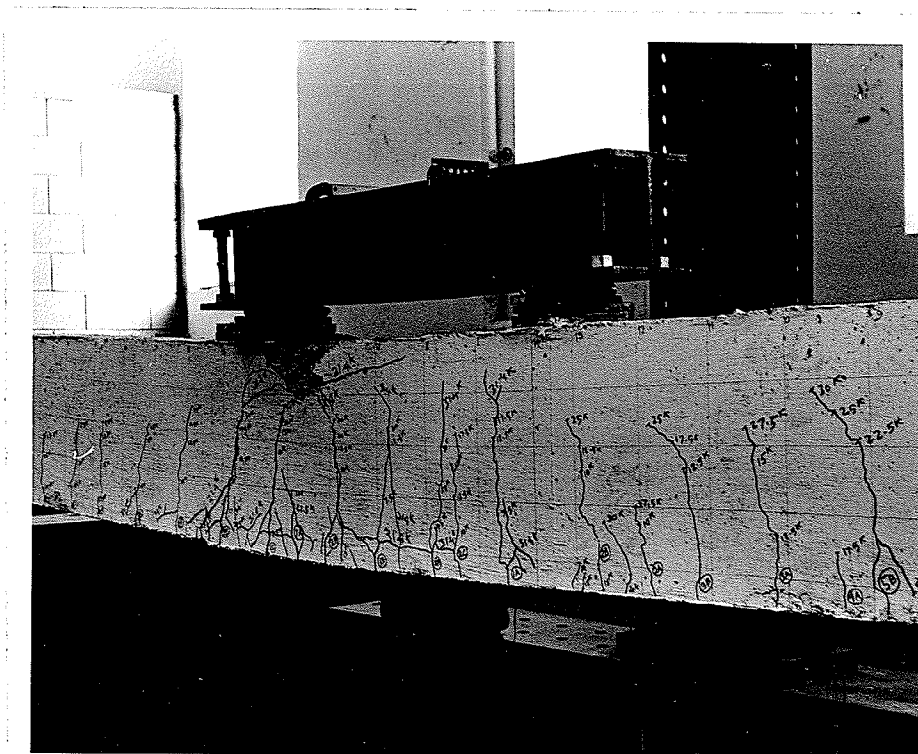
FIG. 46 CRACKING AND FINAL FLEXURAL FAILURE OF BEAM IC-6

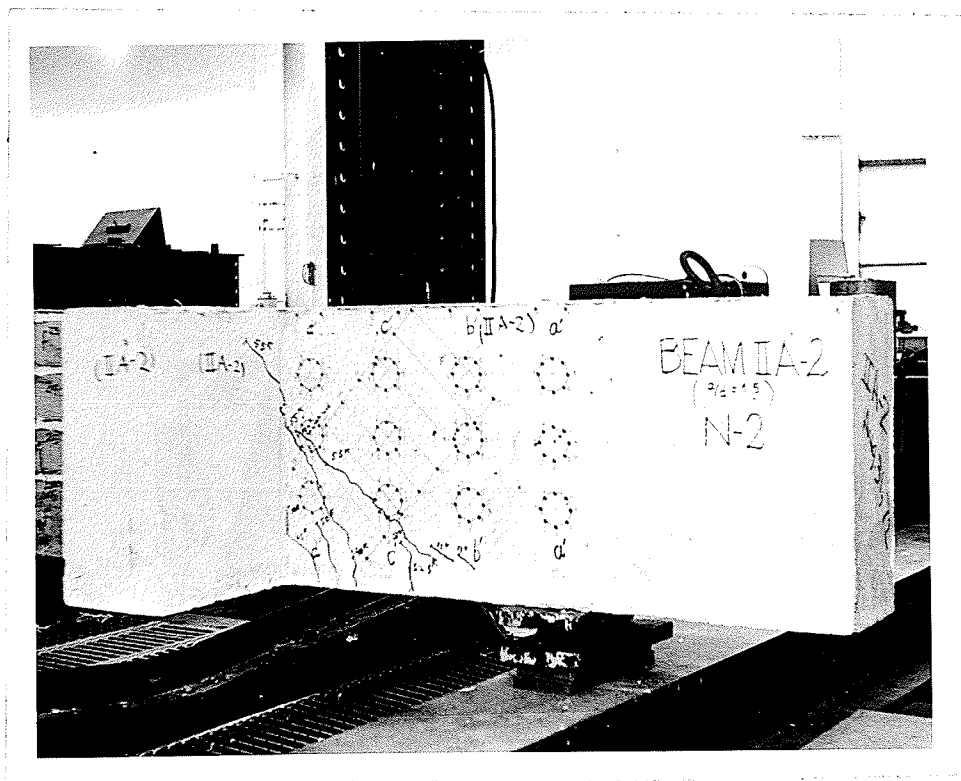
This beam remained remarkably sound as the loading was increased and it was not until a load of 27.5 kips that the first cracks developed. First significant diagonal cracking occurred at a load of 40 kips. With further loading there was a major propagation of a diagonal crack to a height of 8 1/2 inches at a load of 50 kips. At this stage the diagonal cracks had gone into the secondary beam on end S2 but the beam seemed to be fairly intact. At a load of 55 kips, there was a major extension of cracks on all sides. On side S1, a new diagonal crack formed. Another diagonal crack propagated significantly to a height of 14 inches, going into the secondary beam end, then continuing in the section of secondary beam, terminating at a height of 17 inches, about 3 inches away from the edge of the main beam. On side S2, three new cracks appeared, the most critical of these progressed to a height of 12 1/4 inches before entering the secondary beam and progressing further in it to a height of 17 1/2 inches (only 1/2 inch from top edge), 3 inches from the edge of the main beam. Similar cracking occurred on end N2. End N1, especially the secondary beam on this end, was fairly intact. In the meanwhile, the load

FIG. 47 BEAM IIA-2 SHOWING LOCATION OF DEMEC GAUGES AND CRACKS

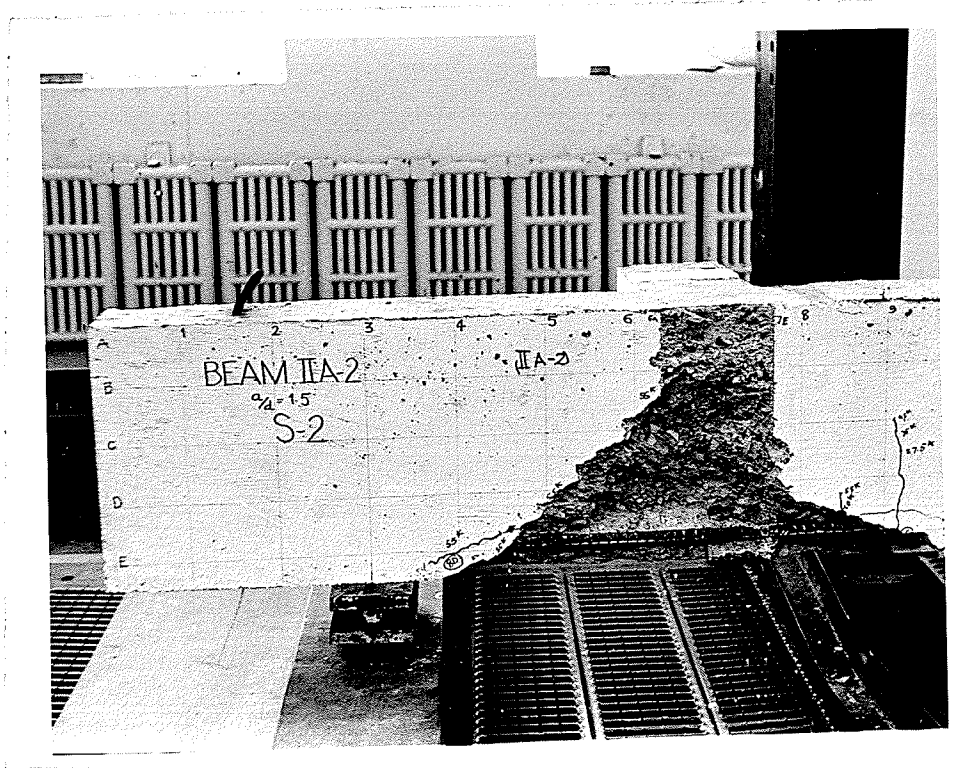
FIG. 48 FAILURE OF BEAM IIA-2 AT THE JUNCTION OF SECONDARY BEAM TO THE MAIN BEAM

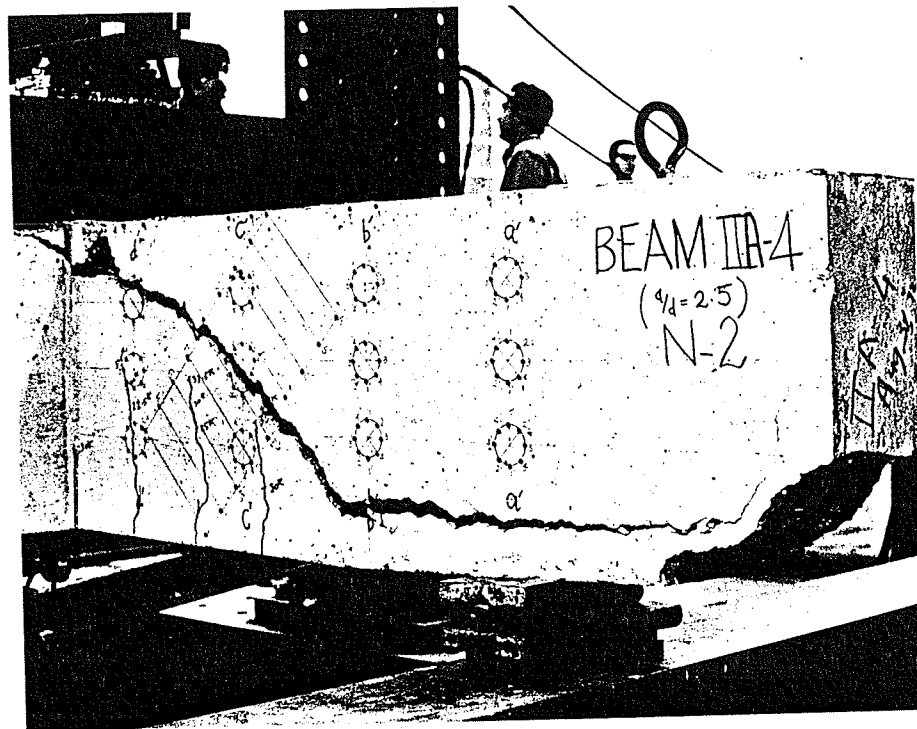
The first flexural cracks appeared in midsection at a load of 15 kips. Cracks in the shear spans were observed from 20 to 25 kips. These cracks progressed vertically and later became inclined. The final failure occurred at a load of 39.6 kips on sides N2/S2 from a crack that had originated only at the previous load increment of 37.5 kips. The diagonal failure crack went through the secondary beam and was observed emerging out in the constant moment zone, about 3 inches beyond the junction of the secondary beams to the main beam. As the diagonal crack crossed the secondary beams, a portion of concrete at its top was broken off and a simultaneous split occurred along the reinforcement. It was observed that ultimate failure developed when the diagonal cracks were well below the top and the beam appeared to be able to carry more load.

FIG. 51 DIAGONAL FAILURE OF BEAM IIA-4 (END N-2)

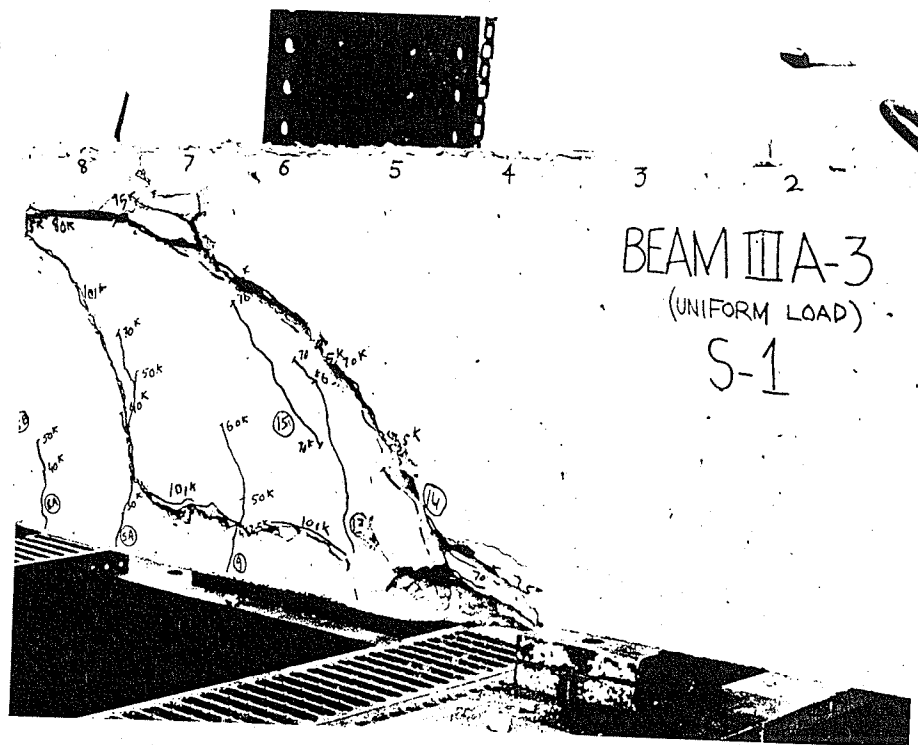
FIG. 57 FAILURE OF BEAM IIIA-3 (END S-1)

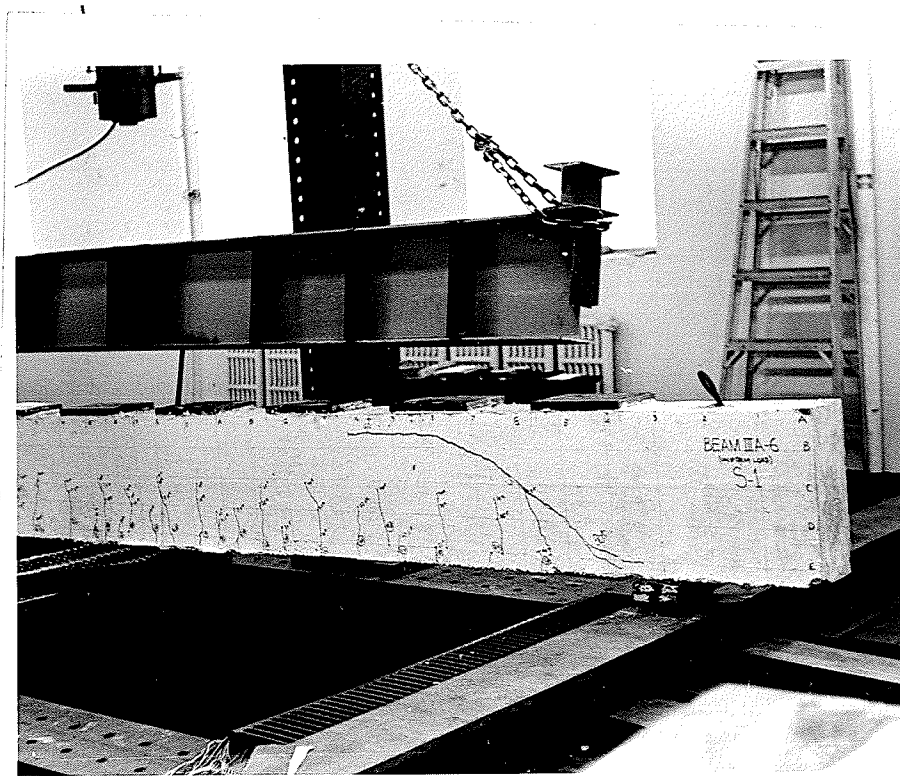
The first flexural cracks appeared at a load of 15 kips. As the load was increased, the cracks remained vertical in the midsection and inclined only slightly in the outer regions of the span. Significant diagonal cracking had developed at a load of 35 kips, the maximum height of diagonal cracks being 10 1/2 inches at this stage. At a load of 40 kips, diagonal cracks appeared on ends S1-S2, which were closer to the supports. At a load of 50 kips, there was a major failure on ends N1/S1, the crack touching the top surface of the beam on end N1 while it tapered off horizontally about 2 inches below on end S1. Cracking also extended on the

FIG. 59 CRACKING ON END S-1 OF BEAM IIIA-6 AT FAILURE

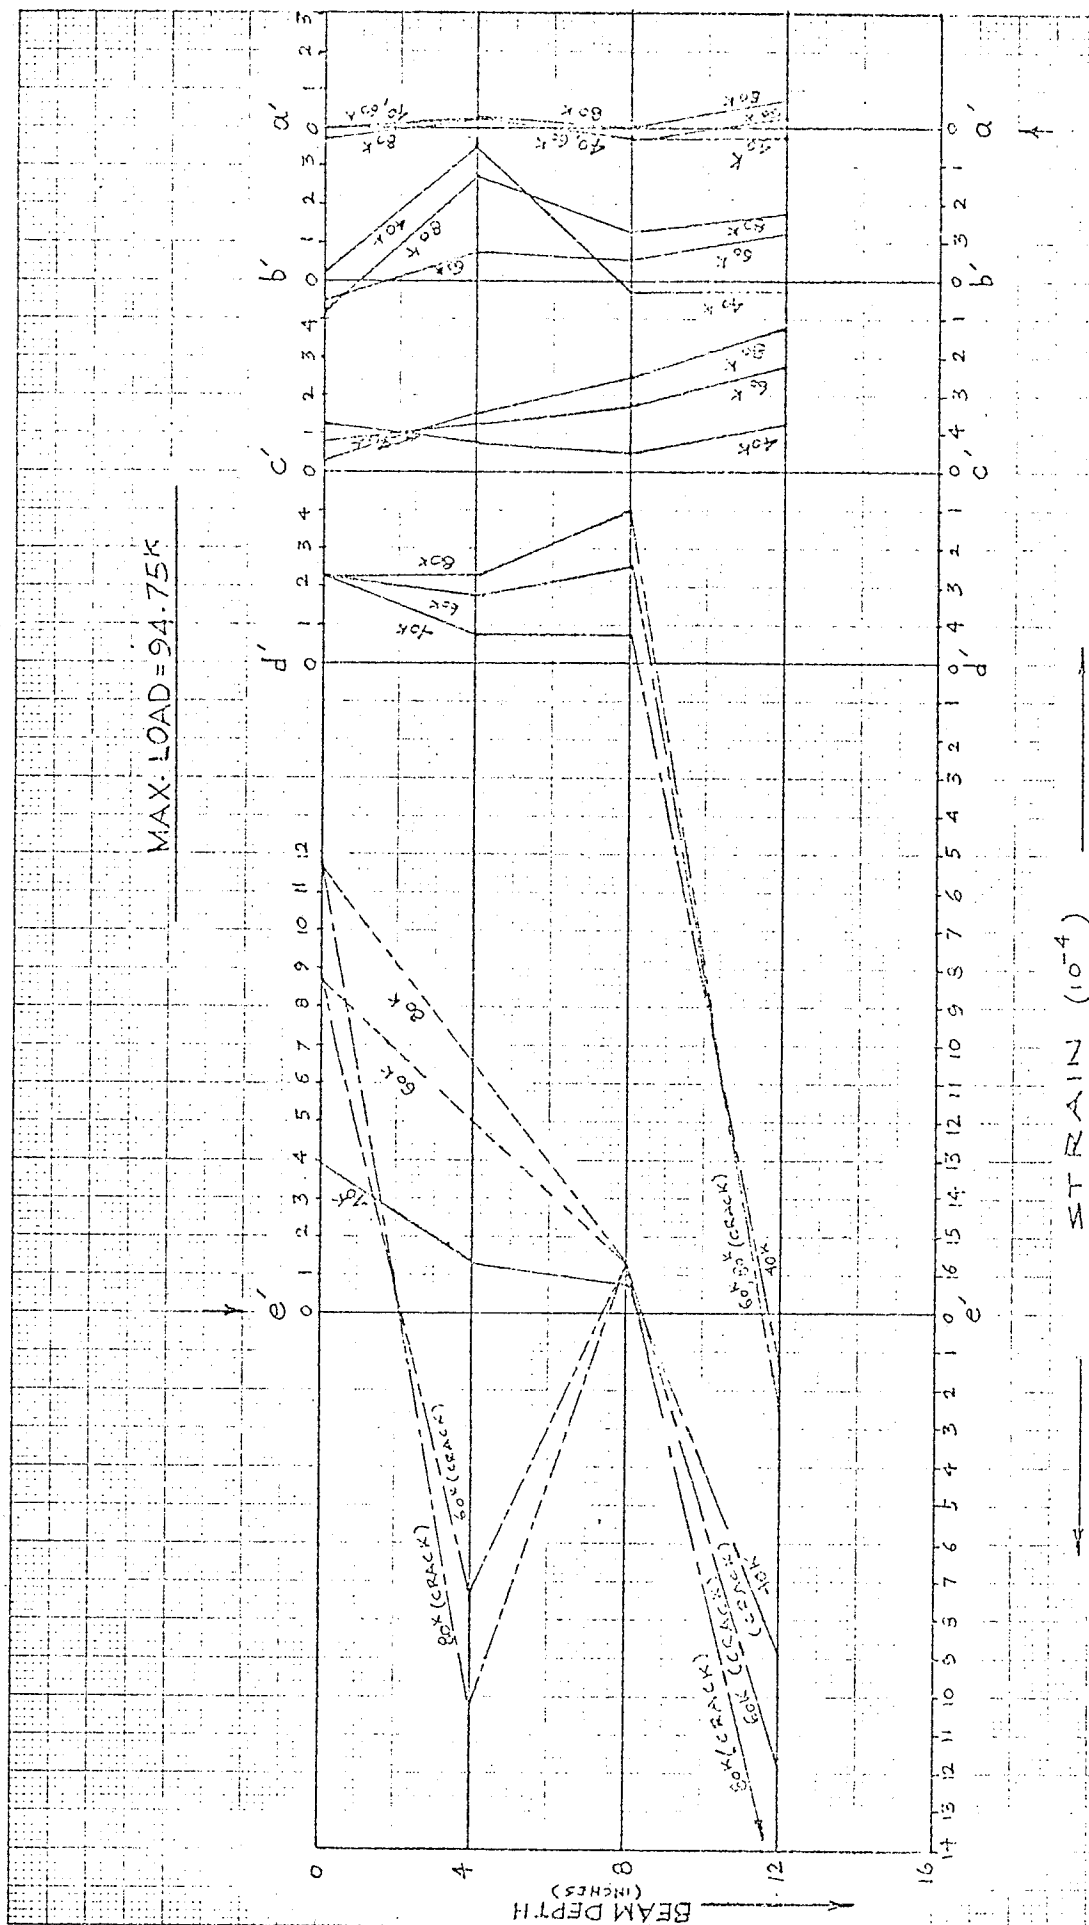
From the above, it can be seen that compressive strains at $3/4$ th of the effective depth of the beam developed at midspan at a load of 30 kips, under the load point at a load of 40 kips and at all other sections at a load of 50 kips. The development of these compressive strains, therefore, followed the progressive development of flexural cracking from midspan region outwards. Compressive strains at sections closer to the support at the 12-inch level only developed after critical diagonal cracking.

FIG. III-2(a) LONGITUDINAL STRAIN—DEMEC DATA

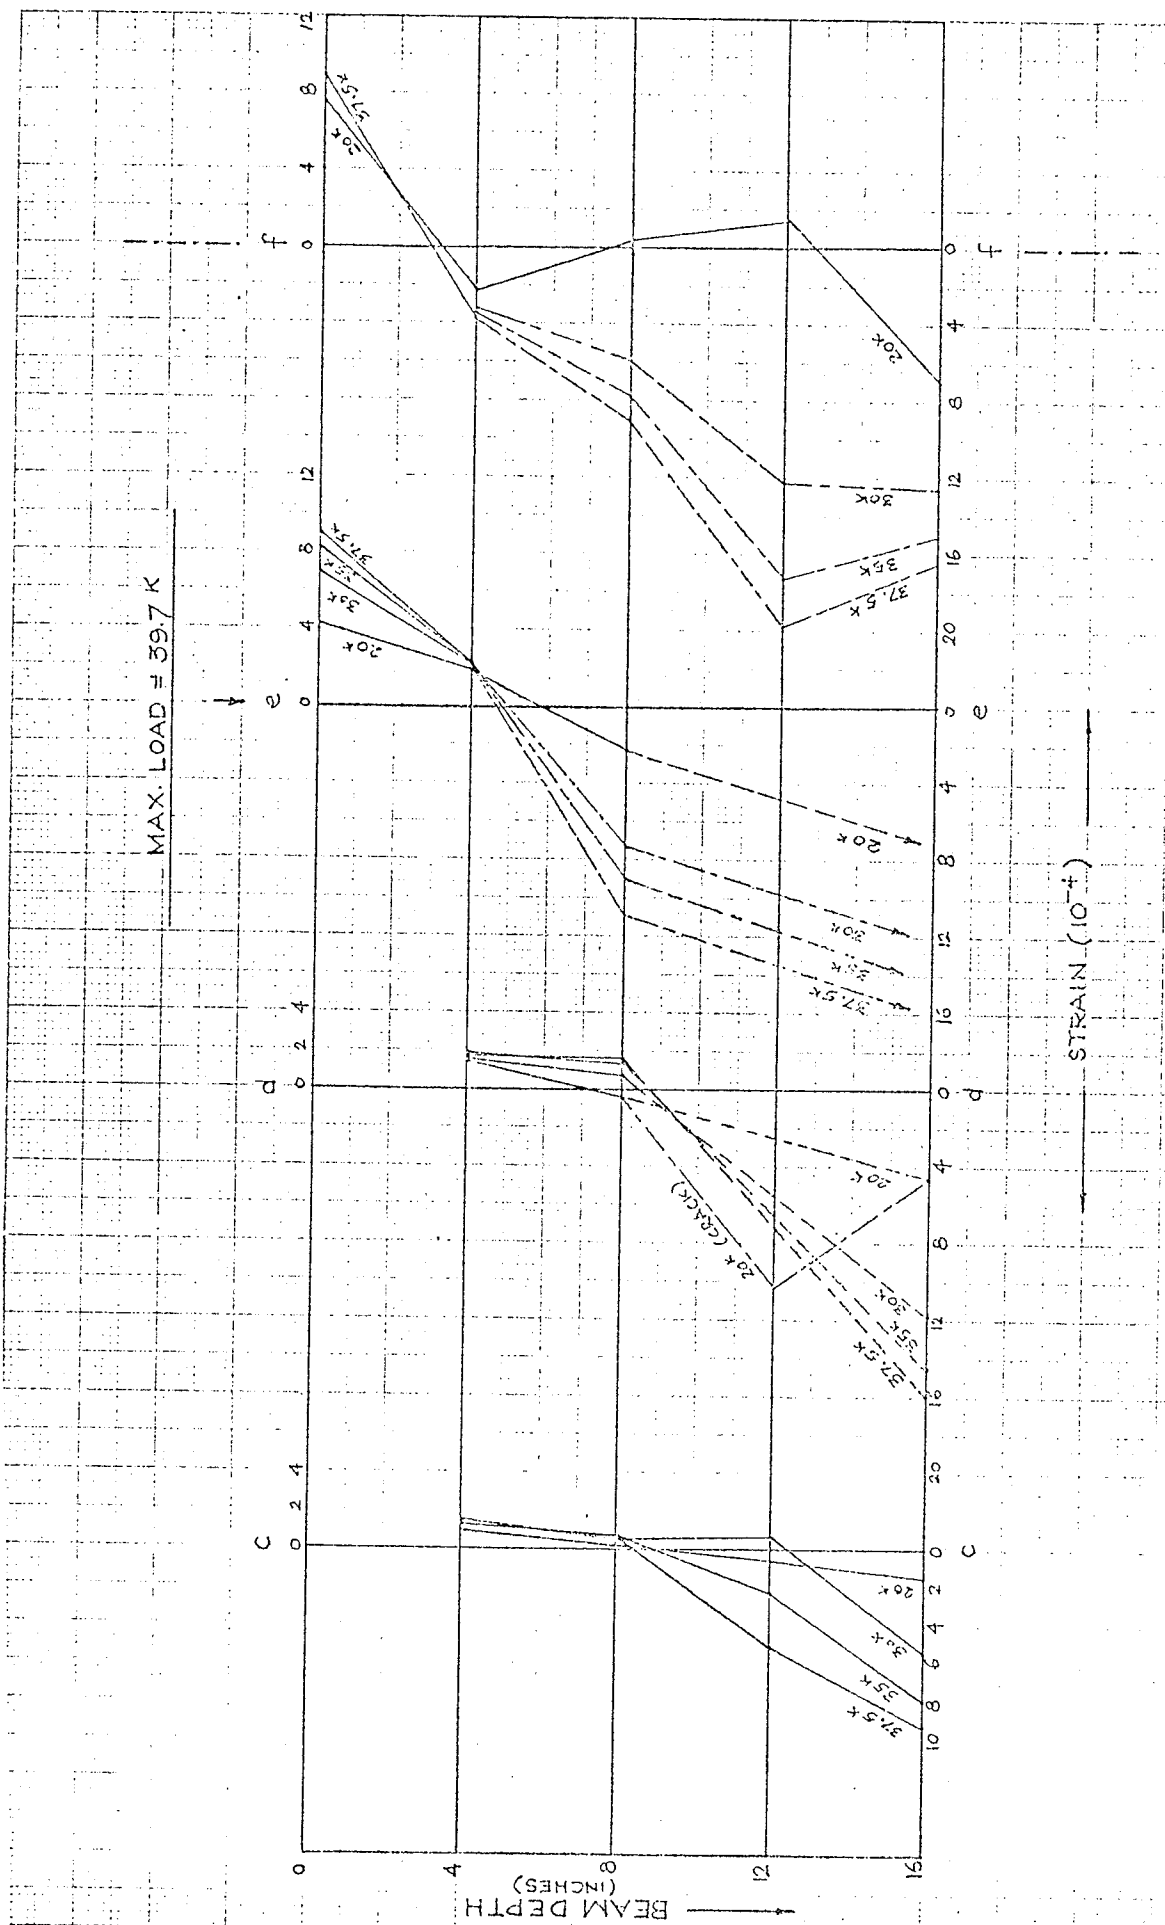
Gauges at 12 inch level at sections a and b showed consistent increase of tensile strains till failure. There were no cracks at these sections. This clearly shows that compressive strains at the 12 inch level did not extend to sections close to the support.

FIG. III.4—LONGITUDINAL STRAIN ——— Electrical Resistance Strain Gauge Data

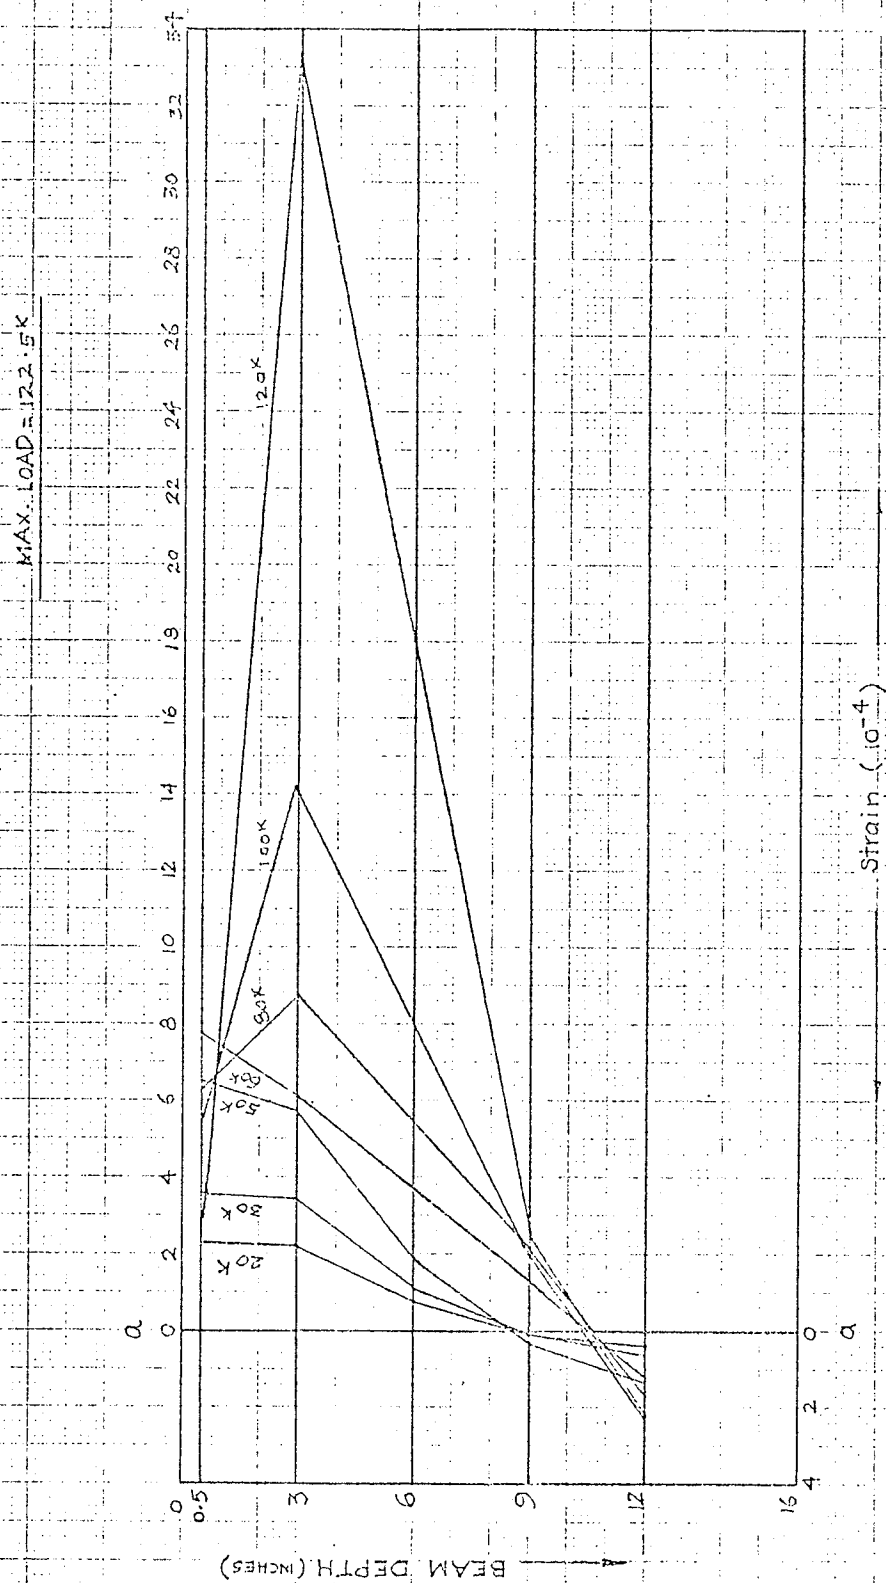
Strain readings from these gauges are not entirely reliable because the same gauges were used in an earlier test on beam IB-5 and it is possible that some of them might have been damaged. No DEMEC gauges were used on this beam.

FIG. III-9 — LONGITUDINAL STRAIN — Electrical Resistance Strain Gauge Data

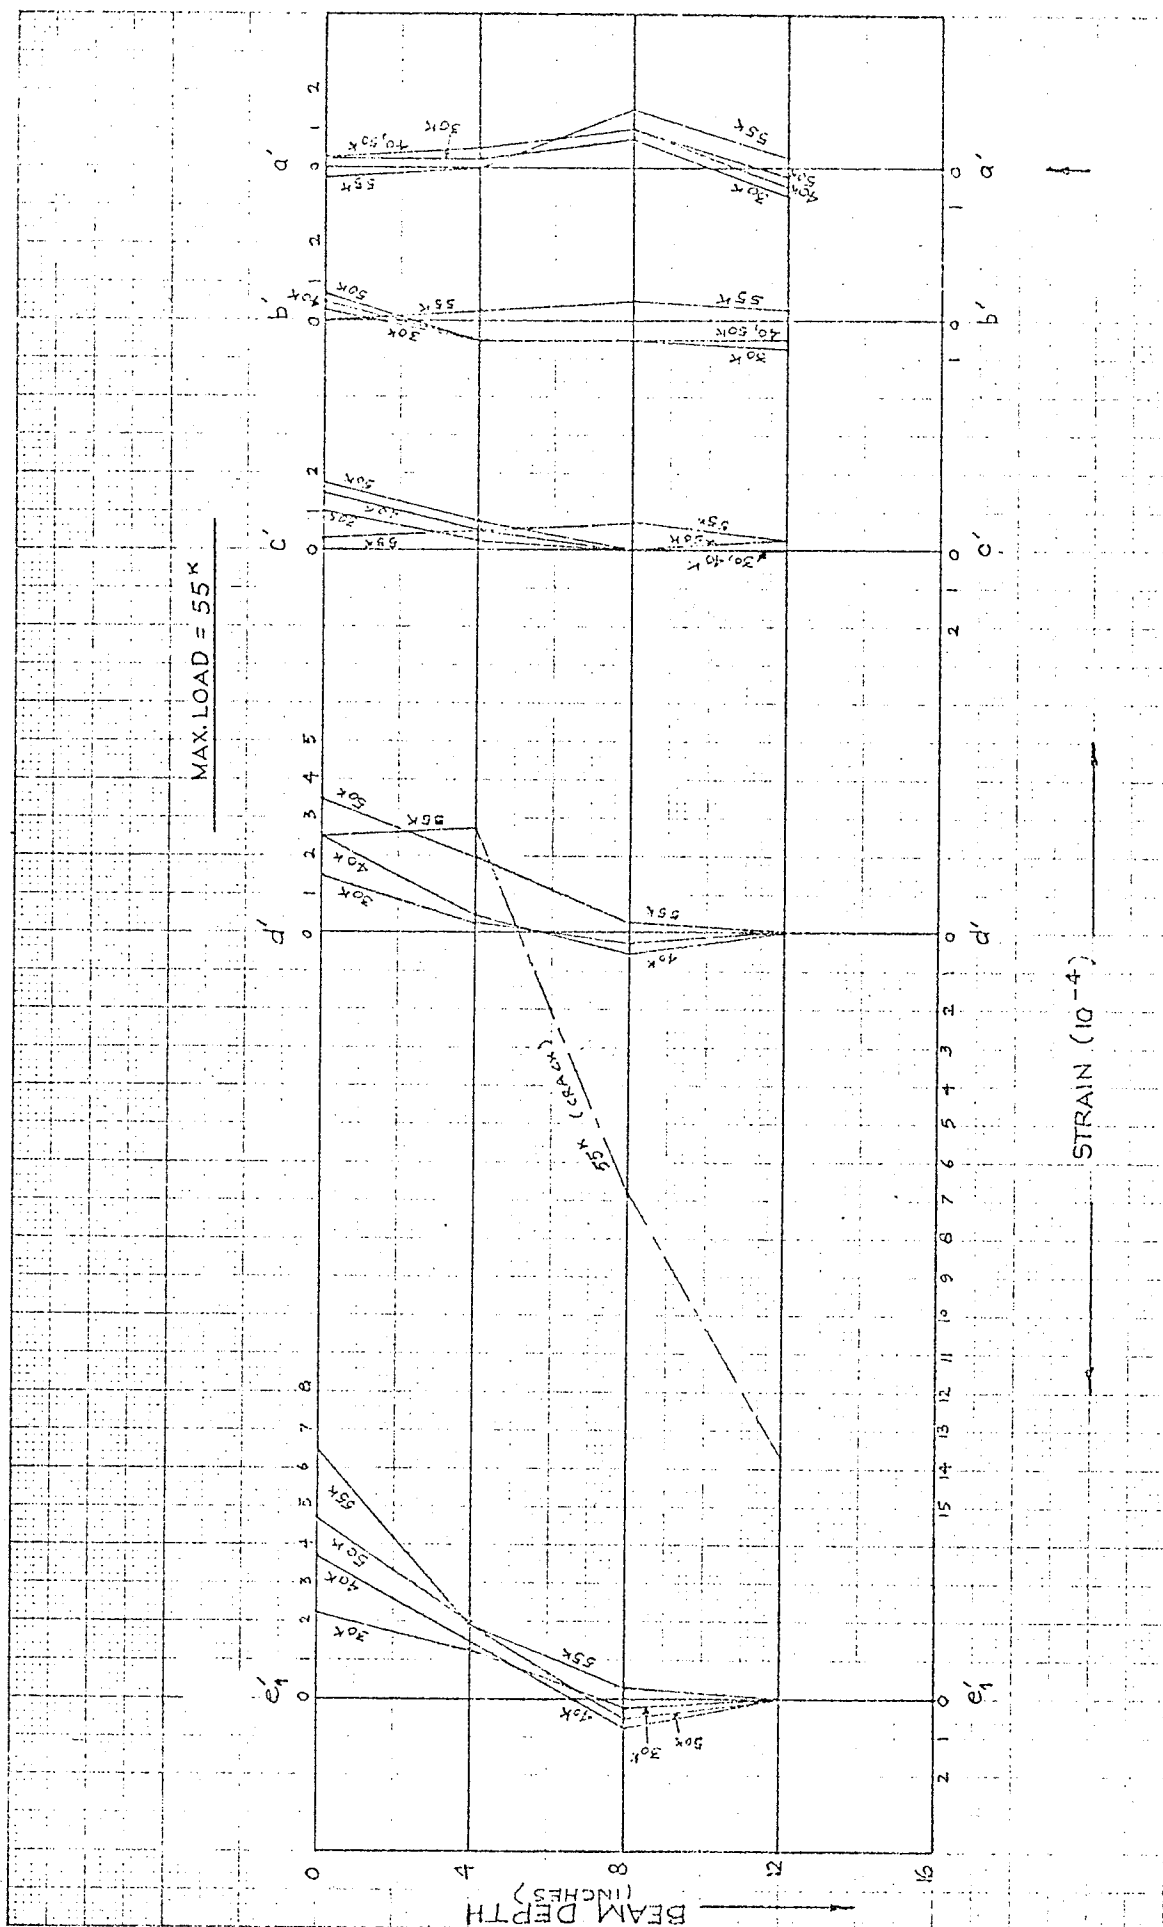
FIG. III-16 — LONGITUDINAL STRAIN — DEMEC DATA
BEAM IIA-2
