SOME ASPECTS OF THE MECHANISMS OF DIAGONAL

FAILURE OF REINFORCED CONCRETE BEAMS

A THESIS

DEPARTMENT OF CIVIL ENGINEERING

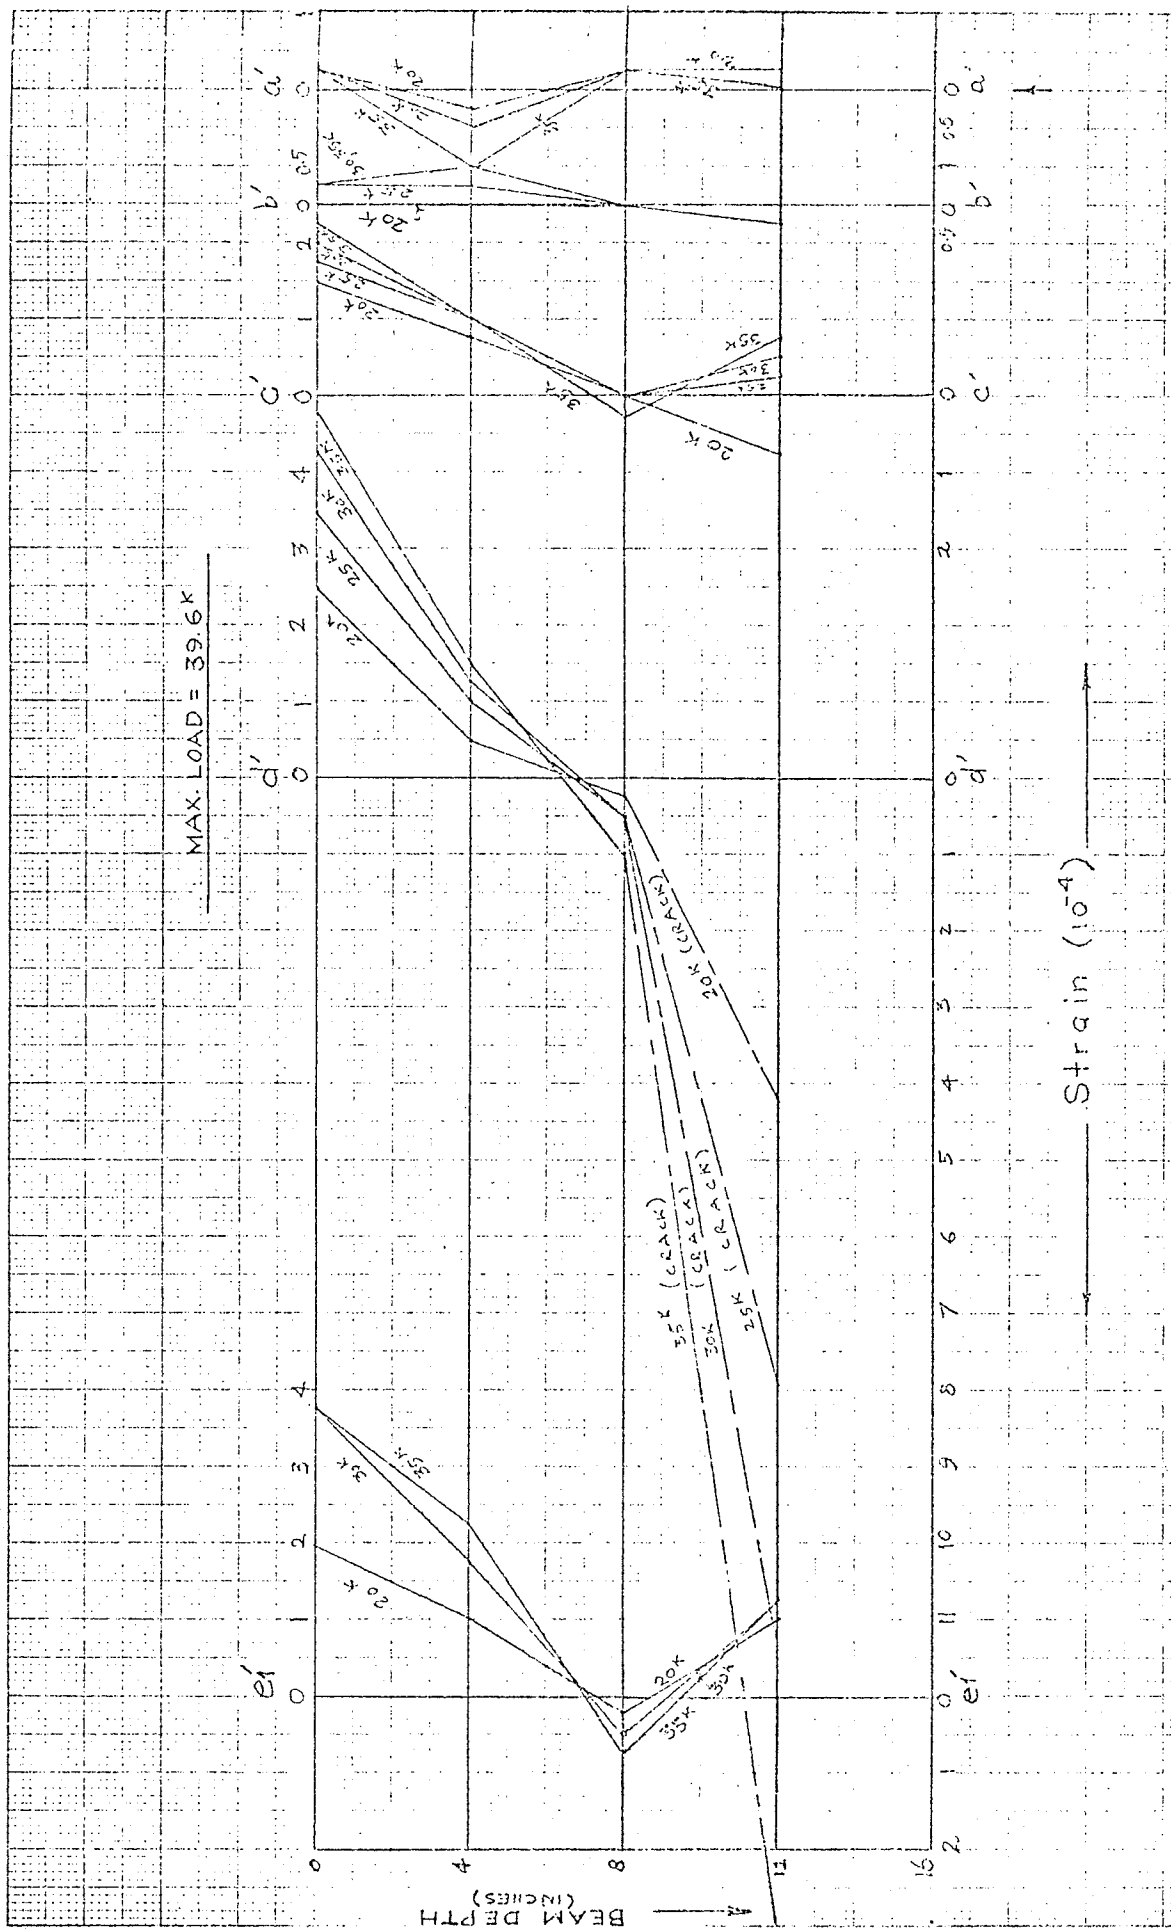
FIG. III.18(a) — LONGITUDINAL STRAIN — DEMEC DATA

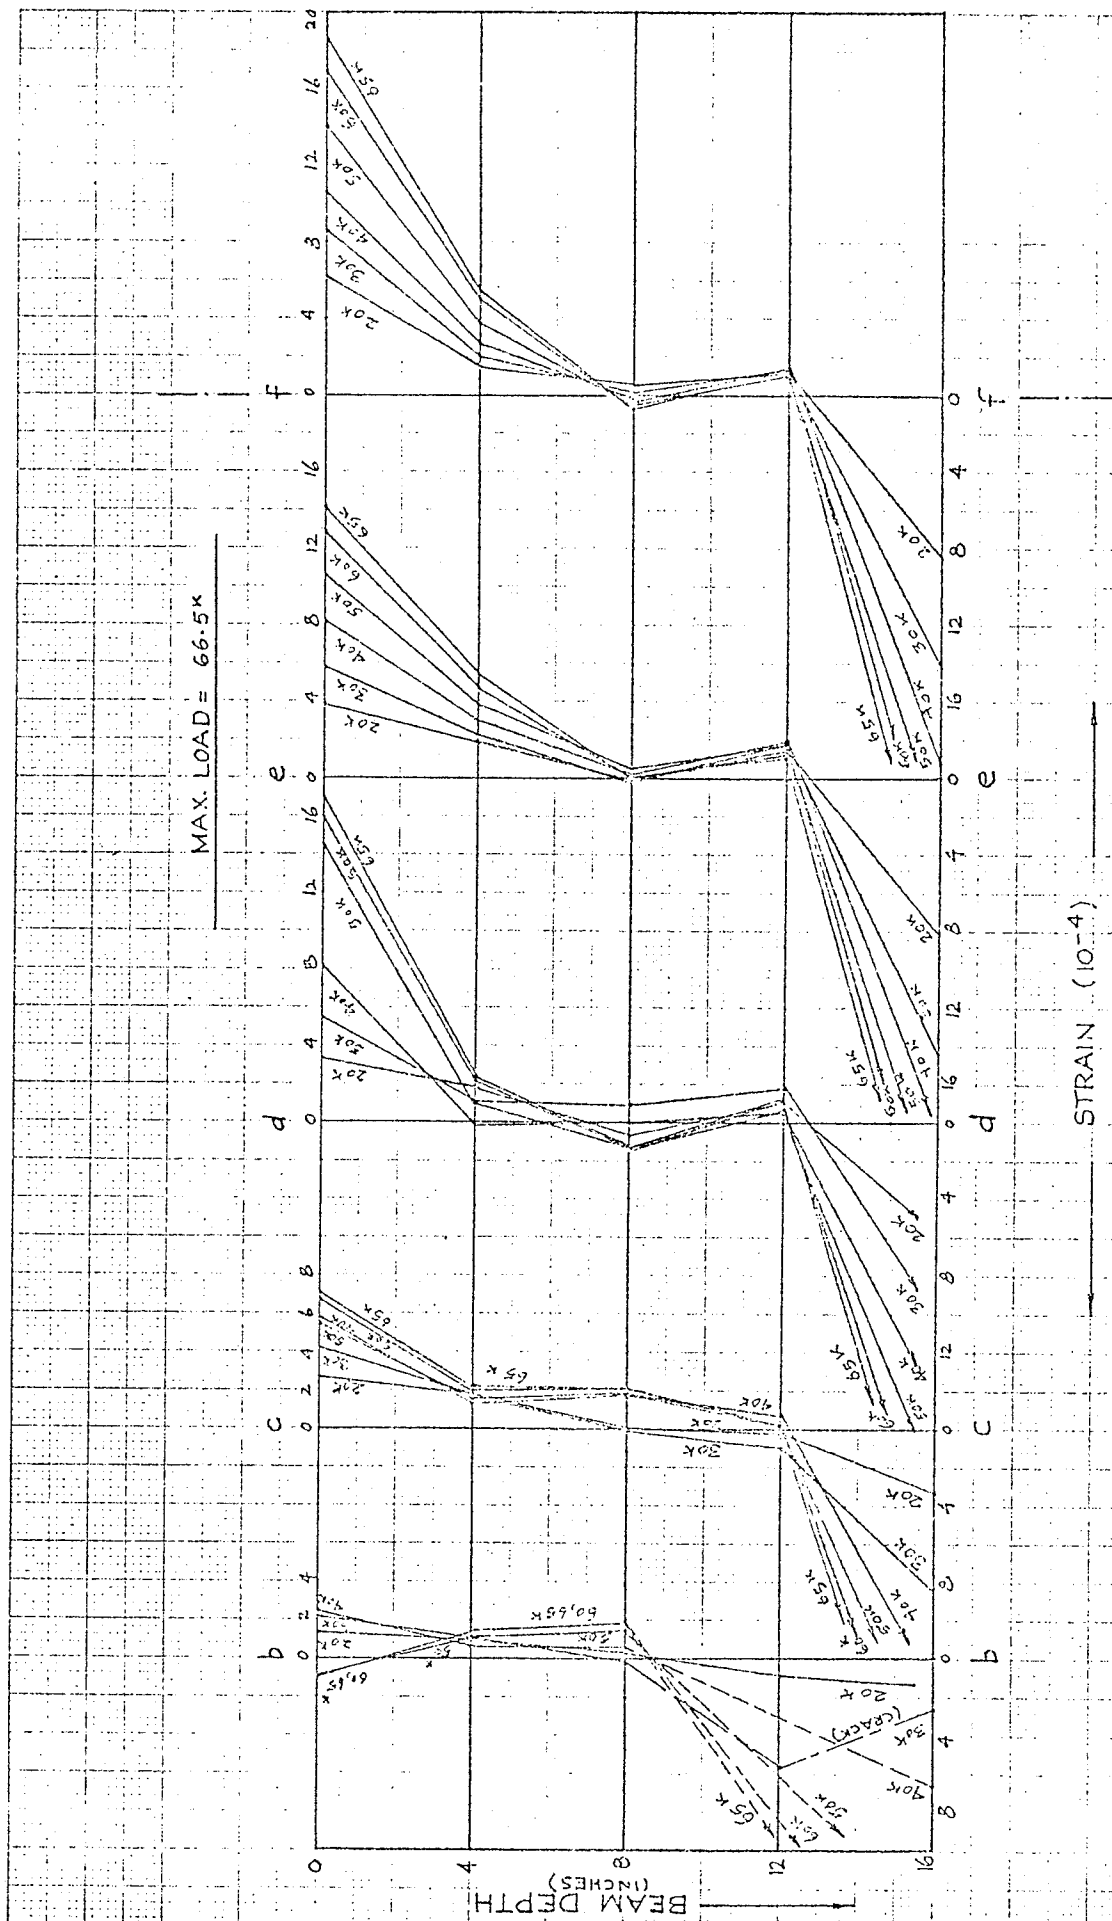
FIG. III-21(b) — LONGITUDINAL STRAIN — Electrical Resistance Strain Gauge Data

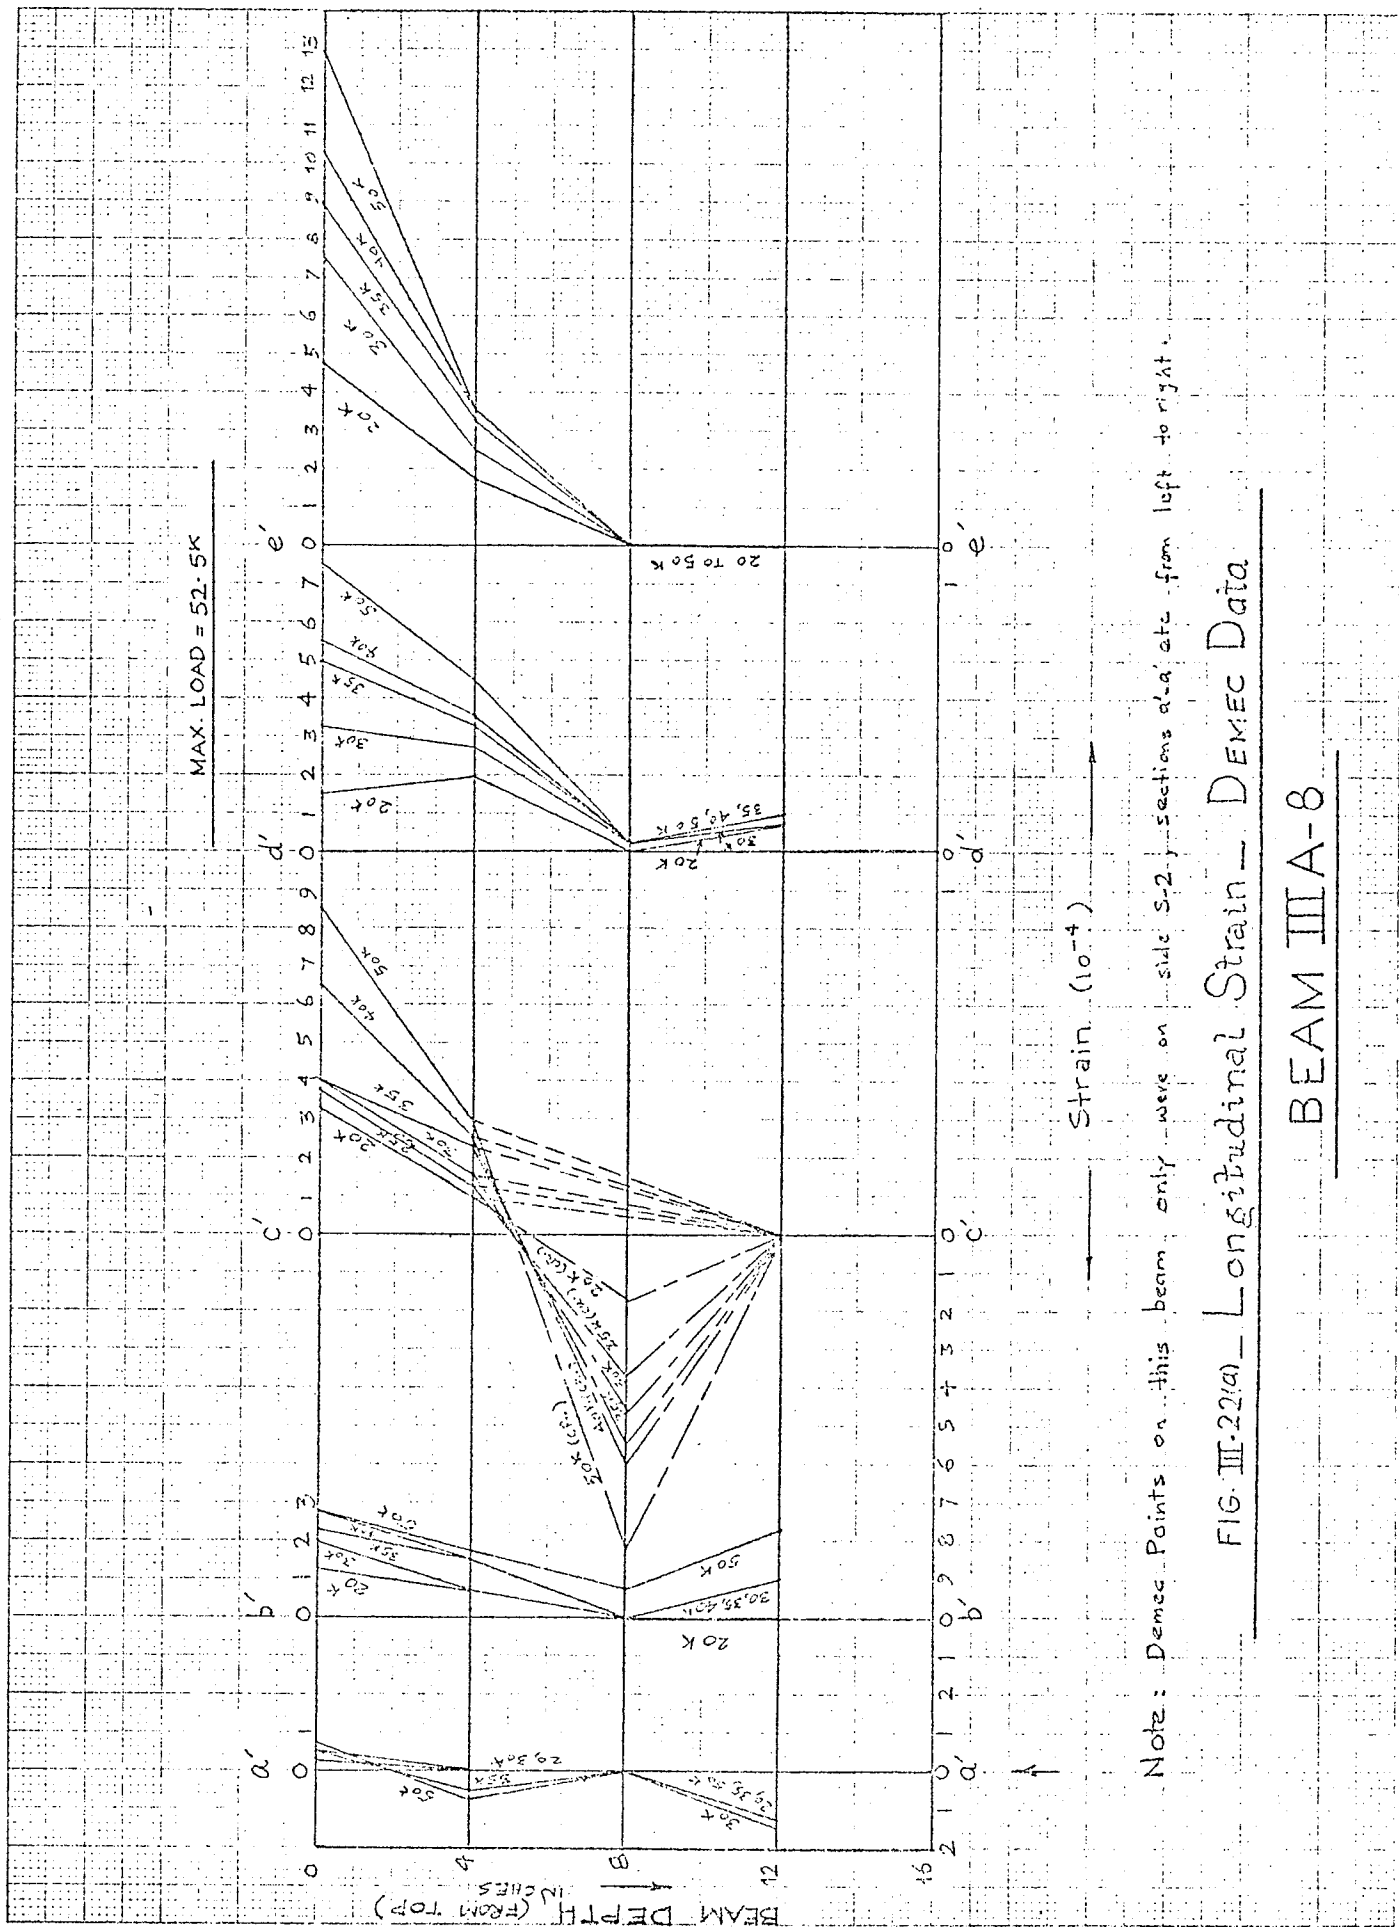
FIG. III-22(a) Longitudinal Strain - DEMEC Data

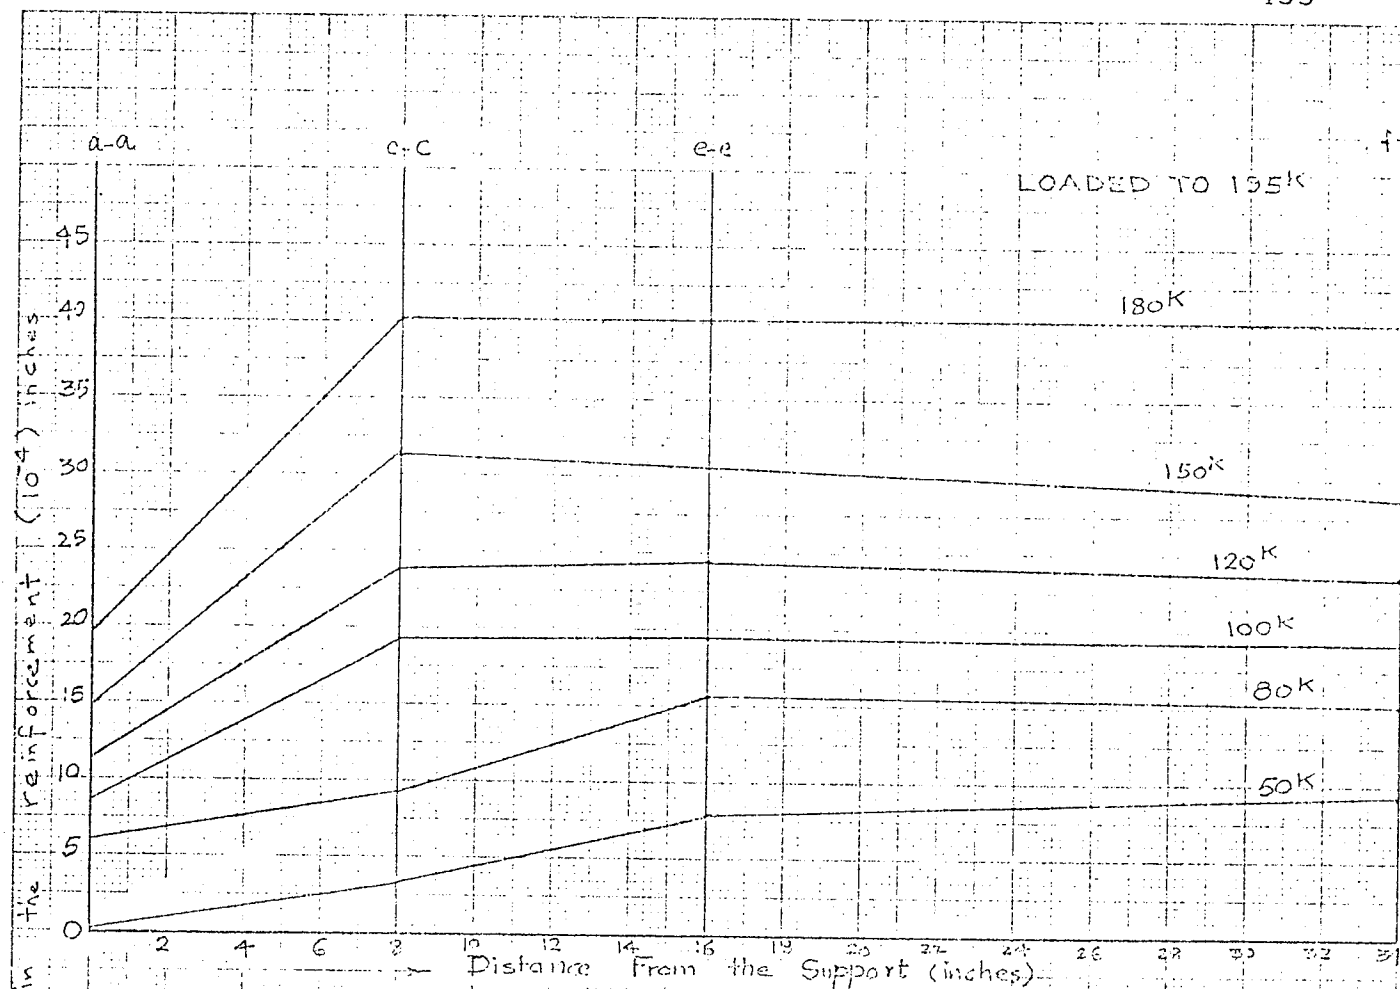
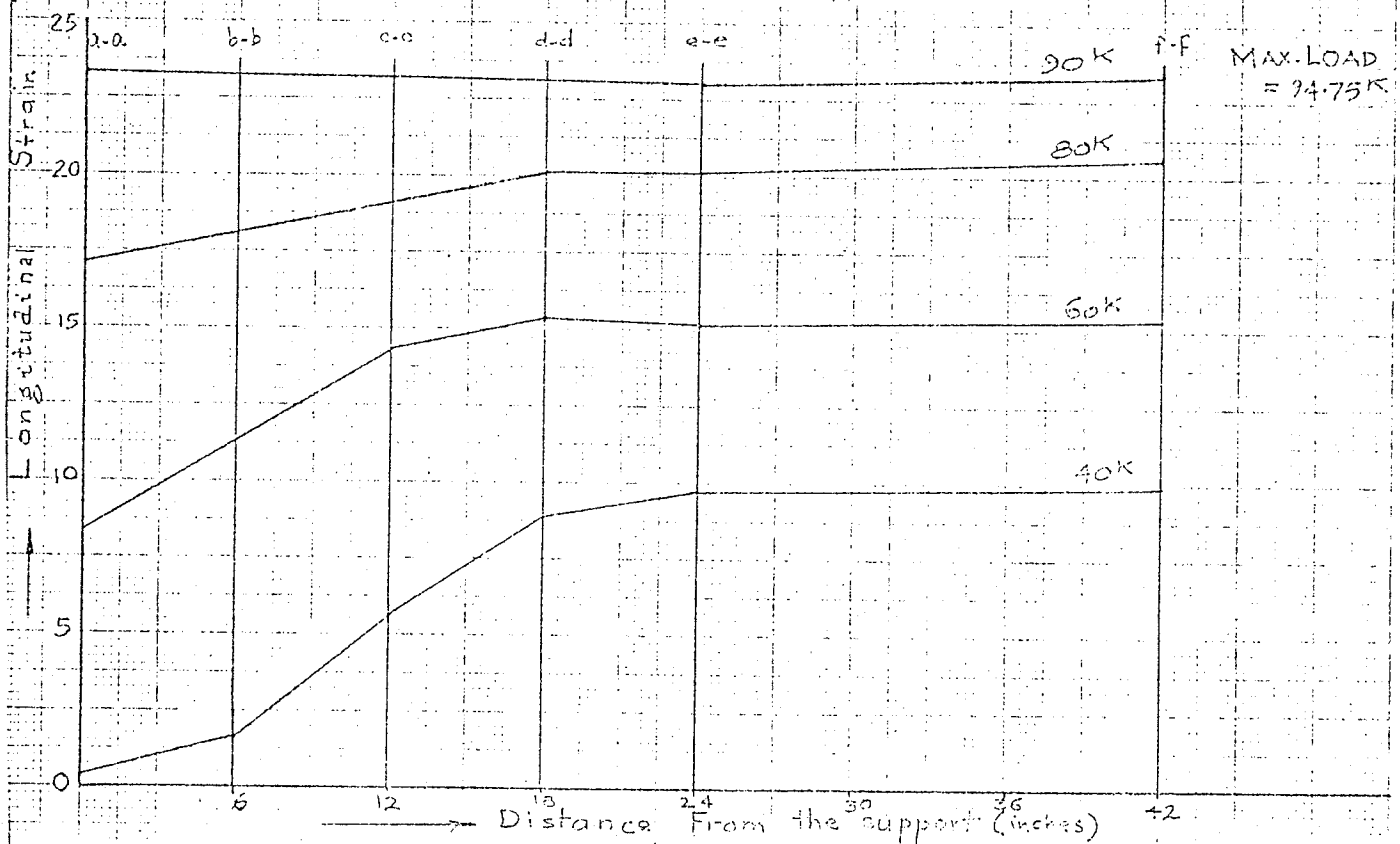
FIG. 23 TOP: BEAM IA-1

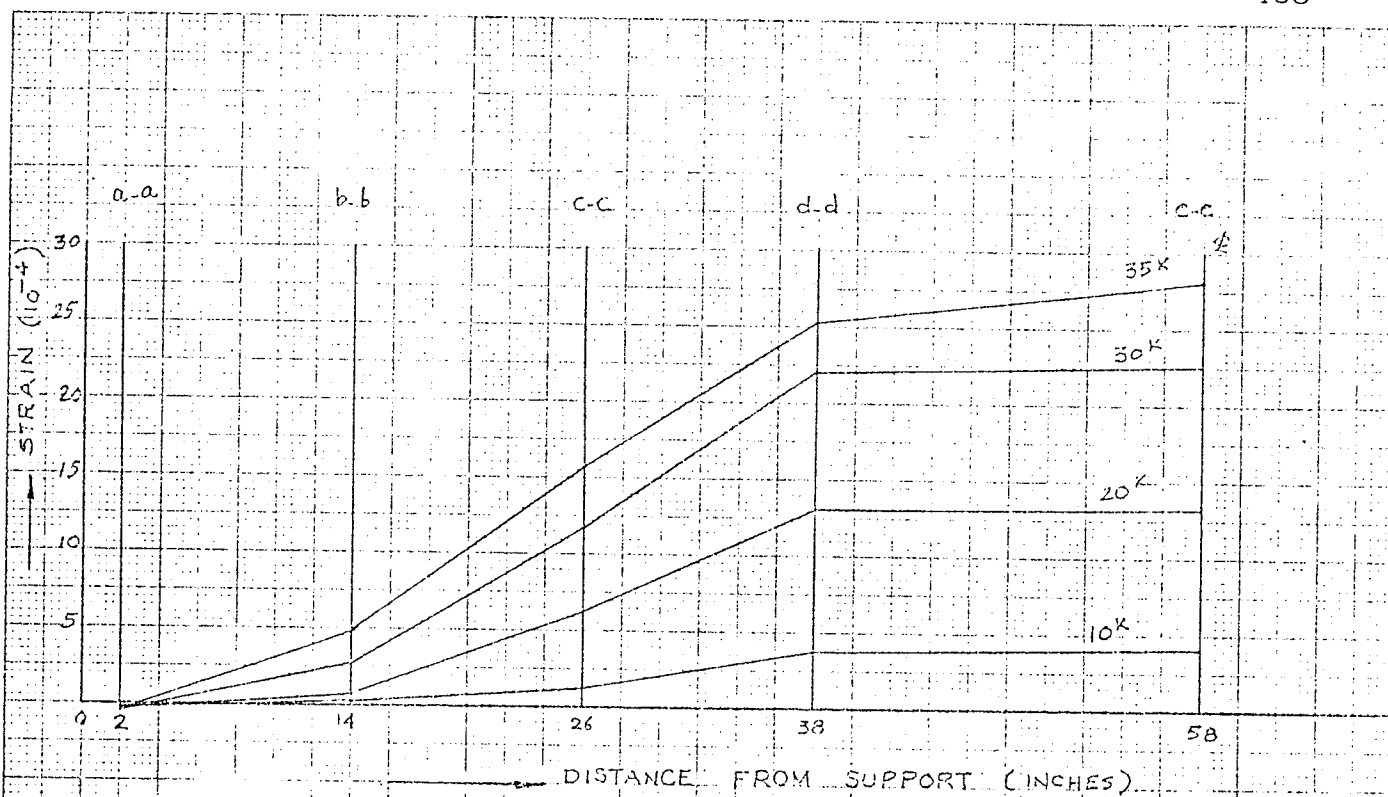
FIG. III.31 — BEAM IB-4: LONGITUDINAL STRAIN IN THE REINFORCEMENT

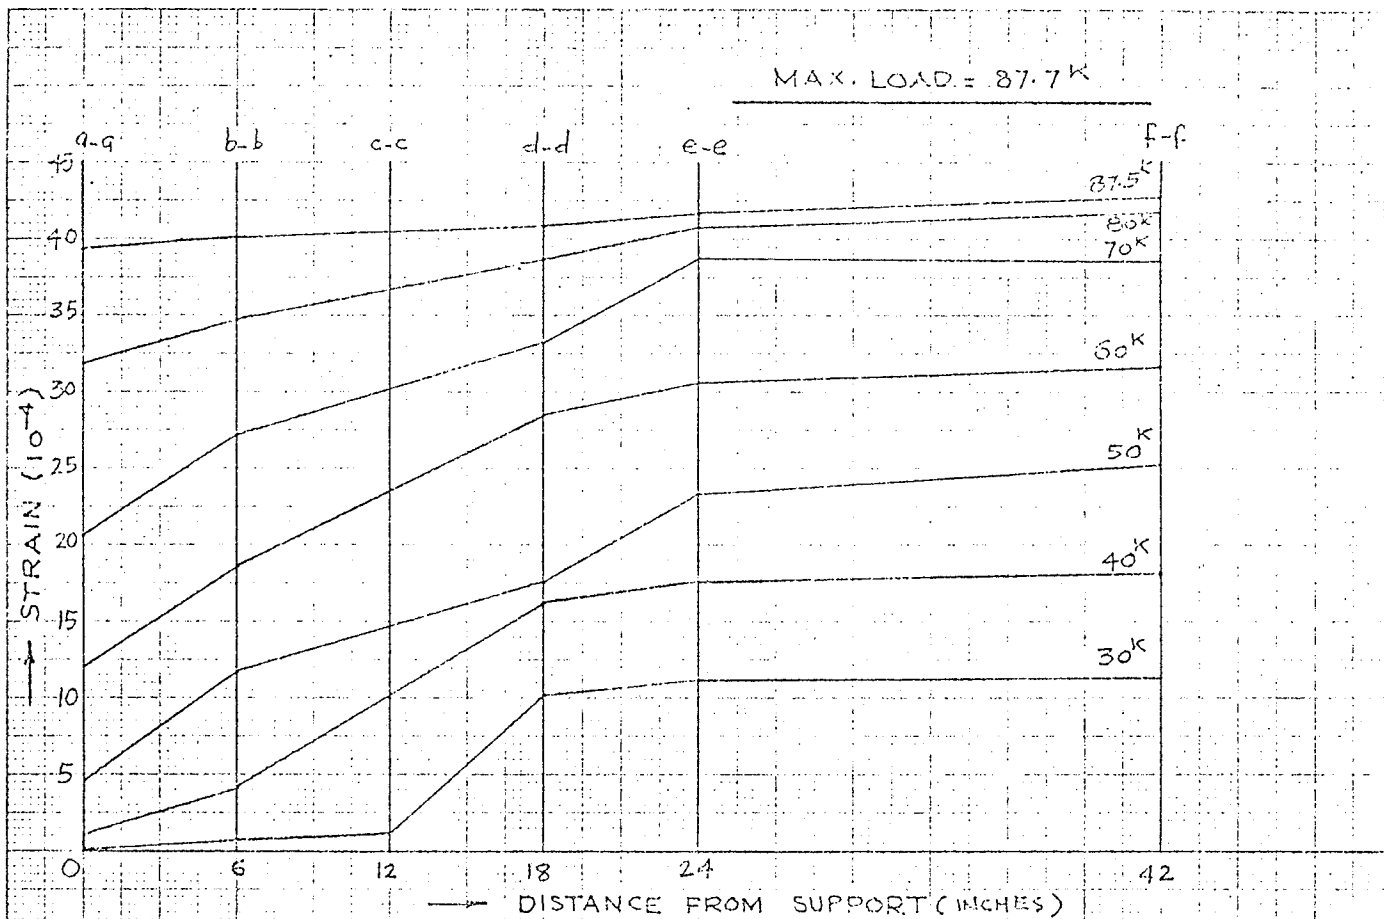
FIG. III.34 — BEAM IC-2: LONGITUDINAL STRAIN IN THE REINFORCEMENT

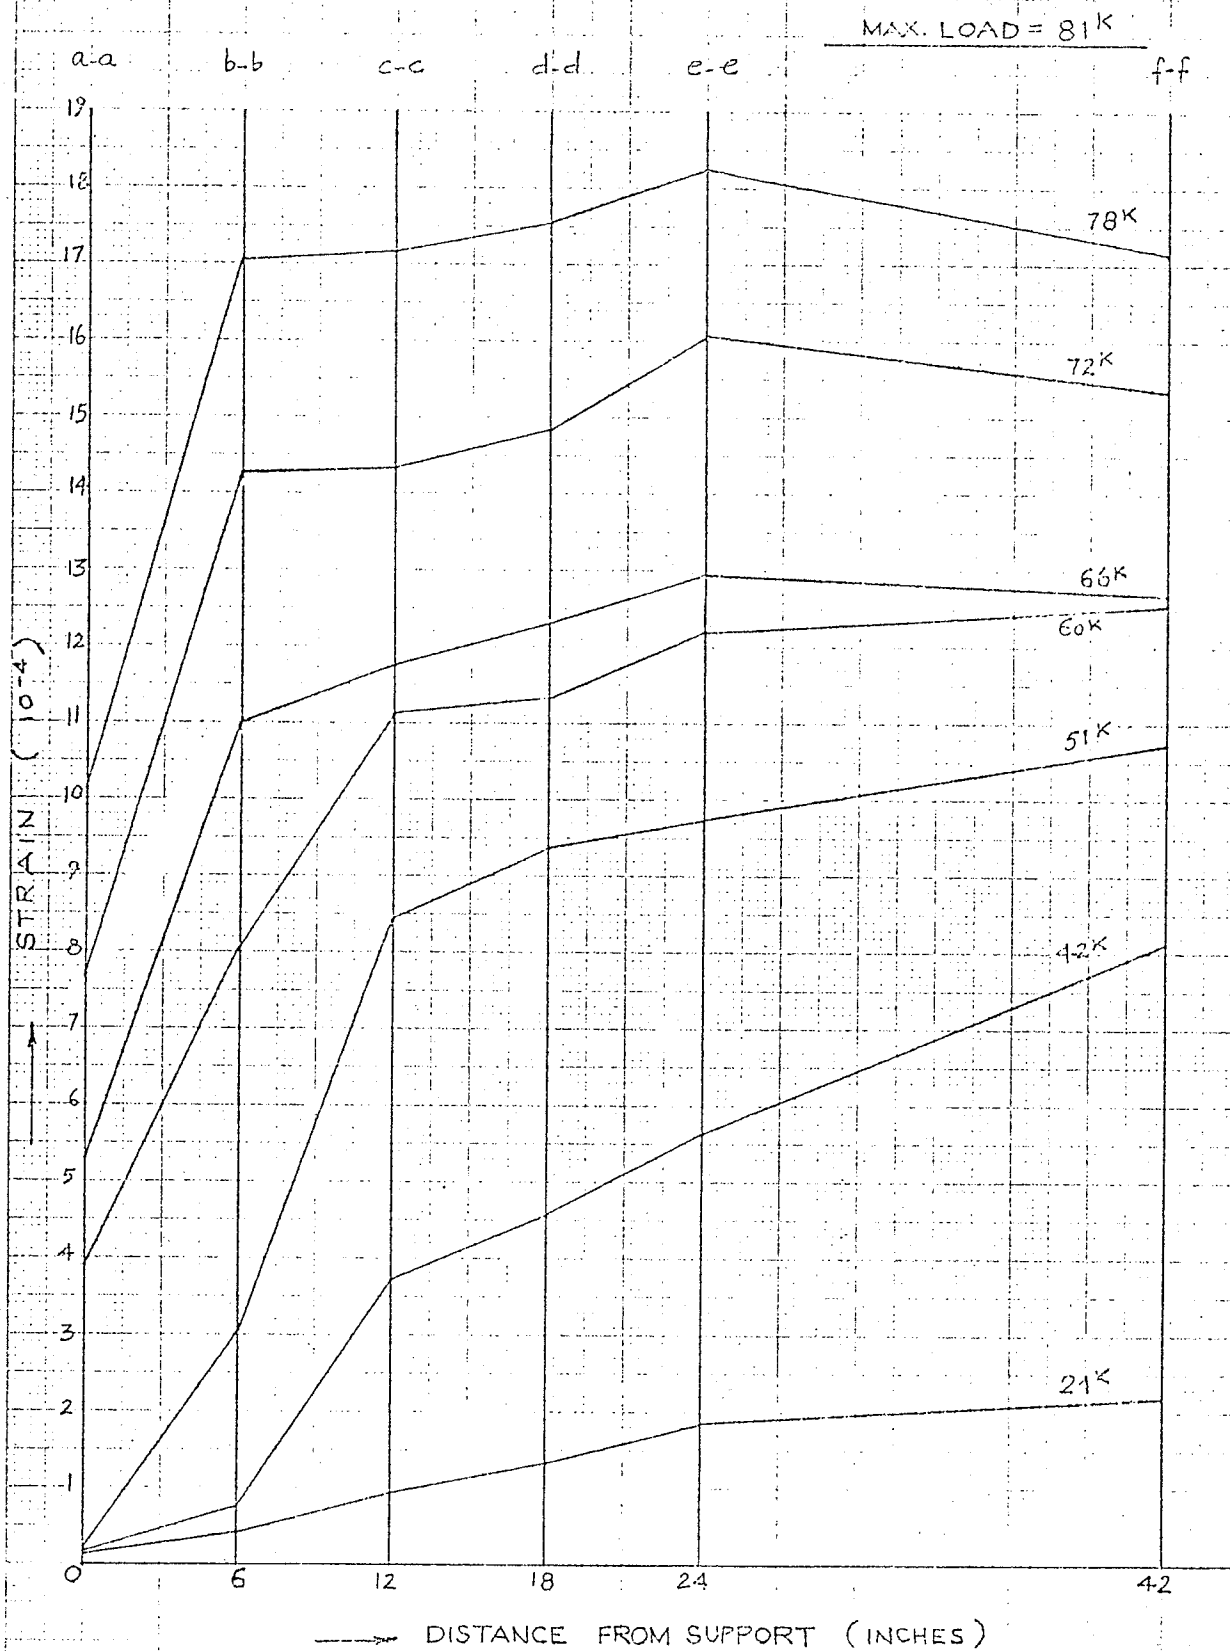
FIG. III.37— BEAM IIA-2 (b) — LONGITUDINAL STRAIN IN THE REINFORCEMENT

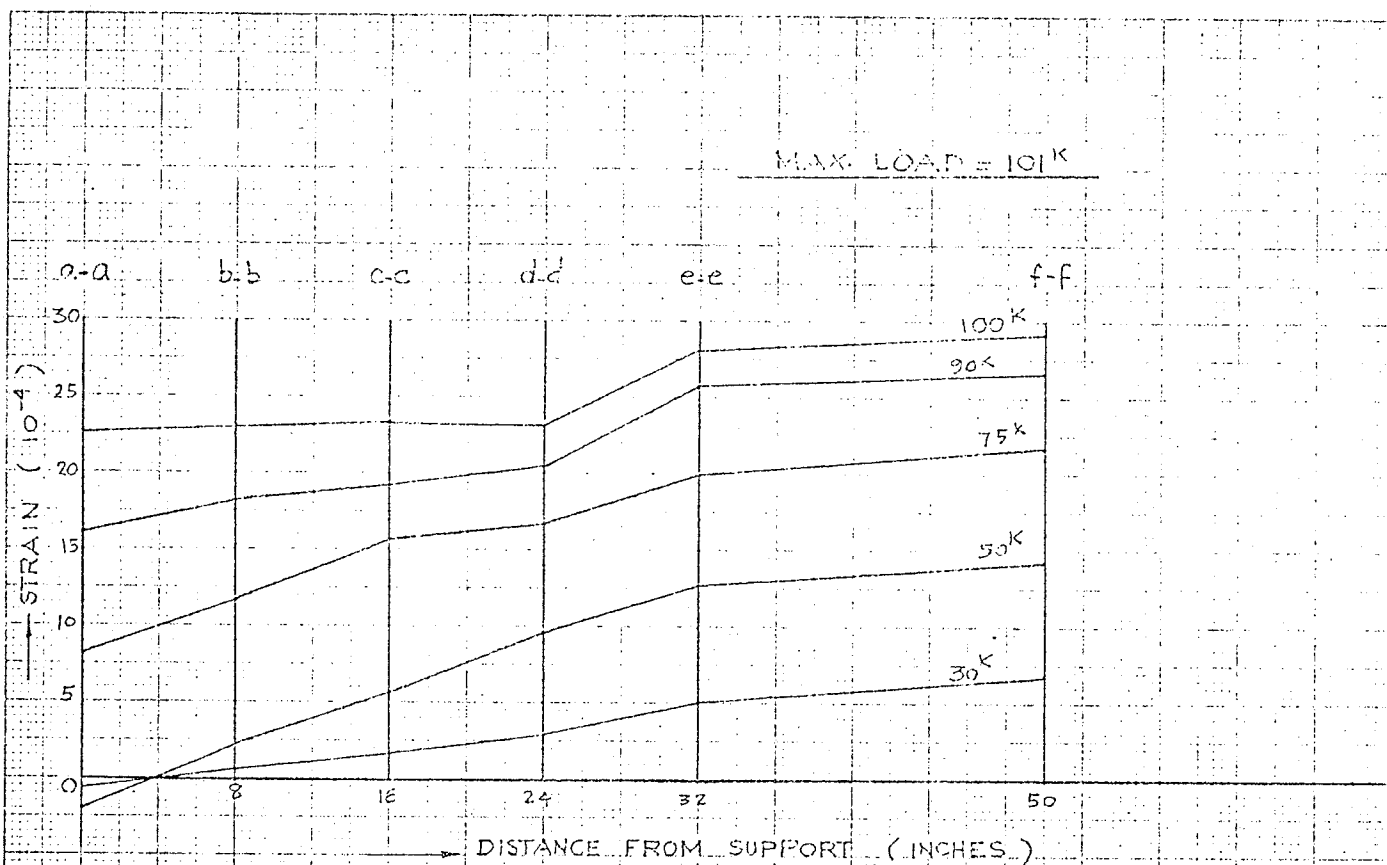
FIG. III.41 — BEAM IIIA-3: LONGITUDINAL STRAIN IN THE REINFORCEMENT

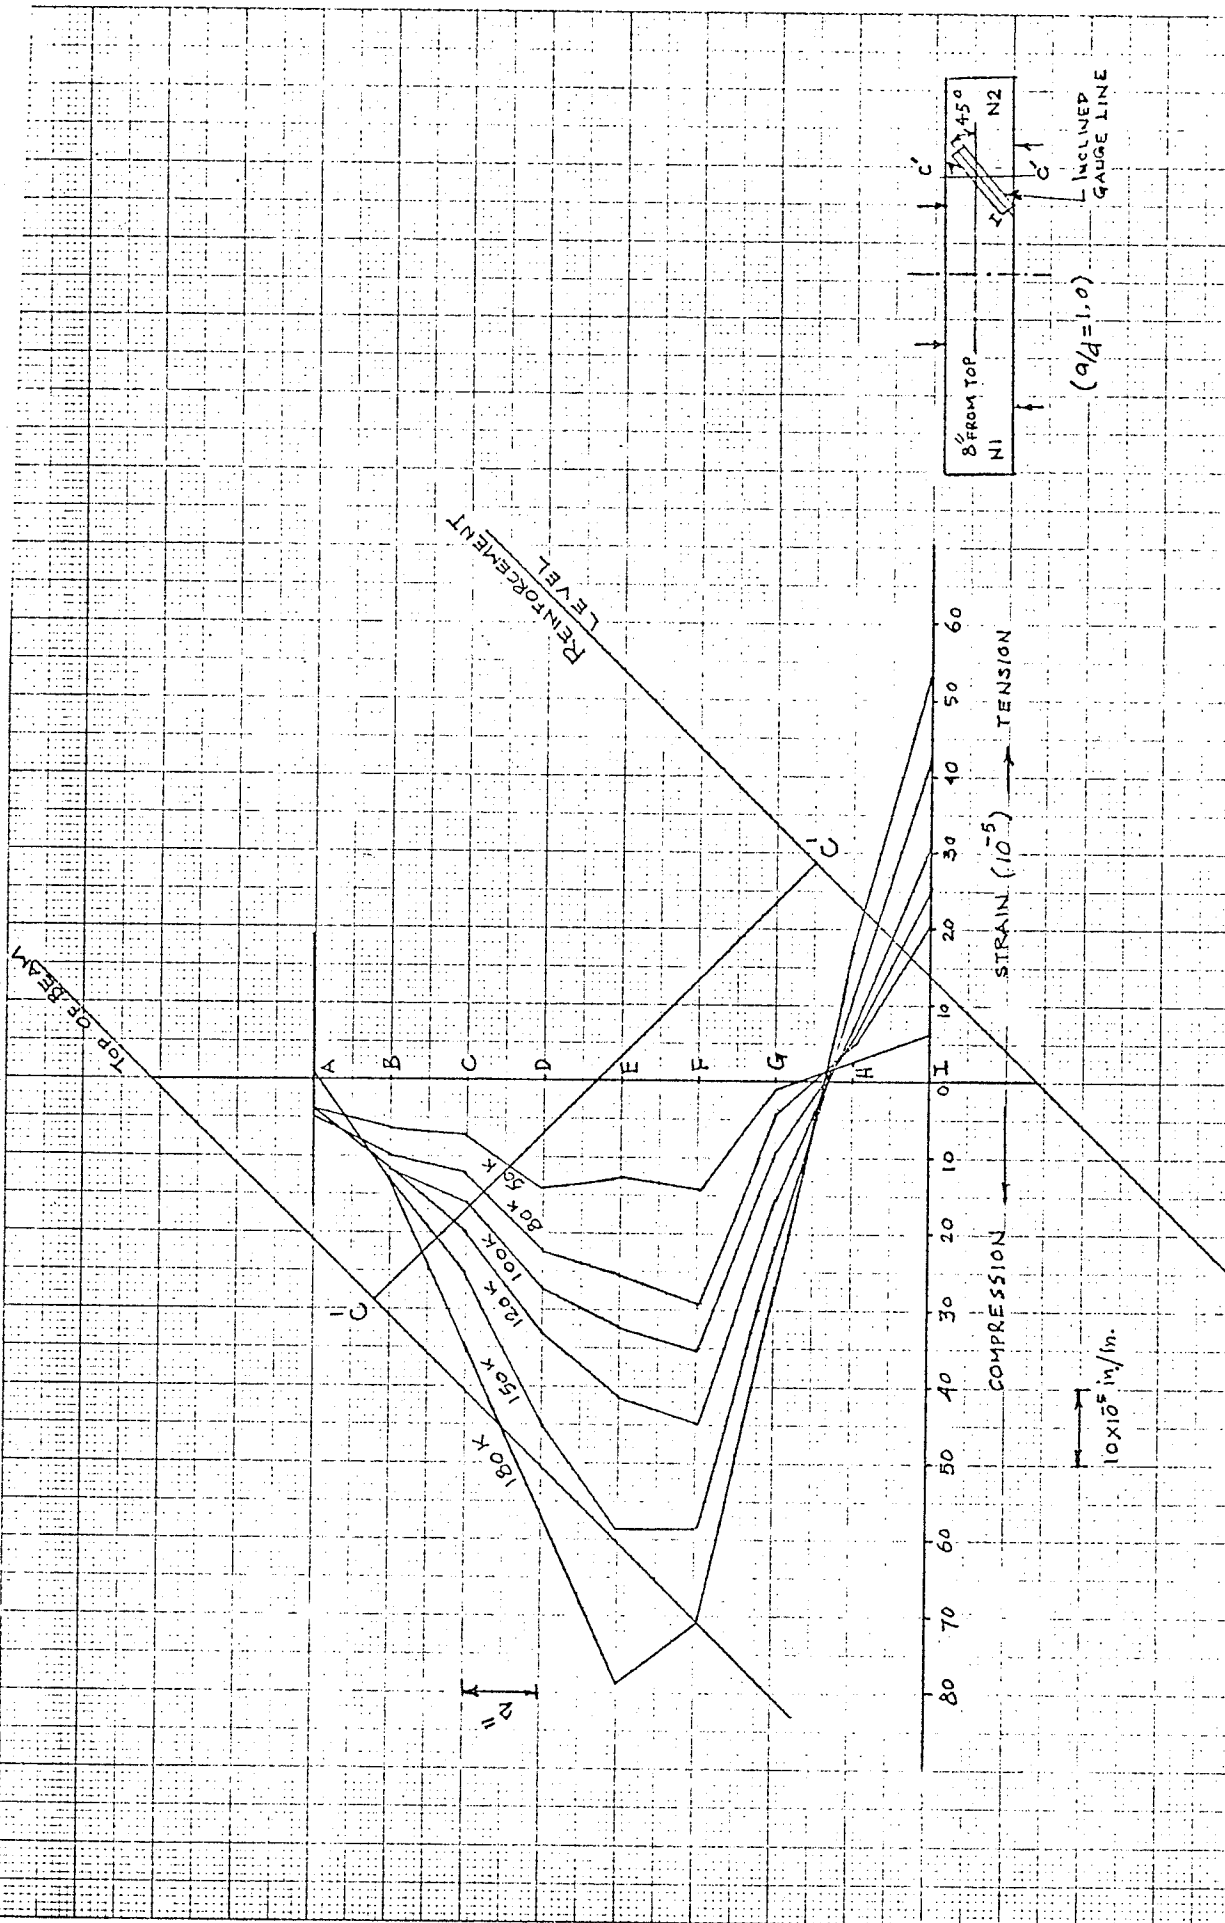
FIG. III-44-BEAM IA-1: Concrete Surface Strain on Inclined Gauge Lines

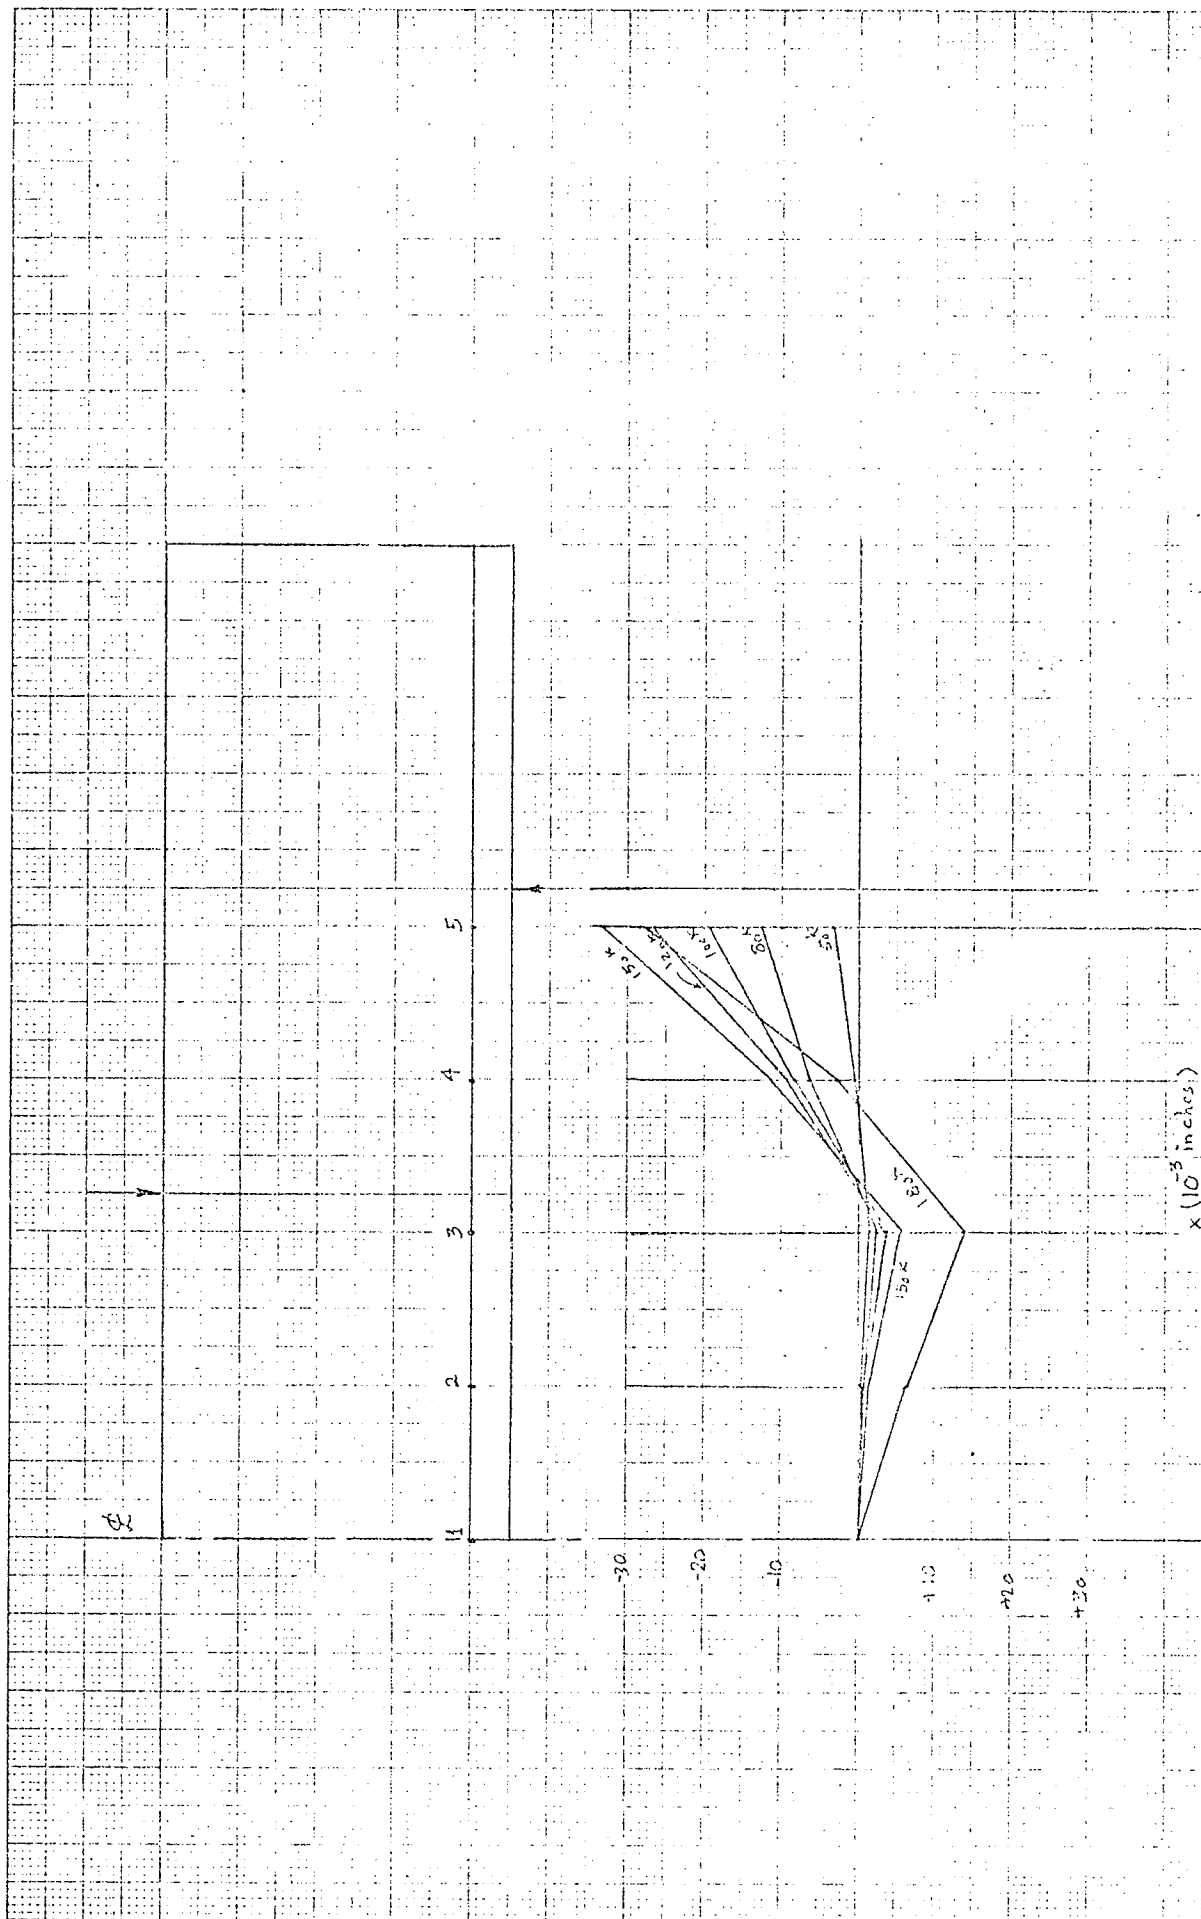
FIG. III-59 — BEAM IA-1 — Horizontal Displacement of Concrete Cantilevers

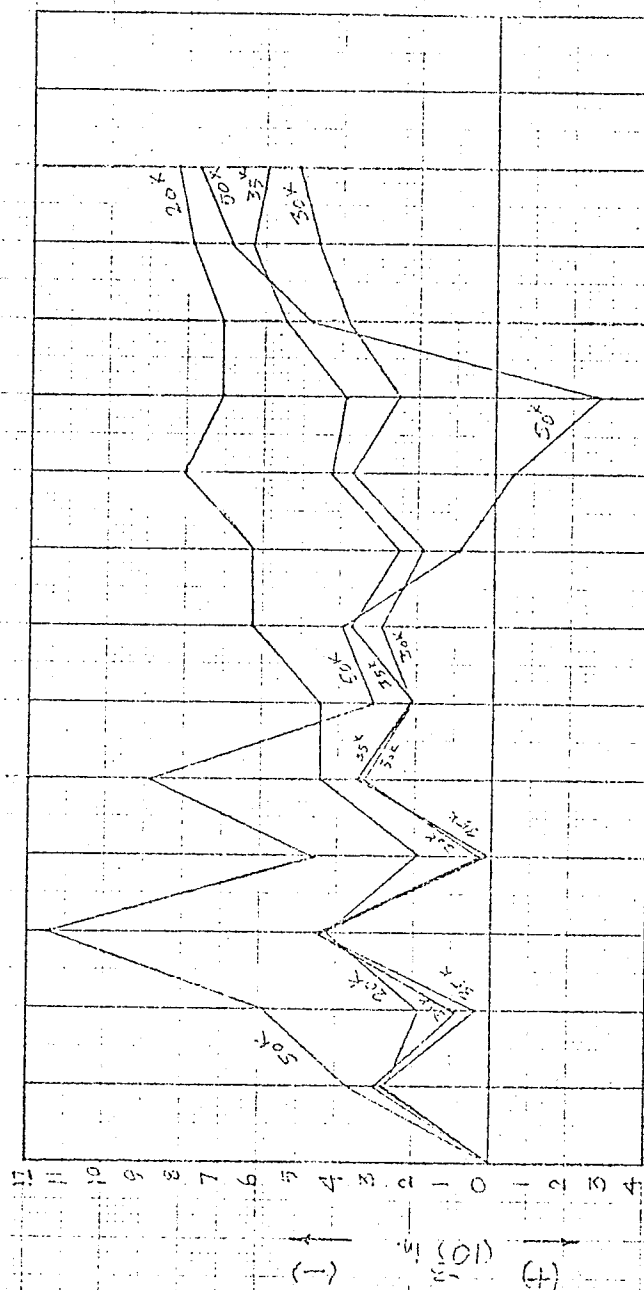
FIG. III.73 — Series III A: Horizontal Displacement of Concrete Cantilevers
Beam III A-8
