AN EXPERIMENTAL INVESTGATION OF THE
EFFECT OF REINFORCEMENT PATTERN
ON THE BEHAVIOR OF A DEEP
REINFORCED CONCRETE BEAM

A Thesis
Presented to
the Faculty of the Department of Civil Engineering
The University of Manitoba

by
Brian Ross Wood
September 1970

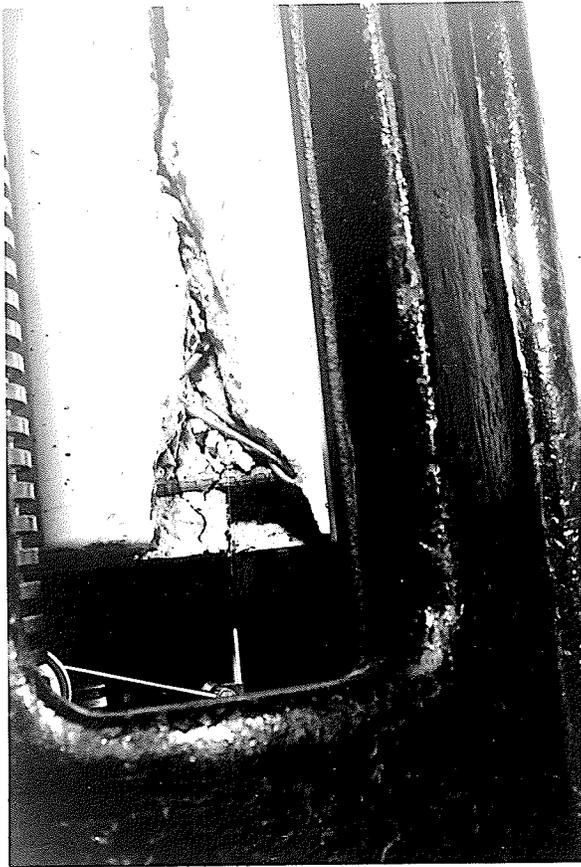
FIGURE 57
FRACTURED TENSILE BAR

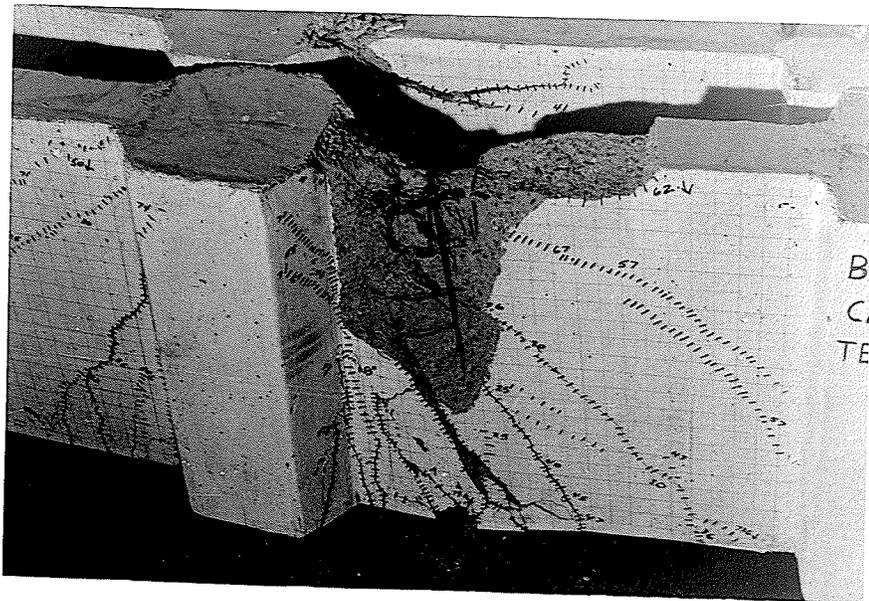
FIGURE 75
BEAM AFTER BROKEN CONCRETE REMOVED
