# ARCHFORM DESIGN AND TESTING OF A STEEL FREE DECK CONSTRUCTED USING PARTIAL DEPTH PRECAST CONCRETE PANELS

A Thesis submitted to  
The Faculty of Graduate Studies  
In Partial Fulfilment of the Requirements for the Degree of

Department of Civil Engineering  
University of Manitoba  
Winnipeg, Manitoba

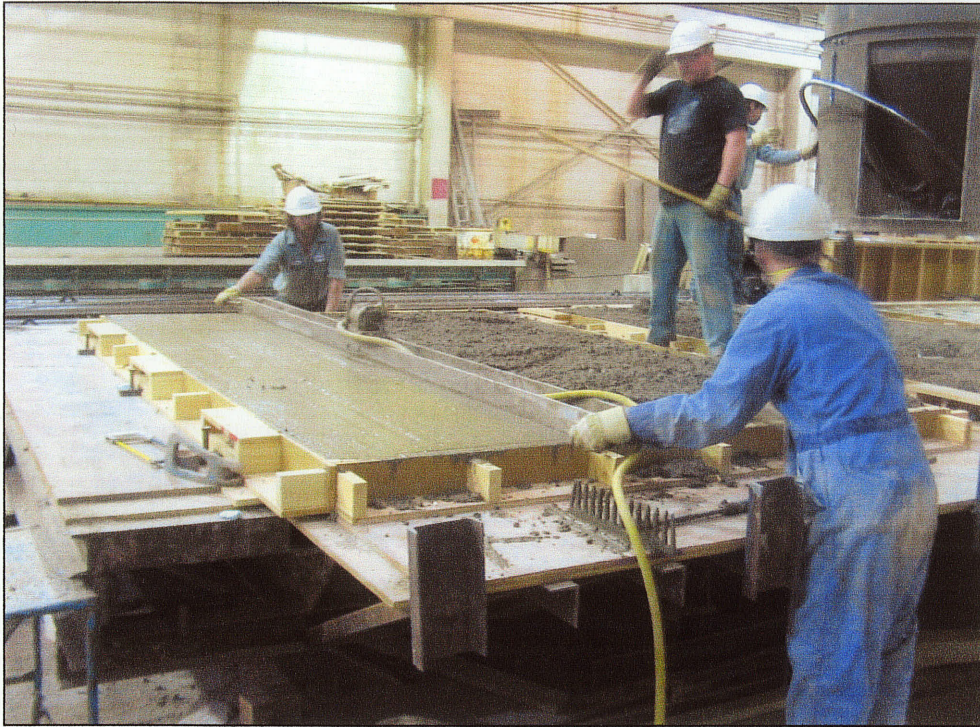
Figure 4-4. Compaction of Concrete using Vibratory Concrete Screed.

Concrete was mixed and poured at the precast plant as shown in Figure 4-4. Concrete was placed using a concrete bucket; shovels and rakes were used to provide a rough levelling. A vibrating screed was used to level the concrete and provide compaction and no handheld vibrators were required since the concrete depth was a maximum of 125 mm. The panels received a smooth trowel finish for the phase one testing.

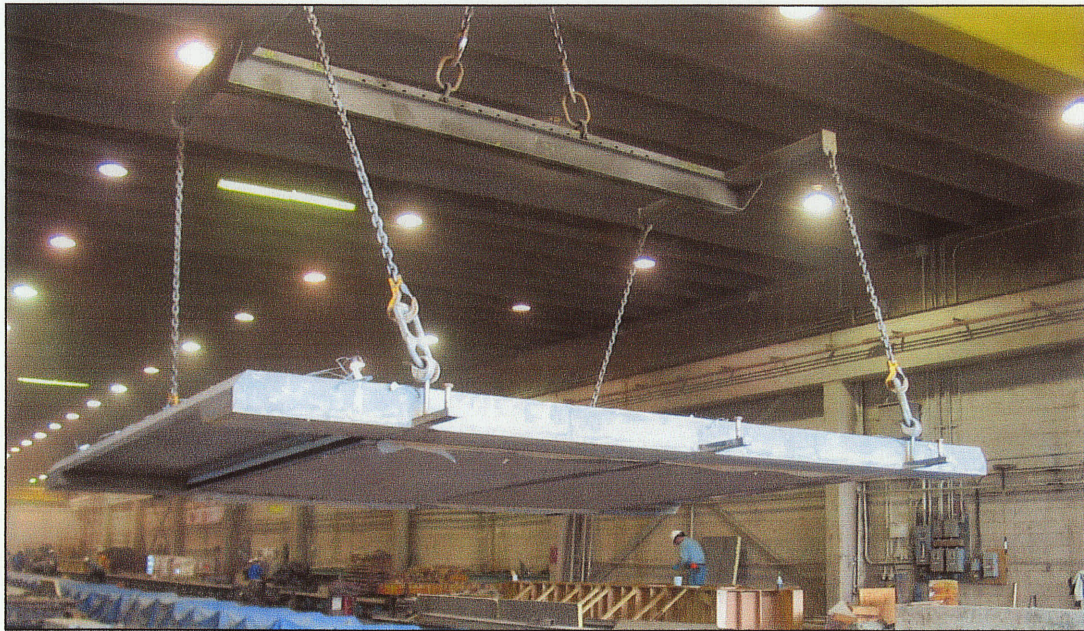
Figure 4-5. Handling and Moving of Panels.

The precast panels were lifted using an additional four Nelson studs at each of the four panel corners or by wrapping a strap underneath the steel strap at each of the four corners (Figure 4-5). These pick-up points were used to move the panels from their place of construction onto a flat bed trailer and from the trailer onto the tops of the girders. Prior to placing the panels on the steel girders, neoprene pads were set in place on top of the girder flange. Minor adjustments of these pads occurred once the panels were placed on the girders.

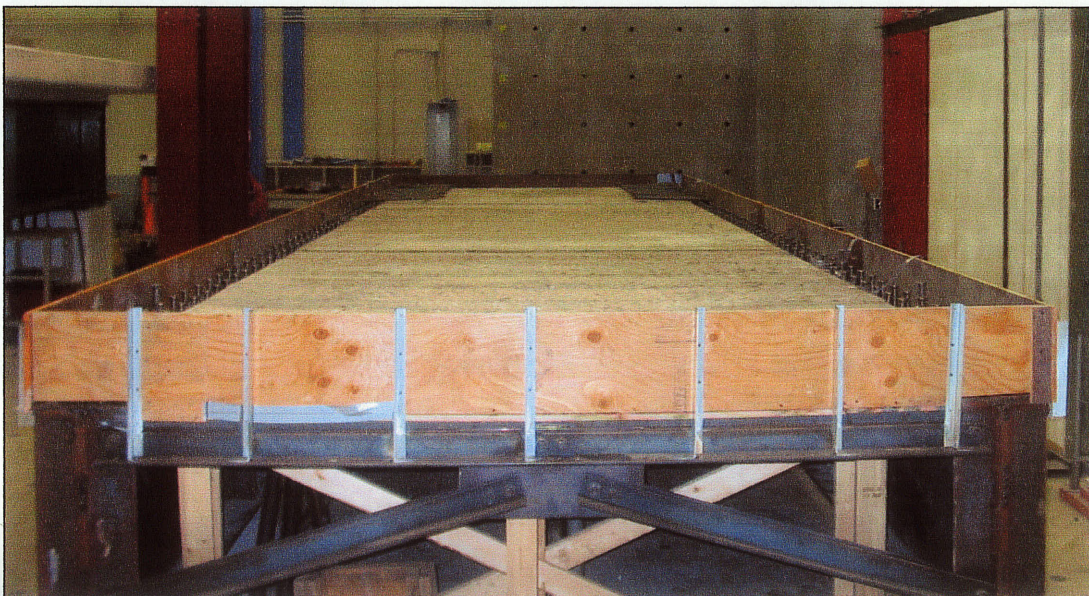
Figure 4-13. Deck Formwork.

A single deck was constructed during the phase two testing. The deck consisted of three precast panels which were used as stay-in-place forms during the pouring of the upper deck concrete. The ends of the deck were thickened and formed using plywood (Figure 4-13) to support cast-in place concrete. In addition, a transverse 200 mm deep steel channel was placed at the end of the girders above the cross bracing and welded to the underside of the girder's top flange. Nelson studs measuring 22 mm in diameter x 150 mm long were welded to the channel web in accordance with the standard edge stiffening detail provided by the CHBDC (Figure 4-14).
