PHYSICAL SALT ATTACK ON CONCRETE: MECHANISMS, INFLUENTIAL FACTORS AND MITIGATION

A Thesis Submitted to the Faculty of Graduate Studies of
the University of Manitoba
in partial fulfillment of the requirements for the degree of

Doctor of Philosophy

Department of Civil Engineering
University of Manitoba
Winnipeg

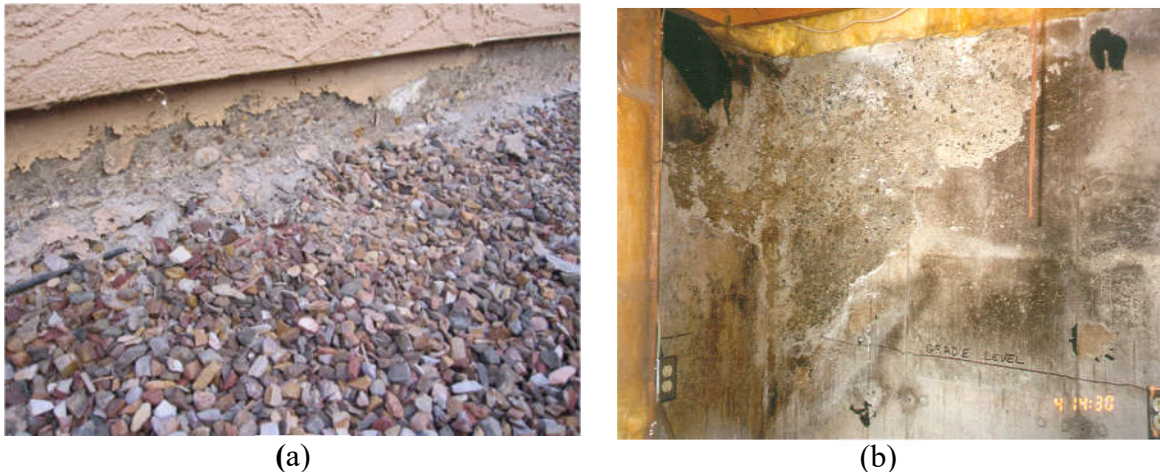
Figure 2.1: Example of PSA occurring in basement walls due to sodium sulfate from: (a) outside (courtesy of Harvey Haynes, California, USA), and (b) inside (courtesy of Robert L. Day, Alberta, Canada).

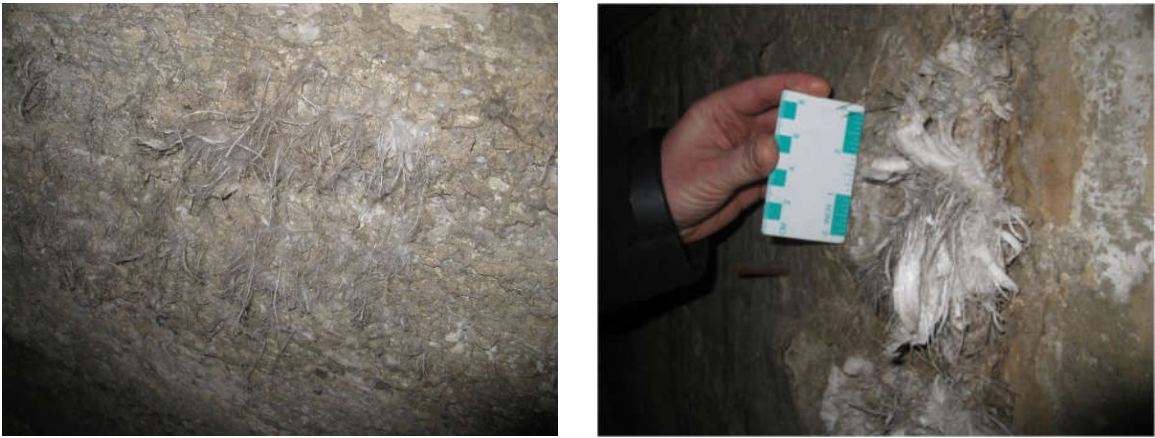
Figure 2.2: Walls in a service tunnel showing efflorescence and scaling of concrete involving sodium chloride (courtesy of Robert L. Day, Alberta, Canada).

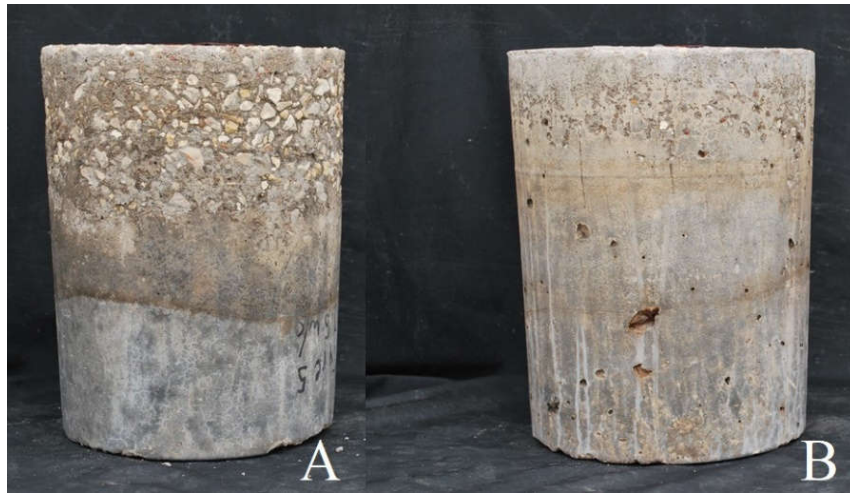
Figure 2.7: PSA on large 0.0189 m³ buckets of 0.50 w/b concrete: (a) Type V cement with 30% Class F fly ash, and (b) Type V Cement without fly ash. [Note: These samples were placed half submerged in soil in the 5% sodium sulfate trench, Fig. 2.4]

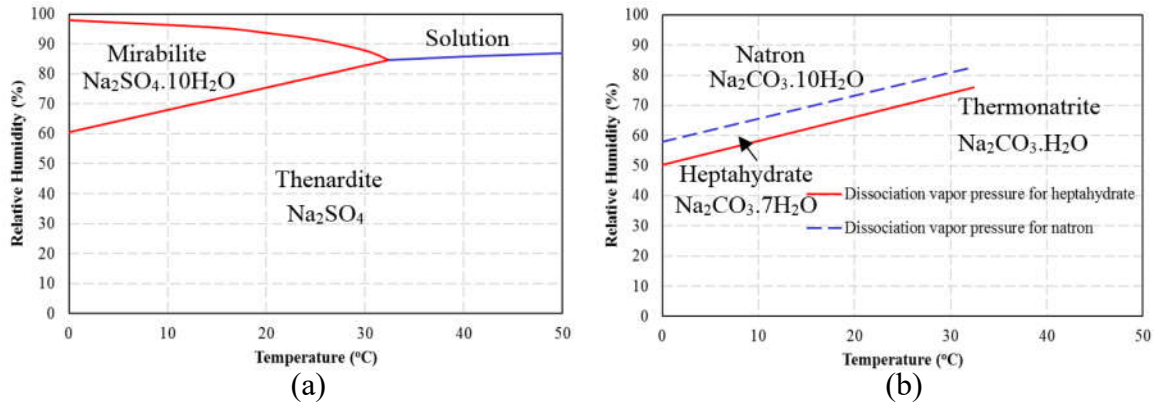
Figure 2.8: Phase diagrams of: (a) sodium sulfate (after Flatt 2002), and (b) sodium carbonate (after Goudie and Viles 1997).

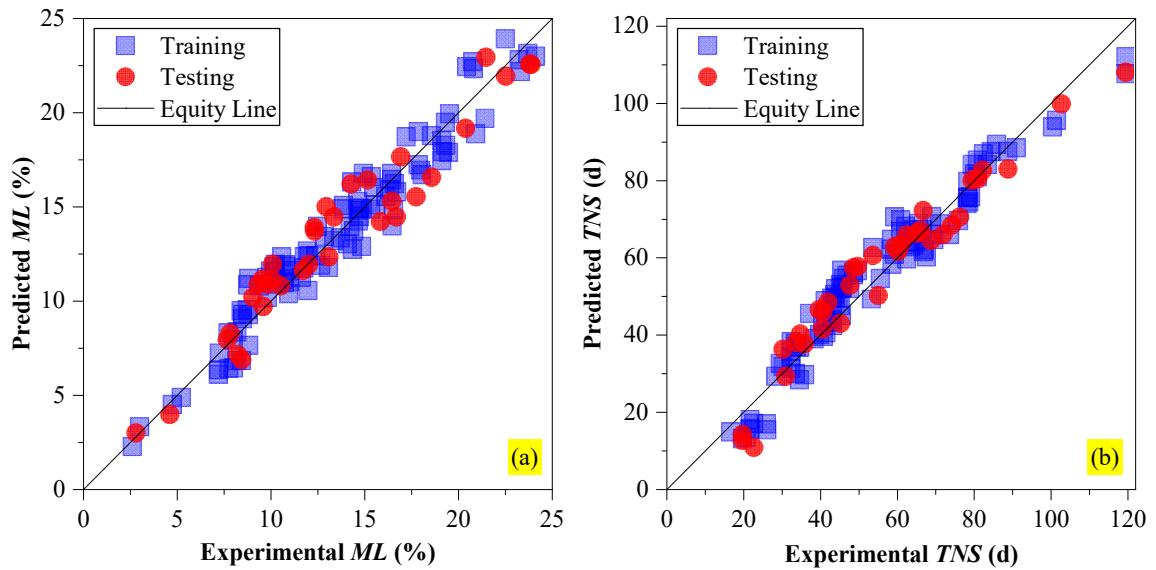
Figure 3.7: Experimental vs. predicted values of: (a) *ML*, and (b) *TNS* models obtained by multiple regression analysis.

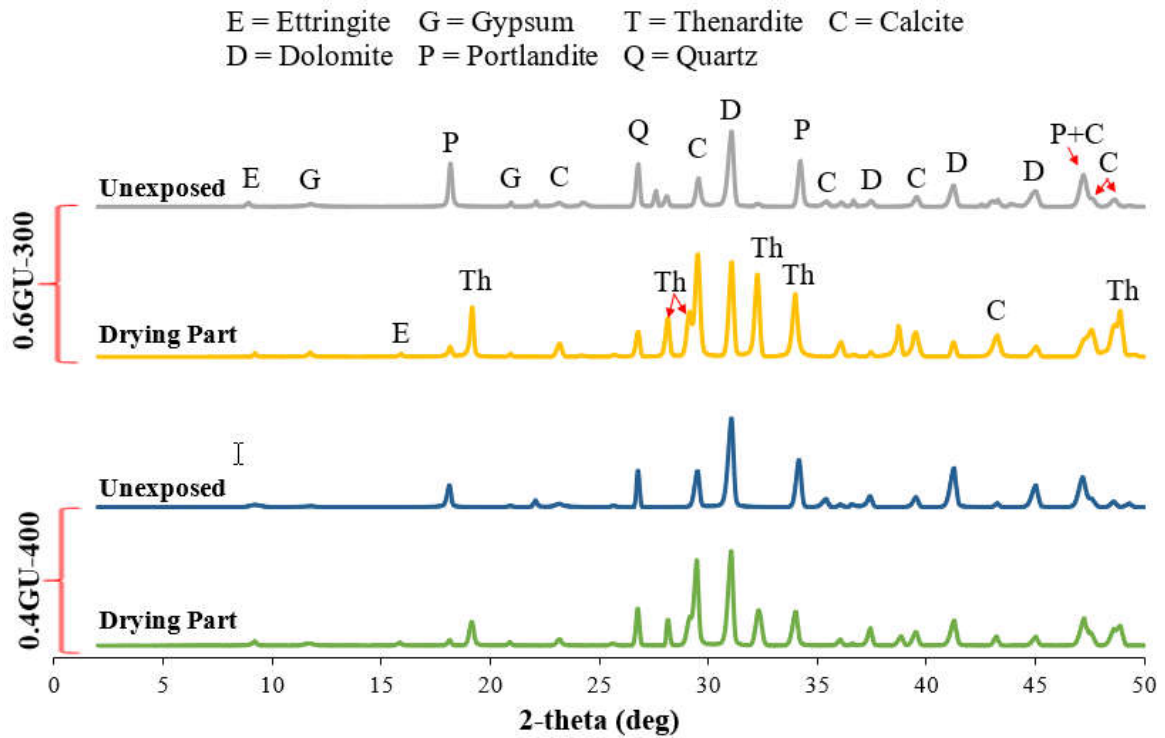
Figure 3.8: Exemplar XRD analysis of unexposed and exposed specimens made with different w/b and B , without SCMs.

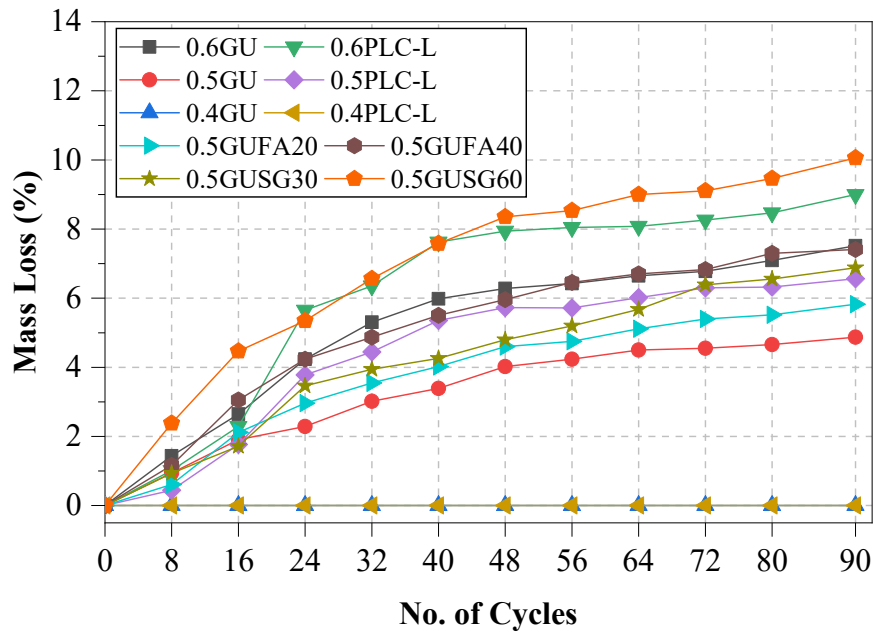
Figure 4.5: Variation of mass loss of specimens during the combined exposure (PSA and carbonation).

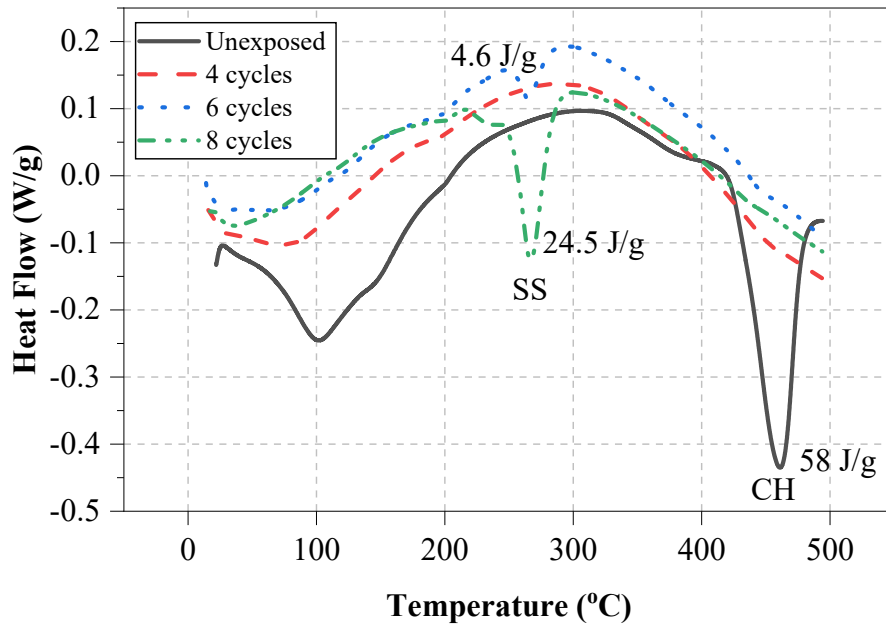
Figure 4.9: DSC curves of 0.5GU specimens (drying portion) exposed to combined PSA and carbonation at different time intervals. (Note: SS = sodium sulfate; CH = calcium hydroxide).

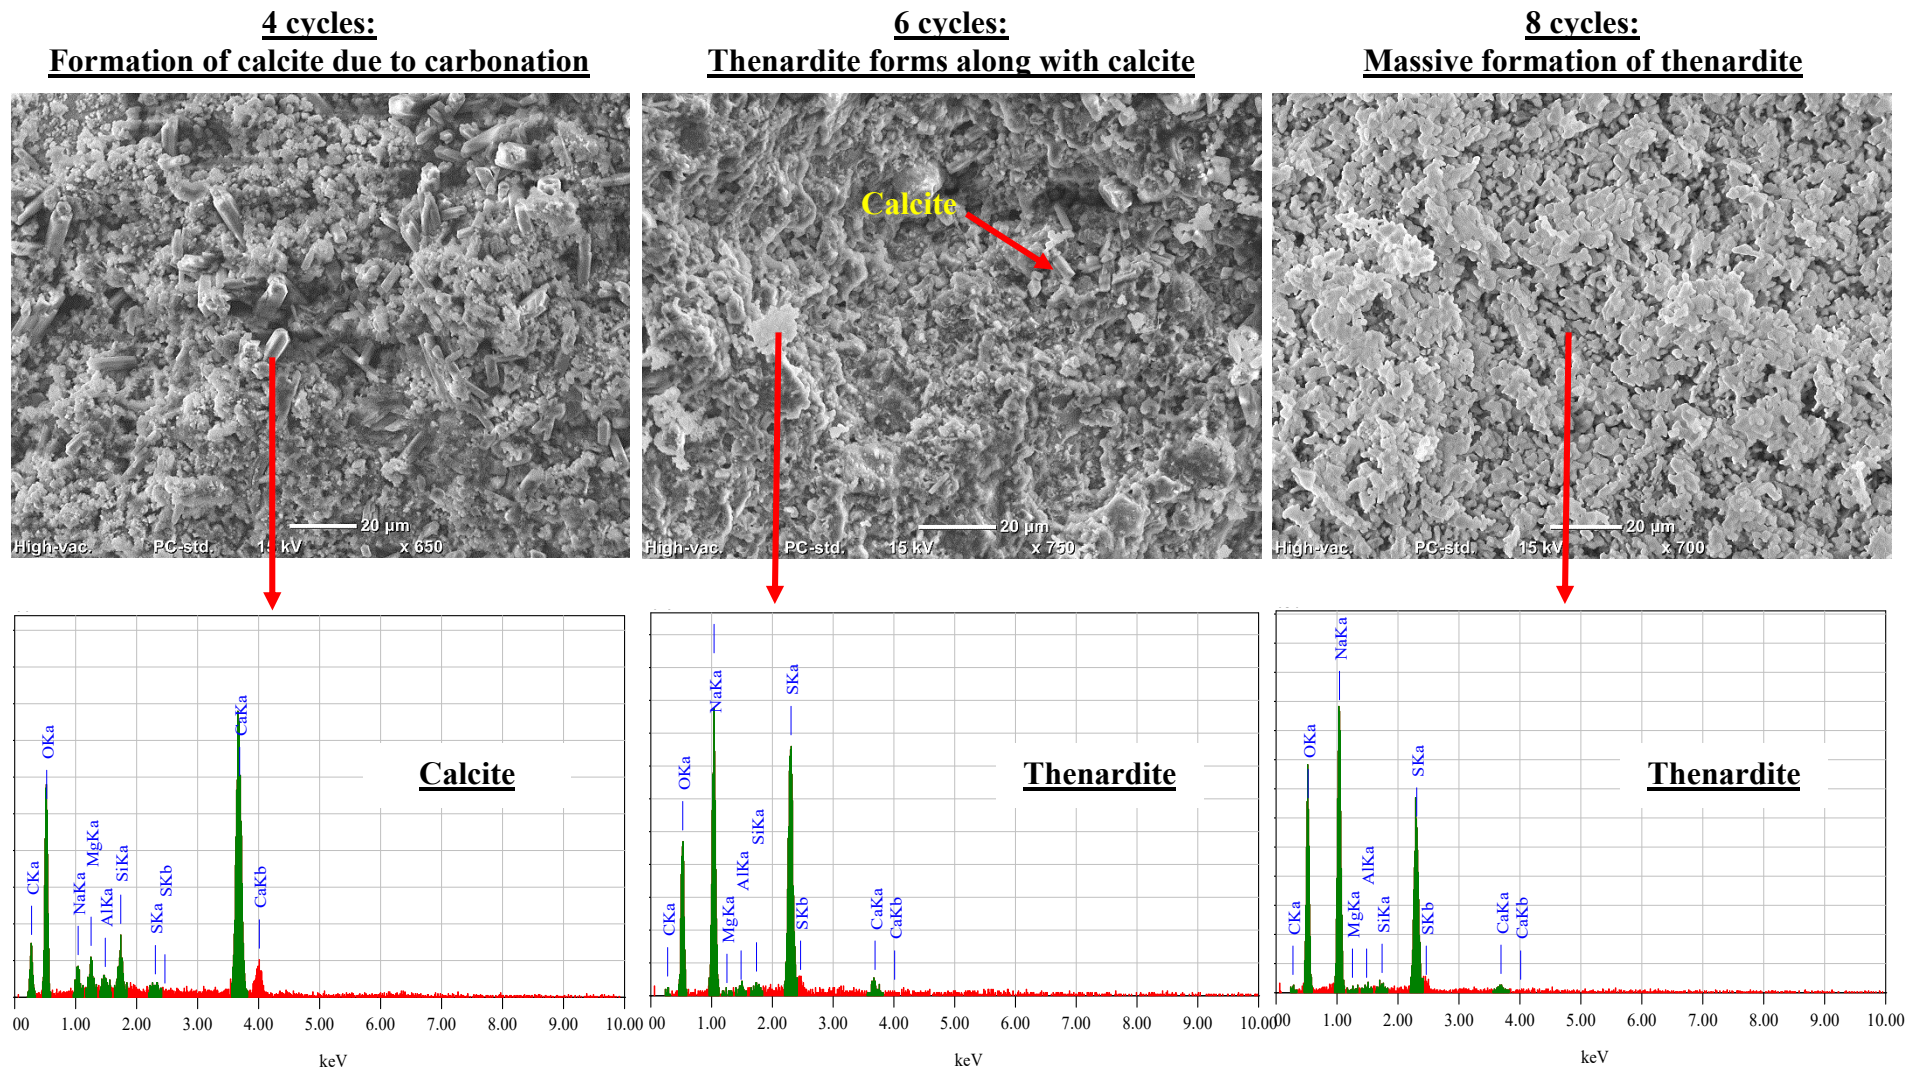
Figure 4.10: SEM and EDX analyses of surface layer (0-3 mm) of 0.5GU specimens showing the alteration of microstructure in the drying portion during the combined exposure.

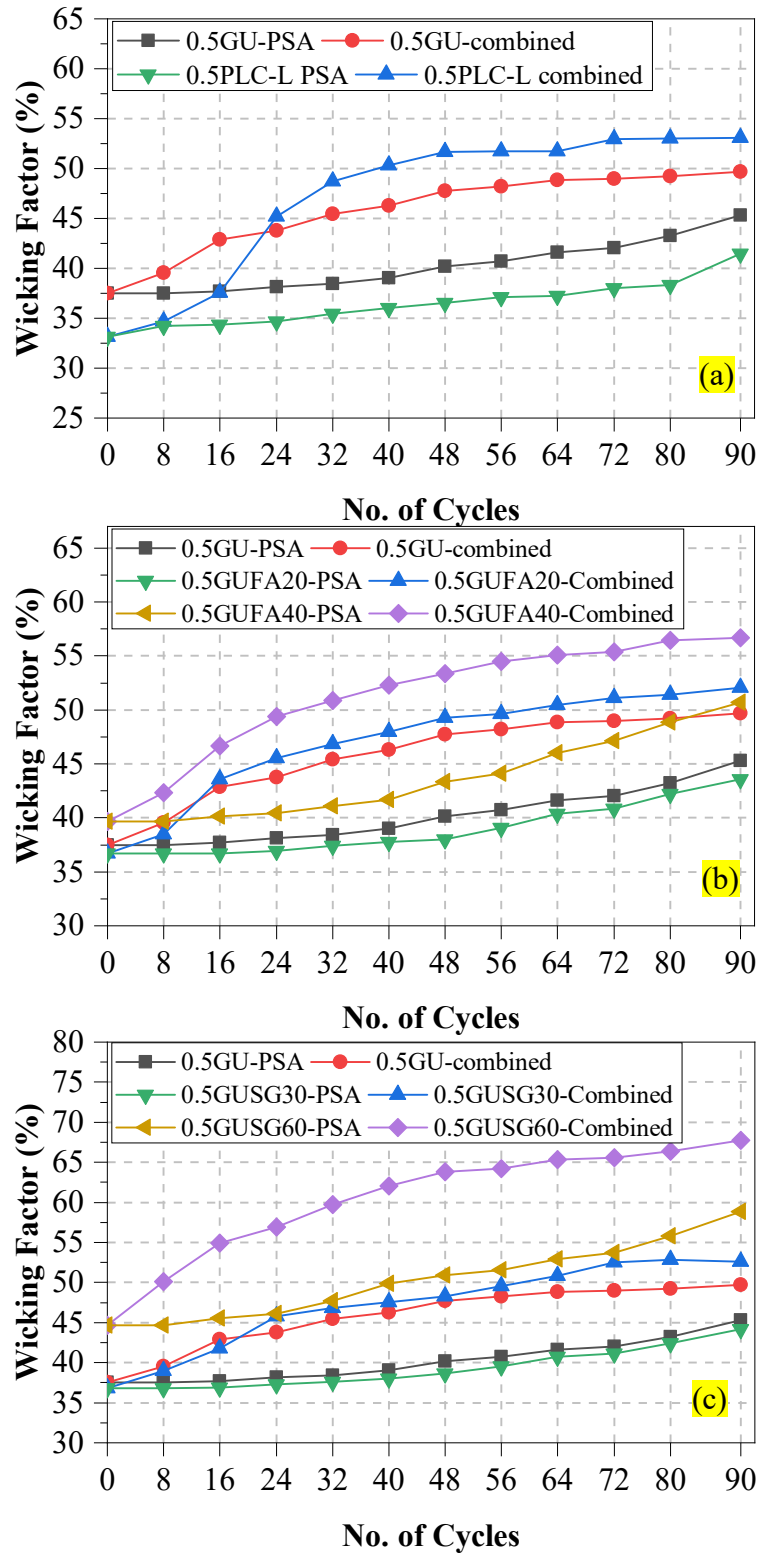
Figure 4.11: Variation of the wicking factor in specimens made from: (a) single, (b) binary/fly ash, and (c) binary/slag binders at w/b of 0.50 under different exposures.

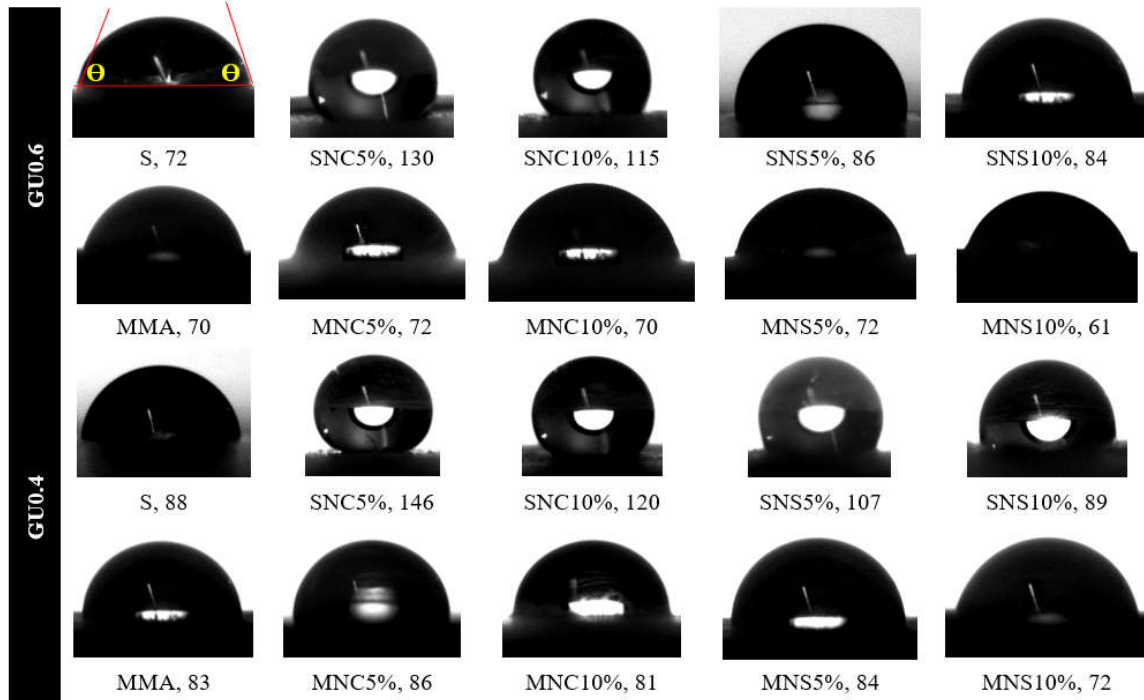
Figure 7.2: Contact angles (degrees) of concrete coated with various nanocomposites at different w/b .
