Repair of GFRP Reinforced Concrete Bridge Barriers

A Thesis submitted to the Faculty of Graduate Studies of
The University of Manitoba
in partial fulfillment of the requirements of the degree of

Department of Civil Engineering
University of Manitoba
Winnipeg, Manitoba, Canada

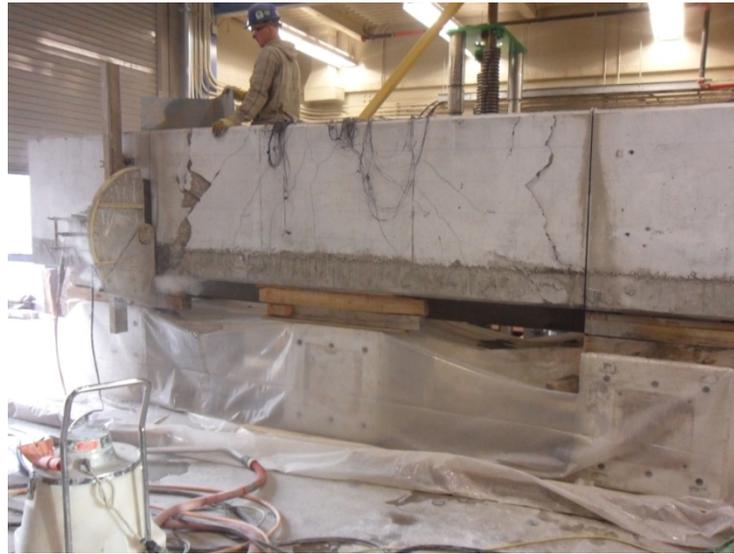
Figure (3.24): Saw cutting of damaged middle portion

- A 3.2-m long damaged middle portion of the barrier wall including the underneath overhang slab was cut off using concrete saw. Figure 3.24 shows the saw cut of barrier wall.

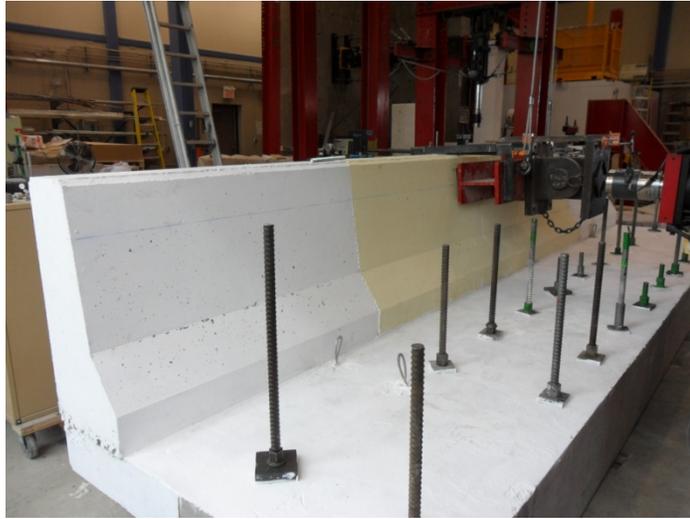
Figure (3.35): Splice repaired middle portion (in yellow color)

- Then concrete was cast in the repaired part. Figure 3.35 shows splice repaired middle portion.

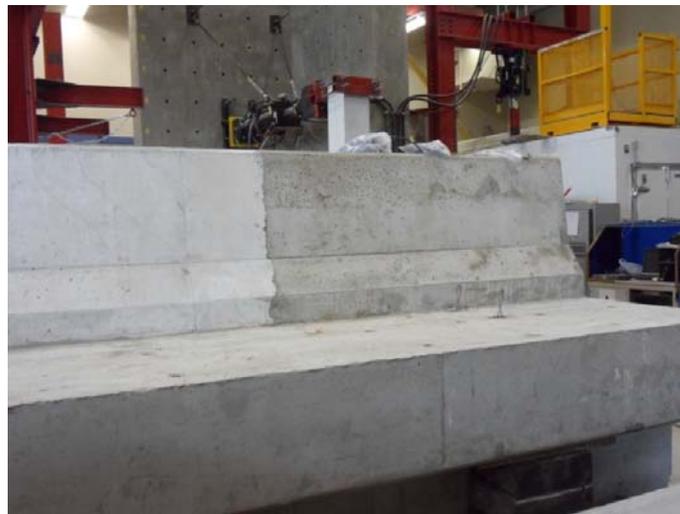
Figure (3.42): Splice repaired edge (in gray color)

- Then concrete was cast in the repaired edge. Figure 3.42 shows the repaired edge after concrete casting.

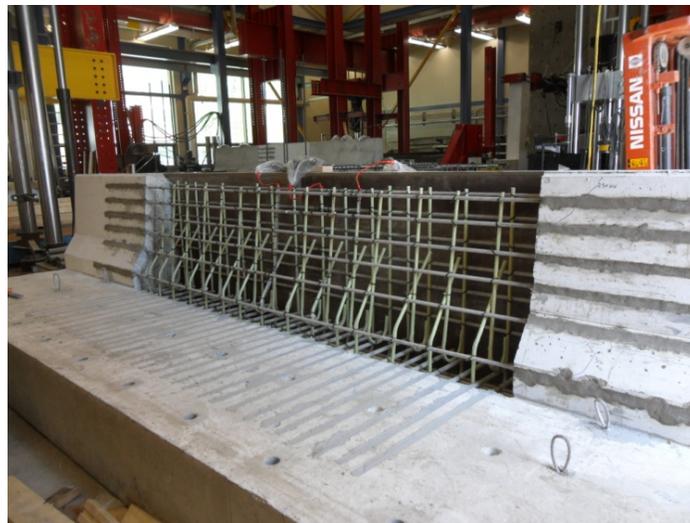
Figure (3.54): New reinforcement at NSM repaired middle portion

- After finishing bar plantations, new reinforcements were tied up. Figure 3.54 shows new reinforcement at NSM repaired middle portion.

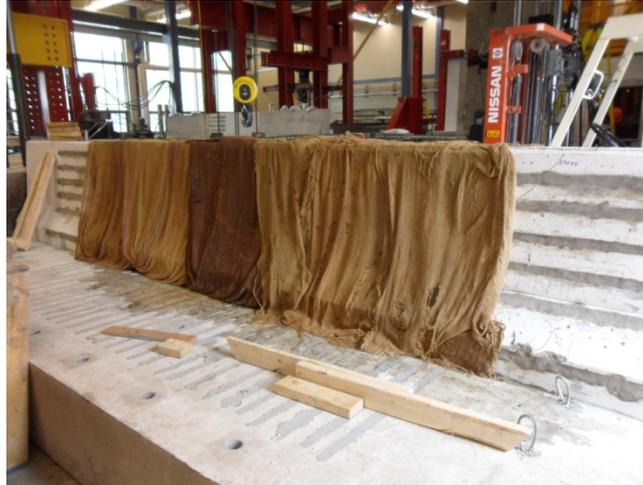
Figure (3.55): NSM repaired middle portion during curing

- Then concrete was casted in the repaired middle portion. Figure 3.55 shows NSM repaired middle portion during curing.

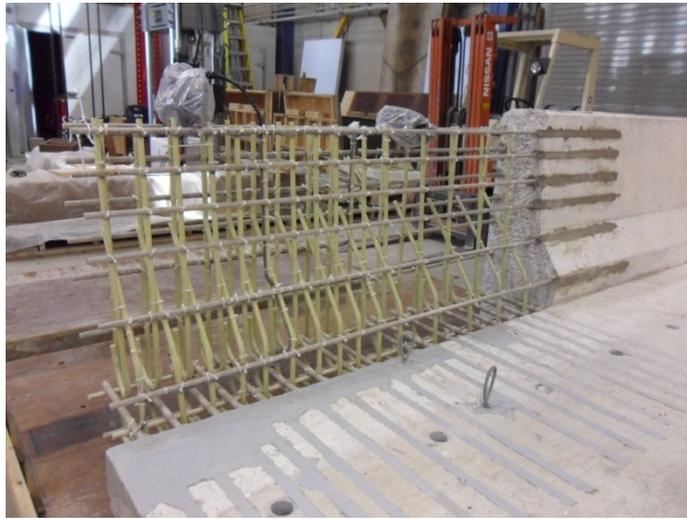
Figure (3.59) New NSM reinforcement at edge

- Strain gauges were placed on vertical, transverse and horizontal bars as shown in Figure 3.3 and 3.5.
- Barrier wall grooves were filled with epoxy up to 25 mm depth and then horizontal bars were placed in them and rest of the depth of grooves were filled by grout. Deck slab grooves were filled with epoxy fully and then transverse bars were placed. Damaged overhang edge was filled with epoxy.
- Epoxy was injected into the holes using injection gun, and then bars were pushed into holes.
- After finishing bar plantations, new reinforcements were tied up. Figure 3.59 shows new reinforcement at edge

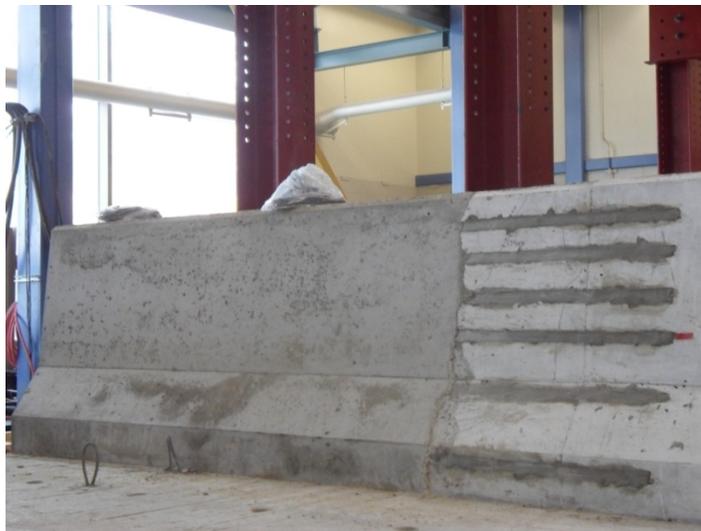
Figure (3.60): NSM repaired edge (in gray color)

- Then concrete was cast in the repaired edge. Figure 3.60 shows the repaired edge after concrete casting.

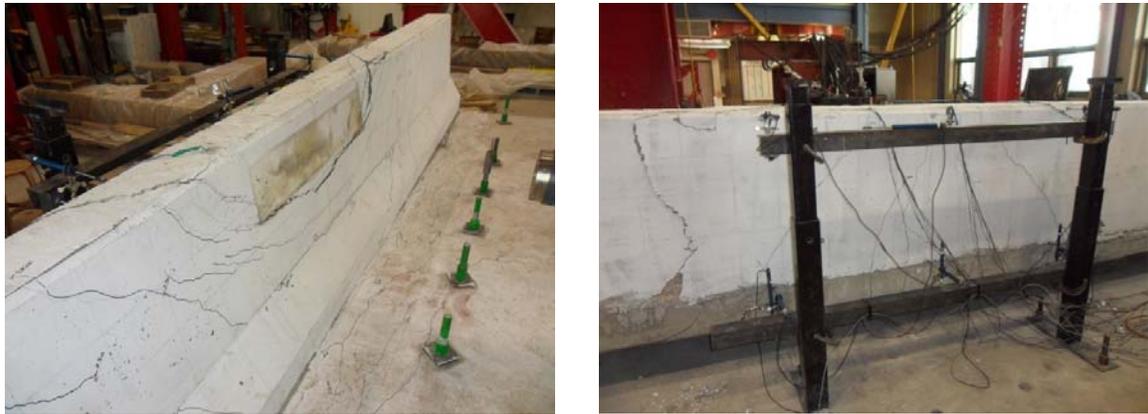
Figure (4.4): Cracking pattern of M1 prototype

m. In both LE and RE prototypes, this critical length was approximately 2.0 m. Cracks formed in trapezoidal shape on the front face of barrier wall. While on the back face, cracks were formed in the vertical direction. Typical cracking patterns are shown in Figure 4.4 to 4.7.

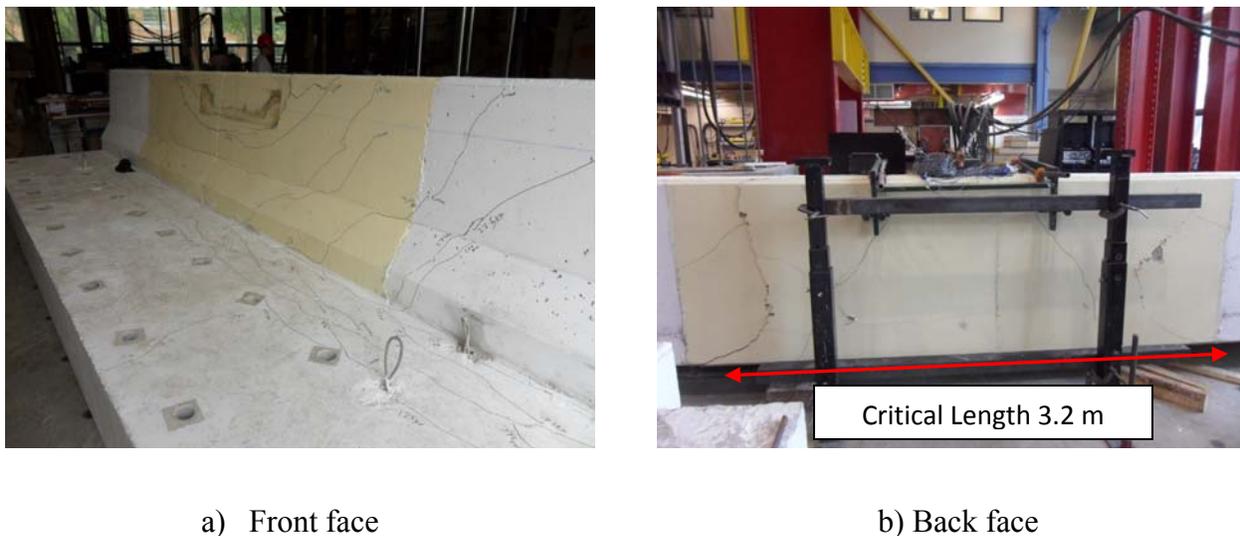
Figure (5.5): Cracking pattern of M1-P
