THE EFFECTS OF PHYSICAL ENVIRONMENT ON BURIED PIPE

A Thesis

Master of Science in Civil Engineering

By
John James Hamilton
May 1956

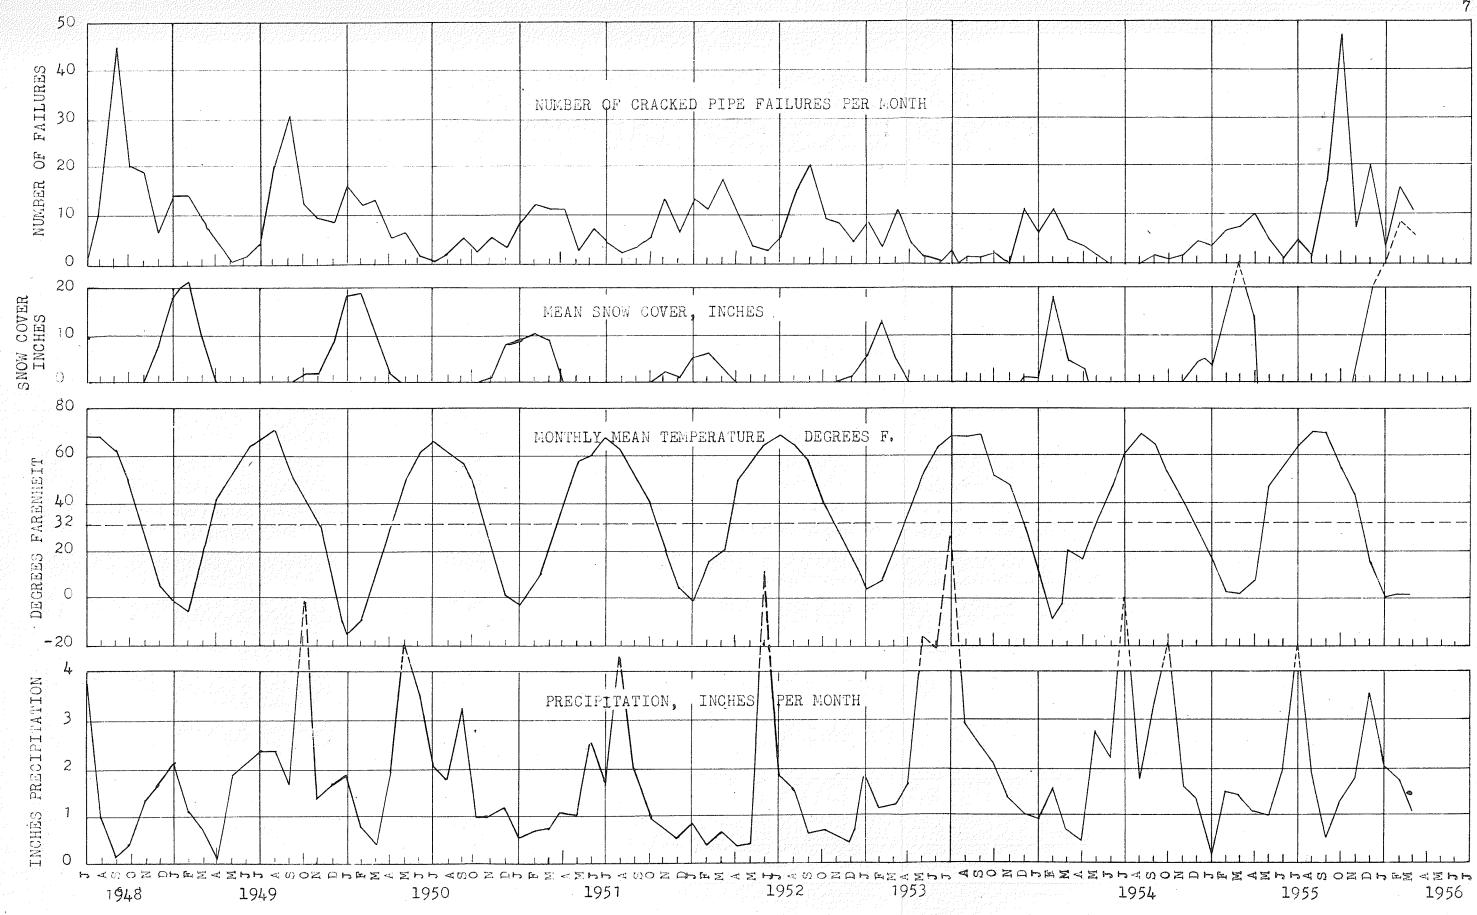
GRAPH 1 - Number of "Cracked Pipe" Failures, Mean Monthly Temperature, Monthly Precipitation, and Snow Cover, Versus Time, July 1948 to March 1956

It is interesting to note that the periods of maximum shrinkage as measured by the University apparatus correspond very closely with periods of peak failures in the Winnipeg Water Works system. These results would seem to substantiate the results of the preliminary investigation which indicated that seasonal soil volume changes had a direct bearing on "cracked pipe" failures.

Prior to the installation of any test apparatus, study of records maintained by the City of Winnipeg Water Works Department, seemed to indicate that seasonal soil volume changes had a direct bearing on pipe failures of the type described by the term "cracked pipe". This designation is used where the pipe has cracked transversely near the mid-length and where flexural failure has been suspected. Graph I prepared from City Records shows the number of failures per month attributed to "cracked pipe" for the period from 1948 to the time of writing. Also shown are monthly mean air temperatures, precipitation, and approximate depth of snow cover, plotted from data obtained from the Meteorological Division, Department of Transport. This graph shows a definite cyclic pattern of failures with the months of September and February having the most failures. The winter failure rate, (usually the peak occurring in January or February but sometimes as late as March) seems to be the most consistent, ranging between 10 to 15 failures per month. The critical month in the fall period is September, in which the rate has reached as high as 48 failures. This September failure peak however, is not nearly as consistent as the winter peak with some years having as low as two breaks during this month. Further study of Graph I seems to indicate that a relatively hot, dry August - September period always preceded a September of peak failure rate, whereas a relatively cool, wet August - September period preceded

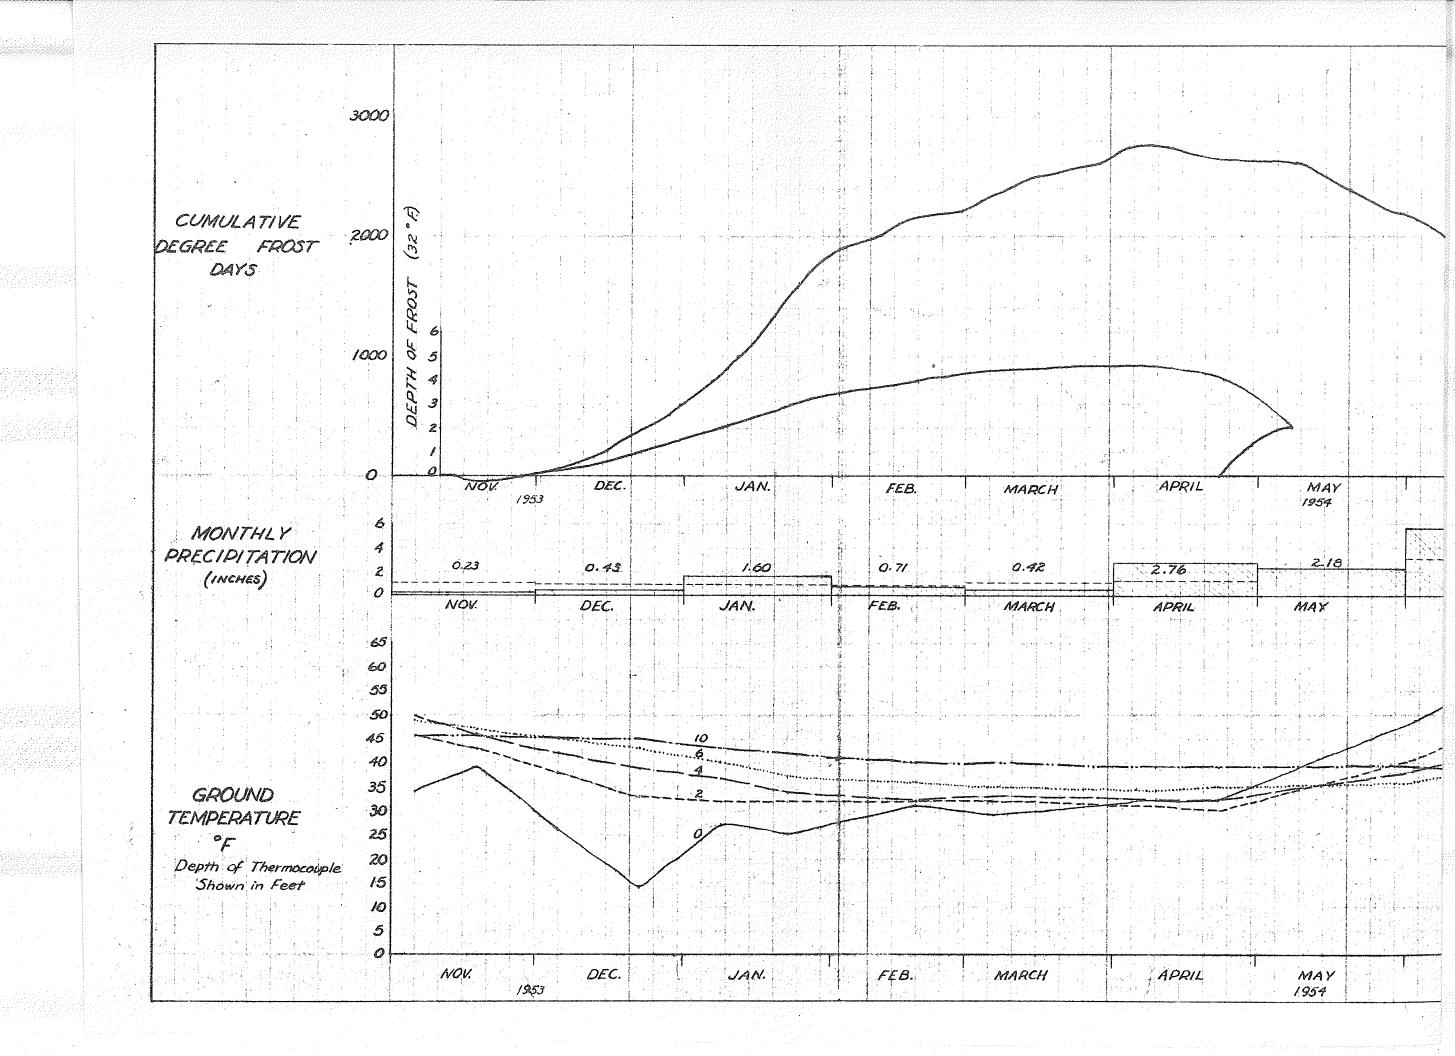
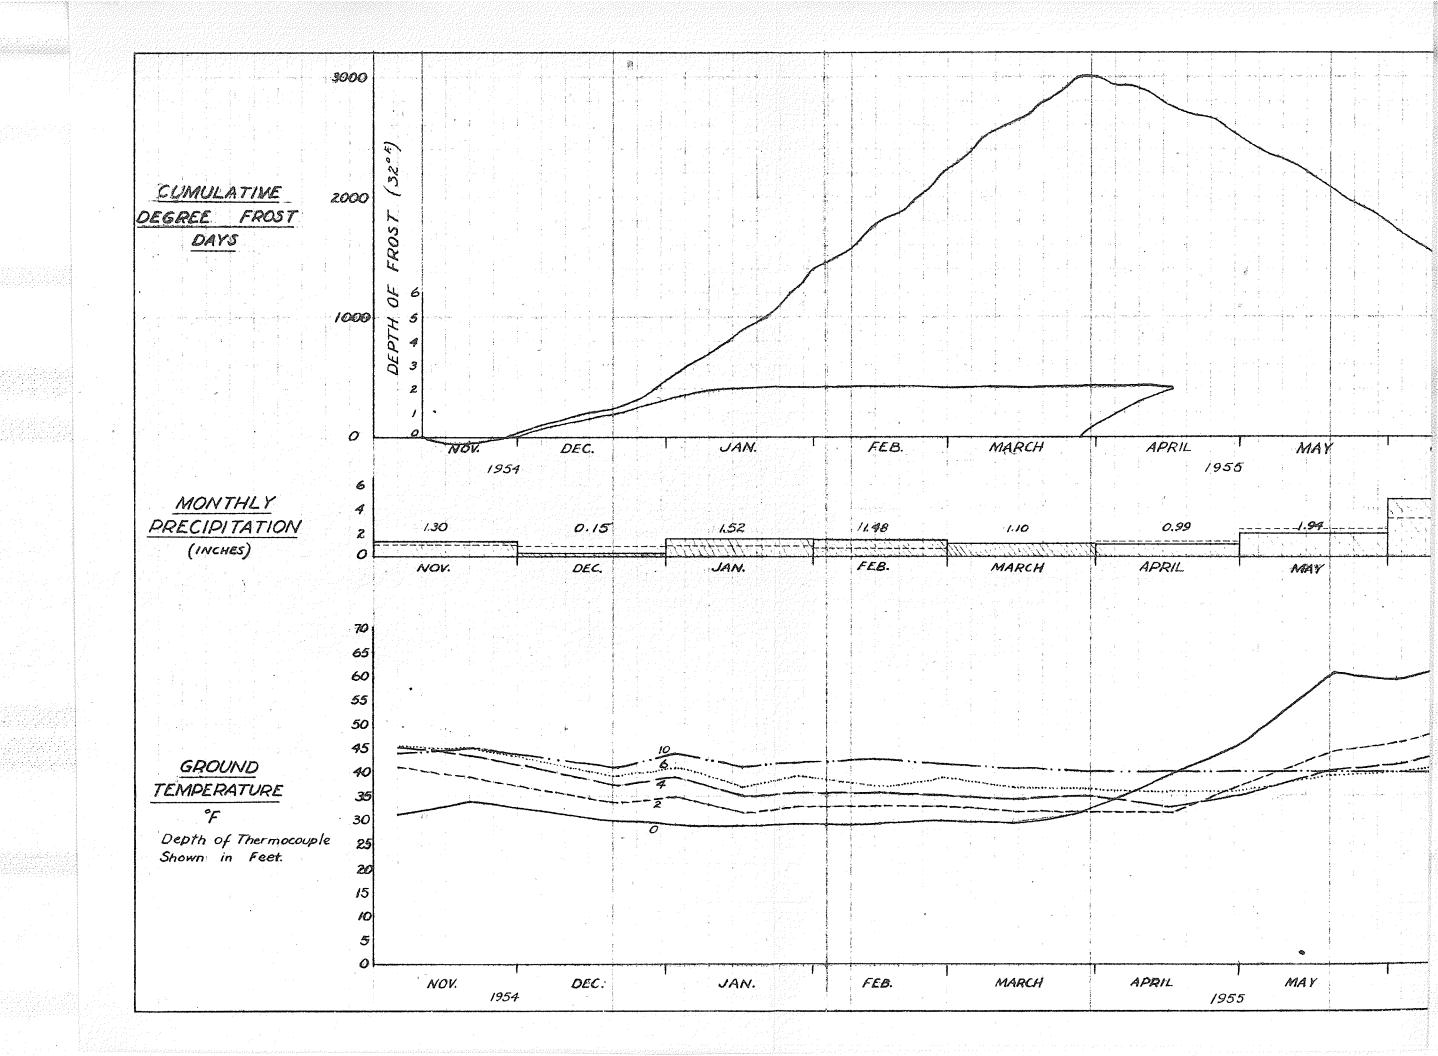
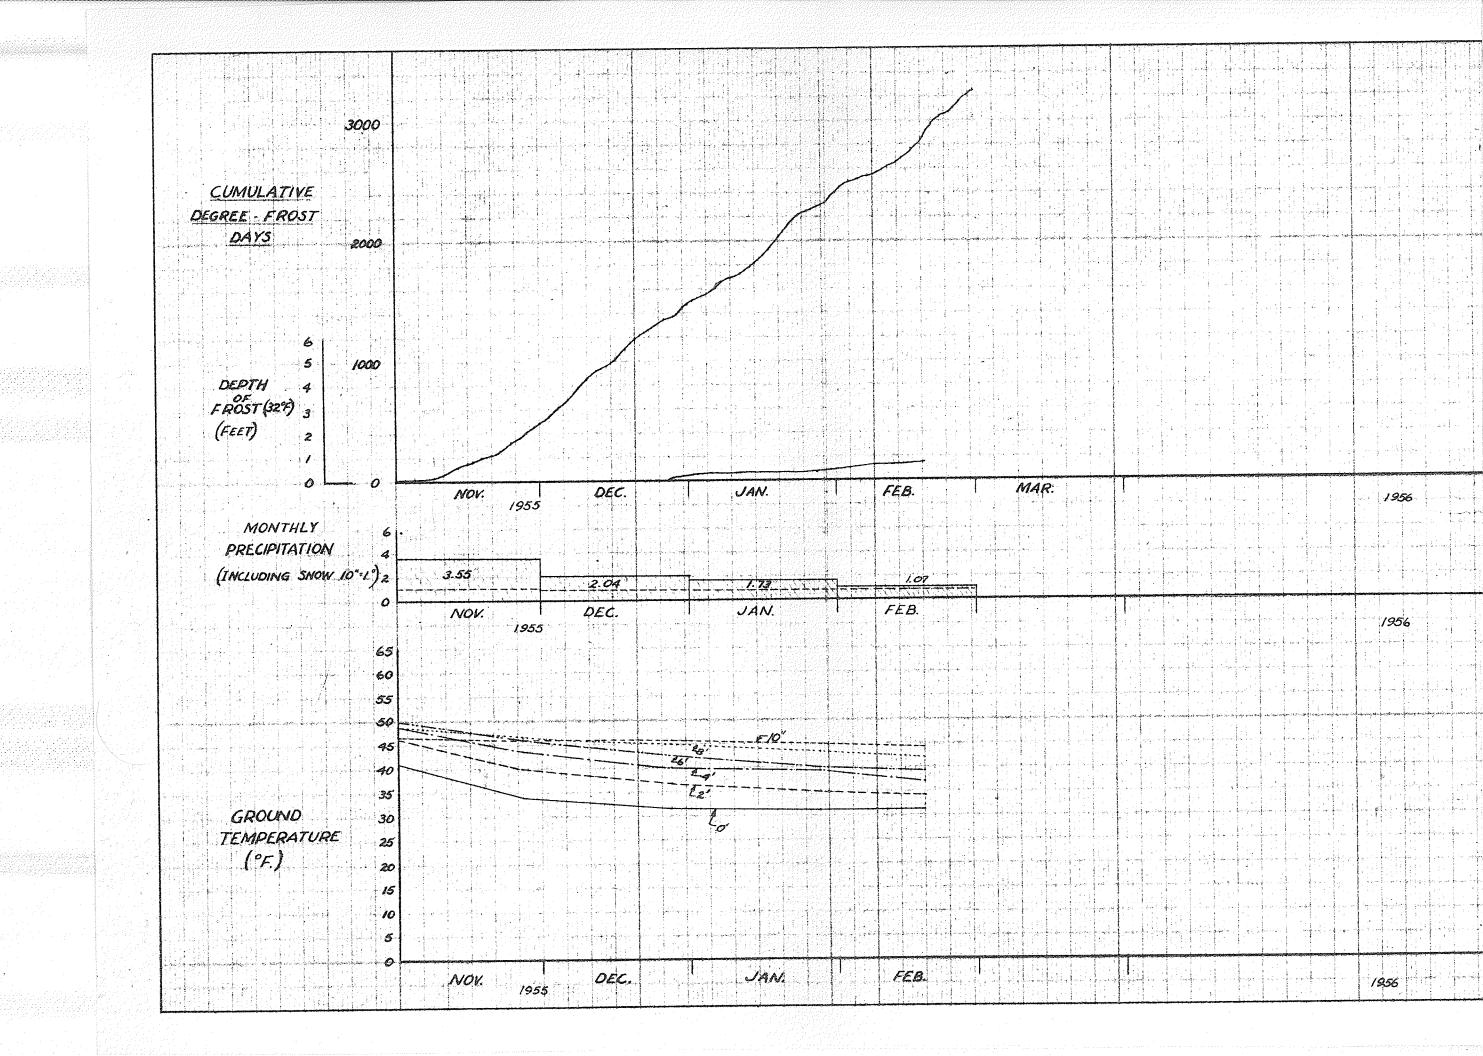
Graphs 2, 3 and 4 have been prepared from records kept by the Civil Engineering Department of the University of Manitoba in an attempt to graphically correlate Cumulative Degree Frost Days, Depth of Frost Penetration, Monthly Precipitation and Ground Temperature. Combined with the Graphs of Monthly Mean Temperature and Mean Snow Cover found on Graph I, a good approximation of soil climate in a typical undisturbed profile is obtained.

Degree Frost Day - a unit representing 1°F. of deviation below 32° Fahrenheit in the mean outdoor temperature for one day.

Cumulative Degree Frost Days - commonly known as the freezing index, is the cumulative total of degree frost days to any date in any winter.

Depth of Frost Penetration - Depth below ground surface to which temperatures equal to or less than 32°F. have been measured by means of thermocouples.

Monthly Precipitation - the sum of monthly rainfall and snowfall using the commonly accepted conversion factor of ten inches of snow equals one inch of rain, from records maintained by the Meteorological Division, Department of Transport. The broken or dotted lines indicate the seventy-

Ground Temperatures - measured by a thermocouple installation in an open field test plot at the University of Manitoba.

Results of this soil temperature study along with results obtained for trench backfill will be discussed later in this thesis.

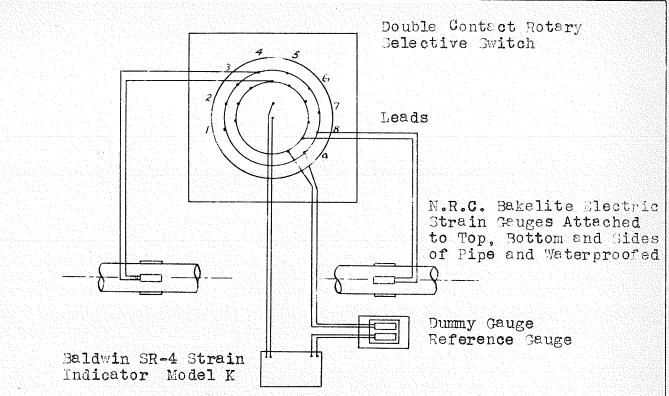
Diag. lA - Schematic Wiring Diagram of a Typical Strain Gauge Installation Showing Dummy and Strain Measuring Gauges, Rotary Switch and Baldwin Strain Indicator

In order to measure pipe movements easily and with a high degree of accuracy apparatus was designed to transmit these movements to the ground surface where they could be measured with an engineer's precise level and rod. The pipe movement gauges consisted of rods supported on the pipe and extending vertically to the ground surface through sleeves with clearance to permit free movement of the rods. A removable cover at the top of the sleeves and a grease packing at the top and bottom prevented the entry of water or other foreign matter between the sleeve and the rod. Three screws radially threaded through the sleeve approximately one foot from the ground surface were used to centre the rod in the sleeve but to insure freedom of movement. Diagram 1B further illustrates the design of these gauges.

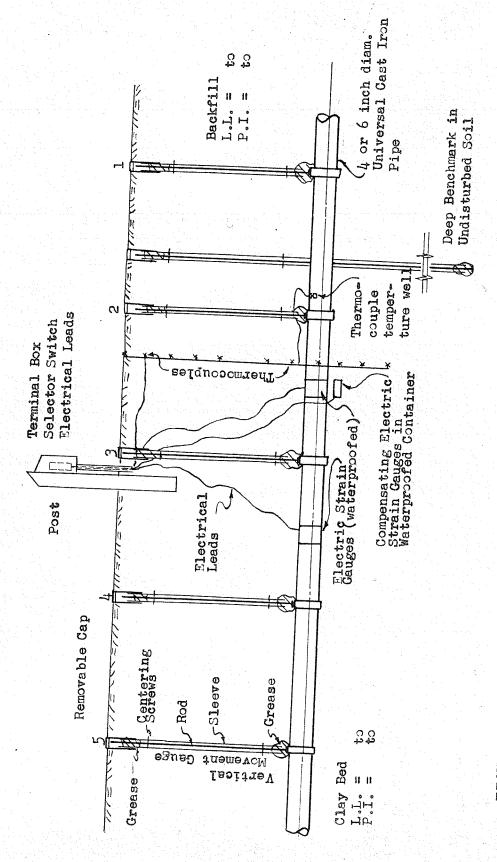
Schematic representation of Vertical Movement Gauges, Electric Strain Gauges and Thermocouple Instrumentation of Cast Iron Watermain Test Installation 7 FIGURE

Fundamentally the test apparatus installed at this site was similar to that schematically represented in Figure 1. However, strain gauges were installed on only one six foot section of the pipe and these gauges were waterproofed as previously described by a plastic tape covering sealed with a self vulcanizing synthetic rubber compound. In this test installation, vertical pipe movement gauges were installed at four successive pipe joints with the fifth gauge being installed on one of the pipe's mid-point. The deep bench mark was founded on undisturbed soil at the twelve foot depth.

The test apparatus installed was the same as that shown in Figure 1. Copper sleeves, as previously described, were installed on test pipes to waterproof the strain gauges. The deep bench mark was founded on undisturbed clay at a depth exceeding 30 feet. The installation was completed in late August, 1954.

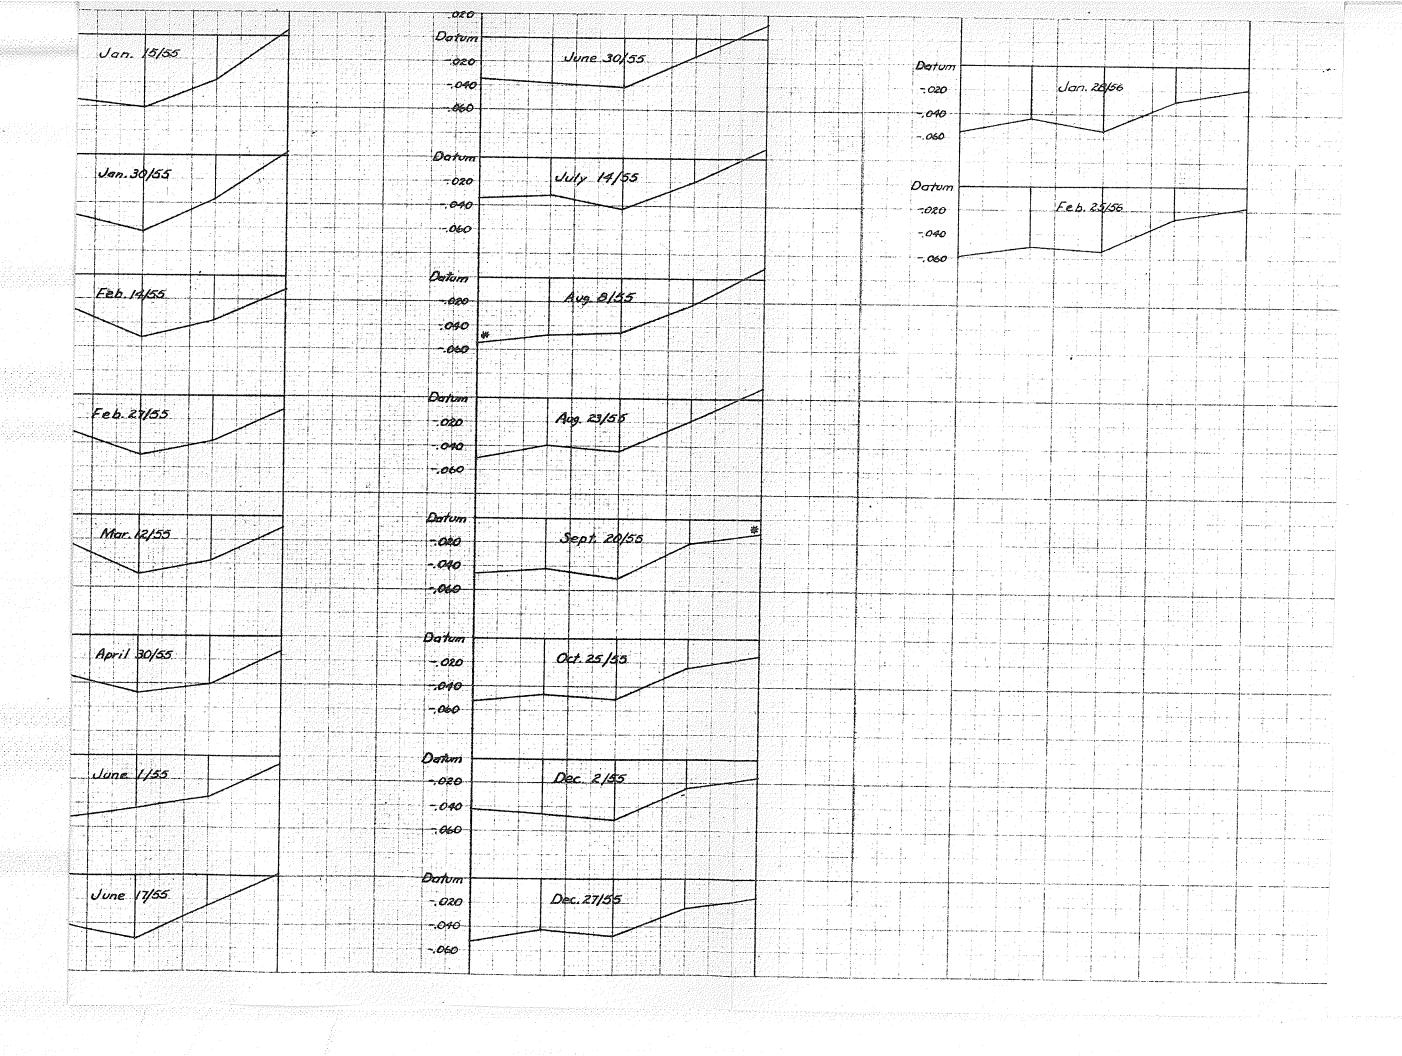
VERTICALRIPE MOVEMENT
VALOUR ROAD
TEST PIPE INSTALLATION

Date of Installation Nov. 20, 1954

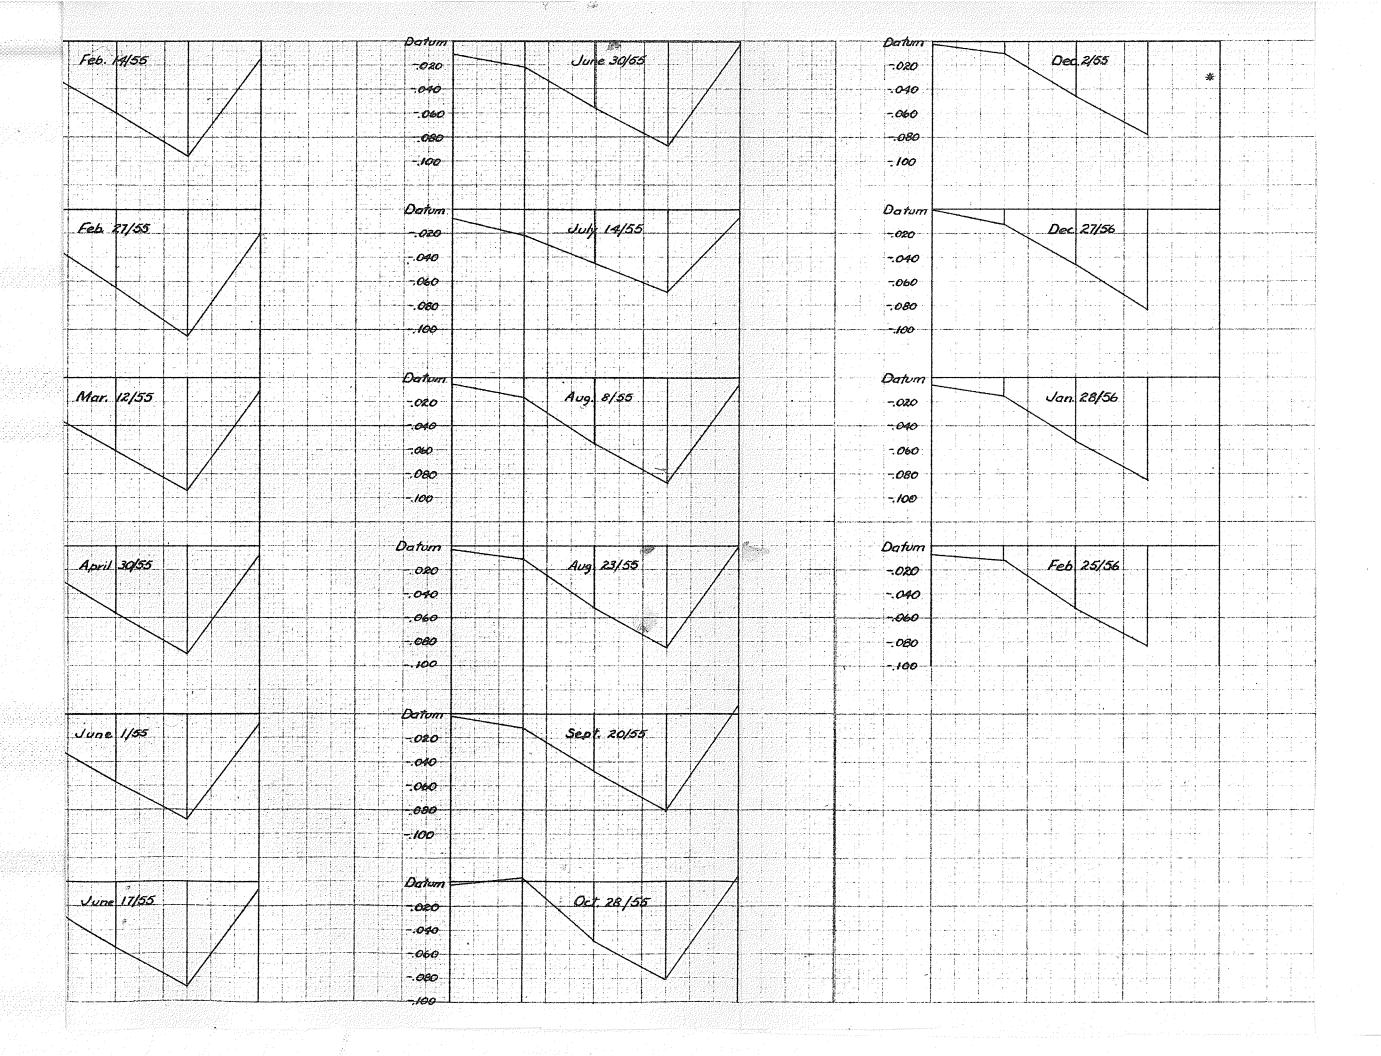
VERTICAL PIPE MOVEMENT
RICHARD AVENUE
TEST PIPE INSTALLATION

Date of Installation Dec. 2, 1955

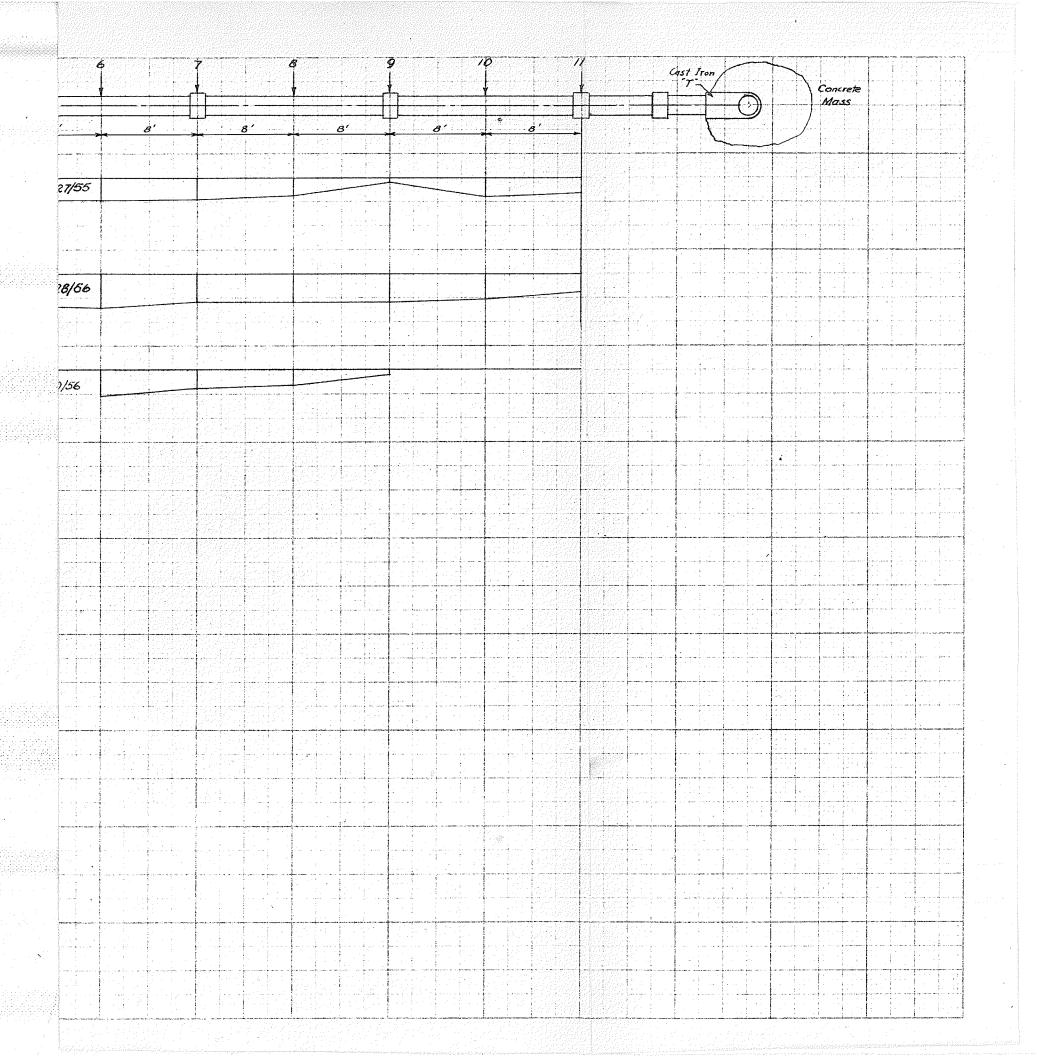
UNIT STRAIN-TEST PIPE 1

CLIFTON STREET

TEST PIPE INSTALLATION

Date of Installation Aug. 24, 1954

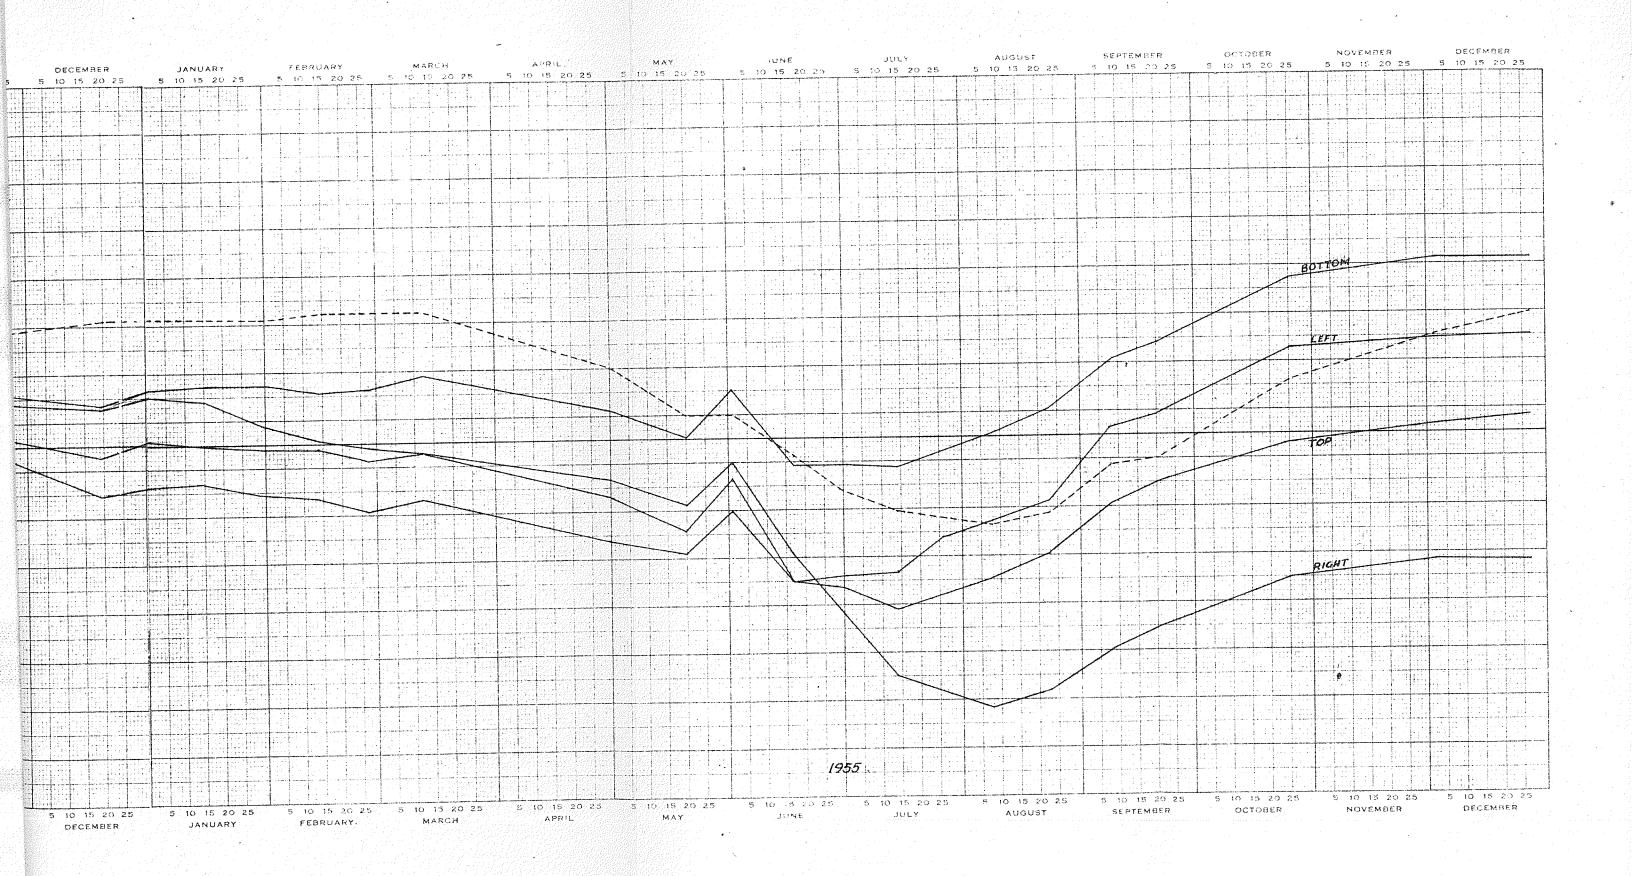
UNITSTRAIN-TEST PIPE 2

CLIFTON STREET

TEST PIPE INSTALLATION

Date of Installation Aug. 24, 1954

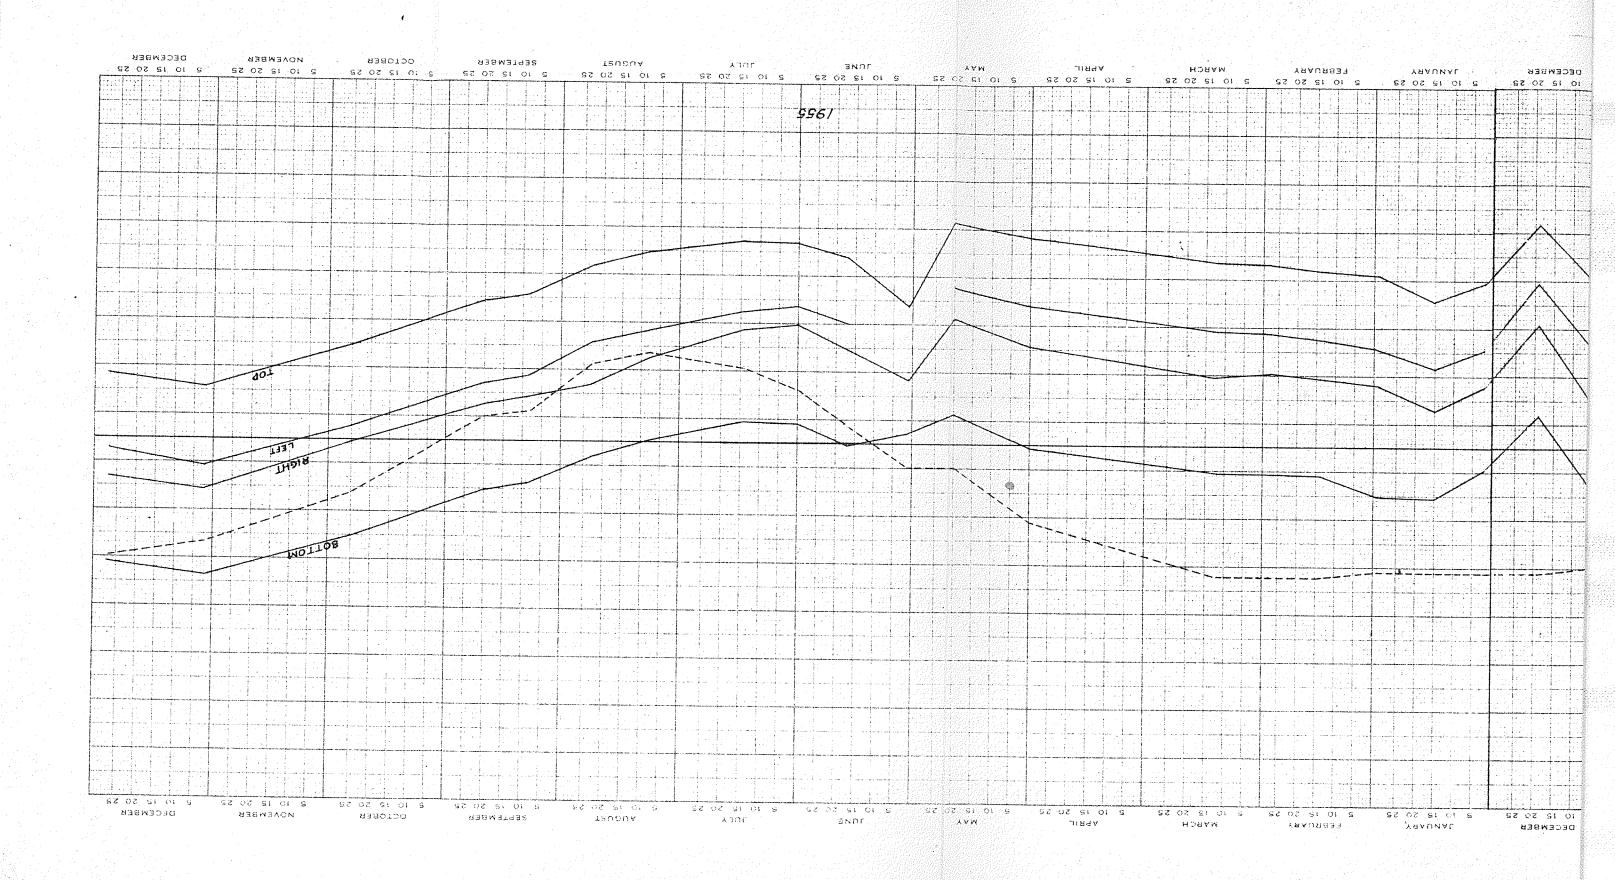
UNIT STRAIN - TEST PIPE 1

VALOUR ROAD

TEST PIPE INSTALLATION

Date of Installation Nov. 20, 1954

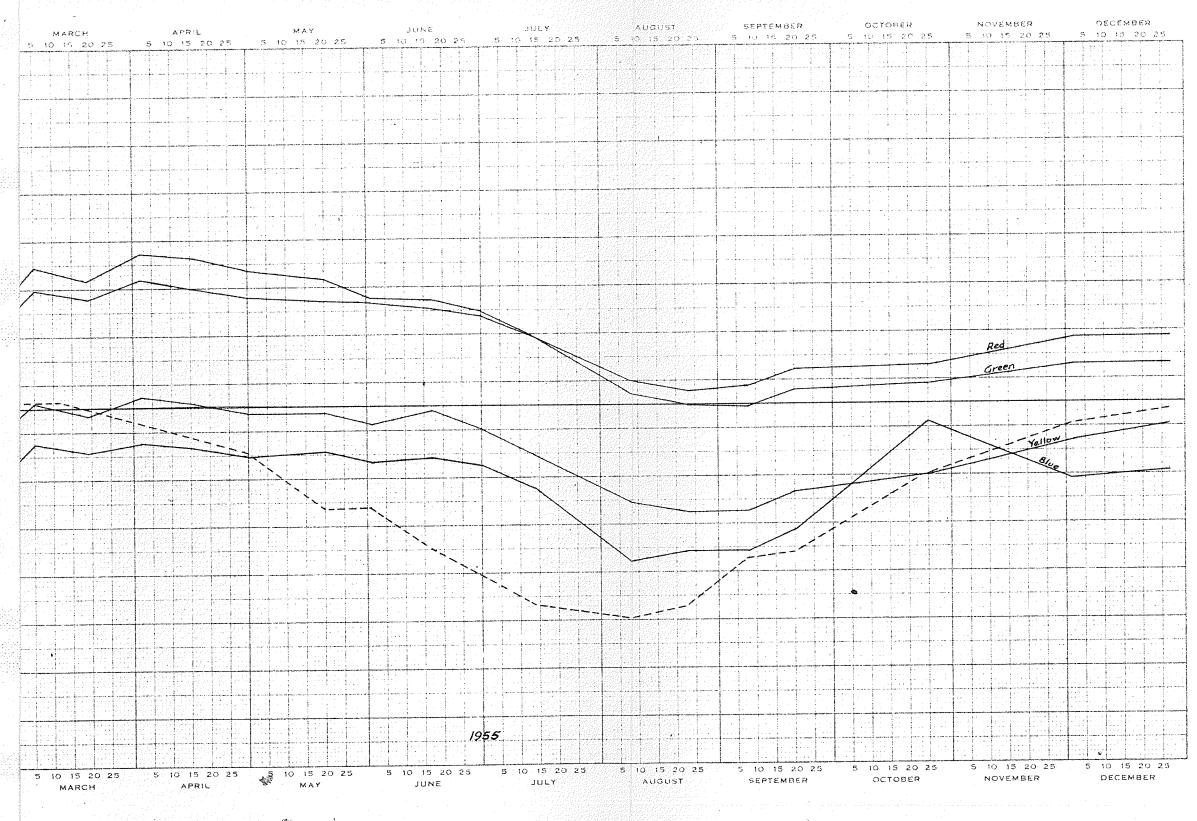
UNIT STRAIN-TEST PIPE 2

VALOUR ROAD

TEST PIPE INSTALLATION

Date of Installation Nov. 20, 1954

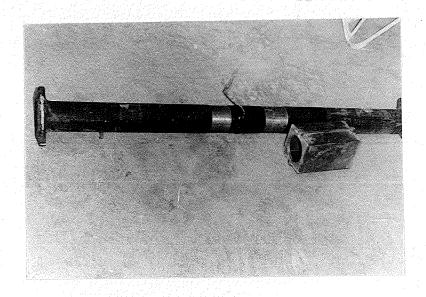
View of test pipe showing machined portion, rubber tape covering electrical strain gauges, and copper sleeve.

An improved method of waterproofing was developed for subsequent strain gauge installations. A metal sleeve made of thin copper sheeting was designed so that it could be clamped around the pipe. All joints were carefully soldered and rubber gaskets were placed between the sleeves and the pipe at points of contact. Several coats of glyptol were applied to all exterior joints and to the connection where the plastic hose left the sleeve. The sleeve was finally packed with grease (by means of a pressure gun) through a nozzle in the sleeve (provided for this purpose). This method of moisture proofing proved to be very successful with all gauges still functioning. Strain measuring gauges installed on the Clifton Street test site have been in operation for over eighteen months with no sign of moisture deterioration.

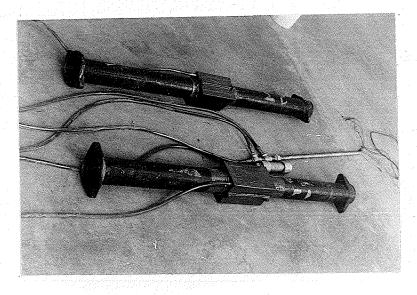
Two test pipes ready for installation with copper sleeves and plastic hoses covering electrical strain gauge leads.

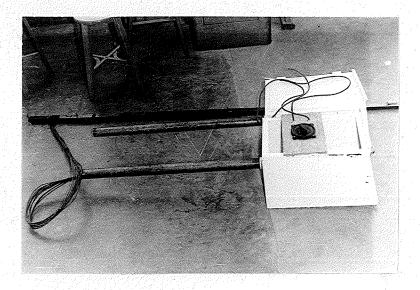
Metal test box with rotary switch mounted in position. Also shown are the thermocouple "stick" and lead wiring.

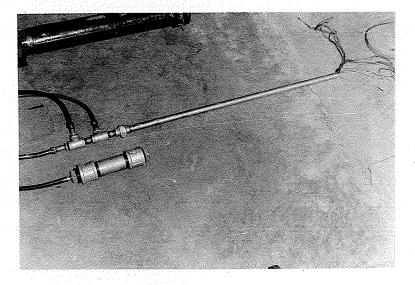
View showing "check" and "reference" gauge container and pipe fittings used to carry the gauge leads above ground to the test box.

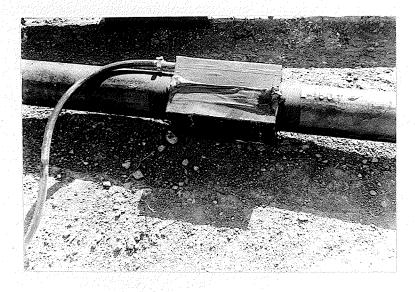
View of test pipe showing joints waterproofed with synthetic rubber compound.

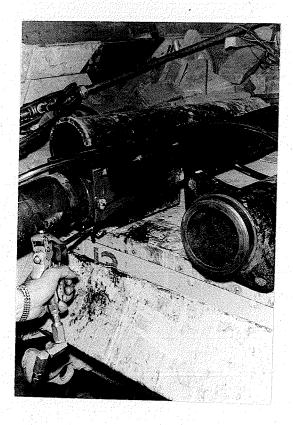
Filling a copper sleeve with grease immediately prior to installation.

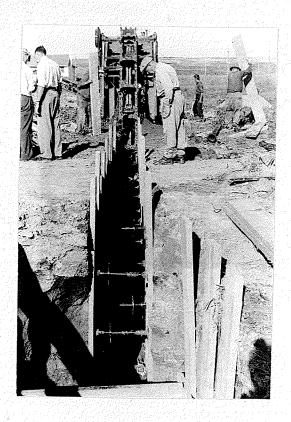
View showing trench, excavator and trench shoring.

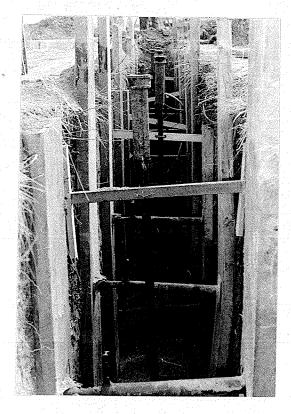
Picture showing vertical movement gauges and the method of supporting them during backfilling.

Note: "Screw-on" caps attached to rods.

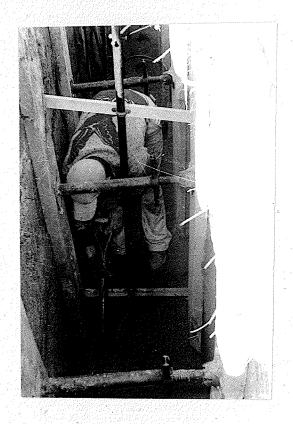
View showing vertical movement gauges and placing of sand back-fill at Clifton Street installation.

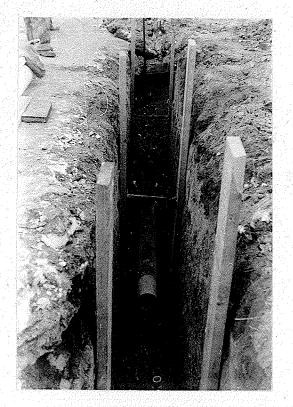
View showing trench, shoring and vertical pipe movement gauge in background. Richard Avenue installation.

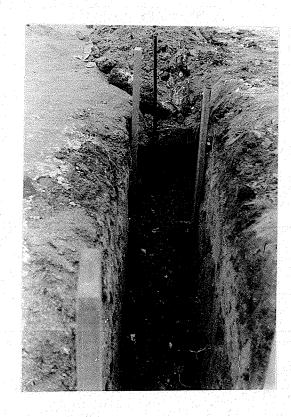
View of trench following partial backfilling.

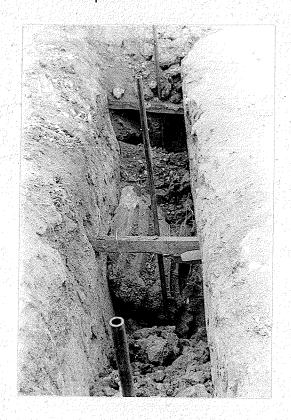
Picture showing "lumpy" condition of backfill material.

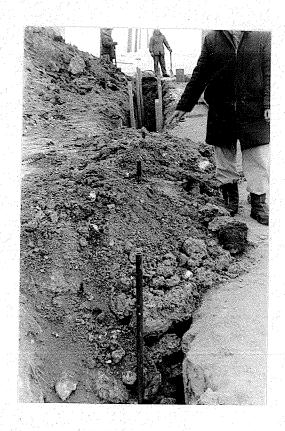
View showing surface appearance of trench backfill and tons of vertical pipe movement gauges without caps.

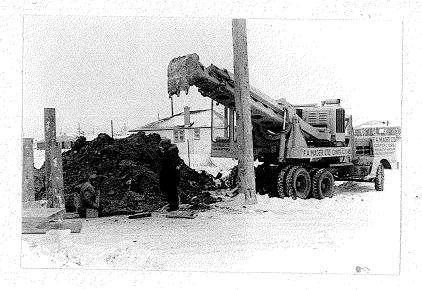
"Gradall" excavator used on Valour Road and Richard Avenue installations.
