# **Flexural Strengthening of Timber Beams with GFRP Bars**

A Thesis

Structural Engineering Division

University of Manitoba

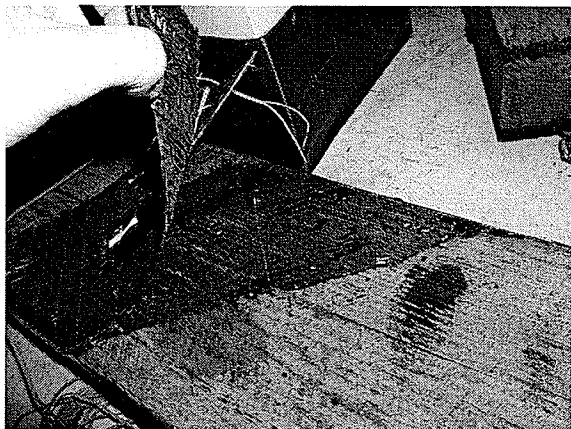
Figure 4.1: Debonded GFRP Sheet

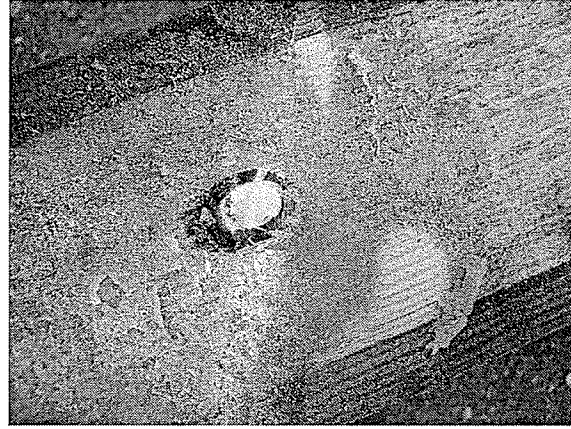
Figure 4.6: Dowel Specimen Failure Mode  
– Compression of Wood Fibres and Epoxy
