AN INVESTIGATION ON THE EFFECTIVENESS OF SHEAR  
REINFORCEMENT IN COLUMN-FLAT SLAB CONNECTIONS

A Thesis

the Faculty of Engineering  
The University of Manitoba

April, 1965

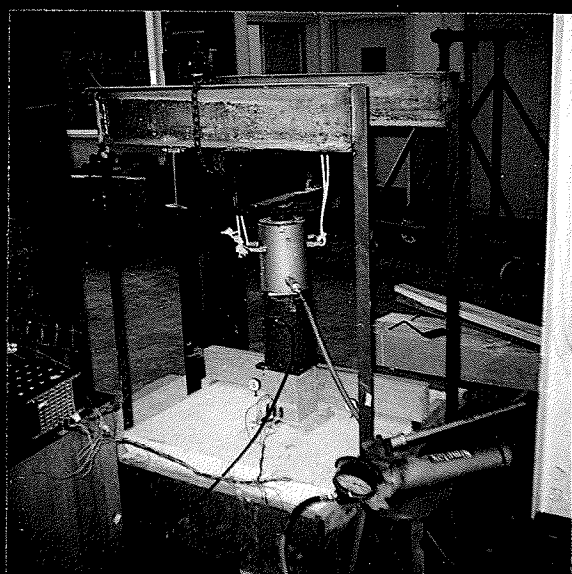
PLATE NO. 3.

Loading frame and typical  
test assembly.

Loads were applied with a 200,000 pound hydraulic jack and the load readings were taken from a strain indicator connected to a Baldwin SR-4 load cell. The slabs were loaded in 2000 pound increments to 30,000 pounds and then in 5000 pound increments to failure. Strains and deflections were taken after each increment. Plate (3) shows the test assembly and instrumentation.

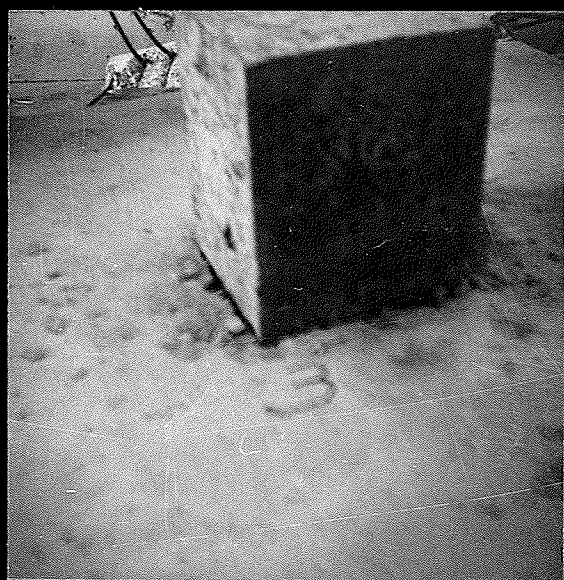
PLATE NO. 8.  
Spalling effect at the  
column-stub interface  
of slab 3.

No apparent cracks could be seen until the applied load had reached 25 kips. Final failure occurred at 40 kips and the failure plane sloped away from the column stub at approximately 45 degrees. Severe spalling at the column slab interface began after the applied load had reached 30 kips. This observation was unique to this test and is shown in plate (8).

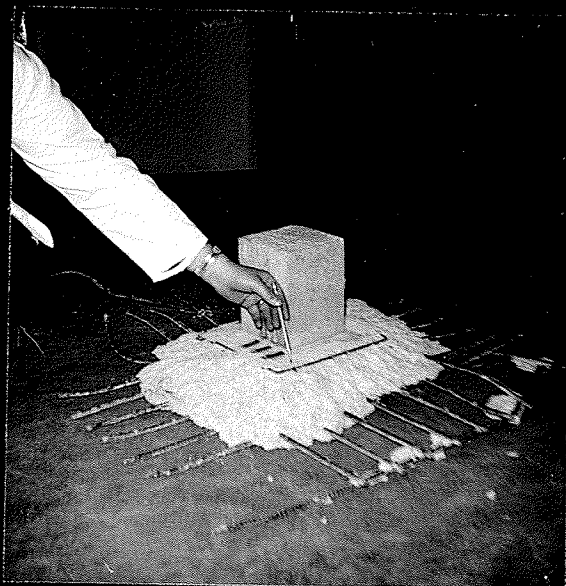
PLATE NO. 9.  
Exposed failure cone of  
slab 4.

First cracking appeared at 20 kips and failure occurred at 45 kips. The yield pattern was well defined, spreading from points directly under the column corners toward the slab edges. The final failure was a violent punch out, not through the shearhead, but beyond it as shown in plate (9). The failure slope was at approximately 20 to 30 degrees and began at the top tie of the shearhead.

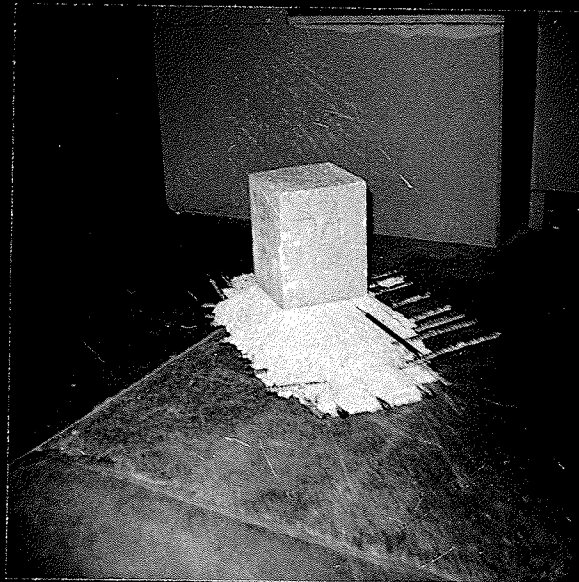
PLATE NO. 12.  
Exposed failure cone of  
slab 3A.

First cracking occurred at 26 kips. The yield pattern became clearly distinguishable at 35 kips and failure was at an applied load of 45 kips. The failure plane was irregular as shown in plate (12), sloping at 45 degrees on two opposite sides and approximately 20 degrees on the other sides.

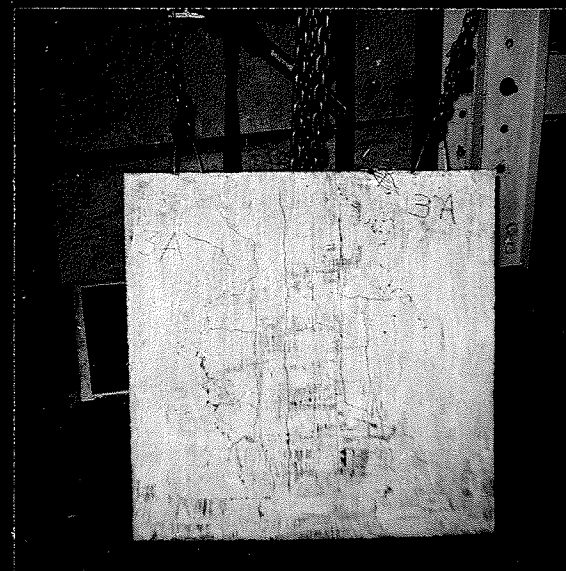
PLATE NO. 13.  
Bottom view of slab 3A  
after failure.

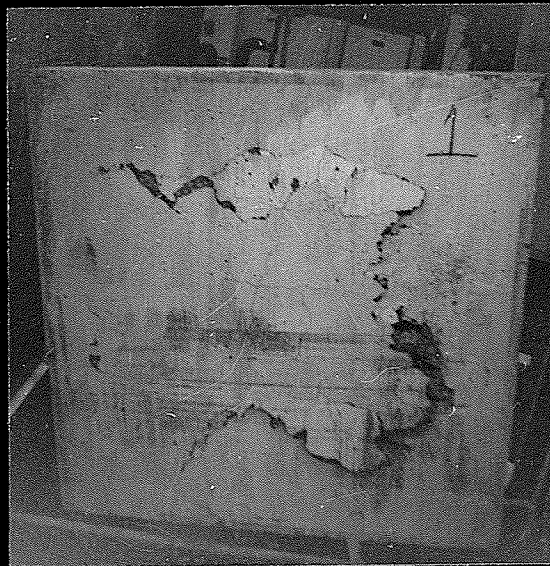
PLATE NO. 15.

Bottom view of slab 1 after failure.

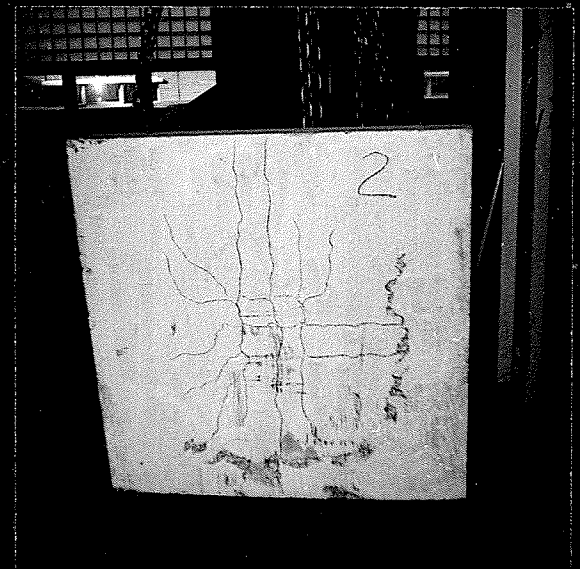
PLATE NO. 16.  
Bottom view of slab 2 after failure.
