**Analyzing the Geographical Impact of Water Control Structures and  
the 2011 “Super Flood” of Manitoba on  
Lake St. Martin First Nation using Historical Aerial Photos,  
Light Detection and Ranging Data, and Geographical Information System**

A Thesis submitted to the Faculty of Graduate Studies of

**MASTER OF NATURAL RESOURCES MANAGEMENT**

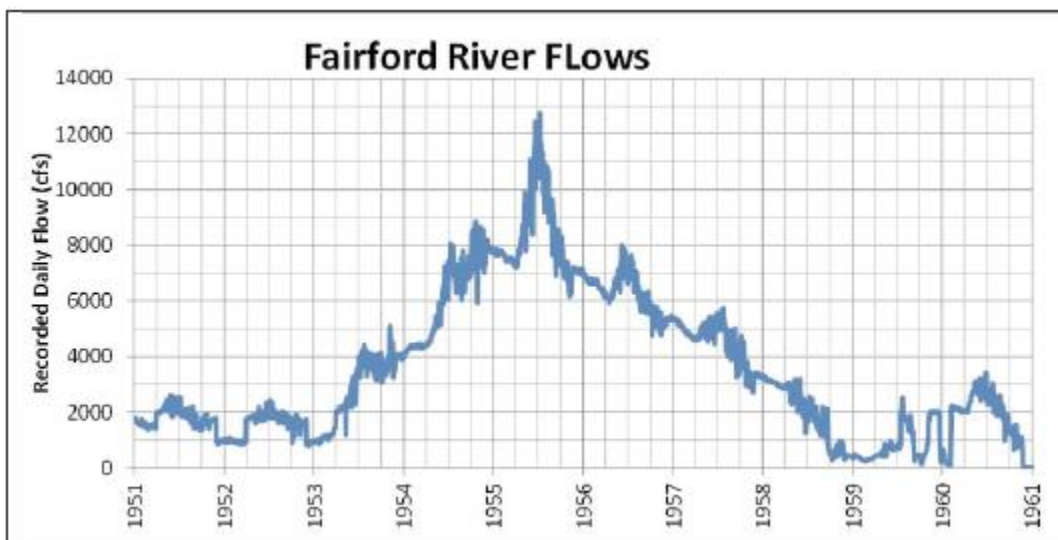
Levels have been recorded systematically on Lake Manitoba since 1924. Levels on Lake Manitoba fluctuated on a multi-year cycle before 1961 when the FRWCS was put into operation. The only major flood recorded prior to 2011 took place in the 1950s. Figure 2.4 shows the levels on Lake Manitoba during this decade. Figure 2.5 shows the flows on the Fairford River.

**Figure 2.5: Fairford River flows for the years 1951-1961**  
**Source: (Manitoba Government, 2013:27)**

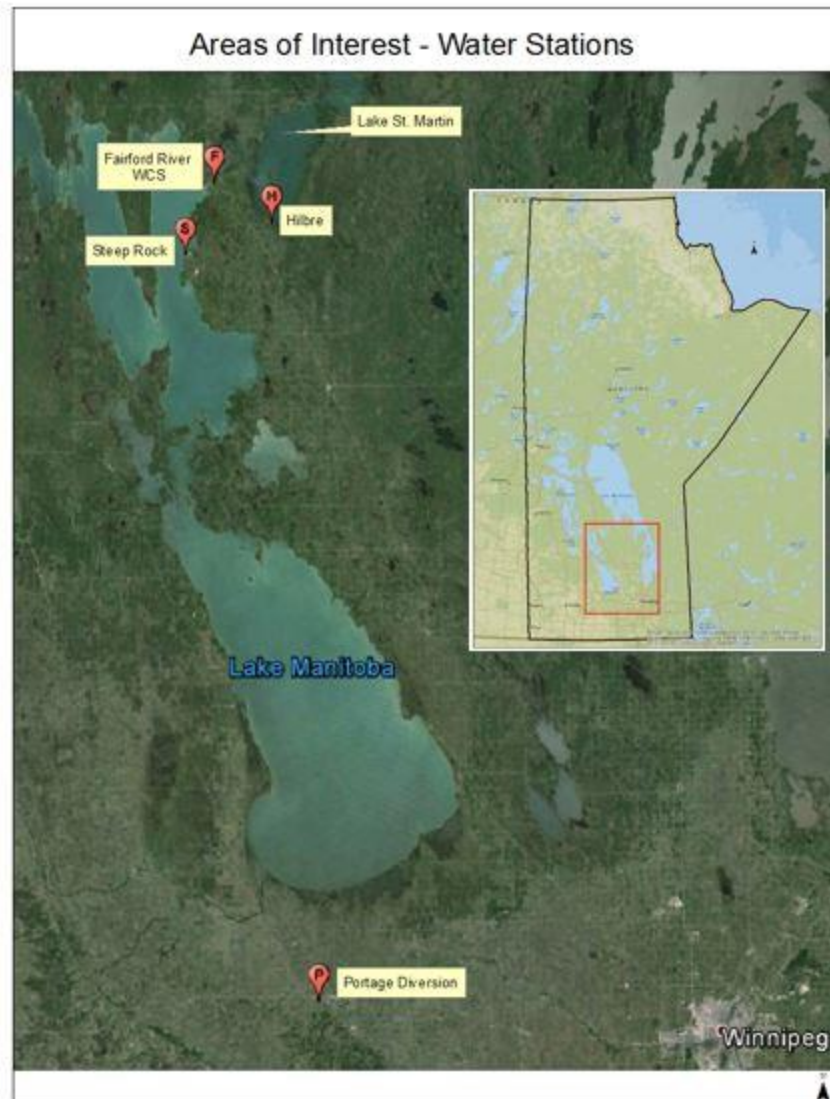
PD was constructed on Assiniboine River near Portage La Prairie, Manitoba in 1970. It is used to divert water from Assiniboine River to Lake Manitoba to prevent flooding to the City of Winnipeg (Mudry et al., 1981). The water station number is 05LL019 and the longitude and latitude coordinates of this water station are 49° 57' 56" N and 98° 22' 49" W (Water Survey of Canada, 2014d).

**Figure 3.0: Canada Water Gauge Stations affecting LSM First Nation**  
**Map source: ArcMap 10.2.2, 2016**

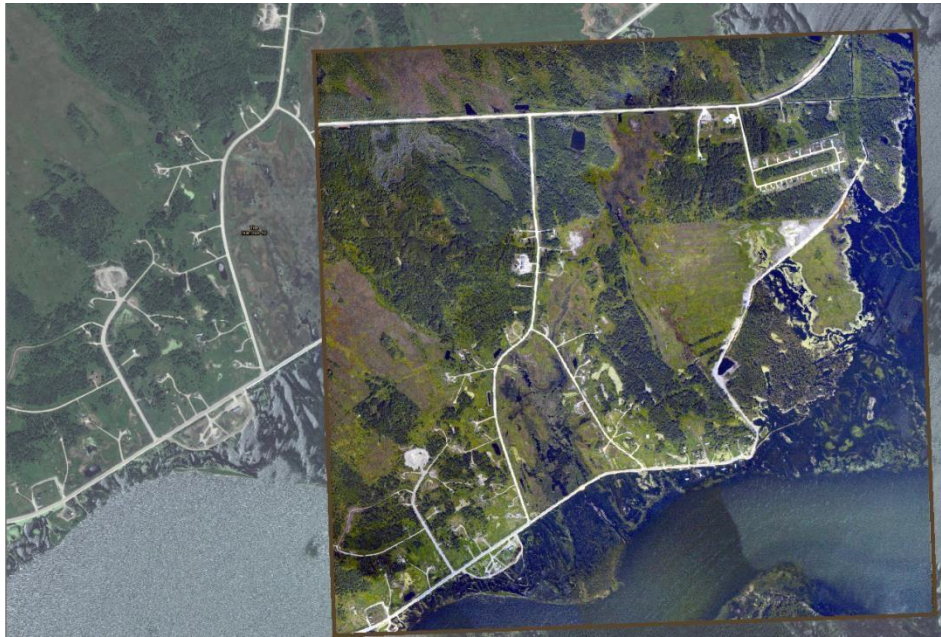
**Figure 3.4: Displaying the georeferenced image in the current display extent.**

4. I clicked the Layer drop-down arrow, and clicked the scanned image layer that has to be Georeferenced.
5. I clicked the Georeferencing drop-down menu and clicked the Fit To Display. This step displayed the scanned image in the same area as the base map.

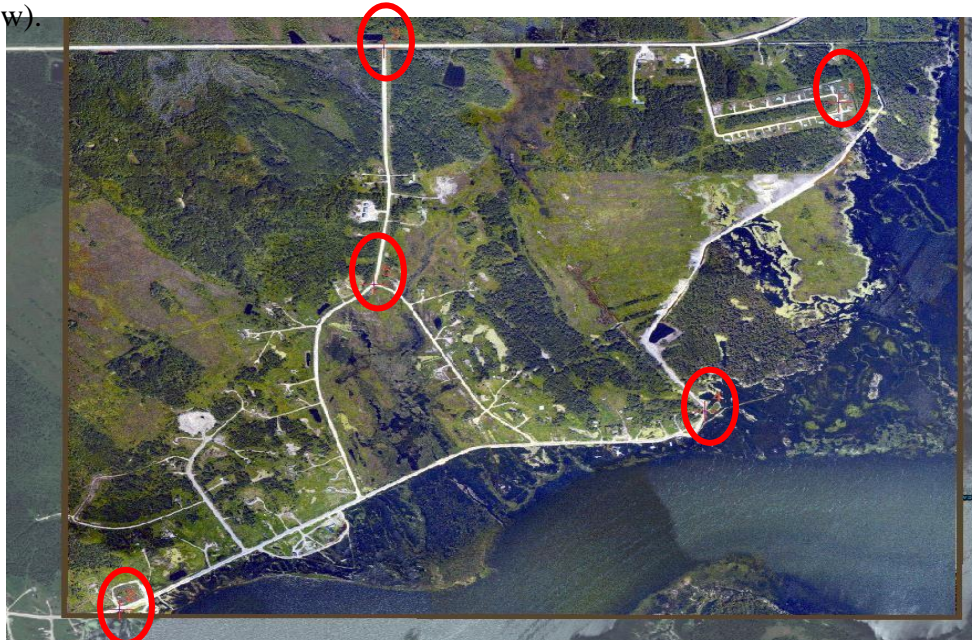
**Figure 3.6: Five control points of the georeferenced image.**

7. I created a link between the scanned image and the base map by adding control points.
8. I repeated the above step at five points. These points included four corners and one center point to give the best georeferenced for an image (marked in red circles in the figure below).

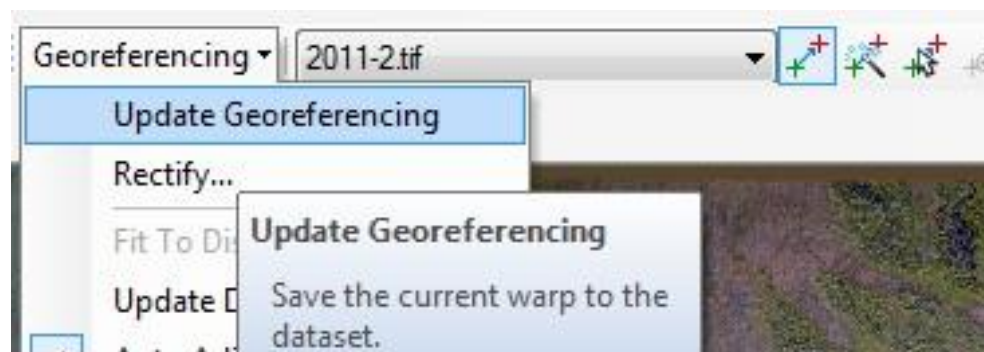
**Figure 3.8: Updated georeferencing tool to check the residual error**

11. To see if the residual error was less than 0.6 m, I updated the Georeferencing tool

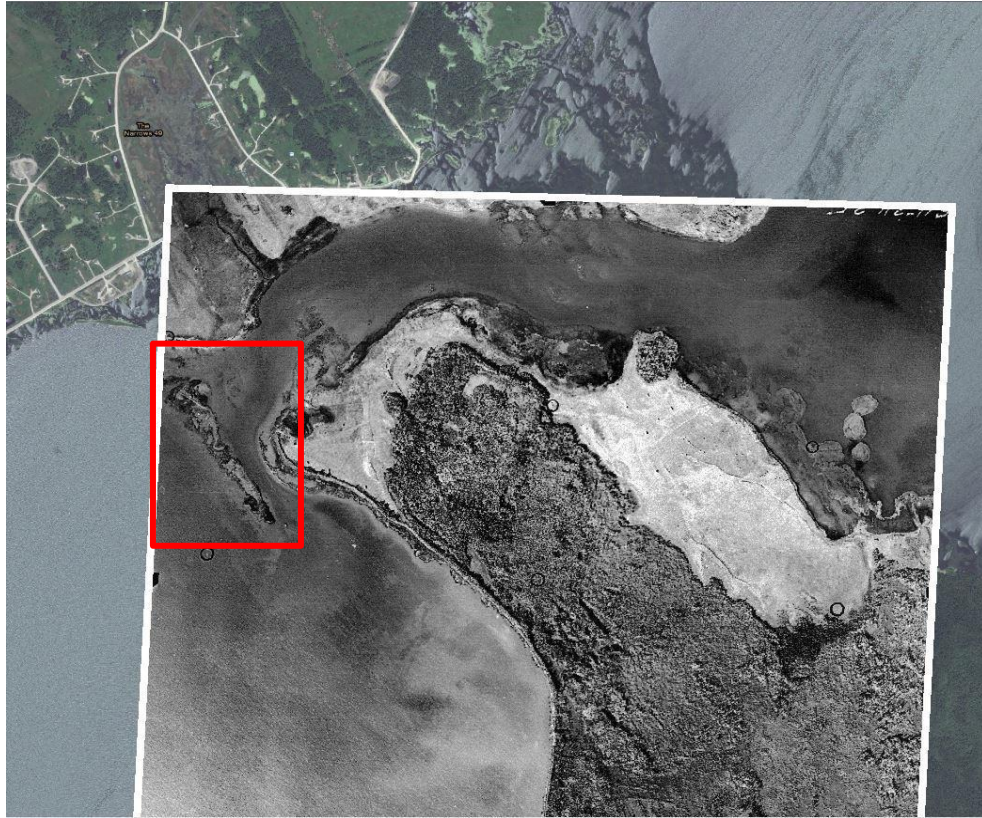
LSM I started with the year 1948. The island, in the year 1948, is highlighted in the red block in the figure 3.16

**Figure 3.16: The Disappearing Island at LSM in the year 1948**

The Island is highly visible in the year 1948. As the operation of FRWCS began in 1961, the island became smaller and with the start of operation at PD in 1970, the island was much reduced. By the year 1986, 80 percent of the island was got submerged under the water indicating the rise of water levels at LSM over the years. By the year 2011, the island is completely submerged under water leaving no trace of it. I then calculated the area lost due to the flooding over the years. For this calculation, I used ArcGIS 10.2.2 with spatial analyst, 3D analyst and Editor tools to create new shapefiles and features from the existing georeferenced aerial images.

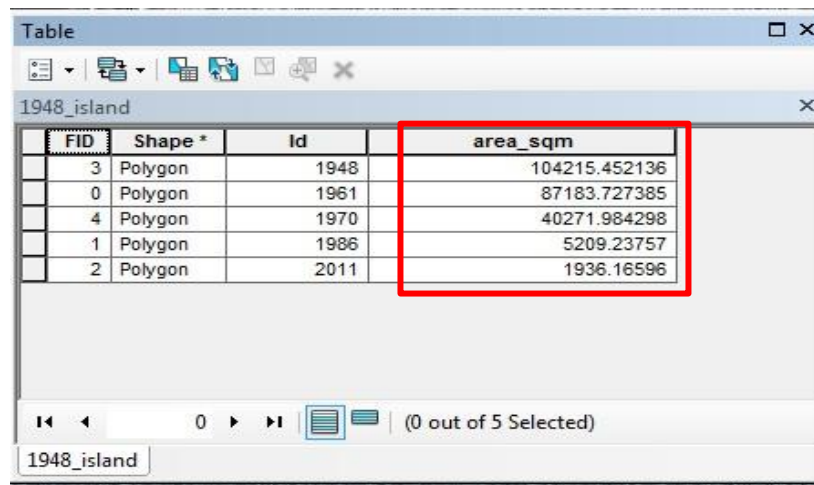
5. The area of each polygon is calculated and displayed in the “area-square meter” field in the Attribute table, as shown in Figure 3.29.

FID	Shape *	Id	area_sqm
3	Polygon	1948	104215.452136
0	Polygon	1961	87183.727385
4	Polygon	1970	40271.984298
1	Polygon	1986	5209.23757
2	Polygon	2011	1936.16596

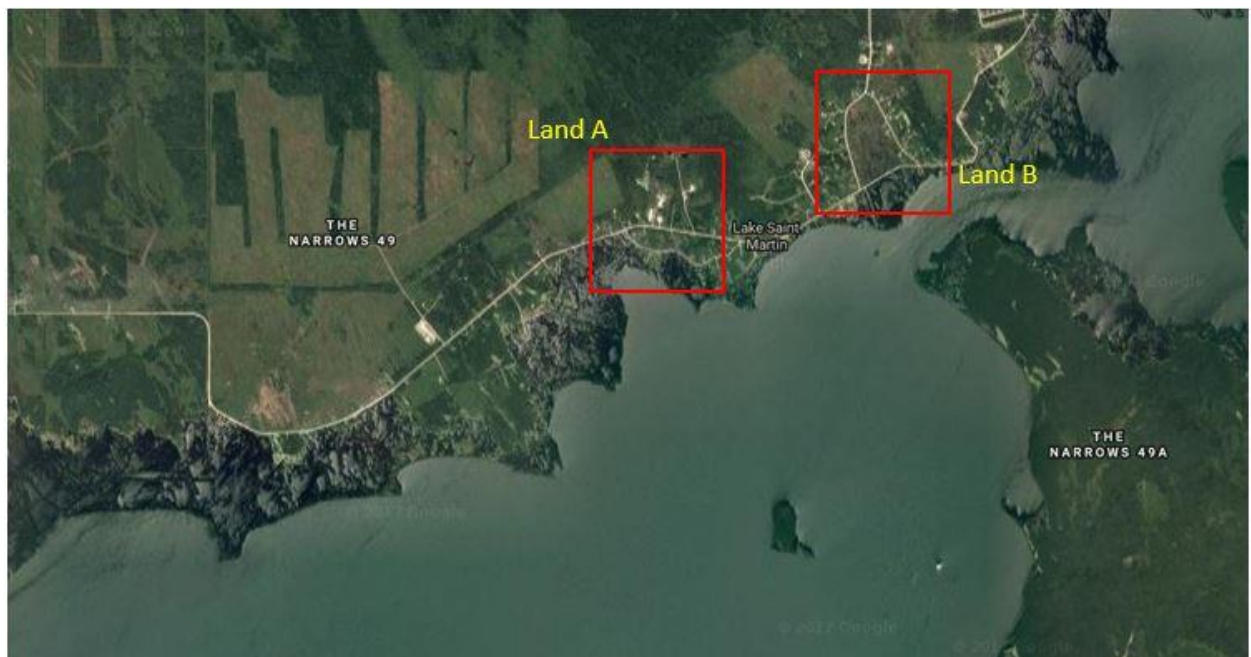
**Figure 4.13 – Selected smaller land parcels (A and B) within LSM First Nation Reserve**
