Natural Stream Landscaping Techniques:  
A Review, and an Application on  
Edwards Creek

A Practicum Submitted in Partial Fulfillment  
of the Requirements for the Degree of  
Master of Landscape Architecture

Department of Landscape Architecture  
Faculty of Architecture  
The University of Manitoba  
Winnipeg, Manitoba, Canada  
April 1989

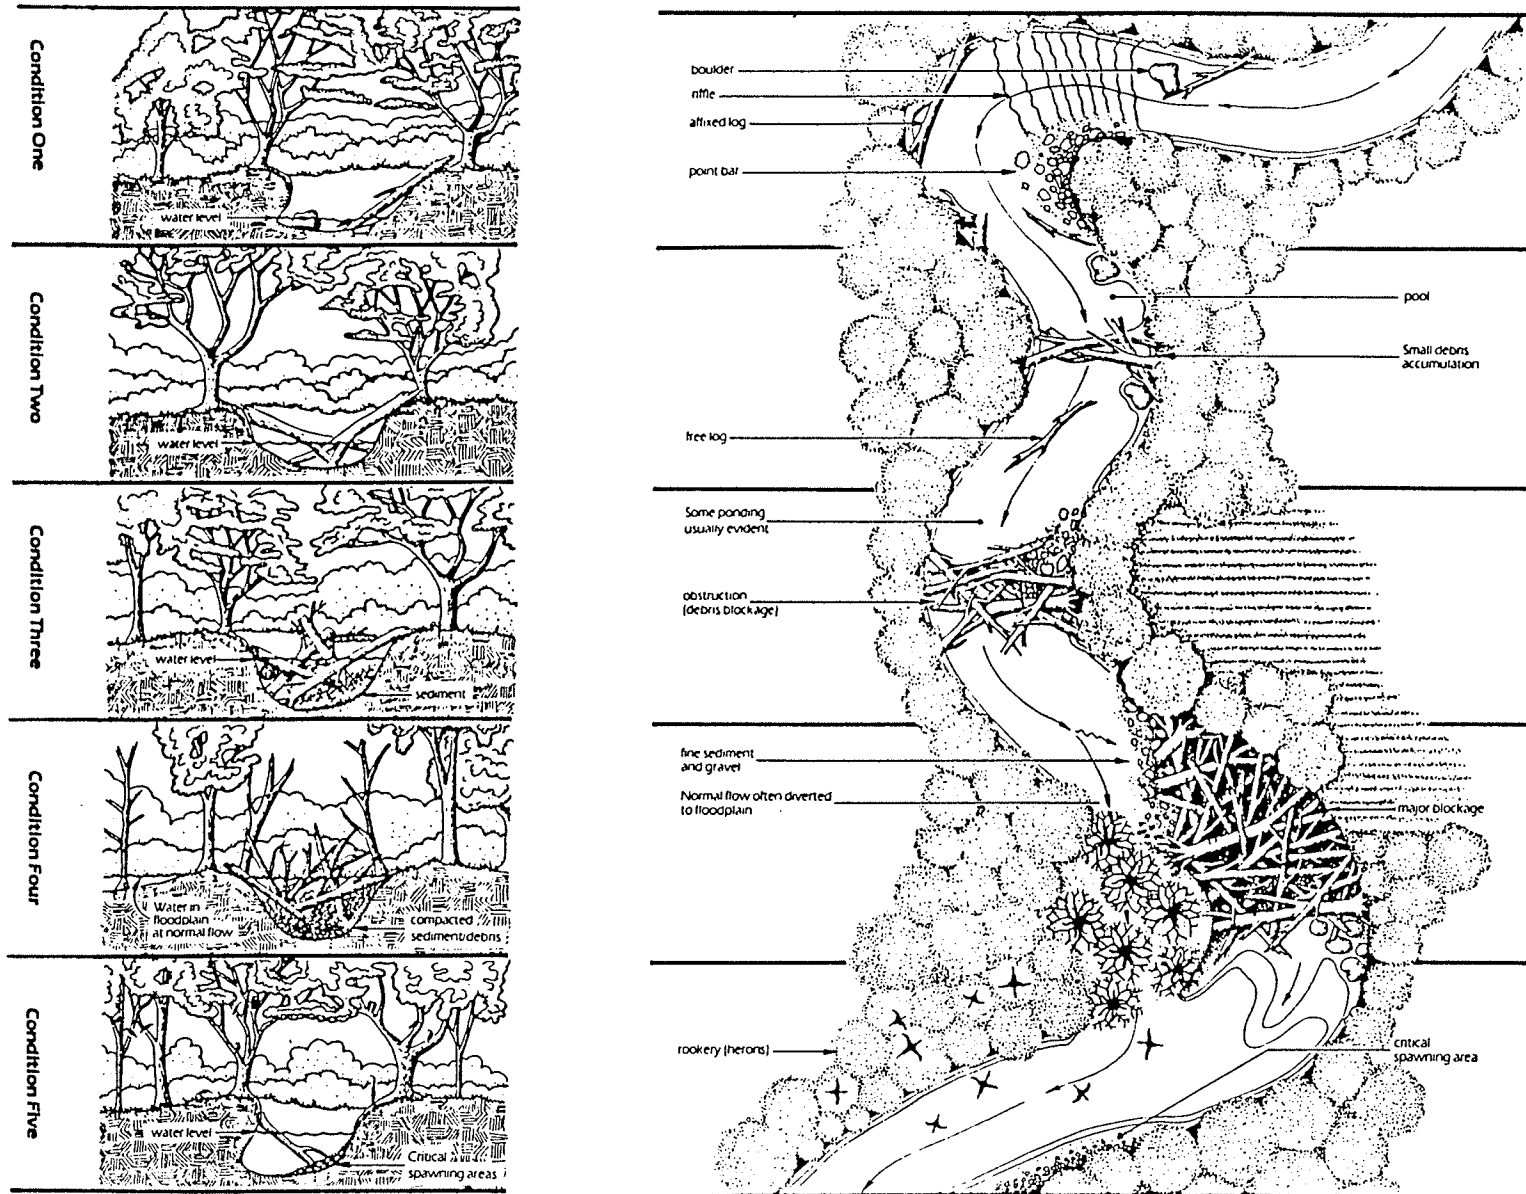
Figure 5 Stream obstruction conditions.

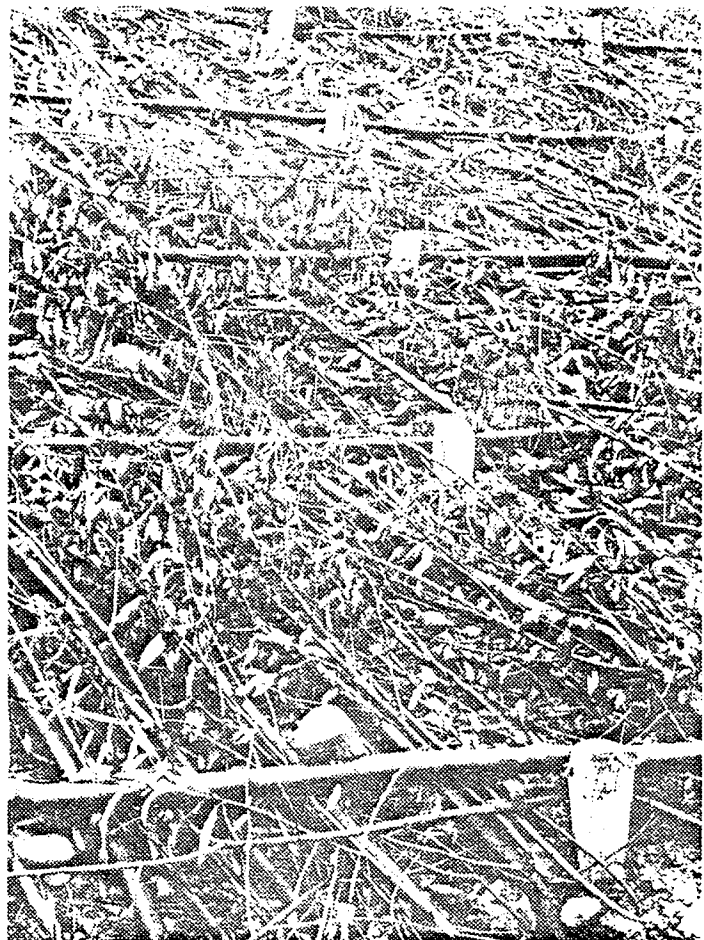
Figure 44 Detail of a newly constructed brushmattress.

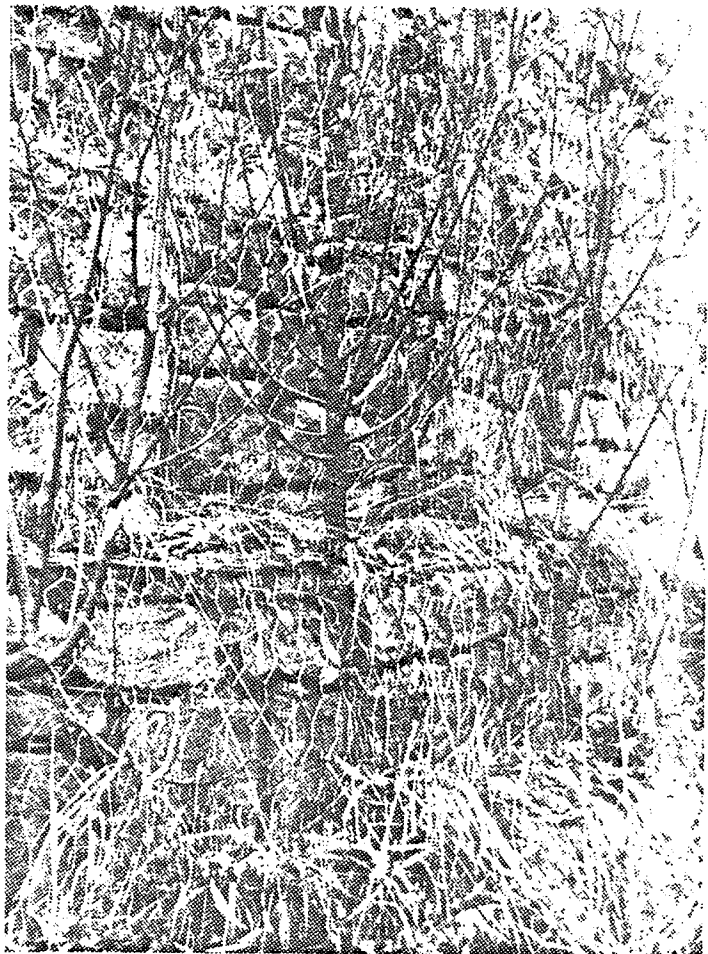
Figure 67 Gabions consisting of a rock pile wrapped in wire mesh, vegetated with live branch layering. If large rocks are used, the branches can be placed only in the joints between the individual gabions.

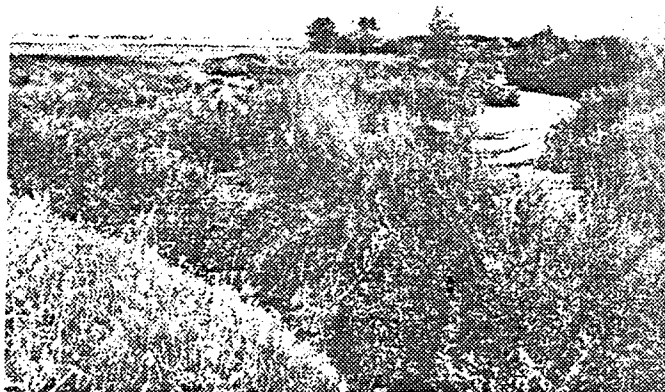
Figure 78 Pile lines. Top, shortly after construction. Bottom, 8 years later. Some of the pile lines have been lost but a good growth of golden willows has kept the creek within the desired channel.

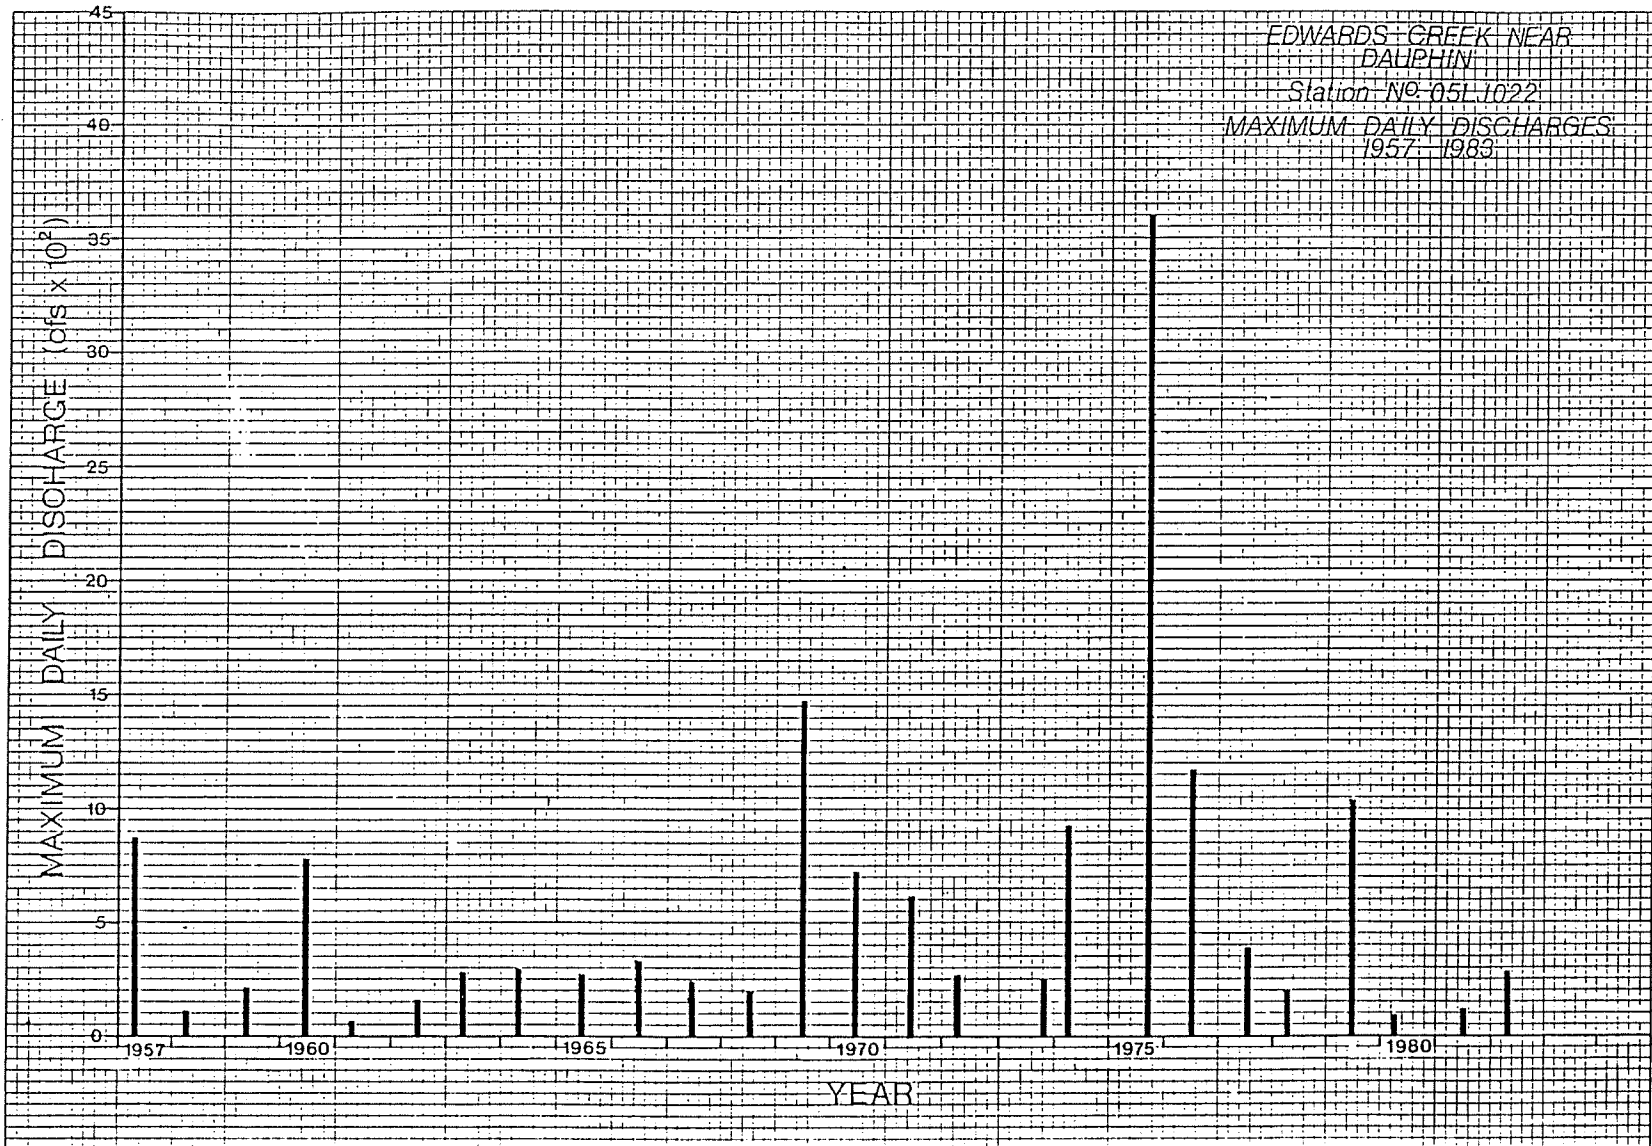
Figure 86 Maximum daily discharge along Edwards Creek 1957 to 1982.

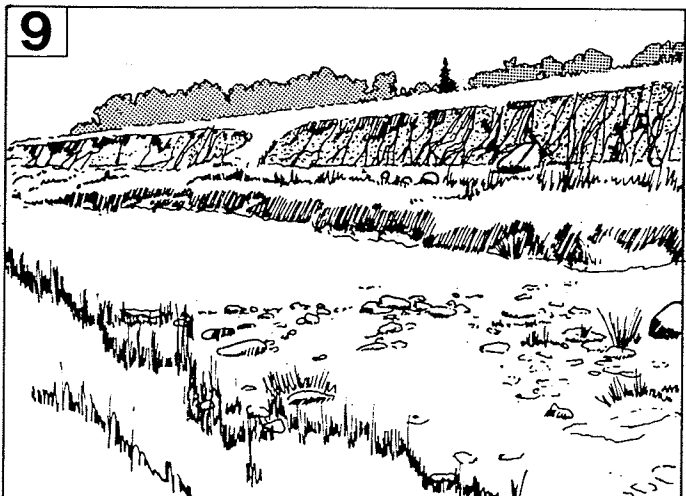
9 Due to a steeper grade, and the consequent increase in flow velocity and sediment transport capability, channel bed degradation and lateral erosion are occurring in this reach.
