# **REHABILITATION OF WOODEN UTILITY POLES WITH SPRAYED-GFRP COMPOSITES**

A Thesis submitted to the Faculty of Graduate Studies of  
The University of Manitoba  
in partial fulfillment of the requirement for the degree of

**MASTER OF SCIENCE**

Department of Civil Engineering  
University of Manitoba  
Winnipeg, Manitoba

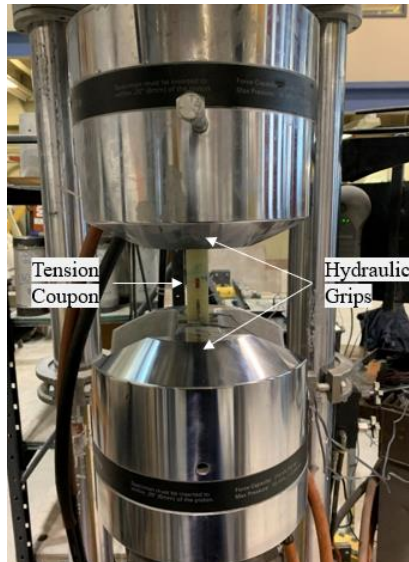
Figure 3.4: Tension coupon test equipment

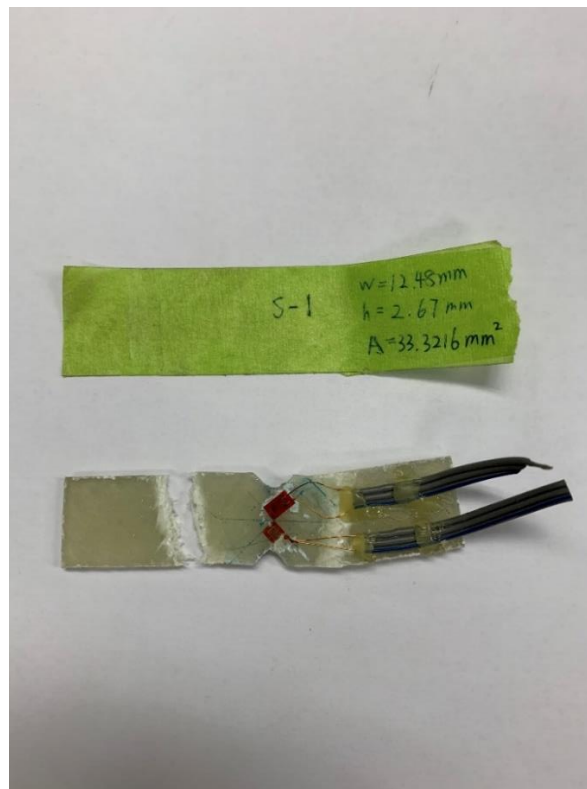
Figure 3.9: Failure mode for a 2.5-mm thick shear coupon

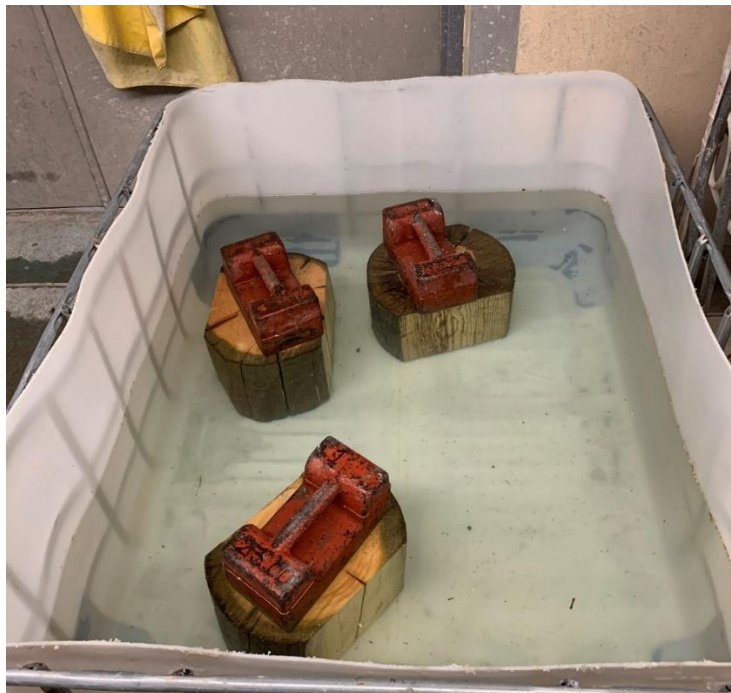
Small pieces of new Class-3 Red Pine (RP) wooden poles were prepared for the pull-off test. Each wood sample was approximately 200 mm (8 in.) high with two parallel smooth cuts, near the top and bottom fibres of the cross-section, tangential to the wood grain to create two flat surfaces for the pull-off test. Each specimen was initially planned to be used for five pull-off tests. However, the actual number of tests per wood specimen depended on the surface condition of the sprayed samples. Moreover, the composite was sprayed on some wood specimens in their original air-dried condition, while for the rest of the wood samples a conditioning procedure was applied. This involved immersing the wood samples in a water tank for 7 hours, one day before the spray, followed by air drying overnight for about 17 hours before the spray. Figure 3.10 shows the immersed wood samples in the water tank.

Figure 3.10: Immersed wood samples

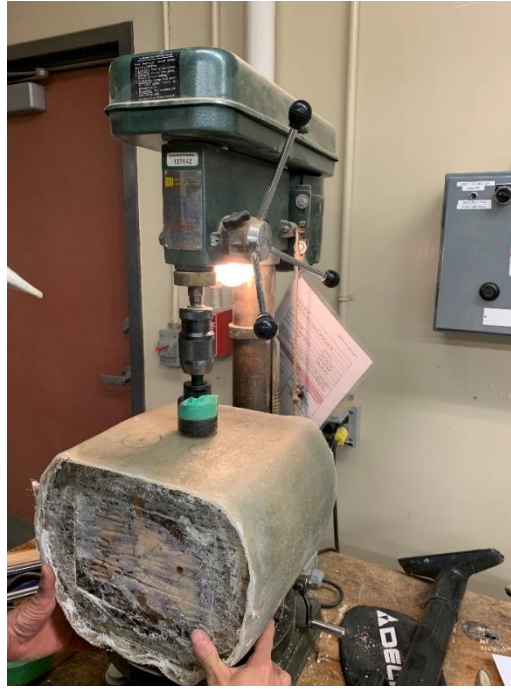
Figure 3.12: Drill the marked specimen.

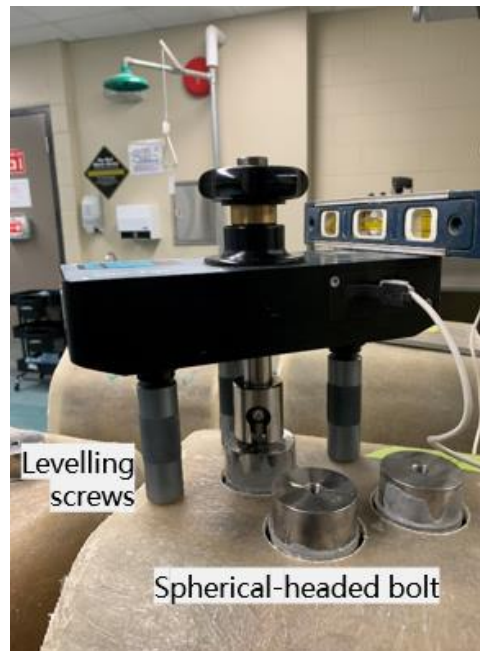
Figure 3.13: Pull-off test setup

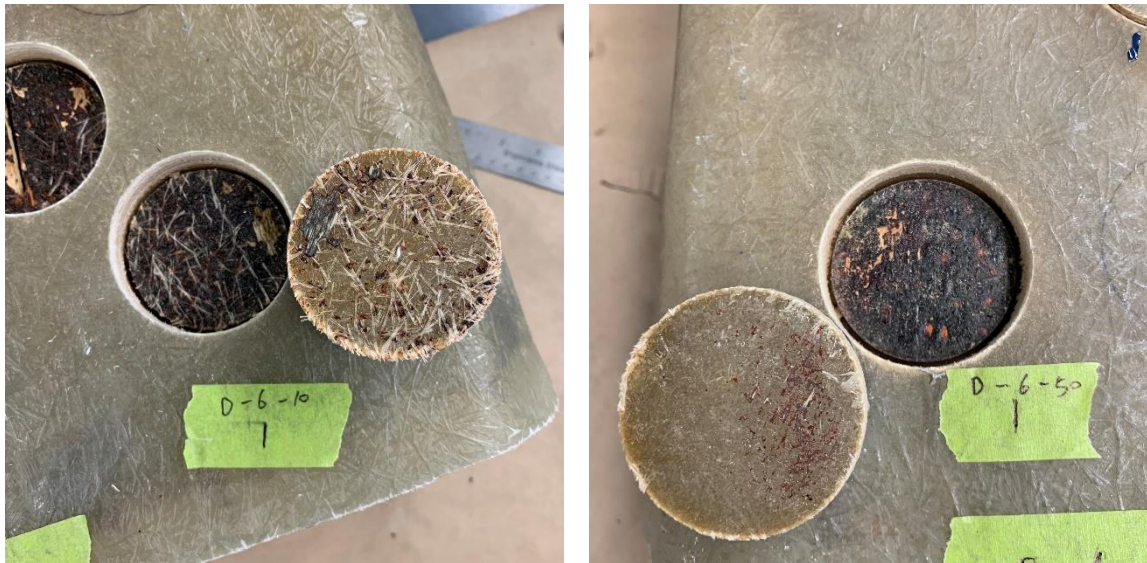
Figure 3.15: Failure mode - PRF samples

Figure 3.15 shows the failure remarks of some PRF samples. All the PRF samples failed between the adhesive and the GFRP coating, which indicates that the bonding between PRF and the sprayed-GFRP composites is too weak. This may also justify the large scatter in the results of those specimens. Therefore, PRF was not considered for use on pole specimens in Phase II.

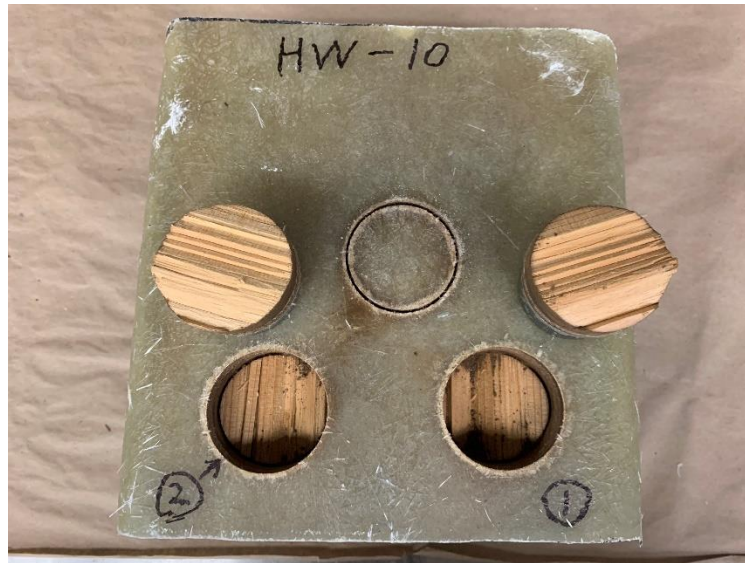
Figure 3.16: Failure mode – HMR sample (H-W-10-0)

Although the bond strengths of the HMR samples were mostly similar to those of the PRF samples, the dominant failure mode for the HMR samples was completely different. All HMR samples failed in wood, as shown in Fig. 3.16, which is a desirable mode of failure. This proved that HMR can be used as a primer when spraying GFRP composites on wood poles.

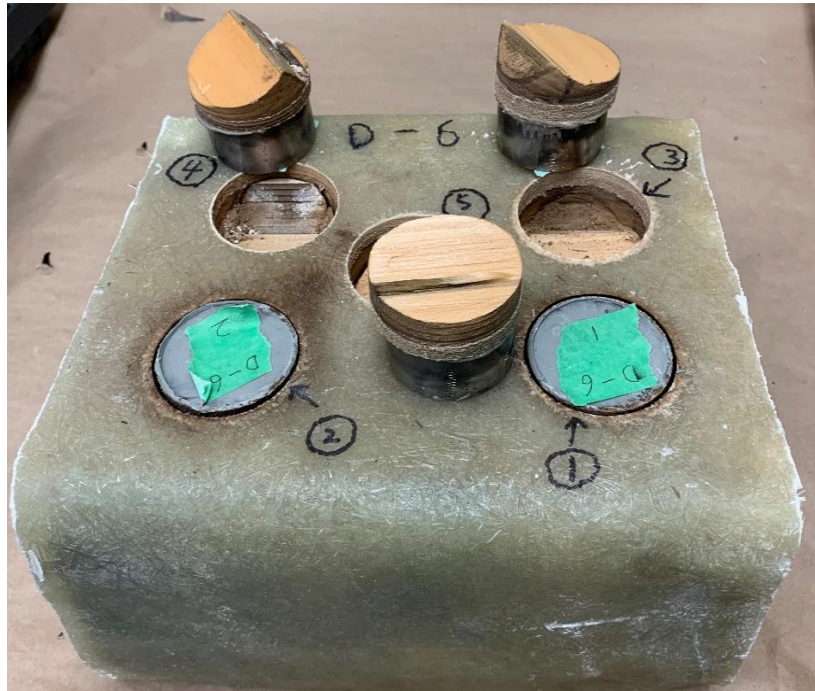
Figure 3.17: Failure mode – sample without adhesive

Since the effects of coating thickness on bond strength are negligible based on the results from PRF samples and HMR samples, lesser original samples were tested. The bond strength was insignificantly affected by specimen conditioning (dry versus wet). The dominant failure mode of all samples without adhesive was the same as the HMR samples, where the samples failed in wood as shown in Figure 3.17. Considering the similar bond strength and failure mode, it was decided, for Phase II of this study, to spray the GFRP composite without priming the pole surface using any type of adhesives.

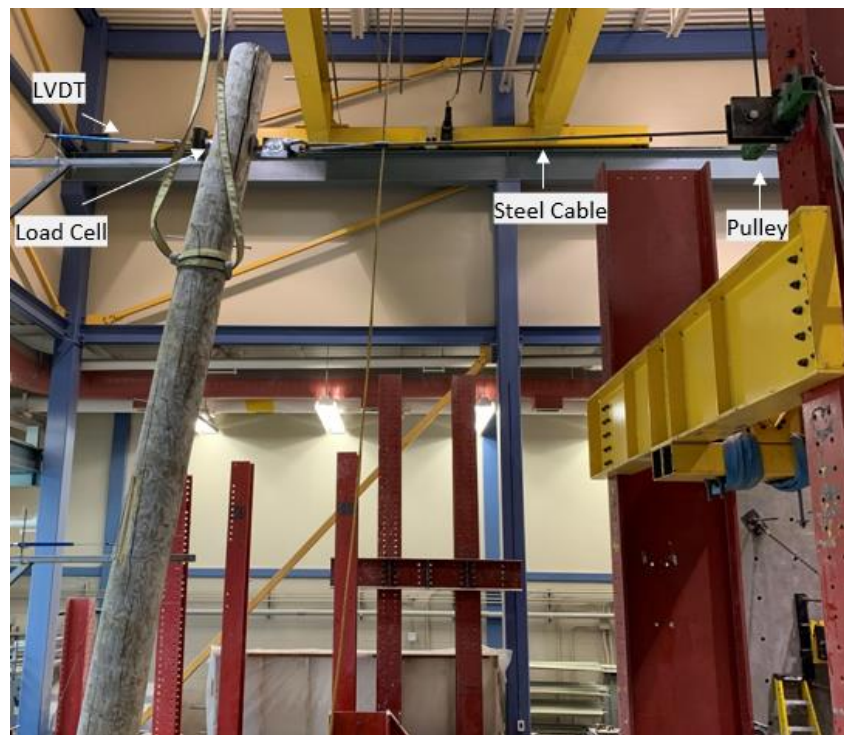
Figure 4.6: Side view of the test setup (top part) during a test

all pole specimens were tested in a vertical position according to the requirements of ASTM D1036–99 (ASTM D1036–99 2017) using the cantilever test method. This was achieved by connecting the loading point of the pole to a crane using a steel cable. A hole was drilled at 610 mm (2.0 ft) from the upper end of each pole and a notch was made around that hole on the tension side of the pole to install the lateral load applying system. The lateral load was applied to the pole using a steel cable, connected to the pole at the loading point from one end and to a 10-tonne capacity overhead crane (moving upward at a constant speed during test) on its other end and passing through a set of pulleys in between. Figure 4.6 shows the side view of the top part of the test setup during a test, and Figure 4.7 shows the test setup schematic.

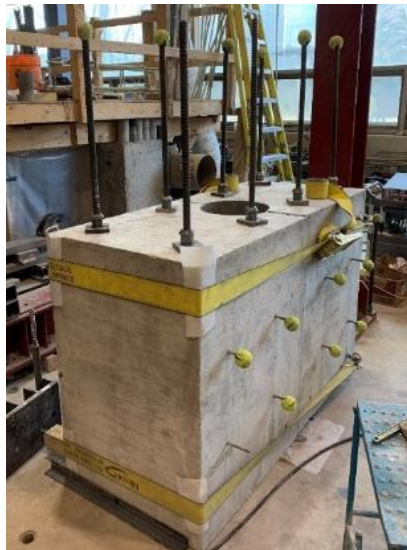
Figure 4.8: Concrete base in the laboratory

concrete (RC) base was used. This RC base comprised of two identical concrete blocks, and each block was cast separately and reinforced with 20M GFRP bars. Each concrete block was  $800 \times 900 \times 1,220$  mm with a semi-cylindrical void on one side, forming a cylindrical void (with a slightly larger diameter than that of the poles) when the two blocks are brought together (Figure 4.8). The void had a 365-mm diameter since a 355 mm (14 in.) Sonotube with a 5 mm wall thickness was used to form the semicylindrical shape during the concrete cast. Concrete was poured into Sonotube before the blocks, to avoid any deformation caused by the concrete pressure while casting the blocks. To provide proper fixity for the RC base, both blocks were tied down to the laboratory strong floor using eight all-threaded high-strength steel bars. Then the pole specimen was placed vertically inside the cylindrical void of the RC base.

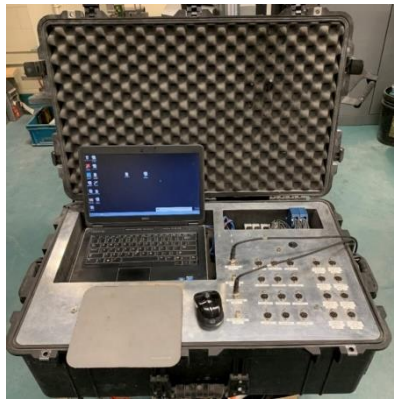
Figure 4.10: Data Acquisition System

To obtain the deflection of the wood poles at the loading point, a linear variable displacement transducer (LVDT) was installed at the height of 6.10 m (20.0 ft) above the laboratory strong floor. In addition, to measure the strains in the NSM-GFRP bars, four electrical strain gauges were installed near the mid-length on the outer surface of each bar as outlined in Figure 4.5 (b). All the aforementioned instrumentation was connected to a computerized Data Acquisition System to collect the measurement data, as shown in Figure 4.10.

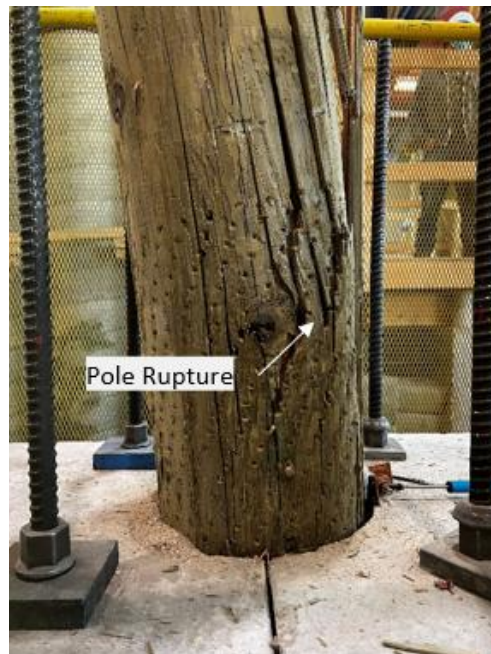
Figure 4.12: Typical failure mode for control poles (pole N-3WC-0-X)
