# **Slope Failure in Cretaceous Clay Shale in Western Manitoba: A Case Study**

**Department of Civil Engineering**

Slope instabilities have been affecting the grade slope of Provincial Trunk Highway 5 near the junction with Provincial Trunk Highway 10 in northwestern Manitoba for over 50 years. In recent years, the instabilities have resulted in significant damage to the highway pavement surface. In 2011, Manitoba Infrastructure and Transportation initiated a geotechnical investigation to gain a better understanding of the failure, identify possible failure mechanisms, and explore various remedial design alternatives in order to stabilize the slope.

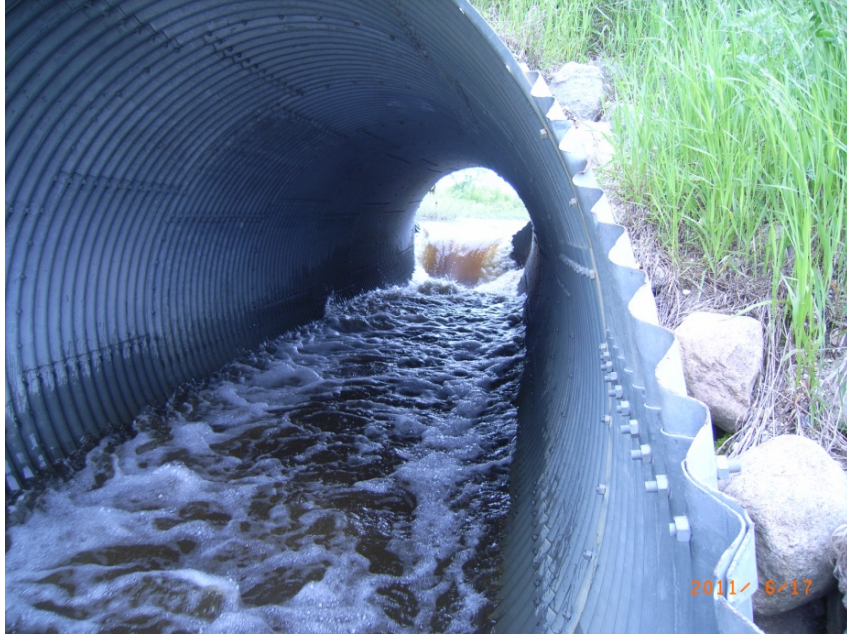
Figure 3.6 – Corrugated Steel Pipe Culvert Crossing Outfitted with Weir During Normal Flow Conditions in June, 2011 (West from outlet)

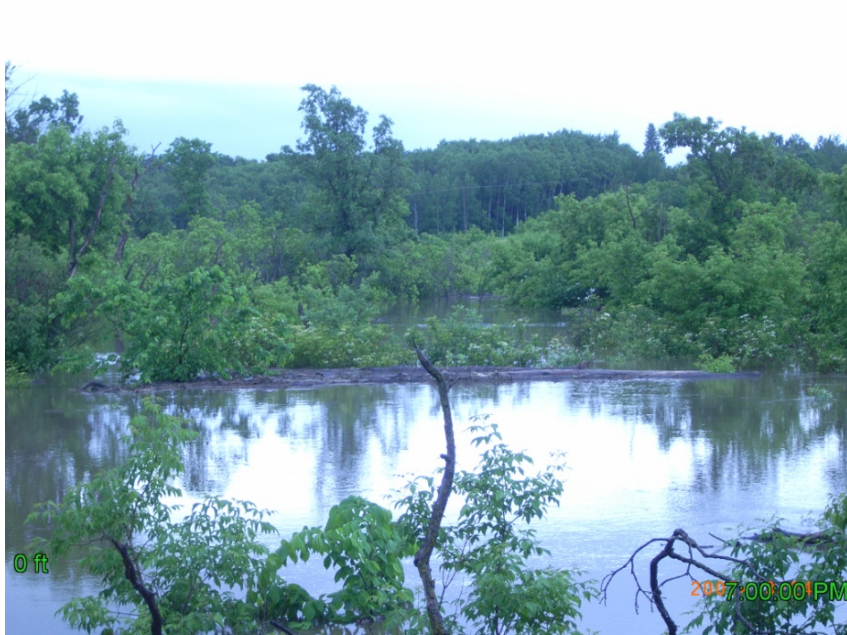
Figure 3.7 – Flooding of Mineral Creek Valley in June, 2013 (Southeast from TH 2011-05)

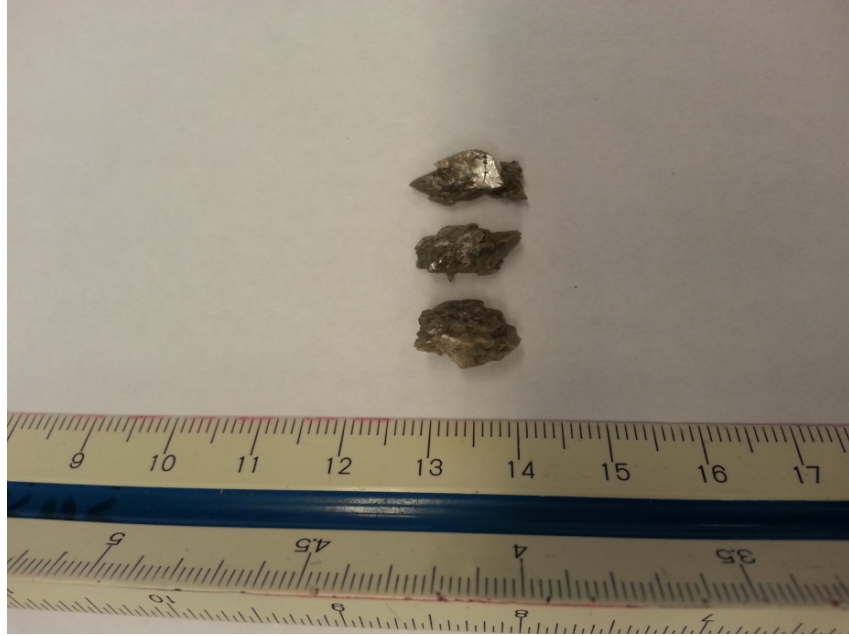
Figure 3.19 – Selenite Crystals Observed in Till-Like Soils

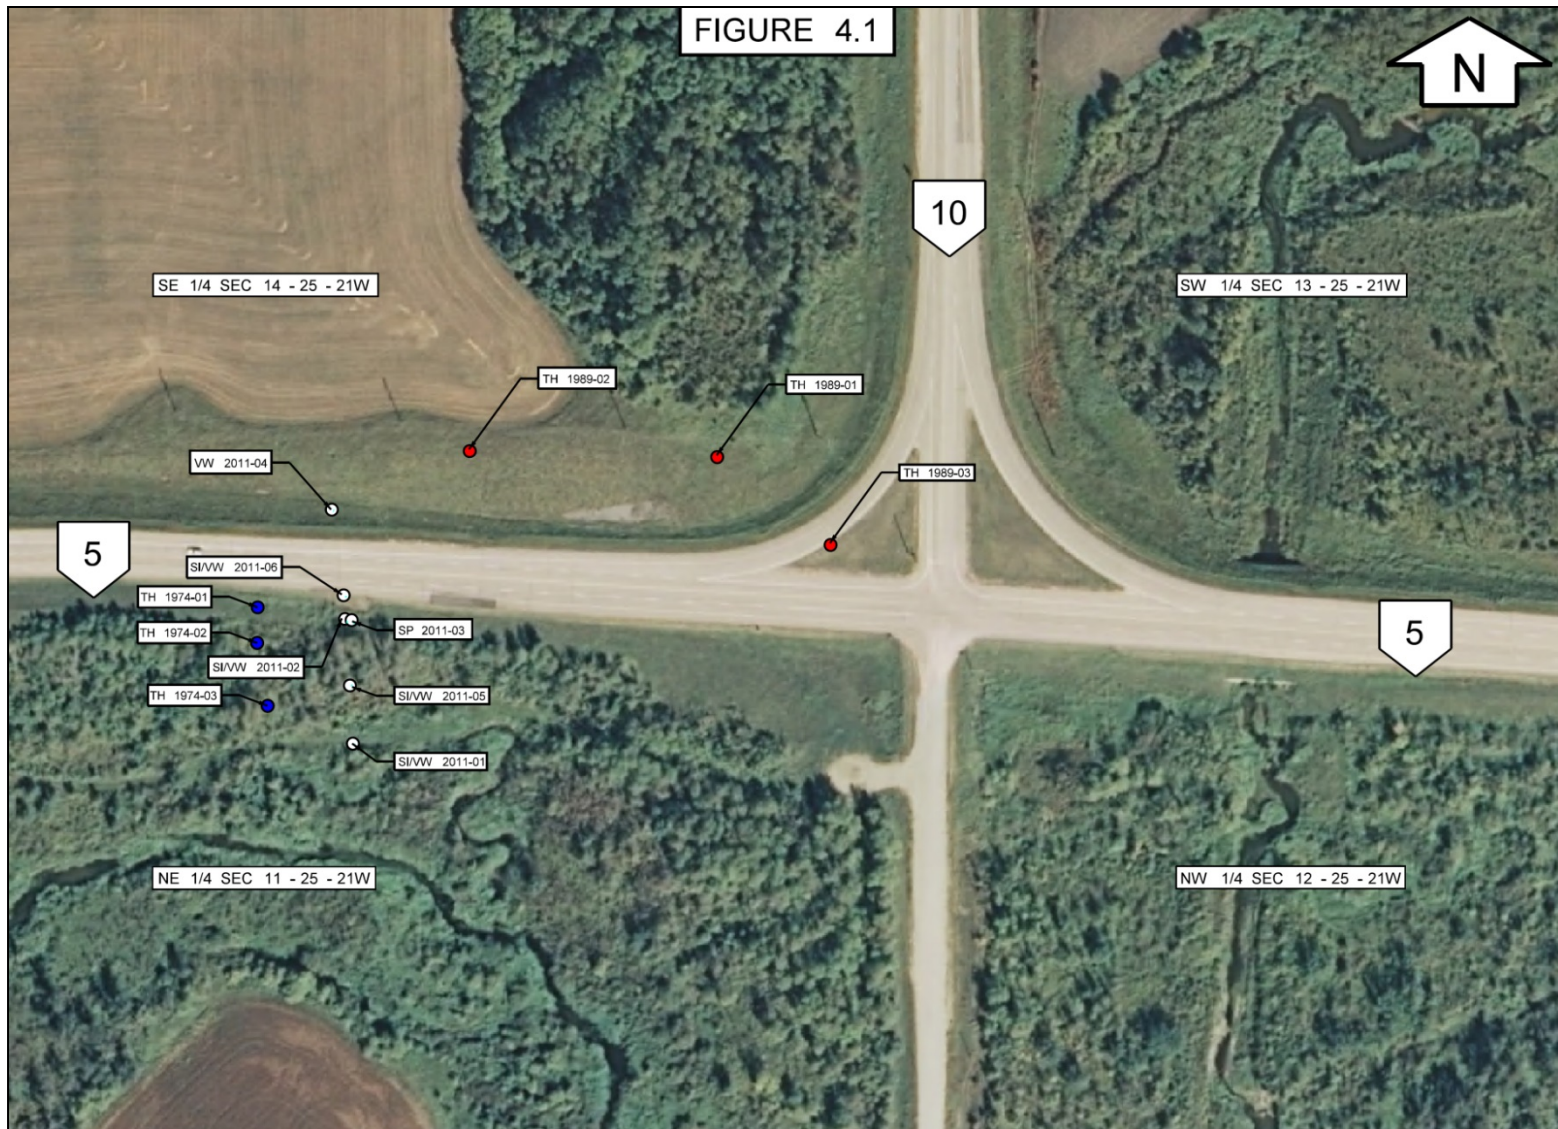
Figure 4.1 – Test Hole and Instrumentation Plan

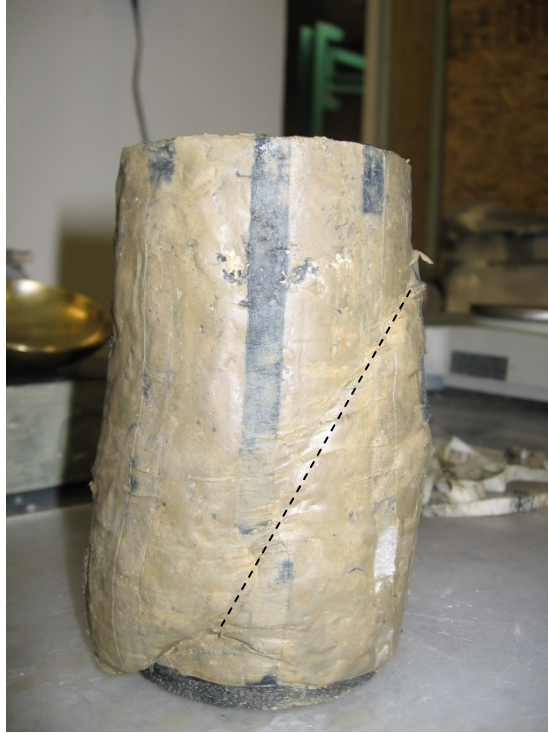
Figure 5.7a – Triaxial Test Failure Surface, Sample T7

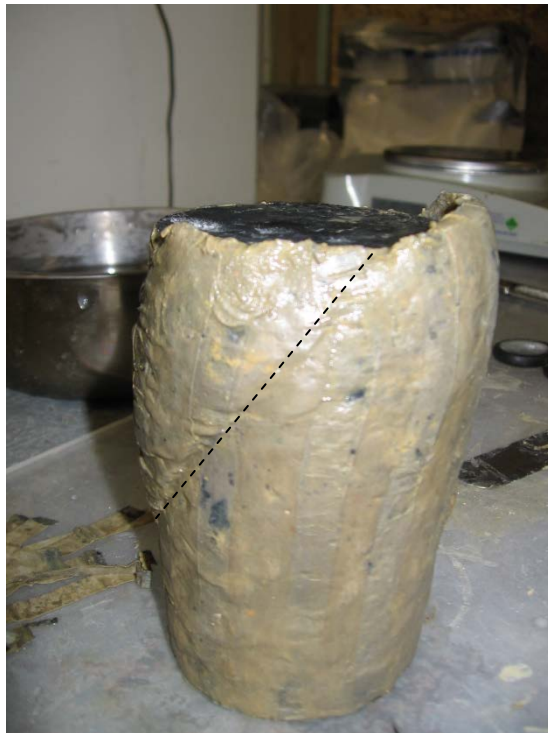
Figure 5.7b – Triaxial Test Failure Surface, Sample T8

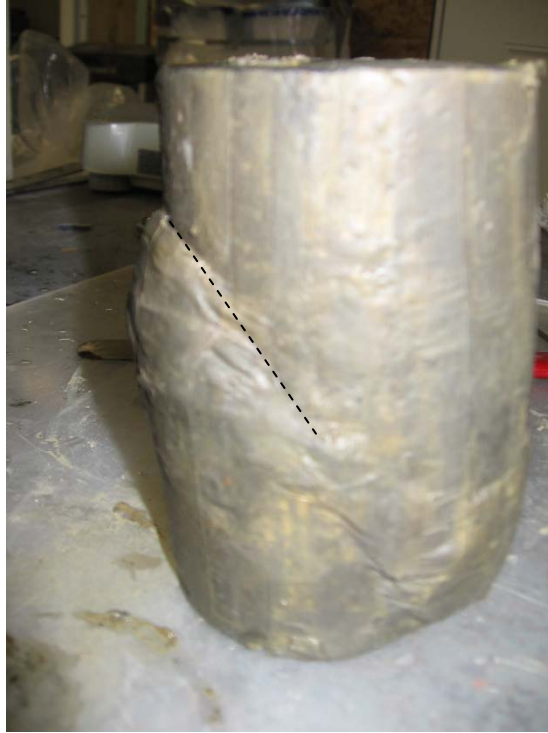
Figure 5.7c – Triaxial Test Failure Surface, Sample T9

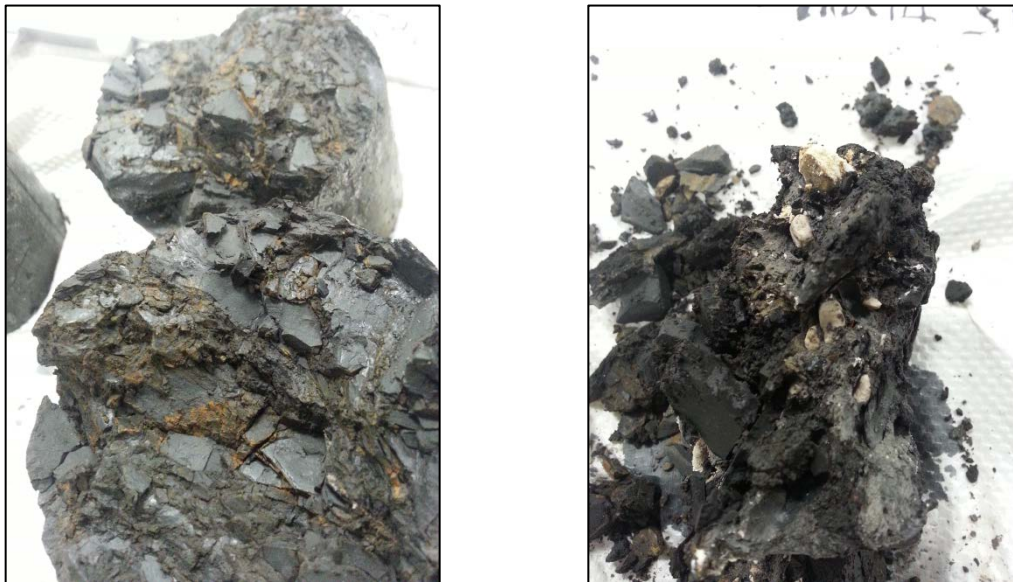
Figure 7.4a (left) – Weathered, Fractured Clay Shale; Figure 7.4b (right) – Gravel Sized Limestone Fragments (TH2011-06, Sample T11)
