# **Durability of Superficially Treated Concrete to Ammonium Sulfate and Sulfuric Acid Solutions Combined with Cyclic Environments**

A Thesis submitted to the Faculty of Graduate Studies of

The University of Manitoba

Department of Civil Engineering

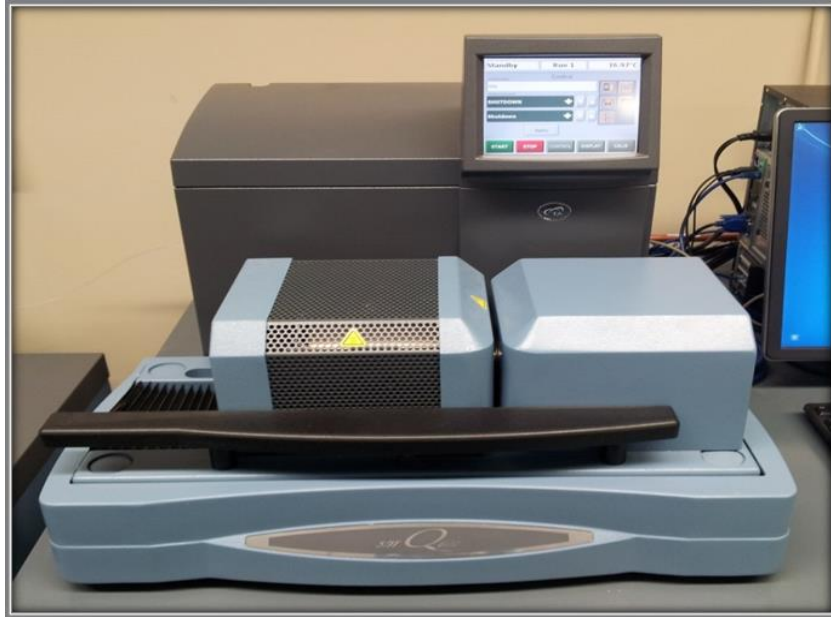
**Figure 3. 1:** DSC instrument by which the thermal analysis was conducted.

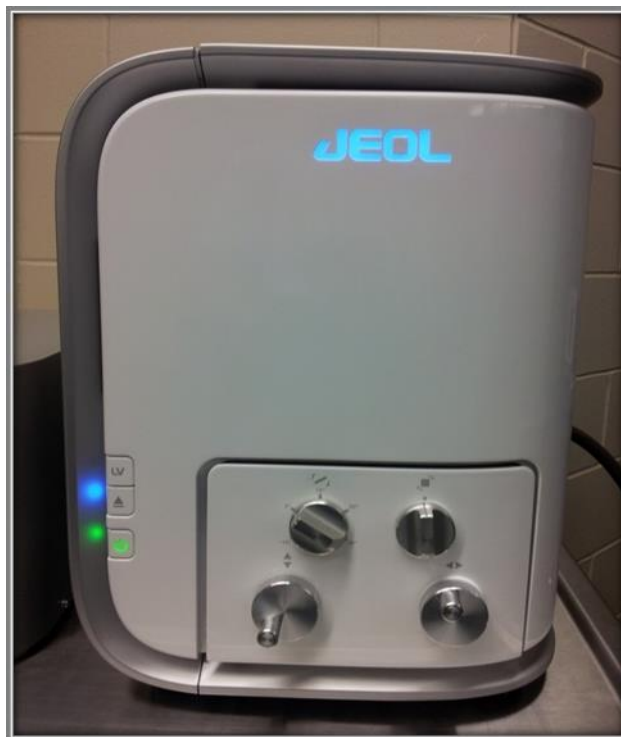
**Figure 3. 2:** SEM chamber where the fracture specimens were mounted for observation.

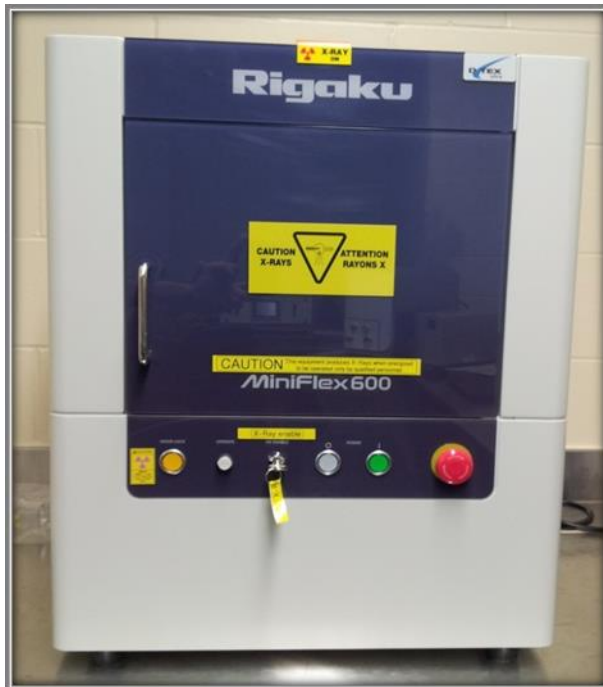
**Figure 3. 3:** XRD instrument by which the mineralogical analysis was conducted.

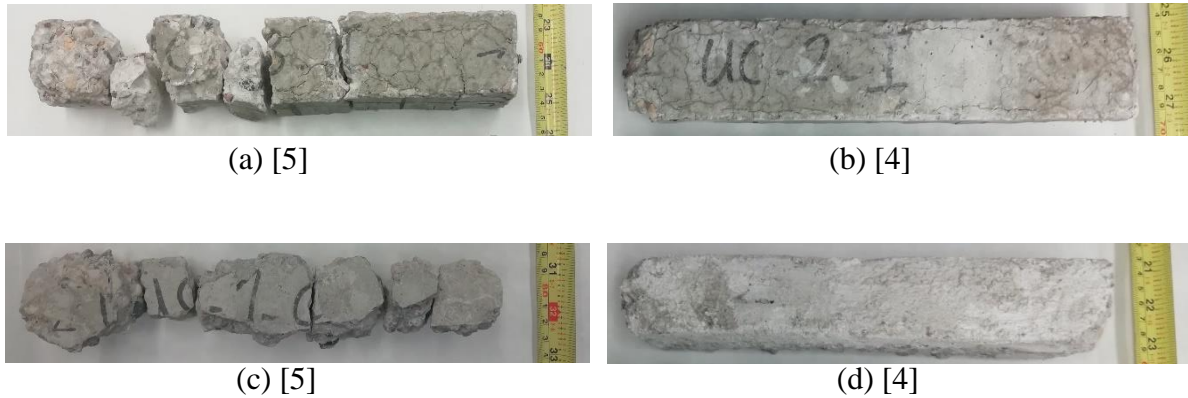
**Figure 4. 4.** Examples of uncoated **concrete** specimens: (a) UC- $w/b$  0.6-full immersion exposure, (b) UC- $w/b$  0.4-full immersion exposure, (c) UC- $w/b$  0.6-combined exposure, and (d) UC- $w/b=0.4$  combined exposure. (Note: numbers between brackets represent the final visual rating).

After 120 days of exposure to 5% ammonium sulfate solution, concrete specimens experienced noticeable features of deterioration such as softening, cracking, and disintegration, depending on the  $w/b$  and type of coatings. Under both exposures, uncoated concrete specimens (UC) with a  $w/b$  of 0.6 were totally disintegrated (visual rating of 5), while concrete with a  $w/b$  of 0.4 (visual rating of 4) experienced swelling and map cracking without breakage of the specimens after 120 days (e.g., **Fig. 4.4**).

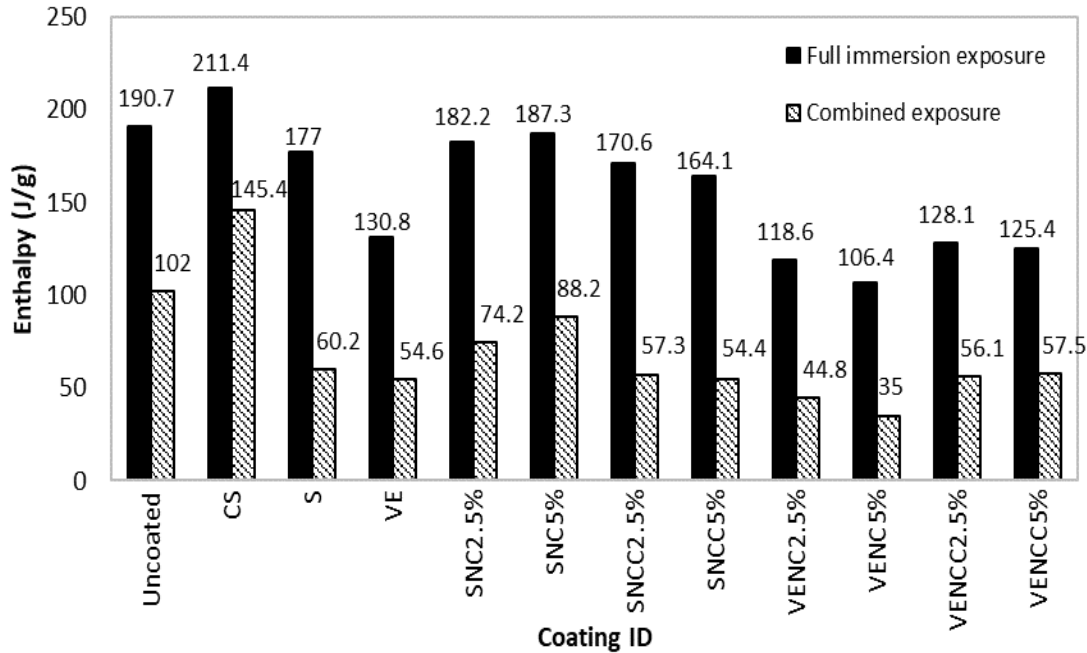
**Figure 4. 7.** Enthalpy of gypsum (dehydration range of 120-135°C) in uncoated and coated specimens (*w/b* of 0.6) after 120 days in full immersion and combined exposures. (Note: accuracy of enthalpy determination is  $\pm 3\%$ ).

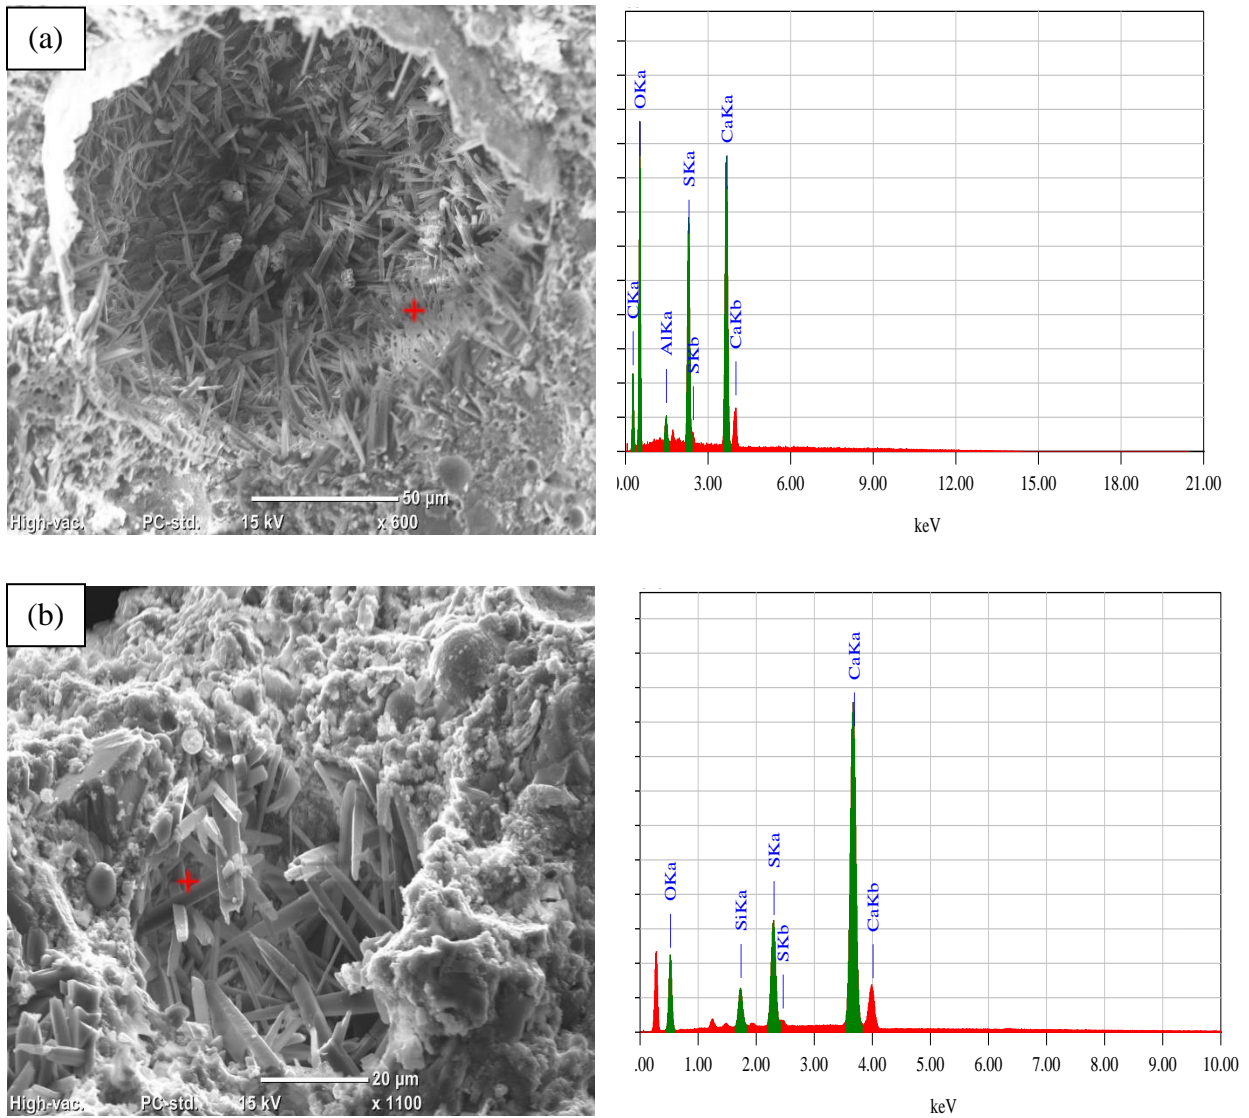
**Figure 4.11.** Uncoated concrete specimens ( $w/b$  of 0.6) after the combined exposure: (a) ettringite clusters filling an air void with associated EDX, and (b) incidental thaumasite formation with EDX.

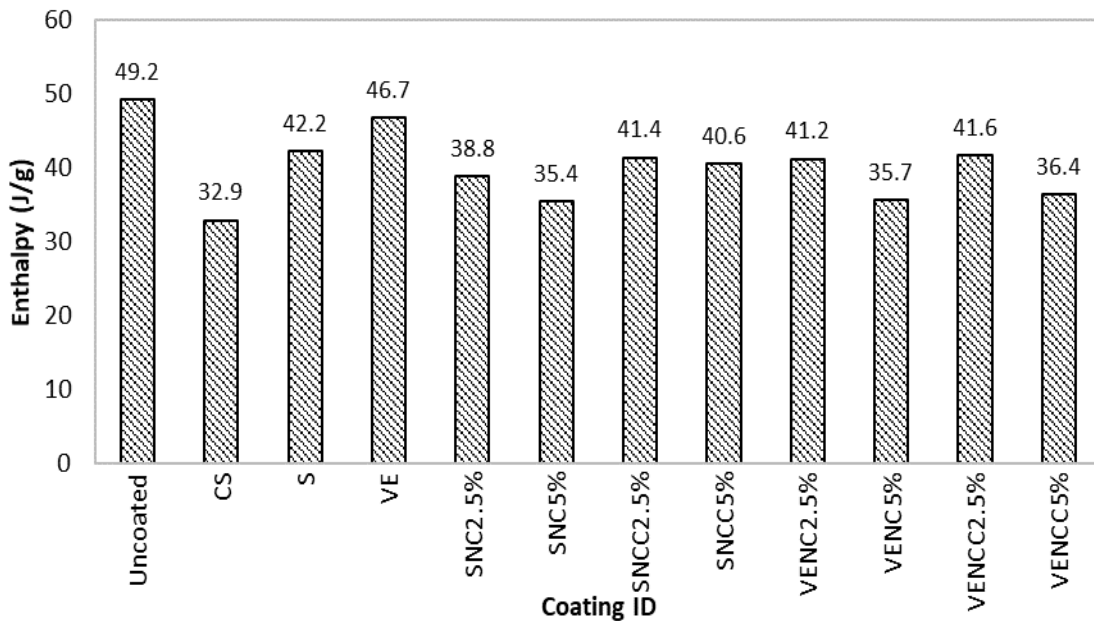
**Figure 4. 13.** Enthalpy of portlandite (dehydration range of 400-450°C) in uncoated and coated specimens ( $w/b$  of 0.6) after 56 days of curing. (Note: accuracy of enthalpy determination is  $\pm 3\%$ ).

relative to that of uncoated specimens (**Fig. 4.13**). However, these processes did not adequately protect the concrete surface from the ammonium sulfate exposures.

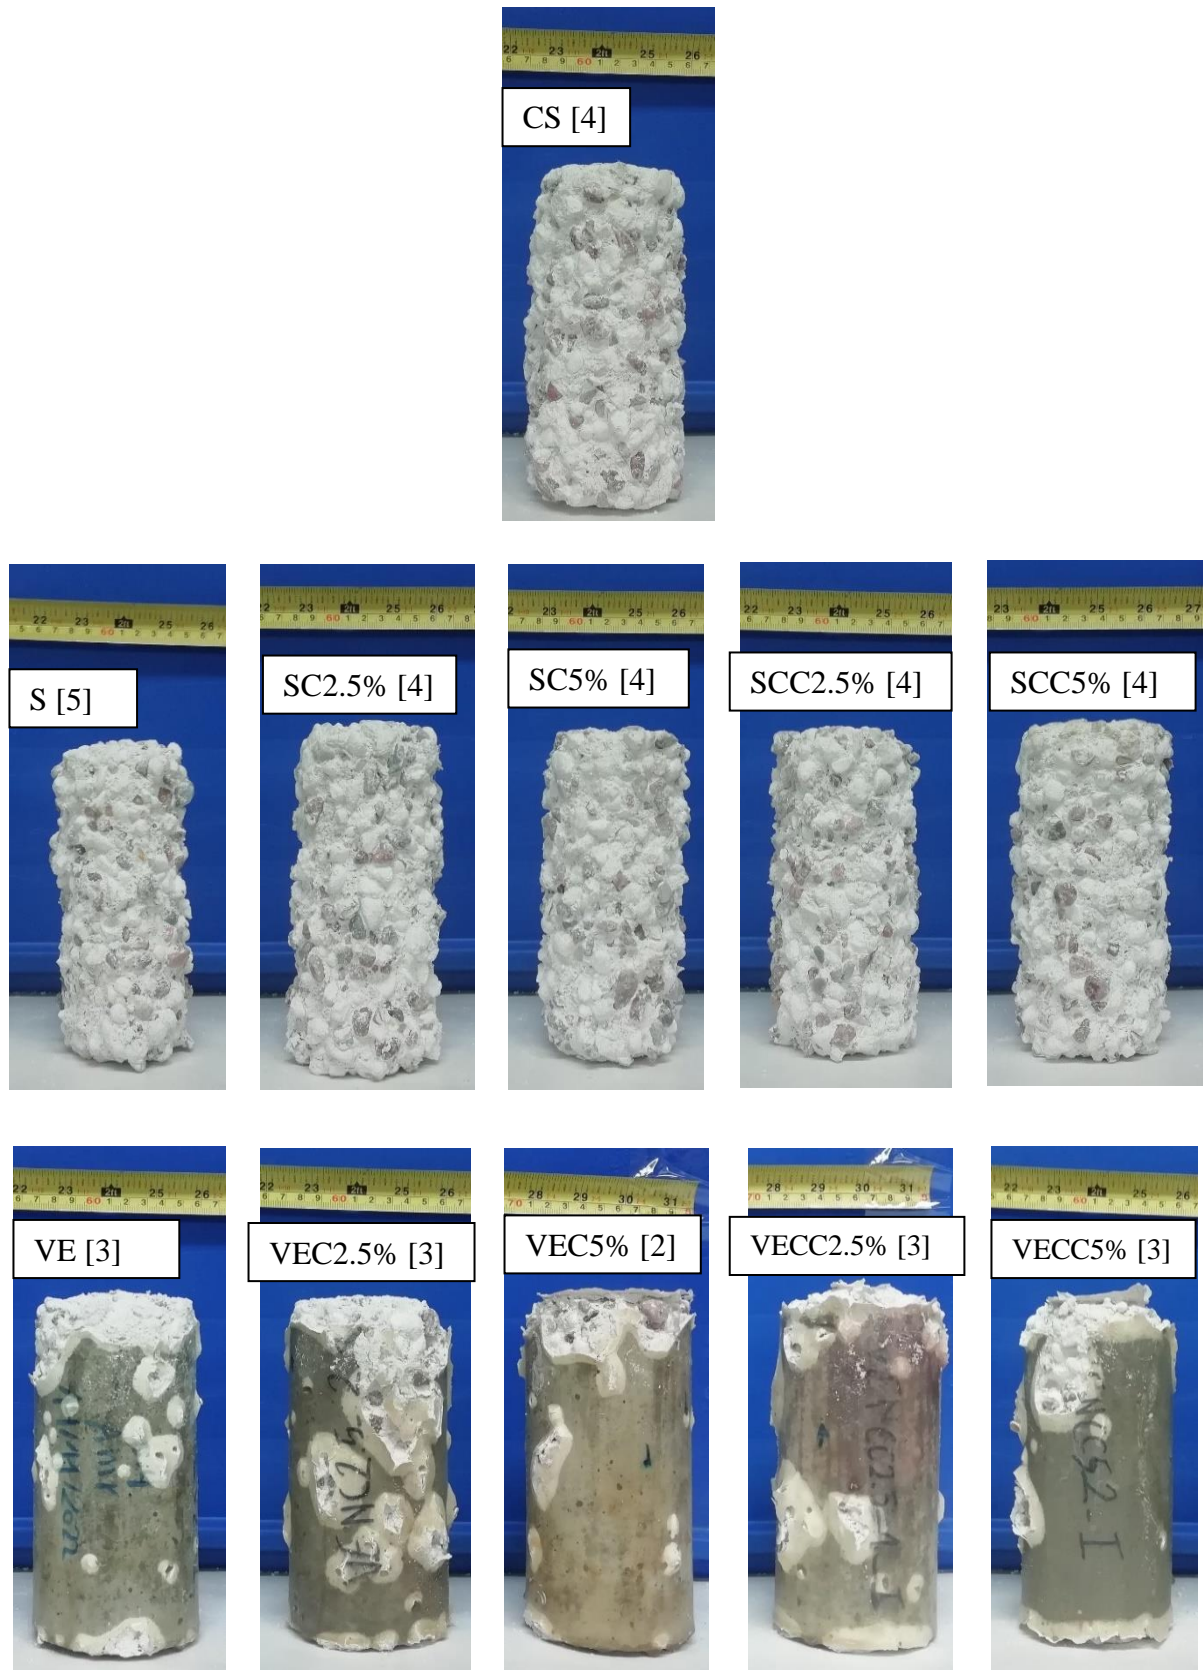
**Figure 5. 2.** Examples of coated concrete specimens (GU-FA0.4) after 10 weeks in the full immersion exposure. (Note: numbers between brackets represent the final visual rating).

concrete specimens coated with colloidal silica experienced softening and intensive surface loss (visual ratings of 4 and 3) under both exposures [e.g., **Fig. 5.2**].

Under both exposures, concrete specimens coated with silane experienced surface softening and notable surface loss of the entire specimens (**Figs. 5.2 and 5.3**). Overall, the neat silane and nano-modified silane coatings showed comparable performance with visual ratings between 3 and 5. Comparatively, concrete specimens coated with neat or nano-modified vinyl ester had the best performance under both exposures maintaining large areas of intact coating (visual ratings of 2 to 3) [**Figs. 5.2 and 5.3**]. They only experienced localized peeling towards the ends and at some spots combined with surface loss, which was also observed for the nano-modified vinyl ester composites. However, the visual assessment could not decisively distinguish the level of preservation among specimens coated with different coatings, and other evaluation parameters (mass change) are thus needed.

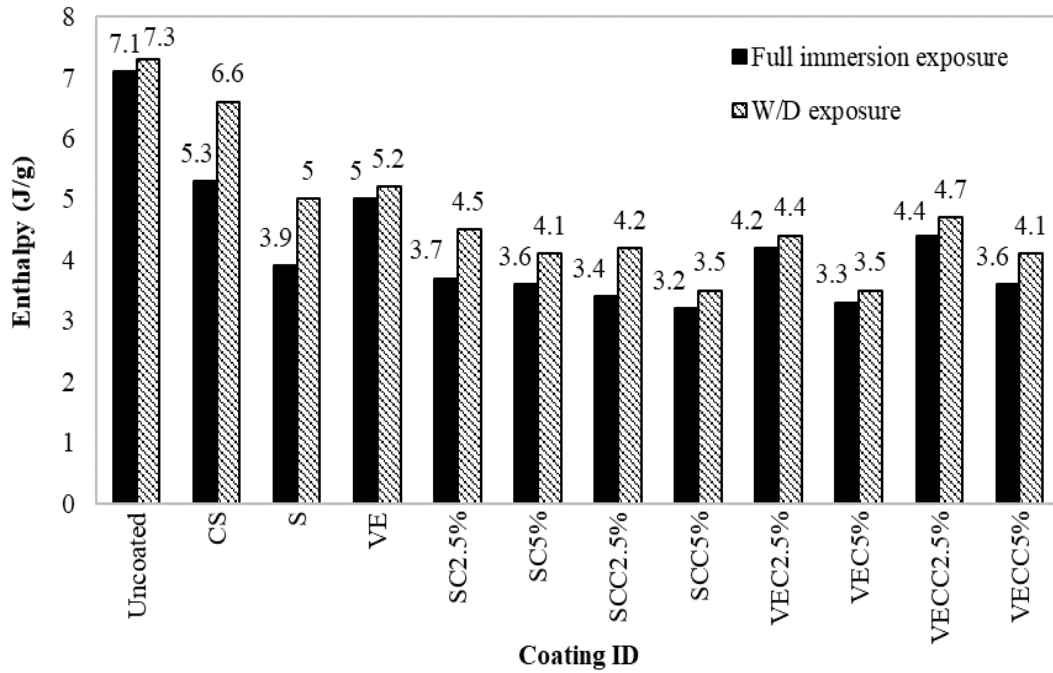
**Figure 5. 10.** Enthalpy of ettringite (dehydration peak at 90°C) in uncoated and coated specimens (*w/b* of 0.4) after 10 weeks in full immersion and W/D exposures. (Note: accuracy of enthalpy determination is  $\pm 3\%$ )
